The Matas "barn", Robin Plantation (16SL66), St. Landry Parish, Louisiana-history and archaeology of a nineteenth century milk house

**THE MATAS “BARN,” ROBIN PLANTATION (16SL66),
ST. LANDRY PARISH, LOUISIANA—
HISTORY AND ARCHAEOLOGY OF A
NINETEENTH CENTURY MILK HOUSE**

A Thesis

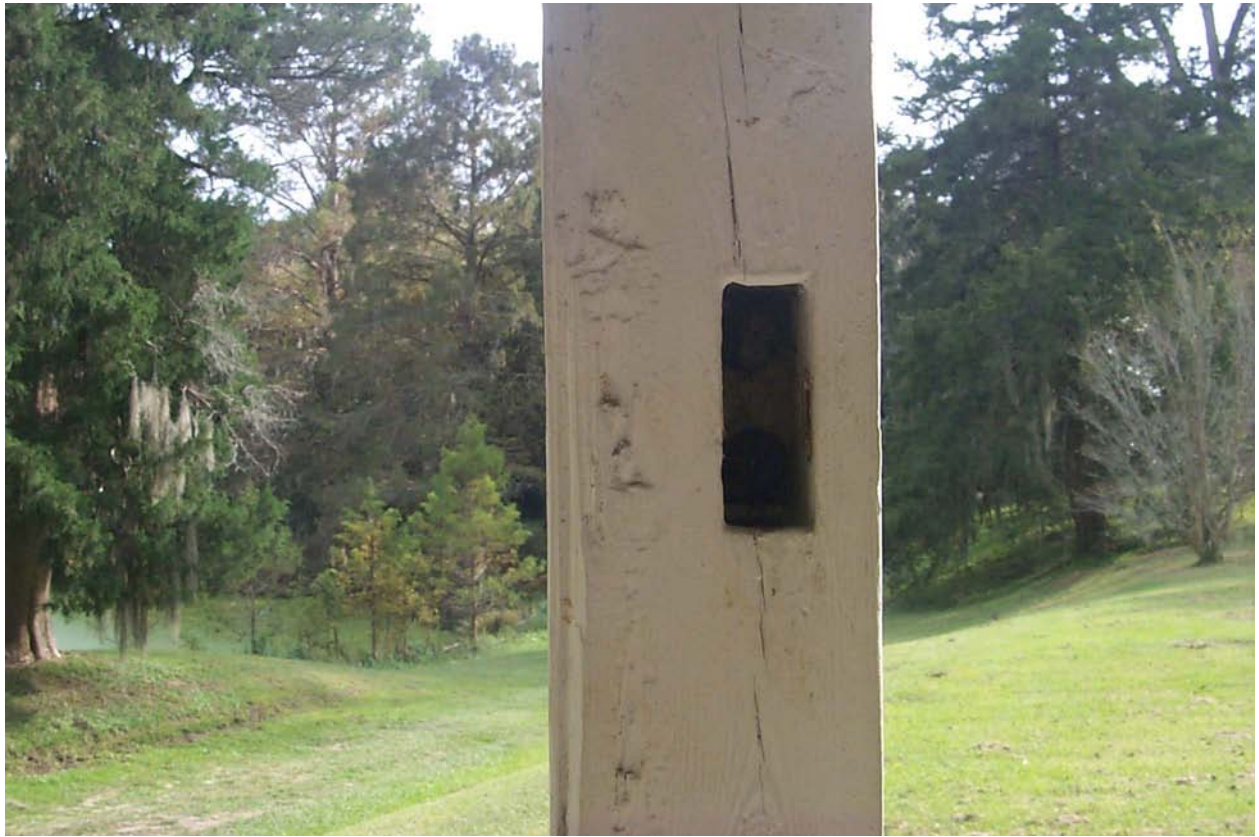
Figure 5.41. Some of the uprights supporting the roof of the Rosedown Milk House were reused from another structure. Note the mortise in this upright.

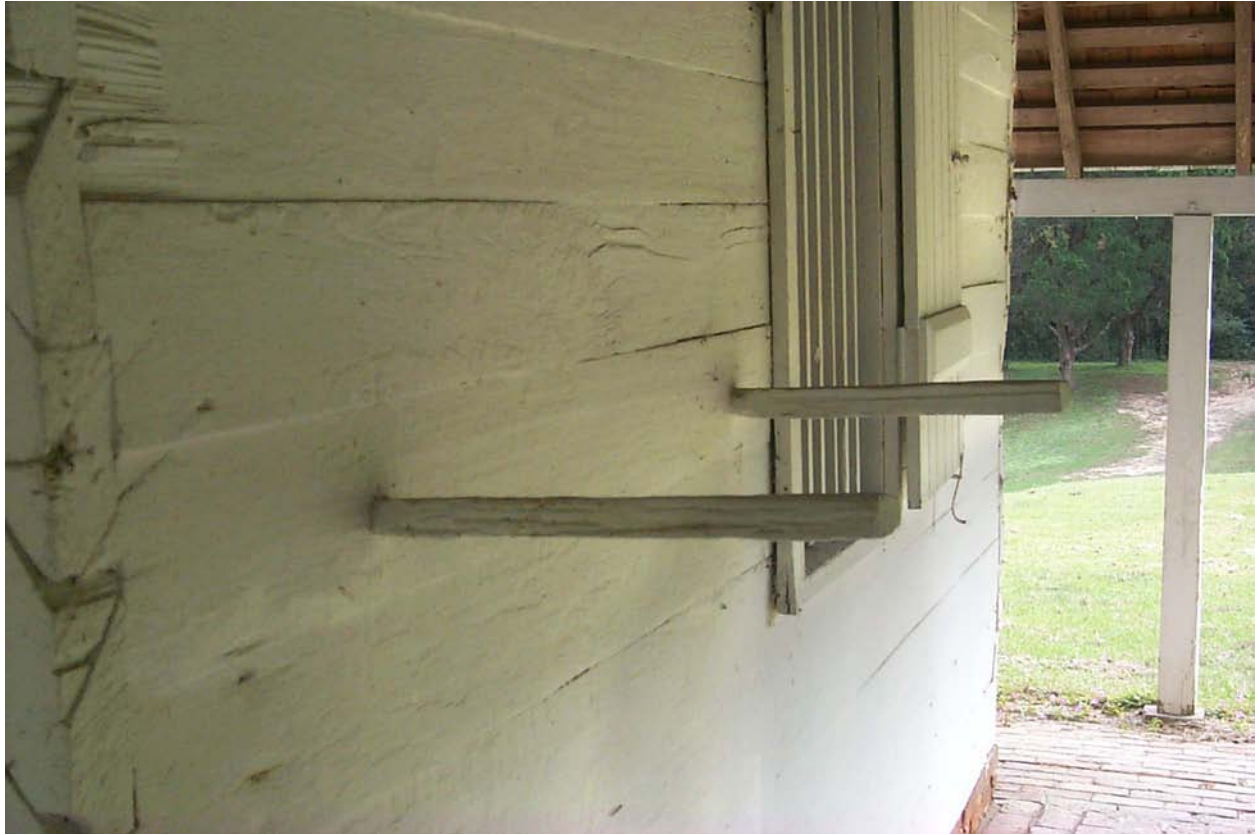
Figure 5.42. These long pegs once held a shelf.

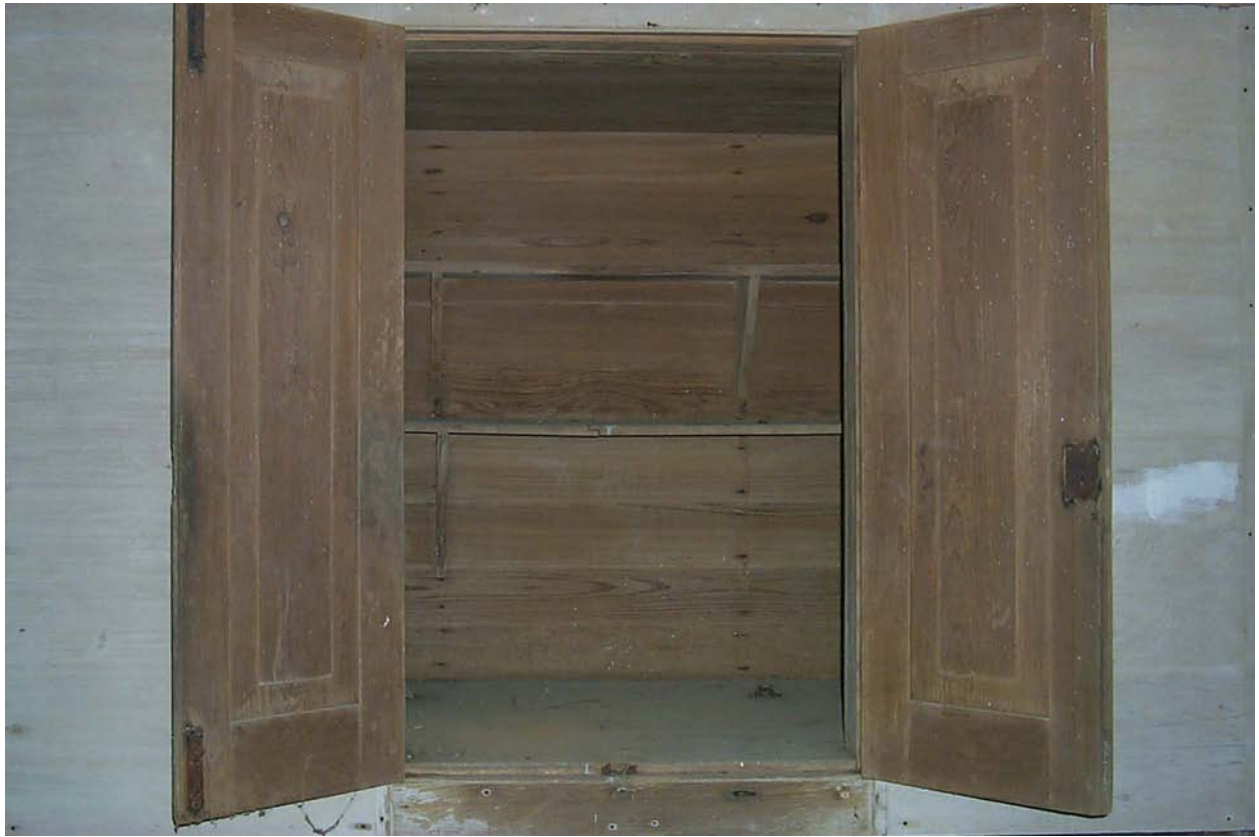
Figure 5.43. This finely made cabinet is located inside the milk house. It was once used to store milk products such as butter and cheese and eggs.
