## **Physical and Mechanical Properties of Historic Building Materials: Towards Documentation and Conservation of Qusayr Amra in Jordan**

The current study investigates the chemical and physical properties of the stone building material used in Qusayr Amra, one of the UNESCO World Heritage Sites in Jordan. The chemical weathering impact of salt crystallization on these stones was evaluated with the goal of improving conservation efforts. Thermodynamic data from the tested samples using Runsalt software showed that Halite, Sylvite and Calcium Nitrate were the main potential soluble salts. High resolution 3D models and scans were produced using laser scanning in order to provide reference data and improve monitoring of the changes that affect the building. The results of this research point to the possibility of reducing the problems in the building by changing the current environmental conditions around the building and thus mitigating the major deterioration factor in this site due to the crystallization and distribution of salt.

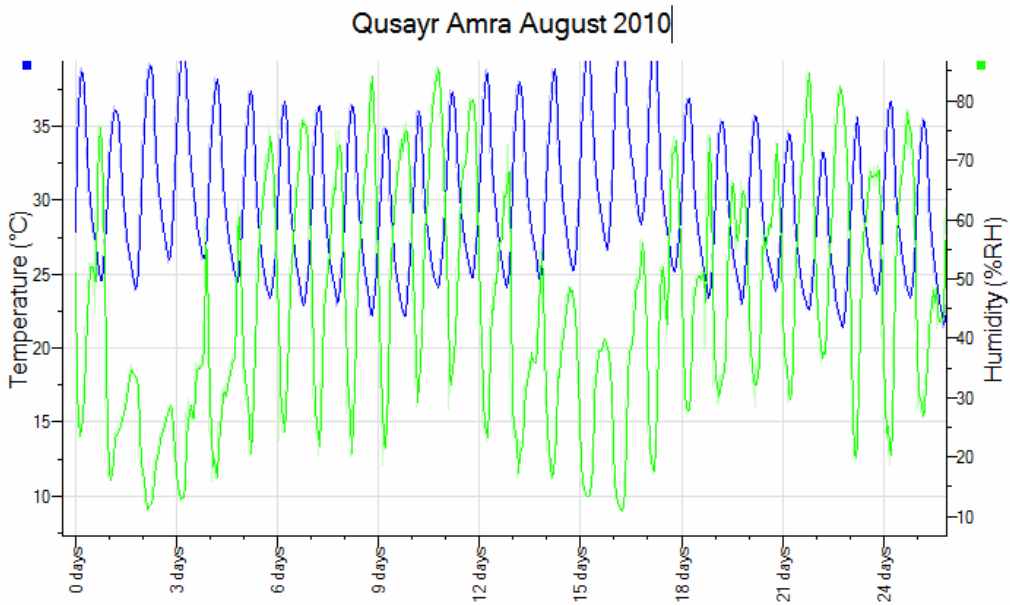
**Figure 5. Relative humidity and temperature readings from the data logger. Location: Qusayr Amra. (Recorded period 1-30 August 2010).**

The Runsalt program requires the input of three types of data: cation and anion content with the average of one environmental parameter (temperature or relative humidity) and the range of fluctuation of the other parameter (temperature or relative humidity). The literature review of the Runsalt applications showed that temperature did not significantly affect the behavior of the salt solution, while relative humidity had the greatest impact. Therefore, the current research used Runsalt with the average temperature of each sampling period as the fixed parameter and with the entire available range of relative humidity (15-98%). The overall temperature for the first fieldwork visit was 30° C.

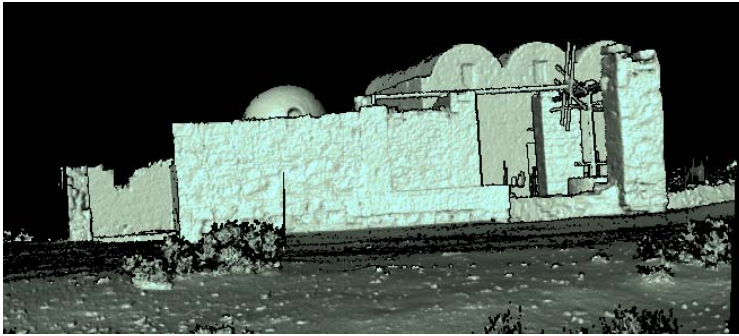
**Figure 7. 3D Models of Qusayr Amra, showing views of the four sides**

In order to select the best method of treatment, several tests were performed on the main stone structural material. A series of experiments were conducted and studied with petrographic methods. These analytical methods, techniques and experimental studies consist of an evaluation of the porosity of the limestone, an open porosity test, a water absorption test, X-Ray fluorescence (XRF), a wetting and drying test and an examination of the soluble salt content. A 3D laser scanning system GS100, manufactured by Mensi S.A., France was used, shown in Figure 6. Different high-resolution images of the damaged areas were collected using a Canon 400D portable calibrated camera, which provides a resolution of 3888x2592 pixels with a focal length of 20 mm. These images were taken at different times (25/11/2008 and 31/8/2009), depicted in Figure 5, and were used to generate a true orthophoto. The 3D model of Qusayr Amra and the wall under study are depicted in Figure 7. The model has an average resolution of two cm.

In addition to the physical and chemical analysis, data about the spatial distribution and texture of the damage on the building surface are needed in order to provide reference data and guide the needed restoration and also for monitoring purposes. To achieve this goal data from laser scanning and digital imagery was combined. In this project, a laser scanner is used in order to collect thousands of 3D points every second at high levels of accuracy and to precisely digitize complicated objects. The 3D laser scanning system GS100, manufactured by Mensi S.A., France was applied; the instrument is depicted in Figure 6. The system is able to measure 5000 points per second. Because it is not possible to have complete 3D coverage for outdoor complex-structured sites based on data collected from a single station, different viewpoints have to be used to resolve the occlusion, as depicted in Figure 7.

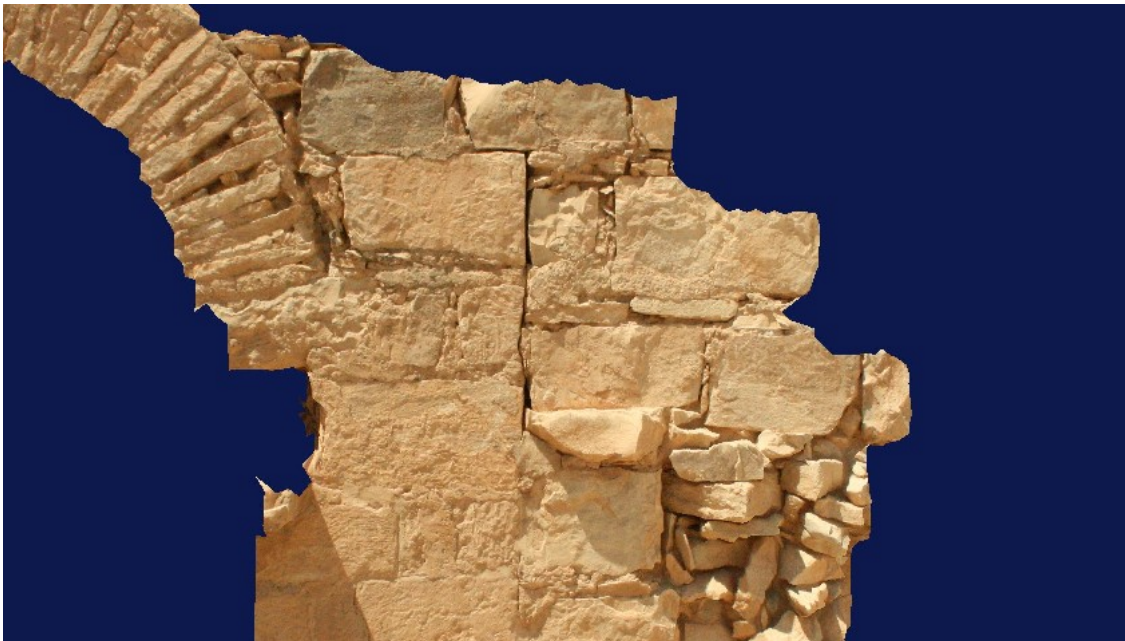
**Figure 9. Textured model (using close detailed high resolution images)**

For this reason, additional images were collected with the Canon 400D camera, which provides a resolution of 3888x2592 pixels with a focal length of 20 mm. These images depicted in the bottom row of Figure 7 were collected at almost the same time and have more texture details, as can be depicted in Figure 9.

By contrast, the proposed method for mapping high resolution digital images onto the measurements gives a highly realistic appearance to the model and offers a descriptive view of the scene that can be used for measuring and monitoring, as depicted in Figure 8.
