مجموعة معمارية لمبنى بالقاسمية: نحو فهم وإعادة تفسير لمنشآته المميزة
د. نشوه محمد سليمان

A Building Complex at Qasimīya¹
'Towards a Perception & a Reinterpretation of Its Characterizing Structures'

Nashwa M. S. Solieman

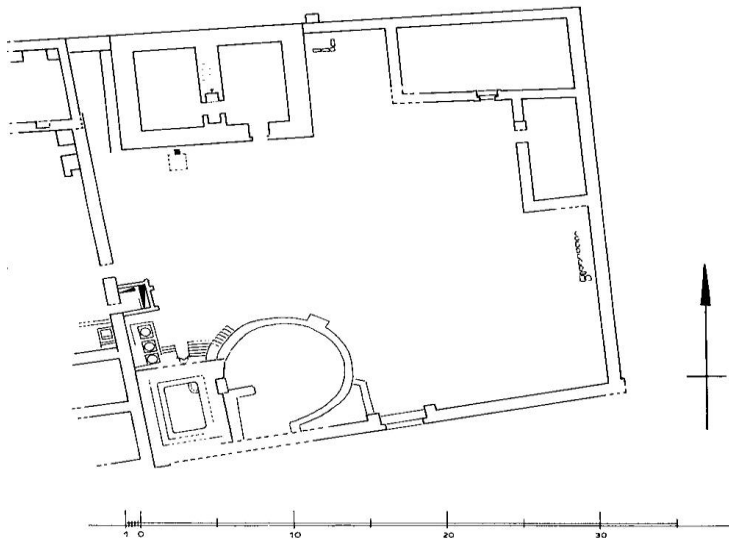
Fig.1: The Early Byzantine Tower House Complex
Surveyed and drawn by P. Grossman

This suburban complex covers a roughly rectangular plot ca. 1110m². It is clearly demonstrated by the thickness of its double walls built of large dressed blocks of hard limestone quarried locally and bonded in clay mortar with occasional use of lime mortar. The main access to the complex is made by a wide entrance – about 2.45m – that lies approximately in the middle of the southern wall and leads directly to the central court. The doorway opens directly on to a street that is running east west direction adjacent to the southern wall of the complex. Very remarkable are

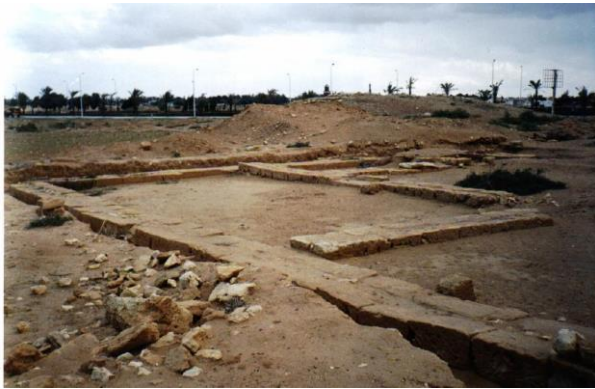
Fig.2: Layout of the rooms' walls from the northern side

The interior space is arranged around the central courtyard in an organization distinctly divided into residential units to the north and east sides of the court and working space at its southwest corner. The layout of the thickened walls delineates two spacious rooms at the northeast corner directly accessed from the court [fig.2].

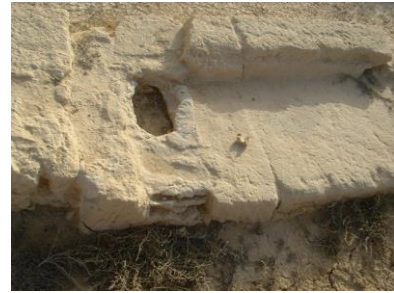
Fig.3
Northern room doorsill

Stone remains of a probable podium may point to a third room adjacent to the eastern one. The doorway of the northern room has a square cavity in the right side of its doorsill as socket marking the existence of a hinged door [fig.3]. The rooms function is unclear as they lack any finds through which one would establish their use, albeit their simplicity preponderate being utilitarian.

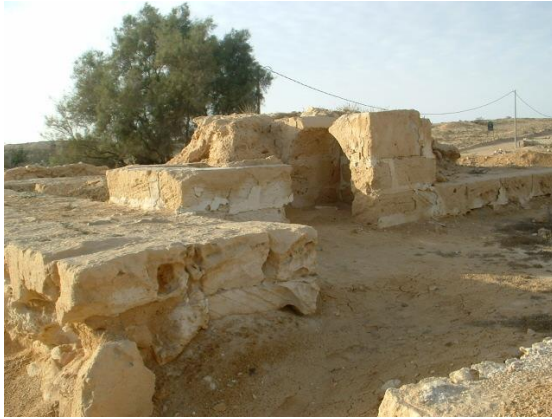
Fig.4 The tower's ground floor
A square bolt-hole in the door-jamb is remarkable

Further to the west there is a solid construction, which is the focus of the residential wing. It consists of two parallel rooms, the eastern of which is directly entered from the court. Its entrance still preserves a bolt-hole cut onto the thickness of the western door jamb indicating that the recess had featured a door or shutter [fig.4].

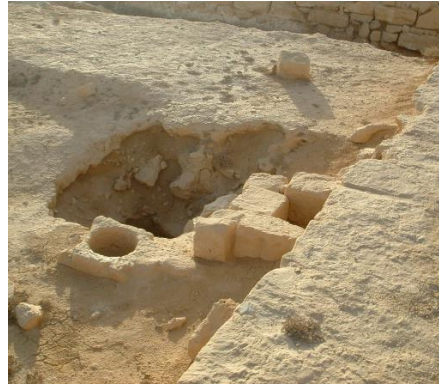
Fig.5 Remains of latrine installations at the foot of the tower

It is, however, by no means clear that the presence of the aforementioned drainage facility at the foot of the tower would normally be for the latrine of the house placed somewhere in one of the upper floors above the western room. The Remains preserved consists of two vertical drains leading to the sewer; the first was square and embedded in the wall, the other was smaller circular and located a bit further to the south. It is assumed that the larger of these pipes are for sewage and the smaller ones for waste water. The sewer is an underground catchment chamber with a gabled roof and it is provided with steps in the sidewalls used when performing cleaning tasks.^١

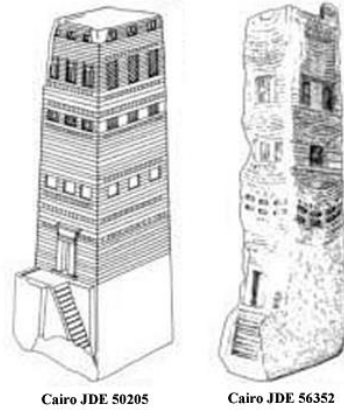
Fig.6 Models of tower houses after Engelbach, R., ASAE 31 (1931),129, fig.3, pl. III

The sturdy feature of this construction preponderates that it might have represented the ground floor of a tower-like structure,¹ which might recall the two lime stone models of tower houses, in the Egyptian museum [fig.6], dated to the Greco-Roman period. Both models have been designed so that the ground floor could become a basement.²

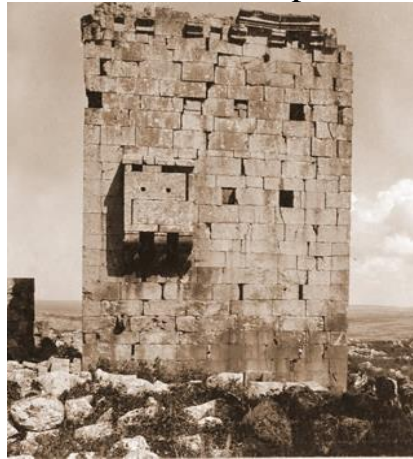
Fig.7
Tower house of Serdjibleh
Syrian Countryside
5th - 6th century AD

Further interesting parallels would be perceived at a variety of structures still stand to full height in the northern and central Syrian Countryside, mostly belong between the 4th and 6th centuries. At times free standing as separate residential buildings, towers were more often built integrally in association with residential farm-houses, adding a distinctive social as well as defensive accent to the household.^٢ Comparable to Syrian counterparts the residential upper stories frequently feature large windows and a small corbelled structure on the wall. The latter forms the house latrine equipped with holes in its stone floor slabs and a door that separated it from the room or corridor [fig. 7].

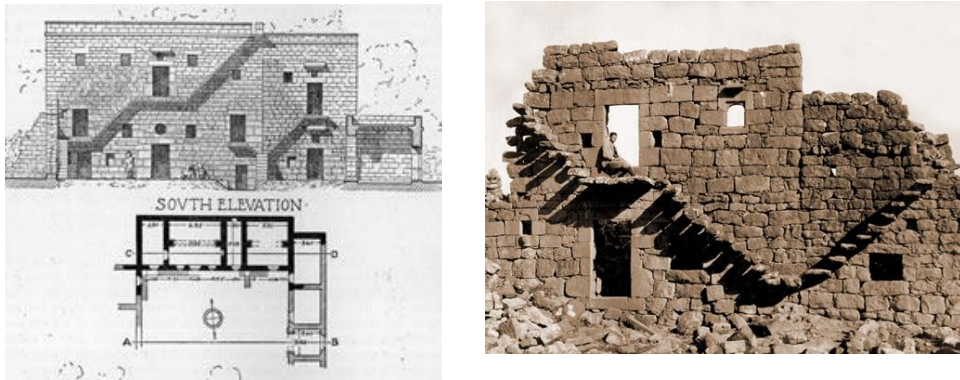
Fig.8: External stairs, Umm Igimal at Syrian country side
(left: house III) (right: house I)

Another piece of evidence would be approached through several Syrian houses mentioned above, where different stories are accessible via external stairs. Each step is made of a single piece of stone, embedded into the wall as a bracket [fig.8].

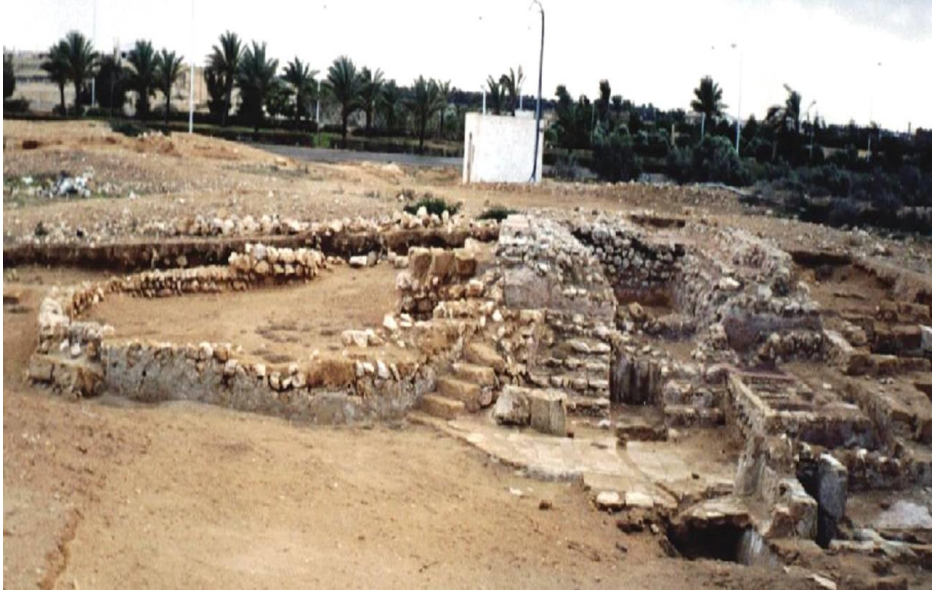
Fig.9: The Fullery Workshop, 'Fullonica', as viewed from The northern side

The last element in our investigation is the distinct working space that occupies the court's southwest corner and is the most distinguished part of the complex (fig.9).

One of the most noticeable features, unlike the whole context, is the well preserved floor pavement with regular shaped rectangular slabs of hard local limestone. In architectural parlance, this might indicate a wish to provide solid surface in a room. One reason for this is that the floor was in a space likely to be subject to wetting.¹

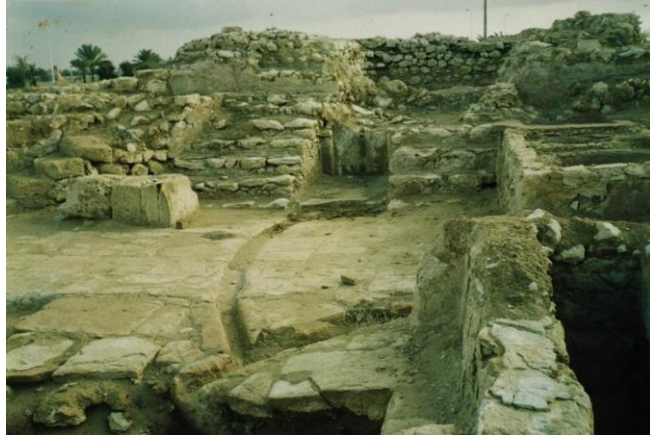
Fig.10:
Distinct draining
canalization in the
paved floor

Another striking feature is the distinct draining canalization under the ground or cut through the pavement of the floor. Also the wide use of the aforementioned reddish waterproofing plaster² is quietly noticed. All these features denote a heavy use of water [fig.10]

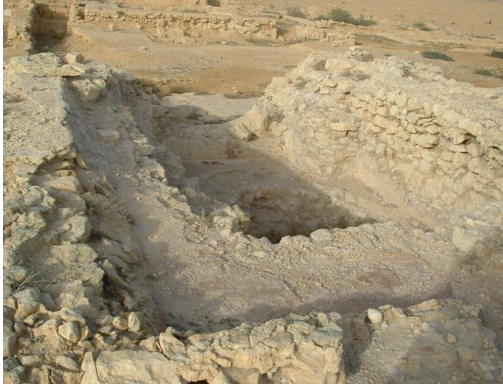
Fig.11 (up)
Large Trough

- The major structure is a large rectangular trough built of stone rubble at a higher elevation and equipped with several external flights of stairs at its northern side. Remainder of other stairs is still observed in its inner northeast corner. It seems that the trough featured heavy duty which demands several repairs and resizing that considerably reduced its size by adding thick inner reinforcement walls [fig.11]. A water-tap was installed at the northern wall of the trough in a small conch niche, remains of its little half dome are hardly observed. It was supplied by a narrow 5cm lead pipe starting at the foot of the inner stairway of the trough. Signs of the running water below the tap would suggest the frequent filling and discharging of the trough that induced the presence of a draining channel remarkably cut through the

floor pavement and pours into a common underground catchment chamber.

- **The large trough:** With regard to its aforementioned characterizing features, and by taking into our consideration its adjacency to the treading vats, and the probable presence of another trough behind. Keeping in mind the confirmed

probability of a piped water supply source. It would be now confirmed that it functioned as the trough required for rinsing cloth as attested through at many of the Pompeian fulleries.¹

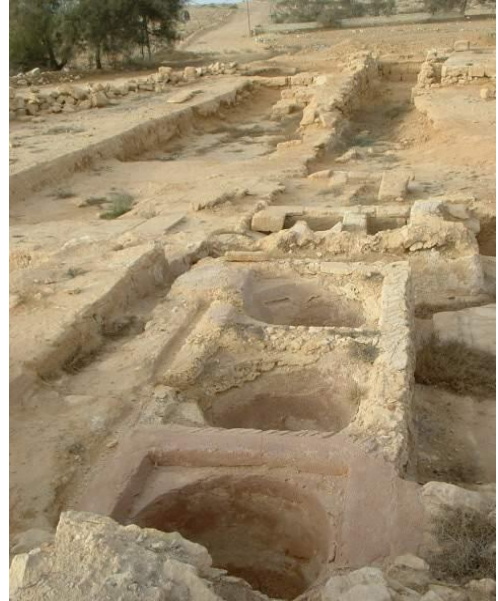
Fig. 12 (right)
Set of circular Vats

- The second main structure of the workshop is a set of three circular vats embedded in a high podium built of masonry attached against the northwest corner of the trough and the western wall of the workshop [fig.12]. The whole set is coated by a thick layer of the hydraulic reddish mortar and furnished with a common water supply channel atop the western side of the podium and a drain channel beneath it. At the joint between the podium and the western wall lies a square ditch, 28cm wide, sloping down northwards, coated with reddish mortar, seemingly intended to draw away excess of water spattered from the vats proposing vital activity. All drains pour into another larger one cut in the pavement, which in turns leads to the same catchment chamber.

- **The set of circular vats:** Comparable with archaeological record it would certainly be interpreted as treading vats customary separated by low masonry or slab walls for the *fullones* to support themselves. In some cases wooden rails were used for support, which is more plausible in our *fullonica* as it lack any partition slabs.¹ A battery of closer vats is found in a series of frescoes on a pilaster in the fullery of Hypsaesus at Pompeii [Reg. VI.8.20] that depicts fullones at work [fig.14a].² Other Pompeian Parallels uncovered in the Fullery of Stephanus [Reg. I.6.7], the Fullery of Vesonius Primus [Reg. VI. 14.21-22] and they were identified as treading stalls.³

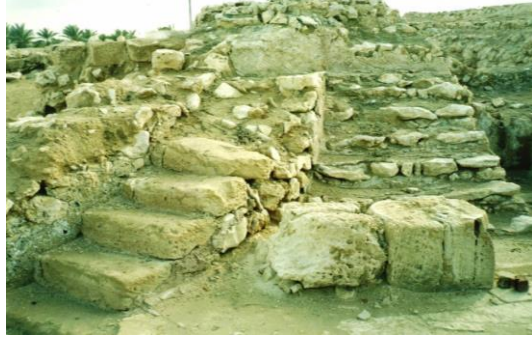
Fig.13: staircases
in contiguity with
the court

- The presence of an external staircase attached to the western side of the circular court and turn in contiguity with its wall and adjacent to the left external staircase leading to the large trough [fig.13].

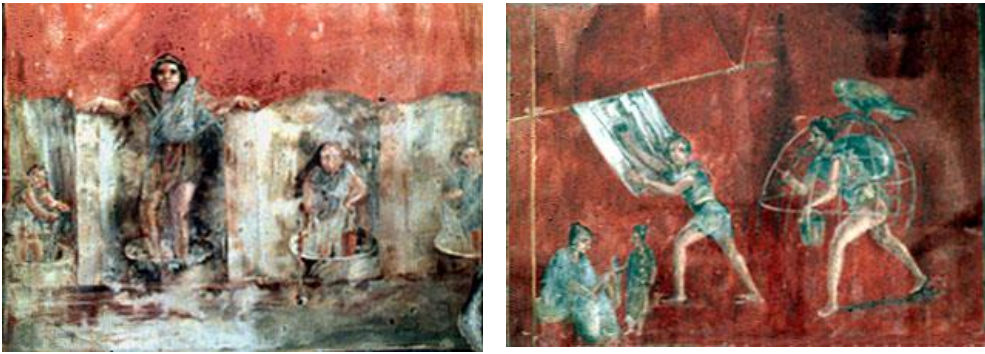
(a) Fig. 14 (b)

Fresco depicting Fullones at work from Fullery of Hypsaeus at Pompeii

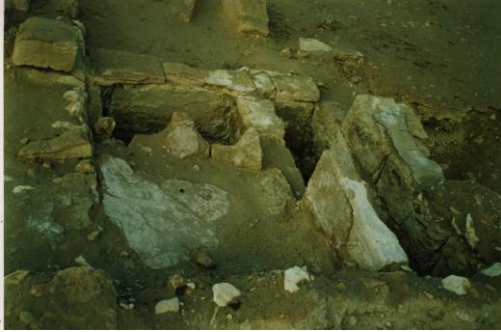
Fig.15: The Latrine Bathroom

Still in the workshop parlance and combined with its arrangement, is the latrine and the bath unit, accessed through a doorway on the western wall of the main complex further to the north of the *fullonica*. It consist of a common latrine with space for several seats, probably provided for workers [fig.15], a room housing a bath with an inner seat attached to its southern side [fig.16], and distributing room communicating between them. The bath/latrine unite is built against the western wall of the workshop, while the rear of the latrine room is protruding in alignment with the treading vats of the *fullonica*. The used waste water from the bathroom is brought by a ground channel to the aforementioned catchment chamber of the workshop, through which the latrine sewer would be drained away.

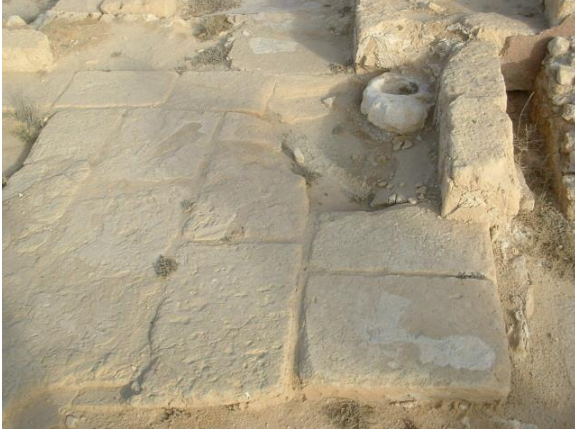
Fig.18: (right)
A reservoir of urine. Pompeii, officina lanificaria 7.11.2-5. (Moeller 1976, 33)

Fig.17: (left)

A Base for a jar at the entrance of the latrine with remarkable signs of wear.

It is worthy to remark that at the entrance of the latrine to the southwest corner of the communicating room there is a stone base mostly to support a jar in front of which the signs of wear in the floor denoting frequent use [fig.17].

- Evidently, urine was always the most exploited detergent used in the fulling process. Stronger, older urine was preferred and that of a camel was considered the most desirable.¹ In the baths of Mithras at Ostia a lead pipe from a public urinal carried fluids directly into a basement corridor leading to two small underground fullonicae.² Fullers used to leave large earthenware vessels in the streets to collect the urine of passers by. Example of such Urine receptacle was identified at Pompeii [fig.18].³ This might explain the provision of the stone base of a jar at the
