AN APPLICATION OF SPATIALLY BASED CRASH ANALYSES AND ROAD SAFETY INVESTIGATIONS TO INCREASE OLDER DRIVER SAFETY

Submitted to the Graduate School of the
University of Massachusetts Amherst in partial fulfillment
of the requirements for the degree of

MASTER OF SCIENCE IN CIVIL ENGINEERING

May 2011

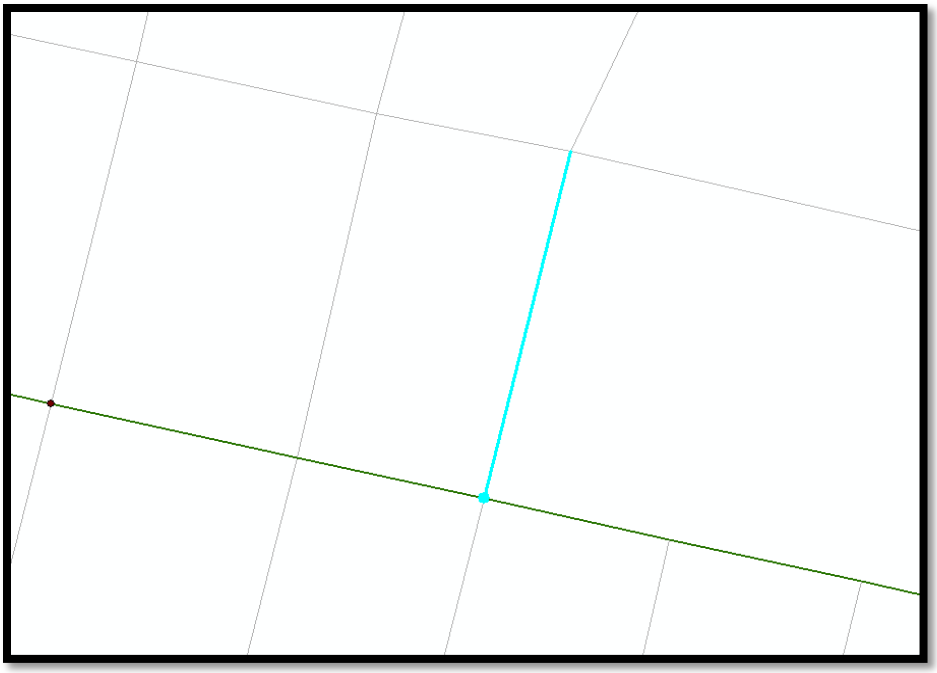
Figure 16. Roadway Segment 135636 Robeson Street Fall River

There were further data quality issues which arose when conducting the intersection HCL analysis. It was originally thought that when a crash occurred at a particular intersection, the roadway segment ID in which it is assigned was to the roadway with the highest functional classification even if the crash actually occurred on the other intersecting roadway. This was critical in this analysis as only one roadway segment ID for each intersection comprising of two or more roadway segments could be used to identifying the ODHCL's as there is no way to know which roadway segments intersect without manually zooming to each location in Arc GIS. However, after further investigation, it seems that this is not always the case as multiple examples were identified in which a roadway segment, having multiple drivers involved in intersection crashes, was not the roadway segment within the intersection having the highest functional classification. For example, Figure 16 shows roadway segment 135636 highlighted in light blue, which is on Robeson Street in Fall River, Massachusetts. The crashes at this intersection, represented by a small light blue dot, snapped to this roadway segment even though the intersecting roadway segment is Route 6, a major arterial roadway. Crashes could have snapped to the roadway segment ids on the approaches to this intersection on Route 6, but unless a minimum of 5 did so, these would not appear within the data set.

As such, it is possible that more drivers were involved in crashes at the intersection than what is included in this analysis in the Identifying ODHCL's and Intersection Road Safety Investigations sections of this paper and it is therefore important to realize that more crashes may have occurred than what it presented. It also complicates this analysis as the intersecting roadway segment of interest is not within the data but must be manually identified on a map, in order to identify the ADT for the intersecting roadway and to confirm that the roadway segment identified is in fact the highest for that roadway, i.e. the segment across from the identified segment could have a higher ADT value. It still holds, however, that these locations are HCLs, as they meet the minimum criterion. Furthermore, the ability to improve the intersection locations to better accommodate the older driving population is still desirable.

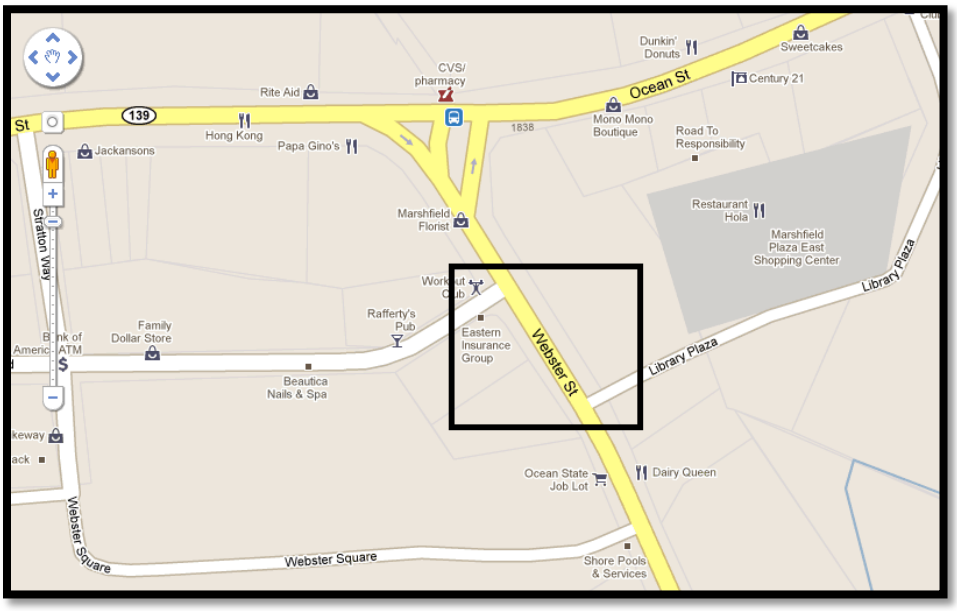
Figure 20. Intersection 229781 Google Map

Intersection 229781 is the intersection of Webster Street & Snow Road in Marshfield, Massachusetts. It has an estimated total ADT of 900 vehicles per day. In 2007 and 2008, there were a total of **5 drivers age 65+ and 6 drivers between the ages of 35-55** involved in crashes at this intersection. Since the ratio of drivers age 65+ involved in crashes to drivers age 35-55 involved in crashes at this intersection is less than the statewide ratio of 1:3.87, this location has been identified as a location in which older drivers are overrepresented in crashes. Of the 5 older drivers involved in crashes at this intersection, 4 older drivers were involved in 2 vehicle crashes and 1 older driver was involved in a 3 vehicle crash. All 5 older drivers involved in crashes at this intersection were involved in angle crashes. The driver contributing code on the crash report form indicates that 2 drivers failed to yield right of way. It should also be noted that 4 drivers were involved in property damage only crashes and 1 driver was involved in a non-fatal injury crash. This intersection was chosen as a location in which a road safety investigation be conducted as it ranked **2nd out of 267 for the age 65+ spot rate method**, **2nd out of 303 for the age 35-55 spot rate method**, and **2nd out of 308 for the age 65+ EPDO rate method**.

The intersection of Webster Road & Snow Road in Marshfield, Massachusetts is a four-way intersection stop-controlled on the minor roadways (Snow Road & Library Plaza). It appears as though major improvements have been made since at these areas which are not yet updated in the EOT_MAJOR ROADS file or in map view in Google maps which were utilized in this project. The road which is shown

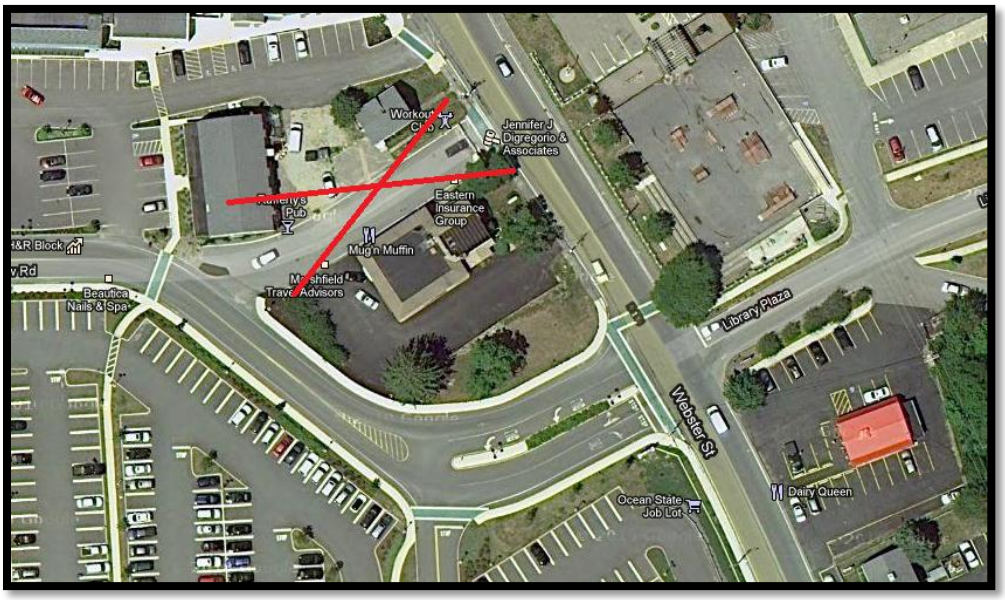
Figure 21. Intersection 229781 Satellite View Showing Roadway Closure

above has been closed and Snow Road now runs further south to connect with Library Plaza. This may be because of a new development, including a Marshalls and many other stores, in this area which can now be easily accessed by using Snow Road. With the reconfiguration of this intersection it appears that many improvements which will better accommodate older drivers have been implemented including new signage, pavement markings, an island, and highly visible crosswalks. In conjunction the intersection is now set further back from the intersection of Ocean Street & Webster Street and Snow Road and Library Plaza align with one another. It seems as though the ADT within the data for Snow Road may be inaccurate (see Data Quality Challenges section). It is clear that the previous location of Snow Road would have had sight restrictions and would have been in very close proximity to the major intersection of Ocean Street & Webster Street. Although these improvements have been made to this area, it remains a busy with a lot going on and a lot to look at. Perhaps a flashing red light could be installed on Snow Road and/or a flashing yellow signal on Webster Street. Additionally, a supplemental warning sign panel mounted below the STOP sign reading "CROSS TRAFFIC DOES NOT STOP" could be included to better accommodate older drivers. As is the case with many locations especially after the winter months, the pavement markings are fading and should be repainted.

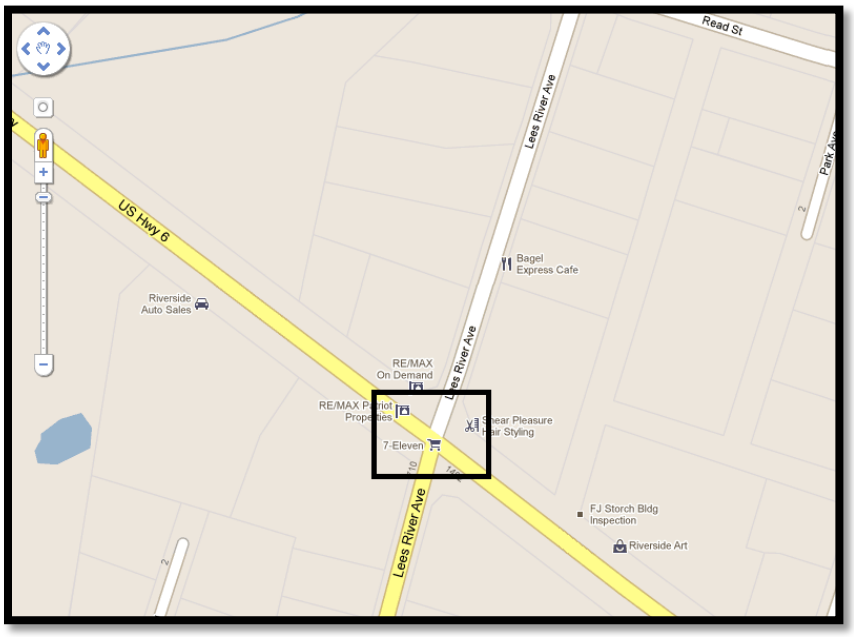
Figure 22. Intersection 348139 Google Map

Intersection 348139 is the intersection of Route 6 & Lees River Avenue in Somerset, Massachusetts. It has an estimated total ADT of 19,700 vehicles per day. In 2007 and 2008, there were a total of **8 drivers age 65+ and 20 drivers between the ages of 35-55** involved in crashes at this intersection. Since the ratio of drivers age 65+ involved in crashes to drivers age 35-55 involved in crashes at this intersection is less than the statewide ratio of 1:3.87, this location has been identified as a location in which older drivers are overrepresented in crashes. Of the 8 older drivers involved in crashes at this intersection, 6 older drivers were involved in 2 vehicle crashes and 2 older drivers were involved in 3 vehicle crashes. Furthermore, 7 older drivers involved in crashes at this intersection were involved in angle crashes and 1 older driver was involved in a rear-end crash. The driver contributing code on the crash report form indicates that 4 drivers failed to yield right of way and 1 driver disregarded traffic signals, signs, or markings. It should also be noted that 1 driver was involved in a property damage only crash and 7 drivers were involved in non-fatal injury crashes. This intersection was chosen as a location in which a road safety investigation be conducted as it ranked **3rd out of 35 for the age 65+ EPDO Index method** and **4th out of 33 for the age 65+ severity index method**.

The intersection of Route 6 & Lees River Avenue in Somerset, MA is a four-way signalized intersection. The intersection is large in nature as Route 6 is a four lane roadway and Lees River Avenue is a two lane roadway. There are no dedicated turn lanes. Route 6 is a high volume and high speed roadway.

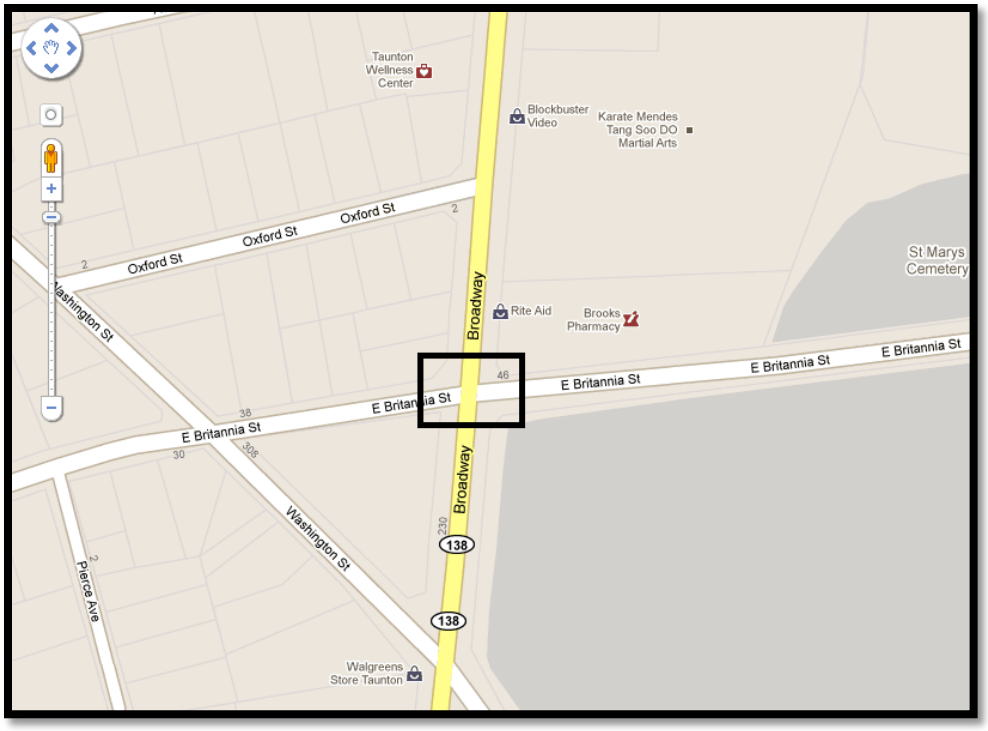
Figure 29. Intersection 375467 Google Map

The intersection of Route 138 & East Britannia Street in Taunton, Massachusetts is a four-way signalized intersection. A protected left turn with dedicated left turn lanes would be the optimal solution, however, the left turn movement volume did not seem too high and therefore this may cause an unacceptable reduction in capacity. Similarly, it seems as though there is not enough space for the addition of dedicated left turn lanes, keeping the same number of through lanes, due to probable right of way restrictions. If this solution was feasible, however, the opposite left-turn lanes should be implemented with a positive offset for unrestricted sigh distance. If this solution is not feasible, the additon of "LEFT TURN YIELD ON GREEN" signs should be implemented overhead for all approaches. These same measures should also be considered on the minor roadway (E. Britannia Street) as this minor roadway is a high volume roadway which a large percentage of turning vehicles. This intersection is currently skewed. Ideally, the intersecting roadways should meet at a 90-degree angle to better accommodate older drivers. However, given the infrastructure in close proximity to this intersection and the probable right of way restrictions, making this change may not be feasible. Given that Route 138 is a major roadway with relatively high speeds, no right turn on red is a strategy which could better accommodate older drivers. This is currently implemented when approaching the intersection from the west and heading east on E. Britannia

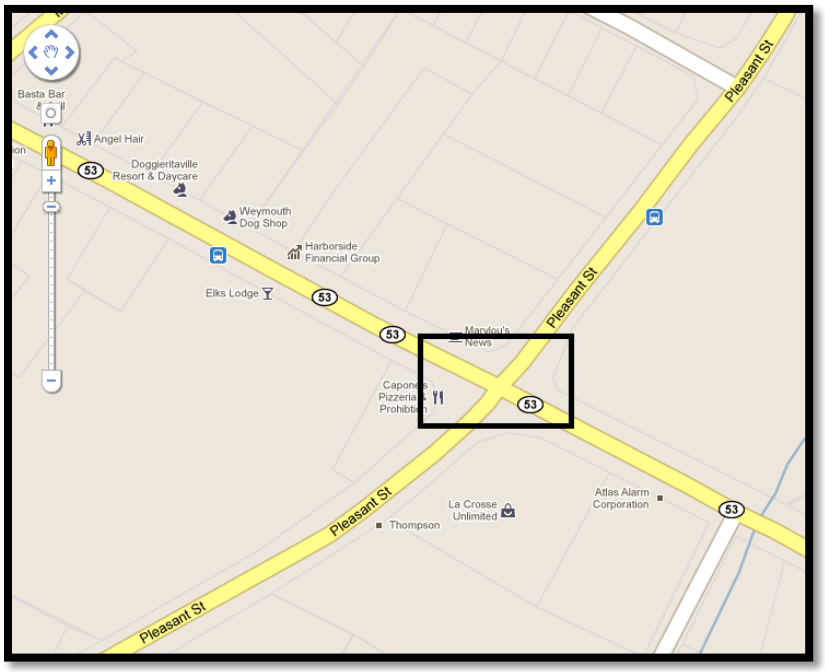
Figure 32. Intersection 424843 Google Map

this intersection. Since the ratio of drivers age 65+ involved in crashes to drivers age 35-55 involved in crashes on this segment is less than the statewide ratio of 1:3.87, this location has been identified as a location in which older drivers are overrepresented in crashes. Of the 16 older drivers involved in crashes at this intersection, 15 drivers were involved in 2 vehicle crashes and 1 driver was involved in a 3 vehicle crash. Furthermore, 12 drivers were involved in angle crashes, 2 drivers were involved in rear-end crashes, and 2 drivers were involved in sideswipe same direction crashes. The driver contributing code on the crash report form indicates that 3 drivers disregarded signals, signs, and markings, one driver followed too closely, one driver made an improper turn, one driver drove too fast for conditions, and one driver failed to yield right of way. It should also be noted that 13 drivers were involved in property damage only crashes while 3 drivers were involved in non-fatal injury crashes. This intersection was chosen as a location in which a road safety investigation be conducted as it ranked **1st out of 9 for the age 65+ frequency method and 4th out of 35 for the age 65+ EPDO index method.**

The intersection of Washington Street (Route 53) & Pleasant Street in Weymouth, Massachusetts is a four-way signalized intersection. It is relatively high speed and volume on both roadways with driveways in close proximity to the intersection. One of the small plazas near this intersection (on the northwest side) has a very small and hardly noticeable "RIGHT TURN ONLY" sign but perhaps this could

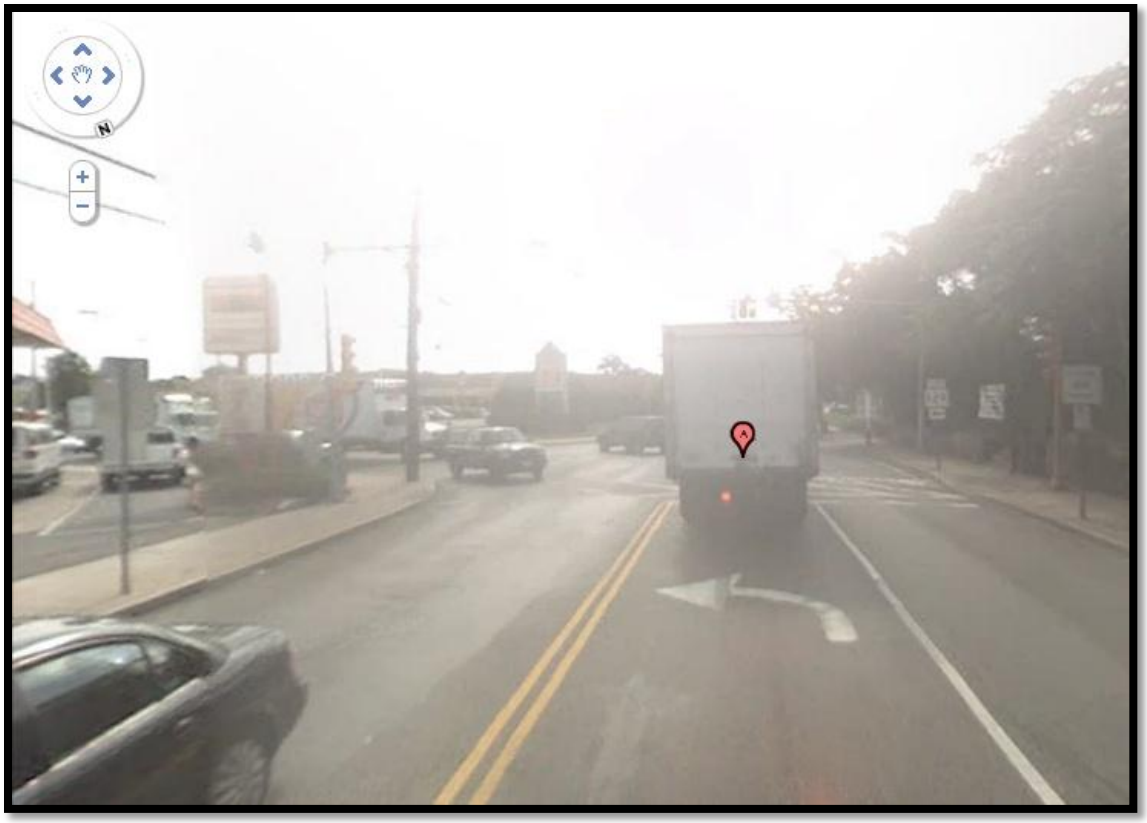
Figure 36. Intersection 217386 Street View

The Older Driver Highway Design Handbook recommends that an all-red clearance interval be consistently implemented with the length determined according to the Institute of Transportation Engineers (1992) expressions to accommodate age differences in perception-reaction time (PRT) and that for all over-the-road signals that the Commission Internationale de I'Eclairage (CIE) 1980 standard for vertical intensity distribution (percent of peak) for a 300 mm (12in) signal be adhered to in the United States to accommodate the increased optical density or reduced ocular transmittance of the older driver's eye, and to improve availability of signal information under divided attention conditions during an intersection approach. Further investigation would be required to see whether this location meets these recommendations.

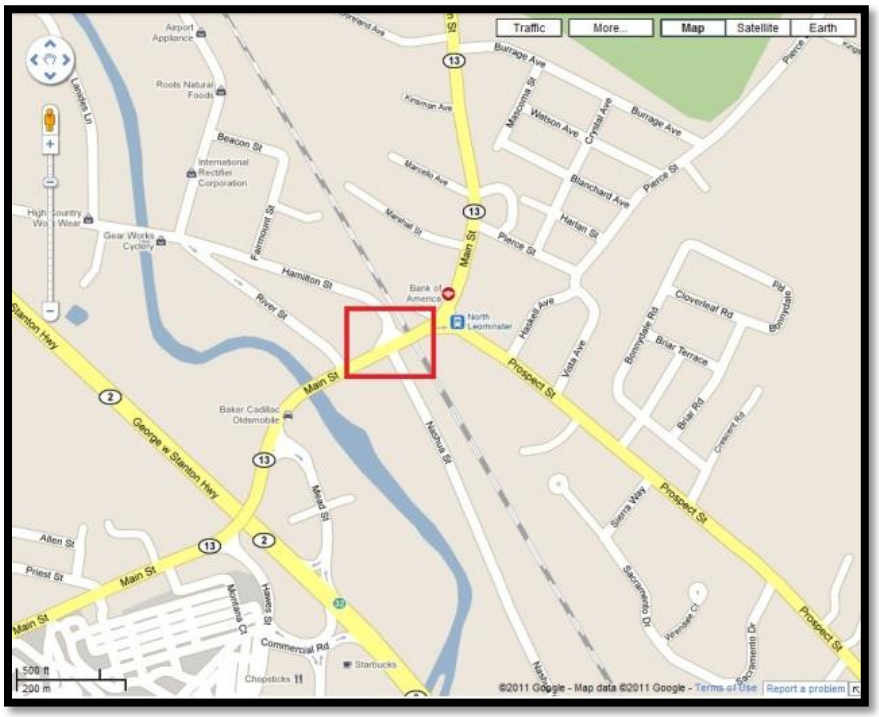
Figure 38. Intersection 201818 Google Map

Intersection 201818 is the intersection of Main Street (Route 13) & Hamilton Street in Leominster, Massachusetts. It has an estimated total ADT of 29,145 vehicles per day. In 2007 and 2008, there were a total of **6 drivers age 65+ and 38 drivers between the ages of 35-55** involved in crashes at this intersection. Since the ratio of drivers age 65+ involved in crashes to drivers age 35-55 involved in crashes at this intersection is greater than the statewide ratio of 1:3.87, this location has been identified as a high crash location for all age groups. All 6 older drivers involved in crashes at this four-way signalized intersection were involved in 2 vehicle crashes. Of the 6 older drivers involved in crashes at this intersection, 4 older drivers were involved in angle crashes and 1 driver was involved in a rear-end crash (the 6th driver manner of collision is unknown). The driver contributing code on the crash report form indicates that 1 driver failed to yield right of way and 1 driver was not paying attention. It should also be noted that all 6 older drivers were involved in property damage only crashes. This intersection was chosen as a location in which a road safety investigation be conducted as it ranked **2nd out of 36 for the age 35-55 frequency method**.

The intersection of Main Street (Route 13) & Hamilton Street in Leominster, Massachusetts is a small and narrow intersection with very high volume. It is confusing to navigate through as the minor

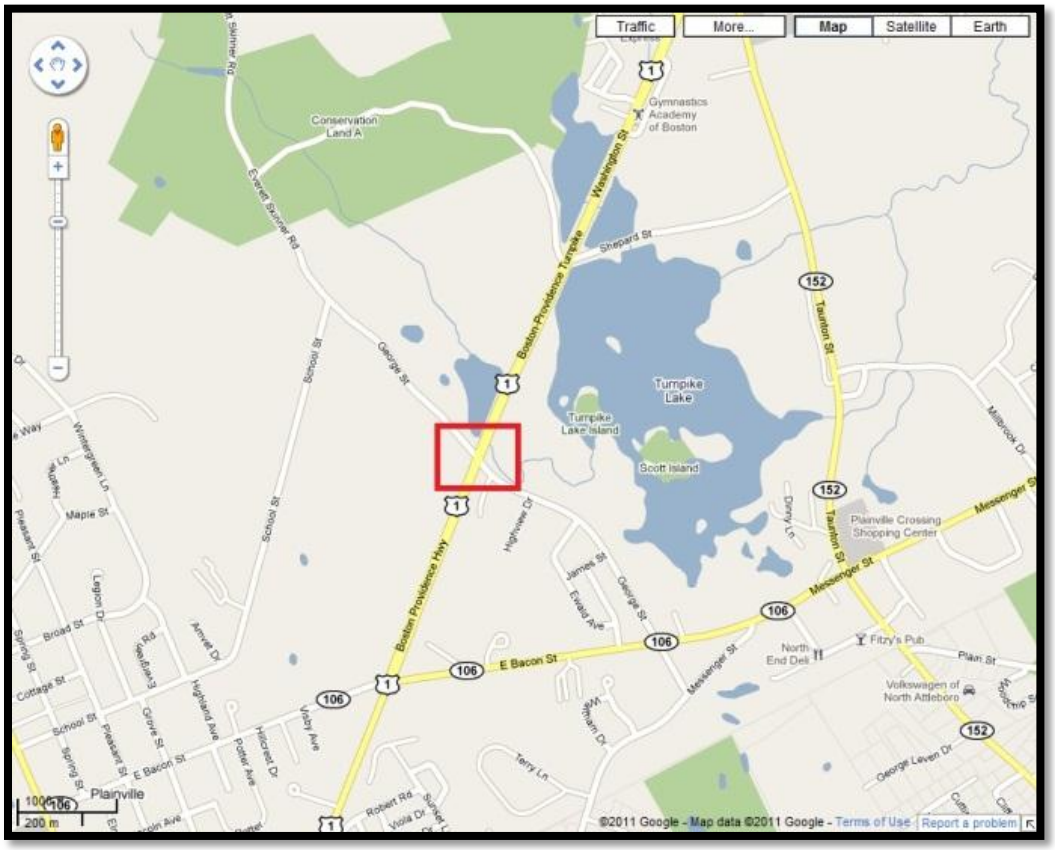
Figure 43. Intersection 307749 Google Map

intersection. Since the ratio of drivers age 65+ involved in crashes to drivers age 35-55 involved in crashes at this intersection is less than the statewide ratio of 1:3.87, this location has been identified as a location in which older drivers are overrepresented in crashes. All 5 older drivers were involved in two vehicle angle crashes. The driver contributing code on the crash report form indicates that 1 driver failed to yield right of way and 1 driver was distracted. It should also be noted that 3 drivers were involved in property damage only crashes while 1 driver was involved in non-fatal injury crashes, and **1 driver was involved in a fatal crash**. This intersection was chosen as a location in which a road safety investigation be conducted as it ranked **3rd out of 33 for the age 65+ severity index method.**

The intersection of Washington Street (Route 1) & Everett Skinner Road in Plainville, Massachusetts is the intersection of a major four lane roadway and a small residential roadway, with stop signs on the minor roadway. When traveling on Route 1, this small roadway is hardly noticeable as it is very low volume. Furthermore, this intersection is currently skewed. Ideally, the intersecting roadways should meet at a 90-degree angle to better accommodate older drivers. At this location, it seems as though

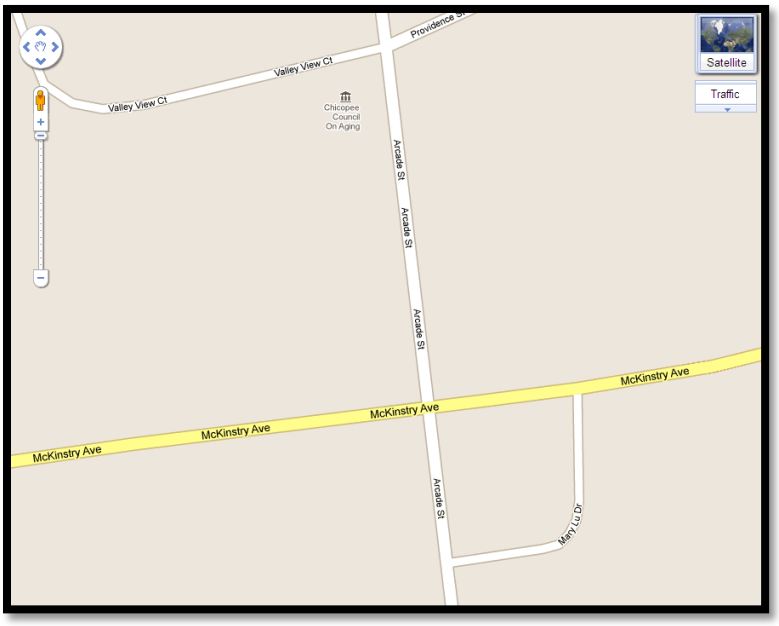
Figure 45. Intersection 97032 Google Map

intersection were involved in 2 vehicle angle crashes. The driver contributing code on the crash report form indicates that 1 driver exceeded the authorized speed limit, 1 driver failed to yield right of way, and 1 driver disregarded traffic signs, signals, or markings. It should also be noted that 2 drivers were involved in property damage only crashes while 6 drivers were involved in non-fatal injury crashes. This intersection was chosen as a location in which a road safety investigation be conducted as it ranked **1st out of 257 for the age 65+ 'average of methods' method.**

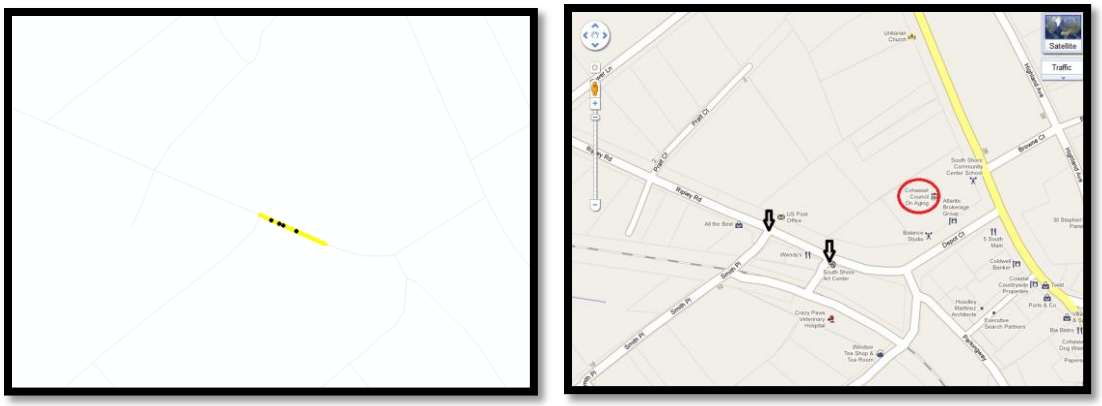
Figure 50. Roadway Segment 102658 ArcGIS and Google Maps

Roadway Segment 102658 is located on Ripley Road in Cohasset, Massachusetts. It extends from Smith Place to 0.0347 miles east of Smith Place. This segment is 0.0347 miles long and has an average daily traffic (ADT) of 3000 vehicles. In 2007 and 2008, there were a total of **5 drivers age 65+ and 5 drivers between the ages of 35-55** involved in crashes on this segment. Since the ratio of drivers age 65+ involved in crashes to drivers age 35-55 involved in crashes on this segment is less than the statewide ratio of 1:4.76, this location has been identified as a location in which older drivers are overrepresented in crashes. All 5 older drivers who were involved on crashes on this segment were involved in 2 vehicle crashes. Furthermore, 1 driver was involved in an angle crash while 3 drivers were involved in sideswipe same direction crashes (the 5th driver manner of collision is unknown). The driver contributing code on the crash report form indicates that 1 driver was not paying attention. It should also be noted that all 5 drivers were involved in property damage only crashes. This roadway segment was chosen as a location in which a road safety investigation be conducted as it ranked **5 out of 175 for the age 65+ crash density method, 5 out of 137 for the age 65+ crash rate method, 3 out of 179 for the age 65+ section rate method, 4 out of 174 for the age 35-55 section rate method, and 2 out of 149 for the age 65+ 'average of methods' method**.

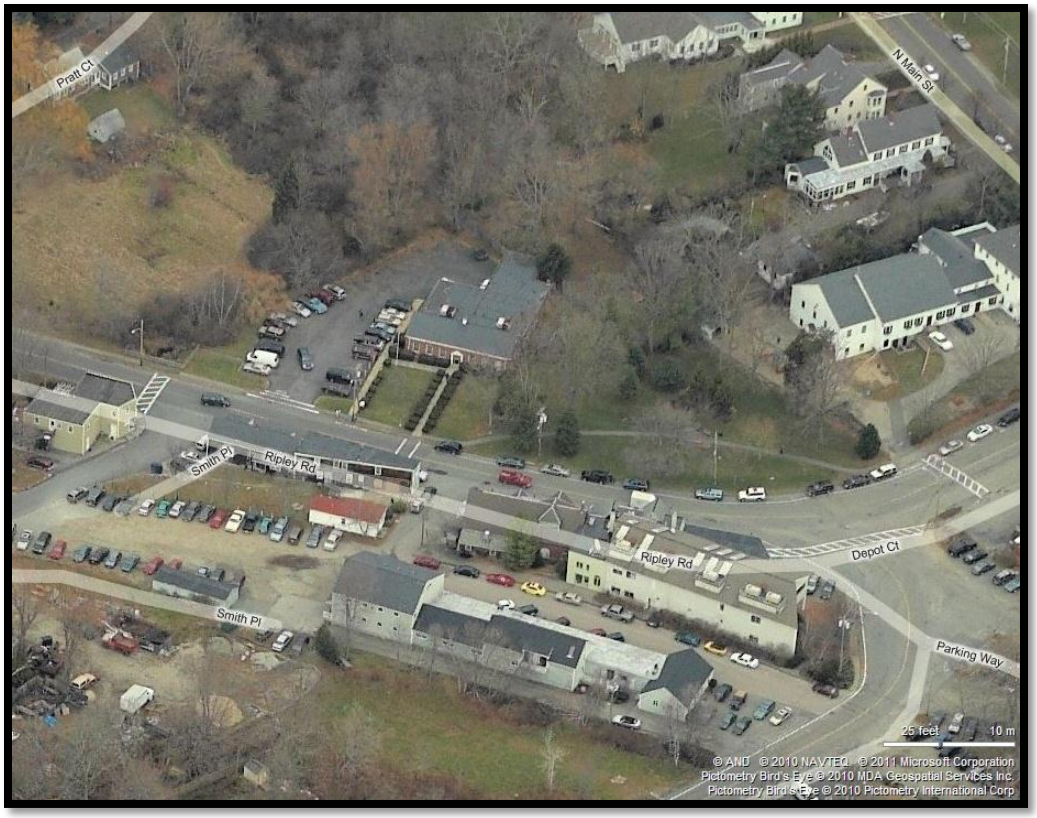
Figure 51. Intersection 102658 Bird's Eye View

This roadway segment (102658) is located in the downtown area of Cohasset, Massachusetts. As such, the speed limit is very slow at 20 mph. The roadway appears narrow and the roadway markings are barely visible. It appears that the post office within the boundaries of this segment has a constant flow of in and out traffic. Furthermore, drivers parallel park in close proximity to the post office on both sides of the roadway, which may be causing sightline restrictions for drivers exiting the post office. Additionally, drivers park around the curve, just east of this roadway segment which may also be an issue. There are no signals and minimal signage in this area. Drivers exiting Smith Place may also be causing conflicts with those exiting the post office. It seemed to be well enforced as an officer was parked and walking around at the time of the site visit. It is interesting to note that the Cohasset Council on Aging is in very close proximity to this older driver high crash location site and it is fair to say that there is a high population of seniors in this area. To reduce crashes in this area, a parking ban may be efficient during peak hours or at times when the crashes seem to be taking place. Additionally, parking should be banned within a certain distance of the post office and around the curve. A flashing yellow beacon may be beneficial so that drivers use caution when passing through this area, in particular the post office.

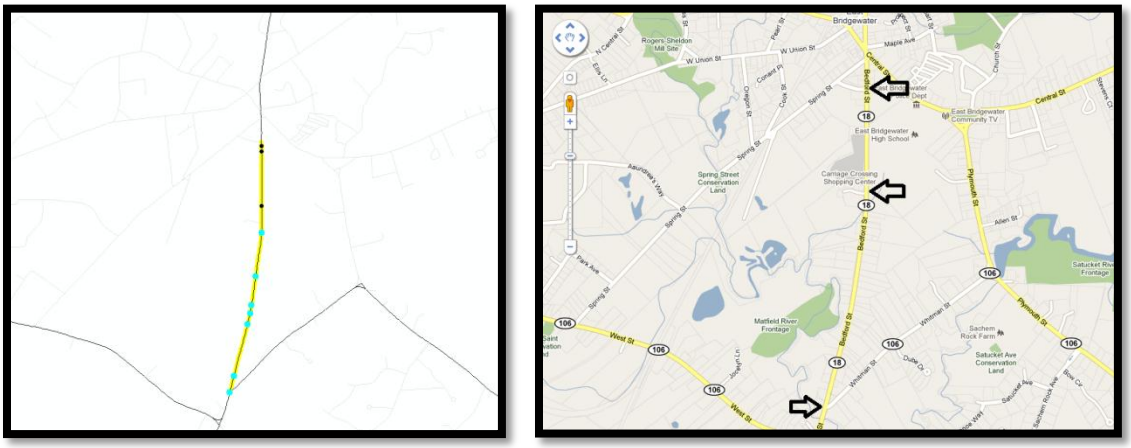
Figure 52. Roadway Segment 123201 ArcGIS and GIS Maps

particular interest (123201), 8 drivers were involved in 2 vehicle crashes while 2 drivers were involved in 3 vehicle crashes. Furthermore, 1 driver was involved in an angle crash while 7 drivers were involved in rear-end crashes and 2 drivers were involved in sideswipe same direction crashes. The driver contributing code on the crash report form indicates that 3 drivers were faulted for following too closely and 3 drivers were not paying attention. It should also be noted that 7 drivers were involved in property damage only crashes while 3 drivers were involved in non-fatal injury crashes. This roadway segment was chosen as a location in which a road safety investigation be conducted as it ranked **2 out of 8 for the age 65+ crash frequency method and 4 out of 23 for the age 65+ EPDO index method**.

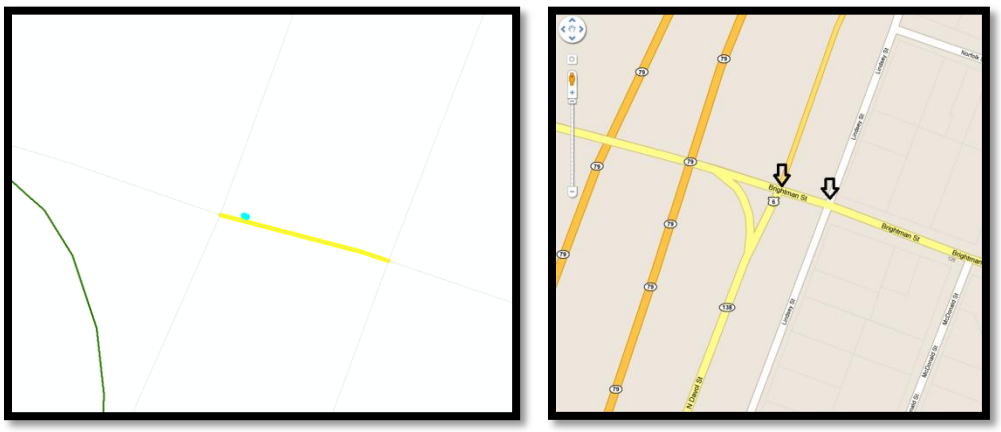
Figure 53. Roadway Segment 137755 ArcGIS & Google Maps

rate method. Its high ranking using these methods is due to the extremely small size of this roadway segment.

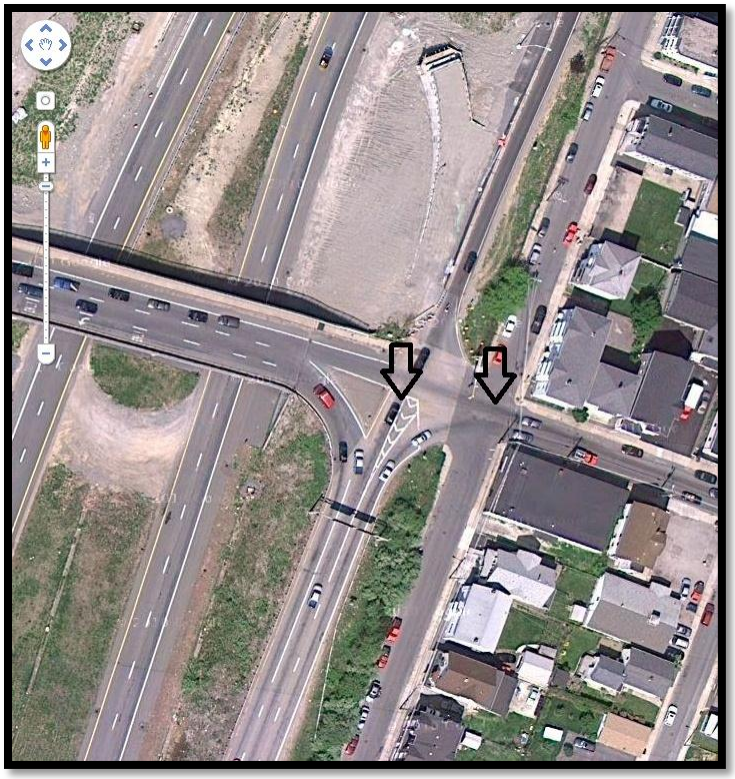
Figure 54. Roadway Segment 137755 Satellite View

Roadway Segment 137755, located on Brightman Street in Fall River, Massachusetts, is a very small roadway segment, encompassing only one very unique intersection. This area is now under construction adding to the complexity of this segment at the time of the site visit. The construction prohibits vehicles from making a right turn onto the segment from N. Davol Street. An off ramp with motorists traveling at high speeds enters onto this roadway segment which leads into a very residential area. When traveling in the opposite direction there is a light which is not functioning. Additionally, there is no clear signage at this location. Solar glare also seems to be an issue at this location. This roadway segment needs better signage. Possibly the addition on “ONE WAY” signs, “WARNING SIGNS”, and “DO NOT ENTER” signs. Pavement markings would also be useful.

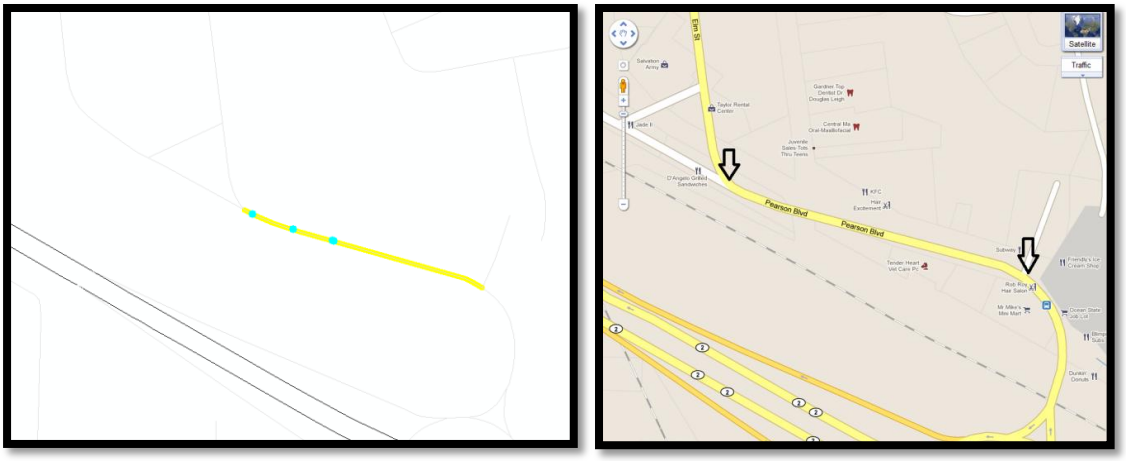
Figure 57. Roadway Segment 155628 ArcGIS and Google Maps

Roadway Segment 155628, located on Pearson Boulevard in Gardner, Massachusetts, is a busy area with a lot of businesses and driveways with motorists pulling in and out to make right and left hand turns. The pavement markings which do exist are very faded and incorrect. In one instance, a left turn arrow exists for the shell station which is to the left of the double yellow centerline, with oncoming traffic in the opposite direction. This is very confusing and a big problem. Similarly there are some instances in which there are no centerlines or line delineation but still left turn arrows on the pavement. Furthermore, the number of lanes which exist is unclear and the shoulder is very small. Additionally, the signalized intersection at Elm Street looks confusing and could be improved. First and foremost, the pavement markings need to be re-painted correctly. Ideally, a larger shoulder would be included to help reduce the chance of rear-end crashes. Ideally, the left turn lanes would be offset from one another as shown in the figure below and as recommended in the *Older Driver Highway Design Handbook* for optimal sight distance. However, if they were configured correctly, the left turn lanes would be more efficient. "RIGHT TURN ONLY" signs could be installed at business exits to reduce angle crashes by eliminating left turns. If space was available, a median would help to separate traffic. This would reduce the number of locations motorists are turning. Driveways could most likely be combined as well.

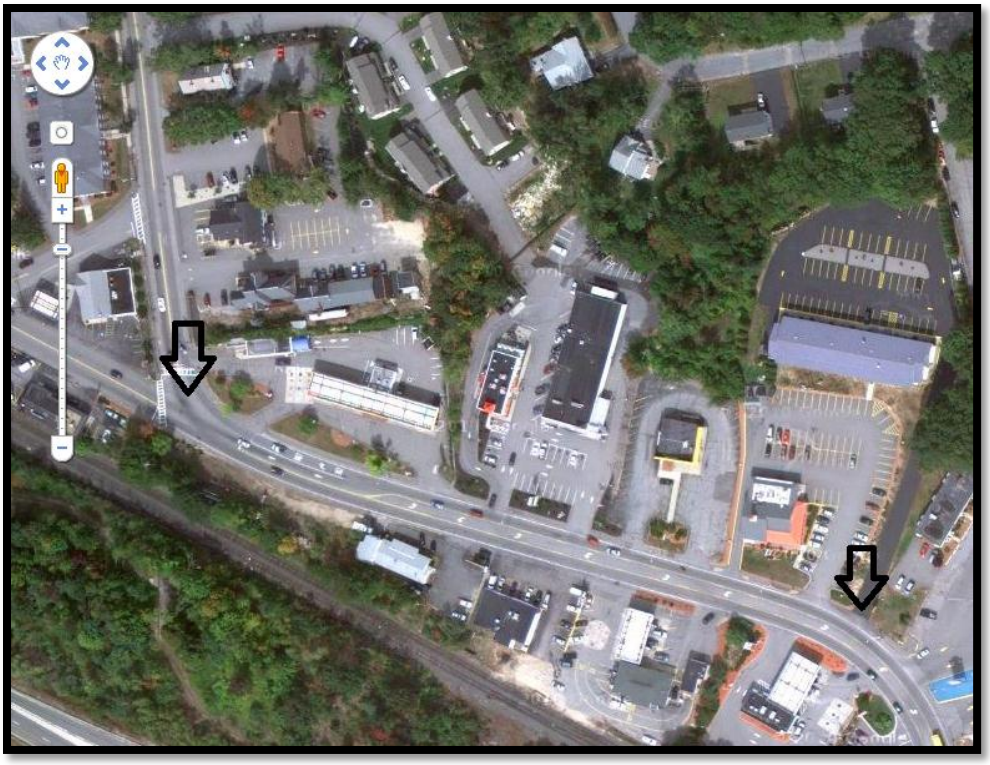
Figure 58. Roadway Segment 155628 Satellite View

Figure 59. Roadway Segment 155628 Street View – Poor Pavement Markings

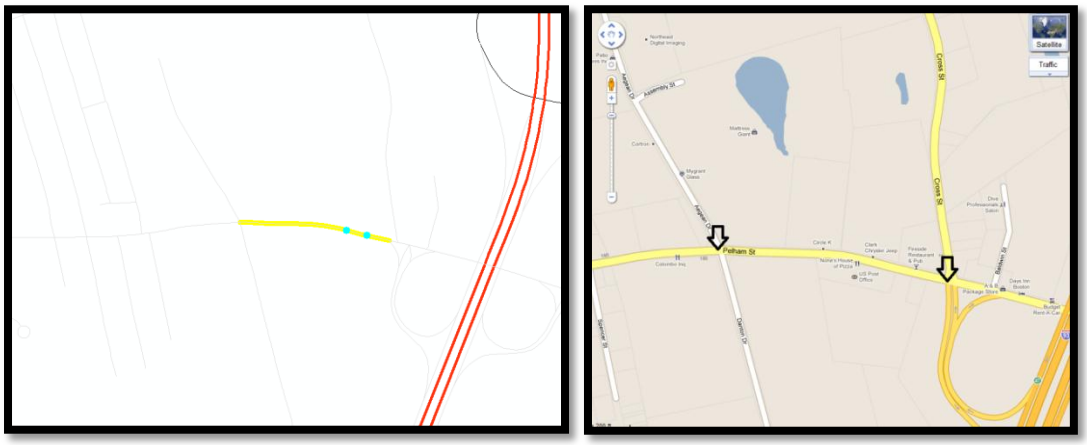
Figure 60. Roadway Segment 242382 ArcGIS and Google Maps

Roadway Segment 242382 is located on Pelham Street in Methuen, Massachusetts. It extends from Aegean Drive to the ramp from Pelham Street to Route 93 Southbound. This segment is 0.218 miles long and has an average daily traffic (ADT) of 2900 vehicles. In 2007 and 2008, there were a total of **4 drivers age 65+ and 5 drivers between the ages of 35-55** involved in crashes on this segment. Since the ratio of drivers age 65+ involved in crashes to drivers age 35-55 involved in crashes on this segment is less than the statewide ratio of 1:4.76, this location has been identified as a location in which older drivers are overrepresented in crashes. Of the 4 older drivers involved in crashes on this roadway segment, 2 drivers were involved in 2 vehicle crashes and 2 drivers were involved in 3 vehicle crashes. All 4 older drivers were involved in rear-end crashes. The driver contributing code on the crash report form indicates that 1 driver was faulted for not paying attention. It should also be noted that 1 driver was involved in a property damage only crash while 3 drivers were involved in non-fatal injury crashes. This roadway segment was chosen as a location in which a road safety investigation be conducted as it **ranked 4 out of 19 for the age 65+ severity index method and 4 out of 159 for the age 65+ EPDO rate method**.

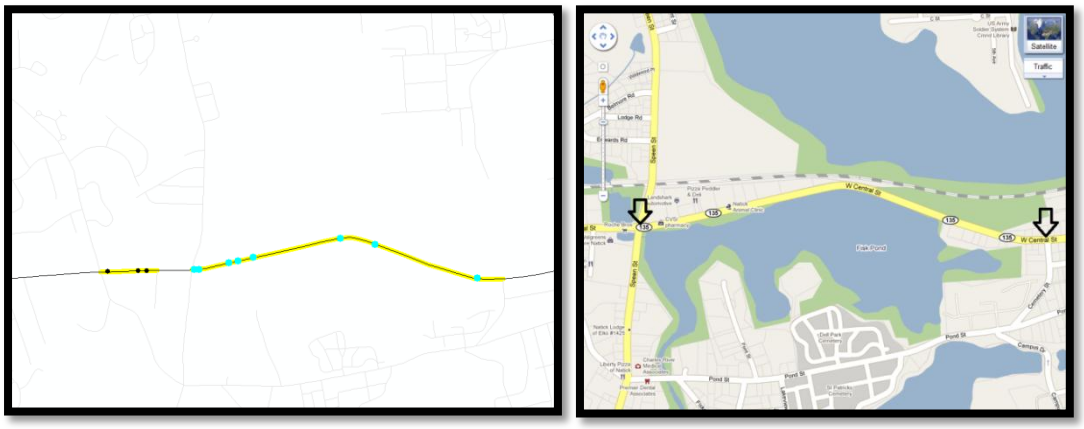
Figure 64. Roadway Segment 259307 ArcGIS and Google Maps

involved in crashes are shown in black.] Of the 10 older drivers involved in crashes on this roadway segment, 4 drivers were involved in 1 vehicle crashes, 4 drivers were involved in 3 vehicle crashes, 1 driver was involved in a 2 vehicle crash, and 1 driver was involved in a 4 vehicle crash. Furthermore, 4 drivers were involved in angle crashes, 4 drivers were involved in single vehicle crashes, and 2 drivers were involved in rear-end crashes. The driver contributing code on the crash report form indicates that 2 drivers were faulted for not paying attention, 1 driver failed to yield right of way, and 1 driver disregarded traffic signs, signals, or road markings. It should also be noted that 3 drivers were involved in property damage only crashes while 7 drivers were involved in non-fatal injury crashes. This roadway segment was chosen as a location in which a road safety investigation be conducted as it ranked **2 out of 8 for the age 65+ crash frequency method and 1 out of 23 for the age 65+ EPDO Index method**.

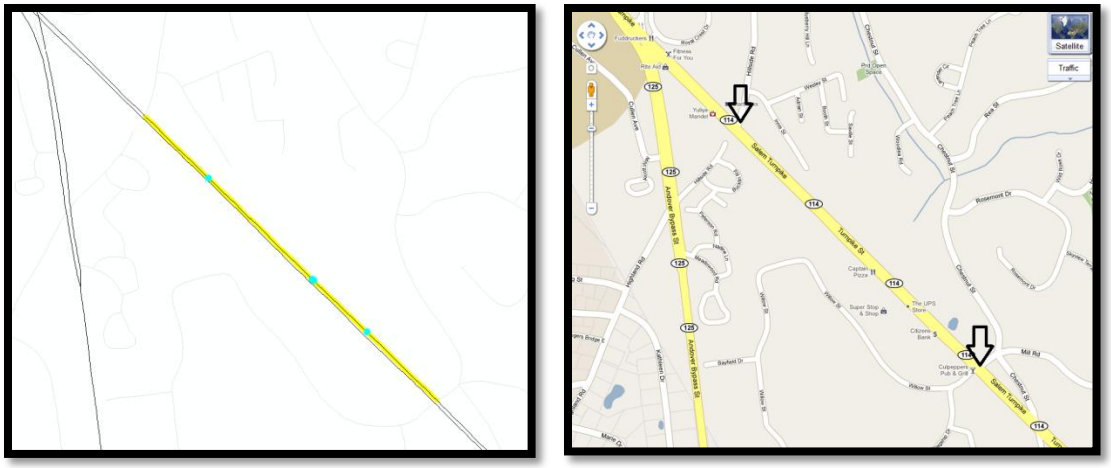
Figure 67. Roadway Segment 279865 ArcGIS and Google Maps

Roadway Segment 279865, located on Turnpike Street (State Route 114) in North Andover, Massachusetts, is a high volume roadway with relatively high speeds. The lane configuration changes multiple times throughout the segment. On the west end (beginning at Hillside Road), this roadway segment is a 3 lane roadway with 2 lanes heading east and 1 west separated by a double yellow line and is residential with some businesses. As you head east, this segment becomes a 3 lane roadway followed by a 5 lane roadway with one travel lane in each direction and a center lane for turning vehicles. Given that this turning lane has no arrows for specific movements (other than one left turn arrow in one spot) it seems confusing in nature. The segment then approaches 2 signalized intersections before ending. At the east part of the segment there are more businesses and more traffic. Throughout this segment the shoulder is very small and the lines are faded and are in need of being re-painted especially given the constant change in road configuration. Given that the five older drivers involved in crashes on this segment were involved in rear-end crashes, wider shoulders would be beneficial. The problem may also be that people are pulling out right in front of another motorist, causing a rear end crash. Wider shoulders would also relieve this situation. Perhaps there are driveways which could be condensed to limit the number of spots drivers are pulling into traffic. Perhaps eliminating the center lane turn lane for both directions would be helpful. This sign is not too common and may be confusing to older drivers. It may also be beneficial to move the location in which 2 lanes merge to 1 lane as this is right at a location in which many motorists are entering and exiting driveways.

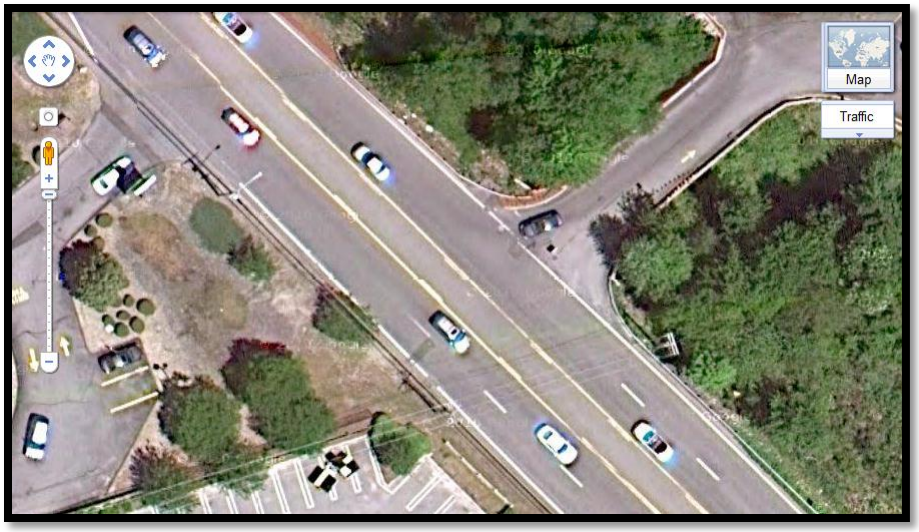
Figure 68. Roadway Segment 279865 – Centerlane Turn Lane

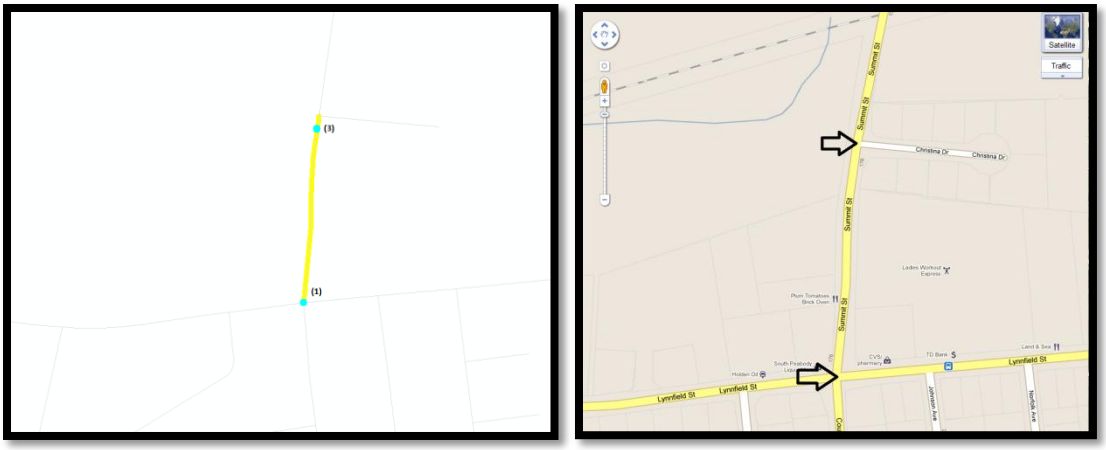
Figure 69. Roadway Segment 300255 ArcGIS and Google Maps

This roadway segment (300255) seemed relatively high volume (the ADT seems to be an underestimate). 3 of the 4 older driver crashes appear (according to ArcGIS) to have occurred around the entrance to the plaza. The plaza currently has 3 entrances and 3 exits for a small plaza. The queue from the signalized intersection of Lynnfield Street & Summit Street seems to regularly back up well beyond the plaza entrances and exits. When not in queue, vehicles seem to travel much faster than would be expected, making it extremely difficult to turn out of the plaza, especially when taking a left hand turn. There are no visible lane markings, sidewalks shoulders, or curbs. Therefore, it is difficult to tell where the plaza entrances/exits/parking lot ends and the roadway begin. Perhaps this problem would be alleviated if it were clear as to where the road edge was and the parking lot began. This could be done by adding a white edge line on the roadway. Bollards and a chain could prevent motorist from entering or exiting the parking lot wherever they wish. Perhaps a one way entrance and one way exit would be beneficial at this location. A "RIGHT TURN ONLY" sign could be placed at the exit so that left turns with limited sight distance due to queuing are not made. Increased signage in general could aid motorist. Furthermore, perhaps a sign telling motorists not to block this entrance plaza would be beneficial for motorists traveling on Summit Street. Stop bars could also be used. Additionally, perhaps the signal at Lynnfield Street could be retimed to reduce the queues at this location.

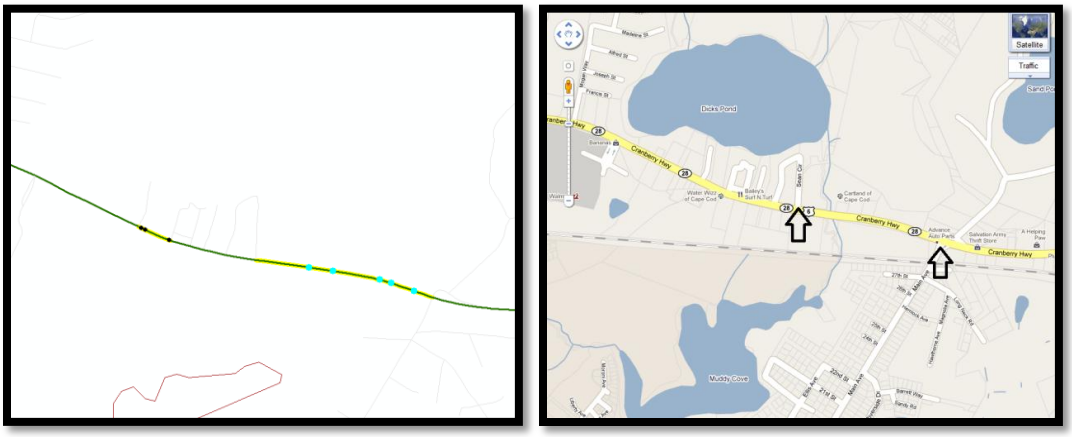
Figure 73. Roadway Segment 396861 ArcGIS and Google Maps

segment was chosen as a location in which a road safety investigation be conducted as it ranked **1 out of 8 for the age 65+ crash frequency method and 5 out of 23 for the age 65+ EPDO index method**.

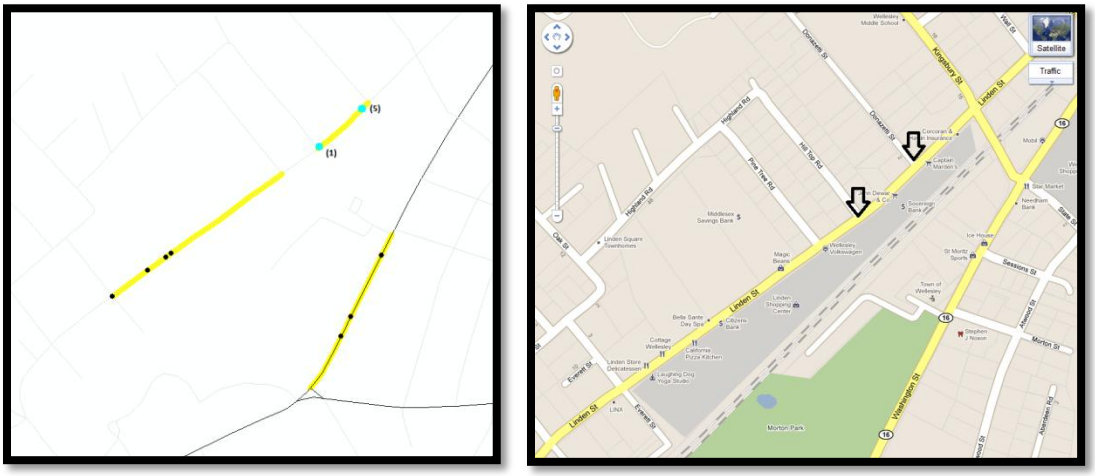
Figure 75. Roadway Segment 404165 ArcGIS and Google Maps

segment were involved in 2 vehicle crashes. Furthermore, 4 drivers were involved in angle crashes while 1 driver was involved in a rear-end crash and 1 driver was involved in a sideswipe same direction crash. The driver contributing code on the crash report form indicates that 1 driver was faulted for not paying attention. It should also be noted that all 6 drivers were involved in property damage only crashes. This roadway segment was chosen as a location in which a road safety investigation be conducted as it ranked **3 out of 137 for the age 65+ crash rate method, 5 out of 179 for the age 65+ section rate method, and 3 out of 149 for the age 65+ 'average of methods' method**.
