AN APPLICATION OF SPATIALLY BASED CRASH ANALYSES AND ROAD SAFETY INVESTIGATIONS TO INCREASE OLDER DRIVER SAFETY

Submitted to the Graduate School of the
University of Massachusetts Amherst in partial fulfillment
of the requirements for the degree of

MASTER OF SCIENCE IN CIVIL ENGINEERING

May 2011

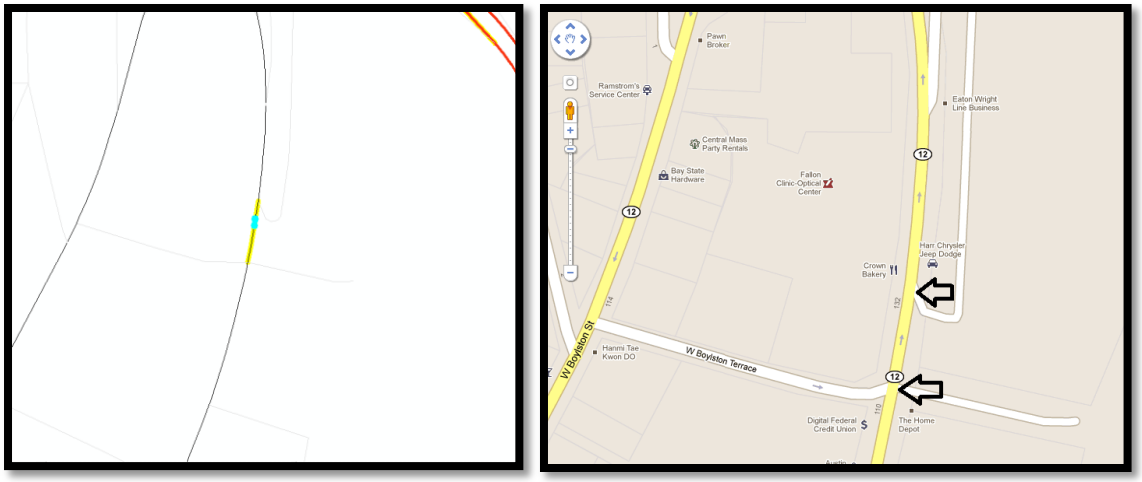
Figure 79. Roadway Segment 440664 ArcGIS and Google Maps

Roadway Segment 440664, located on Gold Star Boulevard (State Route 12) in Worcester, Massachusetts, is a one way four lane segment. Given the small nature of this segment, it can almost be regarded as a single intersection. This intersection is a large signalized intersection. This area is very busy and there is a lot going on to look at. The lane markings are hard to see as they are faded. There is a lot of traffic and the lanes appear narrow. The merge at the exit of Home Depot & Panera Bread is difficult to maneuver and there is limited sight distance as you turn the corner in which there are immediately other driveways in which cars may be exiting or stopped to pull into in either the right lane or the left lane (the same is true as you turn onto Gold Star Boulevard from West Boylston Terrace). Larger shoulders could aid in reducing rear end crashes on both side of this roadway. Perhaps one lane could be eliminated to make this change. The curb radius at Home Depot could be reduced to slow people down as the turn onto or off of this busy driveway.
