# Durability behavior of fiber reinforced polymer and steel reinforced polymer for infrastructure applications

A DISSERTATION

MISSOURI UNIVERSITY OF SCIENCE AND TECHNOLOGY

2017

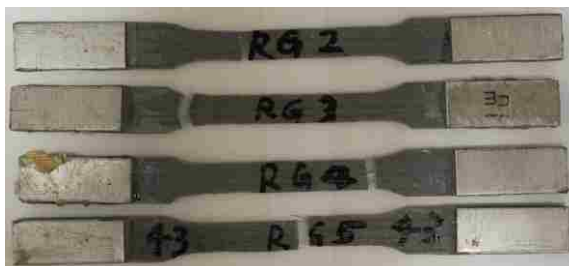
Figure 4.96. Representative tensile failure specimens

It can be seen in Tables 4.27 and 4.28 that no tensile strength loss was observed between the exposed and control specimens. Possible explanations could be the epoxy perfectly protects the micro-fine galvanized and micro-fine brass coating steel fibers, or the duration exposed to the environmental conditions may be not long enough to induce the corrosion of steel fibers in the epoxy resin.

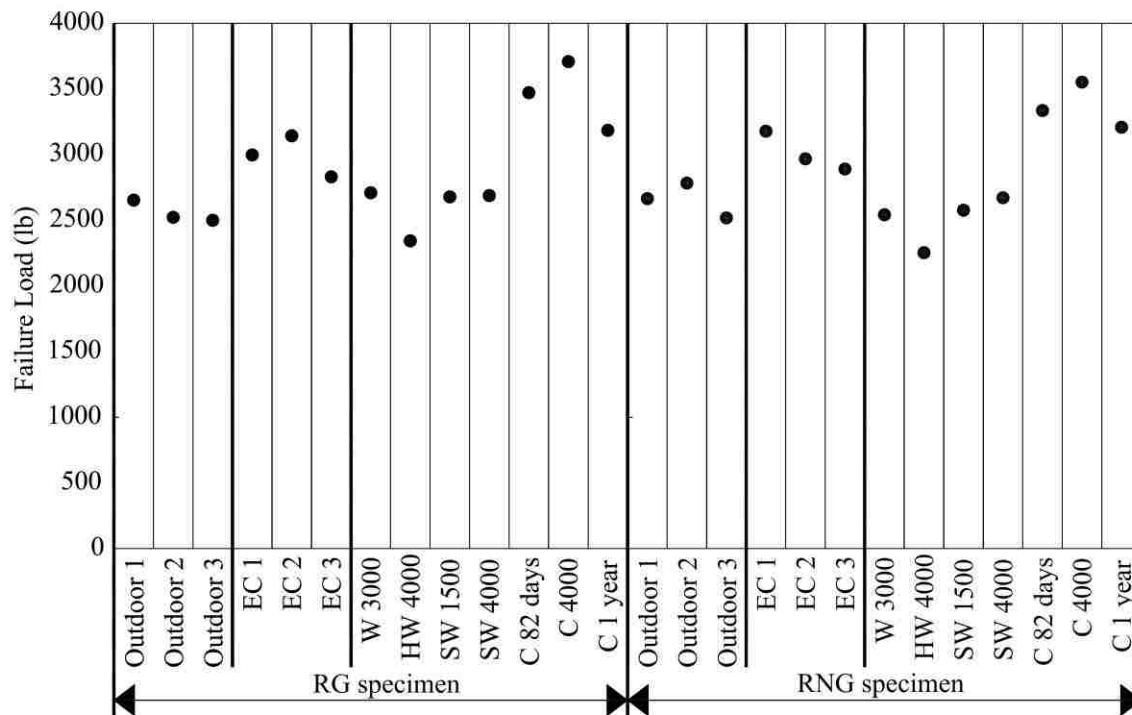
Figure 4.97. Summary of the flexural test results (Note: Outdoor and EC 1, 2, and 3 means the specimens loaded by 40%, 20% of ultimate load, and unloaded specimens)

It can be seen in Figure 4.97 that significant strength loss of the outdoor specimens and the specimens exposed to full immersion was observed when compared to the control specimens. Therefore, the real-time weather exposure and water considerably influenced the bond durability of the SRP-to-concrete systems. There is no apparent difference in ultimate strength between the RG and RNG specimens. In addition, the specimens exposed to hot water exhibited a strength loss of roughly 37% after 4,000 hours of exposure at 122°F (50°C). This is the most severe strength loss among the results. Thus, the temperature that concrete members reinforced with SRP were exposed to should be another crucial concern to deteriorate the bond performance between the SRP and concrete substrate. Even if water immersion at 122°F (50°C) was considered the most serious aging environmental condition for SRP/concrete application, this exposure

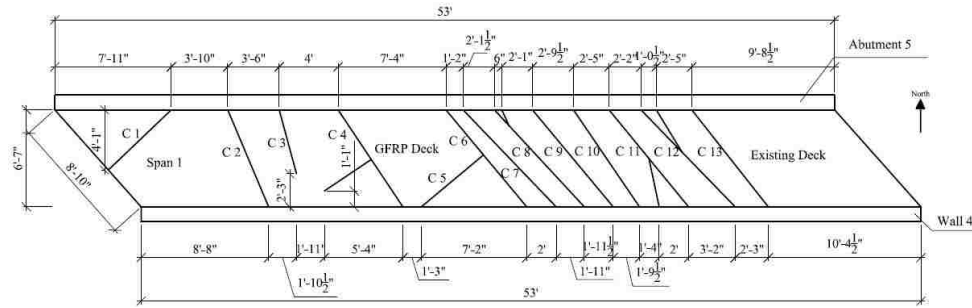
Figure 5.8. The locations of cracks of span 1

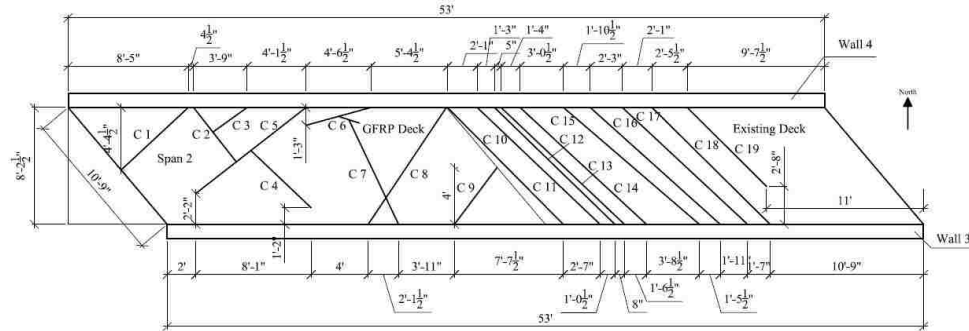
Figure 5.9. The locations of cracks of span 2

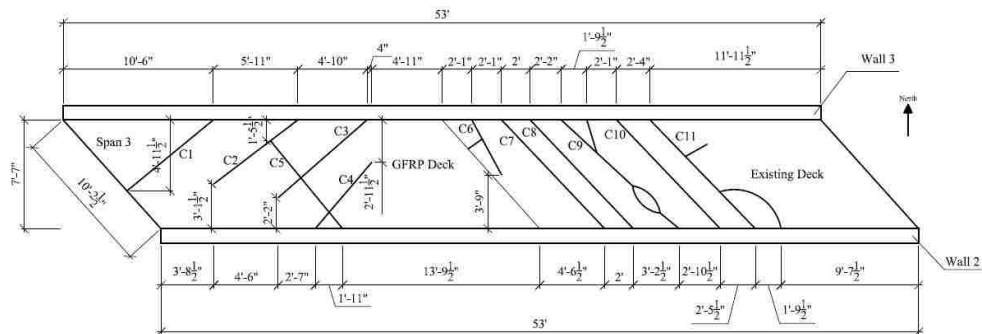
Figure 5.10. The locations of cracks of span 3

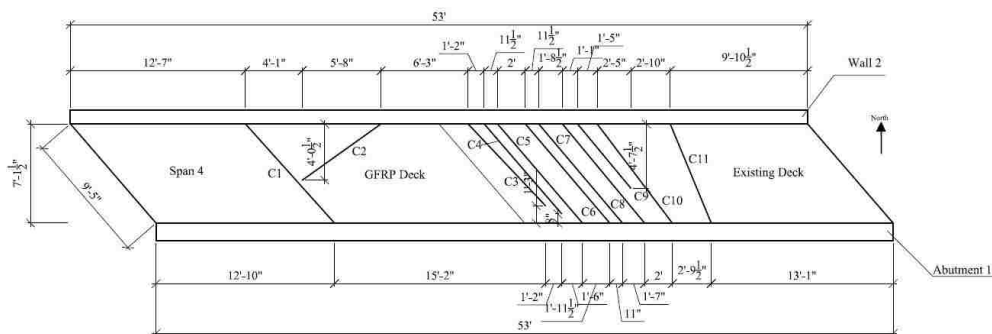
Figure 5.11. The locations of cracks of span 4

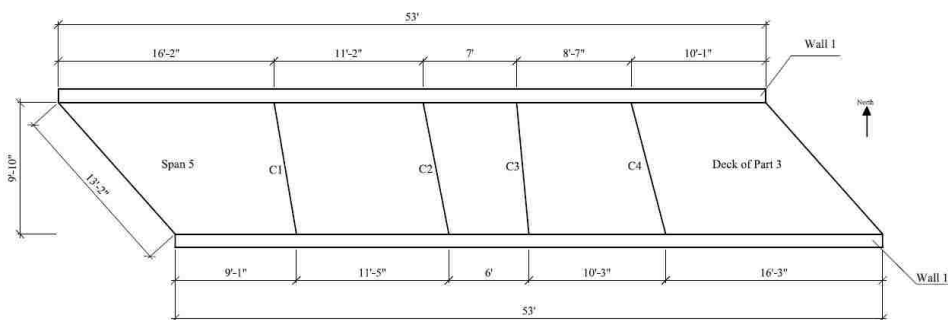
Figure 5.12. The locations of cracks of span 5

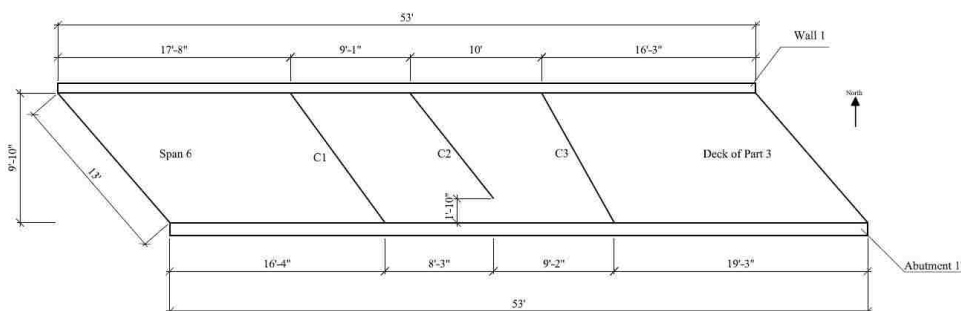
**5.3.1.2 The physical inspection.** This bridge consisted of three decks: the existing deck reinforced with steel, the deck reinforced with FRP bars, and the additional deck reinforced with steel, as illustrated in Figure 5.2. The bottom of the existing concrete deck exhibited more cracks. Figures 5.8 through 5.13 exhibit the distribution of cracks on the bottom of the decks of each span.

Figure 5.13. The locations of cracks of span 6

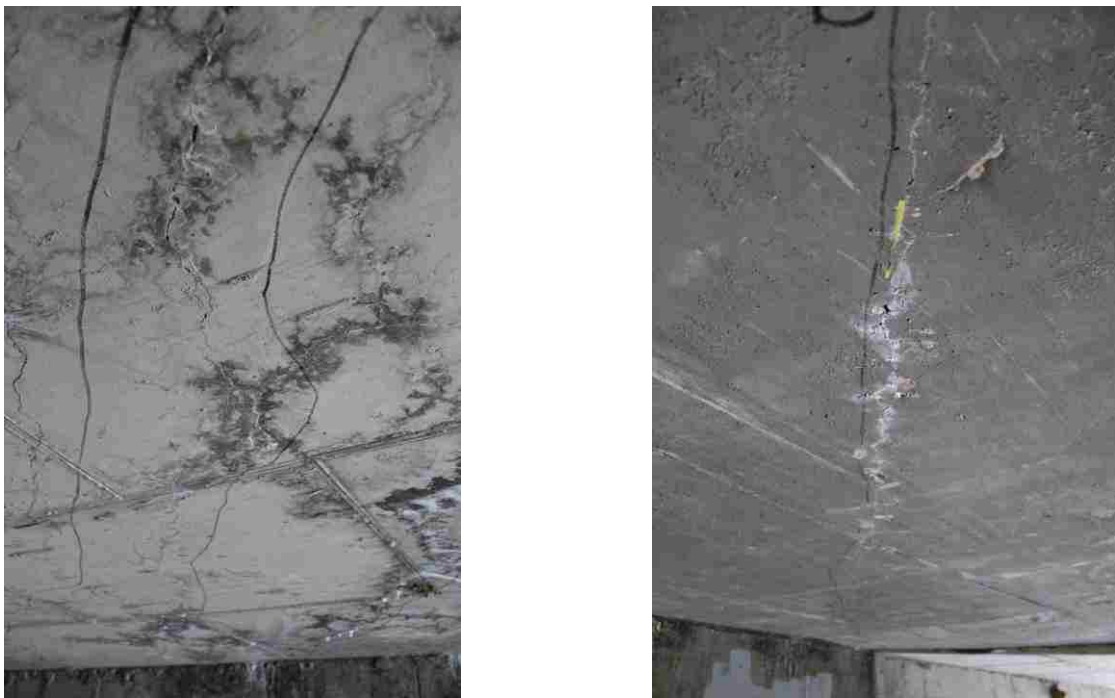
Figure 5.15. The cracks of span 2

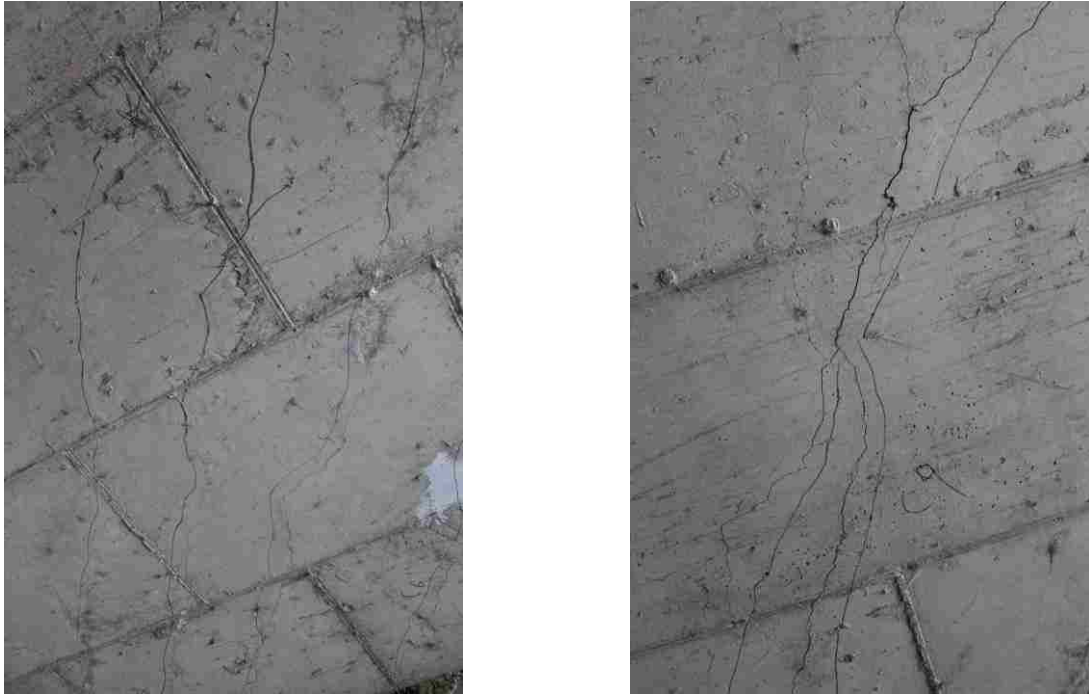
Figure 5.16. The cracks of span 3

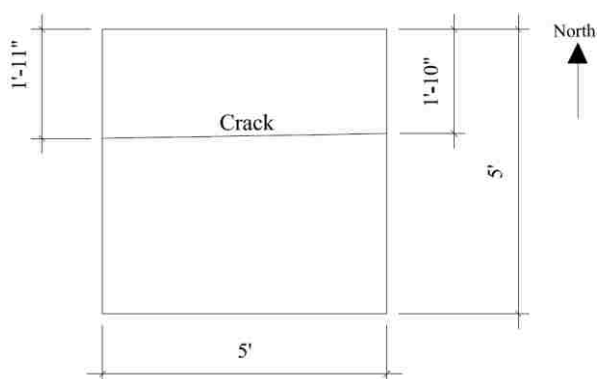
Figure 5.24. The location of crack on the top of Box 1

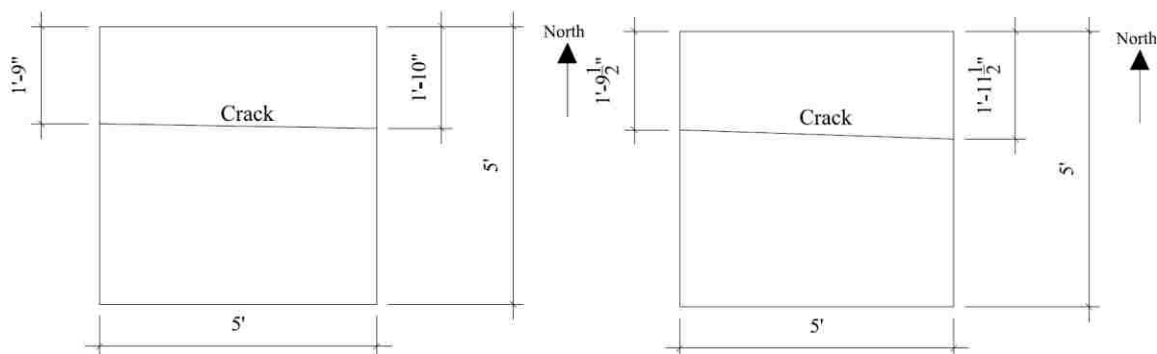
Figure 5.25. The locations of cracks on top (left) and bottom (right) of Box 2

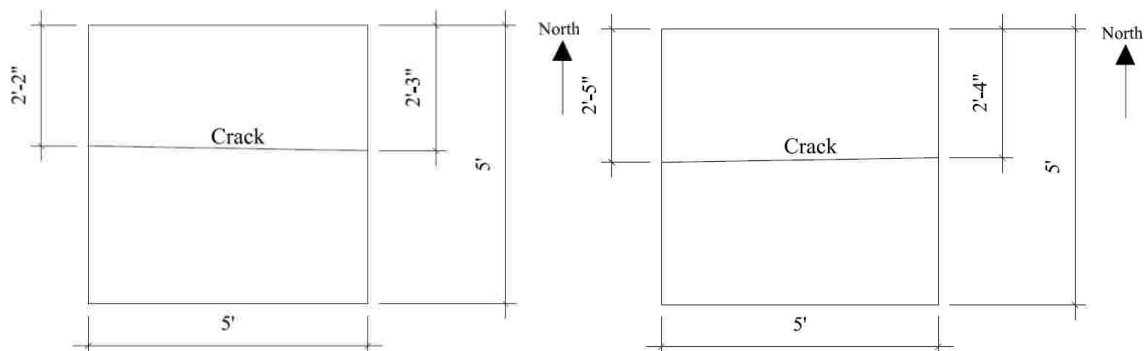
**5.3.2.2 The physical inspection.** This bridge consisted of two rows of box culvert units. Figure 5.23 exhibits the numbers and arrangements of the box culverts. Some cracks were observed on the tops and bottoms of these boxes. No cracks were observed on the sides of the boxes.

Figure 5.26. The locations of cracks on top (left) and bottom (right) of Box 3

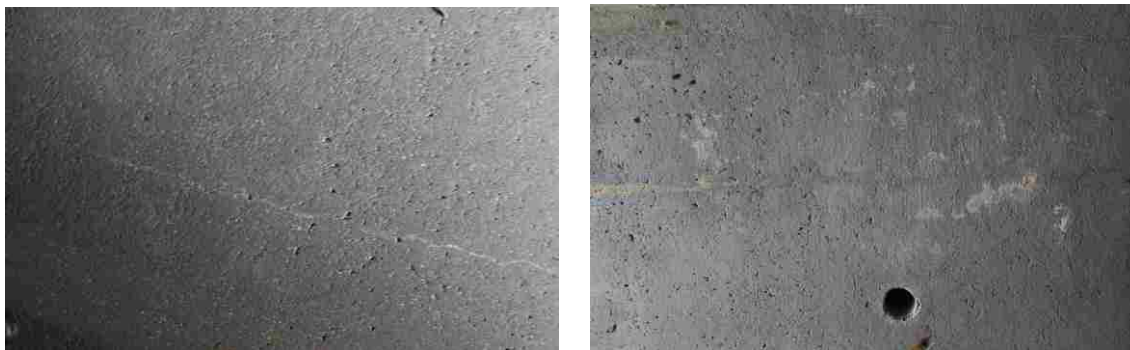
Figure 5.28. The cracks on the top (left) and bottom (right) of Box 12

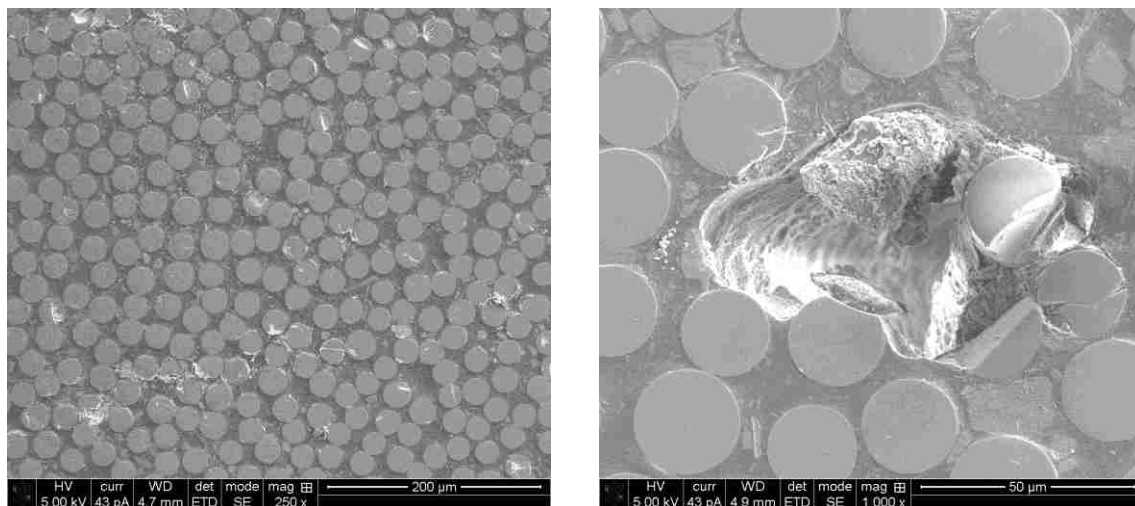
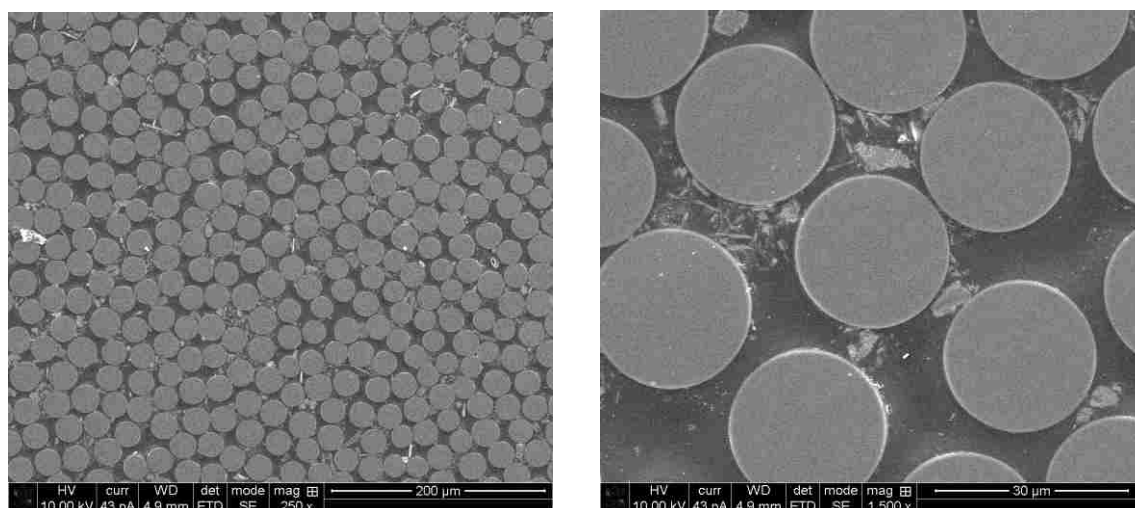
Figure 5.52. SEM images of the fibers and void at magnification levels of 250x (left) and 1000x (right) (Southview Bridge)

There was no sign of deterioration in the GFRP bars extracted from the Southview Bridge and the Sierrita de la Cruz Bridge. None of the glass fibers lost any cross-sectional area in these two structures. There was no degradation of the fibers observed and glass fibers were intact without any gap between the fibers and the

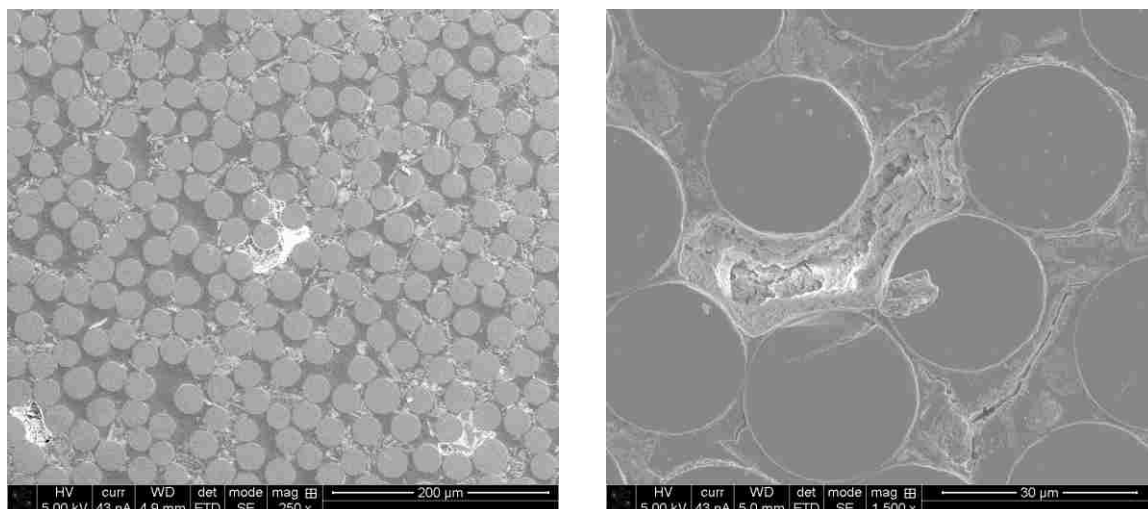
Figure 5.54. SEM images of the fibers at magnification levels of 250x (left) and 1500x (right) (C-1 B-3 of Walker Bridge)

It should be noted that there were some cracks exhibited in Figures 5.54 and 5.56 on the surfaces of GFRP bars extracted from Walker Bridge. The concrete cylinders were extracted from the bottom of box culvert. Water often runs through the boxes of this bridge, causing the FRP bars to be influenced by water. On the other hand, no evidence of deterioration on the glass fibers was observed. Individual fiber still maintained integrity. Therefore, it should be concluded that the resin matrix may be aged after 18 years of field exposure because the bottom of the box culverts that were repeatedly submerged in river water deteriorated.

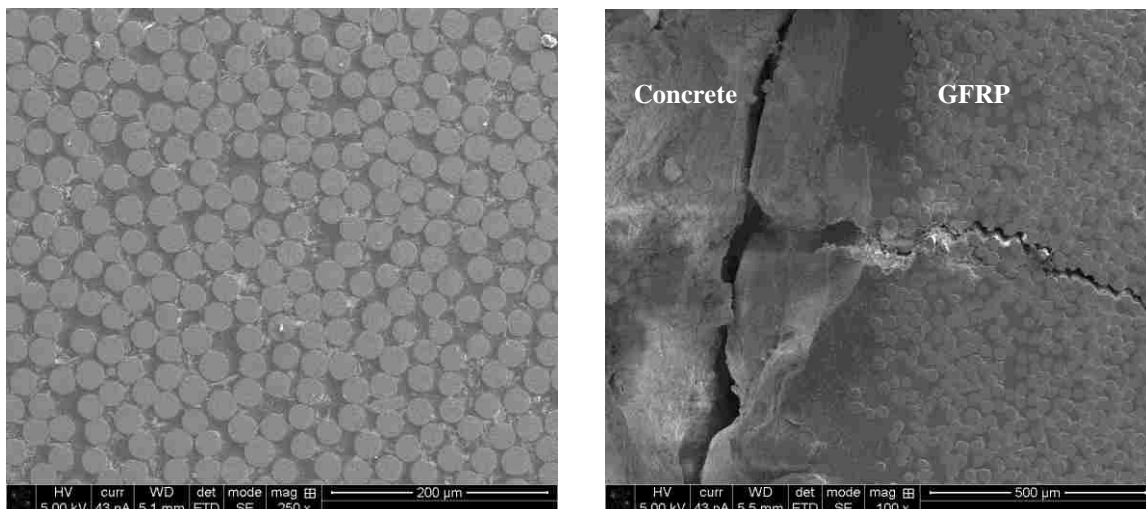
Figure 5.56. SEM images of the fibers and GFRP-concrete interface at magnification levels of 250x (left) and 100x (right) (C-2 B-3 of Walker Bridge)

surrounding resin matrix, indicating no loss of bond between glass fibers and resin. From Figure 5.56, there was a gap between the concrete and the GFRP bar. The sample preparation before the SEM and drying the sample in the SEM chamber may result in the interfacial damage of GFRP-concrete bond [47].

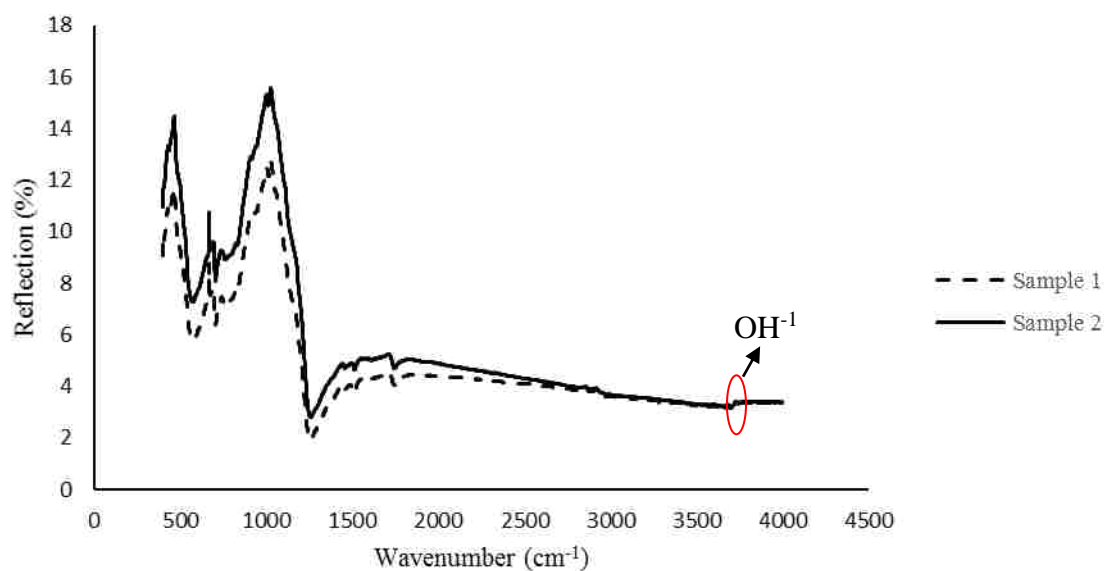
Figure 5.67. FTIR spectra for GFRP samples in Southview Bridge

It can be seen in Figure 5.67 that there were hydroxyl groups in GFRP samples from Southview Bridge. It shows that there was no difference in the spectra of the two samples. Similar conclusions were drawn for the GFRP samples from other bridges. However, due to no control specimens tested in this time, it cannot be concluded that $OH^{-1}$ was from the hydrolysis reaction. Therefore, FTIR analysis of control samples and comparison of the in-service and control specimens will be recommended as future work. Future cores can also be compared to results obtained herein.

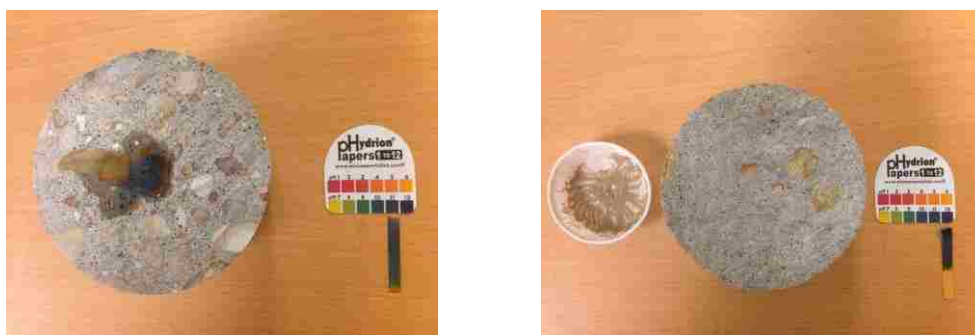
Figure 5.68. pH measurement of sample 1 (Southview Bridge): ASTM F710 (left) and Grubb's method (right)

It can be seen in Figures 5.68 through 5.72 that the pH values of concrete extracted from the three bridges were between 11 to 12 among all methods. The results of the concrete extracted from Walker Bridge and Sierrita de la Cruz Bridge were the same as those reported by UM. These results are also in agreement with expected values reported by Grubb [130]. It should be noted that using the approach recommended by Grubb and the coworkers should be more accurate than that of ASTM F710 (Section 5.2.1) since consistent results were attained by using this method in this study, as shown in Figures 5.68 through 5.71. Consequently, the approach suggested by Grubb et al. should be recommended, and it should be a more accurate method to determine the pH value of concrete. However, the procedure was simpler and faster to perform pH measurement when following ASTM F710 (Section 5.2.1).

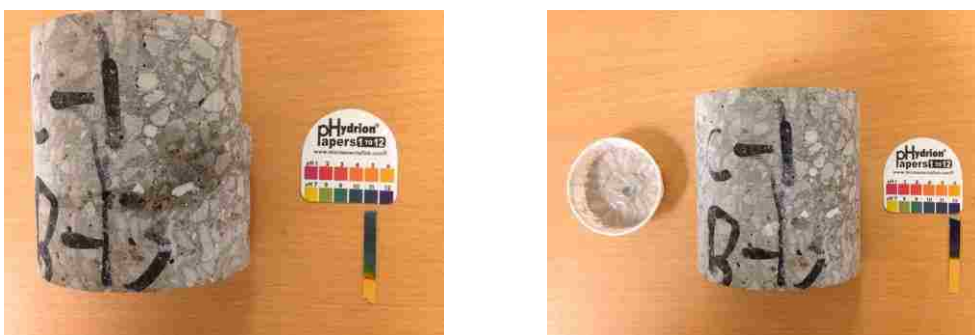
Figure 5.69. pH measurement of sample 2 (Southview Bridge): ASTM F710 (left) and Grubb's method (right)

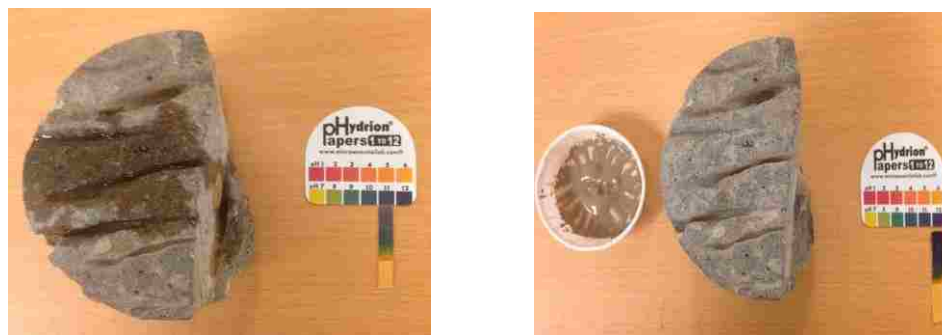
Figure 5.72. pH measurement (Sierrita de la Cruz Bridge): ASTM F710 (left) and Grubb's method (right)

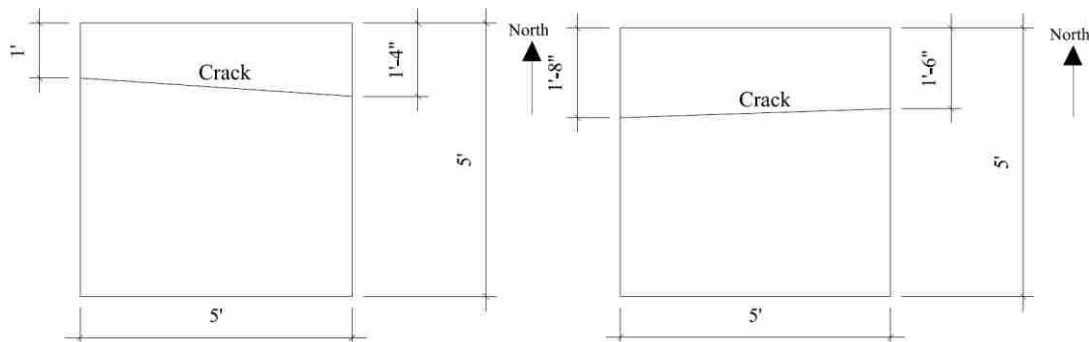
The locations of cracks on top (left) and bottom (right) of Box 4

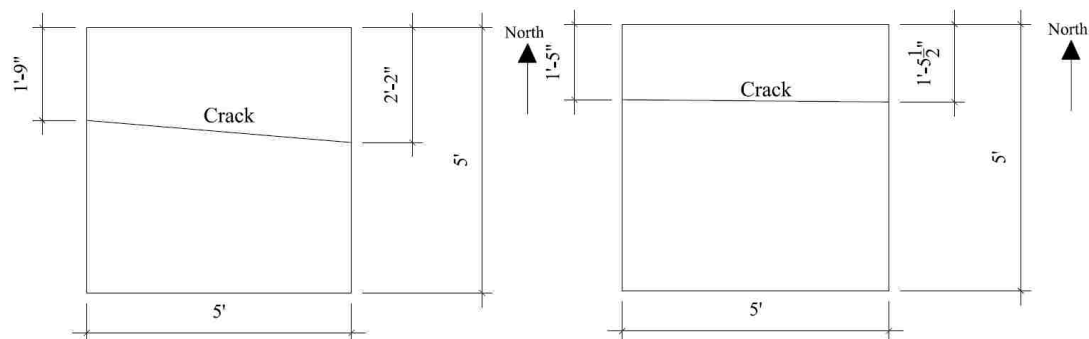
The locations of cracks on top (left) and bottom (right) of Box 5

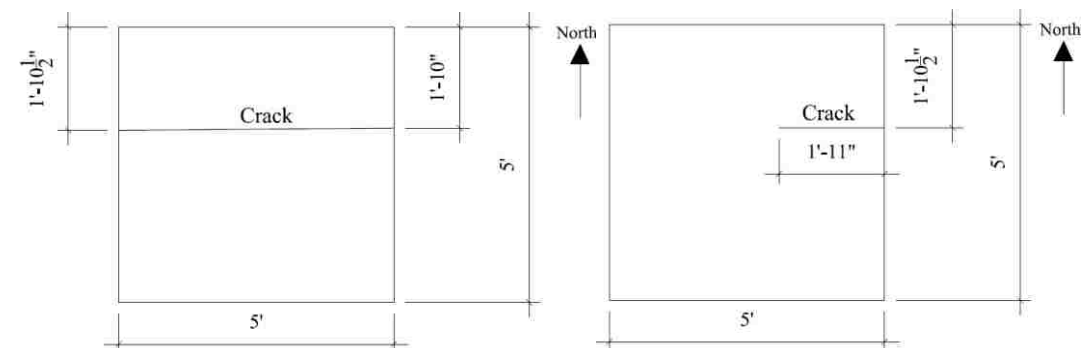
The locations of cracks on top of Box 7 (left) and bottom of Box 10 (right)

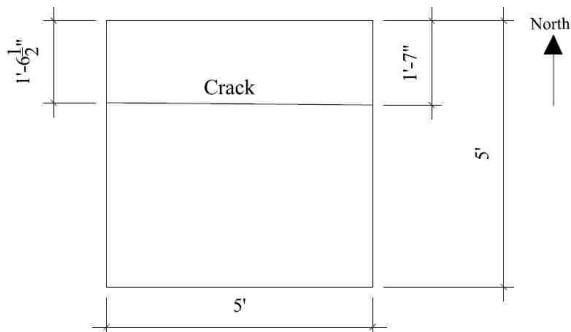
**5.5.2. Investigation for Walker Bridge.** This bridge consists of 18 boxes reinforced with #2 GFRP bars. They were arranged in two rows of nine. Boxes 6, 8, 9, 17, and 18 did not illustrate any cracks. Cracks were observed only on the top for Box 1, 7, 10, and 11.  The other boxes displayed only one crack on the top and another on the bottom. The maximum crack width was 0.0625 in. (1.60 mm).

The locations of cracks on top of Box 11

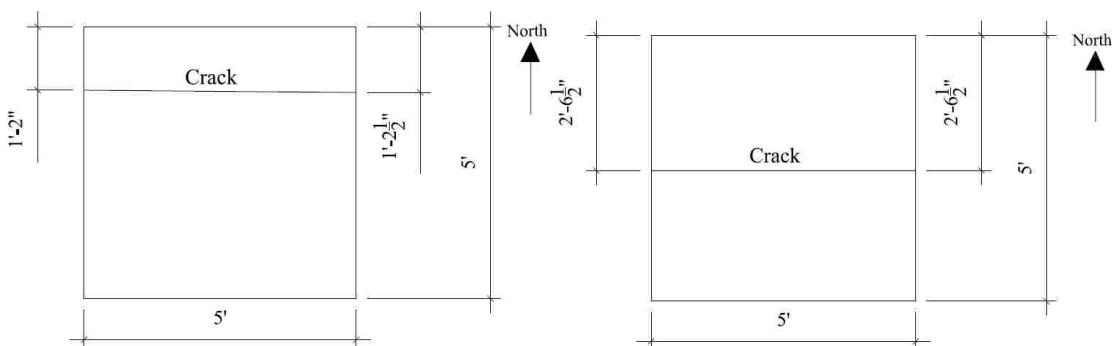
The locations of cracks on top (left) and bottom (right) of Box 12

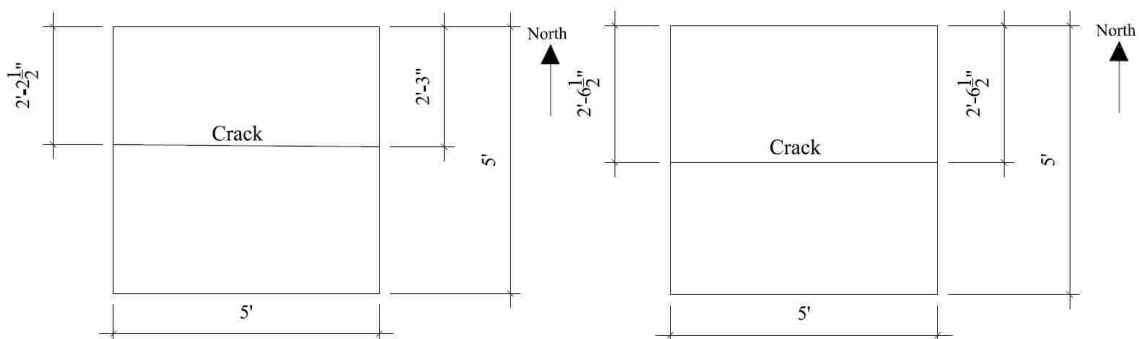
The locations of cracks on top (left) and bottom (right) of Box 13

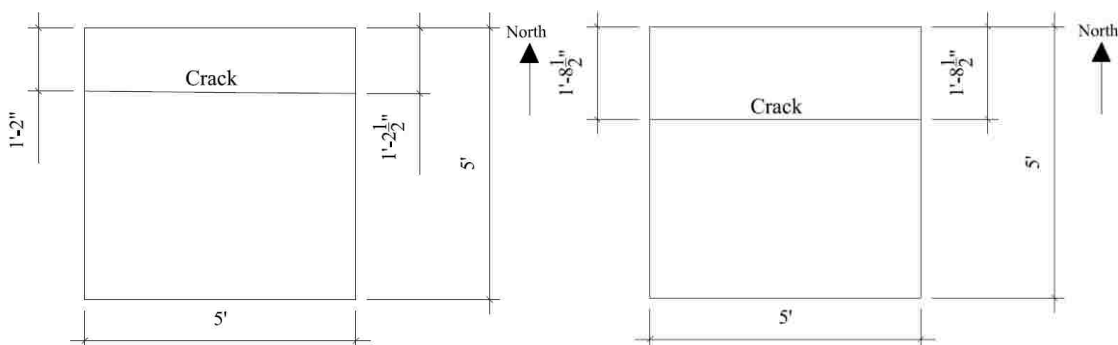
The locations of cracks on top (left) and bottom (right) of Box 14

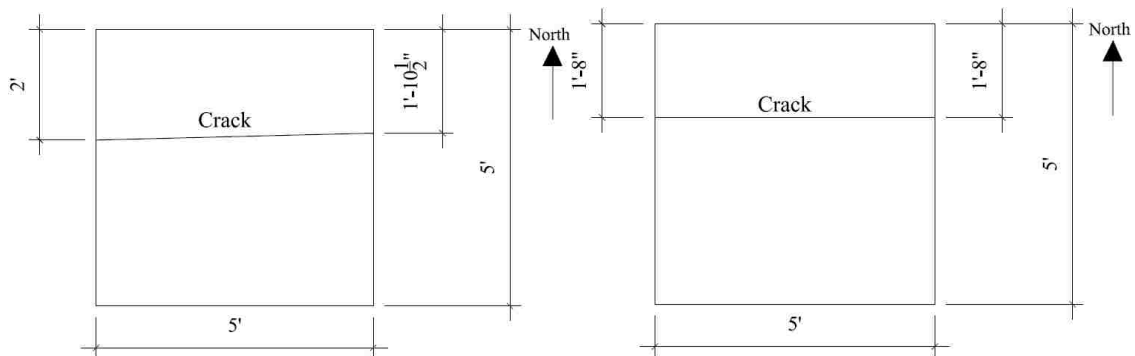
The locations of cracks on top (left) and bottom (right) of Box 15

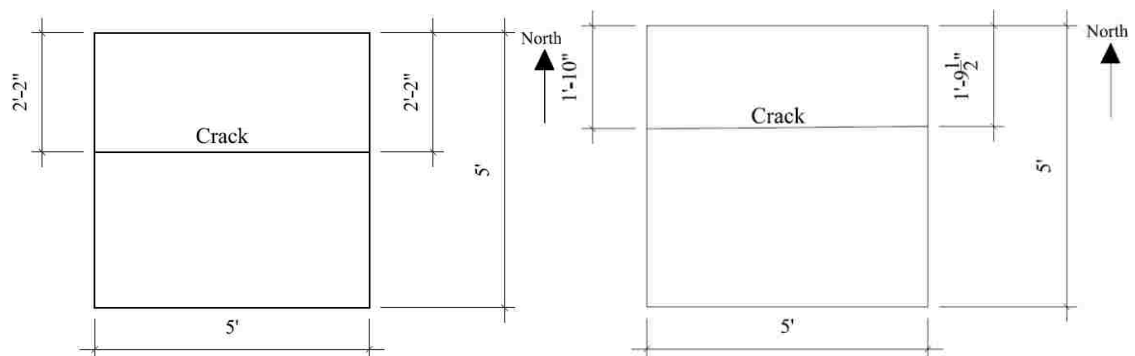
The locations of cracks on top (left) and bottom (right) of Box 16

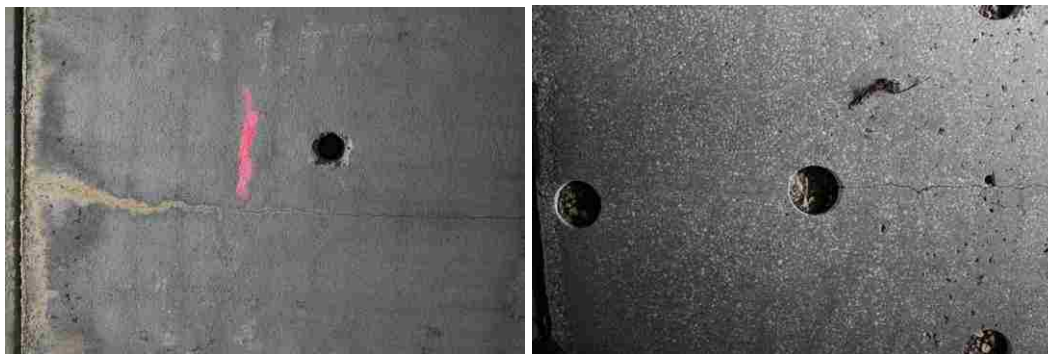
The cracks on the top (left) and bottom (right) of Box 3

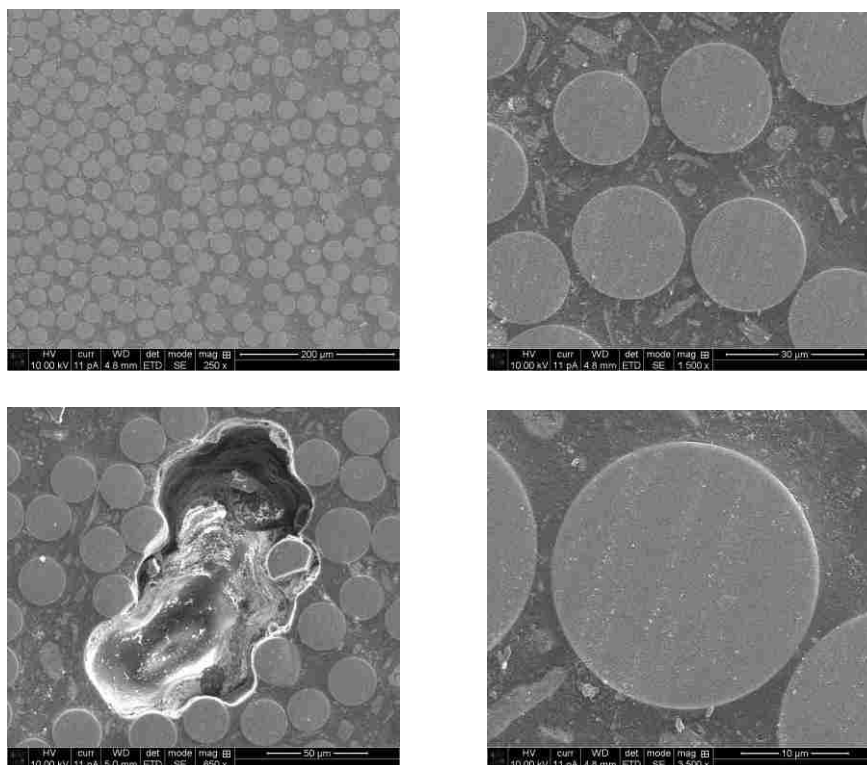
4) For SEM analysis, in each of Southview Bridge and Sierrita de la Cruz Bridge, there was no sign of any deterioration in the GFRP bars extracted from these two bridges. None of the glass fibers lost any cross-sectional area in each of these two structures. There was no degradation of the fibers observed. And glass fibers were intact without any gap between the fibers and the surrounding resin matrix indicating no loss of bond between glass fibers and resin. It should be noted that there were some cracks on the surfaces of GFRP bars extracted from Walker Bridge. The concrete cylinders were extracted from the bottom of box culvert. Water often runs through the boxes of this bridge, causing the FRP bars to be influenced by water. On the other hand, no evidence of deterioration on the glass fibers was observed. Individual fiber still maintained integrity. Therefore, it should be concluded that the resin matrix may be aged after 18 years of field

SEM images of sample 2 at different magnifications (Southview Bridge)

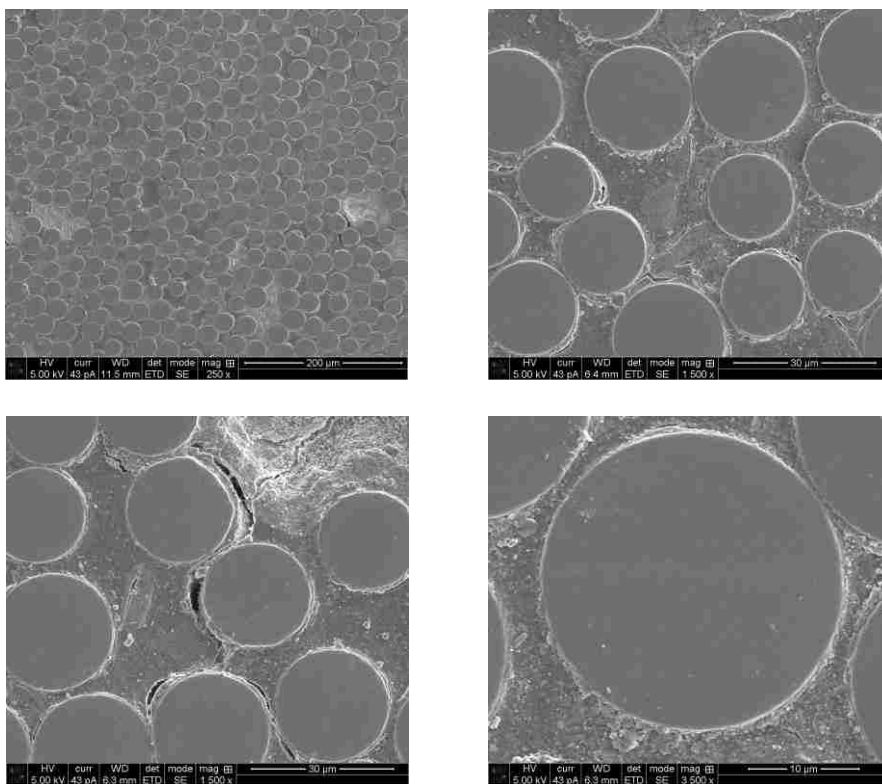
SEM images of sample 3 at different magnifications (Walker Bridge)

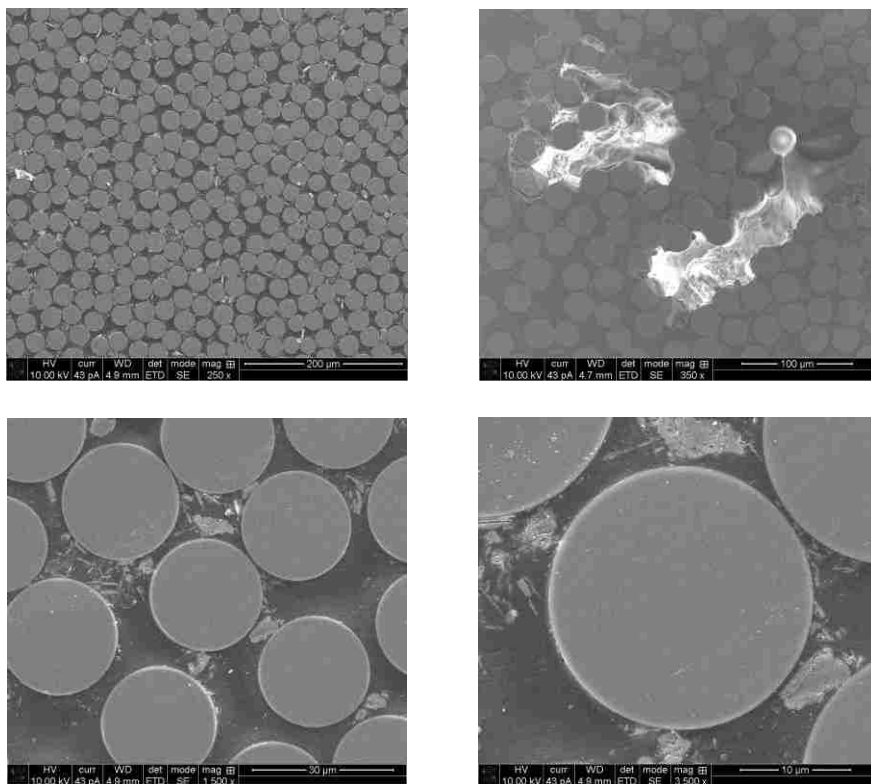
SEM images of sample 1 at different magnifications (Sierrita de la Cruz Bridge)
