Experimental and analytical assessment of prestressed concrete bridges damaged by overheight vehicle impact

Major: Civil Engineering (Structural Engineering)

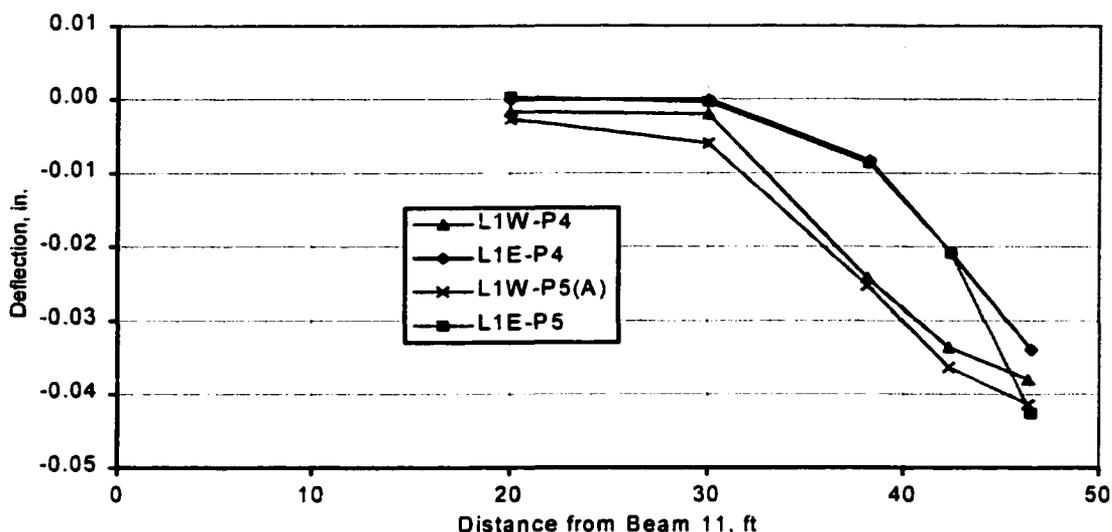
In Figure 3.15, deflections at transverse sections W2 and E2 are compared. The WB and EB bridges behave differently in these tests. The WB bridge has a characteristic reverse curvature in the deflected shapes while such a reversal is not present in the EB bridge. Beams 3, 5 and 7 of the WB bridge, undamaged as in the EB bridge, deflect more than their counterparts in the EB structure. This increase is indicative of a greater share of the applied load, i.e., redistribution of load, being carried by the stiffer portions of the WB bridge due to the presence of damage in the exterior beam lines. The same trend was observed at sections W4 and E4.

Figure 3.15. Comparison of Deflections at Transverse Section W2 and E2: Truck in Center Span.

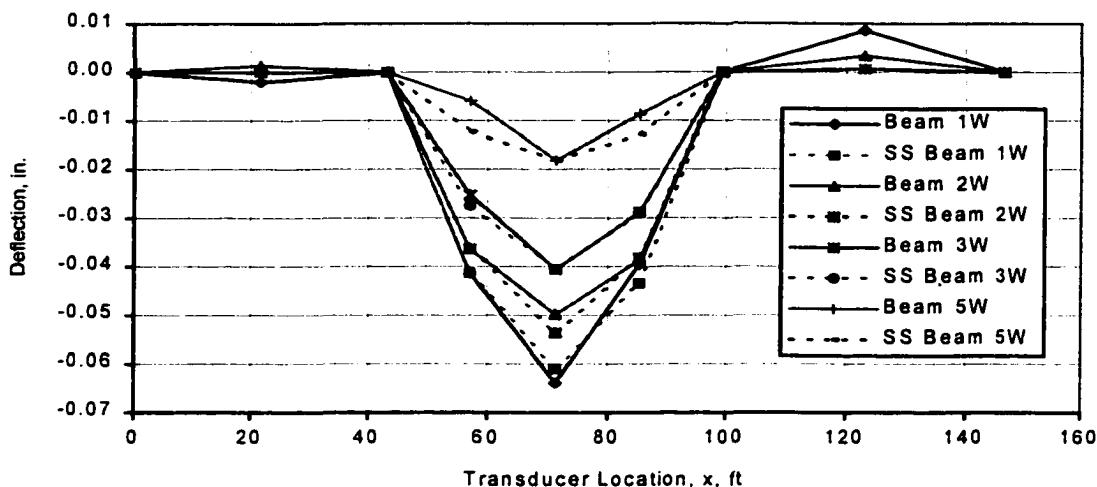
To confirm the minimal observed continuity in the WB bridge, an analytical deflected shape corresponding to test L1W-P5 is plotted as series SS Beam for all of the beams depicted. The analytical model presumes simply supported conditions and no damage, i.e. a constant moment of inertia. An arbitrary flexural stiffness, EI, was assigned to the member. Shear distortions were not considered although they may occur in the damaged region.

In order to compare the deflected shapes, the computed analytical deflected shape was normalized to the experimental deflection at the east quarter point for the damaged beams, Beams 1W and 2W, and at midspan for Beams 3W and 5W. Recall that the damage to Beams 1W and 2W was located west of midspan, hence the east 1/4 point was chosen to normalize the shapes for those two beams. Having computed the deflected shape of a simply supported beam of uniform stiffness, it was found that the ratio of the 1/4 point, midspan and 3/4 point deflections had a ratio of 1.0 : 1.478 : 1.052 for the prescribed loading, inertia and support conditions. Comparing the measured and predicted values in Figure 3.17, it appears that the damage does not have a significant effect on the deflection of Beams 1W – 3W because they are part of a highly redundant structural system. The predicted uniform stiffness deflections and measured deflections at the midspan and 3/4 point locations are approximately the same.

Figure 3.17. Longitudinal Deflected Shape, Beams 1W-5W: Truck 1 at L1W-P5.

Beam 5W is interesting in that unlike Beams 1W – 3W, the deflection pattern is much different than expected for a simply supported beam of uniform stiffness. The deflections appear to be more like that expected of a beam with end restraint. However, with loads placed in Lane 1W, Beam 5W is not subject to direct wheel loads but is drawn down by the loaded beams. As such, a different deflection pattern, i.e. different than the results if the beam were subjected to concentrated wheel loads, is expected.

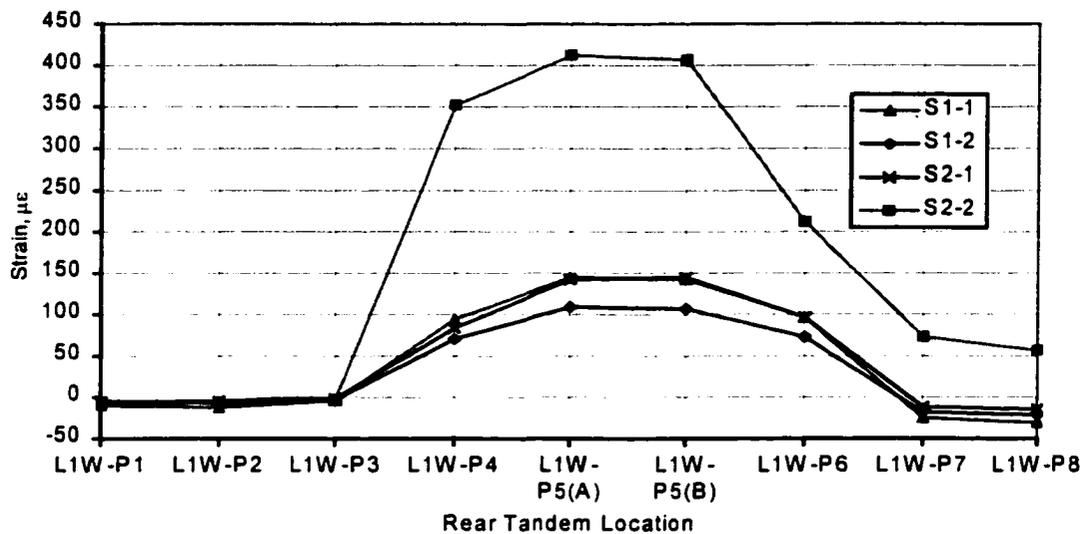
Figure 3.23. Exposed Strand Strains: Lane 1W Loaded.

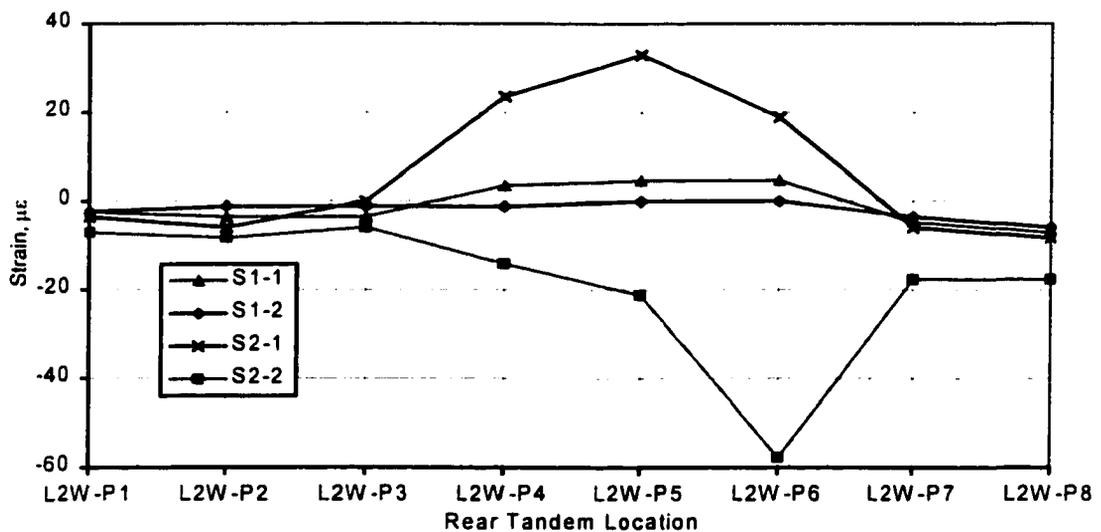
Strains from the exposed strands in the WB bridge are presented in Figure 3.27. The strains in the instrumented strands in Beam 2W are inconsistent; S2-2 is suspect. The data indicate that essentially no load is transferred to the exterior beam of the damaged WB bridge, Beam 1W, and very little to Beam 2W. Comparing the response of gage S2-1 in Tests 1W and 2W, the measured strain decreases from a maximum

Figure 3.27. Exposed Strand Strains: Lane 2W Loaded.

of +145 µε during the Lane 1W tests to +33 µε in the Lane 2W tests, a reduction of approximately 75%. Considering loading, the amount of live load carried by Beam 2W is only 1/4 that carried in the Lane 1W tests. This indicates that damage to exterior or near exterior beam lines, even if severe, is not a significant structural problem as long as traffic is diverted so that it is not in "close proximity" to the damaged element.

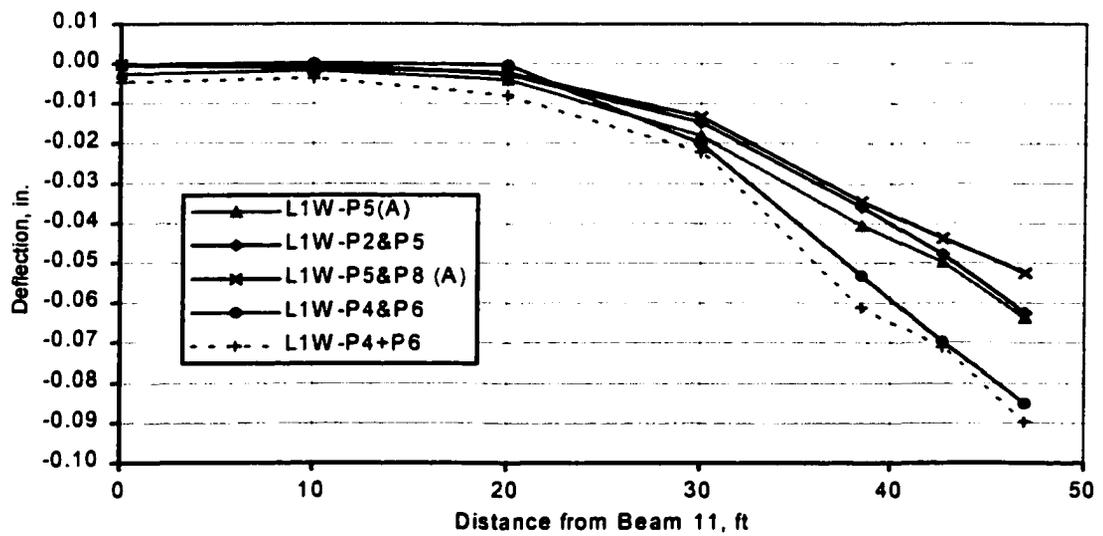
Deflections at midspan of the center span of the WB bridge for several load placements are presented in Figure 3.32. During the tests in which only a single truck was positioned in the center span, L1W-P2&P5 as well as L1W-P5&P8, the response is essentially the same. The response compares favorably to that measured during the single lane tests in Lane 1W, load position L1W-P5(A). Also presented is the response of the center span when trucks were positioned at P4 and P6. Test L1W-P4&P6, compares very well to that obtained by superposition of the effects of Truck 1 placed at P4 and P6, L1W-P4+P6. The minor differences are due to the fact that Trucks 1 and 2 are not exactly alike.

The validity of superposition is also apparent in this figure. The results of two trucks located on the bridge, L1E-P4&P6, are nearly the same as the superimposed results of Truck 1 located at two points independently, L1E-P4+P6. Compared to the WB bridge data presented in Figure 3.32, the EB bridge has a greater deflection gradient across the width of the bridge. Although Beams 1W and 1E have nearly the same deflection, this does not indicate similar load distribution since the WB bridge stiffness has been compromised due to damage. The fact the Beams 3W and 5W of the WB bridge deflect somewhat more than in the EB bridge is an indication of "load shedding" in the WB bridge to the stiffer interior beams.

Figure 3.32. Deflections at Transverse Section W3: Lane 1W Loaded with Trucks 1 and 2.

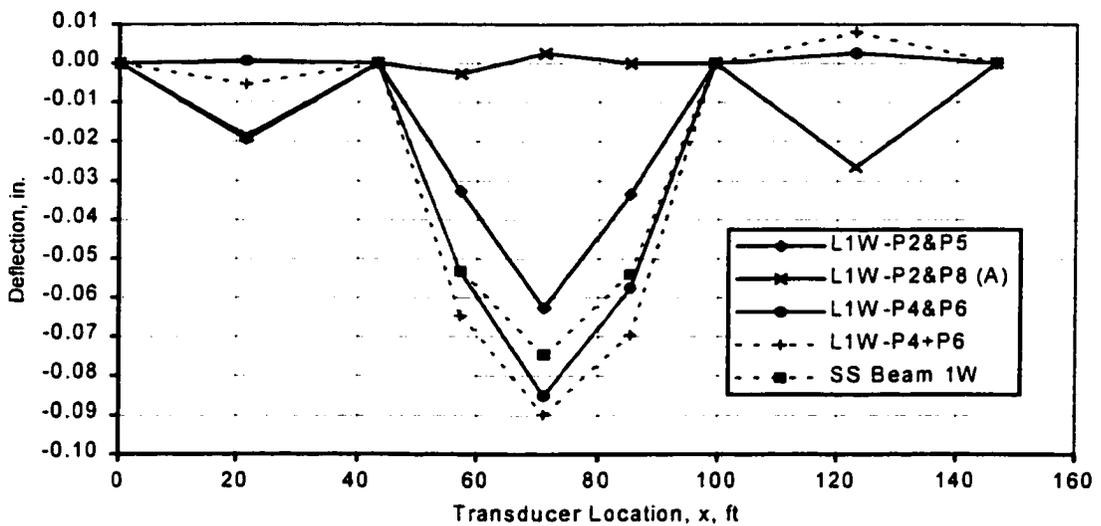
The longitudinal deflected shape of Beam 1W resulting from several load cases is presented in Figure 3.34. Test L1W-P2&P5 involves loading midspan of the east and center spans of the WB bridge simultaneously. As expected, these spans deflect while the west end span remains in essentially a neutral position. As Truck 1 is moved to the west end span for load test L1W-P2&P8, the center span deflects upward while the two end spans deflect downward. Finally, the two test trucks are positioned in the center

Figure 3.34. Longitudinal Deflected Shape, Beam 1W: Trucks 1 and 2 in Lane 1W.

span for test L1W-P4&P6. This test proved to be critical with the deflections of Beams 1W and 2W being greater than during the adjacent lane tests. The recorded deflections from both test trucks on the bridge are somewhat less than the results of Truck 1 at P4 and P6 superimposed however the agreement is acceptable.

Similar to the single lane tests, the analytical deflected shape of an undamaged beam is plotted as series SS Beam 1W. The analytical shape was normalized to the experimentally recorded deflections at the east quarter point of the beam. For the prescribed inertia and support conditions, the ratio of the analytical 1/4 point, midspan and 3/4 point deflections is 1.0 : 1.398 : 1.015. Noting the differences between the

analytical and experimental deflected shapes, it appears that the damage has an effect on the deflection of Beam 1W. Similar analytical/experimental behavior was found for Beam 2W.

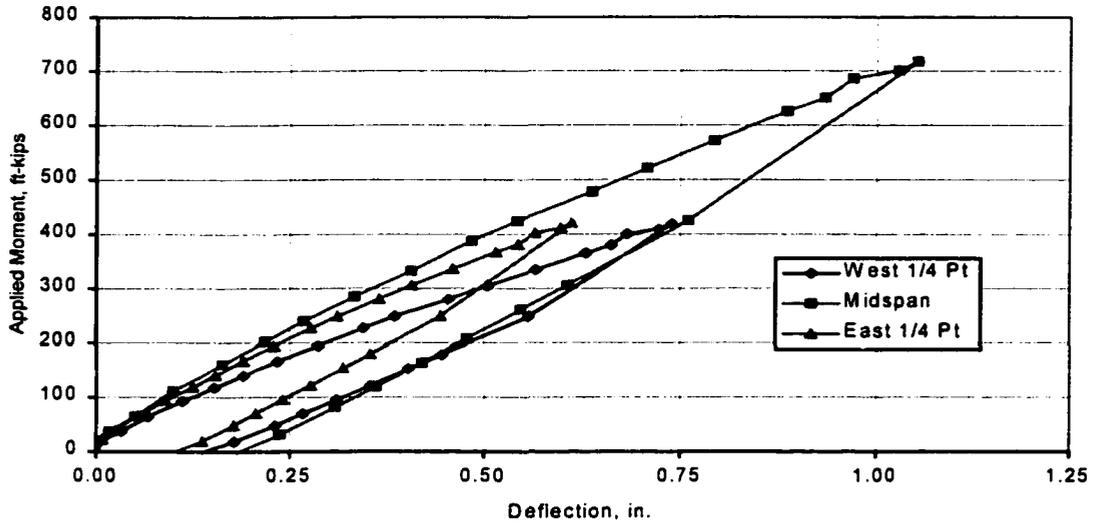
Figure 4.8. Service Test of Beam 1W: Applied Moment vs. Deflection.

Figure 4.8 presents the applied moment versus deflection of Beam 1W during the service load test. Even with the large amount of damage in the web and flange regions the deflection behavior of the beam is essentially linear. The effect of the localized loss of section west of the midspan diaphragm is evident in that under symmetric loading, the west 1/4 point deflects approximately 20% more than the east 1/4 point.

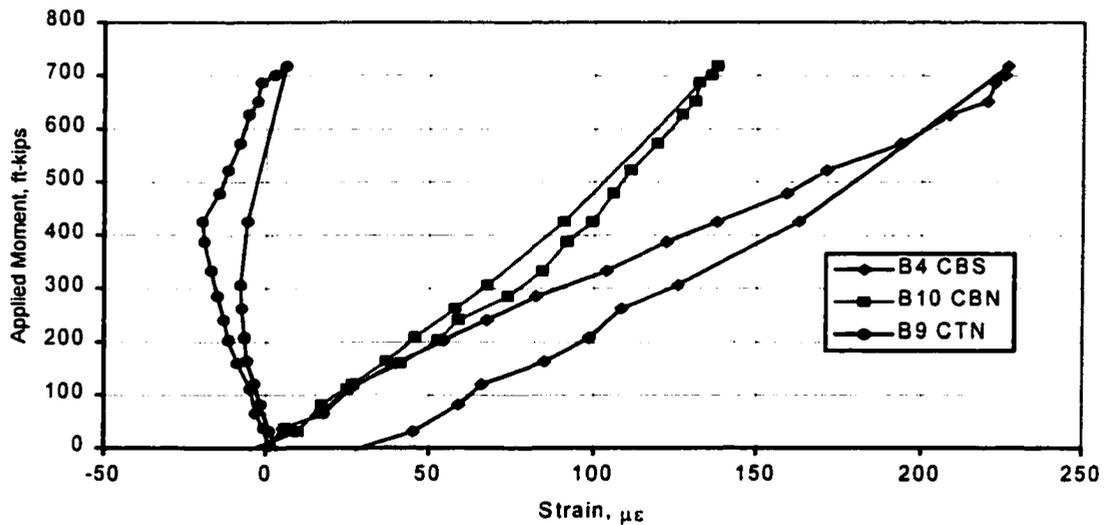
Figure 4.9. Service Test of Beam 1W: Applied Moment vs. Midspan Strains.

Midspan surface strains vs. applied moment are presented in Figure 4.9. Between an applied moment of 300 and 400 ft-kips, the behavior of gages B9 and B10 changes, likely due to the opening of a crack. The quarter point strains are linear throughout the test.

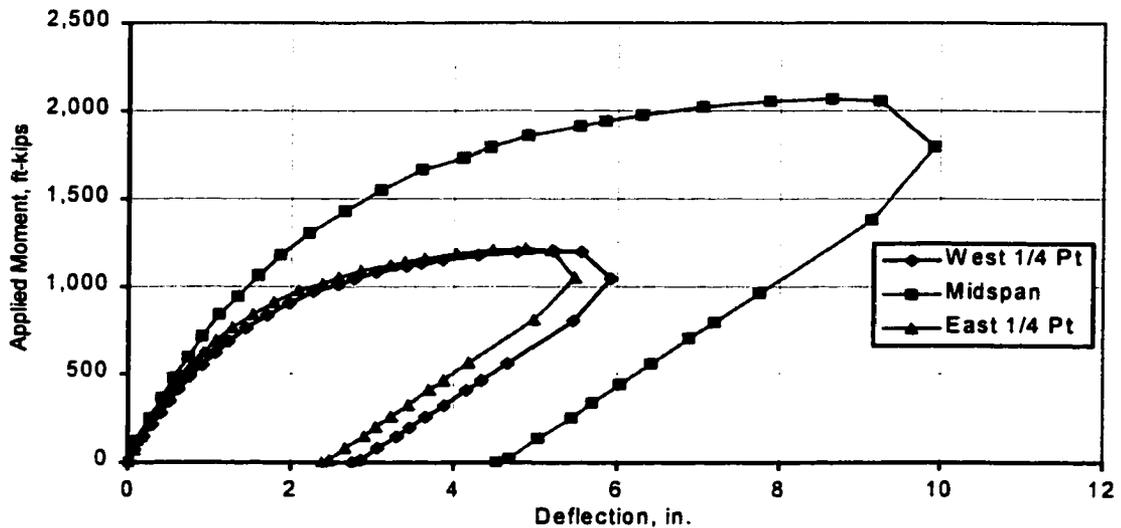
In Figure 4.16, the applied moment versus recorded deflections during the ultimate load test of damaged Beam 1W are presented. The beam behaved in a ductile fashion with significant inelastic response. At ultimate load, the deflection of the west quarter point is 5.22 in. and of the east quarter point, 4.88 in., a 7% difference. These deflections are due to a live load moment of approximately 1210 ft-kips at the quarter points. The ultimate live load moment throughout the damaged region was 2067 ft-kips with a corresponding deflection of 8.62 in. When the ultimate load was reached, progressive failure of the beam began with large vertical flexural and diagonal shear cracks propagating up into the top flange. These cracks are noticeable in Figures 4.12 through 4.15. Along with crack propagation, a portion of the overlay crushed and debonded from the original slab and the beam sheared vertically and displaced laterally in the damaged region; the debonded slab overlay is visible in Figure 4.13. Prior to shear failure, the behavior was unstable with increasing displacement under decreasing loads, a sign of impending failure. Once the beam failed, the load was held constant for approximately 10 minutes while the beam was photographed and examined. The unloading curve is presented to illustrate the recovery of this beam during unloading.

Figure 4.16 Ultimate Load Test of Beam 1W: Applied Moment vs. Deflection.

As a comparison of the AASHTO predicted strength and that measured, consider that the ultimate live load moment of 2,067 ft-kips in addition to a dead load moment of approximately 400 ft-kips is a total moment resisted by the damaged beam of 2,467 ft-kips. This is 14% greater than the most optimistic Code-based prediction of the damaged beam strength presented in Table 4.1, 2,160 ft-kips for a beam with three severed/ruptured strands though recall that the code equation approach may potentially be inapplicable due to the suspect effective prestress level.

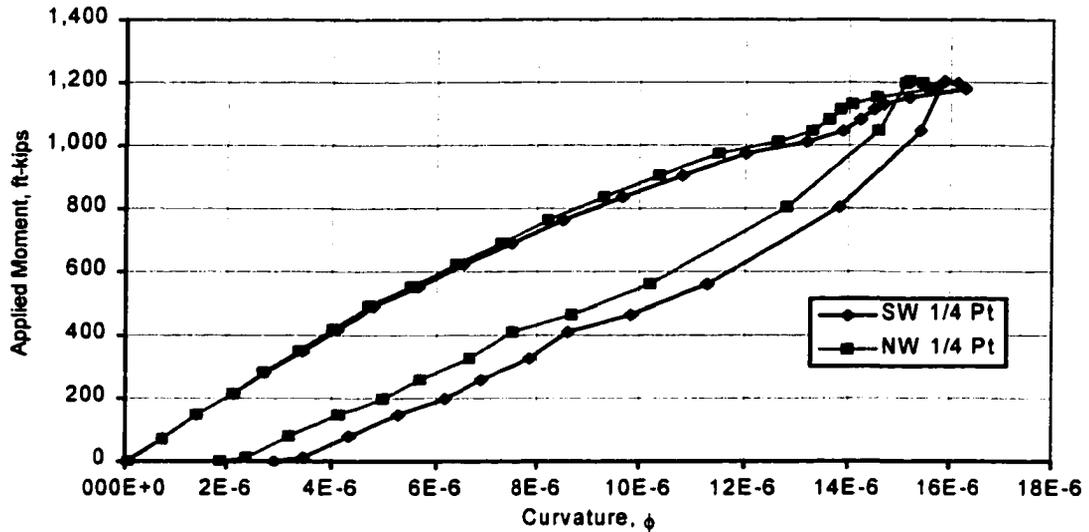
Figure 4.17 presents the moment, M, versus curvature, ϕ, response for the west quarter point where ϕ=M/EI. For a section whose stiffness does not change with applied load, the M vs. ϕ response should be linear. A decreasing slope indicates cracking. Figure 4.17 indicates that the M vs. ϕ response begins to flatten out at a quarter point live load moment in excess of 500 ft-kips.

Figure 4.17 Ultimate Load Test of Beam 1W: Applied Moment vs. Curvature at W Quarter Point.

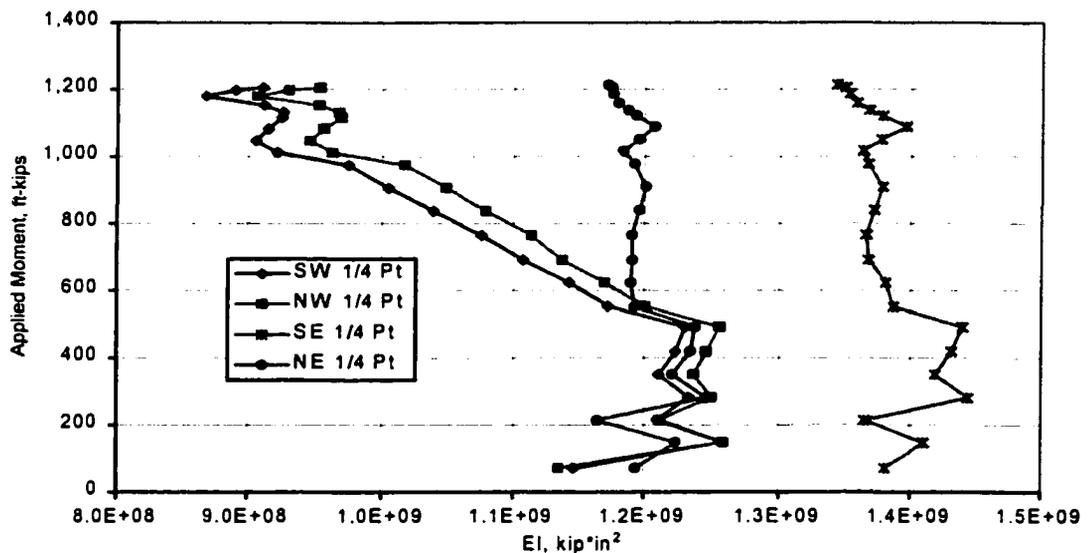
Figure 4.18 Ultimate Load Test of Beam 1W: Applied Moment vs. EI at Quarter Points.

As a measure of flexural stiffness, computed values of EI, based on measured load and curvature data, are presented in Figure 4.18. The figure indicates that EI begins to decrease after a moment of 500 ft-kips is applied at the west quarter point. The east quarter point remains at a fairly constant stiffness even at ultimate load. For a lower bound EI of the uncracked section of approximately 1.25×10^9 kip-in^2 and an assumed "I" of 178,000 in^4 at the quarter points, the implied Modulus of Elasticity is 7,022 ksi, much different than the value of 4,600 ksi computed based on the core compression test results. This poor correlation of predicted and experimental E values is consistent in all beams tested in this research project.

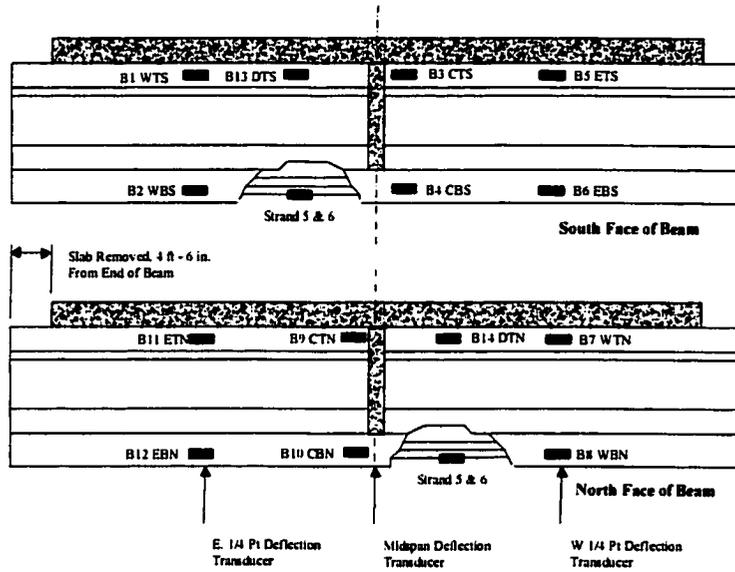
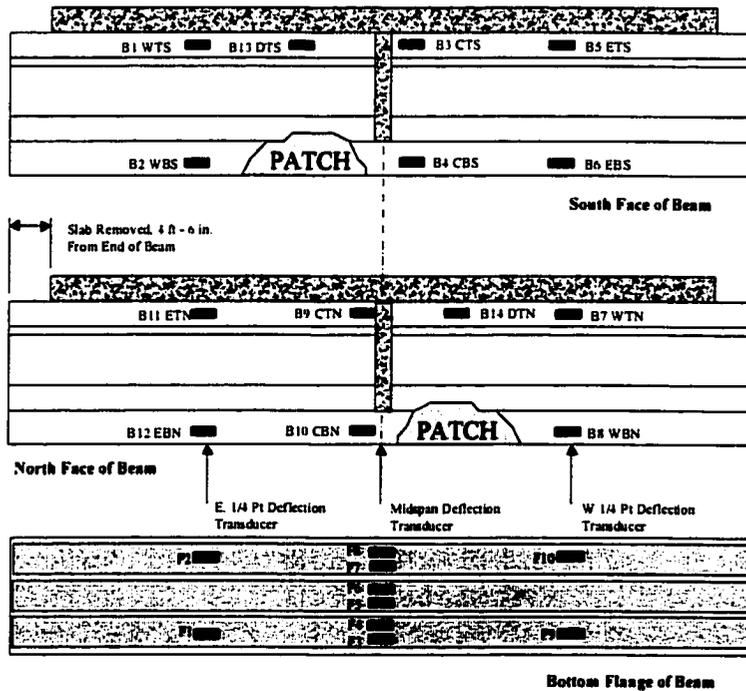
Figure 4.26. Pre and Post Strengthening Instrumentation on Beam 2W.

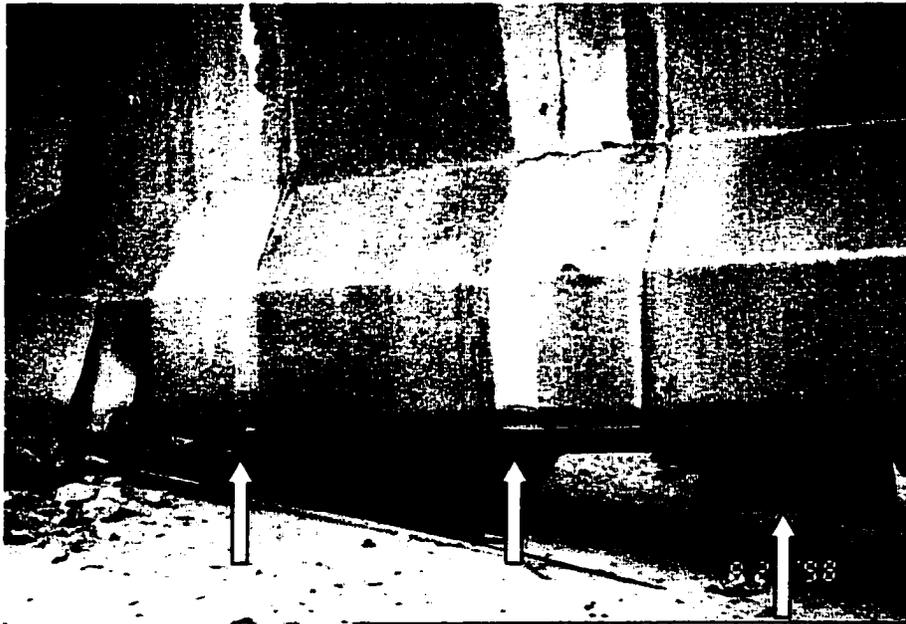
Figure 4.42. Fractured CFRP Stirrups and Debonded Plates Near Midspan of Repaired Beam 2W.

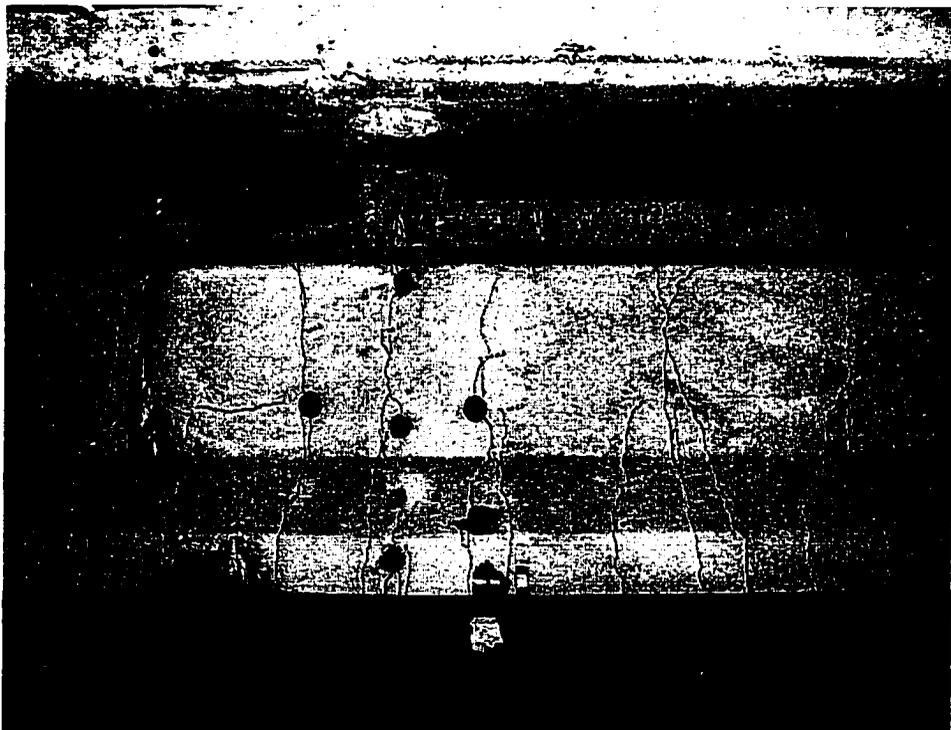
Figure 4.73. Extensive Vertical Cracking in the Constant Moment Region of Beam 1.

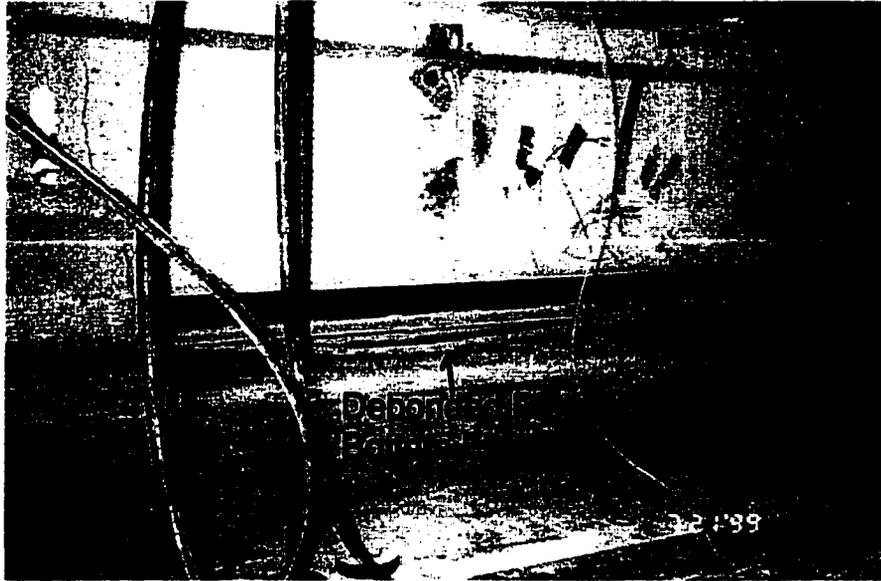
The cause of the lesser strength in the repaired beam as compared to the baseline specimen is failure of the interface between the CFRP and the concrete substrate. At the peak live load moment, the CFRP plates on the underside of the bottom flange peeled away from the bottom of the beam. This is shown in Figure 4.88. The plates must have also slipped longitudinally in order for the bow in the plates to occur. Once the plates peeled from the flange, the horizontal shear load transfer from the plate to the substrate was destroyed over a significant length and presumably a much larger portion of the load was transferred through the ends of the plate and henceforth the GFRP confining wrap. The drop in load capacity from the peak to an approximate moment of 1,100 ft-kips is coincident with the beginning of the debonding of the bottom plates. One should note that prior to this debonding, the repaired and baseline specimen followed essentially the same load-displacement path. As additional load was applied, progressive debonding of the bottom plates occurred until they fell away from the bottom of the beam.

Figure 4.88. Partial Debonding of the Beam 2 Bottom Plates Between the GFRP Confining Wraps.

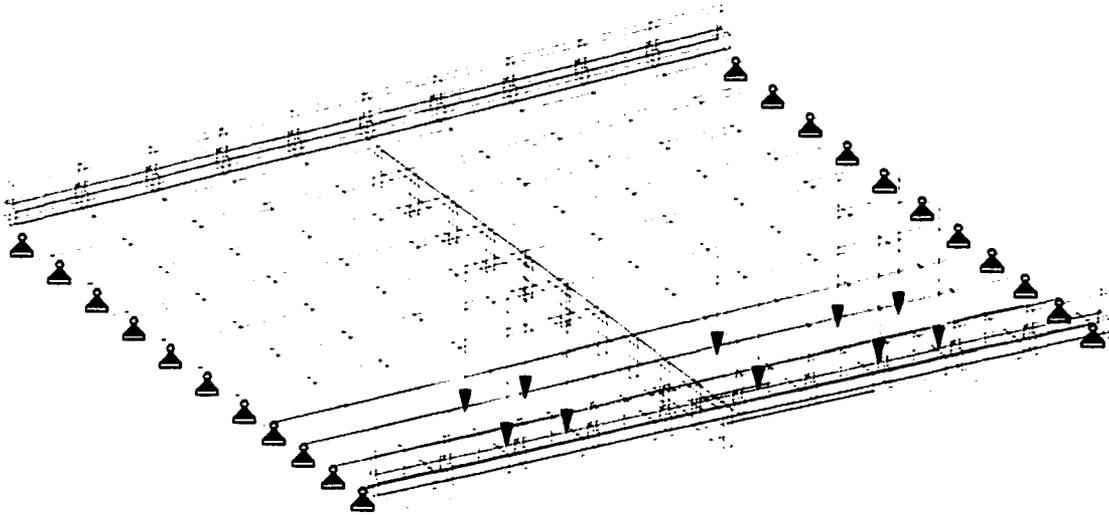
Figure 5.20. Stiffened Plate Model of Damaged WB Center Span, Load at L1-P4&P6 Shown.

An isometric view of the stiffened plate model with the damaged elements is presented in Figure 5.20. The damaged members along Beam 1W are noticeable in the figure to the right of the midspan diaphragm location. Because of the way the beam elements are linked to the bottom of the slab, the relative vertical distance between the centroid of the undamaged and damaged beams is noticeable. With the exception of the damaged regions of Beam 1W and 2W, all other parameters are the same as for the previously tested undamaged model, SP-3.

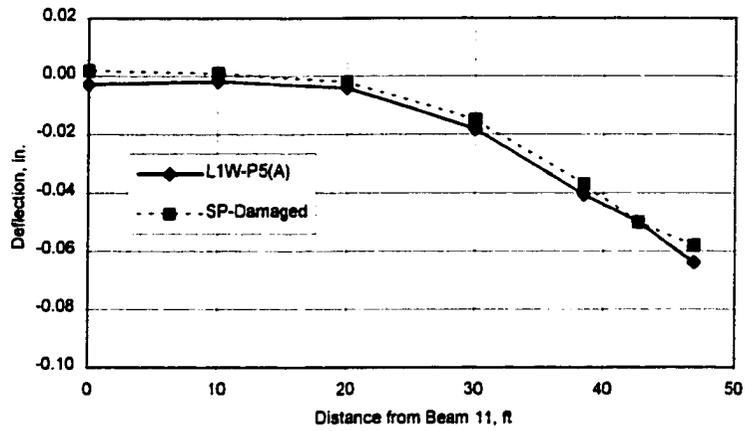
Figure 5.21. Comparison of Experimental and Analytical Deflections for the Damaged WB Bridge.

A series of transverse sections at midspan are presented in Figure 5.21 for the previously described damage scenario. The figures are similar to those previously presented in that they depict the deflections at midspan for various beams due to the three load cases used for model evaluation. In parts (a) and (b) of this figure, the agreement between the experimental and analytical model is excellent while for part (c) there are slight discrepancies.

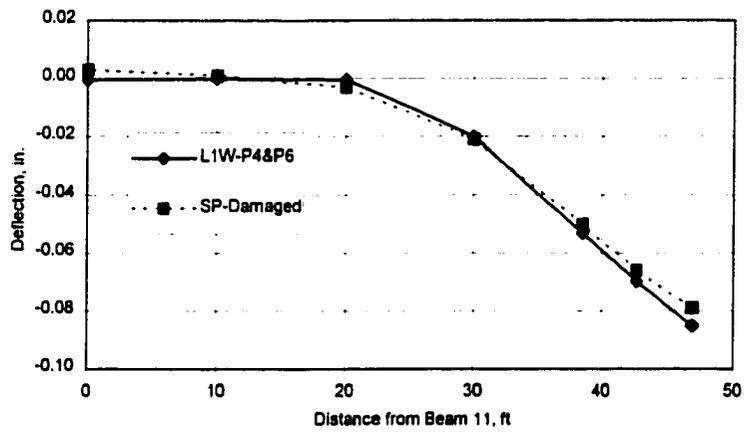
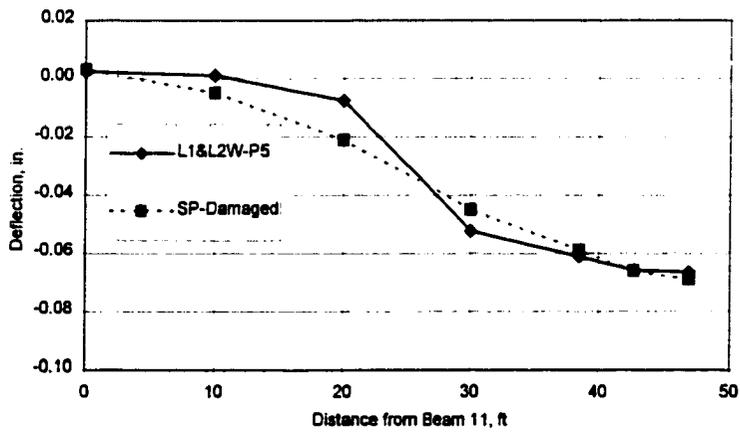
From the results presented in these three transverse sections at midspan of the damaged center span, it can be concluded that the arbitrary amount and extent of damage inflicted to Beams 1W and 2W was reasonable. Recall that the assessment of damage was subjective and based strictly on visual observation of the damage to the bottom flange and web of the beams in question. An alternate approach would have been to "back into" the results by modifying the model numerous times until the analytical and experimental deflections were in agreement. However, such an approach is of little practical value since a practitioner in most cases will not have access to measured deflections for the calibration process.

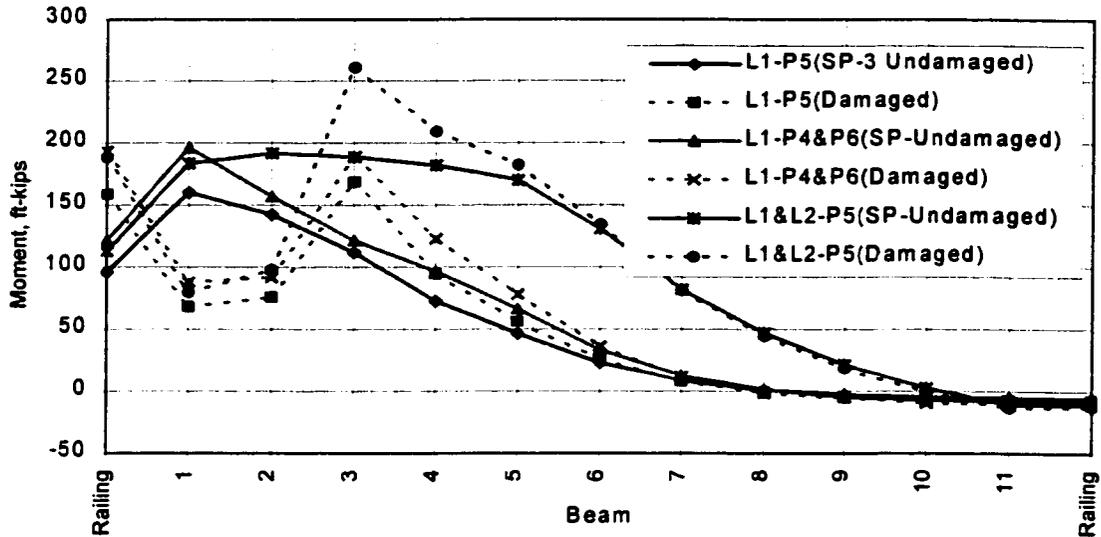
Following the deflection graphs, the internal moments calculated at midspan are presented for all three load cases in Figure 5.22. The results from the original SP-3 undamaged model are presented as solid lines and those from the damaged model analysis as dashed lines. The figure indicates a rather significant redistribution of moments due to the loss of section previously described. The moments in damaged Beams 1W and 2W are decreased by approximately 1/3 to 1/2 with the majority of the redistributed moment being taken up by the barrier curb and rail as well as by Beams 3W and 4W. Note that although there is a slight increase in Beams 5W and beyond, the differences are insignificant. The majority of the redistributed load is absorbed by the adjacent members in close proximity to the damaged elements indicating that for this bridge (and likely for bridges in general), redistribution of load is a highly localized effect. For the case of Trucks 1 and 2 in adjacent lanes, L1&L2-P5, the moment resisted by Beam 3W increases from 189 ft-kips to 261 ft-kips (38% increase). The predicted moment for this beam based on the applied vehicle configuration and the S/5.5 distribution suggested by AASHTO is 253 ft-kips indicating that even in the presence of redistributed live loads due to exterior beam damage, the analytically predicted moment is only 8 ft-kips higher than predicted by AASHTO for an undamaged structure. For this analysis and this bridge, the AASHTO distribution factors in the Standard Specification are safe estimates of the live load in the undamaged beams even following live load redistribution.

Figure 5.22. Load Distribution Comparisons, WB Bridge, Undamaged and Damaged Models.

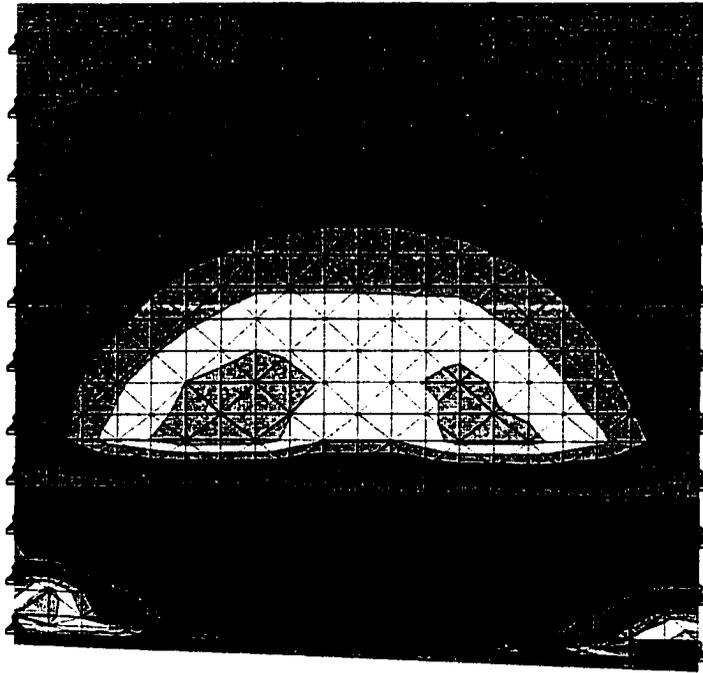
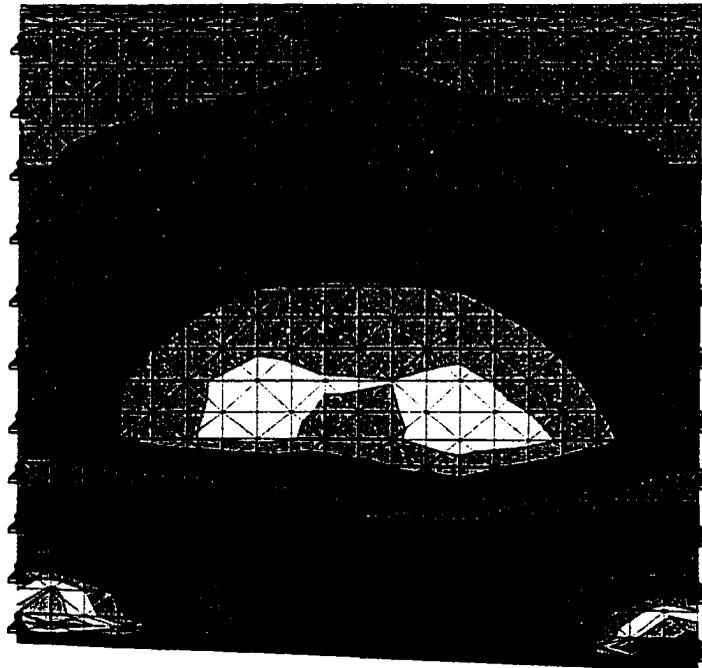
The load is being redistributed through the flexural/torsional stiffness of the slab with localized stress increases in the slab near the damage. Stress contours for transverse bending of the slab are presented in Figure 5.23 for load case L1-P4&P6 where the units for the contours are ft-kips/ft of width of plate. The transverse bending moment for the undamaged case never exceeds 0.68 ft-kips/ft while for the damaged case, the moments are as high as 1.2 ft-kips/ft in the vicinity of the load. Also note that the higher transverse moments are obviously located over the damaged region and that the moments per foot are not symmetric about midspan as they are for the undamaged bridge.

Figure 5.23. Transverse Slab Bending, WB Bridge, Load Case L1-P4&P6.
