MONITORING AND PREDICTION OF DAMAGE IN

FILAMENT WOUND COMPOSITE PIPES UNDER

PRESSURE LOADING

Dissertation

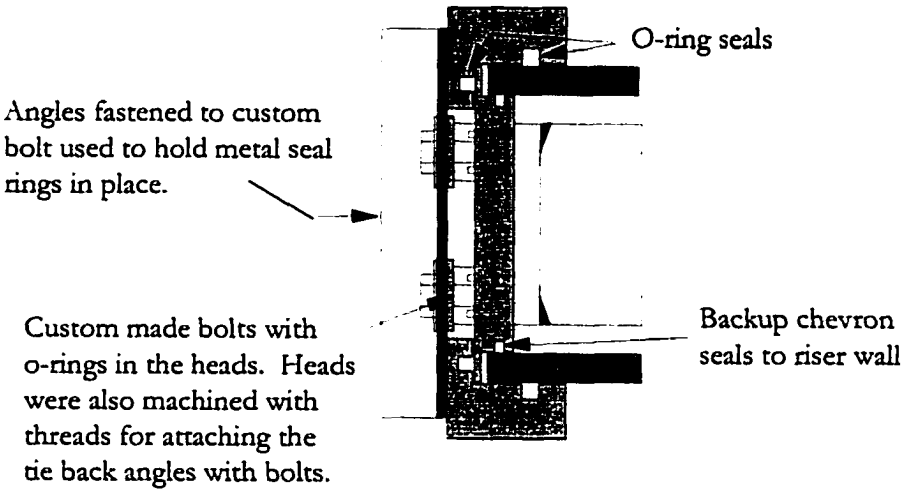
Figure 2.5 Seal detail for external pressure

A major challenge encountered in this test program was developing a seal system at the tube ends to prevent water from entering the inside of the specimen. Two initial attempts at conducting an external pressure test were unsuccessful due to leakage at the seals. The final seal system that proved successful is shown in Fig. 2.5. O-ring seals were used on the outer surface of the tube. In addition, chevron type seals were used on the inner surface as a backup system, in the event that the o-ring seals failed.

Custom made bolts with o-rings in the heads. Heads were also machined with threads for attaching the tie back angles with bolts.

Backup chevron seals to riser wall

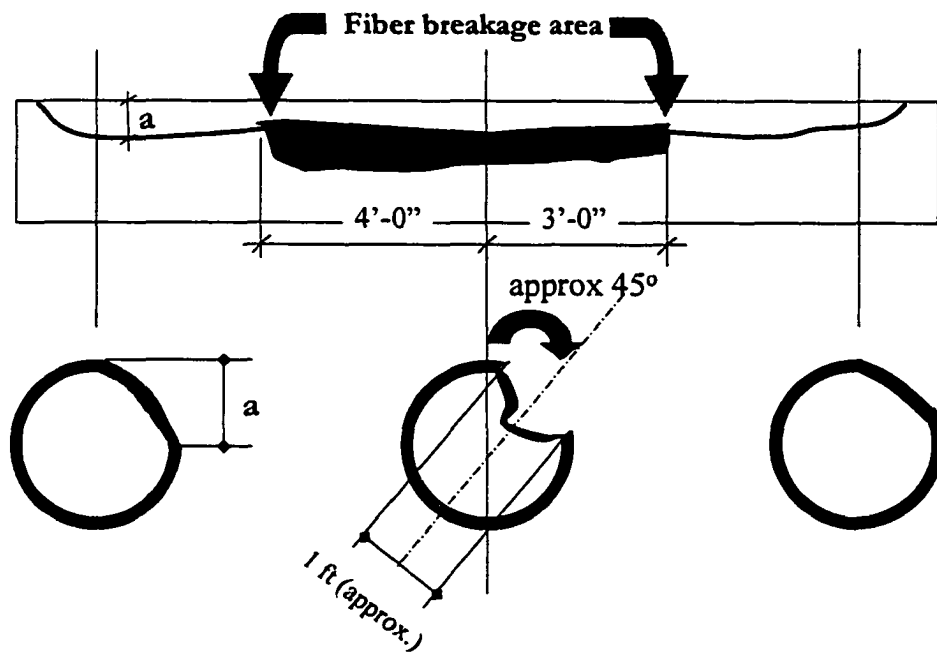
Figure 2.15 Failure profile schematic in riser

round shape. Unfortunately assessing the extent of damage at the ends of the specimen is difficult since they were severely damaged by the impact against the pressure chamber resulting from the failure energy release. On the interior surface of the specimen no damage was observed other than in the area next to the damage band and on the side of the band. The opposite side of the ID was for the most part as smooth and clear as it had been prior to testing. Figure 2.15 presents schematic representations of the failure profiles of the specimen.

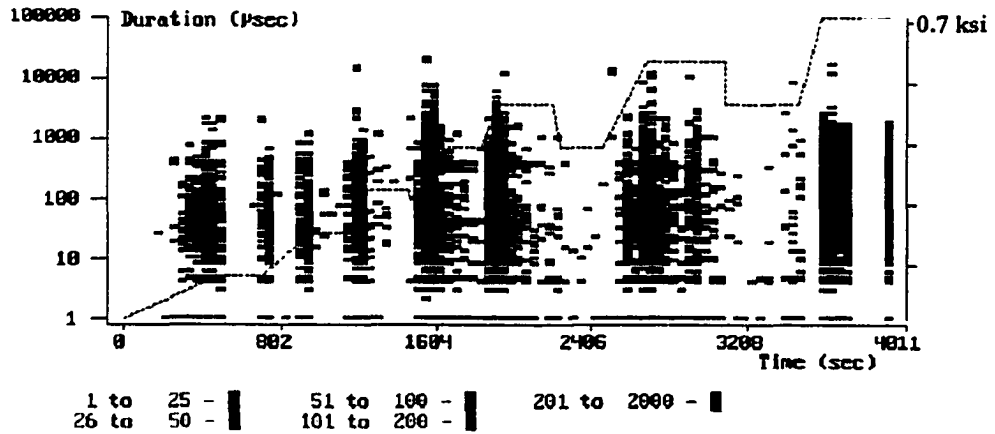
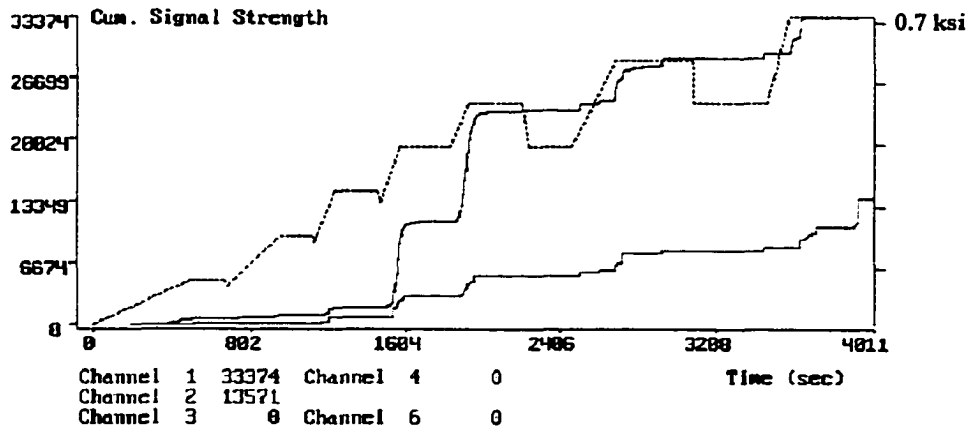
Figure 2.22 Acoustic emission record for preliminary test to 700 psi

A significant number of events were recorded right from the beginning of the loading, which is common in thick walled fiber reinforced composite specimens [2.24]. Typically, emissions began during loading and decayed during the load hold until 700 psi was reached, where during the load hold, an increasing number of events were

recorded. At some point during the 700 psi load hold; the seals began to fail in this test. The seal leaking was detected by the AE and unfortunately masked some of the emission resulting from material changes produced by the applied stress. The increase in emission during load holds became considerable after 500 psi.

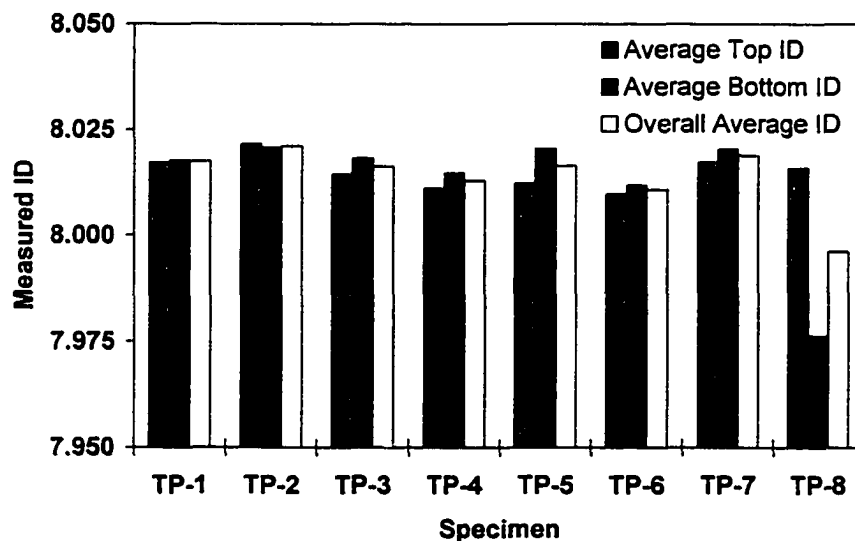
Figure 3.7 Internal diameter measurements first batch

After the specimens from the first batch were received at Ferguson Laboratory, measurements for the wall thickness at the ends of each specimen were made. In addition, the diameters were also measured at the ends. Results from the interior diameter measurements can be seen in Figure 3.7. As seen in the figure, the variations in the ID are very small and values are also very consistent. There is a general trend towards a smaller diameter specimen starting with TP-1 and all the way to TP-8.

Remembering the way these specimens were manufactured and the requirements for removal of the inside mandrel this variation is expected. The figure presents the average of four measurements at each end of the specimen and the average of both. The large variation noted in specimen TP-8 is the result of this being wound on the last part of the mandrel. This is the end that is pulled to remove the specimen from the winding mandrel. This is why only one of the ends is off the average of the diameters.

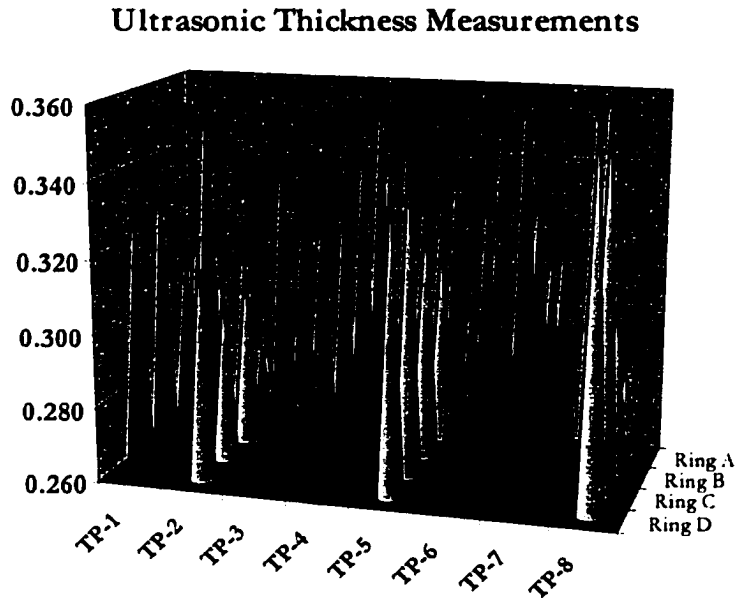
Figure 3.9 Results from the UT scan of first batch of specimens

Figure 3.9 shows the results for these scans for the first eight specimens. The specimens were graphically dived in ring sections for scanning at four equally spaced locations. Three readings were taken on each ring at equal spaces in the perimeter, these then were averaged to form the ring reading.

where no failure surface was noticed or formed. The measurements showed that a large part of the deviation was due to changes in the inner layer thickness and not in the winding.

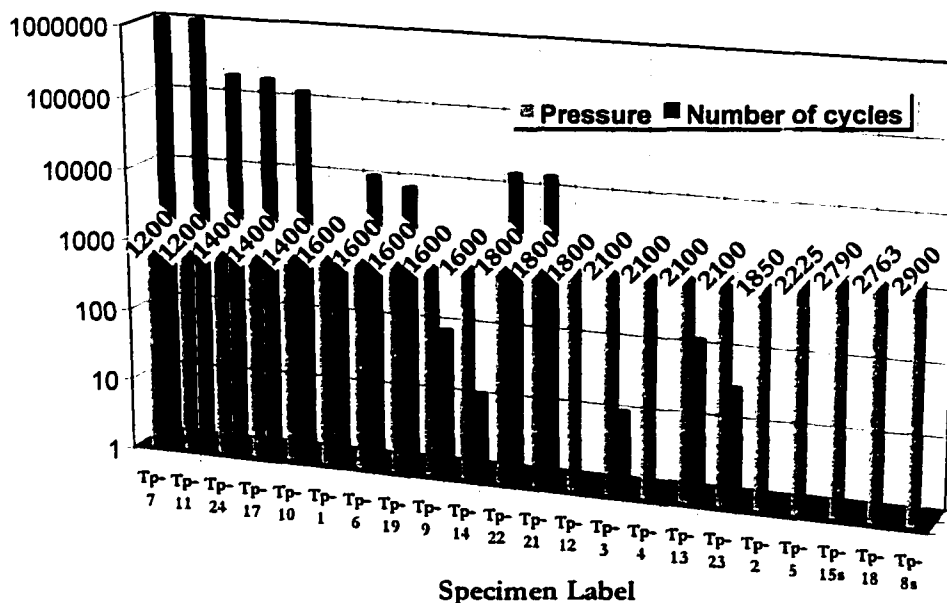
Figure 3.21 Summary of fiberglass test results

In Figure 3.21, two elements of information are shown. The first is the test pressure for each specimen shown in the front bar with the values on the top of each bar. The second is the number of cycles it went through before leakage was recorded, shown in the back bar with the logarithmic vertical axis on the left. The final leakage cycle is included in the count. Therefore, for the static specimens, the pressure shown is the maximum pressure at leakage. For the cycled specimens, pressure shown is the target pressure during the cycling test as show in Figure 3.19. The order of the test as shown in Figure 3.21 is set with the static tests first starting from the right of the figure and moving left with decreasing test pressure. Specimens in the cyclic phase were tested at 2100, 1800, 1600, 1400 and 1200-psi. Therefore, after the static tests, the next group is specimens cycled at 2100-psi, followed by 1800-psi, and so on.

A common factor in the behavior of all fiberglass specimens was the failure mechanism and appearance. All fiberglass specimens failed by leakage at a load hold as required by the AE. As soon as the internal liner cracked, water forced its way through the layers of the fiber winding and found its way to the surface. On the inside surface of the specimens, a single longitudinal crack was visible immediately under the failure surface of the specimen. No other signs of damage were visible on the inside surface. On the exterior surface of the specimen the difference was the extent of delamination observed for each test. Even when the mechanism was the same in all the tests, the observed extent of the delamination changed. Figure 3.22 shows a set of images that represent a typical failure surface and cross section for the fiberglass specimens.

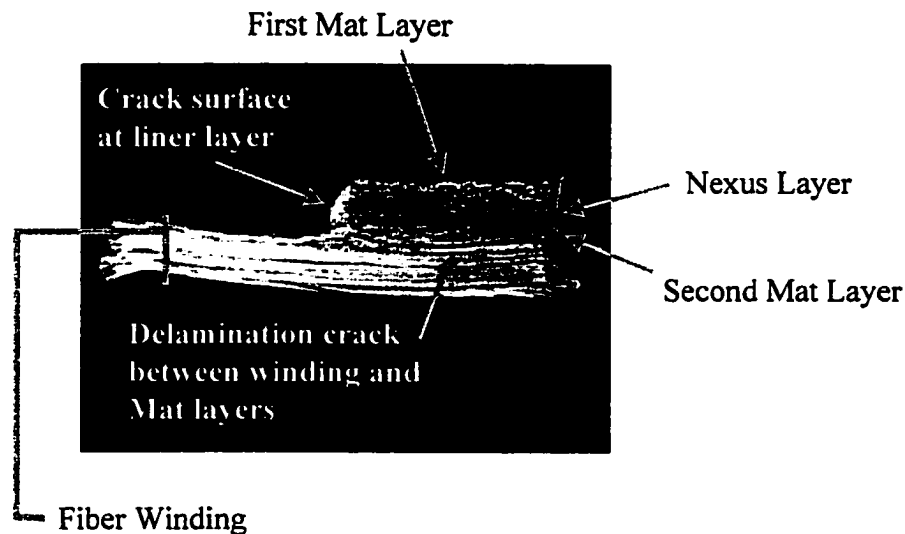
Figure 3.23 Failure surface section

Delamination crack
between winding and
Mat layers

It is clear that the radial crack observed in the inner layers did not propagate in to the outer fiber wound portion of the specimen. Rather, delamination was the most apparent form of damage in the outer filament would layers. A combination of transverse matrix cracking and gaps between fibers and surrounding matrix epoxy possibly provided the path for the water to find its way to the outer surface of the specimen. It also points to the possibility that the winding alone might have leaked at a lower pressure had the inner liner not been in place.

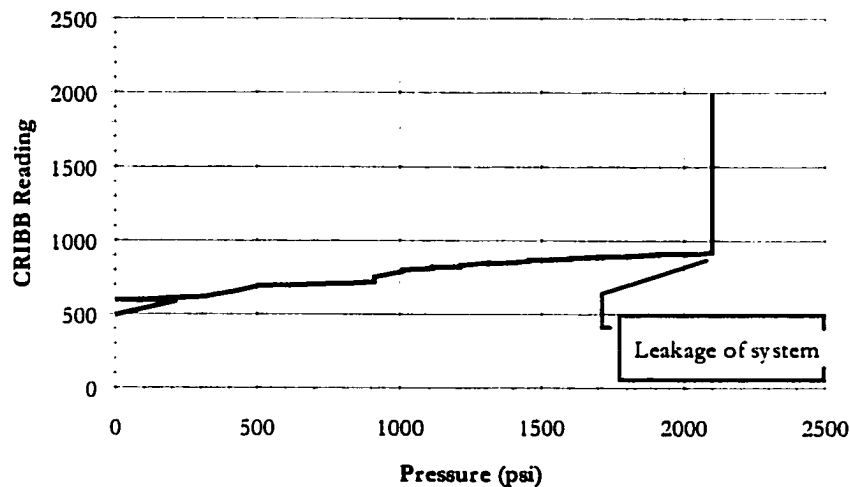
Figure 3.24 Leak detector performance

The performance of the leak detector during all the tests in this program supports the possibility of prior winding matrix failure as indicated above. During the static and cyclic loading of the specimens, the system did not register leakage. This indicates that the inner liner did not fail until the time where the final pressure was reached. In other words, cracking of the inner layers was immediately followed by leakage of the system. Figure 3.24 show a typical plot of the performance of the leak detector in a test.
