A summary and analysis of bridge failures

A SUMMARY AND ANALYSIS OF BRIDGE FAILURES

A Thesis Submitted to the
Graduate Faculty in Partial Fulfillment of
The Requirements for the Degree of
MASTER OF SCIENCE

Major Subject: Structural Engineering

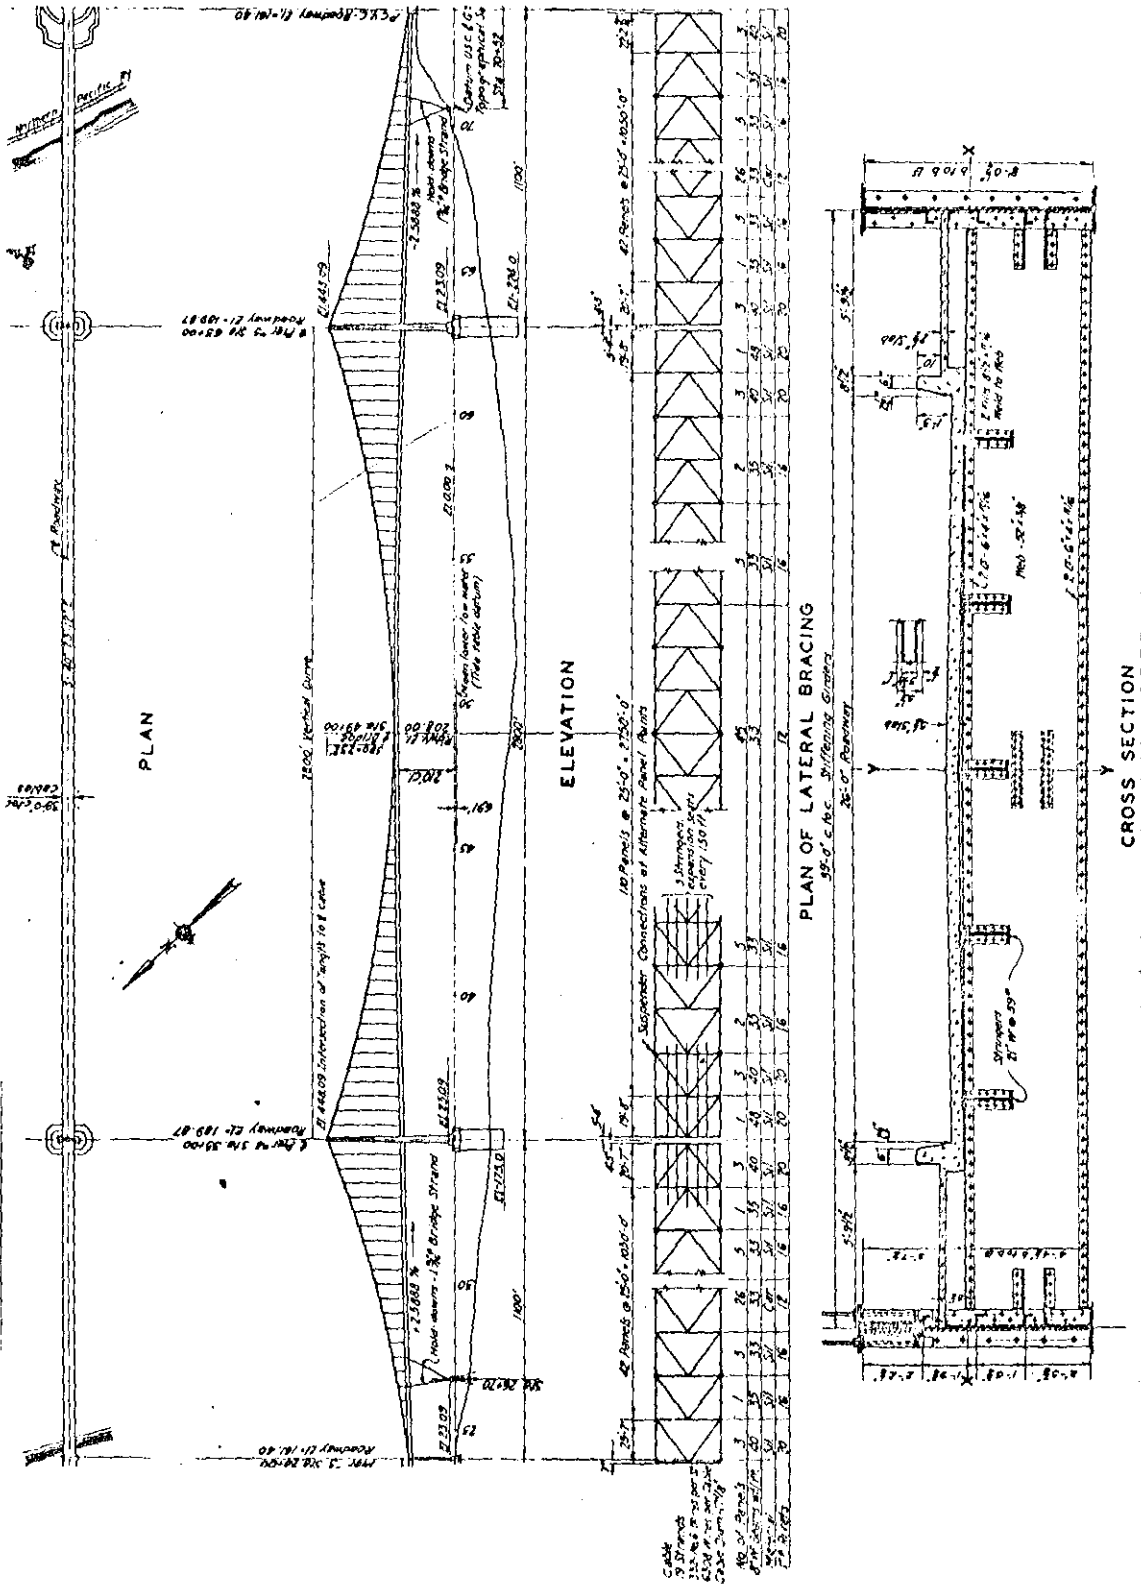
Figure 3. Details of Tacoma Narrows Bridge (56)

November 7, 1940 during a 42 m.p.h. southerly wind blowing at about 45° to the roadway. Large vertical oscillations of large amplitudes took place. At first the roadway remained horizontal in the transverse direction but eventually the opposite sides of the roadway began to oscillate out of phase with each other and the main span began to break up and drop into the Sound.

After the collapse there was only about 400 ft. remaining of the center span deck, the end spans had about 30 ft. of deflection and the towers were deflected about 12 ft. towards the shore. The towers deflected as much as 17 ft. just prior to their obtaining an equilibrium condition.

The investigation board's report on the cause of the failure showed that there was no evidence of faulty workmanship or poor materials. The bridge was very adequate in its ability to carry the live loads for which it was designed. The primary cause lies in the general proportions of the bridge. When comparing this bridge with others in the past which have had no real problems such as this one, it was found that forces which were almost negligible in those of large ratio of width to span length became dominant forces in this bridge. It was not stiff enough to withstand the aerodynamic forces and the design was lacking in capacity to dissipate energy and to dampen the distortions caused by

The initial cause of the failure was the slipping of the diagonal guys. The results following were unavoidable as the forces became too great. The structure was very much affected by the wind forces due to its slender proportions combined with solid stiffening girders.

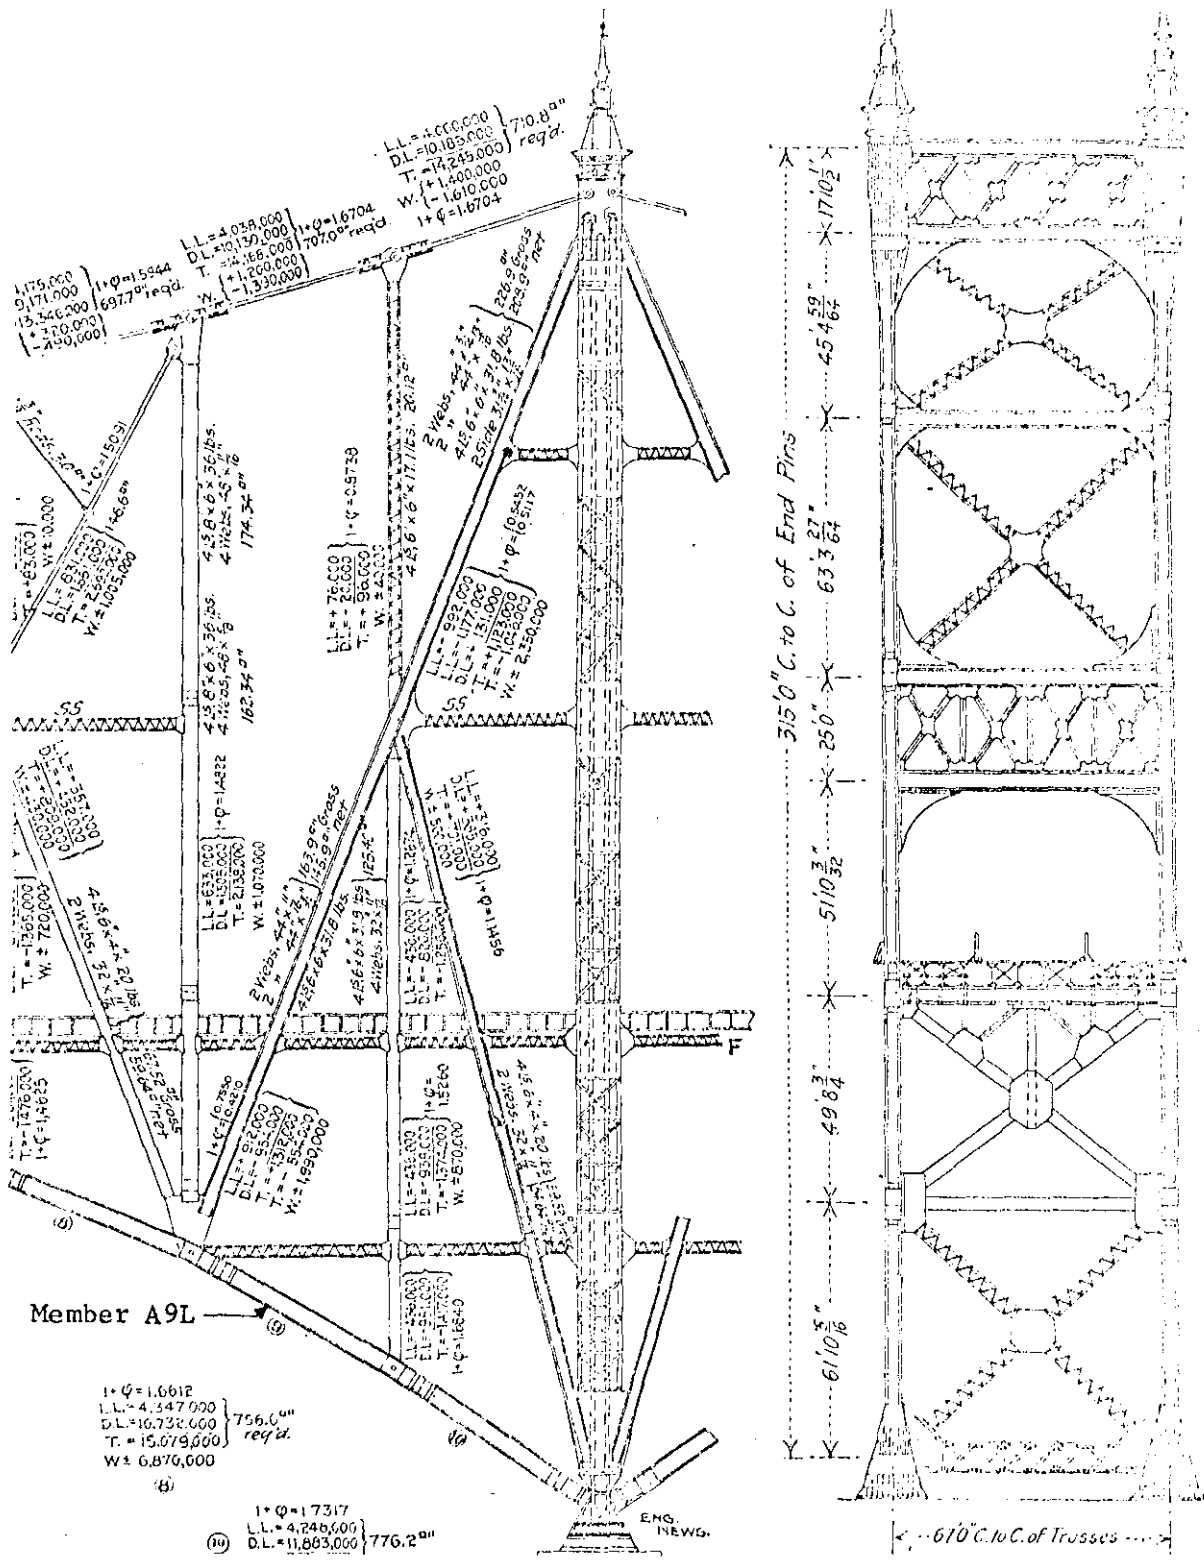
Figure 8. Part stress diagram of First Quebec Bridge (57)

one built up plate nearly 4 in. thick. These four webs were bound together by latticing so as to act as one member. The outside dimensions of the member were 5'-7 1/2" x 4'-6 5/8". The member was reported to have had a kink in one of the inner webs before it left the fabricating shop. The member was also involved in a railway accident during shipment to the site. It was reported that the member had been repaired with excellent workmanship. It is very improbable that the workers would have placed the member in its position in the bridge had it not been straight. The length of the member was 57 ft. and if the deflection of 2 in. existed before erection it would have been noticed and rejected. The resident engineer said the deflection had always been in the member and the deflection was not caused by overstress. This was not the feeling of the other responsible men on the job. Every member was inspected by several people and it is not probable that it would go unnoticed in such an important and massive structure.

The practice at that time regarding bridge design was for the contractor in charge of the fabrication of the bridge to make up the working plans. As a rule, no engineer could afford to maintain a staff of such character and no corporation would listen to a fee that would cover any such expense. The engineer supplies the fabricator with the loading, both dead load and live load, the stresses in the members and the areas required to resist these stresses. The fabricator then builds the members from the stress sheet (see Figure 8).

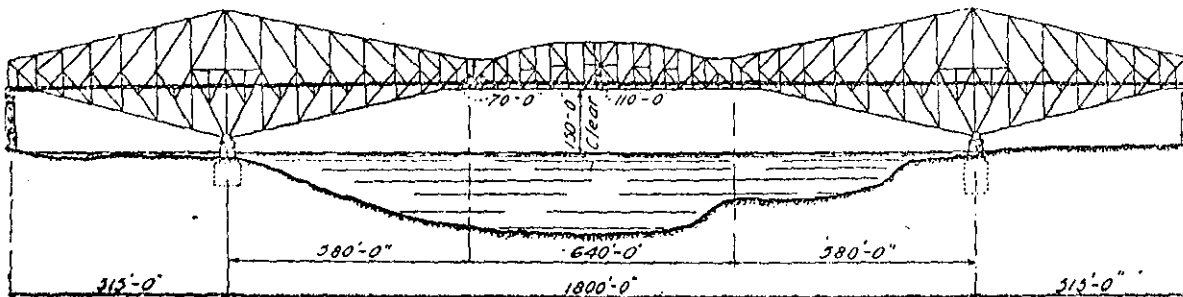
Figure 9. The Second Quebec Bridge, as built (69)

One of the most dramatic bridge failures was the failure of the Second Quebec Bridge on September 12, 1916 (3, 11, 12, 22, 38, 97). It is believed that only 13 lives were lost in this accident. The failure consisted of the center suspended span (see Figure 9 shown on page 54) falling into the St. Lawrence River during its hoisting operation.

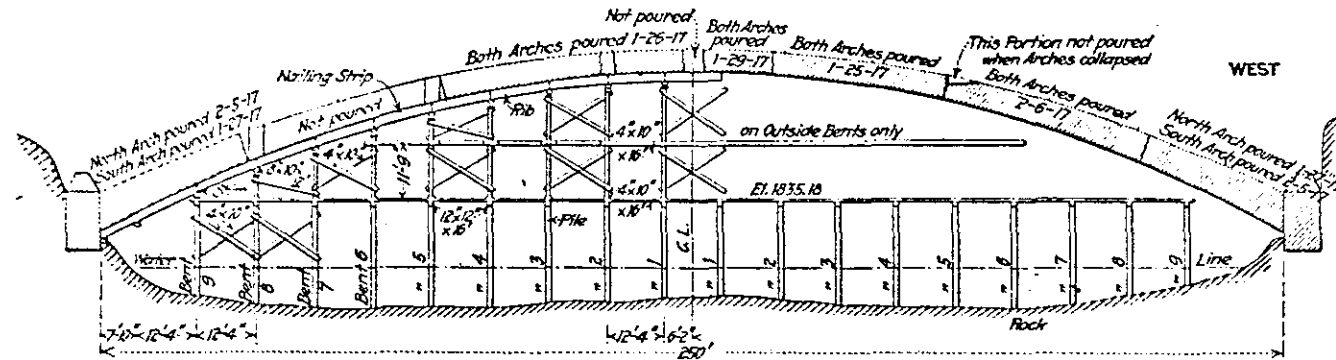
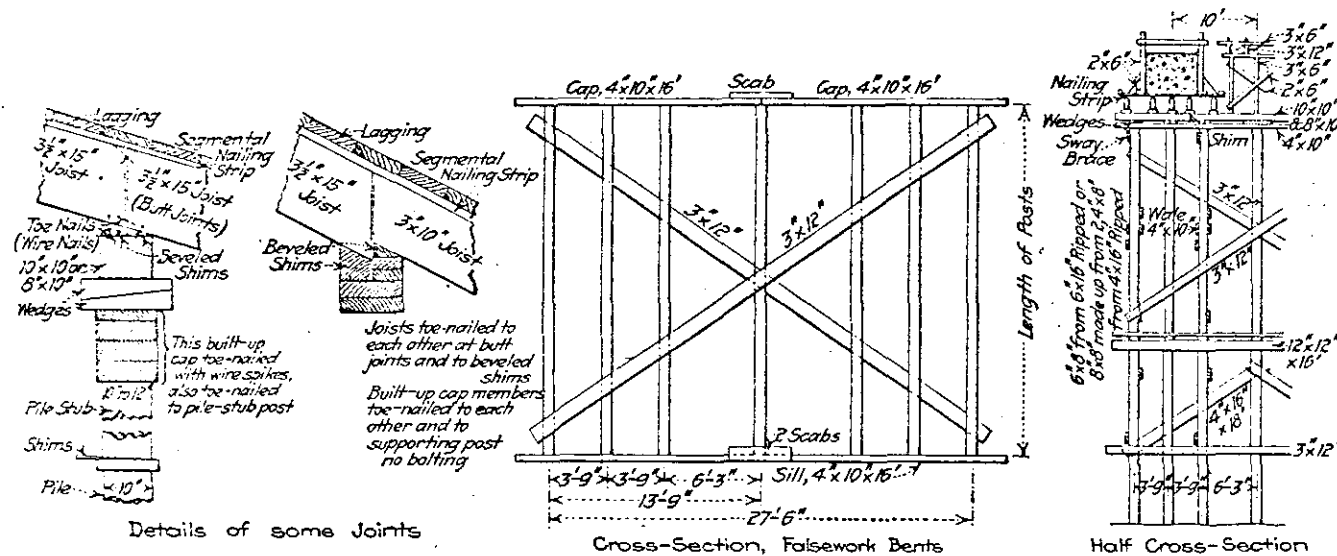
Figure 14. Details of Spokane River Bridge showing progress of construction and falsework (90)

A 250 ft. twin rib concrete arch bridge over the Spokane River in Spokane, Washington collapsed during construction of the concrete arch ribs on February 6, 1917 (20, 90, 102). Three workmen lost their lives. The arch ribs were 6 ft. square in cross-section at the top of the arch tapering to 6 ft. x 8 ft. at the abutments. The collapse took place without any warning while concrete was being placed. The arches were being erected on timber falsework, this being supported on timber piles driven to rock in the river bottom. The progress of the construction along with falsework details are shown in Figure 14. The point to which it was completed before its collapse is also shown.

The falsework consisted of 18 bents of 7 piles. The bents were spaced at 12 feet 4 inches. The falsework was as shown in Figure 14 with four lines of longitudinal sway bracing. The sway bracing was supposed to be bolted to the piles but instead only one to three spikes were used. Many of the piles had not had the bark removed and at least an 8 in. spike was necessary to reach through the sway bracing, the bark of the

pile, and 1 to 2 in. of soft sapwood. This would be a very insecure connection. The piles were said to be driven to solid rock but in some cases it was thought maybe small boulders caused refusal of the pile. Where boulders were known the piles were driven off center sometimes as much as 3 feet.

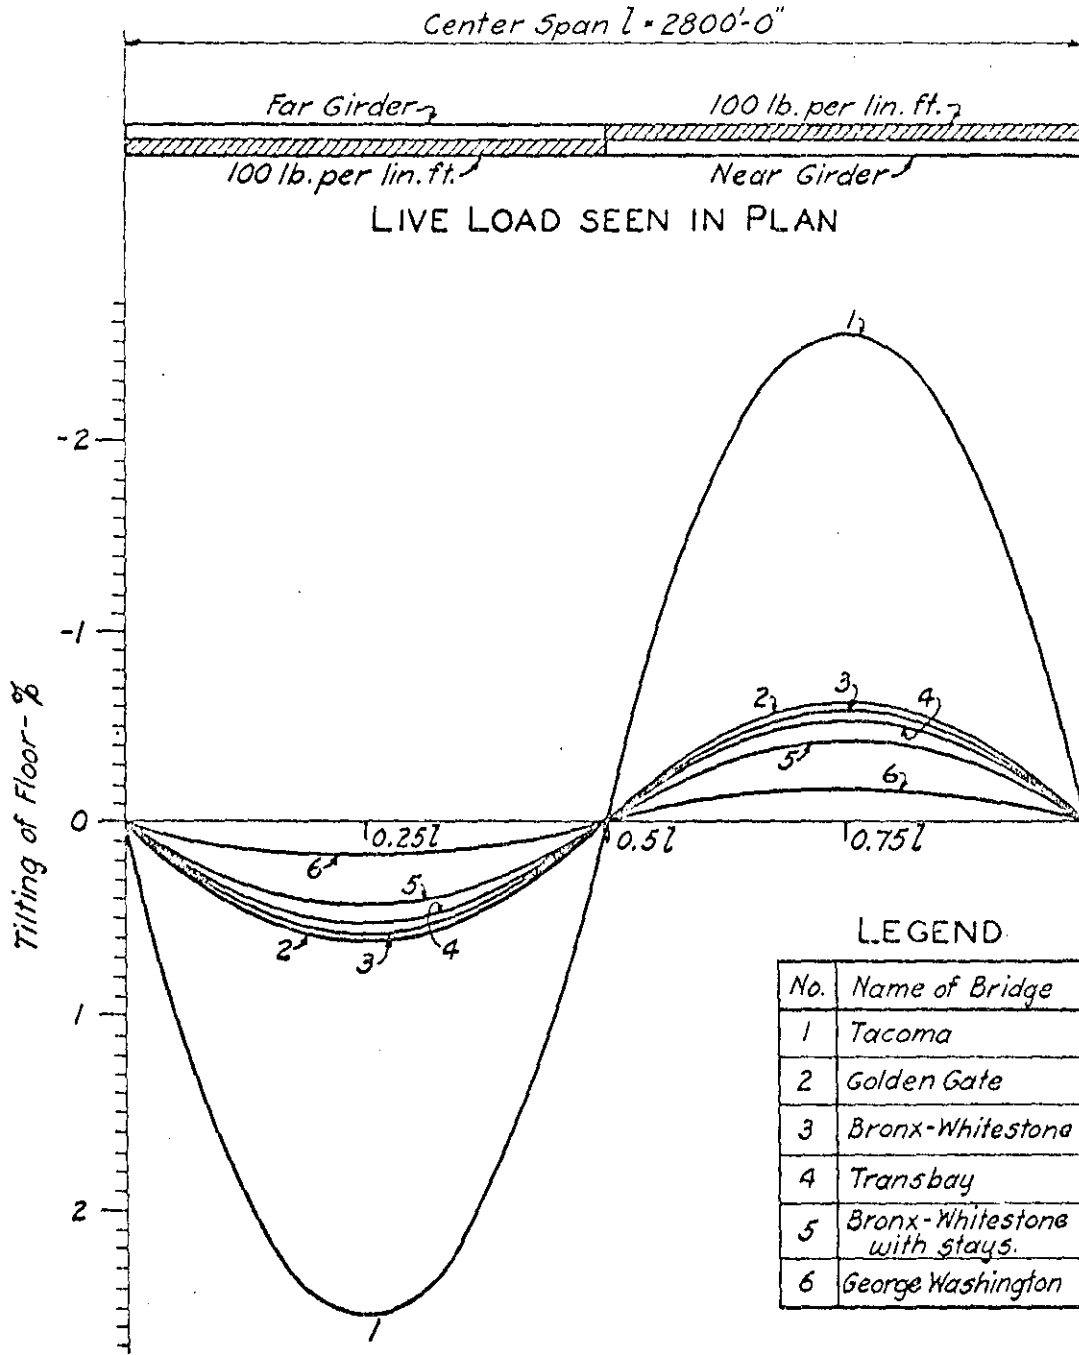
Figure 31. Comparative tilting of floor of the five longest suspension bridges (56)

In a wide and more rigid suspension bridge the transverse tilting of the floor and the resulting torsional stresses in the floor caused by non-uniform distribution of live load and eccentrically applied wind forces would be negligible. In this narrow and flexible bridge the problem became a major one and required investigating. Under normal loading the tilting of the floor system was considerably greater than

in other bridges which were studied. See Figure 31 for comparative tilting of the floors.

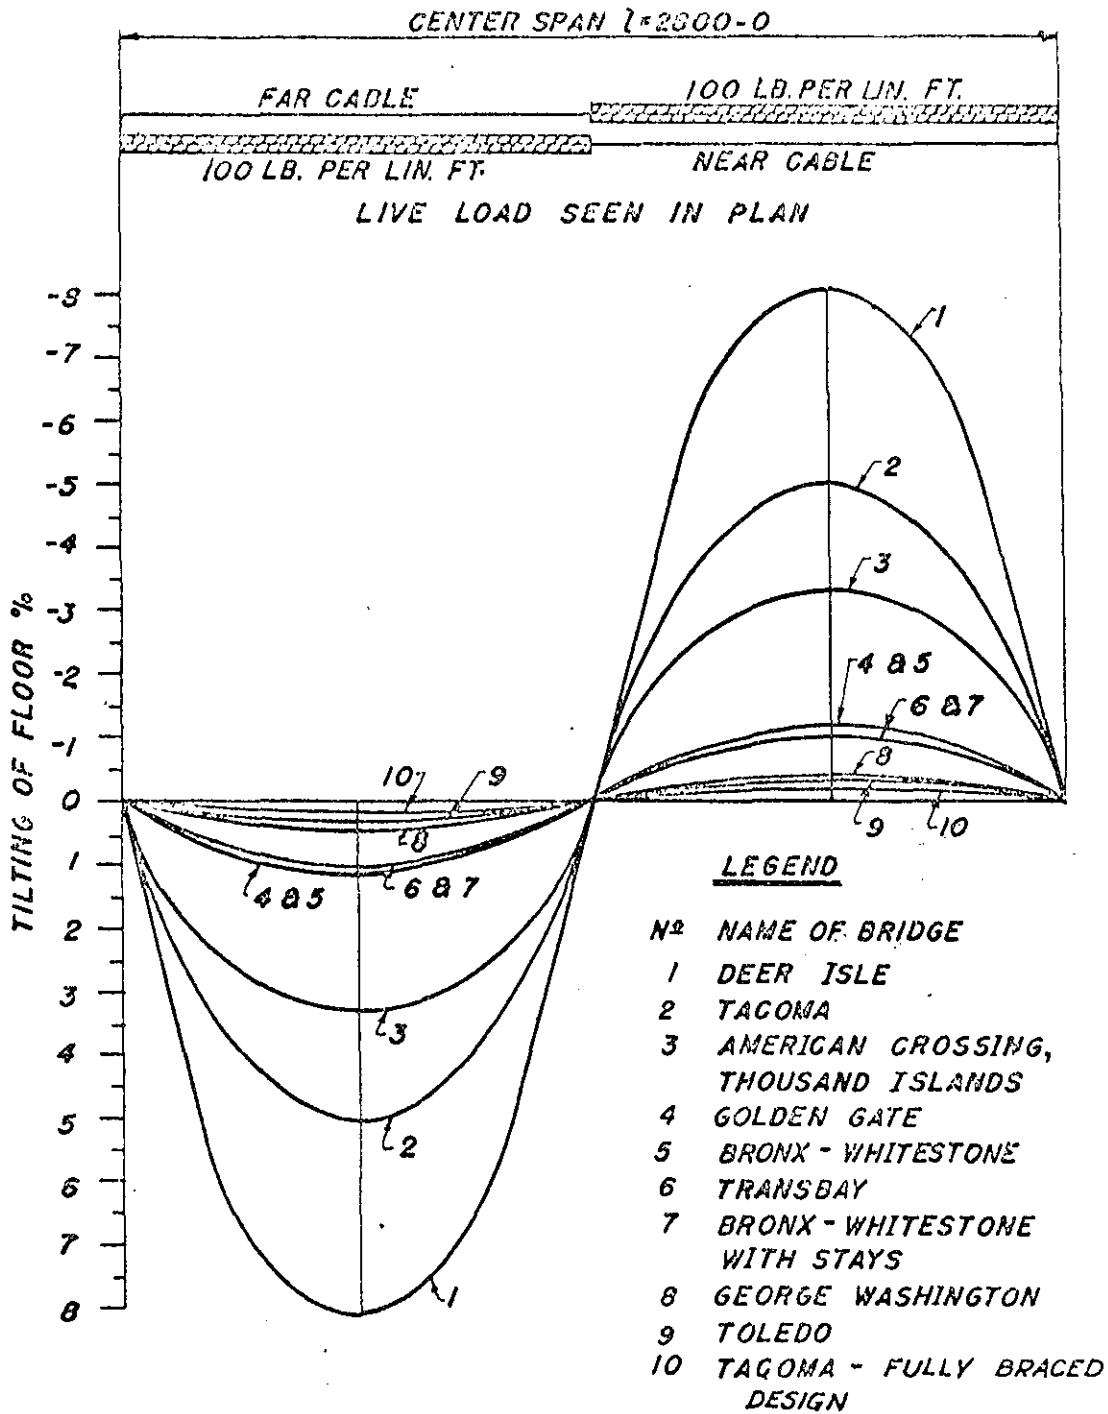
Figure 32. Comparative torsional deformations of ten bridges (56)

The second comparison is based on the floor tilt resulting from a loading of 100 lb. per ft. on the near cable from the tower to mid-span and the same load on the far cable from mid-span to the other tower. These results are shown in Table 5 and Figures 32 and 33.

The ability of a suspension bridge to resist irregular and turbulent wind forces is reflected by their torsional deformations under these assumed loads. The application of 10,000 ft-lbs per ft. of bridge was applied to all the suspension bridges listed regardless of width. The George Washington Bridge, for example, required a load of 94.3 lbs. per ft. up on one cable and down on the other cable. These forces with a distance of 106 ft. between produced a torsional moment of 10,000 ft-lbs per foot. The Tacoma Bridge with a width between cables of only 39 ft. required 256 lb. per ft. applied to the cables to produce a torsional moment of 10,000 ft-lbs per foot. This comparison resulted in a tilt of 38 times that of the George Washington Bridge. If the moment had been proportioned according to width the result would only have been 14 times as great instead of 38.

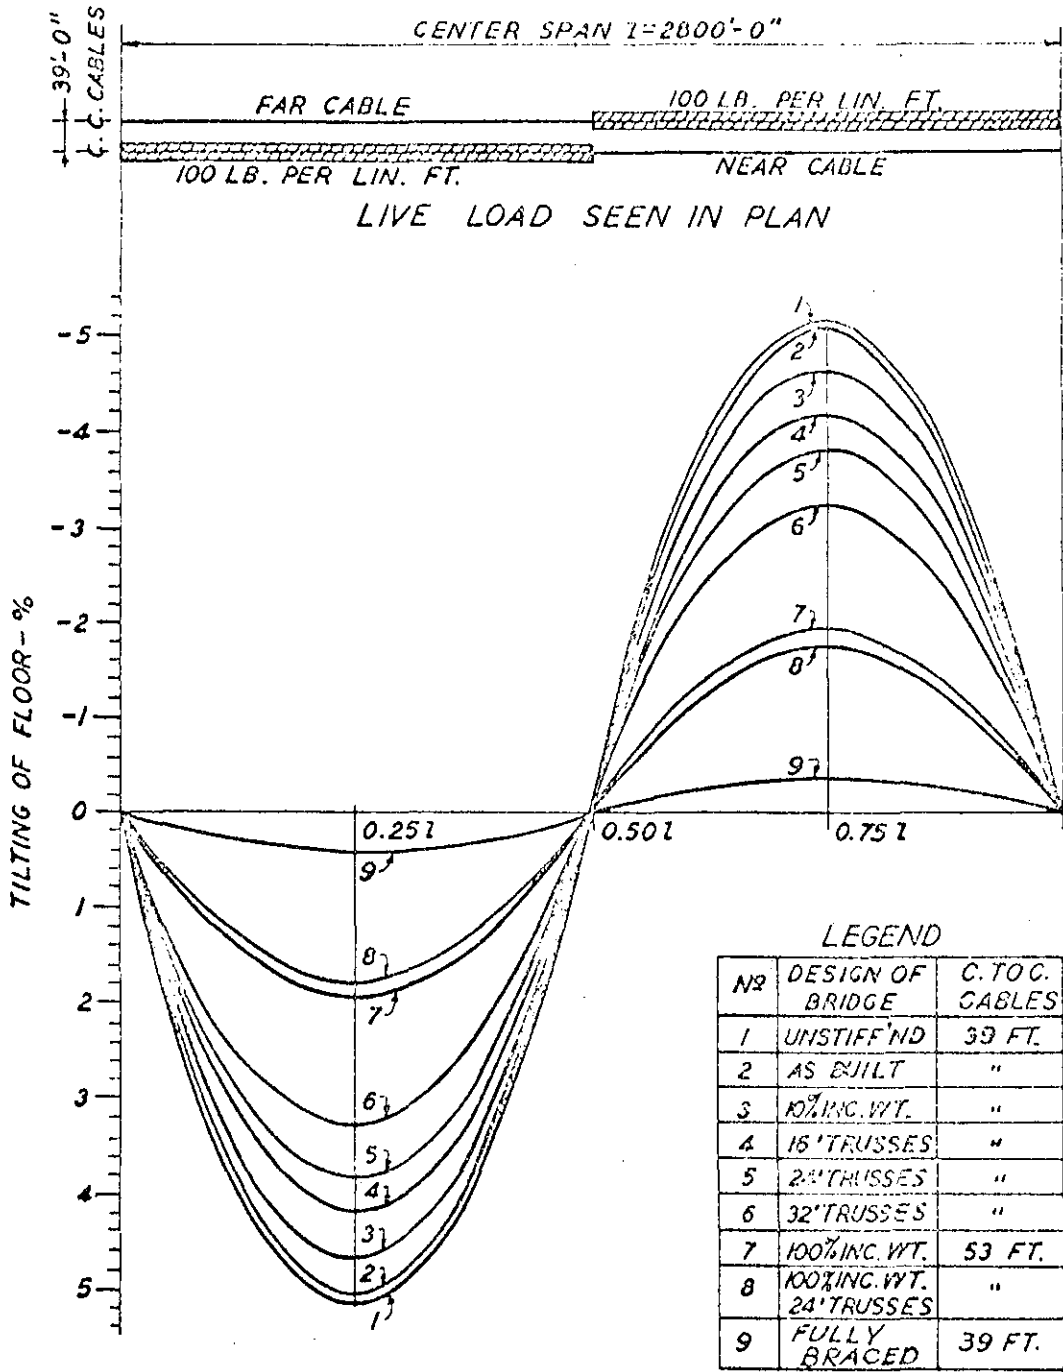
Figure 33. Comparative torsional deformations of nine Tacoma Bridge designs (56)

Torsional resistance which is very critical in the design of suspension bridges can be increased by: an increase in weight of the span, decreasing the cable sag, increasing the moment of inertia of the stiffening trusses, and increasing the width. The effects of these are shown in Figure 33. Comparison No. 9 gives the most resistance to torsion which is accounted for by its being fully braced. The fully braced design consisted of an open grid deck instead of concrete as used in the as-built bridge. It is interesting to note the great increase in No. 8 with the width increased to 53 ft. and 100 per cent more weight.

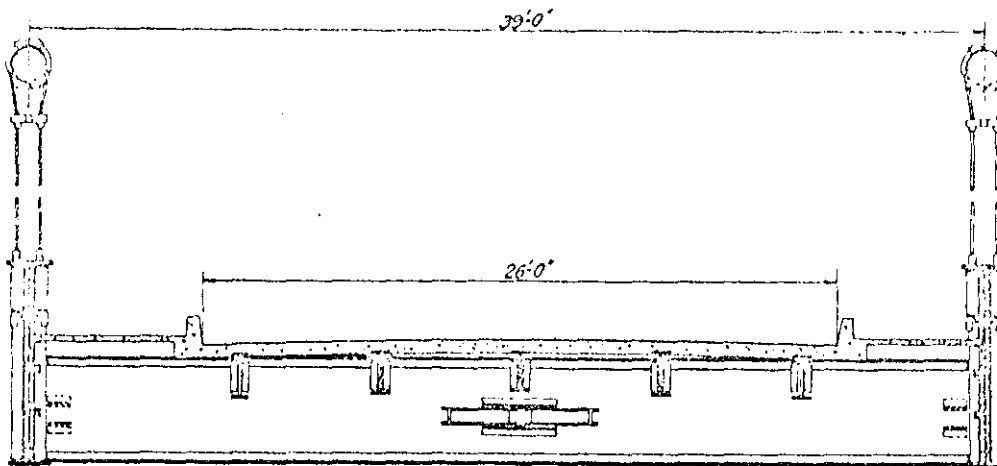
Figure 34. Section through suspended structure of Tacoma Narrows Bridge; as built (56)

By use of the second type of loading the results were as shown in Table 5 with the tilting of the Tacoma Bridge being 10.8 times that of the George Washington Bridge. Also compared is the Tacoma Bridge with a cross-section as built and a cross-section fully braced (see Figures 34 and 35).

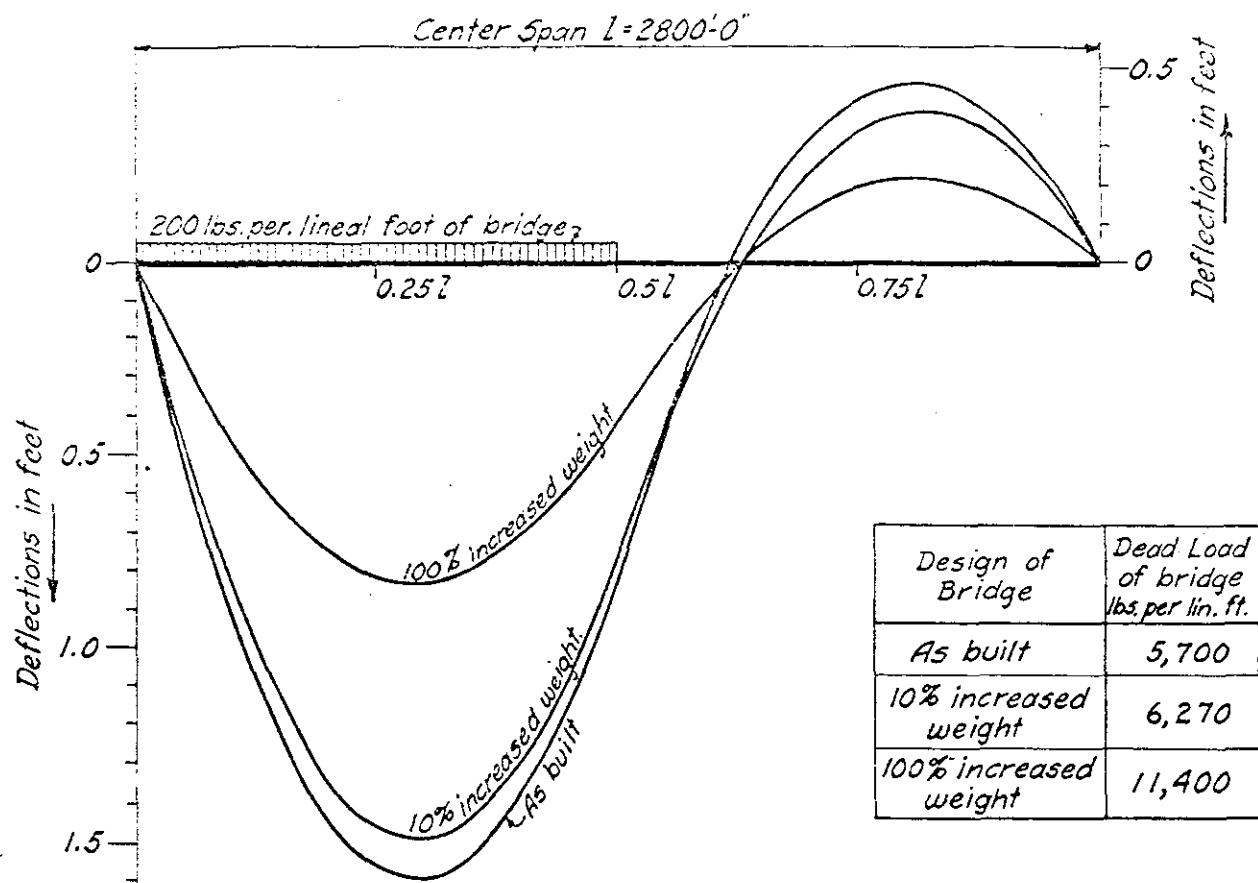
Figure 37. Effect of weight on comparative vertical deflections of the Tacoma Narrows Bridge (56)

The weight of the Tacoma Narrows Bridge was 6,270 lb per ft. An increase of 10 per cent by adding 2 in. to the thickness of the roadway slab would decrease the quarter point deflection by only about 5 per cent as seen in Figure 37. Increasing the weight by 100 per cent which could

be accomplished by doubling the traffic capacity, would decrease the static deflection near the quarter point from 1.59 ft. to 0.83 ft. which is a 48 per cent decrease. To make the bridge with rigidity like the Golden Gate and the Bronx-Whitestone the weight would have to be made $2 \frac{1}{2}$ times greater with the other proportions remaining the same.

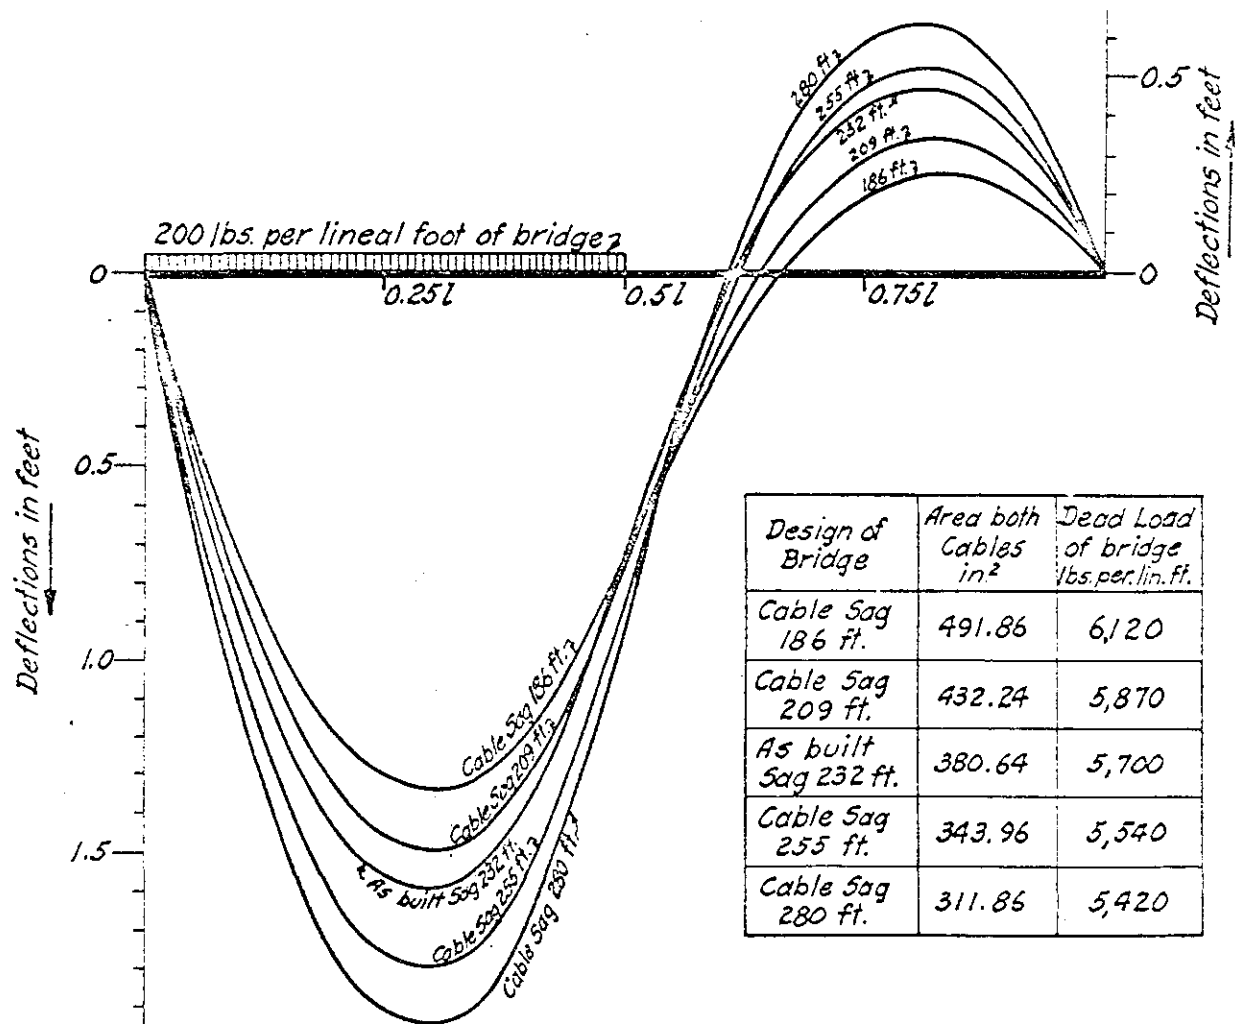
Figure 38. Effect of cable sag on comparative vertical deflections of the Tacoma Narrows Bridge (56)

The cable sag of the Tacoma Narrows Bridge was 232 ft. giving a ratio of cable sag to span of 1:12. A decrease of 10 per cent or a sag of 209 ft. would decrease the deflection at the quarter point from 1.59 to 1.49 which is only 6.3 per cent. This could not supply the necessary rigidity alone. The effect of cable sag on deflection is shown in Figure 38.

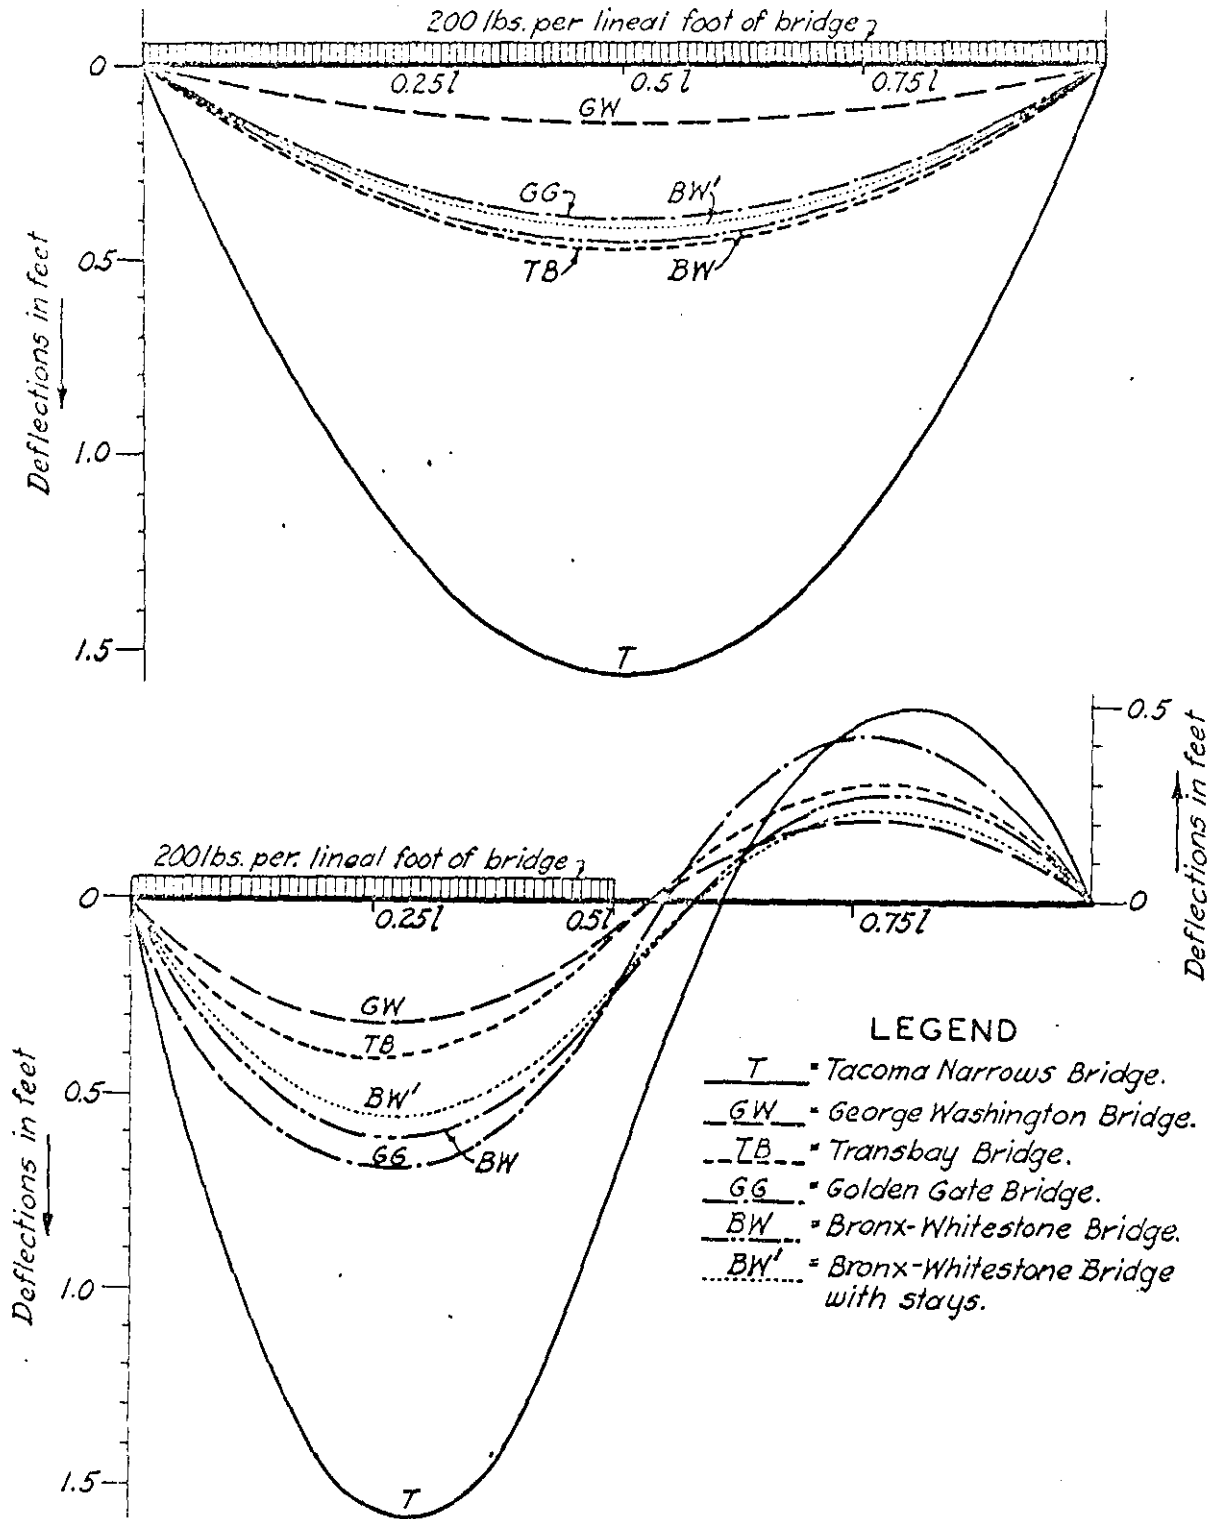
Figure 39. Comparative vertical deflections of the five longest suspension bridges due to a load of 200 lbs. per lin. foot of bridge (56)

These same results can be seen graphically in Figure 39. It is apparent that the vertical deflection of the Tacoma Narrows Bridge was comparatively very large.

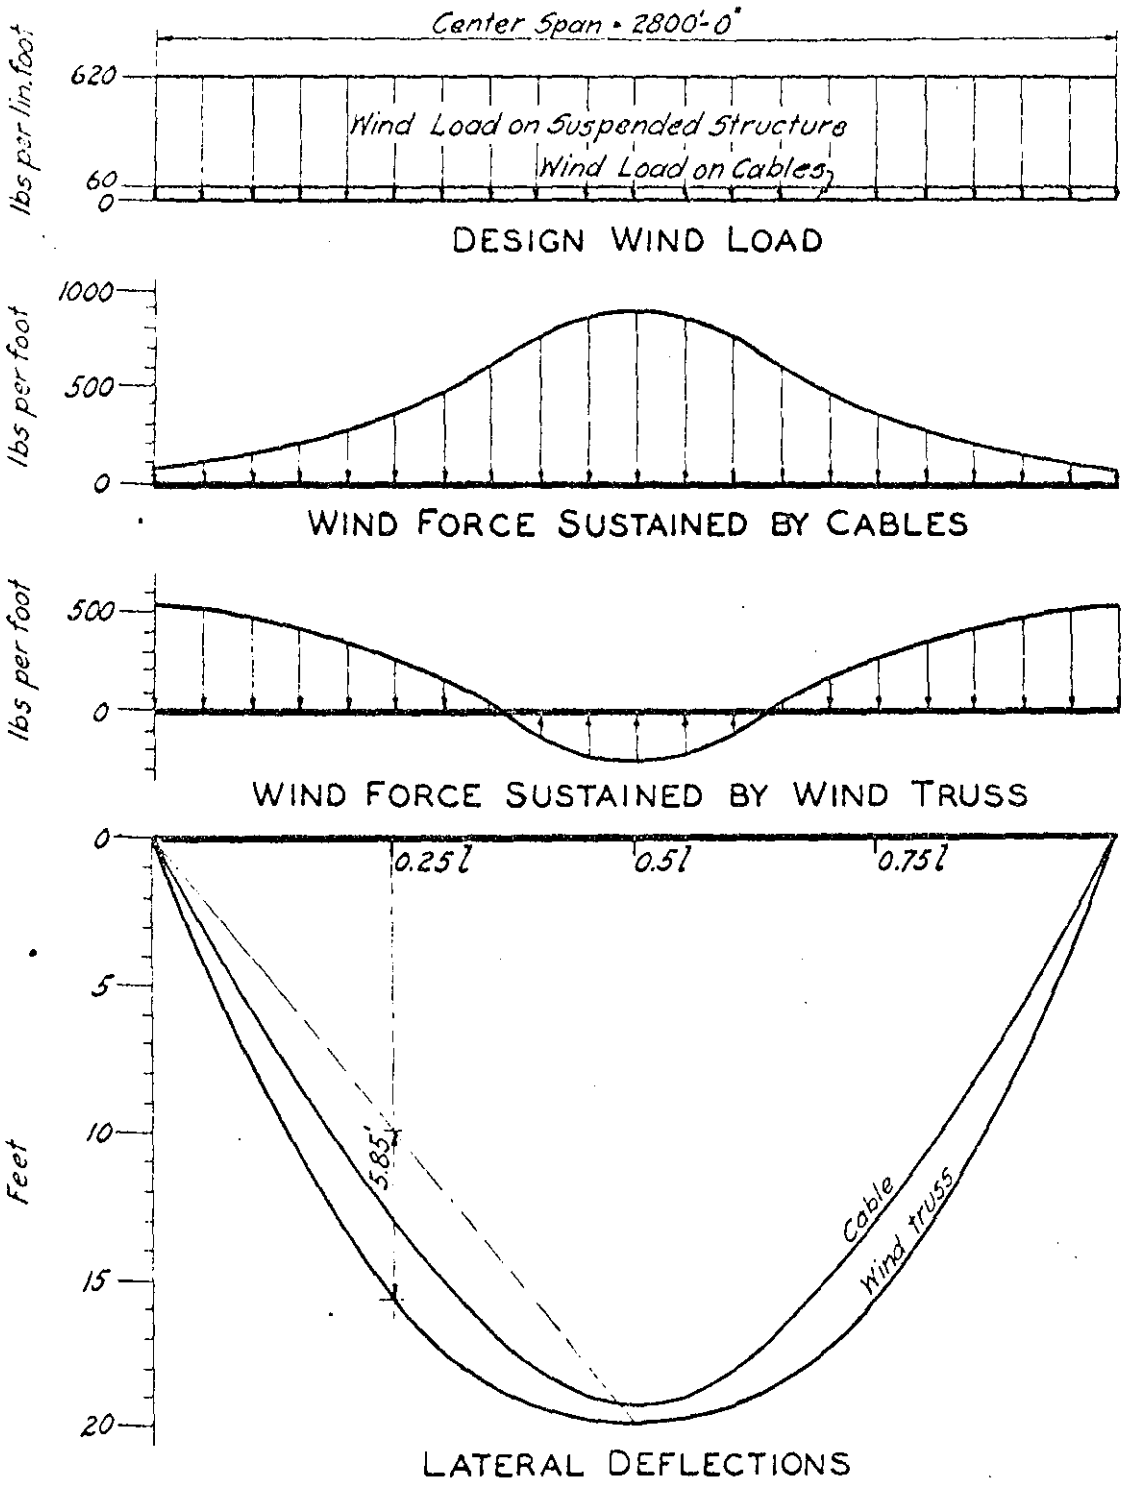
Figure 40. Distribution of 620 lbs. per lineal foot design wind load and resulting lateral deflections of the Tacoma Narrows Bridge (56)

The distribution of wind forces to the floor and cables for the Tacoma Narrows Bridge is shown in Figure 40 and illustrates the supporting effect of the cables on the wind truss. If the wind truss is relatively flexible in the transverse direction much of the wind force acting on the suspended structure is transmitted to the cables and then to the towers. Even the most flexible and narrow long span suspended bridges have a relatively small amount of lateral motion. The lateral stability and deflection are largely independent of the rigidity and width of the wind truss. The rigidity of the wind truss in the lateral direction is a more important factor in resisting torsion when the vertical rigidity is insufficient.
