Bridge deck condition assessment using destructive and nondestructive methods

Brandon Tyler Goodwin

A THESIS

MASTER OF SCIENCE IN CIVIL ENGINEERING

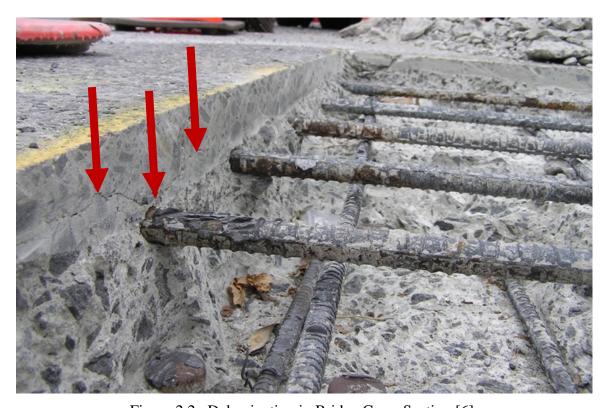
oxygen and water can reach the steel allowing corrosion to occur. Corrosion products from the steel occupy a volume between three to six times that of original steel, inducing large tensile stresses in the concrete [4]. If the tensile strength of the concrete is exceeded, a horizontal crack called a delamination will occur. According to the American Concrete Institute (ACI), a delamination is defined as "a horizontal splitting, cracking, or separation within a slab in a plane roughly parallel to, and generally near the upper surface" [5]. Delaminations can cause an increased rate of corrosion as well as visible deterioration on the bridge deck surface such as spalling and potholes. Figure 2.2 below shows a delamination present in a bridge deck cross section [6].

Figure 2.2. Delamination in Bridge Cross Section [6]

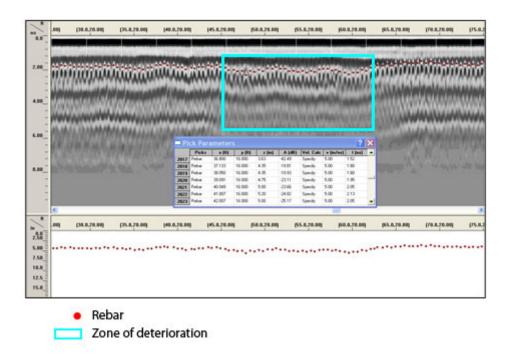
sample GPR results from a bridge deck [30]. The hyperbolas in the image represent reflections from the reinforcing bars. The boxed area shows a section of the bridge deck that is predicted to be deteriorated, as indicated by signal attenuation and varying apparent depths of reinforcing bars.

Figure 2.8. GPR Results from a Bridge Deck [30]

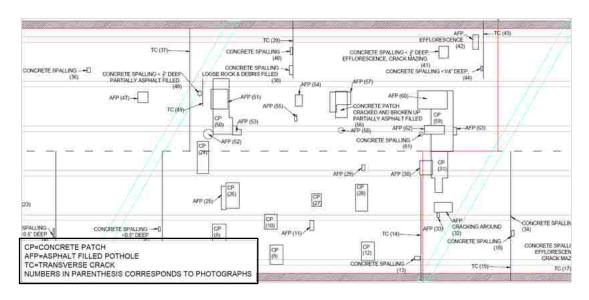
Figure 3.3. Sample Visual Inspection Results

3.1.1. Visual Inspection. Each bridge was carefully examined for defects and deterioration by the researchers on site. The top of each bridge deck was thoroughly examined for signs of defects and deterioration including asphalt and concrete patches, cracks, unfilled spalls, and efflorescence. Where time and access allowed, the underside of the deck was quickly examined for concrete spalling, rust marks, efflorescence, and any other signs of deterioration. Each noted item on the top of the deck was numbered, measured, and photographed. These notes were later incorporated into CAD drawings of the bridge, showing the exact size, location, and type of defect or deterioration as shown in Figure 3.3 below.

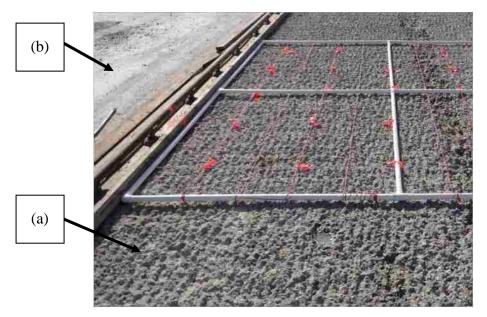
Figure 3.9. Rough Grooved Concrete Surface Caused by Milling (a) and Original As-Built Concrete Surface (b)

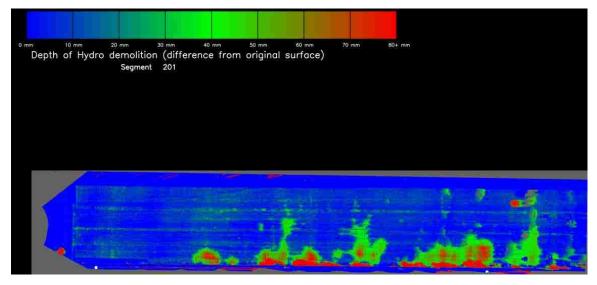
the second scan from the first scan. The reinforcement is visible in the figure, along with the rough, grooved surface created by the milling of the deck surface.

Figure 3.12. Lidar Image of Bridge Deck Showing Depth Difference Between Pre-Rehabilitation and Post-Hydrodemolition

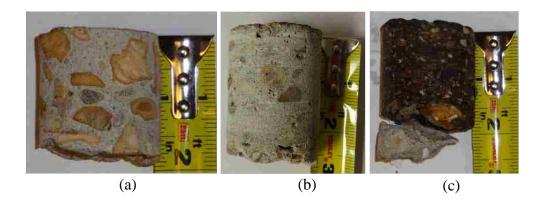
Figure 3.22. Material Types of Extracted Cores from Bridge A1479, (a) As-Built Concrete, (b) Concrete Patch, (c) Asphalt Overlaying As-Built Concrete

3.2.2.3 Cores. Nine cores were extracted from the deck of Bridge A1479. Of the nine cores, five were rated good based on visual evaluation, three fair, and one bad. Refer to Section 3.1.4.1 for the core rating criteria. Seven of the cores were composed of the as-built concrete, one of the cores was taken from a concrete patch as determined by the difference in aggregate, and one core was mostly asphalt, with a 0.5 in. piece of asbuilt concrete on bottom as shown in Figure 3.22 below. Figure 3.23 shows all nine cores extracted from Bridge A1479, along with the visual rating assigned to each during the visual evaluation. Complete core visual evaluation results are included in the Appendix B.

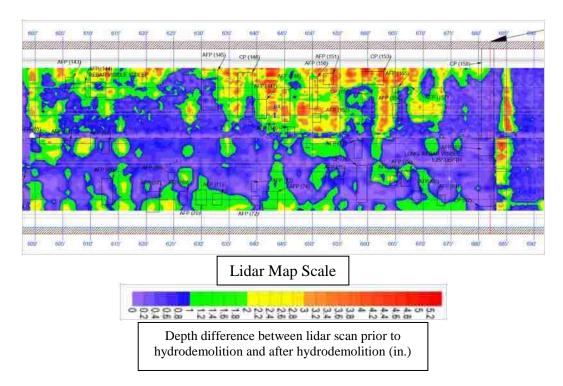
Figure 3.28. Section of Bridge A1479 Drawing Including Lidar Rehabilitation Survey and Visual Investigation Results

3.2.2.4 Hydrodemolition. Hydrodemolition was used as a method to remove loose and deteriorated concrete from the entire inside curb to curb area of Bridge A1479. The rehabilitation of the bridge deck was conducted one lane at a time, with the other lane remaining open to traffic during rehabilitation. When the first lane was finished being rehabilitated, it was reopened, and the second lane was closed to traffic. Lidar data were acquired before and after the hydrodemolition of each lane. All results given below were generated using the difference between the before and after hydrodemolition lidar scans. Three feet from the East and West edge of the lidar map was removed because of inaccurate data due to construction debris along the curbs during scanning. Therefore, all lidar images in this thesis cover only a 26 ft. width of the bridge. Figure 3.28 below shows a section of the bridge drawing with the lidar and visual inspection results.

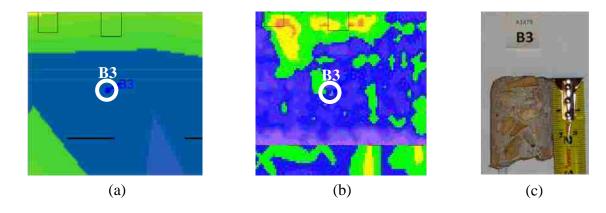
Figure 3.30. Bridge A1479 Core B3 on GPR Map (a), Lidar Map (b), and Core Photograph (c)

Figure 3.30 shows Core B3 on the GPR and lidar maps. As mentioned in Section 3.2.2.3, Core B3 was rated good in the visual evaluation and was located in an area where there was no evidence of deterioration based on the GPR results. Figure 3.31 shows Core B4 on the GPR and lidar maps. Core B4 was rated fair in the visual evaluation due to a delamination at an approximate depth of 1.75 in. Based on the GPR results, the area where Core B4 was extracted from showed evidence of moderate deterioration.

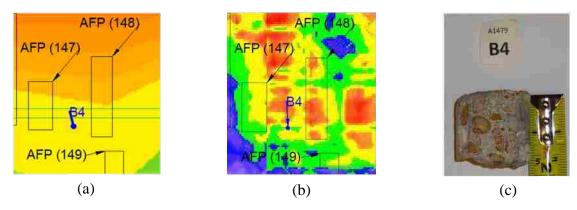
Figure 3.31. Bridge A1479 Core B4 on GPR Map (a), Lidar Map (b), and Core Photograph (c)

Note: Core B4 contained a delamination, concrete below the delamination was not extracted.

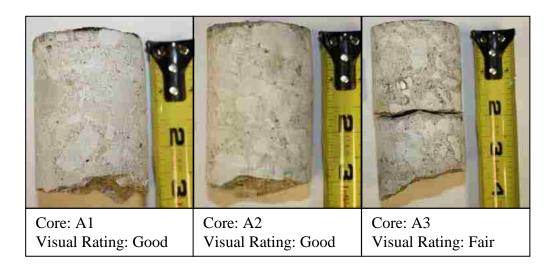
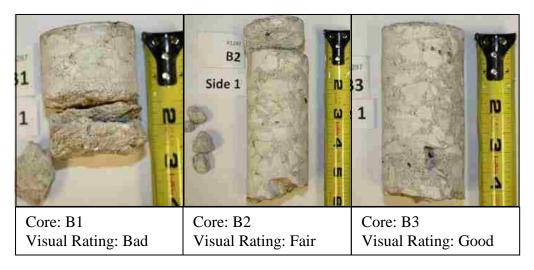
Figure 3.39. Bridge A1297 Cores and Visual Core Ratings

3.3.2.3 Cores. Six cores were extracted from the deck of Bridge A1297. Of the six cores, three were rated good based on visual evaluation, two fair, and one bad. Refer to Section 3.1.4.1 for the core rating criteria. All six of the cores were composed entirely of the as-built concrete. Figure 3.39 below shows photographs of all six cores and their ratings based on the visual evaluation. The complete visual evaluation results are included in the Appendix D.

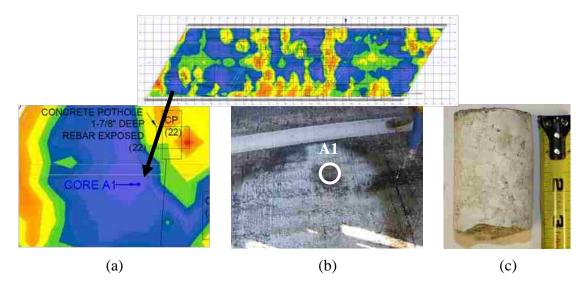
Figure 3.40. Bridge A1297 Core A1, (a) On Bridge Drawing, (b) Deck Image at Core Location, (c) Extracted Core

Based on the GPR results, one core was extracted from an area of the bridge deck that had no evidence of deterioration, and five cores from areas with evidence of moderate deterioration. Figure 3.40 below illustrates the locations of Core A1 on the bridge deck drawing containing the visual investigation and GPR. Core A1 is located in an area with no evidence of deterioration based on GPR and no documented visible deterioration. Core A1 was rated good in the visual examination. Figure 3.41 illustrates Core A2, which is located in an area that has evidence of moderate deterioration based on GPR results. The core has a visual evaluation rating of good.

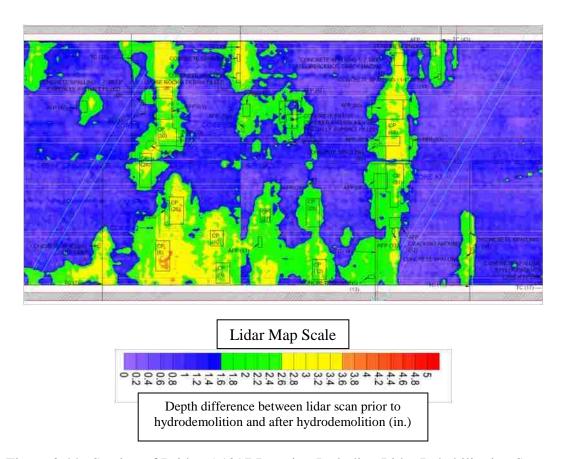
Figure 3.44. Section of Bridge A1297 Drawing Including Lidar Rehabilitation Survey and Visual Investigation Results

Therefore, all lidar images in this thesis cover only a 41.5 ft. width of the bridge. Figure 3.44 below shows a section of the bridge drawing with the lidar and visual inspection results.

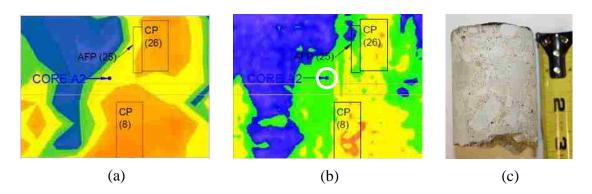
Figure 3.46. Bridge A1297 Core A2 on GPR Map (a), Lidar Map (b), and Core Photograph (c)

Figure 3.45 below shows Core A1 on the GPR and lidar maps, as well as the core hole after the hydrodemolition. As mentioned in Section 3.2.2.3, Core A1 was rated good in the visual evaluation and was in an area where there was no evidence of deterioration based on the GPR results. Approximately 1.6 in. of concrete was removed during the hydrodemolition process in the deck where Core A1 was extracted. Figure 3.46 shows Core A2 on the GPR and lidar maps. Core A2 was rated good in the visual evaluation. Based on the GPR results, the area where Core A2 was extracted from

showed evidence of moderate deterioration. Approximately 2.3 in. of concrete was removed from the hydrodemolition process in the area where Core A2 was extracted.

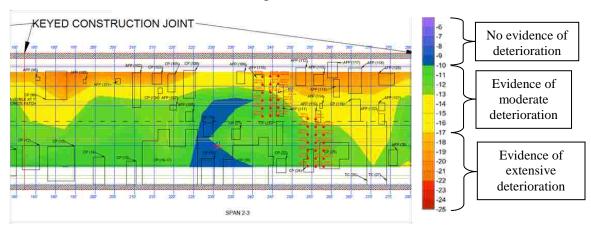
Figure 4.6. Visual Comparison Between GPR Results (a) and Rehabilitation Lidar Survey (b) From Bridge A1479

Figure 4.6 below shows the GPR results and rehabilitation lidar survey for a section of Bridge A1479. Due to the size of the bridge, only a 100 ft. section of the 868 ft. long bridge is shown. Complete results are located in the Digital Appendix discussed in Appendix F. In the figure, a strong correlation between the GPR results and rehabilitation lidar survey is visible. Areas where the GPR estimated higher evidence of deterioration correspond to areas where more material was removed during the rehabilitation process. And likewise, areas where the GPR estimated lower evidence of deterioration correspond to areas where less material was removed during the rehabilitation process.

(a) GPR Top Transverse Reinforcement Reflection Amplitude Results (NdB)

(b) Rehabilitation Lidar Survey KEYED CONSTRUCTION JOINT Depth difference between lidar scan prior to hydrodemolition and after hydrodemolition (in.)

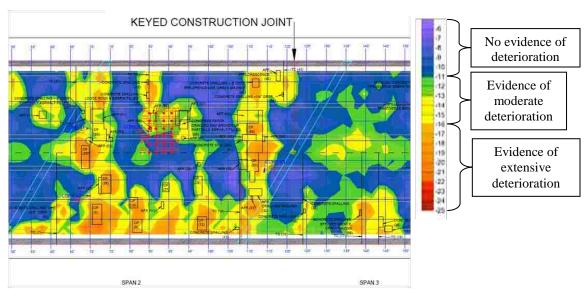
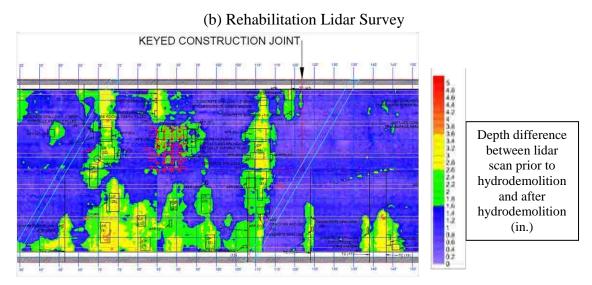
Figure 4.7. Visual Comparison Between GPR Results (a) and Rehabilitation Lidar Survey (b) From Bridge A1297

The GPR results and rehabilitation lidar survey for Bridge A1297 are shown in Figure 4.7 below. Results are show for 100 ft. of the 157 ft. long bridge. Complete results are available in the Digital Appendix described in Appendix F. Similar to Bridge A1479, the GPR and lidar results for Bridge A1297 have a visual correlation. Areas where the GPR estimated higher evidence of deterioration correspond to areas with greater material removal depths from the lidar survey of the rehabilitation. Similarly, areas where the GPR estimated lower evidence of deterioration correspond to areas with lower material removal depths from the lidar survey.

(a) GPR Top Transverse Reinforcement Reflection Amplitude Results (NdB)

The correlation between GPR results and the rehabilitation lidar scans was expected. The GPR responds to areas of saline moisture present in the deck, and for the moisture to ingress into the deck, some form of degradation of the concrete has to be taking place.

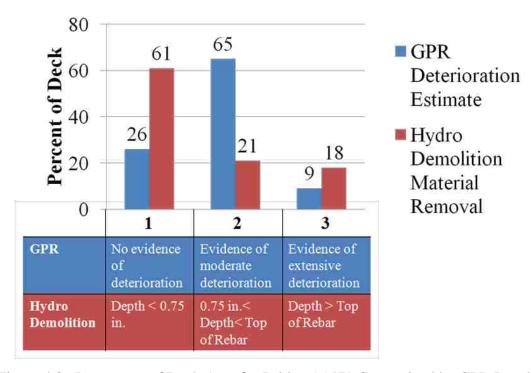
Figure 4.8. Percentage of Deck Area for Bridge A1479 Categorized by GPR Results and Rehabilitation Lidar Survey

Figures 4.8 and 4.9 above were expected to show a trend between the GPR results and the rehabilitation lidar survey because of the visual correlation noted in Figures 4.6 and 4.7. However, no trend between the three different categories of GPR results and rehabilitation lidar surveys is visible.

While interpreting the results shown in Figures 4.8 and 4.9 above, there are several crucial factors that need to be acknowledged. As discussed in Section 3.2, the GPR results used in this thesis are the reflection amplitude from the top transverse layer of reinforcement, therefore these results do not represent the condition of the concrete below the top transverse reinforcement. Because of this, category 3 of the rehabilitation lidar survey is not reflected in the GPR results, because the GPR results presented in this thesis do not extend deeper than the top transverse reinforcement bar. It is also important to note that the topmost layer of reinforcing bars in Bridge A1479 is in the longitudinal direction, which is what the percentages for the three depth removal categories are based on. However, the GPR results are based off of the top transverse reinforcement, which is located 0.625 in. below the top of the longitudinal bars. Also, the GPR results presented
