Detection and characterization of impact damage in carbon fiber aircraft fuselage structure

**DETECTION AND CHARACTERIZATION OF IMPACT
DAMAGE IN CARBON FIBER AIRCRAFT FUSELAGE
STRUCTURE**

THESIS

**Master of Science
Civil Engineering**

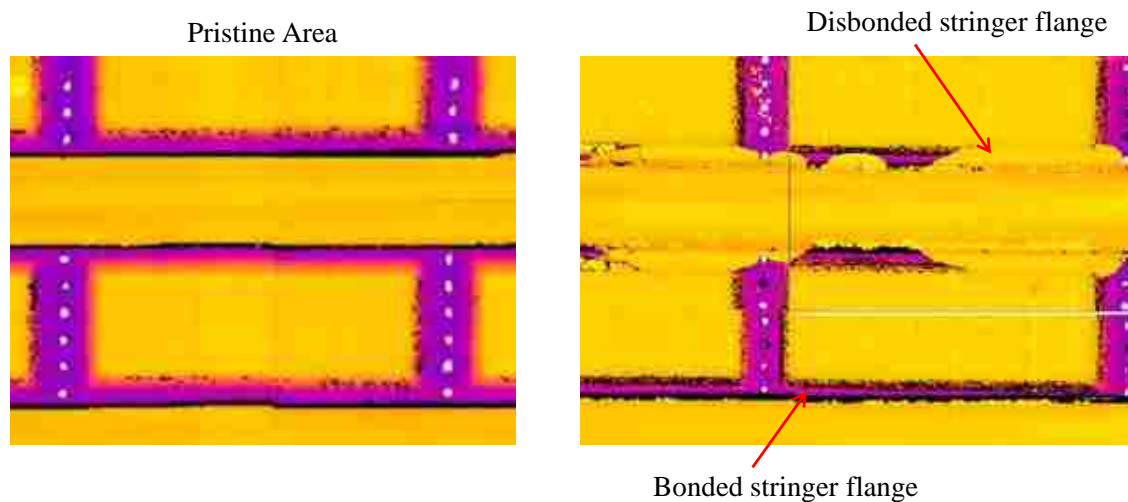
Figure 4-5: Ultrasonic Time of Flight (TOF) C-Scan Showing Delaminated Stringer Flanges

Although it is fairly clear to detect delaminated stringer flanges using the amplitude C-scans, additional, less obvious delaminations could be detected when analyzed side-by-side with time of flight C-scans. An example of a TOF C-scan demonstrating the clear difference between a bonded and delaminated stringer flange is shown in Figure 4-5. The purple areas in the figure are fully bonded flanges. The yellow/orange areas of the flange

are the same depth as the back wall of the skin of the panel, indicating a delamination at the skin-flange interface.

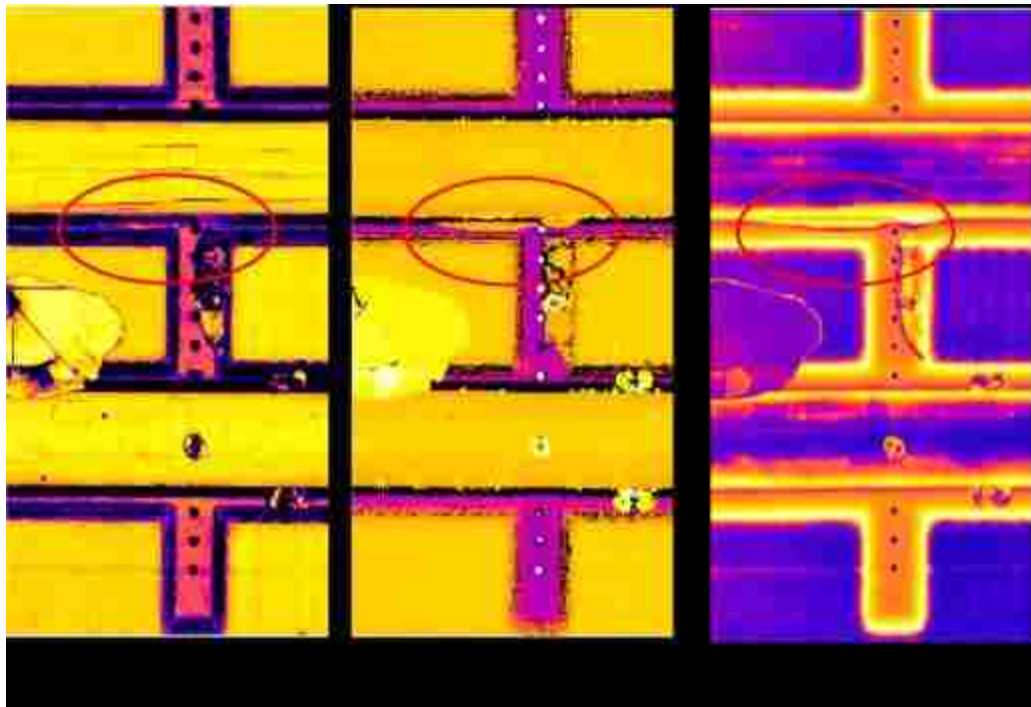
Figure 4-8: Comparison of UT Amplitude, TOF and Resonance

Ultrasonic resonance C-scans were composed using the MAUS V scanning system with a 330 KHz resonance probe. In general, the resonance inspection technique detected the same damage as the pulse echo ultrasonic method. Similar to TOF scans, resonance indicated areas where substructure is disbanded from the skin more clearly than PE-UT amplitude. This can be observed in Figure 4-8, where the small stringer flange disbond in the circled area is detected in the TOF and resonance inspections, but not amplitude.

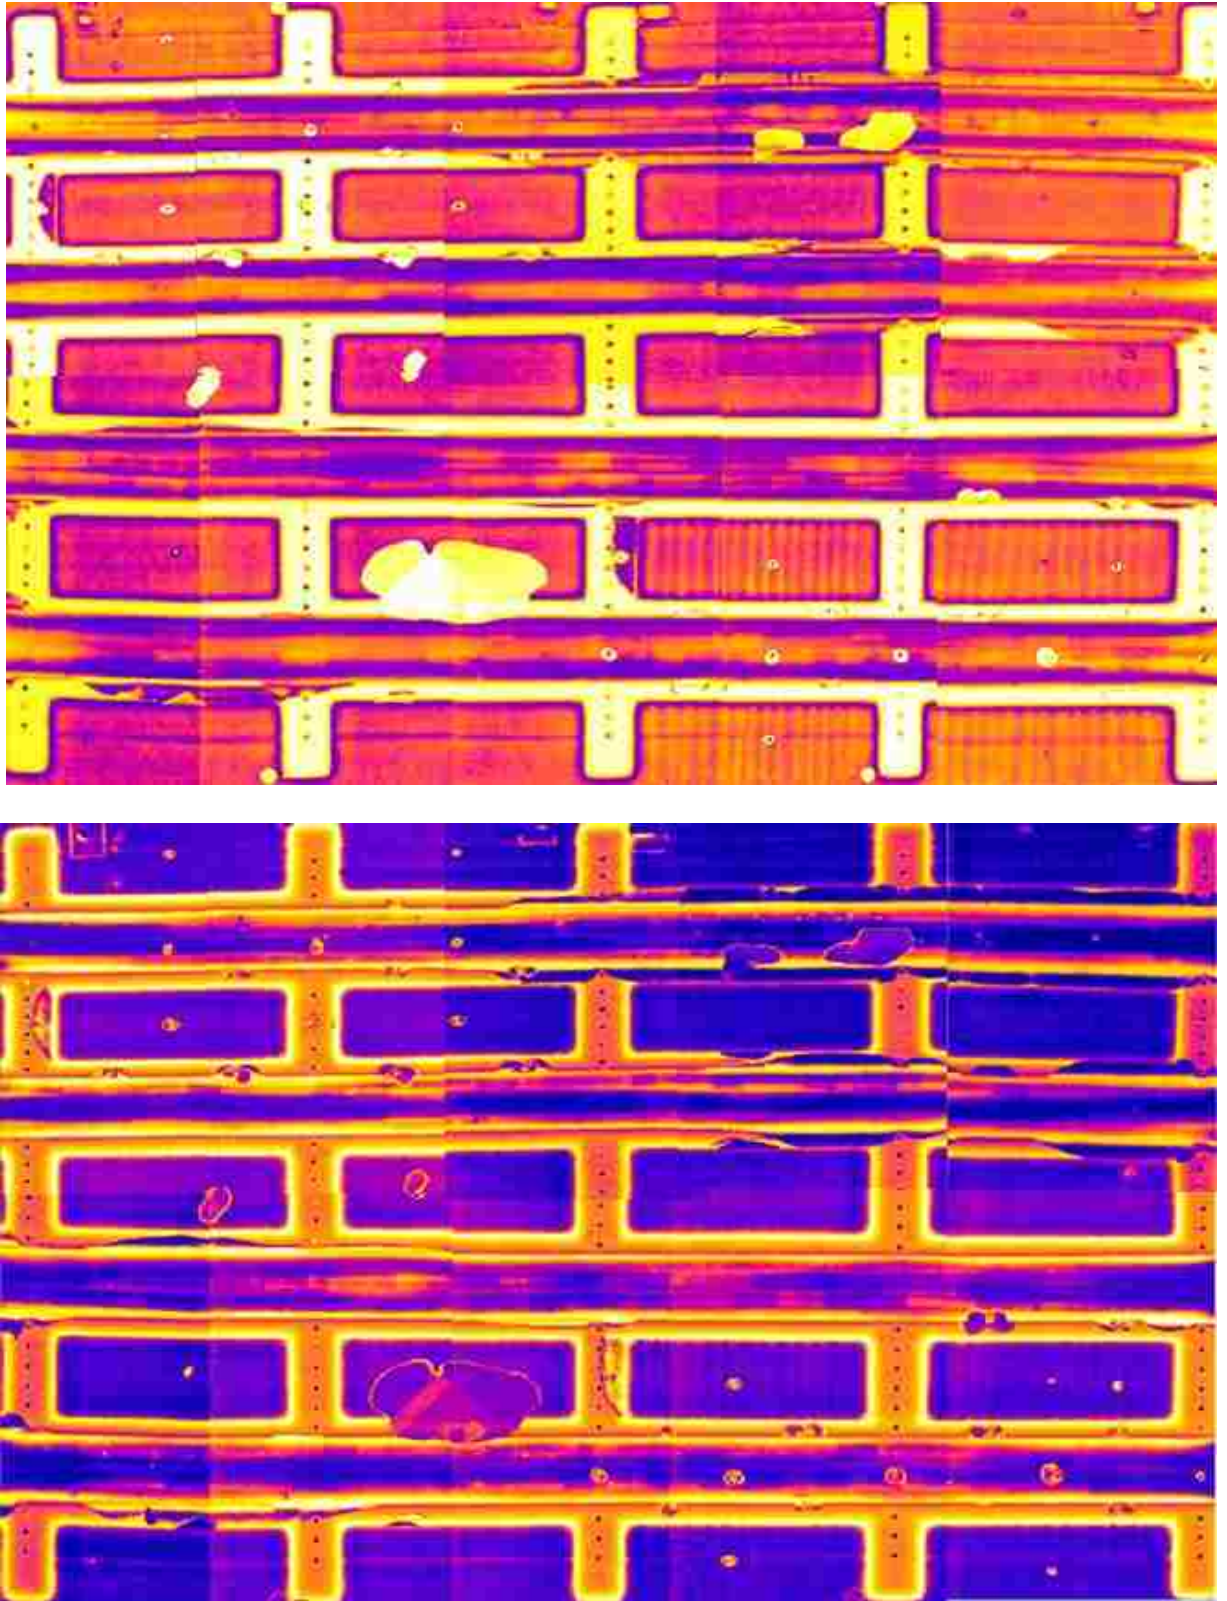
Figure 4-9: Panel A - Resonance Amplitude X plot (top) and Phase Y plot (bottom) C-Scans

Fully assembled resonance scans of panels A and B are shown in Figure 4-9 and Figure 4-10, respectively. There is a slight difference in the color pallet between panel A and B because of the way the resonance inspection technique is zeroed, or nulled. The probe was nulled on a pristine location on each panel, then the inspection was performed. There was a slight difference in the initial null settings between the two panels creating the difference in pallet.

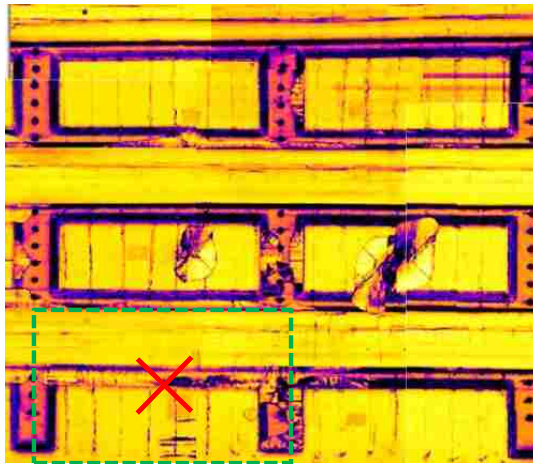
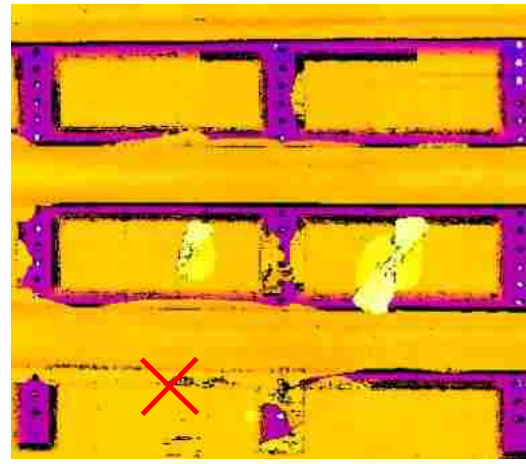
Figure 4-12: Damage Created by Ice Impact at Location 7B (Edge of Stringer Flange) on Panel B

An example of a damage induced by an ice impact at the edge of stringer flange is shown in Figure 4-12. It can be seen in the quadrant view C-scan at the bottom of the figure that the impact was directed mid-way between two shear ties at the edge of a stringer flange. The impact energy of the ice ball was 278.9 Joules and caused the stringer flange to fully disbond. The two shear tie built-up pad sections helped to resist the flange disbonding from continuing farther. Additionally, there was a visible crack at the flange-skin interface along the length of the stringer. This is indicated in the center UT amplitude scan with a green dashed line on the stringer.

Visual Indication: No front side surface visual indication, 17.5” stringer flange crack visible

Damage Area: Interply Delamination 0.0 in², Substructure Disbond 23.16 in²

Type of Damage: Full stringer disbond, no interply delamination detected

Full Stringer Disbond

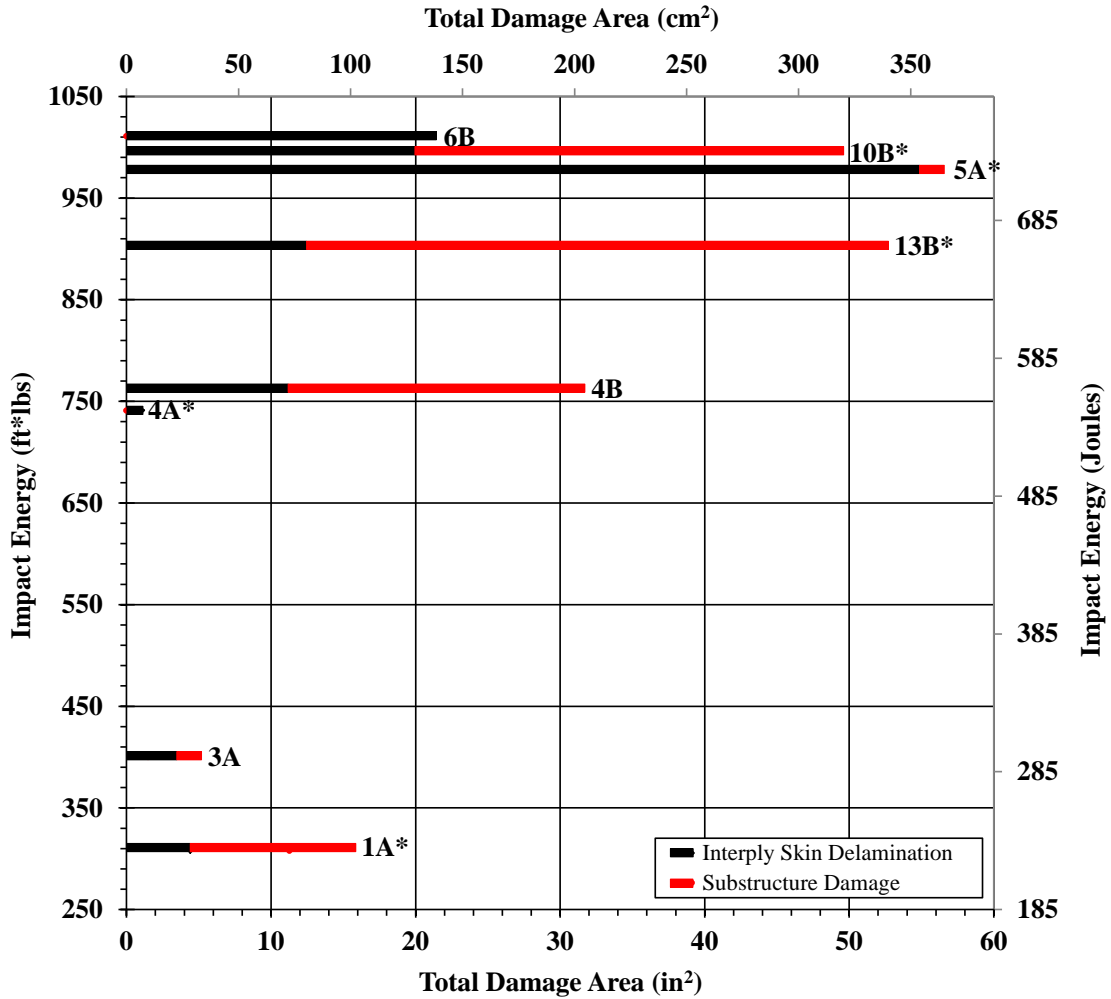
Figure 4-18: Total Damage Area Created by Simulated Hail, Mid-Day Skin Impacts (Type II)

The total damage area, or combination of substructure and interply delamination is charted in Figure 4-18. The black bar in the chart indicates the damage contributed by interply delamination in the skin and the red bar shows the damage contribution from substructure delamination. It can be observed in the chart that it is difficult to determine when substructure disbonding will occur. There is not a set energy threshold that when increased from this threshold substructure delamination will occur.

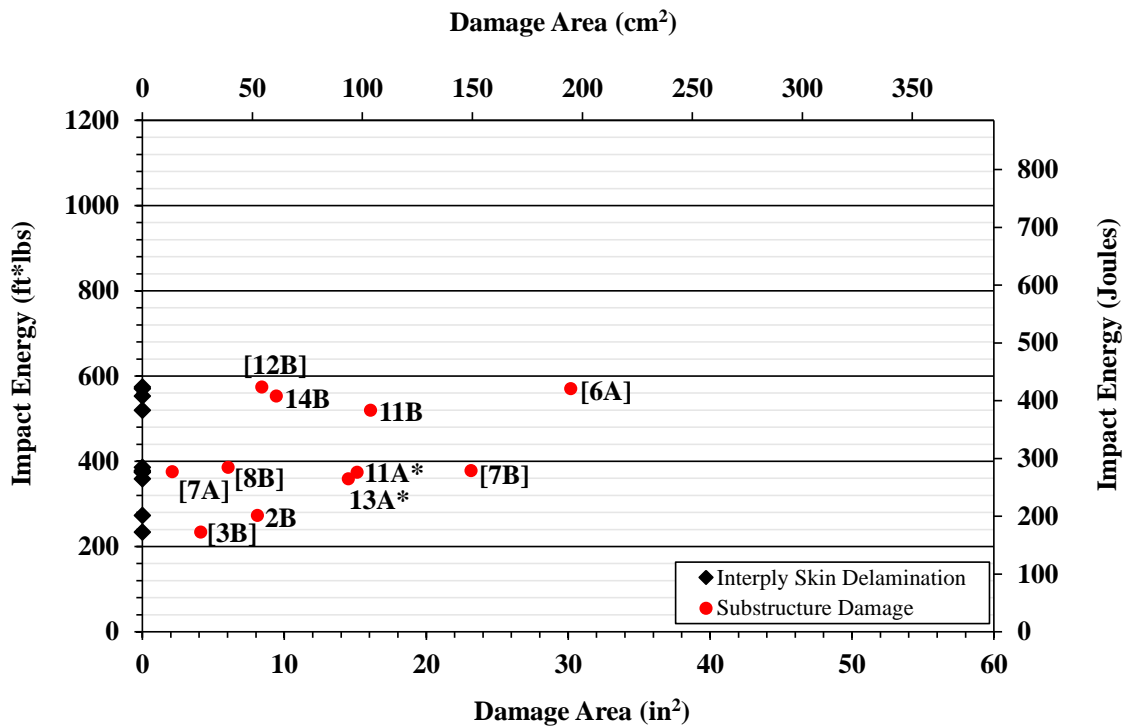
Figure 4-20: Substructure and Skin Delamination Damage Area Created by Simulated Hail, Stringer Flange Impacts

This study investigated impact on both stiffened and unstiffened fuselage structural elements. Impacts conducted at locations over stringer flanges initiated damage at lower levels than impacts over unsupported skin impacts. Figure 4-20 plots the damage area in both substructure and skin elements induced by simulated hail impact over the stringer flange. The plot consists of both 2a and 2b type impacts and was combined for both panels. It was noted that none of the stringer flange impacts caused any type of interply delamination in the 16 ply skin. All of the damage area caused by these impacts was substructure disbonding and typically increased with impact energy. This most likely occurred because of the high peeling stresses that are generated at the edges of the flange when the skin of the panel bends during the impact event. The energy induced into the panel is absorbed through flange delamination and therefore does not lead to interply skin delamination. The total area damage plot for these impacts is not provided because it is the same as the substructure delamination area plot (red dots).

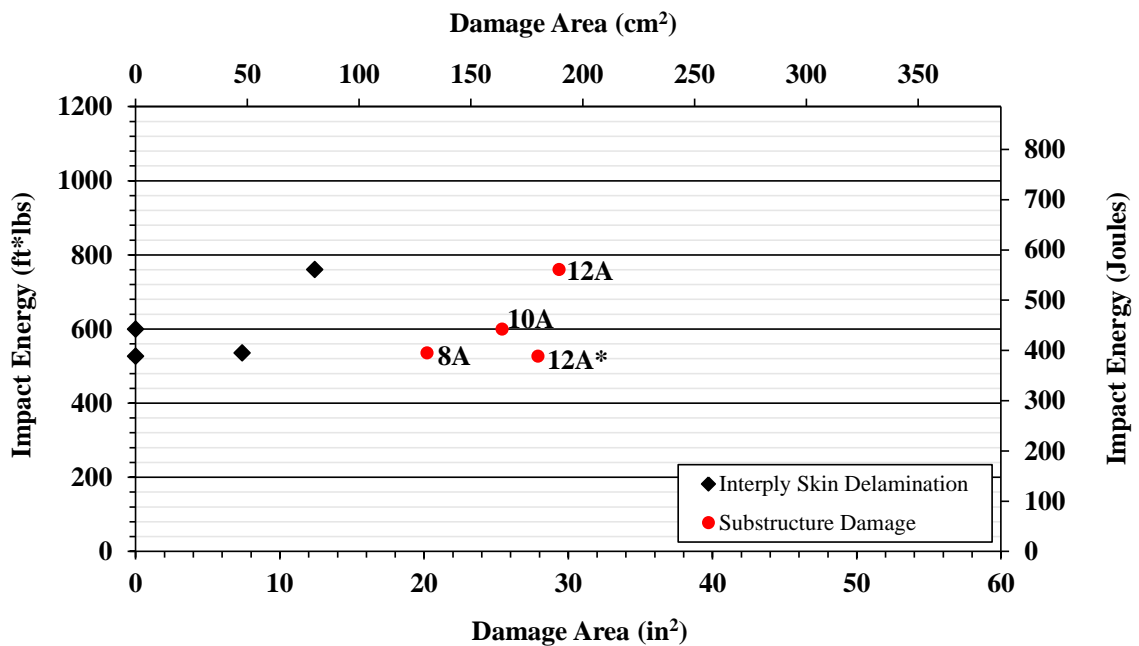
Figure 4-23: Substructure and Skin Delamination Damage Area Created by Simulated Hail, Mid-Stringer Impacts (Type I3)

Damage area induced from mid-stringer hail impacts for both substructure and skin delamination is plotted in Figure 4-23. Similar to mid-bay skin impacts, two of the four mid-stringer impacts generated both interply delamination and stringer flange delamination. To initiate damage at the mid-stringer location, more impact energy was needed than the energy level that produced damage for a mid-bay impact and direct stringer flange impact.

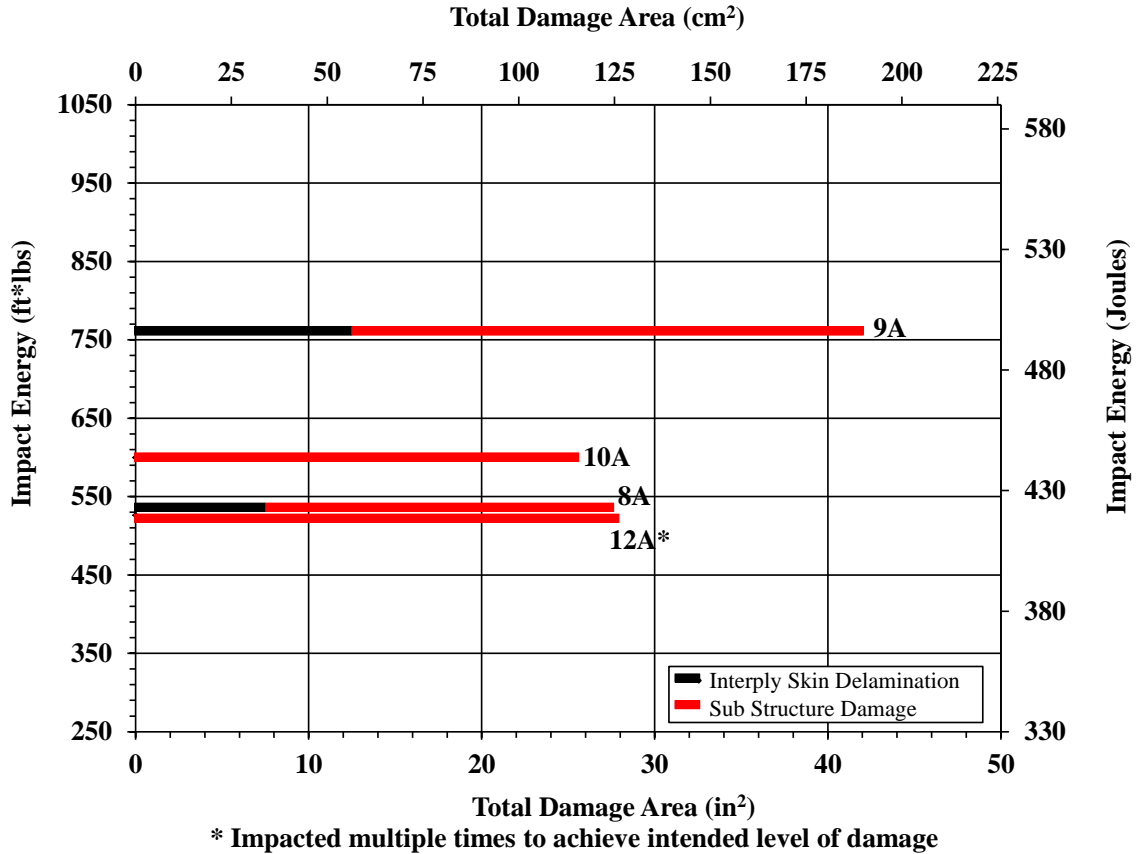
Figure 4-24: Total Damage Area Created by Simulated Hail, Mid-Stringer Impacts (Type I3)

The total damage generated by mid-stringer impacts is shown in Figure 4-24. Although interply skin delamination did occur in two of these impacts, a majority of the damage was caused at the skin to flange substructure interface. Because impacts 8A, 9A and 10A were conducted on the same stringer, the first damage-inducing impact may have had an effect on subsequent, nearby impacts.

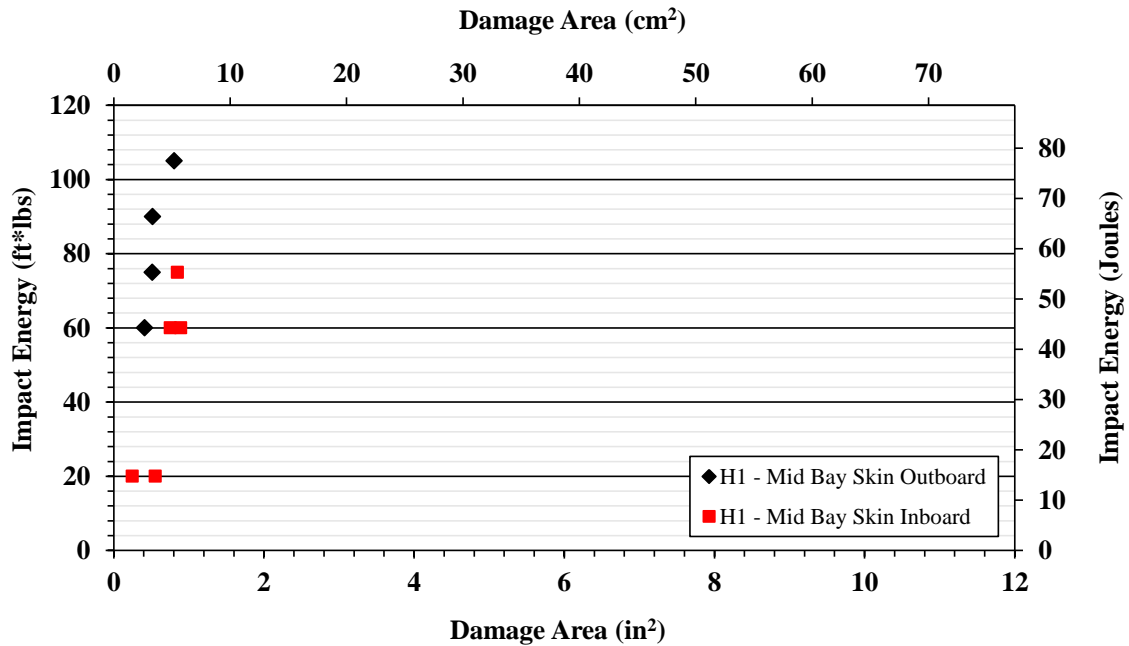
Figure 4-28: Damage Area Created by 2” Diameter Spherical Tip Mid-Bay Skin Impacts (Type H1)

Damage created by mid-bay skin impacts with the 2” diameter spherical tip included near surface fiber crushing and some interply skin delamination. Damage area verses impact energy for these impacts is shown in Figure 4-28. About half of the impacts were conducted on skins that were stiffened by a single stringer on one side (outboard impacts). This resulted in decreased stiffness of the overall outboard skin and damage from impacts in these regions created less damage than mid-bay skin impacts, inboard of stringers two and four. This phenomena is shown in the Figure 4-28 plots and can be attributed to slightly different boundary conditions between the impacts.

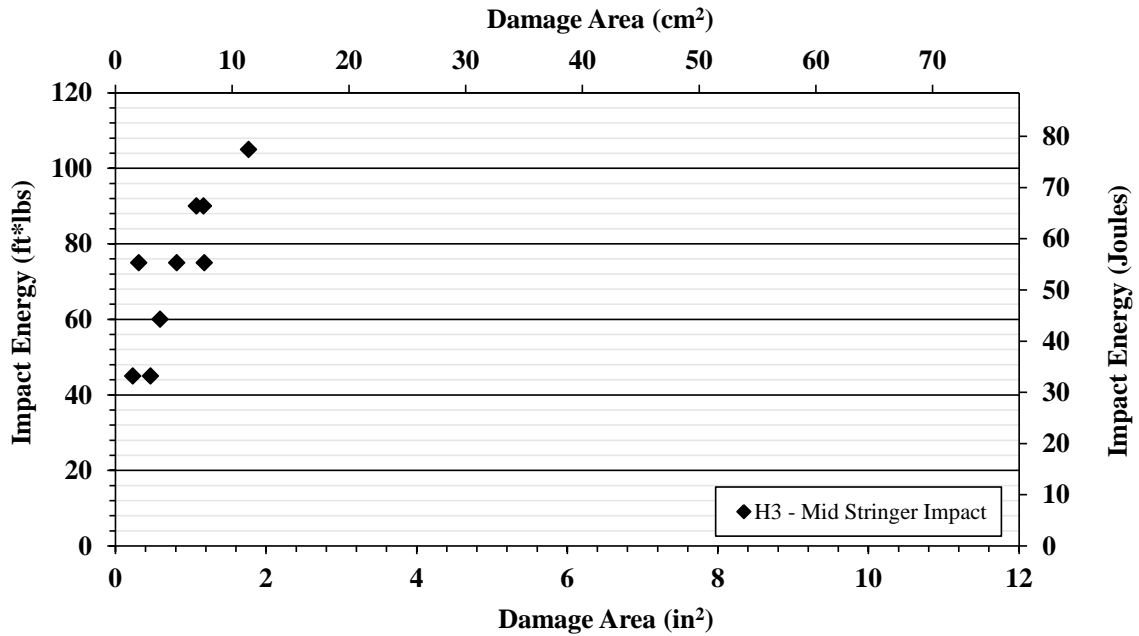
Figure 4-30: Damage area Created by 2” Diameter Spherical Tip Mid-Stringer Impacts (Type H3)

Figure 4-30 plots the mid-stringer impact (between stringer flanges – H3) damage area versus impact energy. These impacts created near surface fiber crushing and some interply delaminations in the skin. No substructure disbonds were observed as a result of these impacts. This particular impact location had the most consistent boundary conditions and therefore resulted in the best trending data.

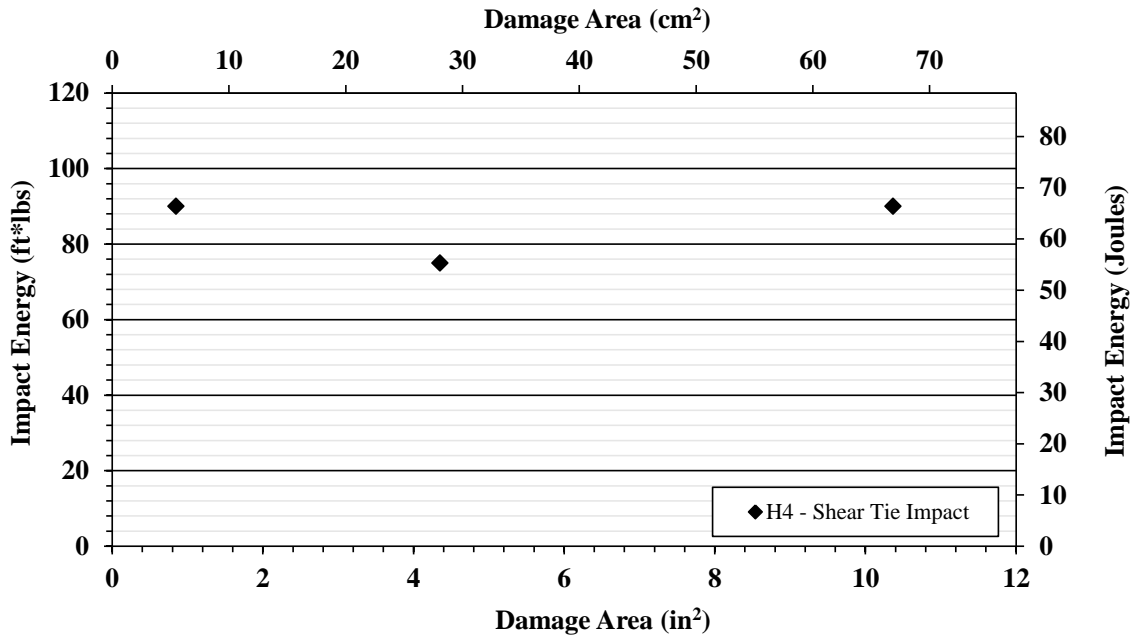
Figure 4-31: Damage Area Created by 2” Diameter Spherical Tip Shear Tie Impacts (Type H4)

Damage area from the three shear tie impact tests (H4) are displayed in Figure 4-31. The two impacts that created approximately 4 in² and 10 in² of damage were located at the edge of the shear tie. The high shear stresses developed during the impact caused the tapered built-up section to delaminate from the skin. The inspection results from the shear tie edge impacts and shear tie center impact clearly show the difference in damage level (see impacts 8, 19, and 23 in Appendix C).

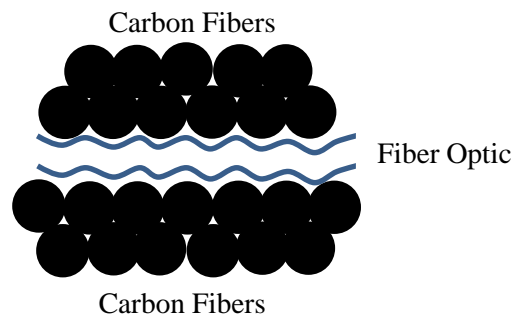
Figure 4-33: Micro Bending of Embedded Fiber Optic Causing Light Attenuation

An initial interrogation of the embedded fiber revealed that there was significant light attenuation within the fiber and that light could not be transmitted through the length of the fiber. The majority of the fiber optic was run in the 90 degree fiber direction and the fiber toes on either side of the embedded fiber were run at -45 degrees and 0 degrees. When the panel was cured under high pressure in the autoclave, the carbon fibers were pressed tightly inducing micro bending along the length of the fiber. Micro bending of the fiber optic is illustrated in Figure 4-33. The initial intention in selecting a fiber for this application was to select a fiber with a high numerical aperture. Fibers with a high numerical aperture are less susceptible to light attenuation due to micro bending. The particular fiber used may not have had as high of a numerical aperture as intended.

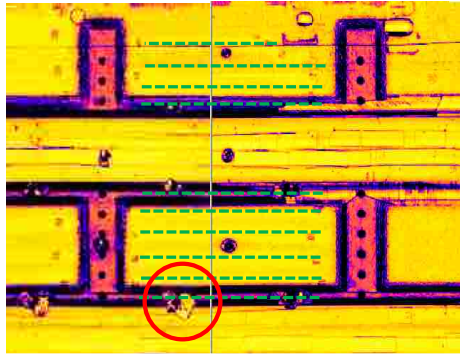
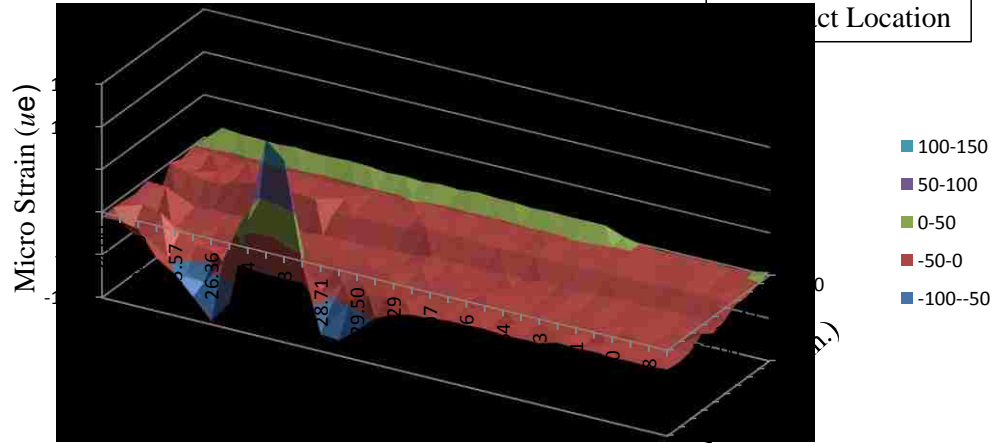
Figure 4-39: Example Fiber Optic Strain Map of Stringer Flange Impact

A sample result constructed using the fiber orientation in bay 2 is shown in Figure 4-39. This particular impact was successfully detected using the bonded fiber optic. A noticeable strain indication of around 120 micro strain is shown in the 3D strain map at the bottom of the figure. It can also be seen in the 3D strain plot that there is a noticeable compressive strain on either side of the impact location, with a positive strain at the center of the impact. This is typical of a dent where the center of the impact corresponds to the peak positive strain of the dent and the compressive strains on either side correspond to the base (reverse bending) of the dent. The full set of strain map results for this fiber orientation and the vertical fiber orientations used in the hard tip spherical impact tests is contained in Appendix C.

Center of Stringer Flange
Impact Energy: 90 Ft lbs
Damage Area: 3.46 in²
Type of Damage: Interply delamination
Strain Indication: Yes, clear detectable strain indication

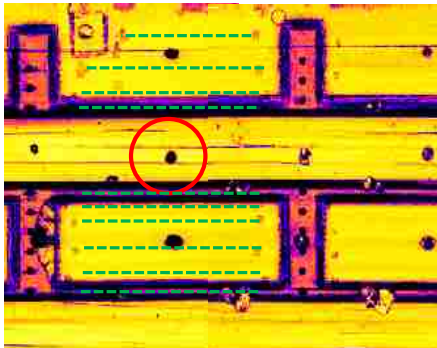
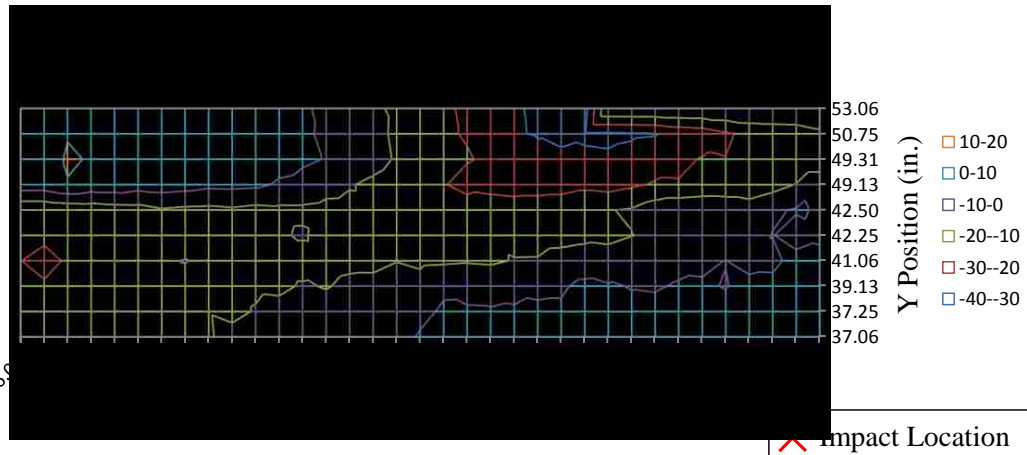
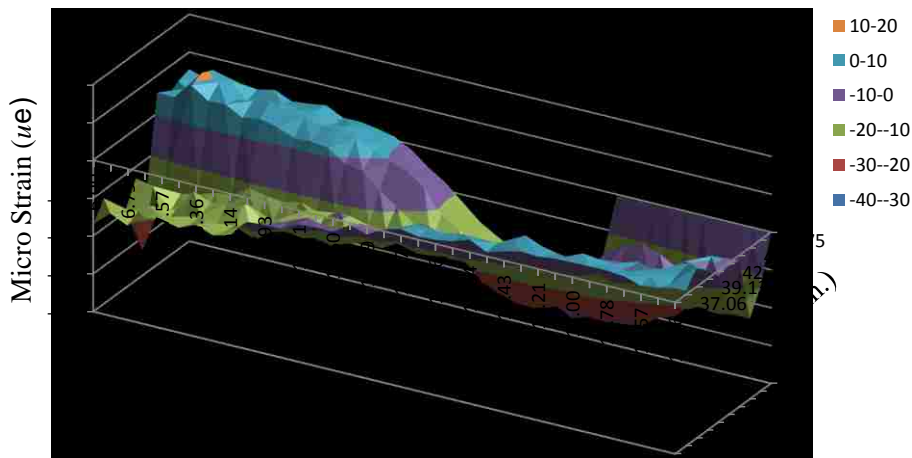
Figure 4-40: Impact at Mid-Stringer Between Flanges that was Not Detectable with the Fiber Optic

Global changes in the strain field were occasionally noticed in some of the post impact strain plots. This may have been attributed to shifts in temperature between the initial baseline measurement and the post impact measurement, or movement of the panel during testing. Typically these were observed in tests where there was not a detectable strain indication of damage and the maximum strain over the length of the fiber was relatively low. An example of a non-detectable impact damage and the resulting strain field measurements is shown in Figure 4-40. This impact was conducted on the skin between the stringer flanges. It can be seen in the impact schematic in the top right of the figure that significant deformation at the impact site including stringer flange disbonding would have to occur in order for the FO to detect the strain change from this impact. It can also be seen in the ultrasonic amplitude C-scan at the top left side of the figure that there was very little damage induced by the impact (0.47 in² of near surface fiber crushing).

Mid-Stringer Between Flanges
Impact Energy: 45 Ft lbs
Damage Area: 0.47 in²
Type of Damage: Near surface fiber crushing
Strain Indication: No, possible temperature shift or change in panel loading

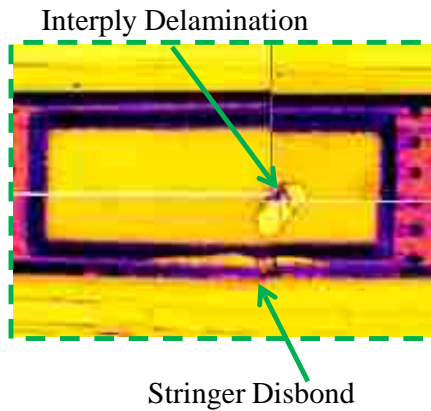
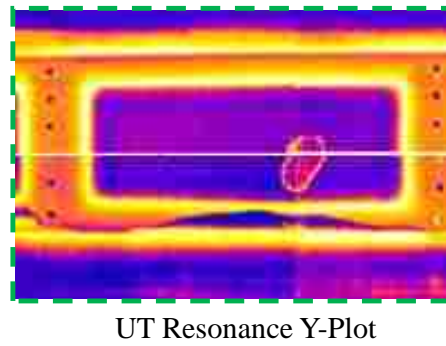
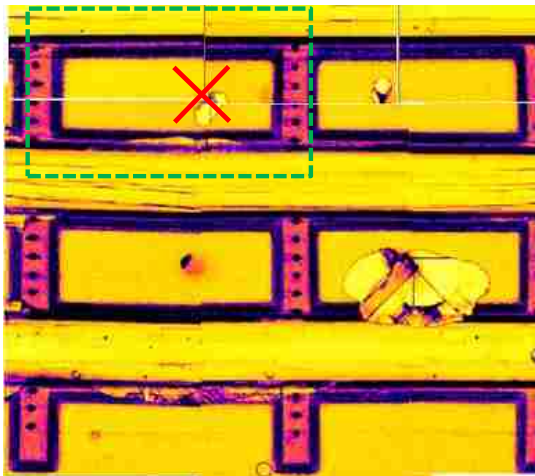
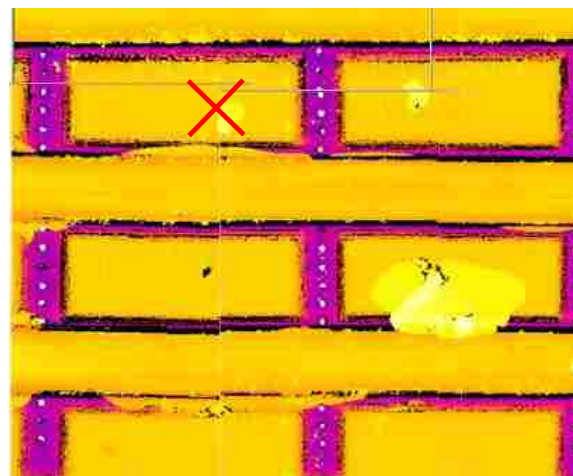
Damage Area: I.D. 4.43, S.D 11.29 in²

Type of Damage: Interply delamination, stringer flange disbonding

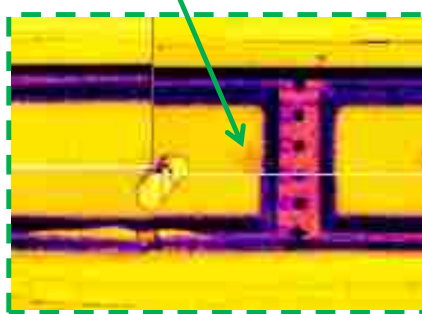
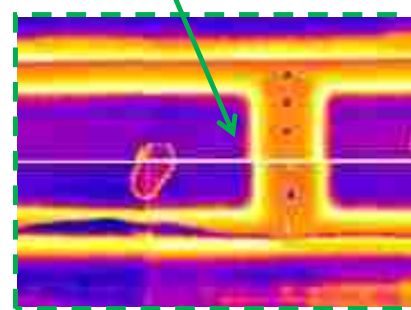
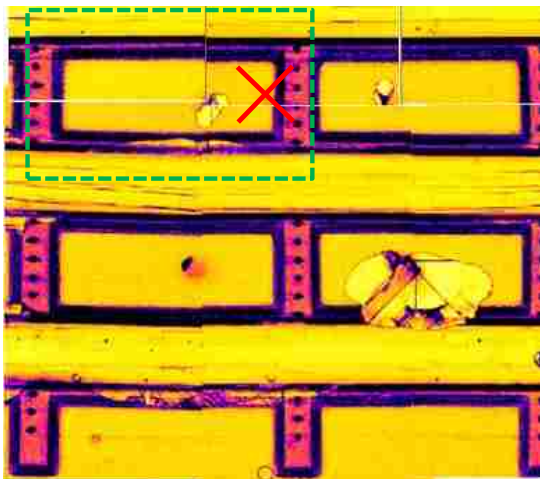
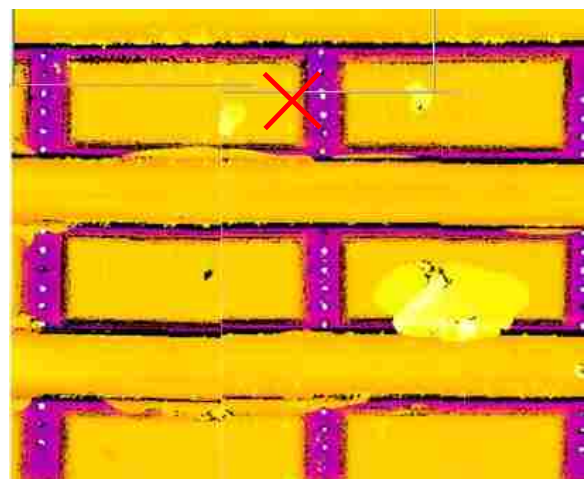
Damage Area: None

Type of Damage: Slight loss in amplitude could indicate micro cracking in matrix at impact location

Slight Increase in Attenuation
(not noticeable in TOF)

No Indication

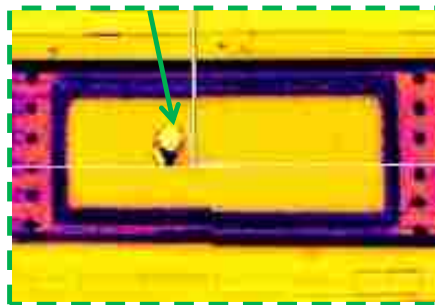
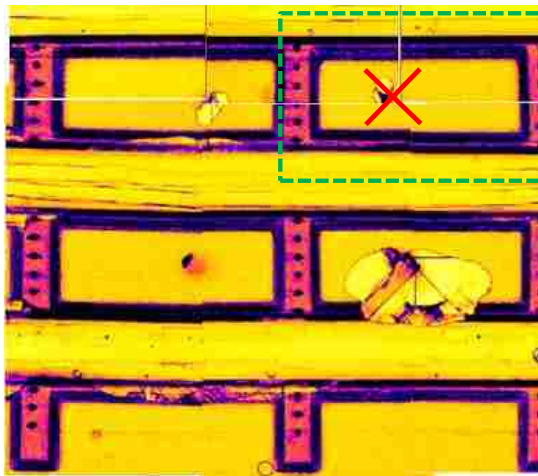
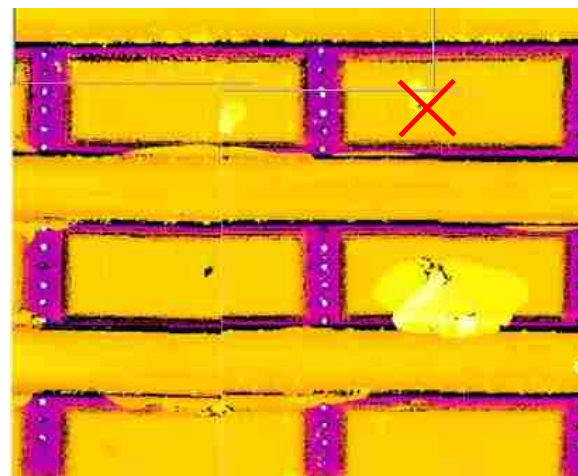
Damage Area: I.D. 3.55, S.D 1.50 in²

Type of Damage: Interply delamination and stringer disbond. Stringer disbond was not detected in UT amplitude, but was in TOF and resonance.

Interply Delamination

Stringer Disbond

Stringer Delamination not detected in amplitude

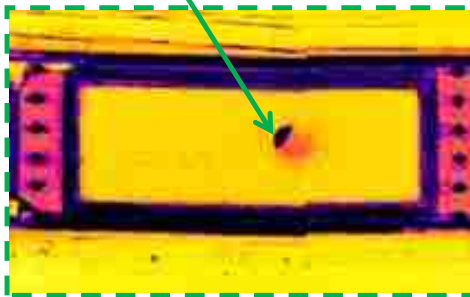
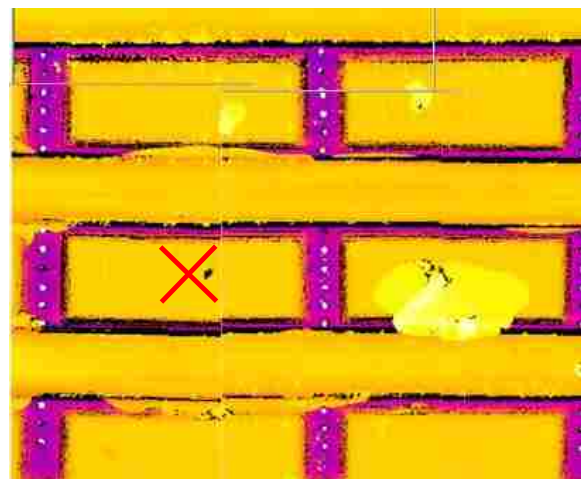
Damage Area: I.D. 1.09, S.D. 0.0 in²

Type of Damage: Near surface fiber crushing, small interply delamination

Small Interply Delamination

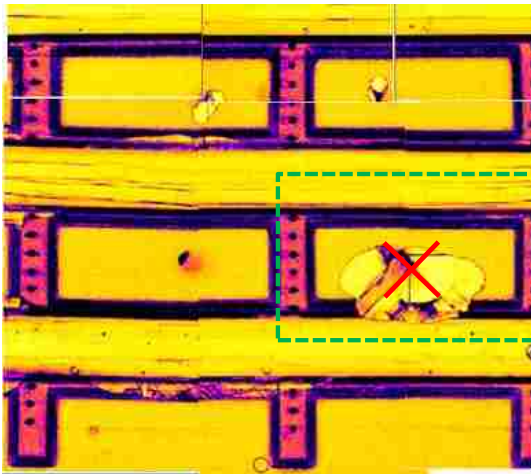
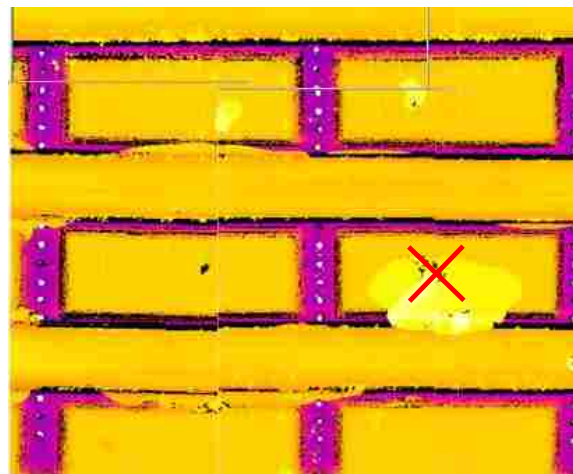
Visual Indication: No front side visible indication, small 2” stringer flange crack detectable on backside

Damage Area: Interply Delamination 54.97 in², Stringer Disbond 1.70 in²

Type of Damage: Mostly interply delamination, small stringer disbond to the upper right of the impact area not detected in amplitude scan

Interply Delamination

Stringer Delamination

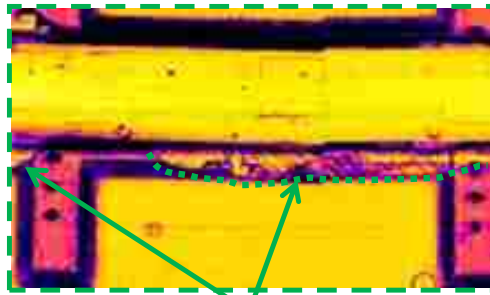
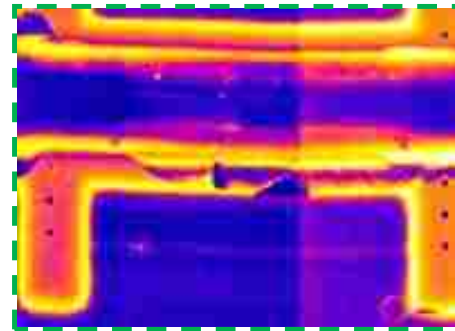
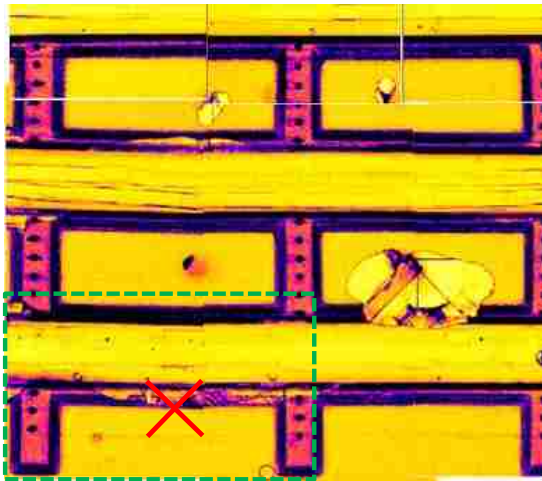
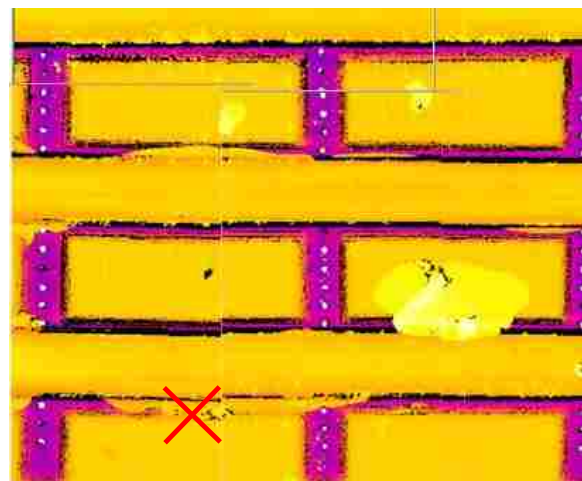
Visual Indication: No front side visible indication, large, 11" long crack visually detectable on back side of stringer at impact location

Damage Area: I.D. 0.0, S.D 30.18 in²

Type of Damage: Cracked through tapered flange at point of impact, un-zipped (disbonded) stringer flange from shear tie to shear tie

Stringer Disbond

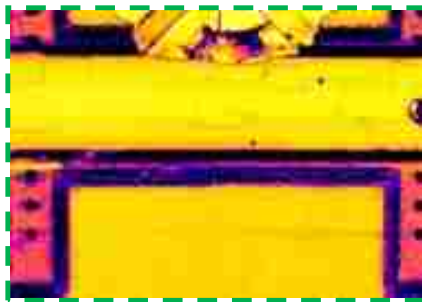
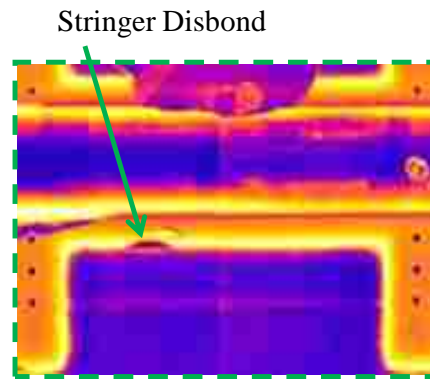
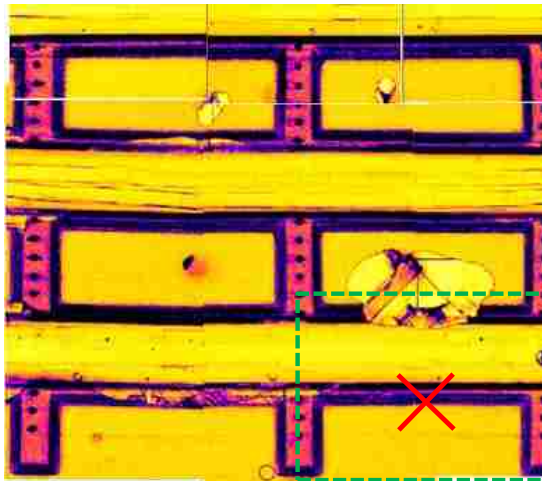
Damage Area: I.D. 0.0, S.D. 2.10 in²

Type of Damage: Small stringer disbond detected in resonance and TOF, but not amplitude

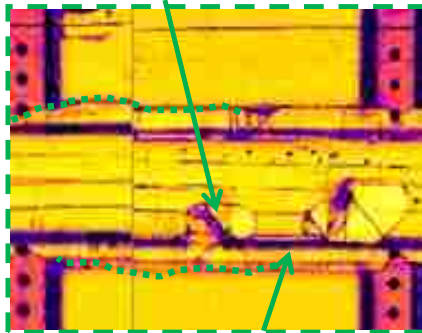
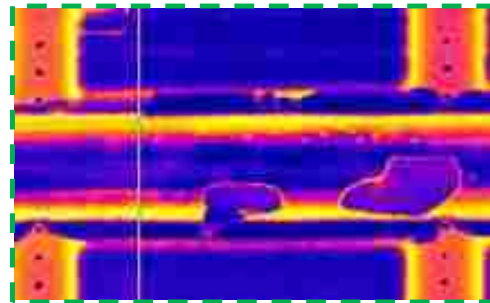
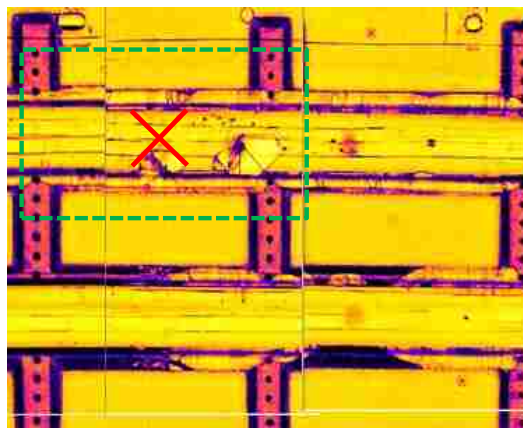
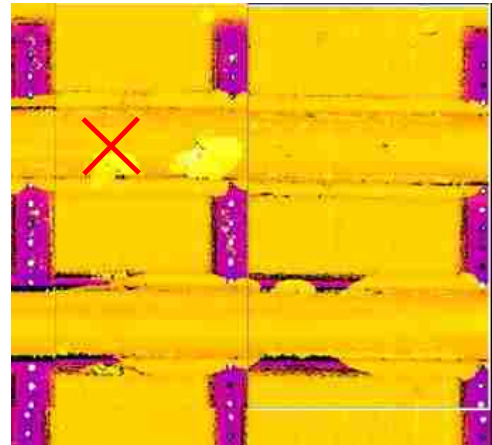
Damage Area: I.D. 7.39, S.D. 20.21 in²

Type of Damage: Full stringer disbond on both flanges, interply delamination at impact location

Interply Delamination

Full Stringer Disbonds

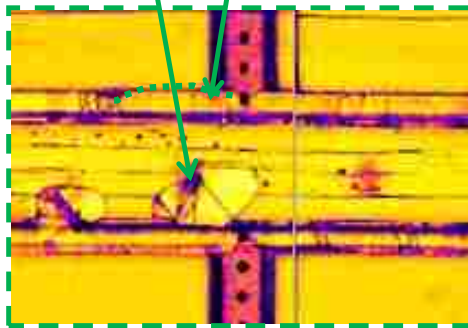
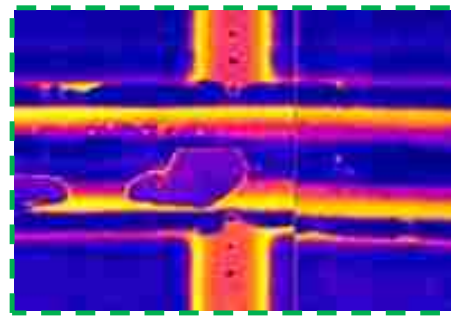
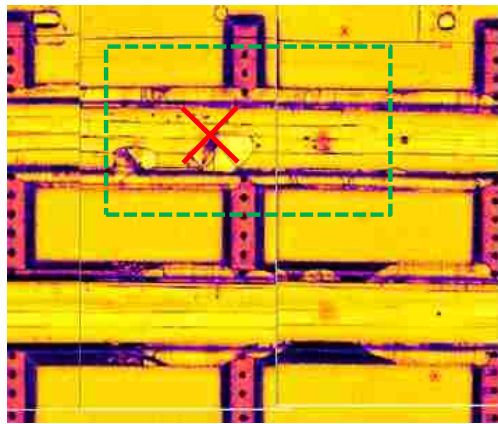
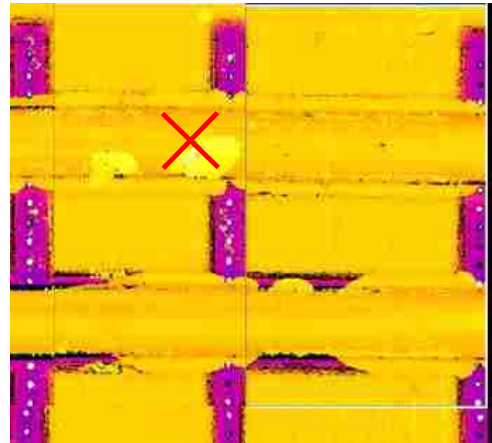
Damage Area: I.D. 12.42, S.D. 29.37 in²

Type of Damage: Disbonded stringers on both sides of impact, interply delamination

Interply Delamination

Stringer Disbonds

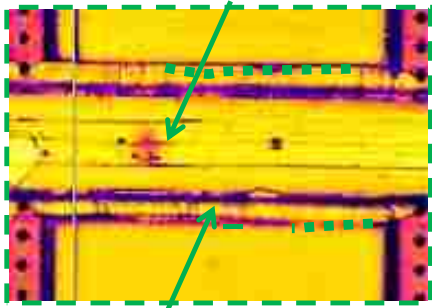
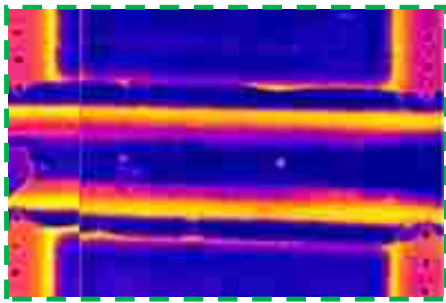
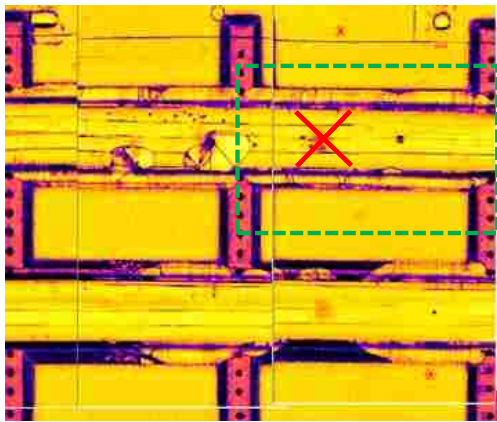
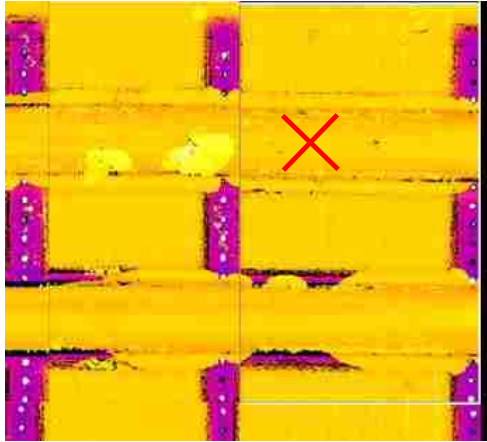
Visual Indication: No front side surface visual indication, 9” stringer delamination detectable on top stringer flange, two small visual cracks in the bottom stringer flange (1” and 4”)

Damage Area: I.D 0.0, 25.41 S.D. in²

Type of Damage: Stringer disbonds, micro cracking in matrix at impact location detected as drop in amplitude

Decrease in Amplitude

Full Stringer Flange Disbondss

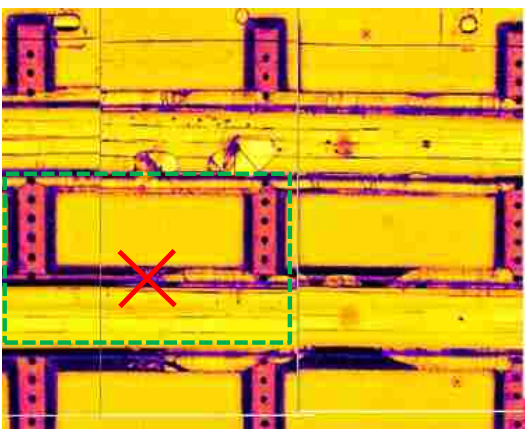
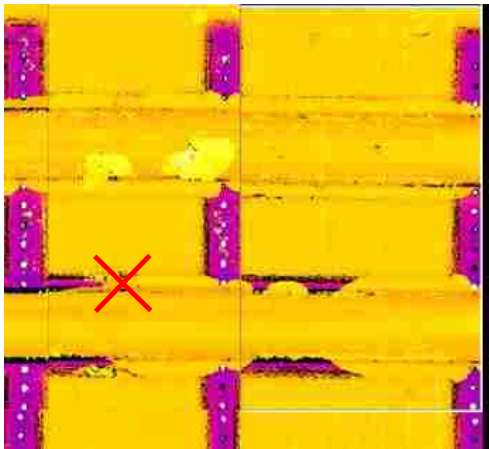
Damage Area: I.D. 0.0, 15.14 S.D. in²

Type of Damage: Stringer disbond detected in amplitude, TOF and resonance, no interply delamination detected in the skin

Stringer Disbond
