Detection and characterization of impact damage in carbon fiber aircraft fuselage structure

**DETECTION AND CHARACTERIZATION OF IMPACT
DAMAGE IN CARBON FIBER AIRCRAFT FUSELAGE
STRUCTURE**

THESIS

**Master of Science
Civil Engineering**

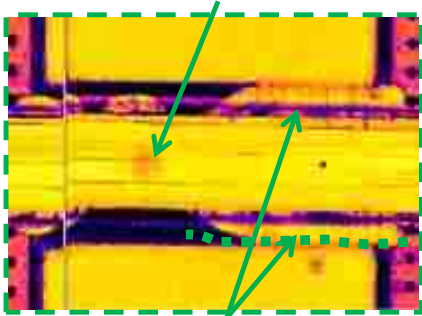
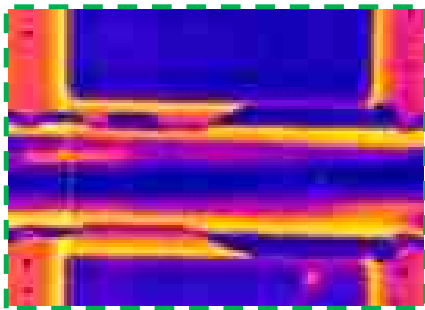
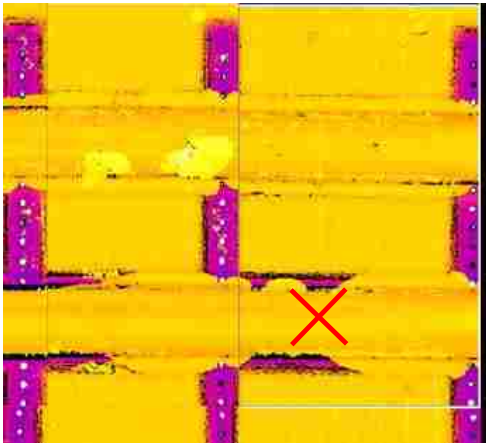
Center of Stringer Between Flanges
Max Impact Energy: 526.2 ft lbs, 388.1 Joules
Max Impact Velocity: 284.1 ft/s, 86.6 m/s
Visual Indication: No front side surface visual indication, 10.5” stringer flange crack detectable on bottom stringer flange
Damage Area: I.D. 0.0, S.D. 27.90 in²
Type of Damage: Stringer disbond, micro cracking in matrix at impact location detected as drop in amplitude

Decrease in Amplitude

Stringer Disbonds

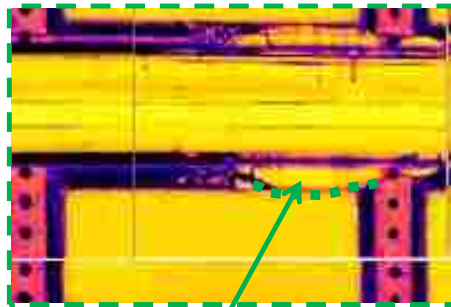
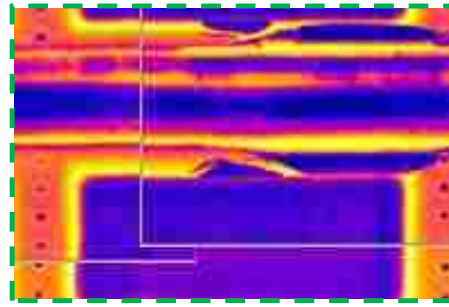
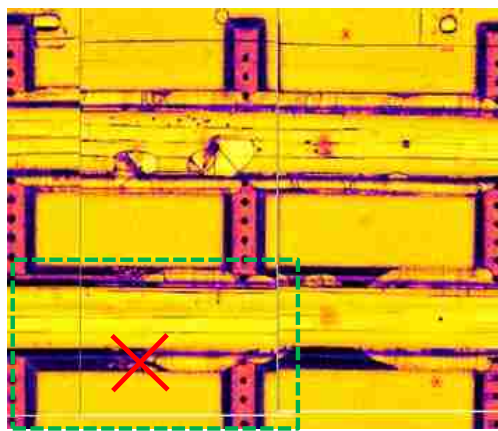
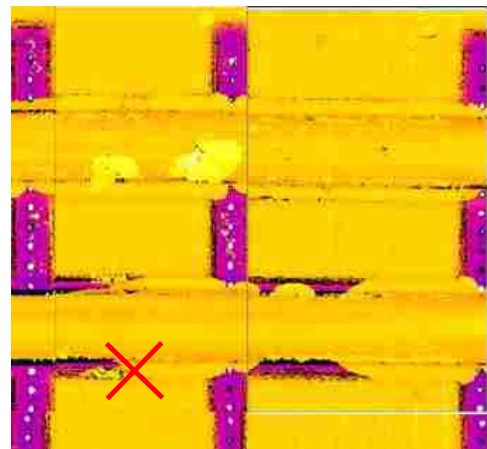
Damage Area: I.D. 0.0, S.D. 14.52 in²

Type of Damage: Stringer disbond

Stringer Disbond

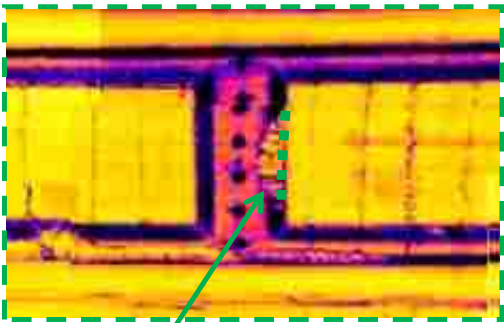
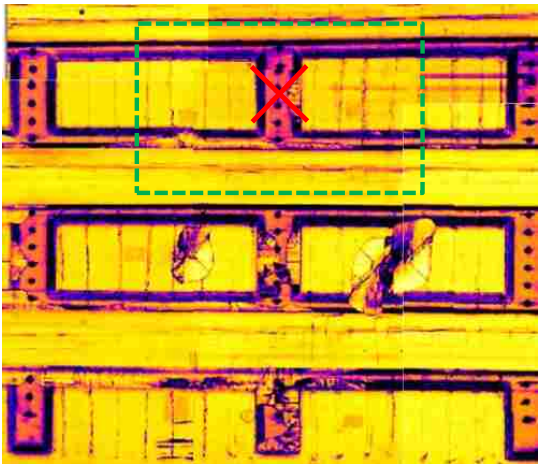
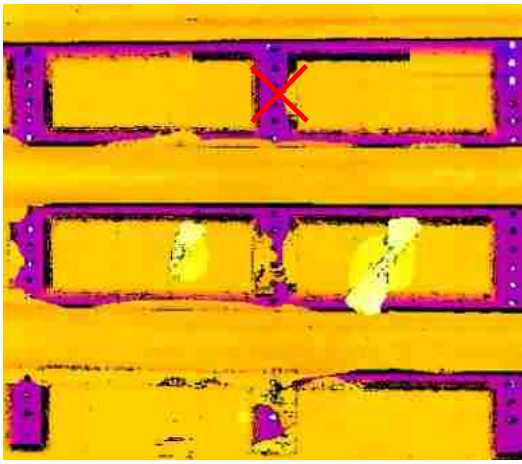
1B – B1/2-SK3-ST0-I4

Visual Indication: Small paint crack around one fastener, 2” crack in built-up pad section, 1” crack in corner bend radius of shear tie.

Damage Area: I.D. 0.0, S.D 3.03 in²

Type of Damage: Shear tie built-up pad section delamination, cracked shear tie

Delamination

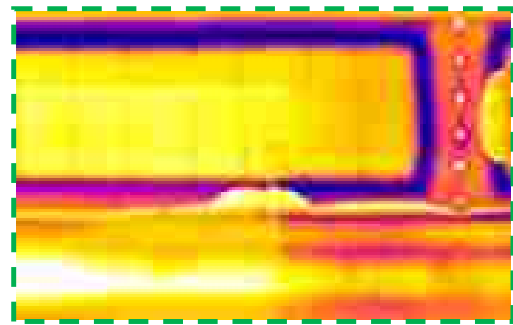
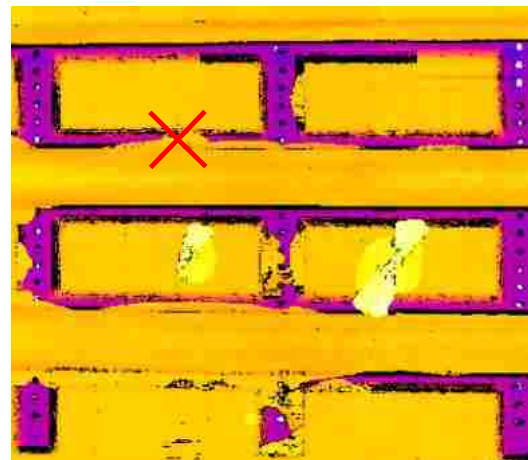
Damage Area: I.D. 0.0, S.D. 8.12 in²

Type of Damage: Stringer disbond detected in amplitude, TOF and resonance, no interply delamination detected in the skin

Stringer Disbond

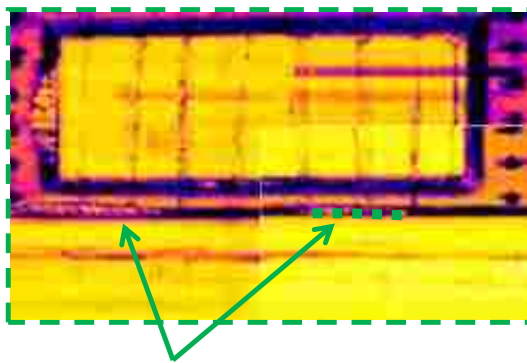
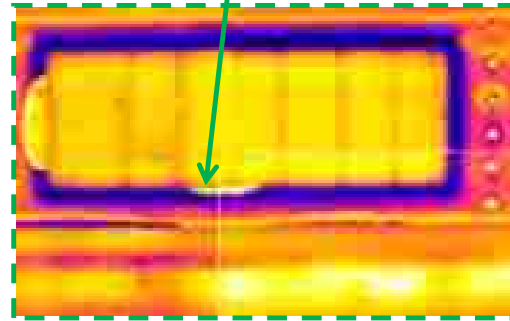
Visual Indication: No front side surface visual indication, 2.5” crack visible on backside of panel at the flange skin interface

Damage Area: I.D. 0.0, S.D. 4.12in²

Type of Damage: Small stringer disbond detected in amplitude, TOF and resonance, no interply delamination detected in the skin

Small Stringer Disbond

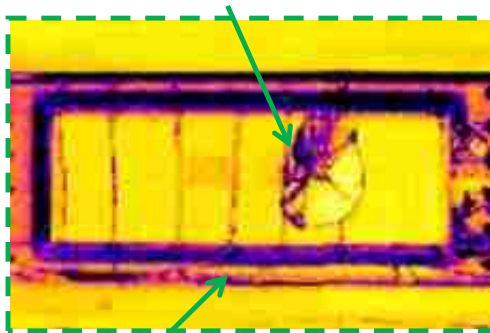
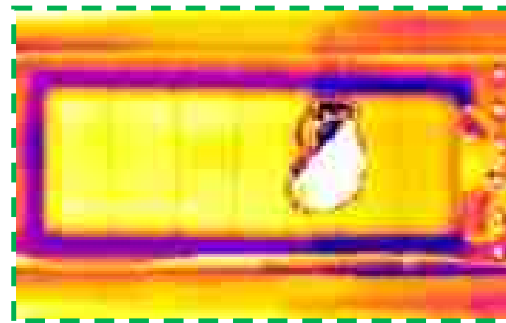
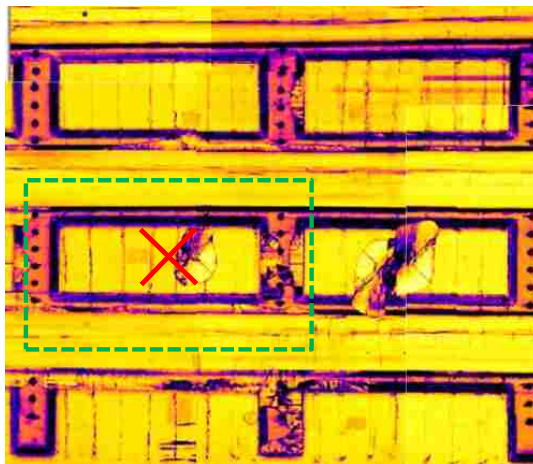
Damage Area: I.D. 11.28, S.D. 20.48 in²

Type of Damage: Interply delamination at impact location, edge of stringer disbond on stringer side.

Interply Delamination

Stringer Disbond

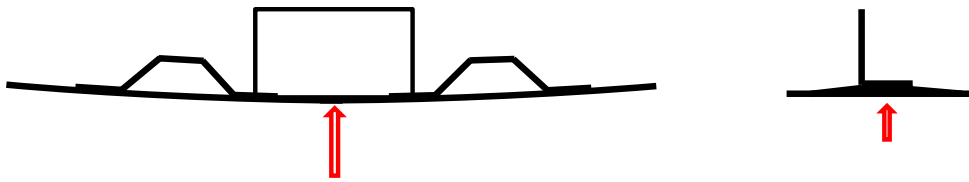
5B – B1/2-SK4-ST0-I4

Center of Shear Tie

Max Impact Energy: 1000.7 ft lbs, 738.1 Joules

Visual Indication: Paint crack around circumference of fastener, 4.5” crack at the skin to built-up pad section interface, 4” crack in the corner bend of the shear tie

Damage Area: I.D. 0.0, S.D. 14.90 in²

Type of Damage: : Delamination of built-up pad section at shear tie, cracked shear tie

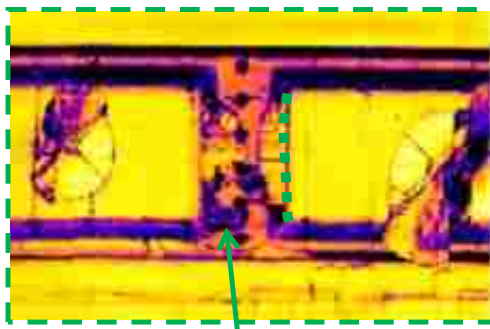
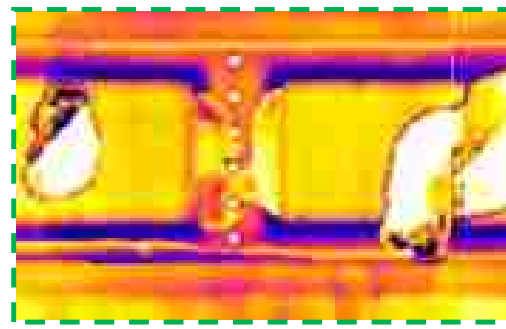
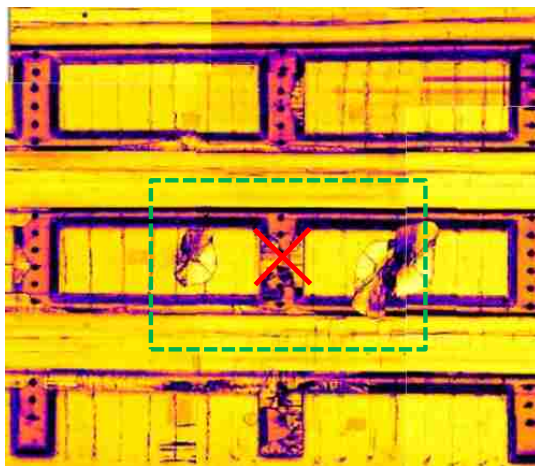
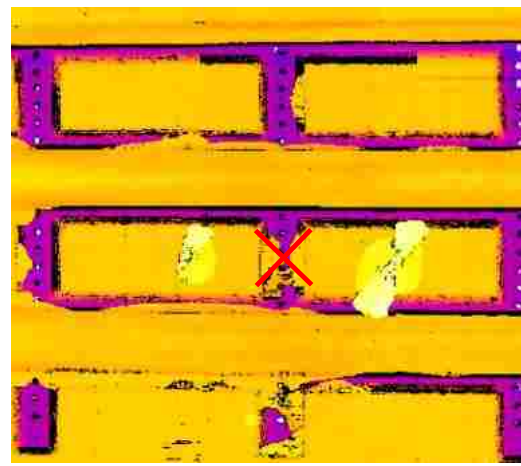
Built-up Section Delamination

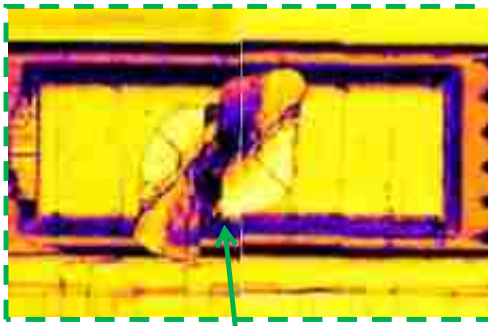
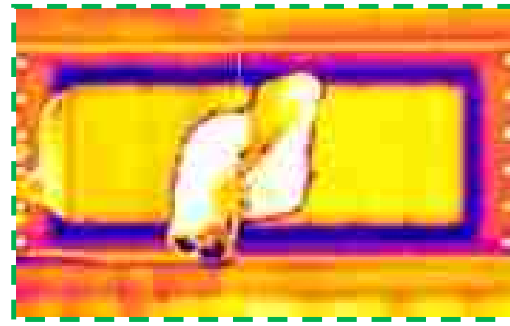
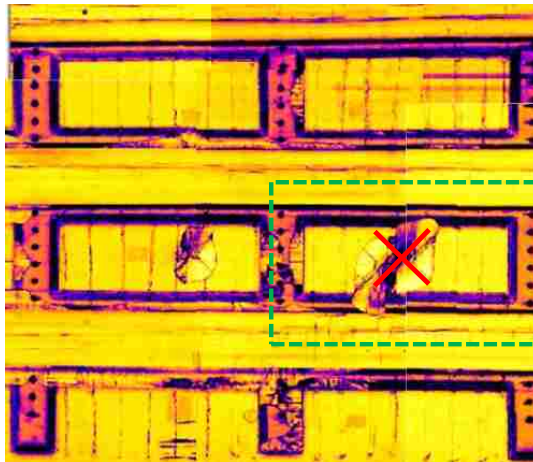
Damage Area: I.D. 21.27, S.D. 0.0 in²

Type of Damage: Interply delamination in the skin

Interply Delamination

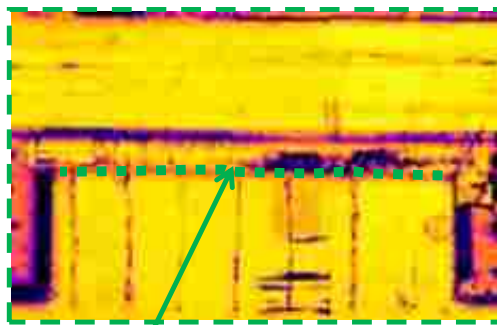
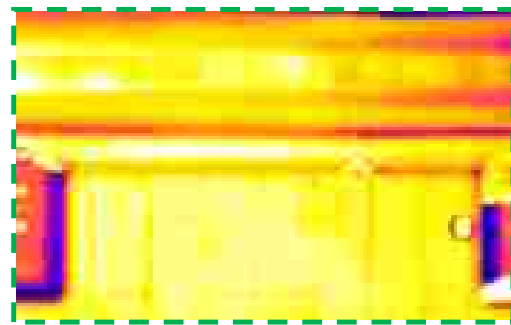
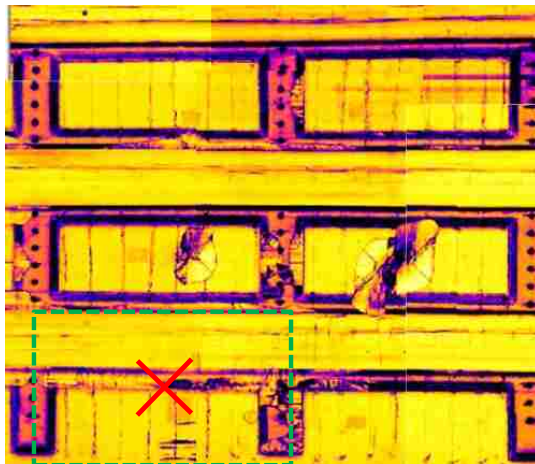
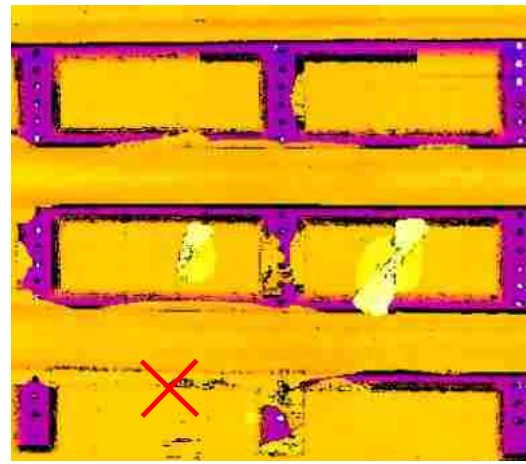
Visual Indication: No front side surface visual indication, 17.5” stringer flange crack visible

Damage Area: Interply Delamination 0.0 in², Substructure Disbond 23.16 in²

Type of Damage: Full stringer disbond, no interply delamination detected

Full Stringer Disbond

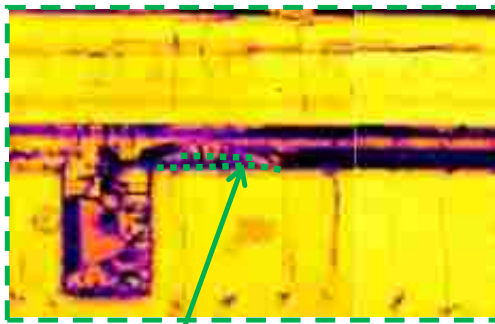
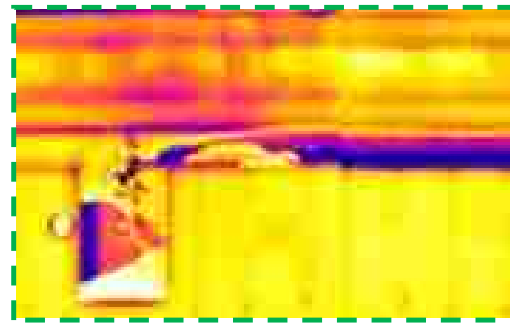
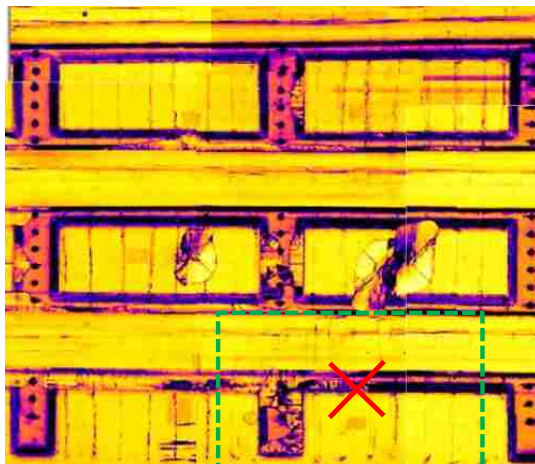
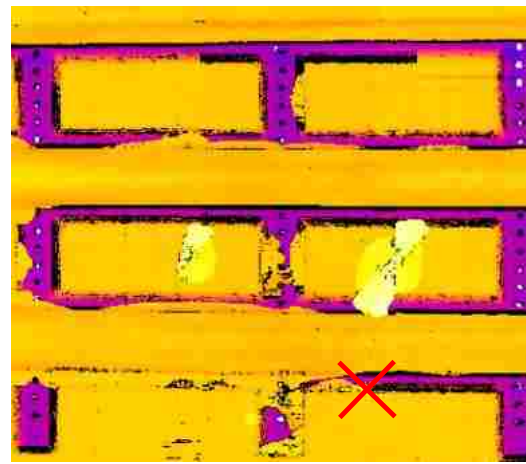
Visual Indication: No front side surface visual indication, multiple cracked plies in the tapered flange ranging from 1” to 2.5”.

Damage Area: I.D. 0.0, S.D. 6.05 in²

Type of Damage: Partial stringer disbonding

Partial Stringer Disbond

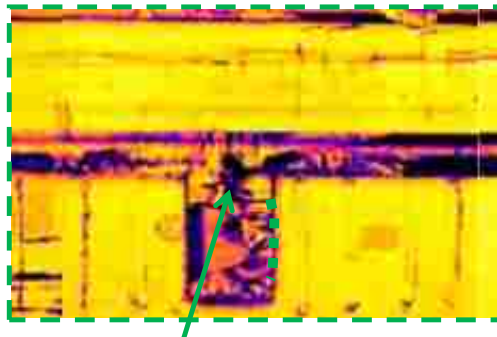
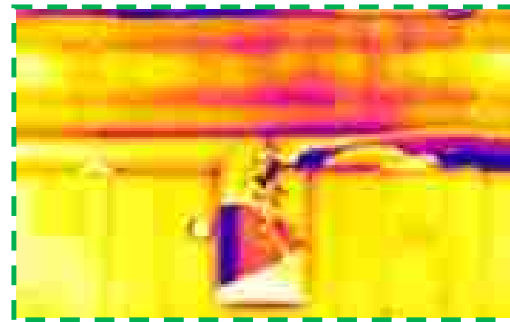
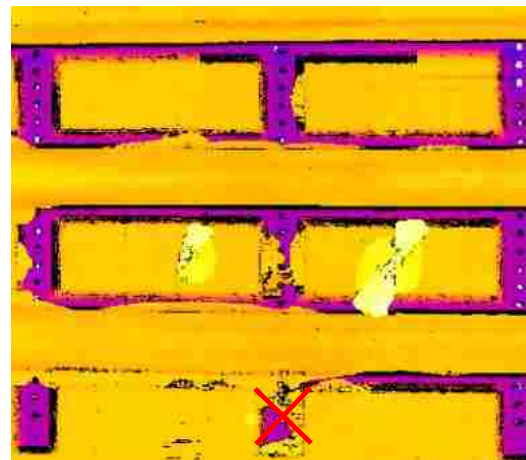
Visual Indication: Paint chip on surface of panel, 1” diameter permanent paint scuff, 2” crack at the built-up pad-to-skin interface, 4.5” crack in the corner bend of the shear tie

Damage Area: I.D. 0.0, S.D. 22.34 in²

Type of Damage: Shear tie built-up pad section delamination

Built-up section Delamination

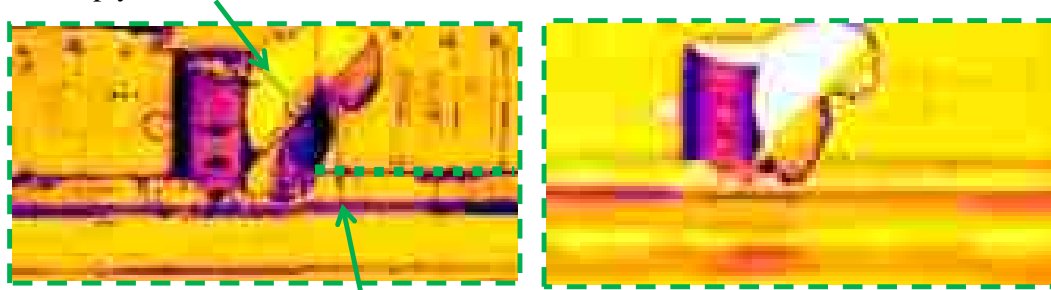
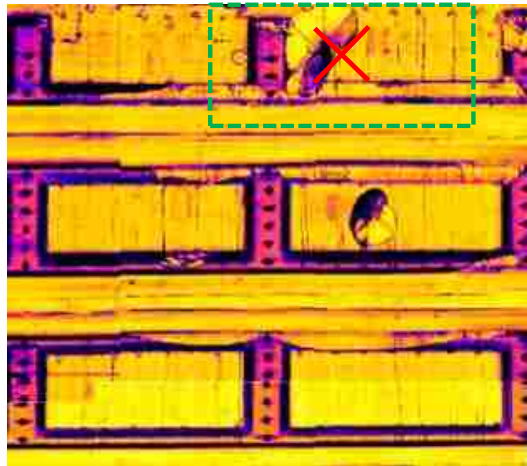
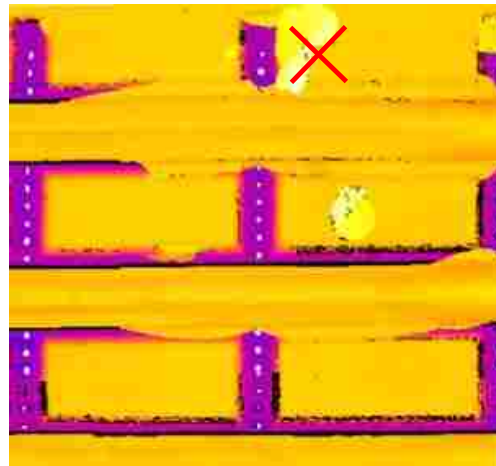
Visual Indication: No front side surface visual indication, 17.5” stringer delamination crack visible on backside

Damage Area: I.D. 20.01, S.D. 29.82 in²

Type of Damage: Interply delamination in the skin, full length stringer disbond, and partial delamination in the shear tie built-up pad section

Interply Delamination

Stringer Disbond

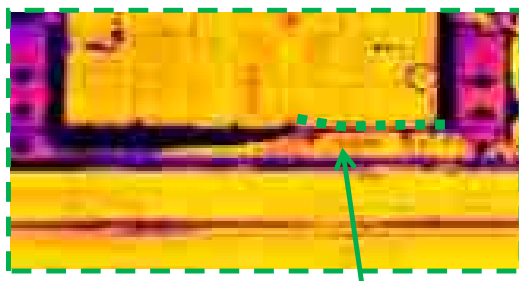
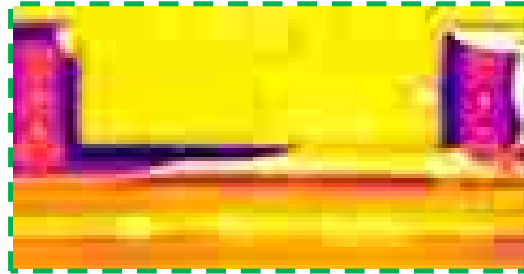
Visual Indication: No front side surface visual indication, 6” stringer flange crack visible on backside of panel

Damage Area: I.D. 0.0, S.D. 16.09 in²

Type of Damage: Stringer flange disbond

Stringer Disbond

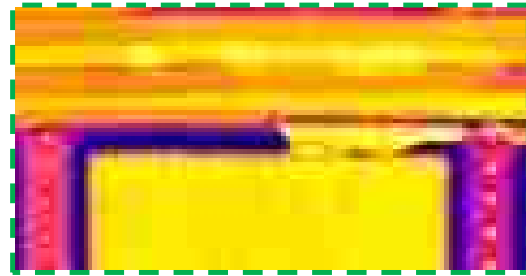
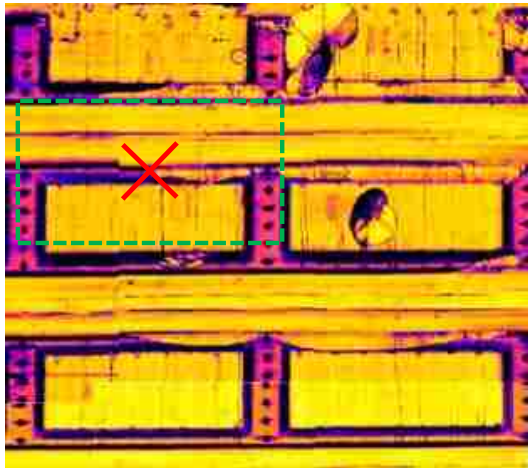
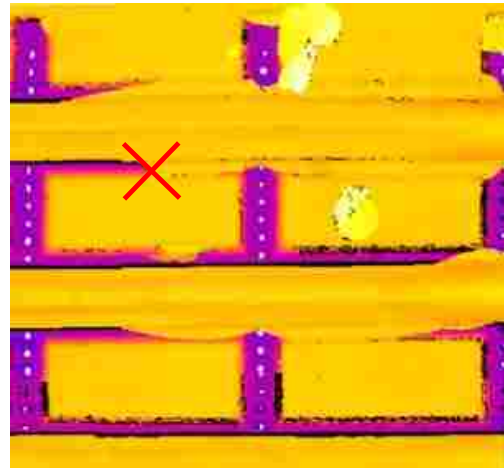
Visual Indication: No front side surface visual indication, 4.5” stringer flange crack visible on backside of panel

Damage Area: I.D. 0.0, S.D. 8.41 in²

Type of Damage: Stringer flange disbond

Stringer Disbond

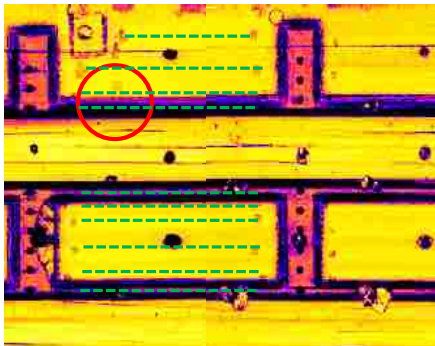
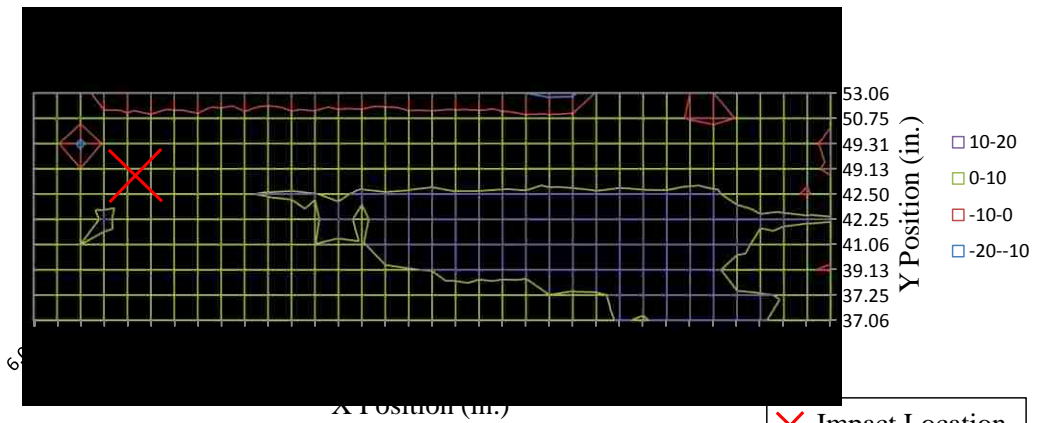
2 - B1-SK1-ST1L-H2b

Center of Stringer Flange
Impact Energy: 45 Ft lbs
Damage Area: Could not determine, masked by co-cured flange
Type of Damage: None
Strain Indication: No

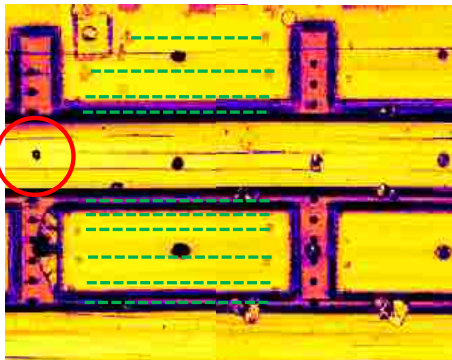
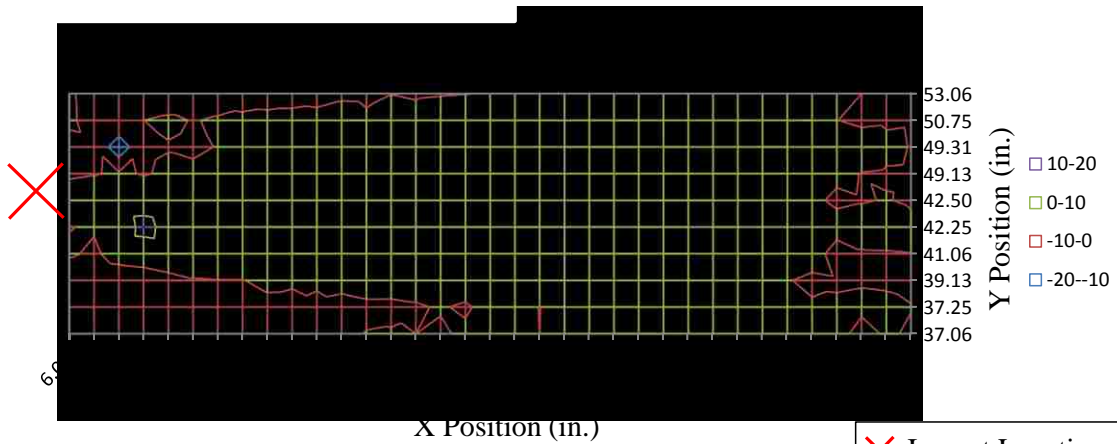
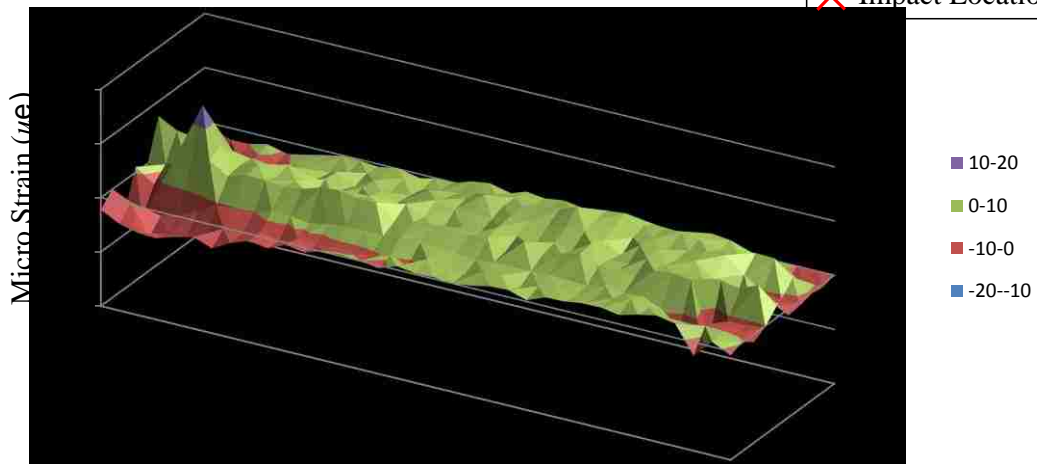
Mid-Stringer on Skin, Between Shear Ties
Impact Energy: 45 Ft lbs
Damage Area: 0.23 in²
Type of Damage: Near surface fiber crushing
Strain Indication: Some strain indication at edge of stringer flange, not detectable

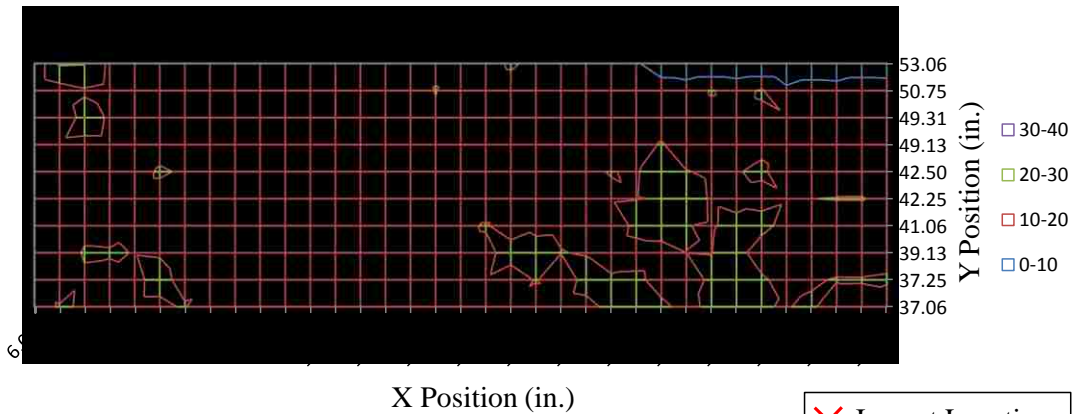
6 - B1-SK2-ST1L-H2c

Edge of Stringer Flange (Not Stringer Side)

Impact Energy: 55 Ft lbs

Damage Area: 0.28 in²

Type of Damage: Near surface fiber crushing

Strain Indication: Minor, local strain increase, not detectable

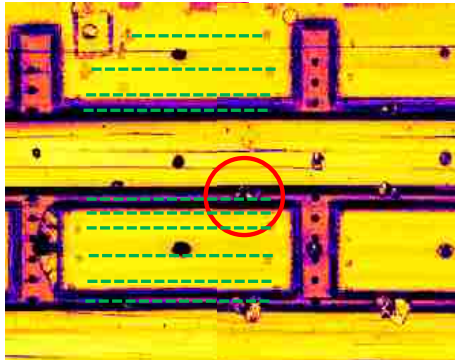
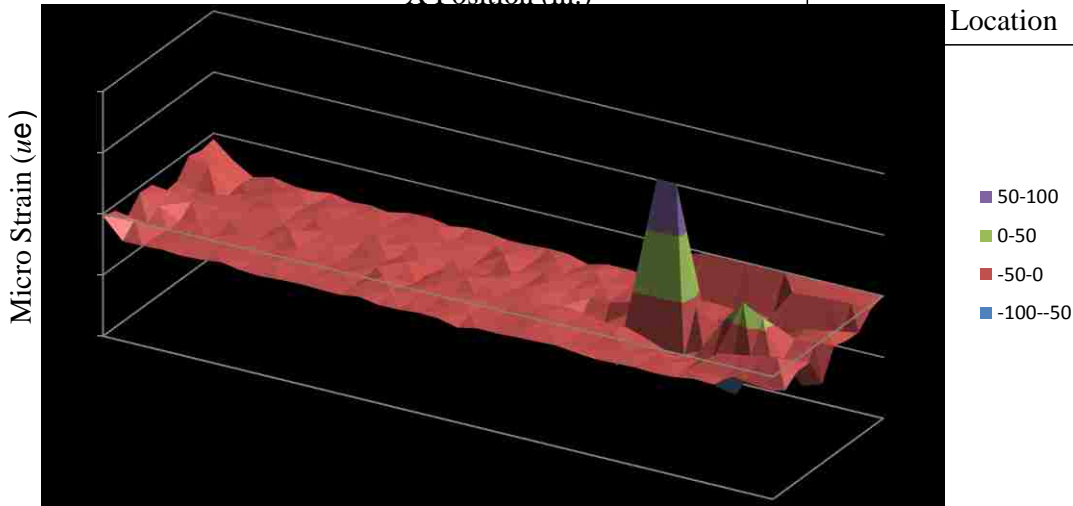
7 - B1-SK2-ST1R-H2c

Damage Area: 1.67 in²

Type of Damage: Interply delamination

Strain Indication: Yes, Detectable Strain Indication

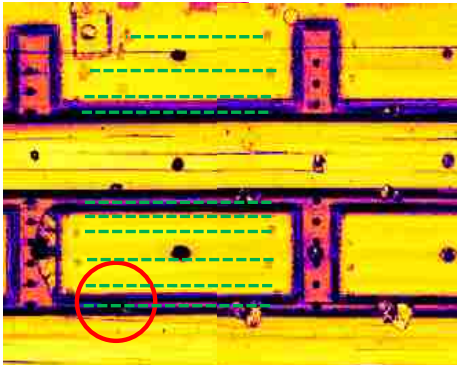
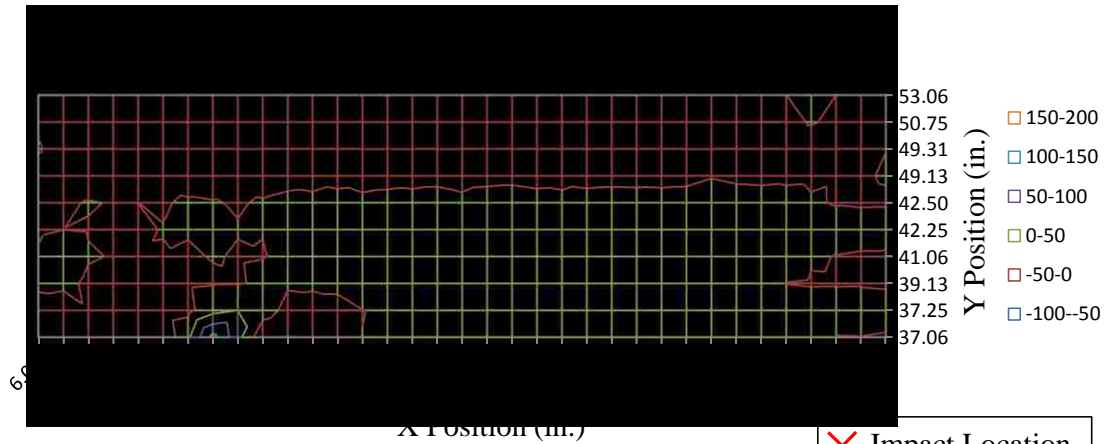
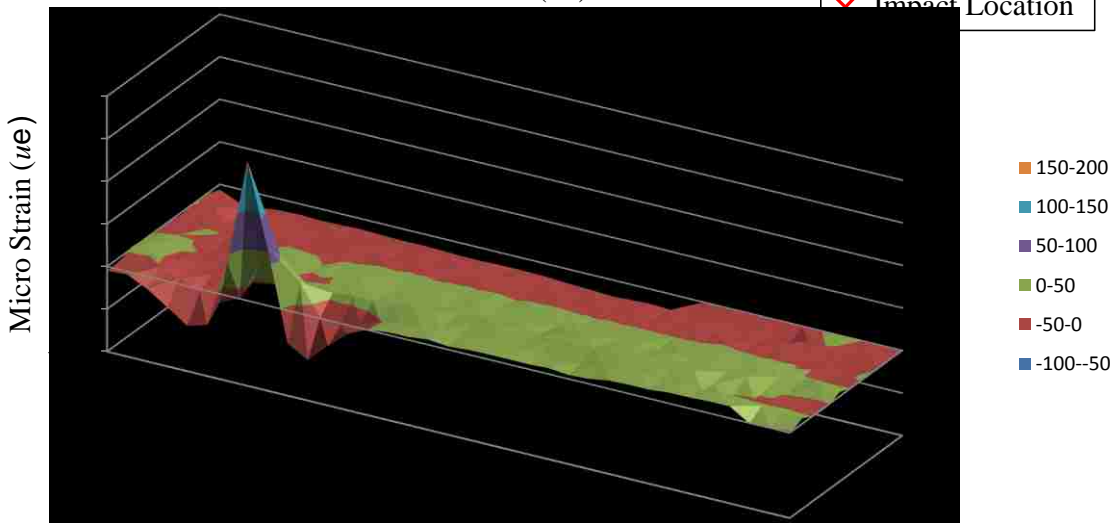
10 - B1-SK2-ST2L-H2b

Center of Stringer Flange
Impact Energy: 75 Ft lbs
Damage Area: 1.36 in²
Type of Damage: Stringer flange delamination
Strain Indication: Yes, detectable strain indication

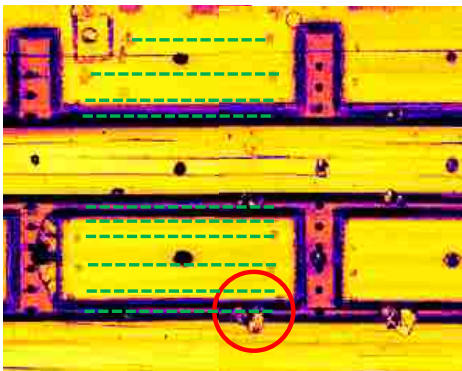
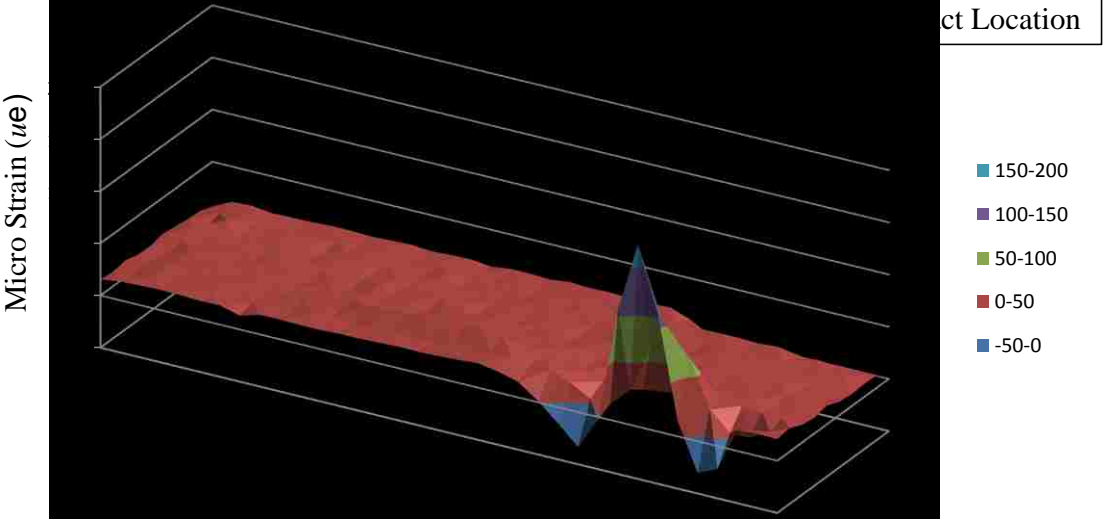
11 - B1-SK2-ST2R-H2b

Center of Stringer Flange
Impact Energy: 90 Ft lbs
Damage Area: 2.19 in²
Type of Damage: Interply delamination
Strain Indication: Yes, detectable strain indication

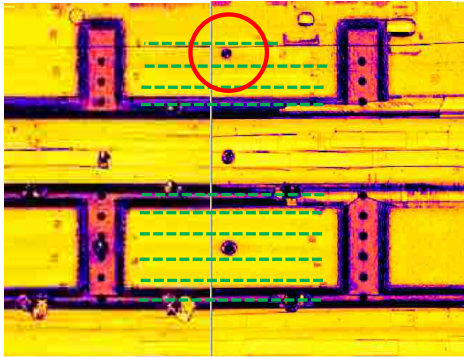
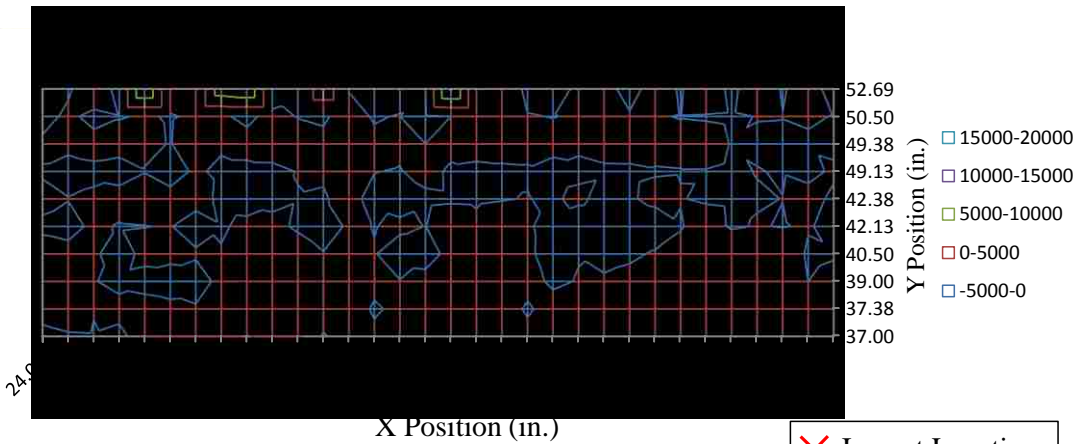
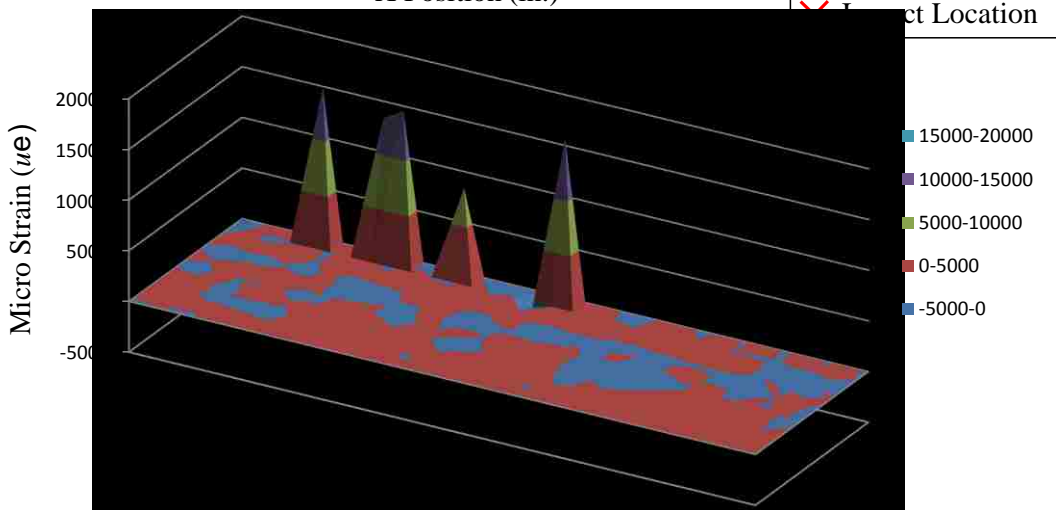
Skin Impact
Impact Energy: 60 Ft lbs
Damage Area: 0.45 in²
Type of Damage: Near surface fiber crushing
Strain Indication: Yes, but caused other indications as well due to high strain levels in the fiber

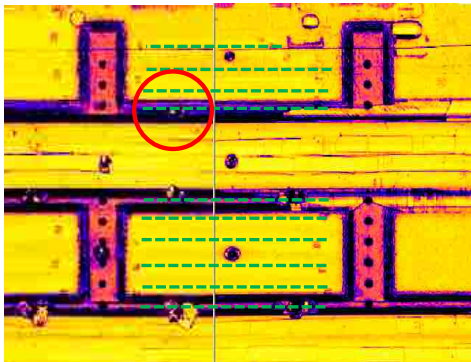
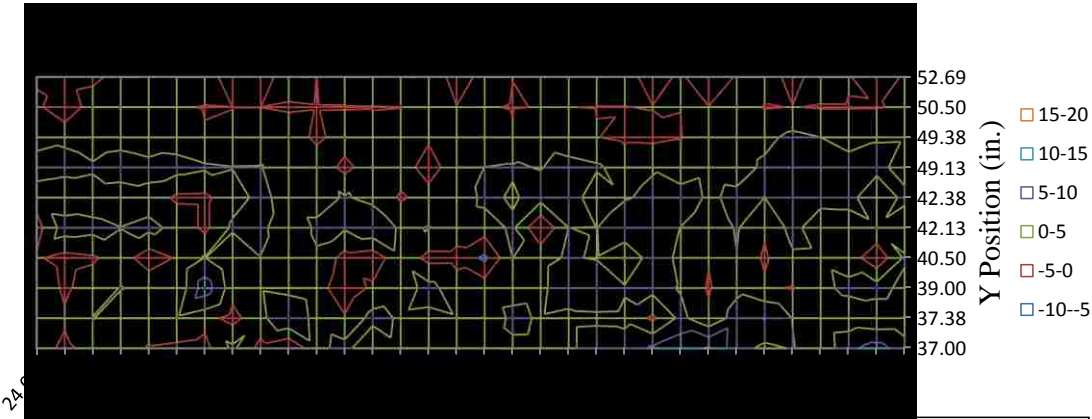
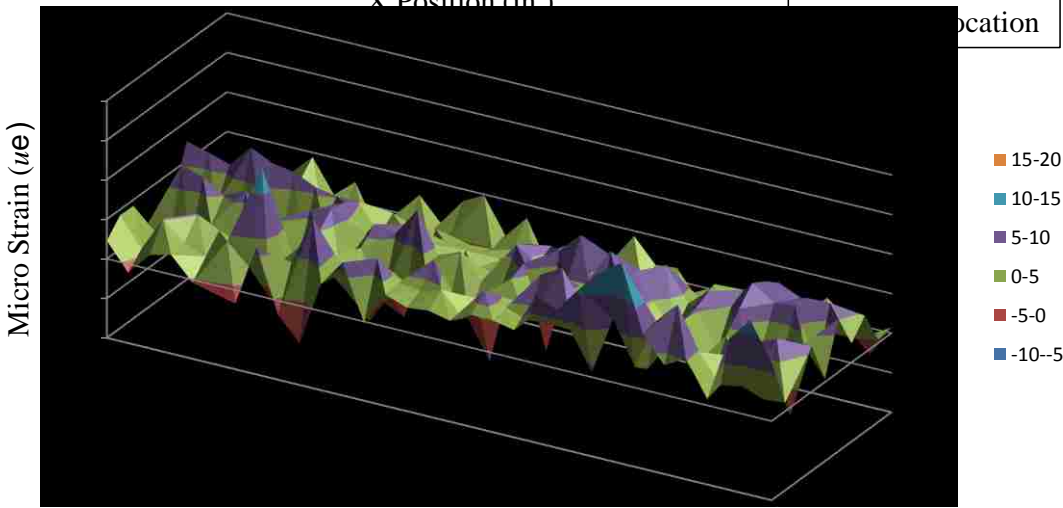
Edge of Stringer Flange (Not Stringer Side)
Impact Energy: 60 Ft lbs
Damage Area: 0.93 in²
Type of Damage: Stringer flange delamination
Strain Indication: No

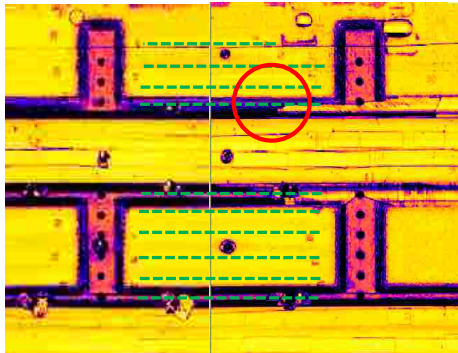
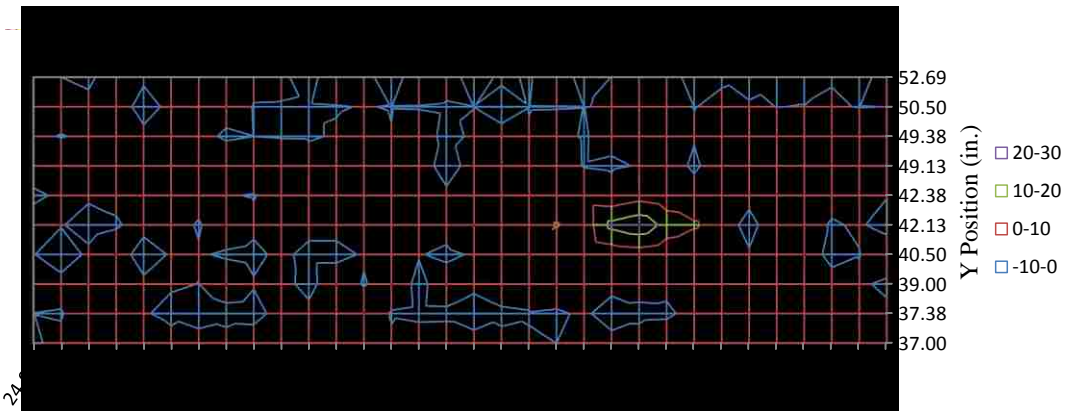
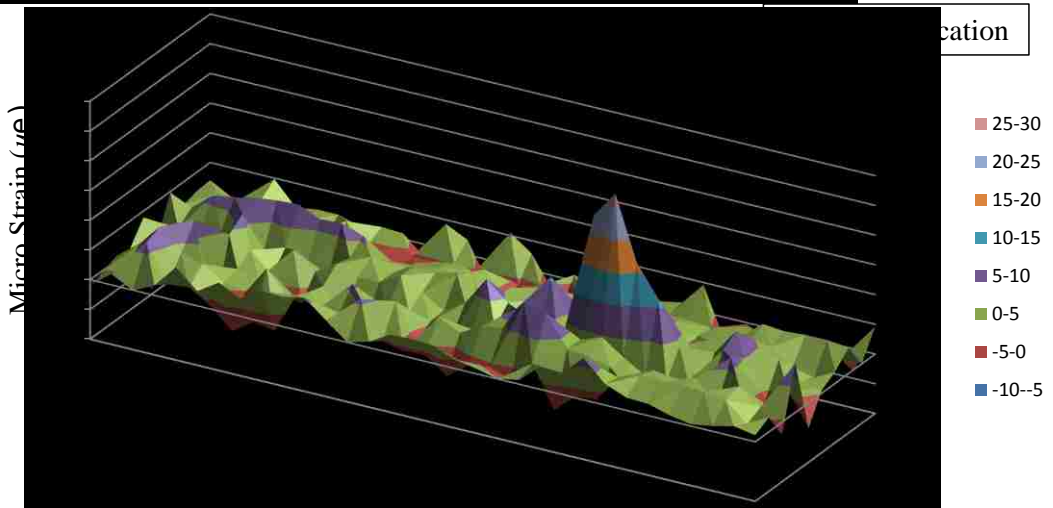
Edge of Stringer Flange (Not Stringer Side)
Impact Energy: 75 Ft lbs
Damage Area: 0.98 in²
Type of Damage: Interply delamination, and near surface fiber crushing
Strain Indication: Yes, detectable strain indication, but in the other stringer fiber

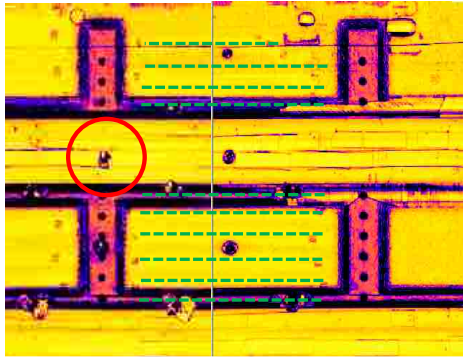
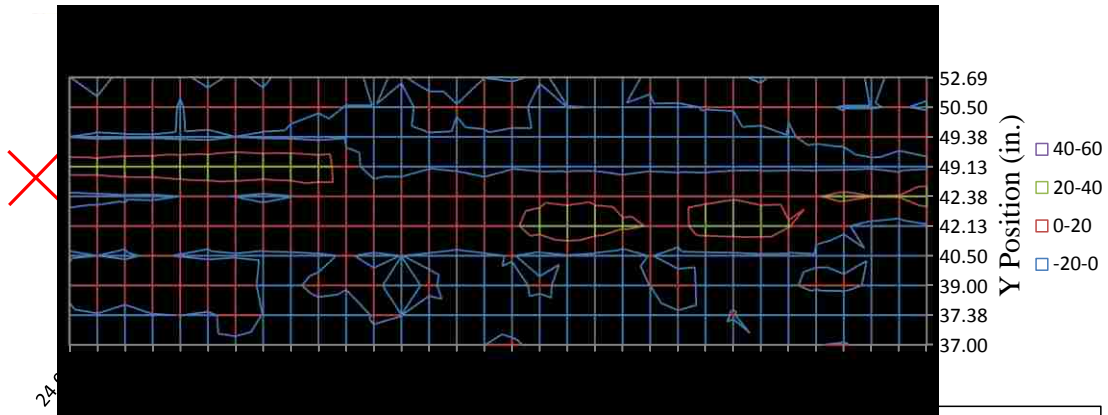
Damage Area: 0.93 in²

Type of Damage: Near surface crushed fibers and interply delamination

Strain Indication: Higher strains indicated on stringer flange fibers, not detectable

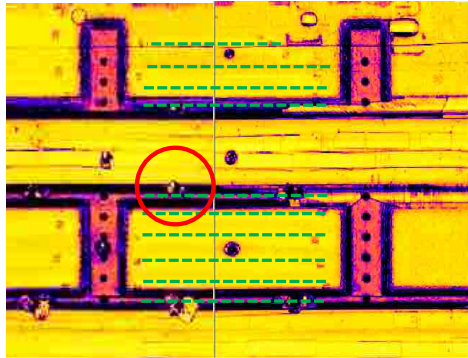
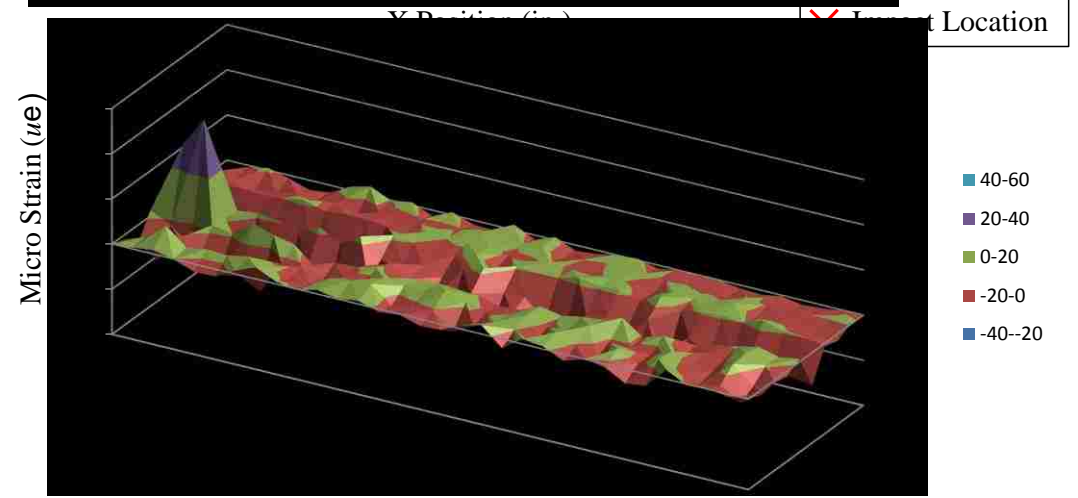
Edge of Stringer Flange (Stringer Side)
Impact Energy: 90 Ft lbs
Damage Area: 1.23 in²
Type of Damage: Interply delamination
Strain Indication: Yes, spikes in strain data (negative and positive) adjacent to impact location

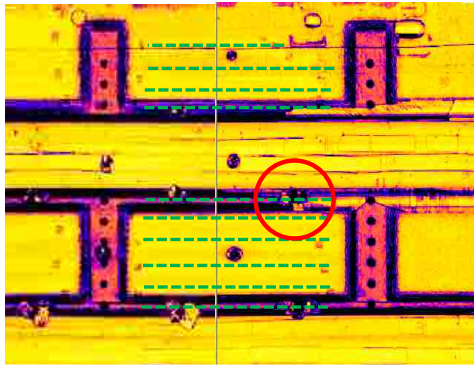
Edge of Stringer Flange (Stringer Side)
Impact Energy: 105 Ft lbs
Damage Area: 2.24 in²
Type of Damage: Stringer flange delamination
Strain Indication: Yes, clear strain decrease and subsequent increase at impact location

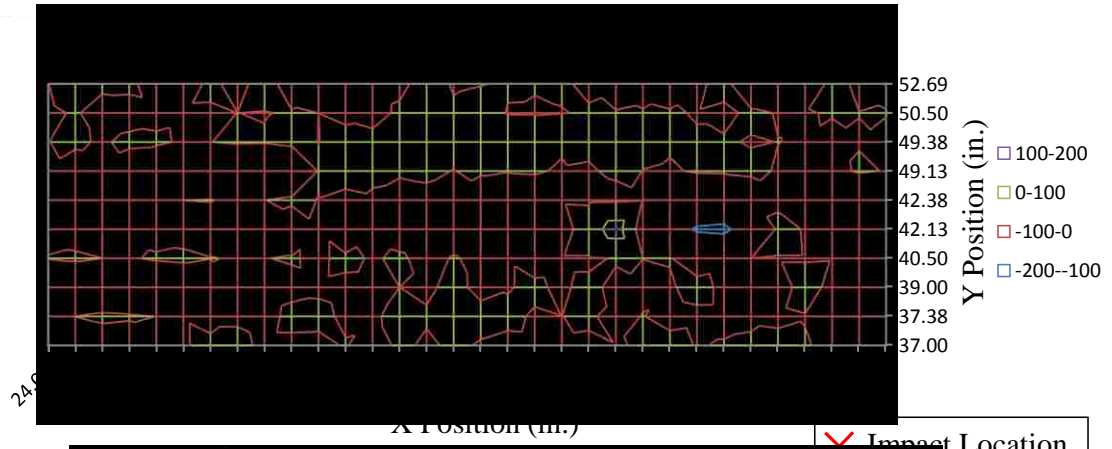
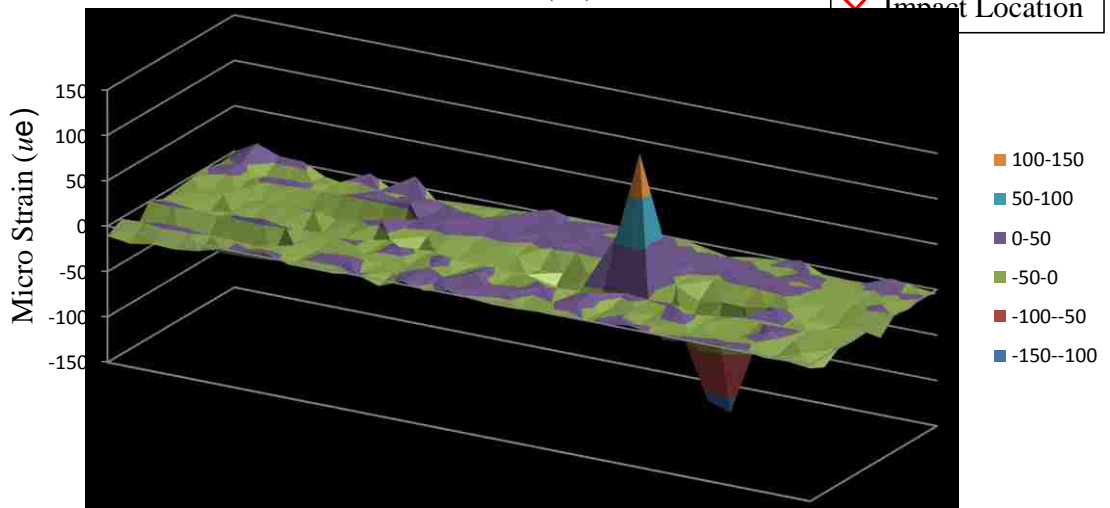
Center Bay Over Skin
Impact Energy: 60 Ft lbs
Damage Area: 0.75 in²
Type of Damage: Near surface fiber crushing and slight interply delamination
Strain Indication: No

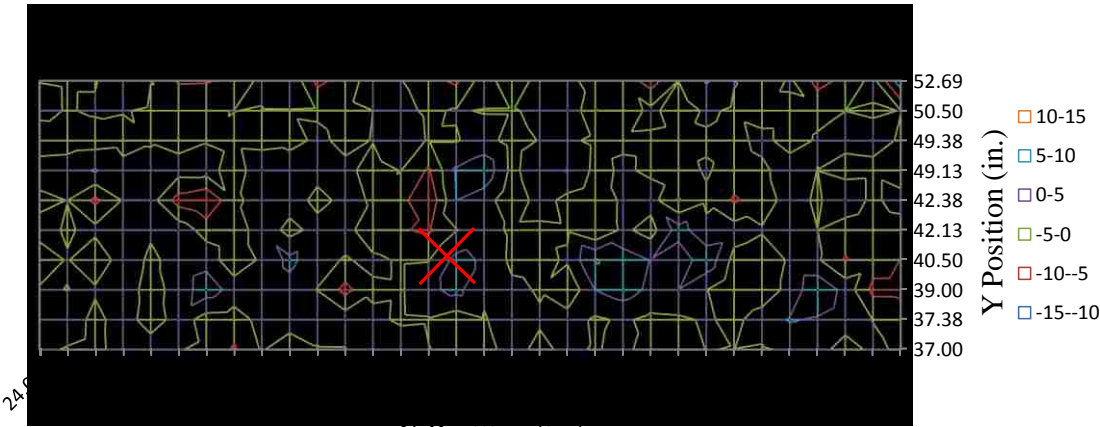
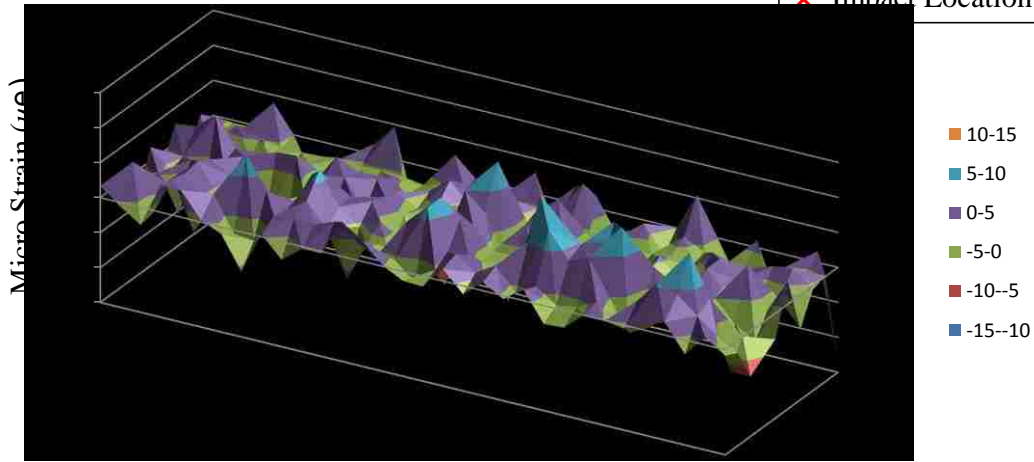
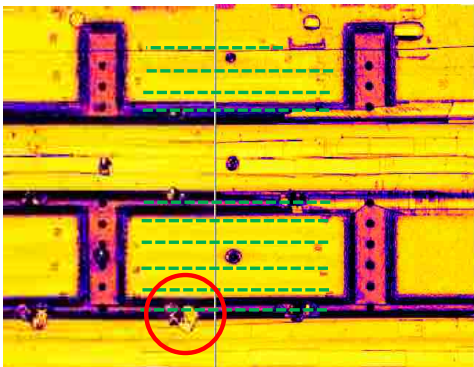
Center of Stringer Flange
Impact Energy: 90 Ft lbs
Damage Area: 3.46 in²
Type of Damage: Interply delamination
Strain Indication: Yes, clear detectable strain indication
