Detection and characterization of impact damage in carbon fiber aircraft fuselage structure

**DETECTION AND CHARACTERIZATION OF IMPACT
DAMAGE IN CARBON FIBER AIRCRAFT FUSELAGE
STRUCTURE**

THESIS

**Master of Science
Civil Engineering**

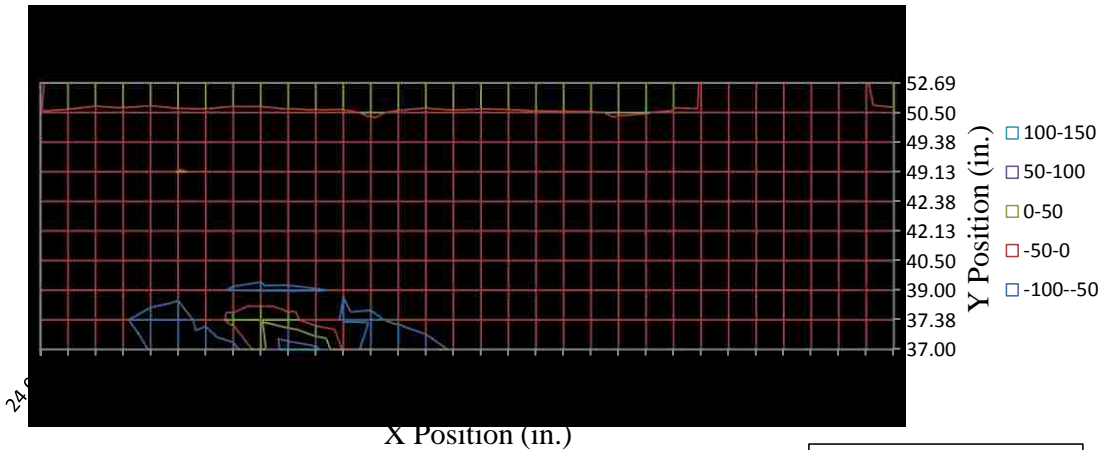
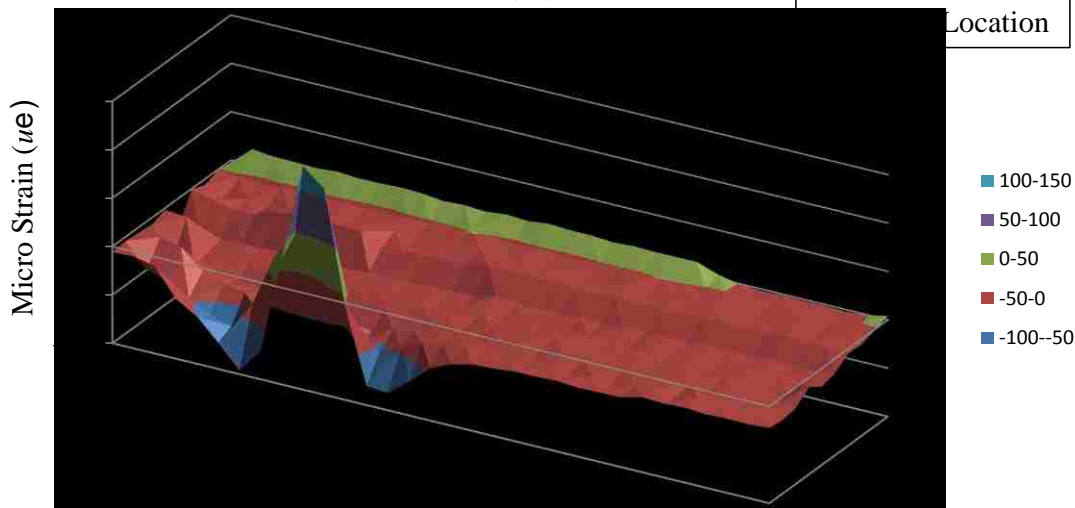
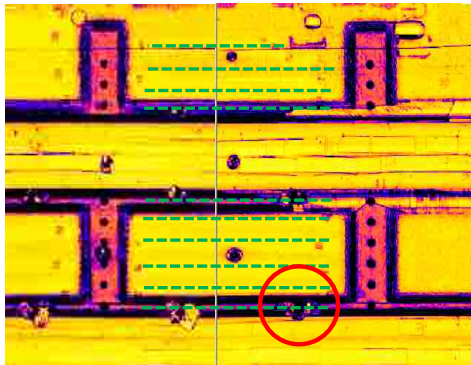
Center of Stringer Flange
Impact Energy: 112.5 Ft lbs
Damage Area: 2.19 in²
Type of Damage: Interply delamination
Strain Indication: High strains detected at impact location (strains much higher than typically observed), not detectable

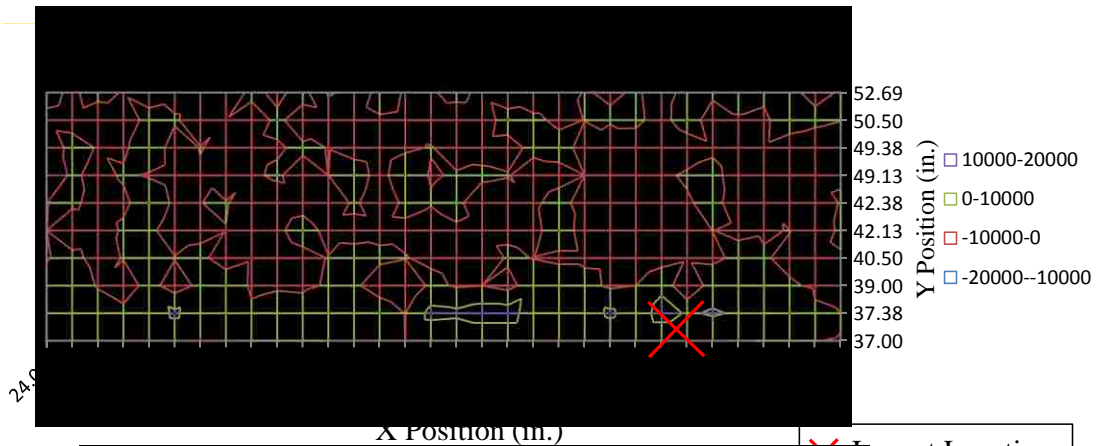
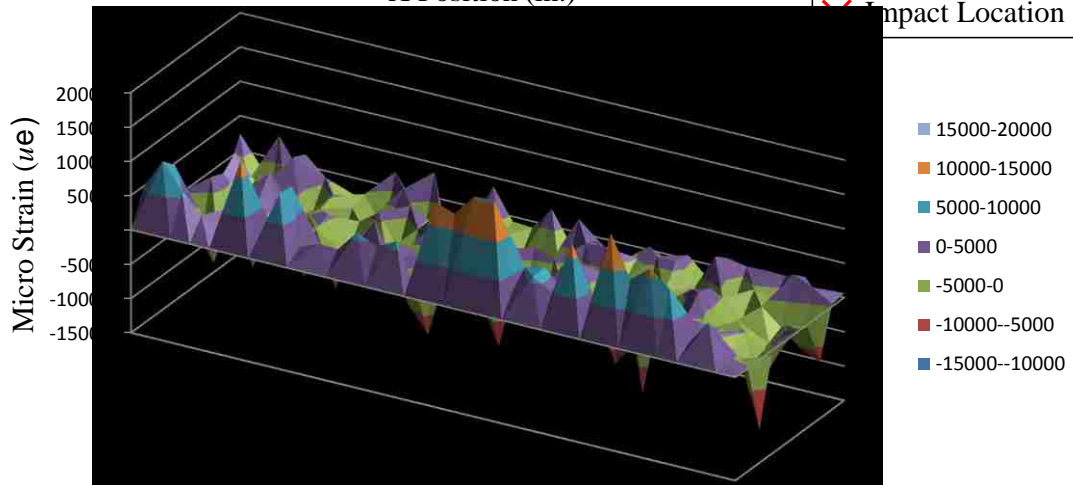
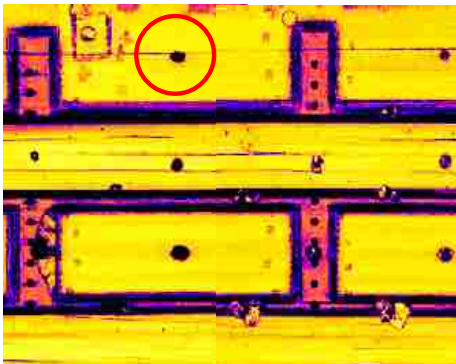
1 - B1-SK1-ST0-H1

Center Bay Over Skin
Impact Energy: 90 Ft lbs
Damage Area: 0.52 in²
Type of Damage: Near surface crushed fibers

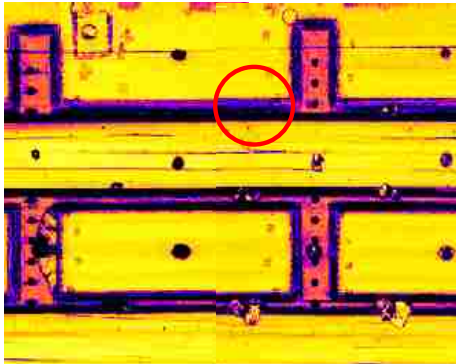
3 - B1-SK1-ST1R-H2b

Center of Stringer Flange
Impact Energy: 60 Ft lbs
Damage Area: Could Not Determine, masked by co-cured flange
Type of Damage: None

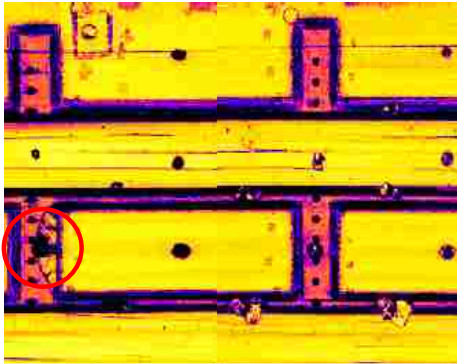
8 - B1-SK2-ST0-H4

Center of Shear Tie
Impact Energy: 75 Ft lbs
Damage Area: 4.35 in²
Type of Damage: Delamination of shear tie tapered section build up to skin interface

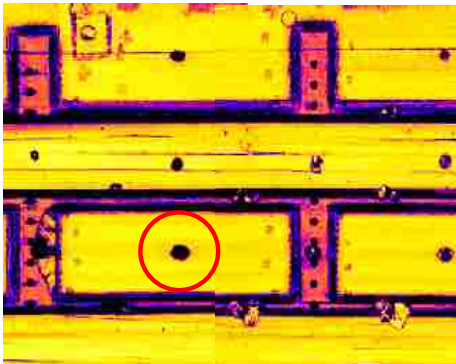
9 - B1-SK2-ST0-H1

Center Bay Over Skin
Impact Energy: 75 Ft lbs
Damage Area: 0.85 in²
Type of Damage: Near surface crushed fibers

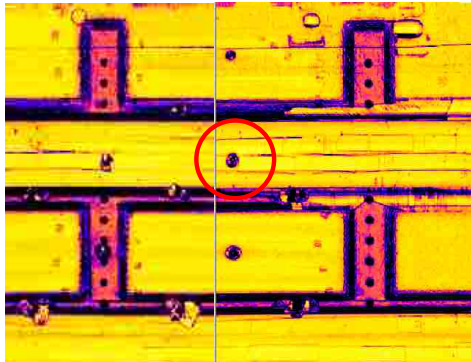
16 - B2-SK0-ST1L-H3

Center of Stringer Between Flanges
Impact Energy: 75 Ft lbs
Damage Area: 0.81 in²
Type of Damage: Near surface crushed fibers, small interply delamination

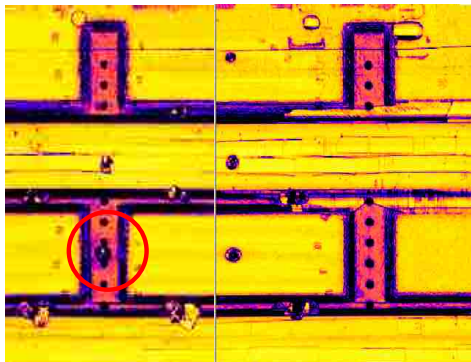
19 - B1/2-SK2-ST0-H4

Center of Shear Tie
Impact Energy: 90 Ft lbs
Damage Area: 0.85 in²
Type of Damage: Interply delamination

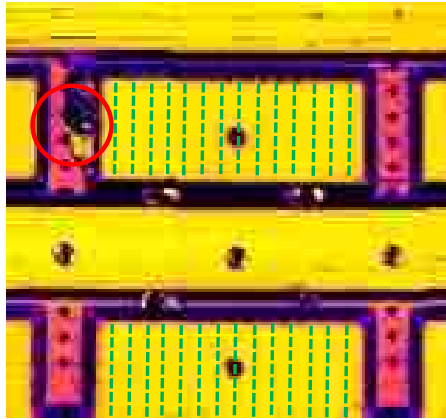
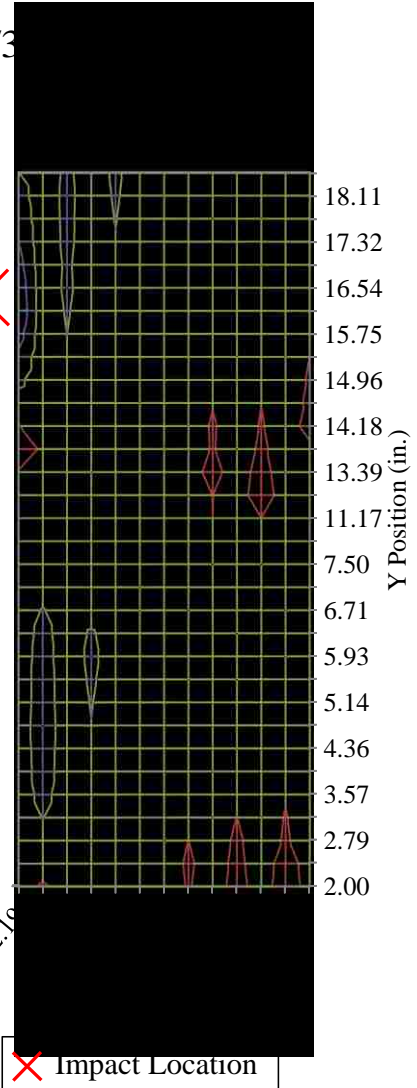
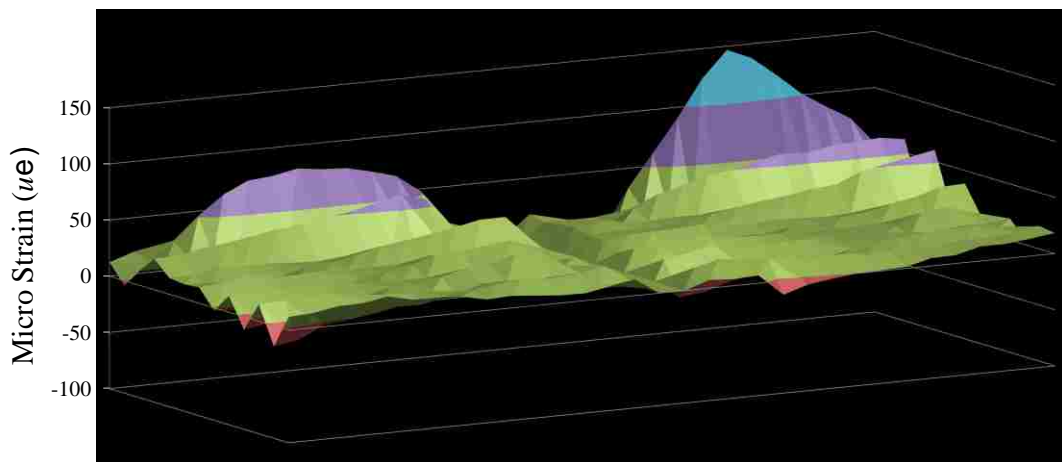
23 – B2/3

Edge of Shear Tie

Impact Energy: 90 Ft lbs

Damage Area: 10.37 in²

Type of Damage: Delamination at the shear tie built-up skin interface. Back side visible crack at interface.

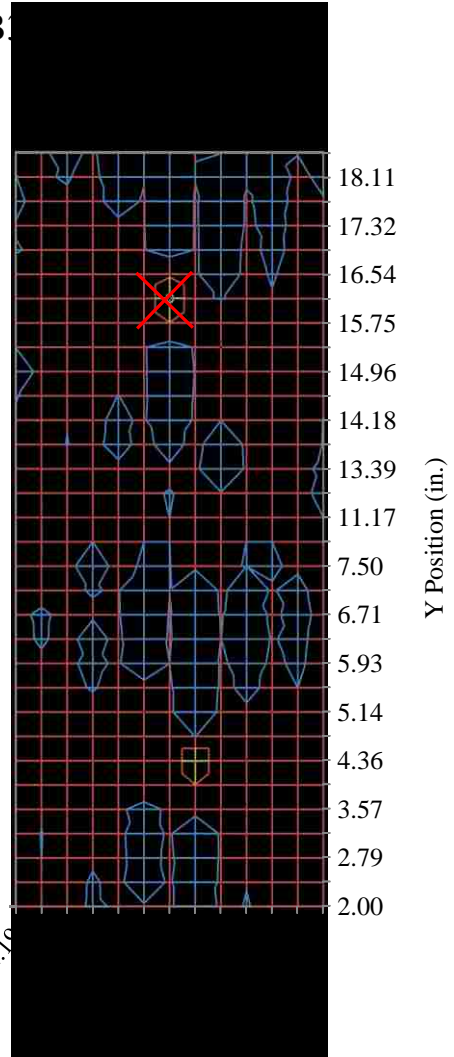
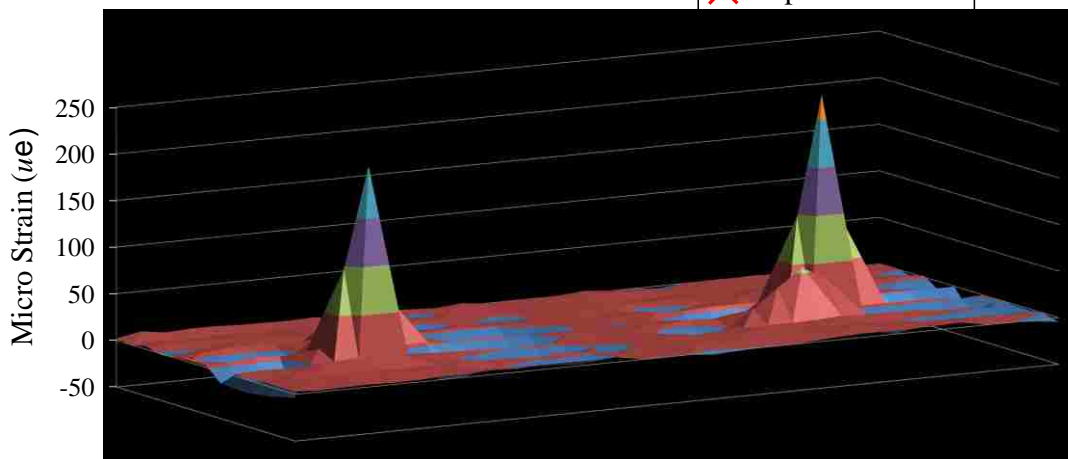
24 - B

Center Bay Over Skin

Impact Energy: 60 Ft lbs

Damage Area: 0.89 in²

Type of Damage: Near surface fiber crushing

Strain Indication: Yes, strain indication, but second indication not at the location of interest also was induced.

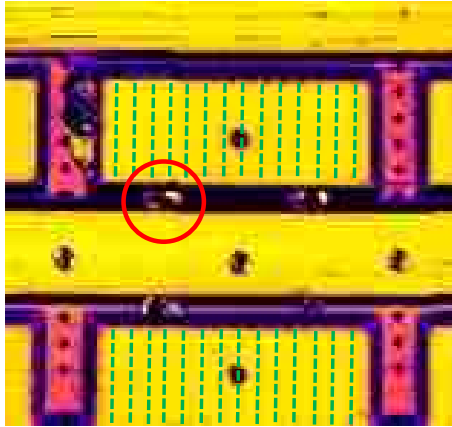
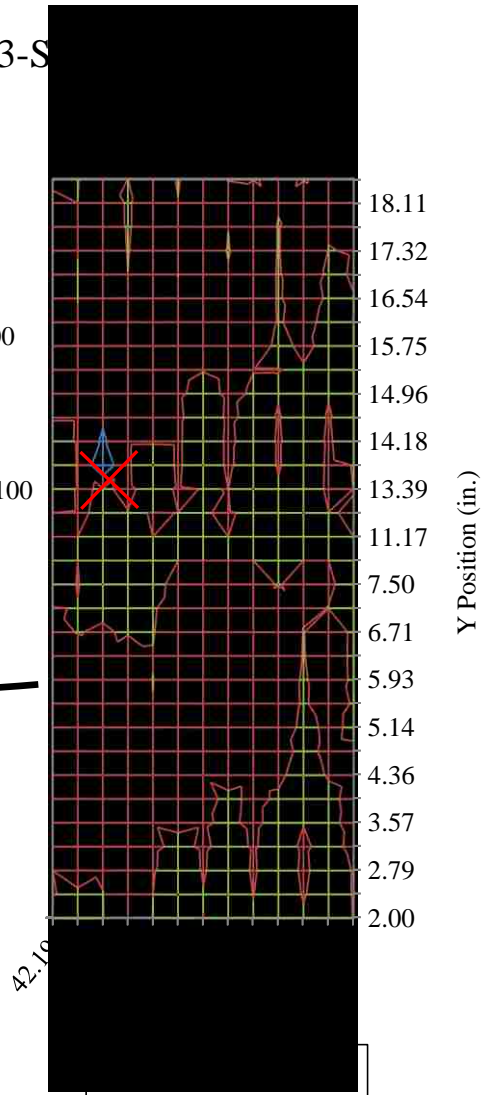
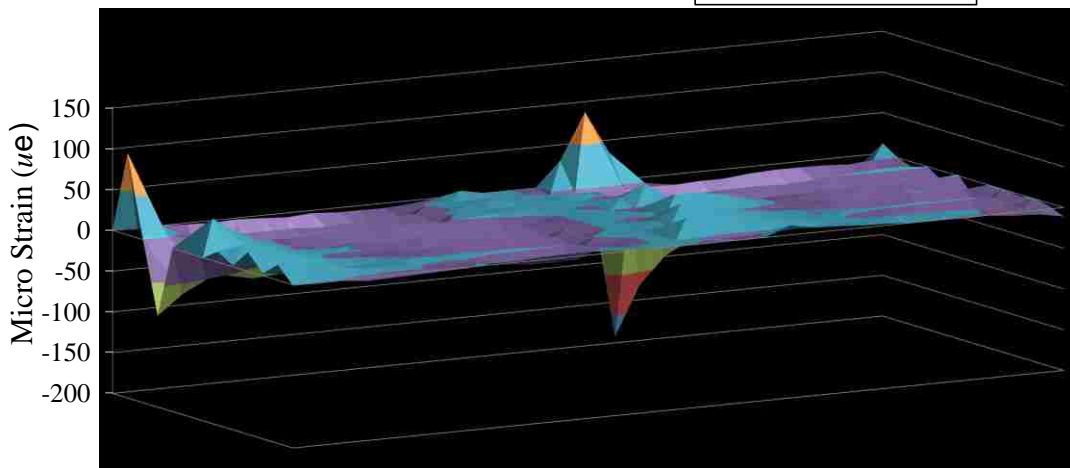
25 – B3-S

Edge of Stringer Flange (Not Stringer Side)
Impact Energy: 60 Ft lbs
Damage Area: 2.85 in²
Type of Damage: Flange delamination
Strain Indication: Yes, compressive strain indication

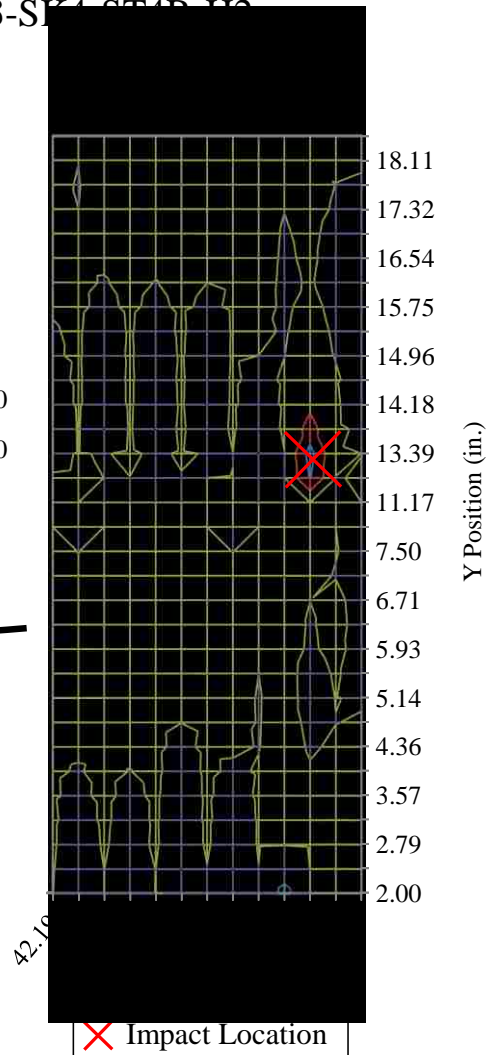
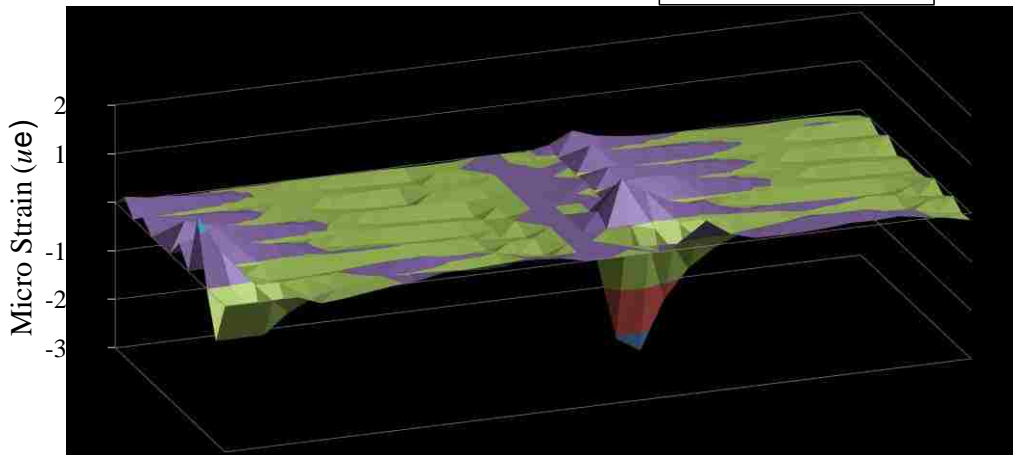
26 – B3-SK4-ST4D-110

Edge of Stringer Flange (Not Stringer Side)
Impact Energy: 105 Ft lbs
Damage Area: 2.43 in²
Type of Damage: Flange delamination, visible crack on surface paint
Strain Indication: Yes, compressive strain indication

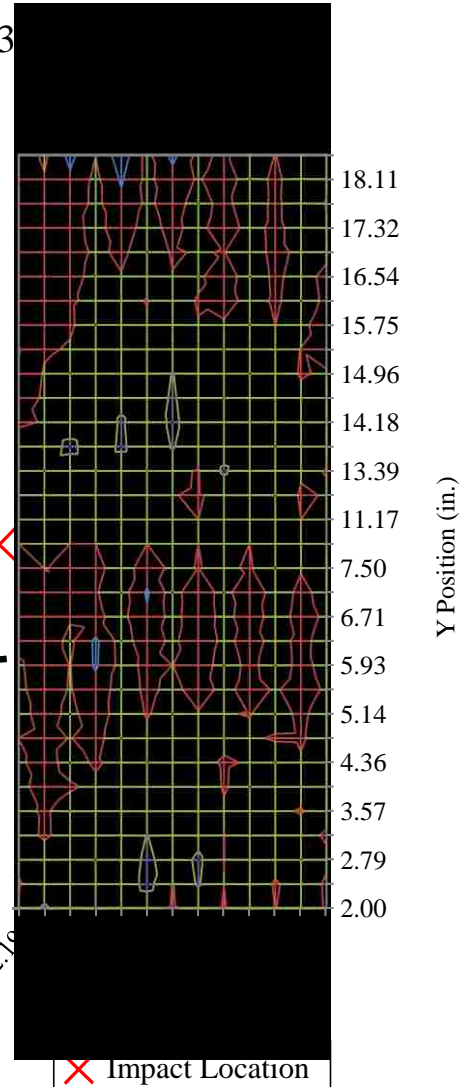
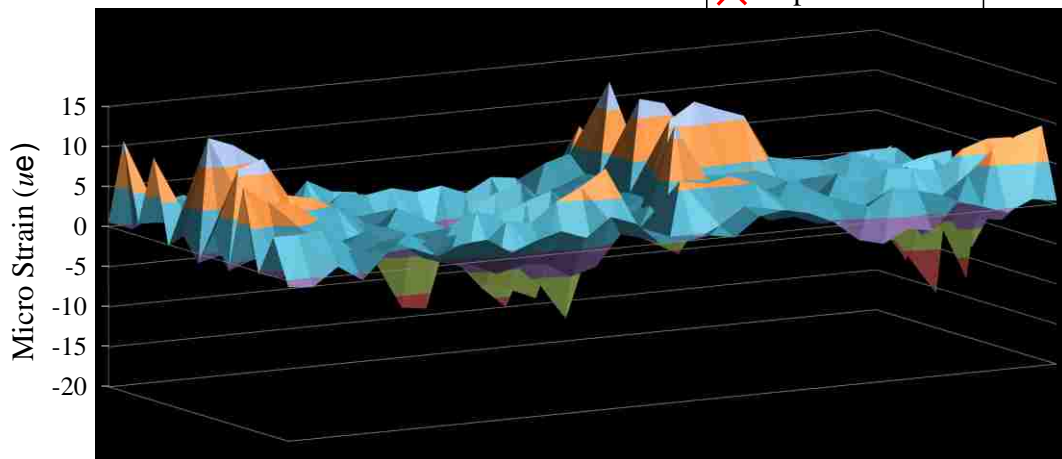
27 - B2/3

Damage Area: 1.07 in²

Type of Damage: Near surface fiber crushing and interply delamination

Strain Indication: No

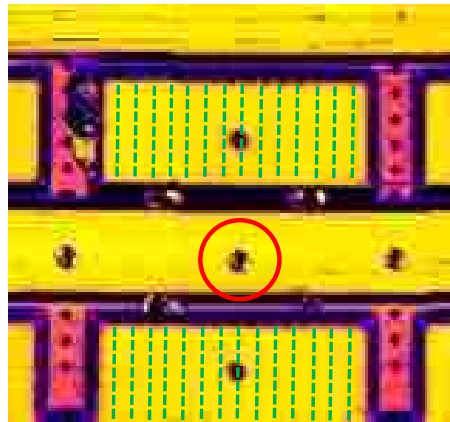
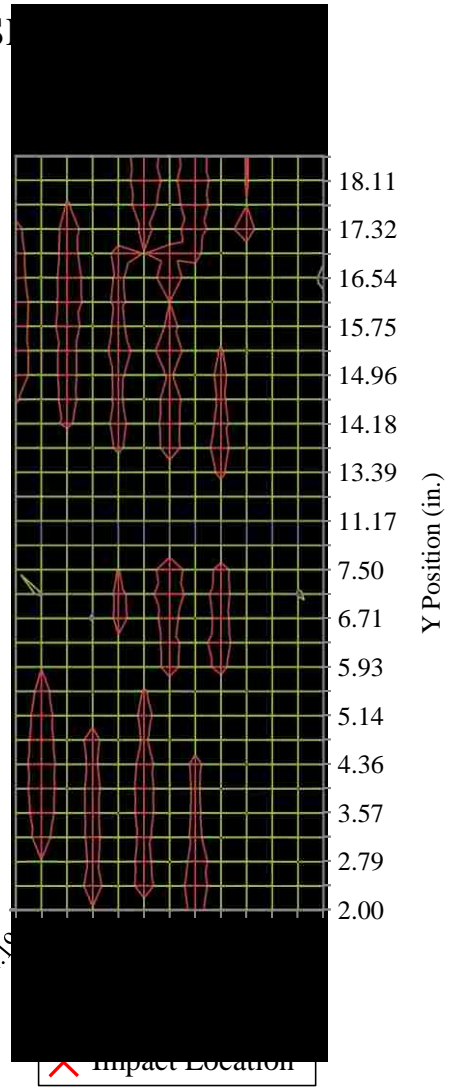
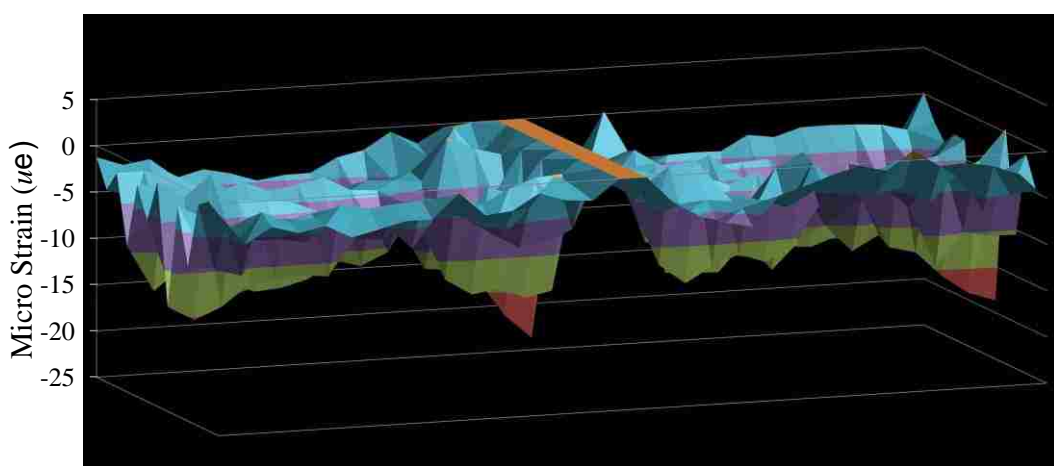
28 – B3-S

Center of Stringer Between Flanges
Impact Energy: 90 Ft lbs
Damage Area: 1.17 in²
Type of Damage: Interply delamination
Strain Indication: Increased compressive strains at fibers nearest to the stringer flange, not detectable

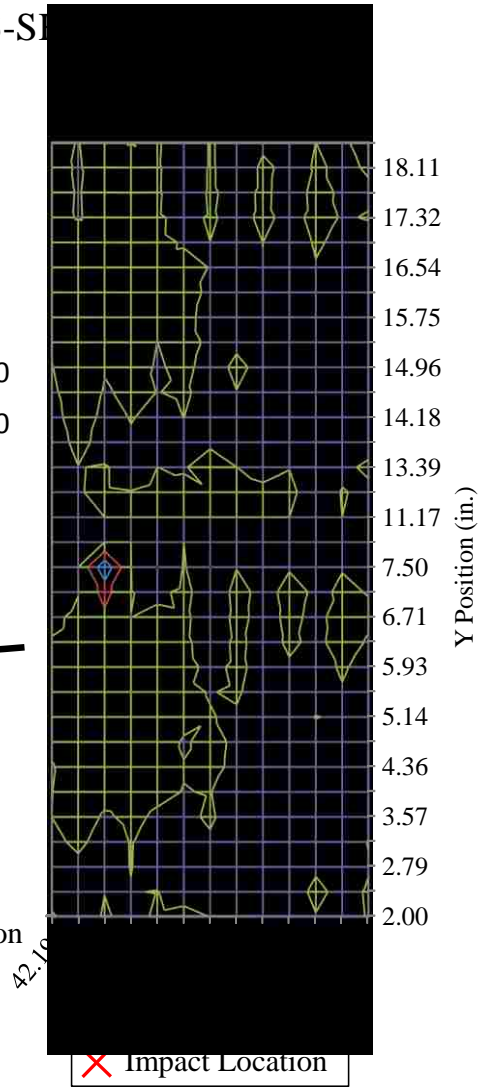
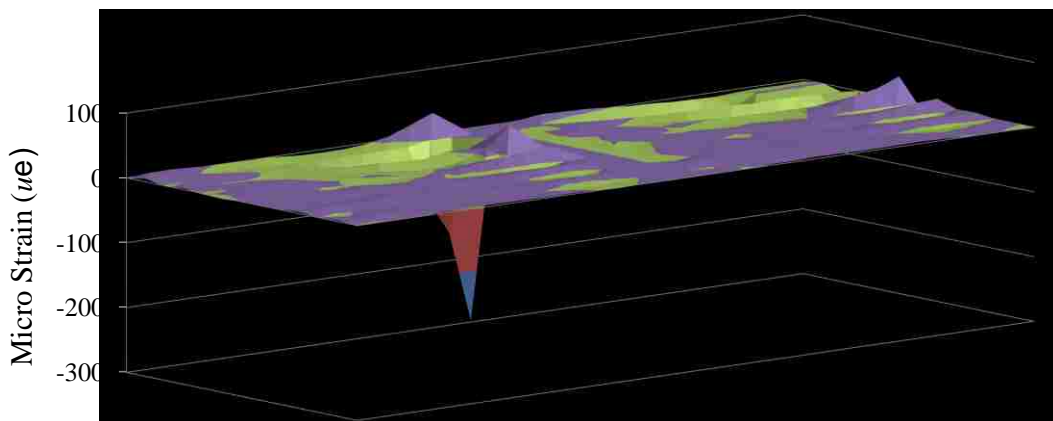
30 – B3-SI

Center of Stringer Flange
Impact Energy: 105 Ft lbs
Damage Area: 3.89 in²
Type of Damage: Interply delamination
Strain Indication: Yes, compressive strain indication

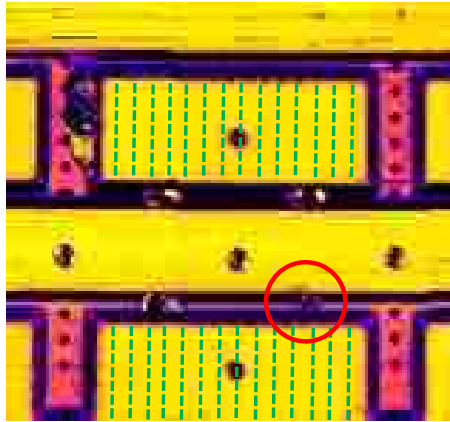
31 – B3-S

Center of Stringer Flange
Impact Energy: 97.5 Ft lbs
Damage Area: 1.63 in²
Type of Damage: Interply delamination
Strain Indication: Yes, clear negative strain peak

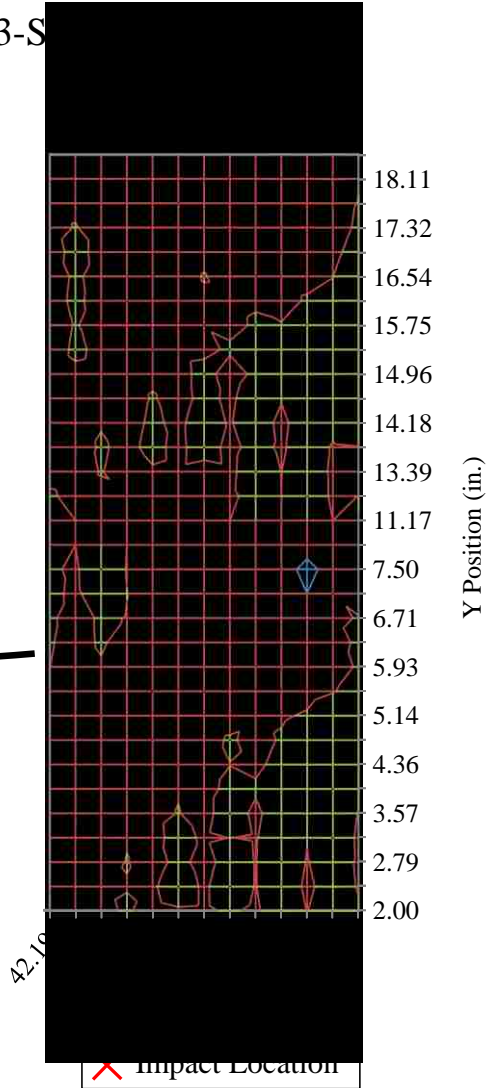
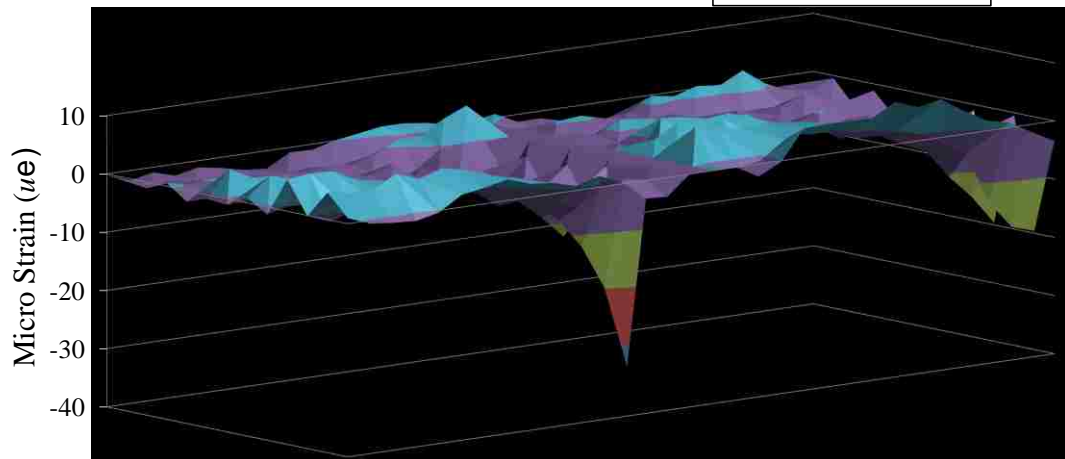
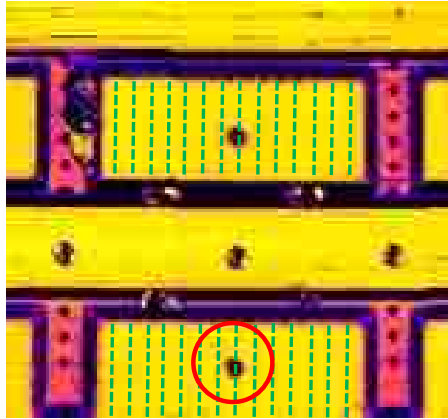
32 – B3-S

Center Bay Over Skin
Impact Energy: 105 Ft lbs
Damage Area: 0.81 in²
Type of Damage: Near surface fiber crushing
Strain Indication: Yes, high strains at impact location

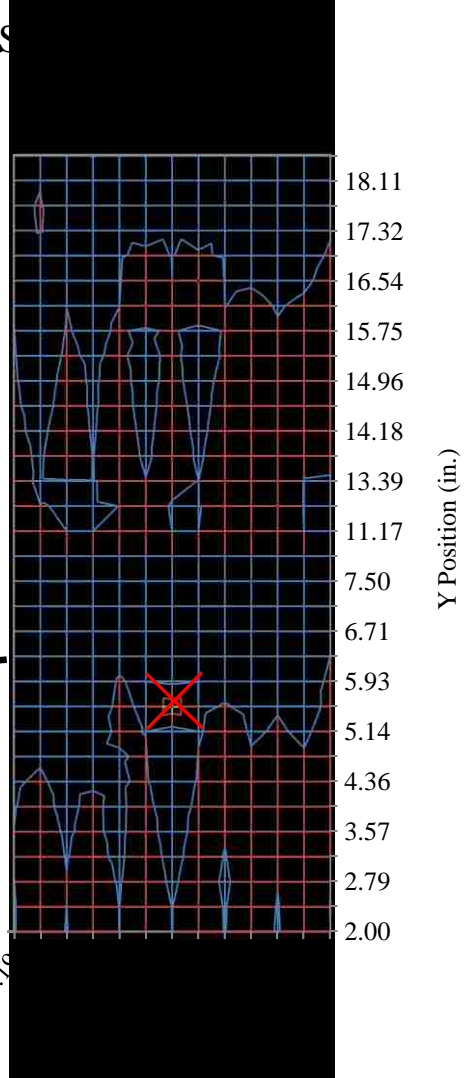
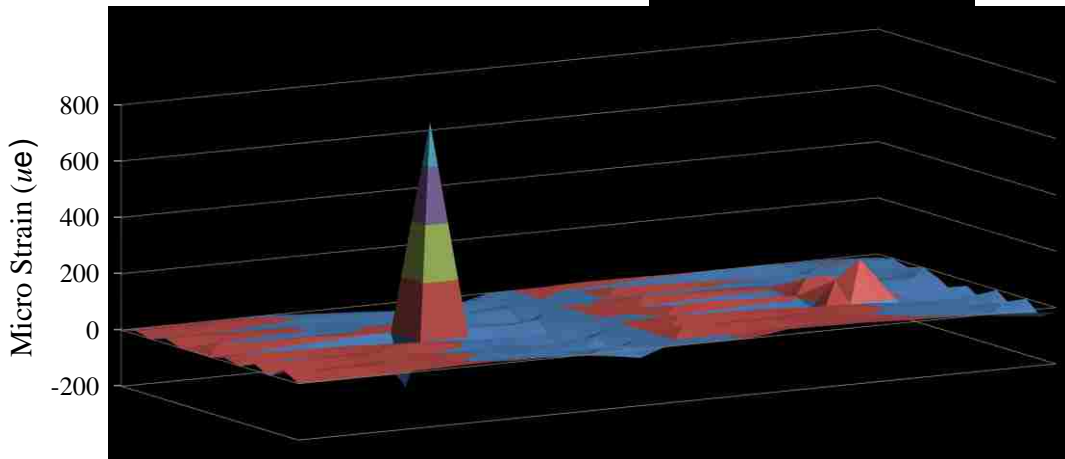
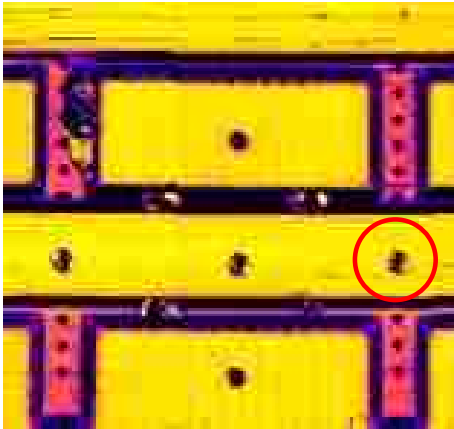
29 – B3/4-SK0-ST4-H3

Damage Area: 1.18 in²

Type of Damage: Interply delamination

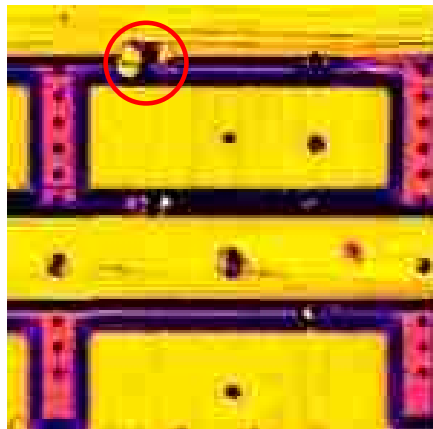
33 – B4-SK4-ST3L-H2c

Damage Area: 5.14 in²

Type of Damage: Interply delamination

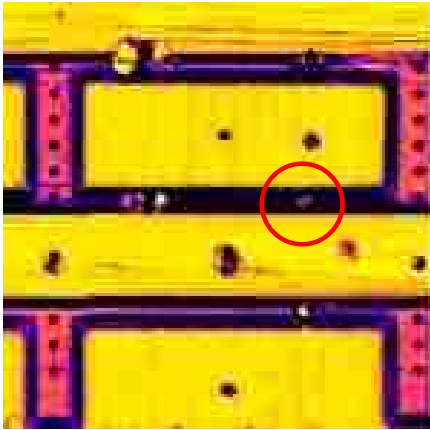
38 – B4-SK4-ST4R-H2a

Damage Area: 0.85 in²

Type of Damage: Interply delamination

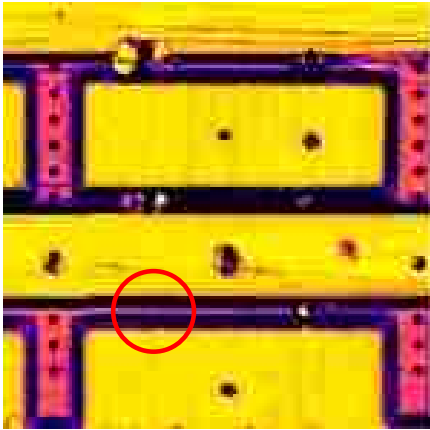
41 – B4-SK5-ST4L-H2b

Center of Stringer Flange
Impact Energy: 60 Ft lbs
Damage Area: 0 in²
Type of Damage: No damage
