**Dewatering and the
Deterioration mechanisms
in sandstone structural
elements and suggestive
treatments to Elkarnak
Temples**

Abd-Elkareem. E.A. (•)

Journal of Faculty of Archaeology at Qena

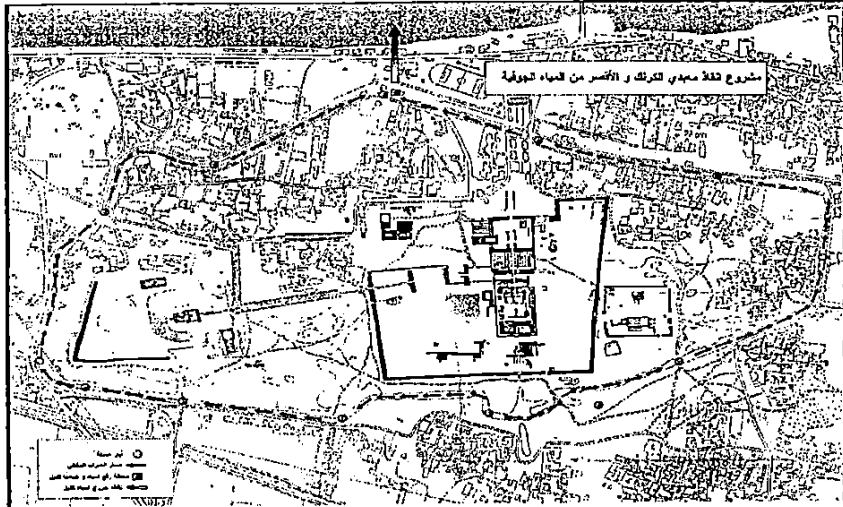
Fig. (16) the direction of dewatered from below Karnak Temples and direction of its pumping in the Nile, 2005, a report prepared by SWECO international Sweden
