Evaluating the Impacts of Hurricane Maria on the Residential Construction Industry in Puerto Rico and the Effectiveness of Reconstruction Efforts

M. Bradley Wells
Brigham Young University

Master of Science

School of Technology
Brigham Young University

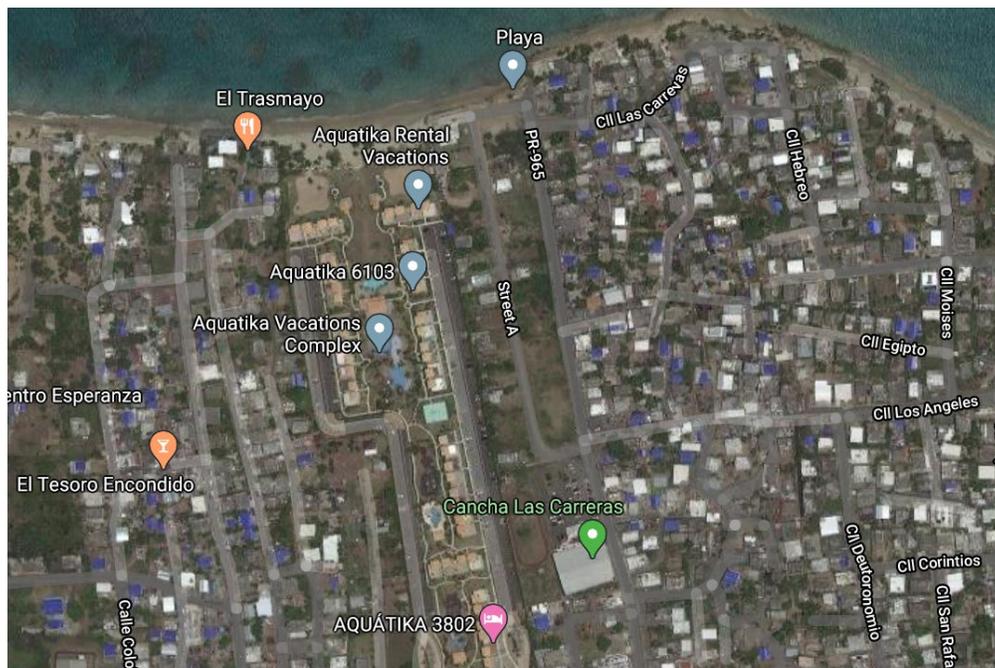
unfinished walls. Roofs were covered still with plywood or plastic, appearing to perhaps collapse at any moment. Some homes still had no running water. Several families lived in single rooms in unfurnished houses, sleeping on the floor (Robles and Patel, 2018). Figure 2-6 shows the widespread number of homes in a poor neighborhood still covered with “temporary” blue tarps multiple years after the hurricanes hit Puerto Rico. This suggests that many of the issues discussed in this literature review continue to hamper reconstruction efforts within the residential sector.

Figure 2-6: Aerial view of Loiza, Puerto Rico, 2020 (from Google, 2020).
