THESIS

EVALUATING THE LONG-TERM DURABILITY OF FIBER REINFORCED
POLYMERS VIA FIELD ASSESSMENTS OF REINFORCED CONCRETE
STRUCTURES

Colorado State University

Fall 2011

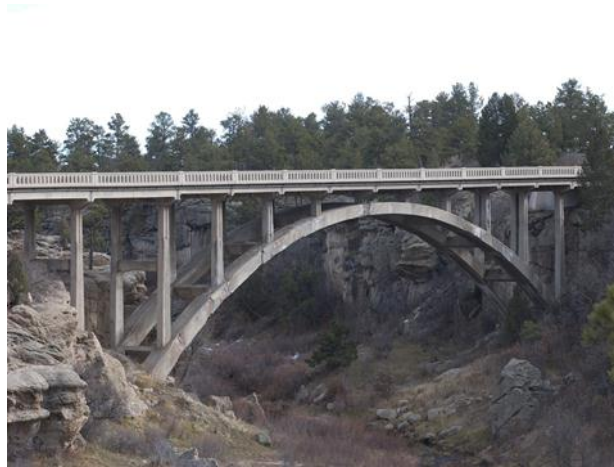
Figure 3.3. Castlewood Canyon Bridge prior to the 2003 repair (Mohseni, CDOT)

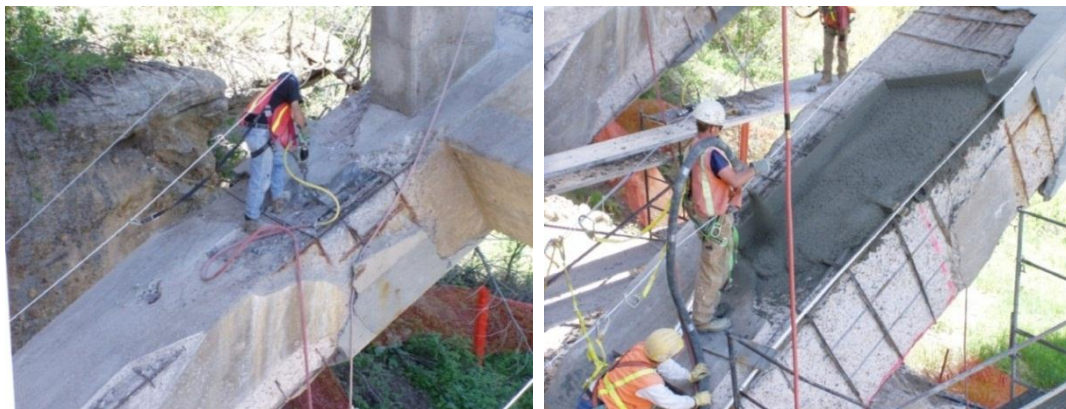
Figures 3.10 and 3.11. Removal of loose concrete using 6.8 kg (15 lbs.) jackhammer and restoring the cross section with shotcrete (Mohseni, CDOT)

Loose concrete, typically no more than the few inches of concrete cover, was removed with 6.8 kg (15 lb.) jack hammers and the exposed steel reinforcement was sandblasted free of rust. Seen below, the cross-section was restored with shotcrete which included a corrosion inhibitor, Sika FerroGard 903, to prevent further corrosion of the steel reinforcement.

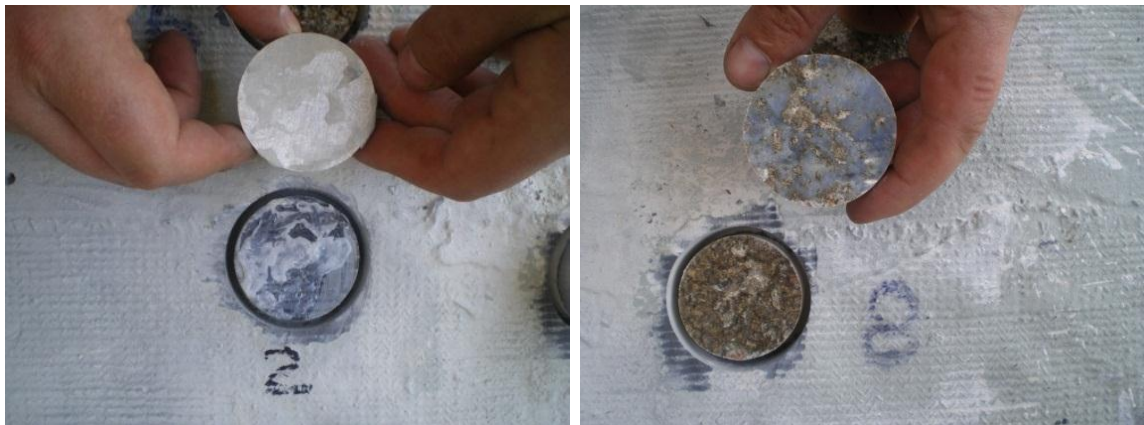
Figure 3.40 and 3.41. Failure Mode A: bonding adhesive failure at loading fixture (on left), Failure Mode E: Adhesive failure at CFRP/substrate adhesive interface (on right)

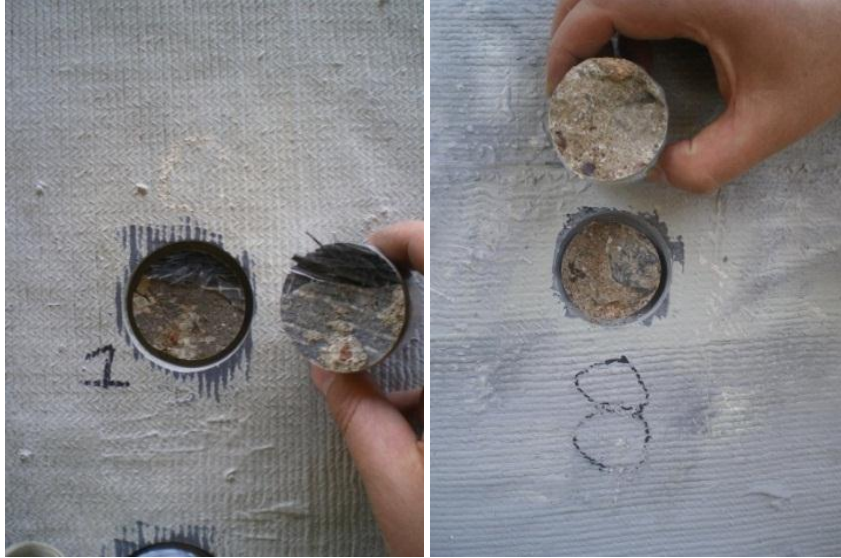
Figures 3.42 and 3.43. Failure Modes B and F: cohesive failure in FRP laminate, and mixed cohesive failure in substrate and adhesive failure at the adhesive/substrate interface, respectively (on left), Failure Mode G: cohesive failure in concrete substrate (on right)

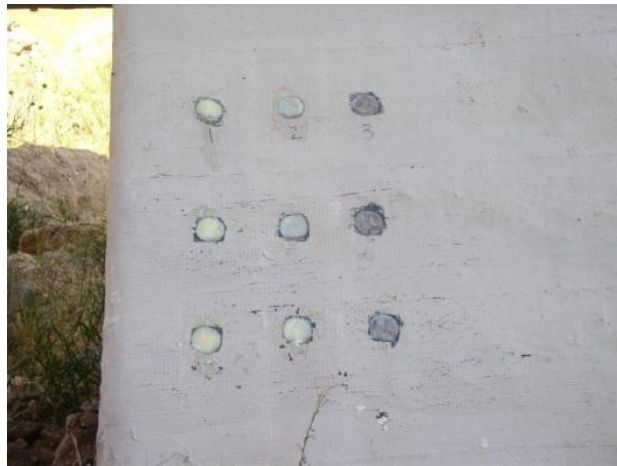
Figure 3.55. Epoxy filled holes following the pull-off tests

Due to the pull-off tests, a total of 27 – 57.15 mm (2 ¼”) diameter holes of varying depths, depending on the failure mode, were created on the arch. These areas were filled with epoxy to restore the profile of the arch. Initially, the same epoxy used to adhere the aluminum pucks to the CFRP was used to fill the holes created from the pull-off tests. Due to the inclined angle, this epoxy, which is less viscous before curing, would slump and run down slope on the locations near the base of the arches. This was undesirable and a more viscous epoxy, 3000 psi Loctite epoxy gel, was used to fill the holes created from the pull-off tests. These filled holes of varying depths can be seen below.

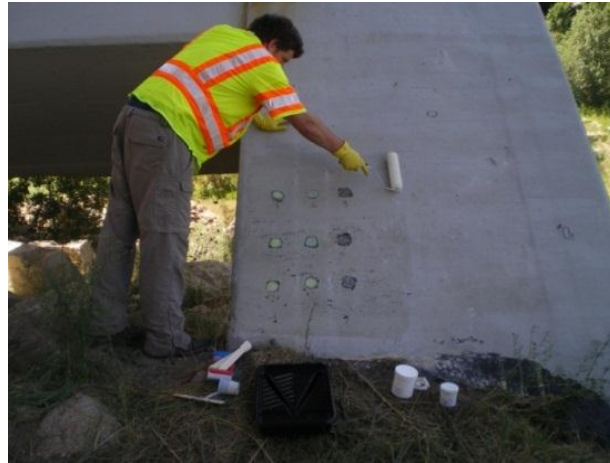
Figure 3.56. Applying a primer coat to the areas for repair

Once the holes were filled with epoxy, the 3 areas of pull-off tests and the 2 areas of removed CFRP (debonded regions) were prepared for a repair process. First these areas were washed using a non-toxic, biodegradable, soap and water, then they were cleaned with 70% Isopropyl alcohol to remove any remaining soap film. CFRP patches must overlap a minimum of 6”; therefore primer was applied to the affected

areas of the arches plus a minimum of 6" in each direction. The primer used for the repair was a two part epoxy made by HJ3, STRONGHOLD Primer Epoxy (STR-BW-200A). The mix ratio was 2 parts of the PC-200 Primer Resin, Part "A", to 1 part of the PC-200 Primer Hardener, Part "B". Once the two-part epoxy was well mixed, the primer was distributed to the repair areas using 9" rollers as seen in the photograph below.

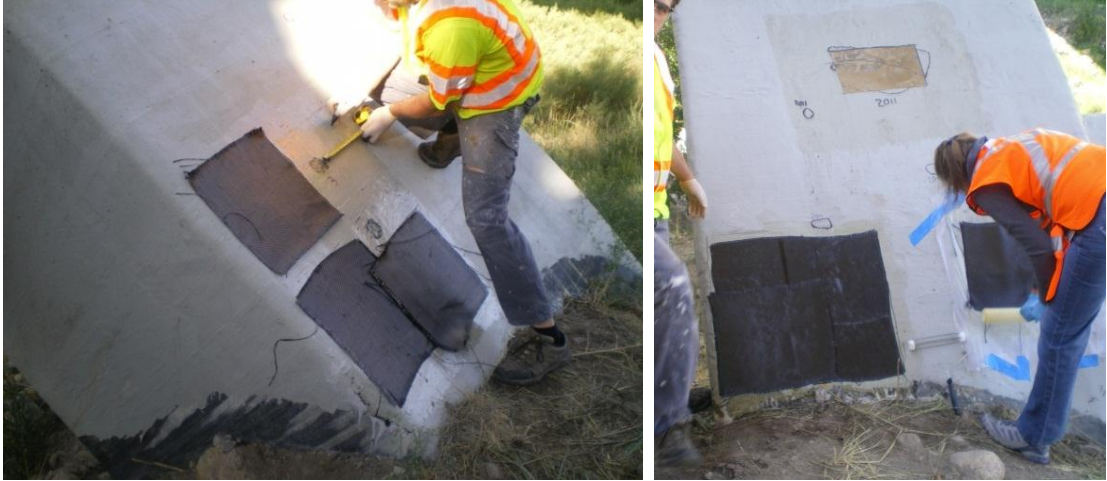
Figures 3.57 and 3.58. Allocating fabric for repair and applying the second layer of CFRP to the area of pull-off tests on the east arch

The CFRP fabric was saturated by applying a well-mixed two part epoxy, two parts of HJ3 SRS-400-A Resin and one part HJ3 SRS-400-B Hardener, to both sides of the fabric. The two part epoxy was also applied to the repair areas identical to that of the primer. The saturated fabric was then placed on the arch and the use of hand pressure and rollers eliminated air bubbles and pockets between the fabric and the substrate. Unidirectional CFRP fabric was used to repair the area where the patches were removed. Proper alignment of the fiber direction in the transverse direction was necessary to repair the transverse wraps. The pull-off tests were conducted closer to the edge of the arches damaging both transverse and longitudinal sections. Therefore, biaxial patches were used to repair these areas. This process is represented in the photographs below.

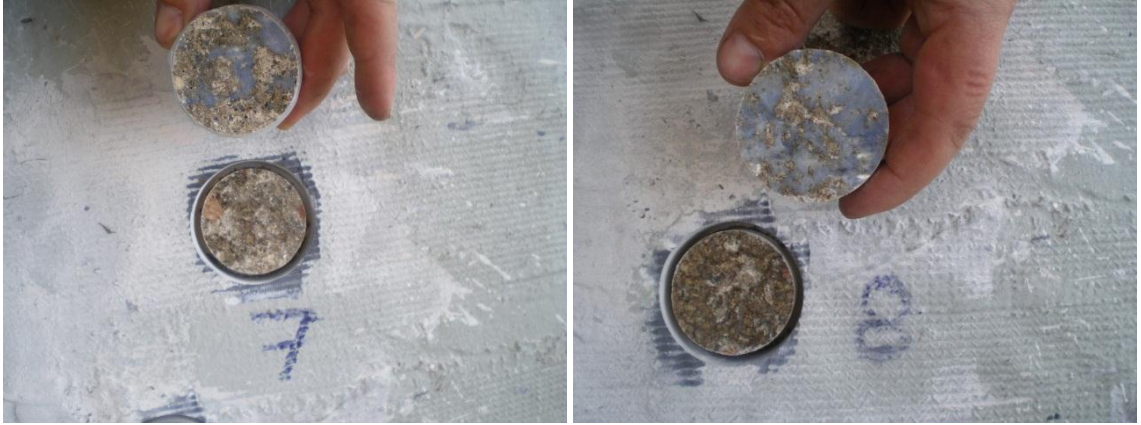
Figures B6 and B7. Test No.7 and Test No.8, weak bond strength

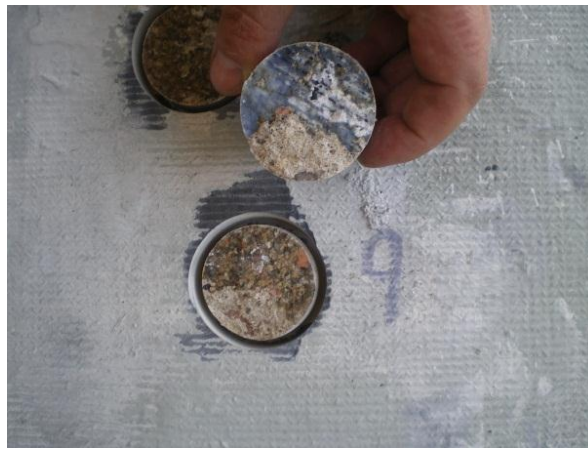
Figure B8. Test No.9, weak bond strength

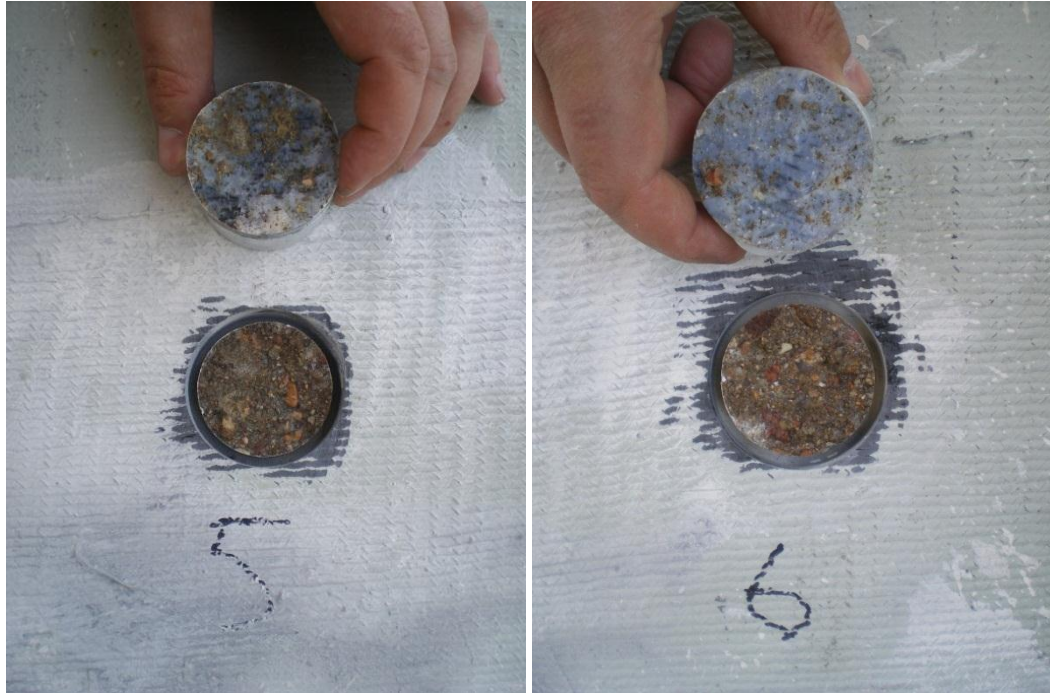
Figures B12 and B13. Test No.14, weak bond strength, and Test No.15, weak bond strength

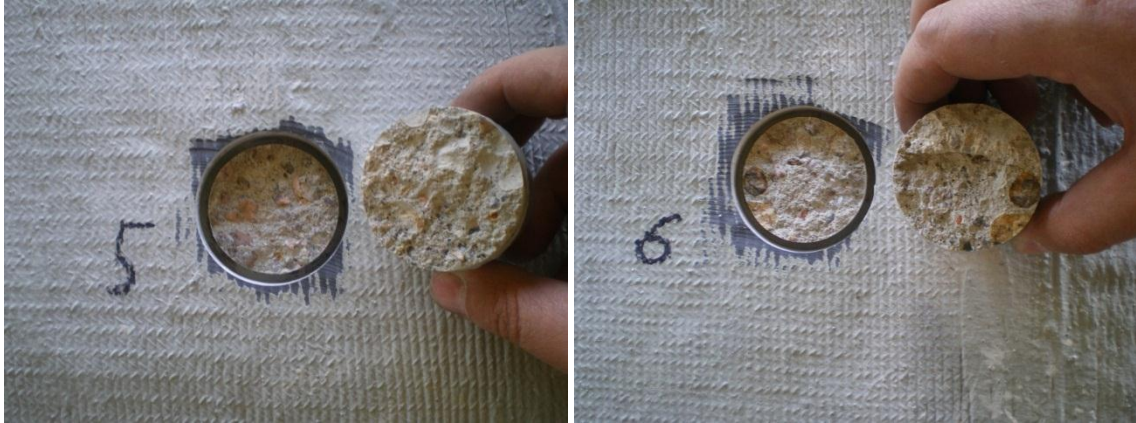
Figures B20 and B21. Test No.23, weak bond strength (poorly mixed concrete?), and Test No.24

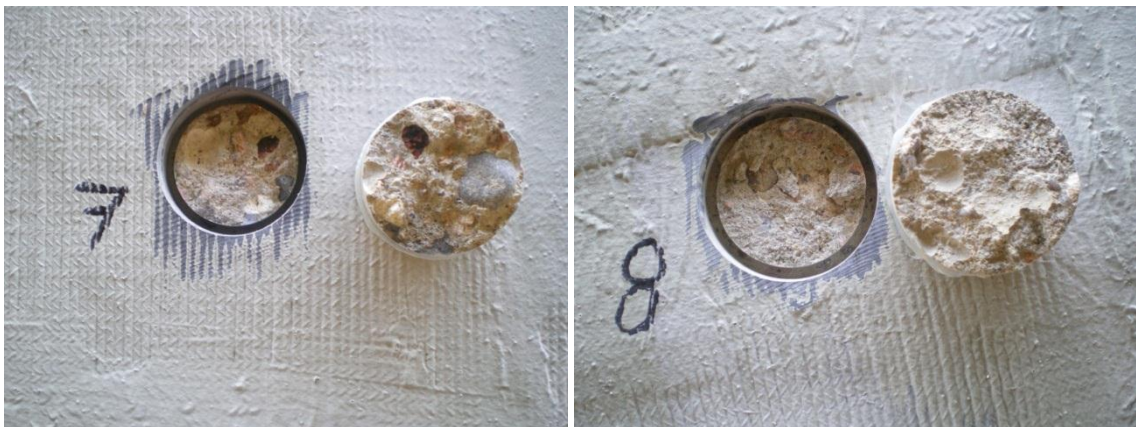
Figures B22 and B23. Test No.25 and Test No.26, note very weak bond strength (poorly mixed concrete?)
