# **EXPERIMENTAL SEISMIC STUDY OF PRESSURIZED FIRE SPRINKLER PIPING SUBSYSTEMS**

Yuan Tian

November 9<sup>th</sup>, 2012

A dissertation submitted to the  
Faculty of the Graduate School of  
the University at Buffalo, State University of New York  
in partial fulfillment of the requirements for the  
degree of

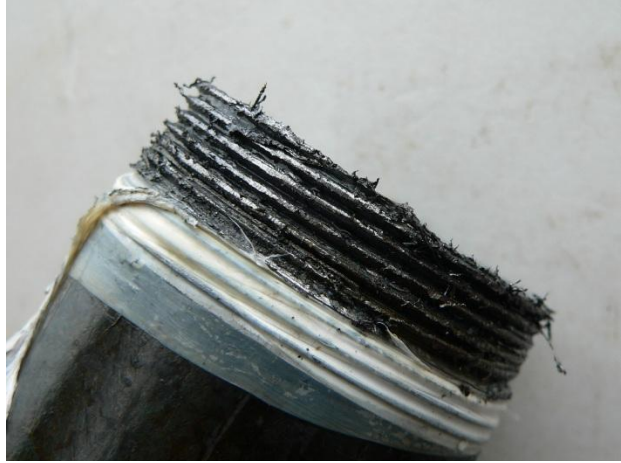
(d) Eroding of threads due to slippage

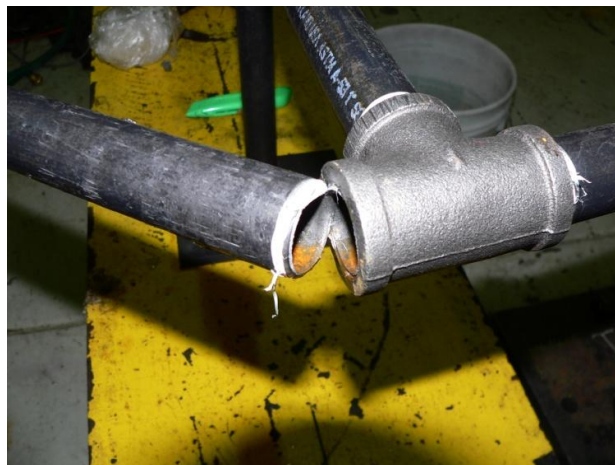
(e) Fracture of pipe

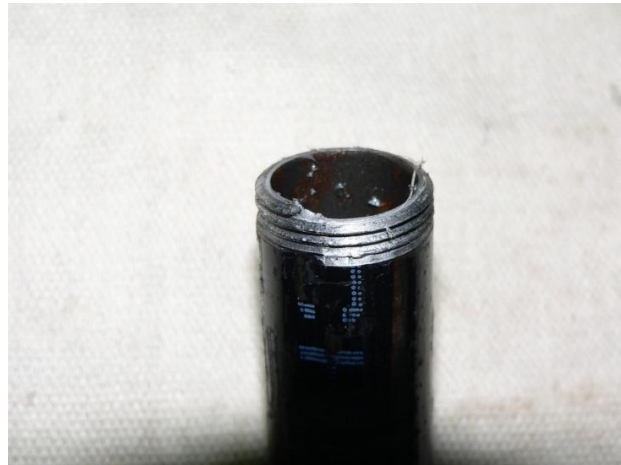
(f) Sheared threads in the pipe

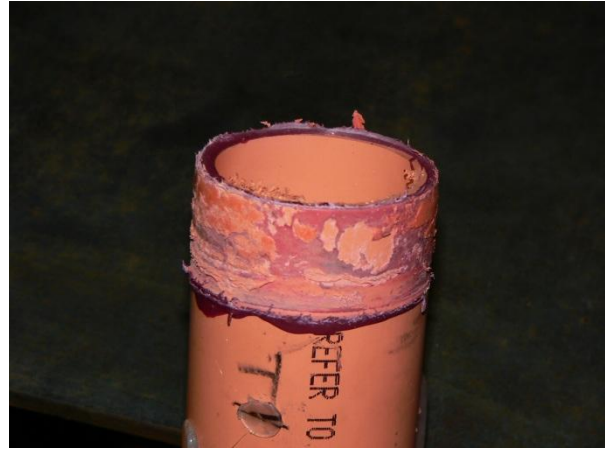
The behavior at first leakage of the CPVC pipes with cement joints was governed by slippage of the cement glue from the pipe surfaces (Figure 3-15). This caused the pipes to pull-out completely from the tee-joint. In most instances, the inner surface of the tee joints peeled off with the cement glue, indicating that the glue was stronger than the piping material. For

(b) Inner surface of the tee joints peeled off with the cement glue

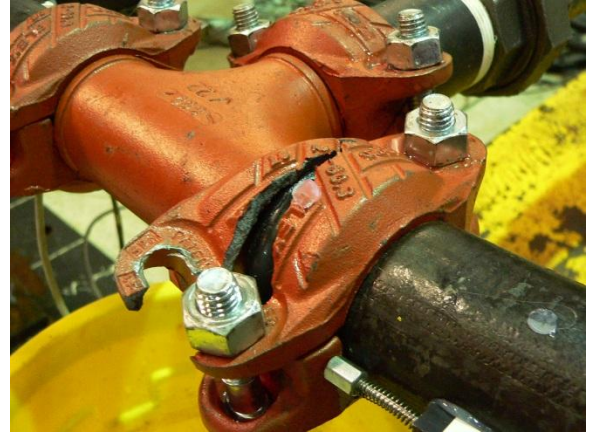
- 1) Fracture was initiated either from the angle pad in contact with the other coupling flange (*Figure 3-17 a*), and housing keys that were designed to be engaged in the groove in the tee joint (*Figure 3-17 b and Figure 3-17 c*), or from the coupling holes for the bolts (*Figure 3-17 d*);

*(d) Fracture of coupling flange initiated from the coupling hole*

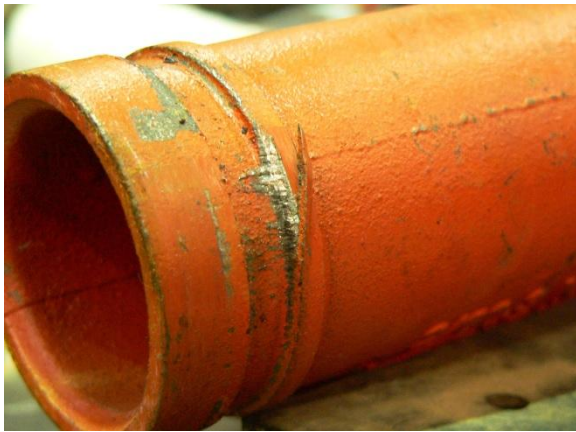
- 2) The edge of the groove in the tee joint sheared off due to the interaction with the coupling flanges (*Figure 3-17 e*);
- 3) The outer surfaces of the pipes around the edge of the groove showed significant wearing damage due to the interaction with the coupling flanges (*Figure 3-17 f*).

*(e) Edge of groove sheared off in the tee joint*

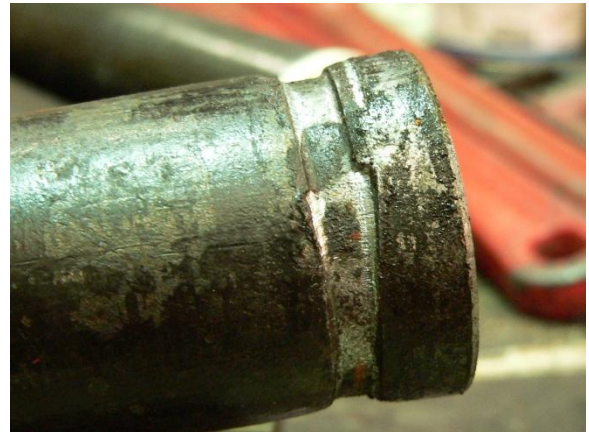
*(f) Wearing damage around the groove in the pipe*

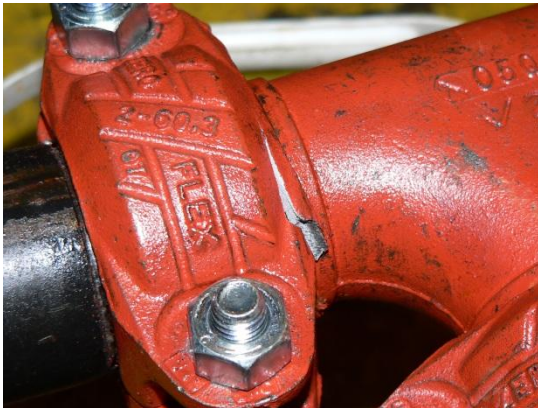
- 1) Fractures similar to those of schedule 40 steel pipes were observed in the coupling flanges  
(Figure 3-18 a);

(a) Fracture of coupling flange initiated from the housing key

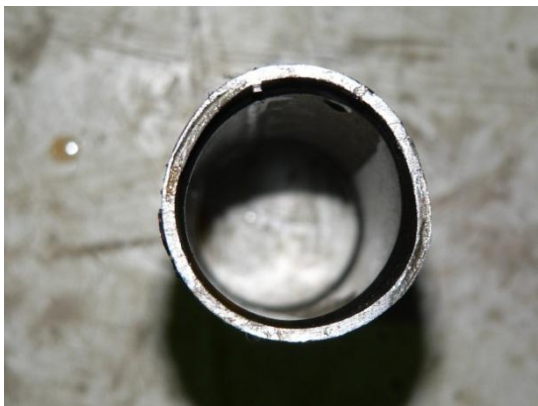
(c) Significant inelastic deformation in the pipe section

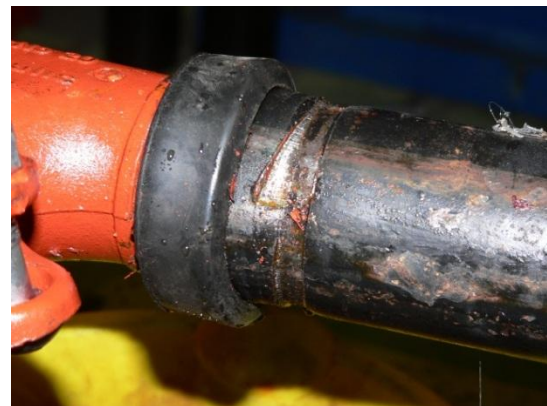
(d) Wearing damage around the groove in the pipe

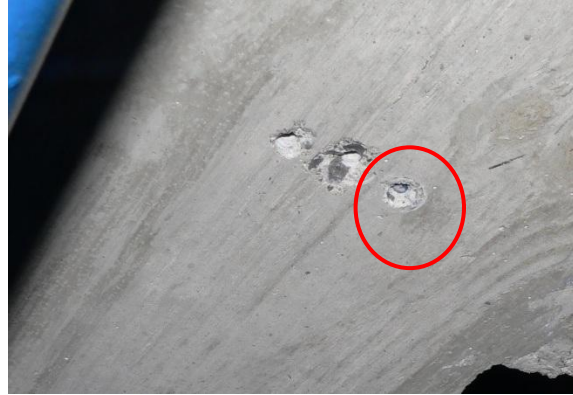
The vertical hanger attached to the LCR-17 load cell (*Figure 4-29*) supporting the branch line on the first level pulled out from the concrete slab due to the failure of the building-attached component at 100% of MCE level. Although the data recorded by the miniature load cell indicated that the axial force was within half of the pullout strength limit of the SAMMY screw, it obviously showed that the failure mechanism of the SAMMY screw was dominated by the shear force in this case (*Figure 4-33*). In addition, as shown in *Figure 4-34*, the vertical hanger attached to the LCR-13 load cell (*Figure 4-29*) supporting the main line on the first level buckled when the first level of the fire sprinkler piping system was fully braced and separated from the vertical riser, indicating that there was substantial vertical displacement.

(b) Remnant of SAMMY screw in the concrete slab  
(Configuration 1-5, 100% MCE level)

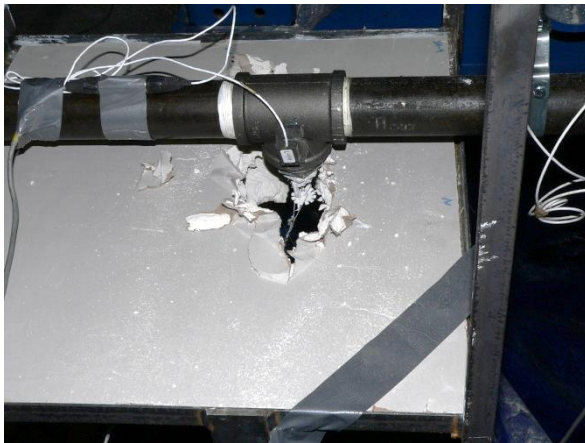
During dynamic testing, the rigid ceiling boxes moved in unison with the UB-NCS platforms due to the stiff steel angles attached to the concrete slab fixed to the platforms. The flexible ceiling boxes, on the other hand, were able to move freely since the wire restraints provided little lateral stiffness. However, both types of ceiling boxes experienced significant differential displacement compared to the specimen because the fire sprinkler protection system also moved relative to the UB-NCS testing frame. As a result, severe pounding occurred between the sprinkler heads and the ceiling tiles. As shown in *Figure 4-35*, large openings were cut through due to the pounding. Similar ceiling damage was observed repeatedly in past earthquakes. For example, extensive openings were cut through at a number of airports during the 2010 Chile Earthquake described in *Chapter 1*.

*(a) Damage of rigid ceiling box  
(Configuration 1-6, 100% MCE level)*

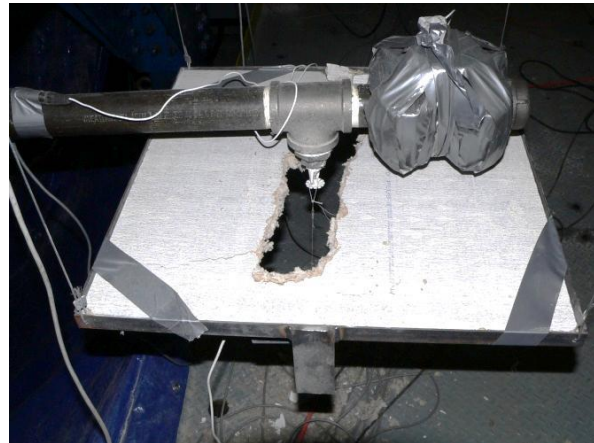
*(a) Damage of flexible ceiling box  
(Configuration 1-6, 100% MCE level)*

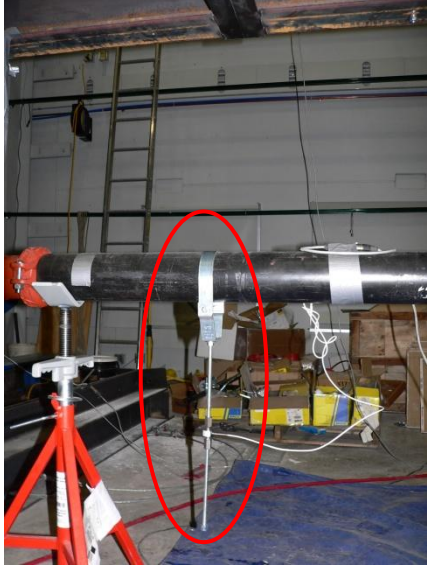
Similar to the first and second specimen, the failures observed during the testing of the third specimen, concentrated on the vertical hangers and the ceiling tiles. A number of photos of the failures are shown in *Figure 4-42*. The vertical hanger attached to the LCR-23 load cell supporting the 4-inch main line at the first level failed as the SAMMY screw for steel was sheared off. In addition, another SAMMY screw (LCR-7) attached to the concrete slab at the second level lost grip and was entirely pulled out from the concrete member. Again, pounding

(a) Vertical hanger sheared off  
(Configuration 3-5, 100% MCE level)

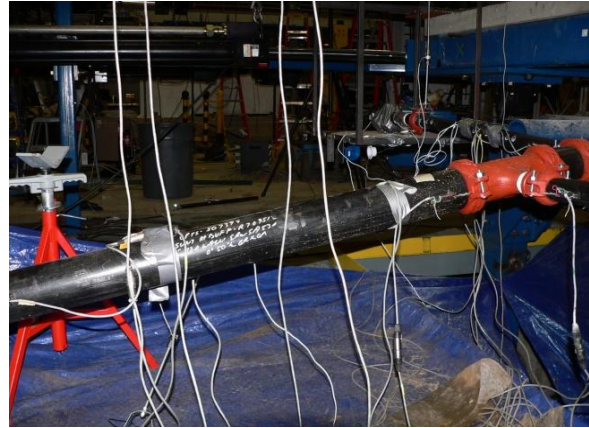
(b) Excessive deformation of main line  
after failure of vertical hanger  
(Configuration 3-5, 100% MCE level)

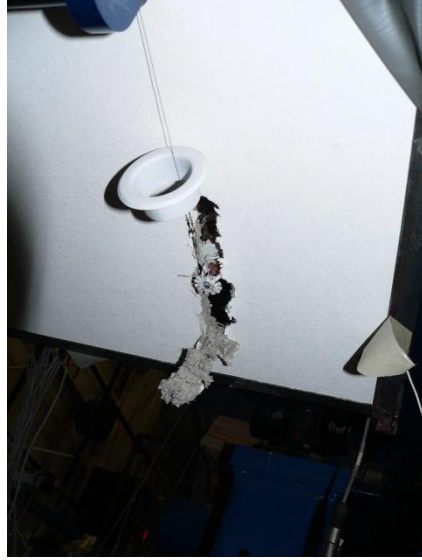
with the pendant sprinkler heads during the dynamic tests led to significant damage to the ceiling tiles (*Figure 4-43*).

*Figure 4-43 Damage of ceiling box*

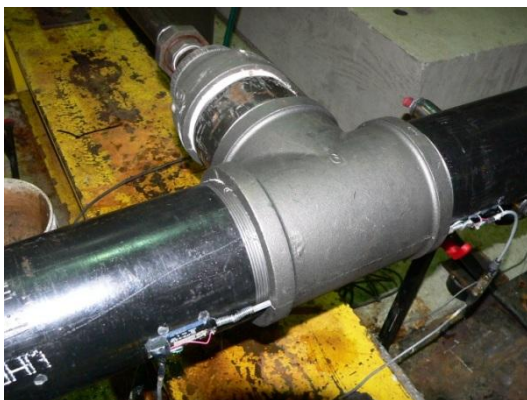
**MONOTONIC TEST FOR 6" BLACK IRON PIPES WITH THREADED JOINTS**

Pipe threads slip from tee threads

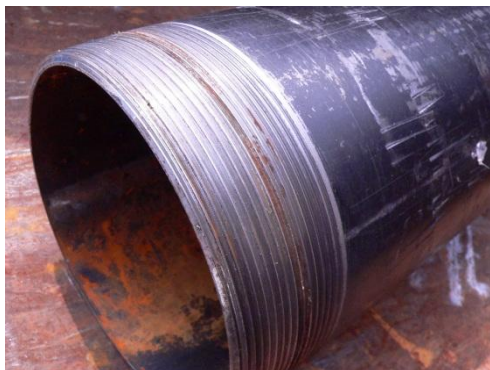
**CYCLIC TEST #1 FOR 6" BLACK IRON PIPES WITH THREADED JOINTS**

Pipe threads erode due to slippage

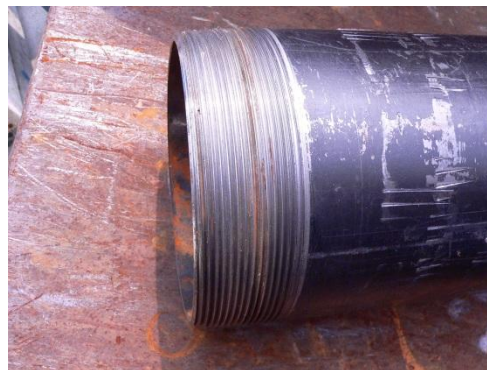
Pipe threads damage

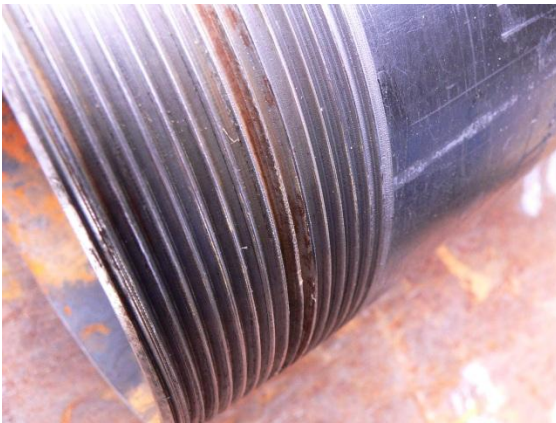
**CYCLIC TEST #2 FOR 6" BLACK IRON PIPES WITH THREADED JOINTS**

Pipe threads damage

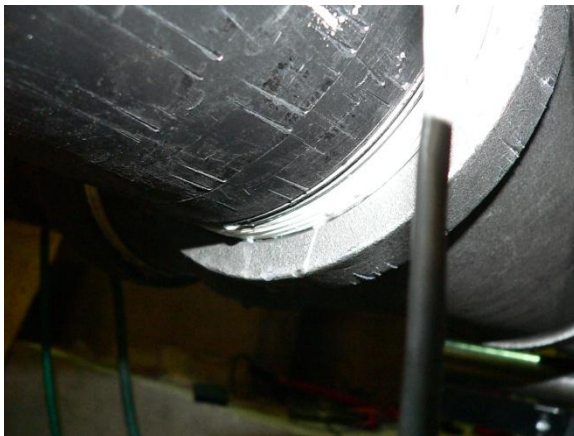
**CYCLIC TEST #3 FOR 6" BLACK IRON PIPES WITH THREADED JOINTS**

Gap generated between pipe and tee joint due to imposed bending

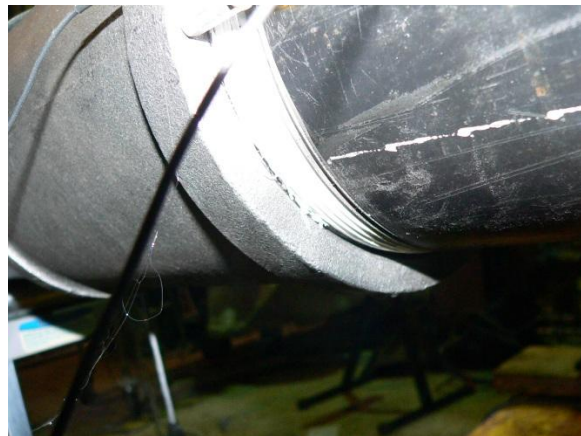
Thread sealant (Teflon tape) degraded

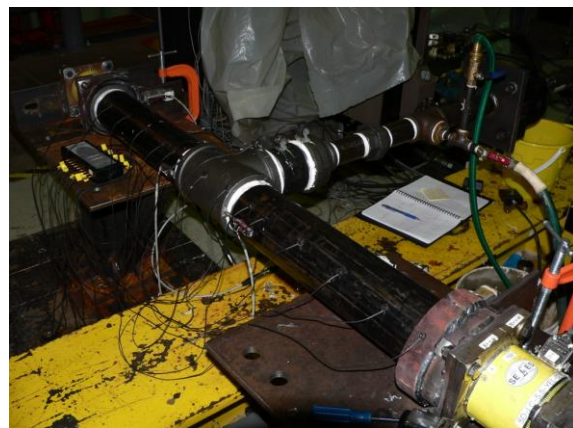
Pipe end bent due to imposed rotation

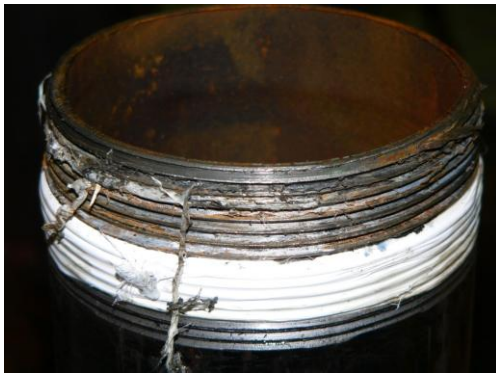
Thread sealant (Teflon tape) degraded

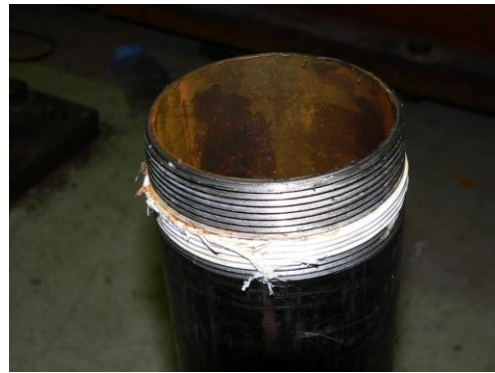
Pipe threads damage

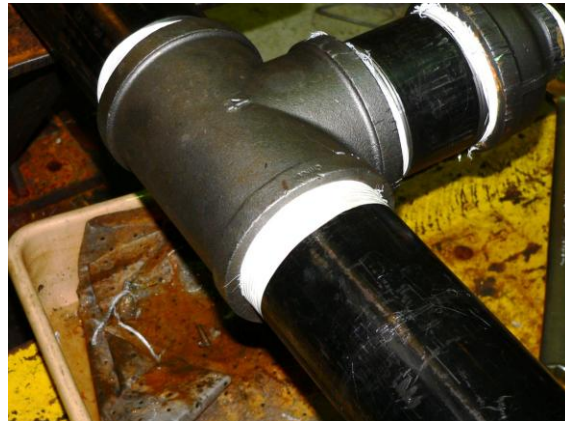
Gap generated between pipe and tee joint due to imposed bending

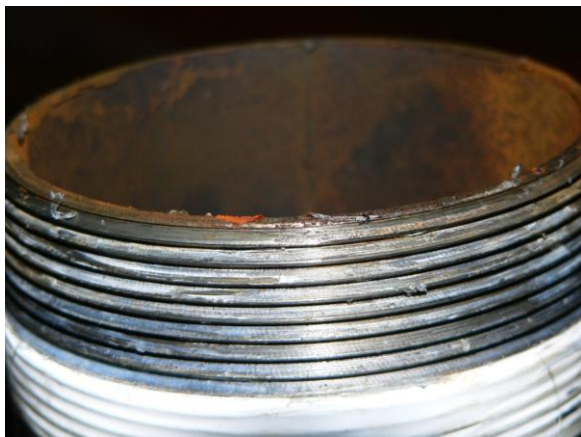
Pipe threads erode due to slippage

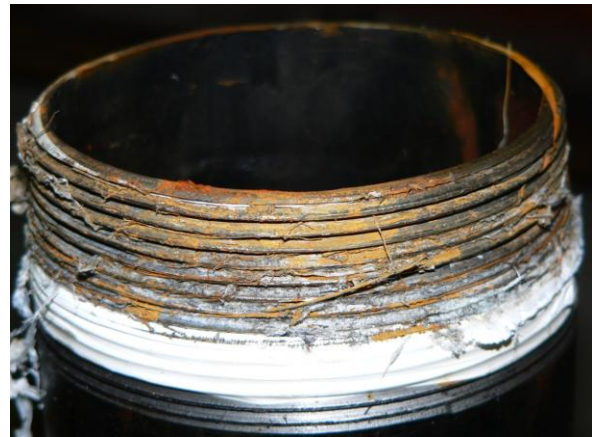
Thread sealant (Teflon tape) degraded

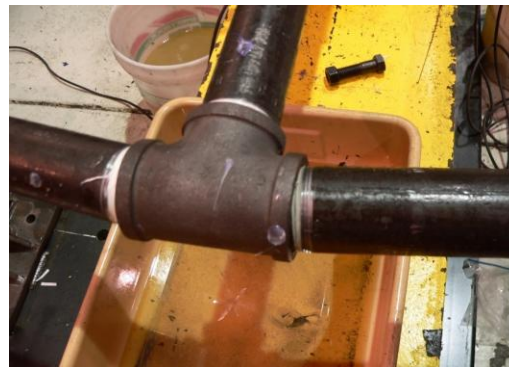
Pipe threads slip from tee threads

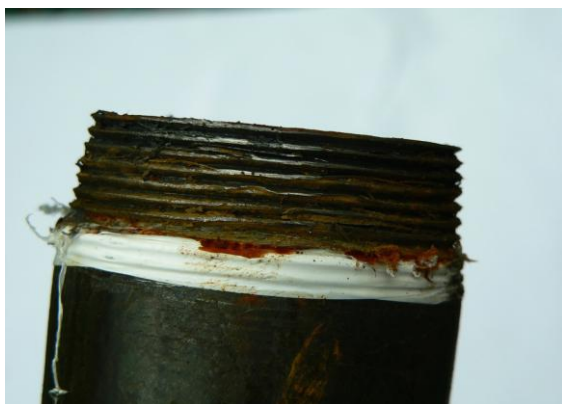
Pipe threads erode due to slippage

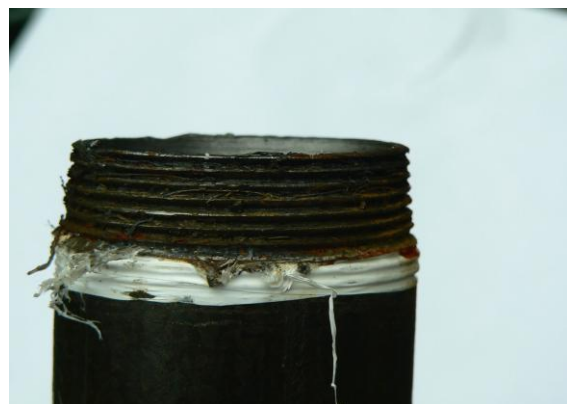
Pipe threads damage

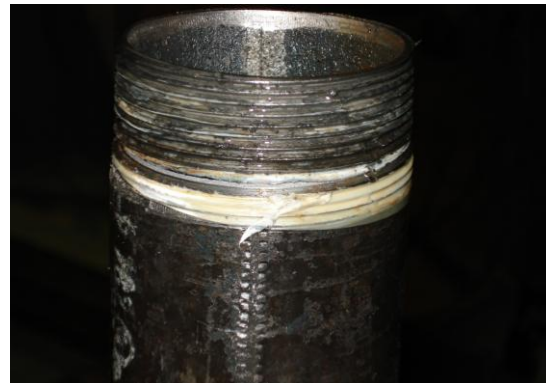
Thread sealant (Teflon tape) degraded

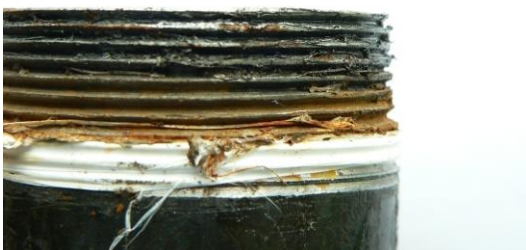
Pipe threads erode due to slippage

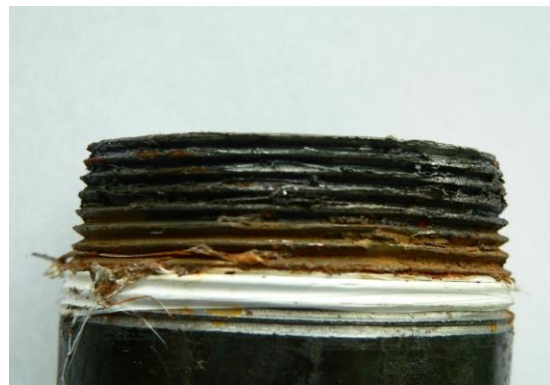
Thread sealant (Teflon tape) degraded

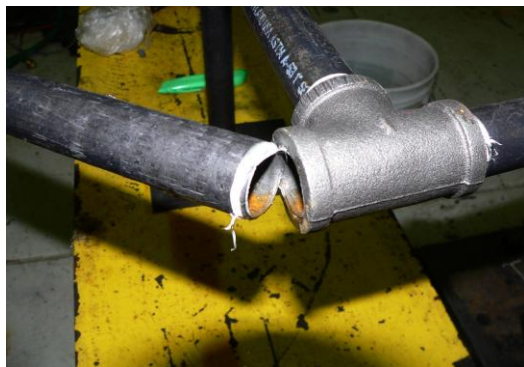
Pipe fractured at the edge of tee

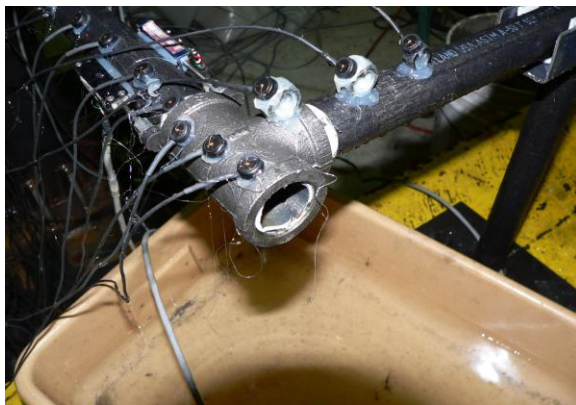
Pipe fractured at the edge of tee

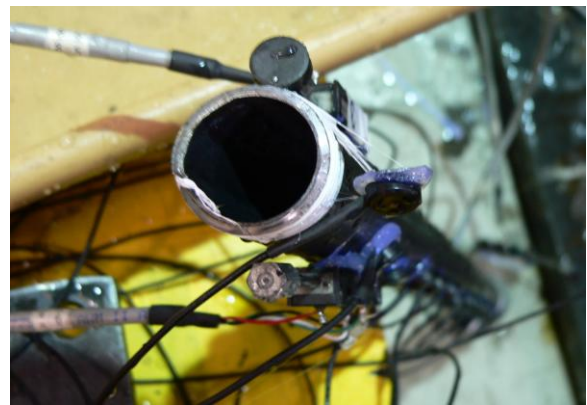
Thread sealant (Teflon tape) degraded

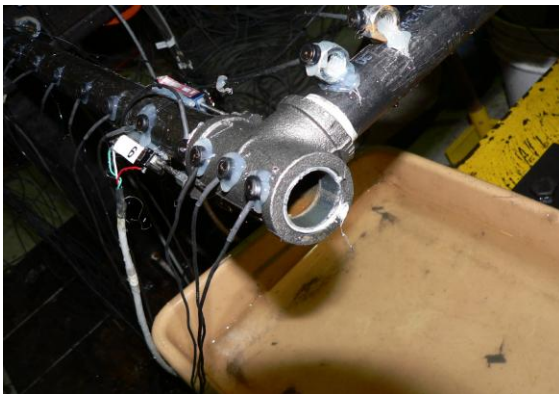
Pipe fractured at the edge of tee

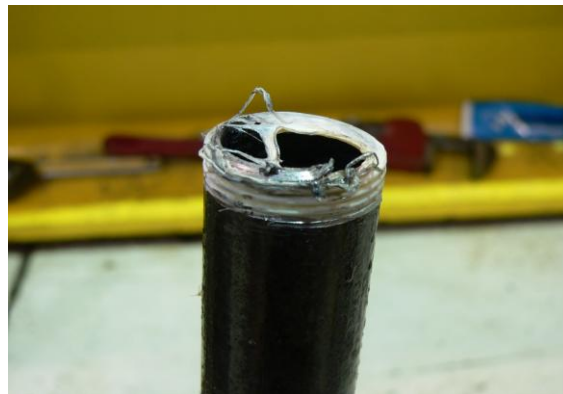
Thread sealant (Teflon tape) degraded

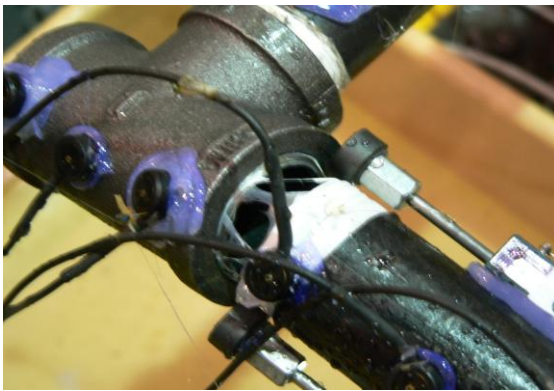
Pipe fractured at the edge of tee

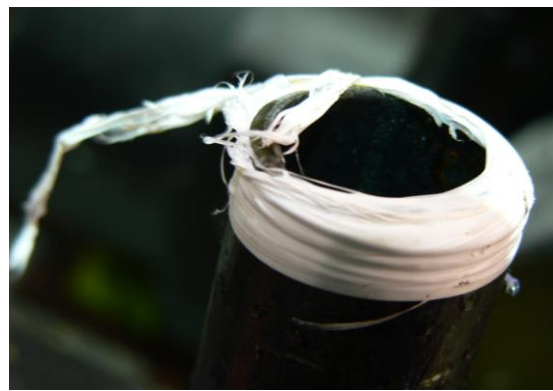
Thread sealant (Teflon tape) degraded

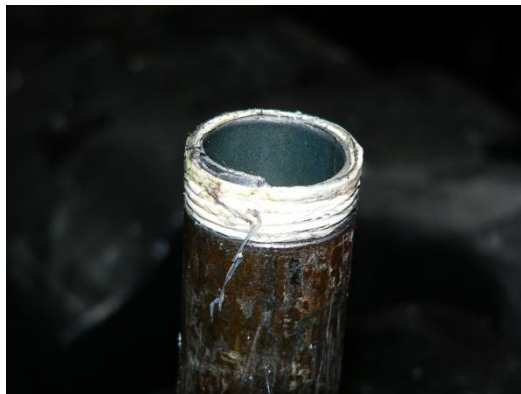
Thread sealant (Teflon tape) degraded

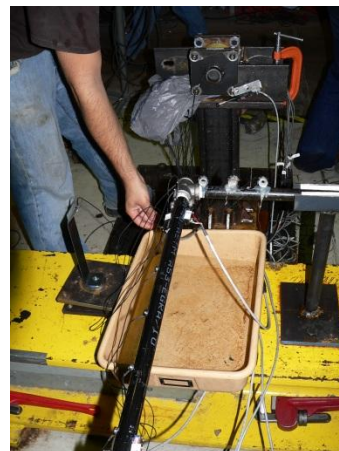
Pipe fractured at the edge of tee

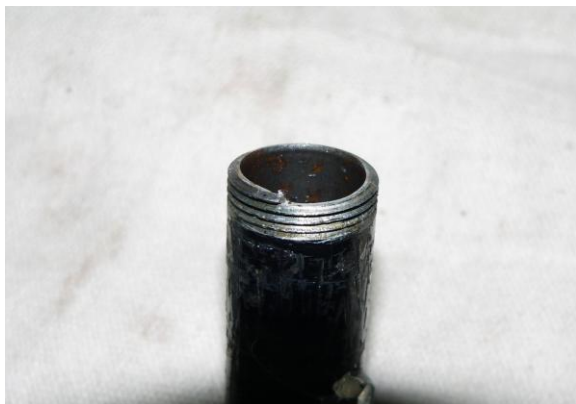
Pipe threads erode due to imposed rotation

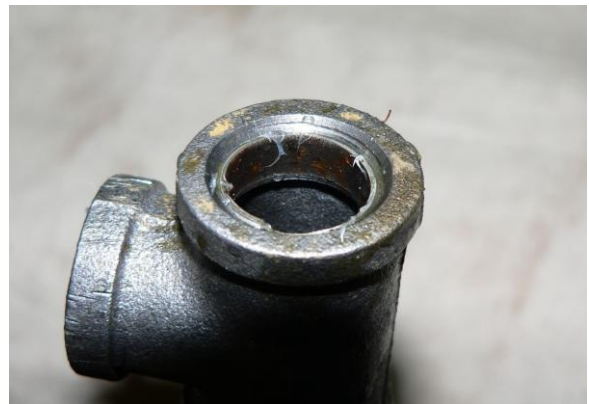
Pipe fractured at the edge of tee

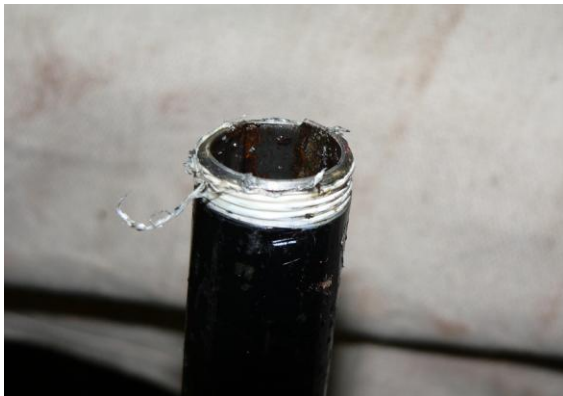
Pipe threads erode due to imposed rotation

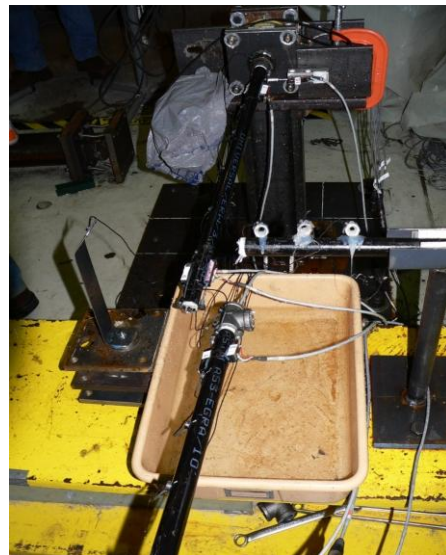
Pipe fractured at the edge of tee

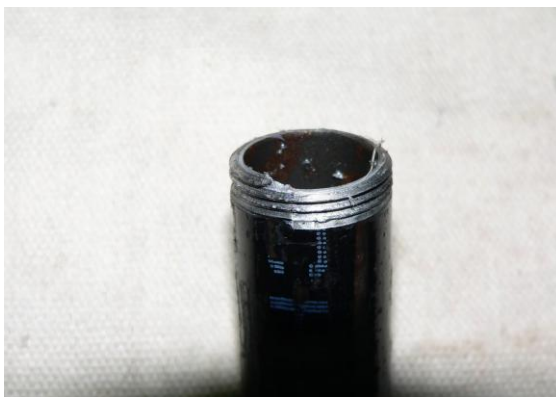
Pipe threads erode due to imposed rotation

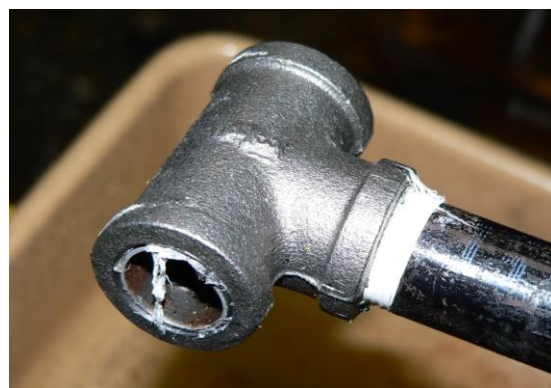
Pipe fractured at the edge of tee

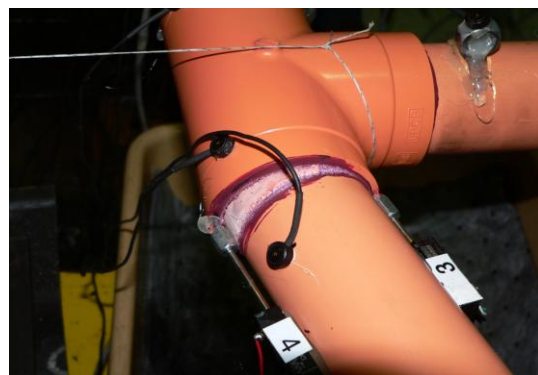
Cement Glue slipped

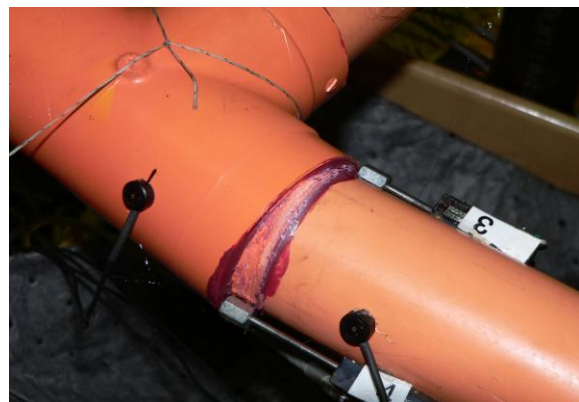
Cement Glue slipped

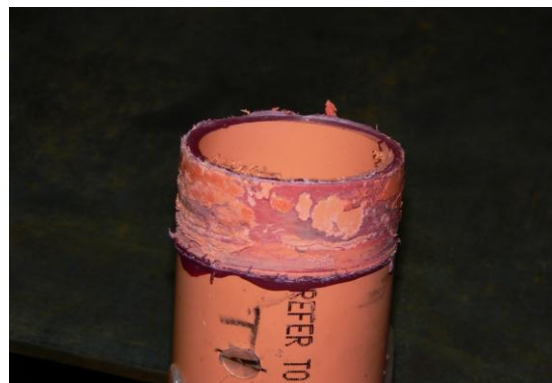
Pipe pulled out from tee joint

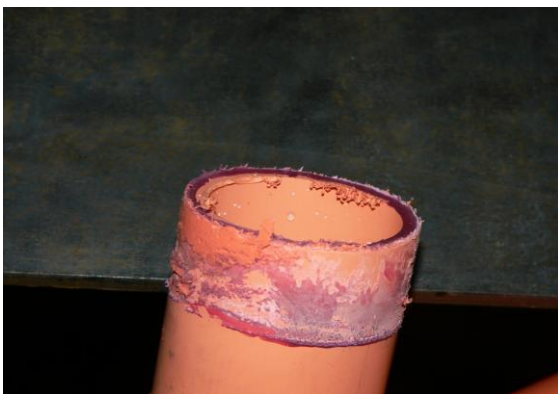
Pipe pulled out from tee joint

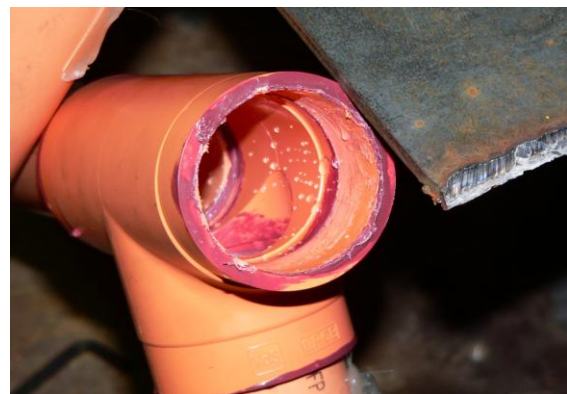
Pipe peeled off the inner surface of tee joint

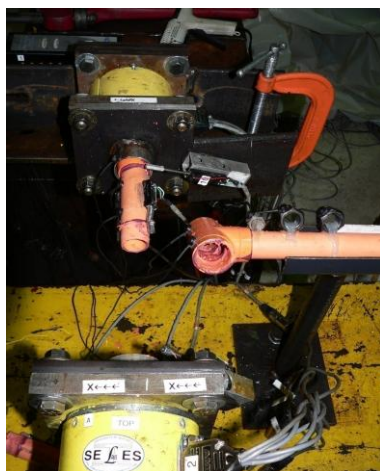
Pipe pulled out from tee joint

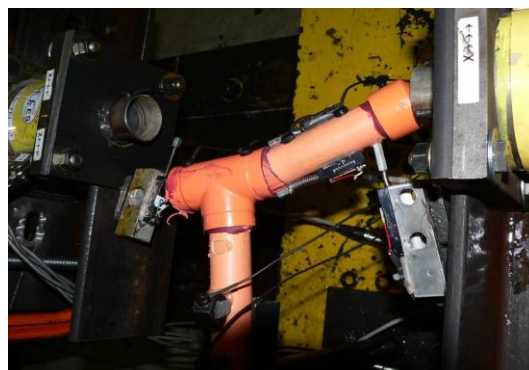
Pipe end bent due to imposed rotation

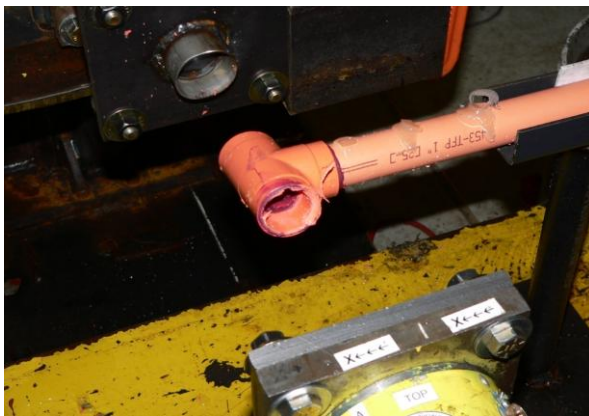
Pipe pulled out from tee joint

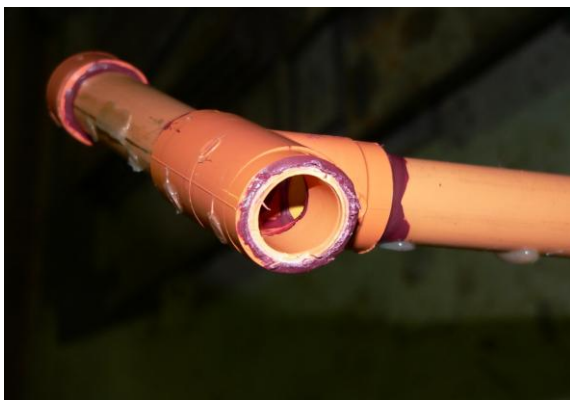
Pipe fractured at the edge of tee

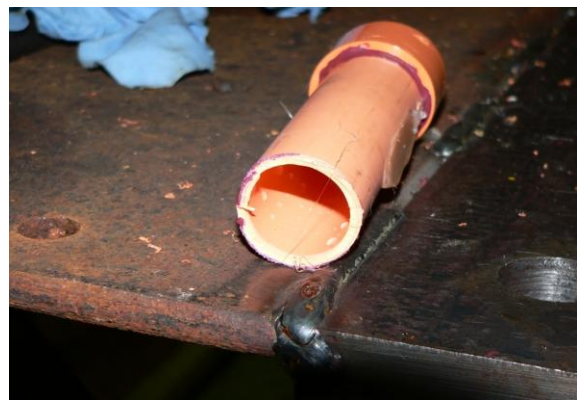
Pipe fractured at the edge of tee

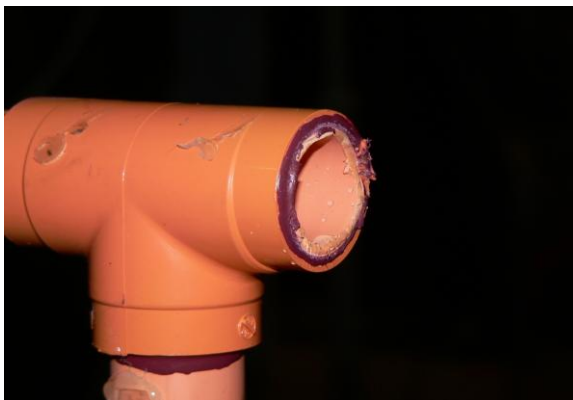
Pipe fractured at the edge of tee

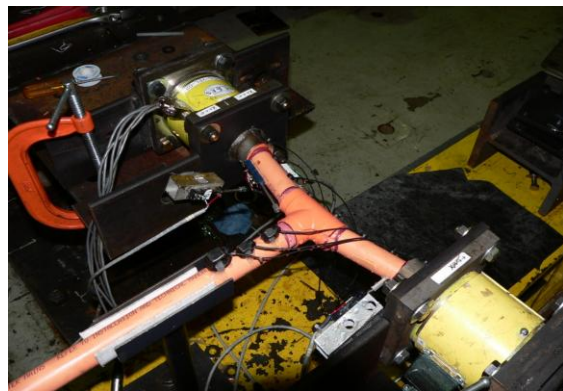
Pipe end bent due to imposed rotation

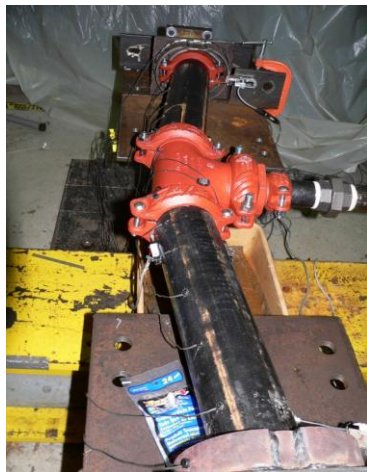
Pipe end bent due to imposed rotation

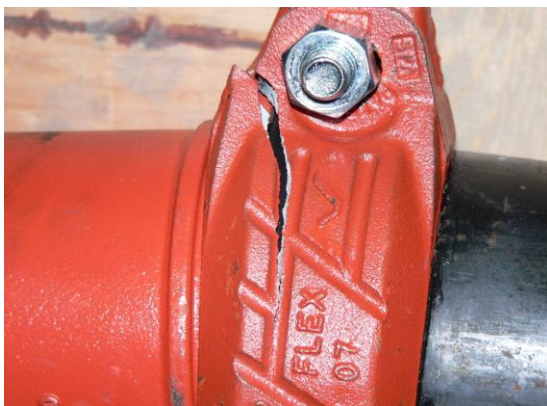
Coupling flange fractured

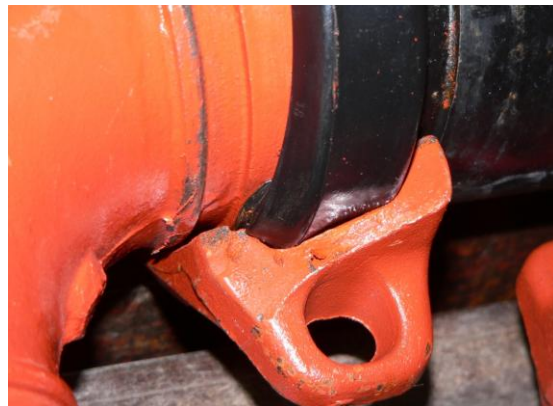
Groove of pipe wore away

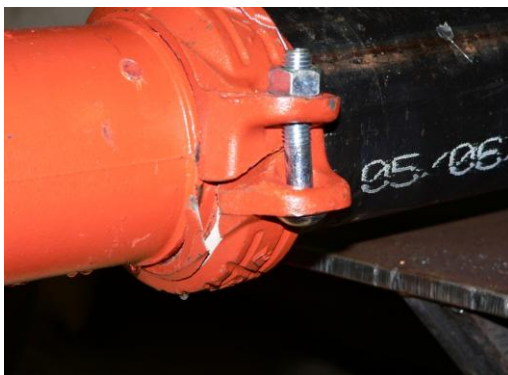
Coupling flange fractured

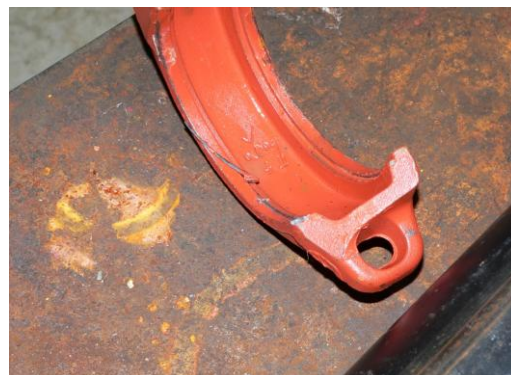
Coupling flange fractured

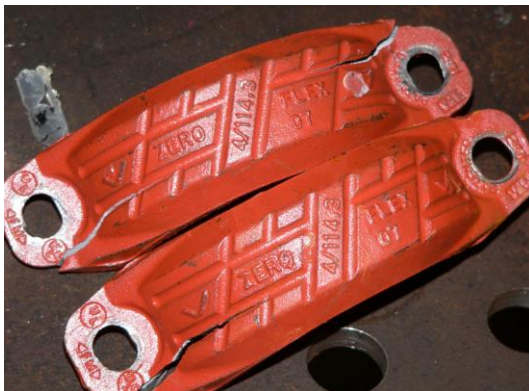
Coupling flange fractured

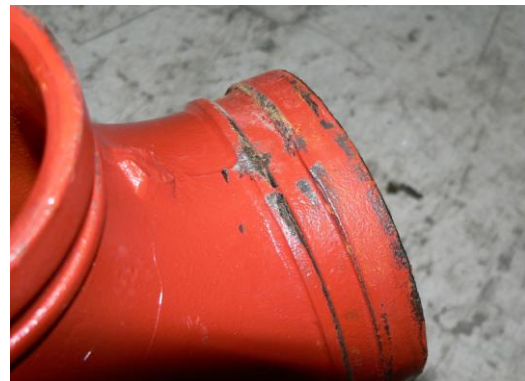
Groove of pipe wore away

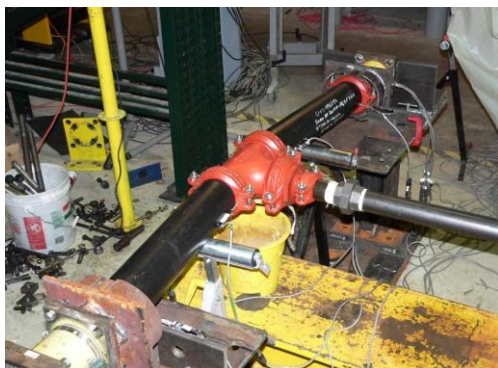
Pipe end bent due to imposed rotation

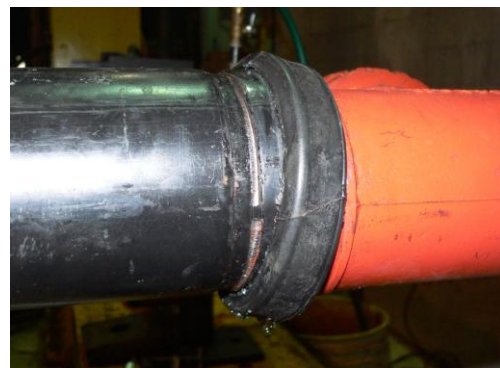
Groove of pipe wore away

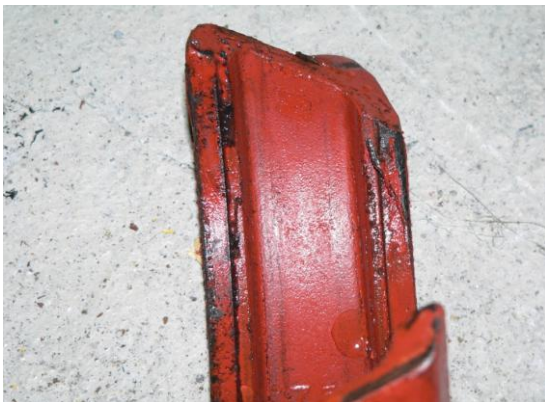
Coupling flange fractured

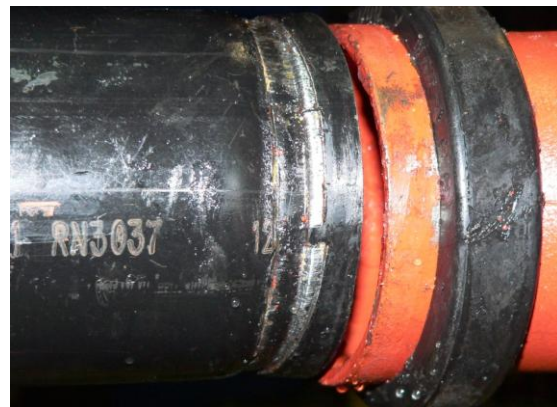
Groove of pipe wore away

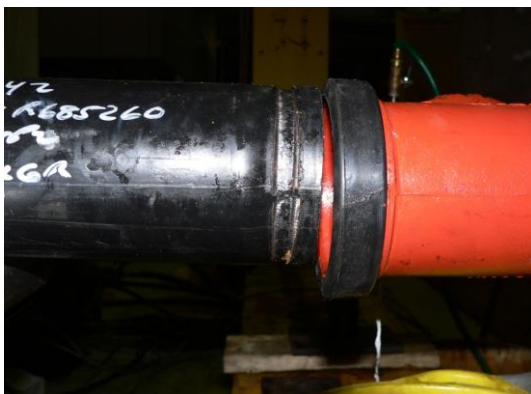
Groove of pipe wore away

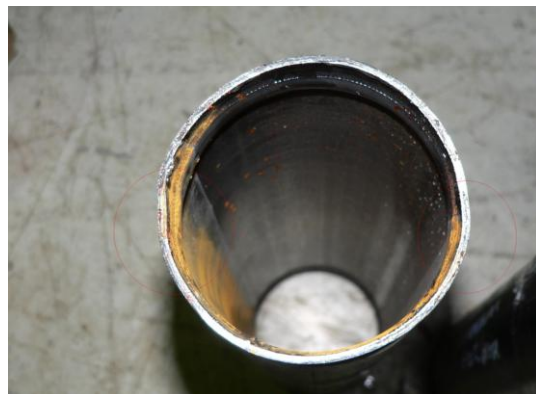
Cross section of pipe yielded and deformed

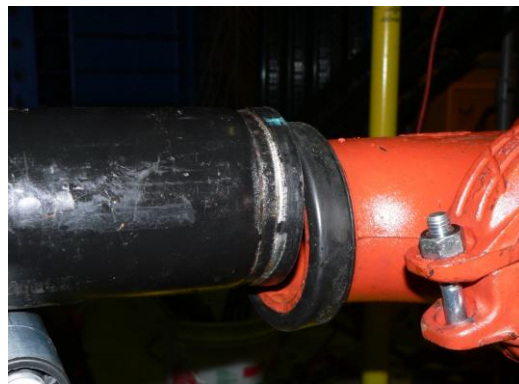
Groove of pipe wore away

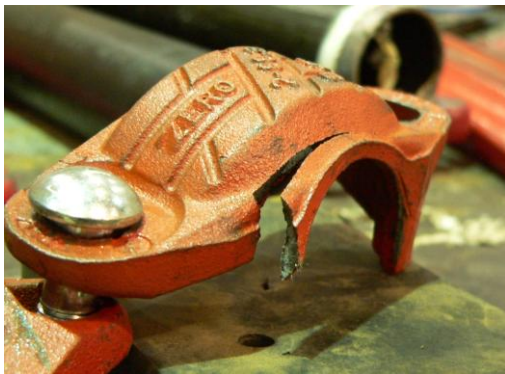
Flange coupling fractured

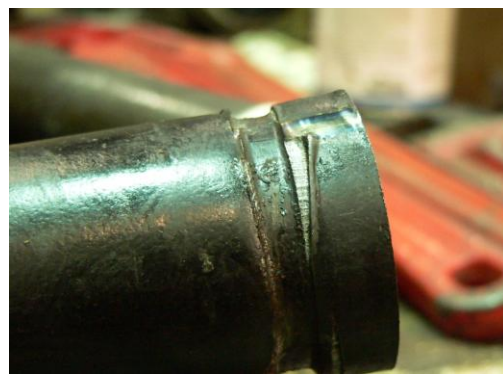
Groove of pipe wore away

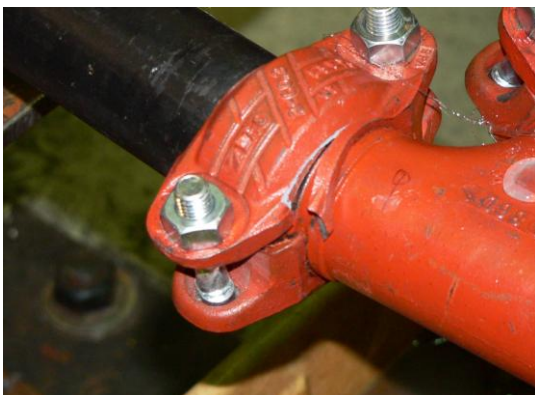
Coupling flange fractured

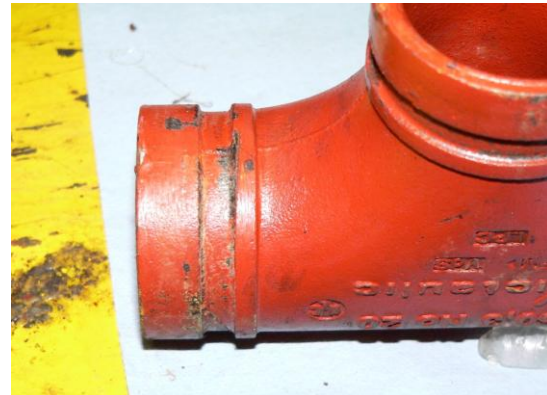
Groove of tee joint wore away

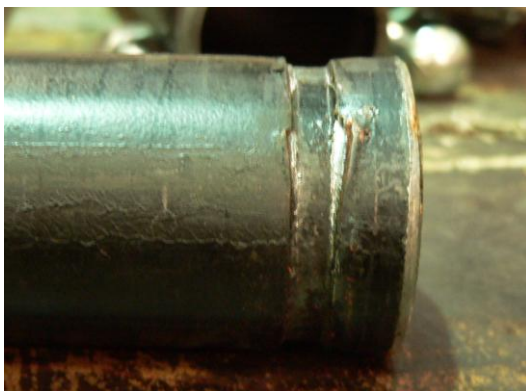
Groove of pipe wore away

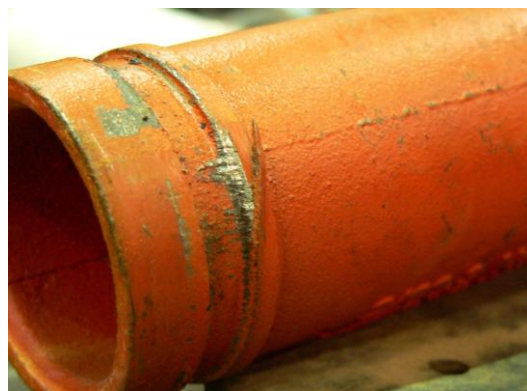
Groove of tee joint wore away

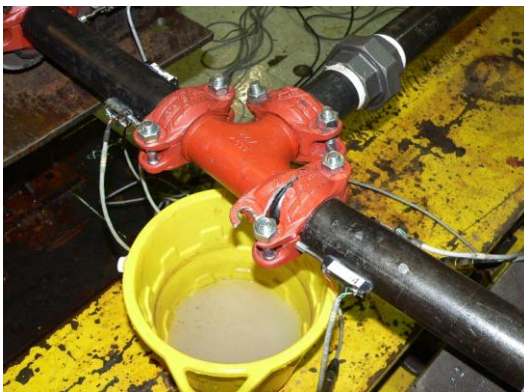
Flange coupling fractured

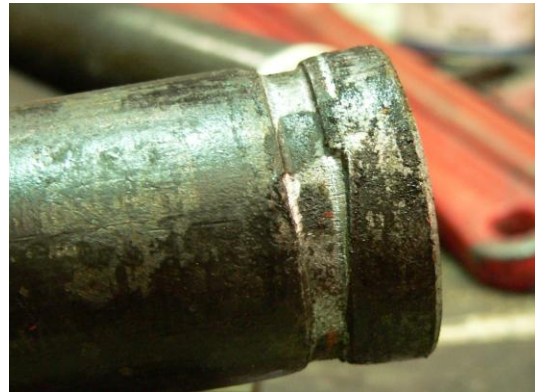
Groove of pipe wore away

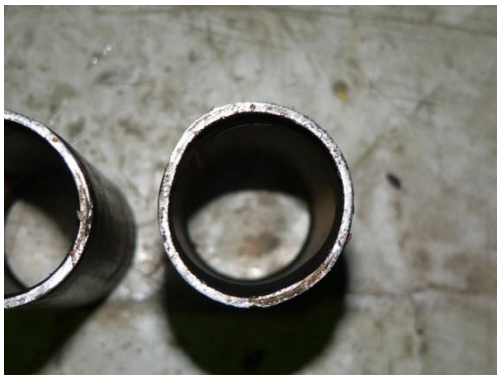
Cross section of pipe yielded and deformed

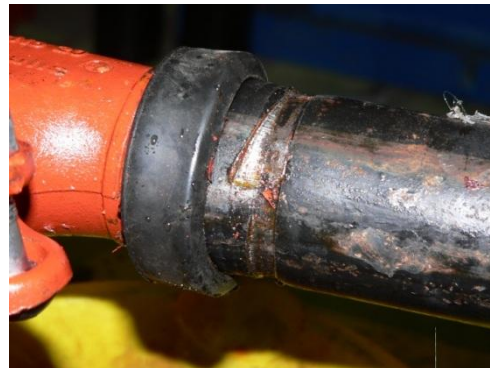
Groove of pipe wore away

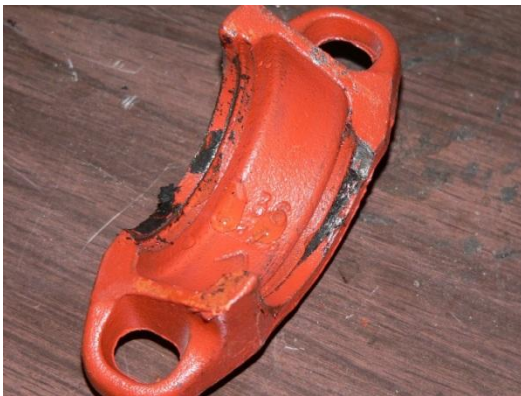
Coupling flange fractured

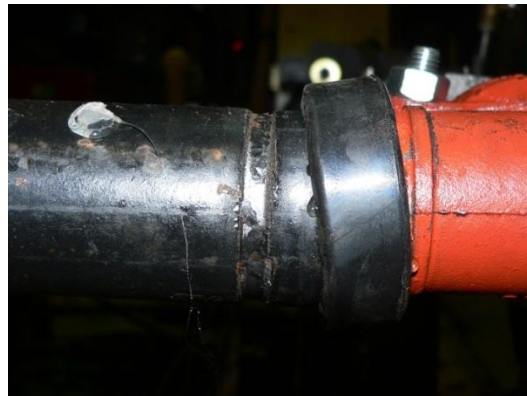
Groove of pipe wore away

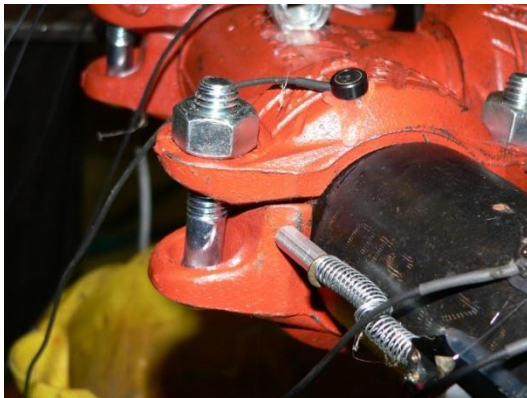
Gap generated between flange couplings

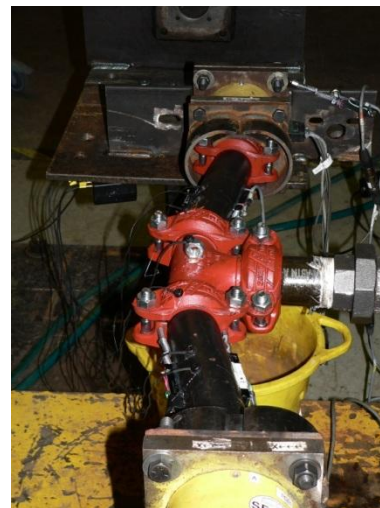
Pipe end bent due to imposed rotation

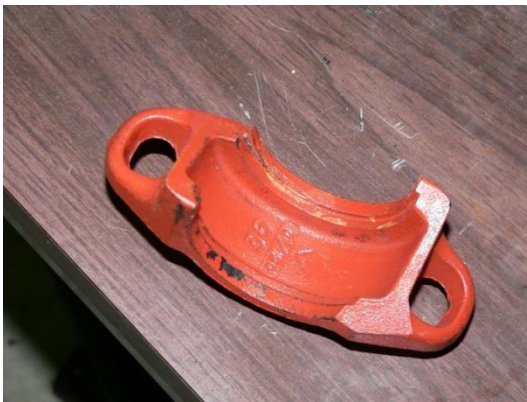
Flange coupling fractured

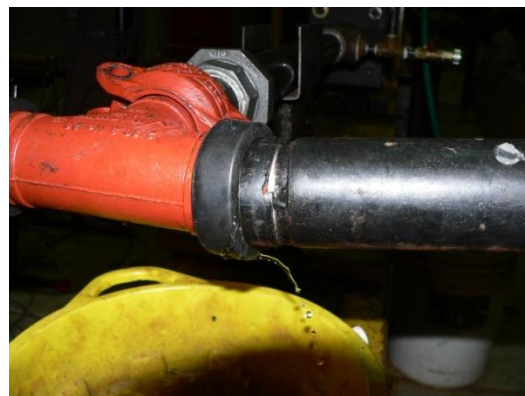
Groove of pipe wore away
