Fleet management of rural timber bridges

Major: Civil Engineering (Structural Engineering)

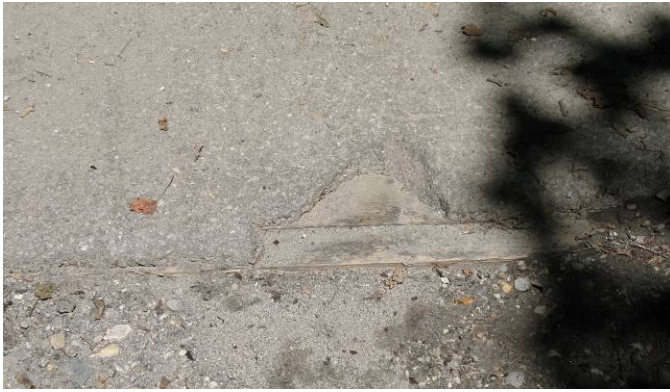
According to the NC-DOT 2005 report, scattered transverse cracks were present at the floor board seems. Though determined to be relatively minor, these cracks were verified by the ISU team during testing in 2006. The asphalt pavement generally looked to be in good condition, however at the transition between the gravel approach and the bridge wearing surface at the west end of the bridge the asphalt was chipping away and revealed the timber decking beneath (see Figure 13). Besides this local case, the transition between the roadway and asphalt does not appear to be problematic for the bridge. An uneven transition could subject the bridge to unnecessary effects from dynamic loads even though slow vehicle speeds on this roadway make this unlikely. In addition, a significant amount of debris had collected on top of the bridge hindering drainage and promoting seepage through the wearing surface to the decking and superstructure.

Figure 13. Pavement Chipping at West End

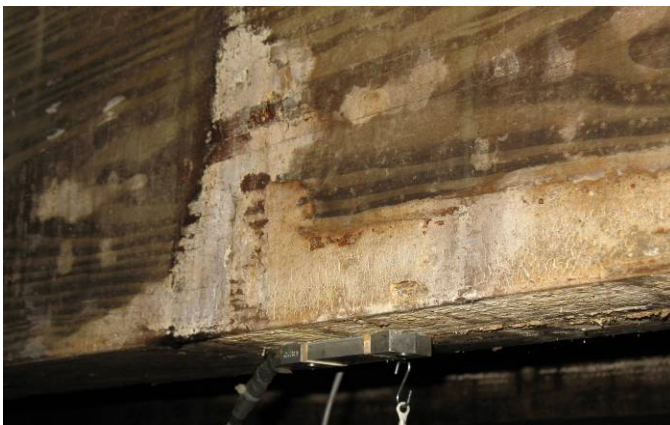
The interface between the deck and the girders was wetter than other areas of the girders. Seepage through the wearing surface was soaking into at least the girder surface at this location, and most of the girders showed signs of water seepage and staining throughout. White residue has also formed on the faces of many of the girders and is assumed to be biotic growth from high moisture conditions. The residue does not appear to permeate the girder, however. Figure 14 shows a typical example of white residue.

Figure 14. Biotic Growth on Girders

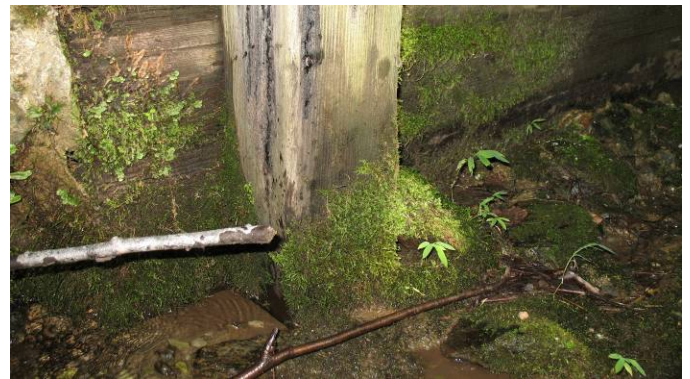
The overall structure is in satisfactory condition and structurally the bridge is sound. No odor like anise or wintergreen signifying fungal growth was present. There was no evidence of insect, mechanical, or ultraviolet degradation. Minor issues of concern besides those already stated include the presence of filtering at the abutments where various locations on the sill and backwalls were very wet. Moss growth was prevalent at the water line at the bottom of the northeast substructure posts (see Figure 15). There were minor checks in the parapet and parapet curb.

Figure 15. Moss Growth at Base of Substructure Posts

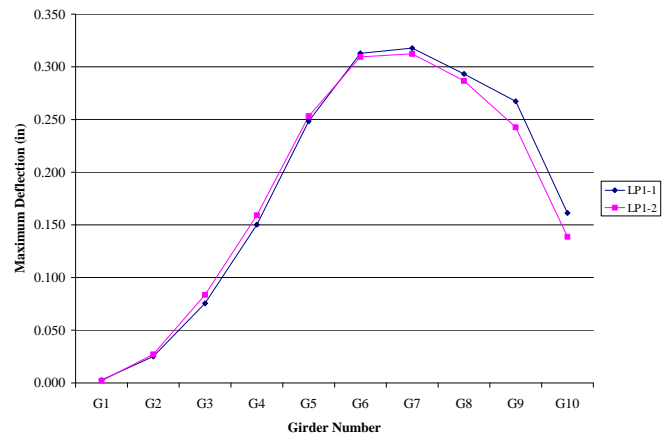
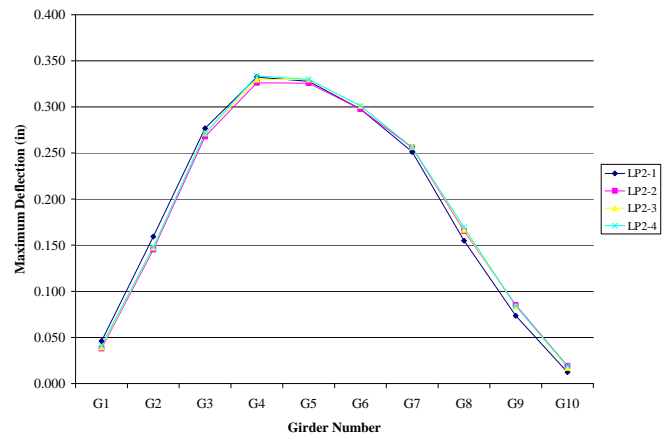
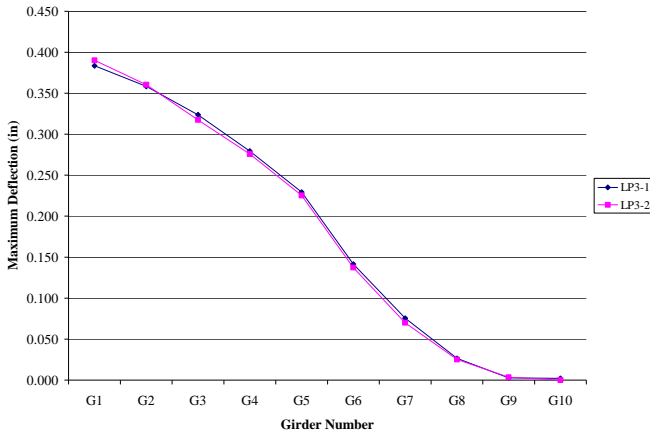
The minimum n -value of the three load paths is 177. This value is less than the minimum recommended value for timber girders. In fact, all of the n -values are below the recommended n -values stated in Table 3. The possible reasons for deflections greater than those recommended will be discussed later.

The deflection of the girders in and of itself does not exceed the deflection that would critically affect strength because timber strength is not critically affected until deflections become excessive. However, the girder deflections do exceed the values necessary to meet recommended limit states for live load deflection derived primarily from wearing surface degradation and maintainability.

Exceeding the live load deflection recommendations can have adverse affects on, but not limited to, the structure fasteners, wearing surface, and aesthetics. Mechanical fasteners such as bolts or nails could become loose or even fail if excessive girder deflections exist. Aesthetically, failed fasteners and wearing surface cracking produces a displeasing sight and perception of an unsafe bridge.

Through visual inspection, transverse cracks in the wearing surface were found. Deflections exceeding the recommended live load limit state would suggest that the wearing surface may show transverse cracking. The wearing surface of this particular bridge is in satisfactory condition, though close attention should be paid to the existing transverse cracks and the effects thereof.

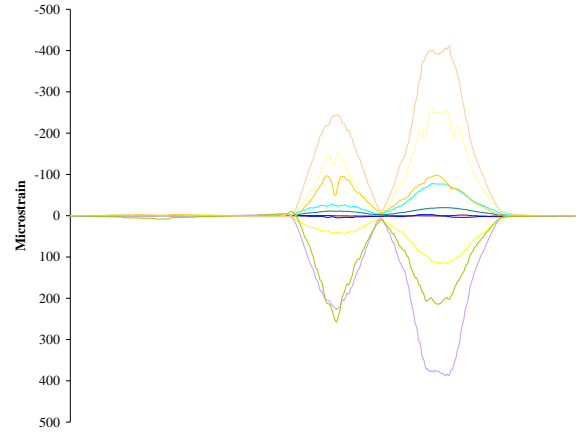
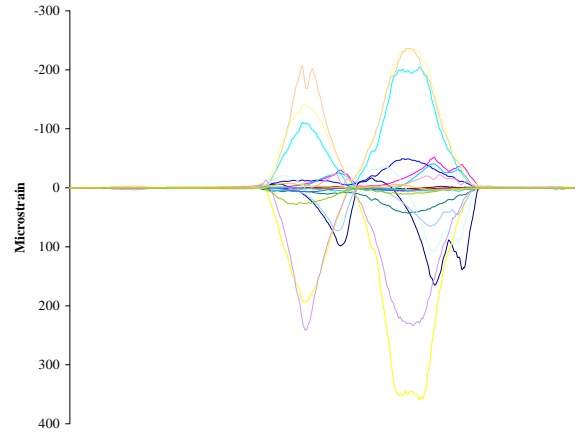
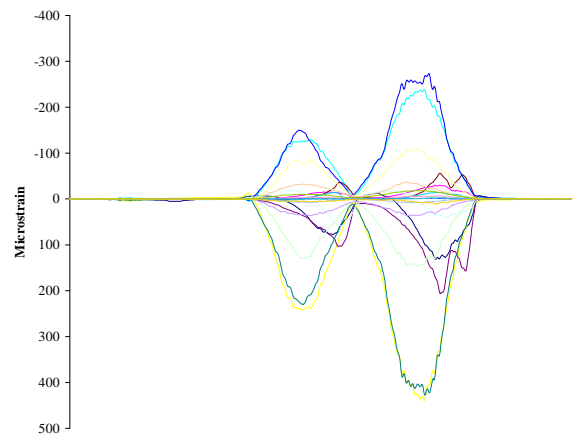
Figures 27 through 29 also illustrate the proportion about the neutral axis at midspan. The proportional pattern of the data signifies that there is very little if any composite action with the deck, i.e., the girders act independently of the deck when subjected to bending.

Strain data for timber bridges should be considered supplementary as the intrinsic properties of wood limits their use for primary analysis. Nevertheless, Figures 27 through 29 do show a reasonable relationship between the truck position and strain pattern. Assuming that the maximum values of compressive and tensile strain are in fact correct, the maximum compressive and tensile stresses can be obtained. The maximum overall compressive and tensile strains obtained from the three load paths are 403 and 437 microstrain, respectively. These strains equate to maximum stresses of 463 and 503 psi, respectively. If the strains are normalized to the AASHTO tandem load design, stresses of 736 and 798 psi are obtained. Allowable stress design limits the total compressive and tensile stresses anywhere from 1150 to 1750 psi depending on the wood grade and moisture content. Therefore it appears that allowable stresses are not exceeded by standard load trucks.

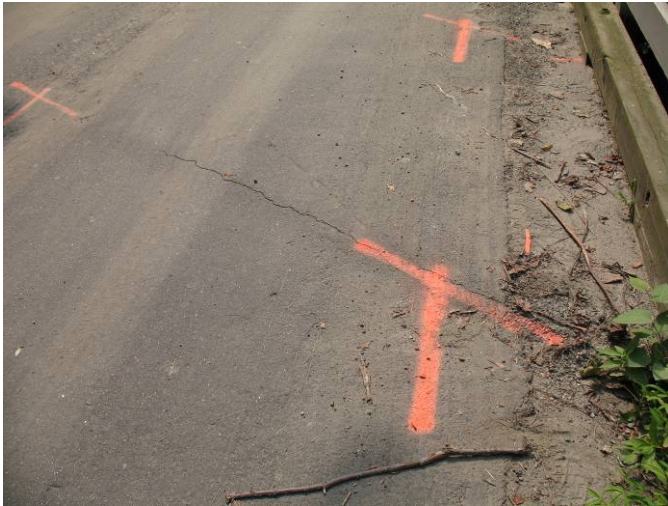
Figure 43. Transition Between Roadway and Bridge

Several transverse cracks were observed throughout the bridge wearing surface. These cracks aligned with the transverse floor boards (see Figure 13). Aside from the cracks, the wearing surface appeared to be in good condition. At the transitions between the roadway and the bridge, however, larger cracks have formed that mirror the abutment backwalls which leaves the bridge vulnerable to filtering at the abutments (see Figure 43). Imminent decay is not likely, though these cracks could be cause for concern in the future

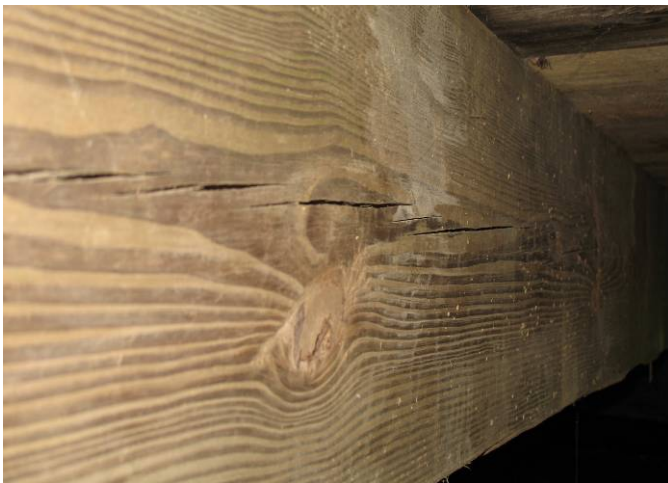
Figure 44. Checking at Centerline of Girder

The superstructure appeared to be well protected from moisture as only very minor water staining was observed. The most note worthy observation was the checking found along the centerline of several girders. This checking is seen in Figure 44 and Figure 45. Though the checking appeared to be minor, the condition should be watched with future inspections. The girder bearing on the sill was sufficient and there is no misalignment.

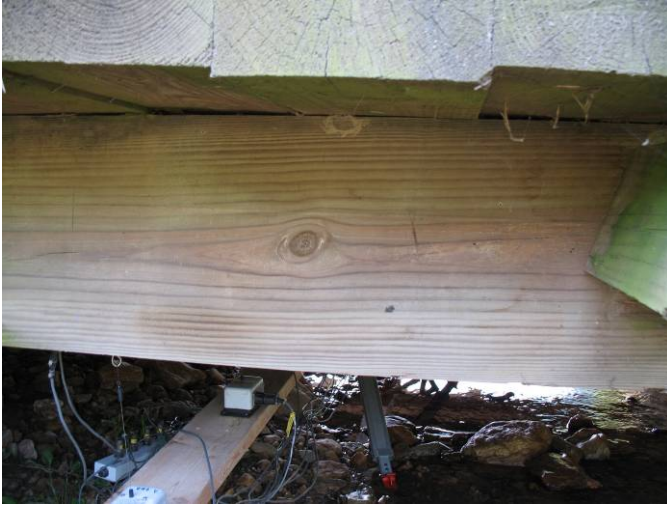
Figure 73. Deck Board Detachment

Overall, the deck appeared to be in good condition. The deck boards were securely fastened to the girders except at the outermost girders where some detachment has occurred (see

Figure 73). Minor water staining from seepage through the wearing surface was present throughout and white residue was present in a number of locations, though there were no signs of imminent decay.

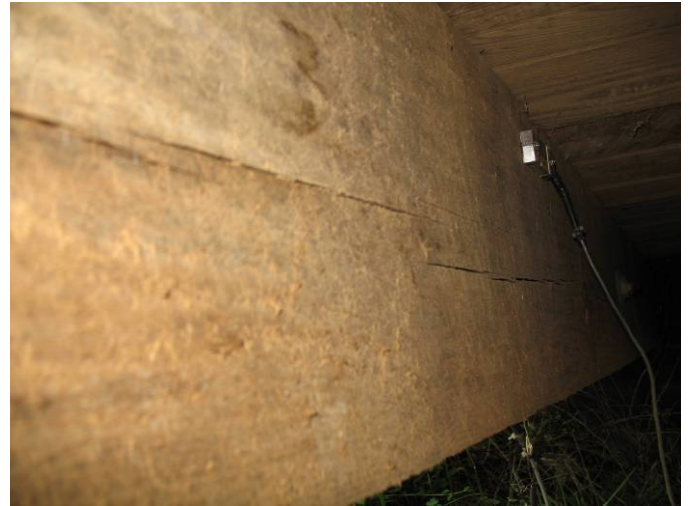
Figure 74. Observed Checking in Girders

A number of checks were observed at or near the centerline of the girders throughout the bridge superstructure. These checks are not detrimental to the structural integrity of the bridge in the current state. Advances in degradation may present future problems at these locations, however. Considering the age of the bridge these checks are not thought to be abnormal. Figure 74 shows an example of observed checks. The girder bearing on the sill was sufficient and there is no misalignment.

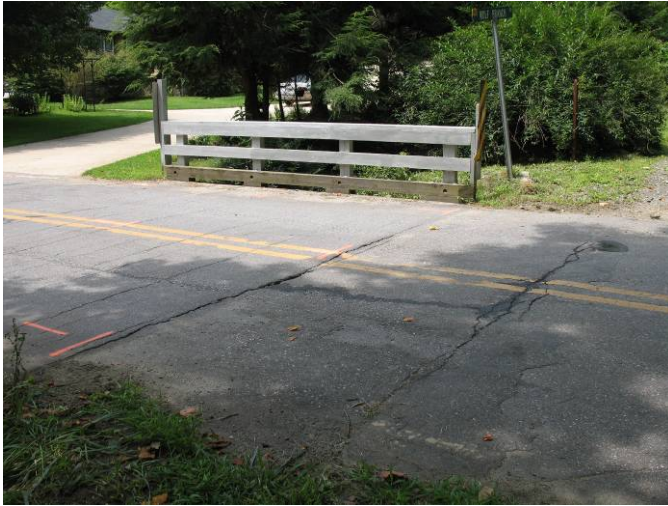
Figure 108. Transverse Cracks at Bridge Approach

At the transition between the roadway and the bridge and at approximately 5 ft before the bridge, large cracks have formed (see Figure 108). An uneven transition could subject the

bridge to unnecessary effects from dynamic loads even though slow vehicle speeds on this roadway make this unlikely.

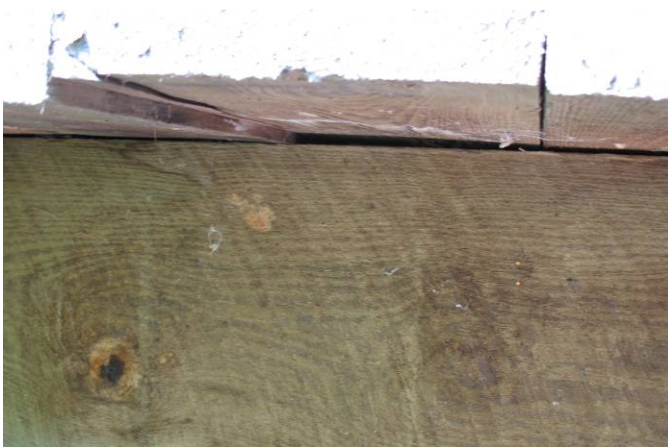
Figure 109. Deck Board Detachment

The deck appeared to be in overall good condition yet some detachment and warping was evident at the ends of the deck boards. Even so, all deck boards appeared securely fastened. Figure 109 shows this detachment. Minor water staining from seepage through the wearing surface was present throughout, though there were no signs of imminent decay.

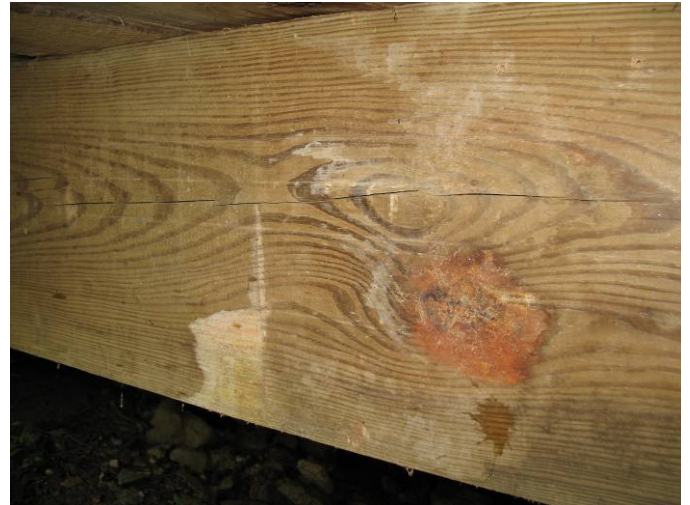
Figure 110. Checking at Girder Centerline

It was noted in the NC-DOT 2004 report that the bridge superstructure was recently rehabilitated. This was evident to the ISU research team. The superstructure appeared in overall good condition though some very minor areas of water seepage were observed. A more notable issue is the checking seen in some of the bridge girders, though the checks are not con-

sidered severe. This checking typically was along the centerline of the girder and a typical case is shown in Figure 110. The girder bearing on the sill was sufficient and there is no misalignment.

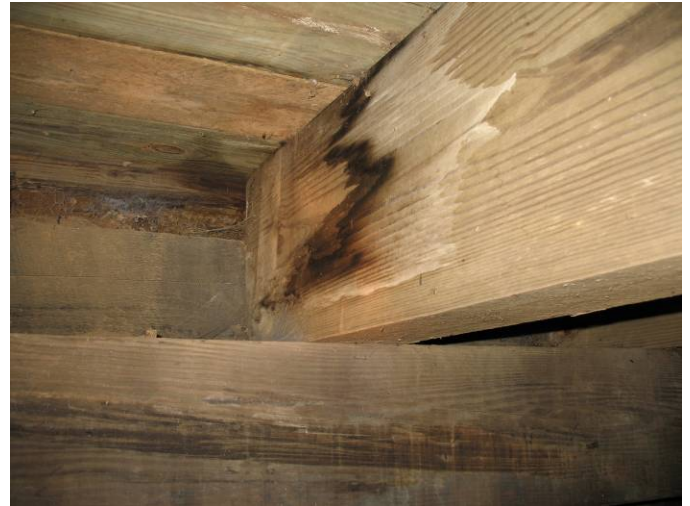
Figure 138. Girder End Conditions

In the NC-DOT 2005 report, the only decay noted was some scattered light decay in the bulkhead timbers. This decay was verified by the ISU team during testing in 2006. Seepage through the wearing surface was permeating at least the girder surface at a number of locations as most of the girders showed signs of water seepage and staining throughout. Water staining appeared to be more of a problem at several girder ends. This could be the result of larger transverse cracks at the approach transition. Typical girder end conditions are shown in Figure 14

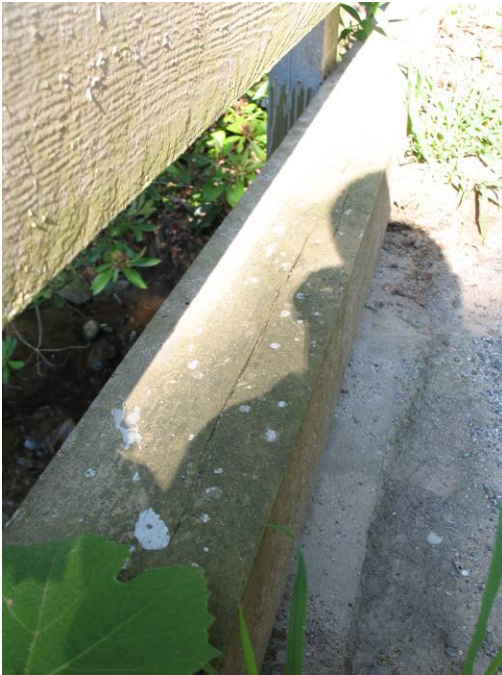
Figure 140. Parapet Condition

The overall structure is in satisfactory condition and structurally the bridge is sound. No odor like anise or wintergreen signifying fungal growth was present. There was no evidence of insect, mechanical, or ultraviolet degradation. Minor issues of concern include the presence of filtering at the abutments where various locations on the sill and backwalls were very wet. There were minor checks in the parapet and parapet curb.

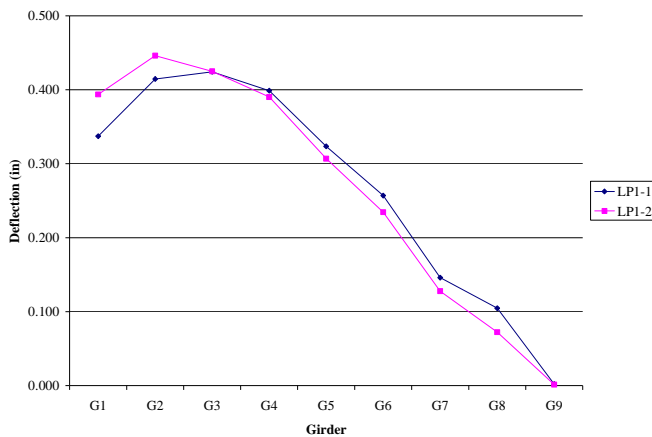
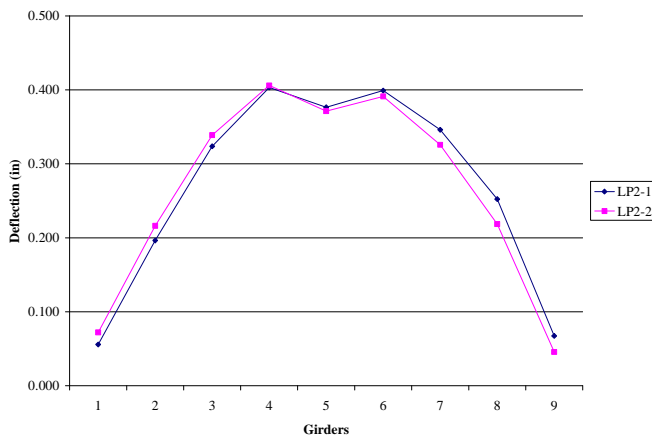
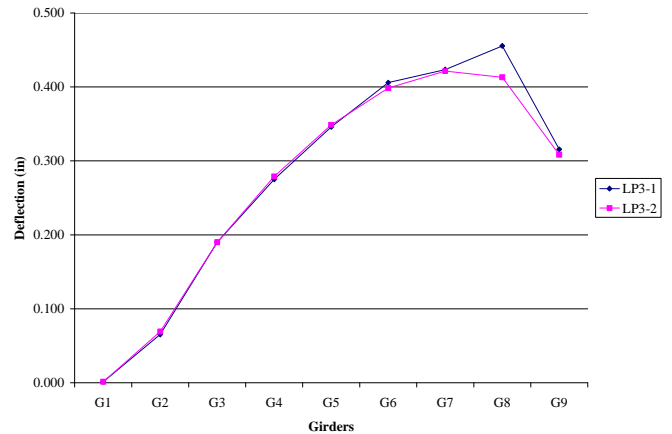
The minimum n-value of the three load paths is 316. This value is less than the minimum recommended value for timber girders. In fact, all of the n-values are below the recommended n-values stated in Table 3. The possible reasons for deflections greater than those recommended will be discussed later.

The deflection of the girders in and of itself does not exceed the deflection that would critically affect strength because timber strength is not critically affected until deflections become excessive. However, the girder deflections do exceed the values necessary to meet recommended limit states for live load deflection derived primarily from wearing surface degradation and maintainability.

Through visual inspection, transverse cracks in the wearing surface were found. Deflections exceeding the recommended live load limit state would suggest that the wearing surface may show transverse cracking. The wearing surface of this particular bridge is in satisfactory condition, though close attention should be paid to the existing transverse cracks and the effects thereof.

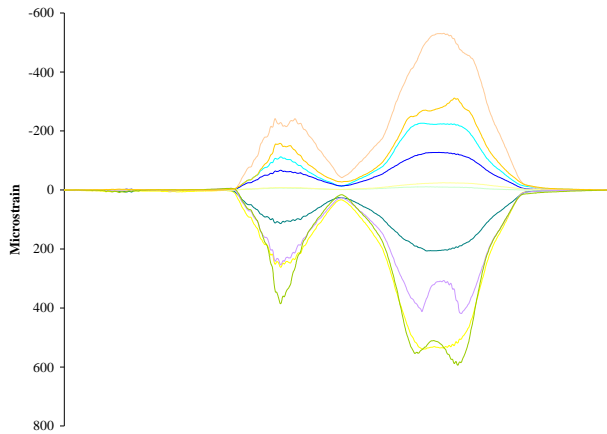
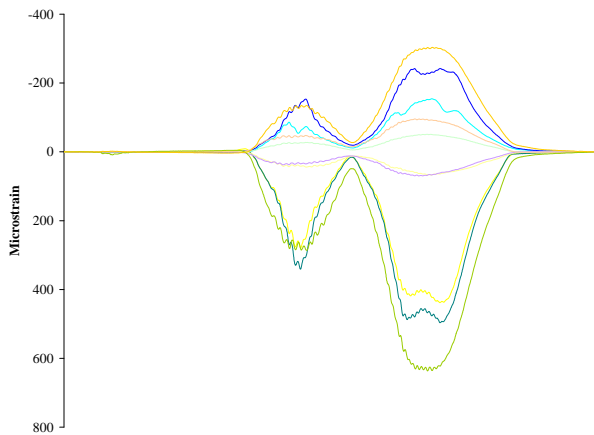
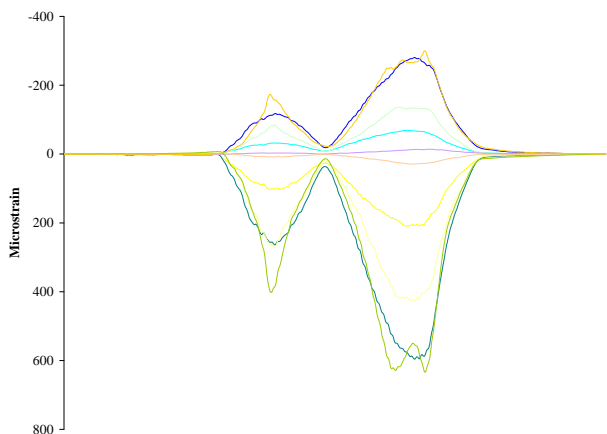
Maximum stresses are determined using the maximum strain values and an estimated modulus of elasticity of the girder. Maximum strain achieved in the girders was at midspan with compression and tensile strains of 530 and 636 microstrain, respectively. The strain plot at midspan is shown in Figures 28 through 30 for load paths 1, 2, and 3, respectively. The compressive strains, or negative strains, constitute the top portion of the graph and the tensile strains, or positive strains, constitute the bottom portion of the graph. It is assumed that all girders remain linearly elastic during loading, therefore a direct relationship exists between stress and strain and the estimated modulus of elasticity can be used to determine the stress. The resulting stresses are discussed in the following section.

Figures 28 through 30 also illustrate the proportion about the neutral axis at midspan. The proportional pattern of the data signifies that there is very little if any composite action with the deck, i.e., the girders act independently of the deck when subjected to bending.

Strain data for timber bridges should be considered supplementary as the intrinsic properties of wood limits their use for primary analysis. Nevertheless, Figures 28 through 30 do show a reasonable relationship between the truck position and strain pattern. Assuming that the maximum values of compressive and tensile strain are in fact correct, the maximum compressive and tensile stresses can be obtained. The maximum overall compressive and tensile strains obtained from the three load paths are 530 and 636 microstrain, respectively. These strains equate to maximum stresses of 610 and 731 psi, respectively. If the strains are normalized to the AASHTO tandem load design, stresses of 817 and 980 psi are obtained. Allowable stress design limits the total compressive and tensile stresses anywhere from 1150 to 1750 psi depending on the wood grade and moisture content. Therefore it appears that allowable stresses are not exceeded by standard load trucks.

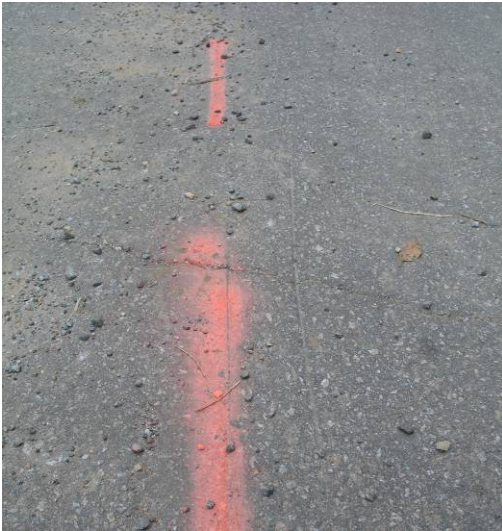
Figure 167. Minor Transverse Cracks

According to the NC-DOT 2005 report, the bridge had been recently rehabilitated. The wearing surface appeared to be in above average condition though several small scattered transverse cracks were present at the floor board seems (see Figure 13). Though determined to be relatively minor, these cracks were noted by the ISU team during testing in 2006. Besides this local case, the transition between the roadway and asphalt does not appear to be problematic for the bridge. An uneven transition could subject the bridge to unnecessary effects from dynamic loads even though slow vehicle speeds on this roadway make this unlikely. In addition, some debris had collected on top of the bridge which could hinder drainage and promote seepage through the wearing surface to the decking and superstructure.

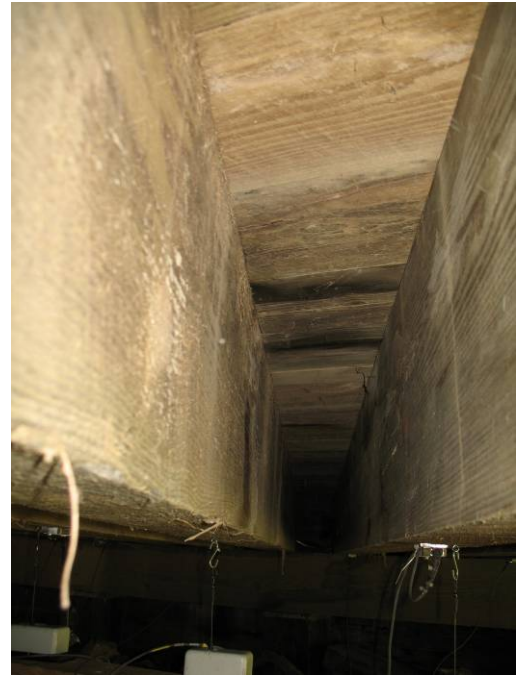
Figure 168. Typical Superstructure Condition

It is evident that the bridge had been recently rehabilitated as the superstructure appeared in excellent condition. Minimal evidence of moisture was present throughout the girders, though some moss growth was observed on the north face of girder number 1. Figure 168 shows the typical condition of the superstructure.

The girder bearing on the sill was sufficient and there is no misalignment. The only noticeable degradation is some minor checking throughout the girders

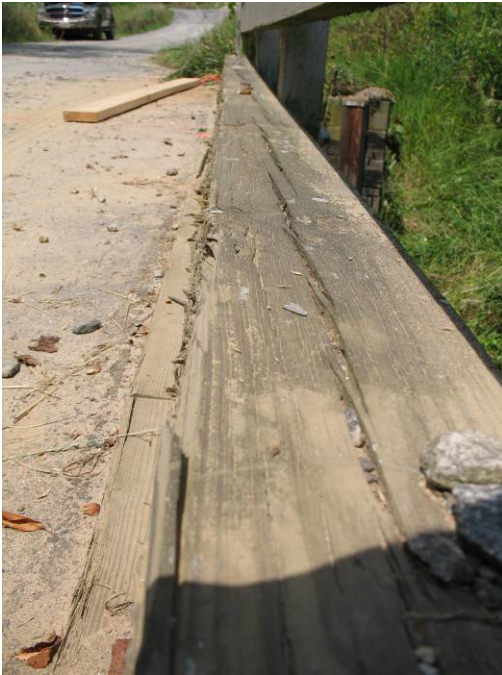
Figure 169. Advanced Degradation throughout Curbs

The overall structure is in good condition and structurally the bridge is sound. No odor like anise or wintergreen signifying fungal growth was present. There was no evidence of insect, mechanical, or ultraviolet degradation. A minor issue of concern besides those already stated includes some collection of debris between the sill and girders at the abutment which appears to be the result of nesting birds or other animals. This could be an area where water retention is higher promoting degradation. Also, though the curbs are not structural members, advanced degradation was observed and should be noted (see Figure 15).

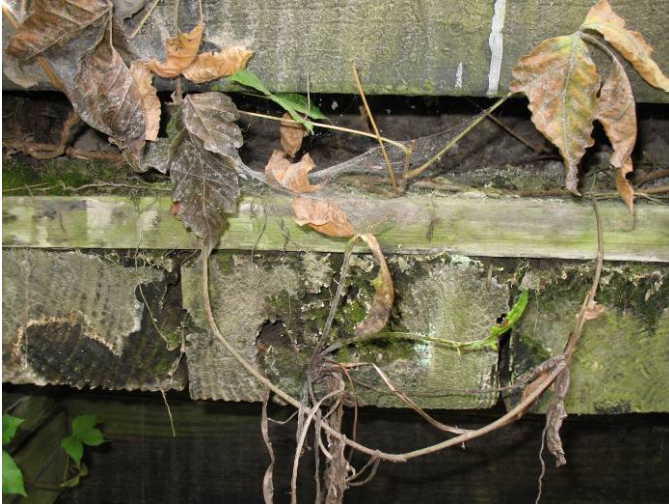
According to the NC-DOT 2003 report, moderate decay in the ends of several deck boards (see Figure 196) and scattered fungus on the underside of the deck was present. These remarks were verified by the ISU team in 2006. Much of the deck was covered with fungal growth and was considerably wet throughout in comparison with other observed bridges of the same type in North Carolina.

Figure 196. Decay in the Ends of the Deck Boards Superstructure

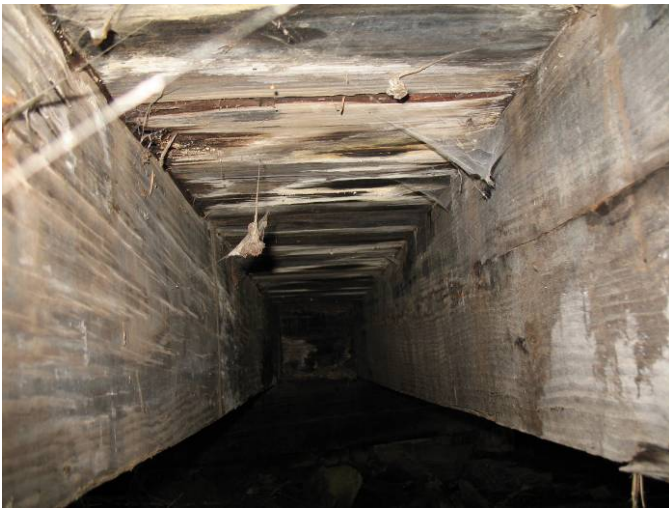
NC-DOT 2003 notes fungus staining over sections of several girders primarily on the top and ends of the girders. At these locations the girders sounded dull, were soft, and light to moderate decay was noted. No crushing, bulging, or signs of failure were observed, however. In addition to the previous remarks, the ISU team noted what appeared to be some mechanical damage possibly done by stream debris and a number of checks in the girders. Figure 197 through Figure 200 show the condition of the superstructure. The bearing of the girders on the sill was sufficient and there is no misalignment.

Figure 197. Girder and Deck Condition

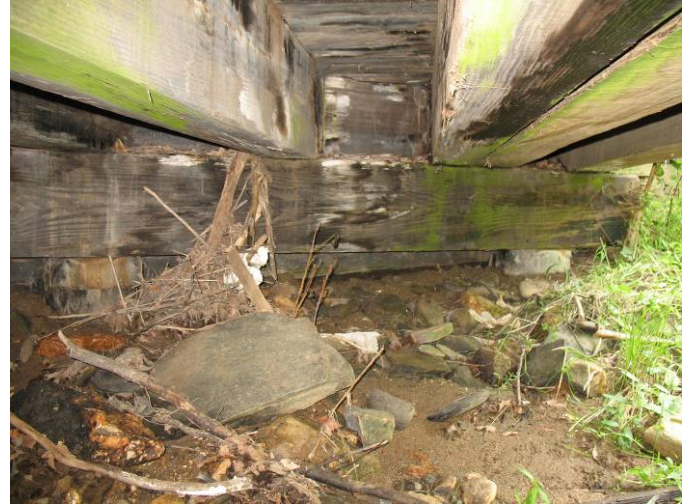
Figure 198. Fungal Growth throughout Superstructure

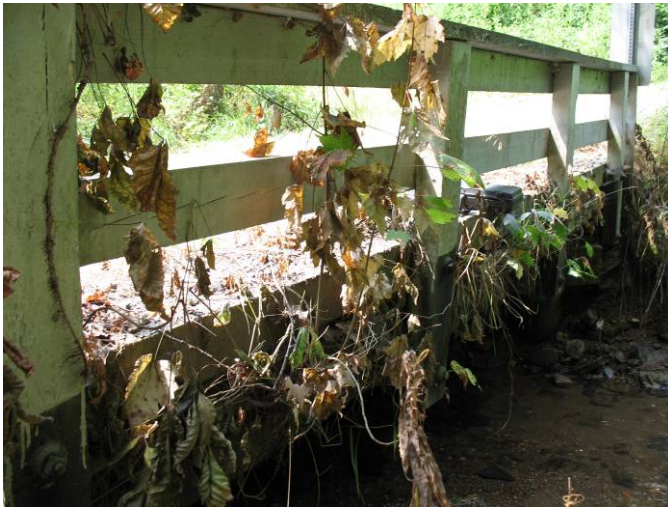
The overall structure is in a state of advanced degradation. Fungal growth and wood decay is scattered throughout and environmental conditions promote the advancement of each. A plus, however, was that there was no evidence of insect or ultraviolet degradation. Issues of concern besides those already stated in previous sections include the presence of filtering at the abutments where various locations on the sill and backwalls were very wet and considerable overgrowth of the surrounding foliage was observed (see Figure 201). There were minor checks in the parapet and parapet curb.

Figure 201. Foliage Overgrowth

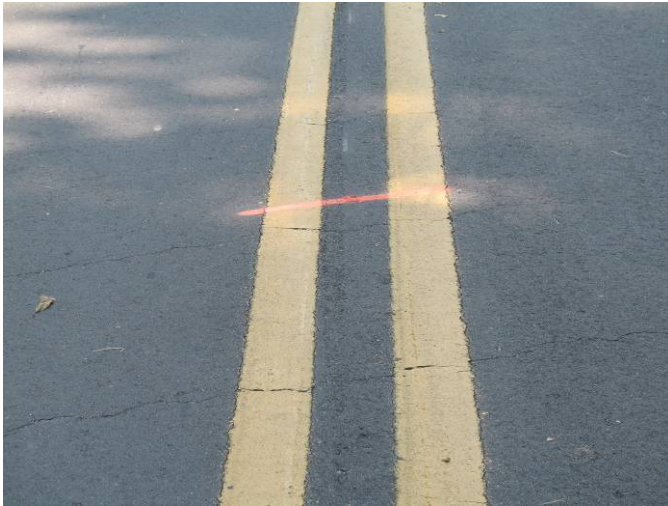
According to the NC-DOT 2004 report, the wearing surface was cracked along several deck timbers. Some transverse cracking was observed by the ISU research team during testing in 2006. Though considered minor, the presence of cracks was verified and they are shown in Figure 228. The asphalt pavement generally looked to be in good condition aside from the transverse cracking.

Figure 228. Observed Transverse Cracks

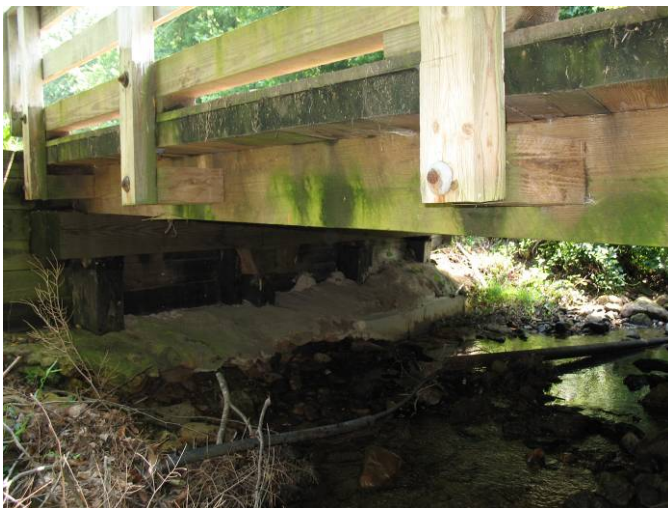
The girders appeared in good condition. It was apparent that the girders are well protected from weathering conditions. Even so, some moss growth was observed on north face of girder 19. This growth does not look to permeate the past the girder face (see Figure 229). Very minor checking was present near the centerline of some girders it appears that some mechanical damage was done to the girders on the upstream side possibly the result of high water debris. The girder bearing on the sill was sufficient and there is no misalignment.

Figure 229. Moss Growth on Girder 19

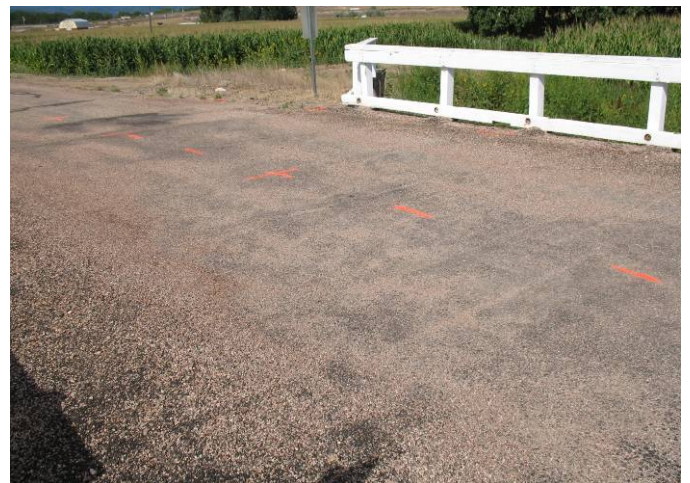
Transverse cracking in the wearing surface in line with the transverse deck boards beneath was observed by the ISU research team. Crack formation started at the transition between the roadway and the bridge and these cracks could pose future problems if not monitored and repaired. An uneven transition could subject the bridge to unnecessary effects from dynamic loads which can be magnified by higher vehicle speeds on this roadway. Figure 257 shows some of the cracking observed.

Aside from the transverse cracking, the wearing surface looked to be in satisfactory condition, though much of the bridge wearing surface is uneven.

Figure 257. Transverse Wearing Surface Cracking

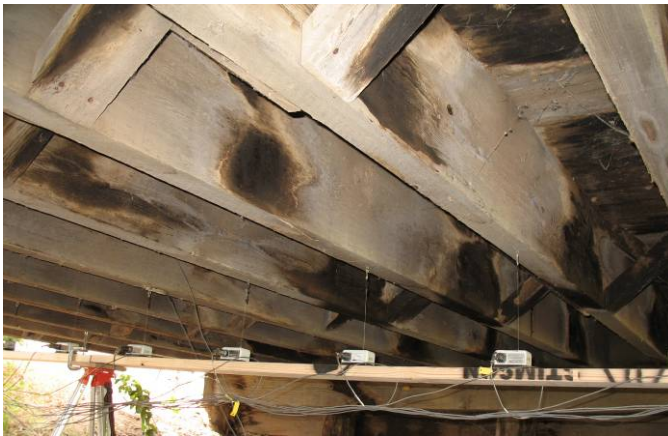
The girders appear in good condition yet some minor degradation was present throughout. The exterior girders were in poorer condition than the rest, presumably a result of more exposure to weathering conditions. Even so, the condition is not cause for concern. These girders should be monitored closely with future inspections because if checking becomes severe, degradation effects can be accelerated further and the structural integrity of the girder could be compromised. Figure 258 shows the general superstructure condition, while Figure 259 shows the exterior girder condition.

Figure 258. General Superstructure Condition

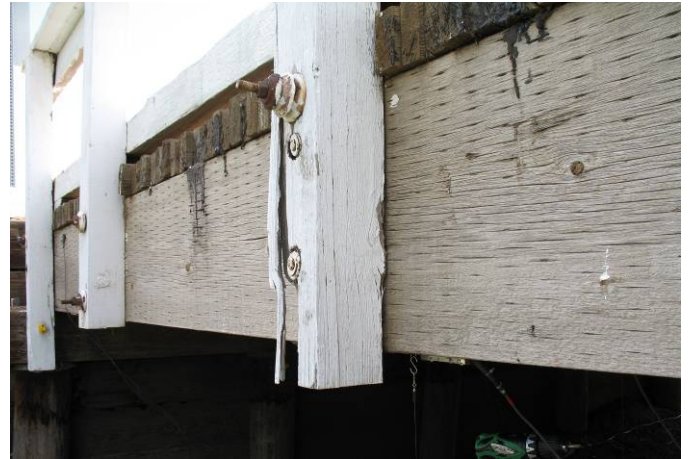
Figure 259. Exterior Girder Condition

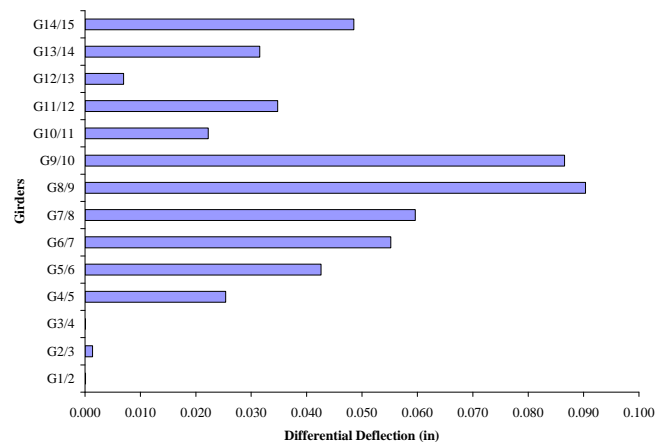
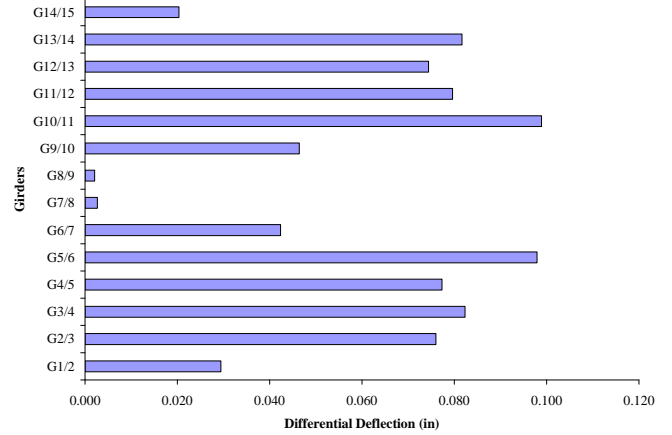
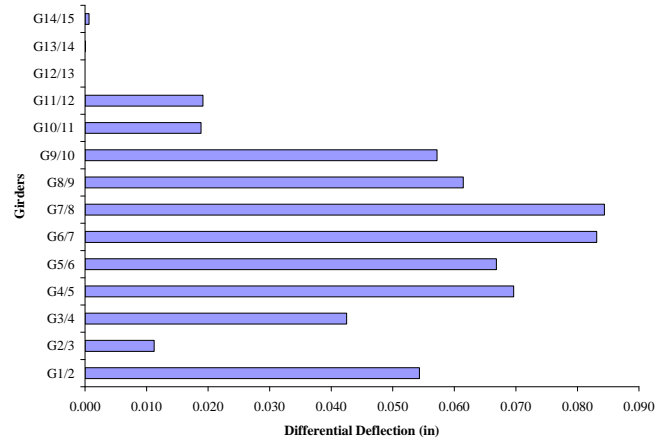
The maximum differential deflection of 0.099 in. occurs in load path 2 and this is nearly 25 percent of the maximum deflection for this load path and 0.054 in. per ft of girder spacing. This differential deflection may cause future problems with longitudinal cracking. The same is true for load paths 1 and 3 as the maximum differential deflections are both around 0.09 in. With larger differential deflections, the possibility exists that the load was not well distributed transversely between the adjacent girders or the assumption that both girders are of equal stiffness was false.

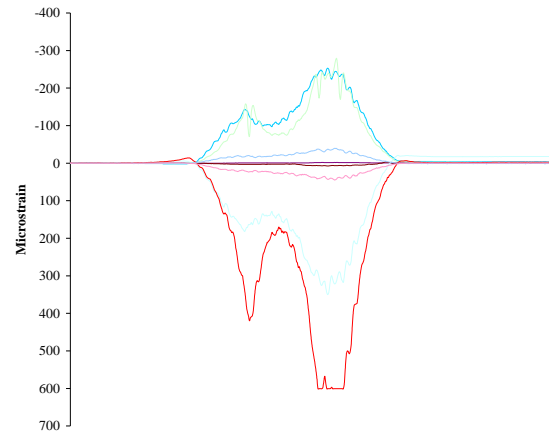
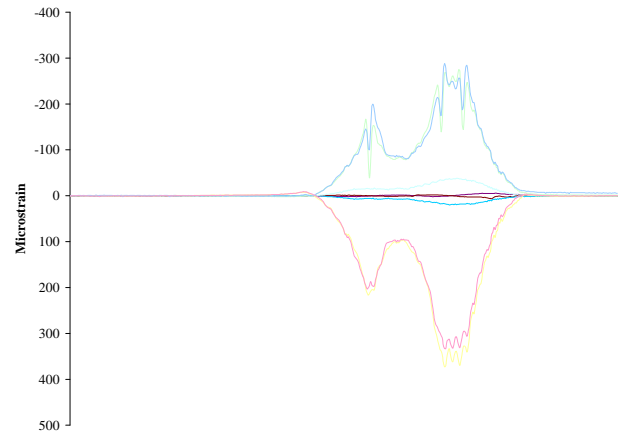
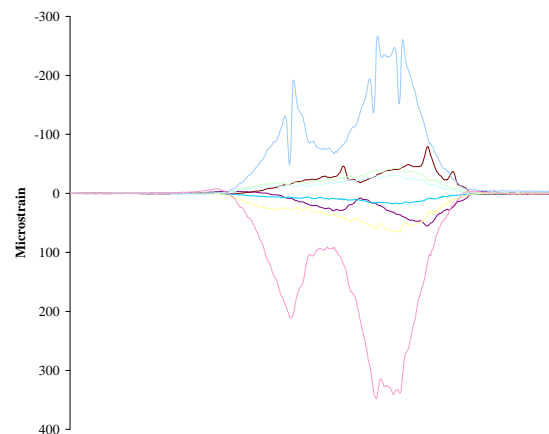
Maximum stresses are determined using the maximum strain values and an estimated modulus of elasticity of the girder. Maximum strain achieved in the girders was at midspan with compression and tensile strains of 288 and 601 microstrain, respectively. The strain plot at midspan is shown in Figures 26 through 28 for load paths 1, 2, and 3, respectively. The compressive strains, or negative strains, constitute the top portion of the graph and the tensile strains, or positive strains, constitute the bottom portion of the graph. It is assumed that all girders remain linearly elastic during loading, therefore a direct relationship exists between stress and strain and the estimated modulus of elasticity can be used to determine the stress. The resulting stresses are discussed in the following section.

Figures 26 through 28 also illustrate the proportion about the neutral axis at midspan. The proportional pattern of the data signifies that there is very little if any composite action with the deck, i.e., the girders act independently of the deck when subjected to bending.

Strain data for timber bridges should be considered supplementary as the intrinsic properties of wood limits their use for primary analysis. Nevertheless, Figures 26 through 28 do show a reasonable relationship between the truck position and strain pattern. Assuming that the maximum values of compressive and tensile strain are in fact correct, the maximum compressive and tensile stresses can be obtained. The maximum overall compressive and tensile strains obtained from the three load paths are 288 and 601 microstrain, respectively. These strains equate to maximum stresses of 331 and 691 psi, respectively. If the strains are normalized to the AASHTO tandem load design, stresses of 438 and 914 psi are obtained. Allowable stress design limits the total compressive and tensile stresses anywhere from 1150 to 1750 psi depending on the wood grade and moisture content. Therefore it appears that allowable stresses are not exceeded by standard load trucks.

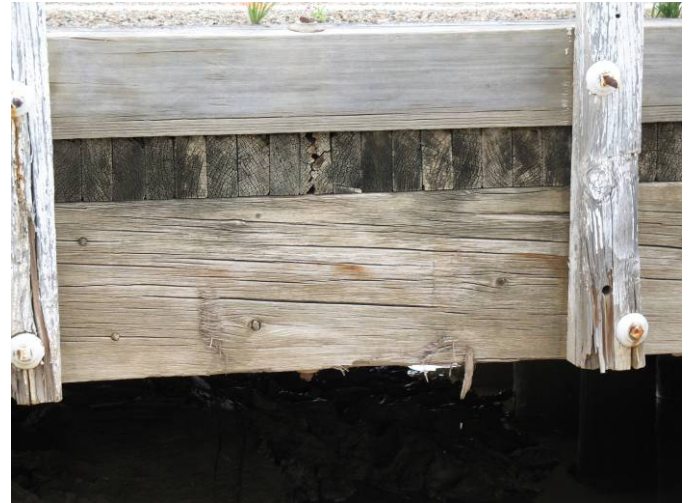
Figure 287. Checking in Exterior Girders

Moderate checking was present in most girders and the exterior girders were in worse condition than the rest, presumably a result of more exposure to weathering conditions. The checks in the exterior girders were deep in some locations and should be closely monitored with future inspections. If checking becomes severe, degradation effects can be accelerated further and the structural integrity of the girder could be compromised. Figure 258 shows the typical checking in the exterior girders. The girder bearing on the sill was sufficient and no misalignment was observed.

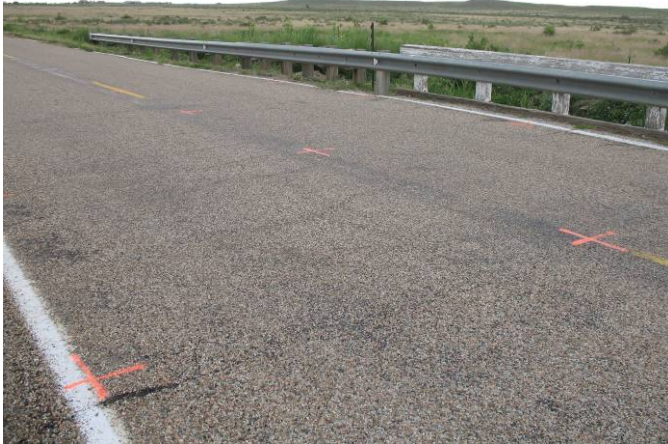
It would suggest that the wearing surface may show transverse cracking if deflections exceeded the recommended live load limit state. Even so, through visual inspection, transverse cracks in the wearing surface were found. The wearing surface of this particular bridge is in satisfactory condition, though close attention should be paid to the existing transverse cracks and the effects thereof.

Some transverse cracking in the wearing surface was observed. Even so, seepage through the wearing surface and into the deck boards and girders was not evident.

Some transverse cracking in the wearing surface reflecting the transverse deck boards beneath was observed by the ISU research team. Cracks have also formed at the transition between the roadway and the bridge and these cracks could pose future problems if not monitored and repaired. Moisture could seep through these cracks and advance degradation in the backwalls, girder ends, and substructure. Also, if the wearing surface becomes uneven at the transition, the bridge could be subjected to unnecessary effects from dynamic loads which can be magnified by higher vehicle speeds on this roadway. Figure 257 shows some of the cracking observed. Aside from the transverse cracking, the wearing surface looked to be in good condition.

Figure 314. Transverse Wearing Surface Cracking

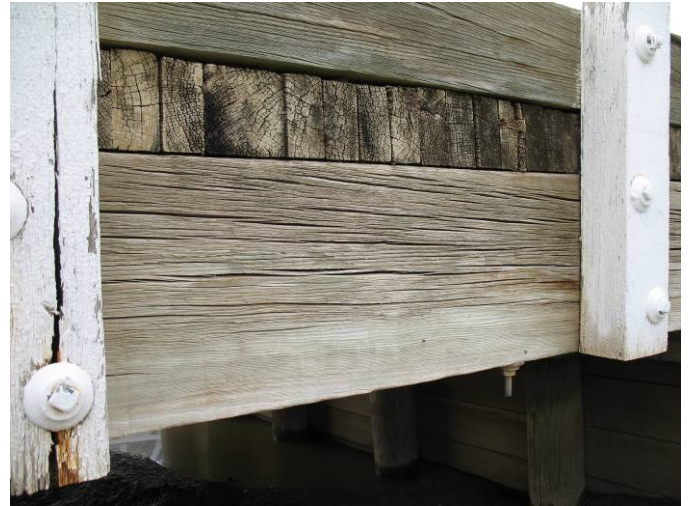
Slight checking was present in most girders and the exterior girders were in worse condition than the rest, presumably a result of more exposure to weathering conditions. The checks in the exterior girders were deep in some locations and should be closely monitored with future inspections. If checking becomes severe, degradation effects can be accelerated further and the structural integrity of the girder could be compromised. Figure 258 shows the typical checking in the exterior girders. The girder bearing on the sill was sufficient and no misalignment was observed.

Figure 315. Checking in Exterior Girders

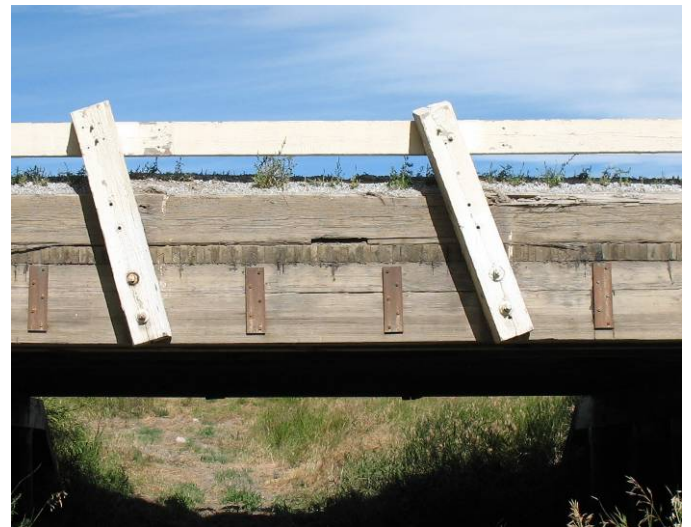
Figure 348. Wearing Surface Thickness

Overall, the wearing surface looked to be in good condition. No cracking was observed in the wearing surface as a new chip seal had just been laid upon the time of the ISU team visual inspection. The wearing surface did have a significant thickness of 15 in. which effectively reduced the parapet height and added a large amount of dead weight to the bridge structure. This is evident in Figure 257 as the wearing surface is shown above the curb.

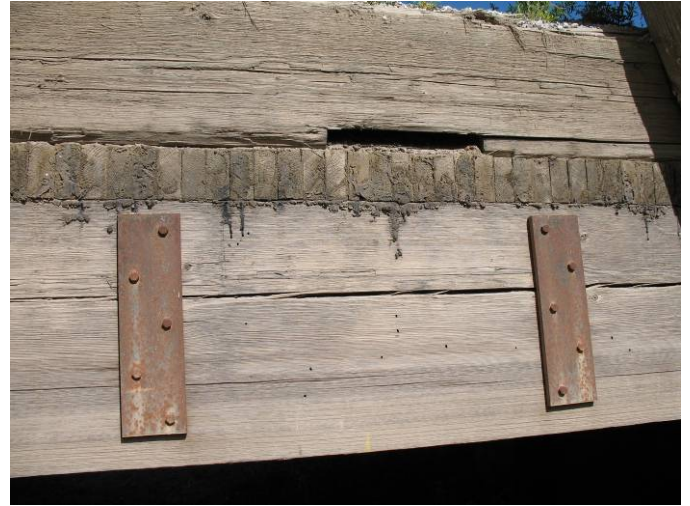
Figure 350. Checking in Exterior Girders

The interior girders looked in good condition; no visual degradation was observed. Conversely, the exterior girders were in worse condition presumably a result of more exposure to weathering conditions (see Figure 258). The checks in the exterior girders were deep in some locations and should be closely monitored with future inspections. If checking becomes severe, degradation effects can be accelerated further and the structural integrity of the girder could be compromised.

The girder bearing on the sill was sufficient and no misalignment was observed.

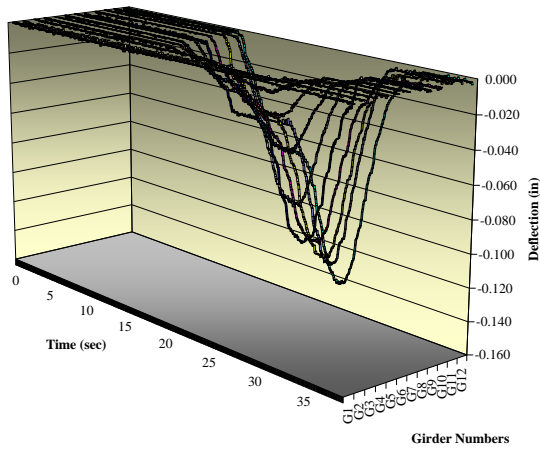
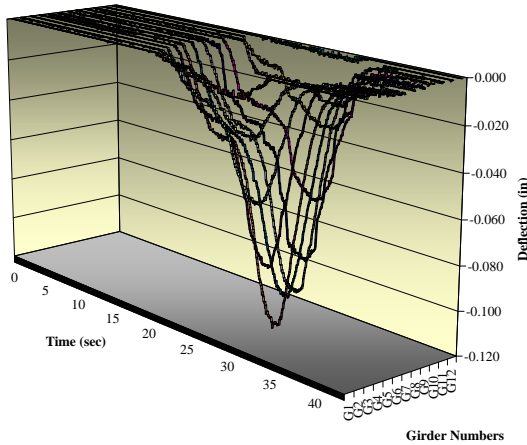
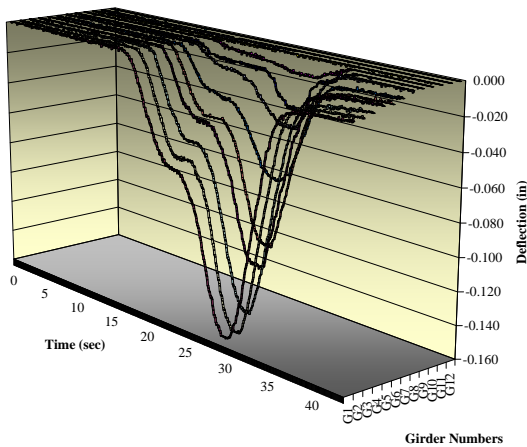
Figures 16 through 18 present the time-history deflections for each girder as the truck traveled across the bridge. Given the relationship of the length of the bridge to the length of the truck one would expect to see two waves of loading as the front axle and back axles traverse the bridge. This is opposed to the loading patterns of longer bridges where one wave is typically present as the entire truck is supported by the girders at the same time. Looking to the above mentioned figures this two wave relationship is quite evident and clearly the deflec-

tions represent the difference in load from the front axle to the back axles.
