Fleet management of rural timber bridges

Major: Civil Engineering (Structural Engineering)

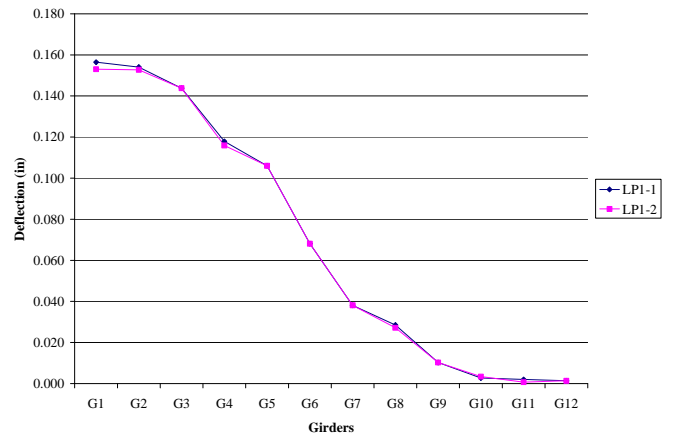
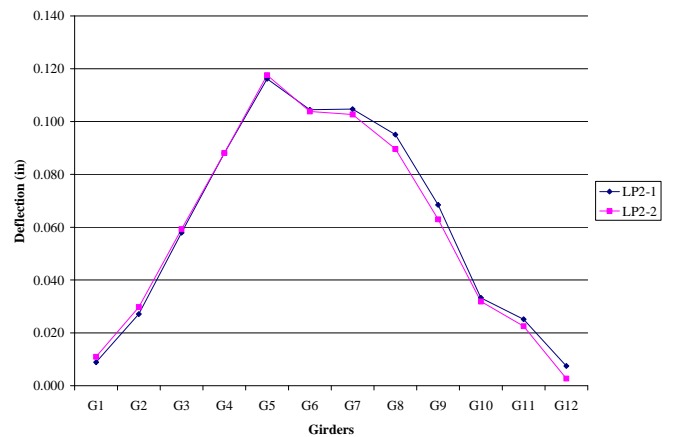
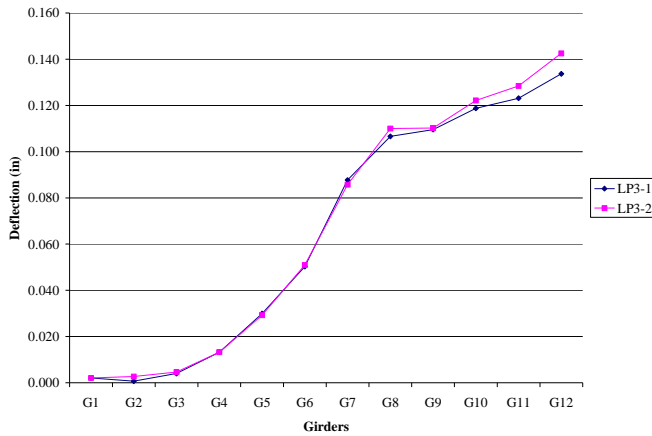
The maximum deflections achieved for each load path are presented in Table 1. Each passing of the three load paths is illustrated in Figures 18 through 20. One can notice the similar trend of the data for each passing of a particular load path. By achieving the same or near same deflections for each passing, one can be sure the deflection behavior of the girders is repeatable. Consequently, only one passing for each load path will be included in the results following this section.

Maximum Midspan Deflection For Each Passing (in.)		
Load Path 1	Load Path 2	Load Path 3
0.156	0.118	0.143

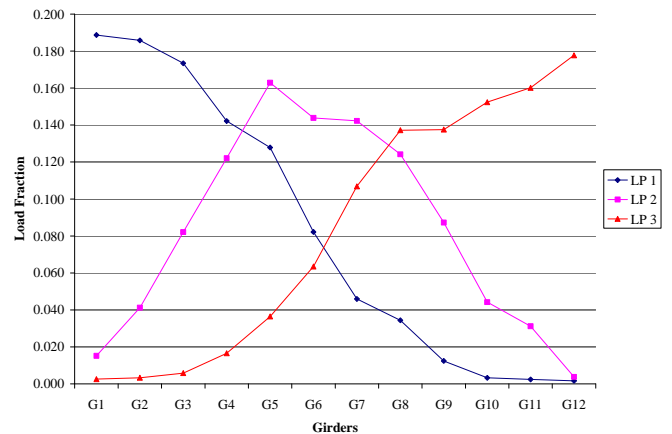
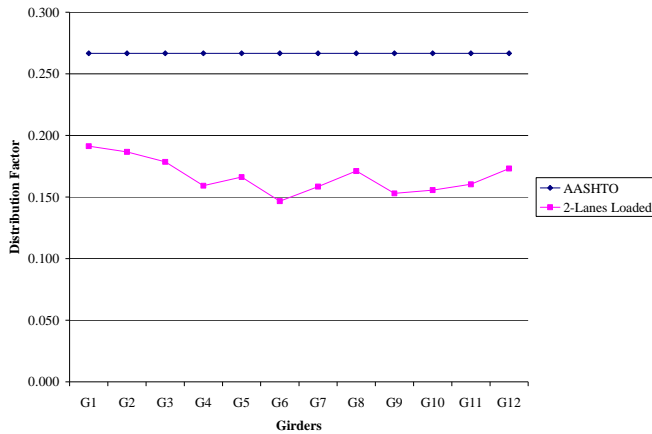
The design live load distribution factors for interior girders as prescribed by AASHTO for plank deck timber bridges is $S/6.7$

and $S/7.5$ for one design lane loaded and two or more design lanes loaded, respectively, and S is equal to the transverse spacing between adjacent girders. For this bridge, the exterior lane live load distribution factors were assumed equal to that of the interior lanes. Shown in Figure 23 is the comparison of design live load distribution values and actual live load distribution. Notice how the design live load distribution factors exceed all of the actual live load distribution factors.

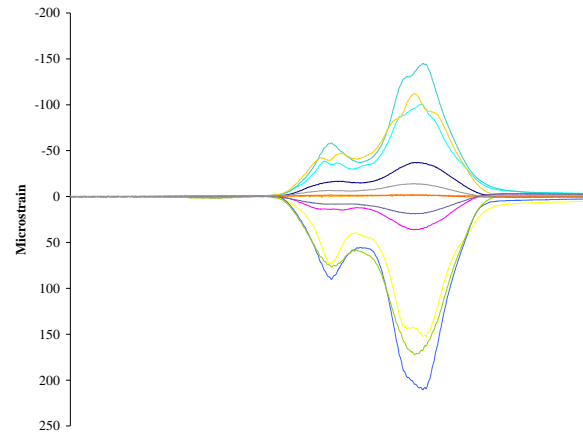
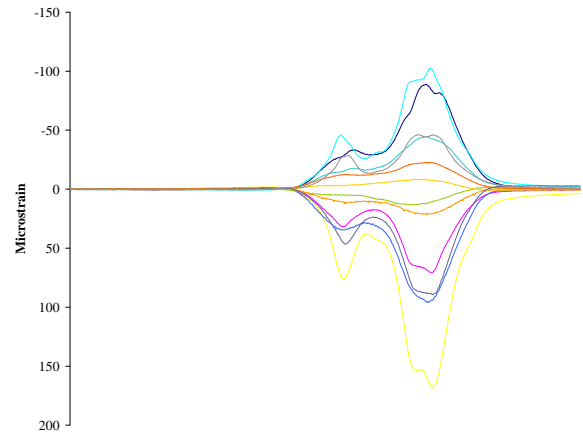
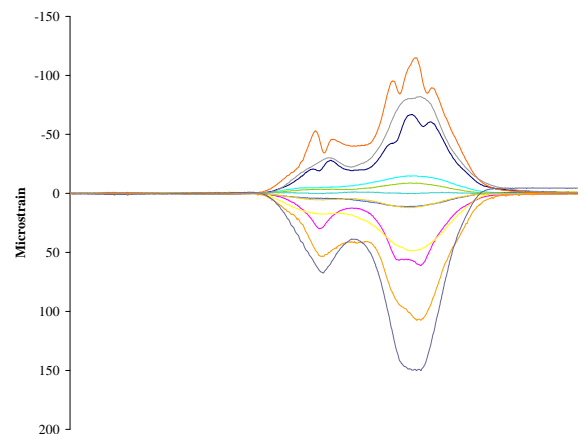
Maximum stresses are determined using the maximum strain values and an estimated modulus of elasticity of the girder. Maximum strain achieved in the girders was at midspan with compression and tensile strains of 145 and 211 microstrain, respectively. The strain plot at midspan is shown in Figures 27 through 29 for load paths 1, 2, and 3, respectively. The compressive strains, or negative strains, constitute the top portion of the graph and the tensile strains, or positive strains, constitute the bottom portion of the graph. It is assumed that all girders remain linearly elastic during loading, therefore a direct relationship exists between stress and strain and the estimated modulus of elasticity can be used to determine the stress. The resulting stresses are discussed in the following section.

Figures 27 through 29 also illustrate the proportion about the neutral axis at midspan. The proportional pattern of the data signifies that there is very little if any composite action with the deck, i.e., the girders act independently of the deck when subjected to bending.

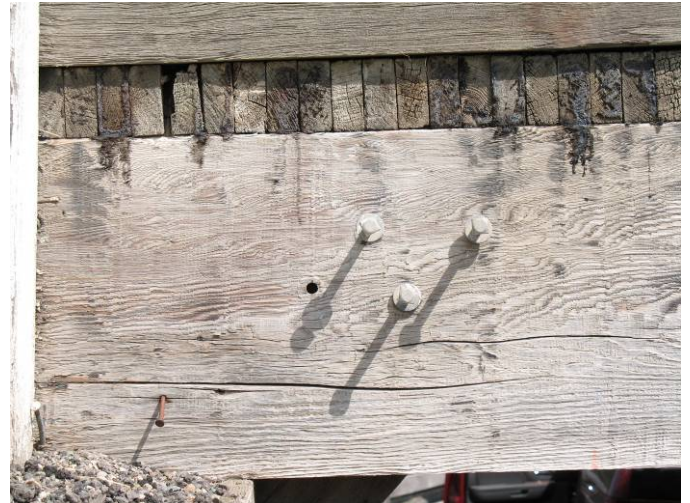
Figure 378. Checking in Exterior Girders

Moderate checking was present along the midline in approximately one-half of the girders. These checks should be monitored with future inspections as a possibility exists that these checks could worsen and the structural integrity of the girder could be compromised. Spotting was present throughout the superstructure presumably from water seepage. Exterior girders were in worse condition than the interior girders presumably a result of more exposure to weathering conditions (see Figure 258). The checks in the exterior girders were deep in some locations. The girder bearing on the sill was sufficient and no misalignment was observed except for girder number 2 where some twisting has taken place.

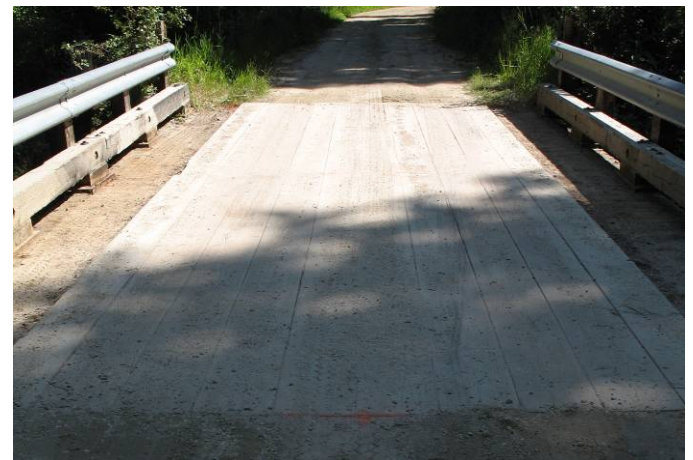
Figure 411. Wearing Surface

Overall, the wearing surface appeared in good condition. No checking or cracking was observed in the timber running planks. The wearing surface is shown in Figure 257.

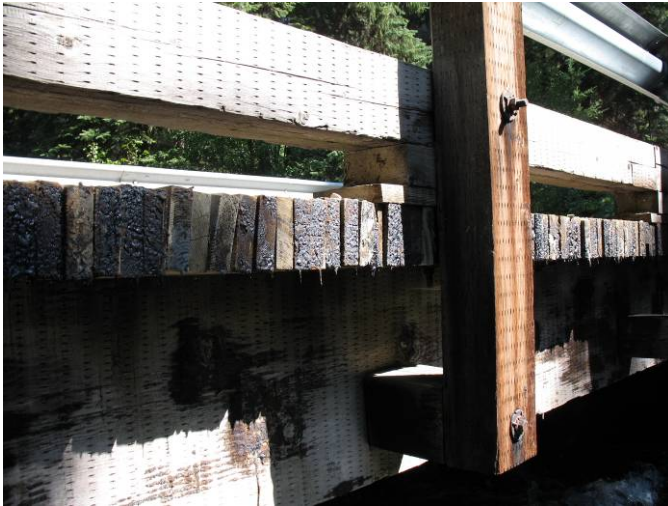
Figure 412. Twisting of Deck Boards

Overall the deck appeared in good condition and all deck boards were securely fastened, though there was minor detachment and twisting of the deck boards at the ends (see Figure 349). Water appeared to be leaking through the decking and water staining was observed by the ISU research team.

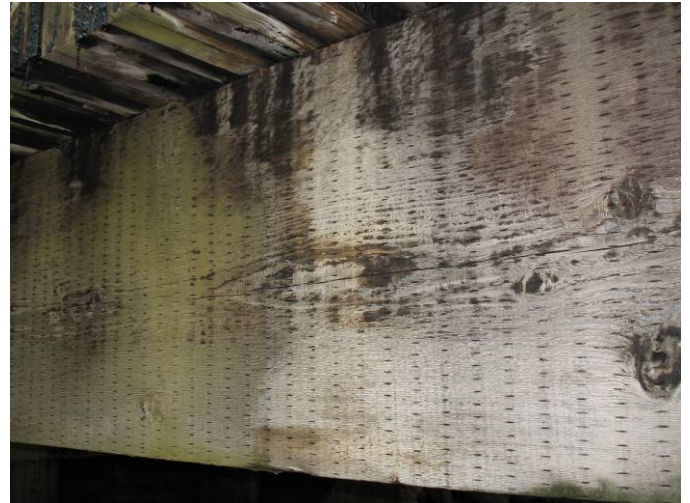
Figure 413. Checking in Exterior Girders

Water staining was also present on the girders in various locations throughout the superstructure and was presumably a result of seepage through the deck boards. The interior girders looked in good condition as no visual degradation like checking was observed. Conversely, checking was observed on the two exterior girders at the girder midline (see Figure 258). The checks in the exterior girders were deep in some locations and should be closely monitored with future inspections. If checking becomes severe, degradation effects can be accelerated and the structural integrity of the girder could be compromised. The girder bearing on the sill was sufficient and no misalignment was observed.

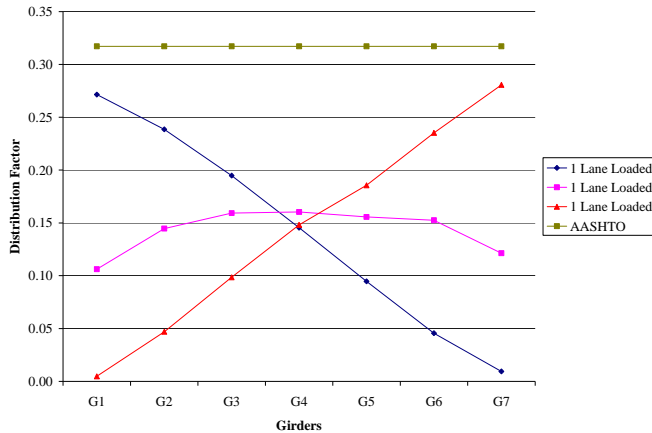
Figure 421. AASHTO Design Live Load Distribution

spacing between adjacent girders. For this bridge, the exterior lane live load distribution factors were assumed equal to that of the interior lanes. Shown in Figure 23 is the comparison of design live load distribution values and actual live load distribution. Notice how the design live load distribution factors exceed all of the actual live load distribution factors.

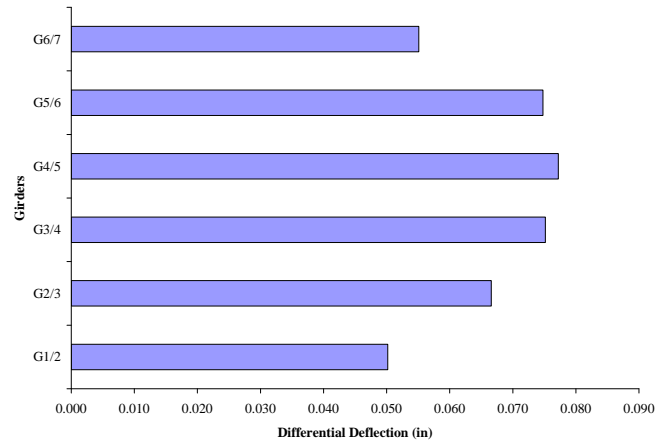
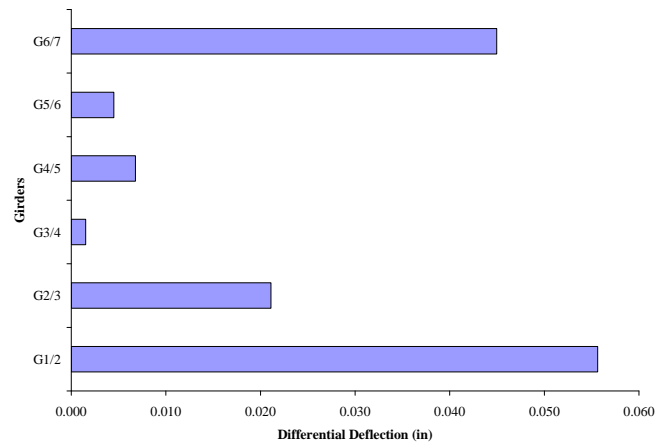
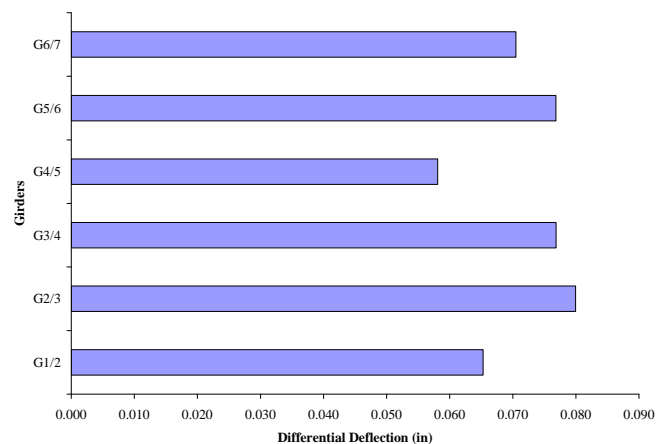
Figure 422. Differential Deflections for Load Path 1

Figure 423. Differential Deflections for Load Path 2

Figure 424. Differential Deflections for Load Path 3

The maximum differential deflection of 0.080 in. occurs in load path 3 and does not appear to be an issue as it is a relatively small amount. The same is true for load paths 1 and 2 as the maximum differential deflections are both below 0.08 in. If the differential deflections were large, the possibility exists that the load was not well distributed transversely between these two girders or the assumption that both girders are of equal stiffness was false.

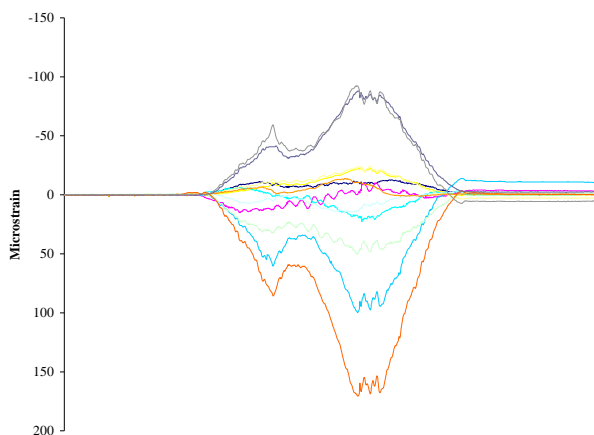
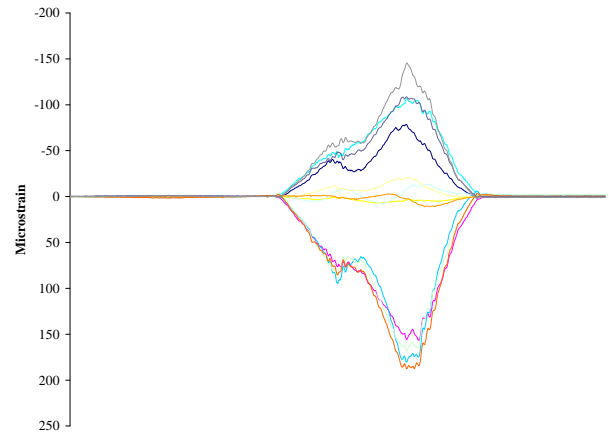
Figures 27 through 28 also illustrate the proportion about the neutral axis at midspan. The proportional pattern of the data signifies that there is very little if any composite action with the deck, i.e., the girders act independently of the deck when subjected to bending.

Figure 425. Strain at Midspan for Load Path 1

Figure 426. Strain at Midspan for Load Path 2

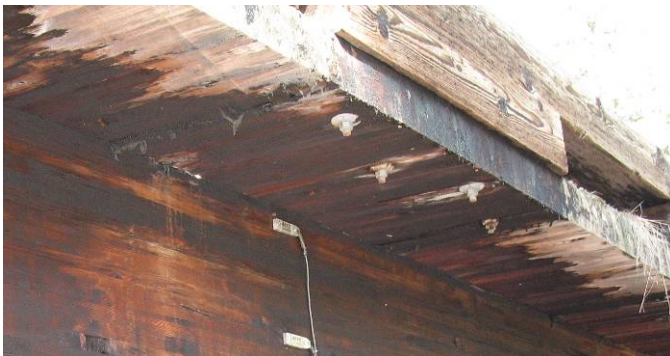
The deck appeared to be in good condition as the underside of the deck was mostly uniform in color signifying that the creosote treatment had not been washed away. Some washing was present at the outside edges of the deck panels, however (see Figure 349). Each of the deck panels was in good condition as no wear between panels was observed and the panels were securely fastened to the girders.

Figure 440. Washing of Creosote at Panels Ends

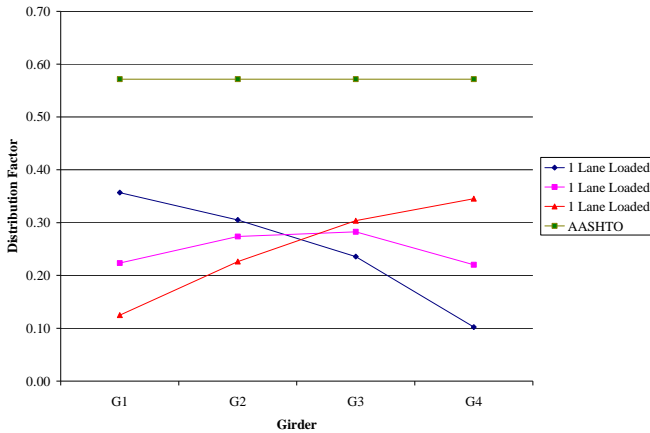
Figure 449. AASHTO Design Live Load Distribution

The design live load distribution factors for interior girders as prescribed by AASHTO for glued-laminated panel deck timber bridges is $S/10.0$ for one design lane loaded and two or more design lanes loaded, and S is equal to the transverse spacing between adjacent girders. For this bridge, the exterior lane live load distribution factors were assumed equal to that of the interior lanes. Shown in Figure 23 is the comparison of design live load distribution values and actual live load distribution. Notice how the design live load distribution factors exceed all of the actual live load distribution factors.
