Investigation of an alternative gravel roads rejuvenation method

Major: Civil Engineering (Construction Engineering and Management)

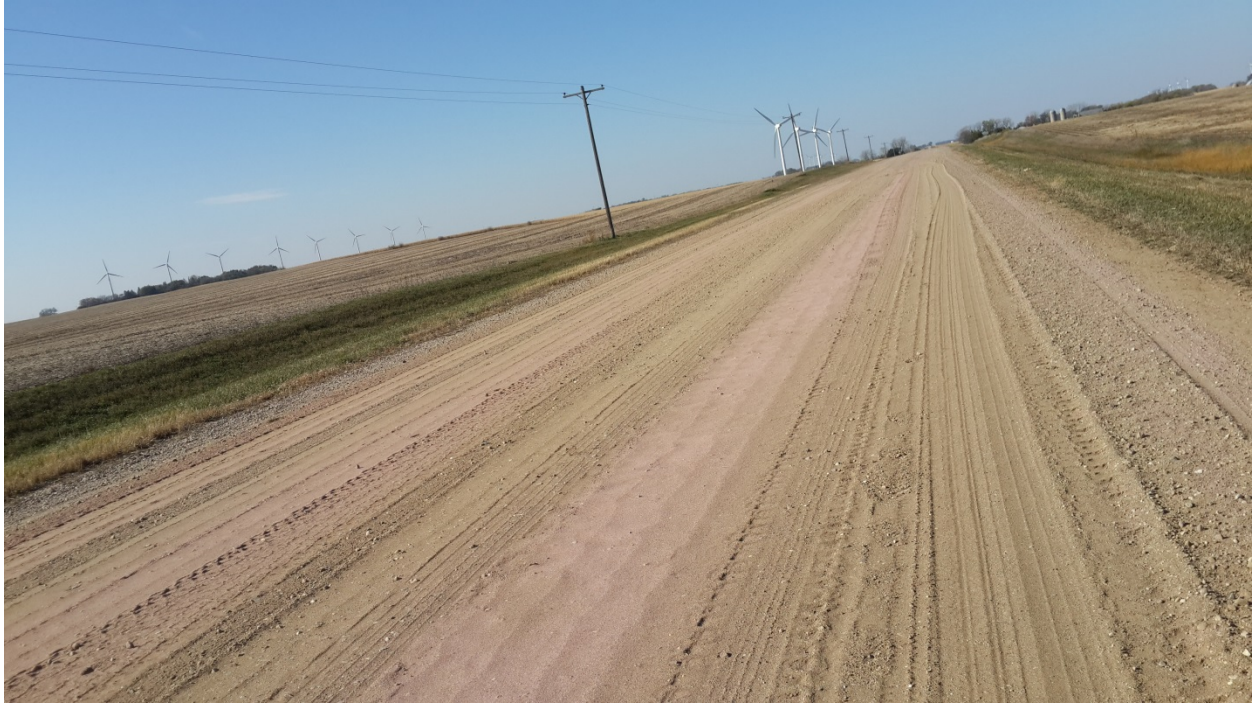
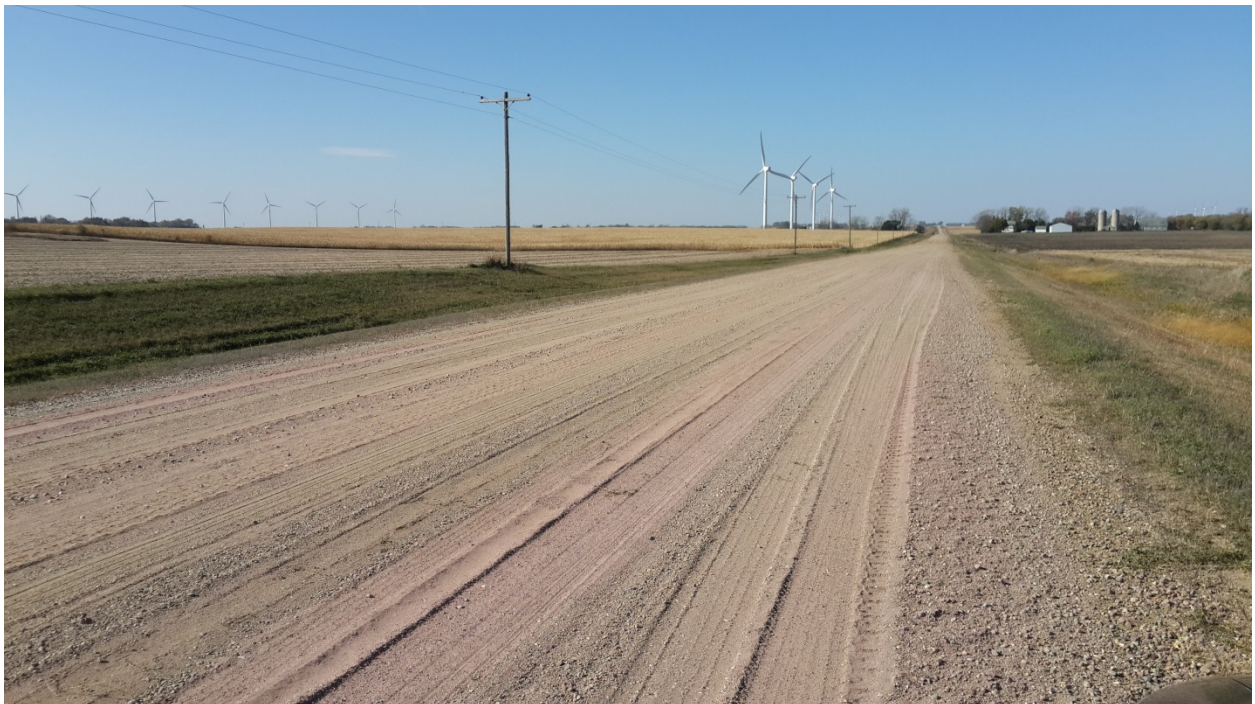
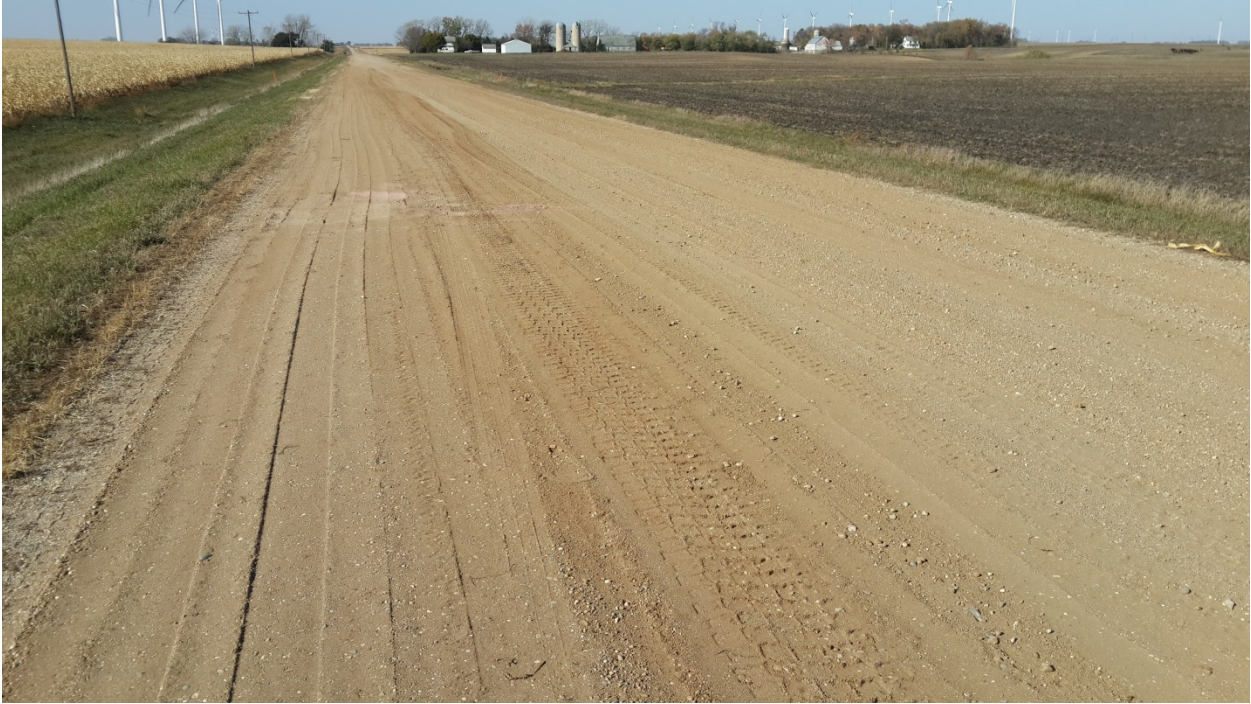
Figure 28 Jackson County Road 76 East Test Section (Photo by the Author)

Figure 29 Jackson County Road 76 Mid Test Section (Photo by the Author)

Figure 30 Jackson County Road 76 West Test Section (Photo by the Author)

It is noticeable that the two experimental sections looked differently from the control section. Reddish path along the road suggests the concentration of crusher dust. More passes of blading or more crusher dust seem necessary to evenly distribute the crusher dust across the road surface.

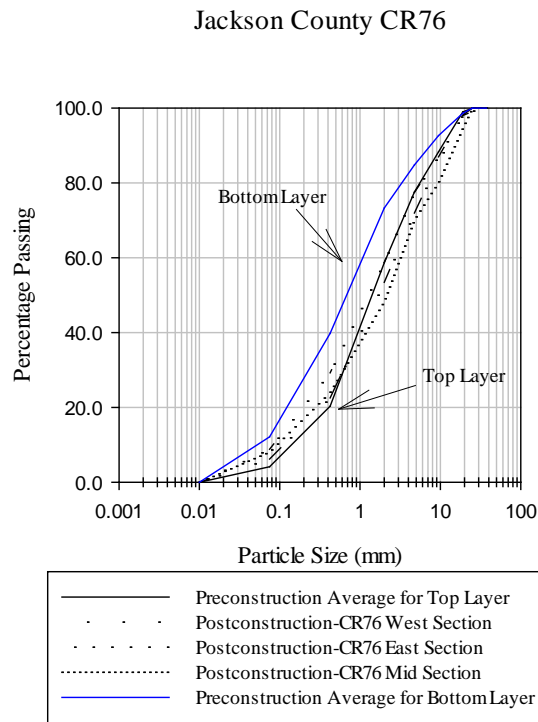
Figure 42 PSD of Material-Jackson County CR 76

The particle size distributions (PSD) of material before and after construction are presented below in Figure 42. Two solid lines represent the PSD curve for top and bottom layers of material, as

indicated. PSD curve for three test sections lies in between the two solid lines at their left tails, indicating the gradation of the top layer has been modified and become finer.

Detailed material properties are summarized in Table 8. The proportion of #200 fine particles increased after crusher dust was mixed in. However, the crusher dust has zero plasticity.

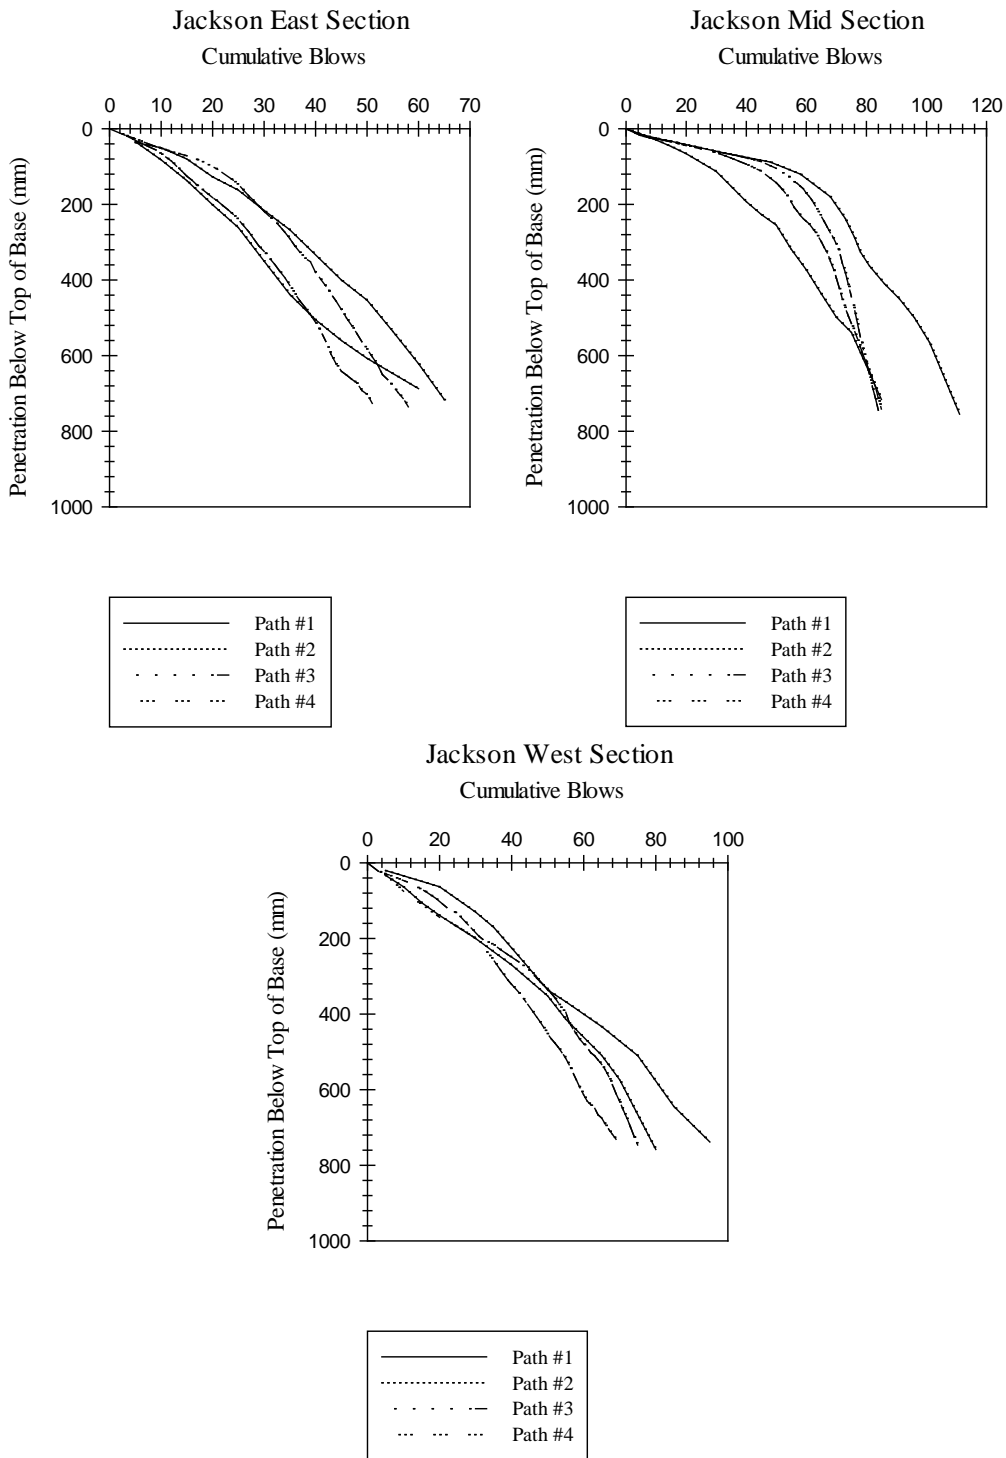
Figure 43 Cumulative Depth against Cumulative Blow-Jackson County (6/21/2014)

Figure 43 reveals that the surface and the subgrade materials are rather consistent with regard to stability since penetration rate (PR) does not change, except for the Middle Section. From the plot for the Middle Section, a pronounced downturn is seen at about 120mm (4.7in) from the surface, suggesting heterogeneity of subgrade material. California Bearing Ratio (CBR) appears to be comparable between West and East Section. However, according to some measurements, the CBR increases to 300 within the wearing surface in Middle Section. Plots are shown in Figure 44.

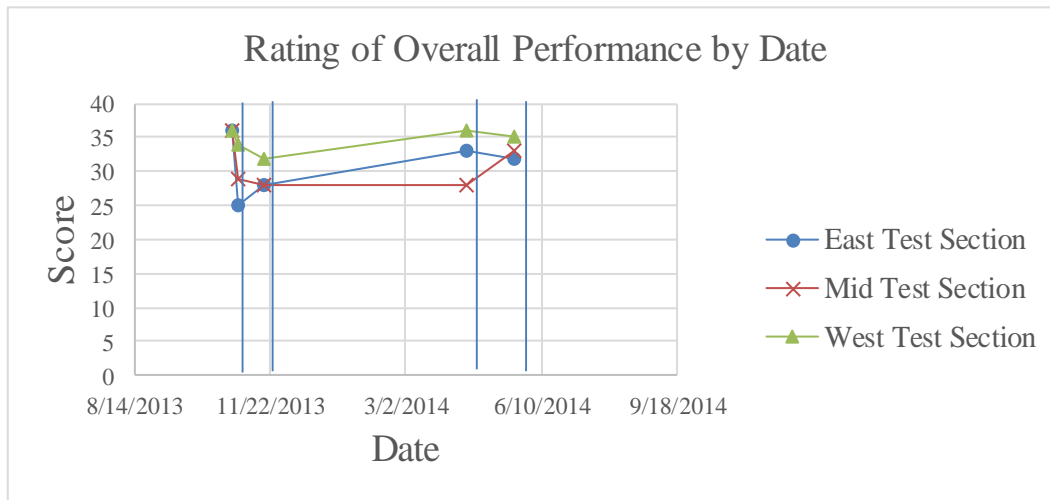
Figure 47 Pavement Condition Rating Result by Data-Jackson County¹

Overall performance rating also indicated that throughout the observation period, the West Section/1st Section outperformed the other two sections, shown in Figure 47. Necessary maintenance activities were implemented during the period of observation. Rating were carried out before the maintenance activities.

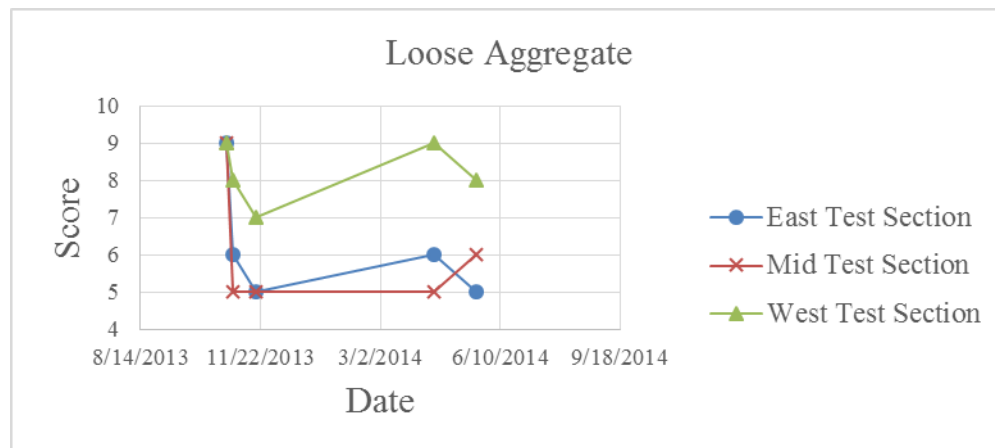
Figure 48 Rating for Loose Aggregate-Jackson County

Figure 48 shows that the two experimental sections suffered from loose aggregate soon after construction and the problem remained since then. Segregation resulted generated a large amount of loose aggregate that compromised the performance of the experimental sections.

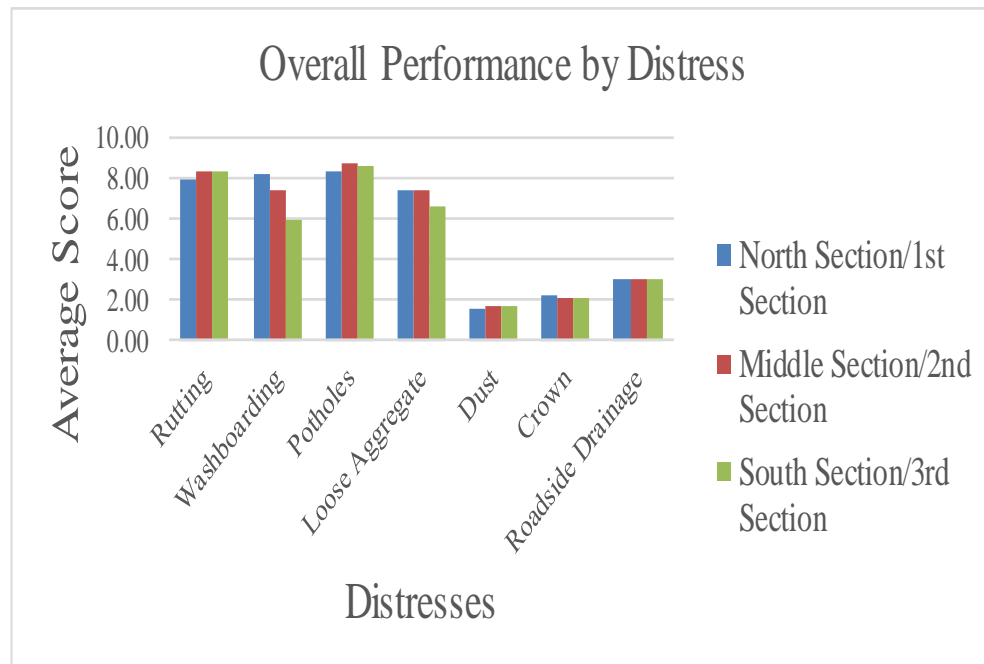
Figure 54 Pavement Condition Rating Result by Distresses-Beltrami County

The South Section/3rd Section was rated “Fair” for the distress of washboarding, which reflects the lasting distress observed in this section. Fair level of washboarding suggests that 10%-25% of roadway appears to suffer from corrugations that are generally 1”-2” deep and vehicle control is compromised. The Middle Section/2nd Section particularly performed well by having few pothole distress. See Figure 54 below.

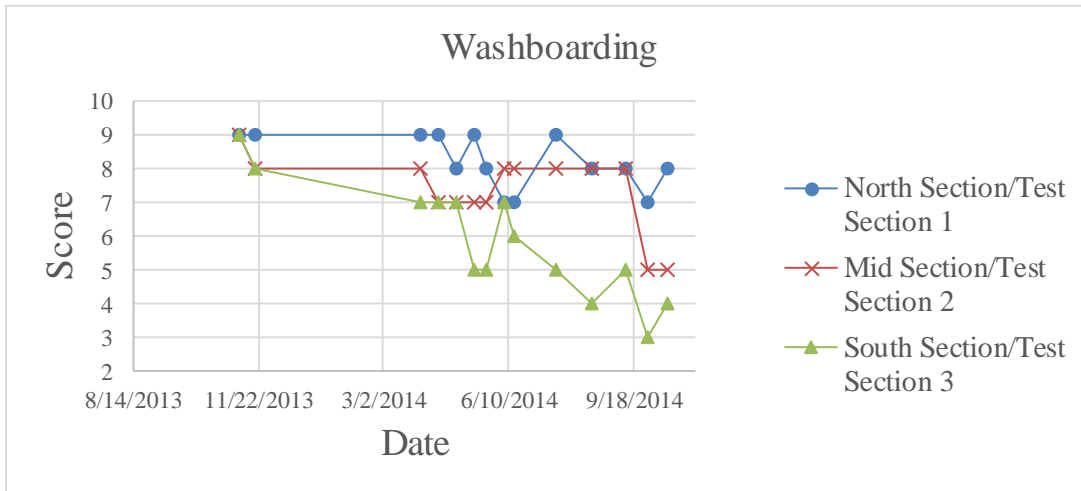
Figure 56 Rating for Washboarding-Beltrami County

The South Section/3rd Section started to deteriorate noticeably beginning in late May as it was entering into a dryer summer season. The deterioration is most pronounced in terms of washboarding, Figure 56.

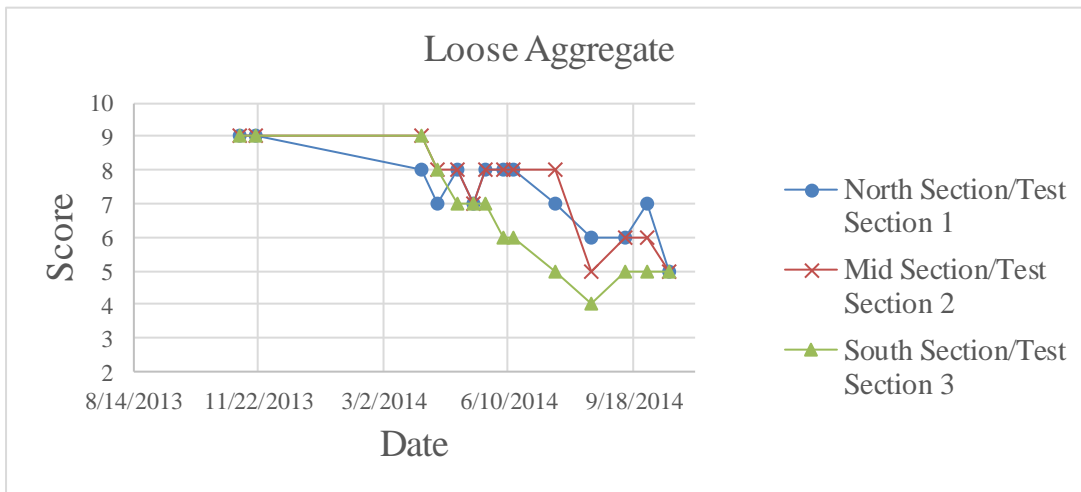
Figure 57 Rating for Loose Aggregate-Beltrami County

Loose aggregate issues started to occur in May as well, and were the worst for the South Section/3rd Section, Figure 57.

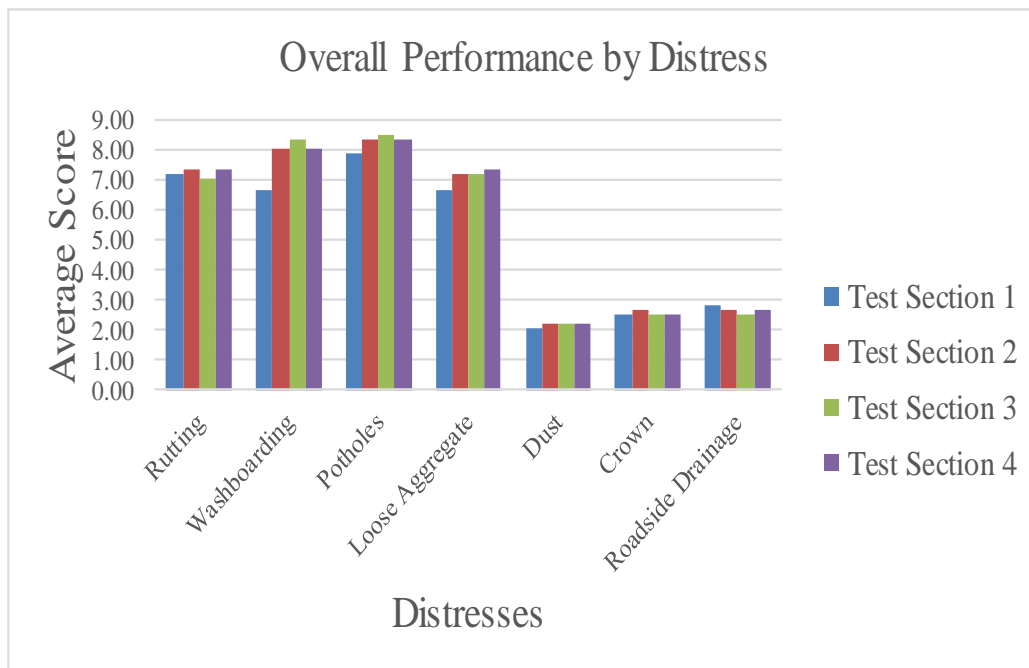
Figure 67 Pavement Condition Rating Result by Distresses-Beltrami County

All four test sections were considered to be performing reasonably well, except that Section 1 received rating of “Fair” with respect to loose aggregate while the other sections were rated “Good”. In addition, Section 1 had more severe corrugation in comparison to the other sections, probably due to the proximity to an intersection. Figure 51 shows the rating result by distress
