January 2013

# Evaluating CFRP-Masonry Bond Using Thermal Imaging

Joseph Christopher Ross

A thesis submitted in partial fulfillment  
of the requirements for the degree of  
Master of Science in Civil Engineering  
Department of Civil and Environmental Engineering  
College of Engineering  
University of South Florida

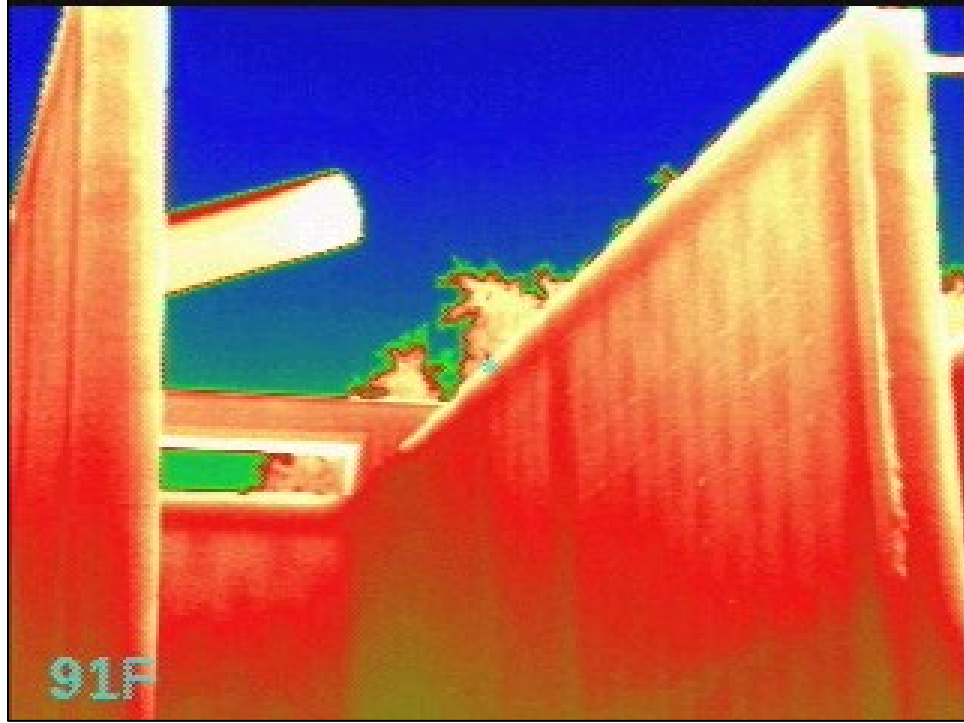
end that overhangs dissipates heat differently than the end that is in contact with the ground. The overhanging portion cannot dissipate heat as readily and therefore is hotter, whereas the grounded end can transfer heat to the ground and can cool down more efficiently. The thermal image in Figure 16 also illustrates this same thermal pattern.

**Figure 16: Passive Heat Variation on North Side of Wall 2 on 10/17/13 at 10:31 AM**

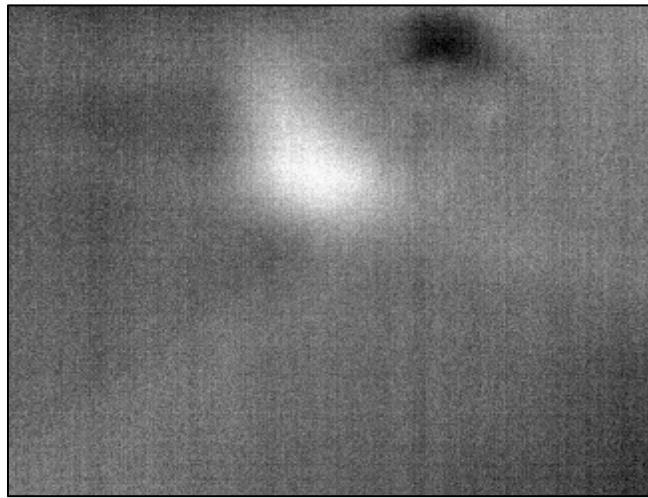
Figure 41 also shows a hot spot not far from the first. This de-bonded area was found by sounding the FRP and confirmed with infrared thermography. This area was also approximately 1” in diameter. It was located 6” above thermocouple location 15 and 2” to the left of this position. Figure 43 shows a photograph of location 15 and its surroundings. The de-bonded areas are visible and appear as the puffy areas of CFRP.

**Figure 39: Hot Spot 1 on 4/28/12 at 12:39 PM (North Side of Wall 2)**

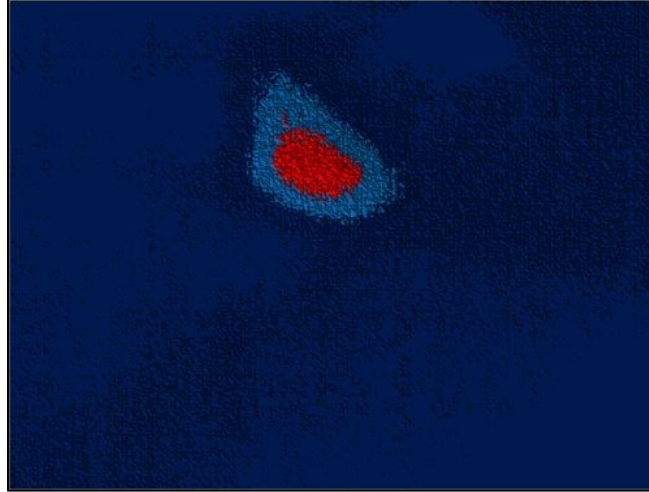
Pull-Off #	Coordinates (X, Y)	Expected Outcome	References
3	14'-1 1/2", 5'-9 1/2"	No Bond	Anomaly #10, Figure 54
4	15'-0", 5'-0 1/2"	No Bond	Anomaly #14, Figure 54
5	14'-9 1/2", 4'-4"	No Bond	Anomaly #16, Figure 54, Hot Spot 2 from Figure 41
6	5'-3", 4'-6"	Substrate Failure	Lower thermal fatigue, Figure 14
7	5'-3", 4'-0"	Substrate Failure	Lower thermal fatigue, Figure 14
8	5'-3", 3'-6"	Substrate Failure	Lower thermal fatigue, Figure 14
9	5'-9", 4'-0"	Substrate Failure	Lower thermal fatigue, Figure 14
10	5'-9", 3'-6"	Substrate Failure	Lower thermal fatigue, Figure 14

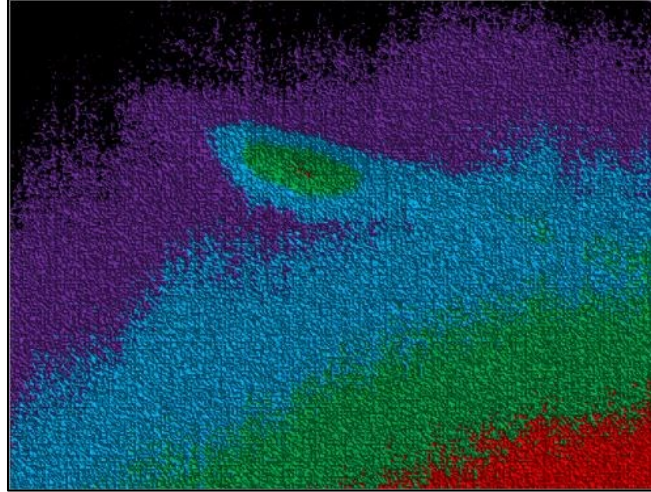
**Figure 41: Hot Spot 2 on 4/28/12 at 1:00 PM (North Side of Wall 2)**

- Wall 2 (See Figure 64 at the end of this chapter):
  - Figure 62 shows the recommended positions for pull-off testing on wall 2. Pull-off 5 was selected because this is the spot that was found by sounding and confirmed with the thermal camera as well as with the thermal

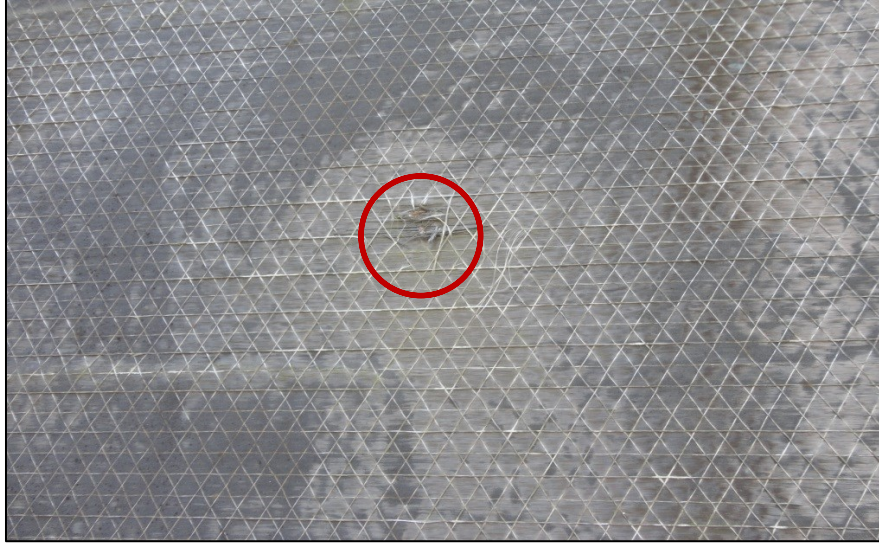
**Figure 48: Tear in Fabric on North Side of Wall 3**

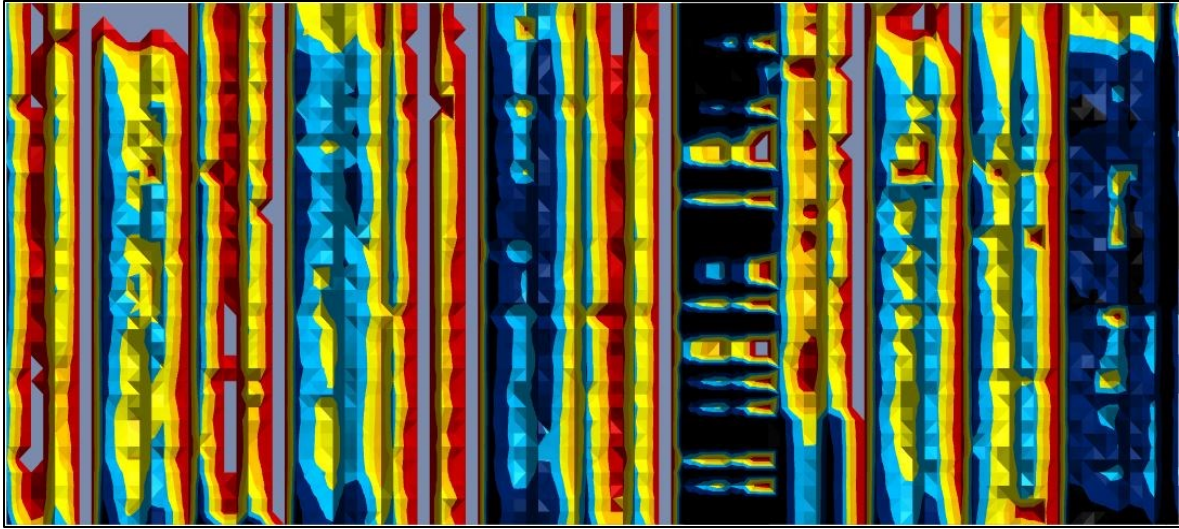
On this day of scanning one of the infrared sensors was not operating properly (IR9). A thermal image has been generated in excel based on the temperature data obtained from the scans. The malfunctioning sensor was in the overlap portion of the scans, so its data has been replaced by the overlapping sensor's data. The last scan (on the far right) is the only one that includes just one strip from the malfunctioning sensor. Figure 51 shows a diagram of the scans that were performed. Figure 53 shows the results from those scans. Figure 54 shows the wall after post processing. Images which overlay sensors onto the scan images are found in the appendices.

Figure 53: Wall 2 Thermal Scan Results Prior to Post Processing

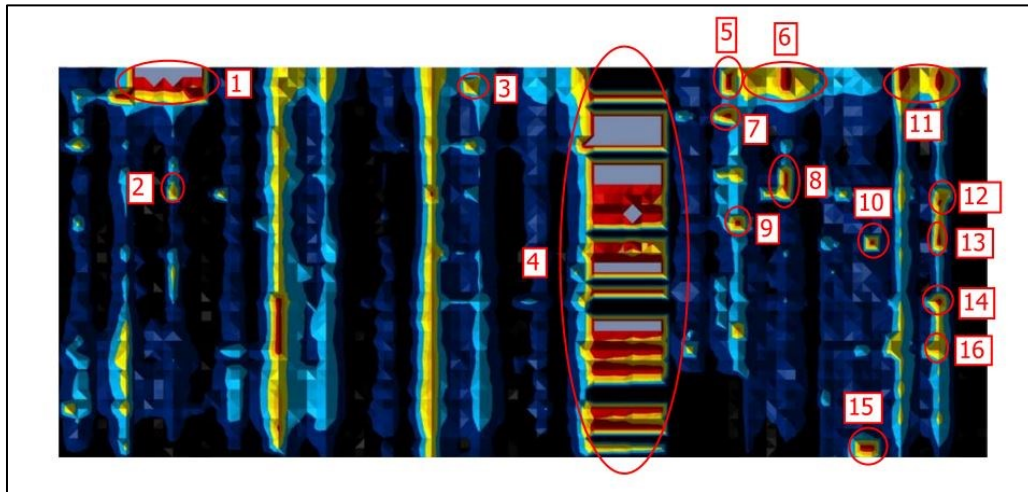
A cartesian coordinate system is used in locating anomalies (and recommended pull-off locations in chapter 8) with the origin as shown in Figure 52. Figure 54 is annotated indicating areas of significance in the scan. Refer to Table 5 for a commentary.

Figure 54: Thermal Scan Results on Wall 2 after Post Processing

Pull-Off #	Coordinates (X, Y)	Expected Outcome	References
1	12'-4 1/2", 6'-1"	No Bond	Anomaly #9, Figure 54
2	13'-0", 6'-7"	No Bond	Anomaly #8, Figure 54

- Locations 1 through 4 are recommended because they showed up in the thermal scan of wall 2. Complete de-bond is predicted.
- Locations 6 through 10 are recommended because they are supposed to be in good/cold regions as indicated in the results shown in Figure 54. These should have higher bond strength. Note that the locations predicted to have high pull-off values are more toward the east and to the bottom whereas the locations predicted to have no pull-off value are more toward the west and to the top of the wall.
