Ultimate load tests of modified Parker type high truss bridge

Ultimate load tests
of a
modified Parker type high truss bridge

A Thesis Submitted to the
Graduate Faculty in Partial Fulfillment of
The Requirements for the Degree of
MASTER OF SCIENCE

Department: Civil Engineering
Major: Structural Engineering

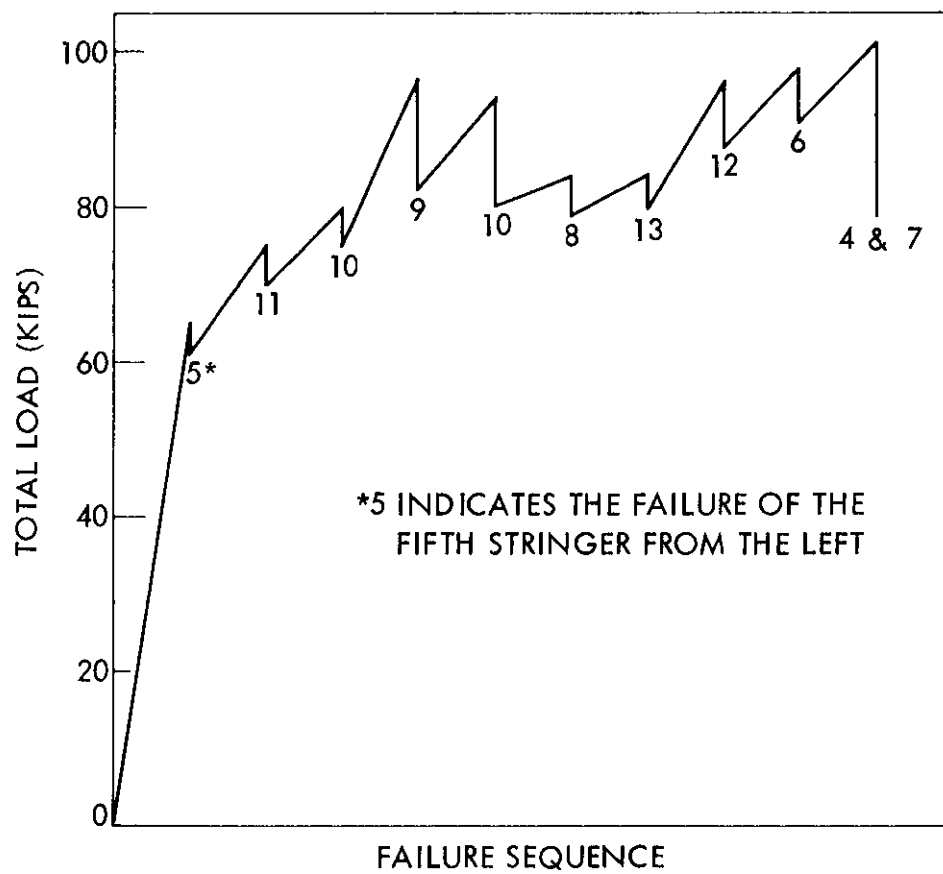
The load was first applied in increments of 10 kips, but as the loading progressed to higher levels, the load increments were reduced to 5 kips until failure was reached. Loading proceeded as planned on the first test at loads up to 65 kips, when the fifth stringer from the left broke. As the load was increased up to the maximum load of 101.5 kips, stringers split and failed. The behavior of the deck at loads above 65 kips can be seen in Fig. 17 and the failure order of the stringers in Fig. 13. At each failure there was a sudden drop in load. However, upon reloading there was usually a recovery of load and a further increase in load. After the failure of 10 stringers the test was terminated because the deck was unable to sustain any additional load. Figure 18 shows the top of the deck at a load near failure. The failed stringers are shown in Fig. 19.

Fig. 17. Load history for deck test 1.

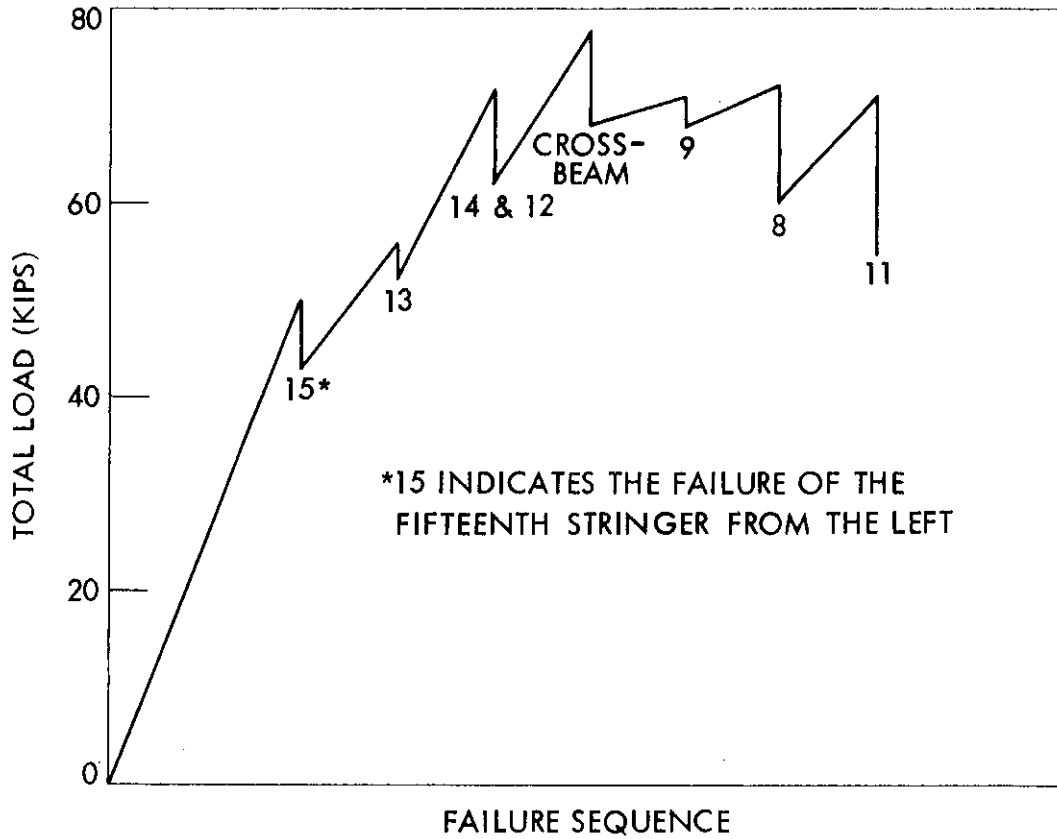
The second test went according to test procedure plans up to a loading of 50 kips. For loads greater than 50 kips the behavior of the deck can readily be seen in Fig. 20. As the load was increased up to the maximum load of 77.4 kips, stringers split and failed. The failure

Fig. 20. Load history for deck test 2.

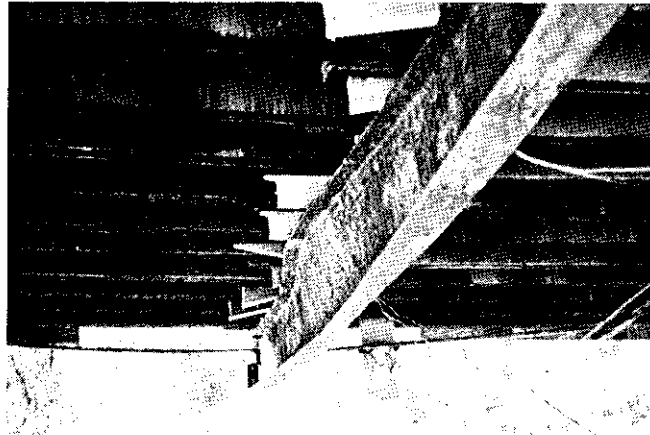
Wedges (Fig. 49) were inserted between floorbeam 5 and the timber stringers to assure deck continuity for the floorbeam 4 test. The purpose was to provide, in effect, a new floorbeam at L_5 so as not to affect the test of floorbeam 4.

Fig. 49. Photograph of wedges inserted to assure deck continuity.

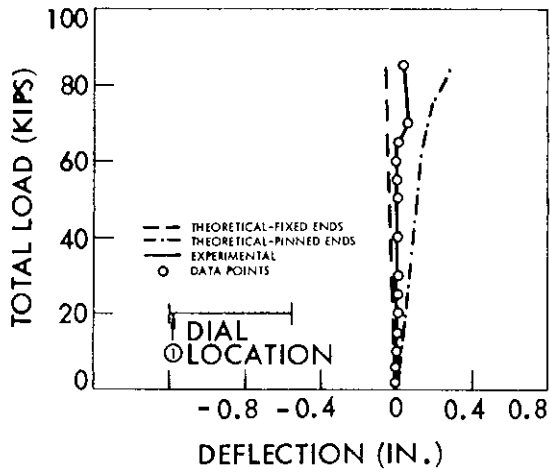
a. Position 1.

The behavior of deck test 1 was typical of that expected. The load-deflection curves for that test (Fig. 53) indicate that the behavior of the deck up to a total load of 60 kips (H 25 truck) was linear. Beyond 60 kips the influence of stringers breaking can easily be seen in Fig. 53. Figure 53c indicates that a nonlinear increase in deflection occurred between 60 and 65 kips of load at the deflection dial located at approximately the one-third point of the roadway (near one of the load points). This increase in deflection

Fig. 53. Load-deflection for deck test 1.

can be attributed to the failure of stringer 5 which was approximately 5 feet from the upstream edge of the deck. The same behavior occurs in Figs. 53a and 53b between 65 and 70 kips of load. The increase in deflection at these points also can be attributed to the failure of the same stringer.

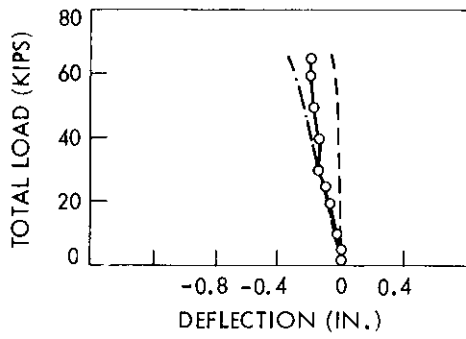
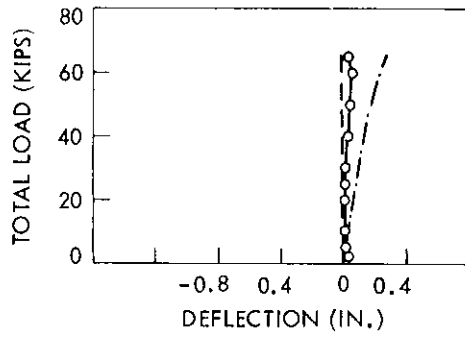
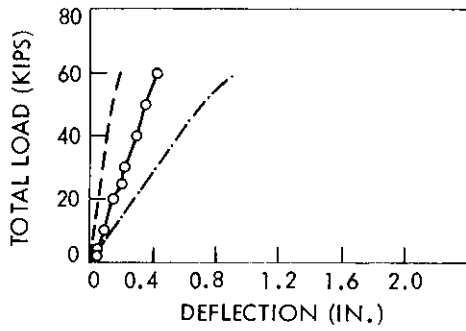
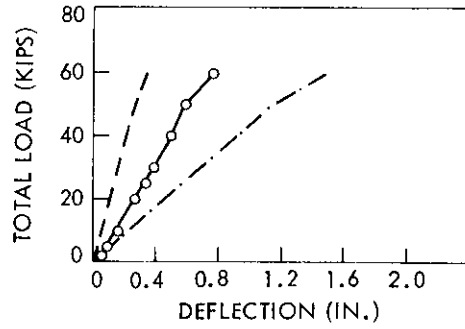
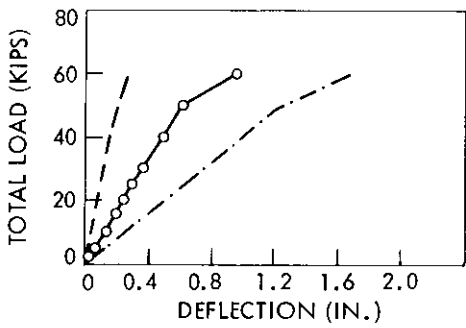
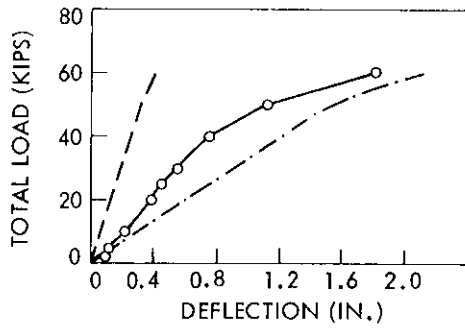
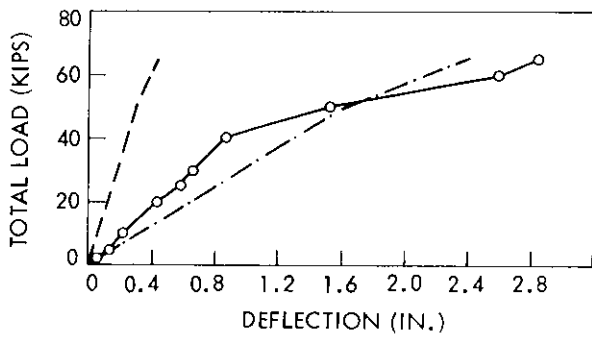
Fig. 54. Load-deflection for deck test 2.

The behavior of deck test 2 was also typical of that expected. The load-deflection curves for that test (Fig. 54) indicate that the behavior of the deck was linear up to a total load of 40 kips (H 17 truck). The behavior of the deck shown by Figs. 54a and 54b is not really indicative of behavior of the entire deck because these two deflection dials were near the edge of the panel opposite the loading. This portion of the deck underwent only uplift and very small deflections.

At loads greater than 40 kips the influence of high stress levels in the stringers and the failure of stringers can be seen in Figs. 54d-54g. Figures 54f and 54g indicate that a nonlinear increase in deflection occurred between 40 and 50 kips of load at these two deflection dial locations near the edge of the deck. This nonlinear increase in deflection was caused by the high stress levels in this portion of the deck. Figures 54d-54g indicate a similar behavior between 50 and 60 kips of load at these deflection dial locations. This increase in deflection can be attributed to the failure of stringers 13 and 15. A different type of behavior is shown in Fig. 54g between the loads of 60 and 65 kips. The slope of the load-deflection curve increases, indicating that other portions of the deck are taking a greater portion of the load than they had previously taken.

Figures 53 and 54 show that the experimental deflection does, in most cases, fall about midway between the theoretical deflections based on simple and fixed ends. Deck test 1, in which the loads were applied symmetrically, exemplifies this behavior. In deck test 2 the loads were applied to one side of the panel causing a departure from this behavior. This behavior can be seen most clearly in Figs. 54f and 54g. The main reason for this behavior is the fact that when a stringer was unable to continue carrying load the foundation stiffness contributed by that stringer was eliminated. The method in which the loss of stiffness was

distributed allowed the side of the panel of deck on which the stringers had failed to have a greater stiffness than actually existed. Therefore, the theoretical deflection was less than the experimental deflection. Thus for the case of eccentric loading the more conservative simple support condition should be used in theoretical deflection calculations.

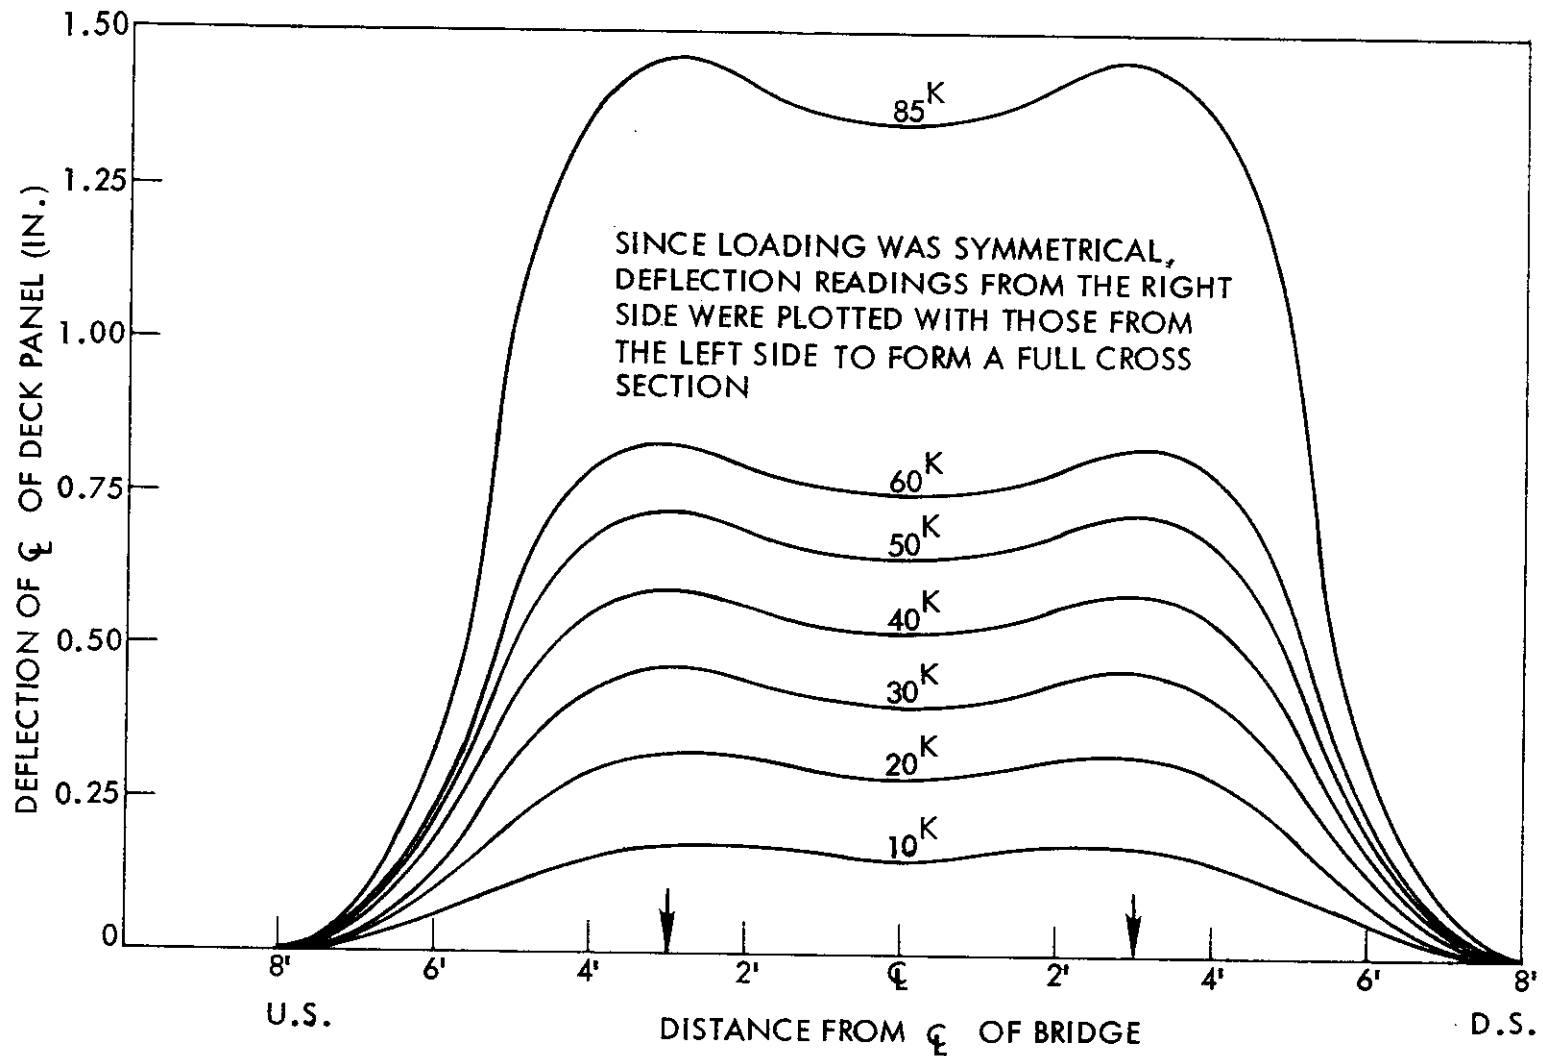
Fig. 55. Deflection cross section at mid-span of deck panel for deck test 1 at various loads.

The deflection readings in Fig. 53 can be combined to form a deflection cross section at various load levels (Fig. 55). This figure

gives an indication of the distribution of the load to each of the stringers. From these deflections, the amount of load distributed to each of the stringers can be calculated. The figure shows that the greatest part of the load is being carried by the stringers around and between the load points. It also indicates that the deflection increases linearly until the first stringer fails.

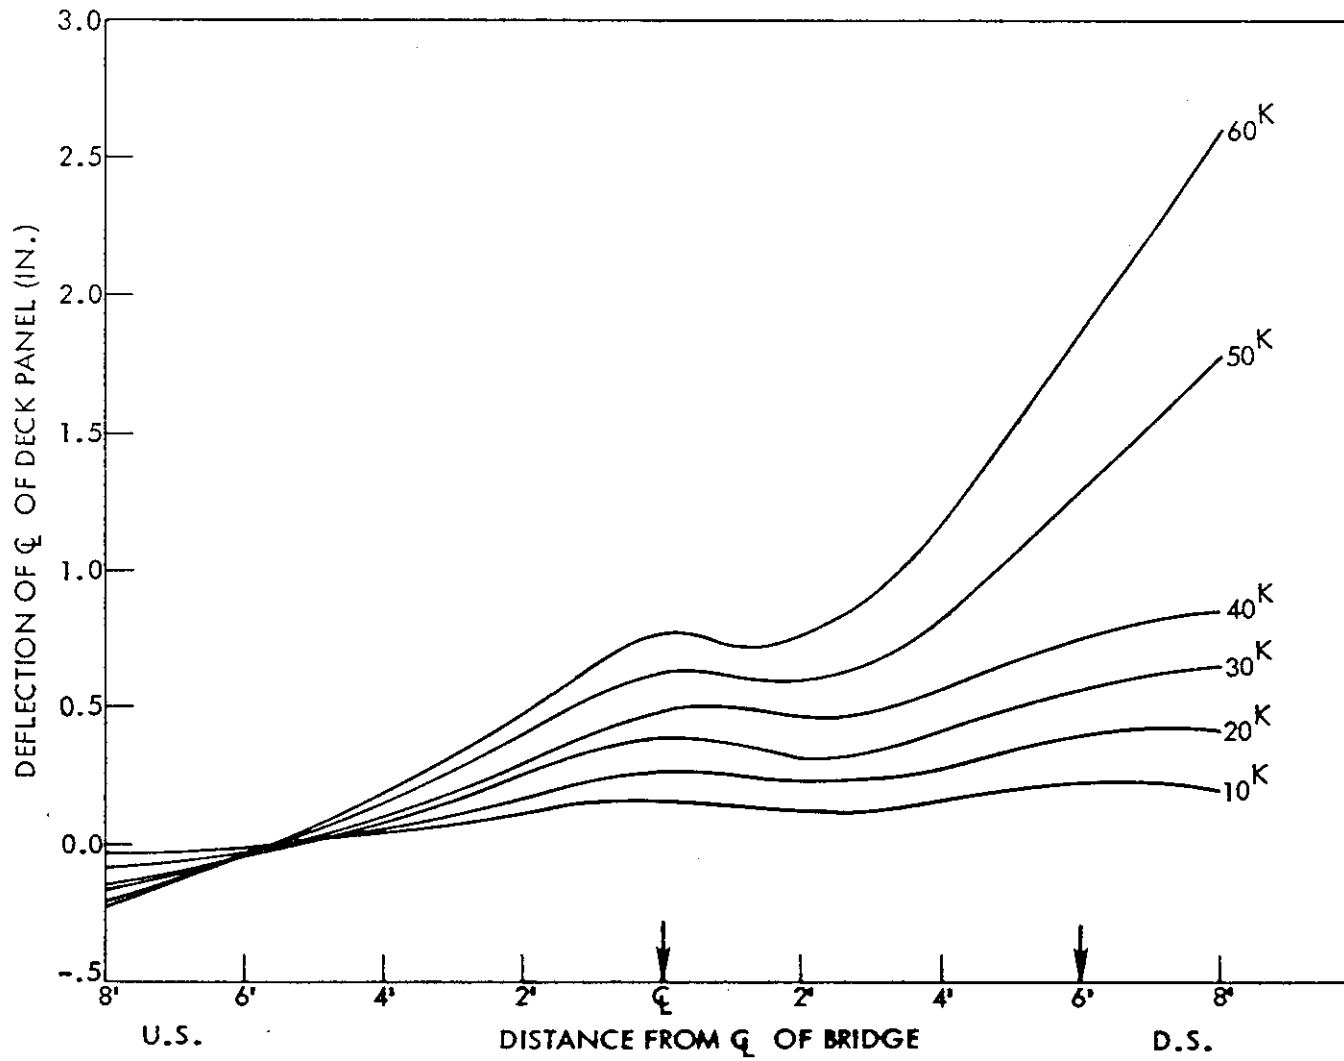
Fig. 56. Deflection cross section at mid-span of deck panel for deck test 2 at various loads.

The deflection readings in Fig. 54 are combined in the same manner as Fig. 53 to form a deflection cross section at various loads (Fig. 56). Figure 56 gives an indication of the distribution of the load to each of the stringers. This figure also indicates that the major portion of the load is being carried by the stringers on the loaded side of the

panel and that the deflection increases linearly up to a total load of 40 kips.

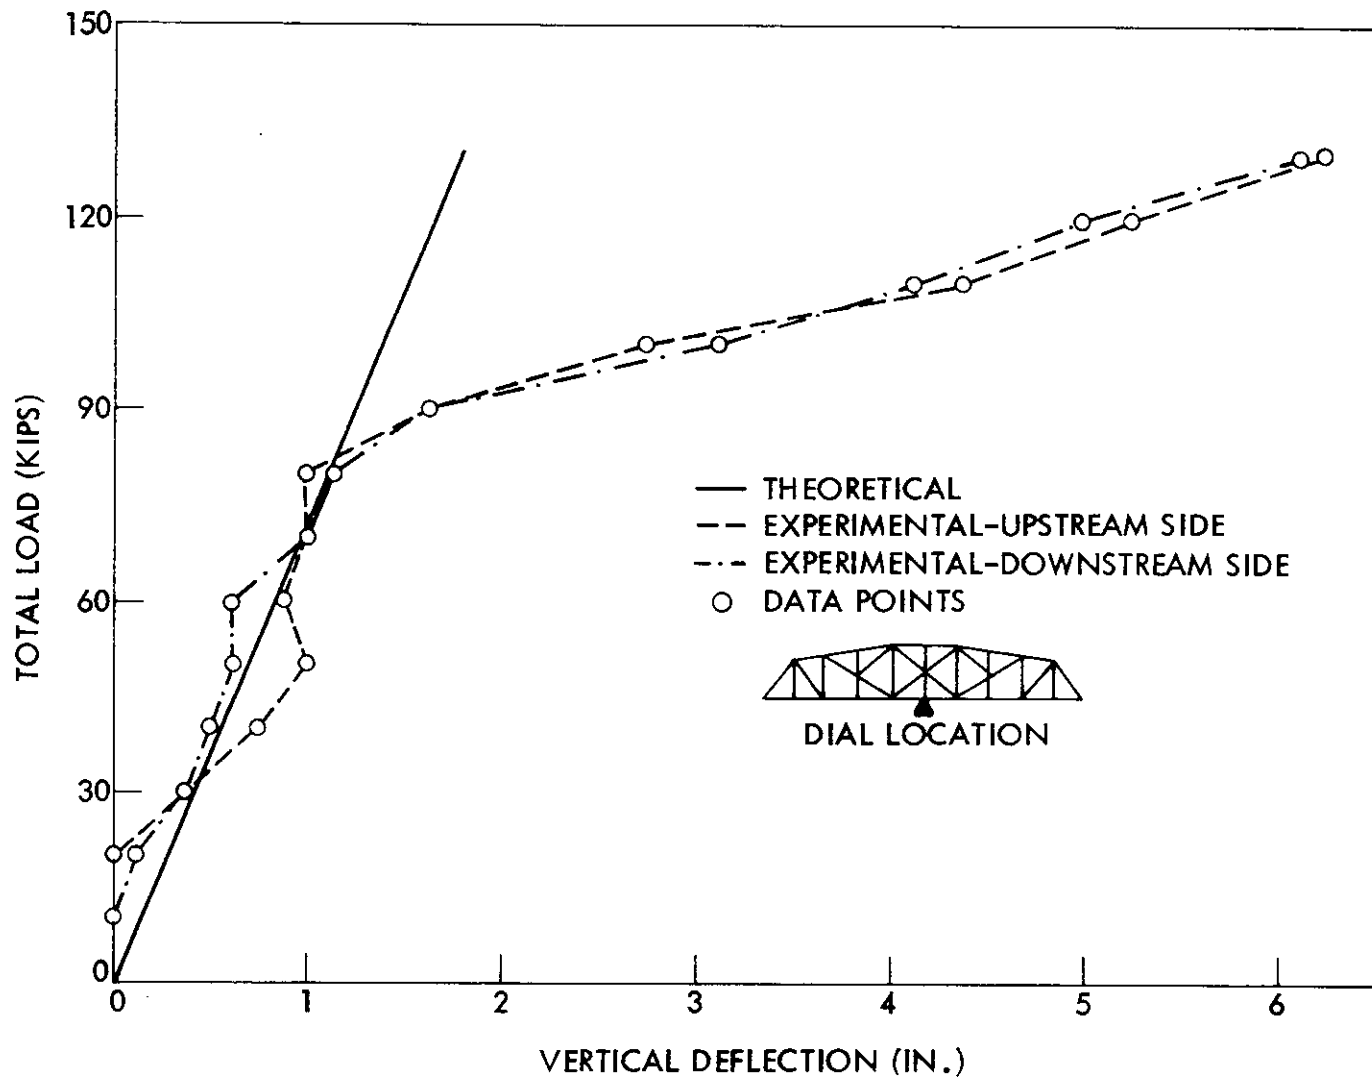
Fig. 57. Total load-vertical deflection at L_5 for truss test.

The behavioral indicators for the truss test were the deflection readings at mid-span and at the three-tenths points and the forces in the truss members as computed from the strain gage readings taken during the test. The experimental strains were converted to stresses assuming that both the wrought iron and steel were elastic-perfectly plastic materials. The materials were assumed elastic up to the yield strain computed from appropriate values of yield stress and modulus of elasticity in Table 2 and assuming no increase in stress beyond the yield strain. The areas of each individual member were used to convert the stresses to forces in the individual members. Figure 57, the theoretical and experimental load-deflection curves for the vertical deflection at mid-span, indicates that yielding began to occur in member L_5M_5 at a total load of approximately 80 kips. The curve was relatively linear at loads less than 80 kips and above 80 kips the slope of the curve decreases indicating yielding of member L_5M_5 . The small nonlinearities at loads below 80 kips are indicative of the effect that rusting of the members and pins and the distorted shape of some members had on the behavior of the truss. Figure 58, the theoretical and experimental load-deflection curves for the vertical deflection at

Figure 59, the total load-force in truss member L_5M_5 curve, indicates, for this truss, approximately the same behavior as the total load-vertical deflection curve at L_5 (Fig. 57). Figures 60-70, curves for other total load-force in truss member, indicate linear behavior up to the maximum load at which readings were taken.

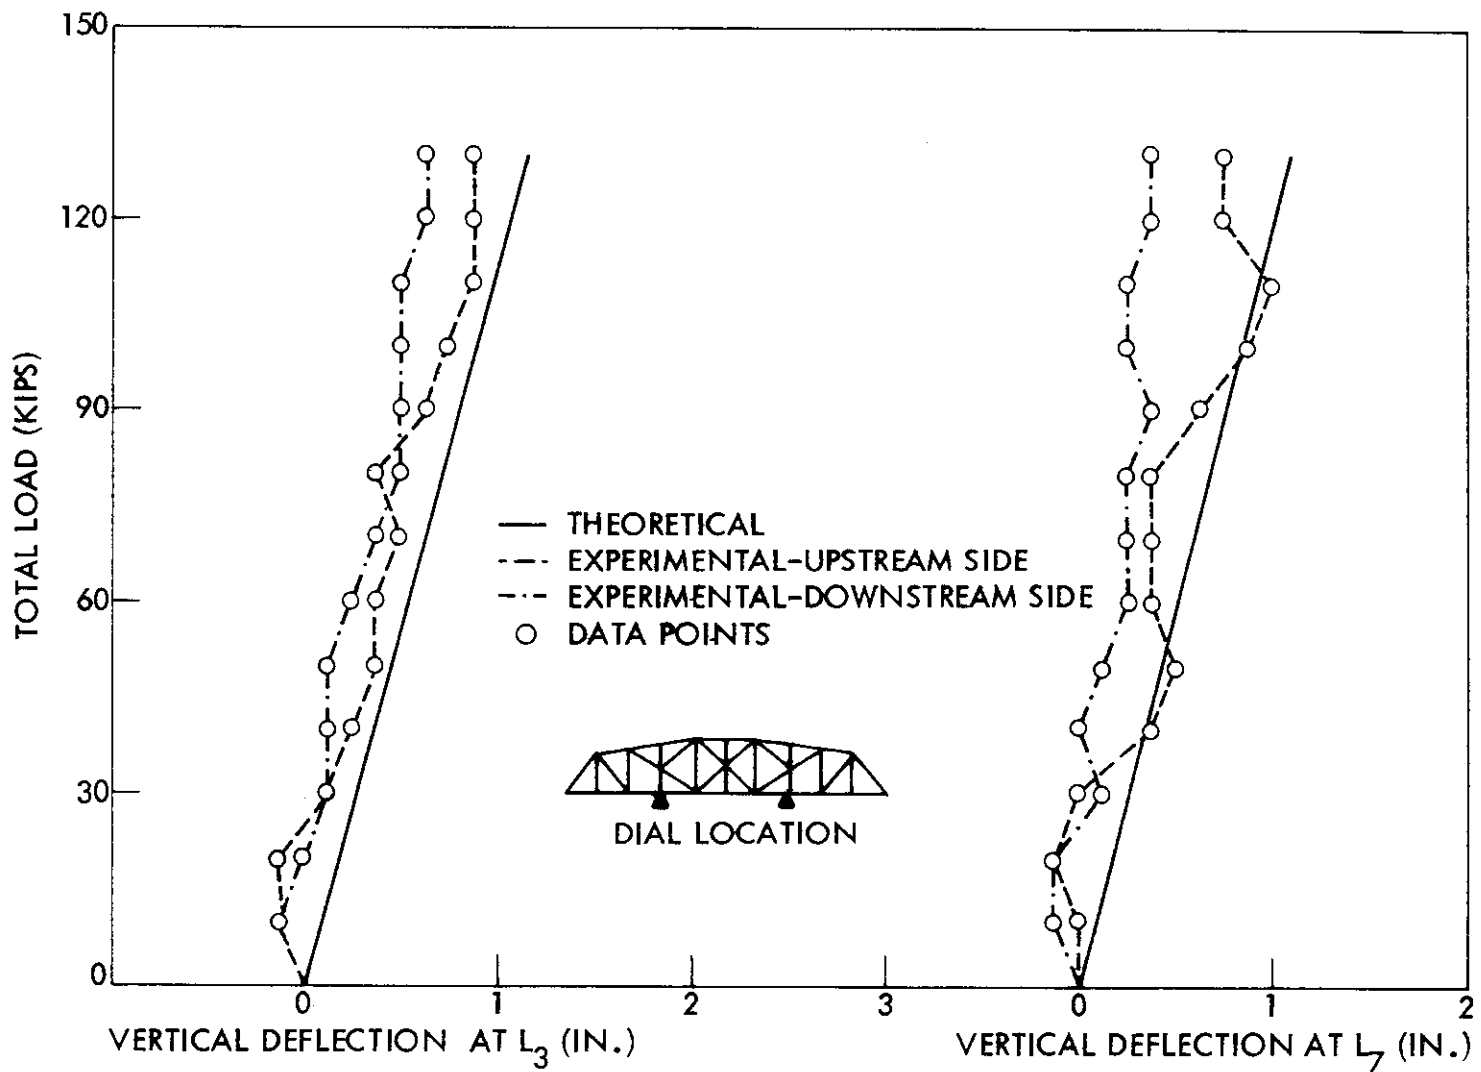
Fig. 58. Total load-vertical deflection at L₃ and L₇ for truss test.

L_3 and L_7 . Figure 58 shows that both of the three-tenths points had fairly linear behavior. Although there is some agreement between the two sides of the truss, the small magnitude of the deflections and the apparent effect of the rusted condition of the truss make it difficult to determine if this agreement is valid. The horizontal deflections of the truss were negligible.

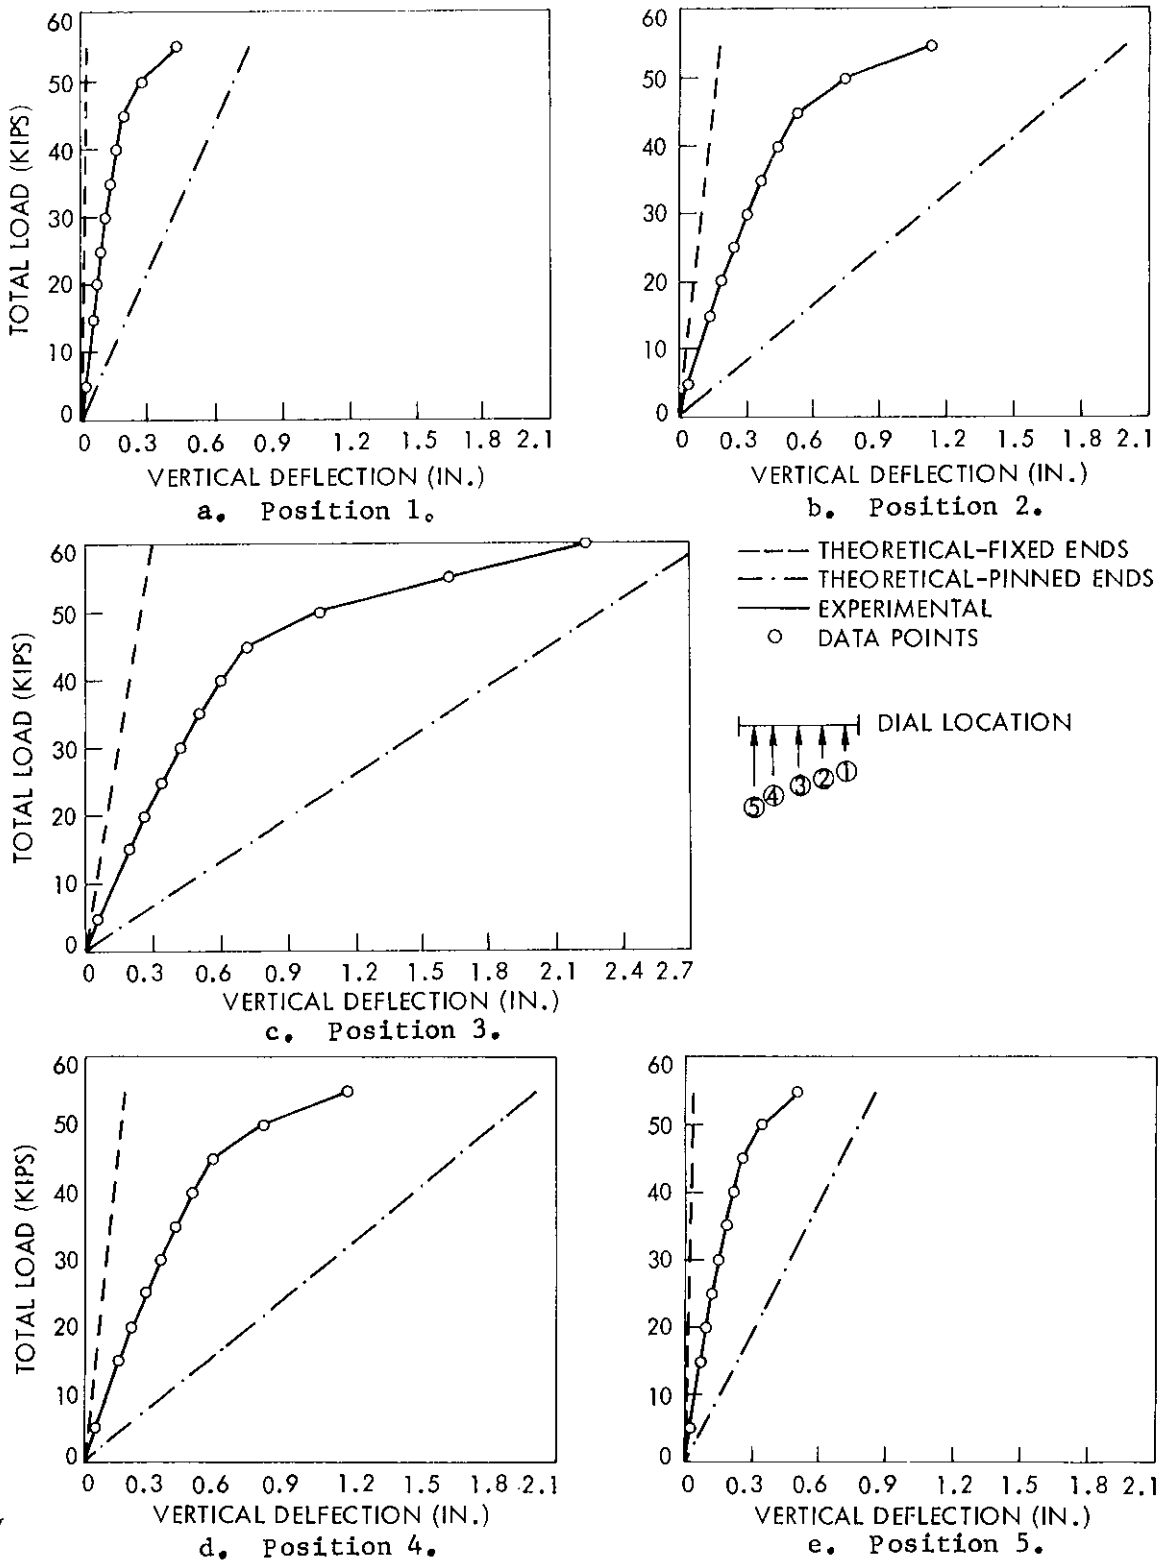
Fig. 71. Load-deflection for floorbeam test at L_4 .

The load-deflection curves for the floorbeam test at L_4 are shown in Fig. 71. Both the experimental and theoretical deflections are indicated. This figure indicates that a departure from linearity occurs at a load of about 40 kips (H 24 truck). At this same load the observation was made that the floorbeam was beginning to buckle laterally. The lateral buckling of the floorbeam is indicated by the departure from linearity of the experimental load-deflection curves in this figure. This indicates that the natural dapping of the stringers provides sufficient lateral support of the floorbeam up to about 60% of the ultimate load. Beyond 60% of the ultimate load the floorbeam buckled laterally between the load points and deflected away from the stringers between the load points because there was no positive tie between the stringers and the floorbeam. Figure 71c also shows that between 50 and 60 kips of load the curve again becomes linear, indicating that the lateral buckling proceeds at a constant rate between these two loads.

Figure 71 shows that the experimental deflections for the floorbeam test at L_5 do fall between limits of fixed and pinned end supports. The experimental deflection curve is closer to the theoretical curve based on fixed ends, thus indicating a fairly stiff end condition. At higher loads the experimental deflection does move closer to the theoretical deflection based on pinned ends, indicating a loss of stiffness at the ends at higher loads. Figure 73 indicates that the

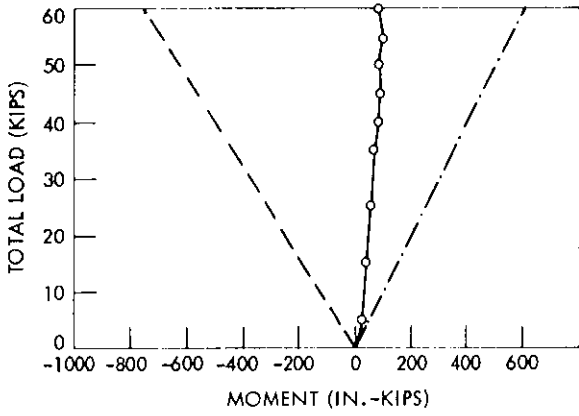
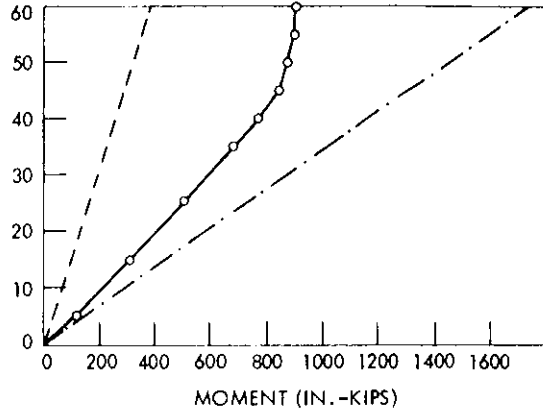
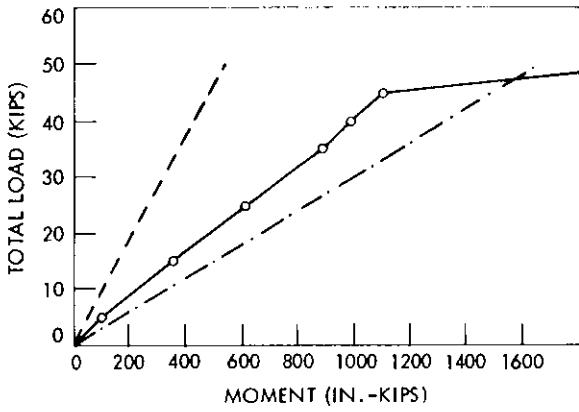
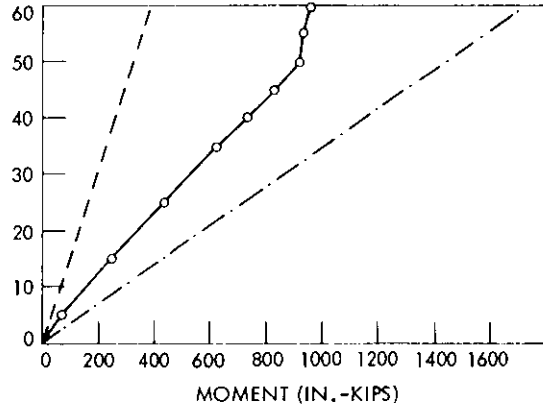
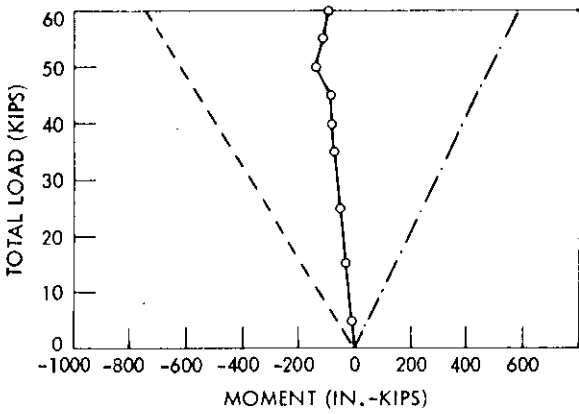
Fig. 72. Load-moment for floorbeam test at L_4 .

The load-moment curves for the floorbeam test at L_4 are shown in Fig. 72. These experimental moments were computed from strain readings from strain gages on the top and bottom flanges of the floorbeam. The strain readings were first converted to stresses, using the same procedure as for the truss members, and these stresses were then transformed into moments on the floorbeam. From these moments it was not possible to determine if any composite action had taken place between the deck and floorbeam. Figures 72b and 72d indicate a departure from linearity at 40 and 50 kips, respectively, indicating the lateral buckling of the beam and a corresponding reduction in the load carrying capacity of the beam. No conclusions can be drawn from Figs. 72a and 72e, because the moments are so small in the end portions of the floorbeam. Figure 72c indicates a trend opposite to that shown in Figs. 72b and 72d. However, this trend is questionable because the strain gages near the center of floorbeam are beyond the yield stress for the steel beam.

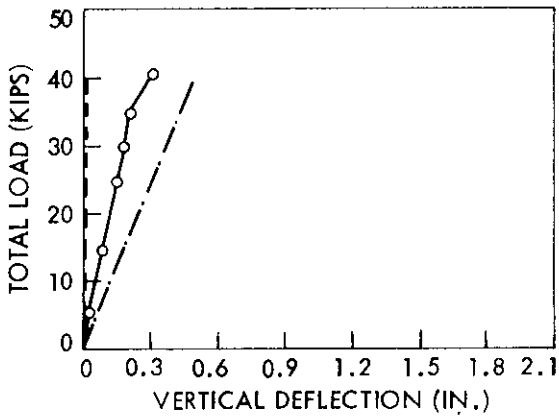
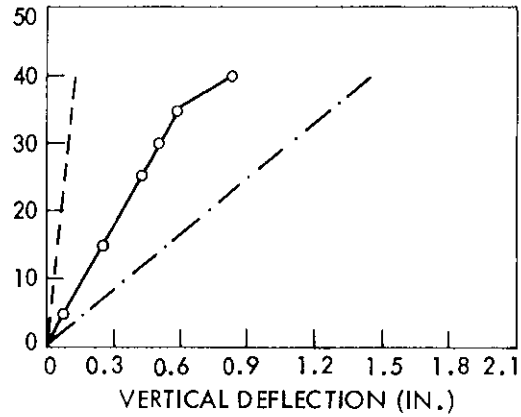
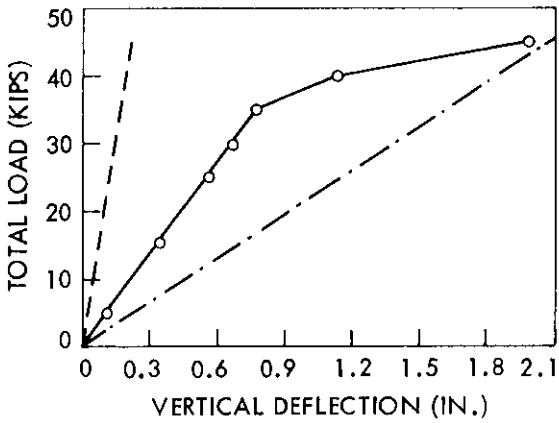
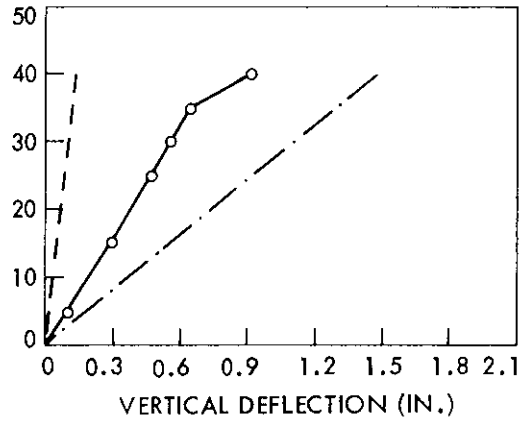
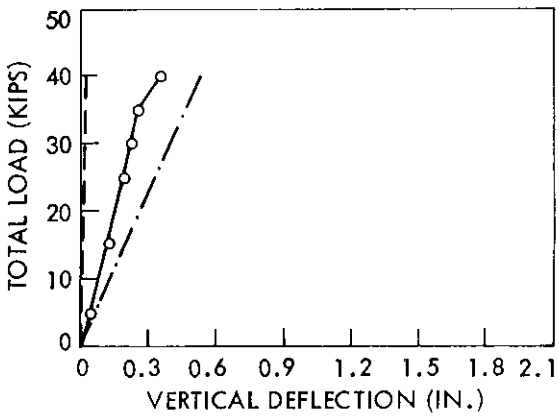
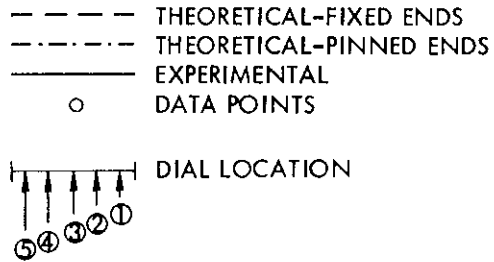
Fig. 73. Load-deflection for floorbeam test at L_5 .

The load-deflection curves for the floorbeam test at L_5 are shown in Fig. 73. This figure indicates a departure from linearity at a load of about 35 kips (H 21 truck). At about the same load the observation was made that the floorbeam was beginning to buckle laterally. This departure from linearity thus gave an indication of the initiation of lateral buckling in the floorbeam. This indicates that the natural dapping of the stringers provides sufficient lateral support of the floorbeam up to about 70% of the ultimate load. Beyond 70% of the ultimate load the floorbeam buckled laterally between the load points and deflected away from the stringers between the load points because

there was no positive tie between the stringers and the floorbeam. Figure 73c shows that between 40 and 45 kips of load the curve again becomes linear, indicating that the lateral buckling proceeds at a constant rate between these two loads.

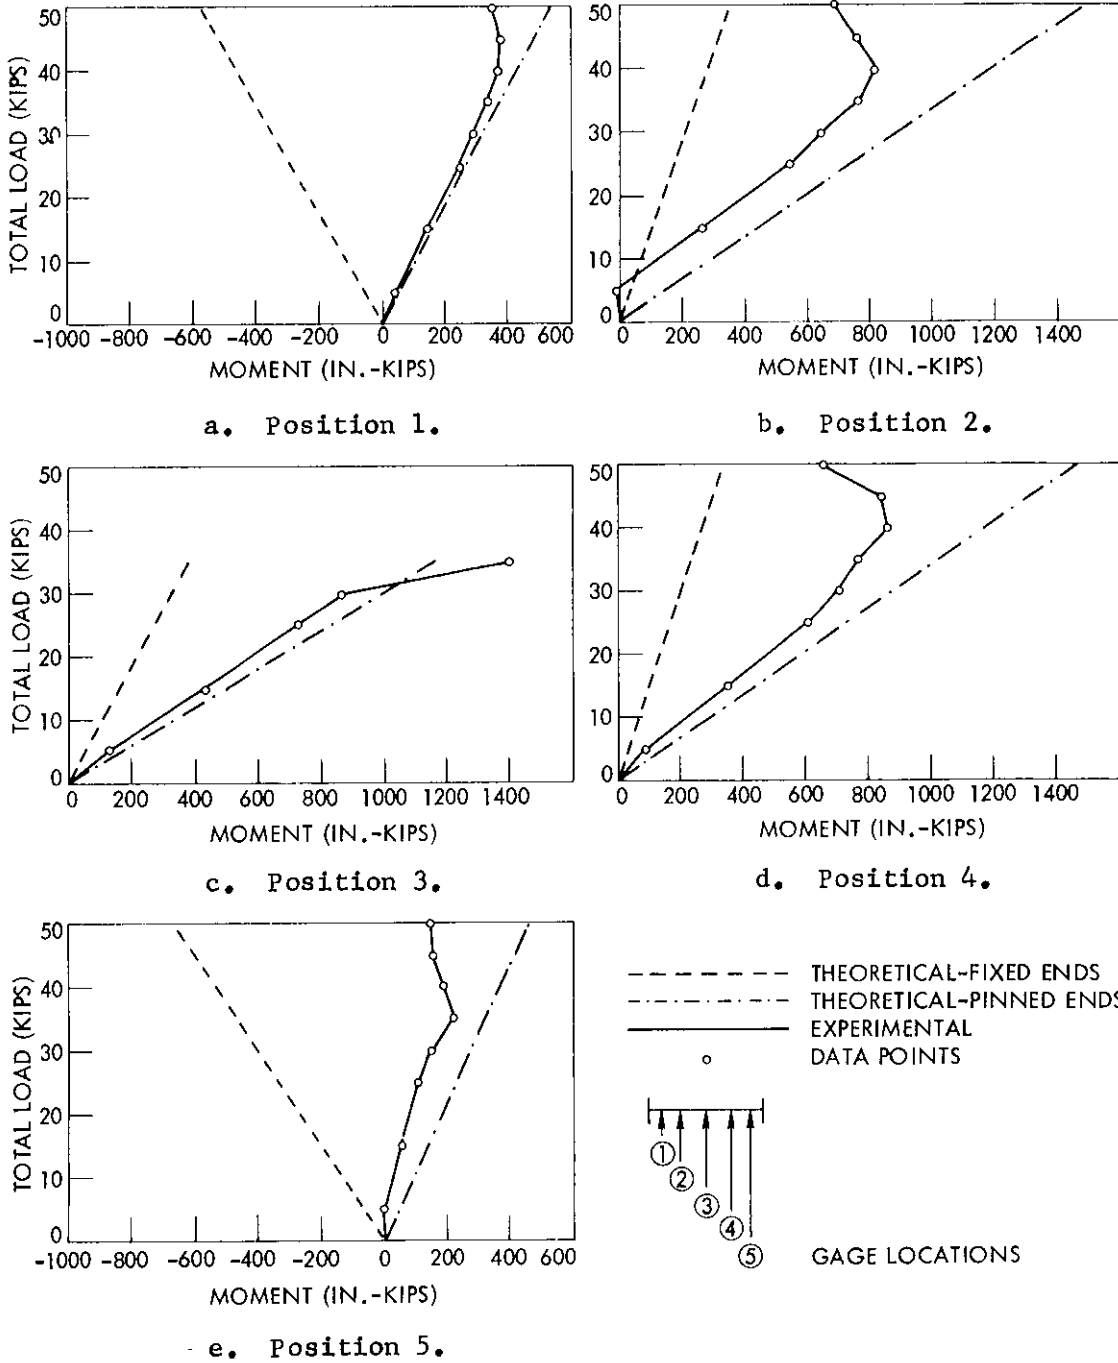
Fig. 74. Load-moment for floorbeam test at L_5 .

The load-moment curves for the floorbeam test at L_5 are shown in Fig. 74. Figures 74a, 74b, and 74d indicate a departure from linearity at about 35 kips, indicating the lateral buckling of the beam and a corresponding reduction in the load carrying capacity of the beam. Figure 74e indicates a behavior which contradicts that seen in Fig. 74a. This contradictory behavior is due to the restraint of the rotation of that end of the floorbeam by a vertical channel on that end of the floorbeam resting against one of the hangers. Figure 74c indicates a behavior similar to that in Fig. 72c, and the same explanation applies for this figure.
