Use of carbon fiber reinforced polymers for the repair of impact damaged prestressed concrete bridges

Brian Jon Kempers

A thesis submitted to the graduate faculty
In partial fulfillment of the requirements for the degree of
MASTER OF SCIENCE

Major: Civil Engineering (Structural Engineering)

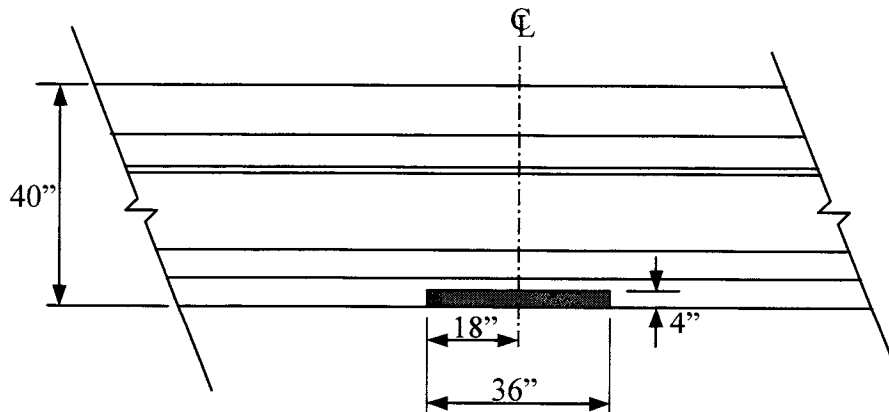
Figure 3.11. View of Damaged Concrete section.

A 3-foot section of concrete was removed from the center of the bottom of the P/C beam. The section was 4 inches deep measuring from the bottom. Four inches was chosen because that left the bottom four strands showing, while the next layer of four strands was still encased in concrete. The four inches taken out also allowed just enough room to be able to patch the damaged area. A large chipping hammer was used for the removal of the concrete, but significant care had to be taken so as not to sever any of the prestressing strands. The damaged section is shown in Figure 3.11, and a photograph of the damaged area is shown in Figure 3.12.

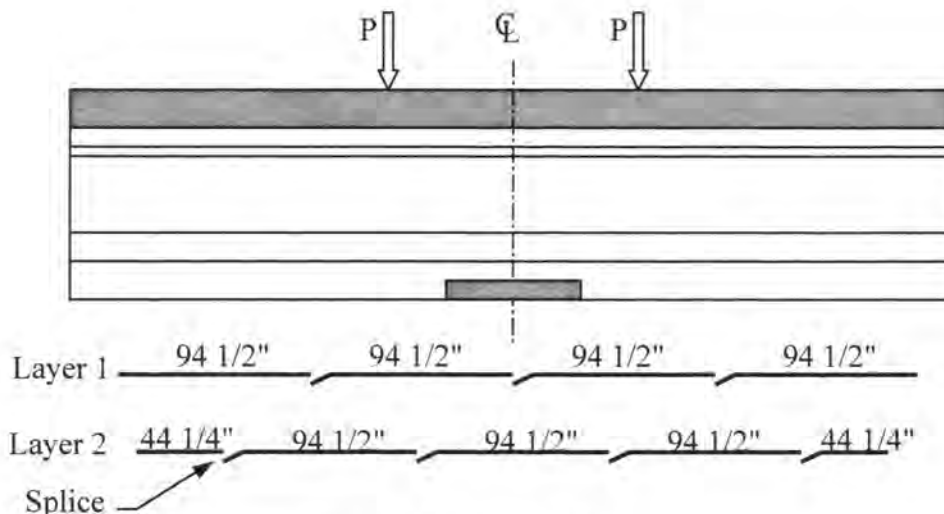
Figure 4.2. CFRP splices.

The second layer of carbon fibers strips was staggered at half intervals from the first layer as shown in Figure 4.2. The A strips were 94 ½ in. strips, and the B strips were 44 ¼ in. strips.

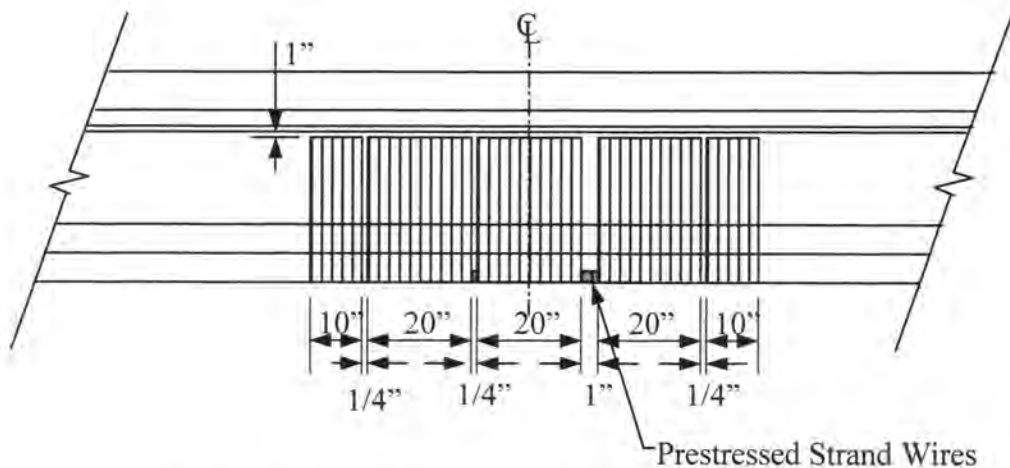
Figure 4.3. Layout and dimensions of transverse wrap.

A CFRP wrap was adhered to the center of the P/C beam to help contain the patch. The wrap extended 40 in. both ways from the center of the beam, which was the entire length of the patched area. Five strips were cut to cover this area: three were left their nominal 20 in. wide, and two were cut down to 10 in. The sizes were chosen to avoid the wires from the prestressed strand gages that stuck out from the patch. All of the strips were approximately 6 ft. long to allow them to cover the entire bottom flange and reach up to cover the entire web leaving only an inch from the bottom of the top flange.

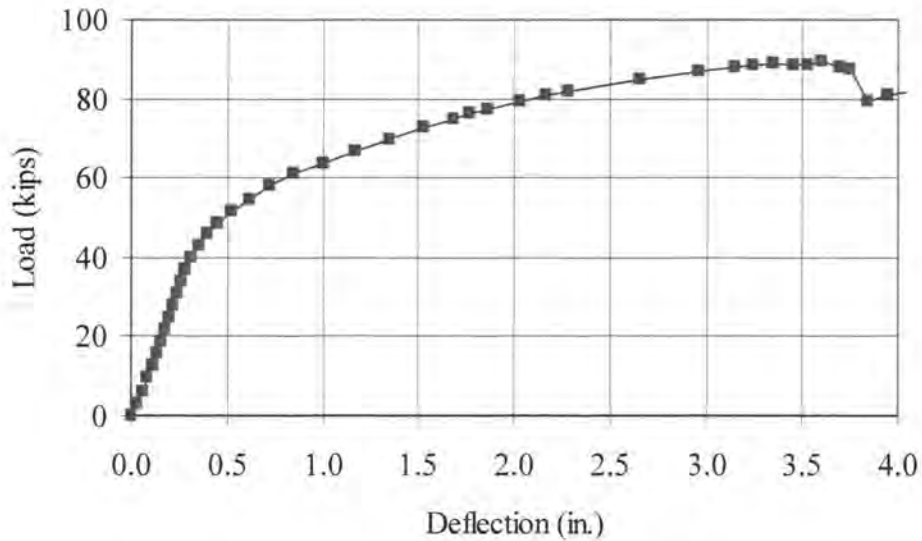
Figure 5.3. Load vs. centerline deflection in laboratory ultimate load test.

After completing the cyclic loading and the service tests, the beam was statically loaded to failure. The ultimate load test deflection results are presented in Figure 5.3; cracking of the beam occurred at approximately 44 kips. With increased loading, the CFRP sheets began to make popping noises at approximately 75 kips. The maximum load reached was 89.4 kips per actuator before a major drop in load occurred. Failure resulted when the CFRP and epoxy caused the concrete to delaminate. Concrete was attached to the CFRP after failure indicating that the epoxy bond was not the cause of the failure.

The mid-span deflection just prior to failure was 3.61 inches. The total applied load of 178.8 kips was greater than the maximum load measured in previous tests of similar CFRP reinforced beams. A similar beam tested with the same longitudinal CFRP and a wrap only around the bottom flange of the beam, (not extending up the web), reached 167.2 kips before failure. Thus, the additional wrap length on the web more than likely increased the failure load. This repaired beam was more ductile than previously repaired beams as it reached a deflection of 3.61 in. before failure occurred. The largest deflection at failure for the

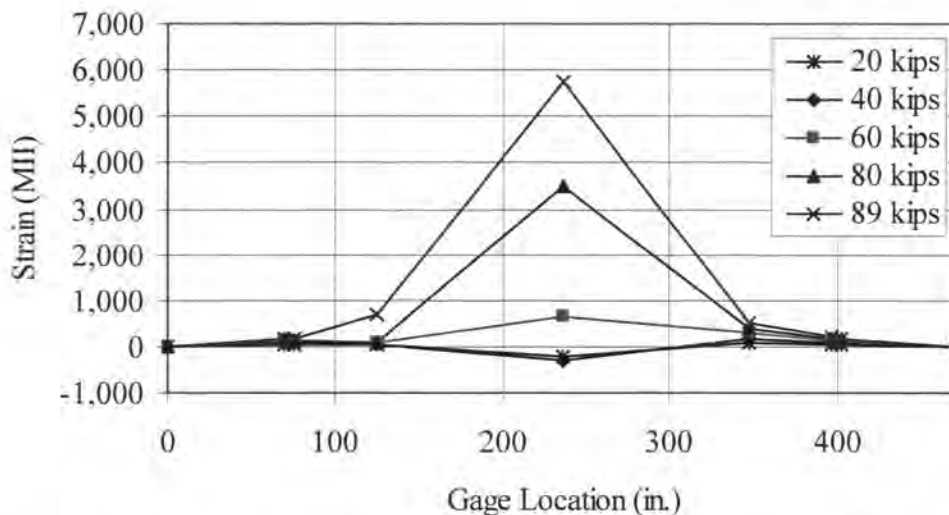
Figure 5.5. Tensile strains along the CFRP sheets in laboratory beam.

The strains in the longitudinal CFRP reached a maximum of 5,850 MII at the failure load, while the maximum strains measured in previous laboratory beam ultimate tests were 5,300 MII or less. The full web wrap previously described prolonged the delamination, thus allowing the beam to reach higher loads. The design strain for the CFRP sheets as stated by the manufacturer was 16,700 MII. Obviously, with the CFRP only reaching 35% of its design tensile capacity, it was not the cause of failure. The longitudinal strains in the CFRP are shown in Figure 5.5.

The strains appear to be quite symmetric under the symmetric loading conditions, although at one of the quarter points, the increase in strain from the 80 kip load to the 89 kip load looks larger than the increase at the other quarter point. This strain increase could be an indicator of an eventual failure mode. The strains near the termination points of the CFRP were still quite low, 194 MII at failure, therefore, debonding near the end of the CFRP was not a cause of failure.

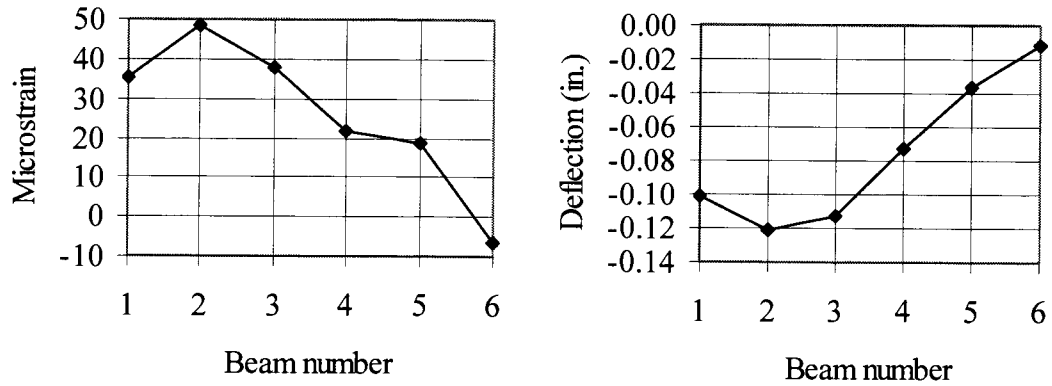
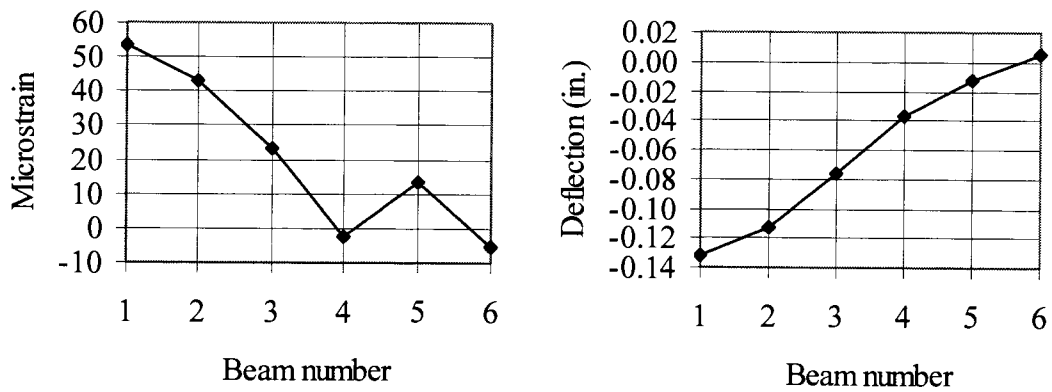
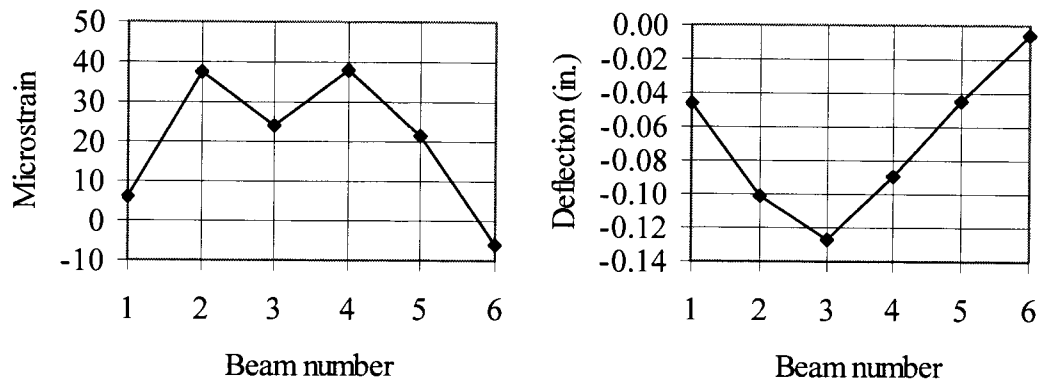
Figures 5.9 through 5.11 show strains and deflections at mid-span of the damaged bridge for Load Cases 13, 19, and 23 (see Table 3.4). Two loaded trucks were placed at various locations along the bridge to measure the strain and corresponding deflection in the beams prior to the CFRP repair. The trucks weighed a combined 102,200 lbs (see Table 3.3). The plots reference the static load cases shown in Table 3.4; these load cases were chosen because they caused the largest strains and deflections at mid-span from two truck loading. The data plots in all three cases show a nearly normal distribution of load among all the beams, except for jump or dip in strain visible on all three strain plots. Several factors were considered when trying to explain the behavior of the structure but no conclusion was finally settled upon. Initially a faulty strain gage was suspected, but an extra strain gage was placed near the existing gage on Beam 5 and it produced similar results, so the abnormal strain curve was left without a logical explanation. The bridge must have been distributing the load in an unusual fashion.

value of 0.31 was computed in Beam 2 from the strain readings of the damaged bridge test, and a value of 0.27 was computed from the deflection data for the same beam. These values were taken from the results from Load Case 13, which caused the highest strains in Beam 2. The actual load distribution factor of the bridge was lower than the design distribution factor. The maximum strain Beam 2 reached was 49 MII which is much less than the 185 MII that was calculated using the AASHTO distribution factor, so it appears that the other beams could be assuming some of the load or that the distribution factor is quite conservative.

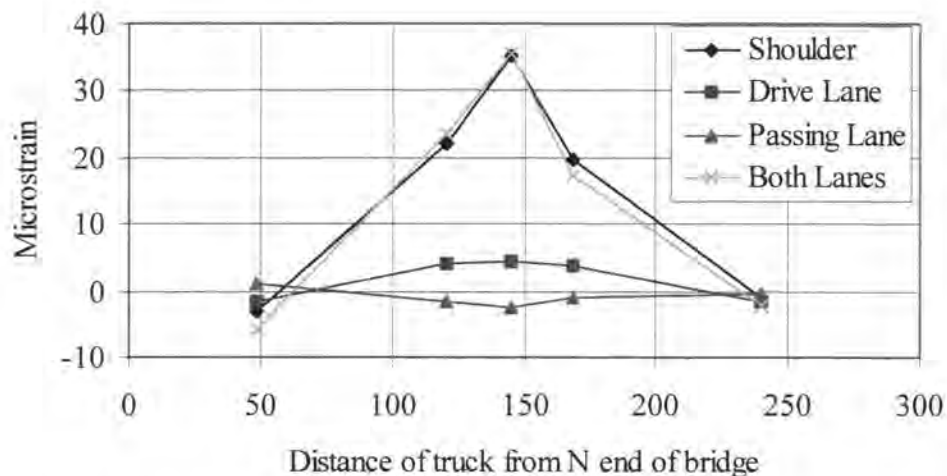
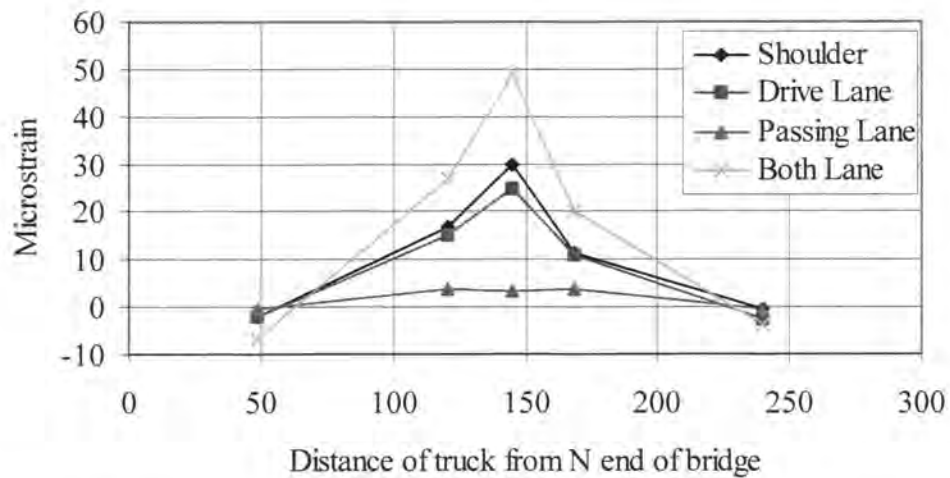
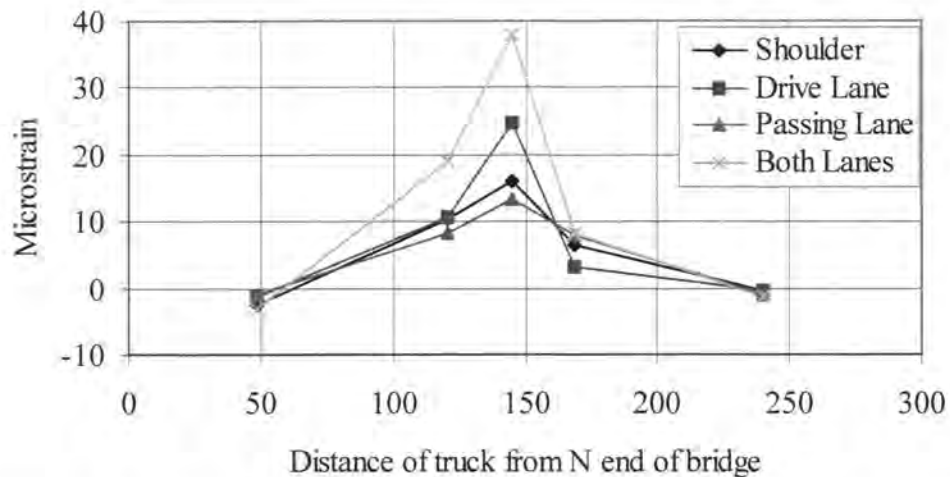
Figure 5.12 through 5.14 show the strain at the center of span 2 as a function of truck position for a single truck placed at five locations along the length of the bridge, and when both trucks were side-by-side at the same five locations. By doing this, the behavior of the more heavily damaged girder can be compared with two girders that only incurred concrete damage. The five positions were the midpoint of span 1; $\frac{1}{4}$, $\frac{1}{2}$, $\frac{3}{4}$ points of span 2; and midpoint of span 3. For all three girders, the strains are either zero or negative when the truck was positioned in Span 1 or 3, showing some moment continuity in the girders. The strains were the largest in the most heavily damaged girder (Beam 2), reaching almost 50 MII, but this can be attributed to the location of the wheel load, which was almost directly over Beam 2, and not the damage.

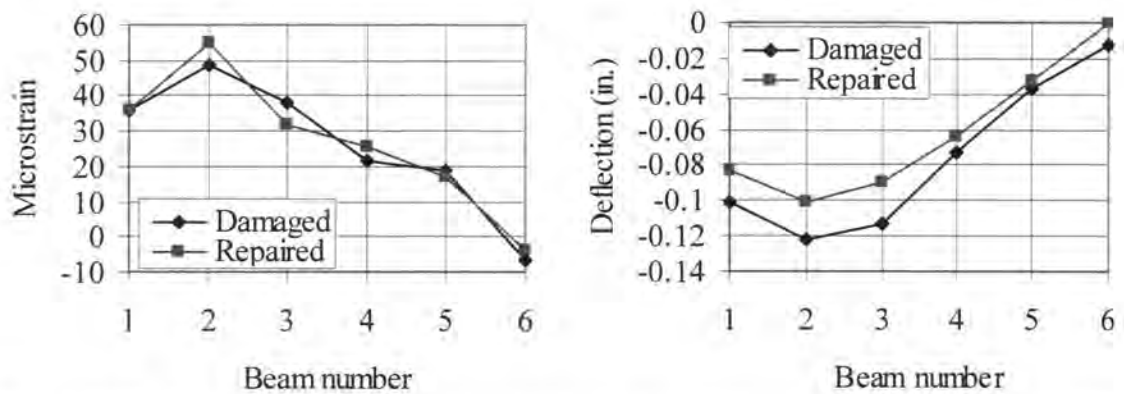
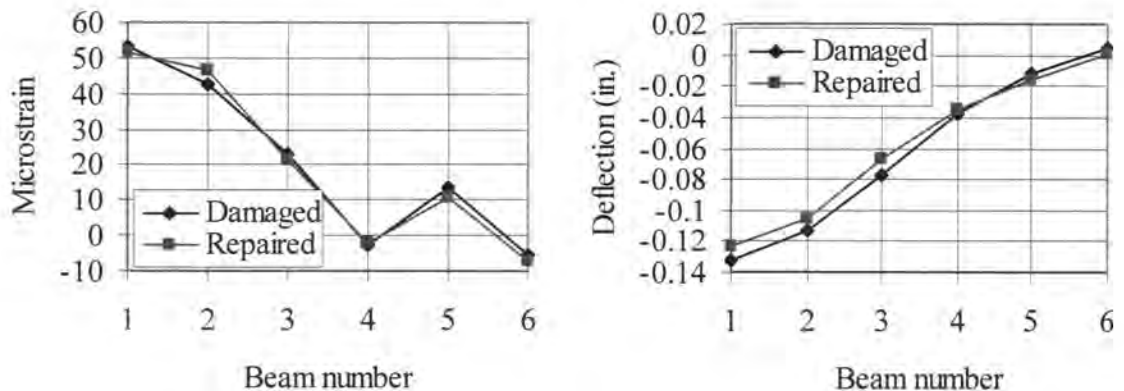
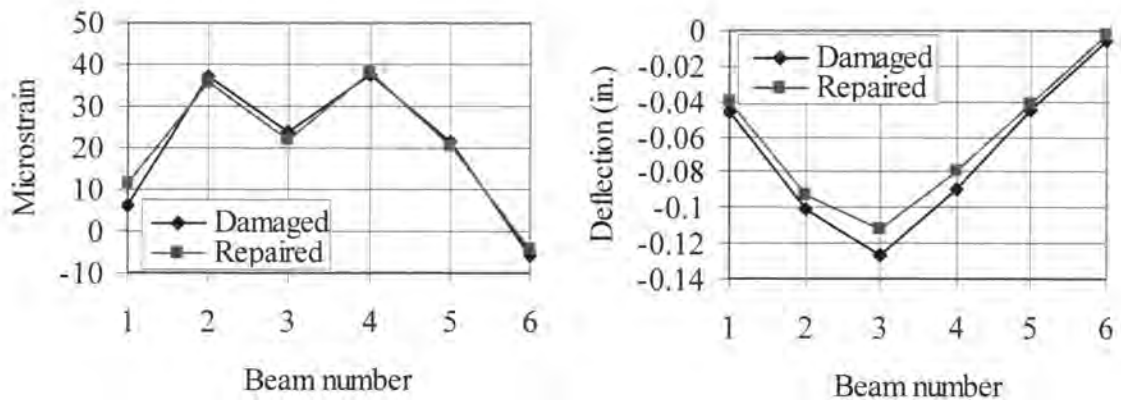
As shown in figures 5.15 through 5.17, the deflection in some of the beams decreased by up to 20%, which could be due to the repair or the positioning of the load trucks during the testing. The strain distribution also appears to have changed slightly, although the unusual jumps and dips evident in the first test are still observed in the repaired bridge test. In all three strain plots, the repaired Beam 2 has slightly higher strains than in the damaged tests, while Beam 3 has slightly lower strains. The addition of the CFRP plates slightly increased the stiffness of the repaired beam causing it to attract more of the load than in the first test. The plates slightly increased the moment of inertia approximately 5%, but the decrease in strain due to this increase was only calculated to be approximately 1%. The load factor computed from the strains of the bridge test was 0.32, and the load factor computed from the deflections was 0.27. The load factor computed from the strain increased with the addition of the CFRP, while the load factor computed from the deflection data stayed the same as the first test.

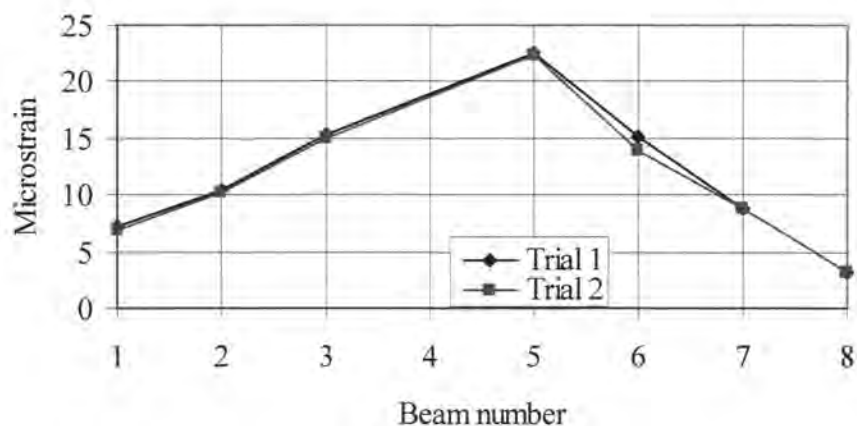
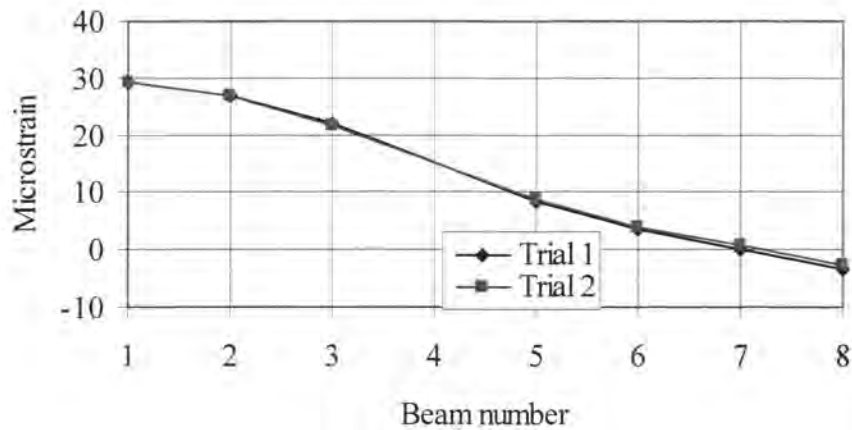
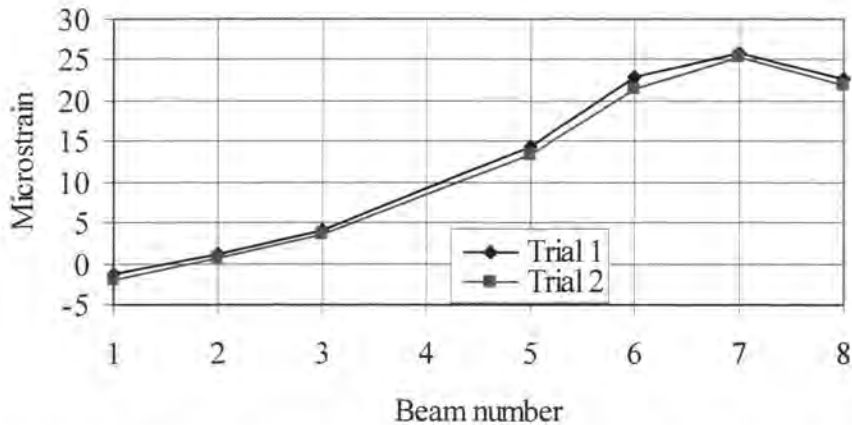
The strains in the extreme outside beams for the center load case, Load Lane 3, were quite small ranging from 3 to 7 MII. The damaged beam did not appear to exhibit any abnormal behavior, as it appeared to behave almost symmetrically to the beams on the opposite side of the bridge, which were undamaged. The strains in the beams at the center of the bridge only reached a maximum of 23 MII, and the highest measured strain in the bridge was 30 MII. This level of strain is extremely small for beams this large and is nothing that should cause any worry or indicate that the bridge is in any danger of failure.

A distribution factor of 0.39 was calculated for this bridge using the 1996 AASHTO LFD Bridge Design Specification manual. A value of 0.28 was computed in Beam 1 from the strain readings of the damaged bridge test for the northernmost truck loading, which caused the largest strains in the damaged beam. The calculated factor is higher than the actual factor, which shows that the undamaged beams were assuming more of the load, or the distribution factor used by AASHTO is quite conservative.

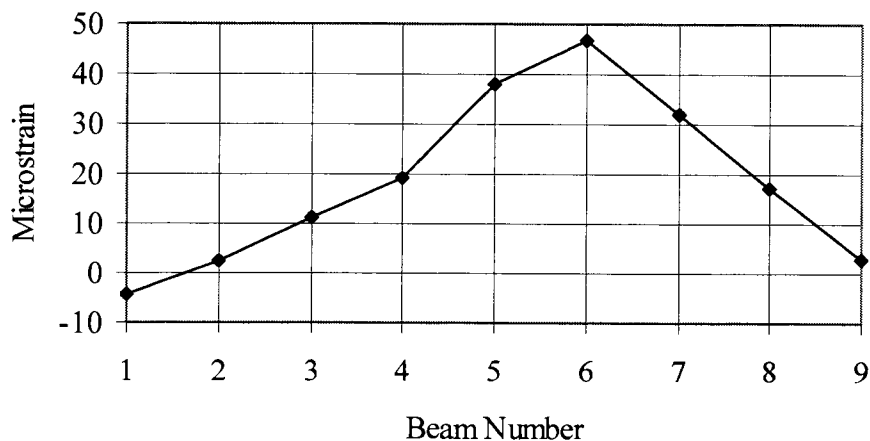
Figure 5.21. Strain at midspan in the De Soto bridge for Load Lane 1.

Figures 5.21 through 5.23 show the transverse strain behavior of the nine beams during the loading for all three load positions. The loaded truck traveled three different loading paths for the test, making each pass twice. The load lanes included the center of the driving lane, the center of the passing lane, and the shoulder on the passing lane side. Beam 9 was the damaged beam, which was on the south side under the passing lane shoulder.

The highest strain recorded for any of the load cases was less than 50 MII, and were always located in the beam directly below the loaded lane. The highest strain in Beam 9 when the trucks were in the normal traveling lanes, (driving and passing lanes), was less than 12 MII. The damaged beam did not appear to have higher strains than would be expected on an undamaged bridge, since Beam 9 behaved similarly to Beam 1 for symmetric loading conditions. It can be concluded that the loss of only one strand out of nine beams is fairly insignificant for service loads.

A distribution factor (based on design assumptions) of 0.44 was calculated for this bridge using the 1996 AASHTO LFD Bridge Design Specification manual. A value of 0.30 was computed in Beam 9 from the strain readings of the bridge test for Load Lane 3, the left shoulder loading, which caused the largest strains in the damaged beam.

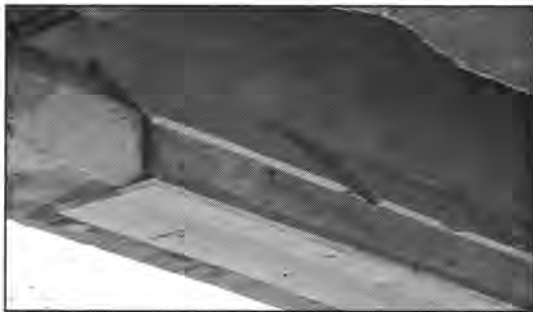
Figure A1. Formwork example.

Step 1: Repair concrete using mortar and epoxy injections according to current standards available. Forms must be used to maintain the original shape of the beam. Figures A1 and A2 show formwork and a completed patch.

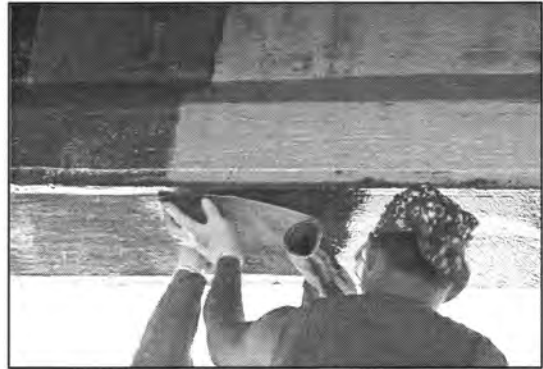
Figure A17. Four inch overlap splice.

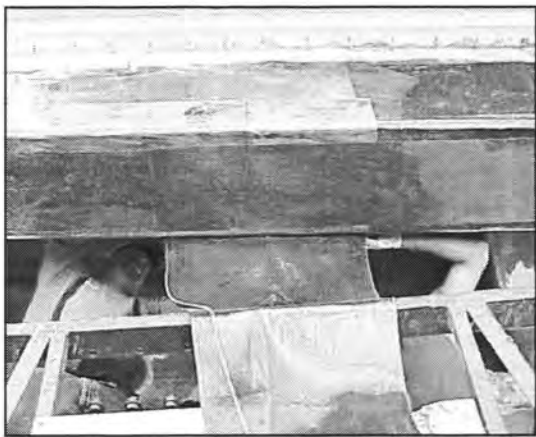
Figure A18. Transverse wrap over the longitudinal FRP.

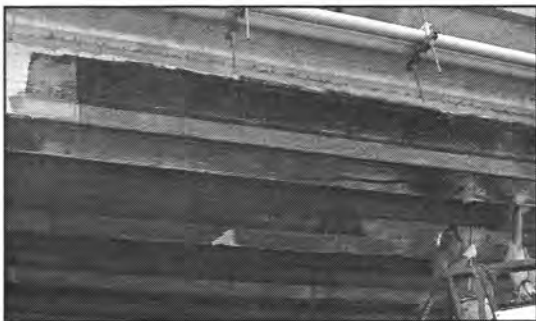
Figure A20. Entire beam after the longitudinal and transverse FRP are installed.

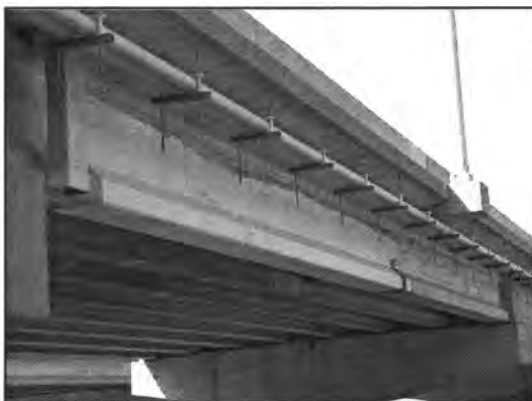
Figure A23. Final view of completely repaired bridge.
