Using Soybean Oil Soapstock for Stabilizing Granular Shoulders

Using soybean oil soapstock for stabilizing granular shoulders

Major: Civil Engineering (Construction Engineering and Management)

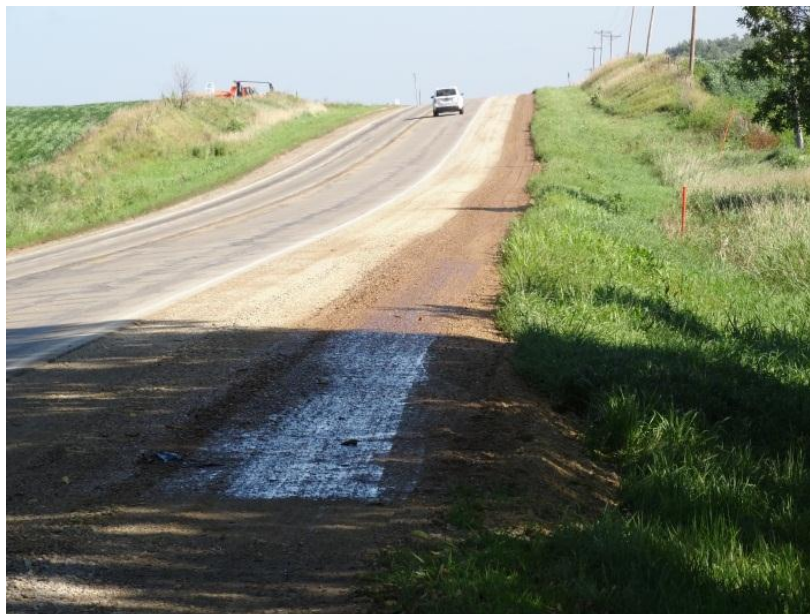
4. After the water had soaked in for about half an hour, the soapstock was sprayed on the moist shoulder by the soapstock distributor. A worker rode on the back of the spray rig to control the number of operating nozzles and ensure the soapstock was distributed evenly on the shoulder at the proper width. This process is shown in Figure 8. Usually, the width of sprayed soapstock was four feet, which required two nozzles working simultaneously. In north of Leland, soapstock was applied at full width going up to the hill, because gullies caused by water erosion were developed near the grass line. The applied result was shown in Figure 9.

Figure 9. Soapstock applied on the shoulder of US 69 up the hill near Leland

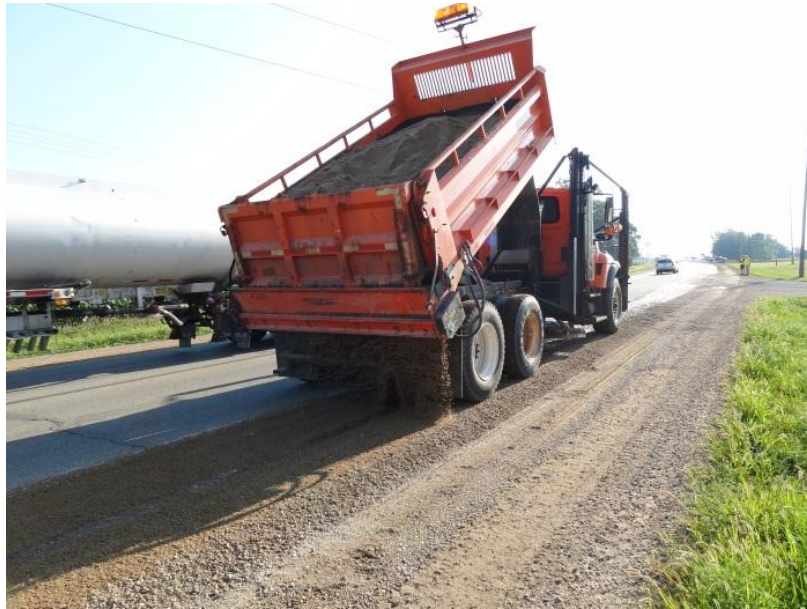
5. After soapstock was applied for 15 minutes to 20 minutes, two sand trucks with the modified chip spreader started to spread a thin layer of sand over the treated surface. The thickness of sand was about half an inch, and the width of sand was adjusted based on the width of soapstock applied on the shoulder. Another sand truck was waiting aside for back-up. When the sand in one truck ran out, the back-up truck would run forward and the empty one would go back for a new stock. The result of this application is shown in Figure 10.

Figure 10. Sand applied on the shoulder of US 18 near Garner

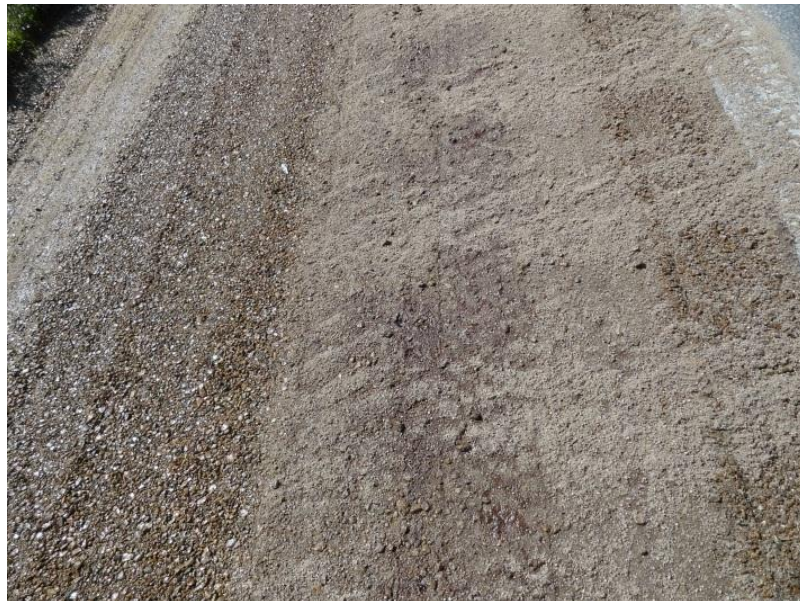
In one place, the recycled asphalt paving material was newly spread on the shoulder. After the soapstock and sand was applied to it, the mixed material looked much like dense-graded aggregate, which had a significant amount of fine particles (Figure 11).

Figure 11. Soapstock and sand applied to recycled asphalt paving materials

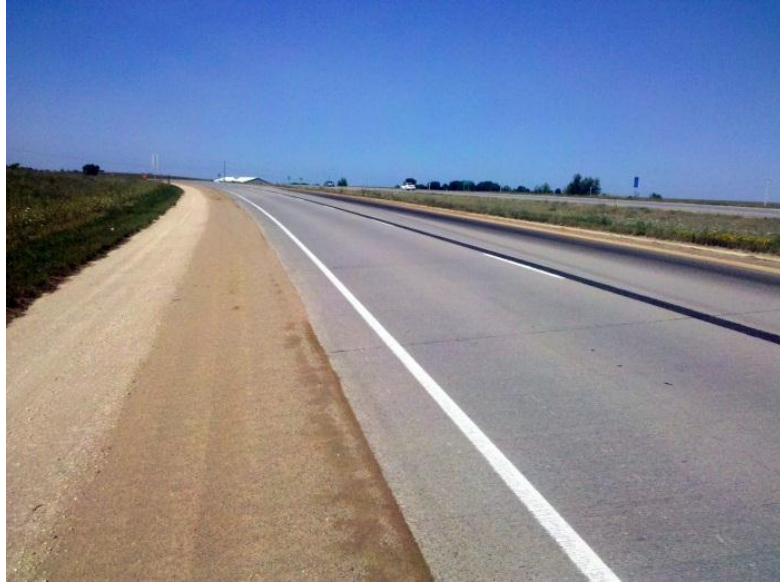
Work Location 2.02 was located on curves of US 63 near Denver. This highway is a four-lane divided highway with a traffic level heavier than the targeted level (6000 ADT). Soapstock was applied on both outside and inside shoulders and adjacent to both southbound and northbound lanes. The result of one section of the treated shoulder is shown in Figure 13.

Figure 13. Soapstock and sand applied on the shoulder of US 63 near Denver

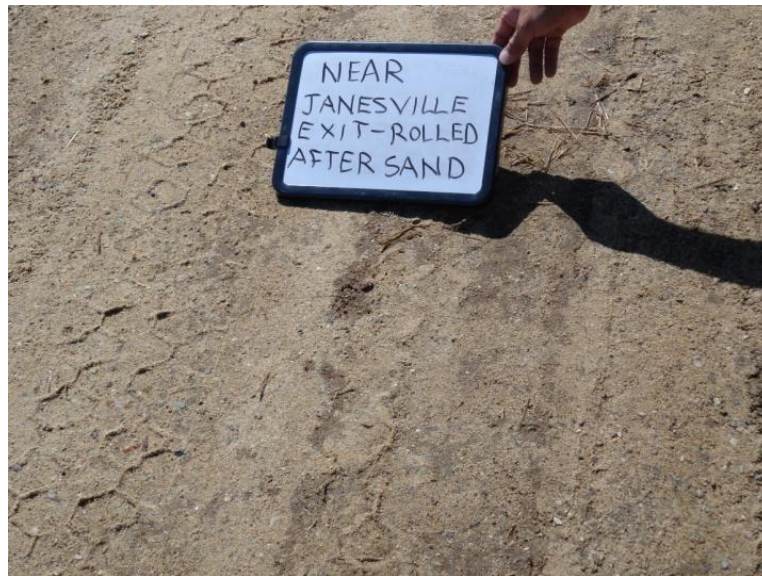
In the same location 2.02, one action observed by researchers might be meaningful for a successful application. Near Janesville exit on US 63 near Denver, the treated surface was rolled after the sand application. The result of this was shown in figure 14.

Figure 14. Surface rolled after sand application for the shoulder of US 63 near Denver

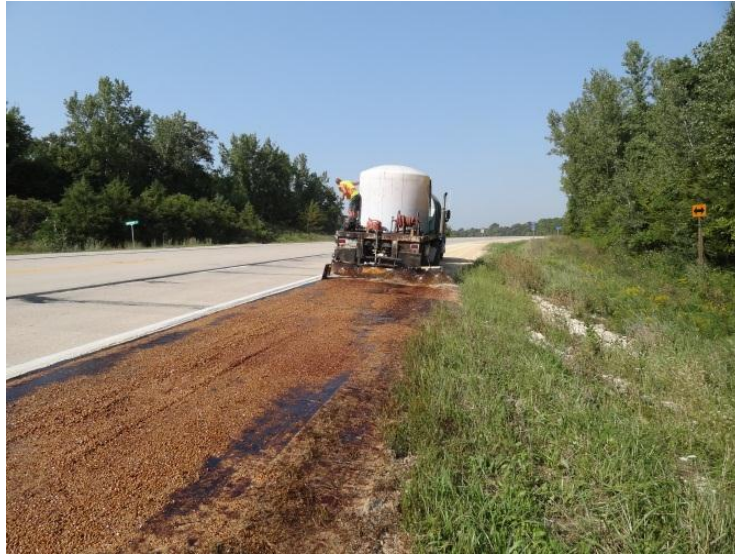
On September 1 of 2011, the weather was sunny and dry in Elkader. On September 2 of 2011, the weather was cool and cloudy with intermittent rain in some places. The general construction activities were performed following the same procedures described earlier for Area I. For location 3.03-3.04 near Elkader, soapstock was applied at 12-ft width because of the gullies developed near the grass line, as shown in Figure 15. The result of one section after sand was just spread on is shown in Figure 16. For location 3.08-3.10 south of Elgin, the shoulders were much narrower than the ones in other places. Thus, soapstock was sprayed at 2-ft width. The road had been temporarily closed during the application.

Figure 15. 12-ft wide soapstock applied on the shoulder of IA 13 near east of Elkader

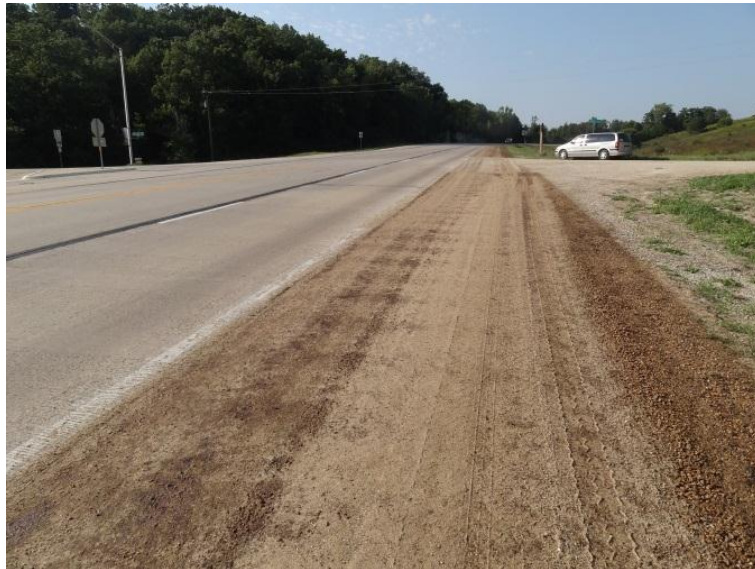
Figure 16. Sand applied on the shoulder of IA 13 near east of Elkader

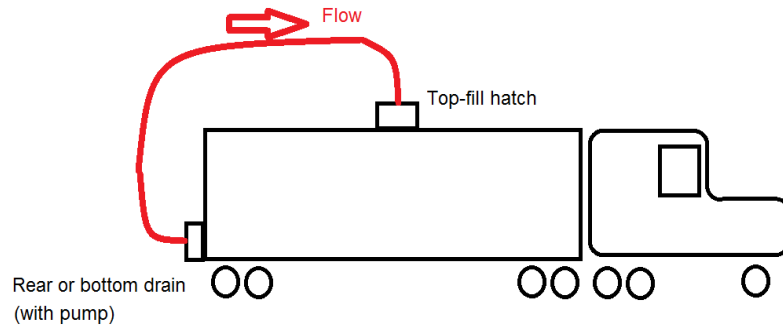
One action drew researchers' attention when Jerry Boer used the plastic pipe and pump to recirculate soapstock from the bottom to the top of the storage tank (Figure 17). The day before this action, the treatment showed inconsistent results between the morning and

afternoon work session, which was believed to be a consequence of soapstock segregation. According to Jerry Boer, material with low viscosity tends to settle down to the bottom, while material with high viscosity tends to flow to the top. After the soapstock was circulated, its viscosity was more consistent, so it could be evenly distributed and provide better performance.

Figure 17. Recirculating Soapstock to provide more consistent density (by Richard Harris)

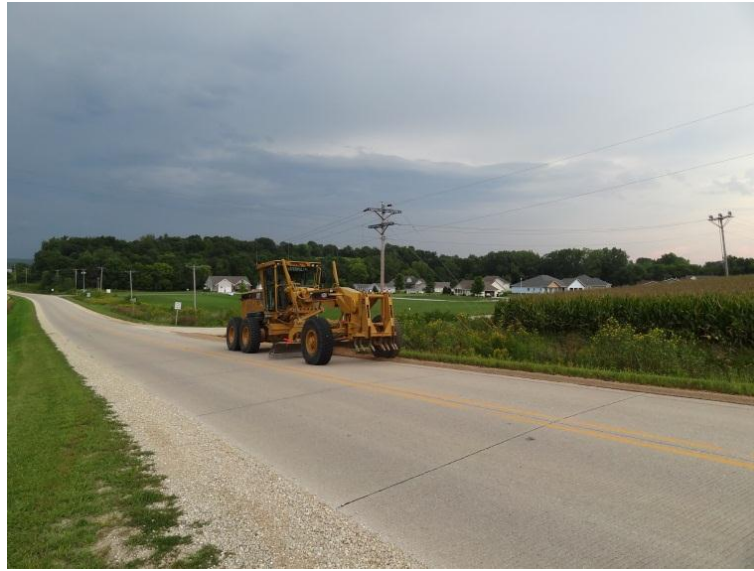
While applying soapstock onto Fayette County W51, the county maintenance crew developed an alternate method for placing sand over the soapstock. A county truck placed sand on the white line by using an edge rut chute. Then, the motor grader bladed sand over the surface on which the soapstock was applied (Figure 18). This worked well for places where the shoulder surface was lower than the pavement, but not for places where the shoulder surface was higher than the pavement. The newly applied soapstock on a higher shoulder surface would be scraped off the shoulder by the motor grader blade.

Figure 18. Grader bladed over the shoulder applied with sand

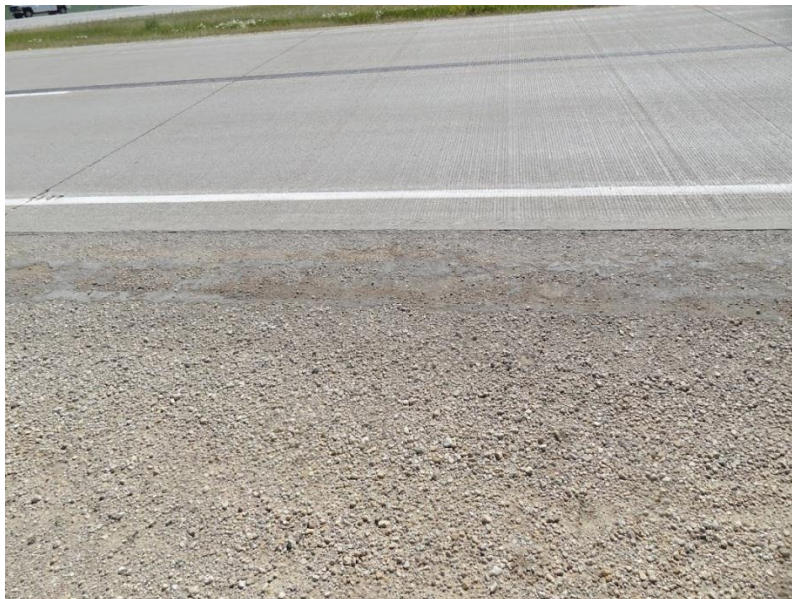
Figure 25 provides an example of good shoulder performance for this area. This shows a shoulder section of IA 3 on adjacent to the eastbound lanes just east of Waverly, where a thick layer of soapstock remained firmly on the shoulder. Another example was shown in figure 26. The shoulder section was on US 63 near Denver, where soapstock had penetrated into the shoulder and could not be easily seen.

Figure 25. Southbound outside shoulder of US 63 near Denver
