# Constructability Testing of Folded Plate Girders

CONSTRUCTABILITY TESTING OF  
FOLDED PLATE GIRDERS

A THESIS

Presented to the Faculty of  
The Graduate College at the University of Nebraska  
In Partial Fulfillment of Requirements  
For the Degree of Master of Science

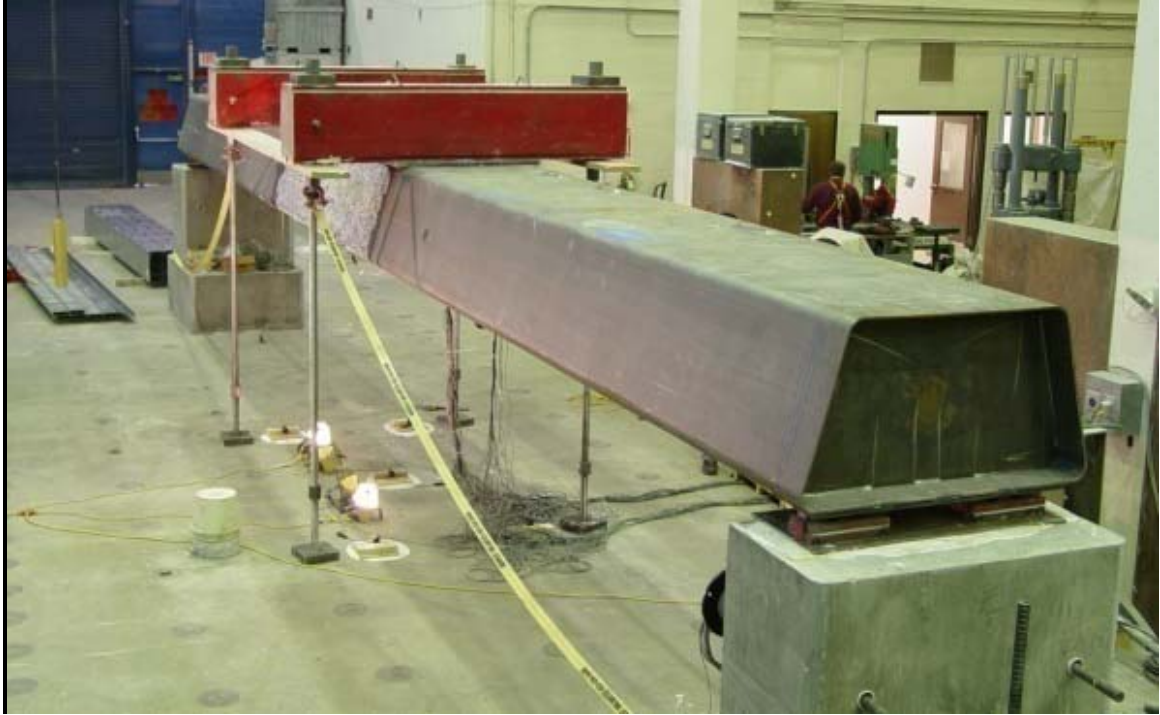
**Figure 2-8 Test A1 setup**

Load was applied using spreader beams with Threaded rods that passed through the floor and into the basement as can be seen in Figure 2-8. Bearing pads were placed between the spreader beams and the top of the girder. In the basement, there were hydraulic cylinders on each bar that created the downward loading during testing. Bracing was added between spreaders to stabilize the load setup during assembly.

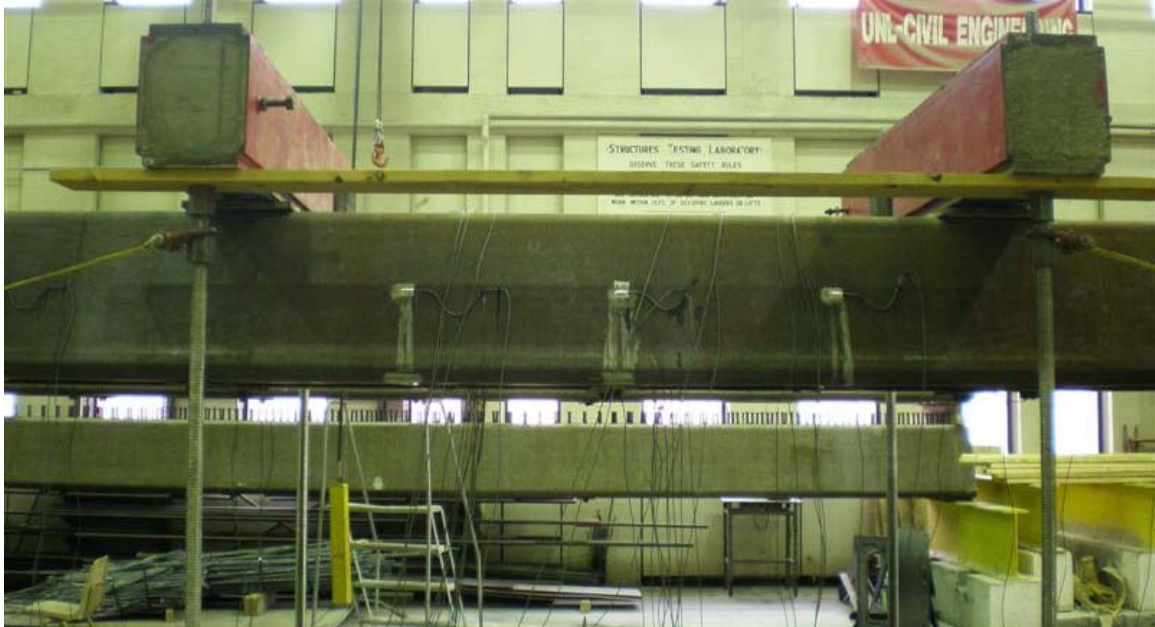
**Figure 2-12 Load points**

The goal of the tests was to observe how the girders would behave in a non-composite situation such as that experienced during construction. Since the continuous loading of a wet concrete slab was unable to be simulated, the system was tested using two discrete load points. The use of two load points provides a constant moment between the load points. The location of the load points was selected to encompass the area of greatest interest. Two symmetric load points were located 4.5 feet from the span centerline as can be seen in Figure 2-12.

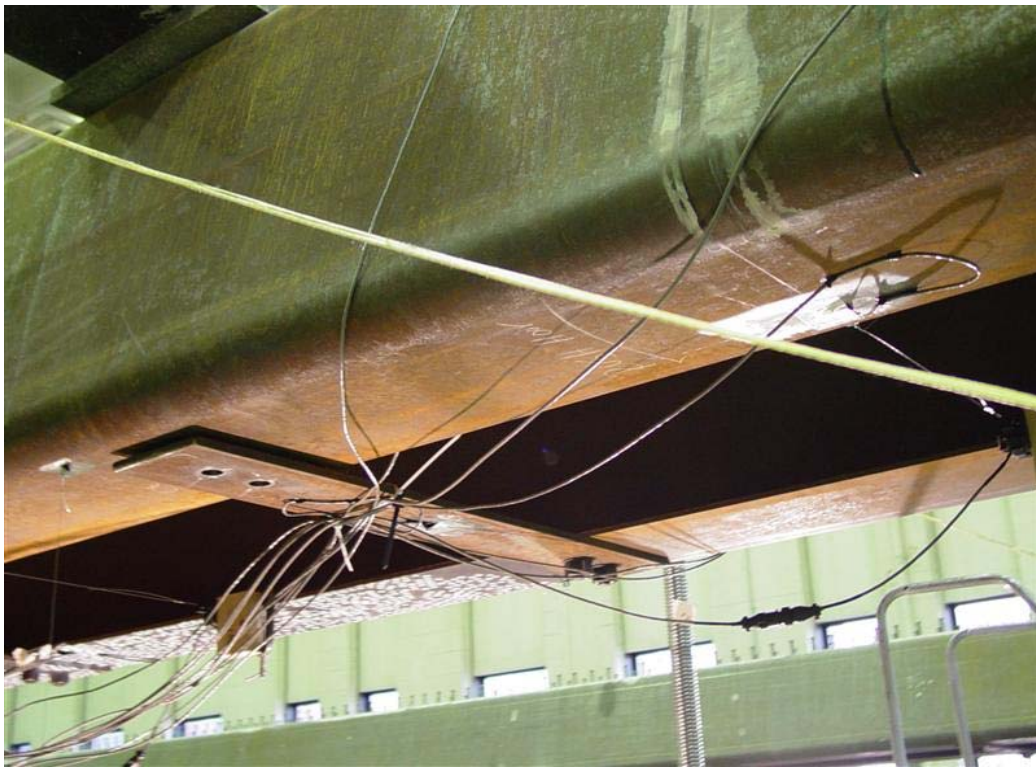
**Figure 2-13 Disconnected tie plate at section H**

Specimen A was loaded to failure during the second phase of loading. During ultimate loading, the middle three tie plates were not connected. The tie plates were disconnected by removing the bolts at one end of the tie plates as can be seen in Figure 2-13. The Specimen A was tested without stiffener plates at the loading points. The second specimen, Specimen B, had the stiffener plates added at the load points to reduce the local deformation behavior due to stress concentrations caused by the concentrated loads. During Test B1, all tie plates remain installed throughout testing. Specimen B was loaded to failure.

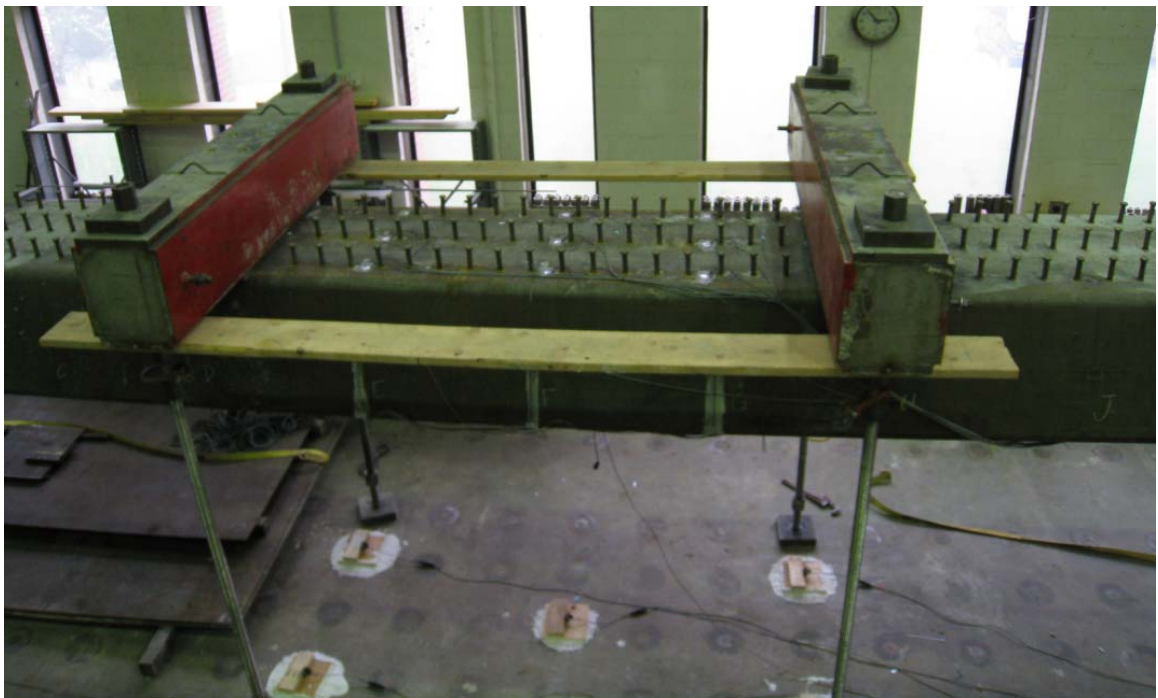
**Figure 2-14 Test B1 setup**

Shear studs can be seen on the top flange of Specimen B in Figure 2-14. Specimen A did not have shear studs on the top flange. Originally, Specimen B was going to be used for a composite test. After the first test, it was desired to do a second non-composite test. Specimen B was available and was selected. The shear studs were removed from the load points so that loading would not be affected. The presence or absence of shear studs had no effect on the performance of the girders.

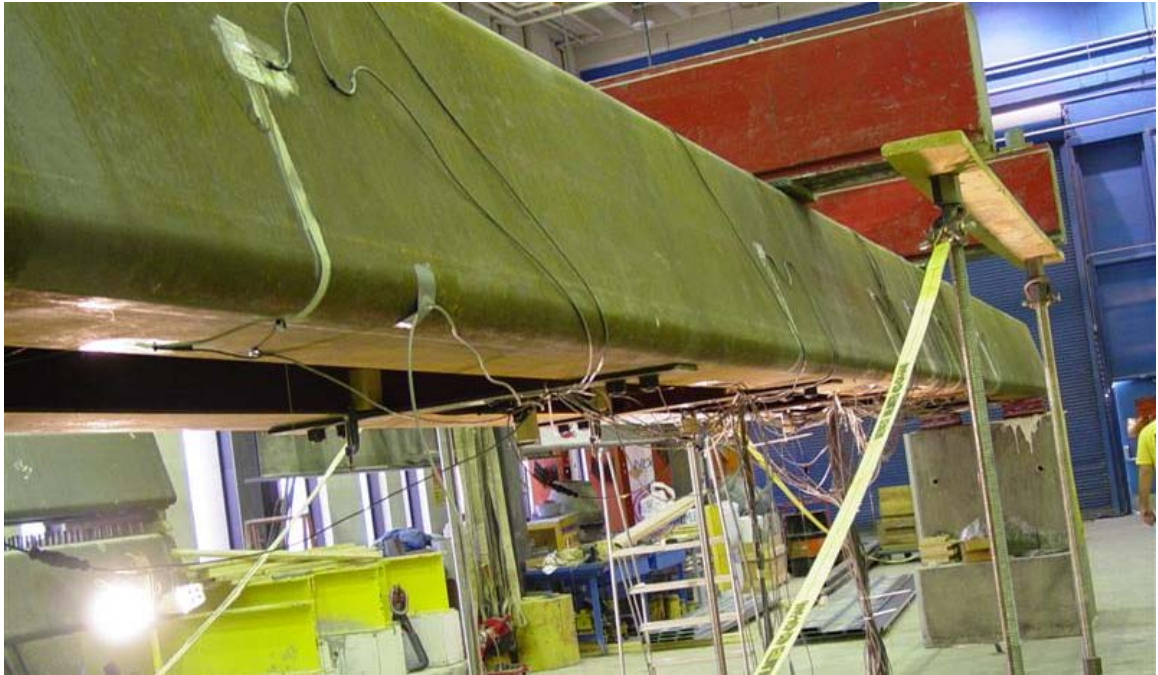
Figure 3-4 Specimen A before testing

Figure 3-4 through Figure 3-9 show the girder before and after the top flange and web buckle. Figure 3-10 shows the buckling of the top flange and web from inside the girder.

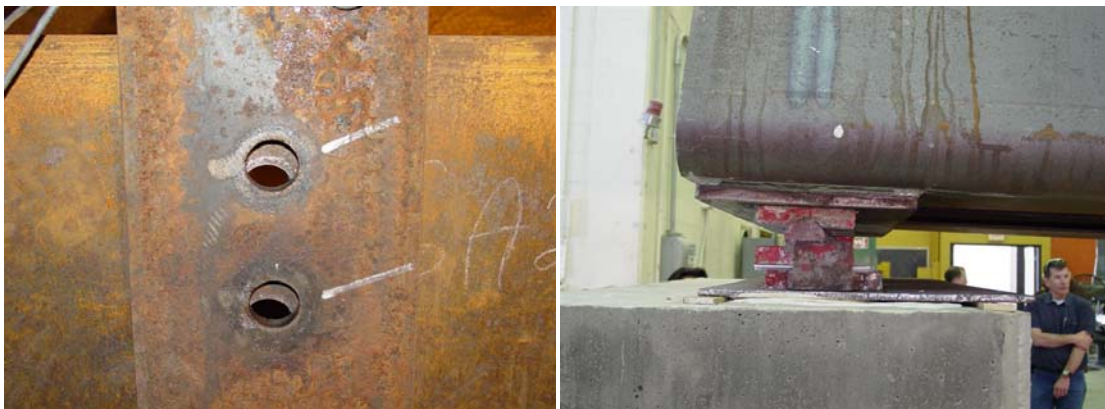
**Figure 3-17 (left) Flange and tie plate bolt hole alignment after loading, (right) girder movement at support.**

Following the three load sequences, the tie plates at sections D, F, and H were removed and the ultimate test was performed. Figure 3-17 shows the girder deformation after testing was concluded. The bolt holes in the bottom flange and tie plate, which were once aligned, are now offset because of bottom flange separation.

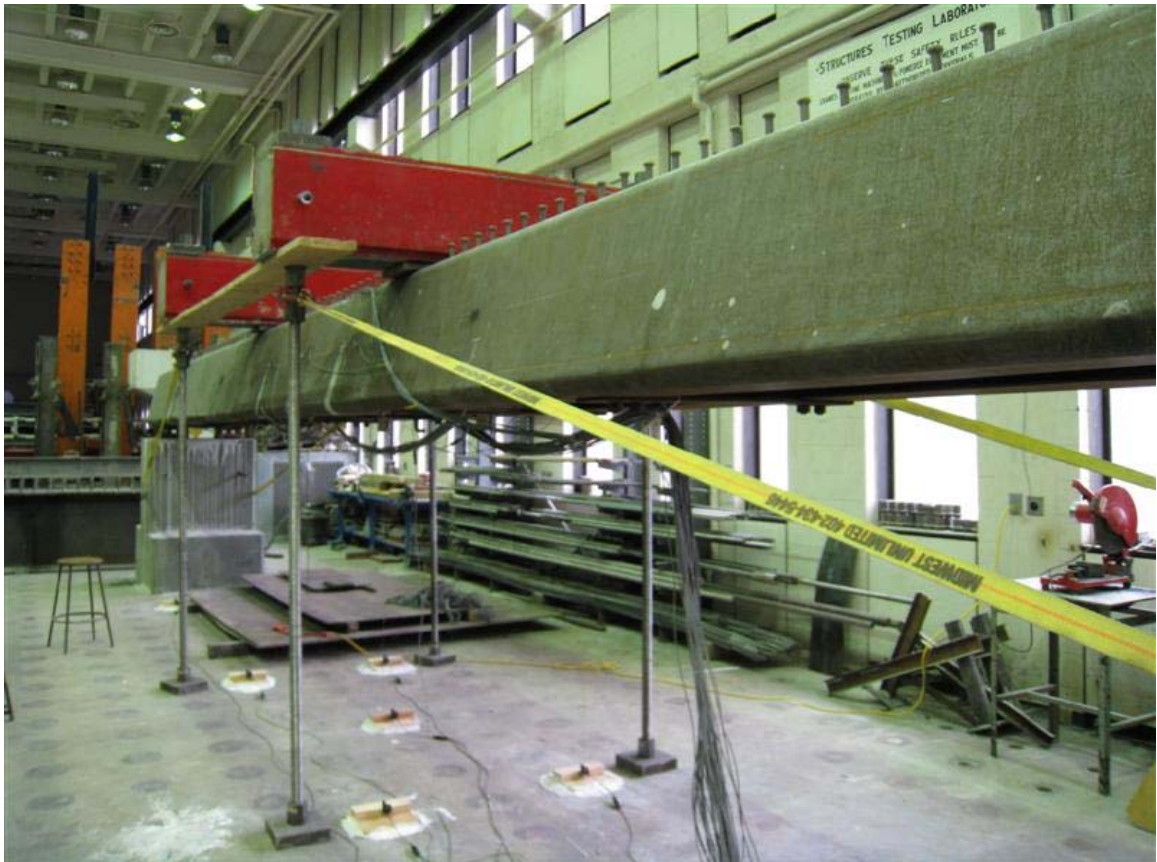
**Figure 3-35** Folded plate girder test B1 setup

Specimen B was tested following the procedures described in the previous chapter. The same load configuration was used for Test B1. Figure 3-35 shows the test setup for the second test. Unlike the first test, no tie plates were removed during testing. After observing how the first girder failure was driven by stress concentrations at the load points, stiffener plates were welded inside the second girder at the load points.

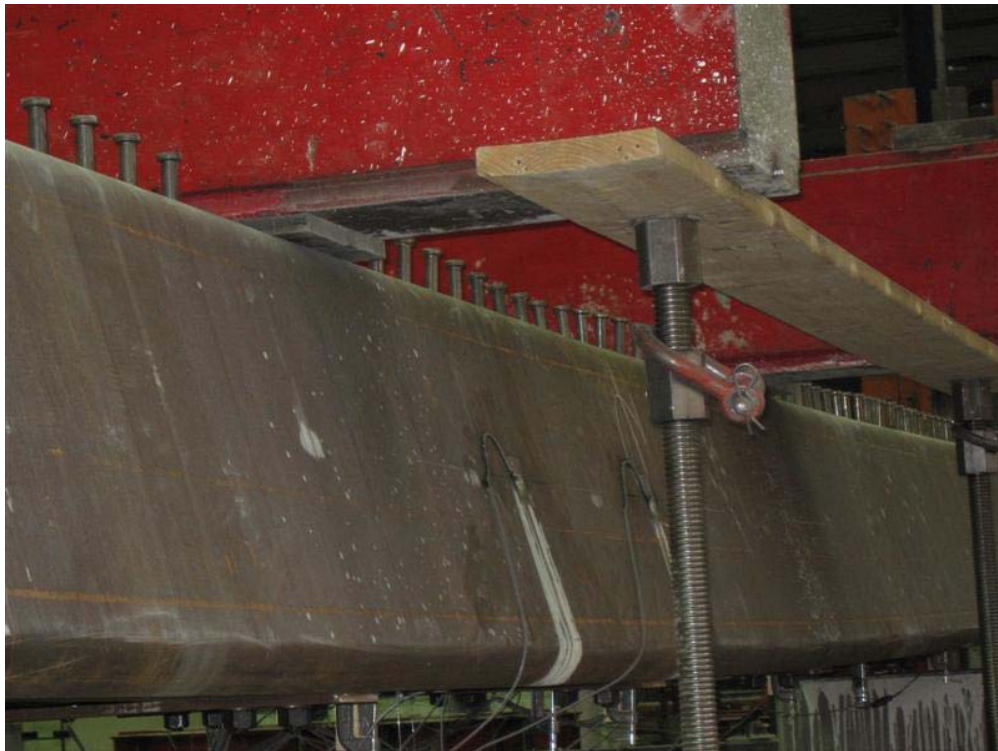
Figure 3-40 Test B1 web at 140kip

Figure 3-39 shows the top flange at 120kips; the deformation of the top flange is becoming more apparent. Figure 3-40 through Figure 3-43 show different parts of the beam at 140kips of load. This is within five kips of the ultimate load, when the girder begins to fail. Figure 3-41 shows that the deformation of the girder is actually bending the tie plate. Figure 3-42 is a picture taken from the west end of the girder looking down the top flange towards the spreader beam. Near that spreader beam, the top flange is buckling downwards. Figure 3-43 shows the deformation of the top flange between the load points.

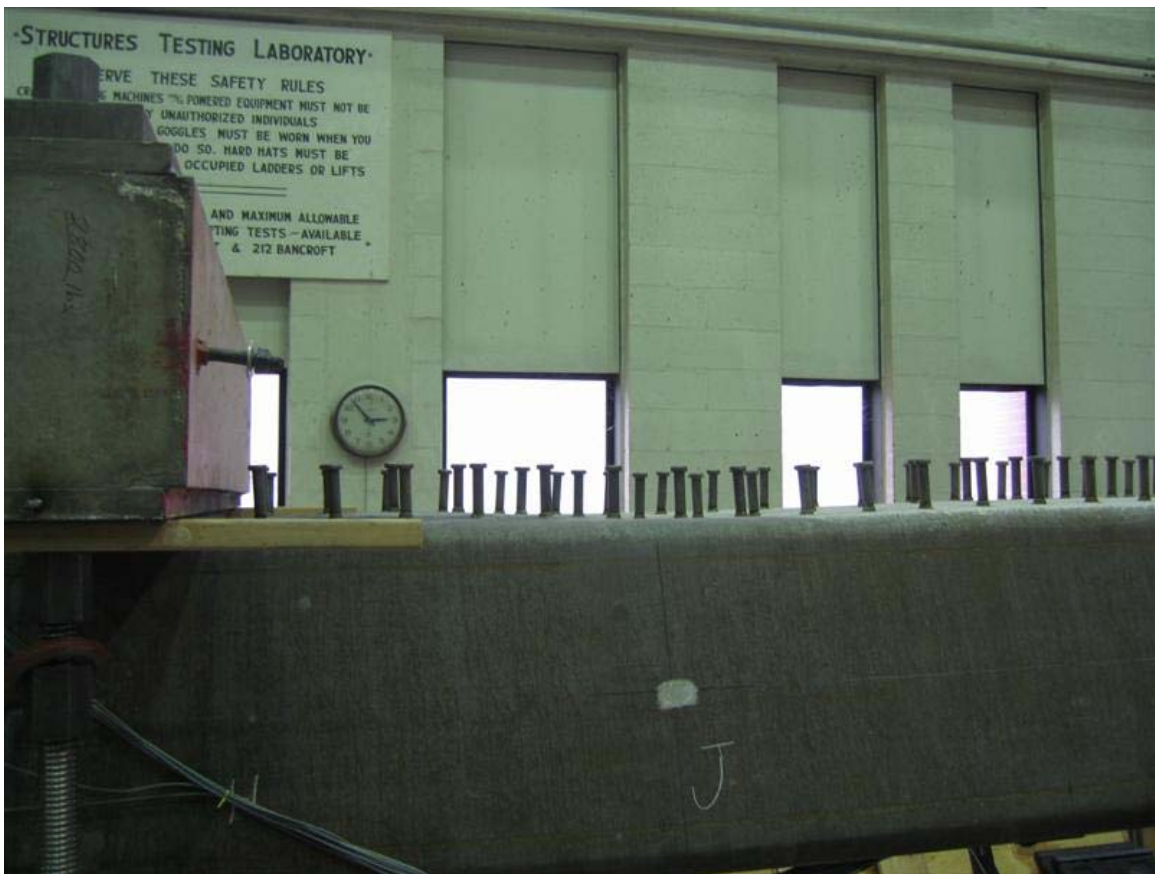
**Figure 3-45 Girder outside load points at 137 kip on way back down**

Shortly after these pictures were taken the girder reached its ultimate capacity and began to fail. Figure 3-44 shows the top flange when loading is at 137kips as the girder continues to fail. Figure 3-45 shows the girder outside of the load points also at 137kips. These two figures show a difference in the amount of buckling taking place in between the load points compared to outside of the load points.

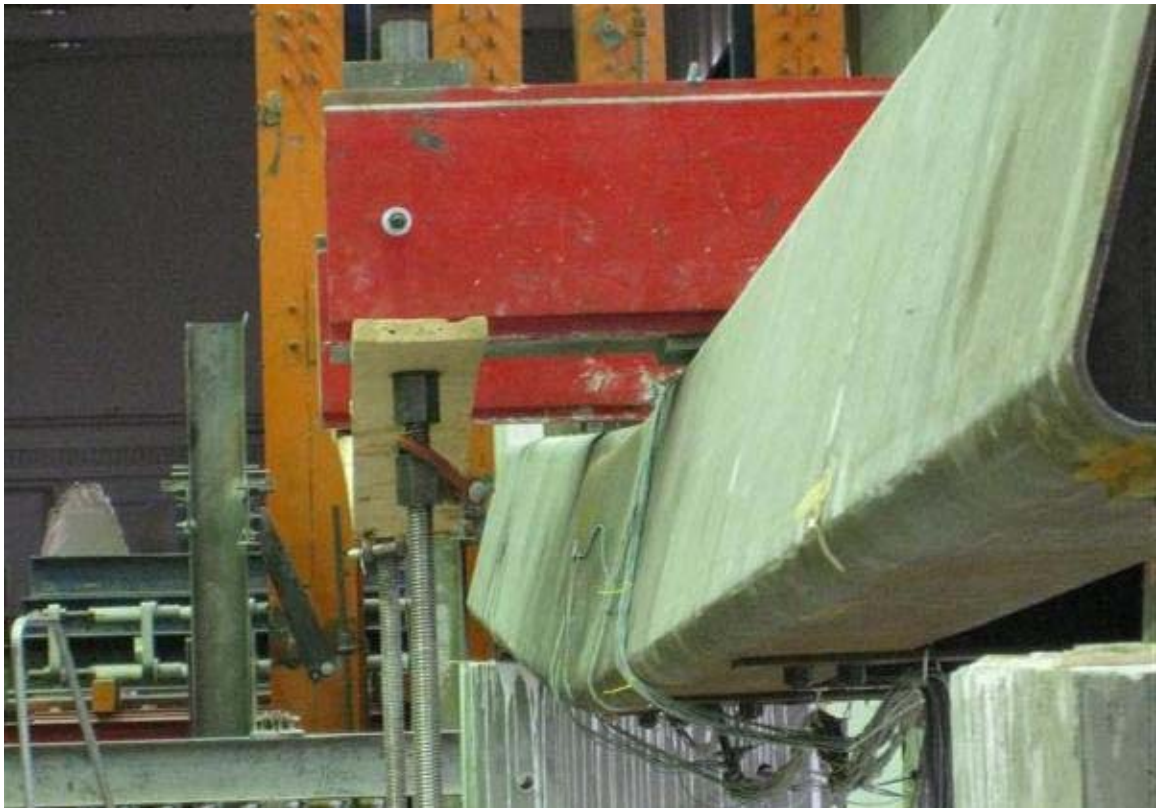
**Figure 3-46 Girder deflection after unloading**

After the girder was unloaded, pictures were taken of the final deformed shape of the specimen. Figure 3-46 shows the overall girder deformation after unloading. The

extreme buckling at midspan resulted in what was almost a hinge. The midspan area contained most of the permanent deformation; the rest of the girder returned to its original state. Figure 3-47 shows the girder on both sides of the west load point. This picture also shows that the majority of the failure occurred at midspan. Figure 3-48 shows the section of the girder between load points and Figure 3-49 provides a closer view of the web buckling.
