## Corrosion of Dual Coated Reinforcing Steel with Through-Polymer Breaks in Simulated Concrete Pore Solution

A thesis submitted in partial fulfillment  
of the requirements for the degree of  
Masters of Science in Mechanical Engineering  
Department of Mechanical Engineering  
College of Engineering  
University of South Florida

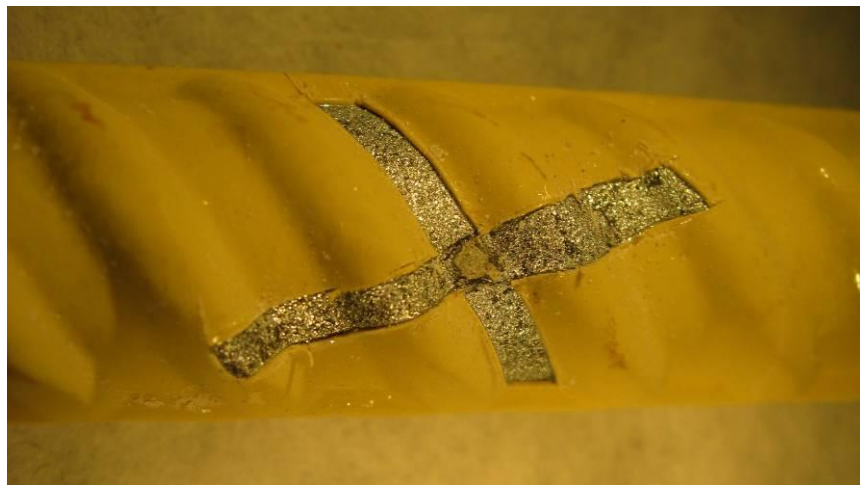
**Figure 12: Specimen Subjected to the Disbondment Measurement Procedure. Specimen was polarized to -500 mV with no-chloride exposure.**

The procedure for evaluating the length of disbondment from the defect was as illustrated in Figures 12 and 13. A 3 mm wide strip of epoxy was scribe-cut between the ribs on each side of the defect. Two more 3 mm wide strips were scribe-cut above and below the defect across the ribs at a  $\sim 90^\circ$  angle from the ribs, as shown in Figures 12 and 13, forming a skewed cross. The scribe-cuts were made through the epoxy layer to the metal using a sharp, thin blade. After the four strips were scribe-cut, the knife was used to detach a small corner of one of the epoxy strips from the metal at the defect edge. This corner was grasped with precision tweezers and pulled until the epoxy strip broke. The distance from the defect edge to the location where the coating strip broke was then measured and recorded. The same procedure was followed with the remaining three epoxy strips. Four defects on each sample were analyzed in this way. The measurements for each sample bar were then averaged and recorded. This method is similar to that used in (Lau and Sagüés 2009).

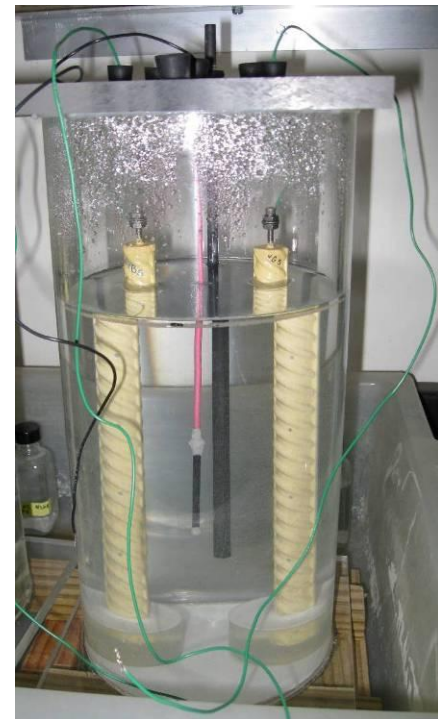
Figure 17: Supplemental OCP No-chloride Exposure Test Cell.

An additional open circuit experiment was conducted to ensure reproducibility of the test method. Two DCR samples were prepared in the way explained previously and shown in Figure 6. They were immersed in SPS solution, with 19 cm of the bar exposed to the solution. The test chamber was a ~14 cm diameter ~30 cm tall Plexiglas cylinder with square Plexiglas pieces used to seal the top and bottom. The square pieces were attached to the cylinder with silicon gel. The container held ~3L of solution. The specimens were sealed inside the test chamber to prevent carbonation of the solution. The top square piece contained holes for wires and electrodes which were plugged with rubber stoppers. The open circuit potentials of the specimens were measured regularly with a SCE.

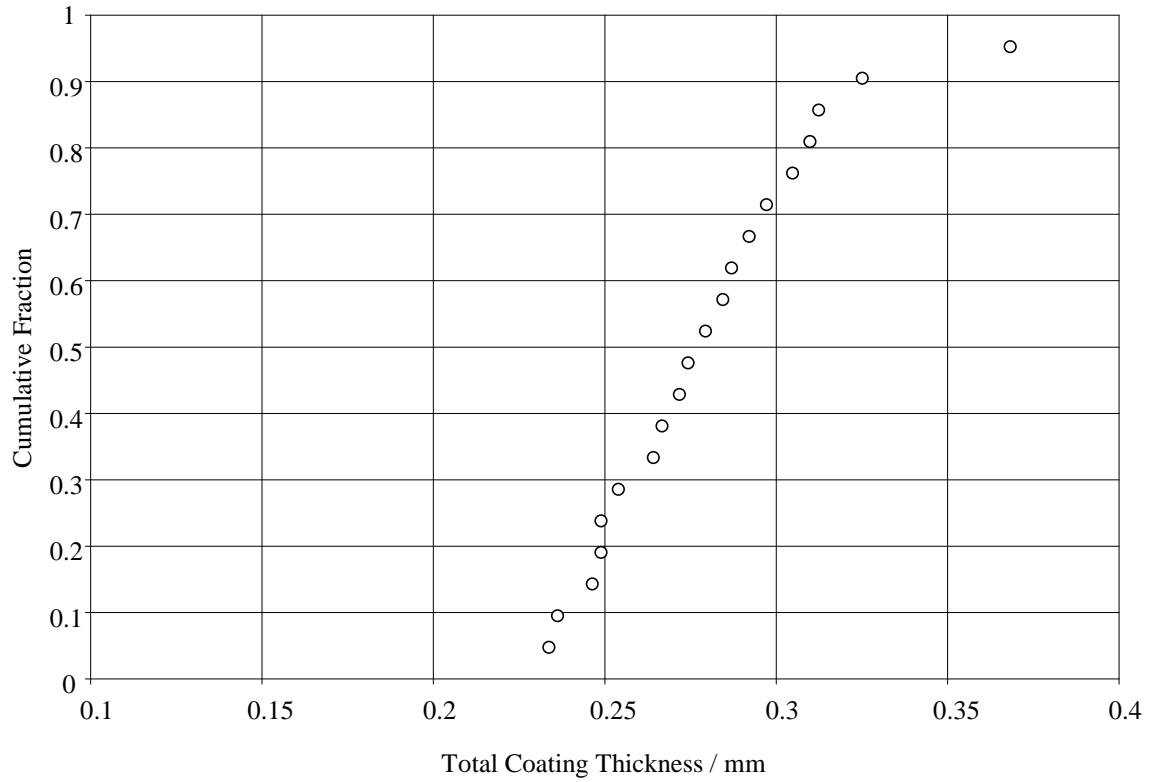
**Figure 18: Combined Polymer and Zinc Coating Thickness Distribution.**

The combined polymer plus zinc coating thickness was on average ~0.28 mm and the standard deviation was ~0.03 mm which meets the ASTM A1055 specification. The cumulative fraction of coating thickness measurements is shown in Figure 18. The zinc thickness was on average ~0.028mm which also meets the specification. The bars selected contained no visible coating defects. Those specimens used in the test were concluded to be representative of the average product produced by the manufacturing company.

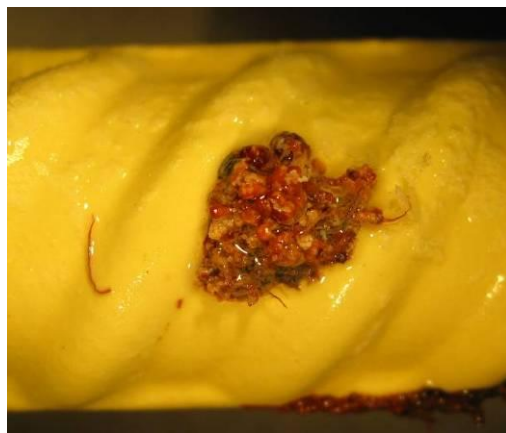
**Figure 19: Solid Corrosion Product that Developed on +100 mV Chloride Exposure Specimens.  
Specimen YG3**

During the period of immersion, only the +100 mV chloride exposure specimens showed corrosion product formation. The oxide was reddish brown in color, indicating an iron oxide, likely oxidized to  $Fe^{3+}$ , which formed tubercles that extended outward from the defects (Figure 19 and 20). Corrosion products developed on one specimen after ~1 day and, on the duplicate specimen, after ~3 days of immersion. This oxide formation had developed in all eight defects on each of the two samples by the termination of the test. In contrast, in the Phase 1 investigation, oxide formed on ECR and DCR +100 mV chloride exposure specimens in less than an hour, so this stage seems to be delayed in the

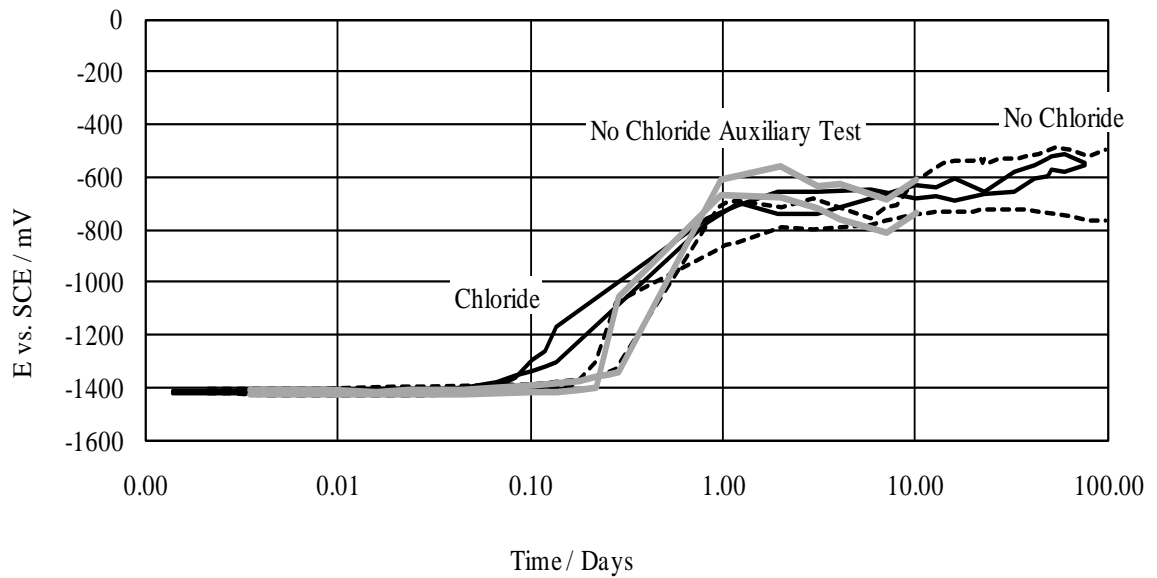
**Figure 21: Open Circuit Potential as Function of Time for Chloride (Solid Black Line), No-chloride Exposure OCP (Dashed), and No-chloride Auxiliary OCP (Gray) Duplicate Specimens**

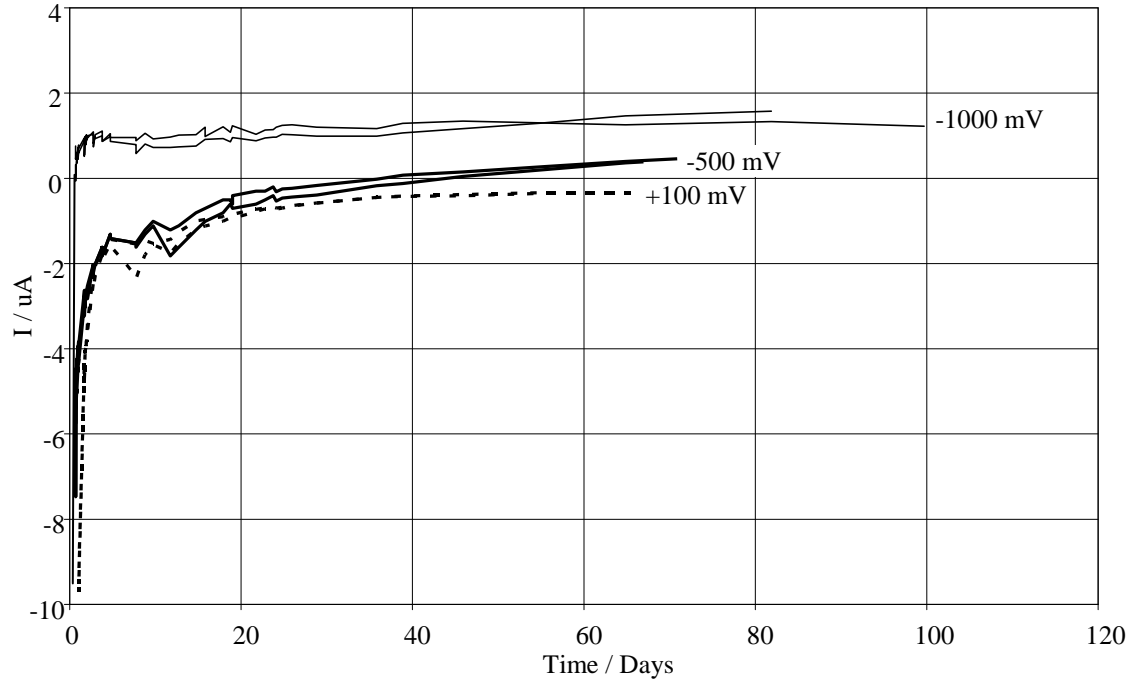
**Figure 22: Polarization Current Evolution with Time for No-Chloride Exposure Duplicate Specimens.**

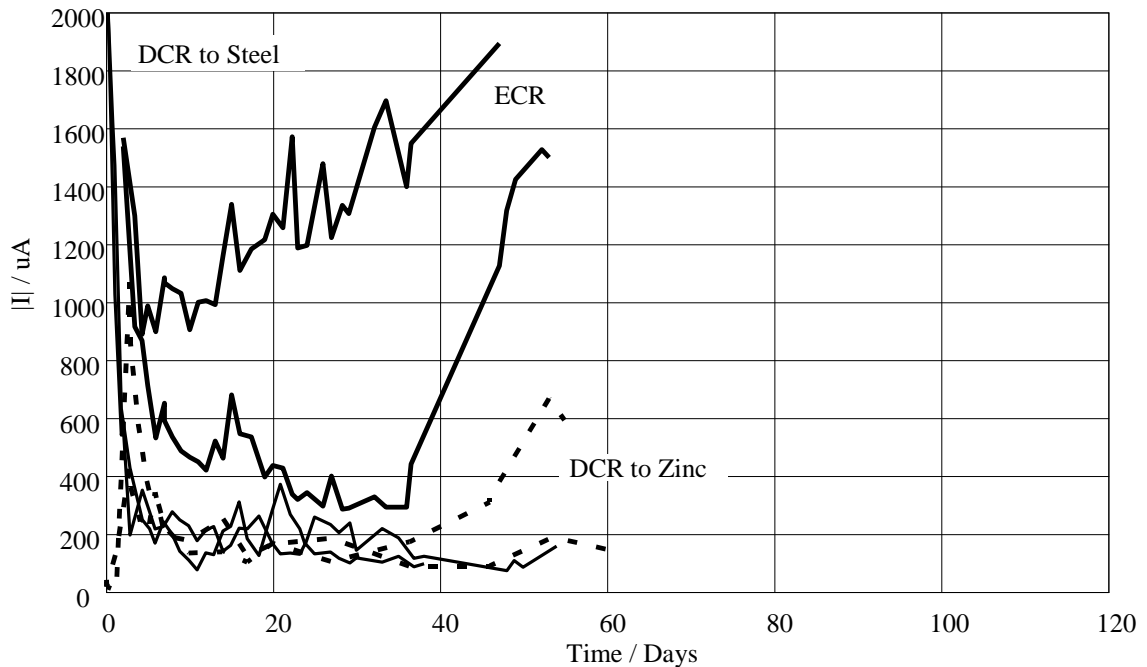
**Figure 23: Polarization Current Evolution with Time for +100 mV Chloride Exposure Duplicate Specimens. This figure includes results from the Phase 1 investigation and this investigation.**

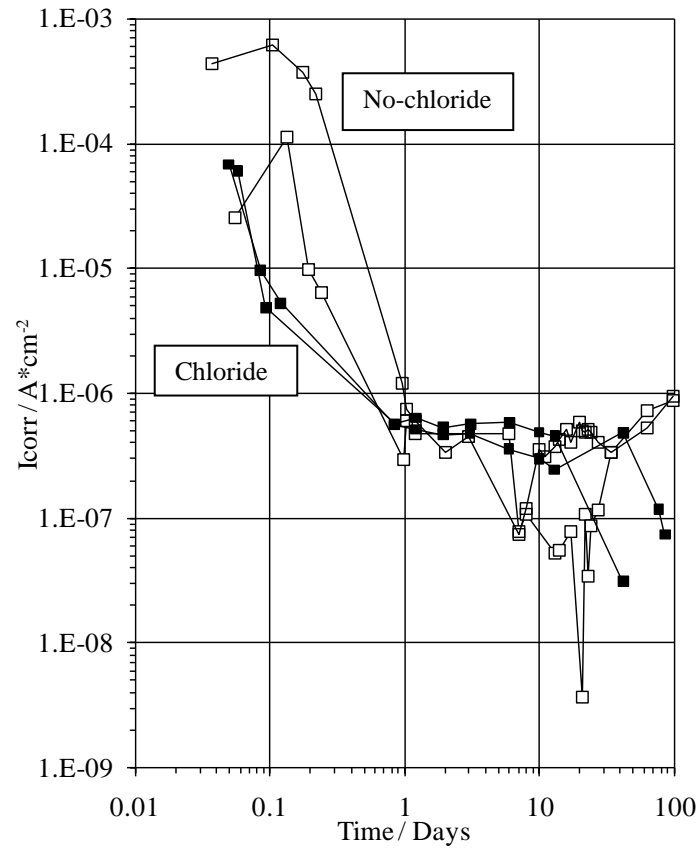
**Figure 26: Nominal Corrosion Current Density from EIS Measurements of Duplicate OCP Specimens as a Function of Exposure Time. Chloride exposure: filled symbols. No-chloride exposure: open symbols.**

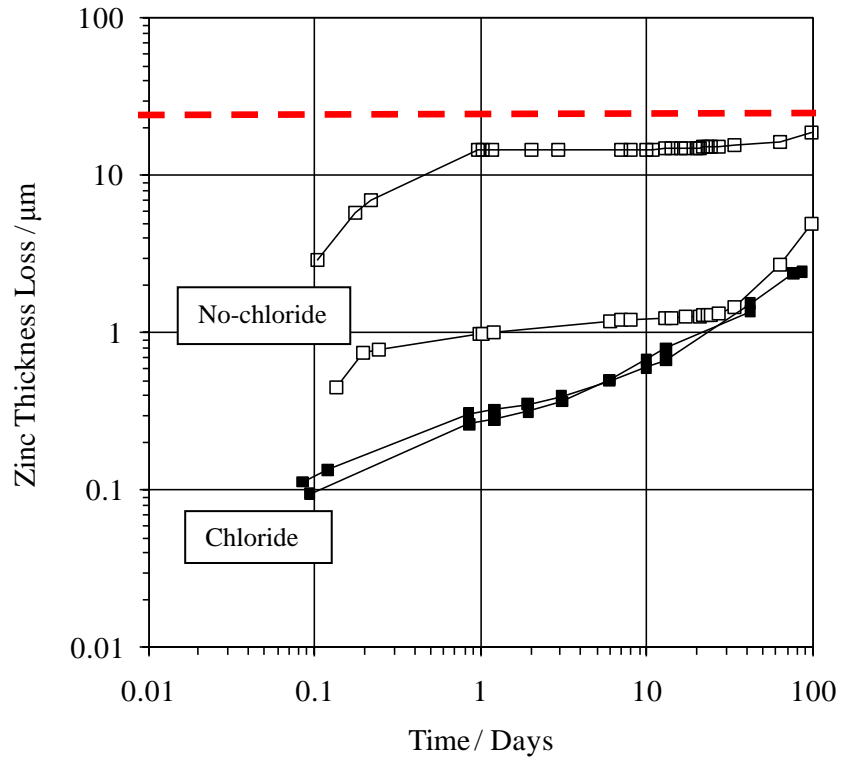
**Figure 27: Nominal Zinc Thickness Loss Estimated from EIS Measurements of OCP Duplicate Specimens as a Function of Exposure Time. Dashed line indicates the average thickness of the sprayed zinc layer.**

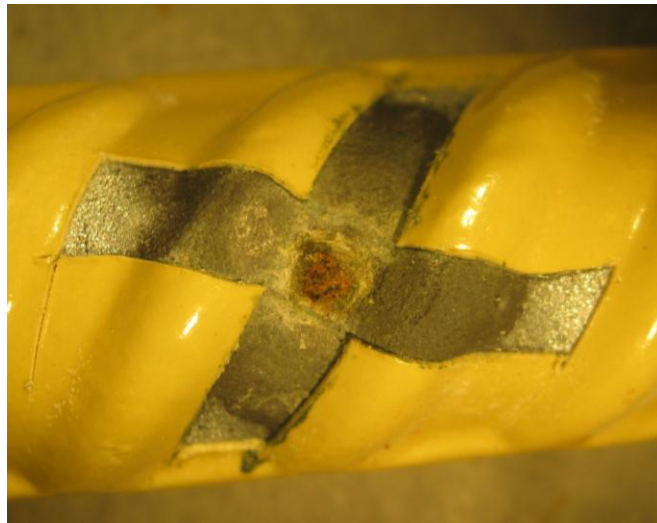
**Figure 34: Discolored Area Around Defect Observed for the +100 mV Chloride Exposure Specimens. Specimen YG3.**

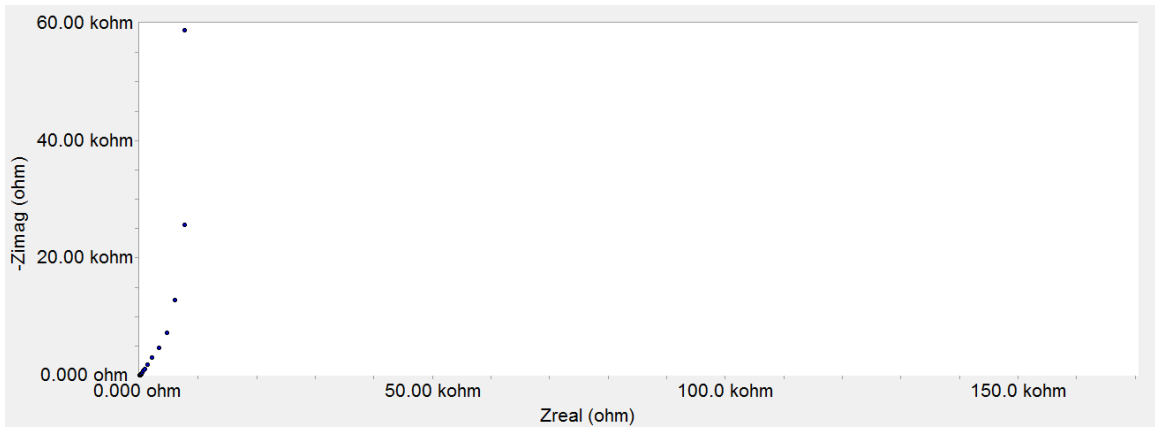
Test c (0.13 days)

Figure 37: Bode and Nyquist Diagrams for YG6 at 0.13 Days of Exposure.

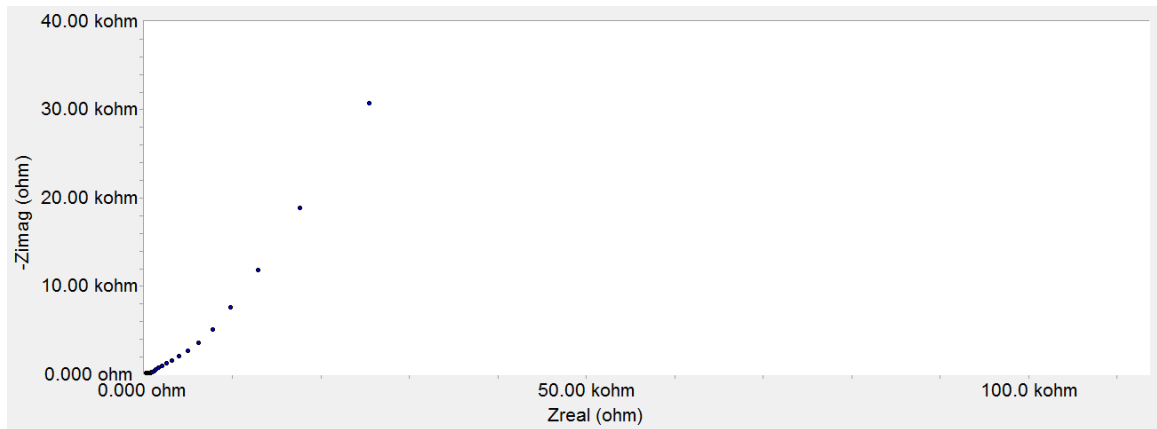
Test 1 (76.83 days)

Figure 46: Bode and Nyquist Diagrams for YG6 at 76.83 Days of Exposure.

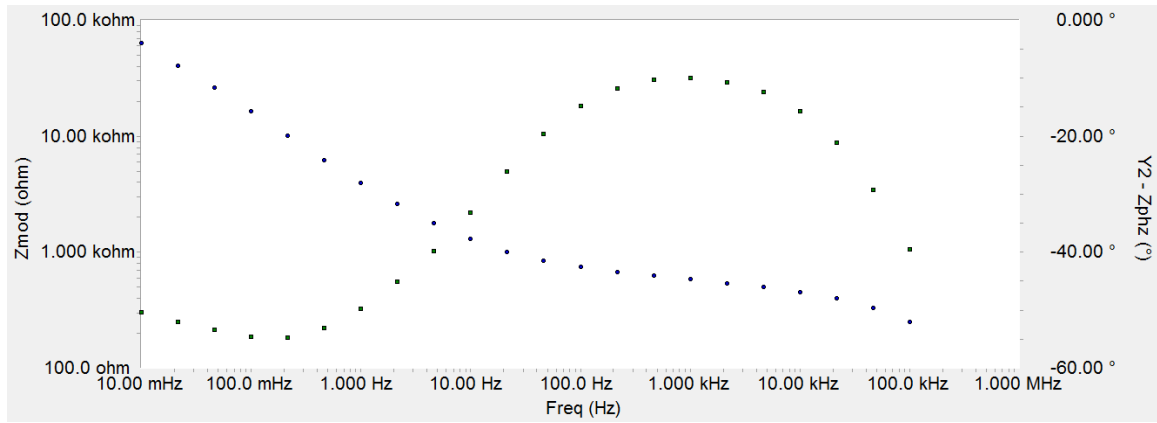
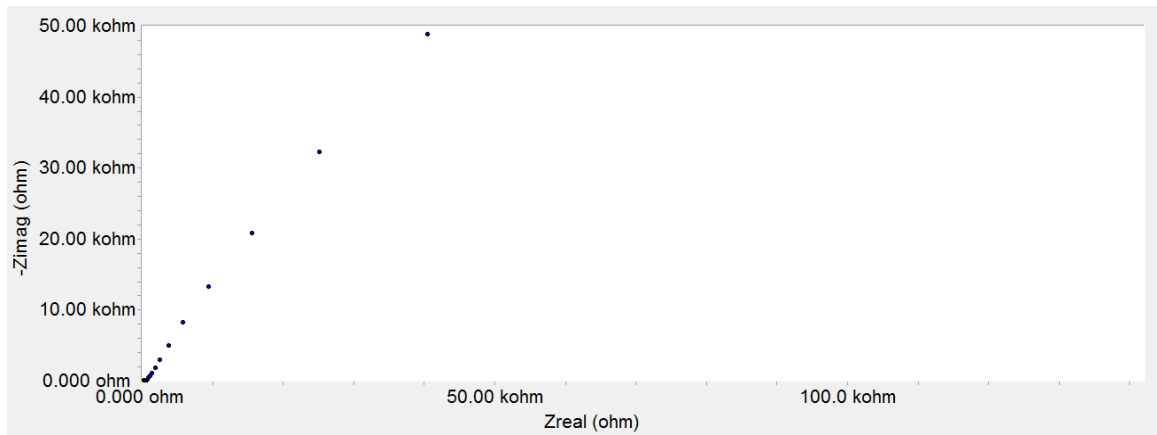
Test i (9.92 days)

Figure 56: Bode and Nyquist Diagrams for YG21 at 9.92 Days of Exposure.

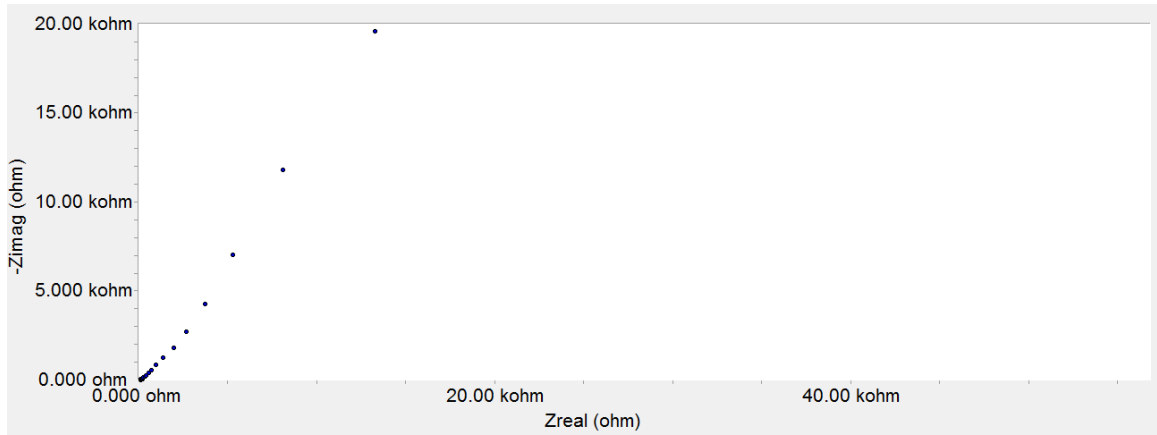
Test h (2 days)

Figure 68: Bode and Nyquist Diagrams for YB14 at 2 Days of Exposure.

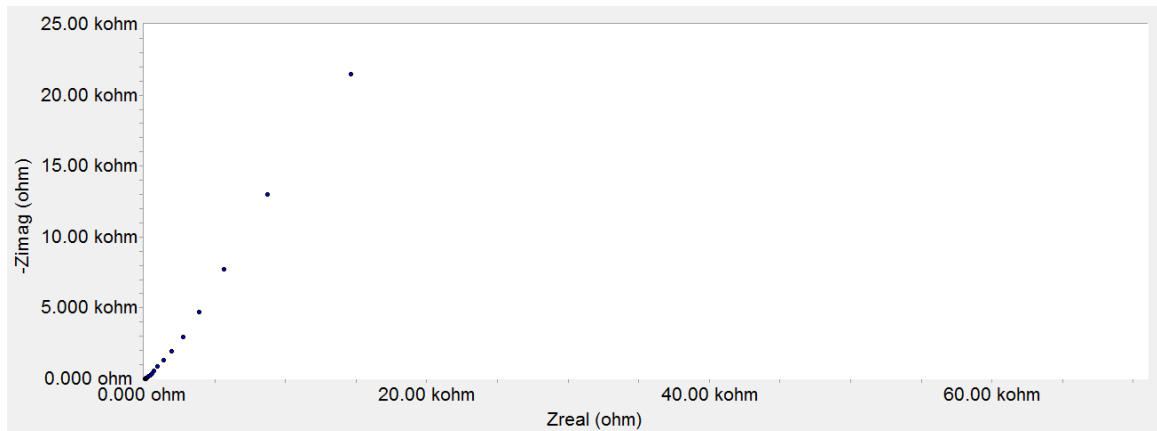
Test i (2.95 days)

Figure 69: Bode and Nyquist Diagrams for YB14 at 2.95 Days of Exposure.

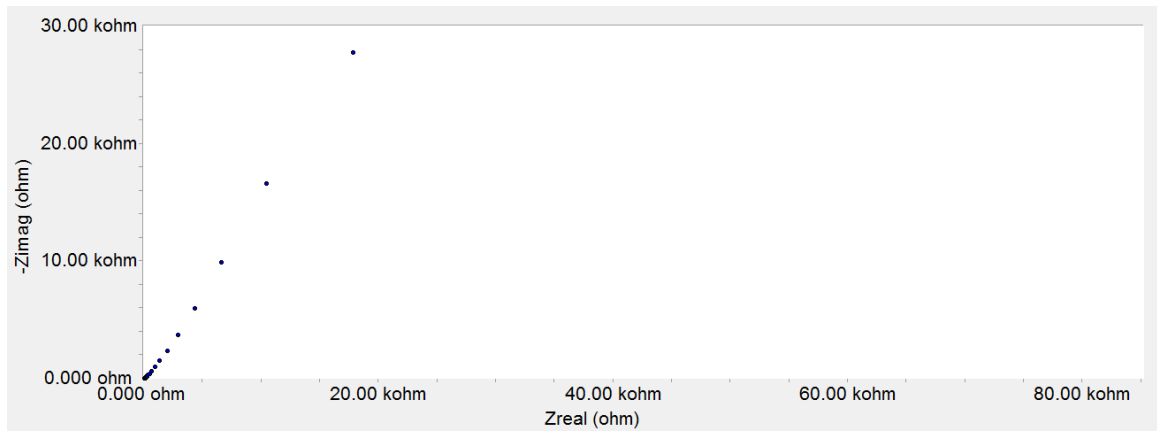
Test n (10.93 days)

Figure 74: Bode and Nyquist Diagrams for YB14 at 10.93 Days of Exposure.

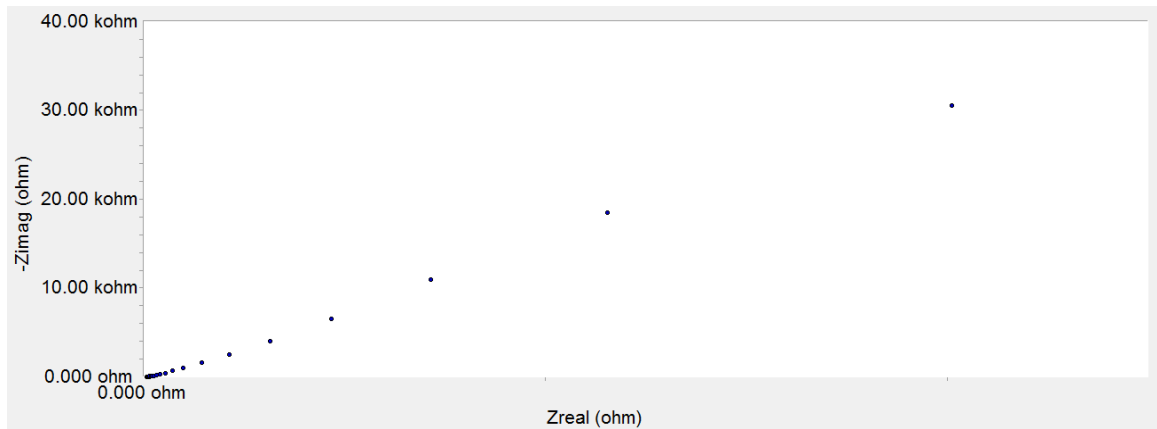
Test p (14.01 days)

Figure 76: Bode and Nyquist Diagrams for YB14 at 14.01 Days of Exposure.

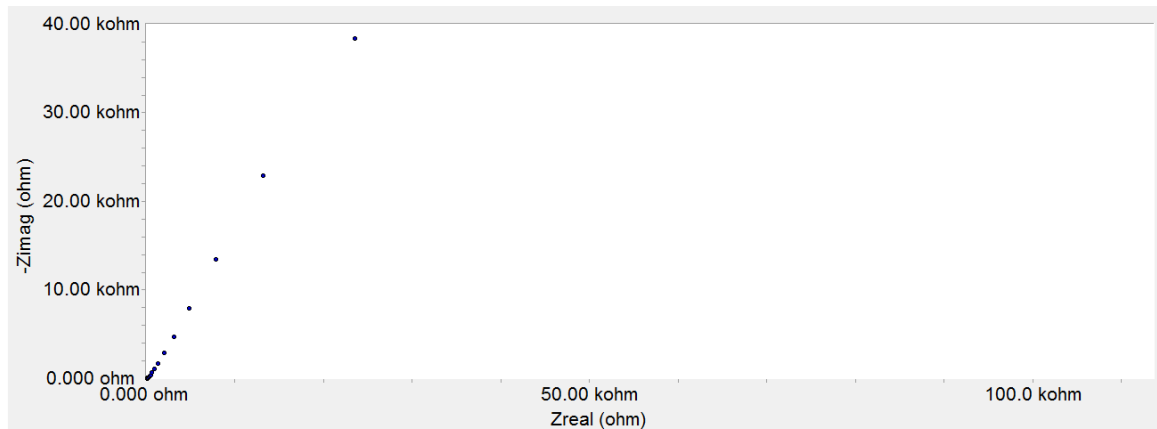
Test y (34.02 days)

Figure 85: Bode and Nyquist Diagrams for YB14 at 34.02 Days of Exposure.

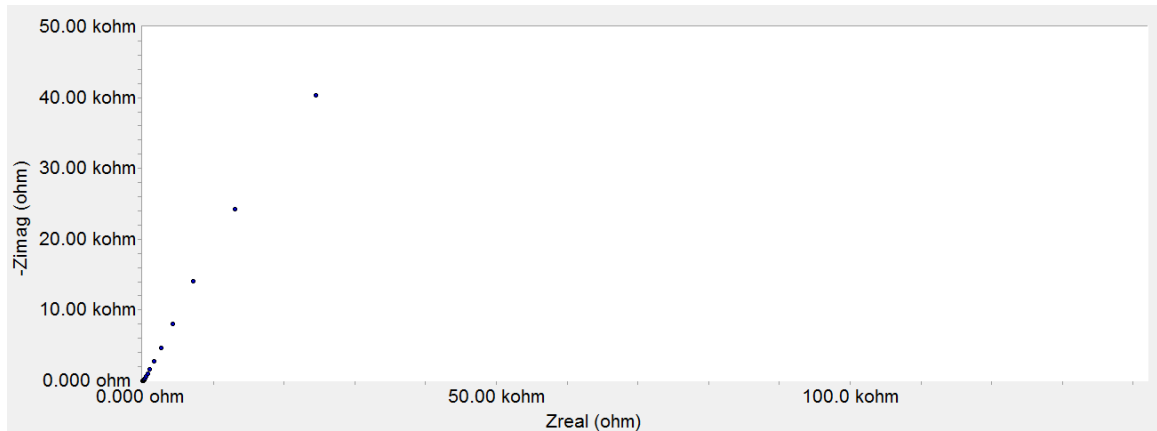
Test z (63.08 days)

Figure 86: Bode and Nyquist Diagrams for YB14 at 63.08 Days of Exposure.

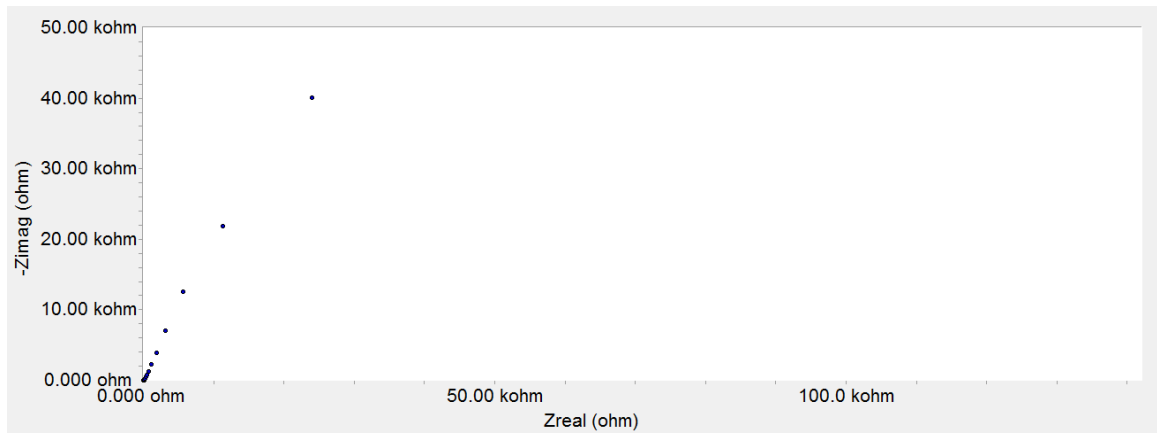
Test aa (97.91 days)

Figure 87: Bode and Nyquist Diagrams for YB14 at 97.91 Days of Exposure.

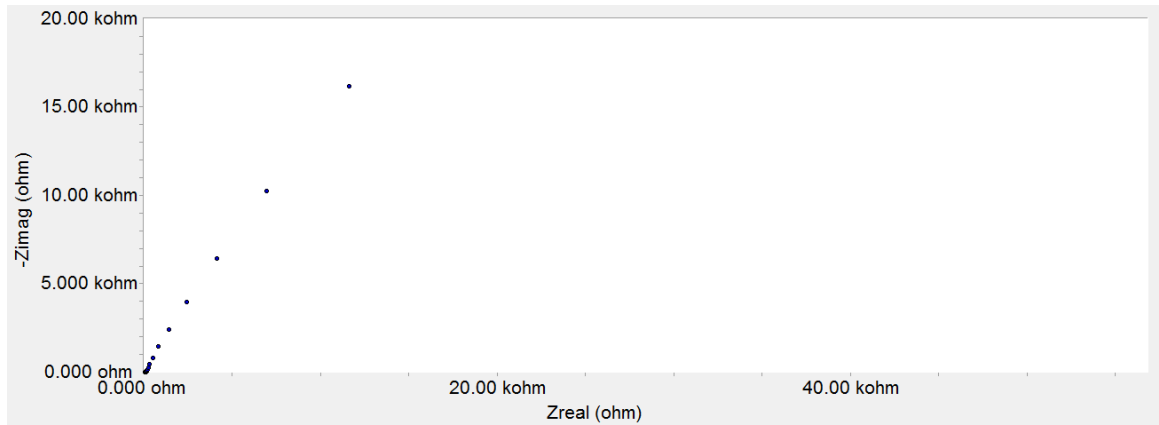
Figure 114: Bode and Nyquist Diagrams for YG7 at 97.93 Days of Exposure.

Test aa (97.93 days)

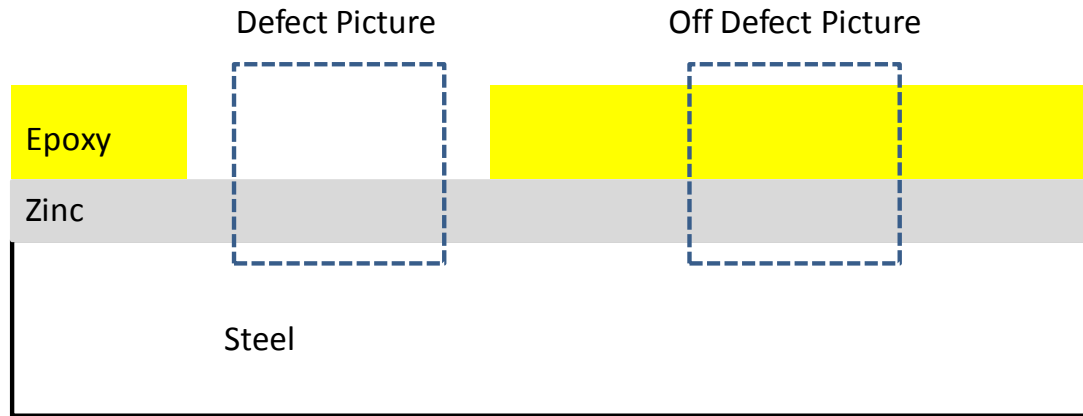
**Figure 115: Metallographic Picture Location Diagram**

The following contains metallographic pictures of specimens. The magnification is 15x except where noted. The locations pictured are on the defect and off the defect as illustrated below. These will allow a comparison of zinc thickness between that on the defect surface and that under the coating.
