Creep of Nextel 720/Alumina Ceramic Matrix Composite with Diamond-Drilled Effusion Holes at 1200°C in Air and in Steam

THESIS

Megan L. Harkins, Major, USAF

AFIT-ENY-MS-19-M-218

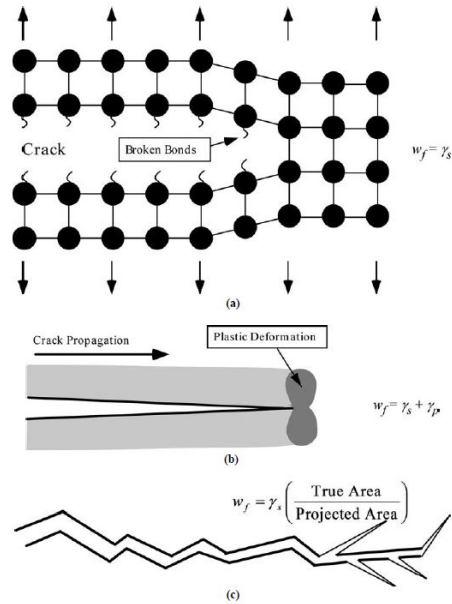
Figure 2: Crack propagation in various types of materials, with the corresponding fracture energy. (a) ideally brittle material, (b) quasi-brittle elastic-plastic material and, (c) brittle material with crack meandering and branching [5].

Error! Reference source not found. depicts the dependence of the fracture energy (ω_f) on the surface energy (γ_s) and true crack area.

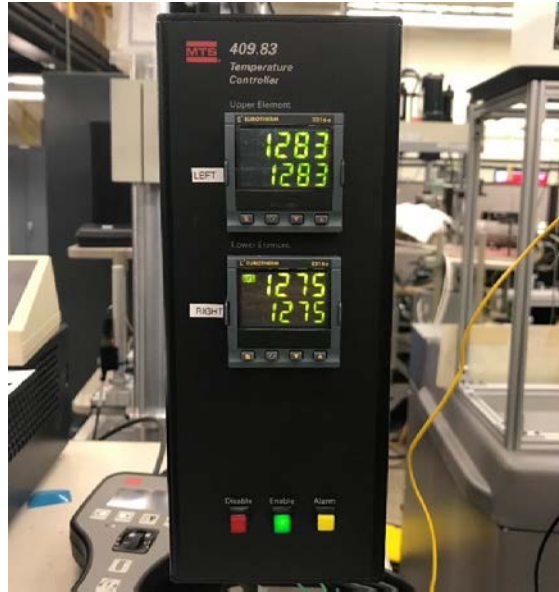
Figure 10: MTS Temperature Controllers

A temperature of 1200°C was maintained for all tests using a compact, dual zone AMTECO hot-rail furnace system (Figure 9) controlled by two MTS (Model 409.83) Temperature Controllers (Figure 10).

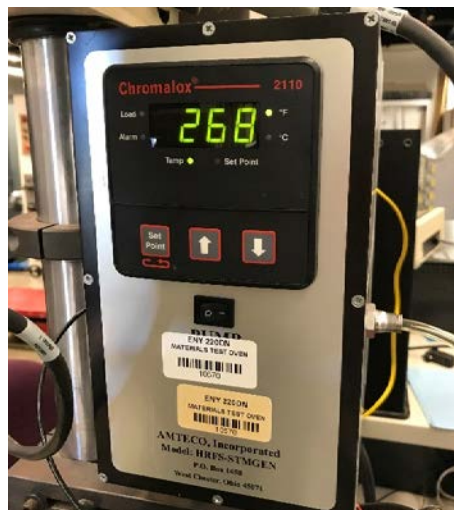
Figure 13: AMTECO steam generation system

In order to produce a near 100% steam environment, an alumina susceptor was specifically designed to house the gage section of the specimen while providing an opening for a steam feeding tube and slots for the two extensometer extension rods (Figure 12). Steam was provided to the susceptor from an AMTECO HRFS-STMGEN steam generation system (Figure 13) in a continuous flow at a rate sufficient to displace the dry air and create a near 100% steam environment around the specimen gage section.

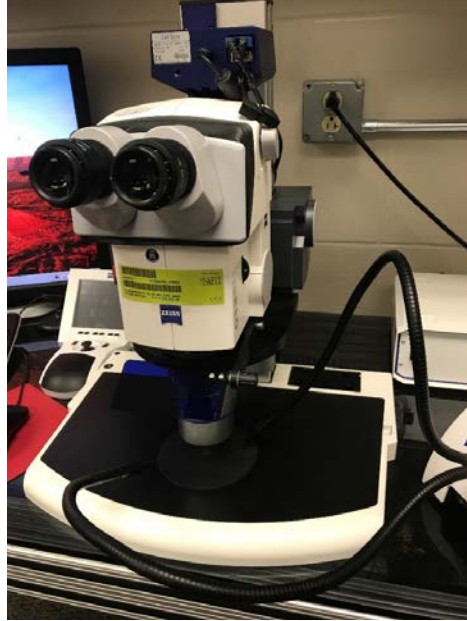
A ZEISS SteREO Discovery.V12 optical microscope (Figure 15), equipped with an AxioCam HRc digital camera and AxioVision software (version 4.8) was used before and after testing to examine the microstructure surrounding a few randomly selected holes as well as the post-test fracture surfaces.

Figure 15: ZEISS optical microscope

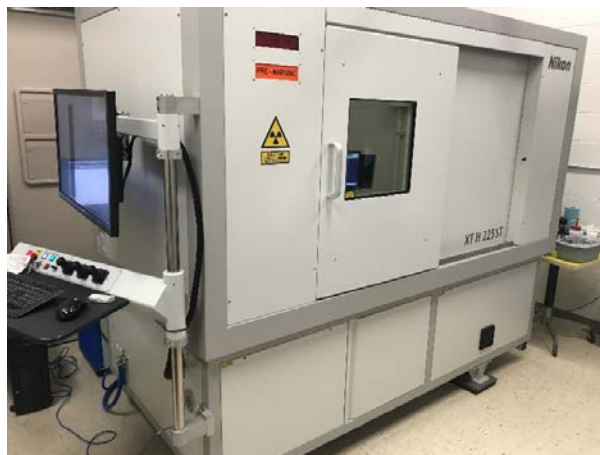
A Nikon XT H 225 ST Computed Tomography (CT) scanner (Figure 16) was used to examine specimens after testing to provide additional insight into interior damage zone penetration that may not be captured via optical microscopy.

Figure 16: Nikon CT scanner

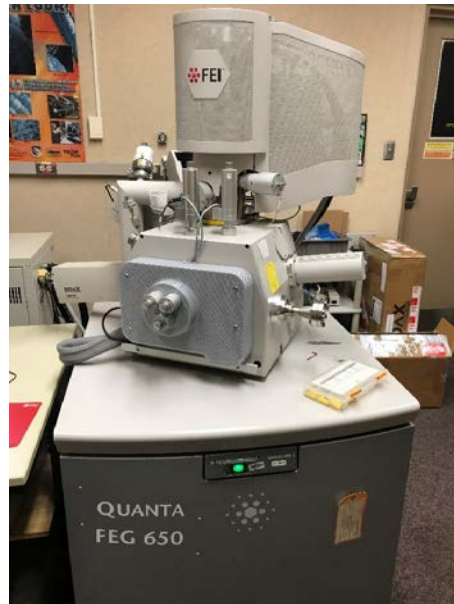
A Quanta FEG 650 (Figure 17) and MAIA3 Triglav TESCAN SEM (Figure 18) were used to further characterize the microstructure of the material by examining the fracture surfaces. Unlike the optical microscope, the SEM can achieve a resolution on

Figure 17: Quanta FEG SEM

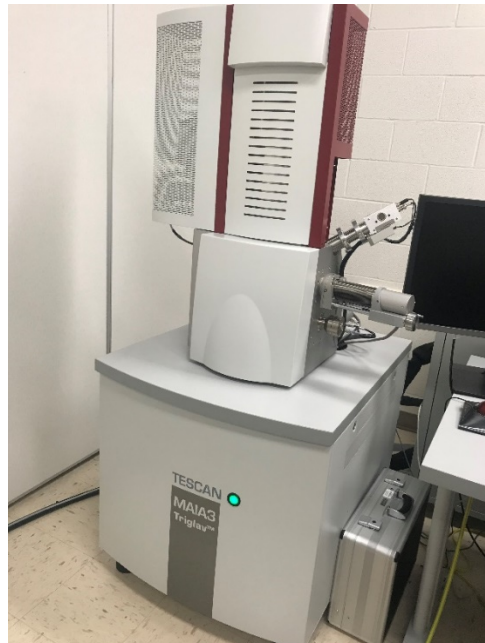
Figure 18: MAIA3 TESCANA SEM

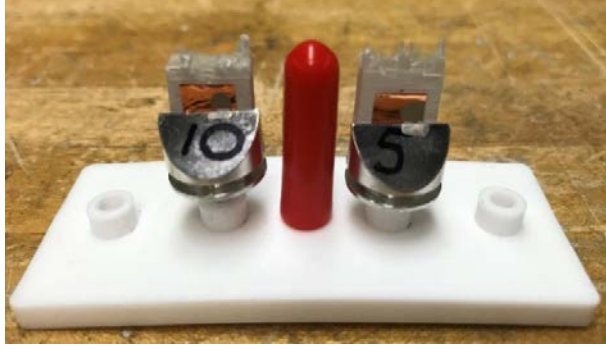
Microstructure examination via optical microscopy and CT scan did not require any specimen preparation. These processes are non-invasive, and could take place at any time prior to SEM examination. Steps required for preparing an SEM sample included removing the fiberglass tabs with a water-cooled saw, adding a piece of copper tape along the length of the specimen to ensure conductivity to the base, rigidly mounting the specimen to a 90-degree platform using a conductive carbon adhesive, adding a drop of conductive silver paint between the platform and copper tape as an additional means to ensure conductivity, and sputter coating the specimen with a ~5 nm thick Au-Pd alloy in the sputtering machine. Figure 23 shows a specimen ready for SEM examination.

Figure 23: Coated specimen prepared for SEM examination

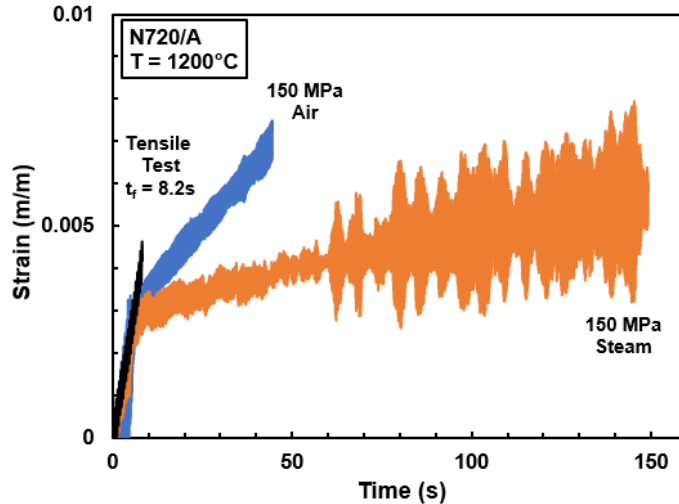
Figure 31: Strain vs time comparison between tension test in air and creep tests at 150 MPa in air and steam for N720/A specimens with diamond-drilled holes at 1200°C

investigation. Specifically, it was unclear whether the deformation produced in the 150 MPa tests was due to creep or progressive failures of the load-bearing fibers. Figure 31 overlays the strain vs time data from the tensile test in air, with the 150 MPa creep tests performed in air and steam. Results in this plot demonstrate that the strain rates produced during load-up to creep stress in each of the creep tests is close to the strain rate produced in the tension test. Once the target creep stress level is achieved, the strain rates observed in the creep tests decelerate. However, the strain rates from the creep data are closer in magnitude to the tensile test strain rate ($\sim 5.0 \times 10^{-4} \text{ s}^{-1}$) than to the previously mentioned creep test strain rates. Additionally, the plot clearly shows that the strain rate in air is faster than that recorded in steam, which ultimately resulted in more accrued strain and a shorter lifetime. The short duration of the 150 MPa creep tests, as well as the high strain rates, indicate that the deformation and failure in these tests are likely caused by continuously increasing stress due to progressive failures of the individual fibers and increased matrix cracking. It is believed that progressive failures of the individual load-bearing fibers start as soon as the 150 MPa creep stress is reached. After each fiber failure, the load is redistributed to the intact fibers resulting in ever increasing stress. Deformation caused by this continual load redistribution is more representative of a tension test to failure than a creep test, which is why the decision was made to remove the 150 MPa creep test data from the consolidated creep data. .

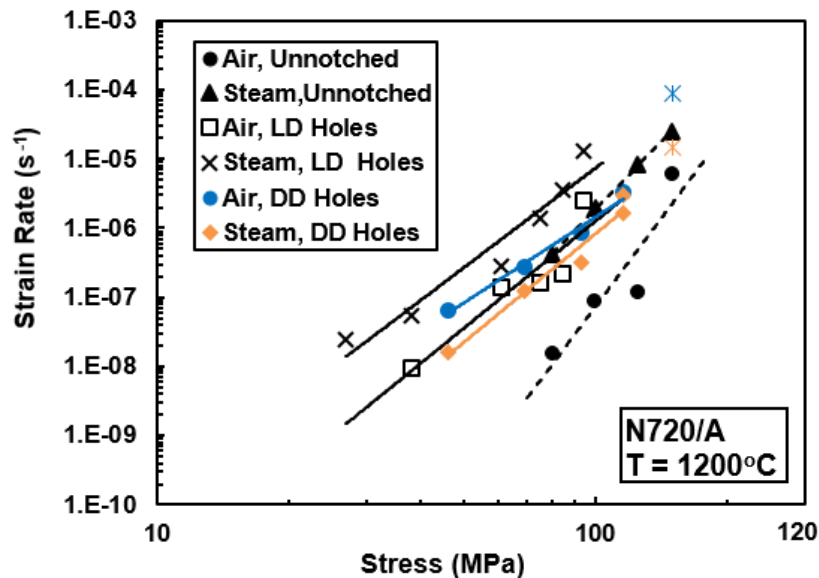
Figure 32: Minimum creep rate vs creep stress for unnotched, laser-drilled and diamond-drilled N720/A specimens tested in air and steam at 1200°C

Continuing the minimum creep rate discussion, Figure 32 consolidates DD, LD and unnotched specimen creep rates in air and steam at 1200°C. One obvious difference identified from this comparison is the impact that steam had on the results. For both the unnotched and LD specimens, the presence of steam accelerated the minimum creep strain rates; however, the opposite was true for the DD specimens.

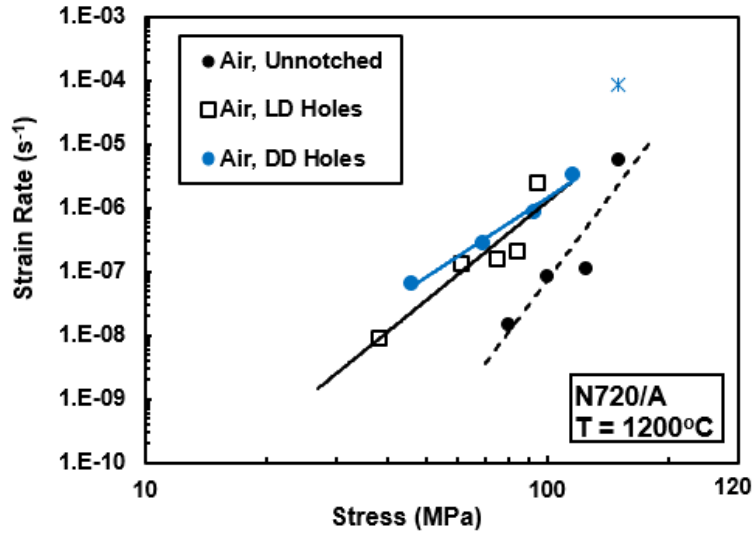
Figure 33: Minimum creep rate vs creep stress for unnotched, laser-drilled and diamond-drilled N720/A specimens tested in air at 1200°C

A closer examination of the creep rates obtained in air (Figure 33) suggest that the presence of a hole (LD or DD) does accelerate minimum creep rates, but the method of hole fabrication has little influence. However, in a steam environment (Figure 34), the creep rates produced by the DD specimens are similar to those of unnotched specimens. These observations suggest that the dominant damage mechanism at play for the DD specimens is different than the damage mechanisms operating for the unnotched and LD specimens. One possible explanation stems from considerations of matrix porosity. Recall that the N720/A composite relies on a porous matrix for its damage tolerant behavior, and that a minimum porosity is required for this concept to work. If the DD holes did not negatively affect the composite microstructure aside from making the CMC more porous, it could be that there exists an upper porosity limit beyond which the creep resistance of the material begins to degrade. This degradation manifests itself in faster creep strain rates which ultimately reduce creep lifetimes. In this case, the added matrix sintering that is present in a steam environment could potentially return the overall porosity of the DD specimens to acceptable levels. While this explanation may be debated, the data indicates that the presence of steam changes the dominant damage mechanism such that strain rates for DD specimens in steam are not only lower than the strain rates seen in air, but are also in-line with rates reported for unnotched specimens.

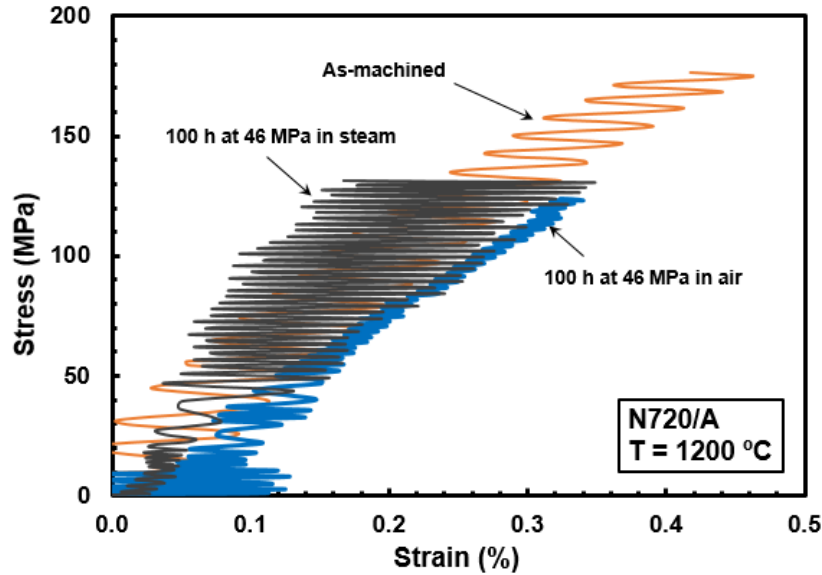
Figure 35: Stress vs strain curves obtained at 1200°C for the as-machined N720/A specimen with diamond-drilled holes and specimens with 100 hours of prior creep in air and in steam

A tension test to failure was performed on the two specimens that reached creep run-out in order to measure the retained tensile properties. Results are summarized in Table 12 and Figure 35.

The stress-strain behavior of pre-crept DD specimens in Figure 35 is qualitatively the same as that of the as-machined DD specimen. Note that the DD specimen pre-crept in air produced larger failure strain than the DD specimen pre-crept in steam. This observation is consistent with the results of the creep tests where larger strains were accumulated in air than in steam. Specifically, the DD specimen that achieved creep run-out at 46 MPa in air accumulated 2.78% strain during 100 h of creep, whereas the DD specimen that achieved creep run-out at 46 MPa in steam accumulated only 0.78% strain. These results once again suggest that additional matrix sintering takes places at 1200°C

in steam. The DD specimen pre-crept in air retained ~70% of its tensile strength, whereas the DD specimen pre-crept in steam retained ~75% of its UTS. This observation suggests that while the properties and performance of the CMC are degraded due to the presence of DD holes (because the composite porosity may now exceed the upper porosity limit), testing in steam may be beneficial to the DD specimens (possibly by reducing porosity and returning it to acceptable levels).

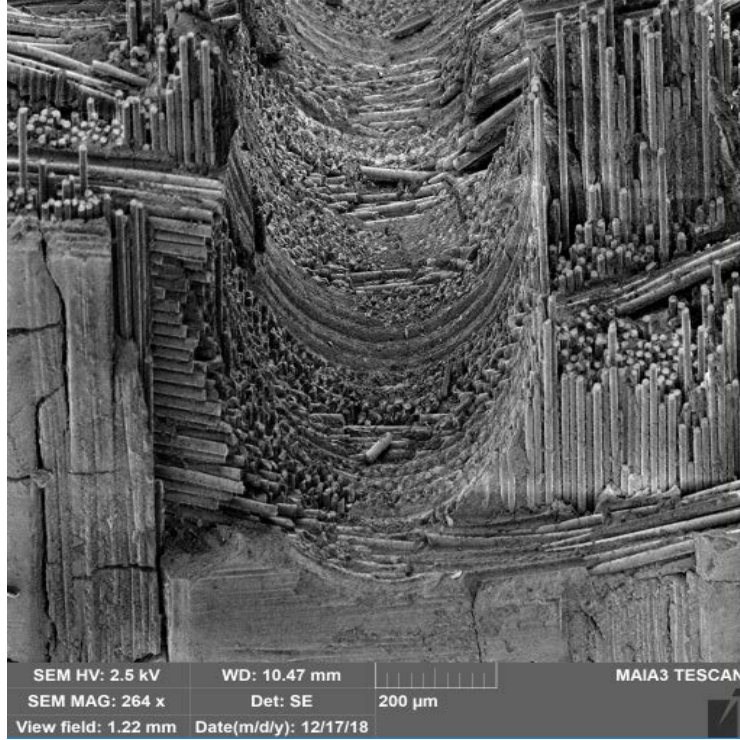
Figure 49: Fracture surface of an N720/A specimen with diamond-drilled holes tested in creep at 1200°C in air ($\sigma_{cr} = 93$ MPa, $t_f = 6.55$ h)

Representative SEM micrographs obtained in this work are shown in Figures 48-53. Note that some SEM images were produced with the Quanta FEG 650 SEM and some with the MAIA3 TESCAN SEM. Figures 48-50 present typical features of a fracture surface obtained from creep tests performed at 1200°C in air, and Figures 51-53, similarly capture features from creep tests performed at 1200°C in steam.

These micrographs consistently show a grainy surface on the hole interior, where both fibers and matrix are readily discernable. Additionally, both air and steam fracture surfaces show signs of fiber pull-out in the vicinity of the holes, with little matrix remaining bonded to the exposed fibers. The lower magnification micrographs also show more regions of coordinated fiber failure for specimens tested in steam, which ultimately contributes to the more planar fracture surface. While matrix sintering is not a distinct feature that can be measured via SEM, it is the presumed cause for the correlated fiber failures in steam based unnotched creep results [11, 12, 14].

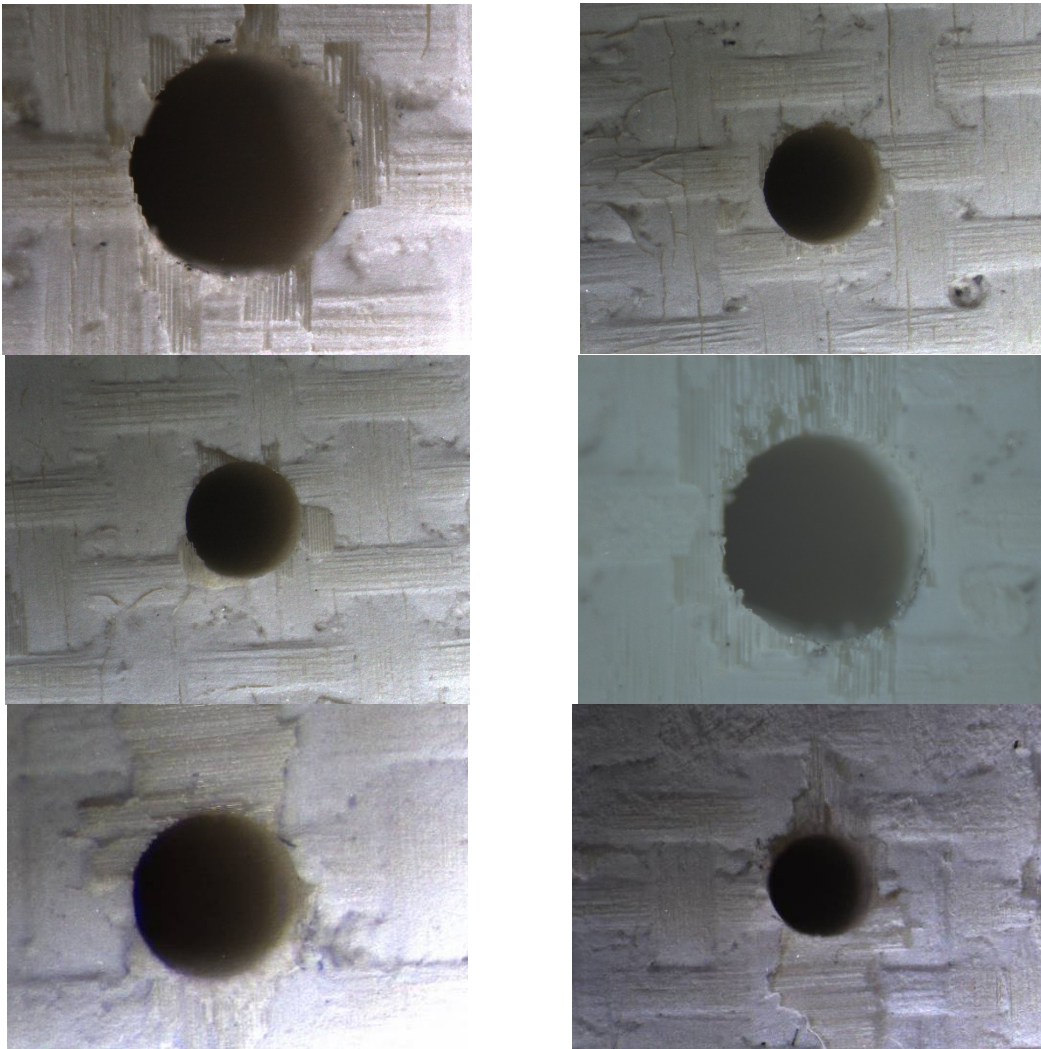
Figure A. 2: Pre-test optical images of randomly selected holes

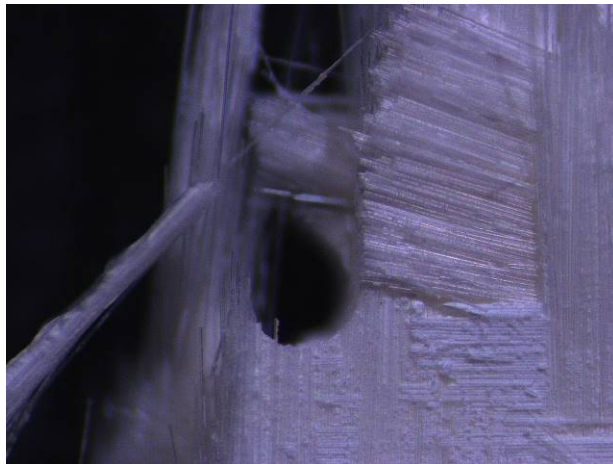
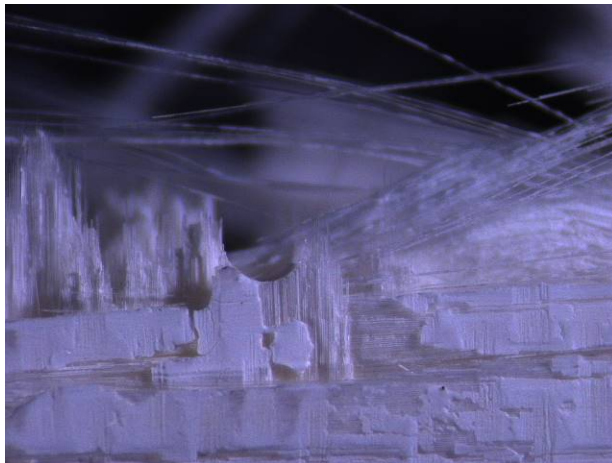
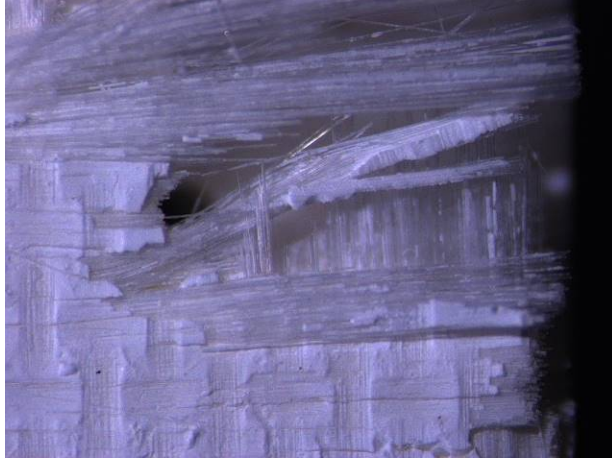
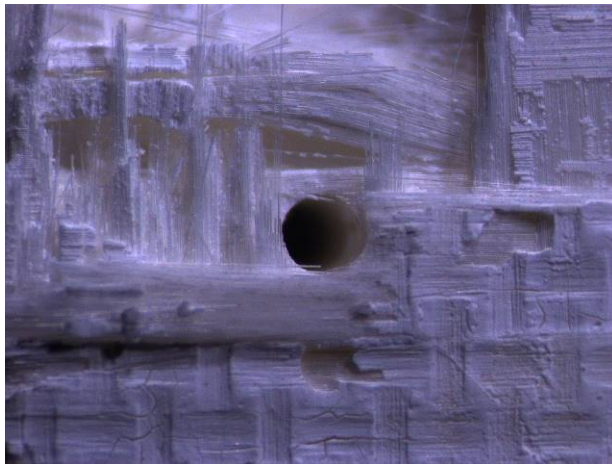
Figure A. 4: Fracture surface of specimen #3, tested in tension to failure at 1200°C in air

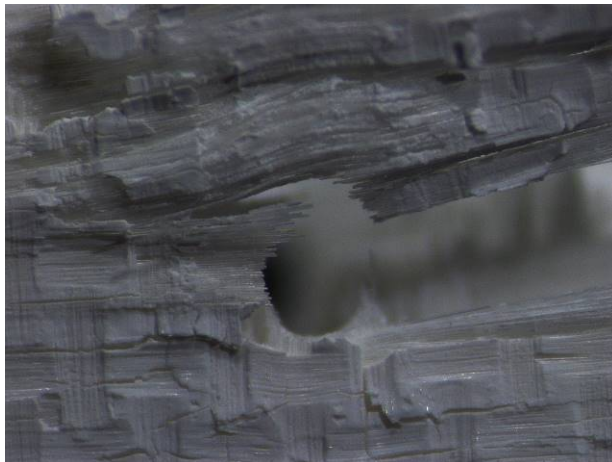
Figure A. 16: Fracture surface of specimen #7, tested in tension to failure following 100 h creep at 46 MPa at 1200°C in air

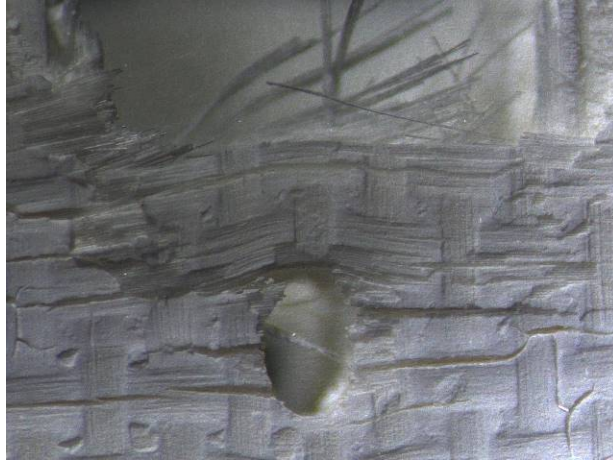
Figure A. 23: Fracture surface of specimen #6, tested in creep at 1200°C in air ($\sigma_{cr} = 69$ MPa, $t_f = 30.95$ h)

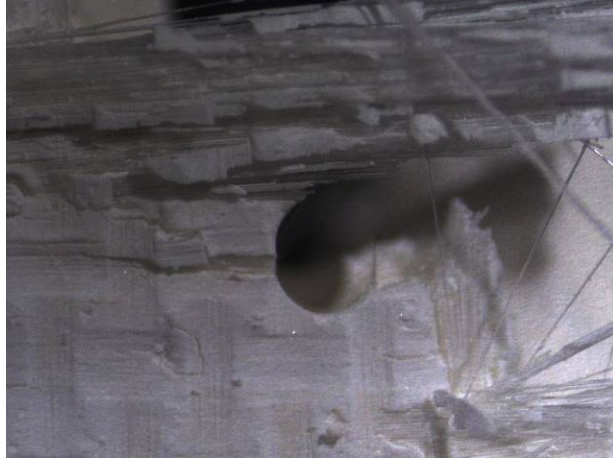
Figure A. 27: Fracture surface of specimen #4, tested in creep at 1200°C in air ($\sigma_{cr} = 118$ MPa, $t_f = 0.59$ h)

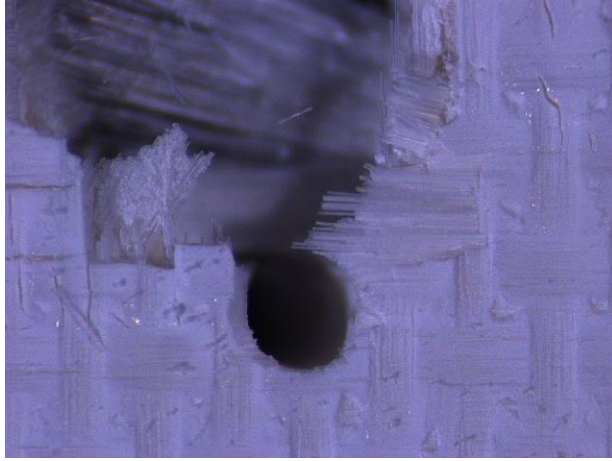
Figure A. 37: Fracture surface of specimen #12, tested in tension to failure following 100 h creep at 46 MPa at 1200°C in steam

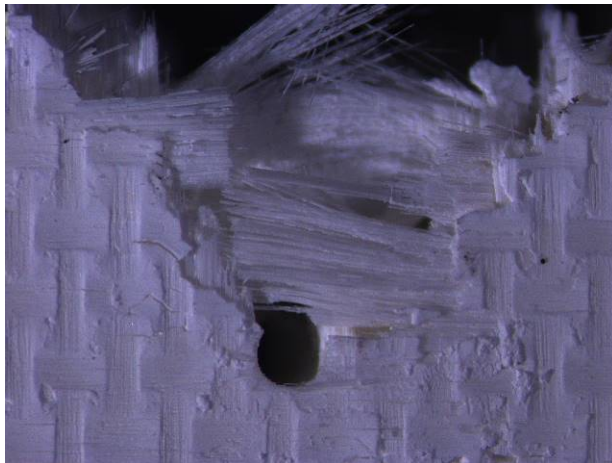
Figure A. 38: Fracture surface of specimen #12, tested in tension to failure following 100 h creep at 46 MPa at 1200°C in steam

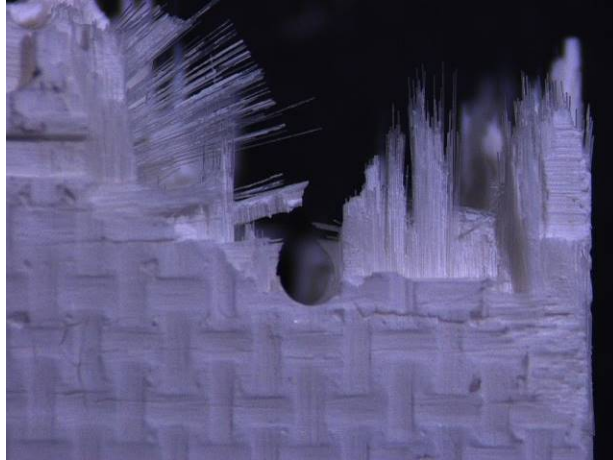
Figure A. 43: Fracture surface of specimen #12, tested in tension to failure following 100 h creep at 46 MPa at 1200°C in steam

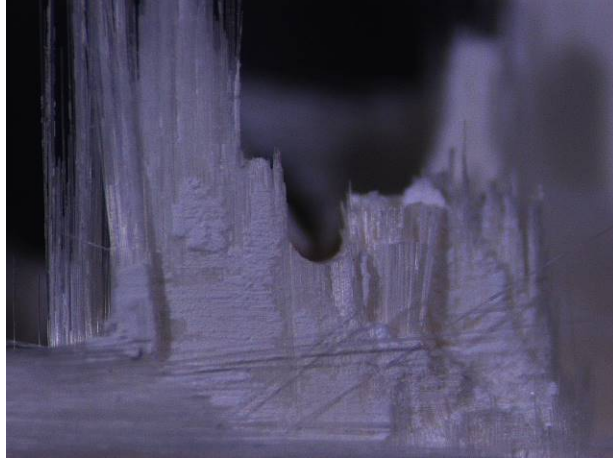
Figure A. 48: Fracture surface of specimen #9, tested in creep at 1200°C in steam ($\sigma_{cr} = 116$ MPa, $t_f = 0.61$ h)

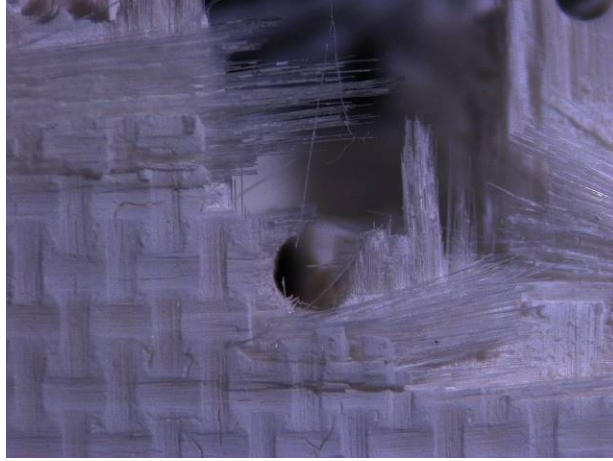
Figure A. 54: Fracture surface of specimen #9, tested in creep at 1200°C in steam ($\sigma_{cr} = 116$ MPa, $t_f = 0.61$ h)

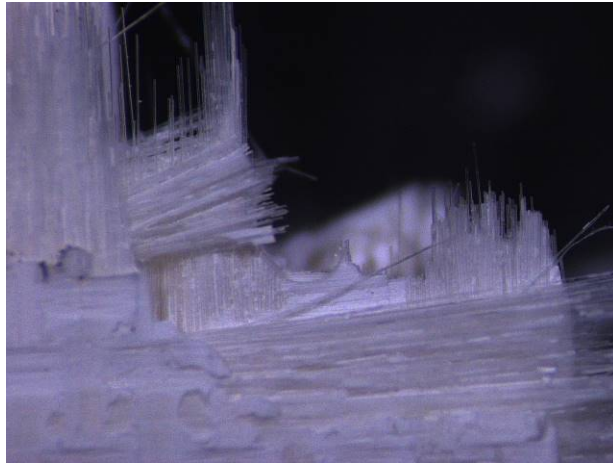
Figure A. 55: Fracture surface of specimen #9, tested in creep at 1200°C in steam ($\sigma_{cr} = 116$ MPa, $t_f = 0.61$ h)

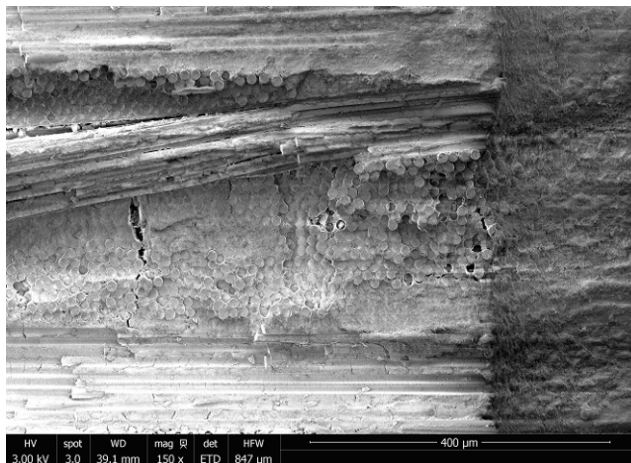
Figure C. 46: Fracture surface of specimen #10, tested in creep at 1200°C in steam ($\sigma_{cr} = 93$ MPa, $t_f = 6.05$ h)

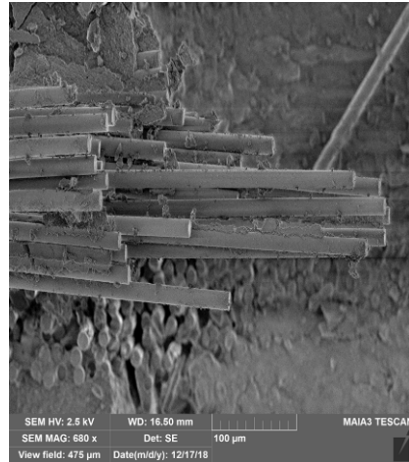
Figure D. 11: Fracture surface of specimen #8 (Area 1), tested in creep at 1200°C in air ($\sigma_{cr} = 150$ MPa, $t_f = 0.01$ h): (a) 75X, (b) 680X

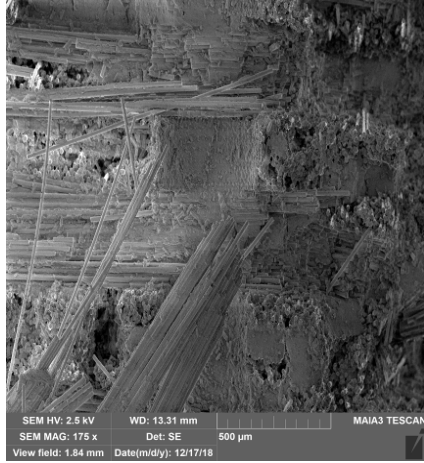
Figure D. 17: Fracture surface of specimen #12 (Area 3), tested in tension to failure following 100 h creep at 46 MPa at 1200°C in steam: (a) 175X, (b) 563X
