Geotechnical remediation of transportation infrastructures: nondestructive evaluation of bridge substructures and stabilization of soft foundation soils

**Geotechnical remediation of transportation infrastructures: nondestructive evaluation of
bridge substructures and stabilization of soft foundation soils**

A dissertation submitted to the graduate faculty
in partial fulfillment of the requirements for the degree of
DOCTOR OF PHILOSOPHY

Major: Civil Engineering (Geotechnical Engineering)

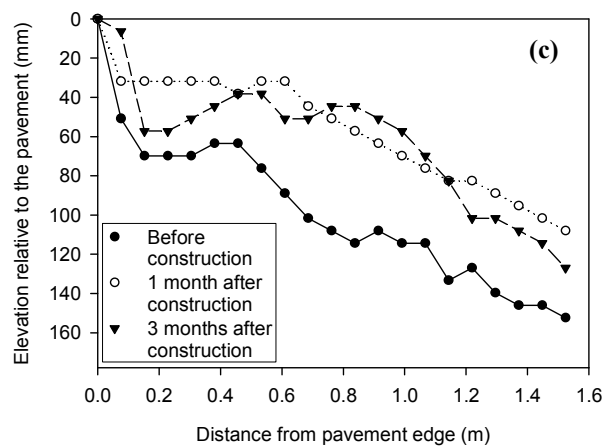
FIG. 2.8 — *Test section No. 1 (a) topical application of the polymer emulsion product (b) delamination of the stabilized granular material after 1 month (c) elevation profiles with time showing redevelopment of edge drop-off*

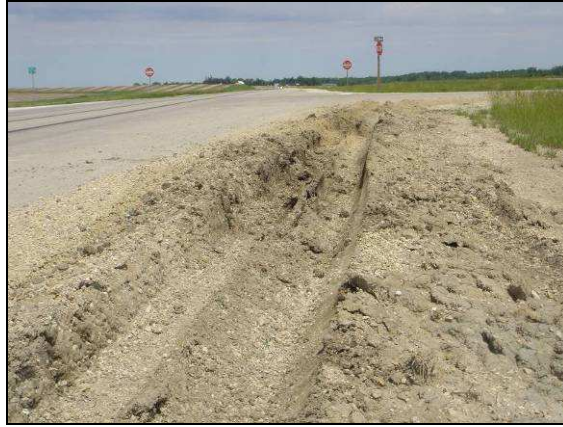
FIG. 2.14 — *Severe rutting extending to the underlying clay layer*

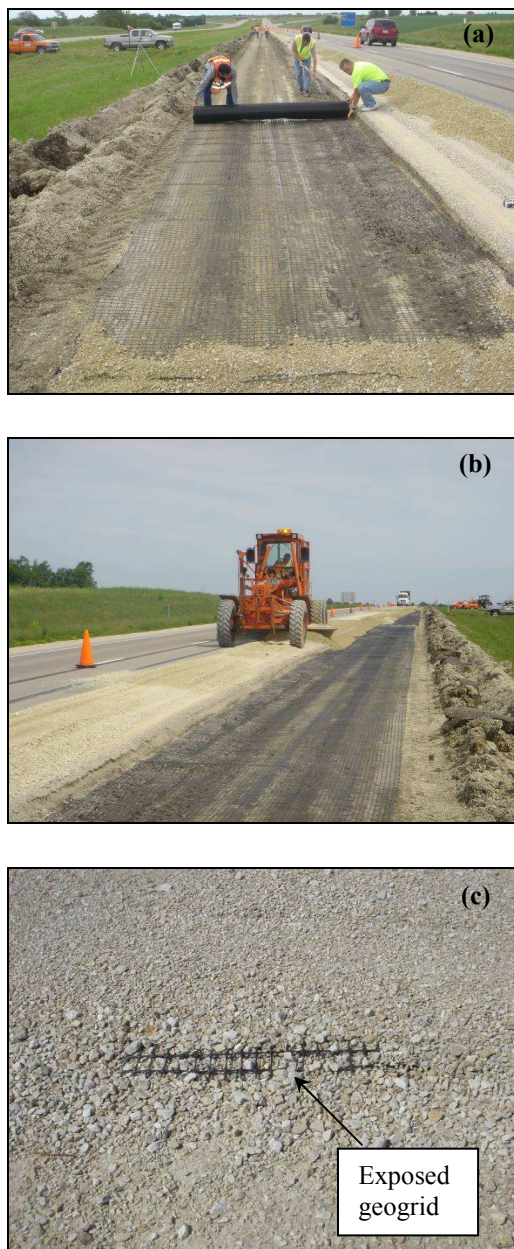
FIG. 2.15 — *Geogrid stabilization (a) rolling the BX1200 geogrid over the soft subgrade layer (b) spreading crushed limestone over the geogrid (c) exposed BX1200 geogrid at about 2.4 from the pavement edge after 10 months*

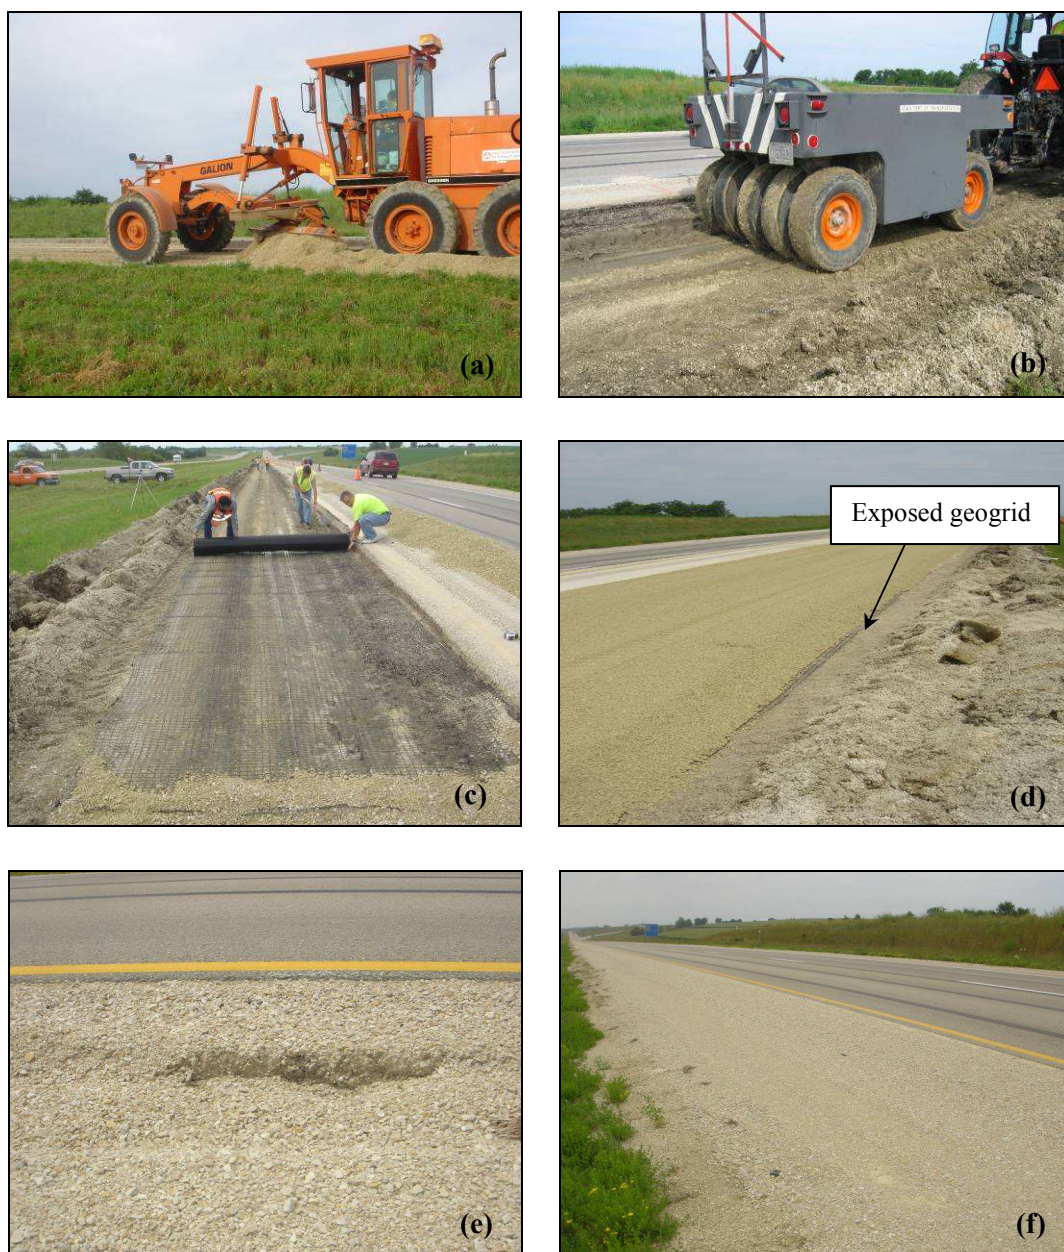
FIG. 3.5 — *Shoulder reconstruction using geogrids (a) motor grader removing the contaminated granular layer (b) pneumatic roller used to compact the subgrade (c) rolling the geogrid over the subgrade (d) spreading the aggregate over the geogrid (e) rutting developed at the control section after one month (f) no rutting at the geogrid stabilized section after one month*

As shown in Figure 3.5a, the existing granular layer was stripped using a motor grader and discarded because of its contamination with the underlying subgrade soil. About 450 tons of crushed limestone were delivered to the site and placed on the pavement adjacent to the test section. The subgrade was leveled using a skid loader and then compacted using a pneumatic roller (See Figure 3.5b). Using a power saw, the geogrids were cut to 2.4 m wide to match the width of the stabilized area. The geogrids were rolled over the soft subgrade starting with Geogrid1 followed by Geogrid2 then Geogrid3 (See Figure 3.5c). The shoulder beyond approximately 300 m was not included in the test section because Geogrid3 was damaged during transportation. The defective grid, denoted by Geogrid3*, was placed without alteration to document the effect of improper geogrid installation. . A motor grader followed by a pneumatic roller were used to spread and compact the aggregate. At the end of construction, it was noted that parts of the geogrids were not adequately covered with aggregate (2.4 m away from pavement) and the edges of the geogrids were exposed (See Figure 3.5d). The entire process of excavation of contaminated material, geogrid placement, aggregate placement, and compaction took approximately five hours. Upon construction completion, the section was opened to traffic. Unlike some chemical stabilization, a geogrid are quickly installed and does not require curing time, which reduces disturbance to traffic.

The first inspection was performed after one month from the date of construction. Edge rut of about 127 mm rut was observed at the control section as shown in Figure 3.5e. The stabilized sections showed no signs of rutting (See Figure 3.5f).

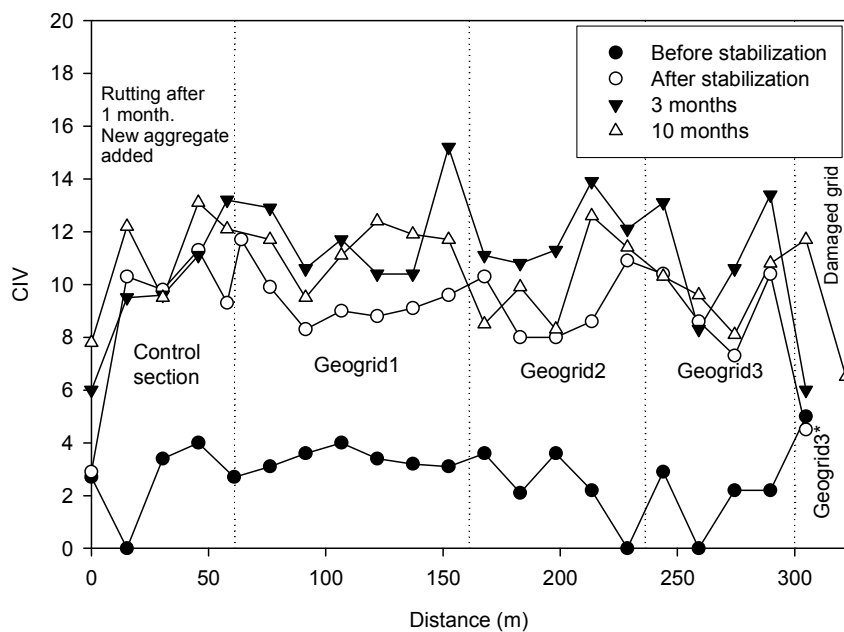
FIG. 3.7 — Profile of CIV with time at 1.2 m from the pavement edge

Using a 20 kg hammer, CIV tests were performed every 15 m as shown in Figure 3.7. Immediately after geogrid installation, CIVs increased. CIVs also increased at the control section as a result of subgrade compaction during the geogrid installation procedure and the addition of virgin rock material. After three months, additional strength at the stabilized sections was measured as indicated by the further increase in CIVs. CIVs measured at the control section did not increase. There was no significant difference between the CIVs measured at the geogrid sections even though the aperture stability modulus, and thus stiffness, varied for each geogrid type. It is possible that the CIV value for the 20 kg Clegg hammer is influenced by a relatively shallow depth and thus was unable to detect different degrees of confinement. At 10 months, CIVs were reduced in all the stabilized sections. Relative loosening of the granular layer after the freeze-thaw period may be the reason behind this reduction.

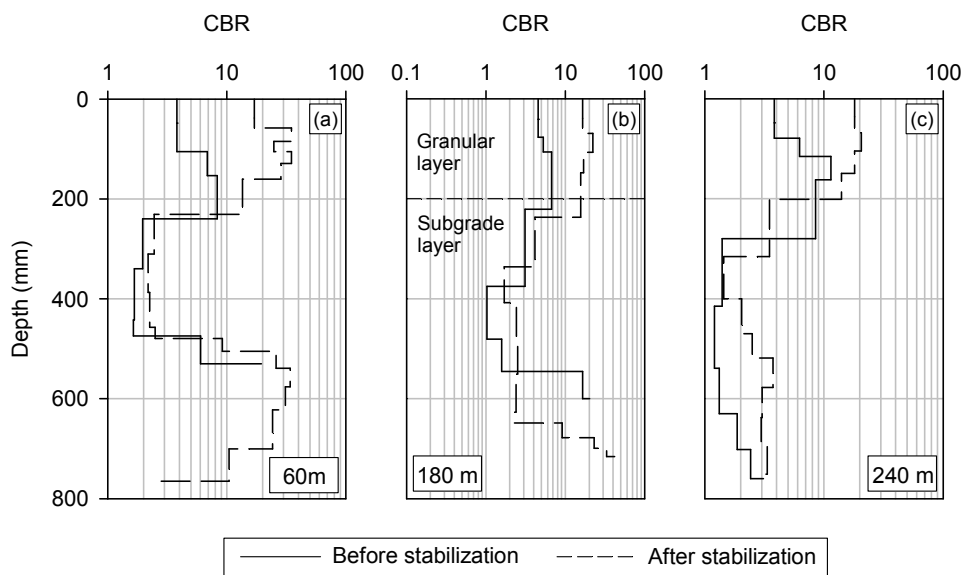
FIG. 3.8 — DCP results before and after stabilization (a) Geogrid1 (b) Geogrid2 (c) Geogrid3

DCP tests were also used to monitor the shoulder section performance. DCP tests conducted before and after stabilization showed an increase in CBR of the granular layer (CBR_{GL}) at all stabilized sections (See Figure 3.8). For the Geogrid1 section, CBR_{GL} increased from 3 to 18, while for Geogrid2 and Geogrid3 sections, CBR_{GL} increased from 4 to 19 and 3 to 17, respectively. There was no significant change in CBR values below the depth of the geogrid.

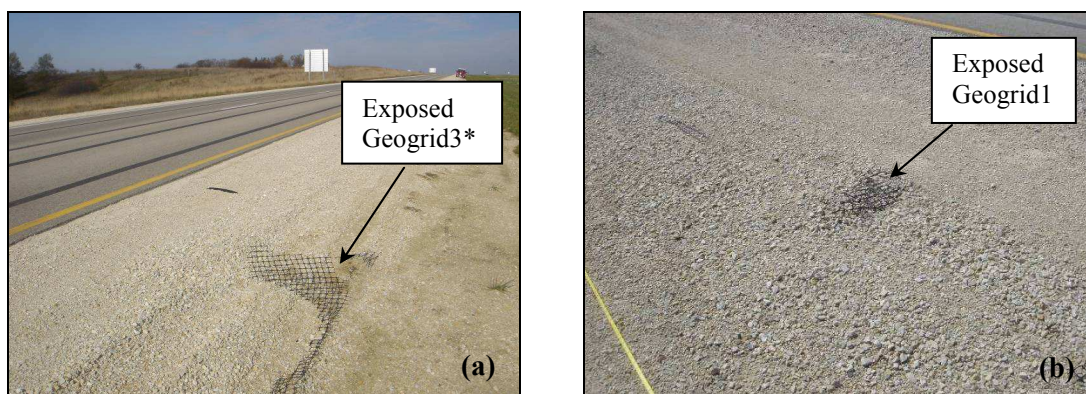
FIG. 3.9 — Exposed geogrid after 10 months (a) Geogrid3* (b) Geogrid1

Parts of the defective Geogrid3 were exposed after four months from installation as shown in Figure 3.9a. The exposure was a result of severe rutting. As expected, improper installation of a geogrid will not provide reinforcement benefits. After 10 months, additional geogrids were exposed. The exposed portions were at a distance of about 2.4 m from the pavement edge where the grids were overlaid by 25 to 50 mm of rock (See Figure 3.9b).

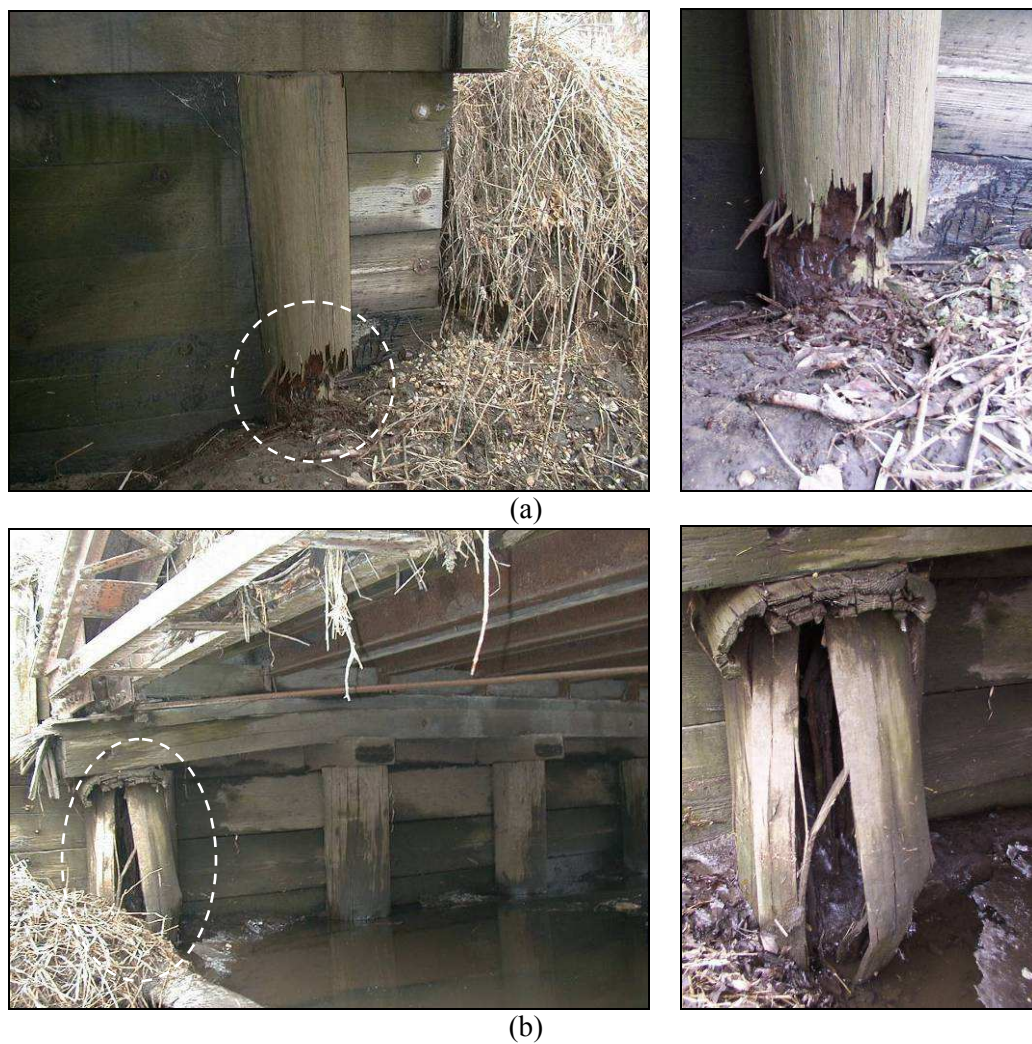
FIG. 4.1 — *Timber pile biological deterioration (a) reduction of pile cross section (b) complete deterioration of pile section*

FIG. 4.1 — Timber pile biological deterioration (a) reduction of pile cross section (b) complete deterioration of pile section

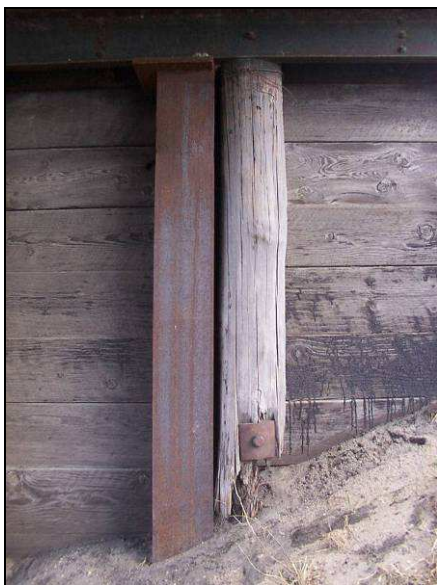
FIG. 4.3 — *New steel pile driven adjacent to a defective timber pile*

FIG. 4.3 — New steel pile driven adjacent to a defective timber pile

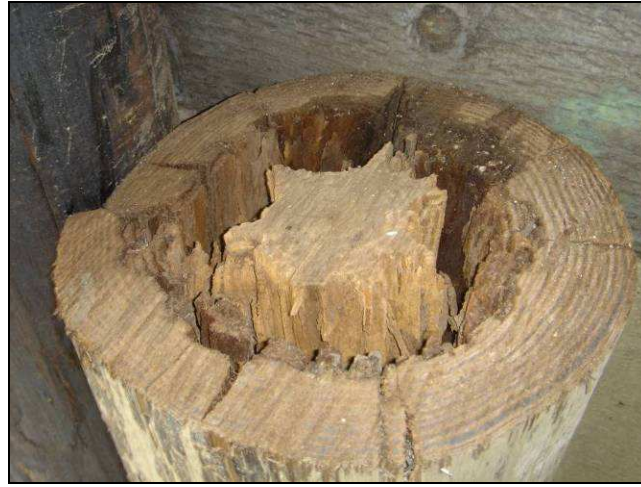
FIG. 4.6 — *Internal pile deterioration that is difficult to detected using the stress wave technique*

FIG. 4.6 — Internal pile deterioration that is difficult to detected using the stress wave technique

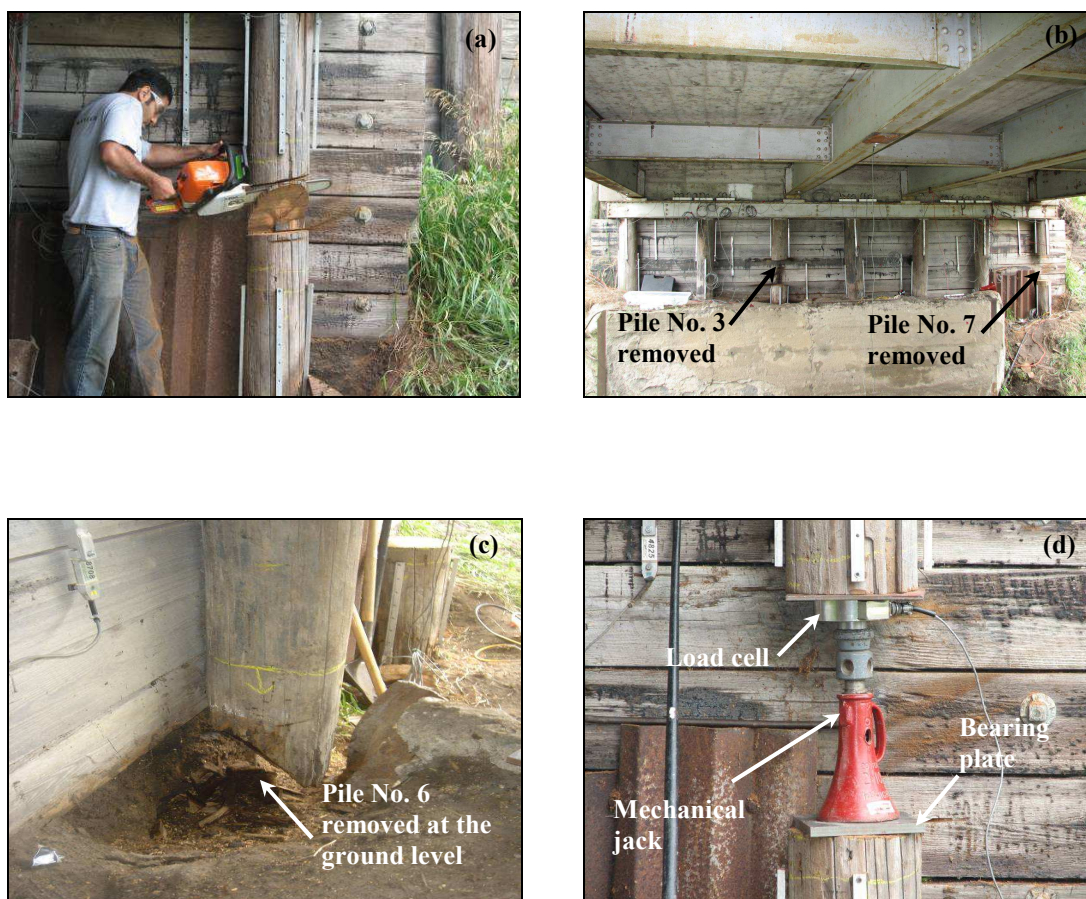
FIG. 5.7 — *Destructive static load tests (a) removing pile No. 7 (b) a section from pile Nos. 3 and 7 removed (c) a section near the ground level is removed from pile No. 6 (d) mechanical jack and load cell used to restore the dead load carried by pile No. 7*

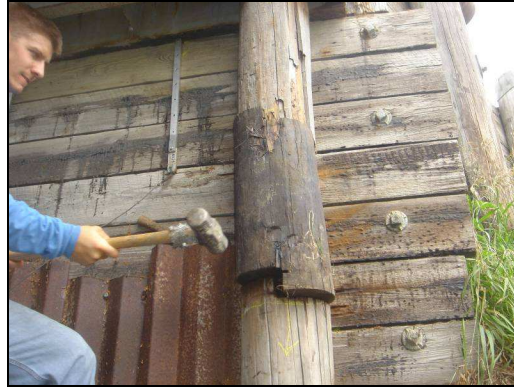
FIG. 5.10 — *Repairing pile No. 7 using the splicing technique*

5.4.3.8. Test No. 8 – Pile No. 7 Repaired
