Geotechnical state-of-the-art in Guatemala -- Ground stabilization

GEOTECHNICAL STATE-OF-THE-ART IN GUATEMALA – GROUND
STABILIZATION

A DISSERTATION

DOCTOR OF ENGINEERING
In
GEOTECHNICAL ENGINEERING

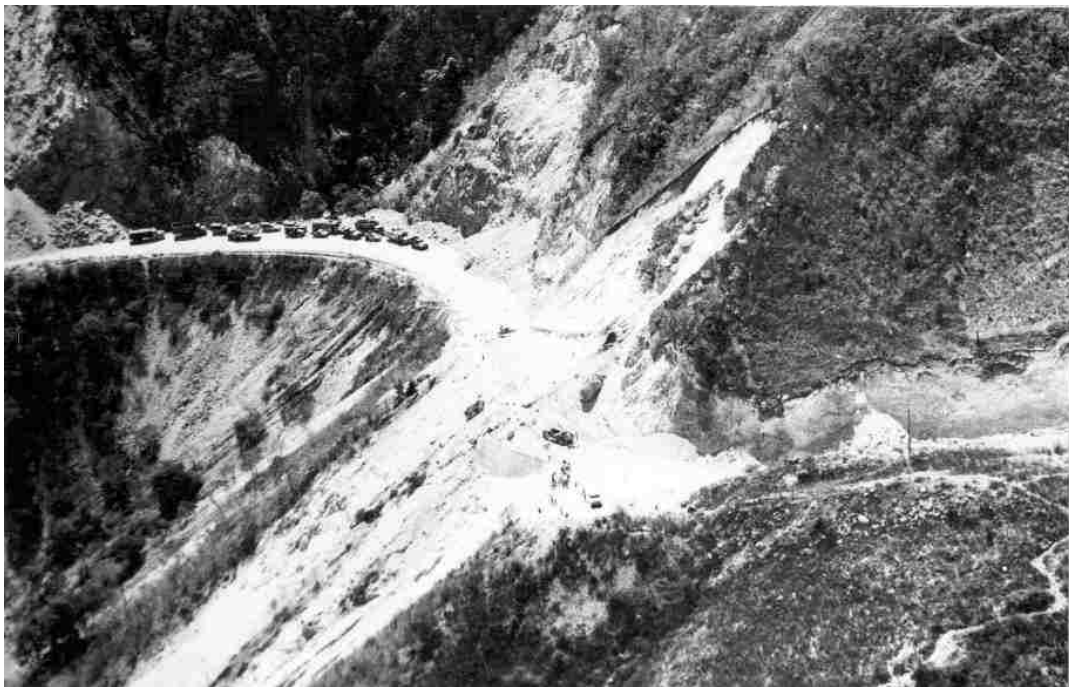
Figure 2.4. One of many landslides blocking the main highway from Guatemala City to El Progreso (Plafker, 1977)

Several geotechnical related failures were observed as landslides, settlements and liquefaction, Figures 2.4 to 2.10 illustrates some of the most critical and representative failures occurred during the earthquake.

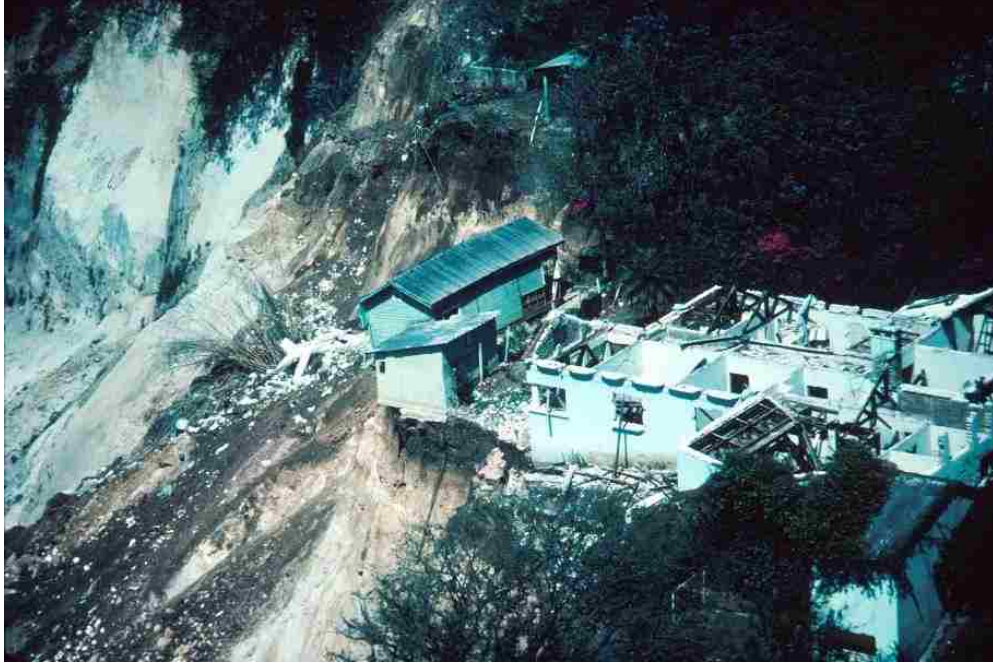
Figure 2.5. Landslide along the edge of a steep walled valley in Guatemala City (Plafker, 1977)

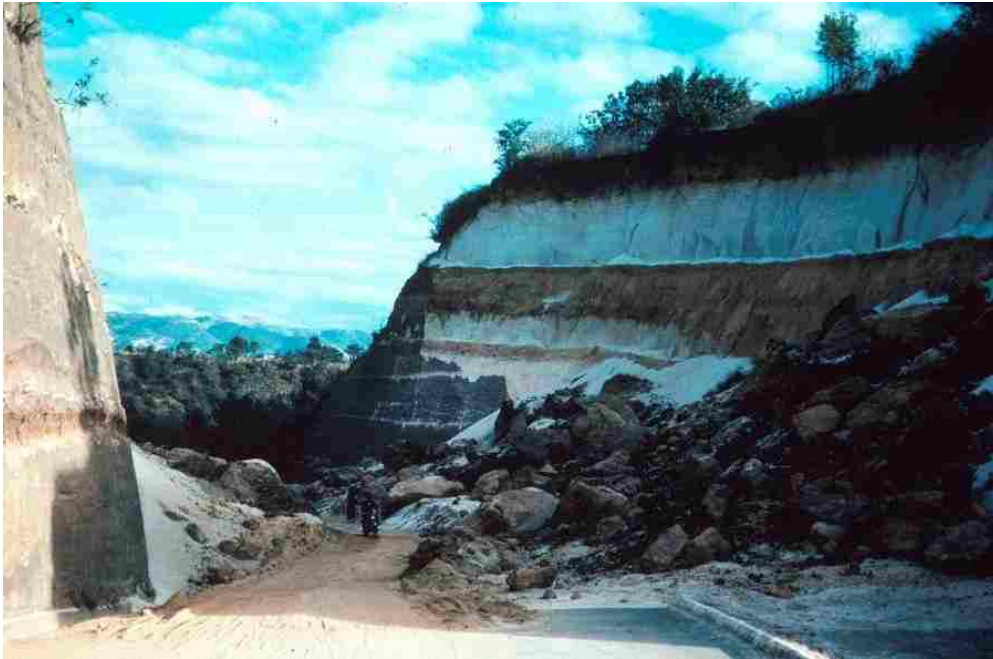
Figure 2.6. Landslides in steep roadcut of stratified pumice and ash deposits at San Cristobal (Plafker, 1977)

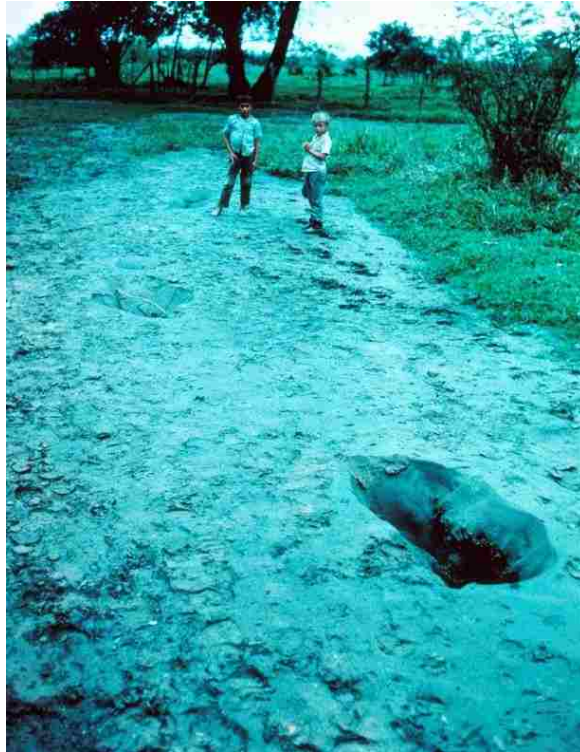
Figure 2.7. Sand mound deposited by a sand blow (Plafker, 1977)

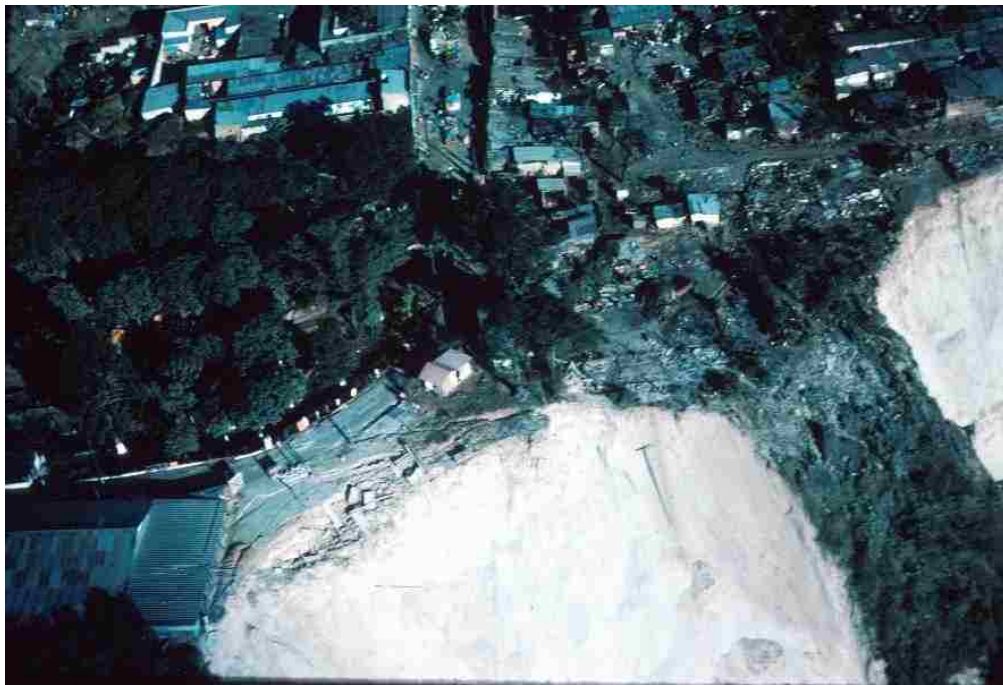
Figure 2.8. Landslides and extensive headwall cracks developed along the edge of a steep walled valley in a Guatemala City suburb (Plafker, 1977)

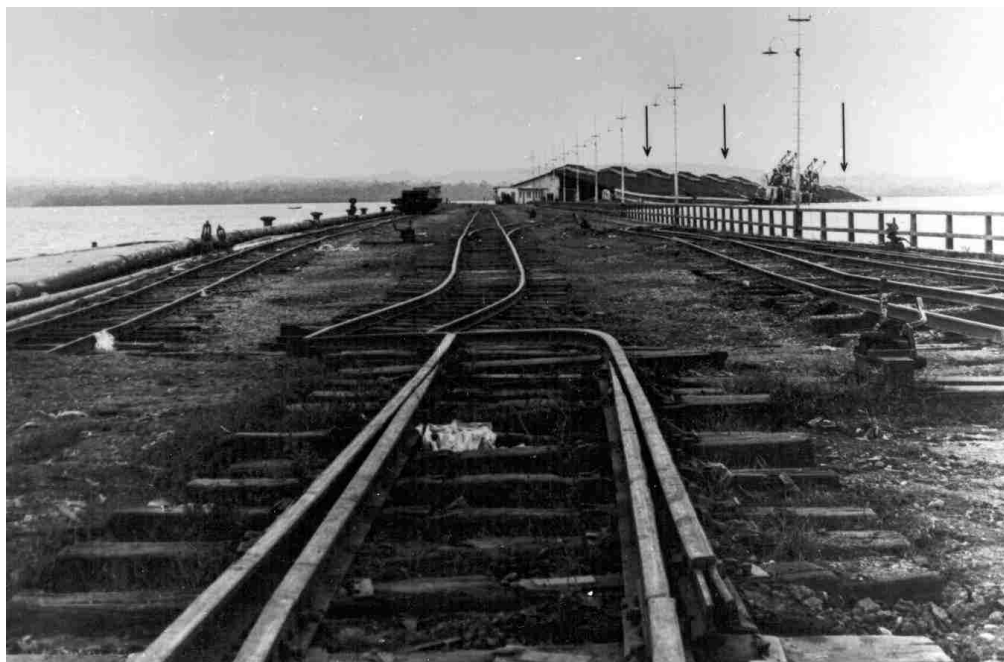
Figure 2.9. Puerto Barrios wharf, destroyed by the February 4 earthquake. Arrows point to the large warehouse partially submerged ((Plafker, 1977)

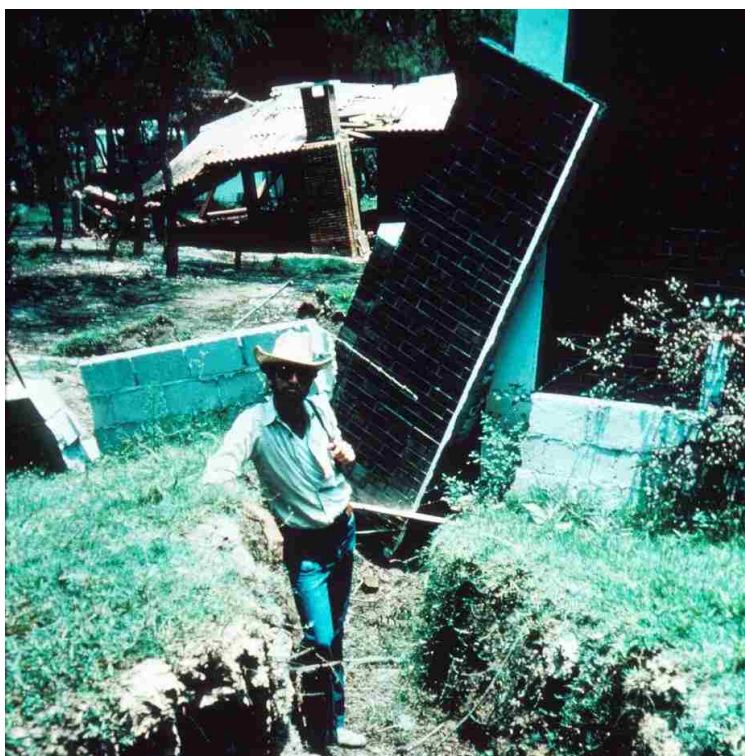
Figure 2.10. Cracks at Lake Amatitlan (Plafker, 1977)

The Figure 2.10. One of many large cracks in a delta at Lake Amatitlan (20 kilometers south of Guatemala City) opened as a result of Earthquake-induced liquefaction of a near surface layer of saturated pumice sand and lateral spreading of the surficial deposits towards the lake. Such cracks caused serious damage where they intersected structures such as the one in the foreground. The front portion of the house in the background sank into the liquefied sand, tilting the brick chimney. (Plafker, 1977)

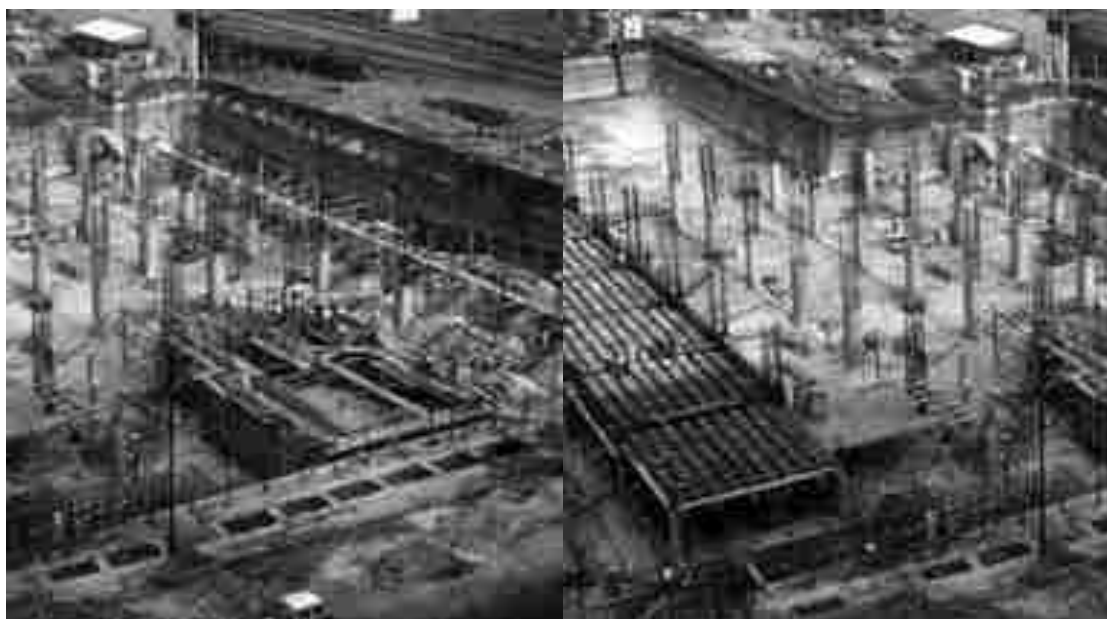
Figure 2.11. Construction of Credito Hipotecario building (Gatonelblu, 2010)

The Figure 2.11 shows images of the construction of Credito Hipotecario building, Figure 2.12 shows Corte Suprema de Justicia building excavation.

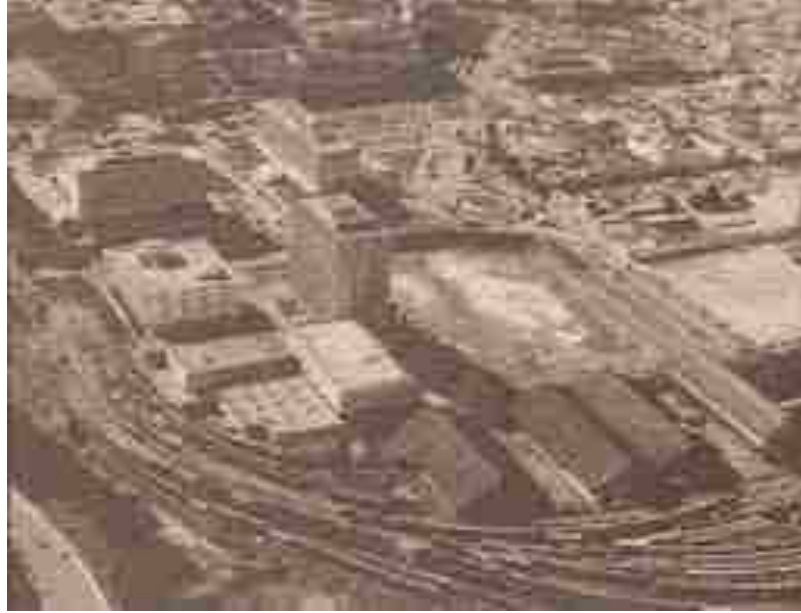
Figure 2.12. Excavation of Corte Suprema de Justicia building (Gatonelblu, 2010)

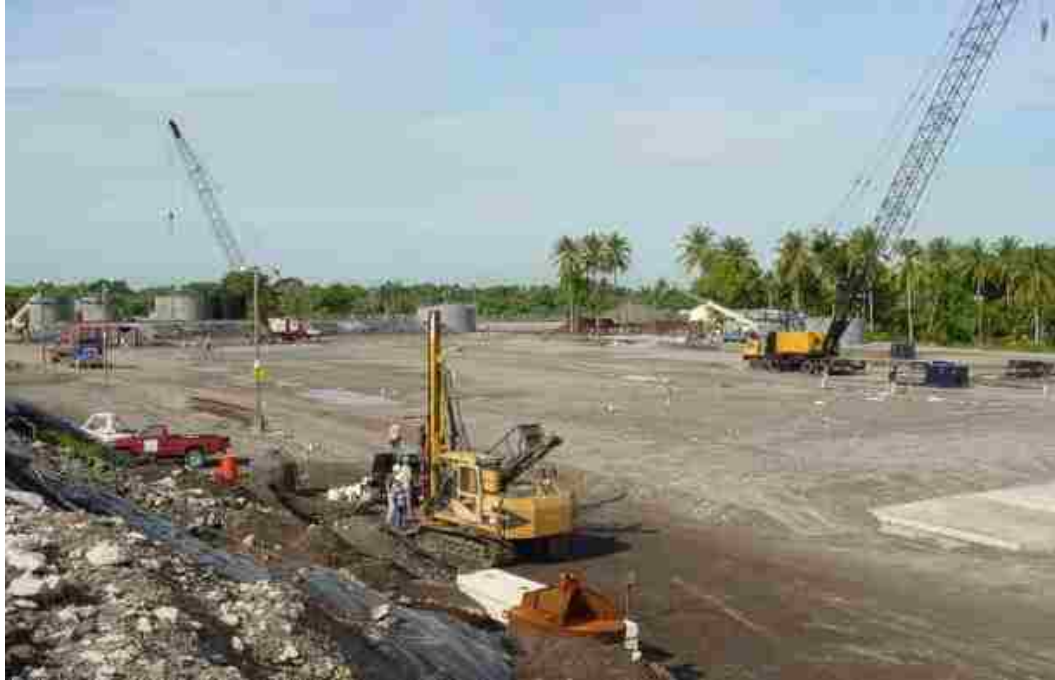
Figure 2.13. Construction site of Arizona Power Plant

A milestone for geotechnical engineering in Guatemala was the construction of the Arizona Power Plant, where two ground improvement techniques were used for first time. The project is locate near Puerto Quetzal in the alluvial plains of the Pacific coast prone to a high seismic risk. Its construction started in 2002 using a direct foundation solution, after the floor slab was poured significant settlements were observed. In order to improve the ground condition, initially a High Dynamic Compaction and e-quake drains treatment were proposed and implemented. This was the first time that high dynamic compaction have been used in Guatemala, and the treatment was performed by ITSA a local contractor, Figure 2.13 shows the site after high dynamic compaction performance and before e-quake drains installation. This treatment did not improved the deep ground against liquefaction risk, so an alternative ground improvement solution was adopted. The selected alternative was Vibroreplacement, Stone Columns, which was also the first time used in Guatemala. The solution consisted of 13.00 m depth stone columns and was performed by Hayward Baker the American subsidiary of the British company Keller.

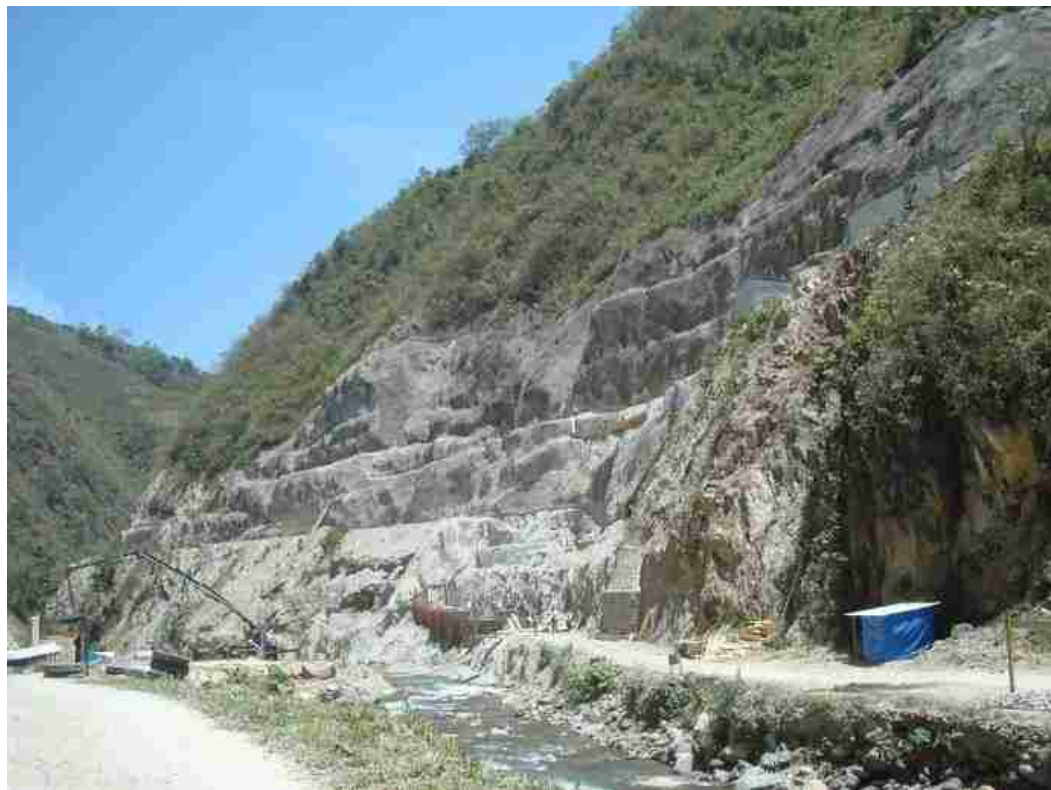
Figure 2.14. Construction site of Santa Teresa Dam

The Santa Teresa dam part of the Hydro-electric power project in 2010 brought a new era in the performance of grouting in Guatemala. In order to control seepage under the dam a grouting curtain was installed. It included the implementation of Grouting Intensity Number method, (GIN) also the first time that this method was used in Guatemala, Figure 2.14 shows the dam construction.

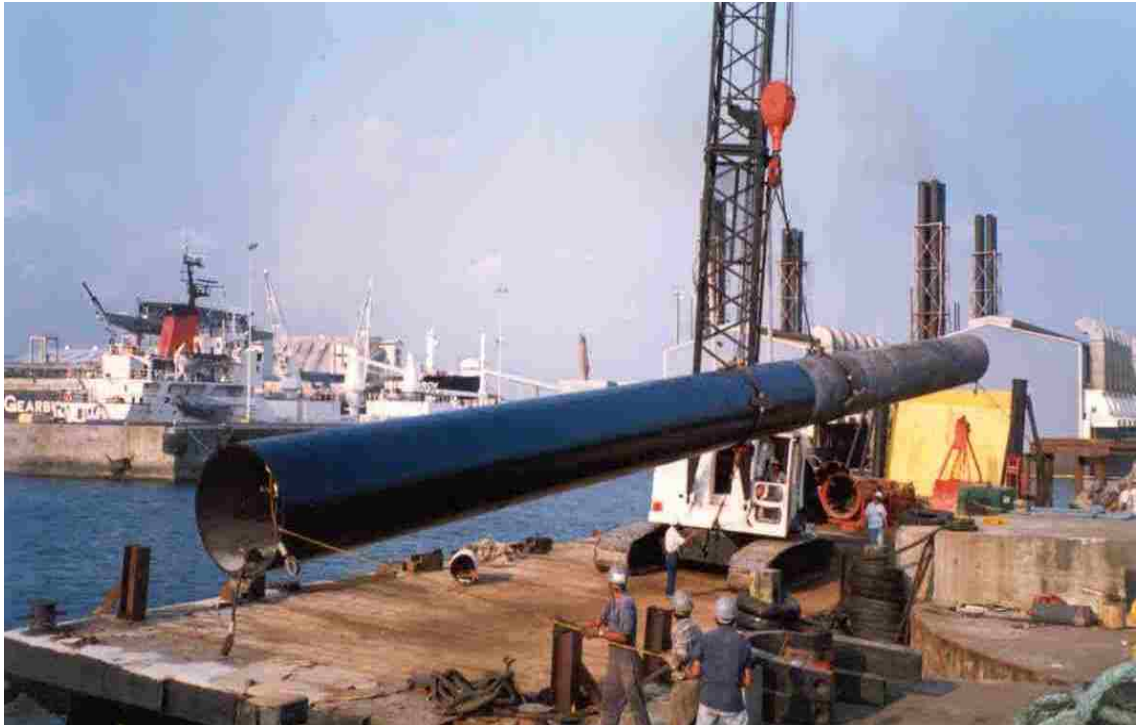
Figure 2.15. Steel piles of Barcaza Man

Puerto Quetzal is the most important marine project performed since 1955, according with the web site of Empresa Portuaria Quetzal. It was built from 1980 to 1983 by the French company Dragages Et Travaux Publics. The wharf consists of a sheet pile wall with a concrete slab in the top. It was the first time that a structure of this type was built in Guatemala. For its construction a small railroad was built in order to ease concrete blocks and rocks transportation. The other relevant projects are San Jose docking station and Barcaza Man Power Station this project are part of thermal electric power plants. Both were the first to use large diameter steel driven piles, 1.50 m. Both were performed from 1999 to 2000 in Puerto Quetzal harbor area by Swissboring Overseas Corp. Ltd. Figure 2.15 shows the handling of the steel piles of Barcaza Man and Figure 2.16 show the pile driving process of the steel pipe piles of San Jose Docking station.

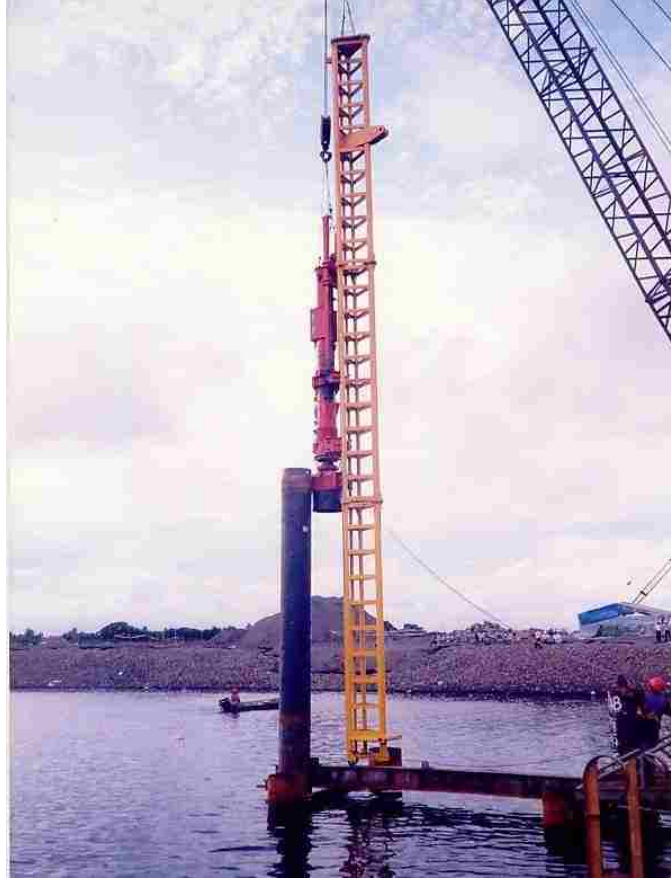
Figure 2.16. Construction of San Jose Docking Station

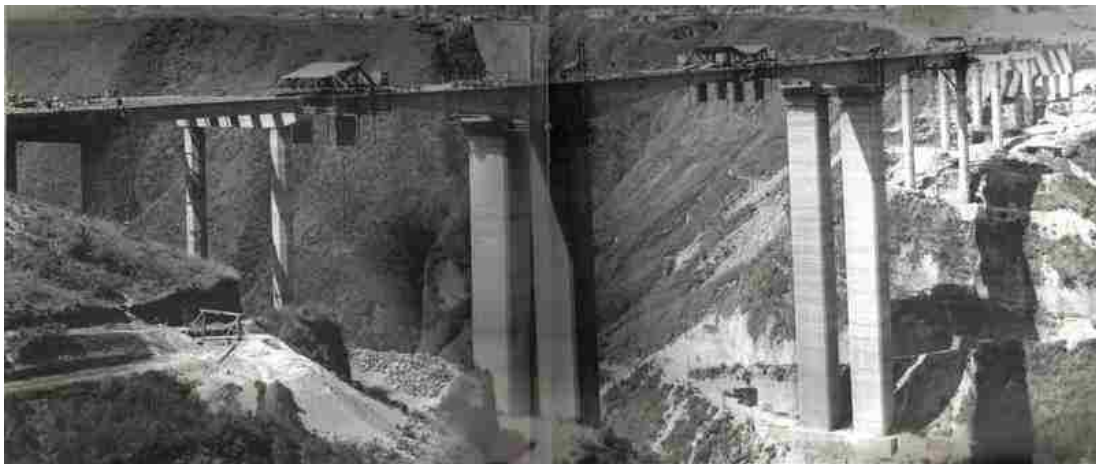
Figure 2.17. Construction of Incienso Bridge deck (Castillo, 2009)

The Incienso bridge, Ingeniero “Martín Prado Vélez” bridge, is the second largest bridge in Guatemala and was the first one to use a post-tensioned box girder system, its construction started in 1973 was inaugurated on June 1974. This is also one of the largest bridges in Central America with a total length of 390.00 m, a width of 25.00 m and height from the bottom of the creek to the deck of 135.00 m. It was built by Ingenieros Urruela y Sittendfeld, Cía. Ltda. from Guatemala, and Ingenieros Civiles Asociados, S. A., ICA, from Mexico (Arriola, J., 2007), Figure 2.17 and 2.18 shows different construction stages.

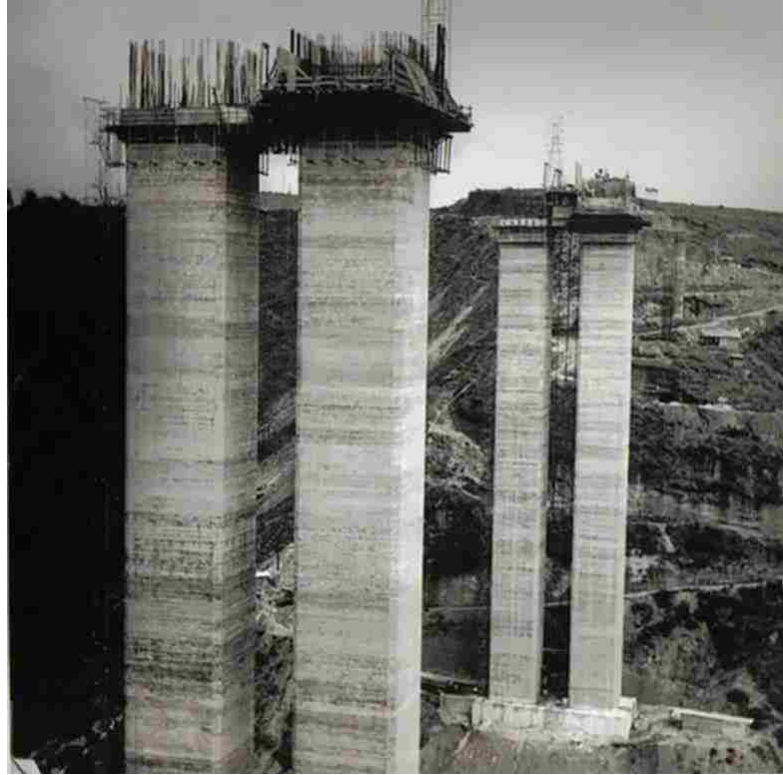
Figure 2.18. Construction of Incienso Bridge piers (Rodas, 2012)

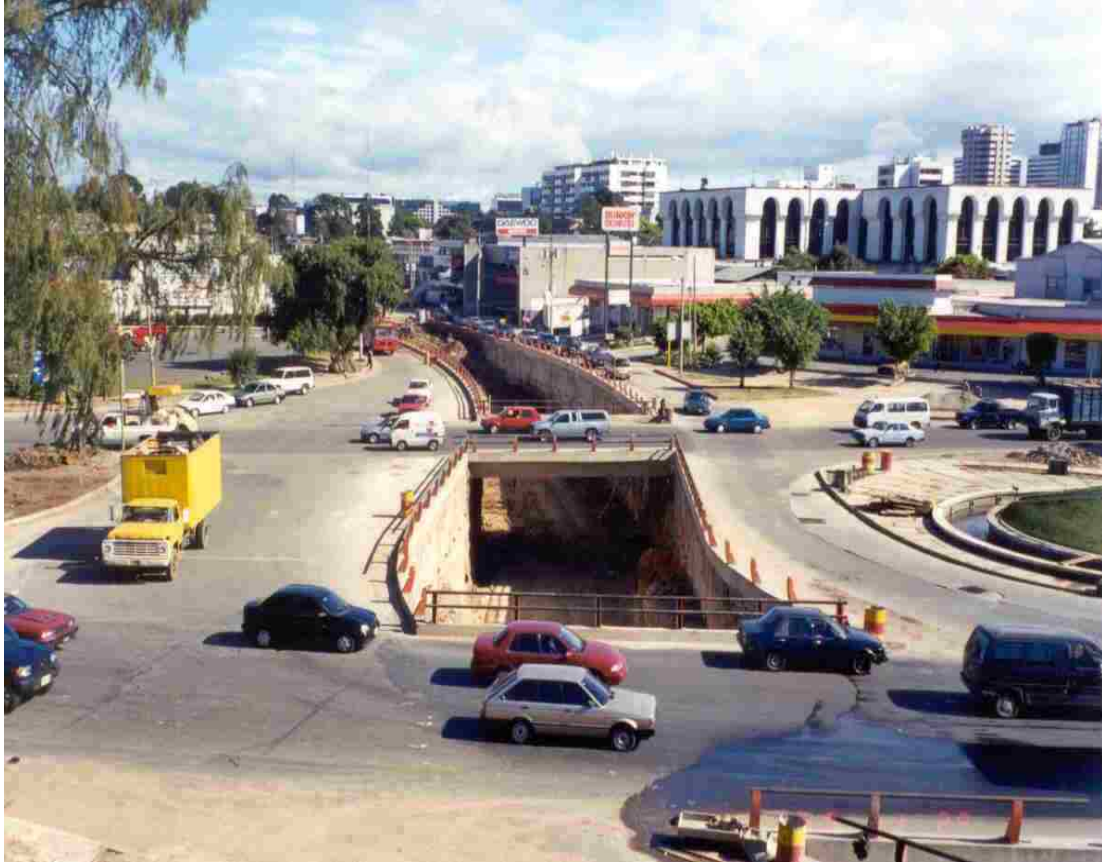
Figure 2.19. Construction of Reloj de Flores Underpass

The bridges over Guacalte and Achiguate Rivers where built in 1999 as the first to use foundation drilled piers built in the alluvial plains. The Reloj de Flores underpass was built in 1999 and includes the construction of the first diaphragm wall in Guatemala, also post-tensioned anchors were used to support the wall. The underpass required a diaphragm wall because the area used to be a lagoon that was filled for the construction of the La Liberación Boulevard, Figure 2.19 shows the excavation stage.

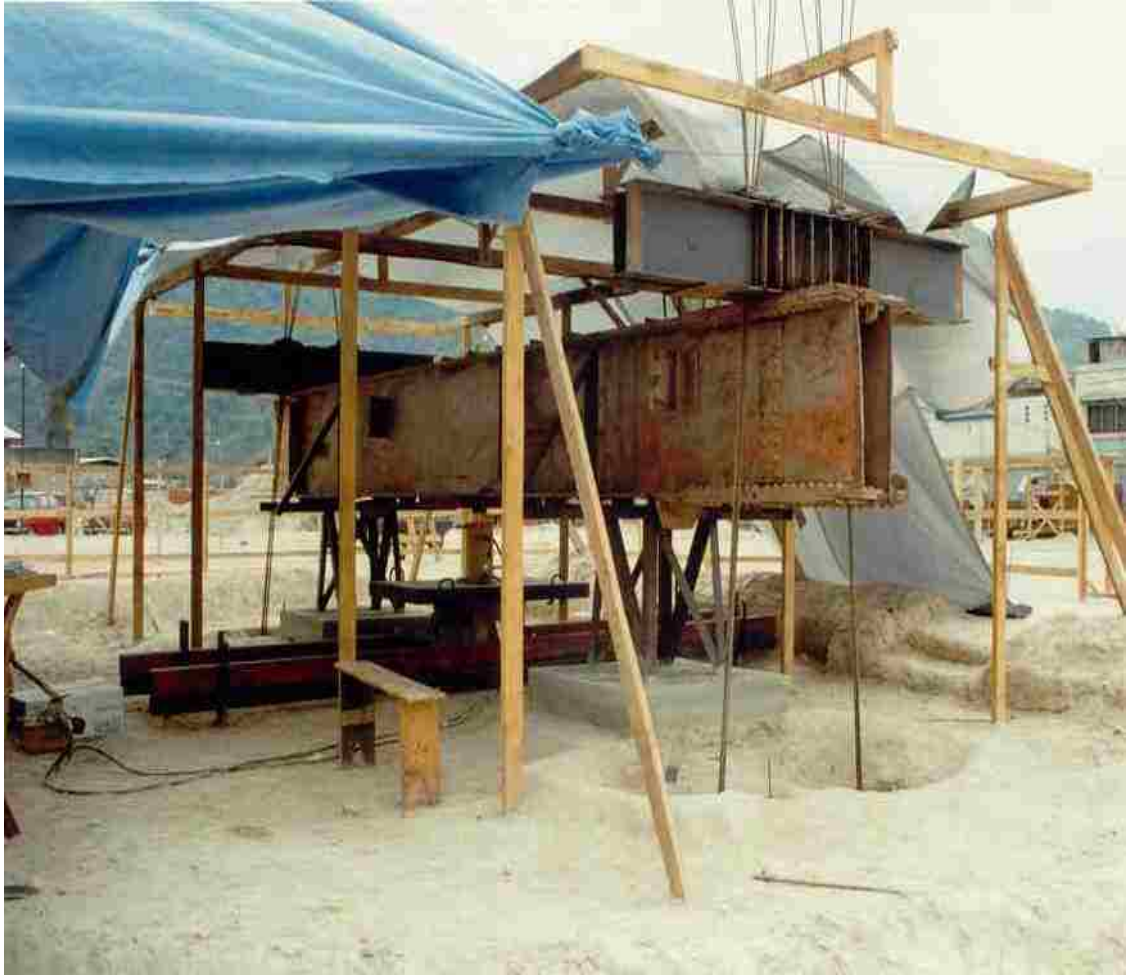
Figure 2.20. Pile load test in Cementos Progreso Cement Plant

The clinker silo construction in 2000 of the Cementos Progreso cement plant in Sanarate included the performance of the first loading test. The load test was a full scale test of 1.20 m diameter drilled pier, using posttensioned anchors as reaction, Figure 2.20 shows the test setup. The test, anchors and pile construction were performed by Swissboring Overseas Corp. Ltd with advice of CPK a Salvadorian consultant firm. Other milestone of piling is also provided by Cementos Progreso in its new San Juan cement plant where 7 load tests were performed using Osterberg Load Cells. The test were performed by the American company Load Test meanwhile the piles were performed by Rodio-Swissboring Figure 2.21 shows drilled shafts and load cells installation.

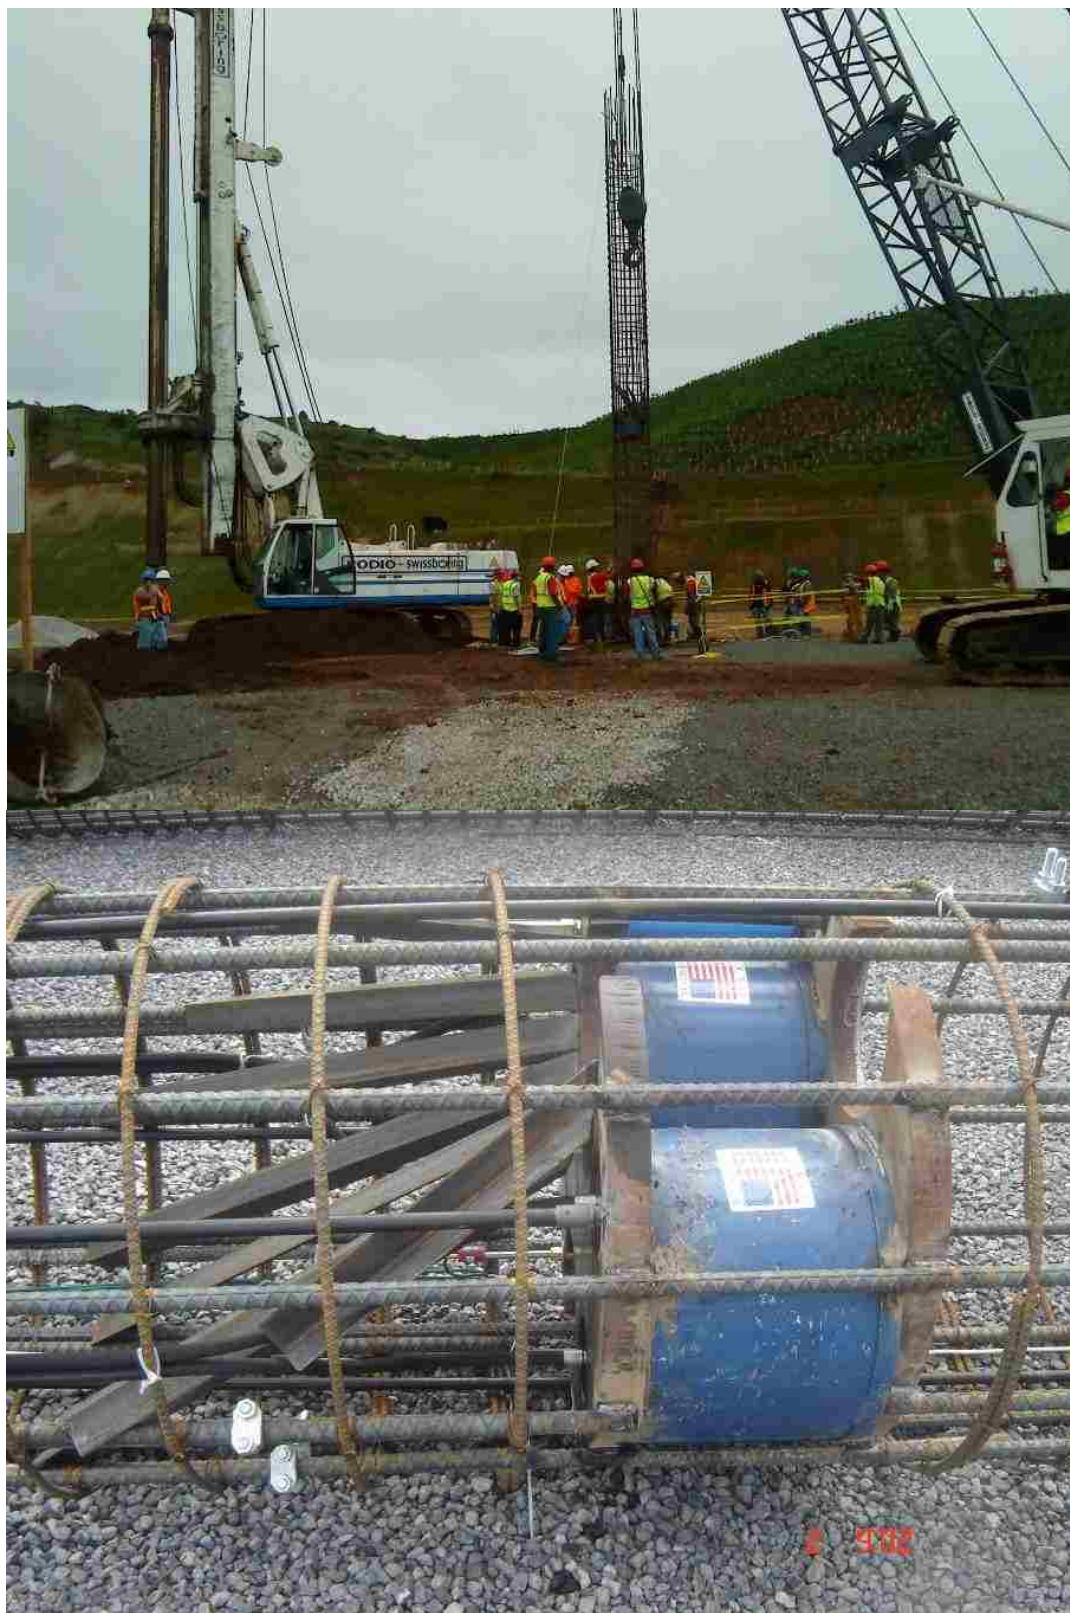
Figure 2.21. Drilled shaft load test of San Juan Cement Plant

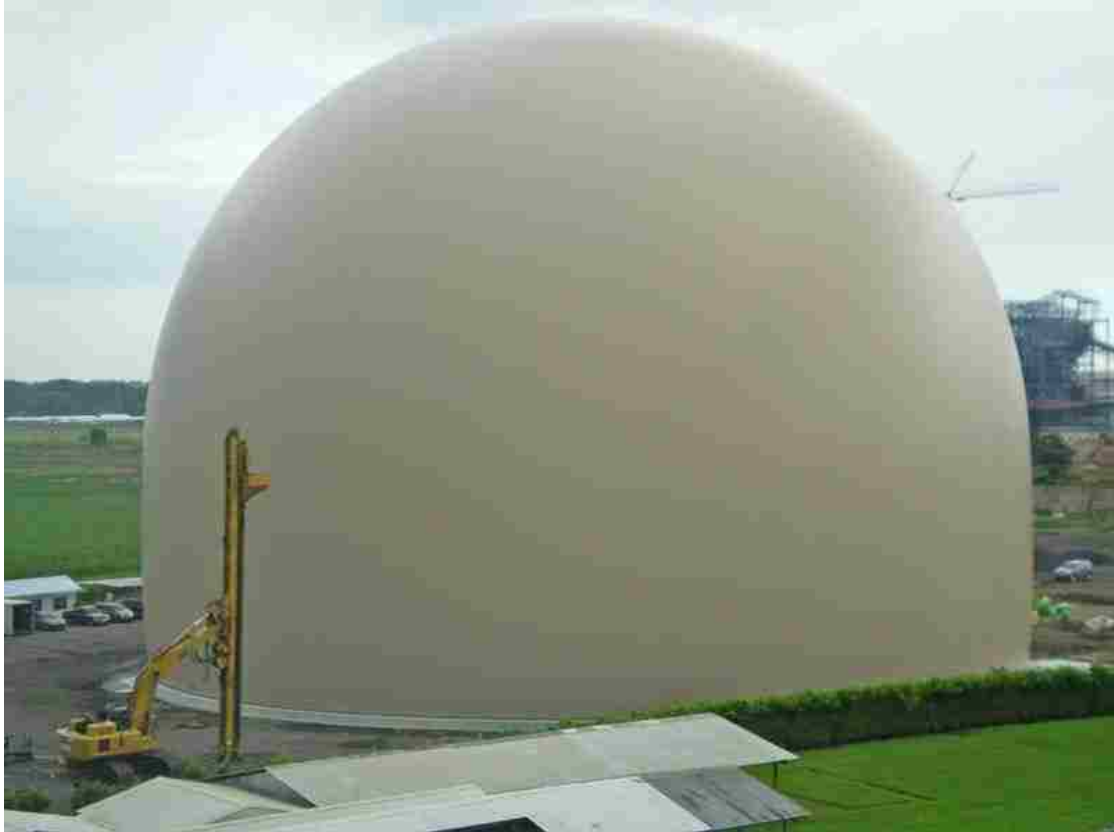
Figure 2.22. Magdalena Sugar Storage Facility (Soiltec, 2012)

The construction of the shotcreted dome of the Magdalena sugar production facility in 2012 by Soiltec was relevant for geotechnical engineering because it was the first time that rammed aggregate piles were used in Guatemala. Figure 2.22 shows the inflatable form for the dome construction and the rammed aggregate pier equipment mounted on a conventional track-mounted excavator.

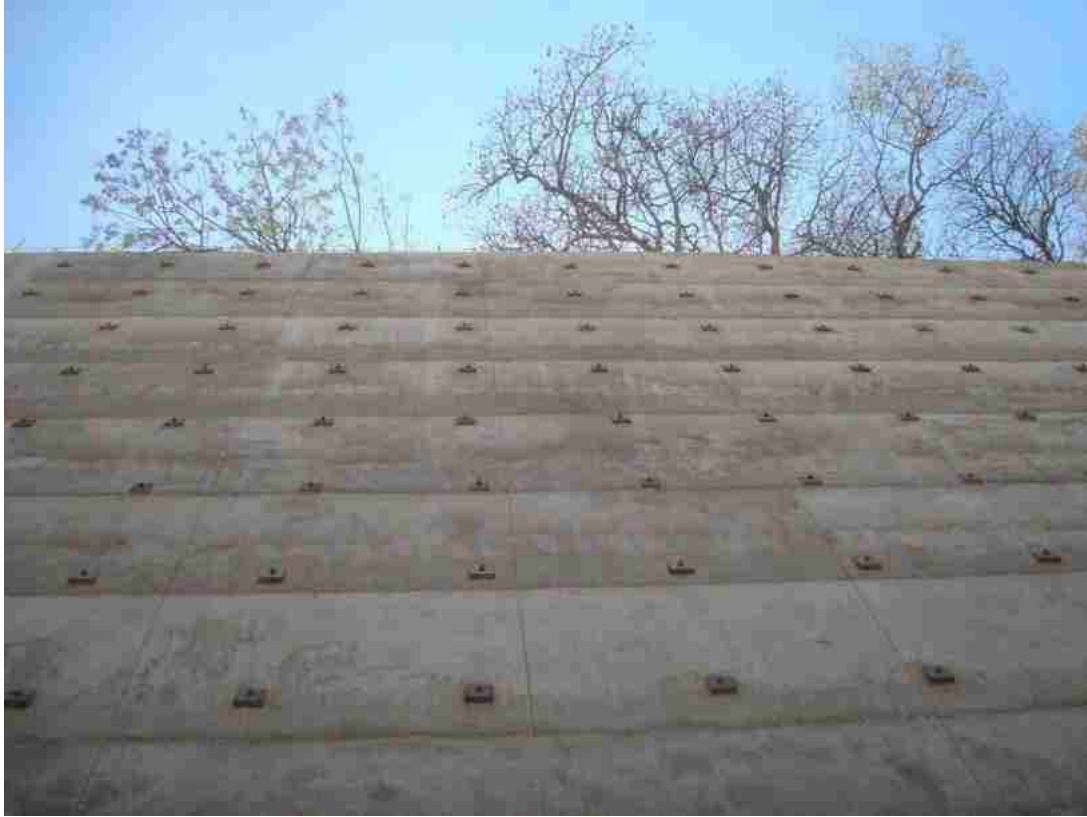
Figure 3.1. Vertical soil nailing wall for excavation stabilization

The Figure 3.1 shows a vertical soil nailing wall for a basement construction.

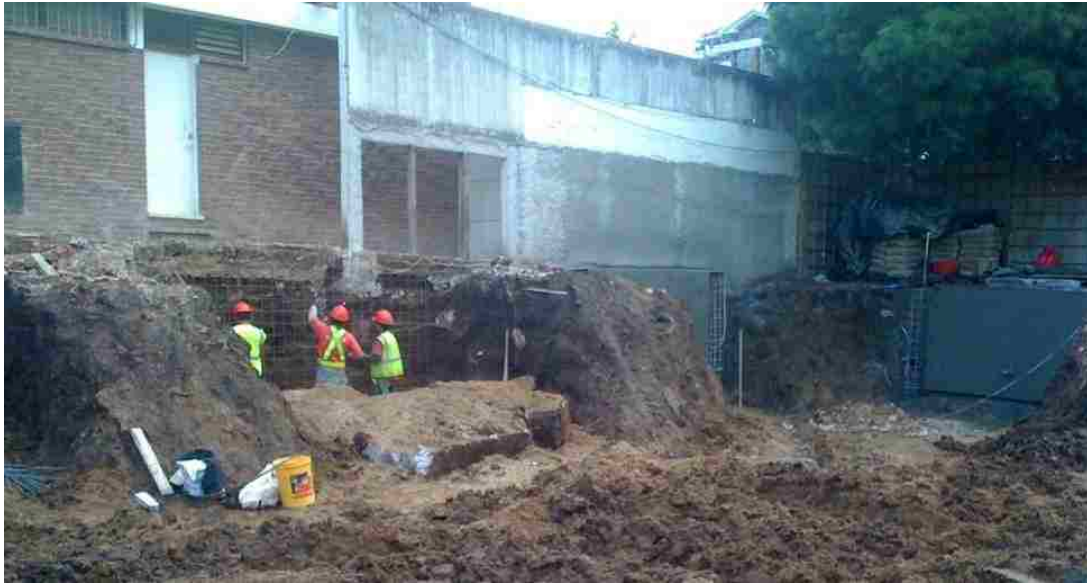
Figure 3.2. Berm utilization during construction

3.1.3.1. Ground conditions. The most important ground condition for soil nail walls performance is the temporary stability during each excavations stage, normally 24 to 72 hour. Is recommended do each stage with some alternates berms as shown in the Figure 3.2.

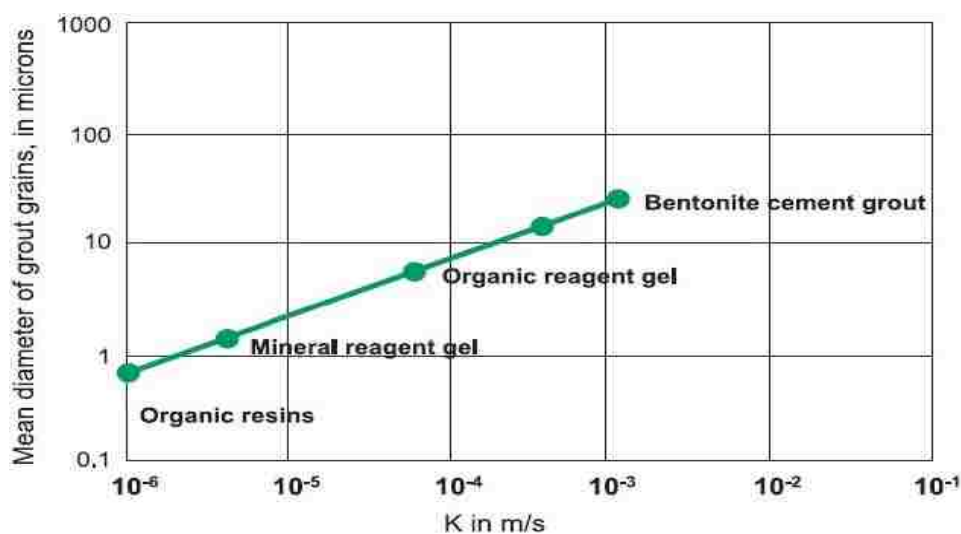
Figure 3.20. Grout penetrability limits based on soil permeability

(Adapted from Soletanche-Bachy, 2011)

Grout penetrability versus soil permeability is shown in the Figure 3.20.

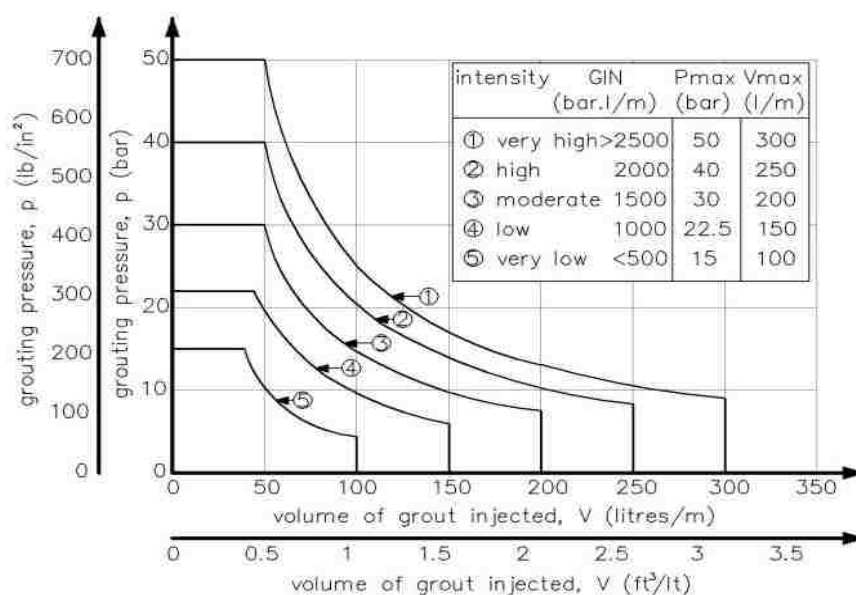
Figure 3.21. Limiting grouting envelopes

(adapted from Lombardi and Deere, 1993)

The GIN method limiting grouting envelopes, in Figure 3.21, help prevent the wasting of grout or damage (e.g., hydrofracture) from grouting pressures that are too high. If relatively large fissures are present, the grout will travel at lower pressures. If a contractor was just watching pressure, large volumes of grout could get pumped into areas where it is not needed. Conversely if only small fissures are present, the grout will need higher pressures to flow. If a contractor was only watching the grout volume, high grout pressures could build up and cause additional rock fracturing, defeating the purpose of the grout curtain. In the GIN method, the grout volume, pressure, and volume x pressure monitored. If any of these values hits the limit for the chosen envelope, then the grouting is stopped for that stage.

For example, if we have a rock formation with small, medium, and large fissures that need to be grouted, then during the first grouting stage, the grout will most easily

flow into the large fissures at lower pressures until the volume limit is reached and grouting is stopped. When that grout has set and the large fissures are filled, the second stage grouting will require more pressure to travel into the medium fissures. Once the grout volume \times pressure hits the limiting curve, the grouting will stop. When the second stage grout has set, the third stage grouting will require even more pressure to push grout into the small fissures. Once the maximum pressure is reached, the grouting will stop and all three sets of fissures should be adequately filled.

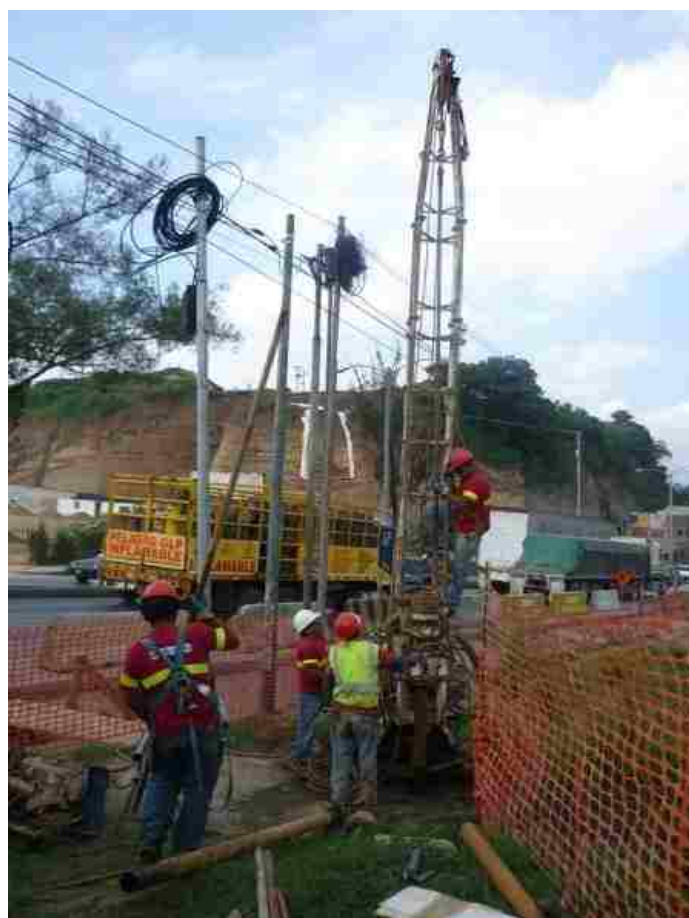
Figure 4.5. Boreholes drilling

4.1.2.3. Geotechnical investigation. To investigate the surface and subsurface conditions at the site a geotechnical field program was planned. The field geotechnical survey consisted of two boreholes of 23.00 m depth with core recovery and performing Standard Penetrations Tests (SPT) at 1.00 m intervals and four block samples. The four block samples were taken from the slope face and were taken to the laboratory for direct shear testing, Figure 4.4 shows the sampling activities. Boreholes were drilled using wire line system (HQ diameter; 96.5 mm outside diameter; 63.5 mm sample diameter) as shown in Figure 4.5 for borehole 2. Boring logs and core boxes photos are included in the appendices. Figure 4.6 shows the borehole locations.

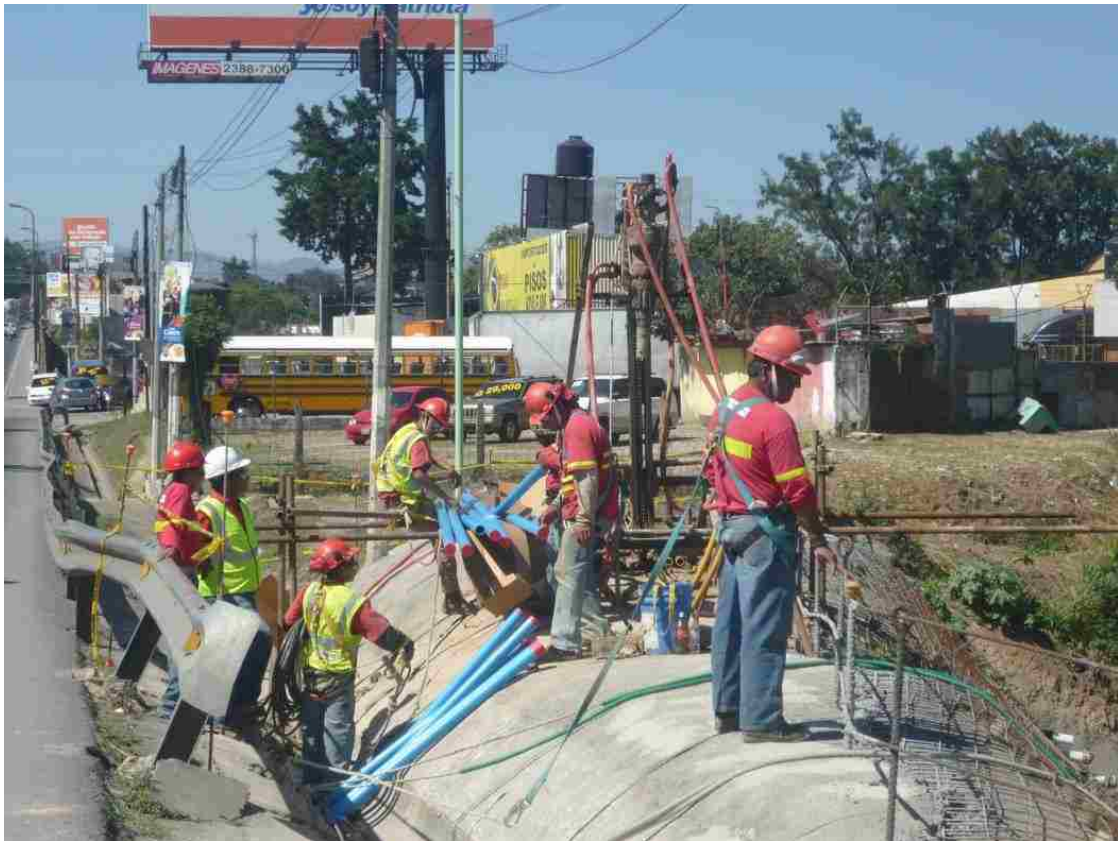
Figure 4.14. Inclinerometer installation

4.1.6.1. Instrumentation. Inclinerometers were installed at three different locations in order to monitoring slope and soil nailing walls movements, Figure 4.14 shows an inclinometer installation. The Table 4.3 shows inclinometers characteristics. Readings were performed with a digital inclinometer and Figure 4.15 shows technicians conducting the inclinometer readings. Inclinerometer system characteristics are shown in the Table 4.4. Digipro software was used to analyze the information. The monitoring program includes the reading of the inclinometer during one year period, in order to have a more complete data of the performance of this wall, Table 4.5 shows the monitoring schedule. Additional readings were conducted in 2015 to examine the long-term performance of earth structures.
