Geotechnical state-of-the-art in Guatemala -- Ground stabilization

GEOTECHNICAL STATE-OF-THE-ART IN GUATEMALA – GROUND
STABILIZATION

A DISSERTATION

DOCTOR OF ENGINEERING
In
GEOTECHNICAL ENGINEERING

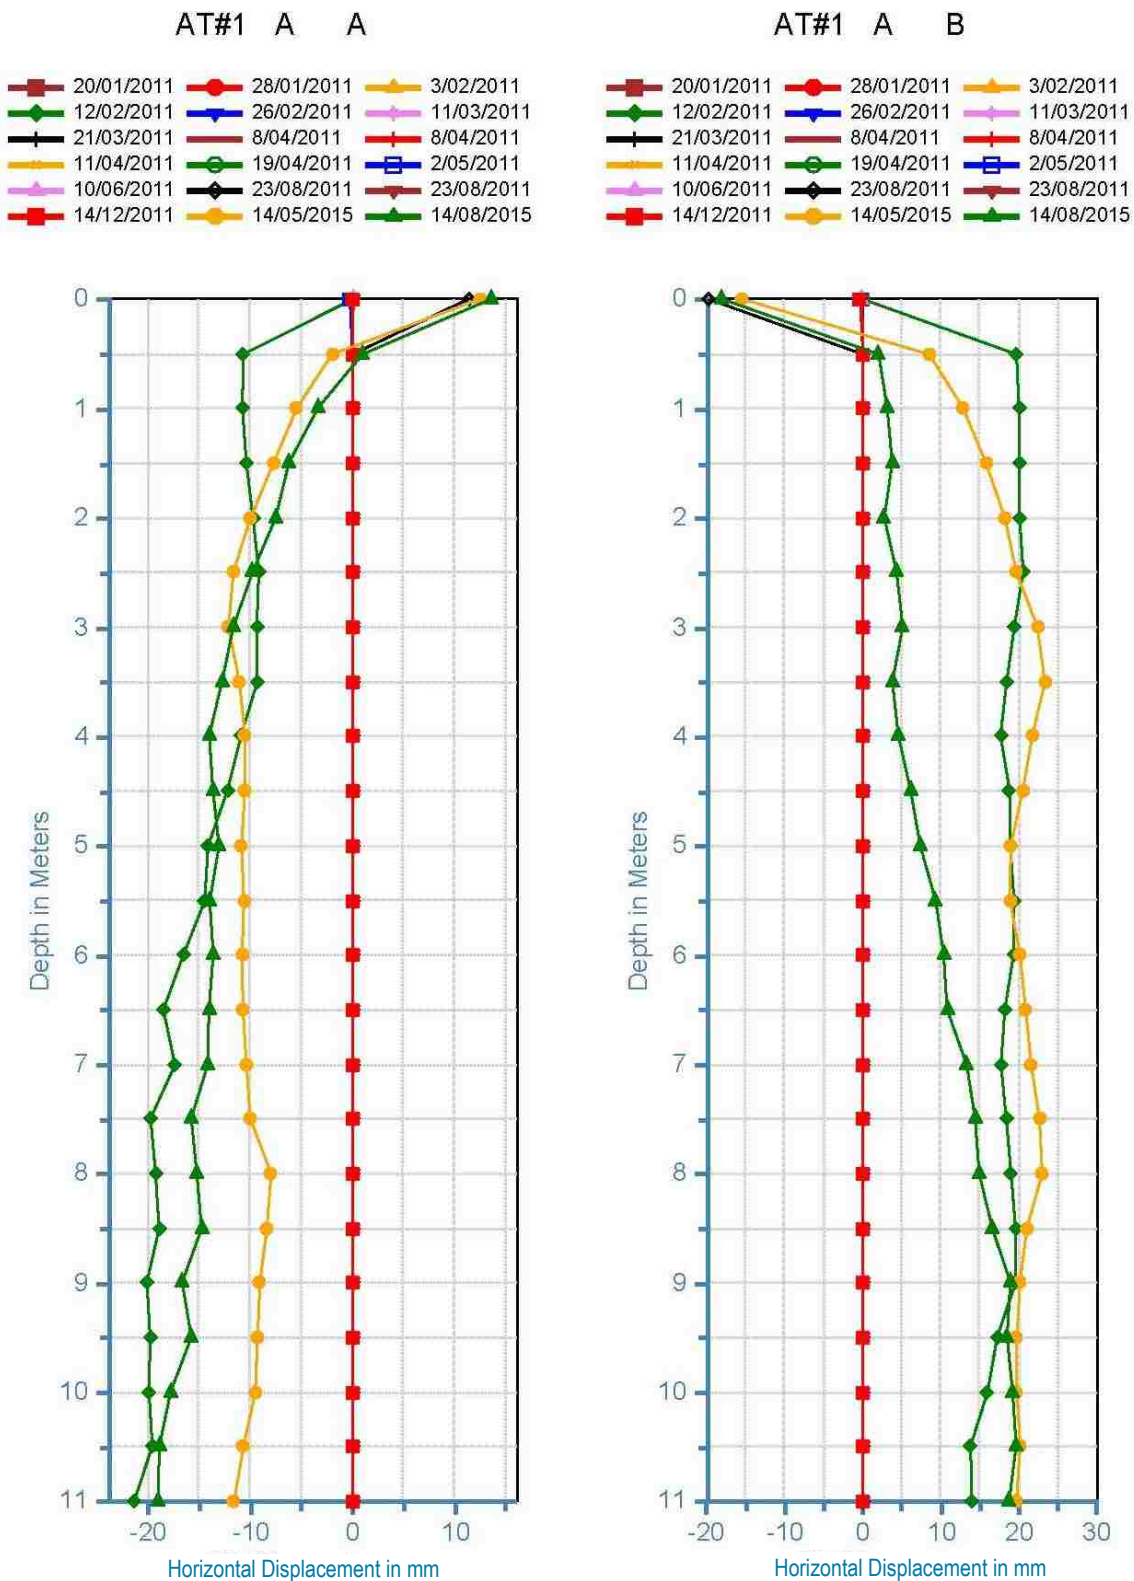
Figure 4.16. Inclinometer #1 displacements vs. depth

4.1.6.2. Performance. In the short-term, after one year of service, performance of the soil nail wall was very good showing almost no movement, at inclinometer #1. Figures 4.16 and 4.17 show the complete measurements history. The slope the inclinometer pipe was vandalized presenting a damage and pipe obstruction. The inclinometer cap was replaced and the pipe was cleaned. Long-term performance measurements on inclinometer #2A shows some peaks but a constant behavior that matches with no movement of soil mass and could represent the damage due to vandalism.

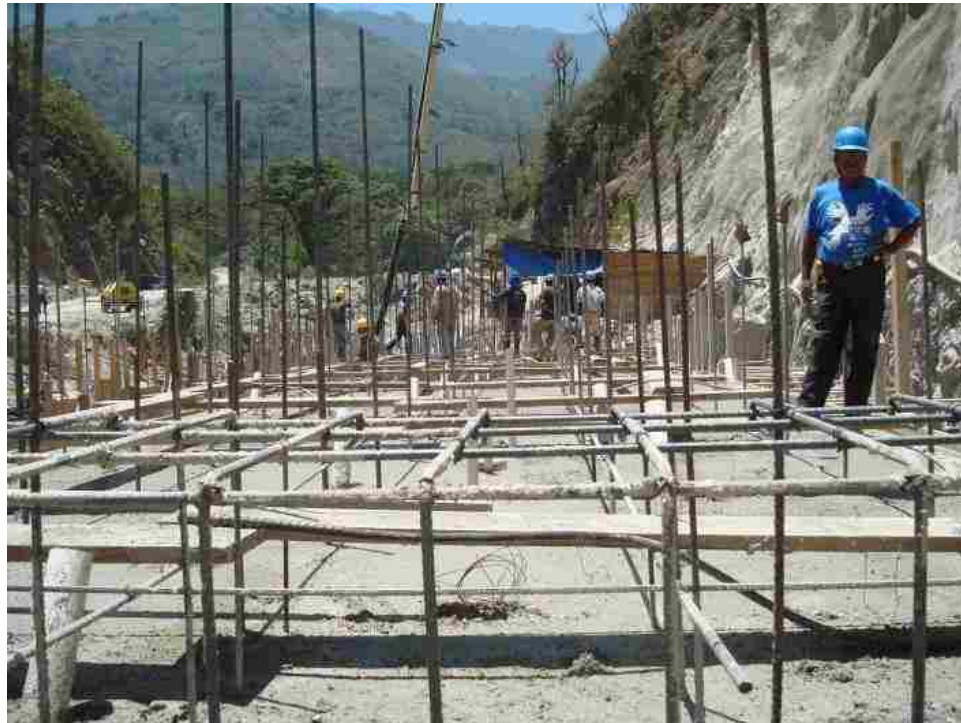
Figure 4.28. PVC sleeves intalled during construction

4.2.5.1. Sleeve installation. In order to reduce drilling and possible damage to the concrete of the dam a 10 cm diameter PVC sleeves were installed in the base of the dam during the initial construction stage. Figure 4.28 show PVC sleeve installed during construction.

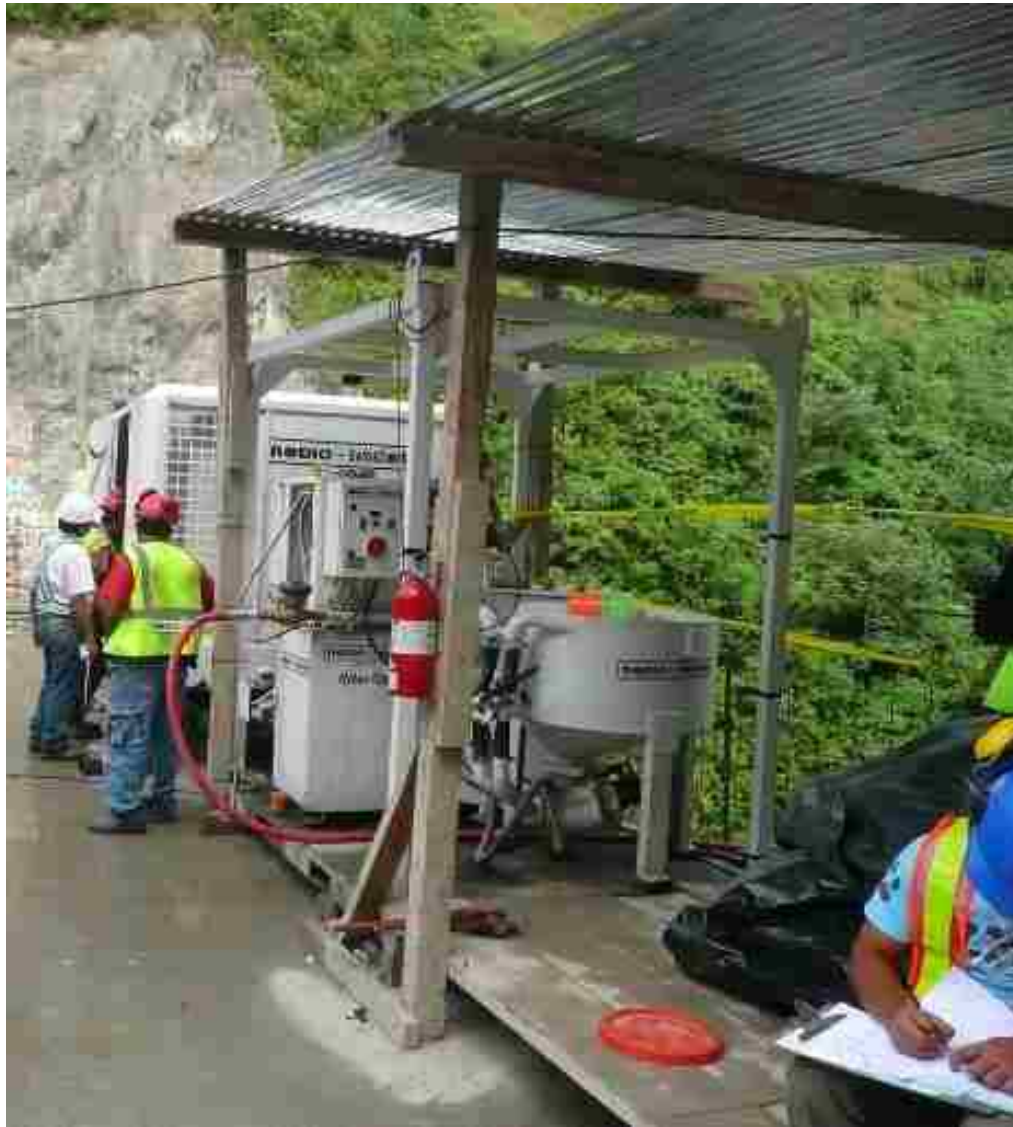
Figure 4.29. PVC sleeves installed during construction

4.2.5.2. Grouting station set-up. Grouting stations were located in strategic points to reduce pumping distance as well as to ease grouting works. During the set-up of the grouting station a foreign technician from the grouting monitoring manufacturer, Jean Lutz, came to the project to perform the initial equipment calibration. This calibration included pressure, volume, grouting rate, stoppage parameters. Figure 4.29 shows one of the two grouting stations.

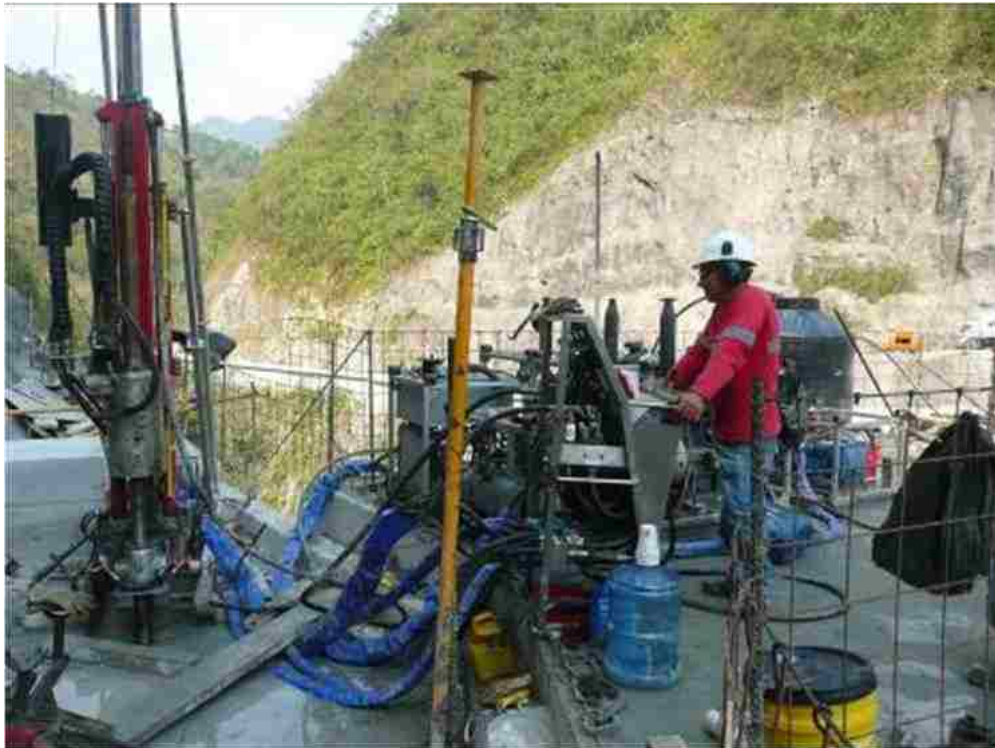
Figure 4.30. Drilling from the surface using wire line system

4.2.5.3. Drilling. Due to access and site conditions, different types of drilling equipment were used. For drilling within the service galleries a Longyear LM-55 electric drill equipment, no combustion, were used. For the drilling from the dam surface an Ingetrol Explorer MD3 hydraulic equipment were used. Rotary core drilling system was used in order to avoid damage the concrete of the dam. Core drilling also allows to verify ground stratigraphy. Boreholes were drilled in NQ diameter, hole (outside) diameter: 75.7 mm; core (inside) diameter: 47.6 mm. Figure 4.30 shows drilling process with the Ingetrol Explorer MD3 equipment.

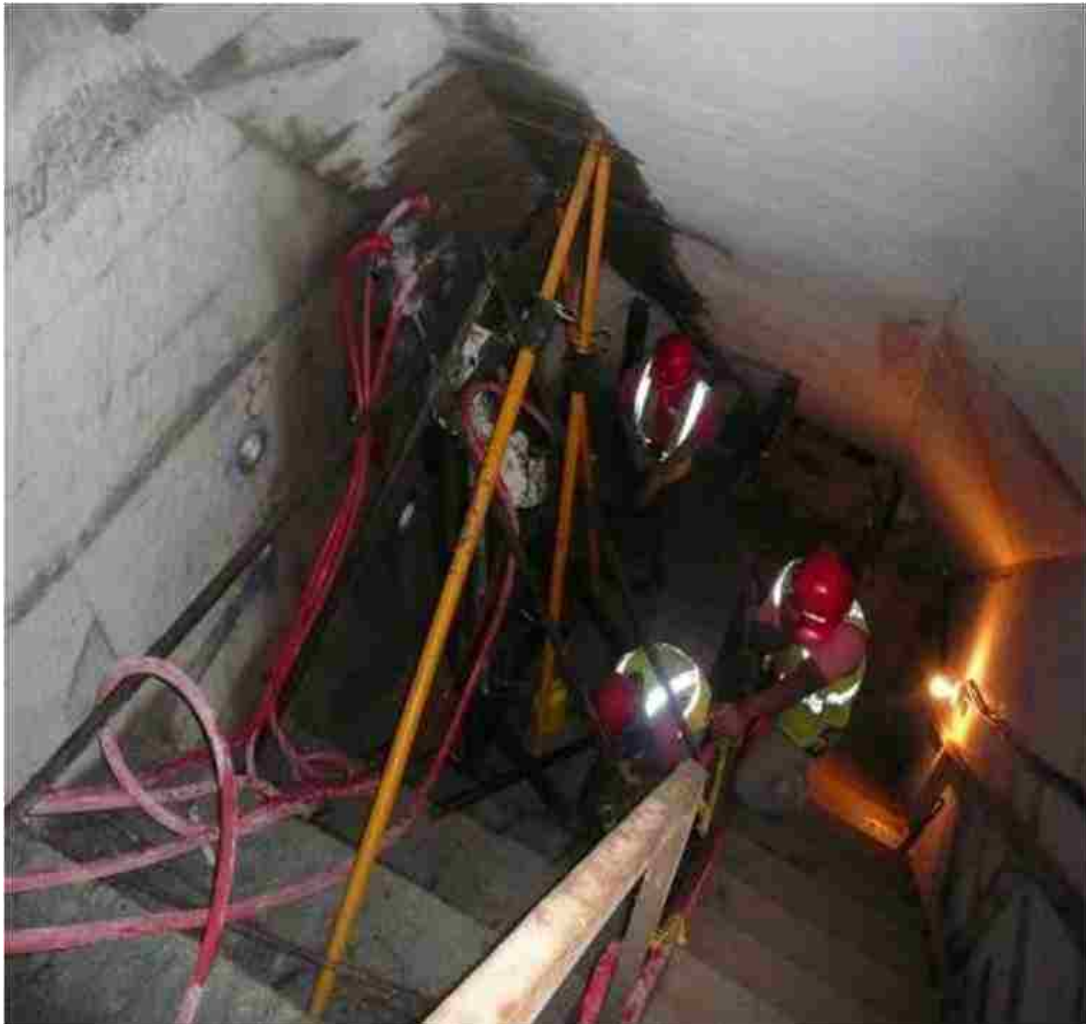
Figure 4.31. Grouting from access gallery using wire line system

valves. An automatic recording equipment Lutin model NX-B53 manufactured by Jean Lutz was used to control the grouting pump. This unit was calibrated for recording pressure, volume and flow, being programmed to use three curves GIN system parameters. This type of recorder prints the results on paper and simultaneously recorded on a card that is used to download the information to a computer and graph the results of each step of injection. Grouting was performed in 3.00 m stretch using a single packer. A split-spacing method was used. Grouting sequence is first downstream line, upstream line and at the end the center line. Figure 4.31 shows grouting works within the service gallery and Figure 4.32 shows Lutin NX-B53 grouting control equipment.

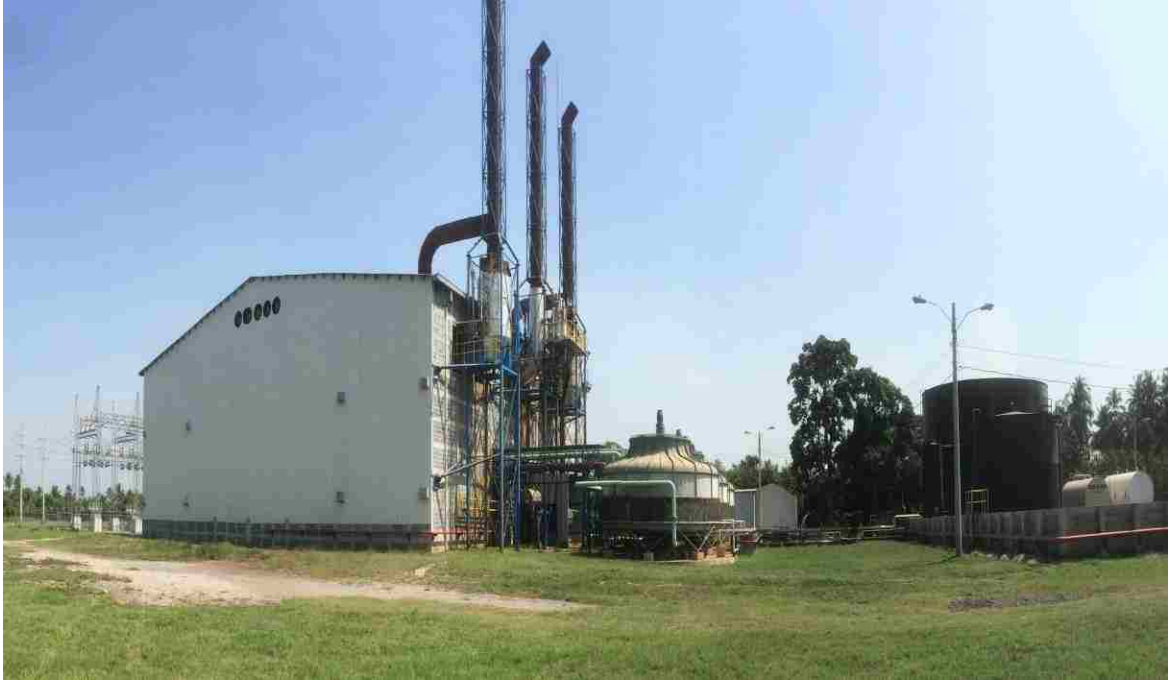
Figure 4.35. Panoramic view of Genosa Power Plant

The power plant consists of a main structure with three engines, auxiliary structures as cooling tower, electrical substation and a storage tanks area, Figure 4.35 shows an actual view of the power plant.

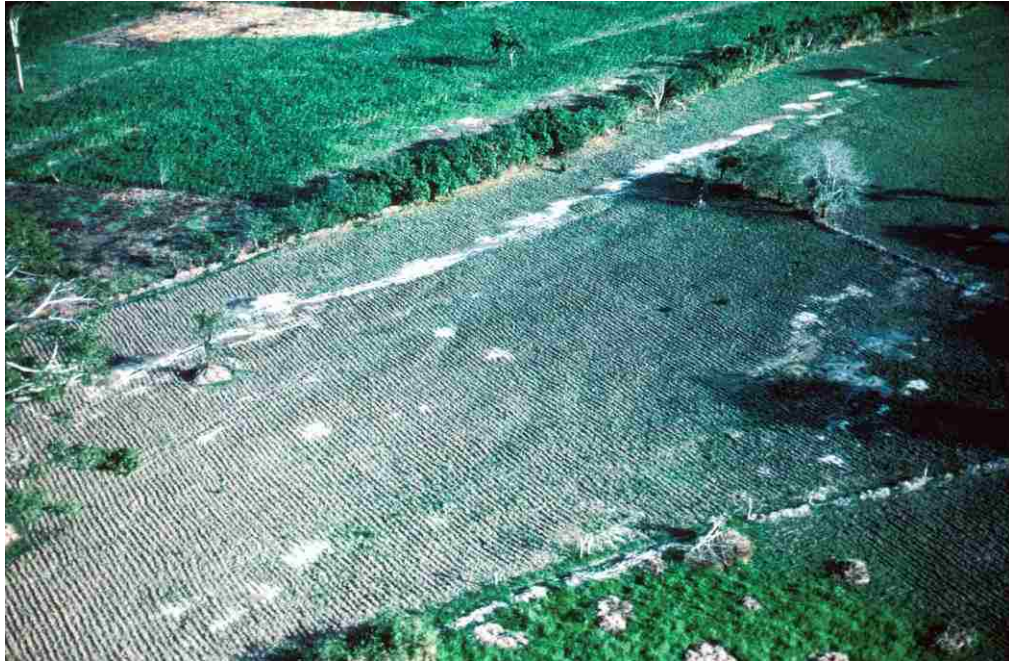
Figure 4.36. Sand blows located near to Motagua River during 1976 earthquake (Plafker, 1977)

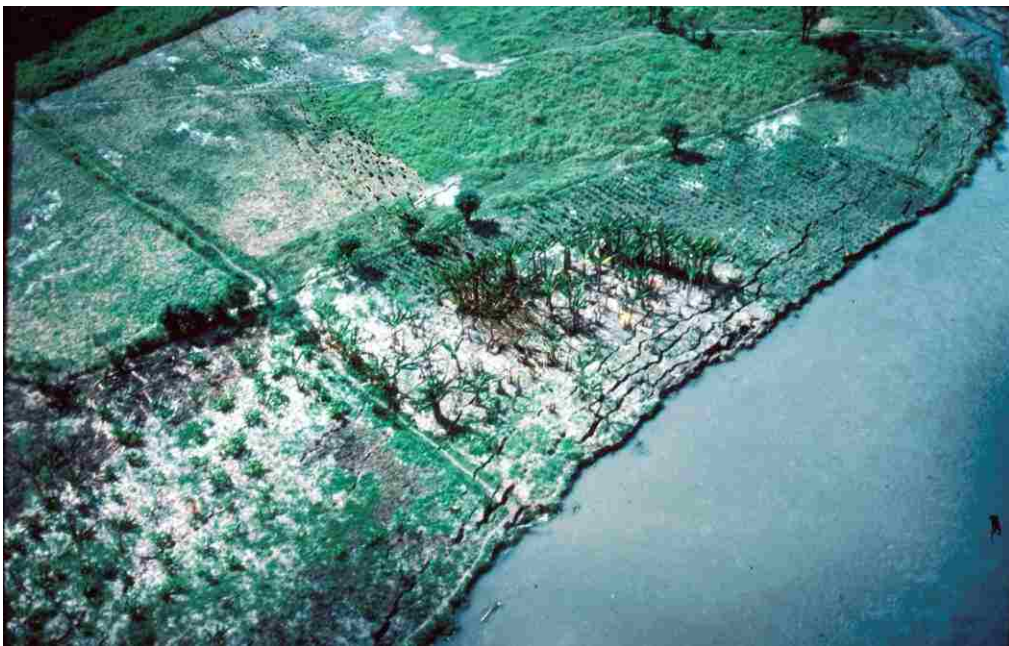
Figure 4.37. Flow liquefaction in a bank of Motagua River during 1976 earthquake (Plafker, 1977)

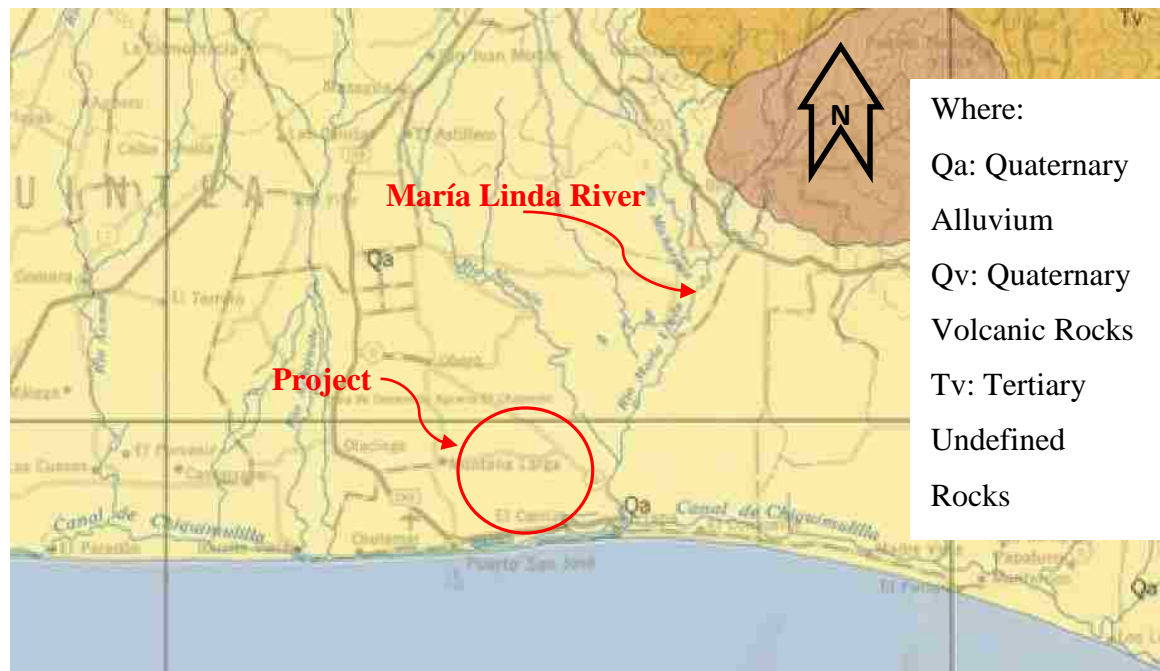
4.3.2.1. Local geologic context. The shallow regional geology consists of Quaternary alluvium (Qa) within the Maria Linda watershed. These soils, consisting of interbedded, underconsolidated and poorly drained layers of sands and silts, and to a lesser extent gravels and clays, having erratic depositional patterns typical of coastal plains. The Quaternary alluvium (Qa), about 1,000 m thick, is underlain by rocks of the Tertiary and rock and sands of the Cretaceous, followed by Ophiolitic Basement.

Figure 4.38. Area geological map (Instituto Geografico Nacional, 1970)

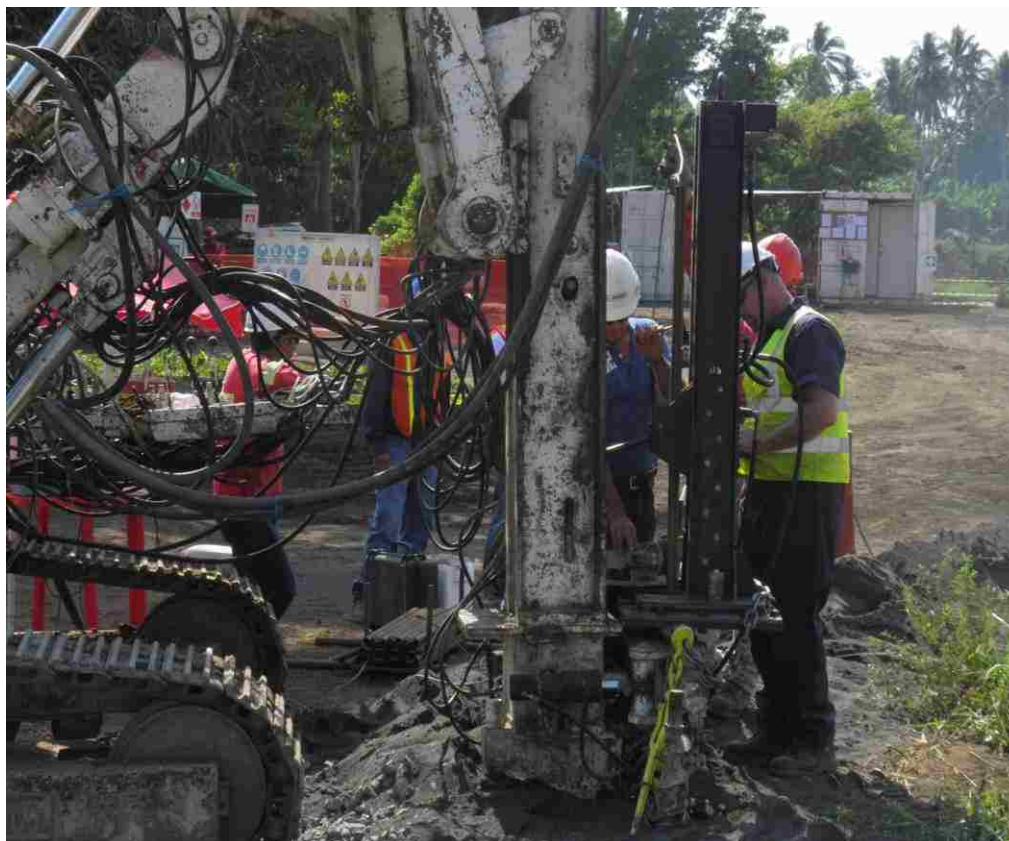
The Figure 4.43 show the performance of the CPTs and Table 4.13 shows a summary of the works performed.

Figure 4.43. CPT performance

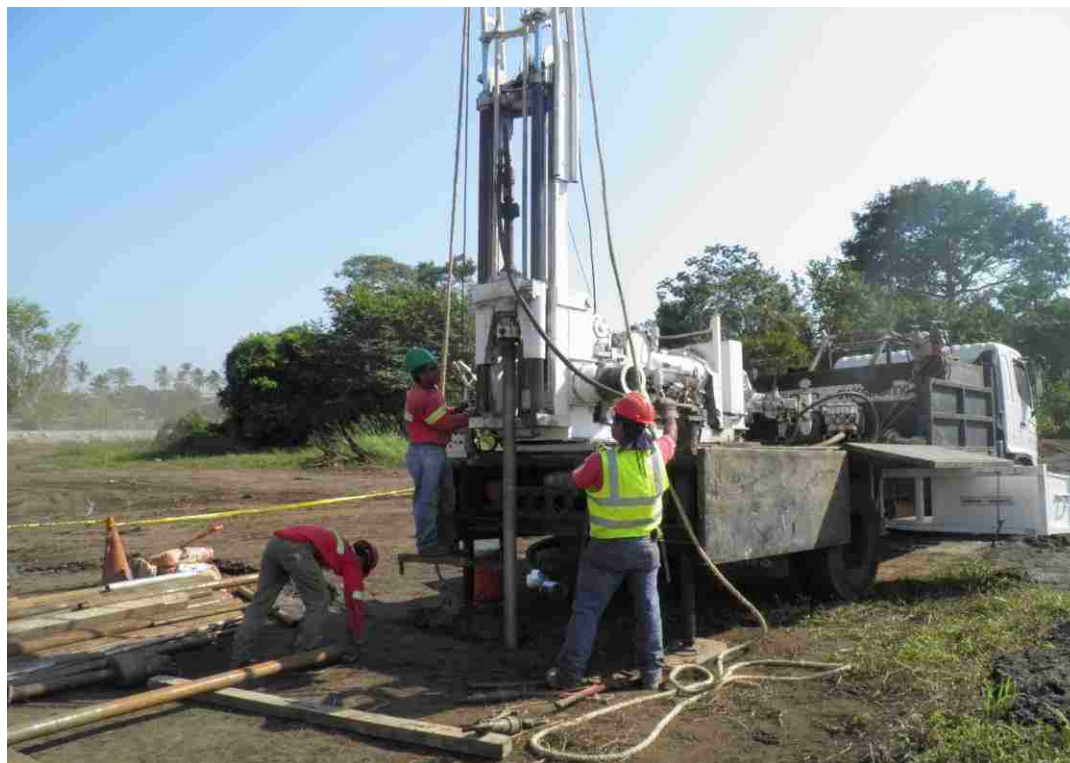
In order to complement the information from CPTs one borehole was drilled using rotary core drilling system in HQ diameter, hole (outside) diameter: 96 mm; core (inside) diameter: 63.5 mm. The borehole was drilled using a Mobile Drill B-57 drill rig, Figure 4.44 shows borehole drilling. From this borehole undisturbed samples from soft soil, were extracted using a Shelby tube, outside diameter: 50.8 mm; length 762 mm.

Figure 4.44. Borehole drilling using rotary core system

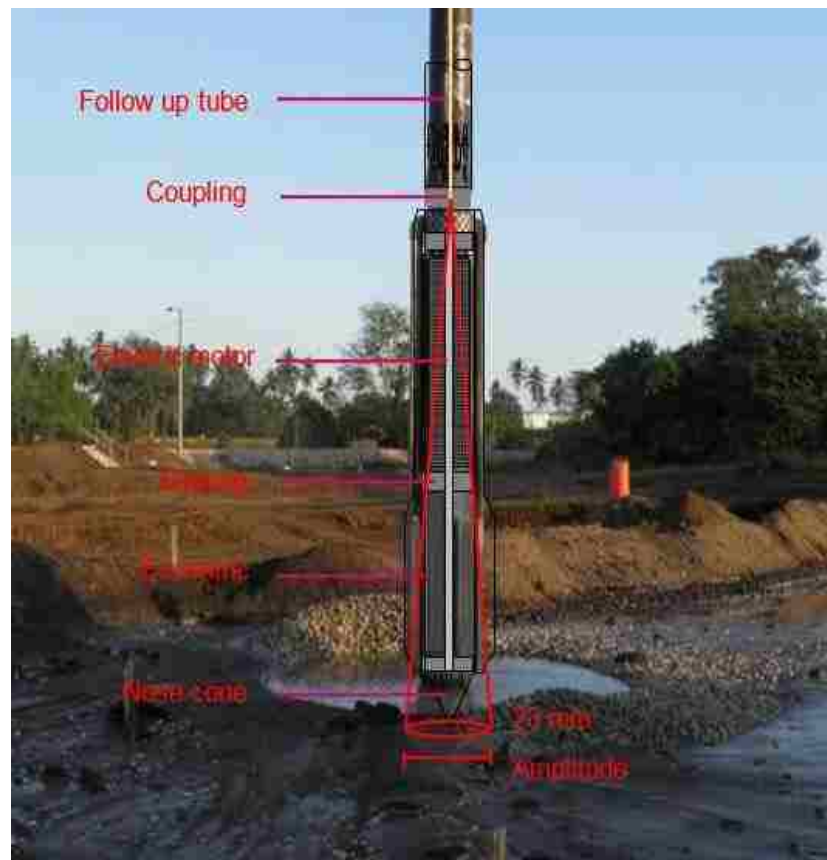
The essential parts of the Vibroprobe are shown on the Figure 4.50. It is essentially a long slender steel tube with two parts: the vibrator and the follow-up tubes. The vibrator, the heart of the Vibratory Probe, consists of a hollow cylindrical body with 300-400mm diameter connected by means of a special elastic coupling to the follow-up tubes of a slightly smaller outside diameter. The characteristics of the V23 vibroprobe are summarized in Table 4.17.

Figure 4.50. V23, Vibratroy probe schematic

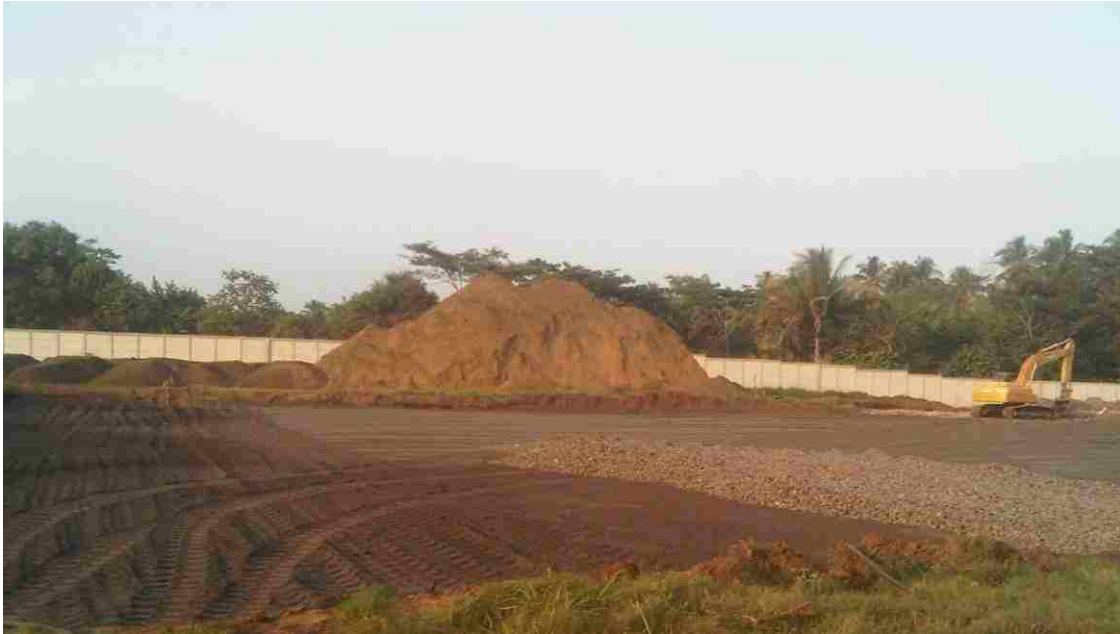
The first step is prepare the working platform. This is very important in order to avoid accidents and allow a proper drainage of the area. The platform and accesses was compacted, drained and levelled in order to accommodate a crawler crane as well as the traffic of loaders required for stone delivery. The spoils and water generated by the stone column installation will be managed to maintain a clean working platform at all times. The working platform elevation was set at +0.50 m, at least 1.50 m above ground water elevation. The Figure 4.52 shows the work platform prior work start.

Figure 4.52. Working platform construction

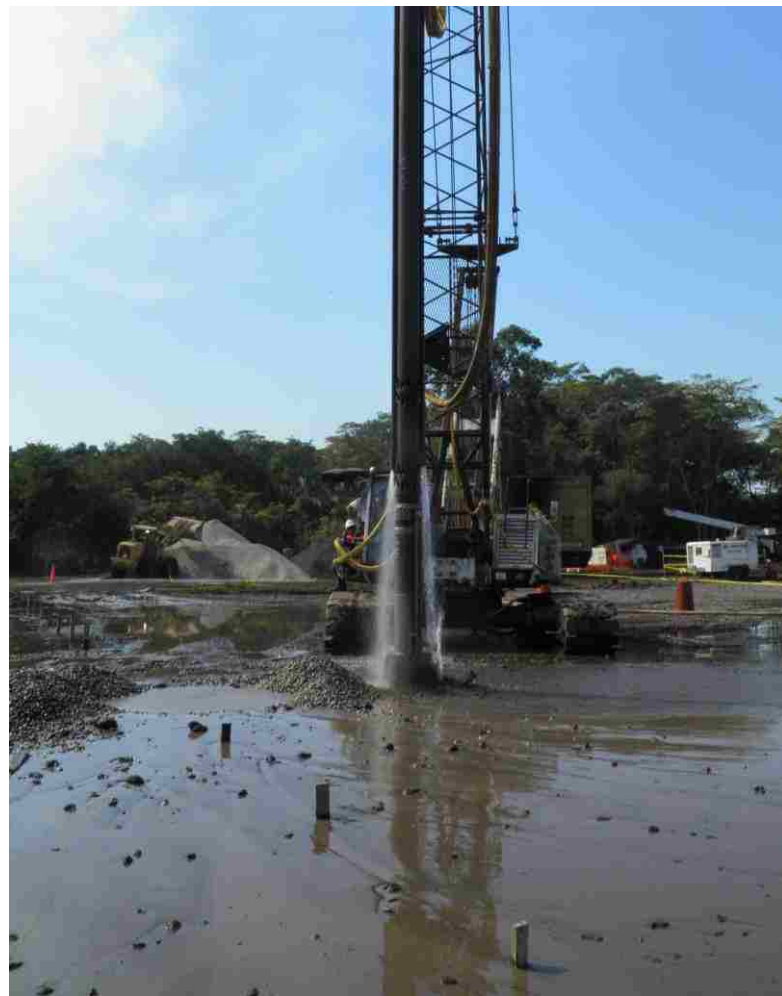
the maximum depth. When the vibroflot has reached again the full depth, the amount of water discharged from the tip of the vibroflot was adjusted so that the water level in the hole stays at about 1.50 m above ground water table or at working platform level. This ensures the stability of the hole. The figure 4.53 present de vibroflot penetration using water and air jet.

Figure 4.53. Vibroflot penetration

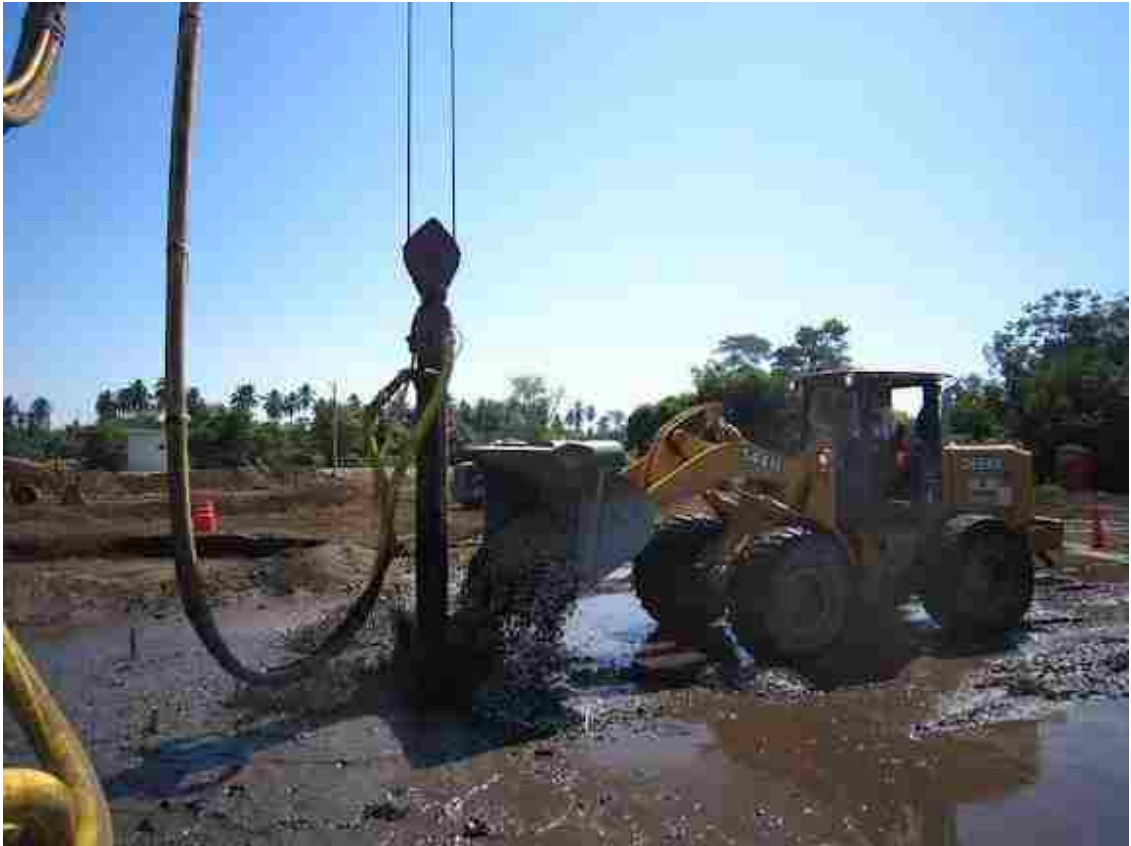
2 - The vibroflot is then lifted by 0.50 to 1.00 m, and coarse gravel or crushed stone is tipped into the hole. The vibroflot is then either re-penetrated to within a short distance of the previously penetrated depth or held at the current depth until the amperage is reached, which is sufficient to produce the specified average column diameter or the required ground compaction. Radial forces produced by the vibrator force the added material horizontally out against the in situ soil, thereby compacting it. The process is repeated until the required volume of stone has been inserted or the required degree of compaction has been achieved. The Figure 4.54 show gravel filling and compaction process.

Figure 4.54. Gravel filling and compaction

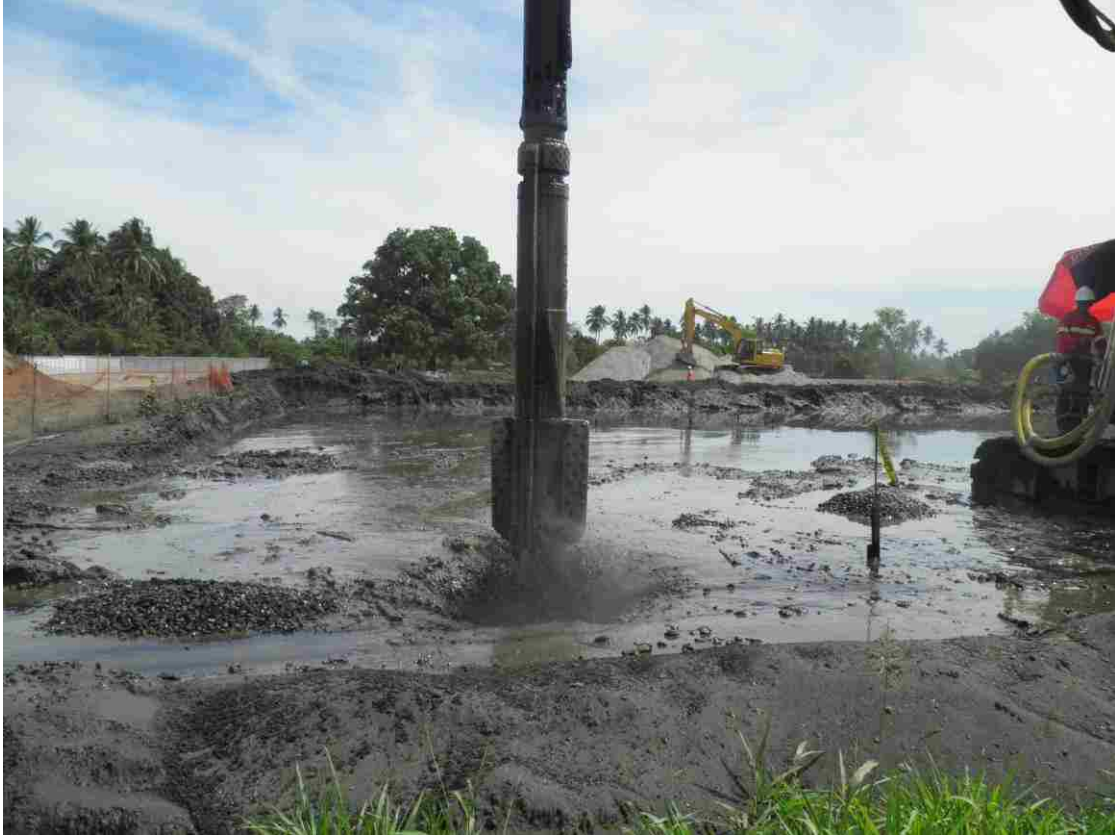
3 - The filling / compaction cycle is then repeated in upward increments up to the working platform level or up to the upper level of the soft silty ground layers or lenses. During this operation, additional gravel or stone is added to the hole but without overfilling to avoid bridging of the gravel. In this manner dense granular material

interlocks with the surrounding ground and densifies it. The Figure 4.55 show final stage of the compaction process. Works were performed between 15th of January and 4th of February of 2012.

Figure 4.55. Final stage of the compaction process

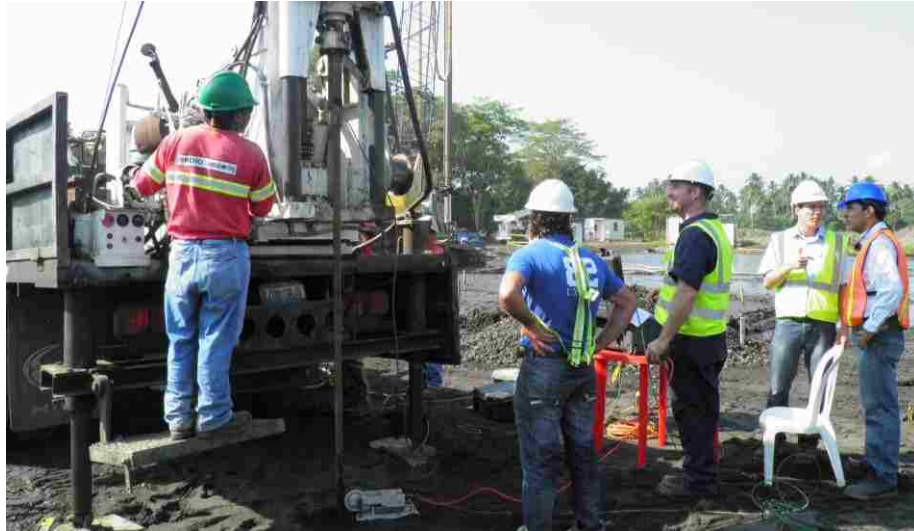
Initially, only 3 Post-CPTs were planned to be carried out as mentioned in the design section (Pre-CPTs 01 to 03) but due to early refusals found at shallow depth (1.00 to 2.00 m) for them, it was decided to immediately increase the number of tests to check that the very hard ground conditions of the first meters were homogeneous over the whole trial area, Figure 4.59 show Post CPT performance. Consequently, 2 additional

Figure 4.59. Post-CPTs performance

All Post-CPTs carried out within the trial area found refusal between 1.00 and 2.00m depth due to the very dense sandy material in the upper part of the profile regardless their location (weakest or mid-points).

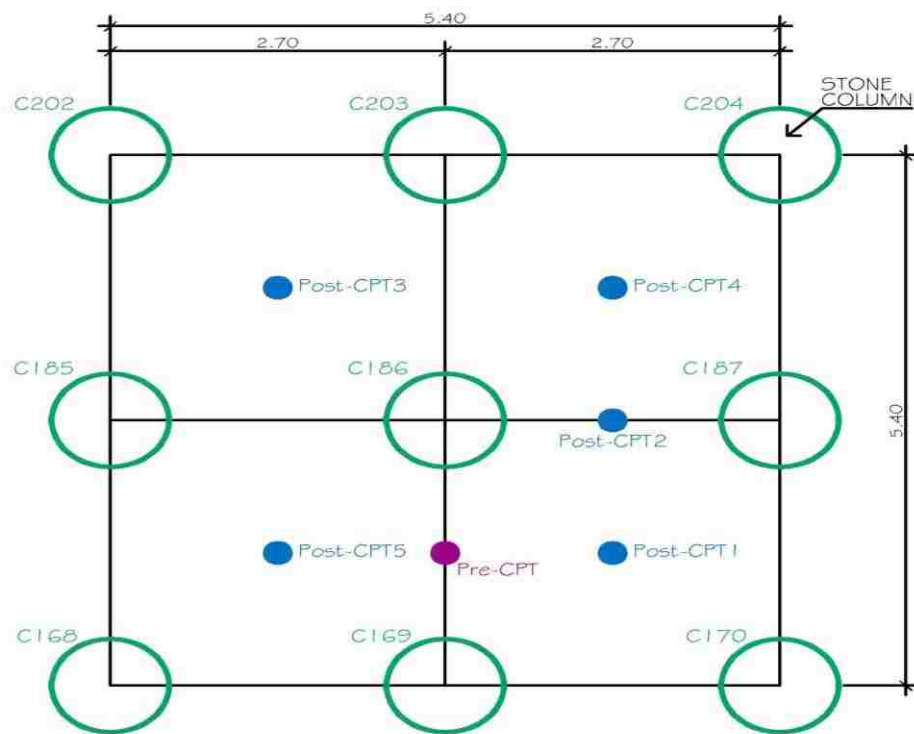
post-CPTs were implemented, Post-CPT 04 and 05 at the weakest point locations as shown on Figure 4.60 and Figure 4.61 presents Post-CPT 04 profile.

Figure 4.60. Trial area setting

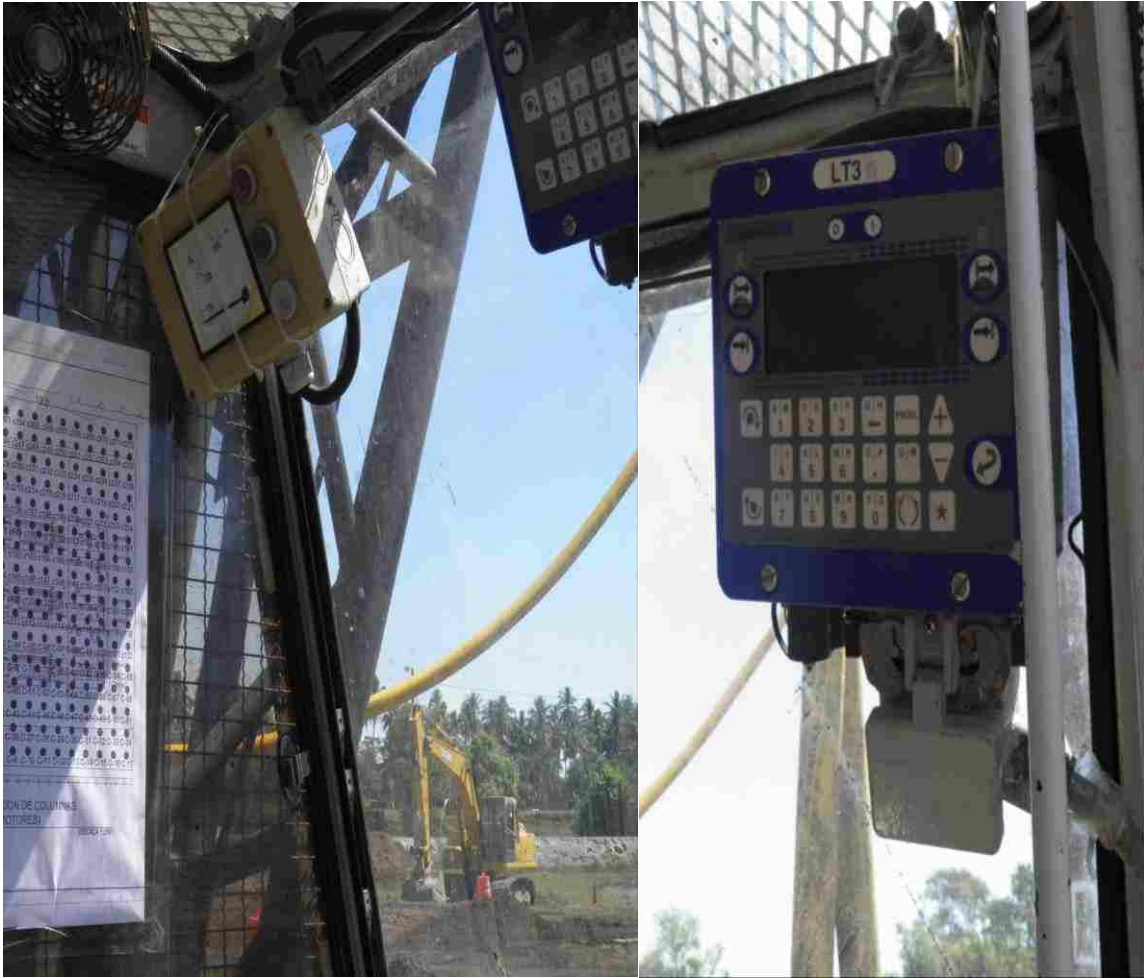
Amperage: A calibrated ampere meter was installed at the vibro-rig as a mean to control the amperage during the penetration and the stone column installation, Figure 4.62 shows Jean Lutz LT3N parameter record equipment and ampere meter. The amperage consumed during penetration and stone column installation is also logged and recorded automatically.

Figure 4.62. Jean Lutz LT3N parameter recorder and ampere meter

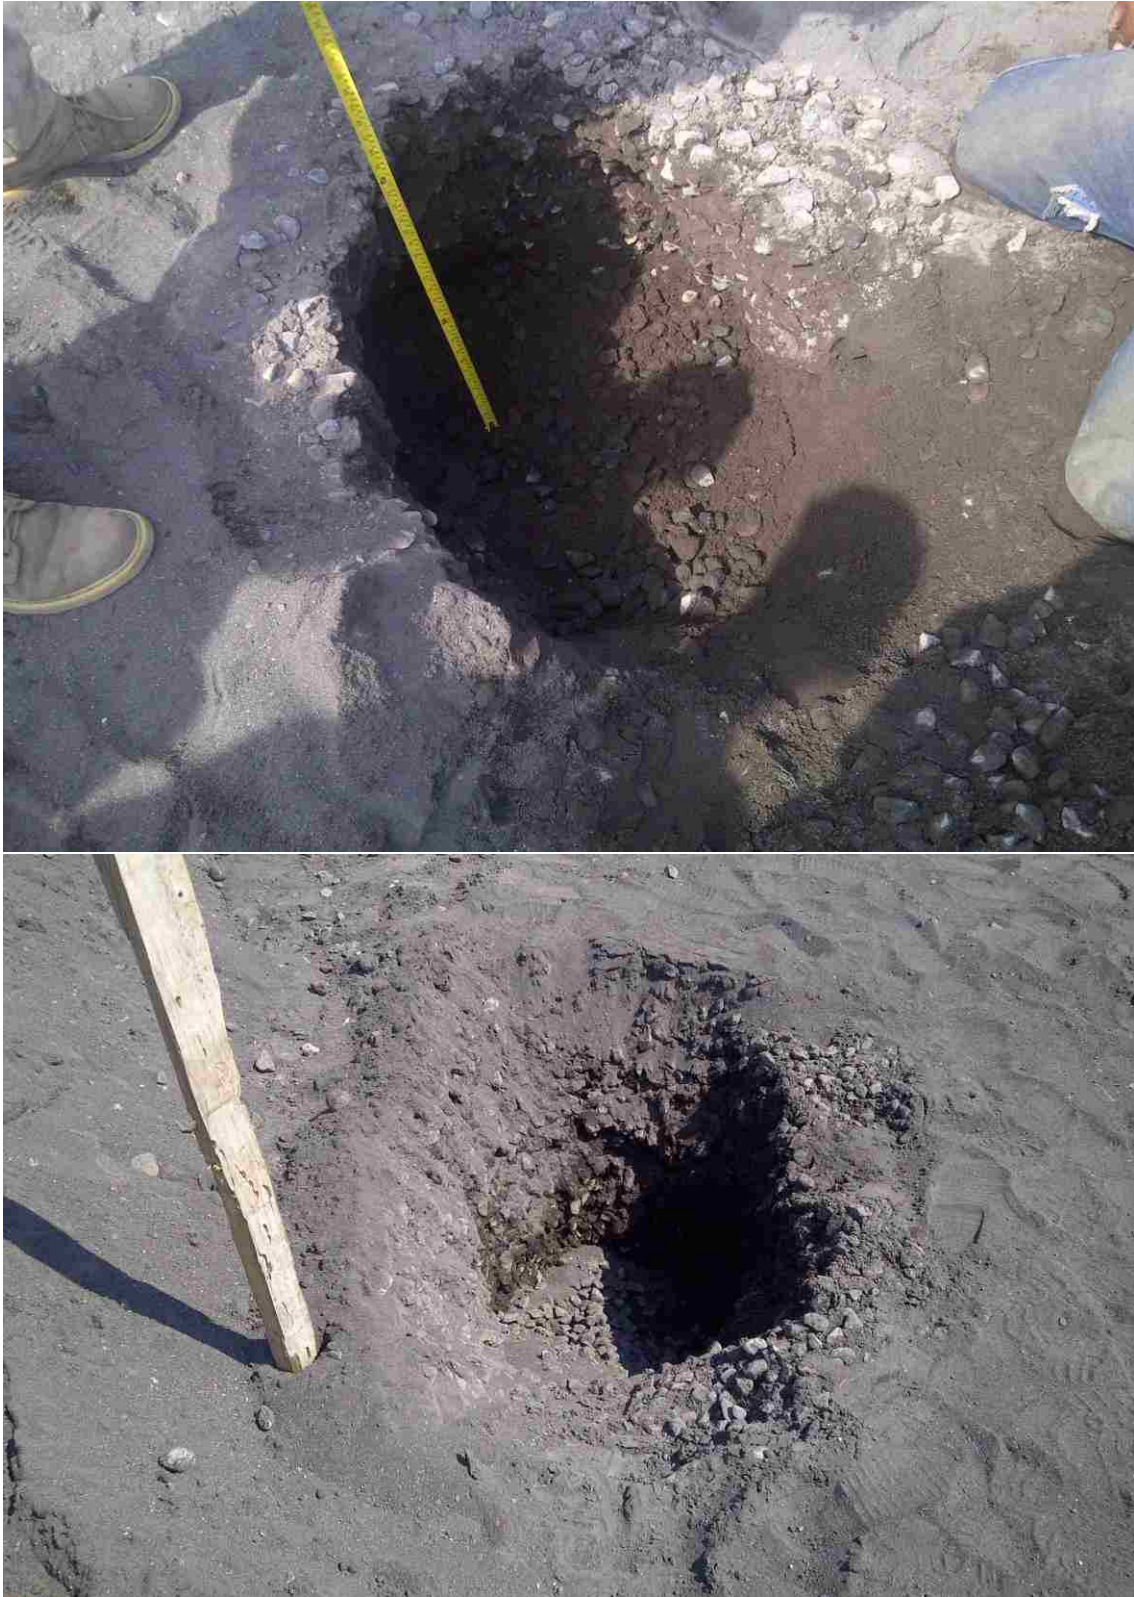
4.3.5.7. Construction anomaly. After the works were finished, during scraping and conformation of the power plant final platform two holes, similar to sand blows were found. The holes have a depth between 60 to 70 cm and a diameter 80 cm. The figure 4.64 presents images of both holes.

Figure 4.64. Construction Annomalies

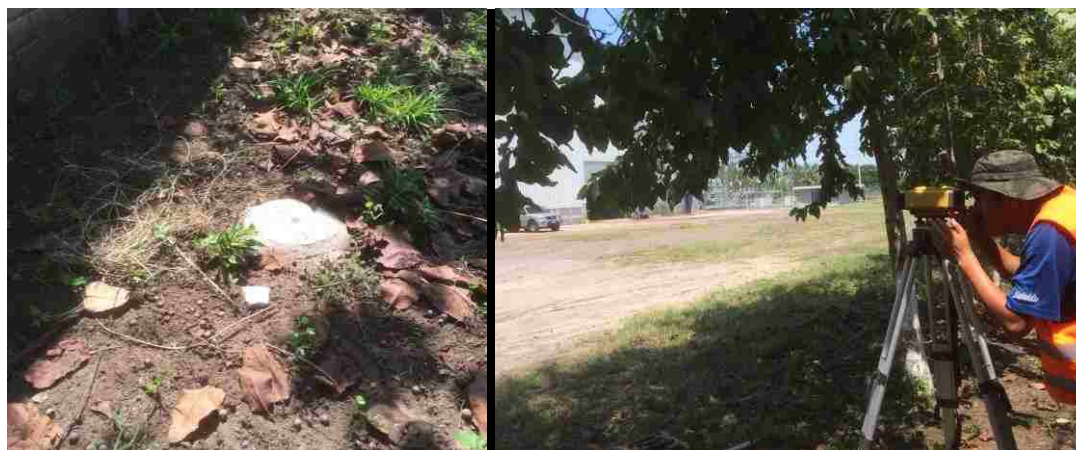
Reading were performed using Topcon DL 102 Electronic Digital Level and a Nikon DTM 322 Total Station, Table 4.19 and 4.20 presents instruments characteristics, Figure 4.66 shows the survey monument and surveying works.

Figure 4.66. Survey monument and surveying works

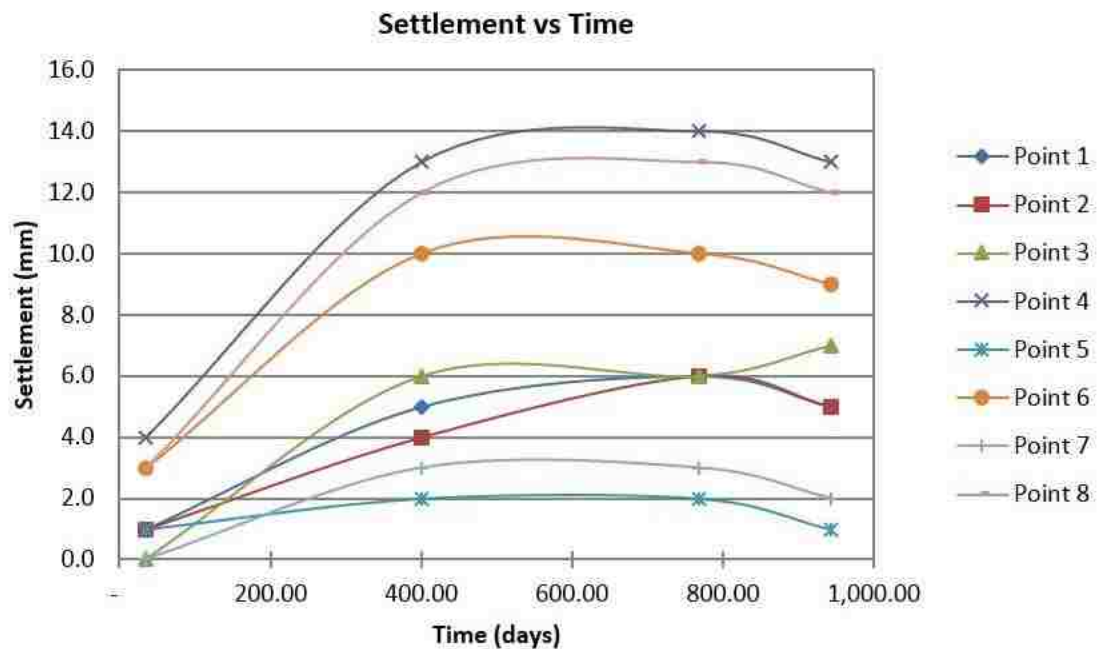
The maximum settlement recorded is 14 mm, Point 4, that is the 28% of the maximum settlement estimated, 50 mm. The corner points showed the greater settlements with a trend of settlement to SE. The middle points of the building showed the smaller settlements, Points 5 and 7. A maximum settlement difference of 12 mm between Point 4 and Point 5 is probably absorbed by the structure without perceptible signs of movement. The Figures 4.67 shows the graphic of the total settlement of each point and Figure 4.68 shows the graphic of the incremental settlement, both graphic shows a trend that no major settlements occurred after a the third reading, about a year after Power Plant operation beginning. Is important to mention that on 7th of November of 2012 an Earthquake of 7.4 of Moment of Magnitude occurred, the epicenter was located in the Pacific coast of Guatemala at about 70 km from the site. During this event liquefaction was observed in Champerico a seafrent community as well as in San Pedro, San Marcos the largest town near to the epicenter.

Figure 4.67. Graphic of settlement vs time

Despite that some settlements were recorded after the earthquake the largest settlements occurred after the initial operation period. In general the no perceptible settlements or movements are observed in the structure as well as no cracks or fissures.

The maximum settlement recorded for the structure supported on the area treated with stone columns was about 14 mm, or about 28% of the maximum settlement predicted, 50 mm. The edges of the structure resulted in the greater settlements and a trend of more settlement towards the SE corner. The center of the building experienced the lowest magnitude of settlement, with a maximum differential settlement of 12 mm, which can be absorbed by the structure without perceptible sign of distress. An incremental settlement behavior was observed with time, the major settlement occurred after the third reading, about one year after the Power Plant began operating. The stone column ground stabilization solution performed remarkably well during the 2012 earthquake (M=7.4). No perceptible displacement or damage were observed. Only minor settlements were recorded after the earthquake the largest settlements occurred after the initial operation period.
