Geotechnical state-of-the-art in Guatemala -- Ground stabilization

GEOTECHNICAL STATE-OF-THE-ART IN GUATEMALA – GROUND
STABILIZATION

A DISSERTATION

DOCTOR OF ENGINEERING
In
GEOTECHNICAL ENGINEERING

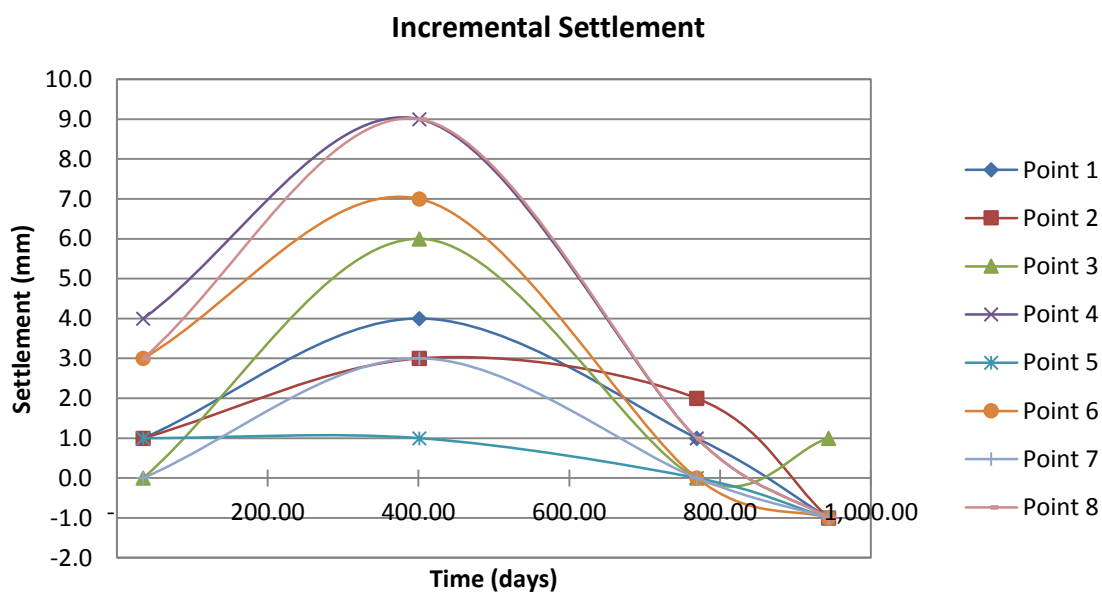
Figure 4.68. Graphic of incremental settlement

Despite that some settlements were recorded after the earthquake the largest settlements occurred after the initial operation period. In general the no perceptible settlements or movements are observed in the structure as well as no cracks or fissures.
