Laboratory testing of precast bridge elements, verification of post-tensioning forces and construction documentation of the Boone County IBRC accelerated bridge replacement project

**Laboratory testing of precast bridge elements, verification of post-tensioning forces
and construction documentation of the Boone County IBRC accelerated bridge
replacement project**

Major: Civil Engineering (Structural Engineering)

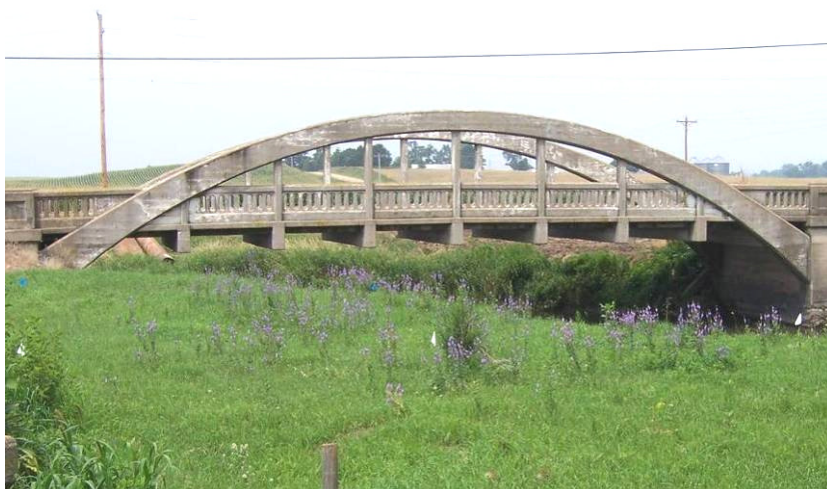
Figure 1. Marsh Arch bridge previously on 120th Street.

This research focused on the bridge constructed on 120th Street in Boone County over Squaw Creek; the bridge replaced an existing Marsh Arch bridge at the site, which can be seen in Figure 1. The new bridge is a continuous, four-girder, three-span bridge with a full-depth, precast deck and can be seen in Figure 2. Bridge dimensions are 151 feet and 4 inches long and 33 feet and 2 inches wide. Deck panels were 8-inches thick, half the width of the bridge, and prestressed in the transverse direction. Each panel had two full-depth channels, located over the prestressed girders, for post-tensioning. Once the panels were erected, the entire bridge deck was post-tensioned in the longitudinal direction, after which the post-tensioning channels were grouted. Precast pier caps and precast abutments were also used in the bridge substructure. Although this exact design had not been previously constructed, a similar partial-depth deck system has been constructed and tested in Nebraska (Badie *et al.*, 1998).

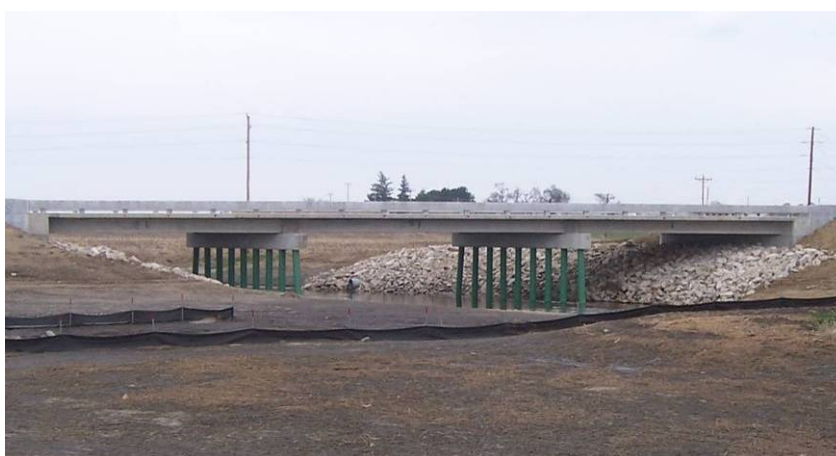
Figure 2. Completed replacement bridge on 120th Street.

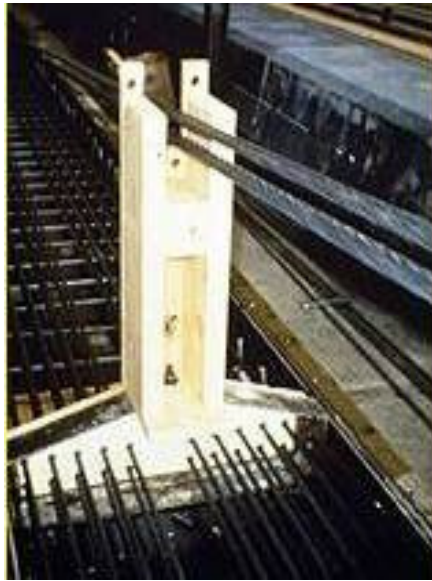
Figure 3. Bulkhead in a prestressed concrete casting bed.

are threaded through the formwork and then stressed. The stressed tendons are anchored to bulkheads located outside the concrete forms. After the concrete is cast and has reached an appropriate strength, the wires or strands are cut, compressing the concrete. A bulkhead located on a precasting bed can be seen in Figure 3.

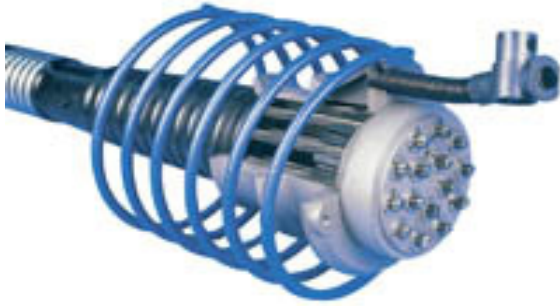
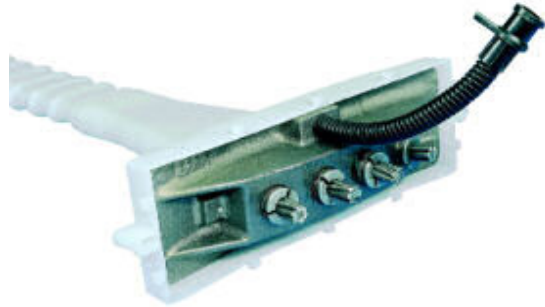
a) DSI bonded multi-strand anchorage

b) DSI bonded multi-strand flat anchorage

Figure 4. Common post-tensioning anchorages (Bonded Strand Post-Tensioning System, 2007) (VSL Post-Tensioning Systems, 2007).

There are several different types of proprietary post-tensioning anchors that can be used, depending on the strand or bar being post-tensioned. The type of anchorage used also depends on the size and strength of the concrete element, the number of strands used, and other design constraints. Several common post-tensioning anchors are shown in Figure 4.

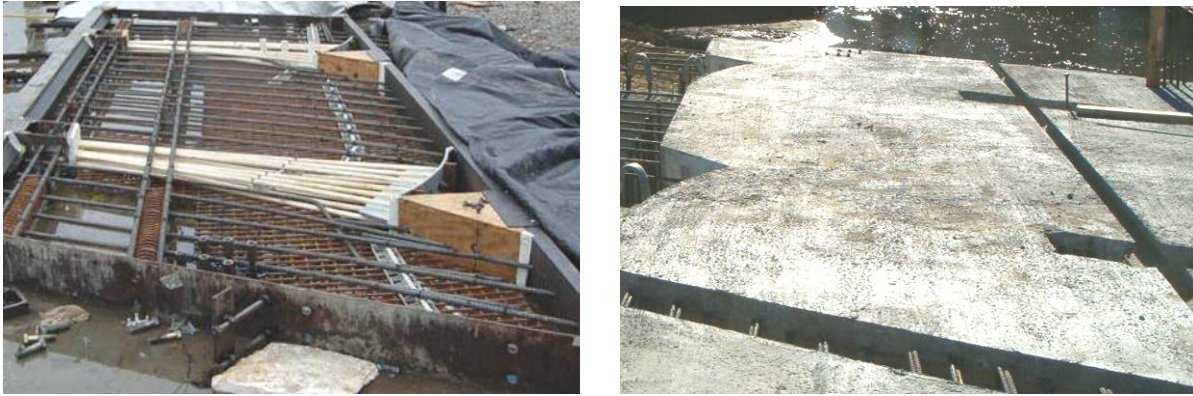
a) end panel reinforcement

b) complete end panel in the field

Anchorage zones in post-tensioned concrete are an area of concrete subjected to high levels of stress. Anchorage zones can be congested and difficult to design and construct due to the size of the anchorages and the amount of mild reinforcing required. To prevent cracking and bursting of concrete in the anchorage zone, secondary reinforcement such as spirals and closed stirrups can be used, and recently fiber-reinforced concrete has been used to reduce congestion (Haroon *et al.*, 2006). The Boone County project did not require abnormally high amounts of post-tensioning strand, but the end panels with the anchorage plates were still congested. Fabrication of one of the end panels is shown in Figure 5a while one of the completed end panels is shown in Figure 5b.

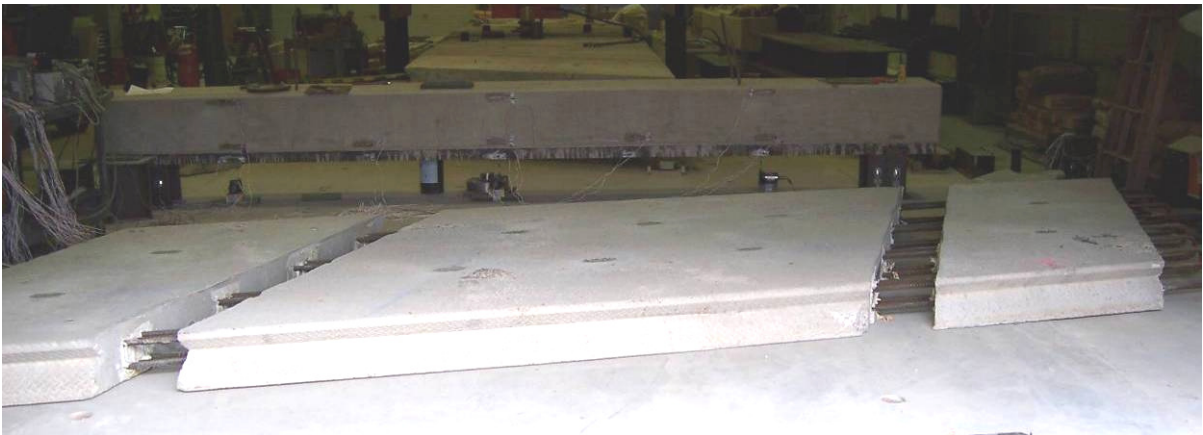
Figure 6. Boone County replacement bridge deck panel.

Post-tensioning channels used in the Boone County project avoided the corrosion protection issues related to the type of post-tensioning ducts and the presence of air voids in the ducts by eliminating the ducts all together. Open channels allowed the strands to be inspected as grout was placed and prevented the formation of air voids around the tendons. The channels in one of the deck panels can be seen in Figure 6.

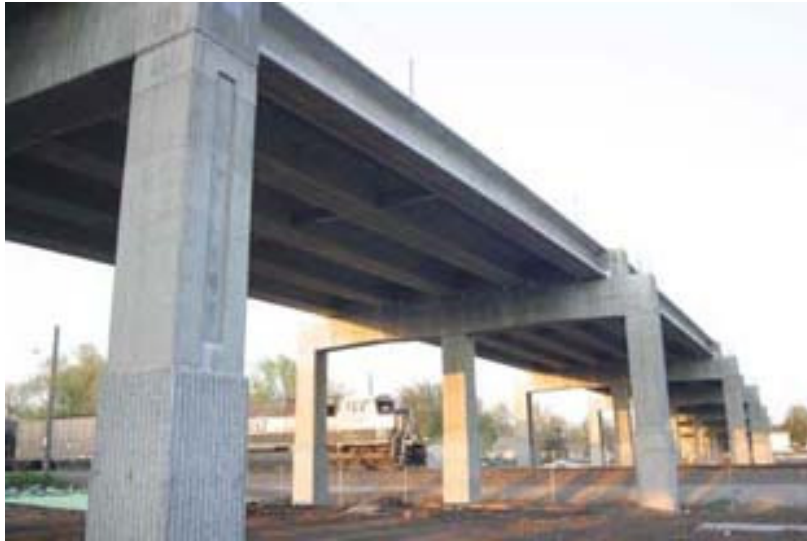
Figure 8. Bridge pier cap located Lincoln, Nebraska.

Precast concrete pier systems use precast piles and a precast pier cap to create a pier. Precast piers are compatible with a number of different foundation and substructure types. For larger bridges, precast pier caps, also called bent caps or cap-beams, may be necessary. A picture of a bridge in Nebraska using precast girders and precast pier caps is shown in Figure 8. Pier caps allow twin-span bridges to use the same piers for foundations. Precast, prestressed or post-tensioned caps can significantly reduce the cap size, which reduces the weight of the substructure. For extremely large bridges, pier caps may be fabricated and transported in two pieces and post-tensioned together on site (Billington *et al.*, 1999).

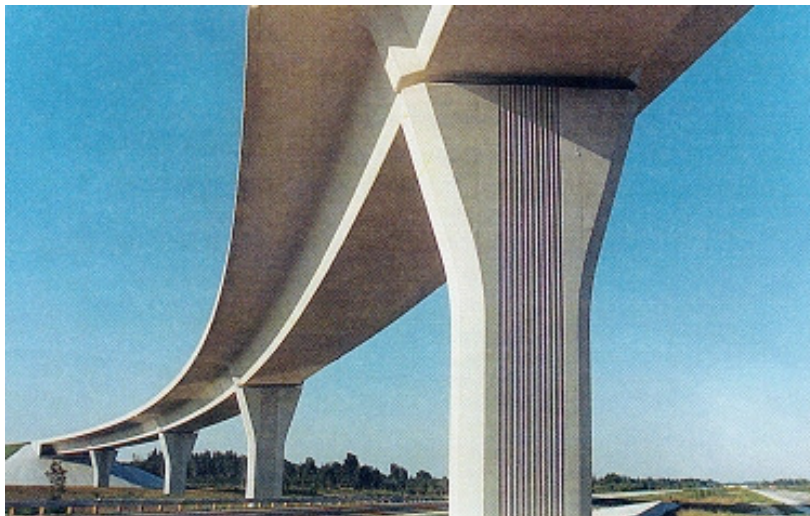
Figure 9. Slender pier design of the Florida Turnpike in Miami, Florida.

Precast elements also have the advantage of using high performance concrete, which typically increases the strength and durability of precast elements. The use of high-performance concrete also results in more slender substructure designs, as can be seen in Figure 9, which also results in significant material savings for a project (Billington *et al.*, 2001).

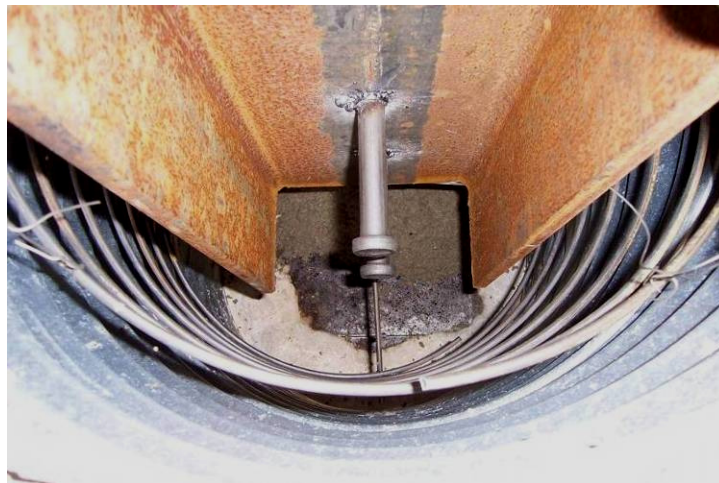
Figure 15. H-pile connection in test specimen before concrete was placed.

Each H-pile in the abutment specimens had four 7/8-inch diameter studs, five inches in length, welded to the pile web six inches apart, two of which can be seen in Figure 14. A No. 2 bar, bent in an 18-inch diameter spiral with a 3-inch pitch was designated in the bridge plans to complete the connection between the abutment and the pile. A portion of the CMP, spiral, and pile section with the studs is shown in Figure 15.

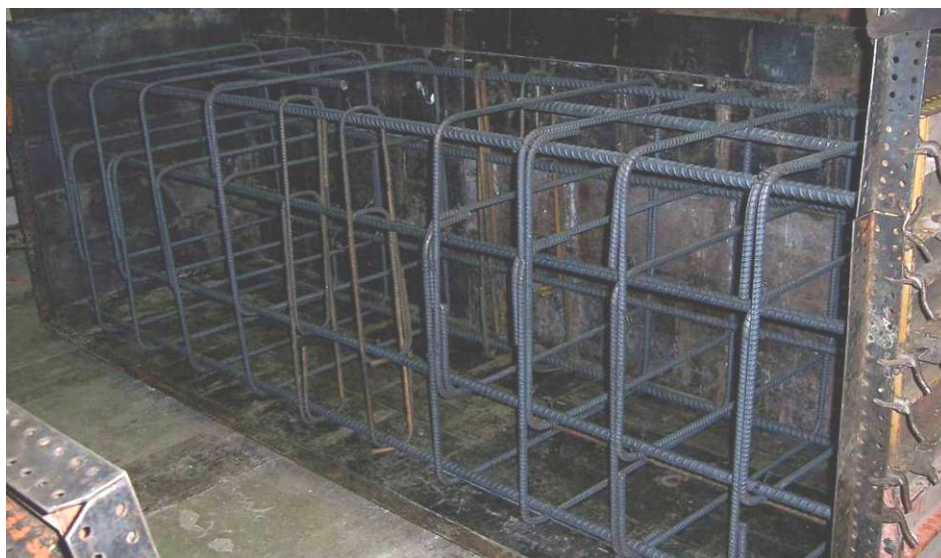
Figure 16. Single pile abutment specimen reinforcement placed in the formwork.

All of the reinforcing steel used was ordered through a local contractor's supply store and was pre-cut and bent to the appropriate dimensions except for the No. 4 ties, which were cut and bent in the laboratory. The reinforcement was assembled in the laboratory and placed in the partially assembled formwork, which had been previously coated with a release agent. One of the reinforcement cages in the formwork before the last side of the forms was attached is shown in Figure 16.

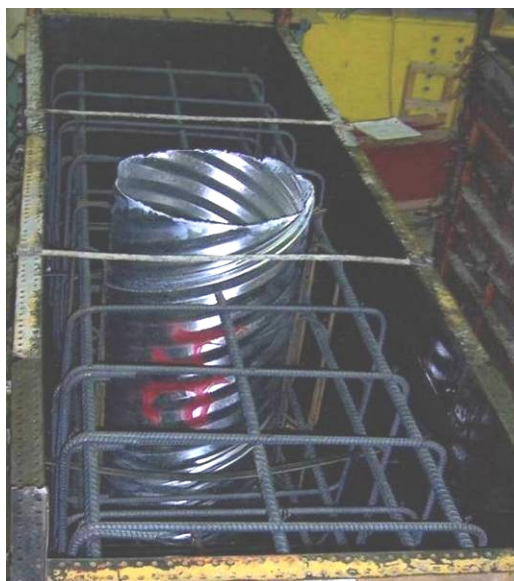
Figure 17. Completed formwork with the CMP for the first abutment test specimen.

After the formwork was partially assembled, the CMP was placed in the reinforcement cage and secured with wire ties, after which the formwork was completed. To give the forms more stability during concrete placement, internal and external steel straps were used. Internal straps were placed at three of the joints in the formwork, one foot from the bottom of the forms. Two external straps were used on top of the formwork. The CMP, external straps, and the completed formwork for one test specimen are shown in Figure 17.

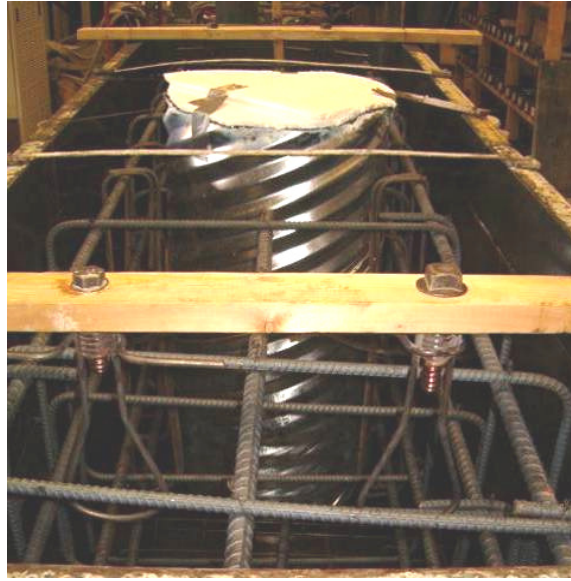
Figure 18. Lifting hooks and styrofoam cover before placing concrete.

The estimated weight of each individual specimen was 7.8 ton. To facilitate lifting and moving the specimens, four lifting hooks were embedded in each specimen. Lifting hooks were attached to wooden “two-by-fours” with bolts and positioned to provide at least two inches of concrete cover for the top of the hooks. Each bolt was greased before the

concrete was placed so after the concrete had cured, the bolts and two-by-fours could be easily removed. Styrofoam was used to cover each CMP to keep concrete out during the casting of the abutment specimens. A view of the lifting hooks attached to the formwork and the styrofoam is presented in Figure 18.

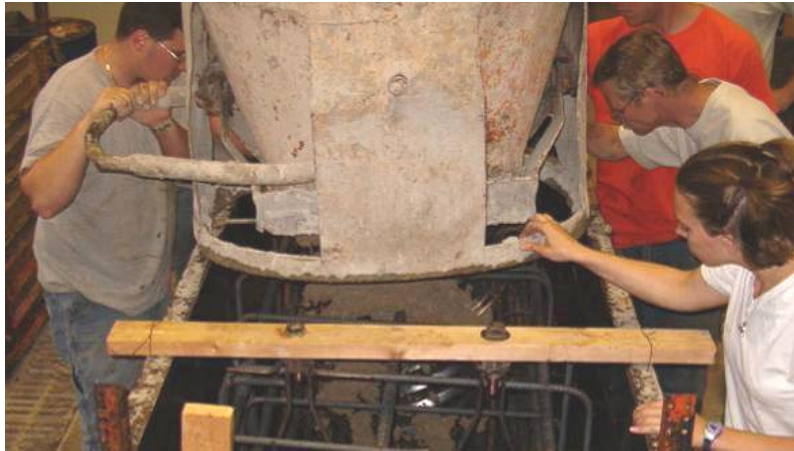
Figure 19. Concrete being placed in the first series of abutment specimen.

crane were used for placing the concrete. Several electric concrete vibrators were used throughout the pour to consolidate the concrete, especially in the area surrounding the CMP. Concrete was placed in approximately four lifts and vibrated between each lift; placement in one of the specimen is shown in Figure 19. While the concrete was being placed, twelve control cylinders were made using the concrete from a particular truck.

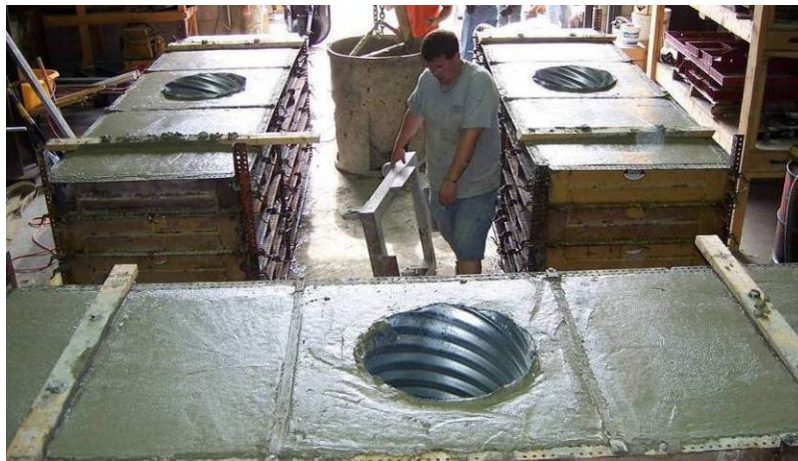
Figure 20. Hand-finished specimen before initial set.

A screed was used to strike off the concrete even with the formwork, after which trowels were used to hand-float the surface. The first finished series of test specimens can be seen in Figure 20. In total, thirteen cubic yards of concrete were required to fabricate the three specimen and control cylinders. Once the concrete reached initial set, the surface was covered with wet burlap and plastic sheets for curing. Each specimen remained covered with the plastic and wet burlap, which was removed after seven days and the formwork was ‘stripped’.

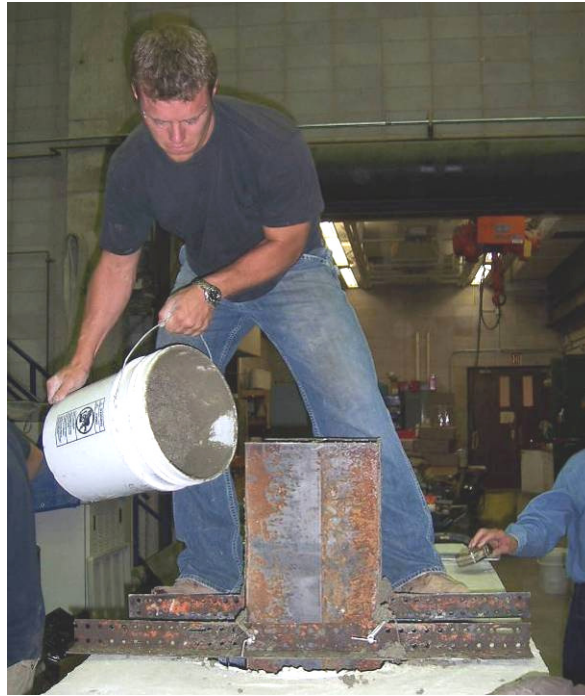
Figure 22. Concrete being placed in the CMP around the H-pile.

Placing concrete in the CMP was challenging. The opening was too small to use the concrete bucket without wasting large amounts of concrete. Thus the concrete was placed by hand using shovels and buckets; a student can be seen placing concrete around the H-pile in Figure 22. Vibrators were again used to ensure adequate compaction, and to eliminate voids under the ends of the piles and around the shear studs. Fifteen control cylinder were made using the grout concrete mix.

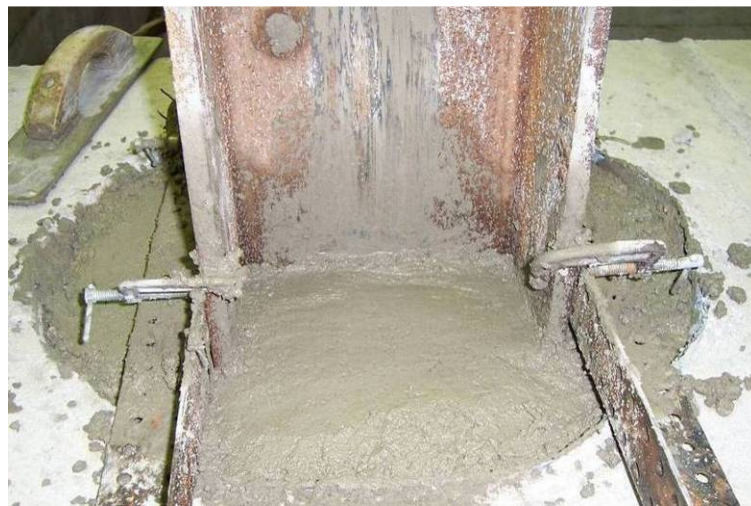
Figure 23. H-pile after being grouted in place.

Grouted concrete was finished by hand, however, because of the small space between the CMP and piles, a straight edge or trowel could not be used. A pile grouted in place can be seen in Figure 23. After the grouted concrete reached initial set, since each CMP was approximately one half inch longer than the depth of the added grout, water was ponded on top of the grout for curing. After 24 hours, the C-clamps and angles previously described were removed. Water was kept on the surface of the grouted concrete for seven days.

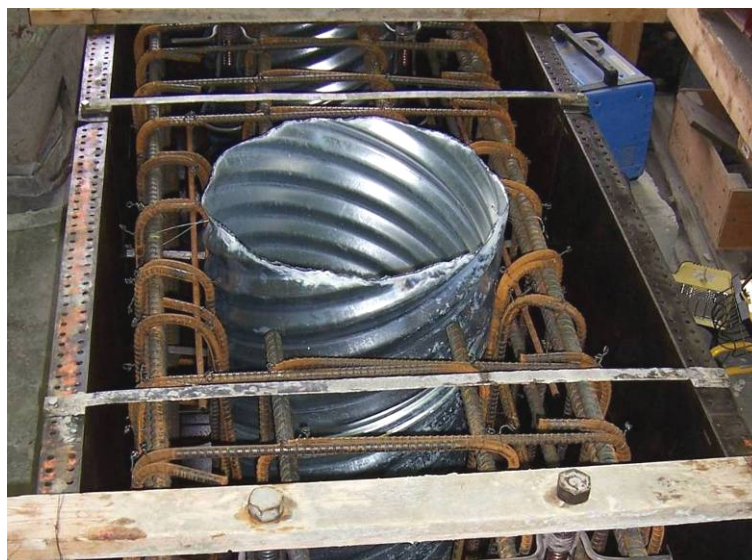
Figure 27. Pier cap reinforcement.

The same formwork used for casting the abutment specimens were used in the pier cap specimens. After the formwork was partially assembled and a release agent applied, the reinforcement cages were placed in the formwork on metal chairs, and the CMP was placed in the reinforcement and secured. Since the abutment specimens and pier cap specimens were the same size, the same lifting hooks and internal and external strap arrangements were used. One of the finished pier cap forms, with the CMP, reinforcement, and external straps is shown in Figure 27.

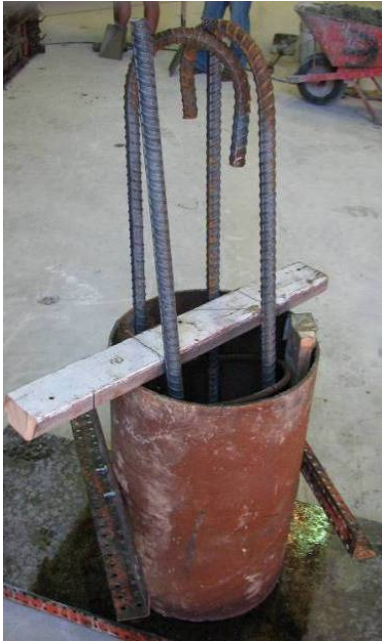
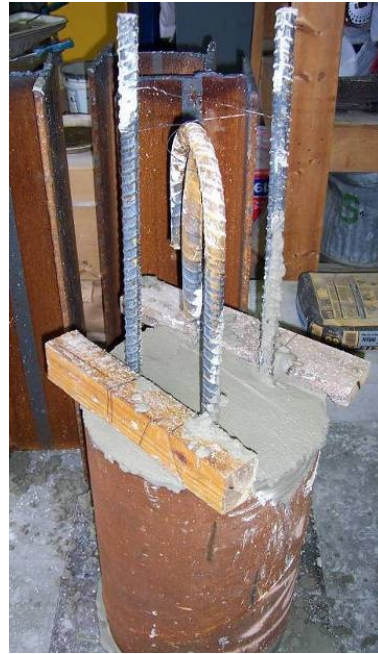
a) pipe pile before placing concrete

b) pipe pile after placing concrete

Figure 28. Pipe pile connection before and after placing concrete.

The pipe pile connection before and after placing concrete is shown in Figure 28. A wooden shim was used to hold the reinforcing steel in place at the correct embedment length. Another wooden shim was used inside the pipe to obtain the desired cover for the No. 4 hoop. Shims were removed after sufficient concrete was placed to keep the reinforcement stable.

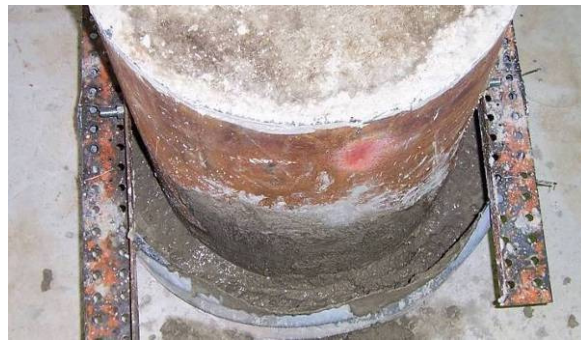
Figure 29. Pipe pile after being grouted in place in PSC1.

Pipe piles were grouted into place seven days after the specimen and pipe pile concrete was placed. The pipe pile was grouted in using the same method as was described for grouting the H-piles into place. Steel angles were bolted to the side of the pipe pile, which in turn was supported by the CMP to provide the desired embedment length for the pile; a pipe pile grouted in place can be seen in Figure 29.

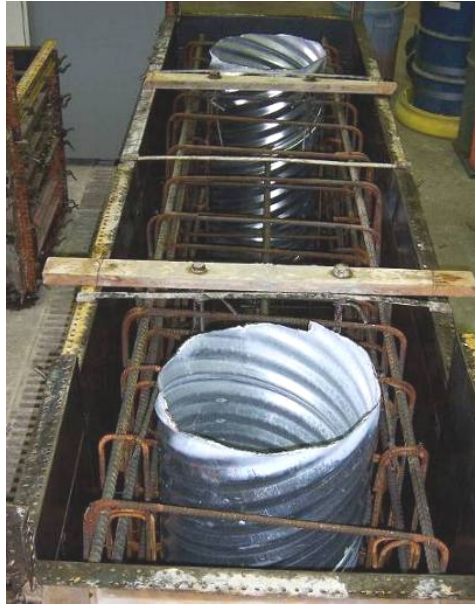
Figure 32. Finished reinforcement and formwork for ADC1.

H-piles used in the double pile specimen had the same welded studs on the pile web as shown in Figure 14. Internal straps were increased from three straps for the single pile specimens to four straps for the double pile specimens; external straps were also increased from two straps for the single pile specimens to three straps for the double pile specimens. Lifting hooks used in the double pile specimens were the same number and layout as were used in the single pile specimens. The reinforcement in the formwork for a double pile test specimen, along with the external straps and lifting hooks, can be seen in Figure 32.

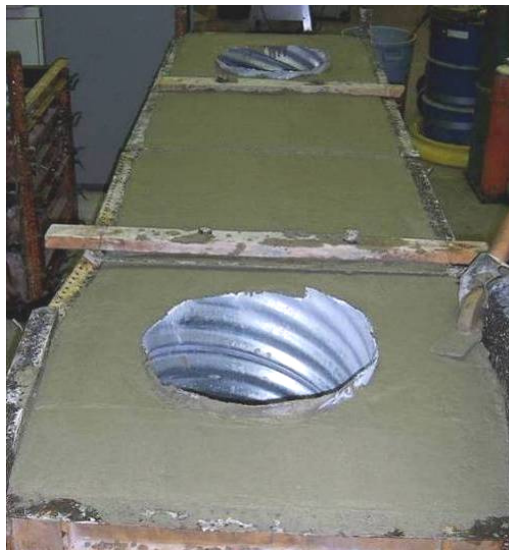
Figure 33. Abutment 6 after hand-finishing.

Concrete used in the double pile abutment specimens was the same mix used in the single pile abutment and pier cap specimens. As with the previous specimens, styrofoam was used to cover the CMP to keep concrete out of the void. Concrete was placed using the overhead crane and concrete bucket, vibrated, and finished by hand. A finished double pile specimen before initial set was reached is shown in Figure 33.

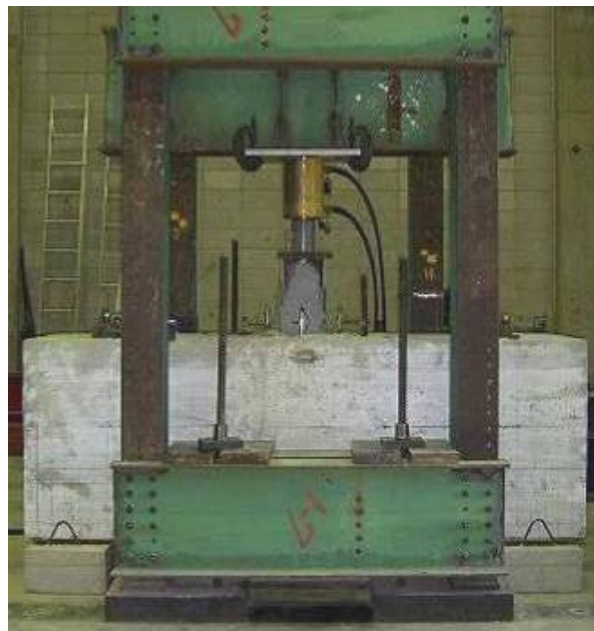
Figure 38. Laboratory test arrangement for ASC1.

As previously noted, the specimens were inverted for testing due to stability concerns. The simulated beams rested on the floor, the specimens were placed on neoprene pads on top of the beams, and the protruding pile was then loaded. An actual test arrangement for one of the abutment specimen is shown in Figure 38.

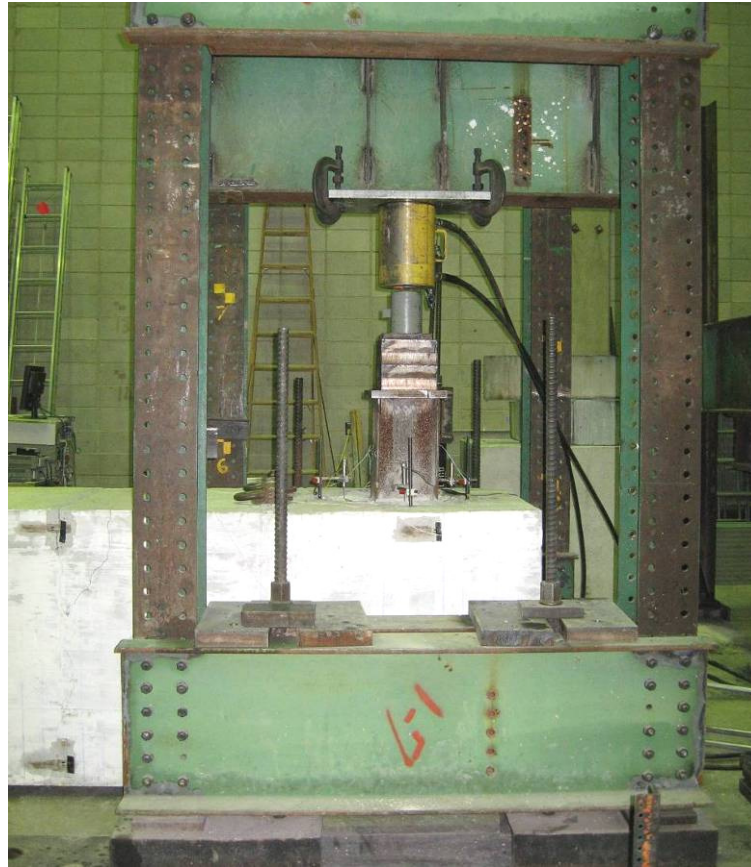
Figure 43. Double pile abutment shear Test 1.

After the combination shear and positive moment tests were complete, the double pile abutment specimen had not completely failed. The area of concrete around the CMP had not cracked, so additional tests were performed on the specimen. Each abutment was adjusted to center one of the piles under the larger load frame. Support conditions were moved so there were two supports located adjacent to the CMP around the pile being tested. A third support was placed under the opposite end of the abutment for stability. The load frame and test arrangement for one of the pile shear test can be seen in Figure 43.

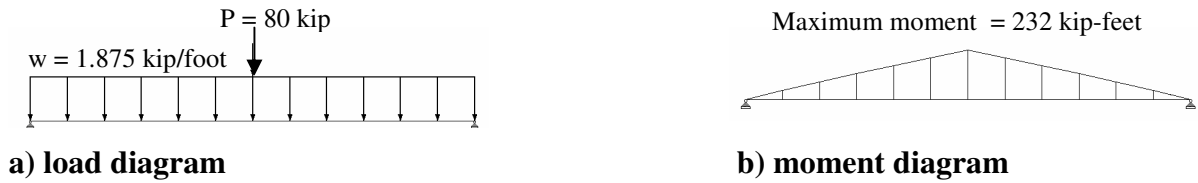
Figure 50. Load and moment diagrams for laboratory tests.

Due to the fact the laboratory specimens were simply supported and the abutments in the field are continuously supported, the loading conditions in the laboratory are more severe than actual conditions. Loading conditions (including self-weight) and moment diagrams for the laboratory specimens and the actual abutments are shown in Figure 50 and Figure 51, respectively. For comparison, the load and moment diagrams were based on a load of 80 kip and the self-weight of the abutment. As shown, the maximum moment resulting from an 80

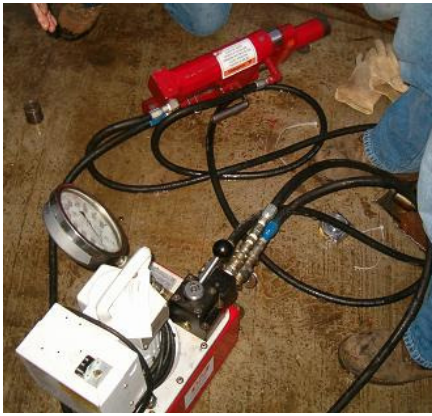
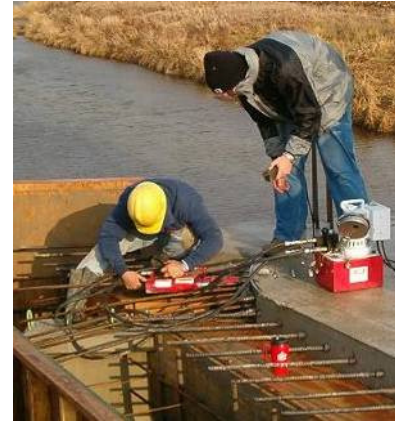
Figure 85. Mono-strand jack used for post-tensioning.

The entire post-tensioning process took approximately four hours. The mono-strand jack used for post-tensioning can be seen in Figure 85. The two halves of the bridge, which were post-tensioned separately, acted independently since the longitudinal joint connecting

a) Mono-strand jack and hydraulic pump

b) Mono-strand jack in use

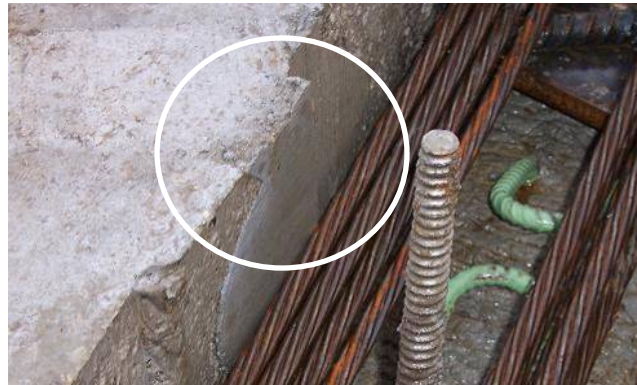
Figure 86. Concrete obstruction in Channel 1.

The stressing sequence was not followed exactly on the south half of the bridge due to an obstruction in one of the channels. After sixteen of the twenty-four strands were stressed, it was noticed that the concrete at one of the transverse joints (see Figure 86) was projecting into the post-tensioning channel and was creating a friction point for two strands. The stressing sequence on that half of the bridge was stopped and the obstruction was

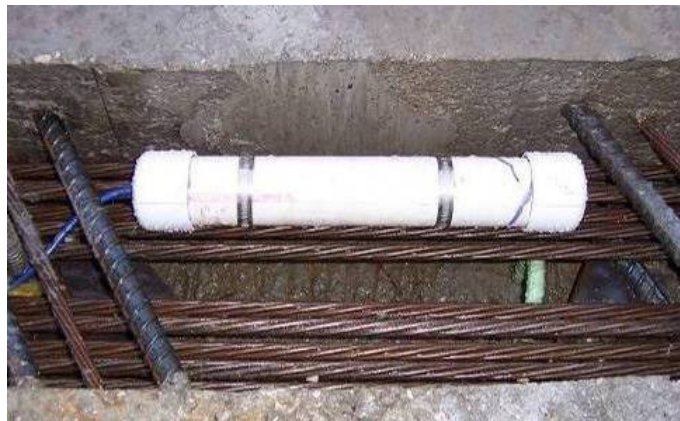
Figure 88. Vibrating wire gage with PVC pipe cover.

The four strand gages located along the centerline (No. 3, 5, 6, and 7) of the bridge were embedded in the post-tensioning channels when the longitudinal joints were cast and the other three gages were removed. Before the channels were grouted, each of the gages that were to be embedded were protected with pre-cut PVC pipe, shown in Figure 88, that were sealed with a waterproof material and secured in place with two hose clamps.

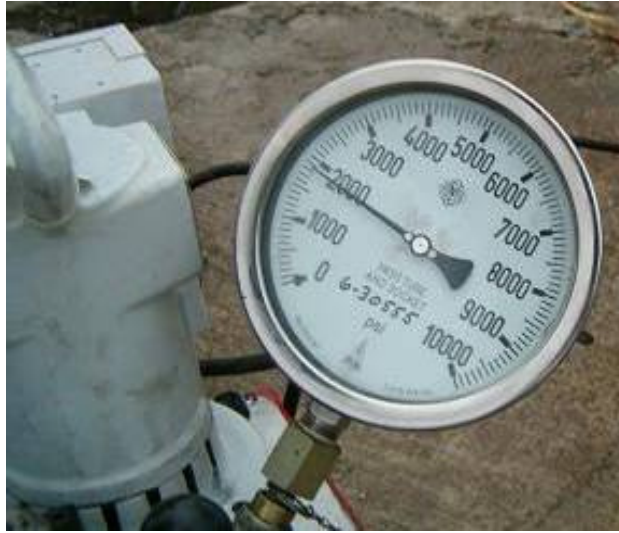
Figure 92. Hydraulic mono-jack gage.

There are two reasons why the force calculated by the contractor does not correspond exactly to the force measured using the VWGs. The first reason is the accuracy of the pressure gage on the hydraulic jack (see Figure 92) the contractor was using. With this gage, getting a precise reading within 100 psi (which corresponds to a force of approximately 0.77 kip) would be difficult. Another reason for the difference is the complexity of calculating the anchor zone and friction losses. Post-tensioning losses are affected by several different factors including initial stress level, type of steel, curvature, and exposure conditions. Several different types of losses can occur and it is common to determine losses as a lump sum value (ACI 318-05, 2005). Since it is difficult to separate losses due to elastic shortening, relaxation, seating, and friction immediately after stressing, it is very possible

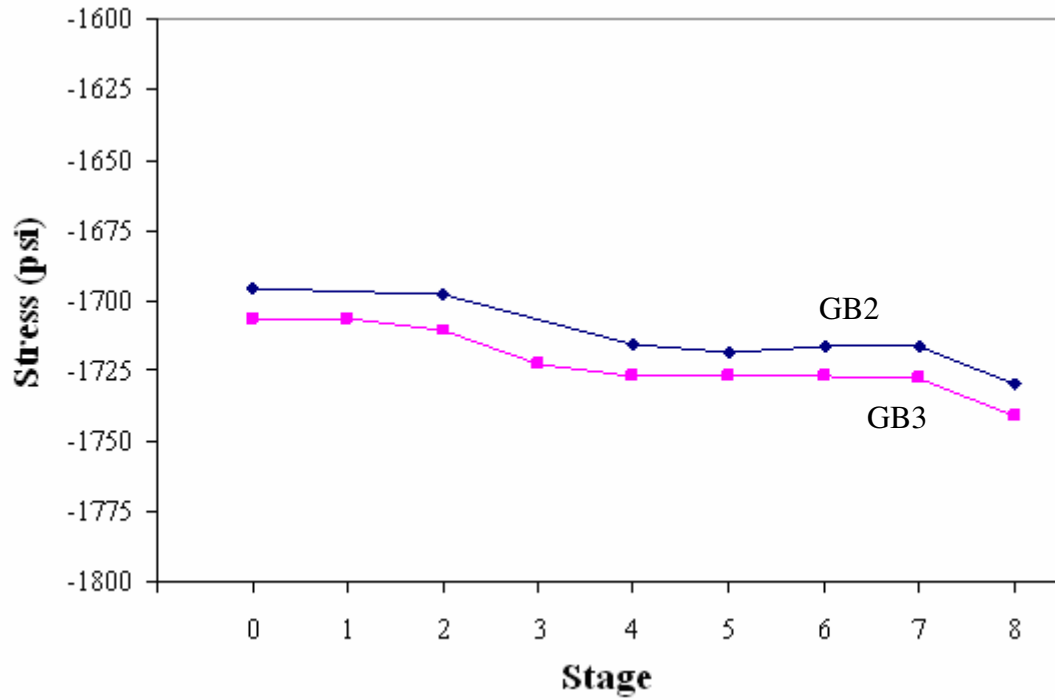
Figure 98. Comparison of deck stresses in Panel B.

The stresses within Panel A were not compared due to the fact that Gage A1 was the only gage working properly during the post-tensioning. The stresses in Panel B were compared first and are presented in Figure 98; only two gages are shown because as previously mentioned, Gage B1 was not working.

The stresses in Panel B did not follow the expected behavior. As illustrated in Figure 98, the higher stresses were measured at Location B3, which was farther away from Channel 1 than Location B2. However, the difference in stress between the two locations was 11 psi, or less than one percent difference.

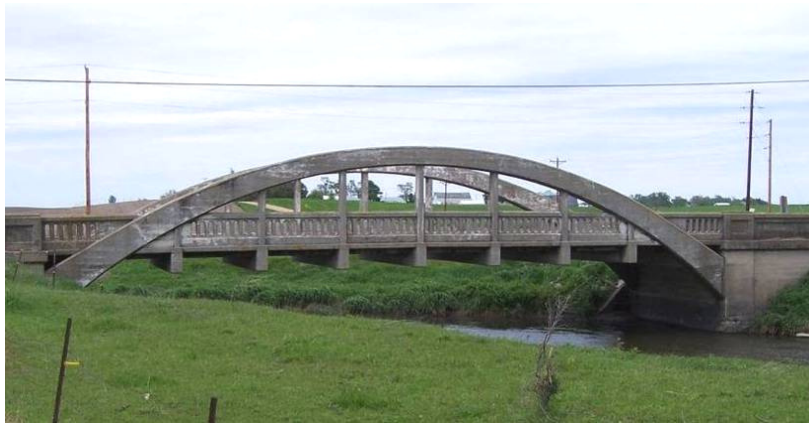
Figure 102. Previous bridge on 120th Street, July 19.

The previous bridge was a single-span concrete Marsh Arch, shown in Figure 102, which was replaced due to width problems and weight restrictions on the bridge. Clear distance between the reinforced concrete arches was 19 feet and the bridge was 77 feet, 6 inches in length. The previous and existing road alignment can be seen in Figure 103; the bridge location remained the same while the intersecting road to the west of the bridge was moved further west to allow room for the larger replacement bridge.

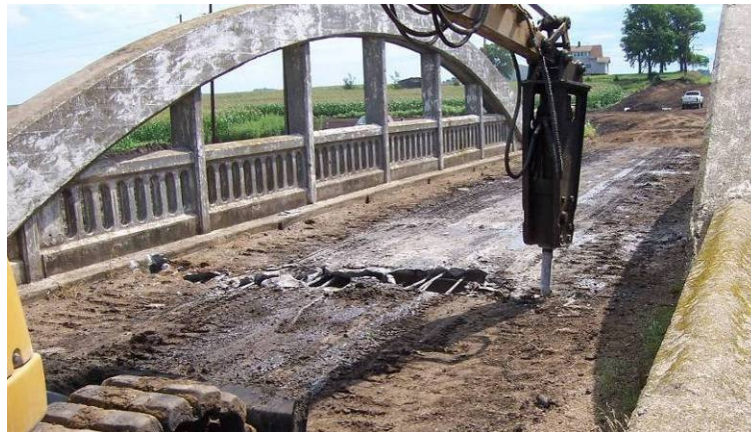
Figure 104. Breaking apart the Marsh Arch bridge deck with a back hoe, July 24.

demolition began; this causeway allowed access between the east and west banks after the original bridge was removed. Demolition of the bridge began the morning of July 24. The contractor used a back hoe with a hammer attachment, shown in Figure 104, to break apart the bridge deck and then used the back hoe to pull apart the bridge reinforcement.

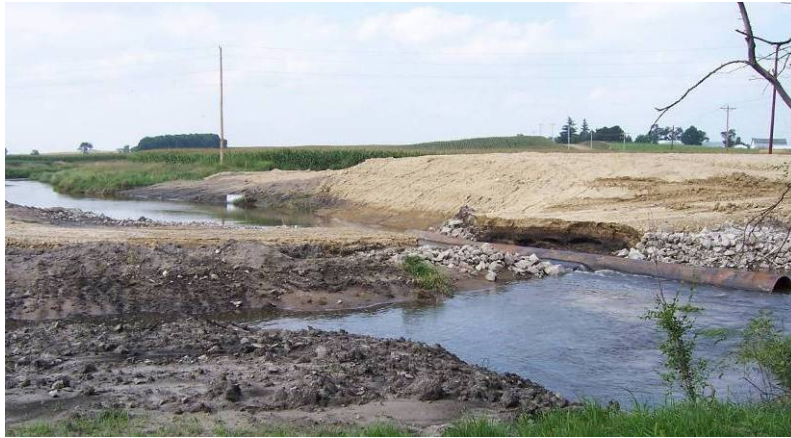
Figure 106. Access road and bridge site, August 11.

During the week of August 7, the Boone and Ames area received approximately one-half inch of precipitation, which caused the access road constructed to wash out. Several working days were lost because the site conditions were too wet to use heavy equipment and the access road had to be reconstructed. Precipitation data for July, August, and September in the Boone/Ames area is presented in Appendix II. Rain damage to the site, along with the washed out access road can be seen in Figure 106.

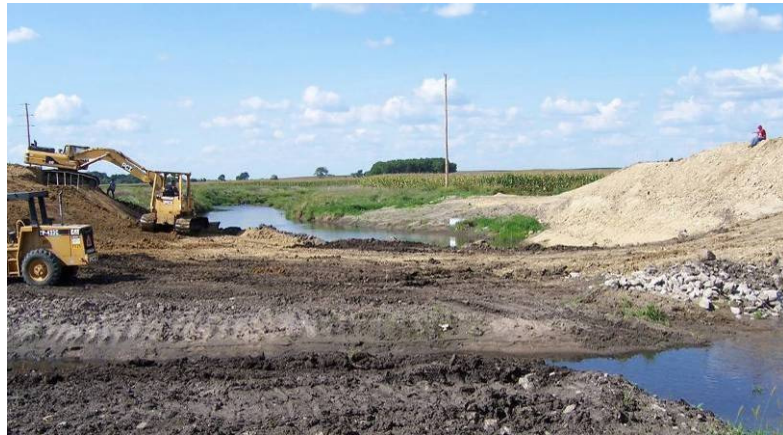
Figure 107. West bridge abutment site prepped for pile driving, September 5.

When the access road was replaced, the contractor removed the original sixteen-inch culvert pipe that was placed under the access road and replaced it with large rock overlaid by sand and gravel. Grading and earth work continued until the bridge abutment locations were properly prepared for pile driving; the bridge site on September 5, 2006 with the west end of the bridge site graded and leveled for pile driving is shown in Figure 107.

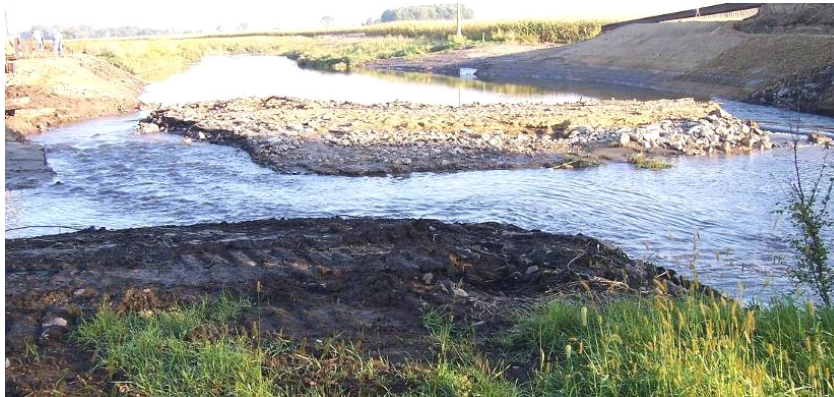
Figure 108. Washed out access road, September 15.

Pile driving began on the west end the bridge on September 14. For the abutments, five HP 10 x 57 steel piles were used. Between September 5 and September 15, over three inches of rain fell in the vicinity of the construction site. Rain and runoff caused the access road to wash for the second time. Even though there was no access to the east side of the bridge, pile driving was finished on the west side; the bridge site after the effects of the additional rain is shown in Figure 108.

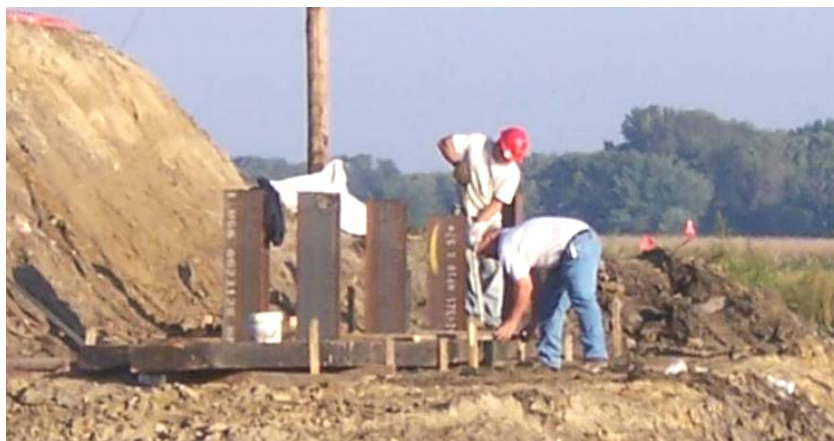
Figure 109. West abutment piles, driven and channels being blocked, September 15.

surface for placement of the precast abutments. To ensure the channels were welded at the correct elevation, survey equipment was used. One of the piles on the west bank was driven incorrectly; the pile (which will be shown later) was rotated 90° from what the plans specified. Steel channels on the west end of the bridge before being blocked up to the correct elevation are shown in Figure 109.

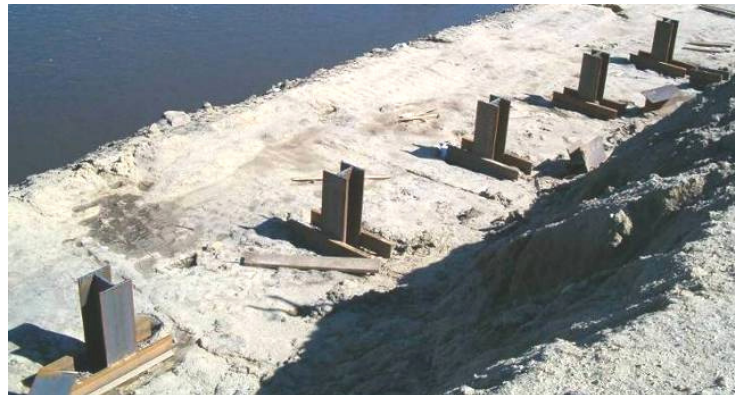
Figure 112. West abutment piles after wood blocking was removed, September 20.

were welded in place, the wooden blocking was removed (see Figure 112). Note in Figure 112 the north-most pile, as previously noted, was driven incorrectly; this error required the channels to be positioned parallel to the longitudinal axis of the abutment, instead of perpendicular.

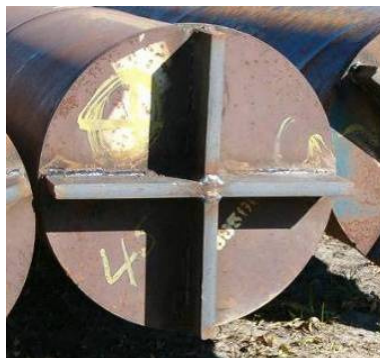
Figure 113. Steel pipe pile driving point, September 28.

The pipe piling for the west pier was driven on September 27 and 28. Each of the piers had nine, 16-inch diameter, closed-end steel pipe piles which were fitted with a pile point (shown in Figure 113) to make driving the piles easier and to prevent damage to the pile.

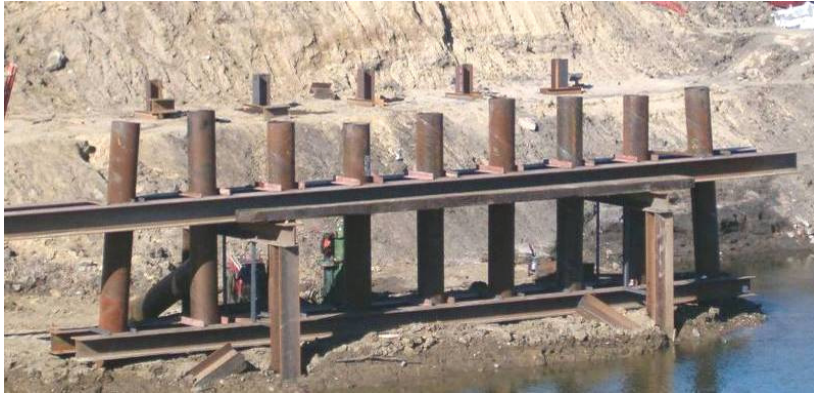
Figure 114. West pier and west abutment piling, September 28.

to provide a support for the precast pier cap, until it was installed and permanently grouted in place. The west pier as well as the west abutment piles can be seen in Figure 114.

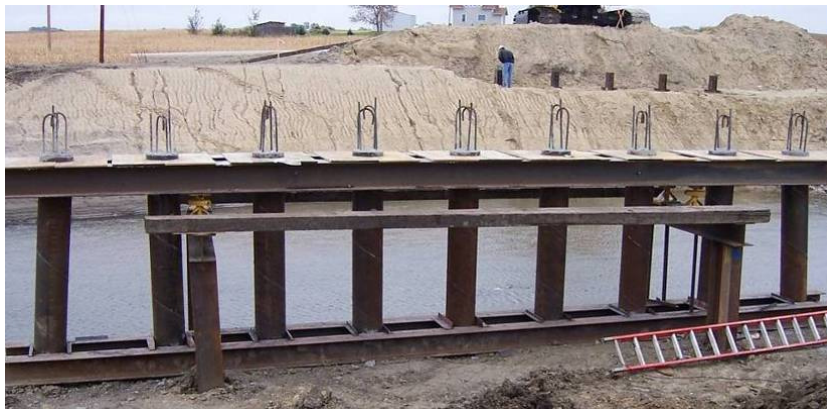
Figure 115. Pipe pile reinforcement for pier cap connection, October 4.

After the pipe piling was in place and secured with steel falsework, the piles were filled with concrete and the reinforcement connections were embedded in the pier cap as the concrete was placed. Pipe piles with the embedded reinforcement can be seen in Figure 115, after concrete was placed inside the pipe piles. The H-piles for the east abutment were driven, cut to length, and had the studs and channels welded in place on October 10 and 11. H-piles for the east abutment can be seen in the background in Figure 115.

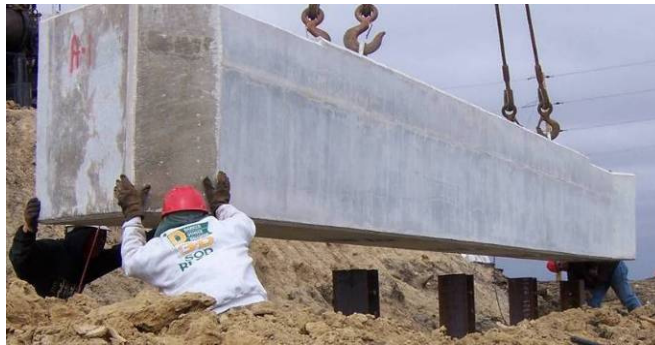
Figure 116. West abutment being lowered in place, October 4.

On October 4, the precast abutment and pier cap for the west side of the bridge were transported to the site and placed; the abutment was delivered and set into place first. Unloading and setting the abutment in place, shown in Figure 116, took the contractor approximately fifteen minutes. There were no clearance issues with the H-piles, thus the operation went smoothly. To connect the precast portion of the abutment with the CIP portion, mechanical splicers were embedded in the precast portion to connect No. 5 reinforcing bars. In Figure 117a, the west abutment can be seen in place as well as the No. 5 reinforcing bars; in Figure 117b, one of the H-piles in the abutment is shown.

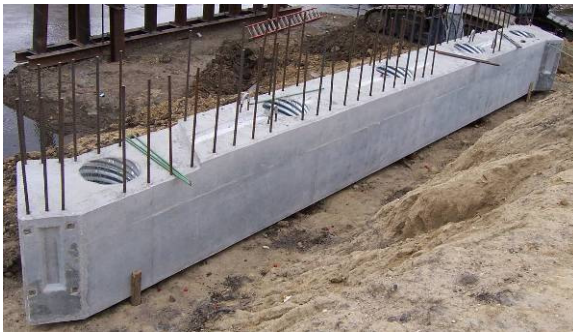
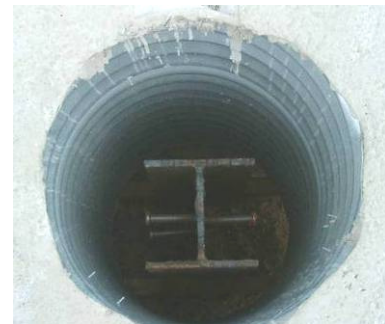
a) abutment in final position

b) H-pile in the abutment

Figure 117. West precast abutment in place, October 4.

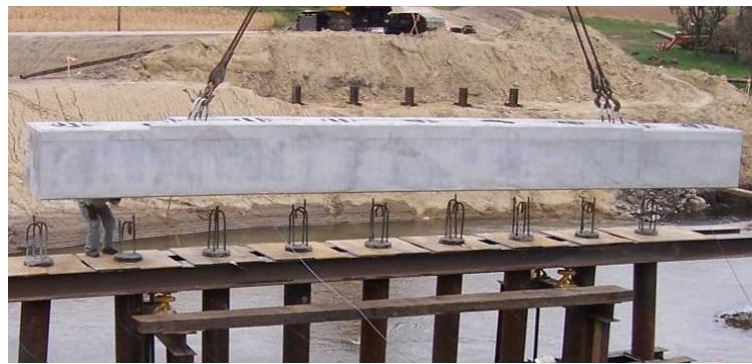
Figure 118. West pier cap being lowered into place, October 4.

Next, the west pier cap was delivered, unloaded, and lowered into place on the falsework in approximately fifteen minutes as well. As shown in Figure 118, the pier cap

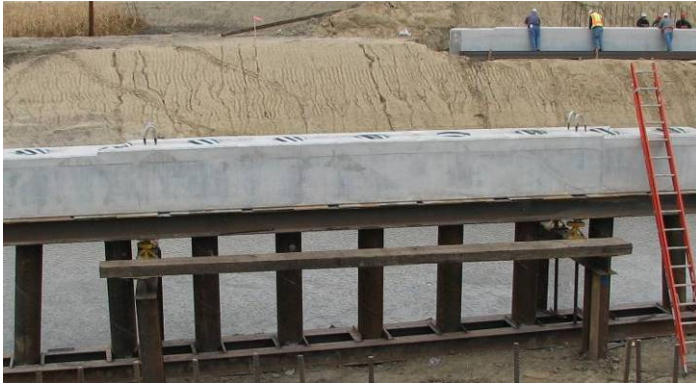
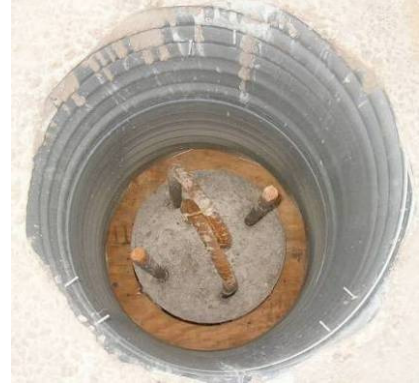
a) pier cap in place

b) pipe pile in the pier cap

Figure 119. West pier cap in place, in the field, October 4.

was set on the falsework without any clearance issues with the pipe piles; the west pier cap is shown in place (Figure 119a) along with one of the pipe piles in the pier cap (Figure 119b).

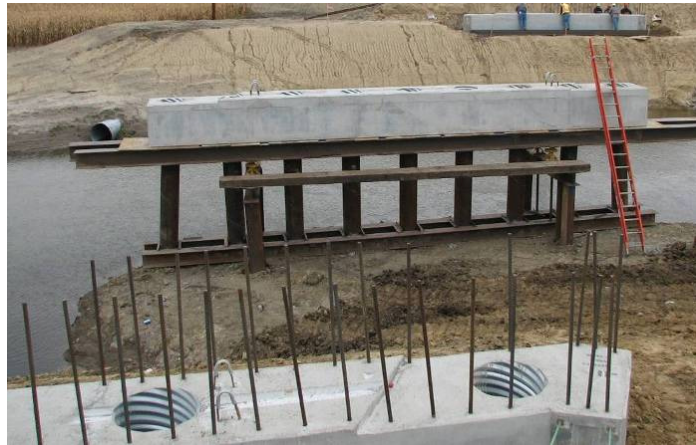
Figure 120. Precast abutments and pier cap in place, October 4.

The east abutment was delivered, unloaded, and set in place on October 4, in the same manner as the west abutment. Both abutments and the west pier cap were placed in approximately fifteen minutes each, and all were placed in the same day (October 4); the only delay in setting each element was waiting for the delivery truck. The east pier cap was the only precast substructure member that was not placed that day, due to the fact the site was still too wet to move the crane into place to drive the east pier piles. Shown in Figure 120 are the two abutments and the west pier cap on October 4, after all three were in place; the external reinforcement attached to the west abutment can be seen in this figure as well.
