Laboratory testing of precast bridge elements, verification of post-tensioning forces and construction documentation of the Boone County IBRC accelerated bridge replacement project

**Laboratory testing of precast bridge elements, verification of post-tensioning forces
and construction documentation of the Boone County IBRC accelerated bridge
replacement project**

Major: Civil Engineering (Structural Engineering)

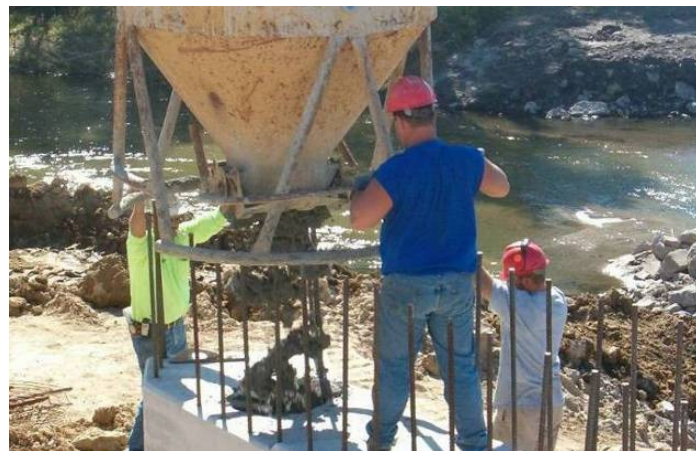
Figure 121. Concrete being placed in the east abutment, October 5.

The following day, the contractor grouted the nineteen piles into place (five in the east abutment, five in the west abutment, and nine in the west pier cap). There were difficulties with the special concrete mix meeting the slump and entrained air requirements and the first mix was rejected. The mix was corrected in the second truck and the contractor used a concrete bucket and crane to place the concrete in the CMP; the concrete was vibrated and finished by hand. Concrete being placed in the east abutment is shown in Figure 121; the finished concrete can be seen in Figure 122.

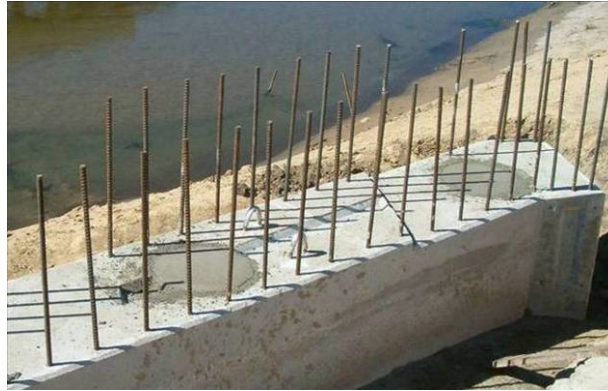
Figure 122. Finished specialty concrete in the east abutment, October 5.

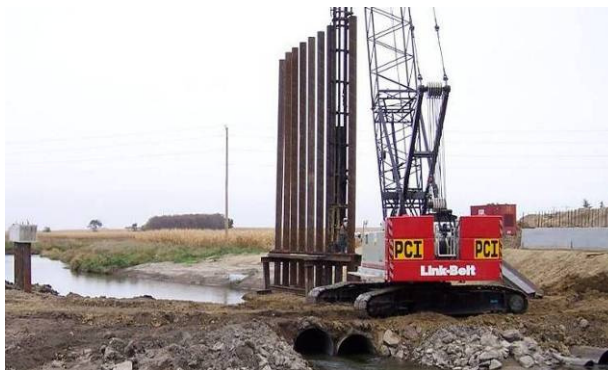
Figure 123. East pier pipe piles being driven, October 10.

By this time (October 5), the construction site had dried sufficiently for the contractor to rebuild the access road to the east side of the bridge. This time, the contractor used one sixteen-inch culvert pipe, one twelve-inch culvert pipe, and two twenty-four-inch culvert pipes, under the access road to increase the flow under the road to hopefully prevent another wash out. Once the road was finished, the crane was moved onto the access road (as shown in Figure 123) and pile driving for the east pier began on October 10.

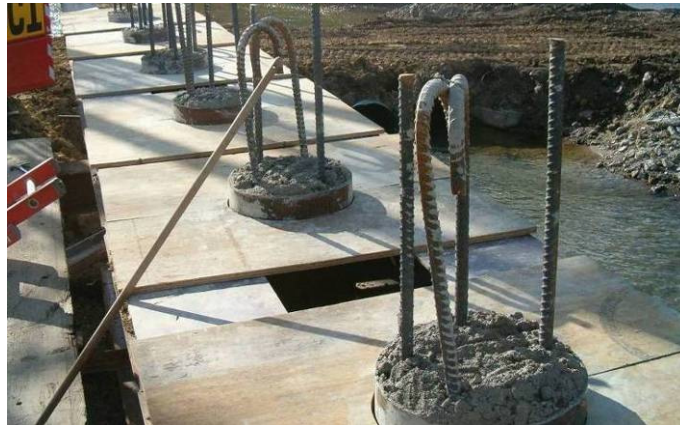
Figure 124. East pier pipe piles filled with concrete, October 12.

west pier. The east pier cap pipe piles are shown in Figure 124, after being filled with concrete. Later that same day (October 12), as shown in Figure 125, the east pier cap was delivered, unloaded, and set in place without difficulty.

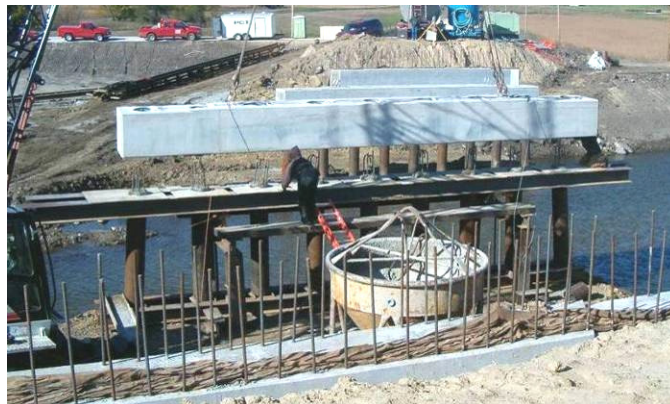
Figure 125. East pier cap being set, October 12.

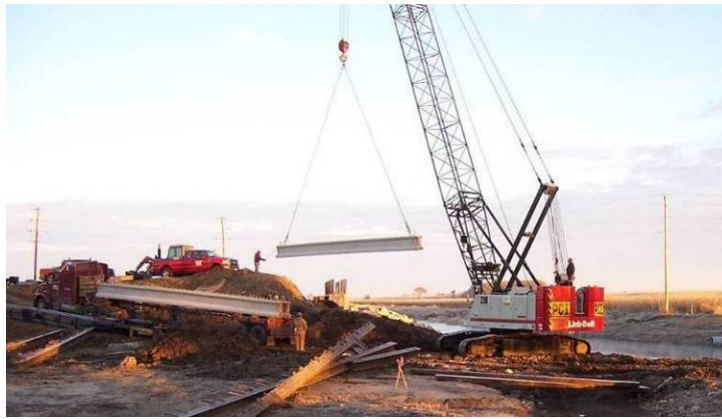
Figure 126. The first bridge girder being lifted into place, October 24.

girder was unloaded and set in place in approximately ten minutes; the first girder of the center span is shown being lifted into place in Figure 126.

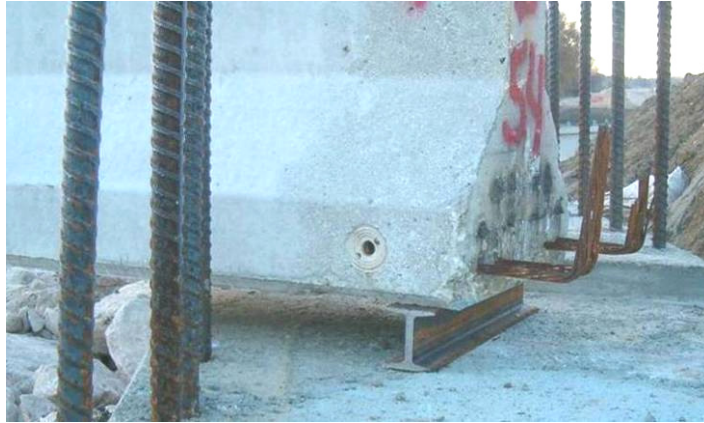
Figure 127. Steel beams used to support the girders, October 24.

All of the bridge girders were set in place on October 24. Small steel beams, shown in Figure 127, supported the girders on top of the pier caps and abutments to keep the girders at the correct elevation until the pier cap diaphragms and the CIP portion of the abutment caps were placed. A view of all of the erected bridge girders (looking east) is presented in Figure 128.

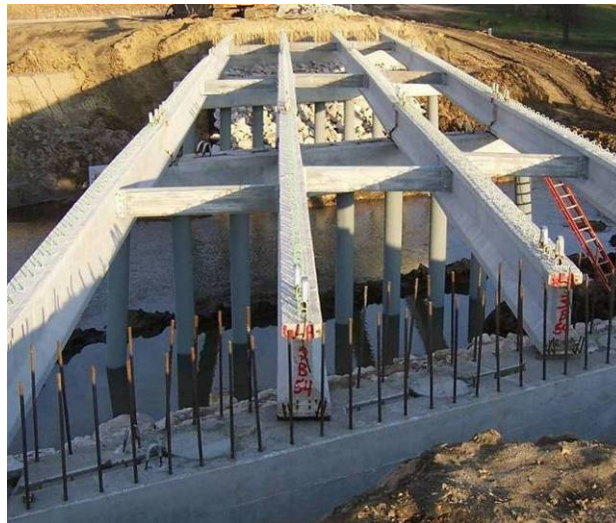
Figure 128. Erected bridge girders, October 24.

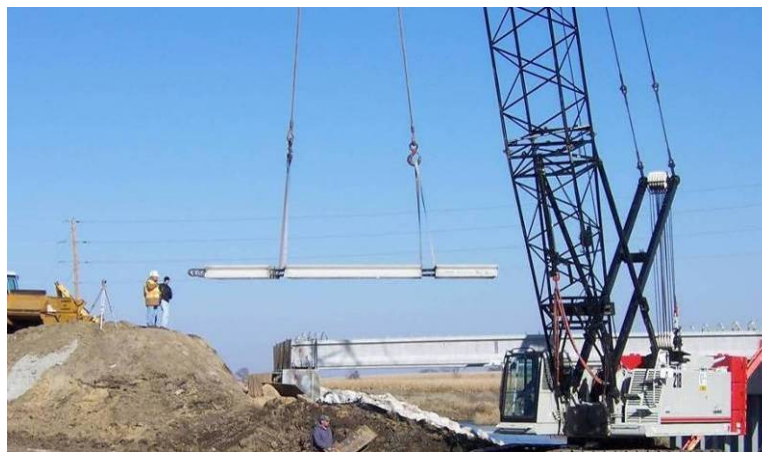
Figure 129. Deck panel being reset on the bridge girders, October 25.

The first of the interior deck panels were delivered on October 25, four panels per truck, and erection thereof began that morning. The first two deck panels set were the panels at middle of the center span of the bridge. However, the panels were not set in the correct location; this error was not noticed until after eight panels had been set. Since the panels had to be set from midspan outwards, the contractor had to remove all eight panels and reset the first two panels. After the initial two panels were correctly positioned, the rest of the panels were then reset. One of the deck panels can be seen being lifted and placed on the girders in Figure 129.

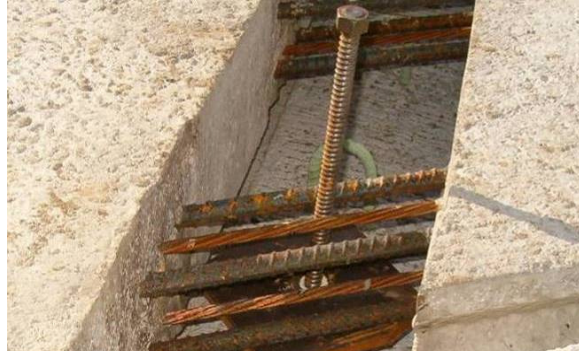
Figure 130. Deck panel leveling screw, October 26.

Over half of the bridge deck panels, sixteen in total, were set on October 25. The remaining panels were delivered and set the next day, with the exception of the four end panels. Four sets steel plates and screws, one of which is shown in Figure 130, were used by the contractor to level the interior deck panels.

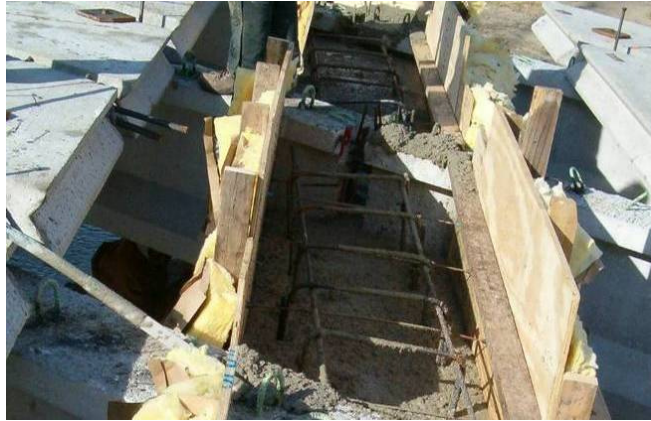
Figure 131. Pier diaphragm before concrete placement was complete, November 3.

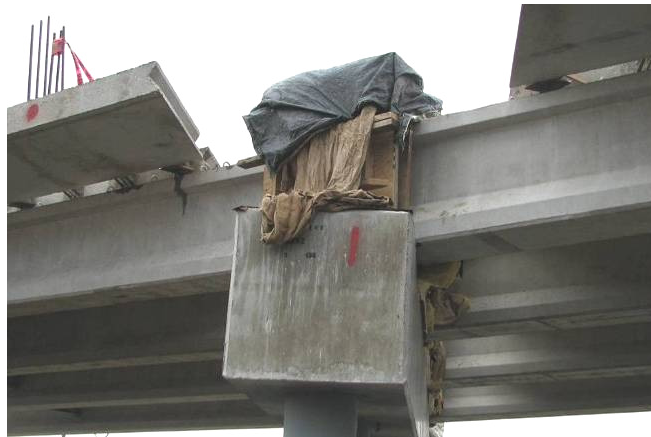
Figure 132. West pier diaphragm covered with burlap and plastic, November 4.

Once all of the deck panels were leveled to the correct elevation, the panels located over the piers were removed so the pier diaphragms could be cast. All of the panels had to be at final elevation so the contractor could form the diaphragms under the panels to the correct height. The diaphragms for both east and west piers were placed on November 3, as shown in Figure 131. After the concrete was placed, the diaphragms were covered in wet burlap and plastic for curing; the west pier diaphragm can be seen in Figure 132, a day after the concrete was placed.

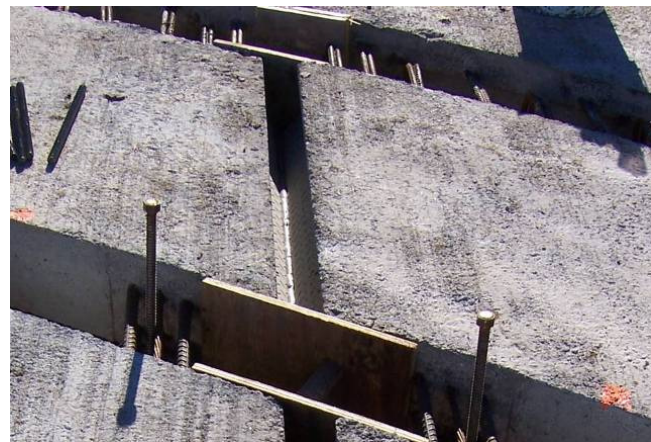
Figure 133. Transverse joint formwork, November 5.

The panels over the piers were replaced after the pier diaphragm concrete had gained sufficient strength and the diaphragm formwork had been 'stripped'. While waiting for the diaphragm concrete to cure, the contractor formed the transverse joints between the deck panels, as shown in Figure 133. On November 8, all four of the end panels were delivered to the site and placed on the bridge; one of the east end panels being lowered into place is shown in Figure 134.

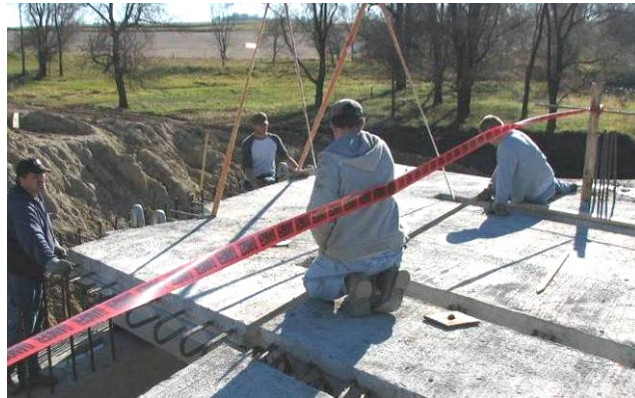
Figure 134. End panel being placed at the east end of the bridge, November 8.

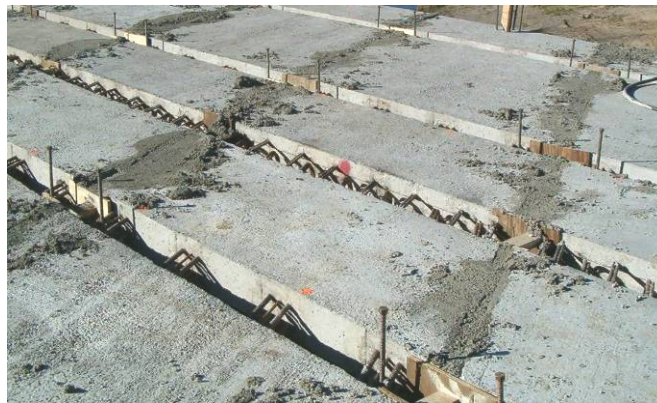
Figure 135. Several transverse joints before finishing, November 8.

The transverse joints between the end panels and the adjacent panels were not formed and cast with the rest of the transverse joints, since the end panels had not reached the required 28-day strength. On November 8 the remaining transverse joints were placed. Several transverse joints can be seen in Figure 135, before being finished; a finished transverse joint is shown in Figure 136.

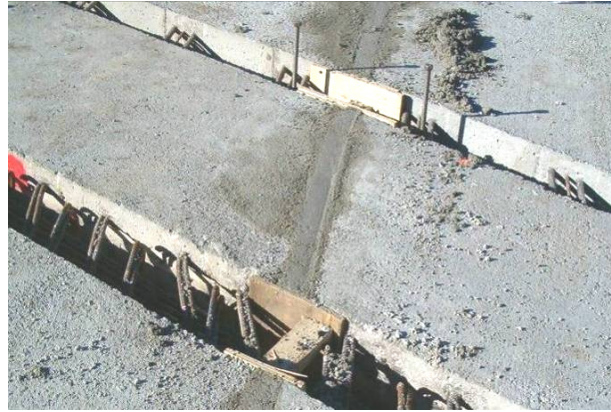
Figure 136. Finished transverse joint, November 8.

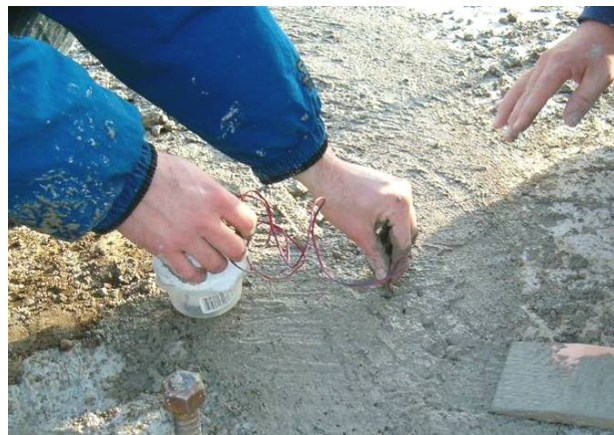
Figure 137. Thermal couple being inserted into end panel joint, November 16.

Post-tensioning the bridge deck could not take place until the end panel transverse joints had reached a minimum strength of 3,500 psi. Since the temperature was dropping, the contractor used heating coils and thermal blankets to heat the joints and decrease the amount of time needed for the concrete in the joints to cure and reach strength. The Iowa DOT placed thermal couples in the transverse joint concrete, shown in Figure 137, so the internal temperature of the concrete could be monitored. Temperature data from the transverse joints are presented in Appendix II. One of the finished end transverse joints can be seen in Figure 138 covered with burlap and heating coils, before the thermal blankets were put in place.

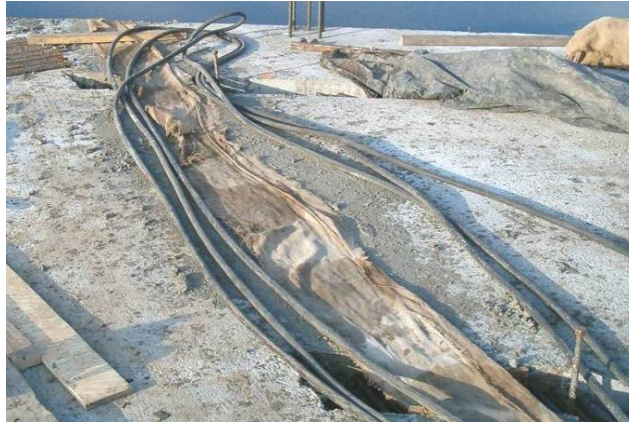
Figure 138. Burlap and heating coils on the west end panel joint, November 16.

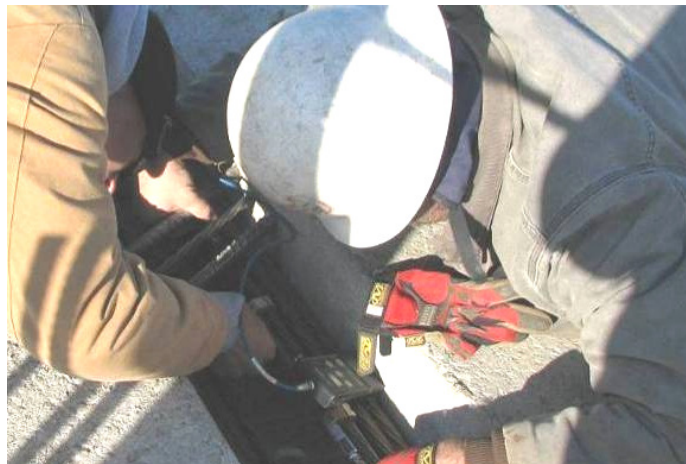
Figure 139. Calibration of one of the vibrating wire gages, November 21.

The contractor was originally going to post-tension the bridge deck on November 21; the VWGs for monitoring some of the post-tensioning forces were attached to four of the tendons and calibrated that morning. One of the gages is shown being calibrated in Figure 139. However, there were problems keeping the joints sufficiently warm; around 2:00 a.m. on November 18, the generator for the heating coils lost power. Power was not restored until around 7:00 a.m. later that morning. Since the strength of the concrete in the end panel transverse joints was not at the required strength, post-tensioning had to be delayed one week for the concrete to cure sufficiently to meet the minimum strength requirements.

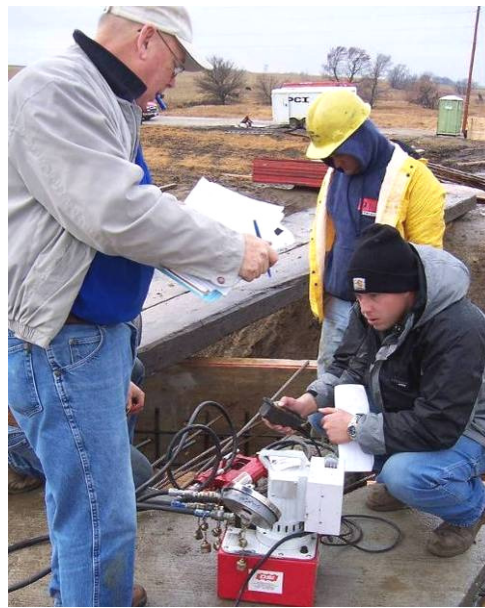
Figure 140. Post-tensioning in progress, November 28.

The following week, the concrete in the joints had gained sufficient strength and the post-tensioning operation, shown in Figure 140, began approximately at 8:00 a.m. on November 28. The order of post-tensioning the various tendons was presented earlier in Section 5.1 of Chapter 5. The entire post-tensioning operation took less than four hours, including the time post-tensioning had to stop for data collection.

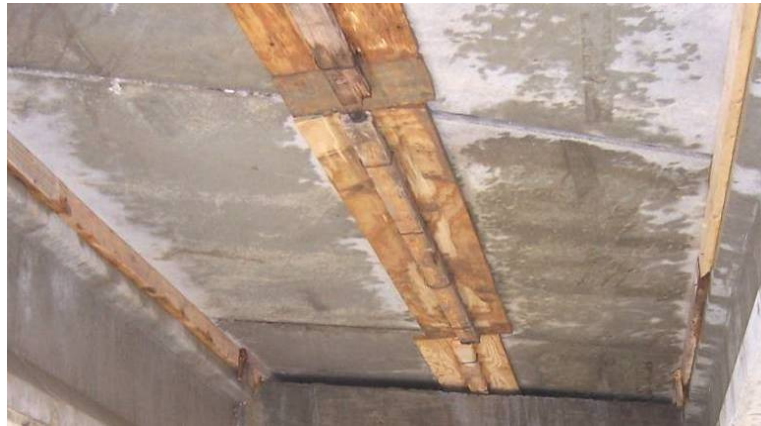
Figure 141. Longitudinal joint formwork, November 28.

During the time spent waiting for the transverse joint concrete to reach the required strength, the contractor formed the longitudinal joint between the north and south half of the bridge and put up formwork for the four post-tensioning channels. Longitudinal joint formwork can be seen in Figure 141 from below the bridge deck. Formwork was attached to the deck using U-bolts.

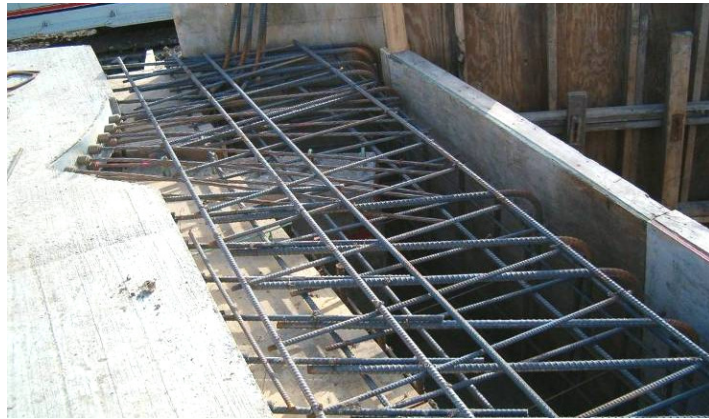
Figure 143. Reinforcement in the west abutment cap, November 29.

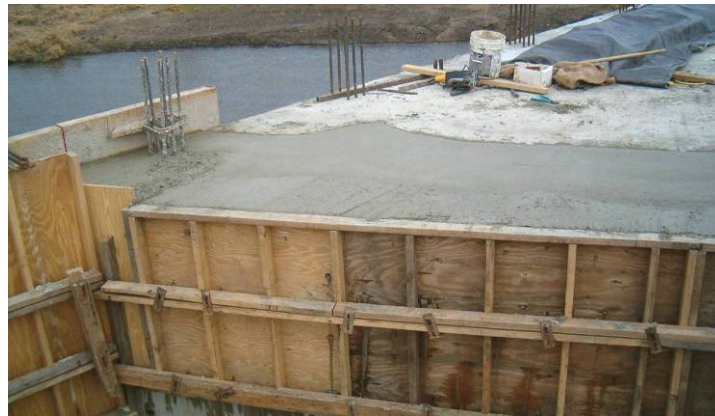
Figure 144. West abutment and wingwall, placed and finished, November 29.

cold temperatures. The next day, November 29, the contractor fabricated the formwork for the abutment cap and wing walls and placed the reinforcement in the formwork; both sets of abutment caps and wing walls were placed on November 29. Next, external reinforcement for the barrier rail was added to the deck panels using embedded mechanical splicers. The reinforcement for the CIP portion of the abutment can be seen in Figure 143 and the finished abutment cap is shown in Figure 144. Note the No. 5 reinforcing bars for the guard rail system attached to the deck panels can also be seen in Figure 144.

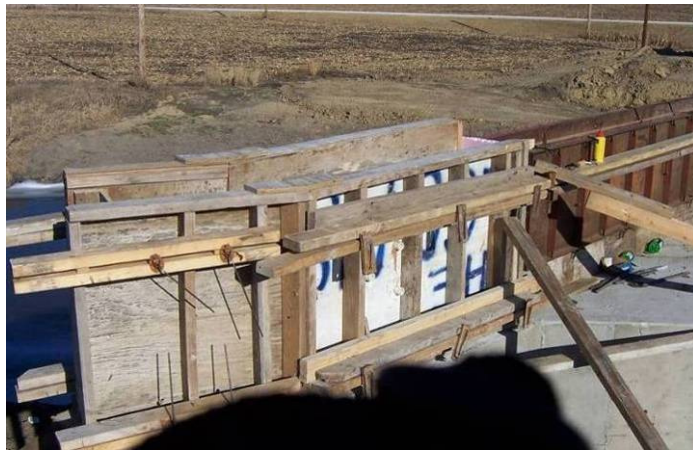
Figure 145. Barrier rail formwork, December 8.

Next, the contractor fabricated the formwork for the CIP barrier rails, (shown in Figure 145), tied the reinforcement cages to be placed in the formwork, and connected the

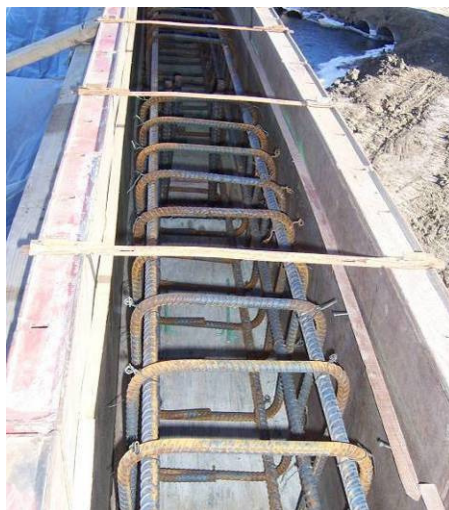
Figure 146. Barrier rail reinforcement, December 8.

external reinforcement to the deck panels using the embedded mechanical splicers. The reinforcement cage for the barrier rail in the formwork is shown in Figure 146. Both barrier rails were placed and finished on December 8; the barrier rail can be seen after being placed, before final finishing in Figure 147. After finishing, the barrier rails were covered with wet burlap and plastic for curing.

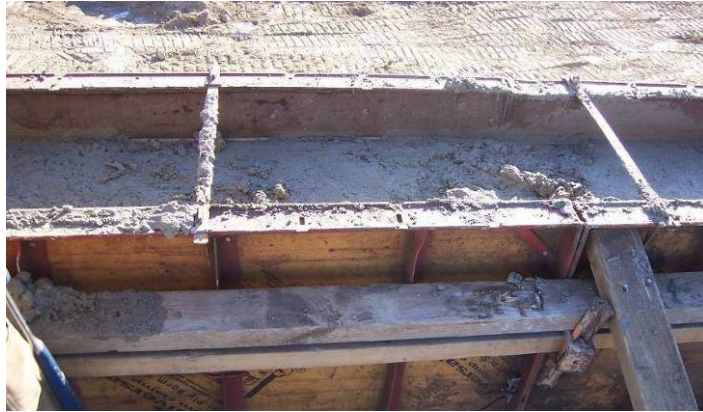
Figure 147. Barrier rail before final finishing, December 8.

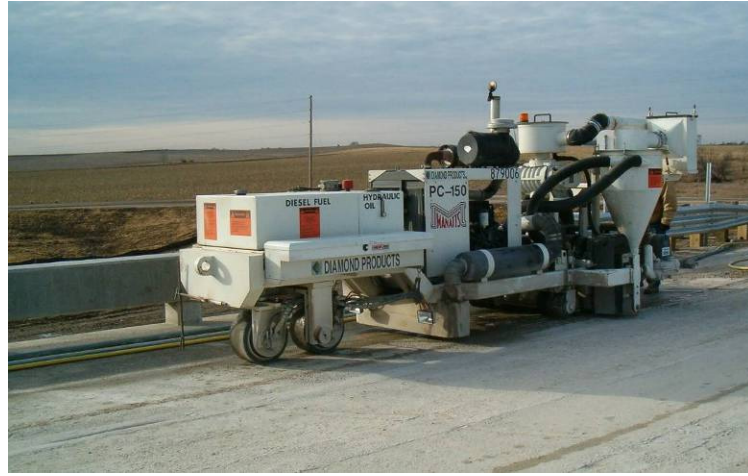
Figure 148. Bridge deck grinding equipment on site, December 27.

The last construction task for the bridge was to grind the surface of the bridge deck. On December 27, the surface of the deck was ground, however, due to equipment breakdown, grinding wasn't completed until December 28. Due to clearance issues with the grinding equipment, shown in Figure 148, the three feet adjacent to the barrier rails were not ground. Figure 149 shows the surface of the bridge deck after the surface was ground.

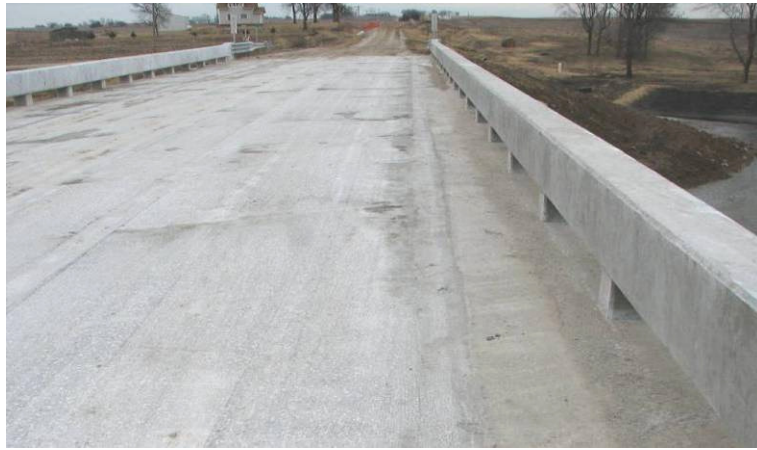
Figure 149. Bridge deck after the surface was ground, December 27.

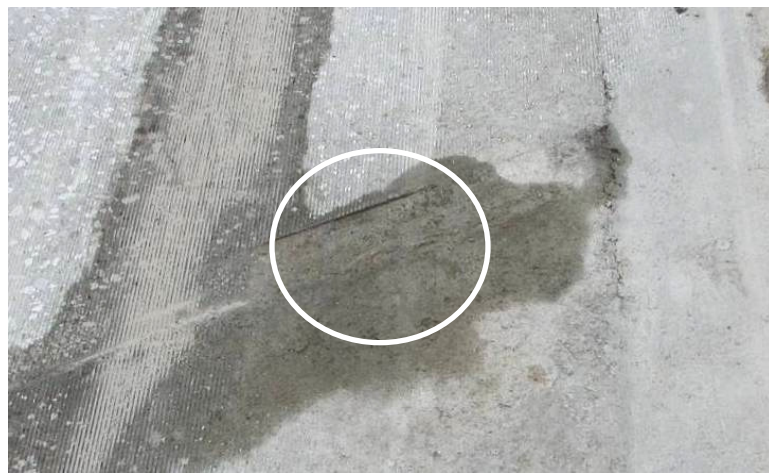
Figure 150. Low area in one transverse joint after deck grinding, December 27.

There were some difficulties encountered with the deck grinding process. Several areas of the transverse joints were not finished high enough, causing low and uneven areas on the deck. Even after grinding, there were several areas where the transverse and longitudinal joints had noticeable low areas. One such area between the transverse joint and the precast panels can be seen in Figure 150. After the bridge deck was ground, the completed bridge shown in Figure 151 was officially opened.

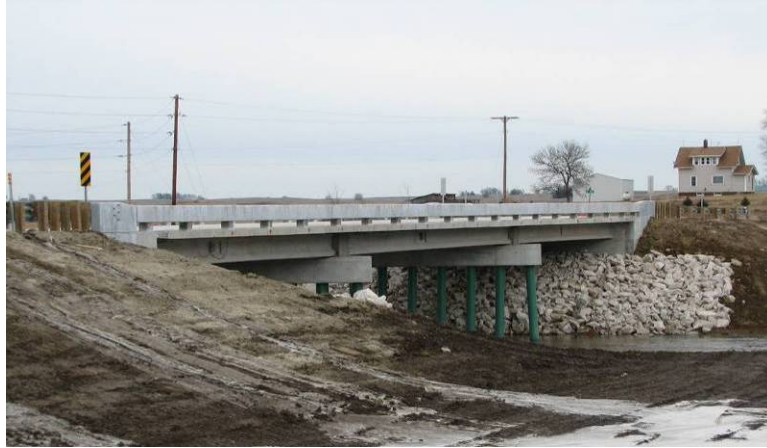
Figure 151. Completed bridge, December 27.
