Mechanical Characterization Of Composite Repairs For Fiber-Glass Wind Turbine Blades

A Dissertation

for the degree of
Doctor of Philosophy

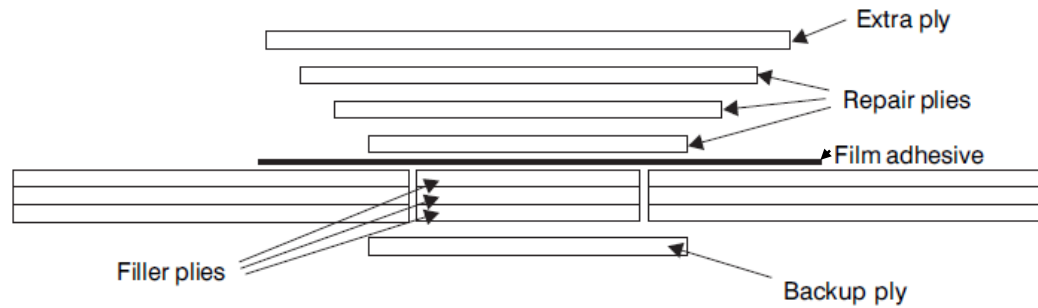
Patch repairs involve the use of filler plies (Figure 1) to make up for the thickness of the original laminate and repair patches are either bonded adhesively or mechanically fastened to the laminate surface externally.

Figure 1.1. Patch repair [4]

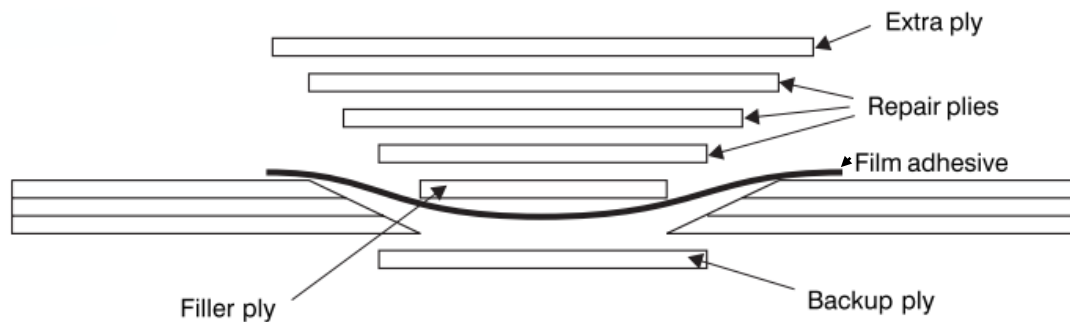
of the laminate (Figure 2). Sometimes a filler ply may be added in addition to the repair plies to have a flatter surface. A wet lay-up is preferred as there might be fitting problems with the pre-cured ones. As in the case of patch repairs, the stacking sequence of the repair plies is the same as that of the parent laminate and an extra ply is added at the top of the repair plies to increase the overall strength and reduce creep as much as possible [3].

Figure 1.2. Scarf repair [4]

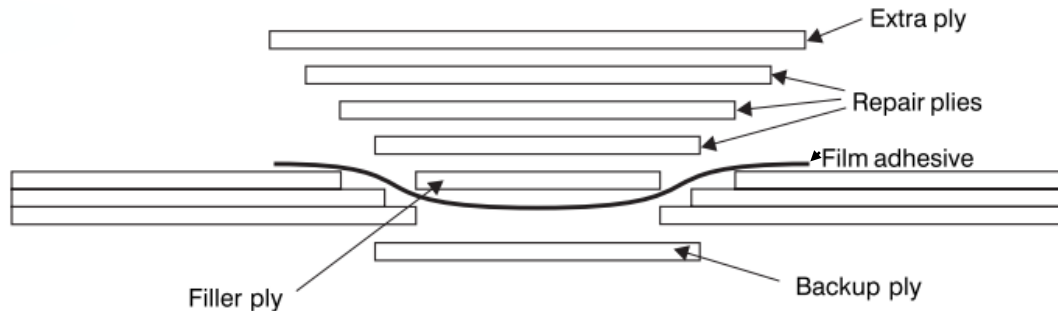
In step repair, as the name suggests, the damaged plies are sanded such that a flat face of the ply is exposed giving the laminate a 'stair-like' appearance (Figure 3). The steps are

Figure 1.3. Step repair [4]

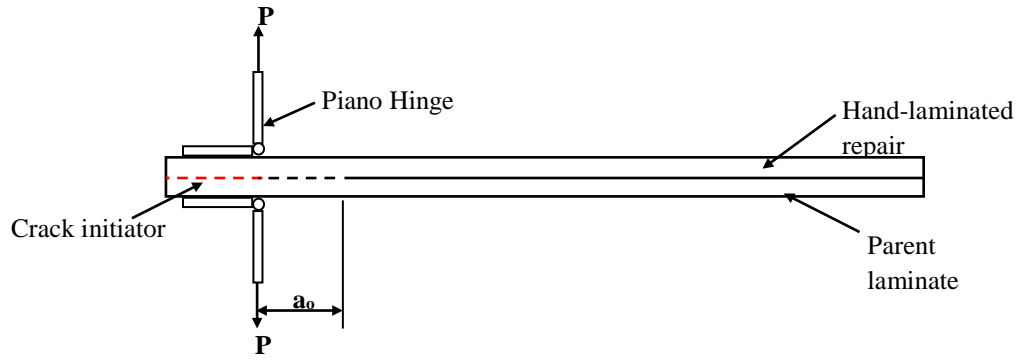
For repair resin screening, DCB specimens (Figure 2.1) were manufactured in accordance with ASTM D 5528 and consisted of two separate parts: the lower adherend or parent plate, representing the blade, and the upper adherend or repair plate, simulating the flat part of a one-sided scarf repair. Both adherends consisted of an even number of plies. A description of the lay-up and the materials used is given in Table 2.2. The company uses a different polyester resin (MB-B) for repairs currently than is used to fabricate the shell of the blade (MB-A). The parent plates for the DCB specimens were made using the current blade shell resin. Simulated repairs were fabricated using each candidate repair resin. Simulated repairs using the current repair resin (MB-B) were tested to serve as a baseline for comparison.

Figure 2.1. DCB Specimen

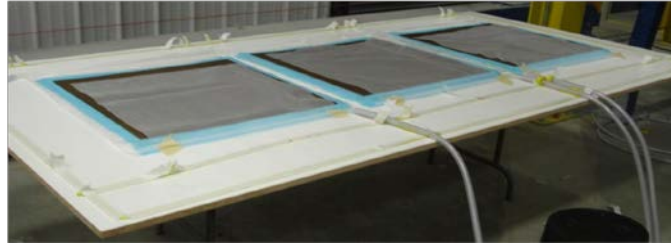
The parent plate representing the blade was manufactured using Vacuum Assisted Resin Transfer Molding (VARTM). A VARTM setup, before vacuum bagging and infusion of resin, is shown in Figure 2.2. After the gelling of the resin, the parent plates were cured at room temperature for 24 hours, and then further post-cured at 60°C for 24 hours and then at 95°C for 3 hours. This was done to fully cure the parent plates and also to have low residual styrene content by minimizing incomplete polymerization through high curing temperature. All parent plates were made continuously one after the other and each plate was then assigned to a repair resin candidate. Care was taken that the time lapse between

Figure 2.2. VARTM set-up before infusion

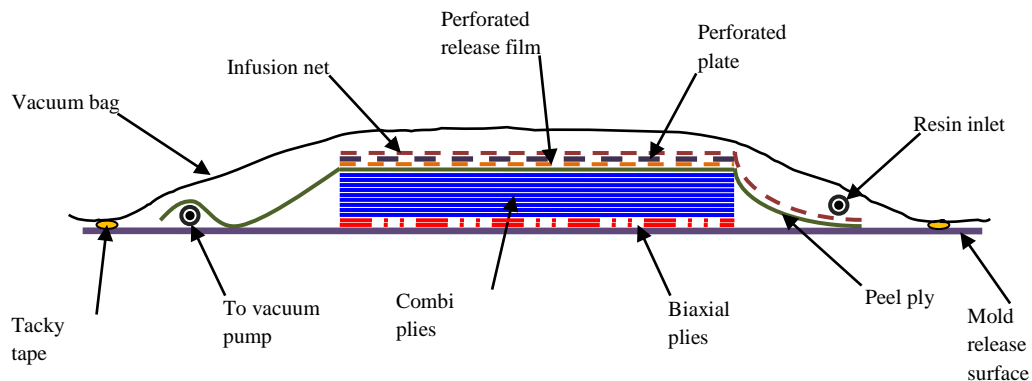
Each parent plate initially consisted of nine, 0.88 mm thick plies with unidirectional glass fibers and a chopped strand mat attached on one side (called Combi plies hereafter) and two biaxial plies (plies with glass fibers at $\pm 45^\circ$) at the bottom (Figure 2.3). Since the lay-up of the parent plate was not symmetric, some warp was observed in the parent plates perpendicular to the direction of the unidirectional fibers in the Combi plies. The extent of warp is depicted in Figures 2.4 and 2.5. The reading on the scale (depth of warp) in Figure 2.4 is 1.25 cm. The total width of the plate was 60 cm. As the specimens were to be cut along 1-direction (direction along fibers), it was decided that the warp would not have a significant effect on the test results.

Figure 2.3. VARTM infusion package

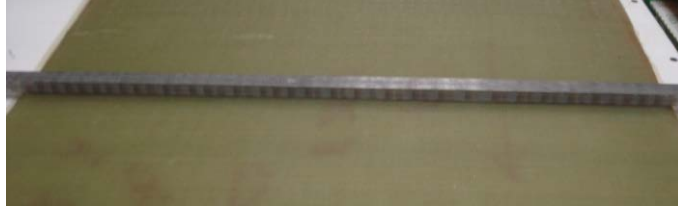
Figure 2.4. Straight rule along Combi plies' 0° direction (1 – direction)

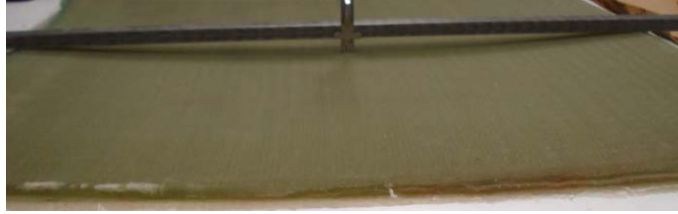
Figure 2.5. Straight rule along Combi plies' 90° direction

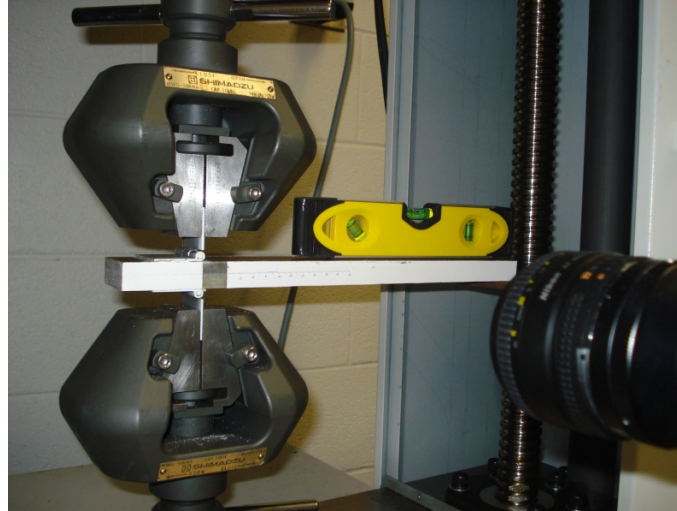
Testing of the DCB specimens was conducted on the Shimadzu AG-IS Universal Testing Machine under displacement control at a crosshead rate of 0.1 mm/min. Higher rates were tried but at those rates crack propagation was too fast for collection of adequate data for fracture toughness calculations. The specimens were aligned and centered with the help of a level when the hinges were being mounted in the load grips with the parent laminate down as shown in Figure 2.6. The end of each specimen, opposite to the end where the hinges were attached, was supported before loading. It was noticed that the supported end lifted (less than 1.0 mm) off the support as the load was applied. Crack propagation was monitored and recorded with the help of a Retiga 1300 camera (Figure 2.6).

Figure 2.6. Experimental set-up for DCB testing

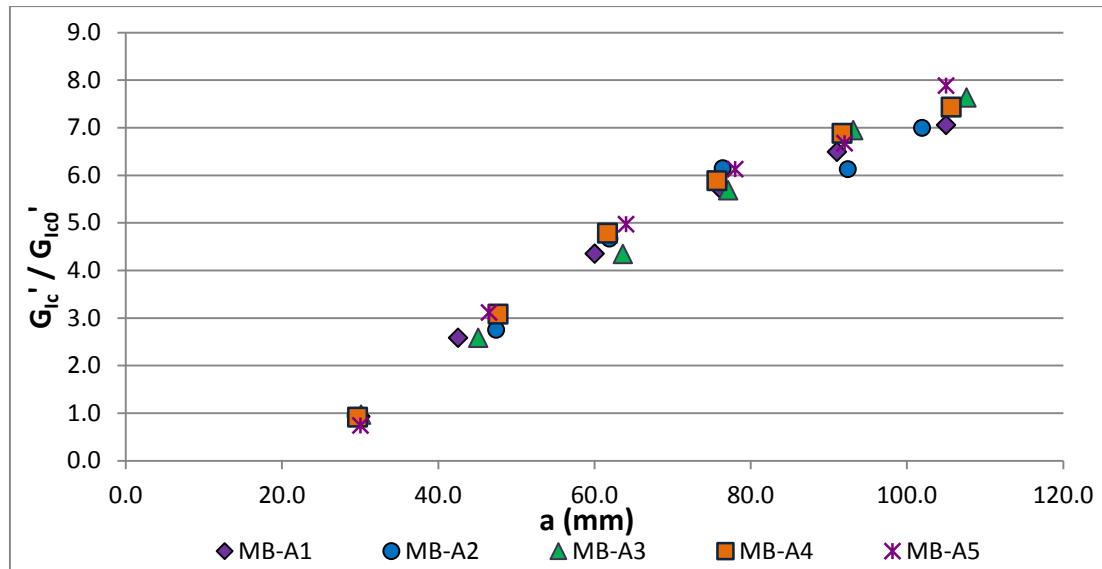
The ratios of corrected values of interlaminar fracture toughness, G_{Ic}' , to the fracture toughness value for main blade resin at crack initiation, G_{Ic0}' , were calculated using Equation 2.2 for each increment in every batch of specimens tested and plotted against a, the crack length. Figure 2.7 and Figure 2.8 show the resulting curves for the main blade

Figure 2.7. G'_{Ic} / G'_{Ic0} vs crack length for main blade resin, MB-A.

These curves indicate the toughness of the main blade at a crack length of approximately 105 mm to be four times more than that of the repairs made by the current repair resin.

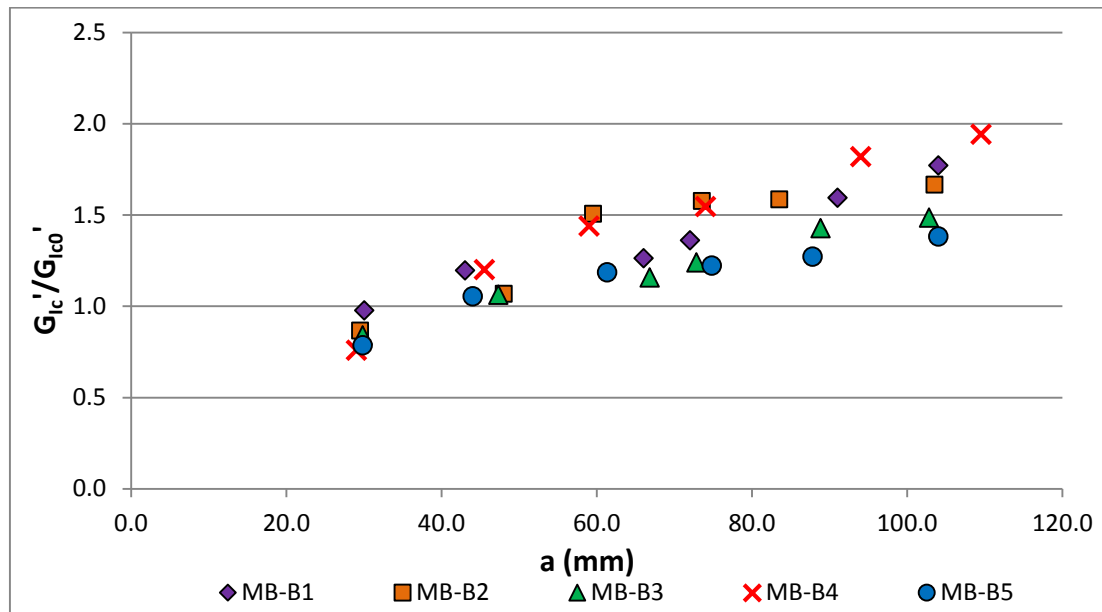
Figure 2.8. G'_{Ic} / G'_{Ic0} vs crack length for current repair resin, MB-B.

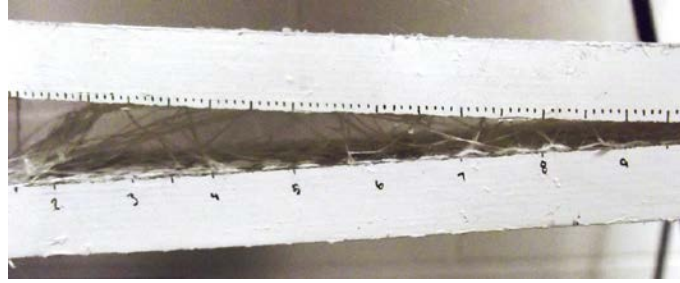
Figure 2.10. Fiber bridging in case of MB-A (main blade resin)

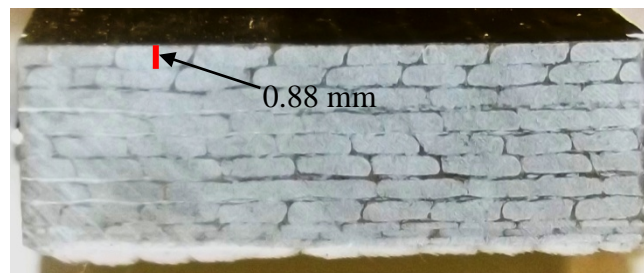
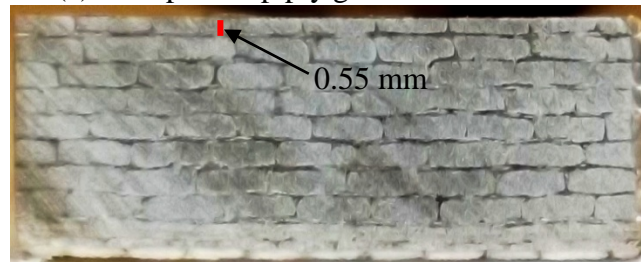
While testing the set of specimens consisting of repairs carried out with repair resins NRR1, NRR4 and NRR5 it was observed that the fracture toughness values obtained were markedly high. Examination of the fractured specimens revealed that the top plies of the parent plates of these specimens had been ground to about half the depth (Figure 2.11) instead of one complete top ply. The specimens for these three resins were manufactured again with the complete top plies ground off so as to get a correct comparison with the other repair resins.

(a) Complete top ply ground off

(b) Partial top ply ground off

Figure 2.11. Grinding difference in case of NRR1, NRR4 and NRR5 resins

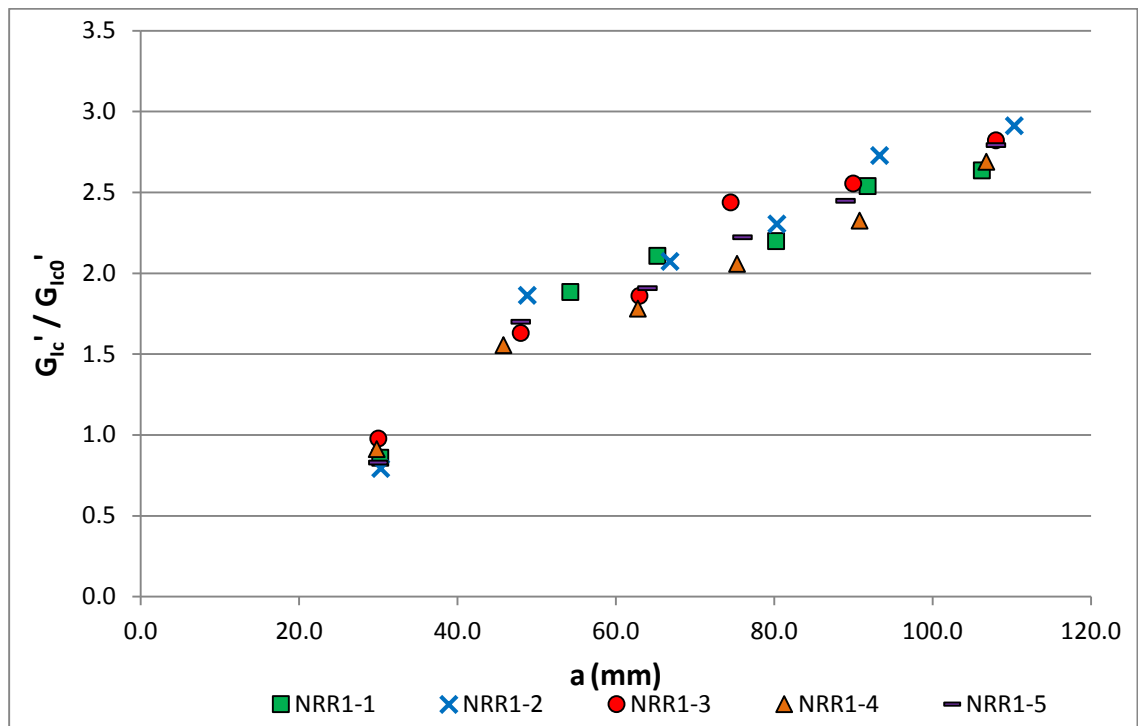
Figure 2.12. G'_{ic} / G'_{ic0} vs crack length for candidate resin, NRR1

candidates (Figures 2.12 to 2.17) to compare with the baseline data obtained from the current repair resin. The profile of almost all the plots was as expected but there was an anomaly in the graph for two specimens of new repair resin candidate three (NRR3) (Figure 2.14). The surfaces of these specimens were examined and patches of dry glass were noticed in the CSM on the repair adherend (Figure 2.18); the positions of these patches corresponded to the spikes in fracture toughness values in the plot. The remaining three specimens also had similar patches though much smaller in size. It was not clear whether the patches were manufacturing defects or due to some property of the resin. However, due to the patches and the erratic nature of fracture toughness values obtained this resin (NRR3) was no longer considered to be a viable candidate even though it gave almost 1.5 times higher fracture toughness values than the current repair resin at crack length of approximately 105 mm.

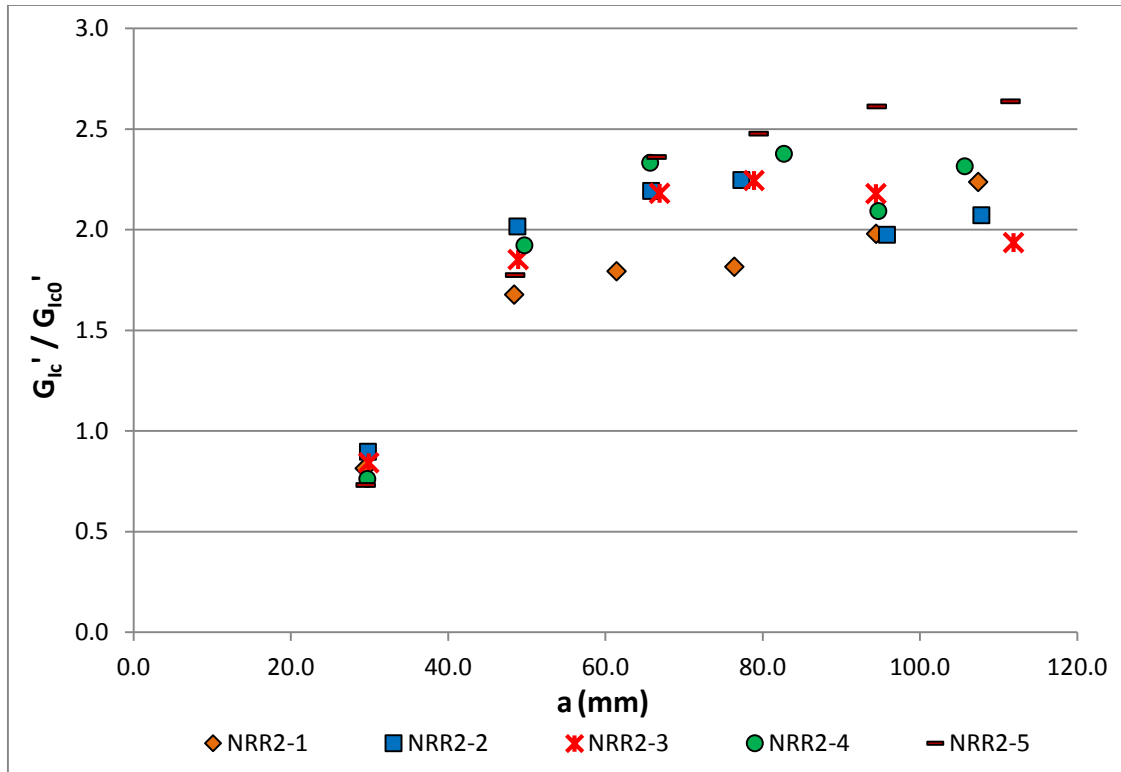
Figure 2.13. G'_{ic} / G'_{ic0} vs crack length for candidate resin, NRR2

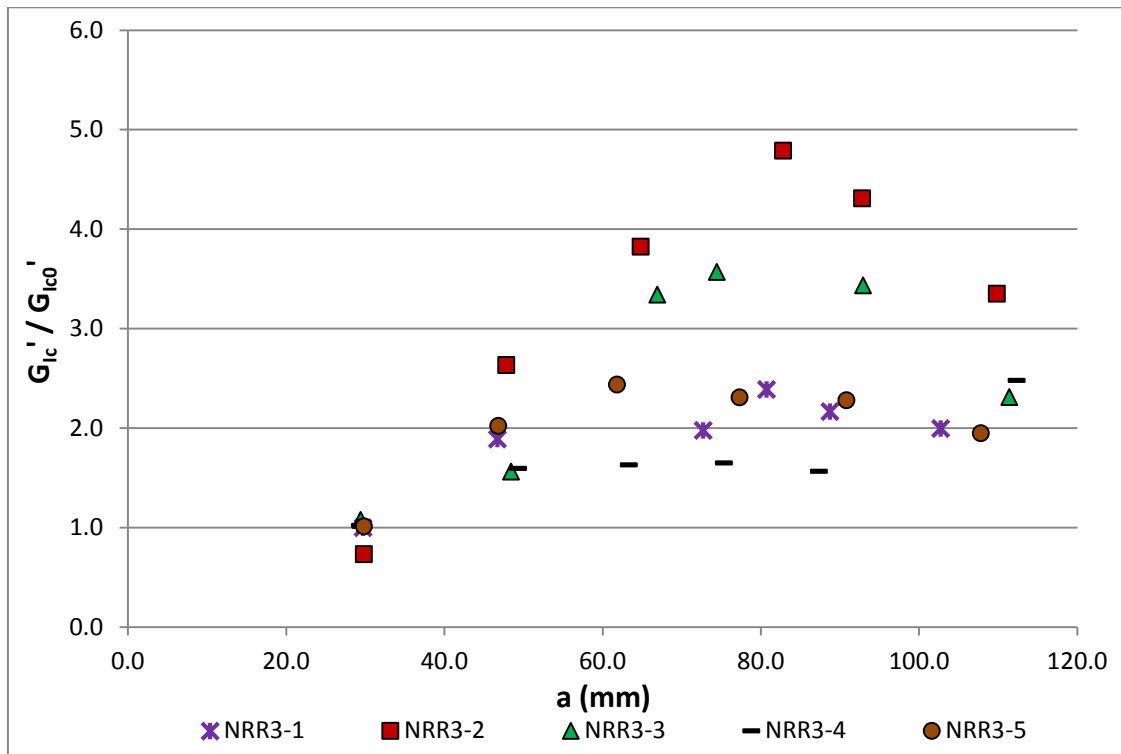
Figure 2.14. G'_{ic} / G'_{ic0} vs crack length for candidate resin, NRR3

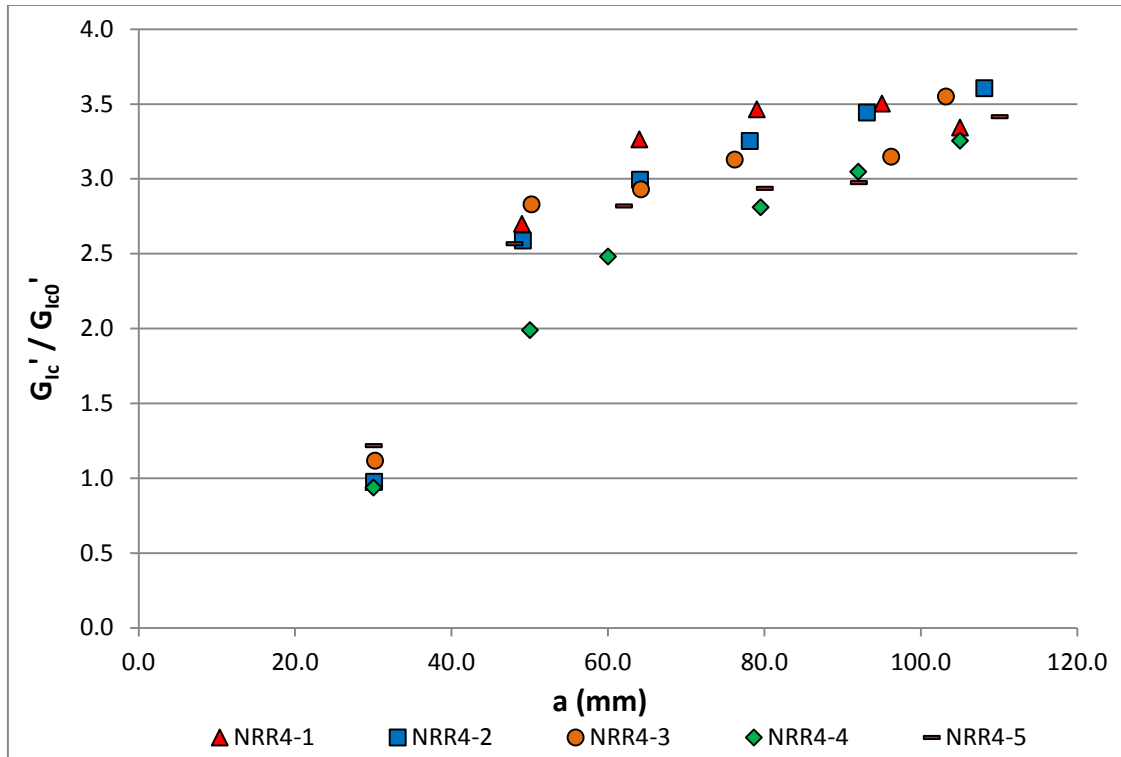
Figure 2.15. G'_{ic}/G'_{ic0} vs crack length for candidate resin, NRR4

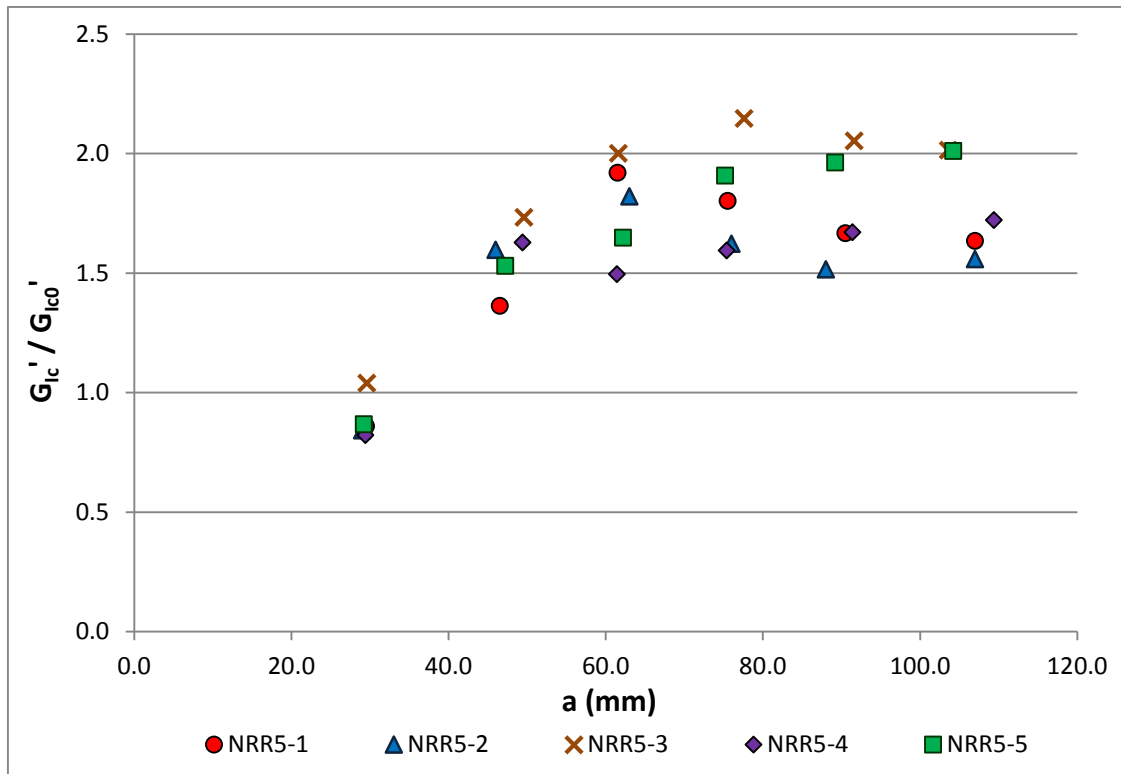
Figure 2.16. G'_{ic}/G'_{ic0} vs crack length for candidate resin, NRR5

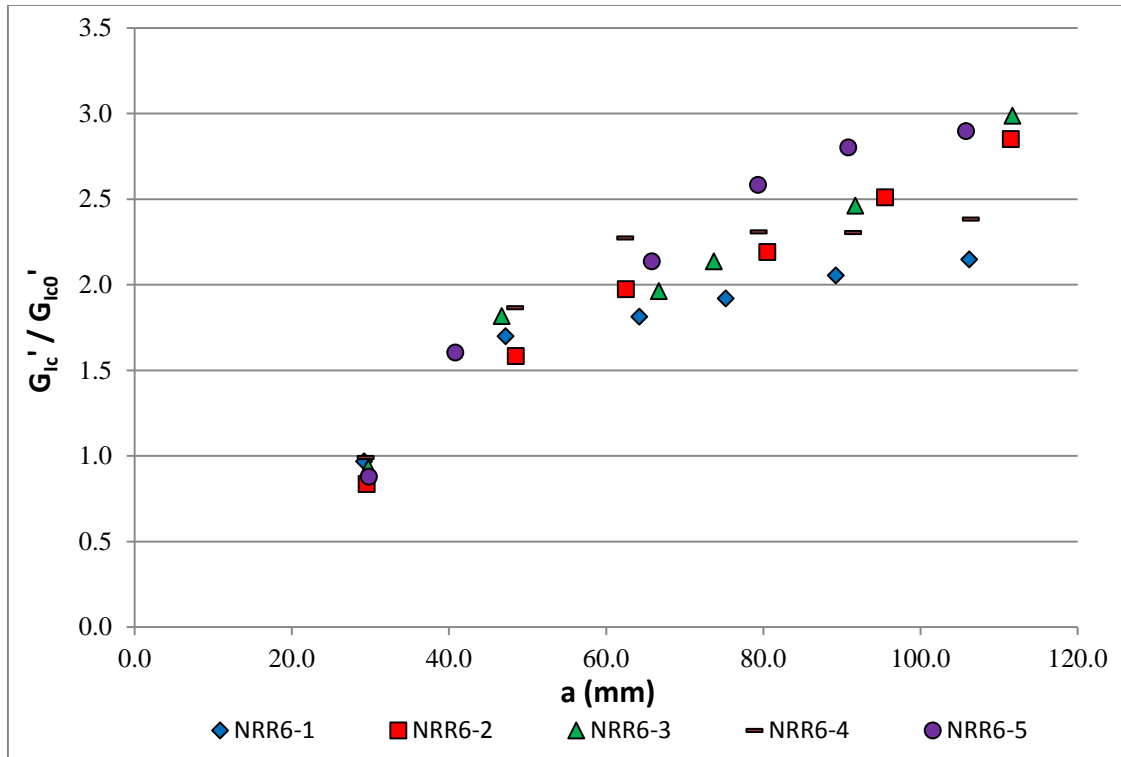
Figure 2.17. G'_{ic}/G'_{ic0} vs crack length for candidate resin, NRR6

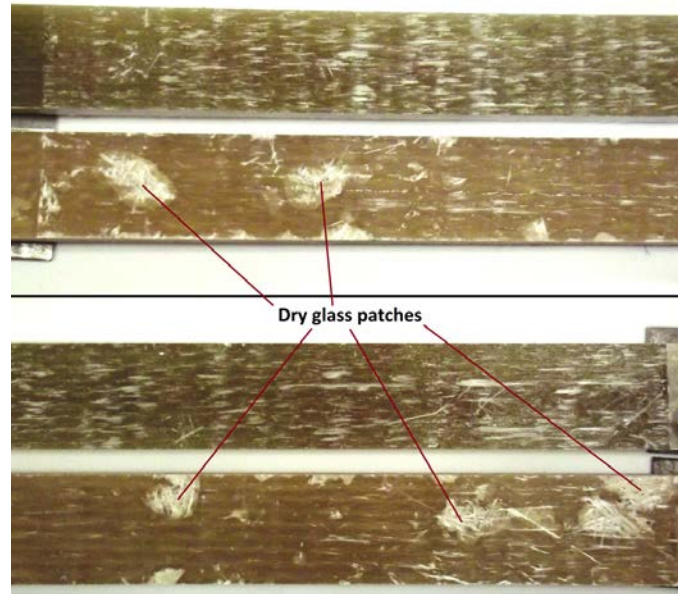
Figure 2.18. Fractured surfaces of NRR3 specimens with dry patches in CSM

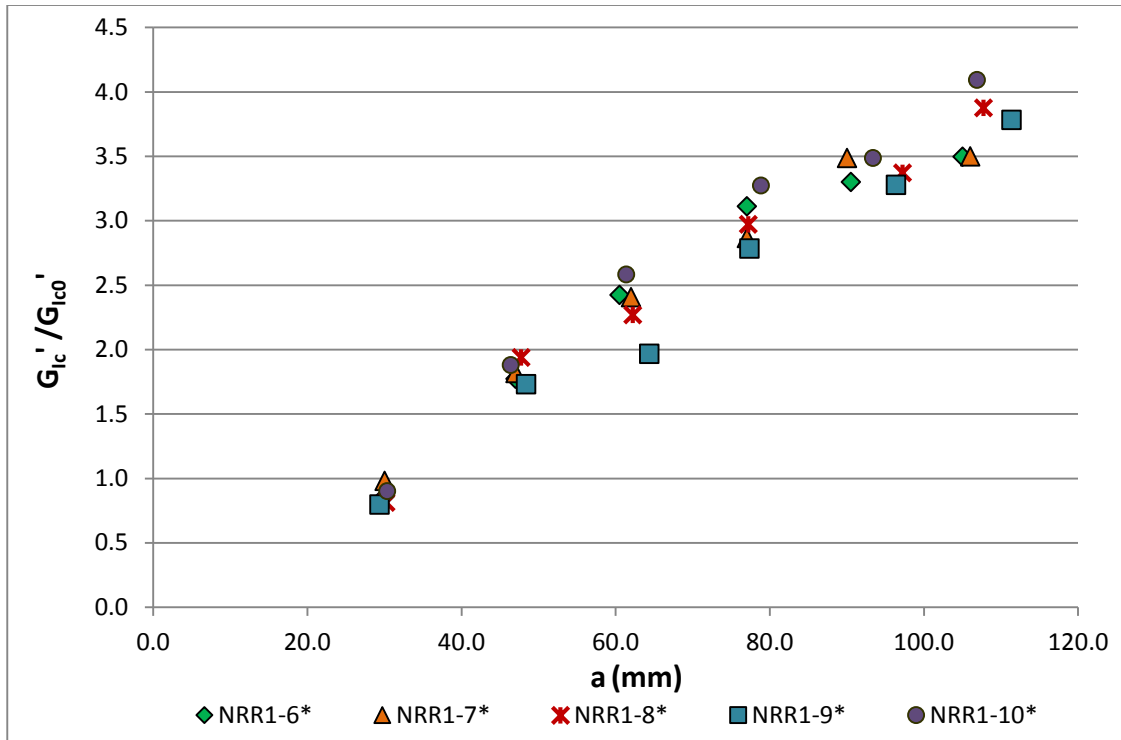
The specimens with the top plies partially ground off and repaired with repair resins NRR1, NRR4 and NRR5 were also tested to examine the fracture toughness difference due to grinding variation. The normalized fracture toughness values for these are plotted against crack length in Figure 2.19 to Figure 2.21.

Figure 2.19. G'_{ic}'/G'_{ic0}' vs crack length for resin NRR1 with partial top ply ground off

In all of the specimens with the top plies partially ground off the fracture toughness values were much higher (Table 2.5) than those obtained from specimens made with same repair resins but with their top plies ground off completely. When the top plies are ground off completely, the resulting exposed surface on which the repairs are carried out comprises mainly main blade resin, MB-A. Whereas, when the top plies are ground off partially, the resulting surface has a mixture of exposed fibers and resin. These exposed fibers bond with the repair resin and this results in pronounced fiber bridging while the specimens are being tested, thus leading to high fracture toughness values. Figure 22 to Figure 24 depict a comparison of the normalized fracture toughness values obtained from specimens with top parent plies completely ground off (numbered NRR#-#) to those with the top parent plies partially ground off (numbered NRR#-#*).

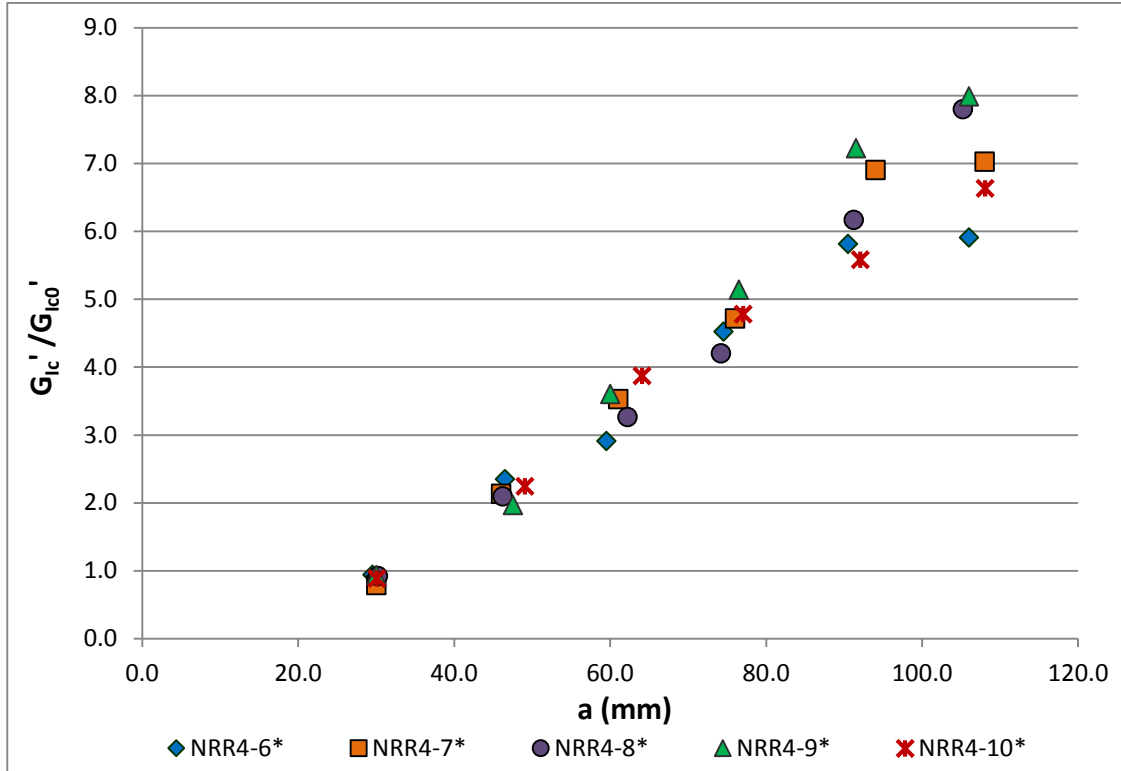
Figure 2.20. G'_{ic}'/G'_{ic0}' vs crack length for resin NRR4 with partial top ply ground off

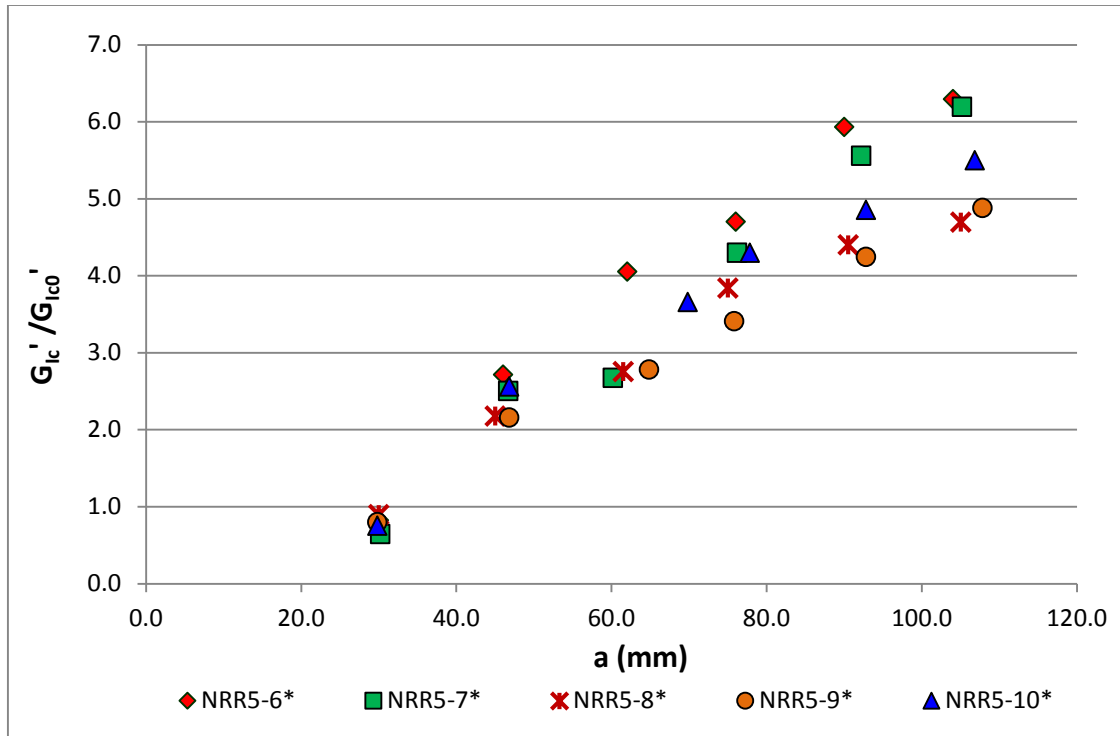
Figure 2.21. G'_{Ic}/G_{Ic0} vs crack length for resin NRR5 with partial top ply ground off

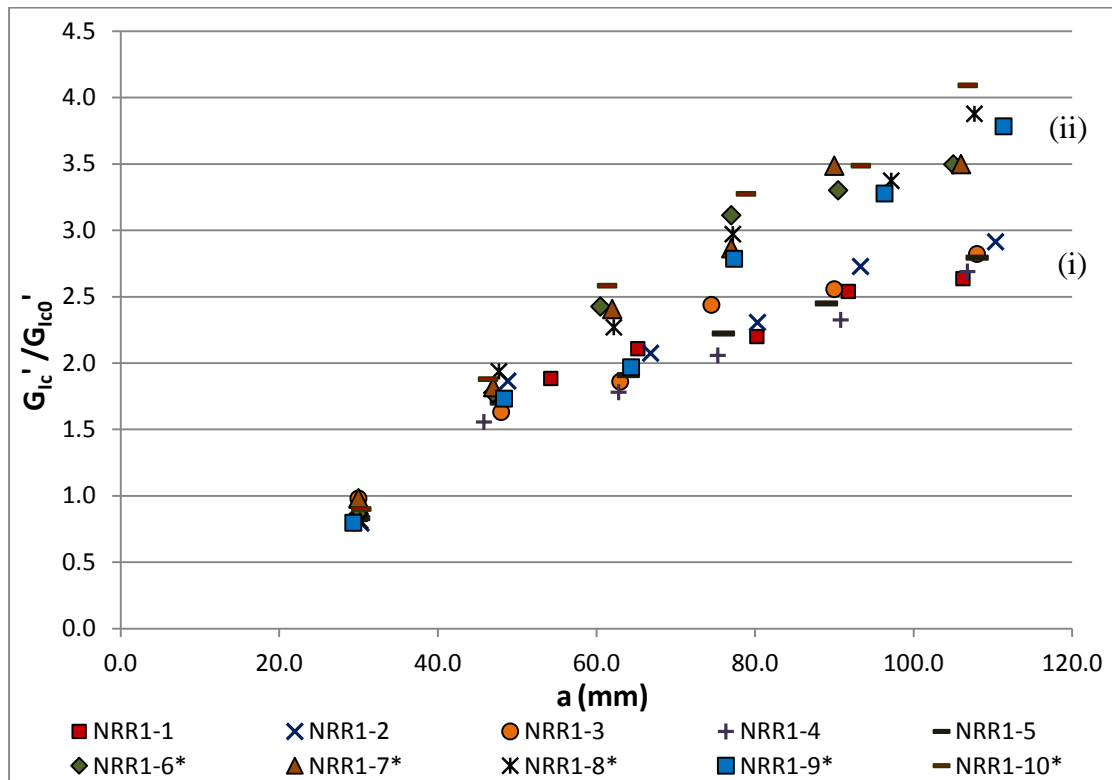
Figure 2.22. Comparison of fracture toughness values of NRR1 specimens with (i) whole top ply ground off (NRR1-#) (ii) partial top ply ground off (NRR1-#*)

From the graphs plotted in Figures 2.22 to 2.24 it is evident that there is little variation in the fracture toughness values at first crack initiation at $a = 30$ mm for the two cases. A closer look reveals that the fracture toughness values, when the specimen first cracks open at the tip of the insert, are higher for the repairs carried out on parent plates with the complete top plies ground off (Figure 2.25). This might be due to the differences in the crack propagation paths in the two cases. For crack initiation at the end of the insert, the fracture toughness values primarily depend upon the bond morphology at the crack tip. The fiber bridging effect comes into play later as the crack propagates along the bondline between the two adherends. In the case of parent plates with the top plies partially ground off the surface at crack tip comprises partial exposed resin and exposed fibers. On the other hand the surface of parent plates with complete top plies ground off comprises mainly resin.

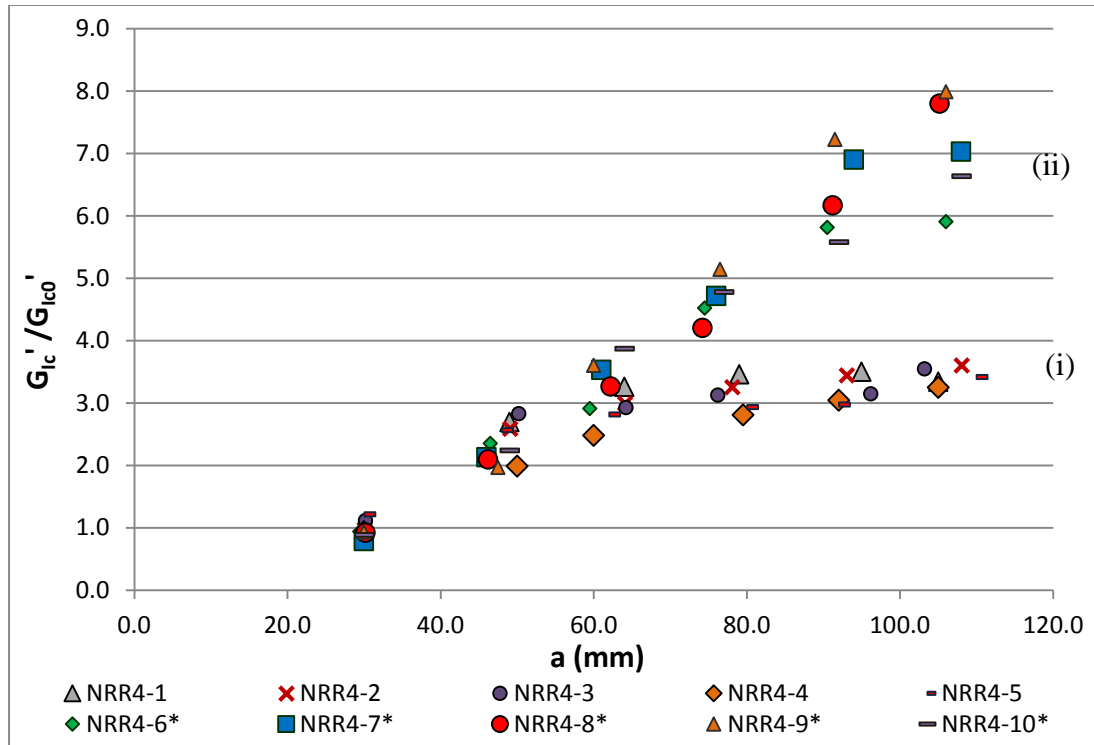
Figure 2.23. Comparison of fracture toughness values of NRR4 specimens with (i) whole top ply ground off (NRR4-#) (ii) partial top ply ground off (NRR4-#*)

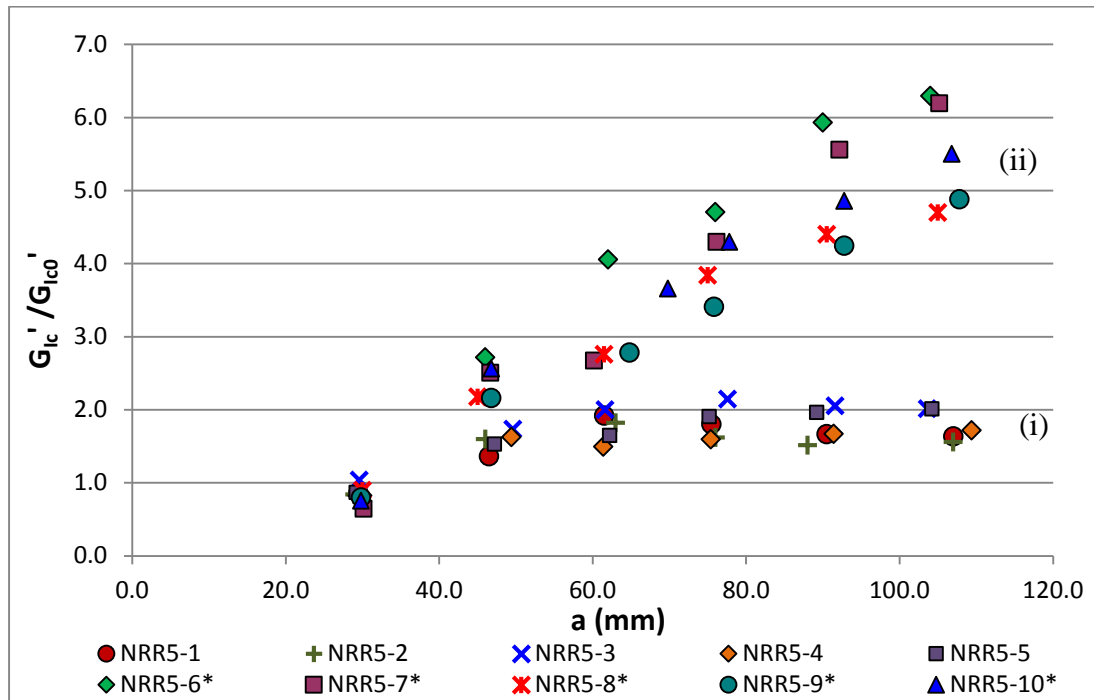
Figure 2.24. Comparison of fracture toughness values of NRR5 specimens with (i) whole top ply ground off (NRR5-#) (ii) partial top ply ground off (NRR5-#*)

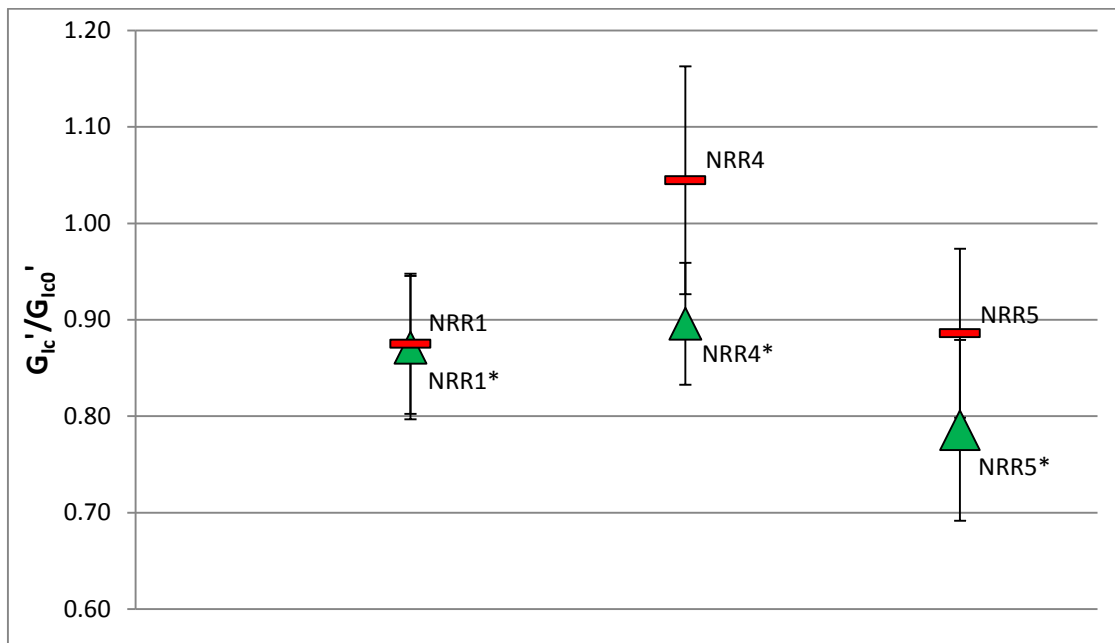
Figure 2.25. Normalized fracture toughness values from crack initiation at $a = 30$ mm for (i) complete top ply ground off case, NRR# (ii) partial top ply ground off case, NRR#*

In all three cases, the specimens consisting of repairs carried out on parent plates with the top plies ground off completely, depicted higher crack initiation toughness values at the insert tip. For repair NRR1, a significant difference was not observed.

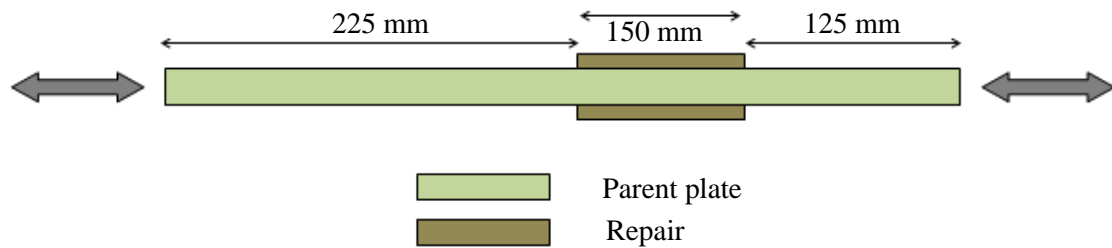
Specimens for fatigue tensile testing consisted of a parent laminate with a strip of repair on either side (Figure 3.1). Eight parent plates (60 cm X 60 cm) were manufactured following same manufacturing technique (VARTM) as used for mode I testing specimens. The sequence of lay-up, curing and post curing details are listed in Table 3.1. As the lay-up was symmetric for these parent plates, no warping was observed.

Figure 3.1. Fatigue tensile test specimen configuration (side view, not to scale)

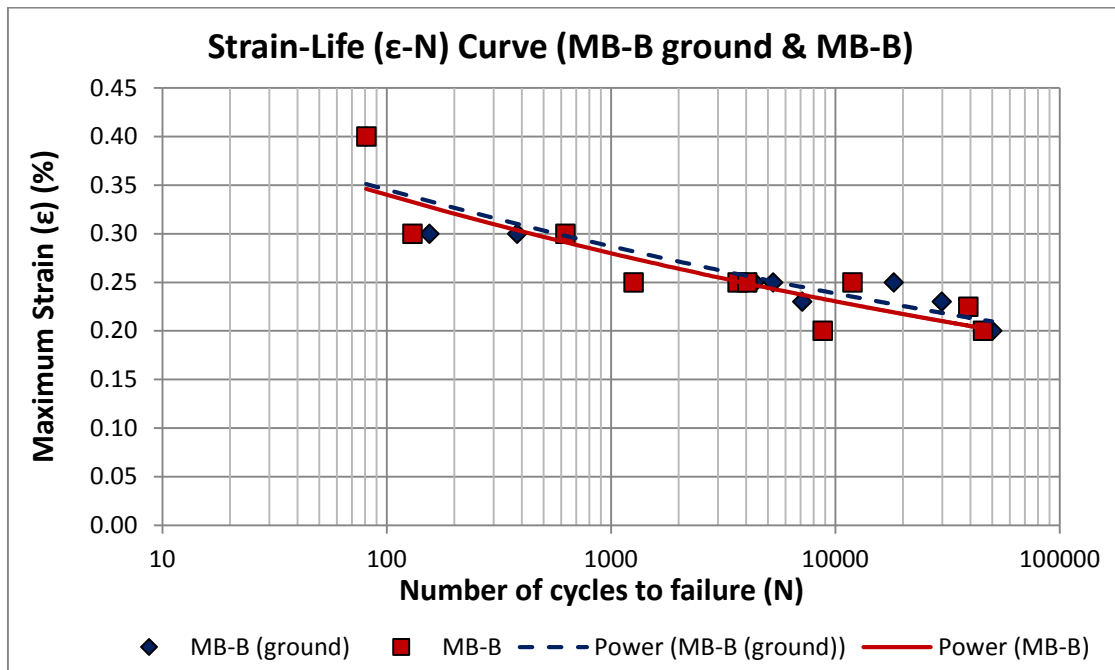
Figure 3.4. Strain-Life plot for ground (MB-B ground) and unground (MB-B) specimens

In the first round of testing, specimens repaired with MB-B repair resin and with and without grinding were tested. The resulting Strain-Life (ϵ -N) and Stress-life (S-N) curves are presented in Figure 3.4 and Figure 3.5 respectively.

Though MB-B ground specimens do perform a little better under fatigue loads, these plots show that there is little difference in the fatigue properties of ground and unground specimens repaired by the same resin. When the region of repair on a parent plate is ground down to remove one complete ply as in the case of MB-B ground specimens, the layer of resin between the top and the second glass plies is exposed. The repair ply is then hand laminated on this freshly exposed resin layer. In the case where the top ply is not ground the repair ply is hand laminated on the resin layer present on the top surface of the parent plate. This similarity in the composition of the repair surfaces accounts for the similar fatigue characteristics in these two repair cases. Since, the ground and unground specimens did not behave very differently under fatigue, fatigue results of specimens repaired without grinding were only considered in order to avoid the effects of variation in grinding depths as those observed on fracture toughness values in mode I testing.

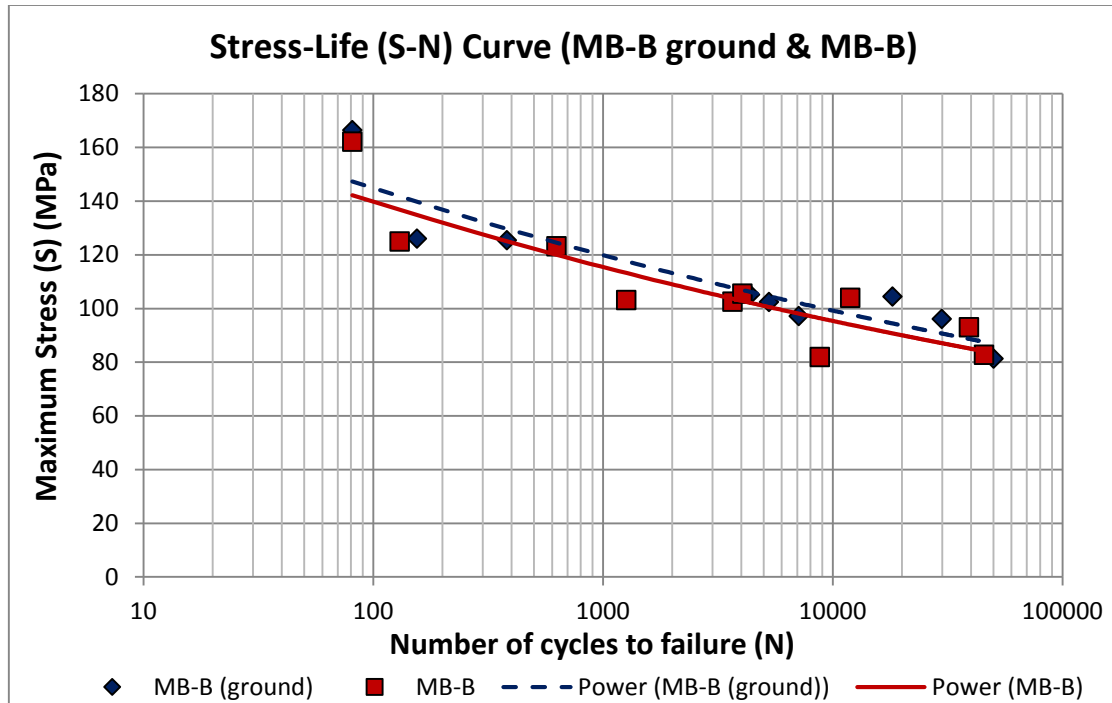
Figure 3.5. Stress-Life plot for ground (MB-B ground) and unground (MB-B) specimens

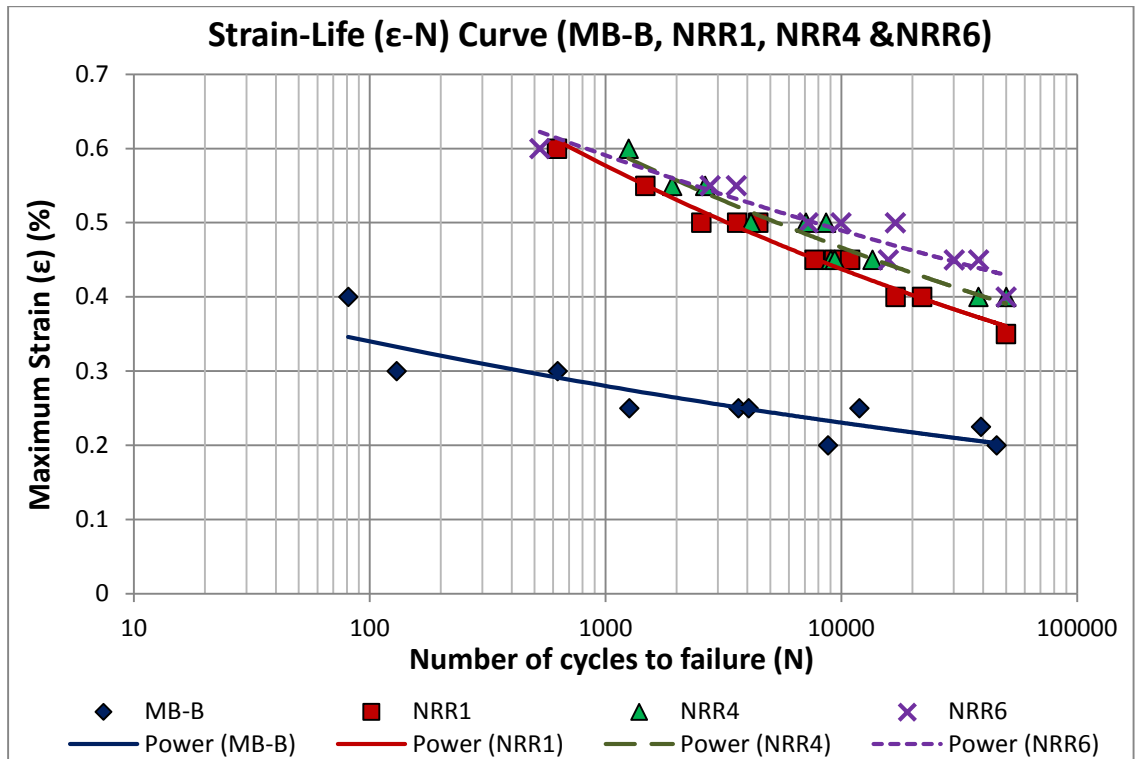
Figure 3.6. Strain –Life plot for unground specimens repaired with MB-B, NRR1, NRR4 and NRR6 repair resins

Strain-Life (ϵ -N) and Stress-life (S-N) curves for the repair resin candidates NRR1, NRR4 and NRR6 and their comparison with base repair resin MB-B are presented in Figure 3.6 and Figure 3.7 respectively. These depict that all three new repair resins shortlisted from mode I testing performed better than the base repair resin MB-B when loaded in tension-tension fatigue. The peak stress in NRR1 repairs at a life of about 50,000 cycles was 147 MPa which was less than the peak stresses for NRR4 (167 MPa) and NRR6 (166 MPa) at a similar life.

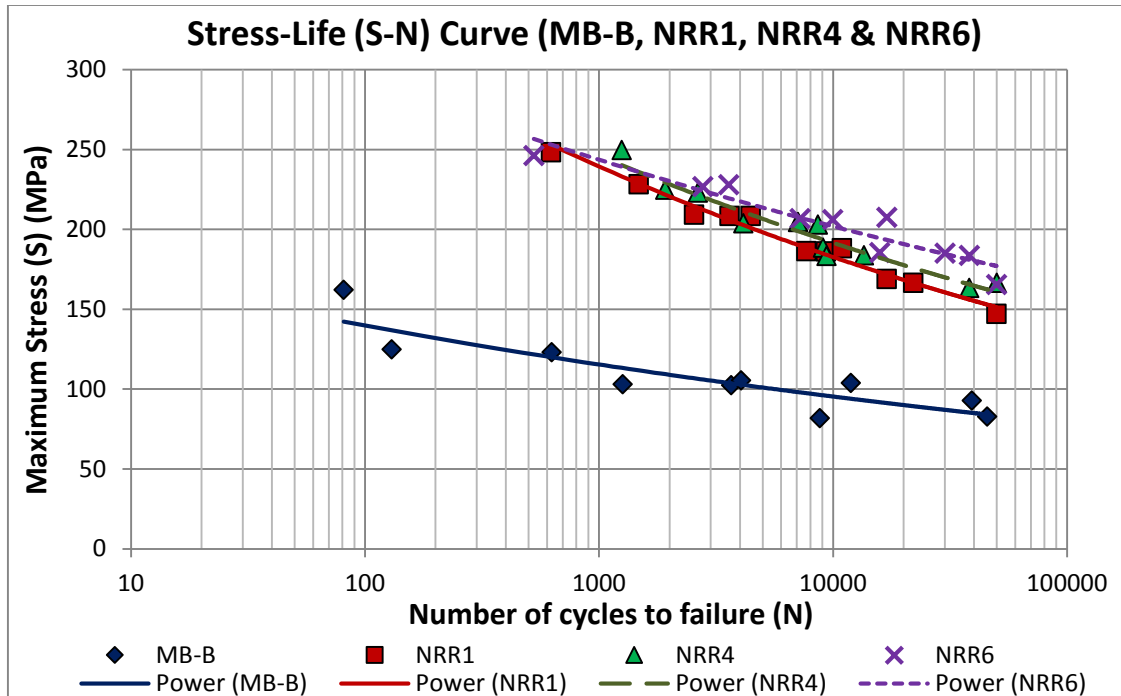
Figure 3.7. Stress –Life plot for unground specimens repaired with MB-B, NRR1, NRR4 and NRR6 repair resins
