Mechanical Characterization Of Composite Repairs For Fiber-Glass Wind Turbine Blades

A Dissertation

for the degree of
Doctor of Philosophy

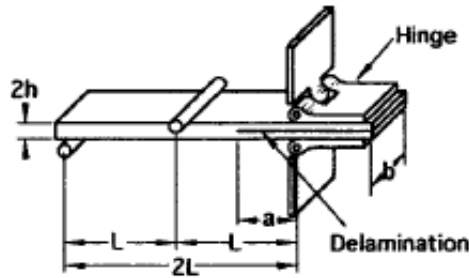
Figure 4.1. Specimen details for mixed mode I – mode II test [61]

For initial testing, specimens were made with the same materials and average thickness of $h \sim 9$ mm (Figure 4.1) as the DCB specimens for mode I testing. Mixed-mode ratios (G_{II}/G_c) of 0.2, 0.5 and 0.8 were used. It was found that the adhesive bond of the piano hinges with the specimen was not able to bear the loads (1.5 ± 0.15 kN) incurred at 0.5 and 0.8 values of G_{II}/G_c . The range of the thickness h of each adherend (Figure 4.1) was recalculated for the required maximum load < 1.5 kN, keeping in consideration that the displacements were not so large as to cause geometric nonlinear errors [61]. The final specimen thickness obtained from the results of the initial mixed mode I – mode II testing and calculations from ASTM D 6671/D 6671M – 06 using estimated critical load and load point deflection values was $h \sim 5$ mm, a reduction of approximately 4 mm from the thickness of each adherend of a mode I testing specimen.

and E_{11} = longitudinal modulus of elasticity measured in tension (MPa), E_{22} = transverse modulus of elasticity (MPa) and G_{13} = shear modulus out of plane (MPa). The half-span length, L , (Figure 4.1) of the mixed mode I – mode II testing fixture was kept 50 mm for all mode mixity ratios. Thus, crack propagation was observed to a distance of 25 mm from the pre-crack tip i.e. to a distance of 50 mm from the load line. After testing had been conducted the flexural modulus was calculated as:

where a_0 = the initial delamination length (mm), m = slope of load displacement curve (N/mm), b = width of specimen (mm), C_{sys} = system compliance (mm/N), and L = half span length of the test apparatus (mm) (Figure 4.1). The fracture toughness and mode mixture were calculated using the equations given below:

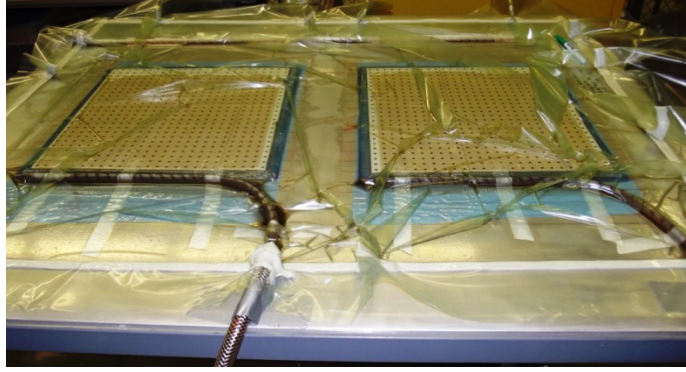
4.2 (a) VARTM

Figure 4.2. Mixed-mode specimen manufacturing

4.2 depicts, (a) the methods of manufacturing of the parent plates, (b & c) surface preparation for repairs and (d & e) repairs being conducted. The repairs were carried out in a similar fashion to that in the case of mode I testing and were allowed to cure at room temperature for 24 hours. Then, post-curing was carried out for 16 hours in the oven at 40° C. After the parent plates had been repaired and cured, they were found to be slightly warped in a direction perpendicular to the unidirectional fibers. This was most probably due to the difference in the composition of the parent plate and repair resins and the shrinkage of the repair resin while in contact with the pre-cured parent plate resin. Again, as in the mode I testing, it was assumed that this warp would not have a significant effect on the test results since the specimens were to be cut in a direction along the unidirectional glass fibers.

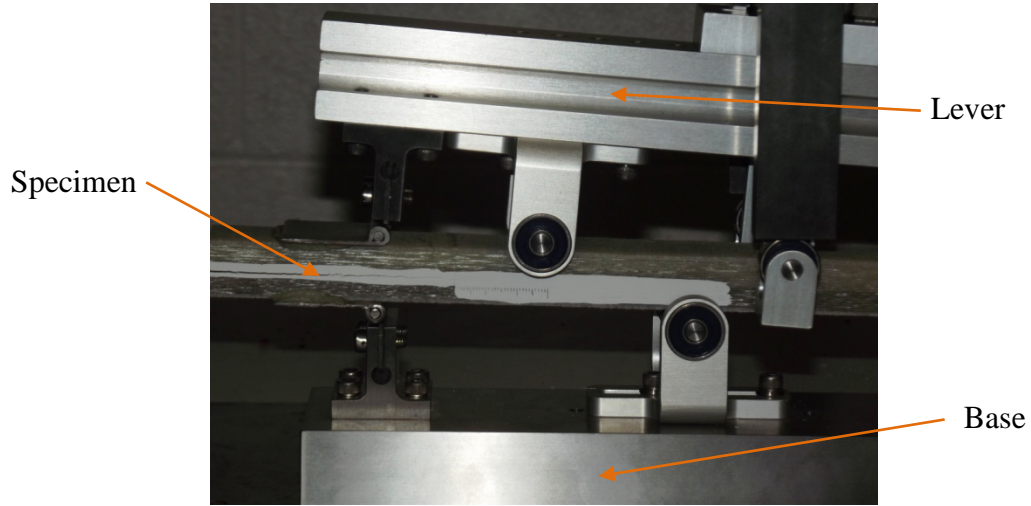
Figure 4.4. Mixed mode I – mode II test snapshot

software. These images were analyzed for stroke displacements using Vic-2D Digital Image Correlation Software. A picture of a specimen being tested in the (ASTM D 6671/D 6671M – 06) fixture is given in Figure 4.4.

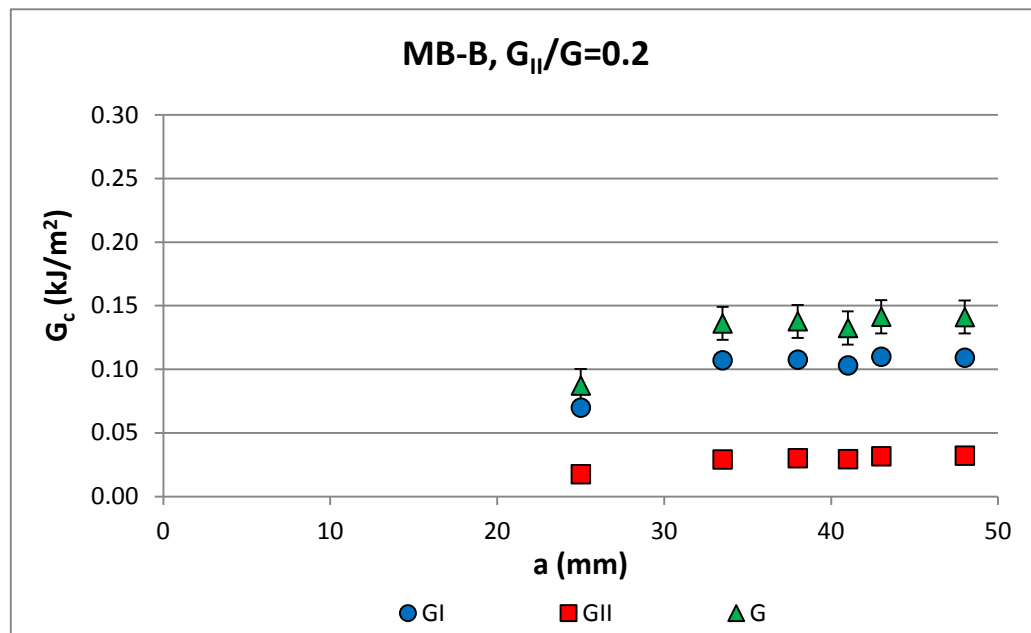
Figure 4.5. (a) Preliminary mixed mode I – mode II testing results for current blade repair resin MB-B

From the initial mixed-mode testing for mixed mode load ratio $G_{II}/G = 0.2$, fracture toughness values of crack propagation for the repair resins MB-B and NRR4 were plotted against crack length (Figures 4.5 (a) – (b)). Preliminary results show that fracture toughness values obtained with delamination growth in accordance with ASTM D 6671/D 6671M – 06 are higher for NRR4 as compared to MB-B. This corroborates with the results obtained from mode I and fatigue testing for these two repair resins.

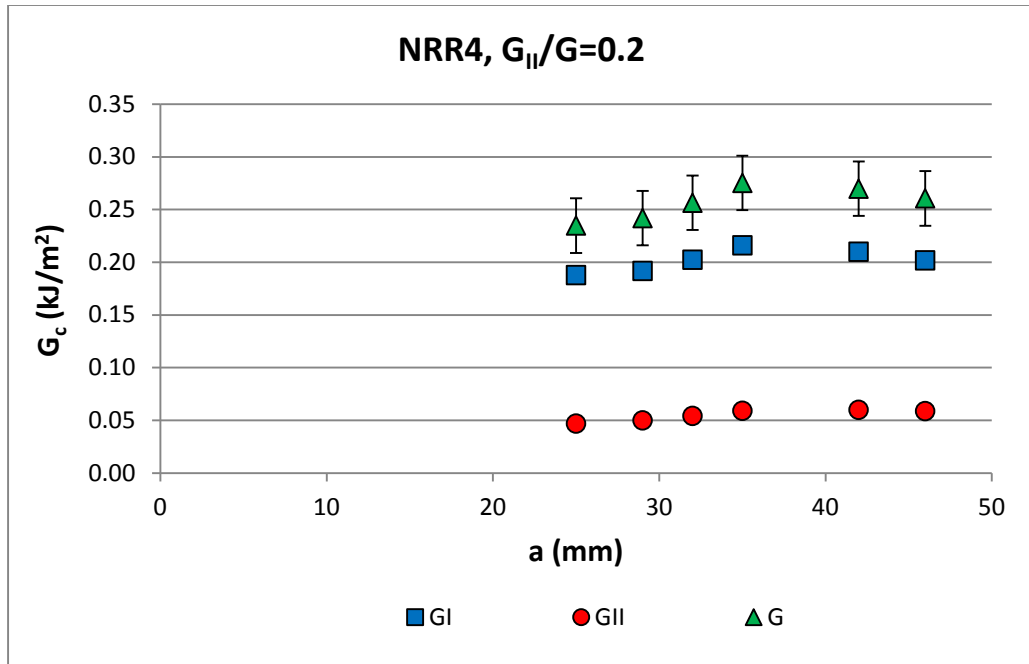
Figure 4.5. (b) Preliminary mixed mode I – mode II testing results for new repair resin candidate NRR4

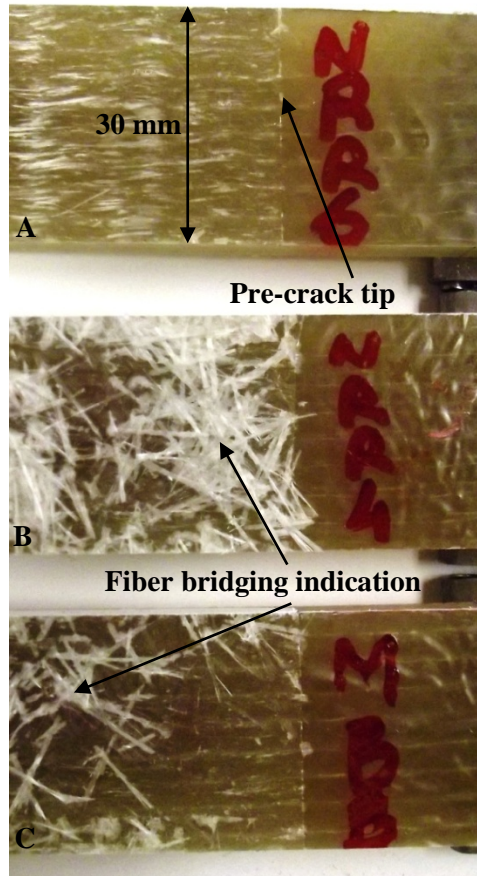
Figure 4.6. Fiber bridging in NRR6 (specimen A), NRR4 (specimen B) and MB-B (specimen C) in mixed mode I – mode II ($G_{II}/G_c = 0.2$) test

In the case of mixed mode I – mode II testing of specimens repaired with repair resin NRR6, the crack propagation was very fast and the camera was not able to capture the crack length values between the 25 mm and 50 mm marks. Thus it was not possible to record the propagation fracture toughness values for this resin. The reason for the fast crack growth can be the lack of fiber bridging as can be seen in Figure 4.6. NRR6 showed better crack initiation fracture toughness values than the repair resin MB-B (Figure 4.7) but they were less than those for NRR4.

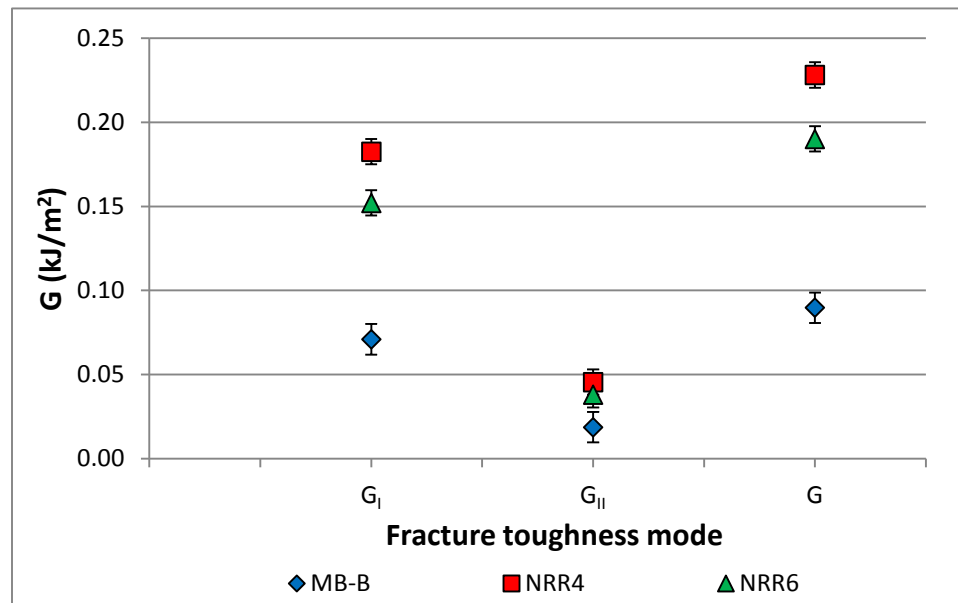
Figure 4.7. Fracture toughness values at crack initiation for MB-B, NRR4 and NRR6

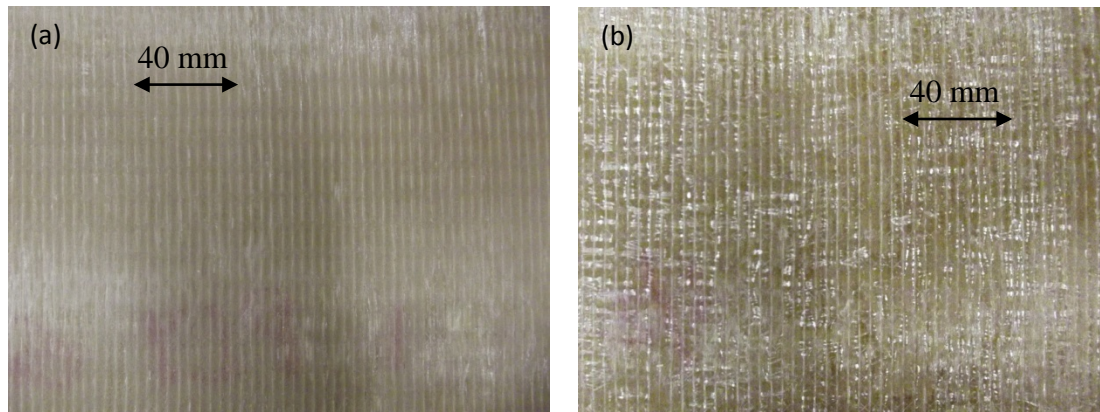
Figure 4.8. Parent plate with (a) complete top ply ground off (b) partial top ply ground off

Specimens consisting of parent plates manufactured with MB-A' and H-glass and repaired with MB-B and NRR4' repair resins were tested after the initial mixed mode I – mode II testing. The length of the lever arm, c , of the mixed mode I – mode II testing apparatus was varied for each of the mode mixtures ($G_{II}/G = 0.2, 0.5$ and 0.8) before testing. Two levels of grinding of the top ply of the parent plate were evaluated. In mode I testing it was seen that difference in grinding depth of the top surface of the parent plate while preparing it for repairs does affect the fracture toughness values of the repairs. For this testing one set of plates was repaired with the top unidirectional glass-fiber ply completely ground off, thus exposing a surface comprising mainly of cured resin as shown in Figure 4.8 (a). The top unidirectional glass-fiber ply of the other set was partially ground off to expose a surface comprising of a mixture of glass fibers and cured resin (Figure 4.8 (b)).

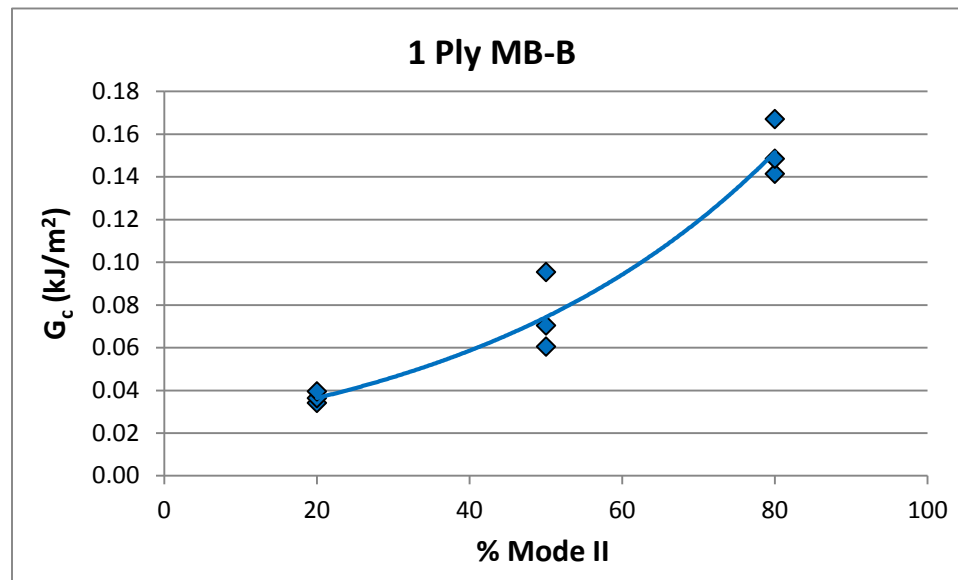
as the crack growth was very fast in mixed-mode testing. A typical fracture toughness contour is shown in Figure 4.9 for the repair carried out using repair resin MB-B after grinding off the top ply of the parent plate completely. The delamination fracture toughness values increase with an increase in the percentage of mode II loading from 20% to 80% as expected.

The scatter in the toughness values does not bear a linear relation with the increase in mode II percentage. As shown in the plot, the mixed mode fracture toughness values obtained at different mode II ratios can be generally fitted by an exponential curve. Similar trend was found by Benzeggagh and Kenane [66] and further corroborated by other researchers like Dharamawan et al [70].

Figure 4.9. Delamination fracture toughness values for MB-B with whole top ply of parent plate ground off

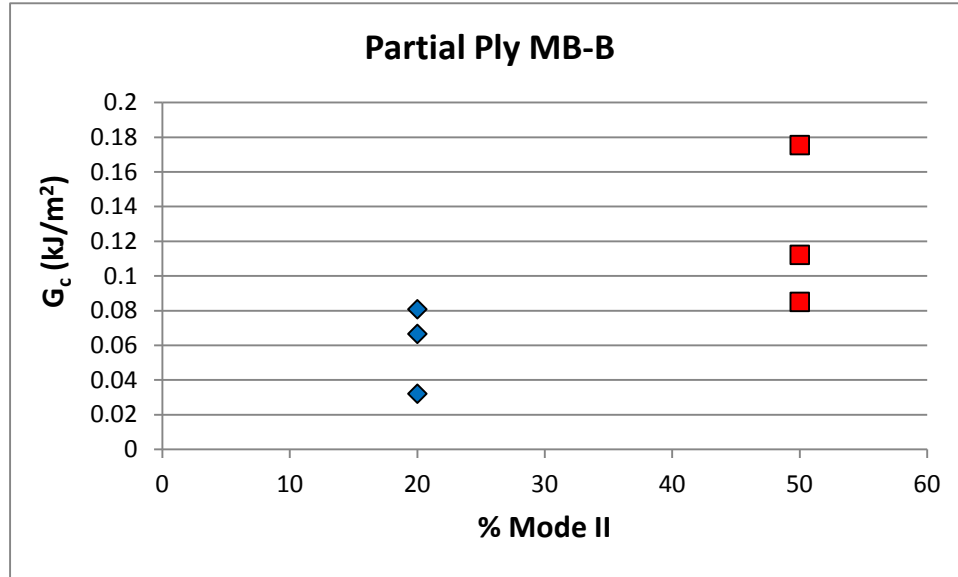
Figure 4.10. Delamination fracture toughness values for MB-B with partial top ply of the parent plate ground off

Similar fracture toughness contours are shown in Figures 4.10 – 4.12 for resin MB-B with partial top ply ground off, and resin NRR4' with complete top ply ground off and resin NRR4' with partial top ply ground off, respectively.

In all of these three cases (Figures 4.10 – 4.12) the methacrylate adhesive used to bond the hinges to the composite specimens was not able to bear the high shear loads at mode mixity ratio $G_{II}/G = 0.8$ and the hinges came off the specimens before crack initiation. The values of delamination fracture toughness for the mode mixity ratio $G_{II}/G = 0.8$ for these specimens were not recorded. The loads at which the hinges came off were of the order of 1.55 ± 0.15 kN. These loads were similar to the loads experienced by the initial mixed mode I – mode II testing specimens (with each adherend thickness ~ 9 mm) when they were tested at mode mixity ratio $G_{II}/G = 0.5$. Equation 4.11 from ASTM D 6671/D 6671M – 06 that was used to estimate the thickness of the specimens so that they would be able to bear the $G_{II}/G = 0.8$ loads does not take into account the fracture toughness of the bond between the composites and the methacrylate adhesive. It takes into account only G_c^{est} which is the estimated value of the composite total mixed mode fracture toughness.

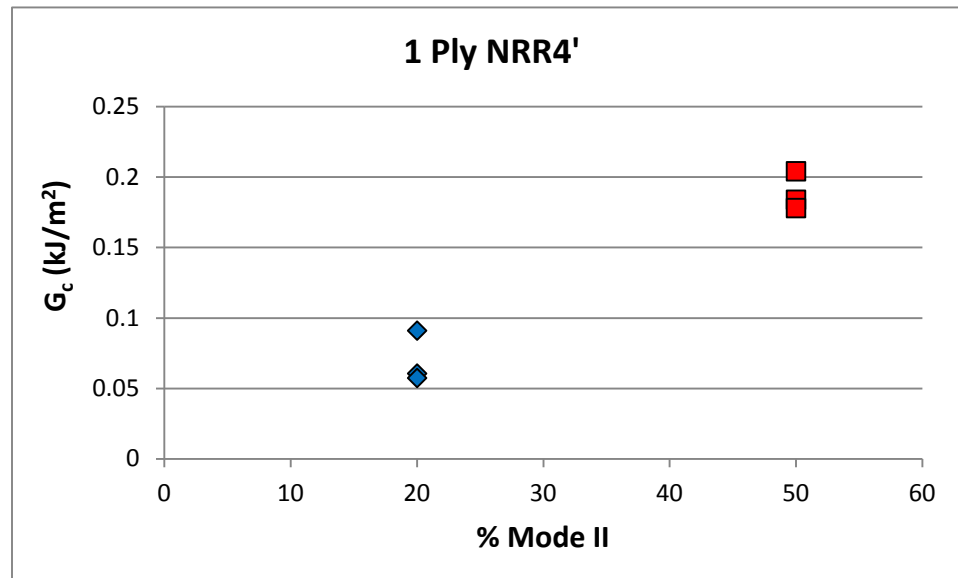
Figure 4.11. Delamination fracture toughness values for NRR4' with whole top ply of parent plate ground off

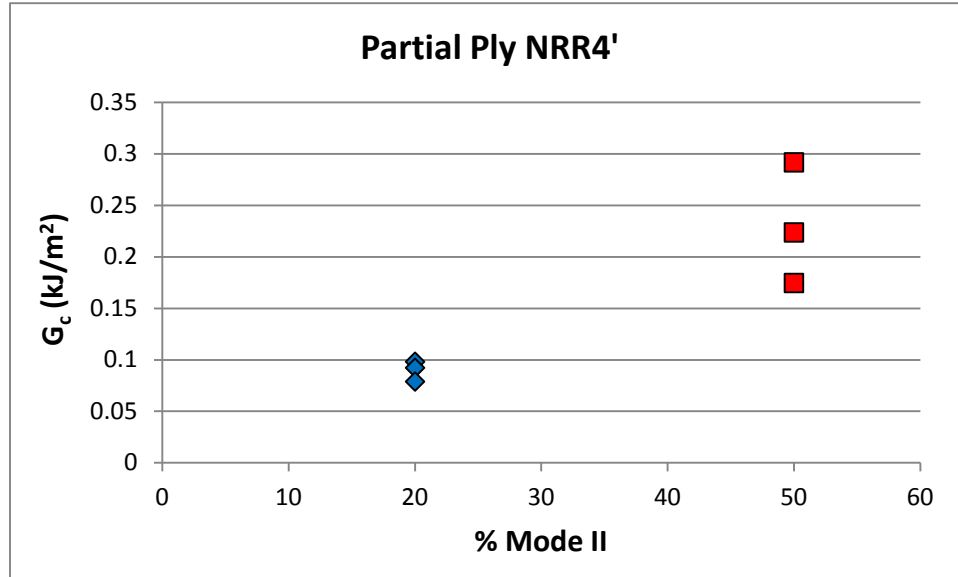
Figure 4.12. Delamination fracture toughness values for NRR4' with partial top ply of the parent plate ground off

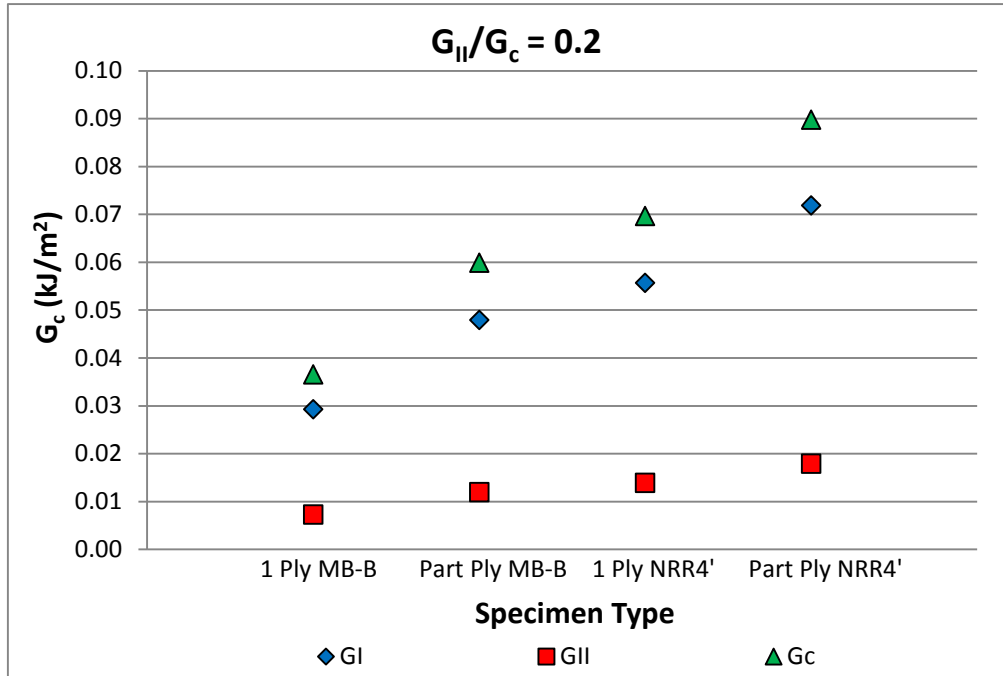
Figure 4.13. Fracture toughness values for MB-B and NRR4' at different grinding levels under mode II 20% loads (1 Ply ~ Complete top ply ground off, Part Ply ~ Partial top ply ground off)

Results from the mixed mode G_{II}/G_c ratios of 0.2 and 0.5 (Figure 4.13 and Figure 4.14) show that specimens repaired with NRR4' exhibit higher delamination fracture toughness values in mixed mode I – mode II testing as compared to those repaired with MB-B. In case of both repair resins, specimens repaired with partial top plies of the parent plates ground off have better fracture toughness values than the repairs with the complete top plies of the parent plates ground off. Similar phenomenon was observed in the case of mode I testing.

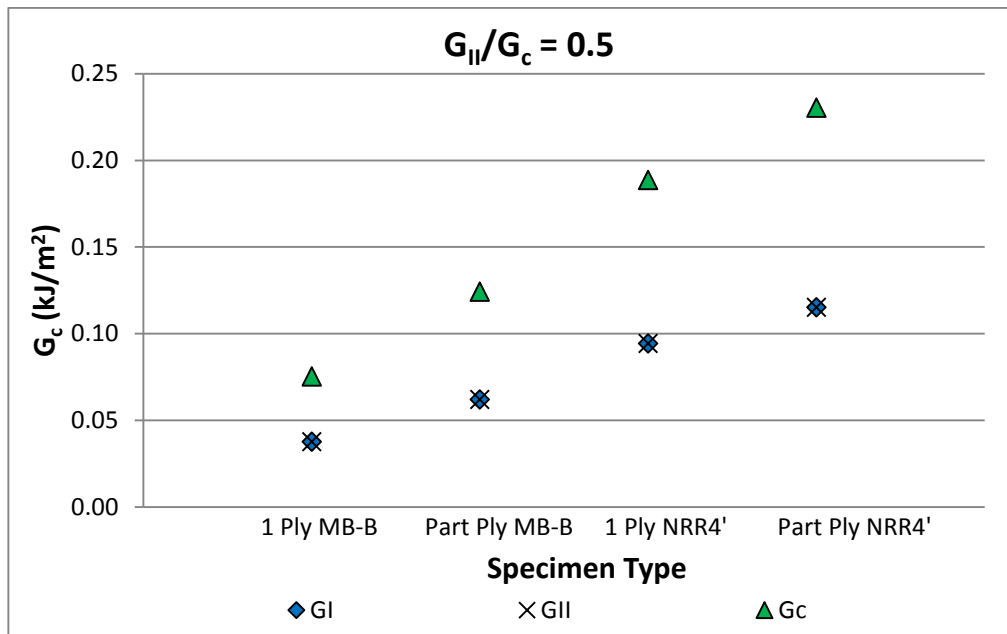
Figure 4.14. Fracture toughness values for MB-B and NRR4' at different grinding levels under mode II 50% loads (1 Ply ~ Complete top ply ground off, Part Ply ~ Partial top ply ground off)

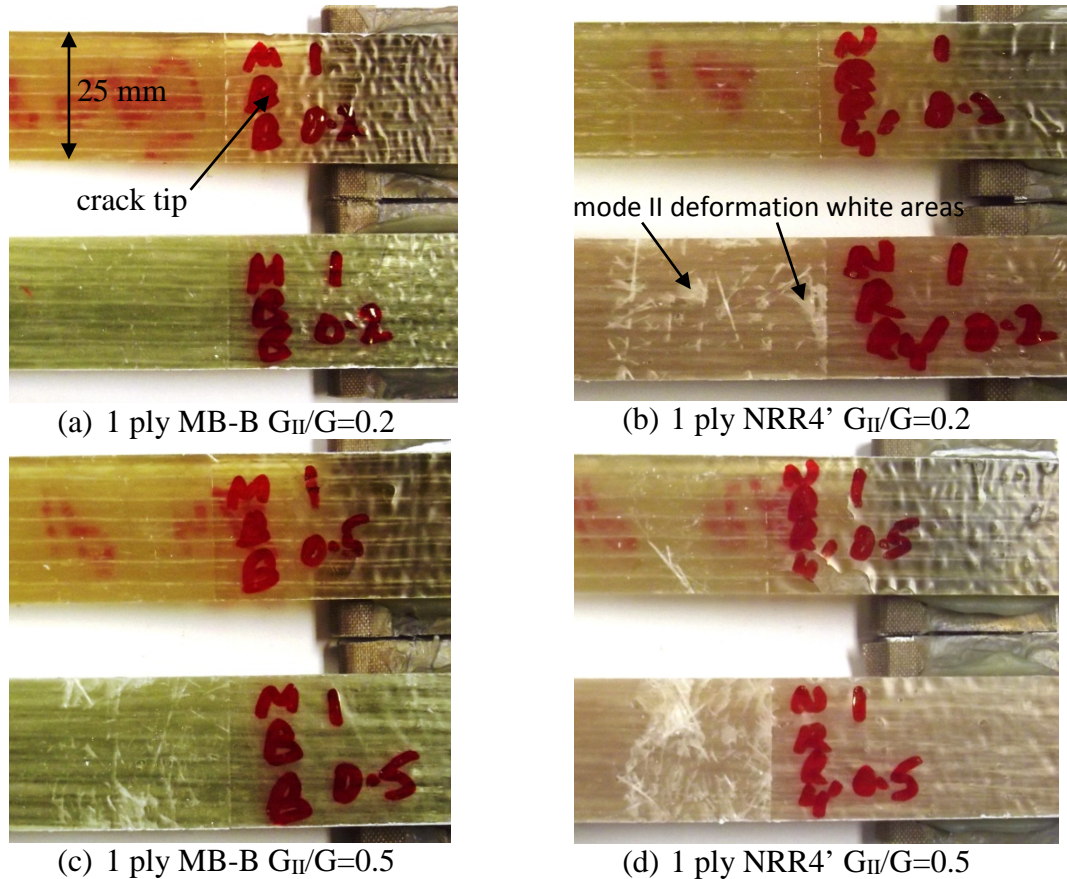
Figure 4.15. Images of surfaces fractured under different mixed mode I – mode II loads

Images of the fractured surfaces of specimens tested under various mixed mode ratios are shown in Figure 4.15. The MB-B specimens that were tested with mixed mode ratio $G_{II}/G = 0.2$, do not show significant signs of fiber bridging or effects of mode II load (Figure 4.15 (a) and (e)). In the case of MB-B specimens tested with mixed mode ratio $G_{II}/G = 0.5$, there are some signs of plastic deformation of the repair resin (depicted by white regions) under shear loads (Figure 4.15 (b)). For mode II 80% loads the MB-B specimens have more pronounced signs of fiber bridging as well as deformation of the repair resin due to shear loads.

The fractured surfaces of all specimens repaired with NRR4' resin show marked regions of fiber bridging and shear deformation of the repair resin under mode II loads. This is reflected in the higher fracture toughness values obtained for the NRR4' repair resin. In

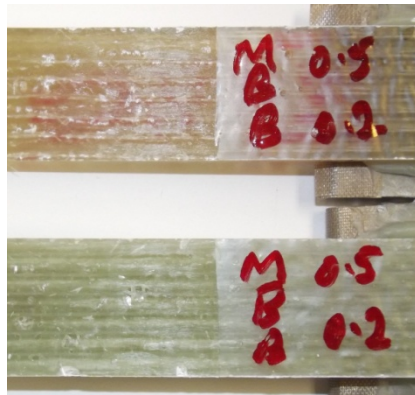
(e) Partial ply MB-B $G_{II}/G=0.2$

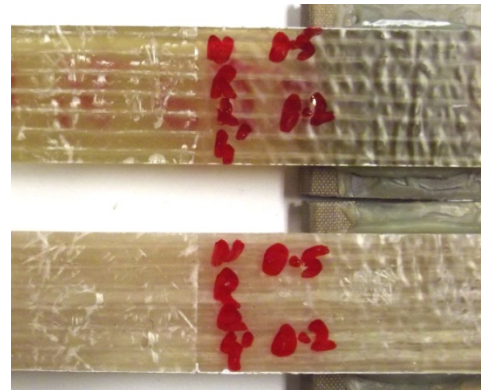
(f) Partial ply NRR4' $G_{II}/G=0.2$

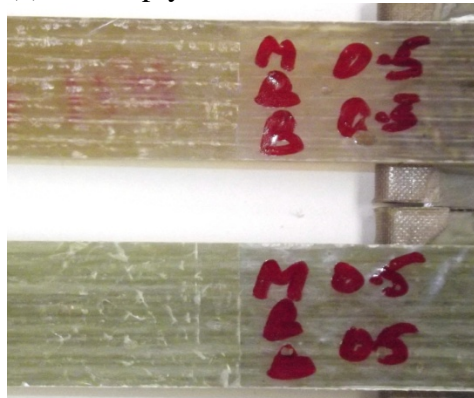
(g) Partial ply MB-B $G_{II}/G=0.5$

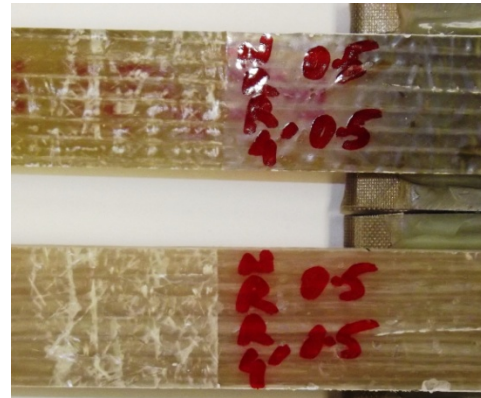
(h) Partial ply NRR4' $G_{II}/G=0.5$

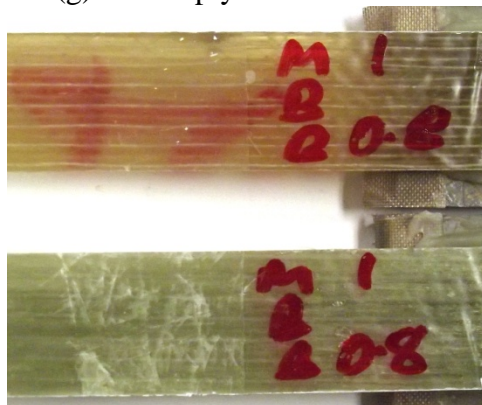
(i) 1 ply MB-B $G_{II}/G=0.8$
