Self-centering bridge pier columns with structural fuses

A thesis submitted to the graduate faculty
in partial fulfillment of the requirements for the degree of
MASTER OF SCIENCE

Major: Civil Engineering (Structural Engineering)

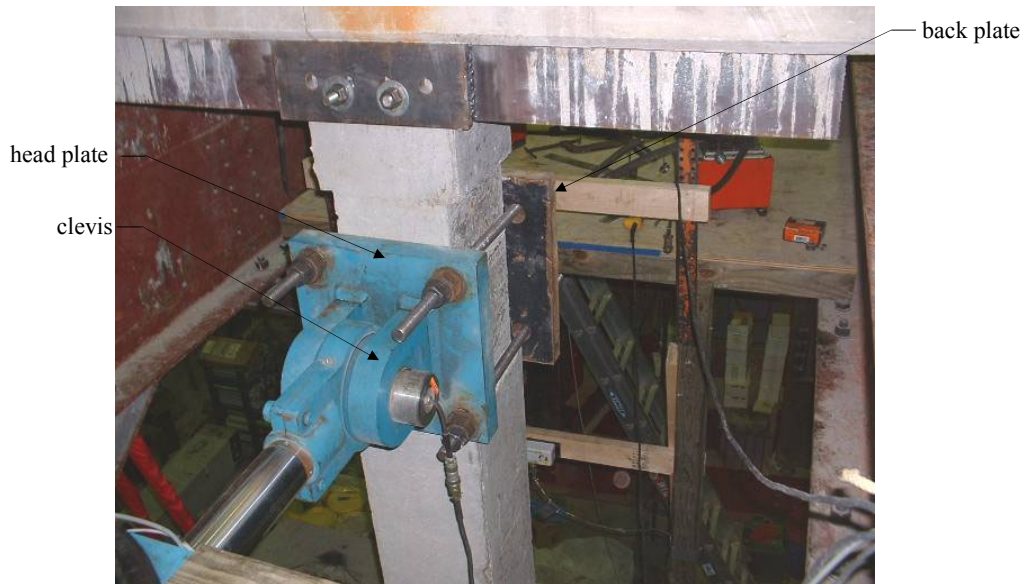
Figure 10. Photograph of actuator connection to column.

the column segments with fuse plates, the column was stabilized until post-tensioning could be applied. The actuator was then connected to the column using a clevis and two bolted plates as shown in Figure 10. The actuator was fitted with clevises (i.e. hinges) at both of its ends to ensure that no concentrated moment was applied to the column through the actuator.

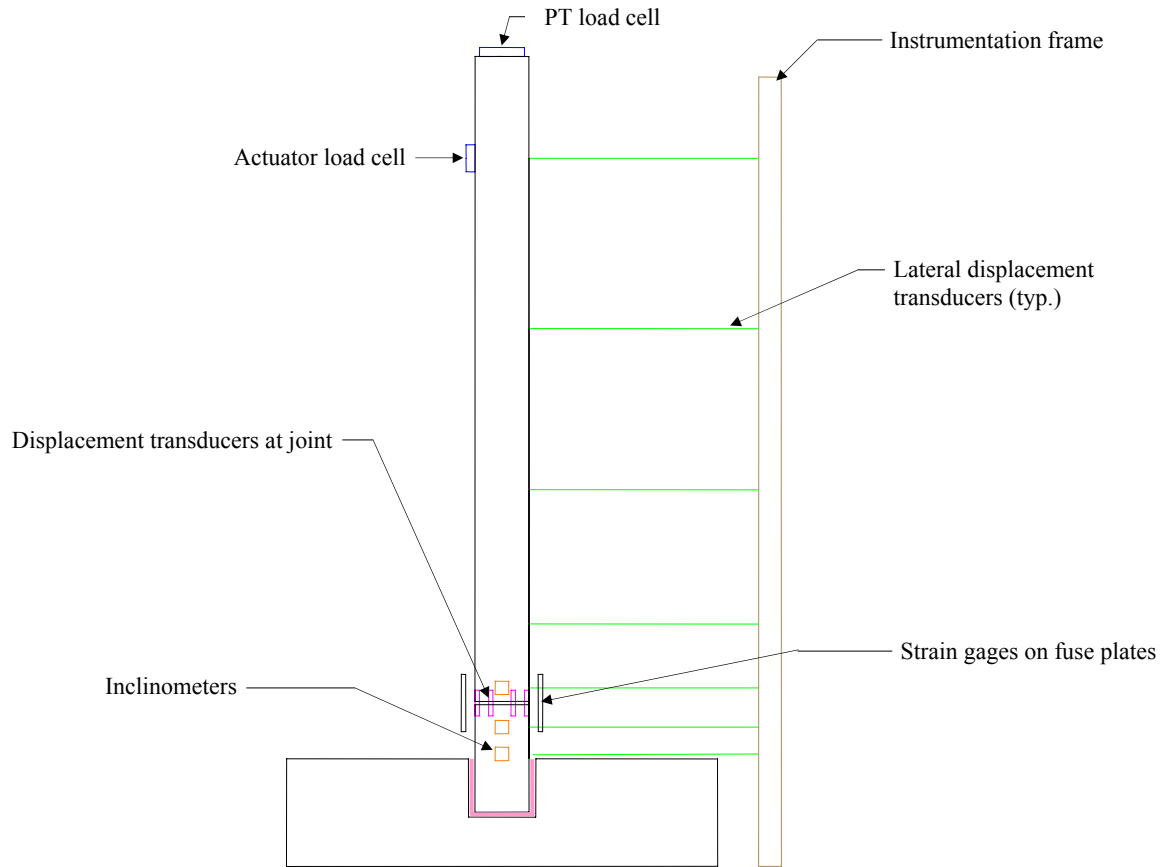
Figure 12. Instrumentation schematic.

Instrumentation for each experiment included two load cells (one on the horizontal actuator to measure lateral load and one on the post-tensioning rod to measure changes in post-tensioning force as the column displaced laterally), six string potentiometers for measuring

displacement along the length of the column, eight linearly variable displacement transducers (LVDT's) for measuring vertical movement between the segments at the joints, four inclinometers for determining the rotations of the column shaft and horizontal actuator, 8–12 strain gages on the internal reinforcement, and 6–12 strain gages on the fuse plates. Internal strain gages were located on the reinforcement in both the top and bottom column segments. The gages in the bottom column segment were located at the base of the column, while the gages in the top column segment were located 1 ft above the joint (i.e. 2 ft above the base of the column). On the first three segmented specimens (Columns 2, 3, and 4), gages were placed on the corner reinforcement only. On the last two jointed specimens (Columns 5 and 6), gages were placed on all six steel reinforcement bars. The internal strain gages are shown for a 2 ft column segment in Figure 11, while the exterior instrumentation is shown in Figures 12 and 13. A wooden instrumentation frame was assembled for each test to support the lateral displacement transducers. This instrumentation frame was not in contact with the testing frame to ensure that the data acquired from the string potentiometers mounted on the frame measured absolute displacements of the test columns.

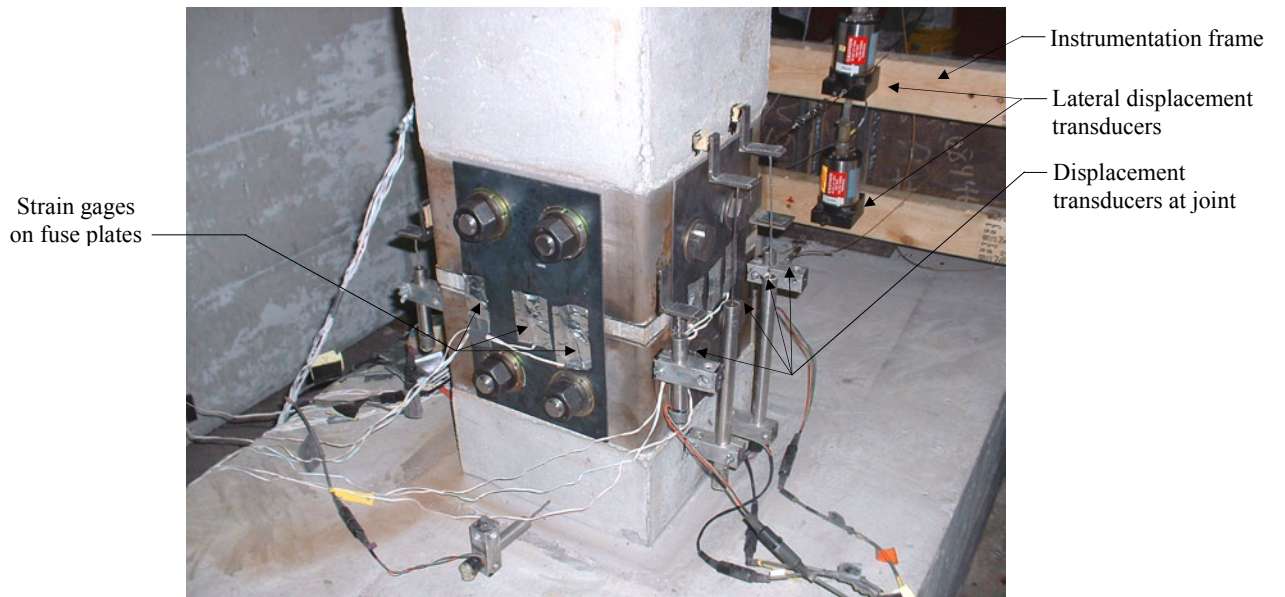
Figure 13. Photograph of instrumentation.

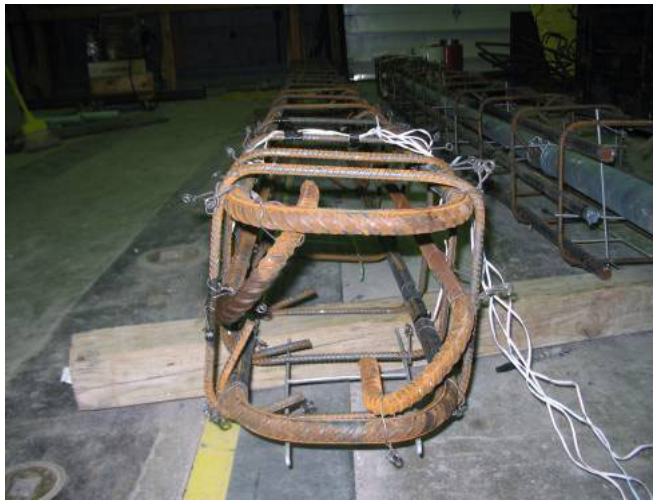
Figure 15. Base end of control column reinforcement cage.

For the longitudinal reinforcement in the control column (Column 1), the corner bars on the bottom end of the column embedded into the foundation socket consisted of two U-shaped bars. One-hundred-eighty degree hooks were used on this end for the interior two bars to achieve anchorage.

Transverse ties were spaced every foot along the height of the two column segments. On the bottom end of the column, the first stirrup was placed 5 in. from the end of the column to help confine the hooks and hoops; column reinforcement is shown in Figure 15.

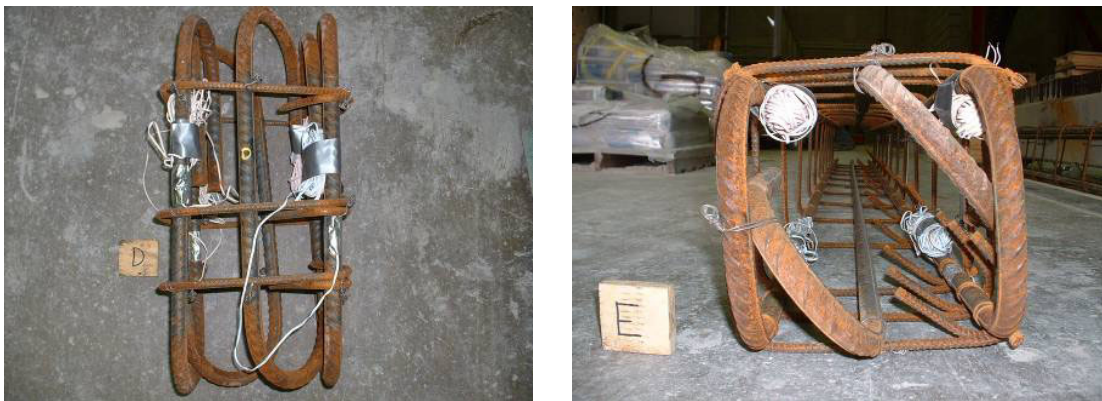
a.) Columns 2-4, 2 ft. segment reinforcement

b.) Columns 2-4, 12 ft. segment reinforcement

Figure 16. Photographs of column 2-4 reinforcement.

The first three segmented columns (Columns 2-4) had reinforcement details similar to those used in the unjointed control column (Column 1). U-bars were used on the construction-joint ends of the column segments for the corner bars as they were for the control column (Column 1). Similarly, the interior bars in each segment had one-hundred-eighty hooks on the construction-joint end. These U-bars and hooks were wrapped around the ducts in the steel collars in an attempt to prevent the through-bolts from pulling out of the ends of the column segments when the columns were loaded. For the 2 ft. column segment, hooks were used at the base of the reinforcement to provide anchorage. Similar transverse ties were used in these columns as in the first column. Additional column details for Columns 1-4 are shown in Figures 16-18.

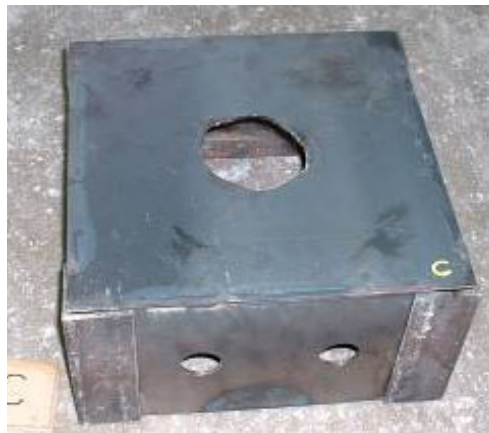
Figure 17. Collar for Columns 2–4.

For the first three segmented columns (Columns 2-4), the collars were fabricated from 3/16 in. thick plate and angles welded together. Holes were drilled in the plates to accommodate 1.1 in. outside diameter steel ducts for through-bolts spaced 4 in. apart on the tension and compression faces of the collar. For these three columns, fuse plates were only used on the tension and compression faces of the column.

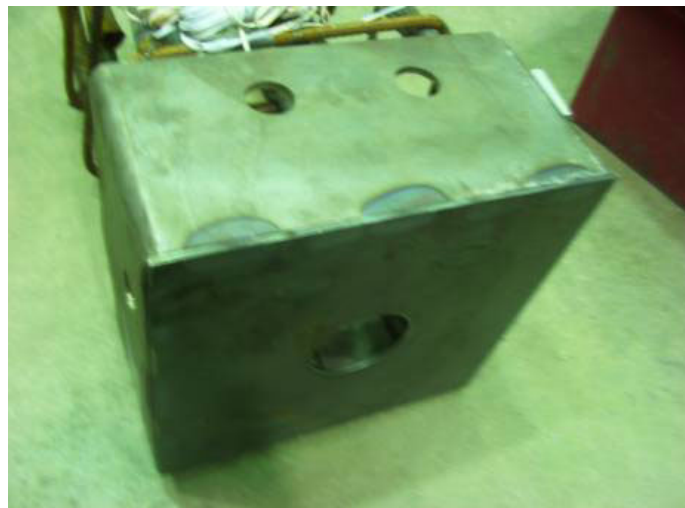
Figure 23. Column 6 collar.

As in Column 5, a structural steel tube (HSS 12 in. x 12 in. x 1/4 in.) was used for the collars of Column 6. The only alteration from Column 5 for these collars was the vertical spacing of the through-ducts. In these collars, a 1 in. gap was provided between the pairs of ducts perpendicular to each other. The ducts for the lateral faces of the column were spaced 1 in. closer to the construction joint. The ducts on the tension and compression faces of the collars were spaced 1 in. farther away from the construction joint. This was done to provide room for additional concrete between the ducts, as well as to avoid consolidation issues in this relatively congested region. The collar used for Column 6 is shown in Figure 23, and additional details for Column 6 are presented in Figure 21.

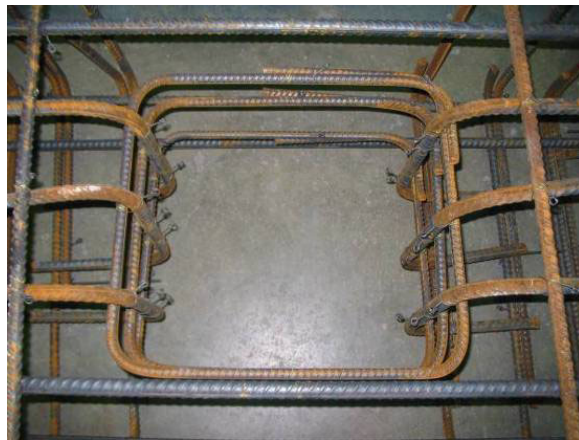
Figure 25. Photograph of center socket reinforcement.

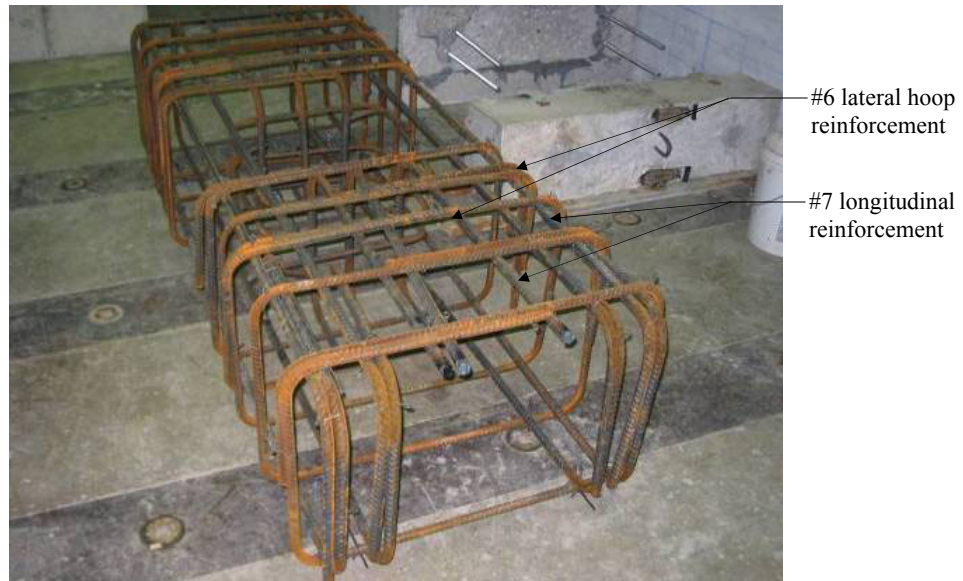
Figure 26. Photograph of foundation reinforcement cage.

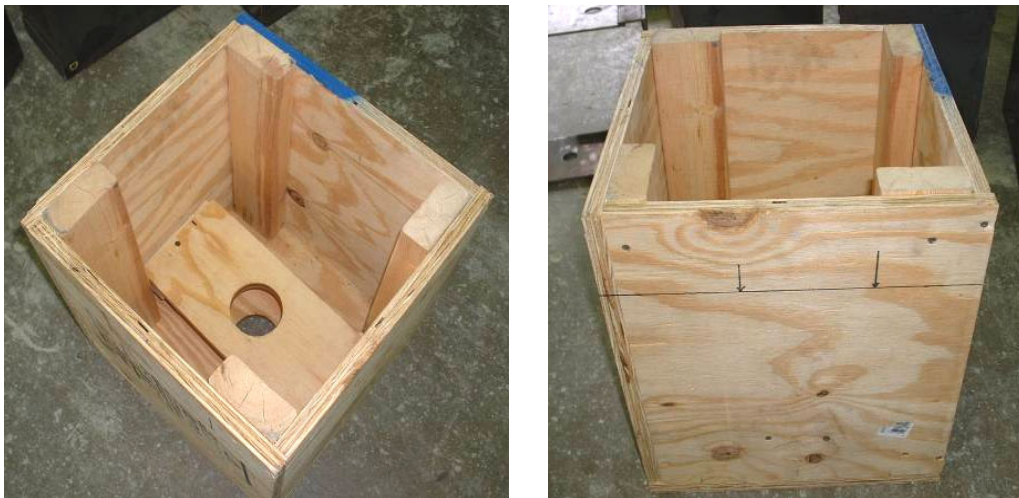
a.) Top view

b.) Inside view

Figure 27. Photographs of center socket boxout.

After construction of the reinforcement cage, the boxout for the center socket (shown in Figure 27) was tied in place. As previously mentioned, this socket allowed the bottom column segment to be epoxy grouted in the foundation block. A 2.5 in. diameter hole was drilled in the center of the socket boxout to allow for the center post-tensioning duct. Two additional 2.5 in. ducts (shown in Figure 24) were spaced 3 ft. on either side of center to align with the holes in the strong floor, permitting two post-tensioned tie-down bars to secure the foundations to the lab floor. A photograph of these ducts can be seen in Figures 28.

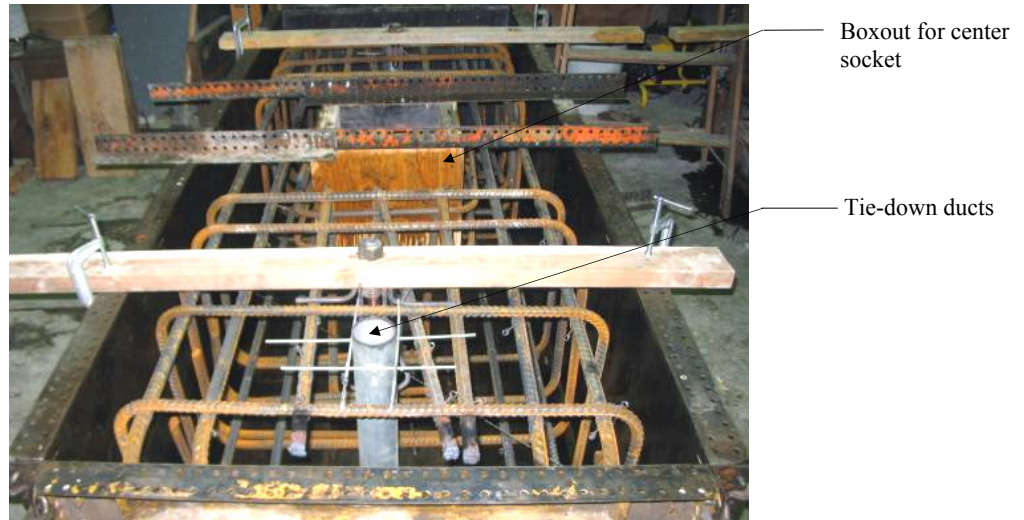
Figure 28. Photograph of foundation reinforcement and tie-down ducts in forms.

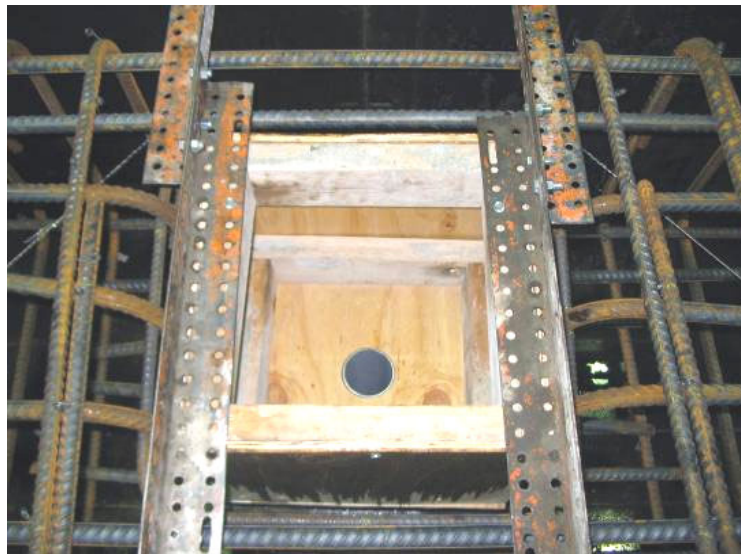
Figure 29. Photograph of boxout in forms.

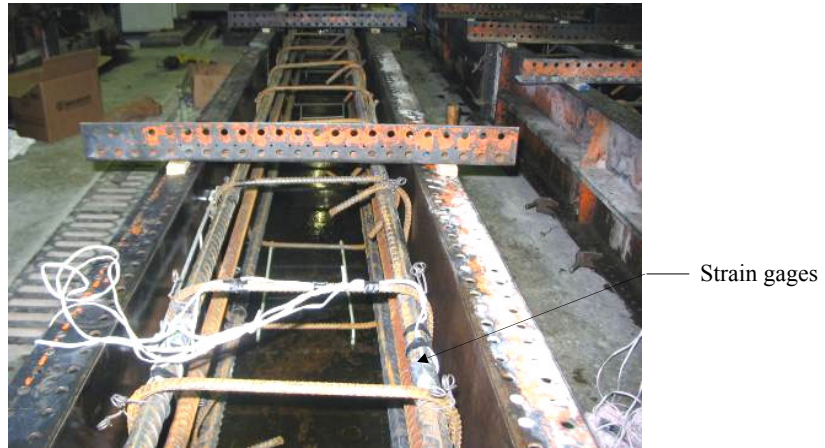
Figure 30. Photograph of Column 1 reinforcement.

For Column 1, the reinforcement cage was first tied and positioned in standard steel forms. Strain gages were placed on the longitudinal reinforcement; four gages were located one foot from the bottom of the column on the exterior four longitudinal bars. The column's reinforcement cage positioned in the steel forms can be seen in Figures 30-32.

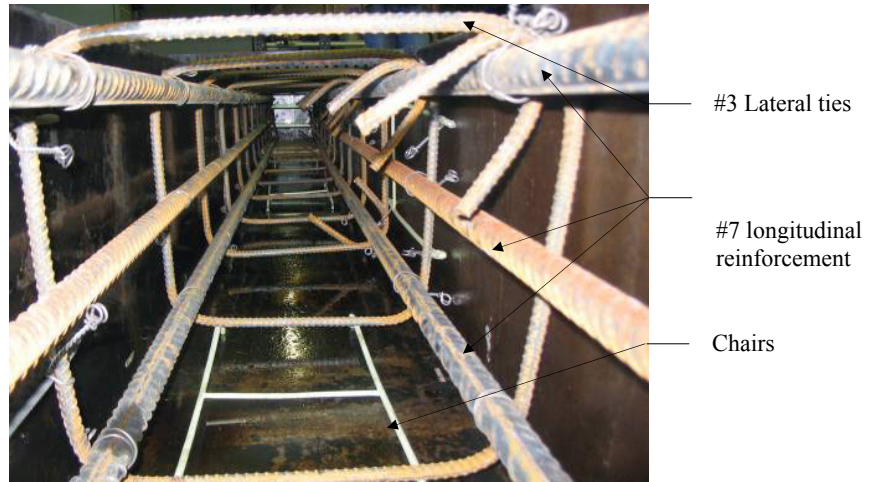
Figure 31. Photograph of chairs and reinforcement in Column 1.

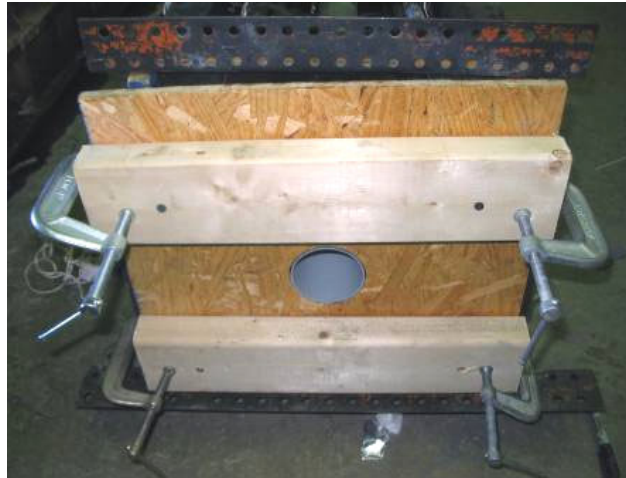
Figure 34. Photograph of Column 2 bulkhead.

The 12 ft. column segment for Column 2 was constructed in a similar manner as the control column. However, several alterations were made to allow for segmented construction. As with the control column (Column 1), four internal strain gages were used in this column. They were placed 12 in. from the bottom of the column on the four corner longitudinal bars. A central duct for the unbonded post-tensioning bar was included in this segment. The steel collar was placed in the forms on the base end of the 12 ft. column. Plywood bulkheads, as seen in Figure 34, were used to cap the end of the forms and securely position the post-tensioning duct. Details of the 12 ft. Column 2 segment in the forms are shown in Figures 34-37.

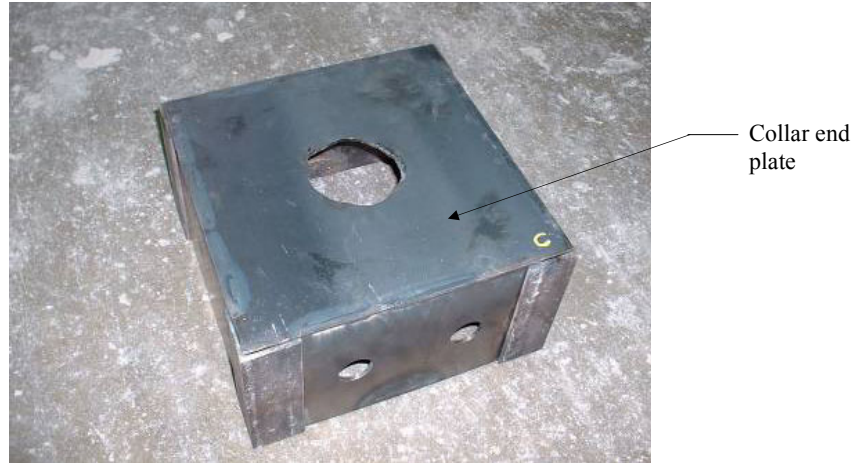
Figure 41. Photograph of Column 3 collar and end plate.

The third and fourth segmented columns (Columns 3 and 4) had a similar construction process as the first segmented column with one major difference. A steel plate was welded to the end of the collars for Column 3 to assist in confining the concrete near the construction joint. A 2.5 in. hole was cut in the center of this plate to accommodate the post-tensioning duct. Due to the experimental nature of this plate, it was not included for the Column 4 collars at the time of casting. The collar used for Column 3 is shown in Figure 41; construction details of the column segments used for Columns 3 and 4 are shown in Figures 42-50.

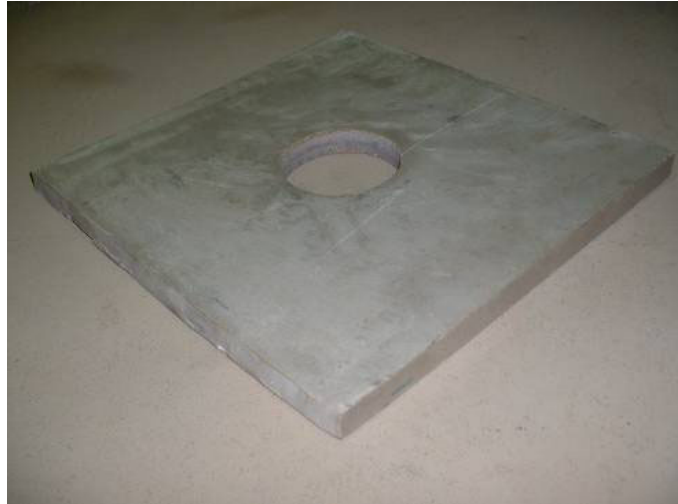
Figure 63. Photograph of epoxy grout plate.

To form the epoxy grout bearing plate, Sikadur 32, a high modulus, flowable epoxy, was mixed with Grade 37 silica sand in a 1:1 ratio. This mixture was also used to grout each column base into its foundation socket. The average compressive strength of the epoxy grout used was 12 ksi in fifteen 3 in. diameter by 6 in. long cylinder breaks, while the elastic modulus of the epoxy grout plate was 1,300 ksi. It should be noted that the elastic modulus for this material can easily be adjusted by altering the sand-to-epoxy ratio. When tested in compression, this material exhibited large plastic strains without cracking. A prefabricated epoxy grout bearing plate, shown in Figure 63, was used for Columns 2 and 3.

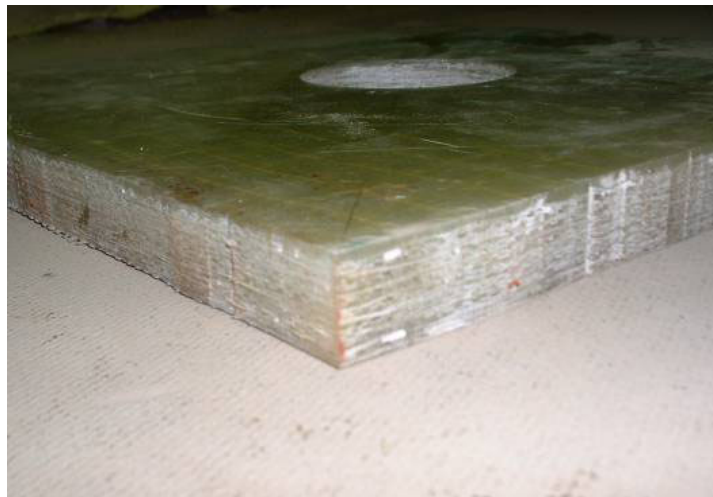
Figure 65. GFRP plate.

A GFRP bearing plate was used in Columns 5 and 6; an epoxy resin served as the matrix for GFRP, while glass fiber layers provided tensile reinforcement against lateral splitting. Seventeen layers of woven fiber fabric were laid up in alternating 90° orientations to construct the 0.75 in. thick plate. The elastic modulus for the GFRP bearing plate perpendicular to the fibers was approximately 1,600 ksi, and the average compressive strength of the epoxy matrix determined from 3 cylinder breaks was 13 ksi. The GFRP bearing plate is shown in Figure 65.

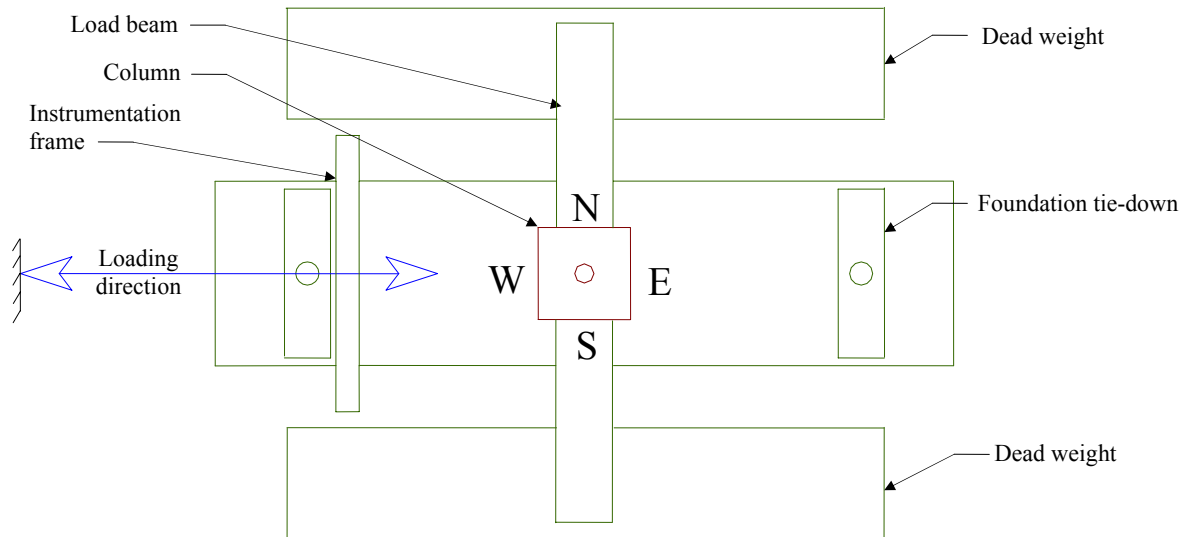
Figure 70. Top view of test setup showing column orientation in test frame.

The load applied by the actuator, which was oriented in the east/west direction, is shown in Figure 70. During each positive (push) half-cycle, the actuator displaced the column to the west, while during each negative (pull) half-cycle, the actuator displaced the column to the east. As discussed in Chapter 1, 44 kips of dead load was applied to each column. This load consisted of the dead weights, load beam, and column, which was included in the dead load because most of the instrumentation was located at the base of the column. Furthermore, while no post-tensioning was applied to Column 1, 44 kips of post-tensioning was applied to Column 2, and 66 kips of post-tensioning was applied to Columns 3-6.

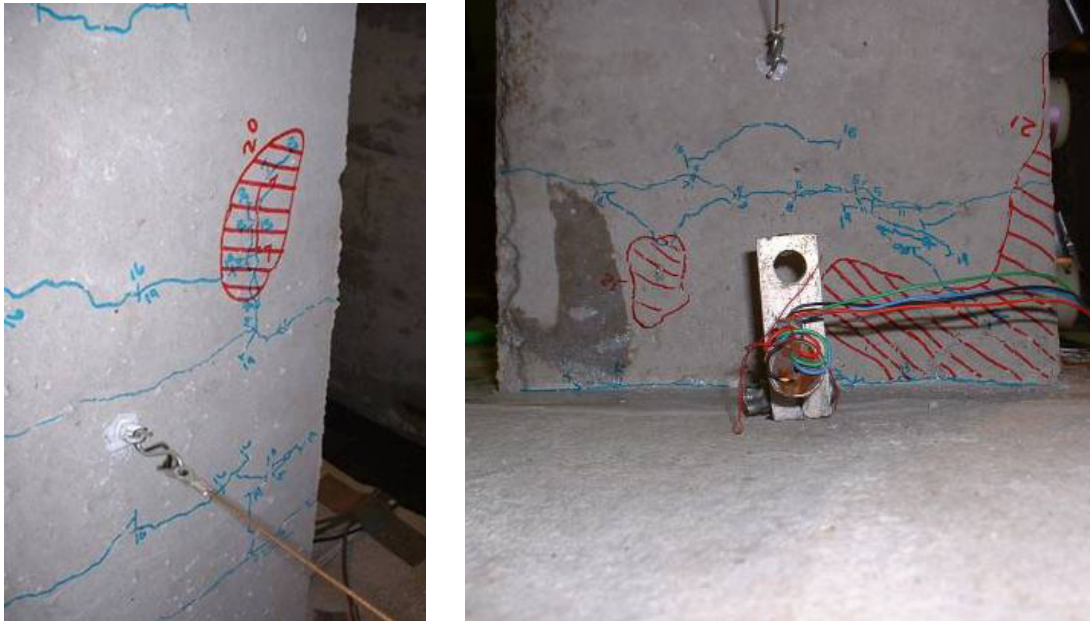
Figure 75. Photographs of Column 1 - Cycle 20.

a.) West face initial compression damage b.) Localization of compression damage on southwest corner

Cracks continued to expand and develop further up the column as cycles continued and lateral loads increased (see Figures 73 and 74). From Cycles 20 to 22, several areas on the compression face of the column began to exhibit localized compression damage and are denoted by hatched areas drawn on the column faces (see Figures 75 and 76). Major compression damage that localized in the southwest corner of the column was observed on Cycle 20 (displacement = ± 5.0 in.) (see Figures 77a and 78). As the previously observed damage increased on subsequent cycles, the column began to tilt to the south, perpendicular to the axis of loading. On Cycle 21 (displacement = ± 5.0 in.), Column 1 attained its maximum lateral load of + 9.7 kips.

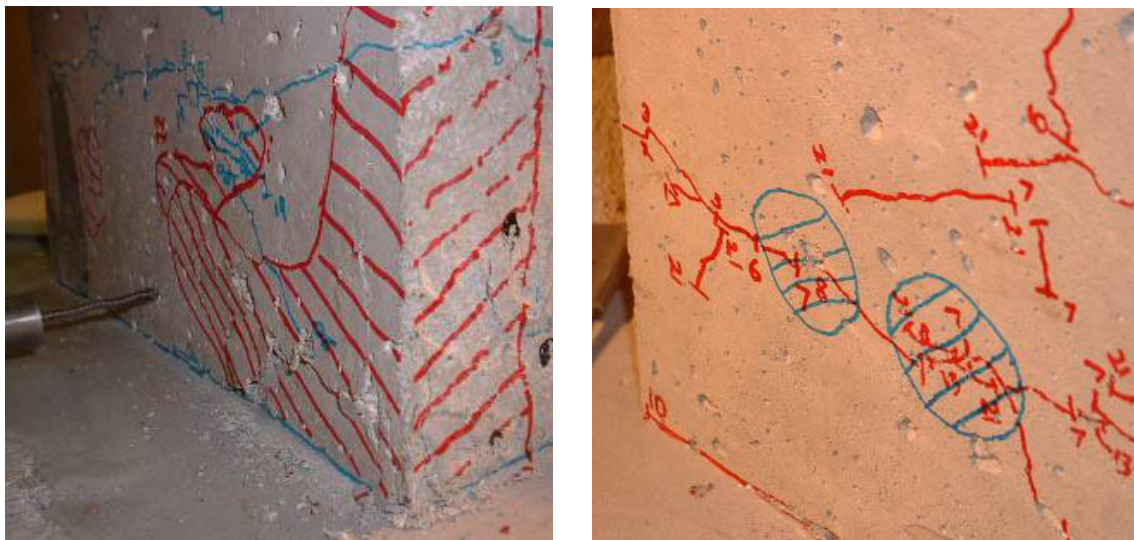
Figure 76. Photographs of Column 1 - Cycle 22.

a.) Southwest corner compression damage

b.) East face initial compression damage

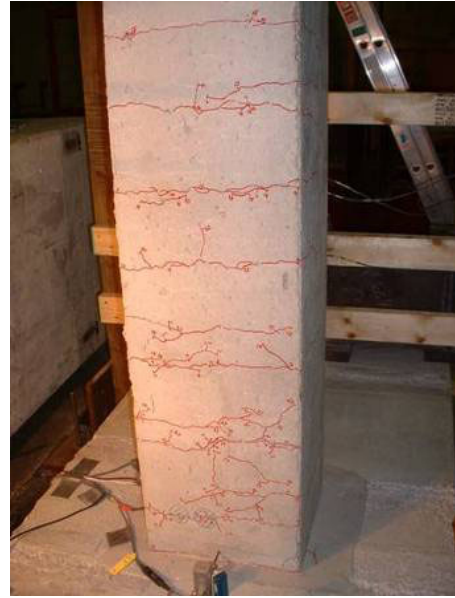
Figure 77. Photographs of Column 1 - Cycle 23.

a.) Southwest corner compression damage

b.) East face crack progression

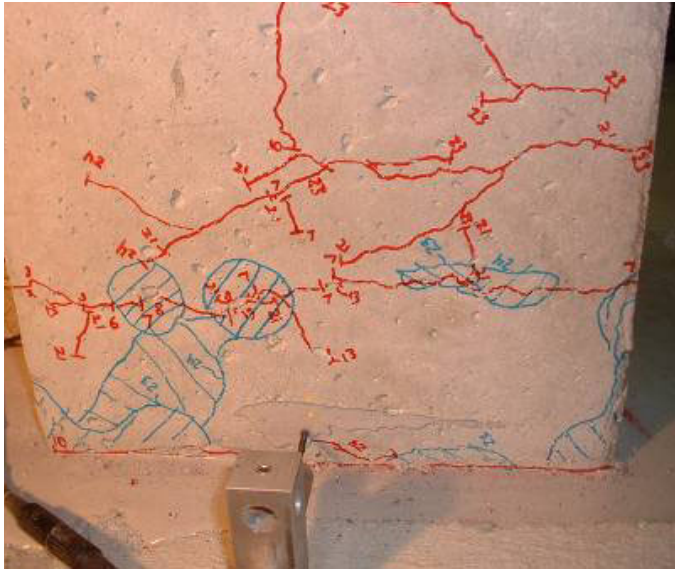
Figure 79. Photographs of Column 1 - Cycle 24.

a.) East face damage

b.) North face crack progression

Additional cycles produced more spalling of concrete, most notably on the southwest corner of the column near the base (see Figures 79-81), a reduction in lateral load, and further tilting of the column to the south (see Figure 82). It was observed during Cycle 25 that the load beam was in contact with the testing frame (see Figure 82a). On Cycle 27 (displacement = ± 9.0 in.), the damage was severe enough that the longitudinal reinforcement in the column was visible and exhibited clear signs of buckling (see Figures 82-84). Furthermore, the lateral load applied to the column had fallen off sharply, and the column was in danger of becoming

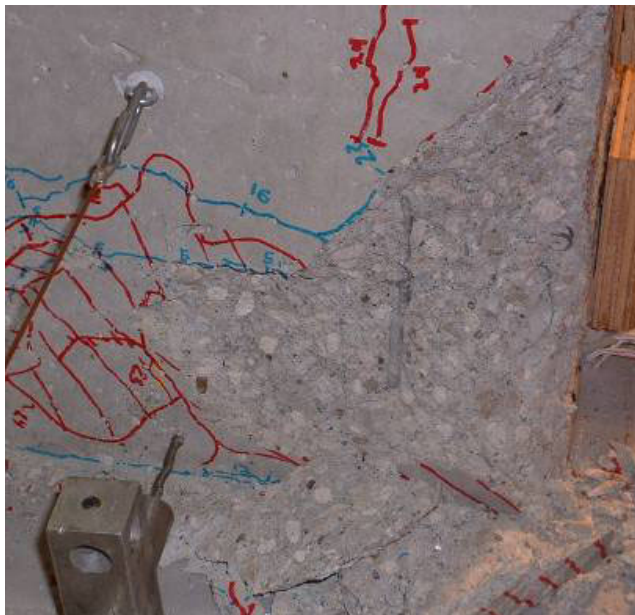
Figure 80. Photographs of Column 1 - Cycle 25.

a.) Southwest corner damage

b.) East face damage

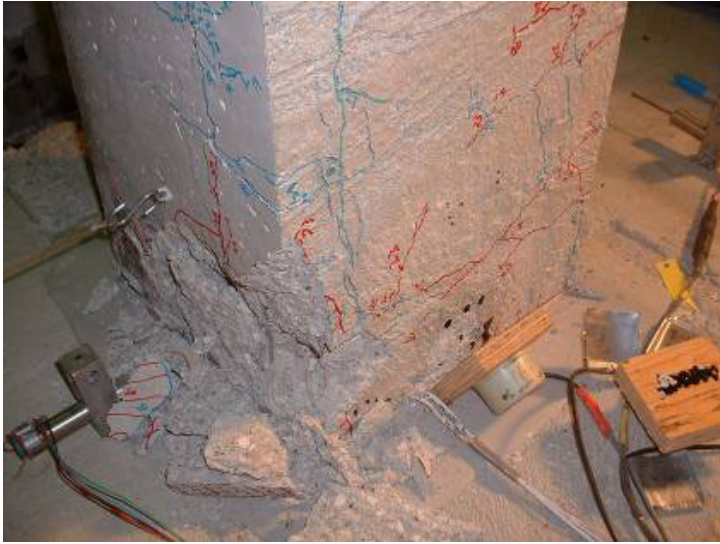
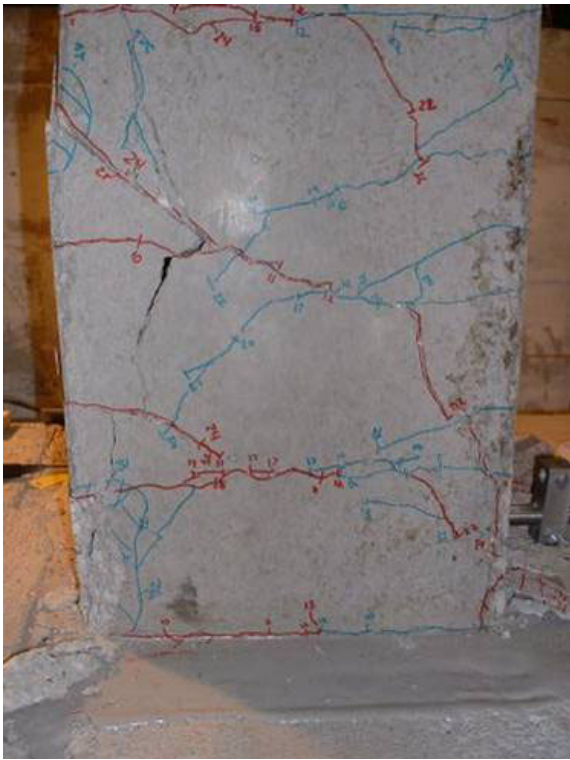
Figure 81. Photographs of Column 1 - Cycle 26.

a.) Severe spalling of southwest corner

b.) Visible southwest corner reinforcement

c.) North face cracking/spalling

d.) East face bulging due to buckled reinforcement

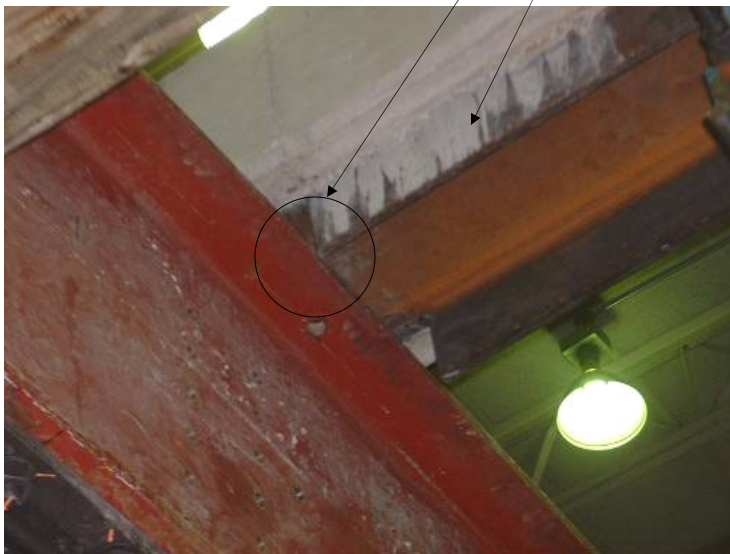
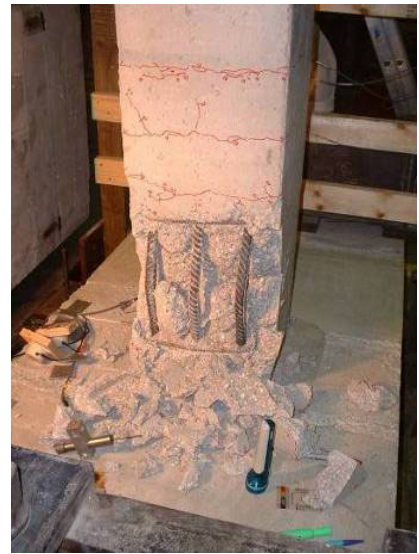
Figure 82. Photographs of Column 1 - Cycle 27 damage/frame impingement.

Contact between load frame and load beam — Flange of load beam

a.) Frame impingement with underside of load beam

b.) East face reinforcement exposed

c.) North face cracking/bulging

d.) West face damage

During the last three positive (push) half-cycles of + 7.0 in., + 8.0 in., and + 9.0 in. displacements, the load beam impinged on the load frame when displacements exceeded + 7.0 in. This impingement and the associated tilting to the south occurred only on the positive portions of the loading cycles. This caused spuriously high lateral load readings on these half-cycles. Testing was continued beyond the + 7.0 in. displacement, because the problem did not occur on the negative (pull) half-cycles. Thus, testing was continued until failure occurred on the negative half of Cycle 27. Due to this occurrence, only the data collected for negative half-cycles for the three largest displacement cycles were considered reliable and indicative of typical column behavior.

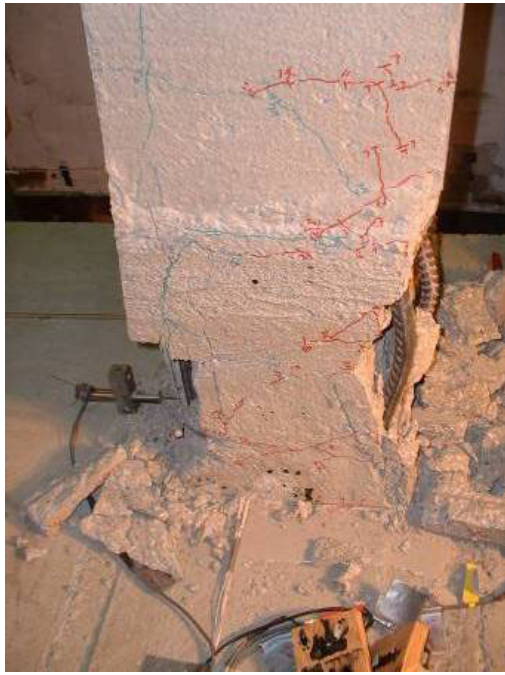
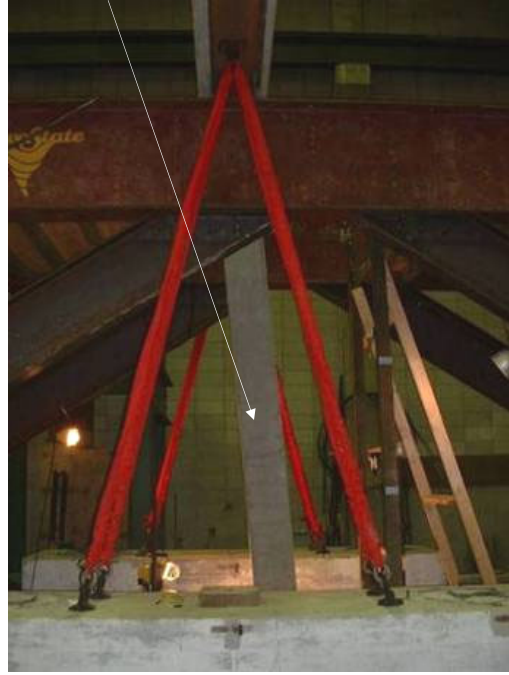
Figure 83. Photographs of Column 1 - Cycle 27 damage and deformation.

Column 1 in frame

a.) South view of damage

b.) Column deformation on pull half-cycle

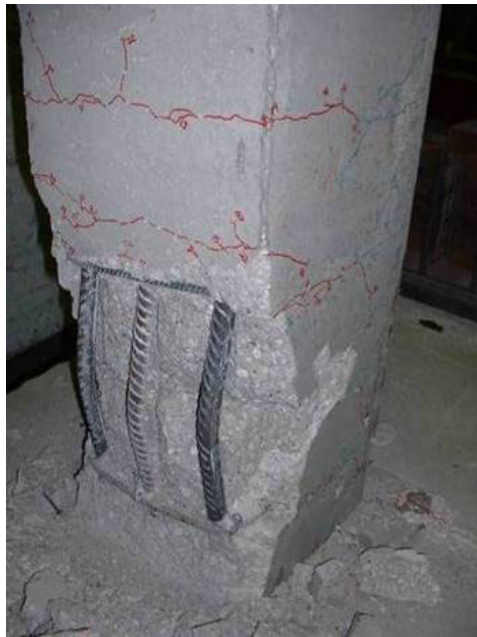
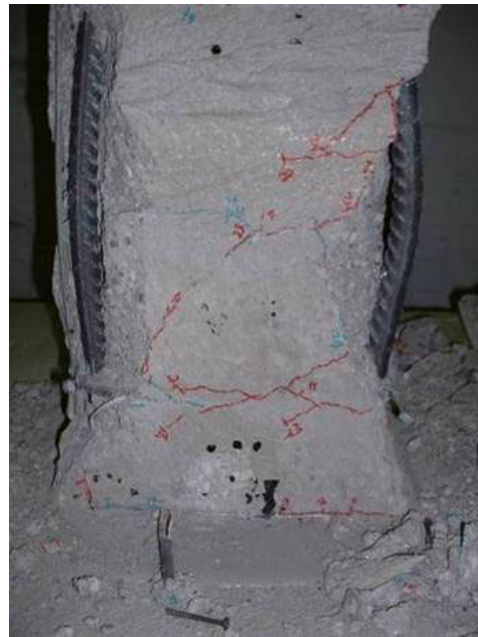
Figure 84. Photographs of Column 1 – After testing

c.) Final damage to east face

d.) Final damage to south face

Behavior of the control column closely matched that expected of a conventional, cast-in-place column in the field with the exception of the localized failure at the southwest corner (see Chapter 7 for quantitative comparisons). Cracking initially occurred near the base of the column and spread upward as lateral loads and deflections increased. Peak loads occurred near the time that yielding of the bonded reinforcement occurred and was followed by a period of increasing lateral displacements at or near the peak load. This continued until rotational capacity near the base of the column was reached and ultimate failure, marked by buckling of longitudinal bars and crushing of core concrete, occurred.

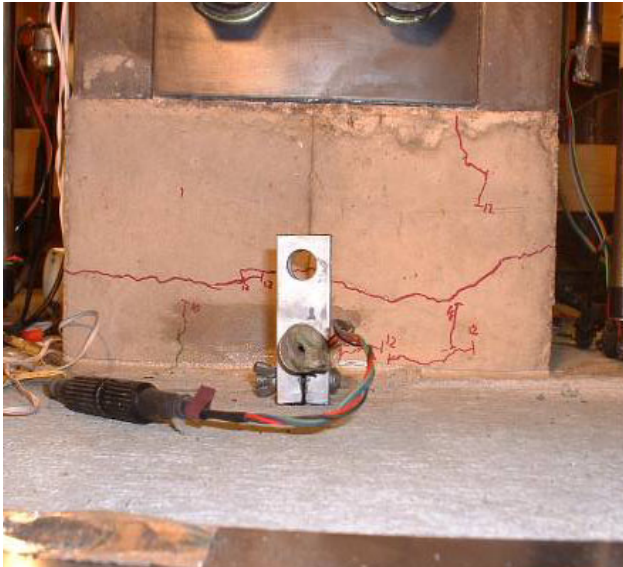
Figure 87. Photographs of Column 2 – Cycle 14a.

a.) East base cracking

b.) Initial buckling of east plate

cracks formed every 8 in. to 12 in. across the column for several feet above the construction joint (see Figures 86 and 88). The fuse plate in compression began to buckle on Cycle 13a (displacement = +/- 1.5 in.) and is shown buckling during Cycle 14a in Figure 87b. During Cycle 15a, the crack that formed between the upper column collar and the concrete grew noticeably (see Figure 88). Since Cycle 16a was the predetermined cycle to replace fuse plates, testing was stopped and new plates were mounted on the column. At this juncture, a peak load of + 6.39 kips had been applied to the column.

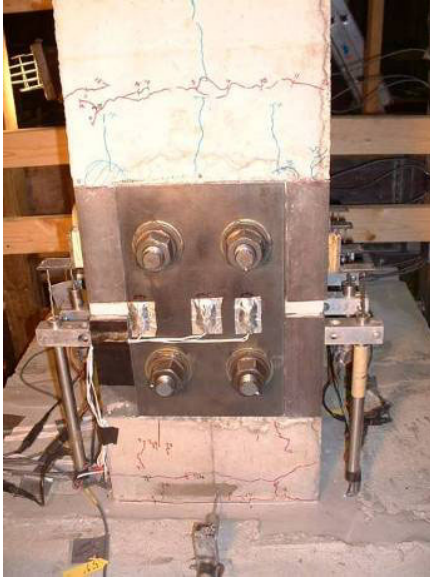
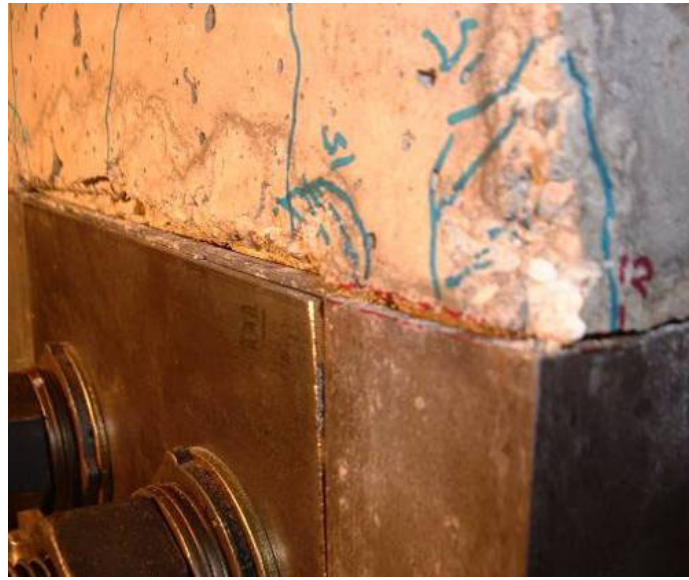
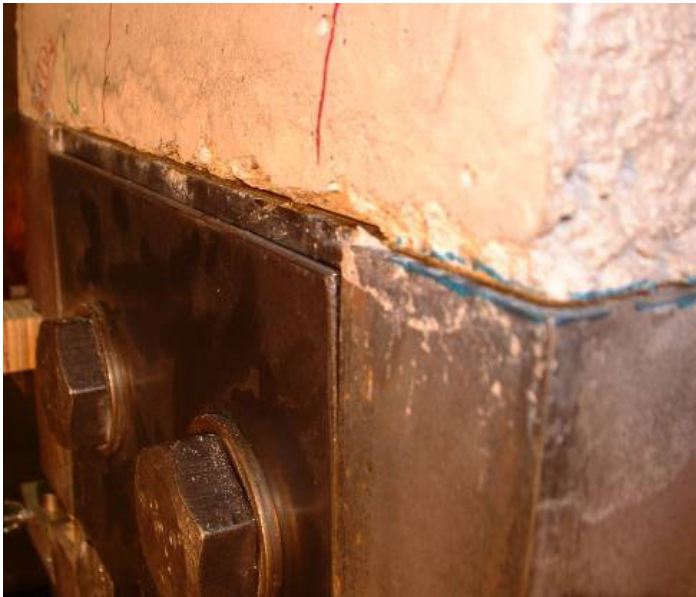
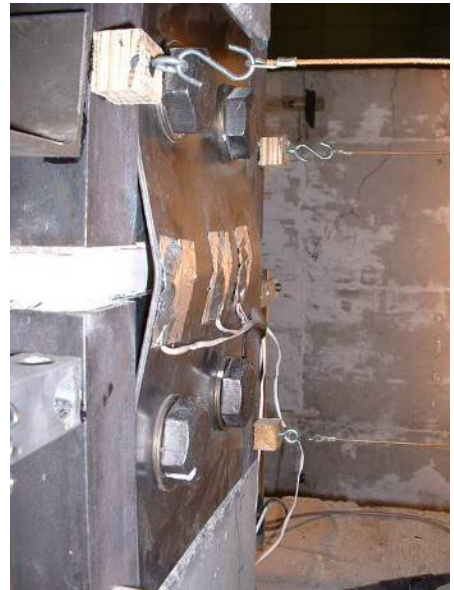
Figure 89. Photographs of Column 2 – Cycle 16b.

a.) East face

b.) Northeast corner collar/column interface

c.) West collar/column interface

d.) Buckling of replaced west plate

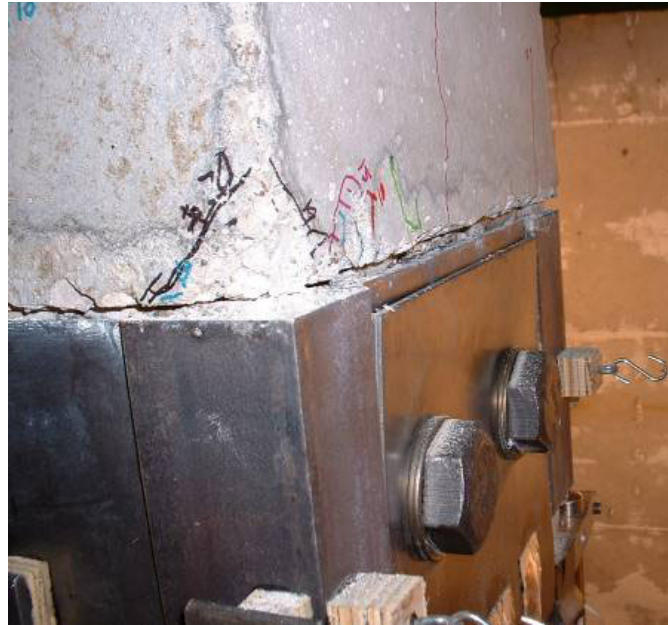
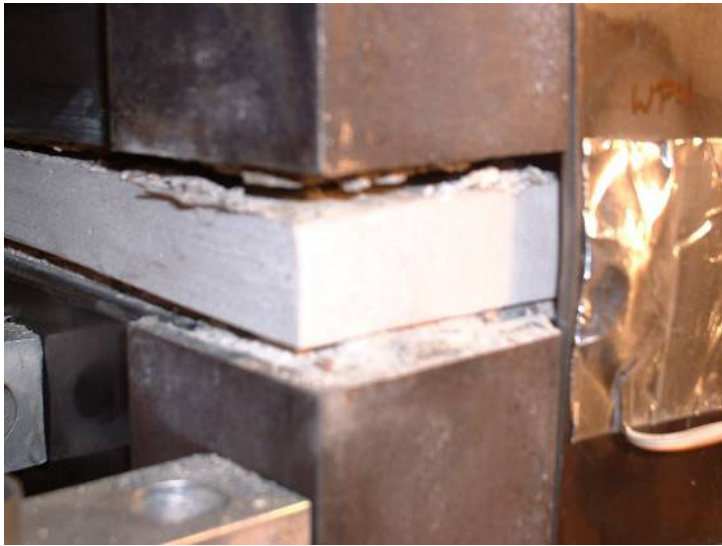
a.) East plate buckling during last cycle

b.) West collar/column interface final crack width

c.) Northwest corner of bearing plate

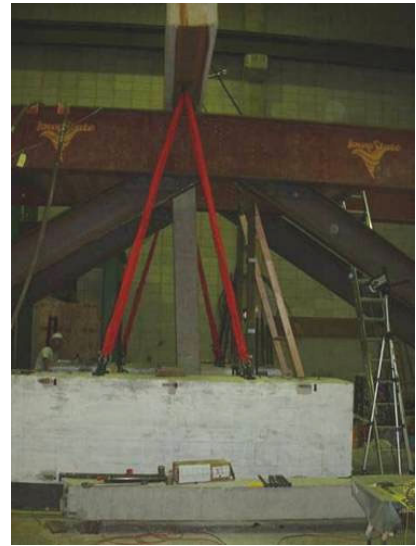
d.) Column tilt during negative half-cycle

Figure 92. Photographs of Column 2 – Cycle 23b.

Cycle 23b in Figure 92b. Also during Cycle 22b, a crack was observed on the northwest corner of the bearing plate. The test was stopped after Cycle 23b due to the opening of the crack between the collar and column; it was evident that the decrease in load at each displacement was due to this phenomenon. A maximum load of + 6.64 kips was observed during Column 2's test on Cycle 14a (displacement = +/- 2.0 in.), while a maximum displacement of 6.0 in. was recorded for the test. At + 6.0 in., a load of + 4.48 kips was achieved, while a - 3.27 kip load was achieved at - 6.0 in. Quantitative lateral load versus displacement is shown in Chapter 7.

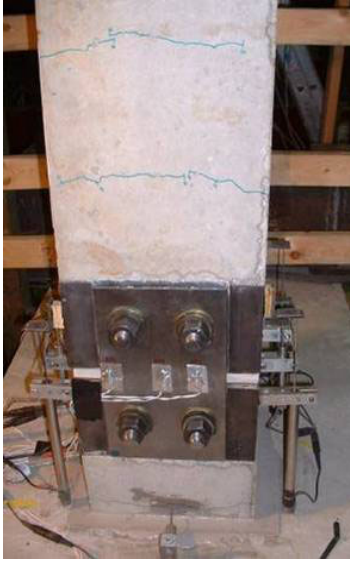
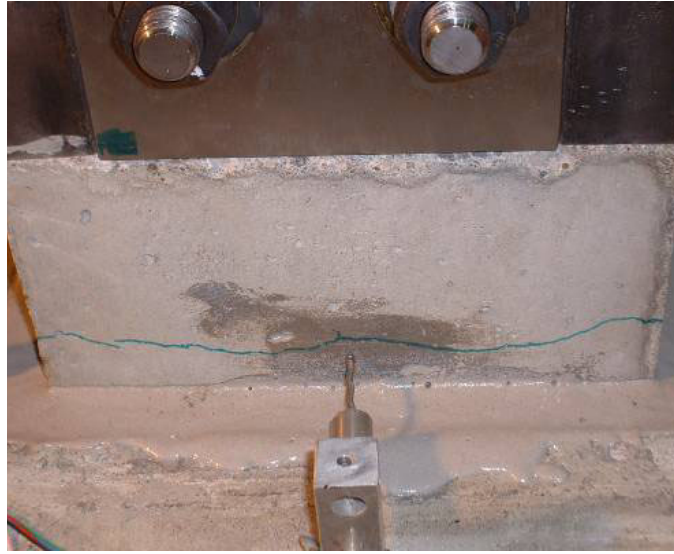
a.) East face crack progression

b.) East base initial cracking

Figure 94. Photographs of Column 3 – Cycle 10a east face.

Testing of Column 3 commenced and continued until ± 9.0 in. displacements were reached. The incremental damage accrued over the imposed displacement regimen is illustrated in Figures 93-105. Cracking across the entire column was observed on Cycle 10a (displacement = $\pm .75$ in.) (see Figures 94 and 95). On the positive (push) half-cycle, cracking occurred at the base of the column on the east face, as well as 1 ft. above the top collar; on the negative (pull) half-cycle, cracking occurred 1 in. above the base on the west face of the column. During the next several cycles, small cracks formed every 6 in. to 10 in. up the column face for several feet above the construction joint (see Figures 97a and 97b).

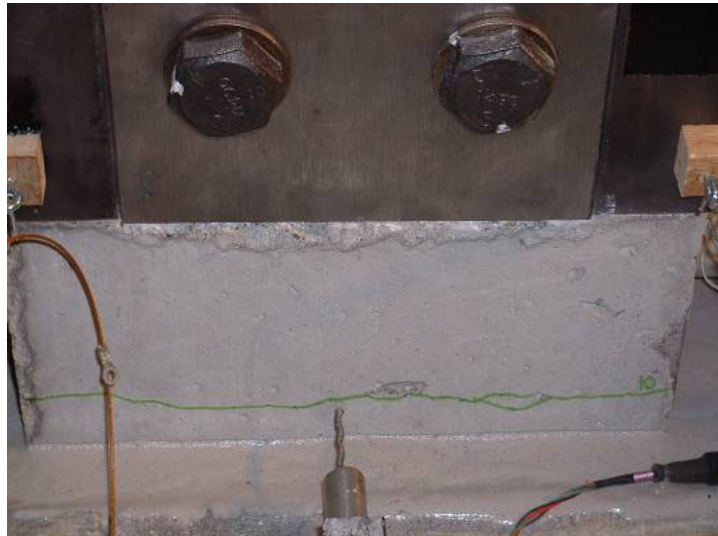
a.) West face crack progression

b.) West base initial cracking

Figure 95. Photographs of Column 3 – Cycle 10a west face.
