Self-centering bridge pier columns with structural fuses

A thesis submitted to the graduate faculty
in partial fulfillment of the requirements for the degree of
MASTER OF SCIENCE

Major: Civil Engineering (Structural Engineering)

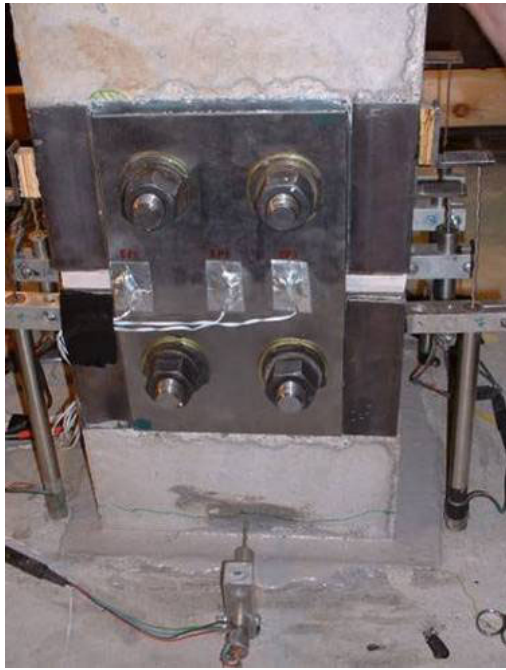
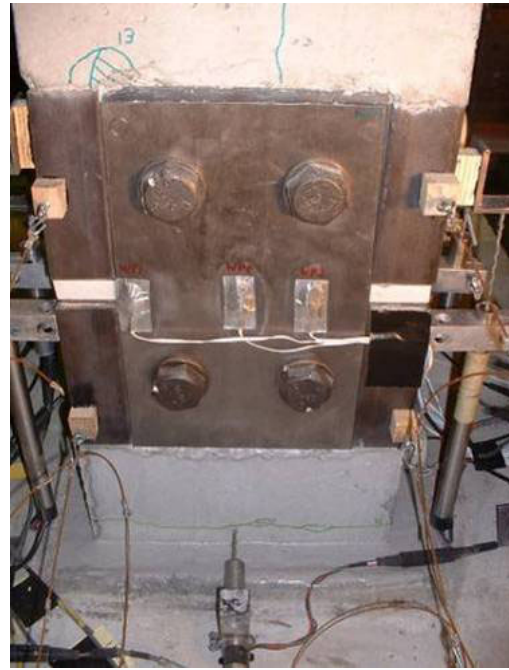
a.) East plate and column face

b.) West plate and column face

Figure 96. Photographs of Column 3 – Cycle 14a fuse plates.

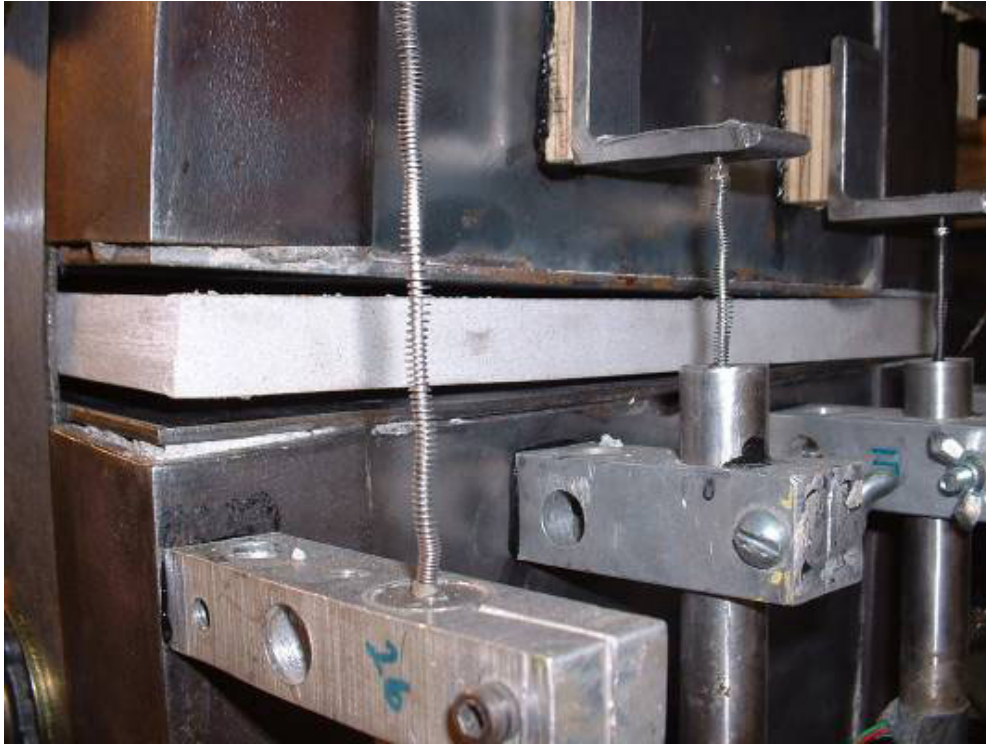
Figure 102. Photograph of Column 3 – Cycle 21b joint opening during push half-cycle.

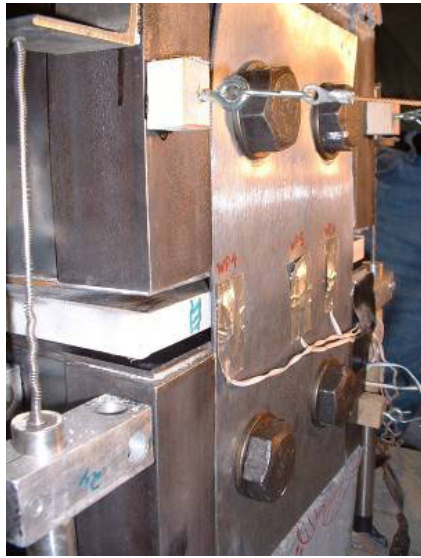
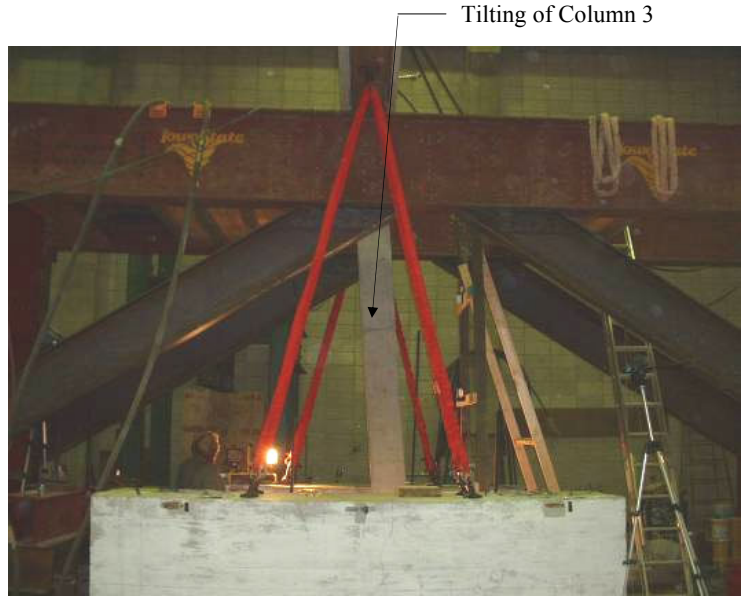
a.) Northeast corner joint opening

b.) Pull half-cycle column deformation

Figure 105. Photographs of Column 3 – Cycle 22b.

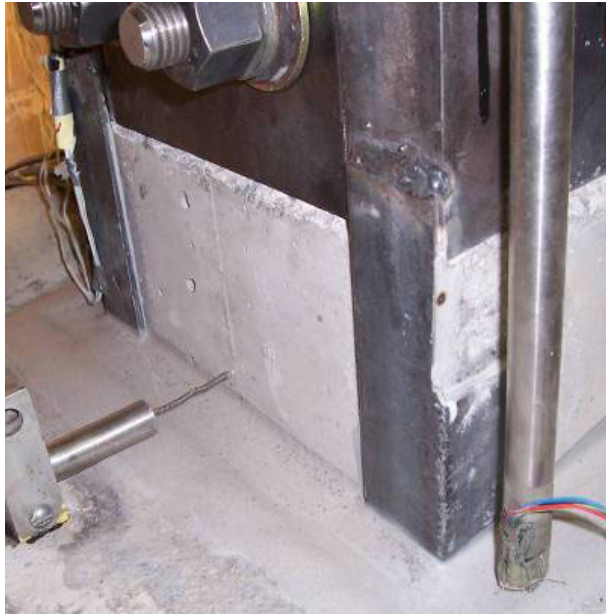
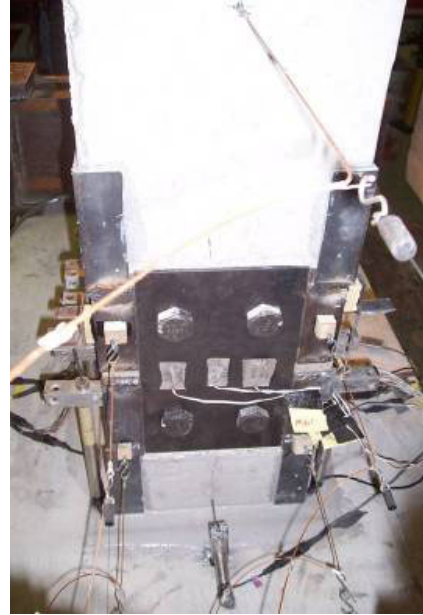
a.) Northwest retrofit angle on bottom column segment

b.) West face prior to testing

Figure 107. Photographs of Column 4 – Cycle 7a.

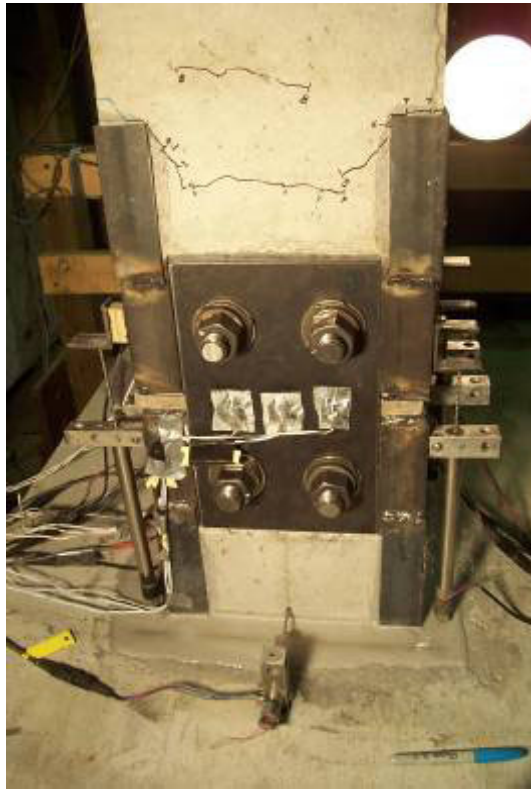
Figure 108. Photograph of Column 4 – Cycle 7a east face.

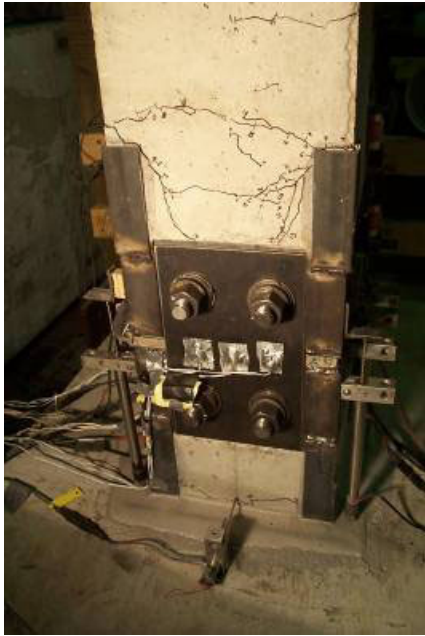
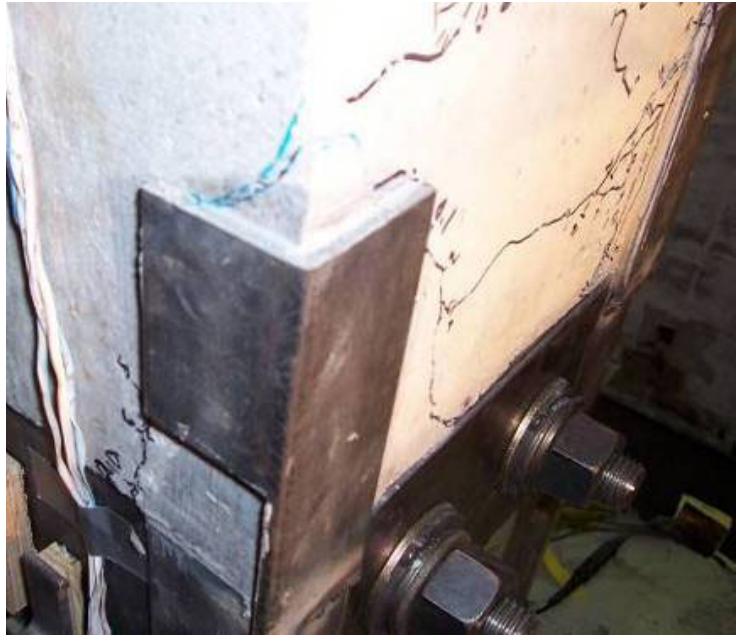
a.) East face crack progression

b.) Incipient cracking at southeast retrofit angle

Figure 109. Photographs of Column 4 – Cycle 11a.

Figure 109). Small cracks were noted on the corner of the bearing plate on Cycle 15a (see Figures 110b and 111a). On Cycle 14a (displacement = ± 2.0 in.), several "pinging" sounds were heard from the west fuse plate during the negative (pull) half-cycle, indicating the onset of slippage. Slippage between the tension fuse plate and the collar was observed on Cycle 15a (displacement = ± 2.5 in.) as well. Actuator control problems then occurred on Cycle 15a at + 0.42 in. displacement and on Cycle 16a at + 0.40 in., - 0.46 in., - 1.71 in., and - 1.09 in. Also, on Cycle 16a, the upper segment exhibited severe cracking around the external retrofit angles (see Figure 112), and the fuse plates in compression had clearly buckled. Since this was also the predetermined cycle to replace fuse plates, testing was stopped and new plates were mounted on the column. At this time, a peak horizontal load of + 6.32 kips had been applied to the column.

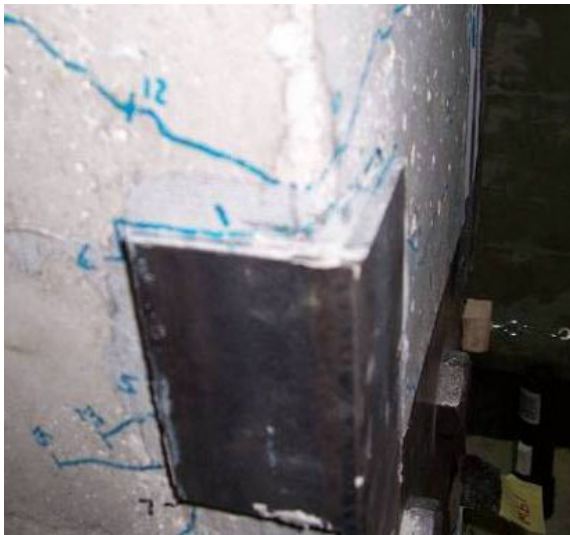
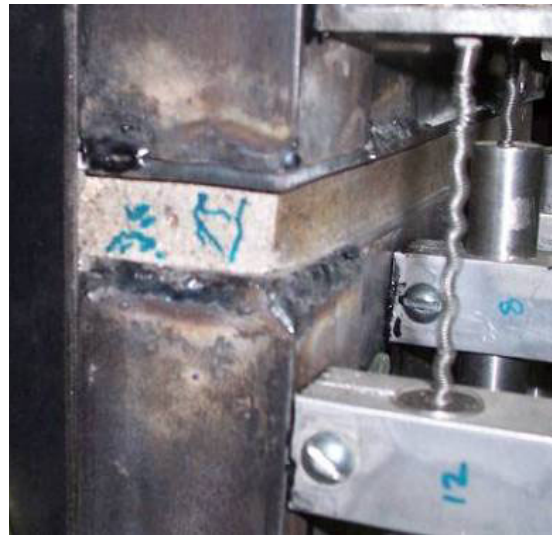
a.) Cracks forming around southeast retrofit angle

b.) Northeast corner bearing plate compression damage

Figure 110. Photographs of Column 4 – Cycle 15a.

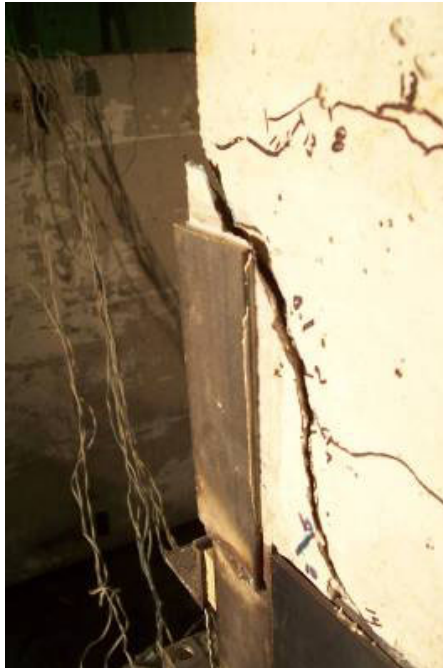
Figure 112. Photograph of Column 4 – Cycle 16a southeast retrofit angle damage.

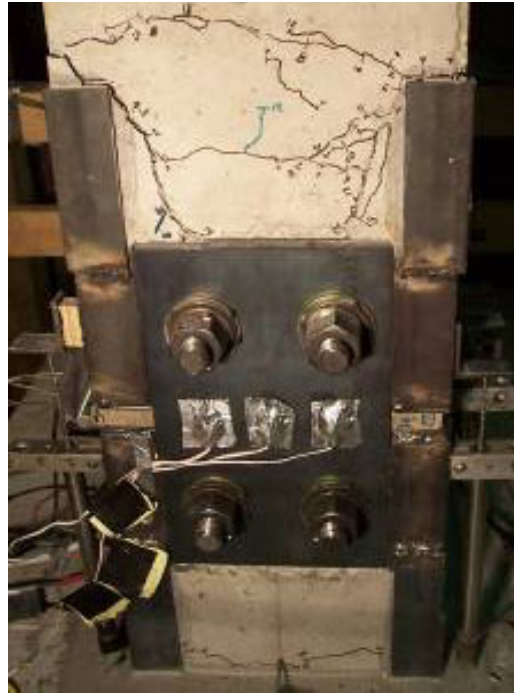
Figure 113. Photographs of Column 4 – Start of test 4b.

After replacing the fuse plates, the displacement regimen was restarted. The damage accrued in the column up to this point can be seen in Figure 113. Actuator control problems continued to increase in frequency and magnitude throughout the remainder of the Column 4 test. From Cycles 19b to 22b, damage to the upper column segment increased and the upper

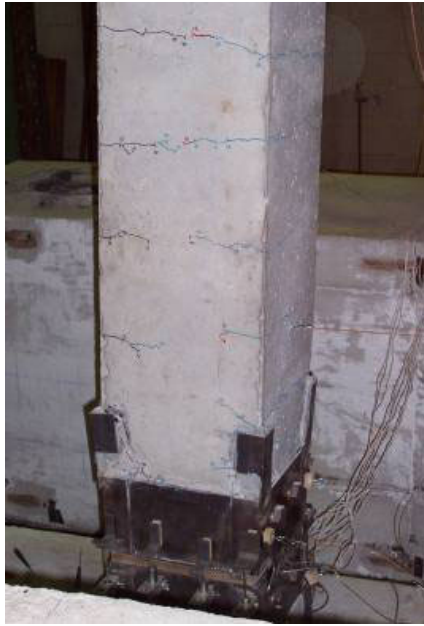
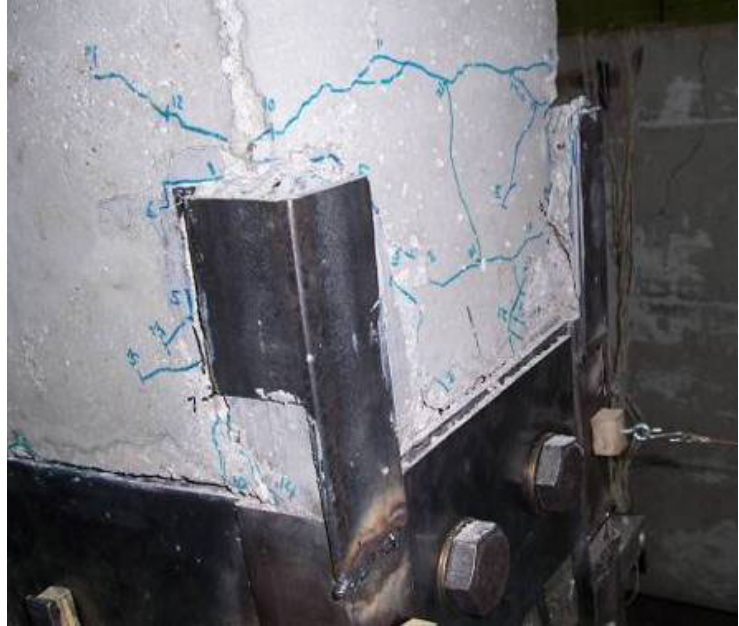
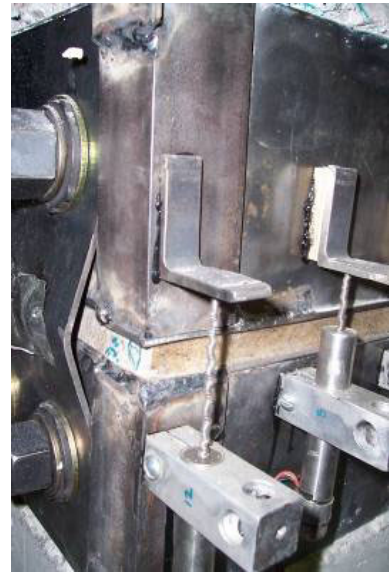
Figure 117. Photographs of Column 4 – Cycle 22b.

a.) Northwest corner damage

b.) Upper segment damage and retrofit failure

c.) North face damage and retrofit angle failure

d.) Northeast corner fuse plate buckling

repair angles became detached from the column face (see Figures 114-117). By this point, rotation of the column concentrated almost exclusively at this location as the collar again pulled off the end of the segment. Testing of Column 4 was stopped after Cycle 23b, as it was again evident that the decrease in load at each displacement was due to this pull-off phenomenon. A maximum horizontal load of + 6.39 kips was observed on Cycle 19b (displacement = +/- 4.0 in.) and a maximum displacement of 6.0 in. was observed for the test. At + 6.0 in., a load of + 4.45 kips was achieved, while a - 5.16 kip load was achieved at - 6.0 in. Quantitative lateral load versus displacement data from the testing of Column 4 are presented in Chapter 7.

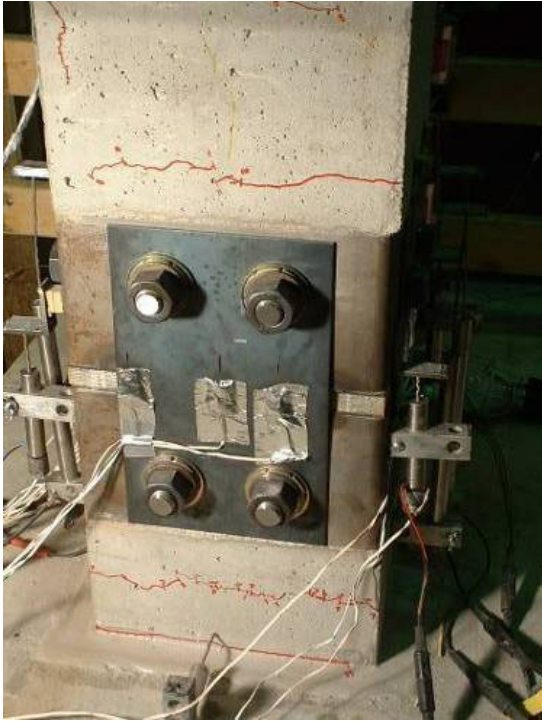
Figure 121. Photographs of Column 5 – Cycle 13a east face.

a.) Cracking around column joint

b.) Upper segment crack progression

After restarting the test, additional cracks formed across the column on Cycle 13a (displacement = +/- 1.5 in.) (see Figures 121 and 122). On Cycle 14a (displacement = +/- 2.0 in.), a small amount of compression damage was noted under the collar on the west face of the column (see Figure 123). This minute chipping was observed on previous specimens and was caused by the collar bearing on the surface of the concrete column. The depth of chipping was limited to the thickness of the collar and could be eliminated in the future by placing a small gap or indentation in the concrete at this location. Additional small regions of compression damage were marked on the positive (push) cycles of Cycles 15a and 16a (see Figure 125). By Cycle 16a, the fuse plates were visibly buckling. Since this was also the predetermined cycle to replace fuse plates, testing was stopped and new fuse plates were mounted on the column. At this time, a peak horizontal load of + 7.45 kips had been applied to the column during the positive (push) half-cycle, while a horizontal load of - 8.53 kips had been applied during the negative (pull) half-cycle.

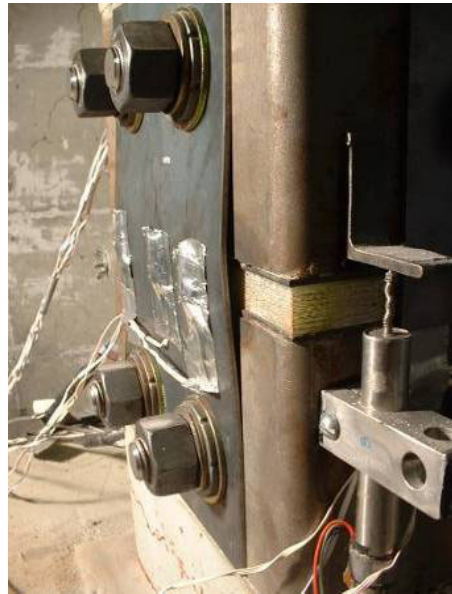
Figure 123. Photographs of Column 5 – Cycle 14a west face.

a.) West face at base

b.) East plate initial buckling

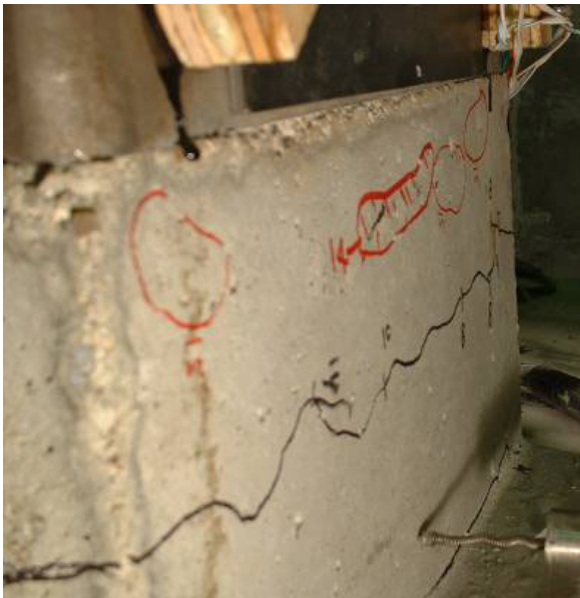
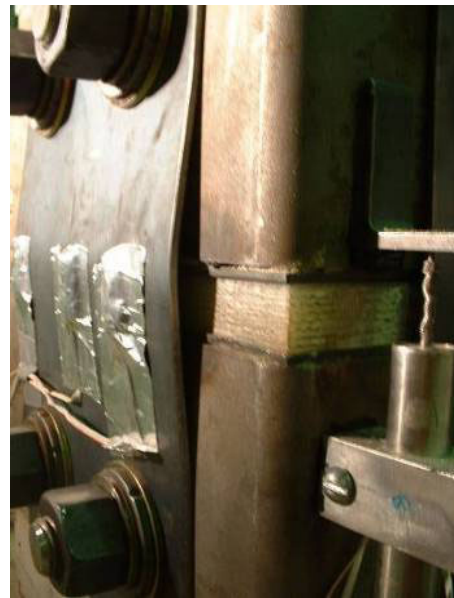
Figure 124. Photographs of Column 5 – Cycle 15a.

a.) West face compression damage and cracking at base

b.) East fuse plate buckling

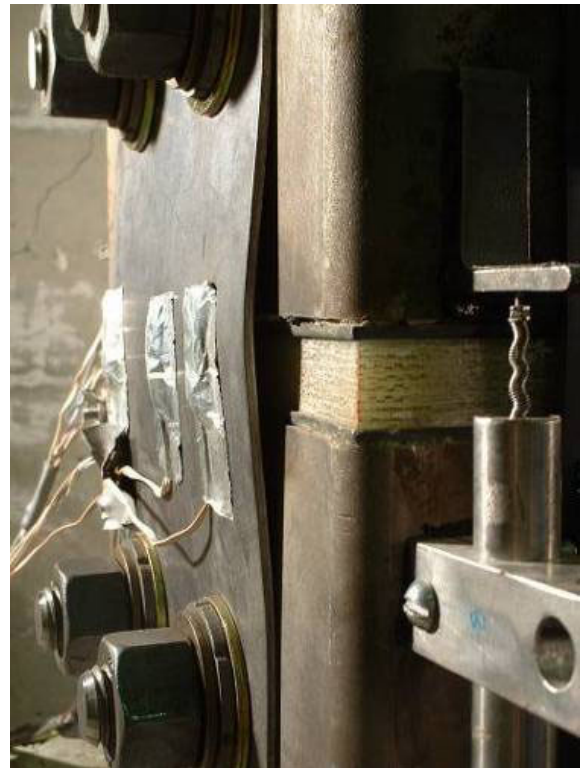
Figure 125. Photographs of Column 5 – Cycle 16a.

a.) Upper segment compression damage

b.) West fuse plate initial buckling

a.) West face cracking at the end of Test 5a

b.) East plate buckling in compression

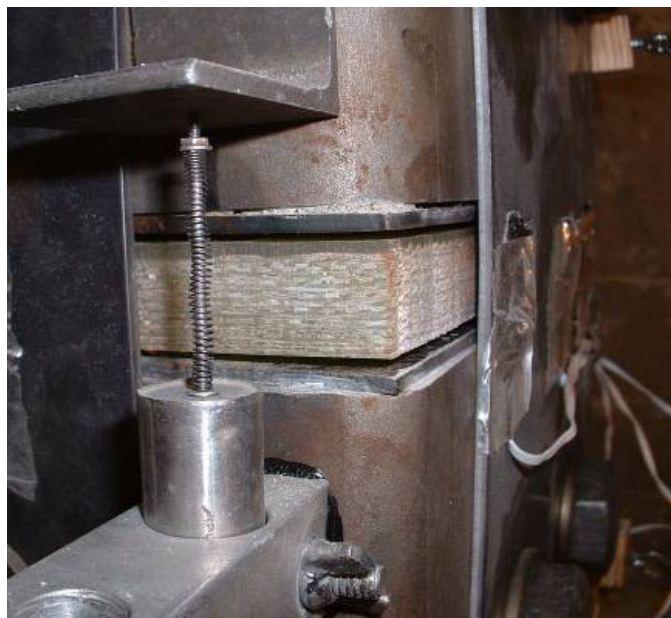
Figure 127. Photographs of Column 5 – Cycle 21b.

a.) East fuse plate buckling

b.) West joint opening during pull half-cycle

After setting interlocks and increasing the dither in the control system in an attempt to improve actuator control, testing was resumed. On Cycle 21b, several "pings" were heard in the plates, indicating slipping between the plates and the steel collars. Prior to the previous actuator incidents, no evidence of slippage had been noted. On the negative (pull) half-cycle

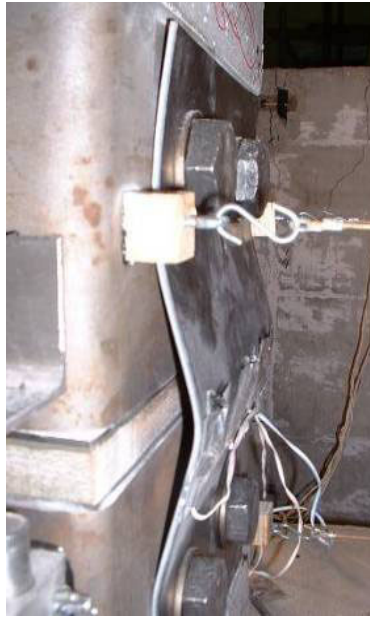
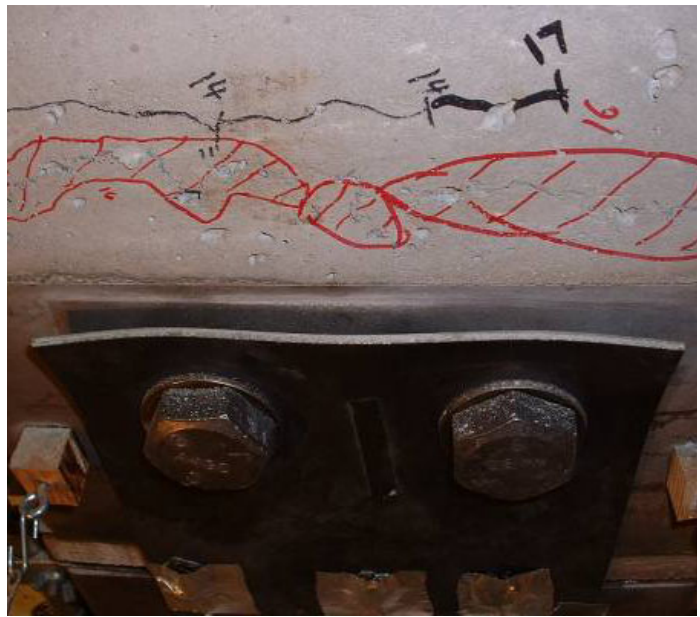
Figure 128. Photographs of Column 5 – Cycle 23b.

a.) West fuse plate buckling

b.) Bolt bearing on west fuse plate causing plate curling

of Cycle 21b, the top of the west plate began to curl due to this slippage and subsequently began bearing on the through-bolts. This condition continued on each cycle and can be seen during Cycle 23b in Figure 128b. With each significant "pinging" noise, a loss of load was also observed while displacement of the column continued. Slippage and the resulting bearing condition continued during each cycle until the full stroke of the actuator was reached (see Figures 128b, 130a, 130b, 133, 134c). Despite this slippage, the gap opening at the column segment continued to widen throughout the remainder of the test (see Figures 127b, 131a, 132c, 135a, 136c, 137b) and the crack width at the interface between the upper column segment and collar remained small. The final condition of the west fuse plate and the condition of Column 5 are shown after Cycle 30 in Figure 138. Post-test damage for all sides of Column 5 can be seen in Figure 139.

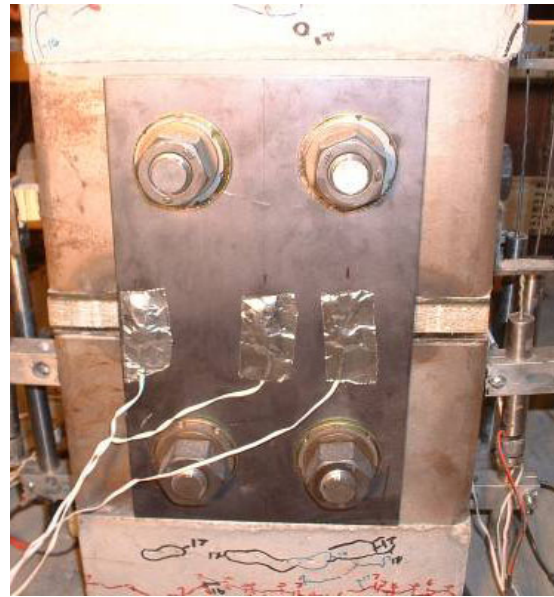
Figure 129. Photographs of Column 5 – Cycle 24b joint opening.

a.) Southeast corner joint opening

b.) East joint opening during push half-cycle

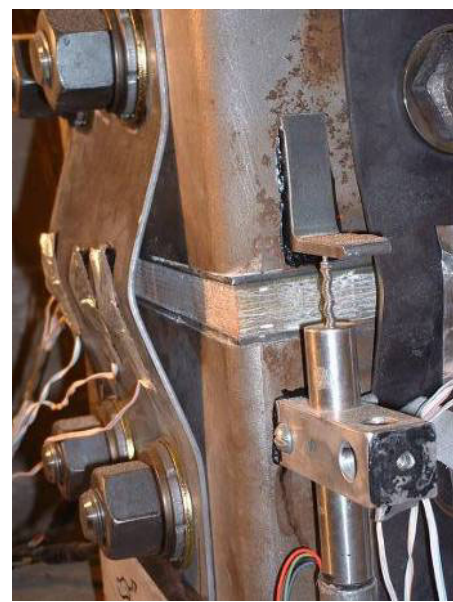
Figure 130. Photographs of Column 5 – Cycle 24b.

a.) West face damage and fuse plate buckling

b.) Southwest corner fuse plate buckling

c.) East fuse plate buckling

d.) Northeast corner fuse plate buckling

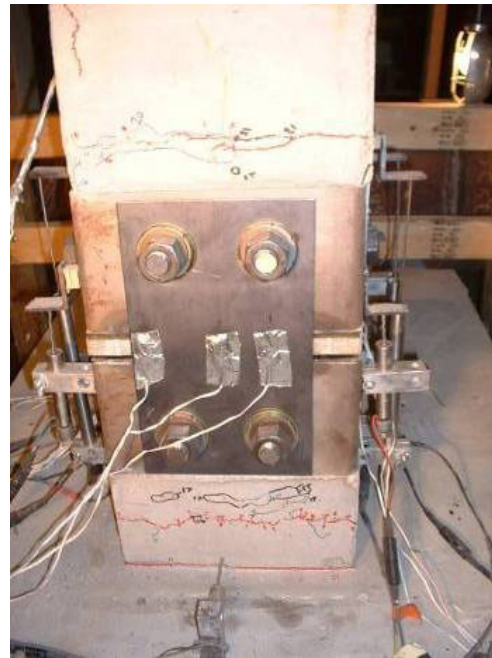
Figure 132. Photographs of Column 5 – Cycle 27b push half-cycle.

a.) Differential buckling in north fuse plate buckling

b.) West fuse plate buckling

c.) East joint opening

d.) East joint opening and segment damage

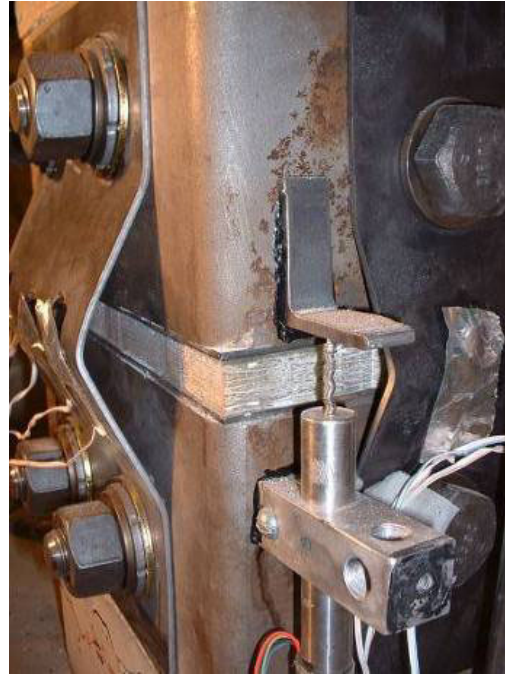
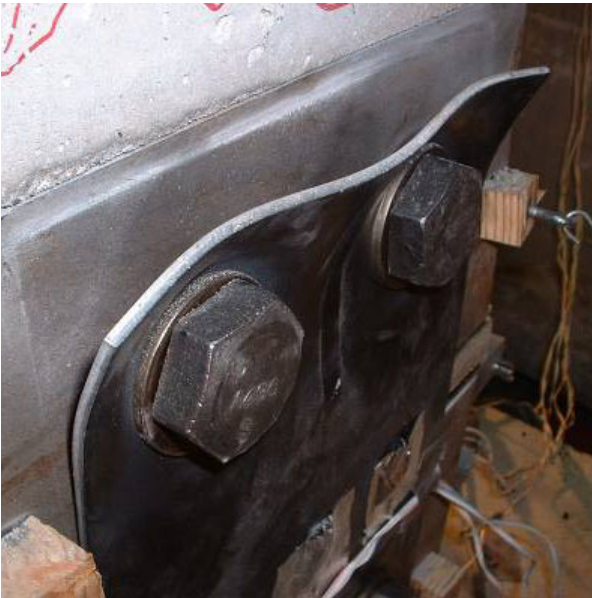
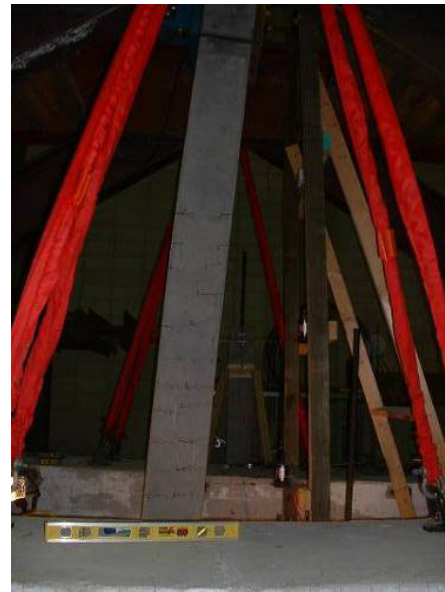
Figure 134. Photographs of Column 5 – Cycle 28b.

a.) East fuse plate buckling and column damage

b.) East fuse plate buckling

c.) Curling on top of the west plate

d.) Column deformation during push half-cycle

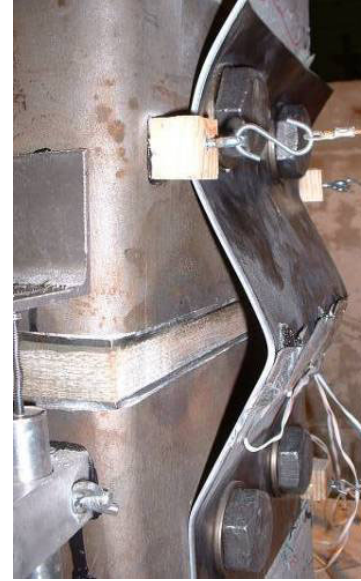
Figure 136. Photographs of Column 5 – Cycle 30b push half-cycle.

a.) North fuse plate differential buckling

b.) West fuse plate buckling

c.) East face damage and joint opening

d.) East joint opening

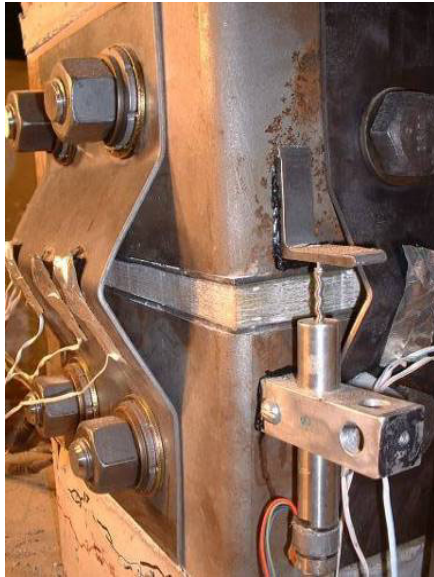
Figure 137. Photographs of Column 5 – Cycle 30b pull half-cycle.

a.) East fuse plate buckling

b.) West joint opening and bearing of west fuse plate on bolts

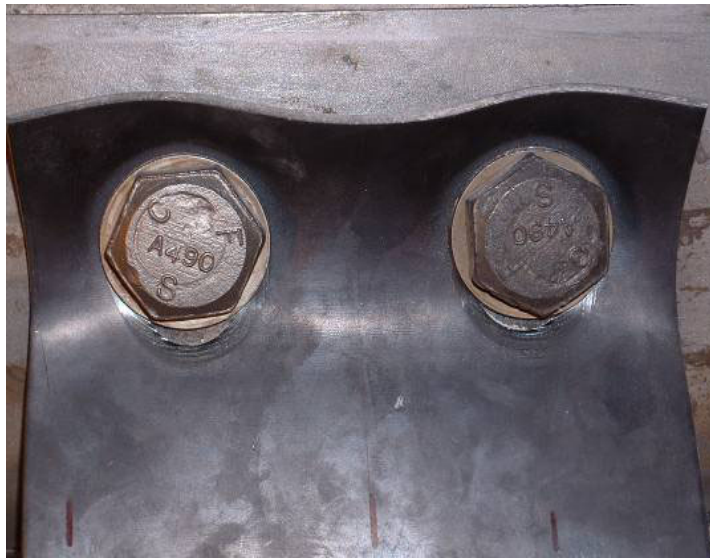
Figure 138. Photographs of Column 5 – After test.

a.) Residual fuse plate buckling

b.) Residual curling on top of west plate

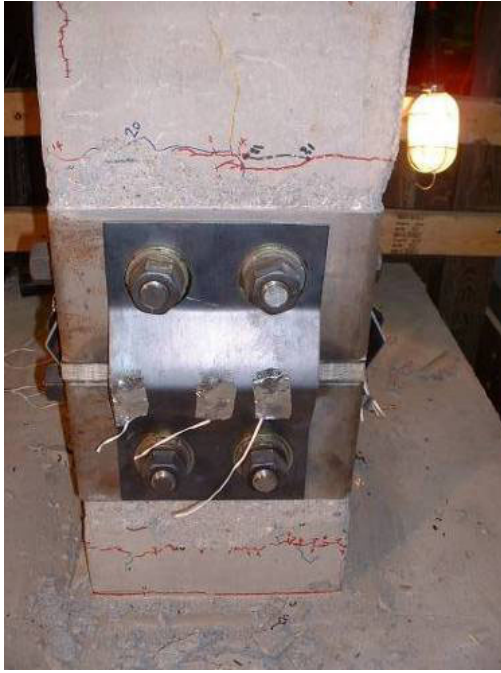
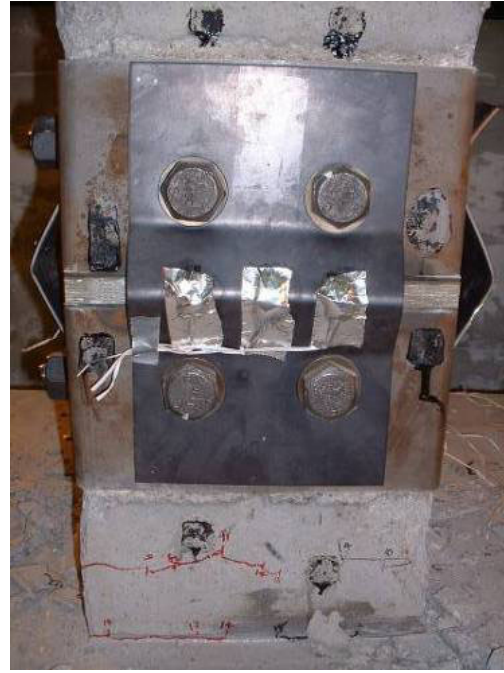
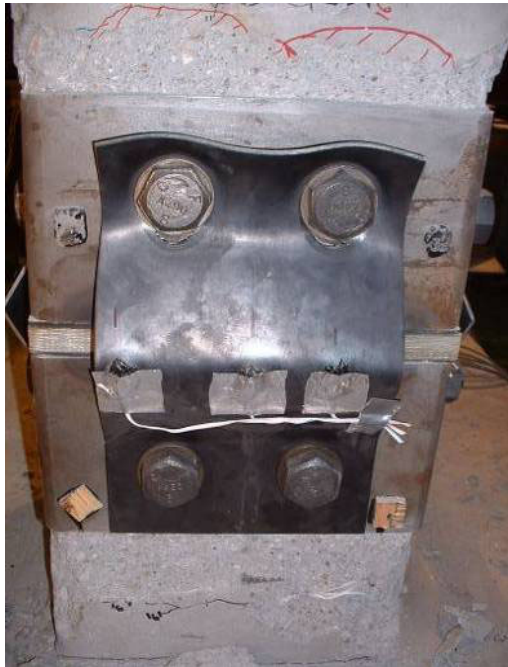
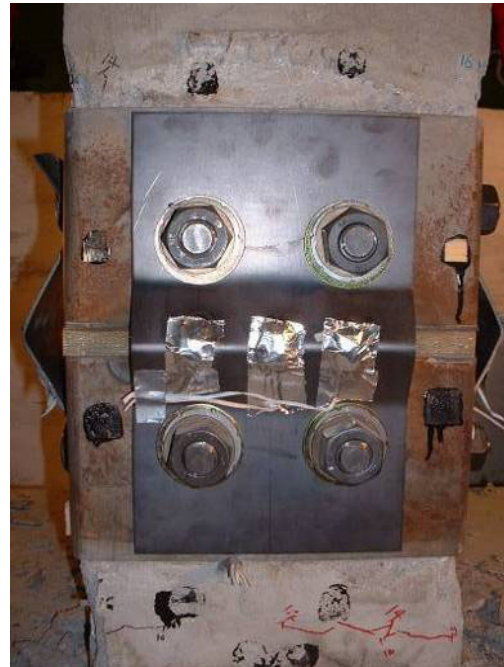
Figure 139. Photographs of Column 5 – Final damage after test.

a.) East face after test

b.) North face after test

c.) West face after test

d.) South face after test

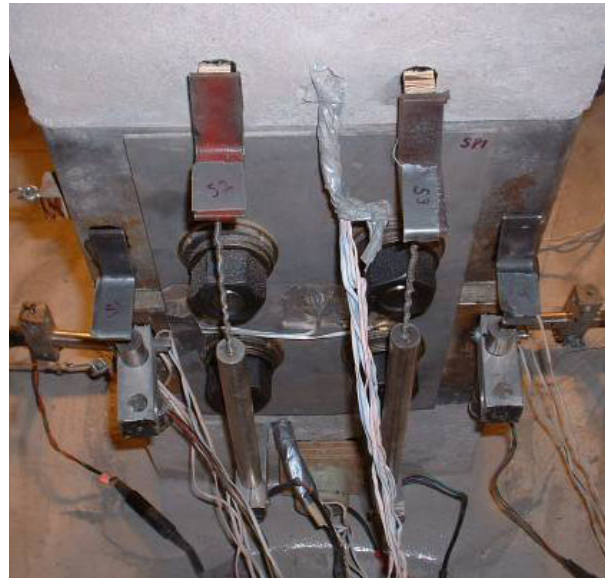
Figure 140. Photographs of Column 6 – Segment joint prior to testing.

a.) Northeast corner

b.) South face

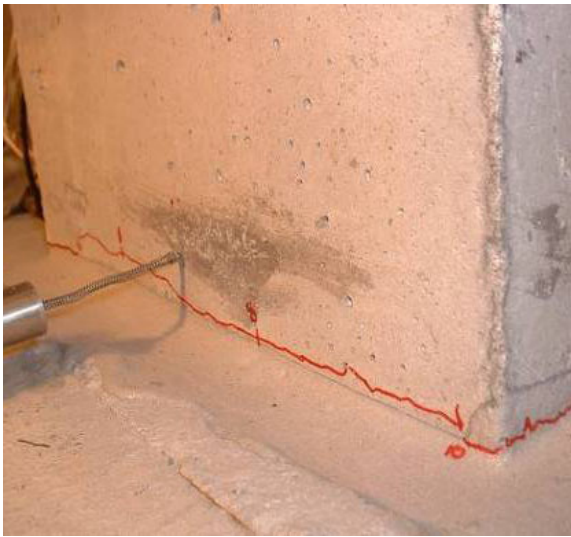
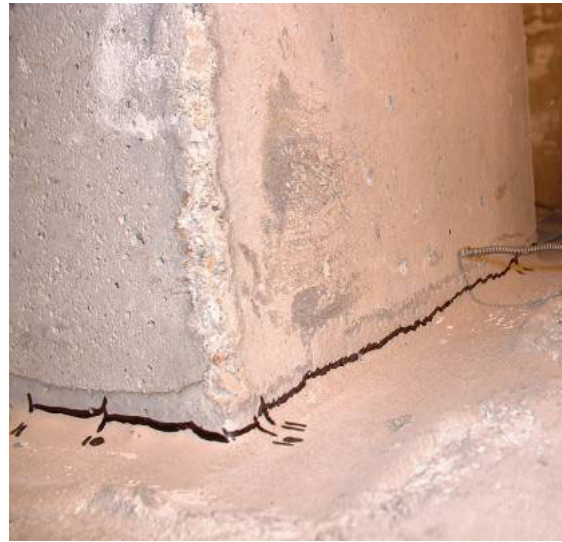
Figure 142. Photographs of Column 6 – Cycle 11a.

a.) East face initial cracking

b.) West face initial cracking

Cycle 8a (displacement = +/- 0.5 in.). Cracking across the entire base of the column (see Figure 142a), as well as cracks 6 in. and 18 in. above the base of the column, was observed on Cycle 10a (displacement = +/- 1.0 in.) on the east face of the column. Cracking across the west face was noted at the base on Cycle 11a (displacement = +/- 1.0 in.) (see Figure 142b). Additional cracking of Column 6 was noted on subsequent cycles until replacement of the fuse plates took place (see Figure 143). Relative to Column 5, Column 6 had a narrower opening of the construction joint up to this point. On Cycle 16a (displacement = +/- 2.5 in.), buckling in the plates was barely detectable due to the shape recovery of the SMA material. However, this was the predetermined cycle to replace fuse plates, so testing was stopped and new SMA fuse plates were mounted on the column. Up to this point, a peak horizontal load of + 7.22 kips had been applied to the column.

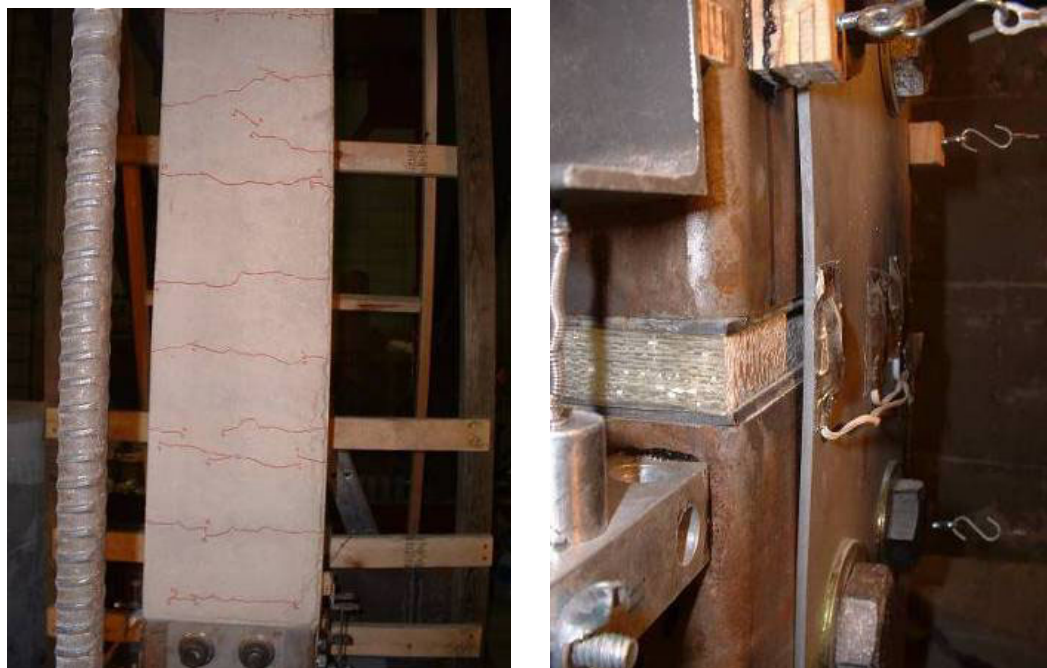
Figure 144. Column 6 – Cycle 16a.

a.) East face of upper segment crack distribution

b.) West fuse plate initial buckling

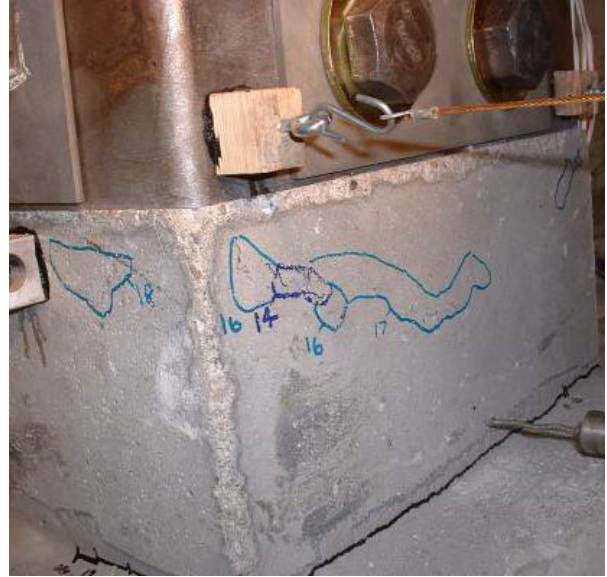
Figure 147. Photographs of Column 6 – Cycle 18b.

a.) Upper west column segment compression damage

b.) Northwest corner compression damage

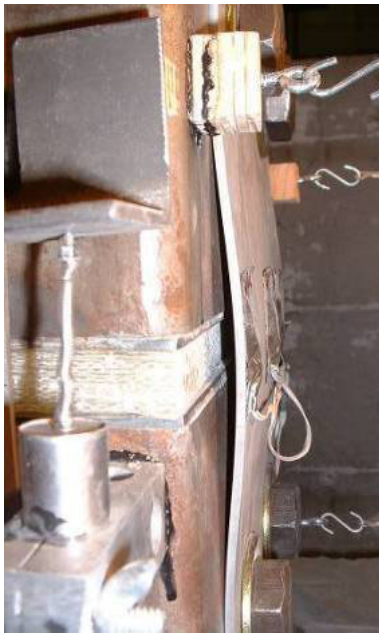
Figure 148. Photographs of Column 6 – Cycle 19b.

a.) West fuse plate buckling

b.) East face compression damage

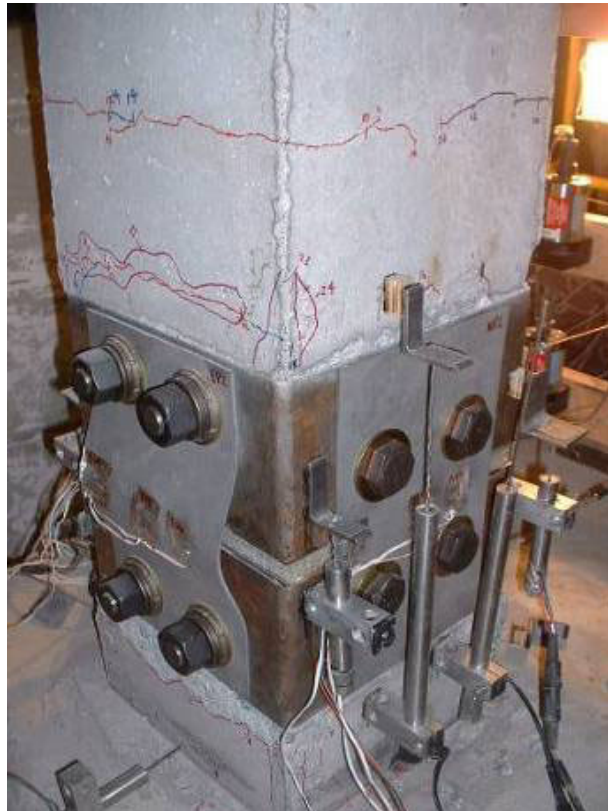
Figure 155. Photograph of Column 6 – Cycle 26b, column damage.

The damage to Column 6 up to Cycle 26b can be seen in Figure 155. Fuse plate buckling and joint opening that took place during Cycle 28b is illustrated in Figure 156. On Cycle 29b, the south fuse plate fractured below the top left bolt and washer at a displacement of -5.22 in. (see Figure 157a). This fracture was likely caused by the small-radius bending of the lateral plates due to buckling on previous cycles. Testing was continued until the -9.0 in. displacement on Cycle 29b (see Figure 157b), when testing was terminated; the column began to tilt perpendicular to the axis of loading due to the fractured fuse plate, and it caused the load beam to impinge on the load frame (see Figure 158).

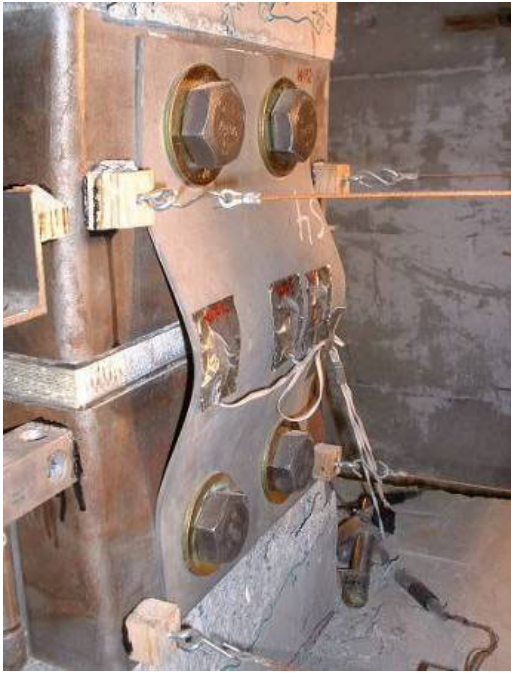
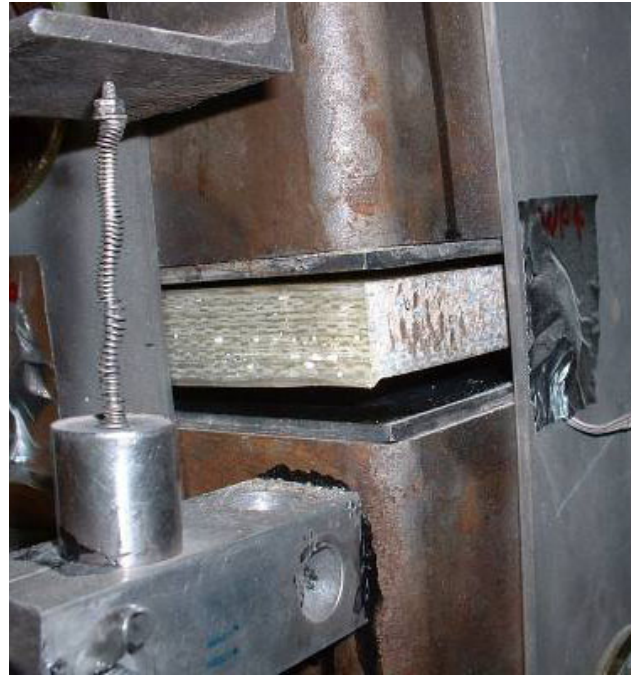
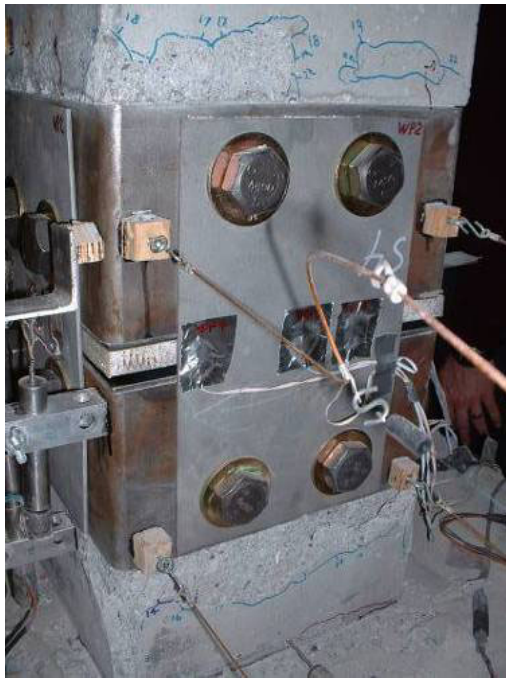
a.) West fuse plate buckling

b.) Northwest corner joint opening

c.) West face under tension

b.) East face under compression

Figure 156. Photographs of Column 6 – Cycle 28b.

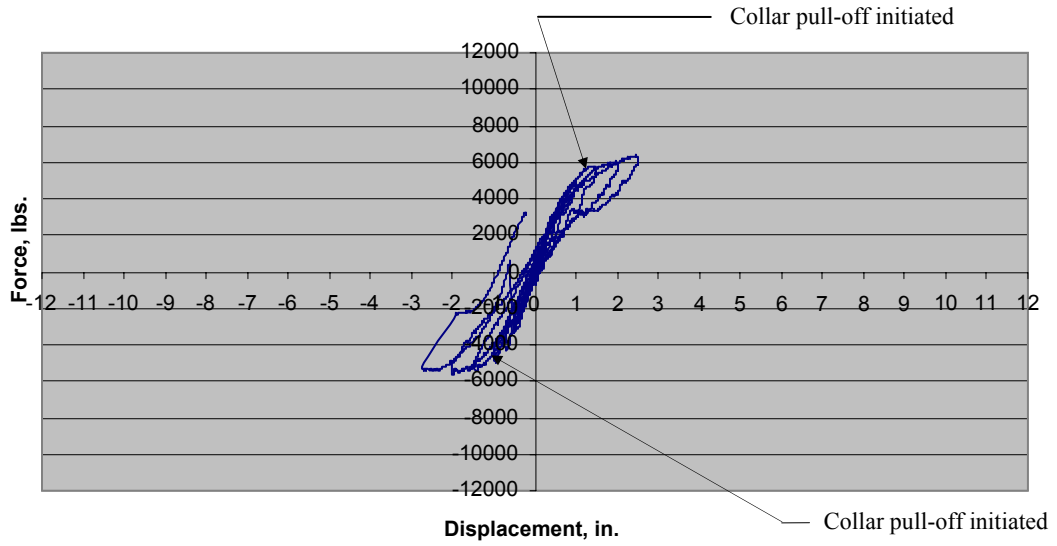
Figure 161. Test 2a load vs. displacement hysteresis.

Figure 162. Test 2b load vs. displacement hysteresis.

Figure 163. Test 3a load vs. displacement hysteresis.

Figure 164. Test 3b load vs. displacement hysteresis.

Figure 165. Test 4a load vs. displacement hysteresis.

Figure 166. Test 4b load vs. displacement hysteresis.

Results for Columns 2, 3, and 4 are not presented in Table 4 because their lateral load capacities were diminished due to the failure mechanism discussed previously. Lateral load versus lateral displacement hysteresis for each of these tests is shown in Figures 161-166.

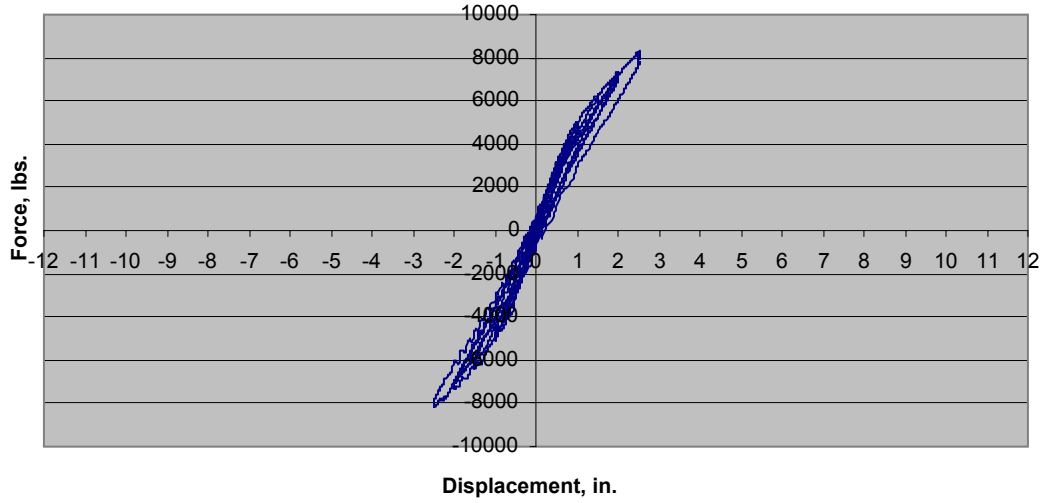
Figure 169. Test 6a load vs. displacement hysteresis.

Figure 170. Test 6b load vs. displacement hysteresis.

Column 6 sustained the largest loads of any of the columns tested. It resisted a maximum lateral load of - 10.48 kips on Cycle 23b at - 5.87 in. displacement on the negative (pull) half-cycle, while a + 10.13 kip load on the positive (push) half-cycle was achieved. Maximum loads on subsequent cycles for Column 6 remained at or above 90% in the positive direction and above 86% in the negative direction of the absolute maximum loads sustained during the test. Testing was stopped shortly after the fracture of the fuse plate on the south side of the column caused tilting perpendicular to the loading direction. Additionally, the full stroke of the actuator was achieved on the positive (push) portion of the loading regimen (see Figures 169 and 170).

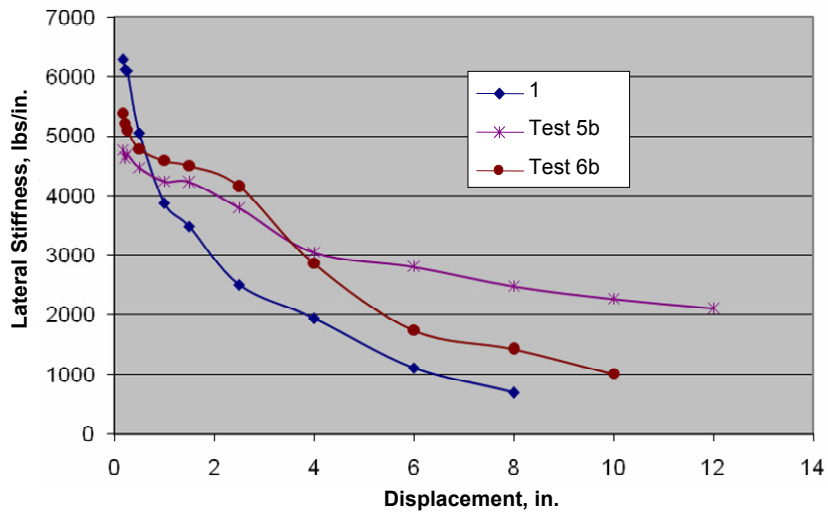
Figure 172. Test “b” lateral stiffness comparisons between Columns 1, 5, and 6.

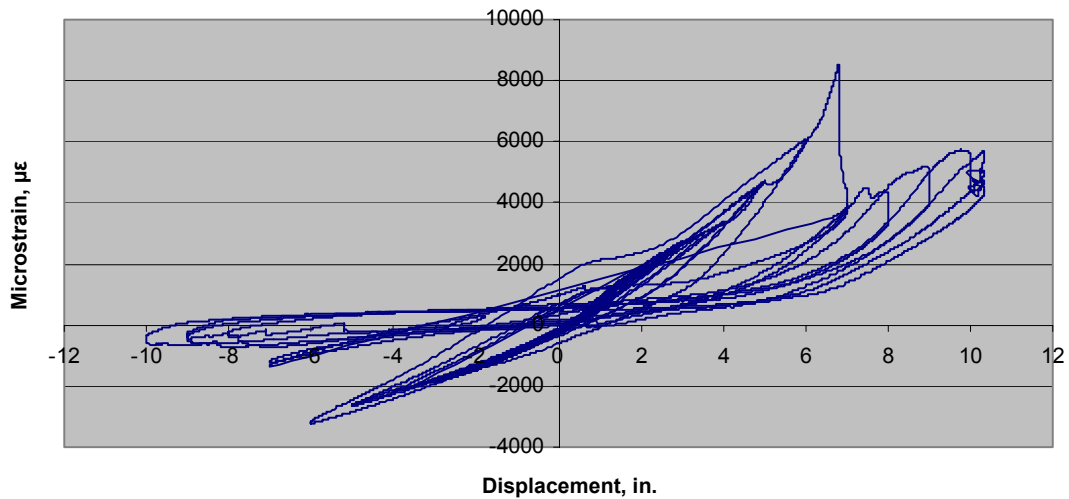
Figure 181. Column 6a lower segment longitudinal reinforcement strain.

Figure 182. Column 6b lower column longitudinal reinforcement strain.

Figure 183. Column 6a upper segment longitudinal reinforcement strain.

Figure 184. Column 6b upper segment longitudinal reinforcement strain.

As in Column 5, strain gages in Column 6 were located at the base section of the column on all six longitudinal reinforcing bars, as well as one ft. above the construction joint on all six reinforcing bars. The strain data presented in Figures 181-184 were measured on the northeast reinforcing bars in the lower segment and the upper segment. The data from the "a" portion of testing (Figures 181 and 183) indicate that the reinforcement in the upper segment remained well below yield strain while the bottom column gages recorded strains

approaching yield prior to fuse plate replacement. The data from the “b” portion of testing (Figures 182 and 184) indicate that the reinforcement in the bottom column segment reached maximum tensile strain in excess of 8,000 microstrain (Figure 182), while the top column reinforcement strains reached 4,000 microstrain in tension (Figure 184). These values help to explain the increased damage and residual displacements experienced by Column 6.
