## Through-Thickness Reinforcement and Repair of Carbon Fiber Based Honeycomb Structures Under Flexure and Tension of Adhesively Bonded Joints

THROUGH-THICKNESS REINFORCEMENT AND REPAIR OF CARBON FIBER BASED HONEYCOMB  
STRUCTURES UNDER FLEXURE AND TENSION OF ADHESIVELY BONDED JOINTS

MASTER OF SCIENCE

MECHANICAL ENGINEERING

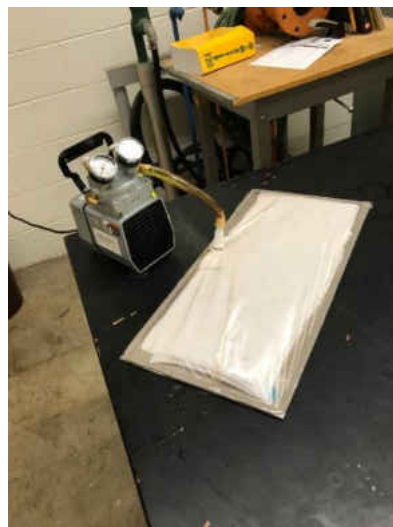
Figure 5: Fabrication process: (a) layup of sandwich panel and (b) vacuum bagged panel

The materials required for fabrication included two aluminum plates to be used as tools (top and bottom tools), tacky tape, vacuum bagging sheet, high temperature peel ply, breather material, flash tape, a vacuum port, and the raw supplies (unidirectional carbon fiber prepreg from Fibreglast, Nomex honeycomb from Rock West Composites, Loctite EA 9696 epoxy adhesive film, and teflon) (Figure 5). The equipment used in fabrication included a vacuum pump and Wabash Genesis series heat press. (Figures 6)

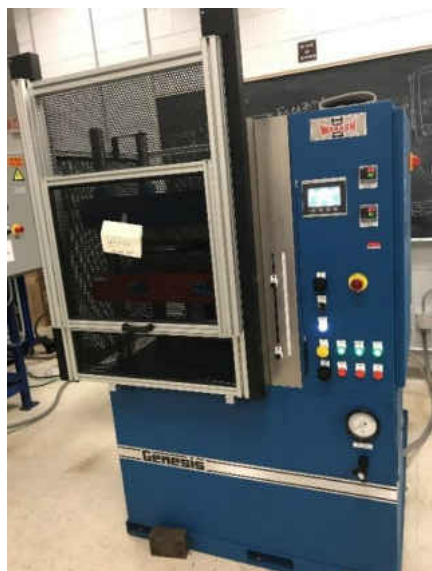
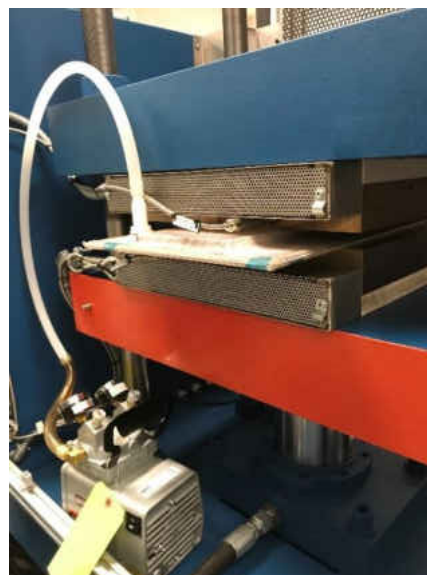
Figure 6: Curing process: (a) Heat press (front) and (b) heat press (rear)

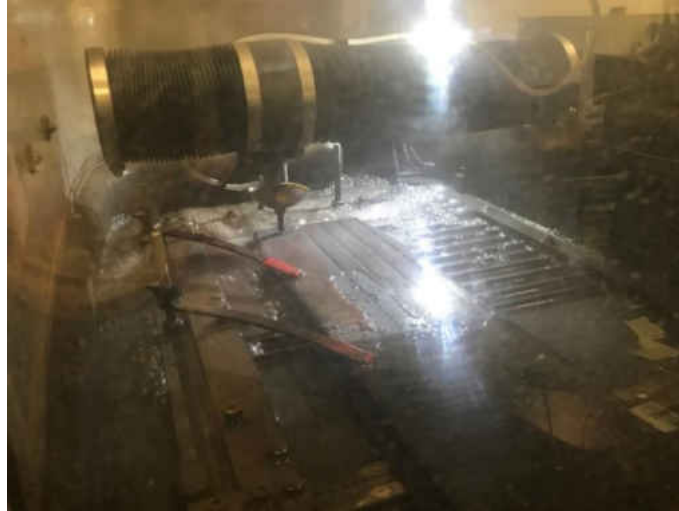
*Figure 7: Waterjet cutting of a panel*

There were three different types of manufactured plates, as each plate was either pristine, disbonded, or delaminated. Each plate was then cut into five samples lengthwise, as the center 6.2" x 21" were of concern and the edge effect on all four sides were cut off, as the plates were oversized. Cutting was performed through the use of an OMAX ProtoMAX waterjet cutting machine. A 1.040" separated each cut, as the machine is accurate with position to the thousandth of an inch, and 40 thousandths of an inch was found through experimentation to be the cut thickness (Figure 7). Waterjet cutting provided many benefits in this stage of fabrication, as opposed to other conventional methods. Low heat, CNC capabilities, cleanliness, and safety are among the top reasons for this method of cutting. A disadvantage with this specific machine is that its cutting limitations are on a 12" x 12" platform. This did not prove to be too great of an issue, given the size of an object that could be laid flat in the machine is approximately 24" x 14". Once all the cutting was performed from one side to just over the half-way point, the plate was simply flipped around and aligned with the cutting path so that the five samples could have the second half of the cutting completed.

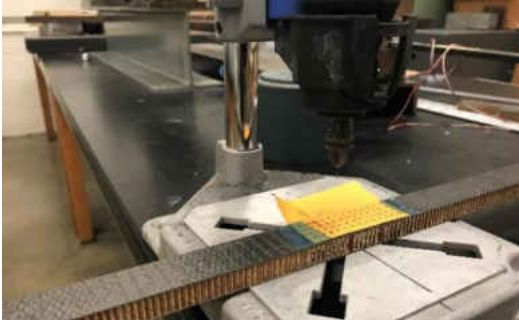
Figure 10: Drilling setup for TTR

The process of conducting through thickness reinforcement, either in a manner of repair or reinforcement is the same. In the center three inches of the sample, a grid pattern of 0.75mm holes are drilled through the facesheet in the area of concern with a rotary tool attached to a press, acting like a traditional drill press (Figure 9). Once these holes are drilled, the sample is cleared of the carbon / epoxy dust by blowing it off and then wiping it with acetone so that the epoxy can have an effective cure in a future step. At this point, 0.5mm pultruded carbon rods are cut to approximately 3/4" so that they may be placed in the drilled holes and allowed to stick out (it is better for the rods to be too long rather than too short). A good visualization of the placement of these rods is shown in Figure 10, where the carbon rods are acting as a repair on an eight ply facesheet sample with a delamination and propagated crack. Once the cut rods are in place, a two part epoxy is mixed and applied to the region, allowing for the bonding of the rod to the facesheet and honeycomb core (Figure 11). Once fully cured, the excess carbon rods and resin above the top surface of the facesheet are sanded down so that the repair may be better analyzed.

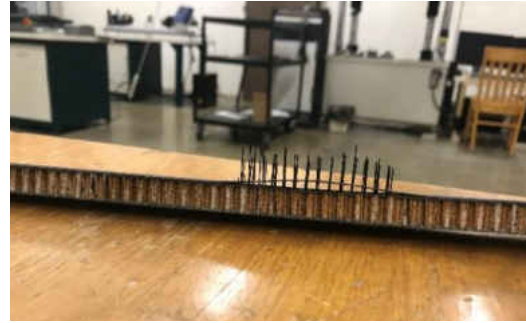
Figure 9: TTR applied to critical area

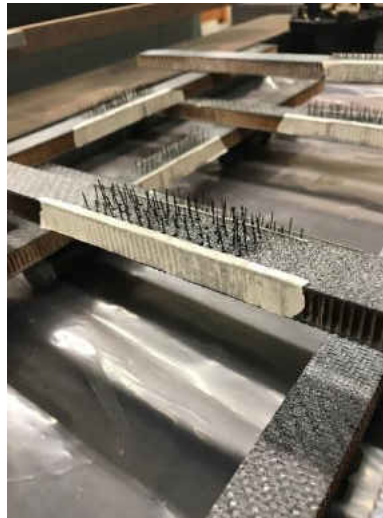
Figure 11: TTR curing process

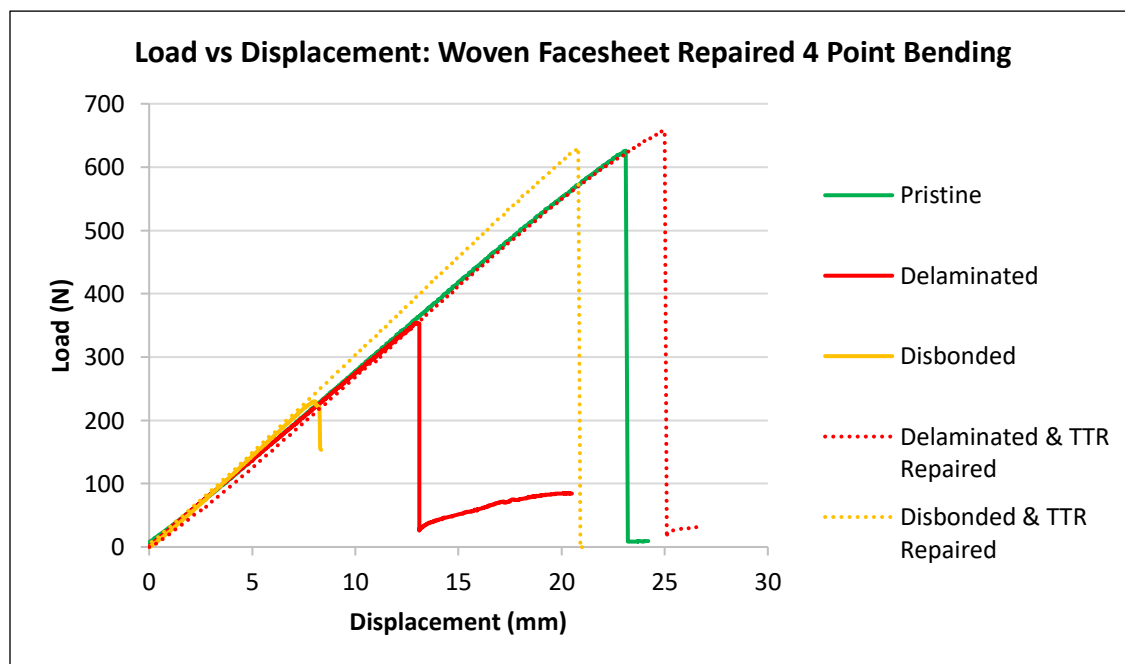
Figure 17: Mr. Suresh's graph comparison of TTR repaired samples to controls

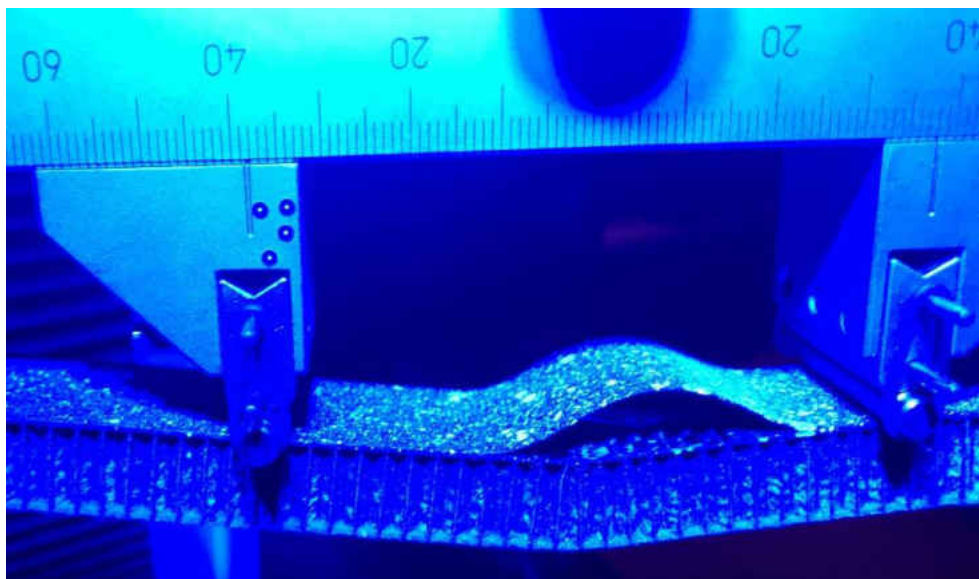
Figure 23: Failure of 4 ply unidirectional delaminated sample

Delaminated 4-Ply Unidirectional Samples			
Sample	Max Load (N)	Stiffness (N/mm)	Failure Type
4U-DEL-1	250	23.311	Crack Propagation
4U-DEL-2	266	24.186	Crack Propagation
4U-DEL-3	264	23.857	Crack Propagation
Average	260	23.785	
Standard Deviation	7.12	0.36

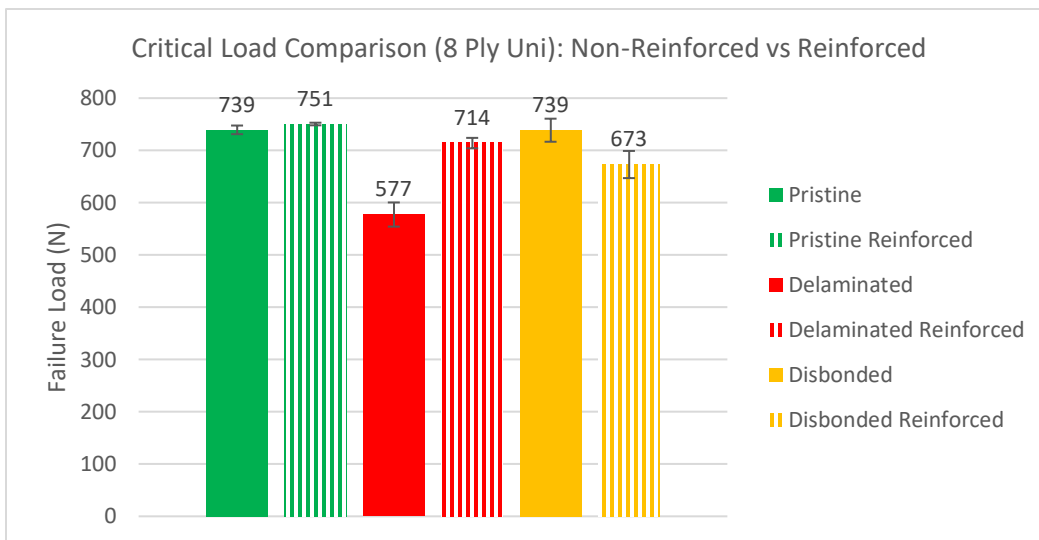
Figure 30: Comparison of unidirectional non-reinforced and reinforced eight ply samples

Upon testing of the eight ply facesheet samples, a noticeable difference in stiffness and load carrying capacities was observed. Figures 29 through 32 show the loading charts and graphs of the different sample types within the eight ply facesheet design and can be used in comparison to the previously shown charts and figures.

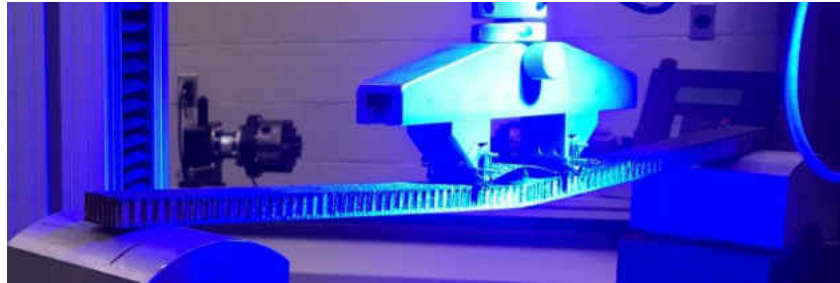
Figure 36: Failure of 8 ply unidirectional delaminated sample

Delaminated 8-Ply Unidirectional Samples			
Sample	Failure Load (N)	Stiffness (N/mm)	Failure Type
8U-DEL-1	603	51.149	Crack Propagation
8U-DEL-2	582	51.013	Crack Propagation
8U-DEL-3	547	49.581	Crack Propagation
Average	577.333	50.581	
Standard Deviation	23.099	0.709

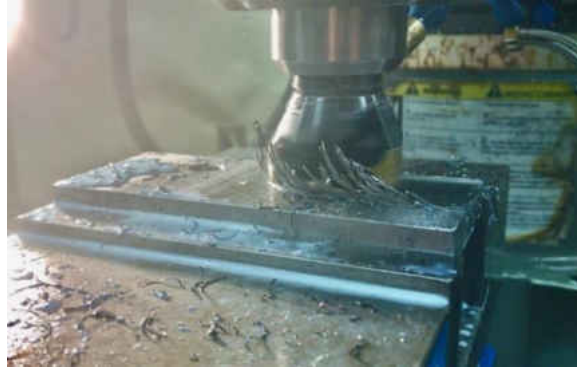
*Figure 54: Machining of end adaptor plate in ODU's machine shop*

Since all facesheet plies were to be unidirectional and the joint area was oriented in a  $0^\circ$  manner, a very high load and stiffness was expected. In response, an end adaptor made of 4140 steel, rather than aluminum, was chosen. This would help increase critical load of the sample (should it approach the limits of the selected end adaptor material), decrease deflection within the end adaptor, and reduce material cost. Due to the size of our chosen aluminum plate tool, it was only feasible to manufacture a plate that could only make two samples at a time. An end adaptor was designed that would allow for at least two samples to be made from it, have a pinned connection, and have at least 1" by 2.5" of adhesive bond. The ODU machine shop machined these adaptors (Figures 53 and 54).

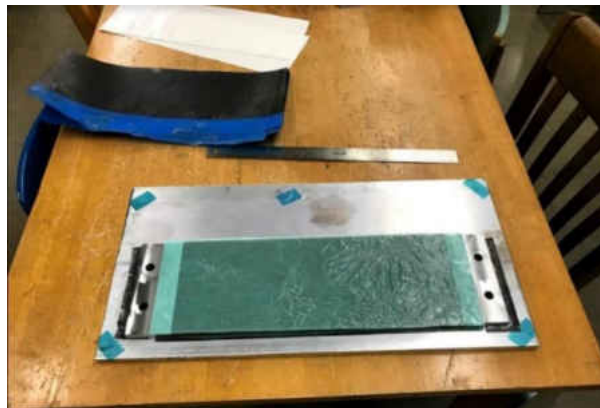
*Figure 55: Fabrication of a double lap joint panel*

For construction of the plates, a traditional layup method was used, as a full plate without a gap or joint was initially made. As mentioned before, the facesheets on each side were six plies, all with a  $0^\circ$  orientation. Just as in the four-point bending samples, the same 0.460" thick Nomex honeycomb material was used for the core, as was the Loctite EA 9696 adhesive film. An added element to the layup was the insertion of the steel end adaptors. Careful consideration of the alignment of the steel end adaptors was taken. Figure 55 shows the basic layup procedure with separate plies of carbon fiber prepreg laid underneath the adaptors with a teflon layer between to prevent curing to the adaptors.

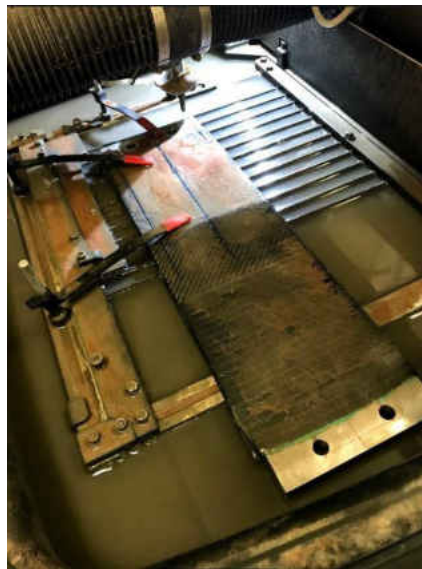
*Figure 58: Cutting of double lap joint panel with waterjet machine*

Once the joints are cured, the plate has a second round of cutting in the waterjet machine (Figure 58). A line is carefully drawn up the center of the plate length-wise, where the plate is cut up the center and  $\pm 2.540''$  offset from that center line. Due to the non-uniformity of the materials in the plate, a shorter 2.75'' cutting path was made to cut through the steel end section while a quicker 12'' cutting path did the rest of the cutting past the center of the plate. Just like the four-point bending samples, the plate was longer than 12'', which required the plate to be flipped around, lined up, and cut from the other side.

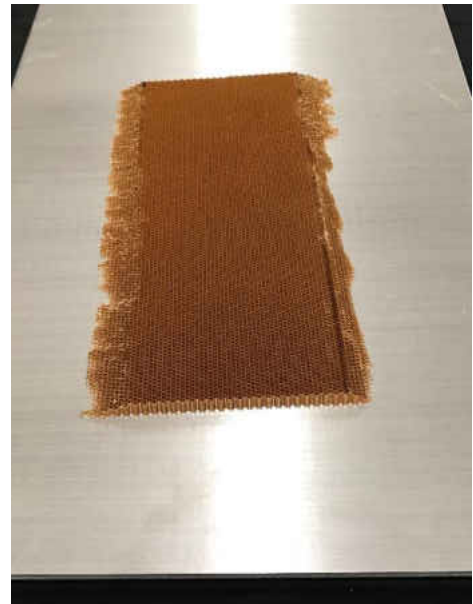
Figure 62: Tapered cutting attempt of honeycomb core

pressure parameters, which were programmed to the curing cycle. Unfortunately, this panel did not turn out so well, due to a lack of autoclave fabrication experience (Figure 61). This led to research of the caving in problem, where a solution in tapering was brought to my attention. From a study performed by the Hexcel Corporation, a tapered angle of 30 degrees or less to the tool side was found to be ideal and to prevent caving in of the composite panel. [25] Some disadvantages of this tapering method include the amount of material waste, the time and tooling required to make the tapered cuts, and the amount of space that would be taken up on the 12" by 24" tool plate. There was simply not going to be enough room for a sample with a tapered core. This theory was tested with a core cut by hand (it wasn't pretty), and it was clear that another solution had to be devised (Figure 62).

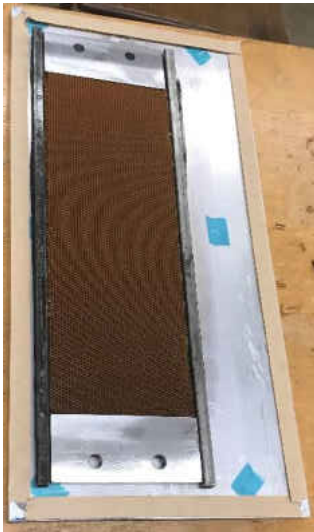
*Figure 63: Panel with steel side supports*

In an effort to reduce or eliminate the caving in of the honeycomb core at its width, a 0.5" by 0.5" tube stock of steel would be cured in at the sides of the panel. These tubes would help to support the sides, acting as a tool that becomes a part of the composite structure (Figure 63). This method proved successful by saving time, money, space, and this project as a whole. Figure 64 shows the results of this method, where a slight bow in the tubing (or small caving in) occurred; however, this still leaves the structure very rectangular in shape and allows for the center 5.04" to be used in this experiment.

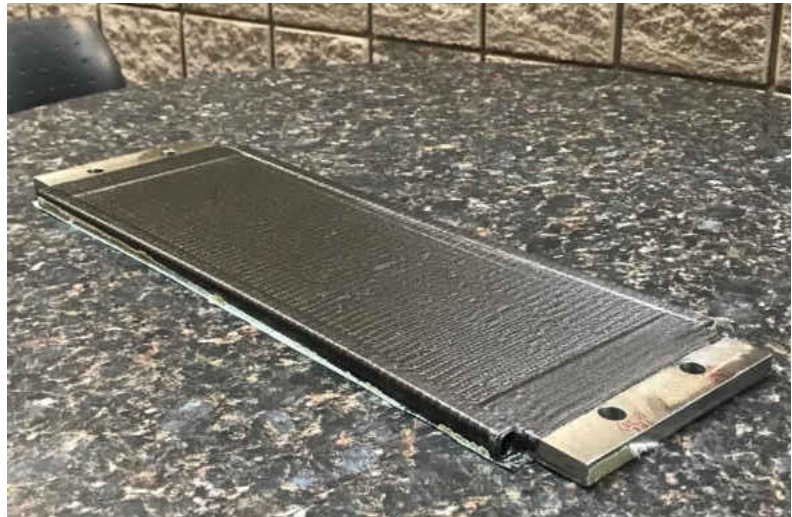
*Figure 64: Successful curing of a panel in the autoclave*

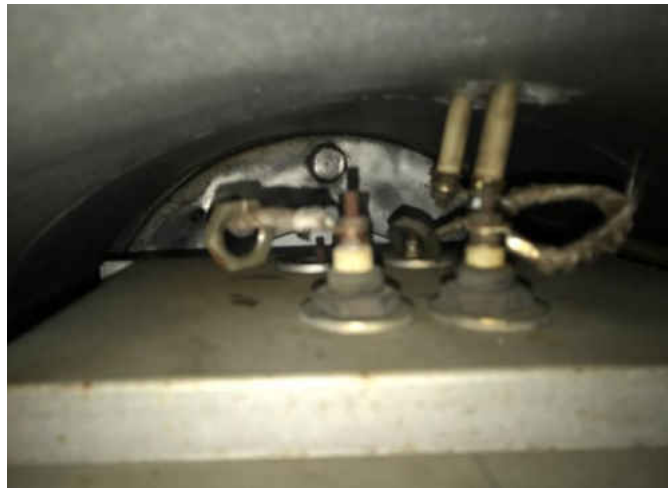
*Figure 65: Wiring issue with autoclave*

what could be the root cause of the issue. A wire had come loose from one of the top four posts on the heating element and had welded itself to the top of the element, creating a short circuit (Figure 65). A new fuse was ordered, along with new high temperature 8 gauge wire. What would seem like a simple wire replacement would soon become more complicated.

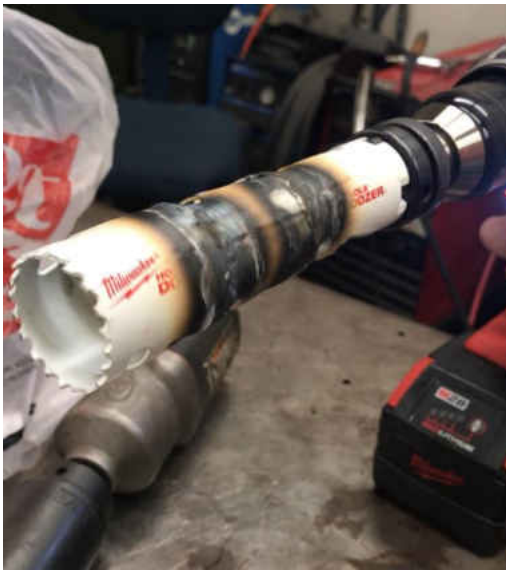
Figure 66: Custom tool made for repairing of autoclave

the solution to cut through the wall around the pipe with a hole saw, although a very brute approach, was determined to be the best solution. A repair for the hole being made was thought out well in advance of the first cut, as it was important to also improve the machine's future serviceability. As the insulated wall was very thick, a special tool had to be made in order to make this cut. Three Milwaukee hole saws were machined in necessary places and then welded together to form one long hole saw (Figure 66). This hand-made tool was successful in making the cut through the wall without touching the pipes connected to the heating element (Figure 67). This allowed the heating element to then be able to come out of the autoclave, and the remaining material of the insulated wall that clung around the pipes was cut off with an angle grinder.

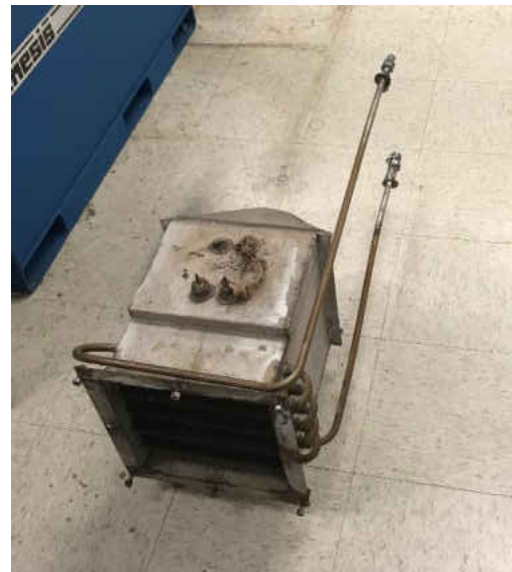
Figure 67: Heating element removed from autoclave

Once the necessary parts were taken out of the autoclave in order to access the heating element, another access problem became apparent. The inside diameter of this machine is approximately 18.25", and the heating element is rectangular on all sides with a front face diagonal dimension very close to this 18.25". This makes it very difficult to put a hand in, much less turn a wrench, as the heating element could not be easily moved out due to its connection to the water pipes, which had fittings on the other side of an insulated aluminum wall.

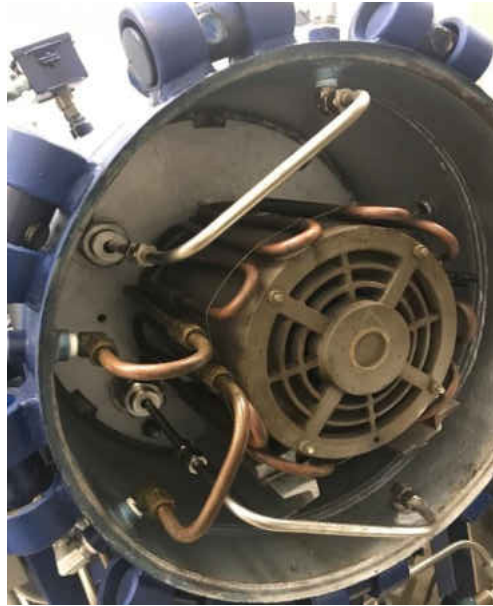
*Figure 68: Repair of Autoclave*

The solution was to fill the hole with a 1.5" threaded rod with the center 1.0625" bored out to allow for the pipes and fittings to pass through their holes. On each end of the rod would be a washer and two nuts compressing high temperature JB Weld putty that would help to seal off the insulation from the pressurized chamber. On the side of the wall where the fittings were present, two aluminum inserts would wrap around each pipe and press into the bored threaded rod to allow for air flow that was choked to the manufacturer specifications, having an inner diameter of 0.75" (Figure 68).

Now a repair was to be made to the structure, as permanent damage was done. The wall contains a fiberglass insulation, held in place by material similar to chicken wire and sandwiched

between two aluminum walls, the first almost half an inch thick, with the other being much thinner. It is important to note that the insulation was isolated from the chamber pressure because when pressure comes into contact with fiberglass, it gets compressed and loses its effectiveness for thermal insulation. Another important aspect is the original size of the hole. Two half inch outer diameter pipes went through the insulated wall via 0.75" inner diameter holes that sealed off the insulation. This dimension would be critical, in that all mass air flow into the curing chamber goes through these two holes. It would also be important to maintain the original manufacturer specifications to minimize the hot air allowed back in past the insulation wall, as that area houses a fan that must be kept cool.

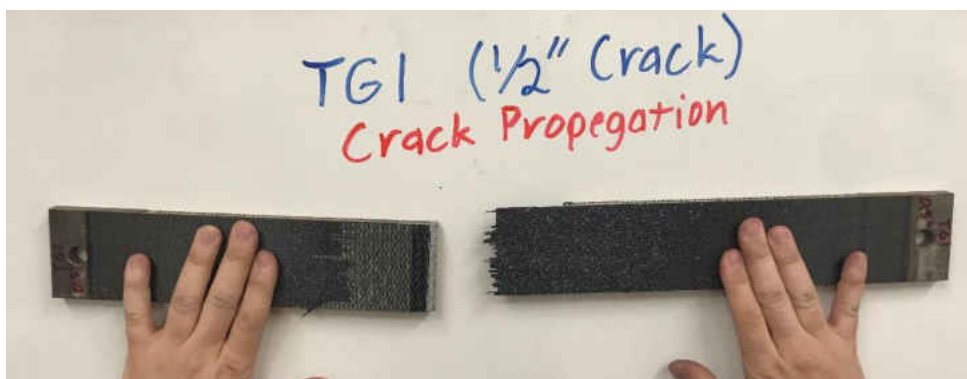
All non-reinforced 1/2" crack defected samples showed major crack propagation. Furthermore, signs of prevented crack propagation were present in the TTR reinforced 1/2" crack defected samples. Further knockdown in load capacity and a fairly constant stiffness were observed when compared to the 1/4" crack defected samples with and without TTR reinforcement. The recorded data and images of the failure types for these samples are in the table and figures below.

Figure 80: Crack propagation failure of a double lap joint 1/2" defect sample (front)

Figure 81: Crack propagation failure of a double lap joint 1/2" defect sample (side)

Figure 82: Crack propagation failure of a double lap joint 1/2" defect sample (back)

Figure 83: Prevented delamination of a double lap joint 1/2" defected sample (front)

Figure 84: Prevented delamination of a double lap joint 1/2" defected sample (side)

1/2" Teflon Crack			
Sample	Maximum Load (lbf)	Stiffness (lbf/in)	Failure Type
TG1	11297	101470	Major Delamination
TG2	12513	101045	Major Delamination
Average	11905	101258	
Standard Deviation	608	213	
% Difference to Pristine	-20.2%	13.9%

1/2" Teflon Crack with TTR			
Sample	Maximum Load (lbf)	Stiffness (lbf/in)	Failure Type
TG3	12787	100212	Prevented Delamination
TG4	11999	92214	Prevented Delamination
Average	12393	96213	
Standard Deviation	394	3999	
% Difference to 1/2" Crack	4.1%	-5.0%

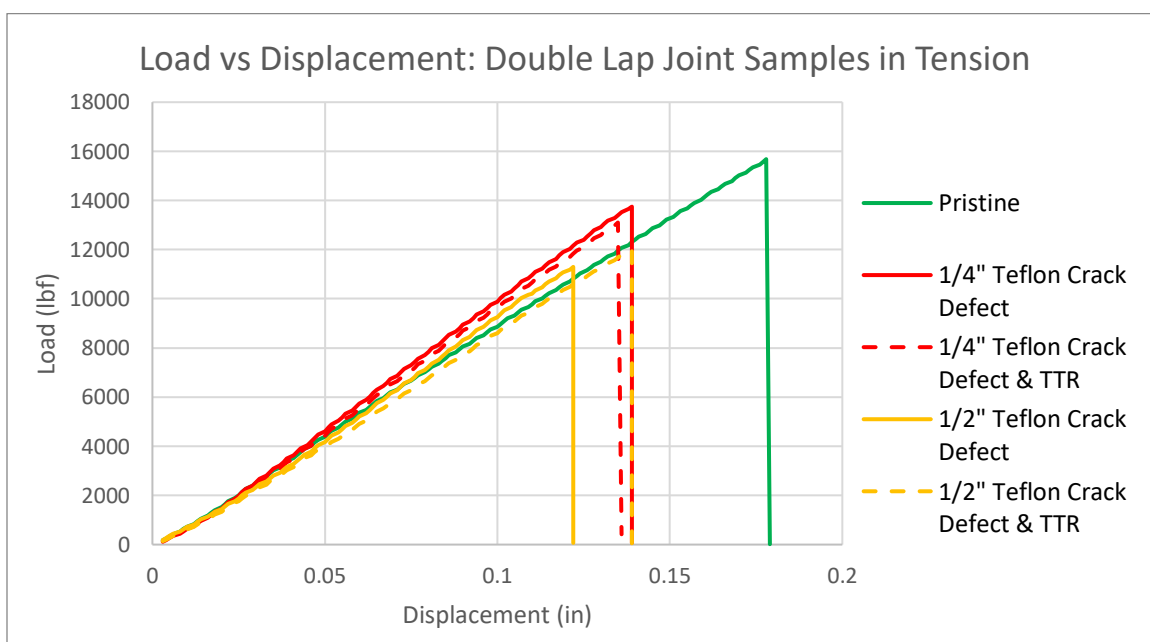
Figure 85: Load vs displacement curves for double lap joint samples

When combining the loading data together across all sample types, Figures 85 and 86 are obtained. In the load vs displacement graphs, a small deviation in the stiffness among samples is shown, in addition to the differing peak load values. The bar chart displays the average failure loading values of each group of samples, along with their standard deviations.

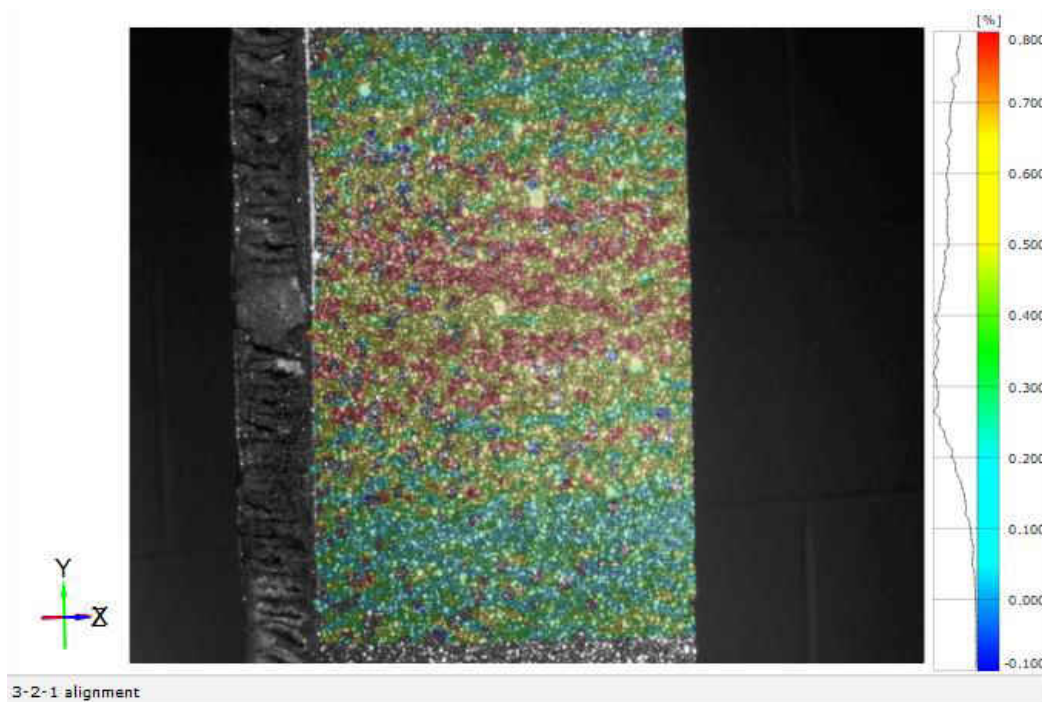
Figure 90: DIC strain image of a DLJ sample with a 1/2" delamination before failure

Figure 91: DIC strain image of a DLJ sample with a 1/2" delamination and TTR before failure

When looking at the strain images, a few interesting findings came from the DIC. Figures 87 through 91 show the visualized strain for all different sample types in this study. Prior to failure of the pristine sample, the strain appears to build up on each side of the 0.1" gap. This could be explained by the sudden geometry changes that occur in this region and how the sample goes from ten plies of thickness to four and back to 10 at this joint section.
