Mechanical Properties of Retrieved Highly Cross-linked Polyethylene Acetabular Liners in Total Hip Arthroplasty

Gurpreet Singh, The University of Western Ontario

Supervisor: Brent Lanting, *The University of Western Ontario* Joint Supervisor: Robert Klassen, *The University of Western Ontario* Joint Supervisor: Douglas Naudie, *The University of Western Ontario* A thesis submitted in partial fulfillment of the requirements for the Master of Science degree in Surgery © Gurpreet Singh 2017

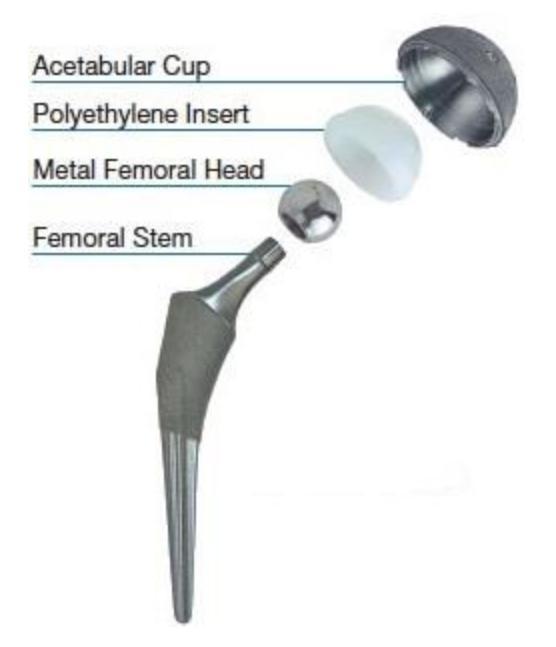
Figure 1-6 - Metal on polyethylene total hip replacement. (Permission from Total Hip Arthroplasty (THA). OrthopaedicsOne Clerkship. In: OrthopaedicsOne - The Orthopaedic Knowledge Network. Created Dec 13, 2010 21:12. Last modified Dec 14, 2010 09:10 ver.3. Retrieved 2017-06-01, from http://www.orthopaedicsone.com/x/-oDYAg.)

Metal femoral head on ultra-high-molecular-weight-polyethylene (UHMWPE) acetabular liner has been the most common bearing surface in THA (Figure 1-6). In THA, the acetabular cartilage is replaced with a hemispherical metal acetabular shell which fits into the patient's acetabulum. A UHWMPE polyethylene liner is locked into the acetabular metal shell. On the femoral side, the native head is removed and a metal stem is inserted into the intramedullary canal of the femur. A metal head is placed on to the neck portion of the stem. The modularity in the modern components gives multiple options to match the patient's anatomy and restore function. From a fixation standpoint, cementless and cemented fixation options exist for the acetabular shell and the femoral stem. Cementless fixation is preferred for young patients with good bone quality, while cemented fixation is used for older patients with osteopenic/osteoporotic bone.

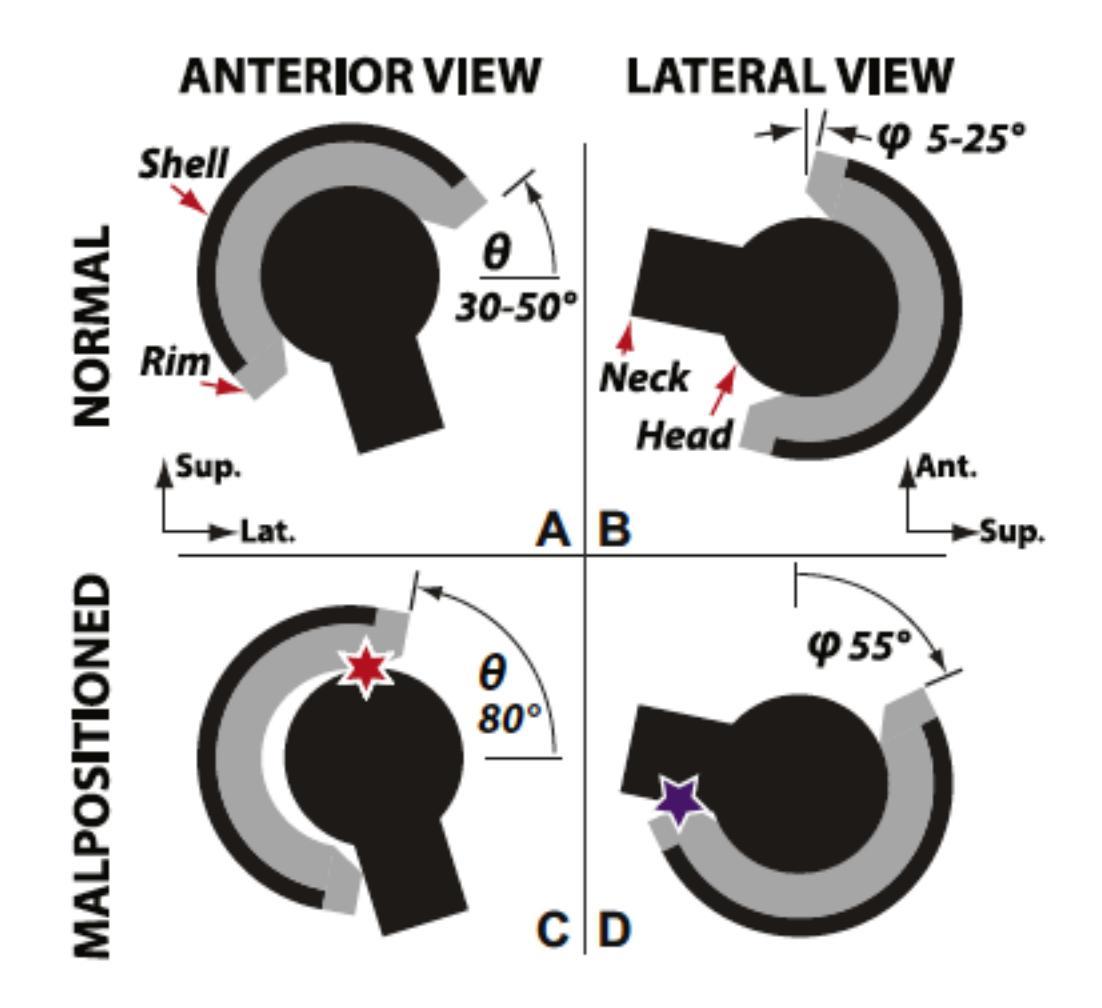
Figure 1-7 - A and B show an acetabular component with normal abduction and anteversion angle respectively. C and D show an excessively abducted and anteverted acetabular component. (Permission from Furmanski J, Anderson M, Bal S, et al. Clinical fracture of cross-linked UHMWPE acetabular liners. Biomaterials. 2009;30(29):5572-5582.)

The acetabular component position can influence center of rotation of the articulating femoral head. The center of rotation of the femoral head should be restored to its predisease position, usually by medial positioning of acetabular shell. This effectively increases the lever arm of the abductors, decreasing joint reactive forces, ultimately resulting in decreased wear of the UHMWPE liner. The abduction angle is chosen to match the patient's anatomy of around 40 degrees to maximize the range of motion. The more vertical placement or increased abduction angles can result in edge loading of the acetabular component and decreased range of motion before impingement (Figure 1-7). Excessive anteversion can result in impingement of the prosthetic neck on the posterior side of the acetabular rim during extension and external rotation, resulting in anterior dislocation (Figure 1-7). Conversely, inadequate restoration of anteversion of the

acetabular component leads to neck impingement on the anterior acetabular rim during flexion and can result in posterior dislocation.

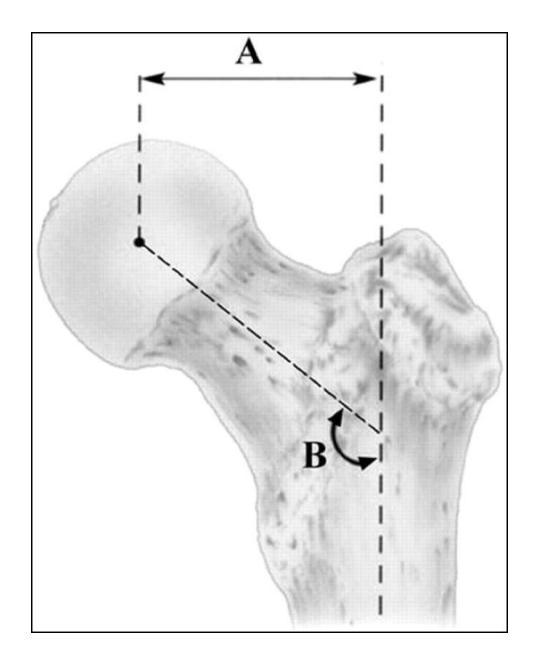
Figure 1-8 - Femoral offset is represented by the perpendicular distance "A" from the center of the femoral head to the long axis of the femur. The neck-shaft angle is represented by angle "B," which subtends the long axis of the femoral neck and the long axis of the femoral shaft. (Permission from Charles M, Bourne R. Soft-tissue balancing of the hip. J Bone Jt Surg 2004;86:1078–88. doi:10.1054/arth.2002.33263.)

Femoral offset is defined as the distance between the center of the femoral head and the long axis of the femur. Restoration of offset is important in hip biomechanics by appropriate tensioning of the abductor muscles (Figure 1-8).

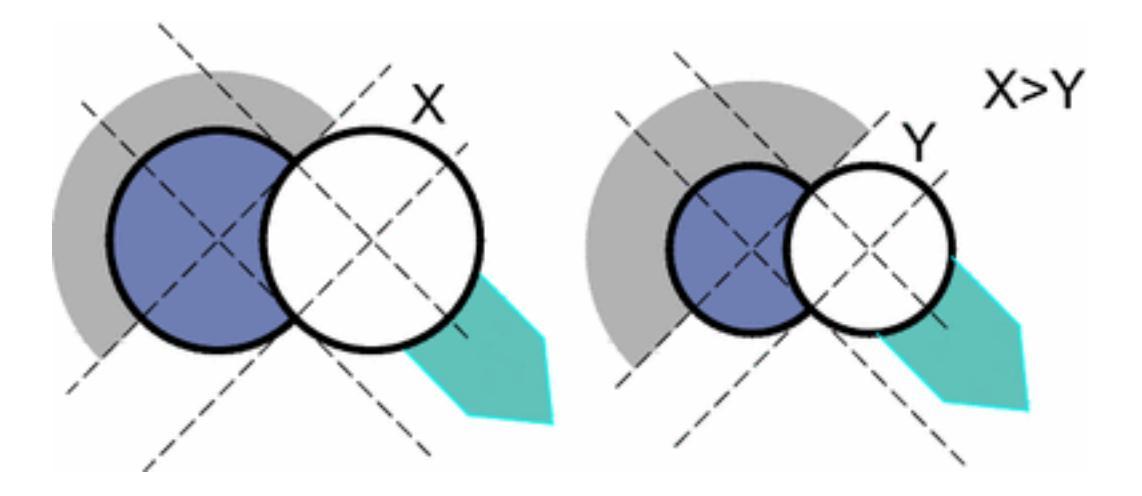
Figure 1-9 - Demonstrated above is the increase in jump distance with an increase in femoral head size. (Permission from Veitch SW, Jones SA. (v) Prevention of dislocation in hip arthroplasty. Orthopaedics and Trauma 2009 200902;23(1):35-39.)

The head to neck ratio, which is the ratio between the diameter of the prosthetic head and neck, is another important factor to consider. The increase in head diameter relative to the neck increases the jump distance before dislocation, reducing the incidence of dislocation (Figure 1-9). However, this comes at the expense of increasing volumetric wear of UHMWPE with increased head surface area articulating against the acetabular liner.

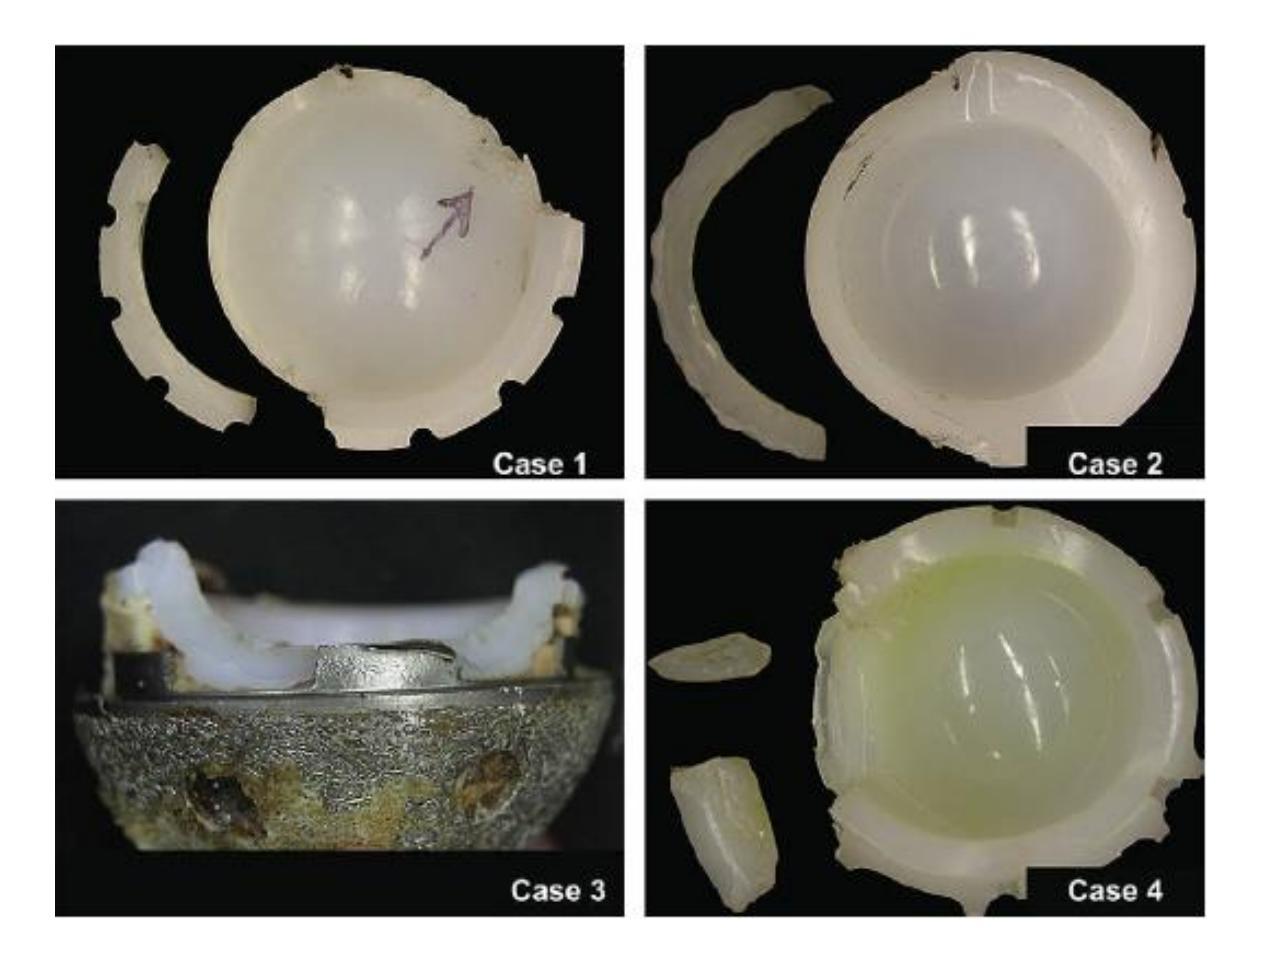
Figure 1-10 - Demonstrated above are the fractures at the rim of HXLPE liners. (Permission from Furmanski J, Anderson M, Bal S, et al. Clinical fracture of crosslinked UHMWPE acetabular liners. Biomaterials. 2009;30(29):5572-5582.)

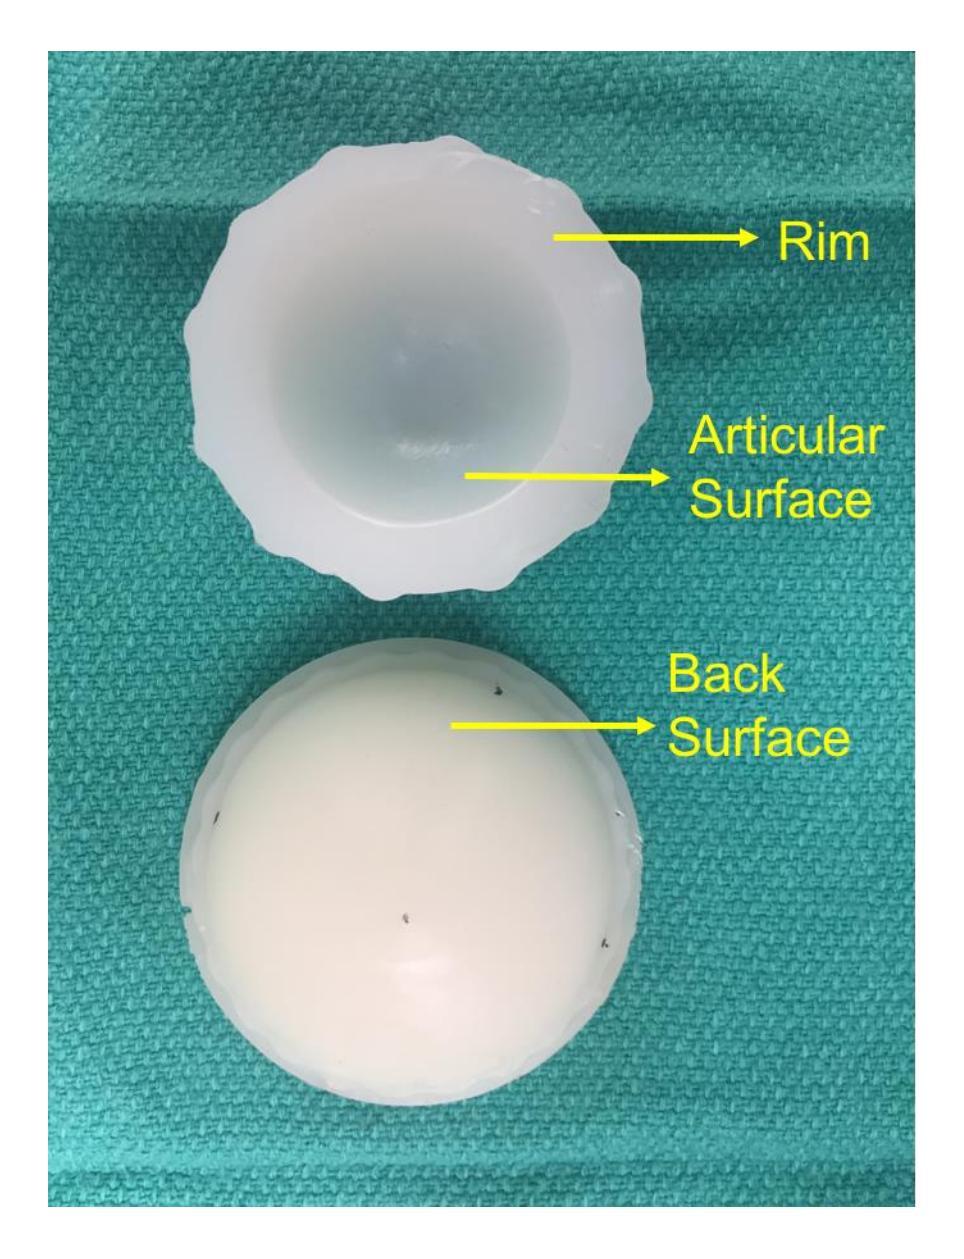
Figure 1-11 - Different regions of the polyethylene liner are labeled.

The objective of this masters is to better our understanding of the fractures at the rim (Figure 1-11) of the HXLPE liners. Implant retrieval analysis have shown clear evidence of oxidation at the rim of HXLPE acetabular liners with increasing time in vivo.

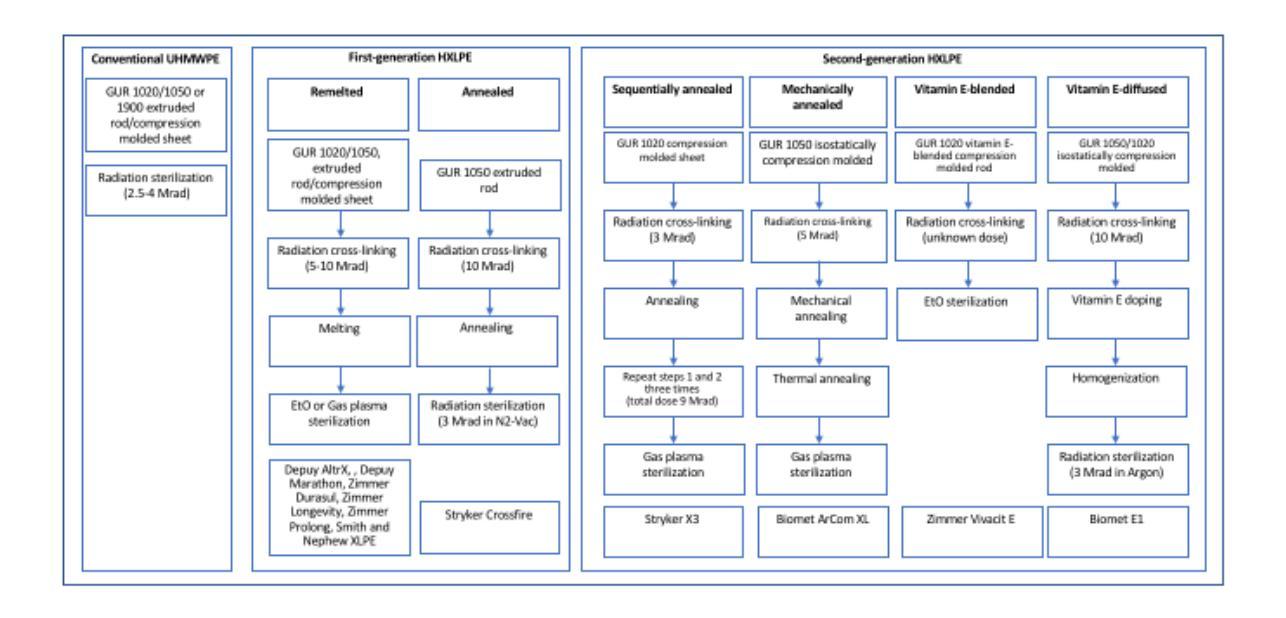
Figure 2-2 - Schematic depiction of manufacturing of UHMWPE in THA. (Modified with permission from Oral E, Muratoglu OK. Vitamin E diffused, highly crosslinked UHMWPE: a review. Int Orthop 2011; 35: 215–23.)

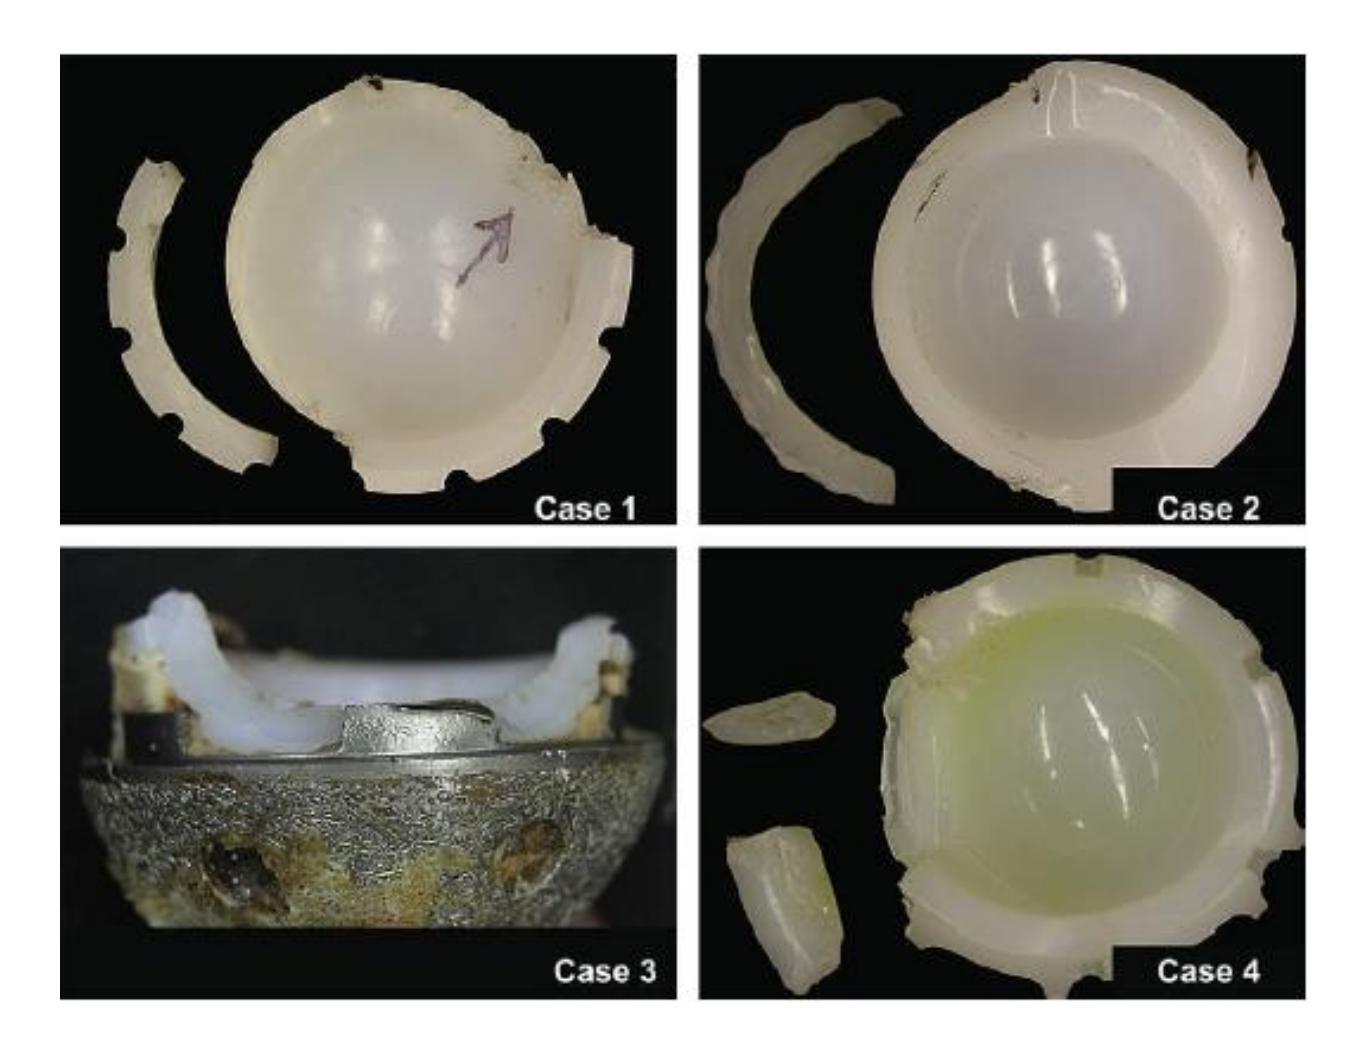
Figure 2-3 - Pictures demonstrating fractures of HXLPE liners (Permission from Furmanski J, Anderson M, Bal S, et al. Clinical fracture of cross-linked UHMWPE acetabular liners. Biomaterials. 2009;30(29):5572-5582.)

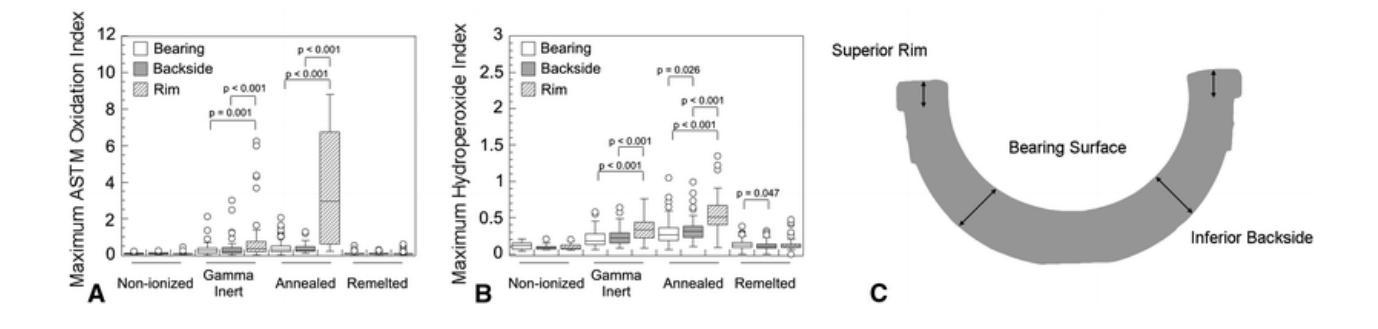
Figure 2-4 A. Oxidation index and B. Hydroperoxide index (a measure of oxidation potential) of retrieved samples of conventional (listed as non-ionized, gamma inert sterilized above), annealed (first-generation HXLPE), remelted (first-generation HXLPE) liners. The relative oxidation of annealed liners can be seen. Also, the regional variations with preferential rim oxidation can be noticed. C. Illustrates the sampling locations for testing at the rim, bearing surface and backside of the liners. (Permission from MacDonald D, Sakona A, Ianuzzi A, Do first-generation highly crosslinked polyethylenes oxidize in vivo? In: Clinical Orthopaedics and Related Research. Vol 469. Springer; 2011:2278-2285.)

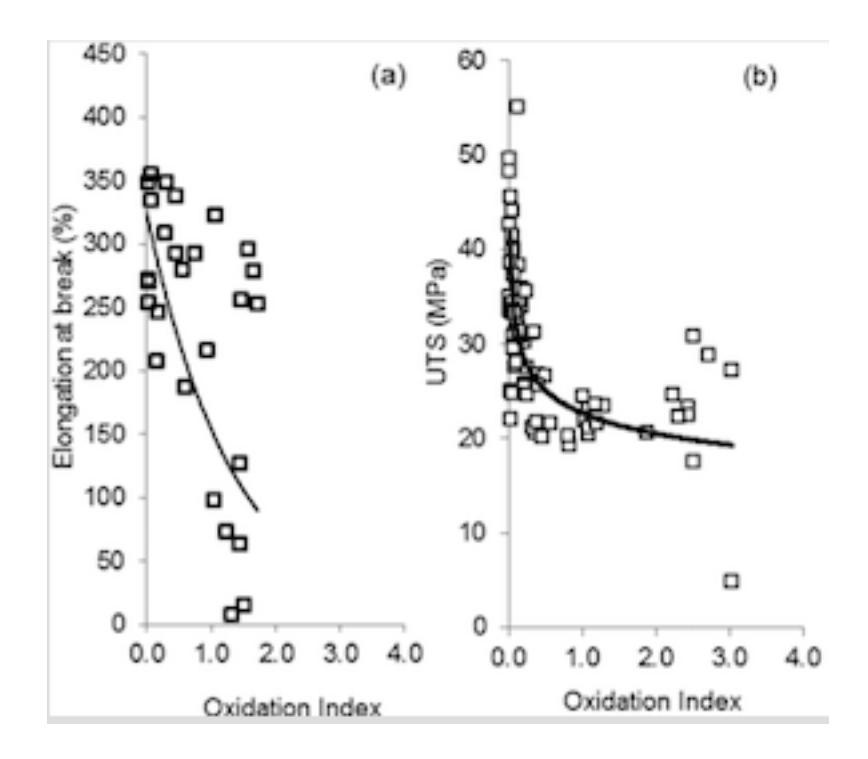
Figure 2-5 (a) The elongation at break and (b) ultimate tensile strength decrease as oxidation increases in irradiated melted HXLPE with in vitro thermo-oxidative aging. (Permission from Oral E, Neils AL, Doshi BN, et al. Effects of simulated oxidation on the in vitro wear and mechanical properties of irradiated and melted highly crosslinked UHMWPE. J Biomed Mater Res B Appl Biomater 2016; 104: 316–322.)

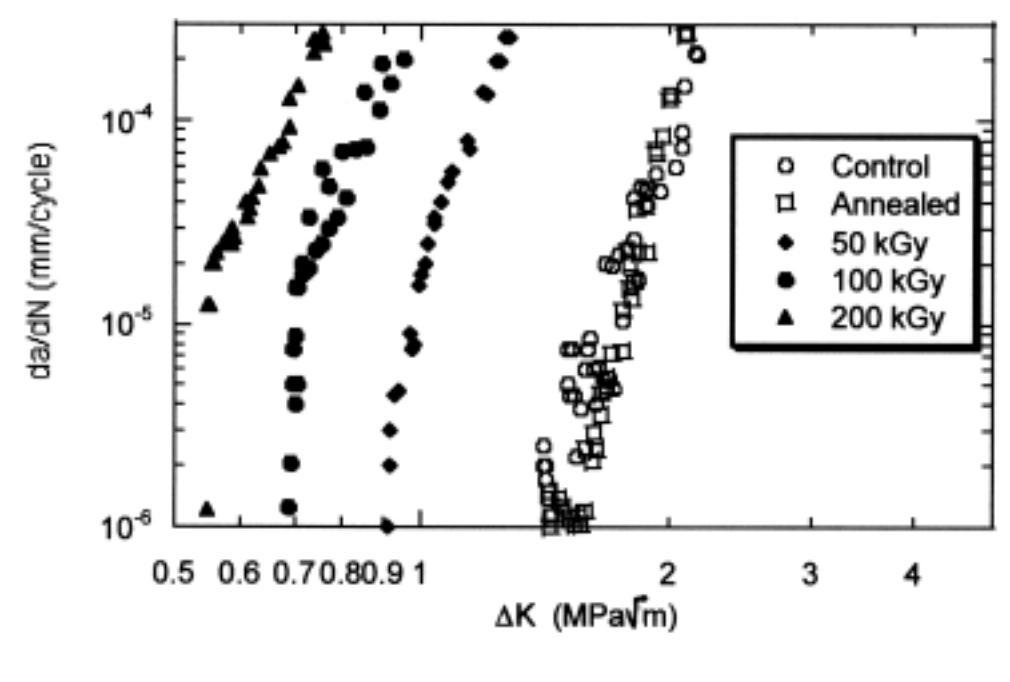
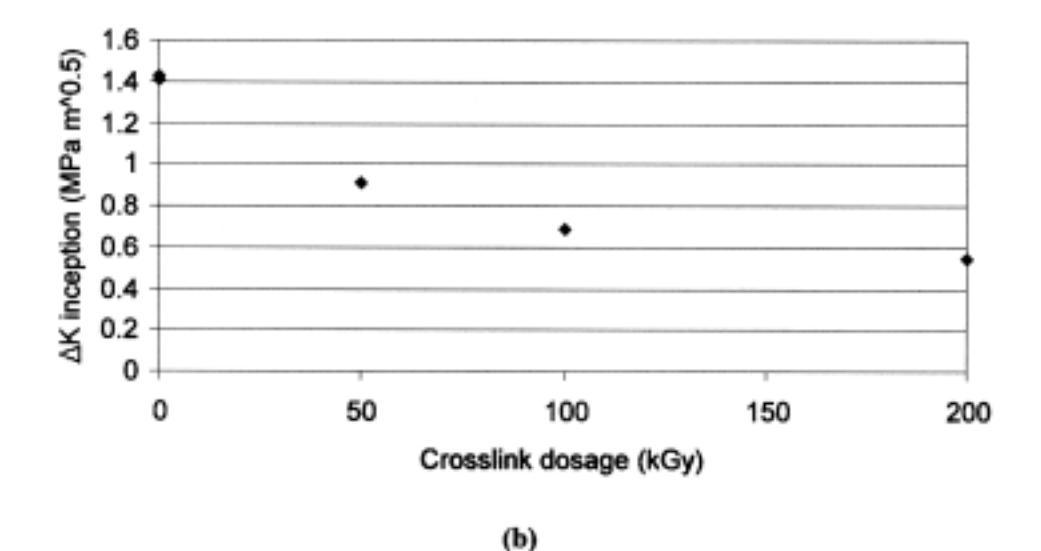
Figure 2-6 (a) Fatigue crack propagation of five groups of polyethylene (b) Fatigue crack propagation inception values as radiation dose increases (Permission from Baker D a, Bellare a, Pruitt L. The effects of degree of crosslinking on the fatigue crack initiation and propagation resistance of orthopedic-grade polyethylene. J Biomed Mater Res A. 2003;66:146-154.)

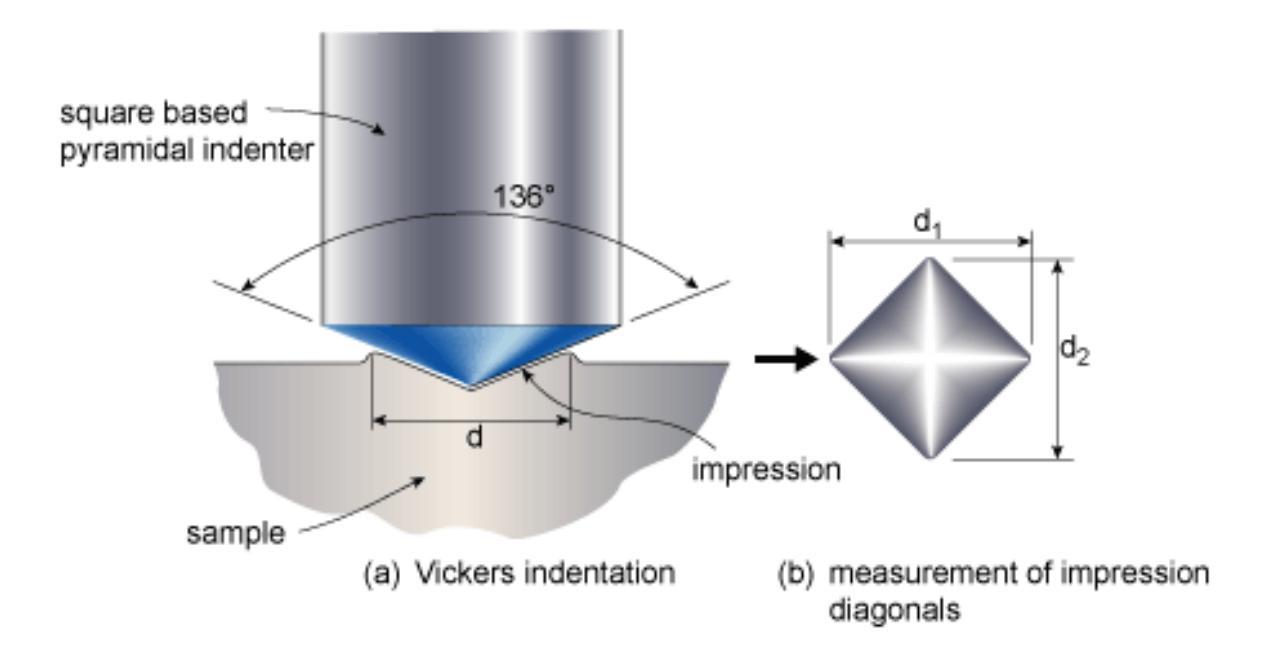
Figure 4-1 (a) Vickers indentation, where a hard tip indenter is loading a sample resulting in an impression. (b) d1 and d2 represent the diagonal lengths of the indent produced from the force applied. (Courtesy of TWI Ltd, Hardness Testing Part 1 - Job Knowledge 74 n.d. http://www.twi-global.com/technical-knowledge/job-knowledge/hardness-testing-part-1-074/ (accessed June 13, 2017))

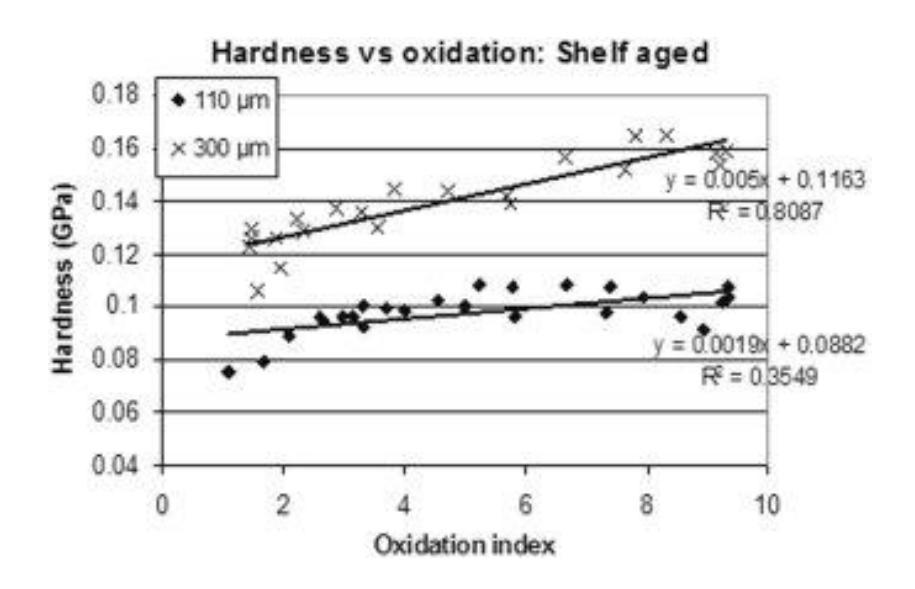
Figure 4-2 An increase in hardness is demonstrated with increasing oxidation in shelf aged tibial inserts. (Permission from Wernlé, J. D., & Gilbert, J. L. Micromechanics of Shelf-Aged and Retrieved UHMWPE Tibial Inserts: Indentation Testing, Oxidative Profiling, and Thickness Effects. J Biomed Mater Res Part B: Appl Biomater, 75, 113–121.)

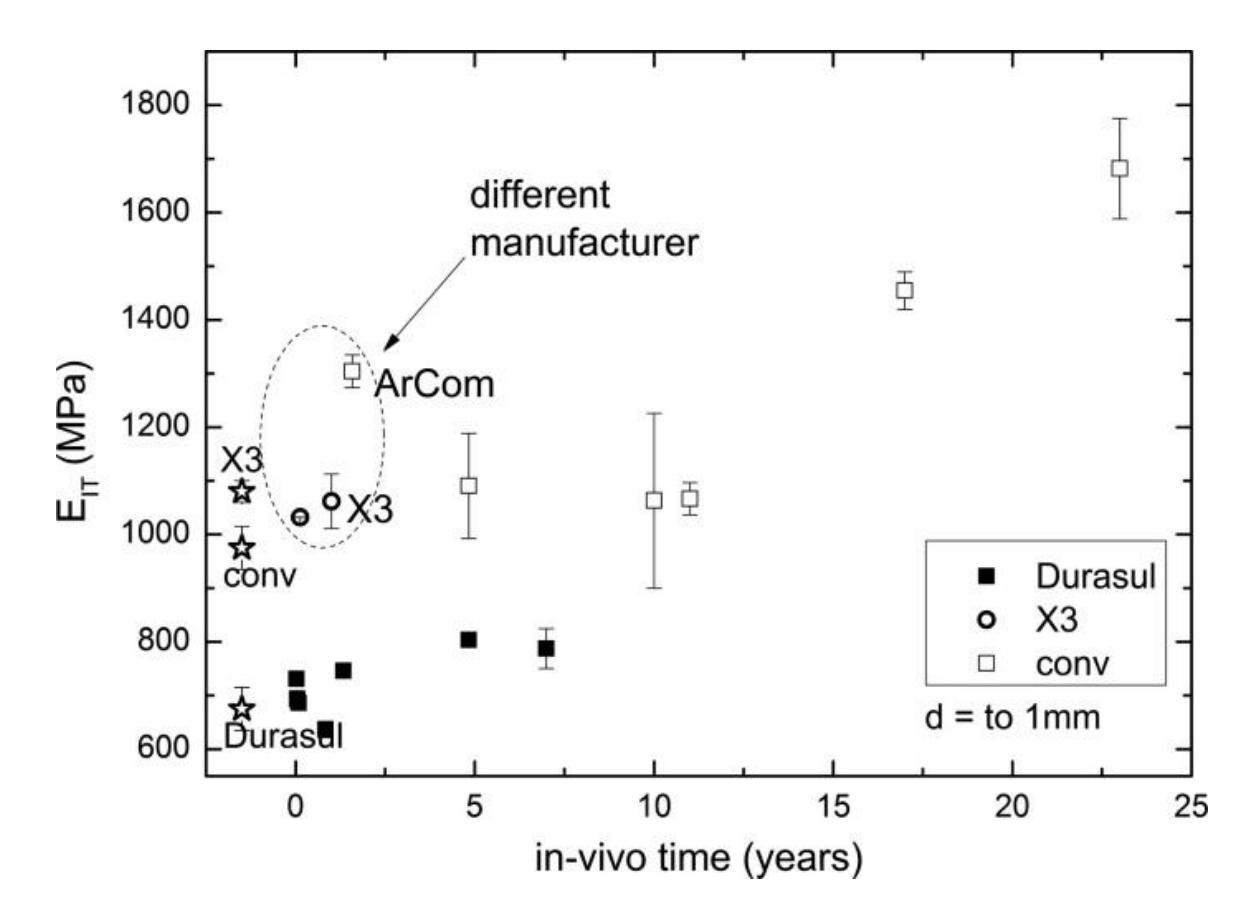
Figure 4-3 DSI testing results measuring modulus of elasticity (EIT) of various retrieved UHMWPE liners with varying in vivo time. (star symbol above represents control never implants samples from each polyethylene) (Permission from Laska, A., Archodoulaki, V.-M., & Duscher, B. (2016). Failure analysis of retrieved PE-UHMW acetabular liners. Journal of the Mechanical Behavior of Biomedical Materials, 61, 70–78.)

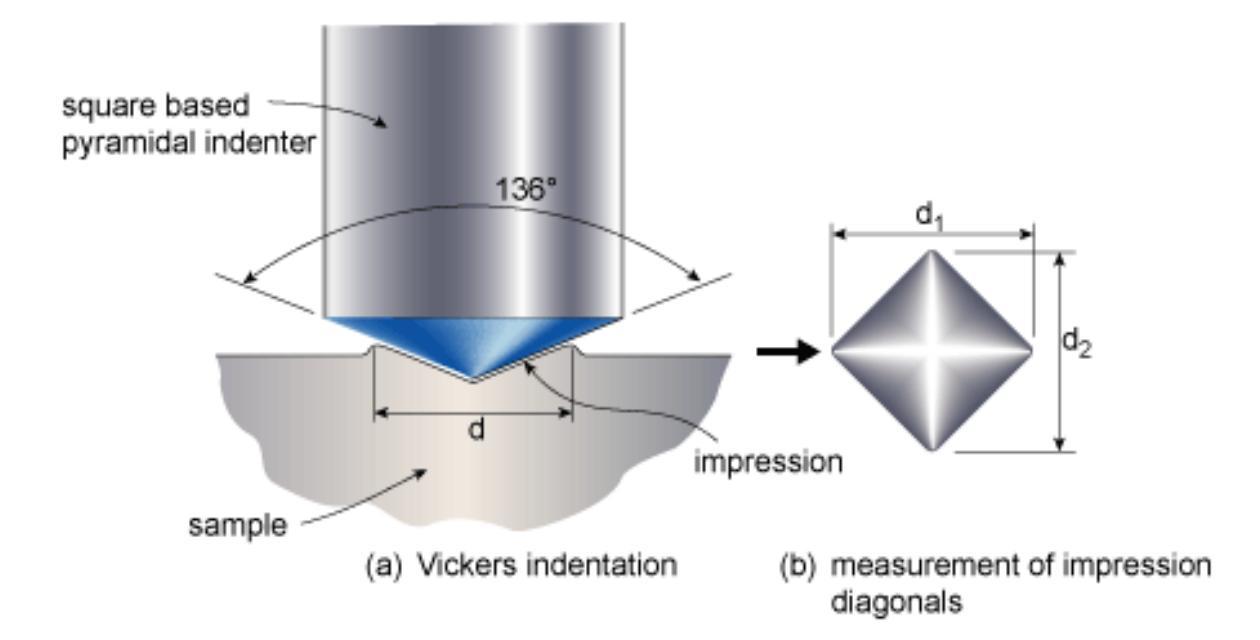
Figure 5-1 (a) Vickers indentation, where a hard tip indenter is loading a sample resulting in an impression. (b) d1 and d2 represent the diagonal lengths of the indent produced from the force applied. (Courtesy of TWI Ltd, Hardness Testing Part 1 - Job Knowledge 74 n.d. http://www.twi-global.com/technical-knowledge/job-knowledge/hardness-testing-part-1-074/ (accessed June 13, 2017))

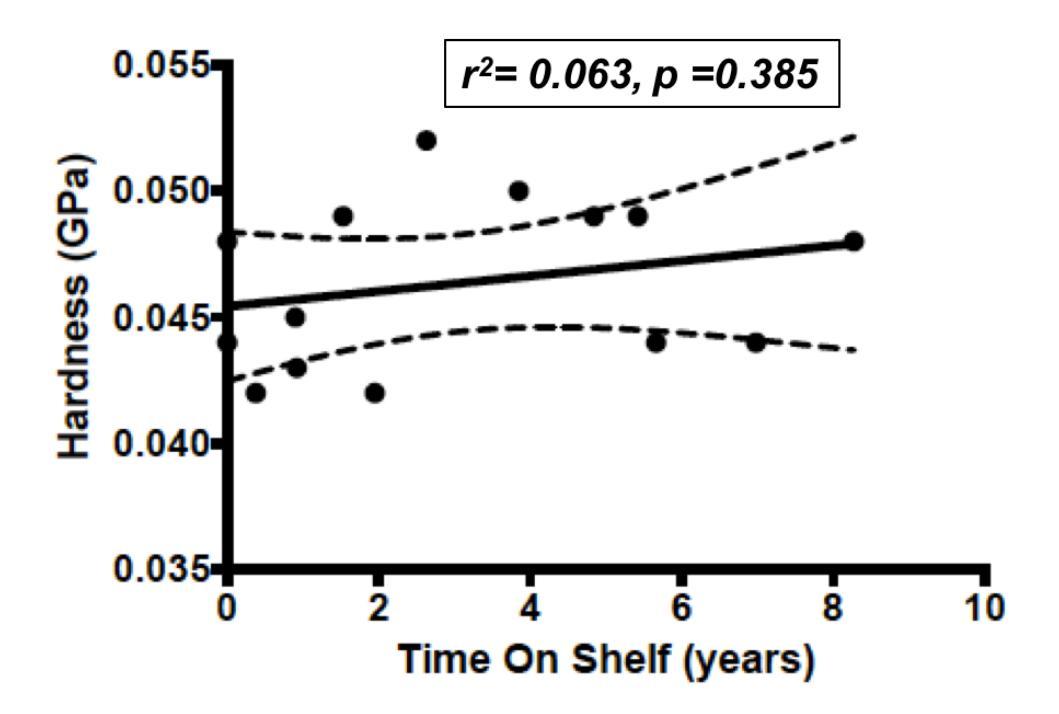
Figure 5-2 A linear regression analysis shows no significant correlation between hardness and shelf time of the tested liners.

Patient		Avg. Hardness	
Number	Ex Vivo Time (Years)	(GPa)	Stdev
Control 1	0.00	0.044	0.003
Control 2	0.00	0.048	0.004
1	0.4	0.042	0.003
2	0.9	0.045	0.005
3	0.9	0.043	0.004
4	1.5	0.049	0.003
5	2.0	0.042	0.005
6	2.6	0.052	0.006
7	3.9	0.050	0.002
8	4.8	0.049	0.004
9	5.4	0.049	0.003
10	5.7	0.044	0.002
11	7.0	0.044	0.004
12	8.3	0.048	0.005

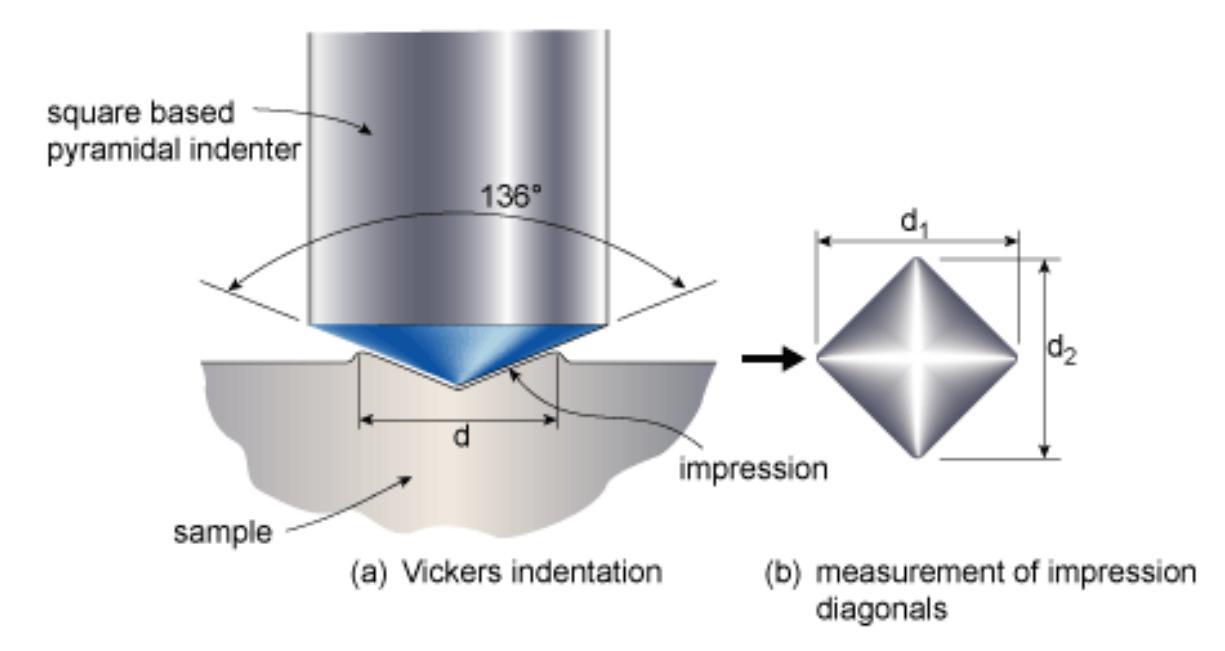
Figure 6-1 (a) Vickers indentation, where a hard tip indenter is loading a sample resulting in an impression. (b) d1 and d2 represent the diagonal lengths of the indent produced from the force applied. (Courtesy of TWI Ltd, Hardness Testing Part 1 - Job Knowledge 74 n.d. http://www.twi-global.com/technical-knowledge/jobknowledge/hardness-testing-part-1-074/ (accessed June 13, 2017))

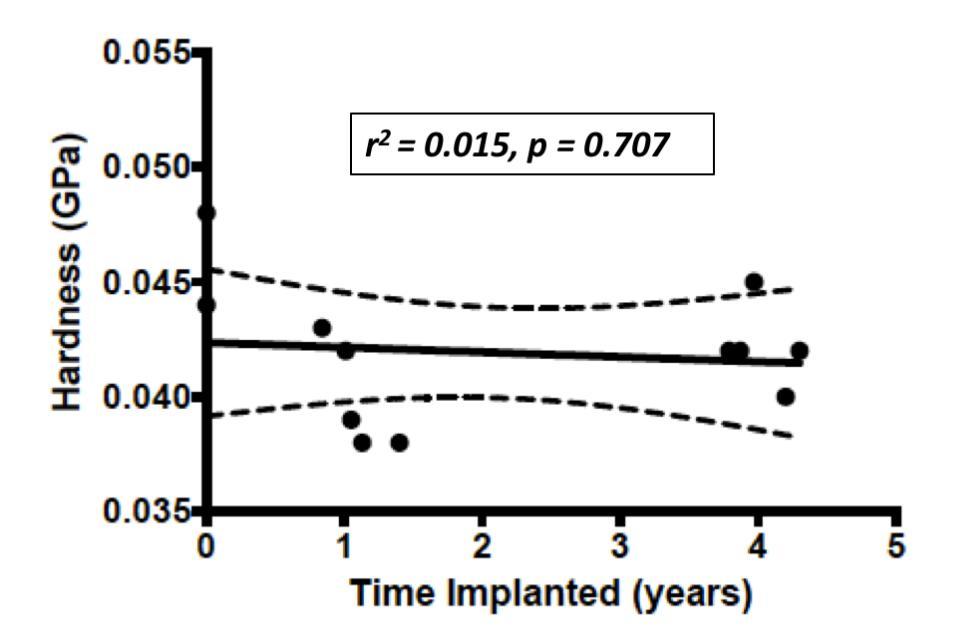
Figure 6-2 A linear regression analysis shows no significant correlation between hardness and time implanted of the tested liners.

Vickers Hardness	
Sample	Time in vivo (years)	(Gpa)	Std Deviation
Control 1	0.0	0.044	0.003
Control 2	0.0	0.048	0.004
1	0.8	0.043	0.004
2	1.0	0.042	0.003
3	1.0	0.039	0.002
4	1.1	0.038	0.002
5	1.4	0.038	0.002
6	3.8	0.042	0.004
7	3.9	0.042	0.004
8	4.0	0.045	0.003
9	4.2	0.040	0.002
10	4.3	0.042	0.001
