## A study of the effect of jointing on the blasting of granite, Graniteville, Missouri

A STUDY OF THE EFFECT OF JOINTING ON THE BLASTING  
OF GRANITE  
GRANITEVILLE, MISSOURI

A  
THESIS  
submitted to the faculty of the  
SCHOOL OF MINES AND METALLURGY OF THE UNIVERSITY OF  
MISSOURI  
in partial fulfillment of the work required for the  
Degree of  
MASTER OF SCIENCE, MINING ENGINEERING,  
MINING GEOLOGY OPTION  
Rolla, Missouri  
1952

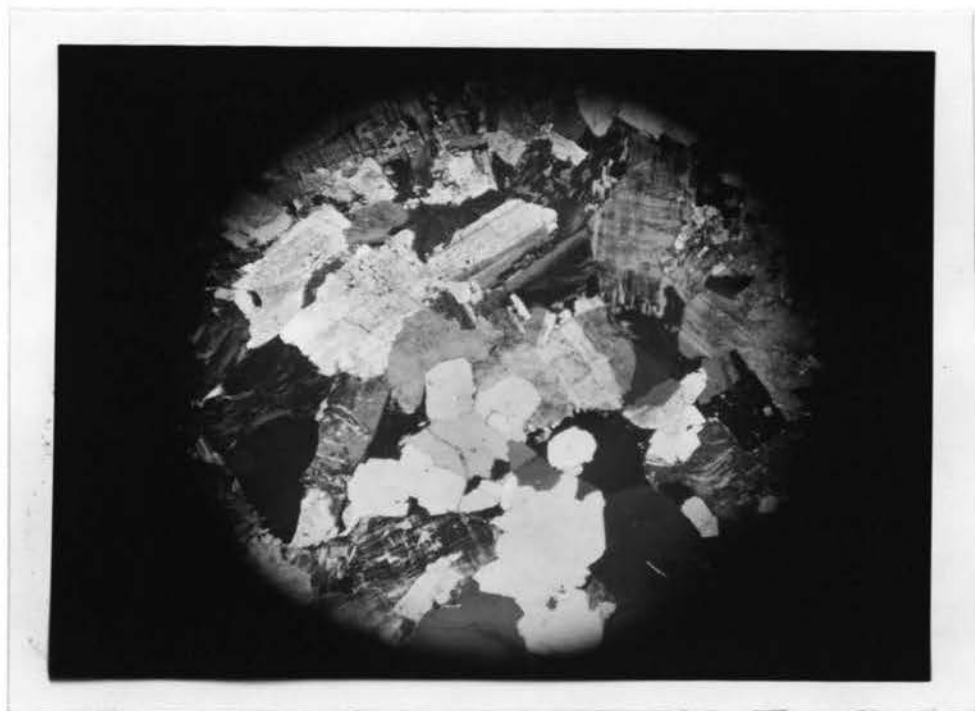
FIGURE 1

Photomicrograph of Granite

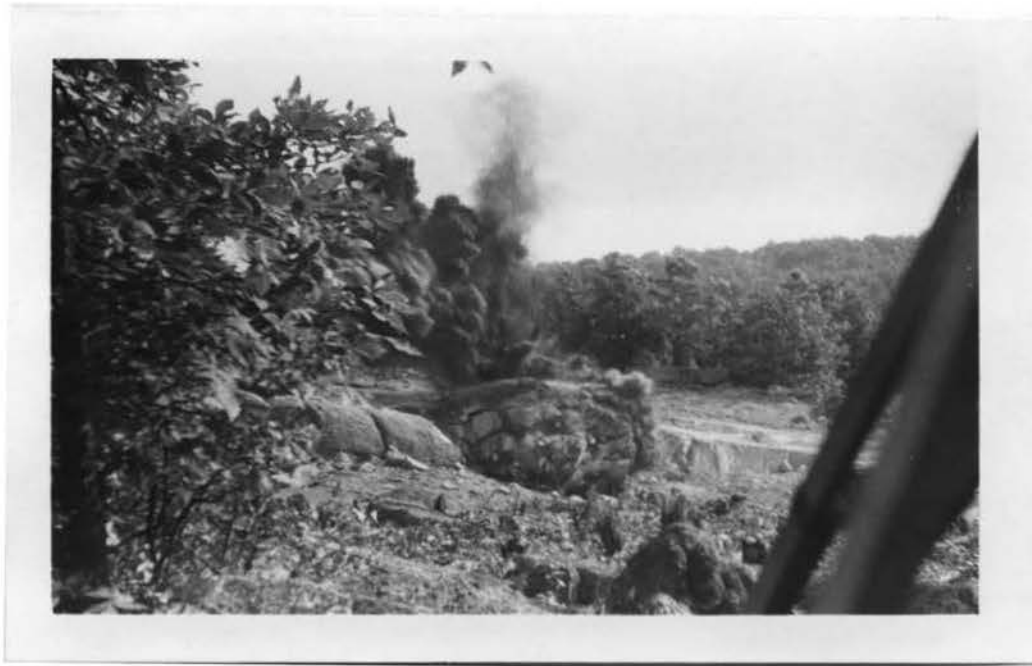
FIGURE 6

A typical round as fired at Graniteville.  
Note the blocky character of the material in  
the round.

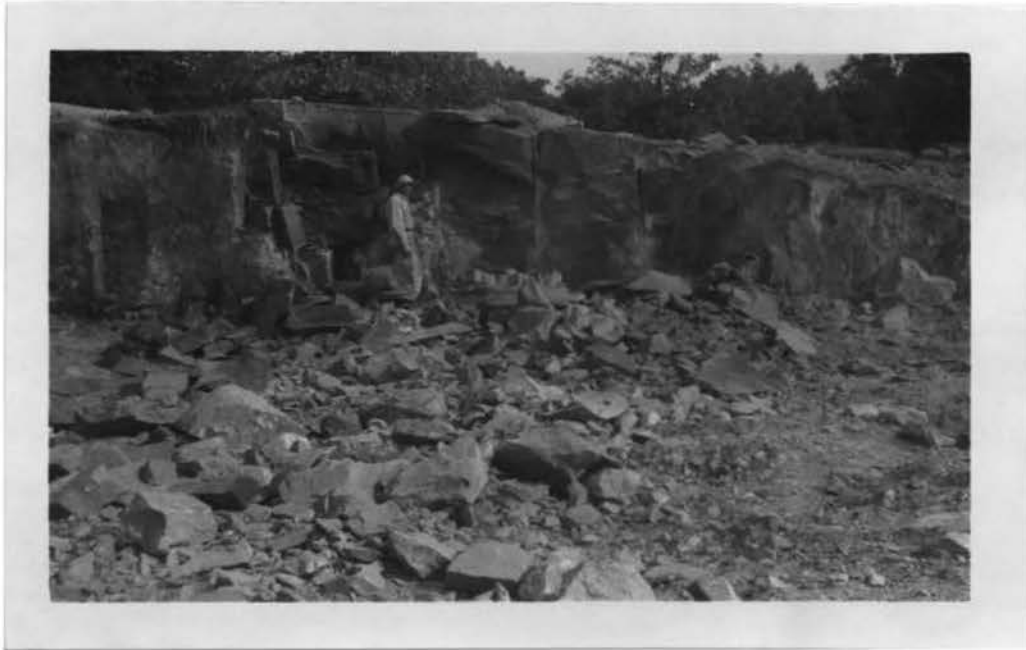
FIGURE 18

East face after Round G-11. Note that the top of the right hole is cut off. The guilty fracture can be traced from the center hole across the outline of the remaining hole.

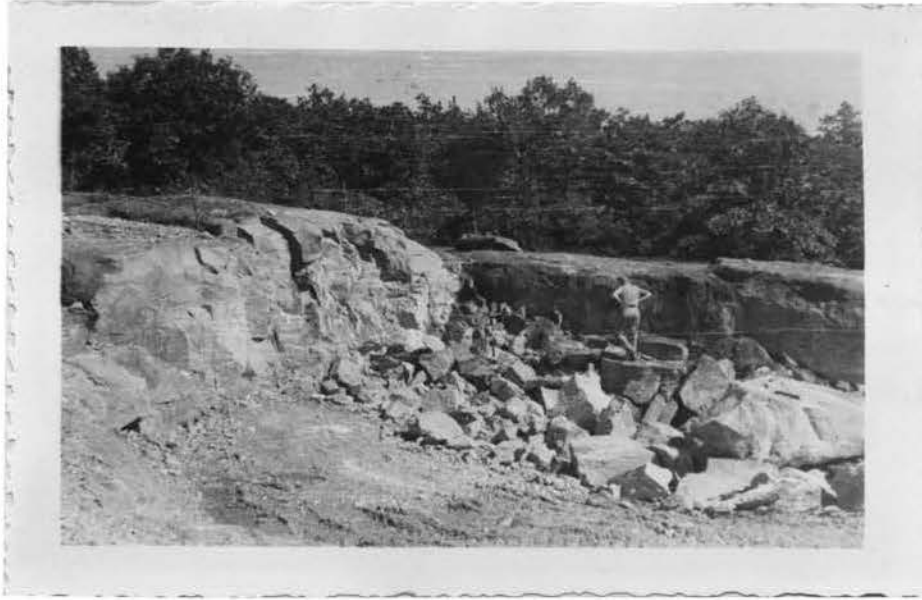
**FIGURE 19**

Quarry face after Round G-13.

The round was drilled midway between the face produced by Round G-11 (a joint plane) and the prominent northeasterly striking heading zone. Pattern VIII was used. On firing, the ground between the face and the holes broke in a favorable manner. The round broke to the eastern margin of the area of close jointing. The upper portion of this material was crumbled and shattered and slumped over the lower portion which was split in large boulders. The numerous longitudinal joints of the heading combined with three sheeting joints provided the potential blocks for such a breakage. A large slab (10.5 feet x 5.2 feet x 3.6 feet) was heaved 5 feet from the quarry face. The block was pushed from the west wing, where a sheeting joint was found 3.6 feet below the surface. This distance corresponded with the short dimension of the boulder. The joint set was opened to the west as far as the wing left by round G-12. The

heading zone also was opened to the east. Numerous new fractures were induced by the blasting. The normal burden of the round was thrown clear of the material produced by the back-breakage. The fragmentation of this material was in the medium and fine categories.

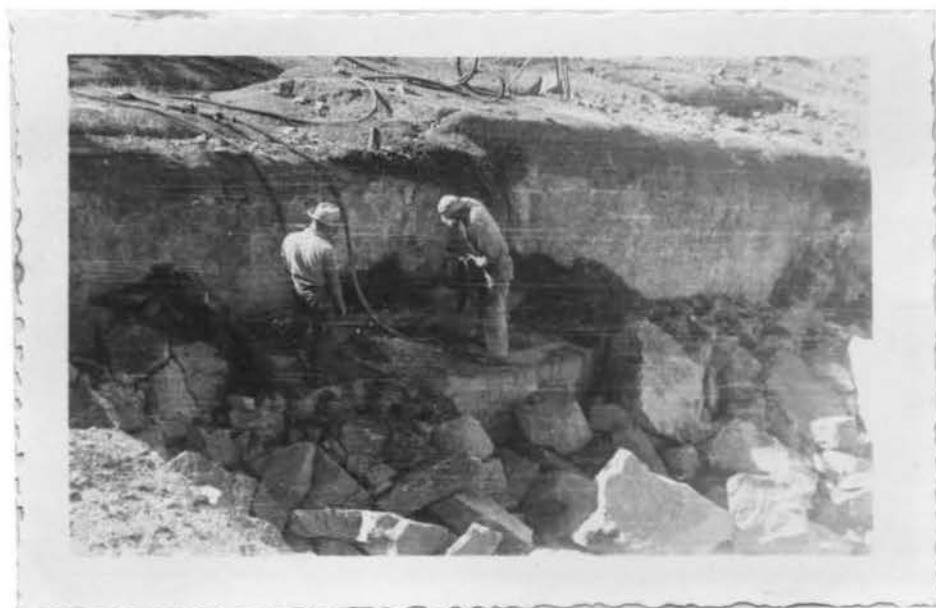
FIGURE 20

Preparing the slab, produced by  
Round G-13, for secondary  
blasting.
