University of New Mexico UNM Digital Repository

CHARACTERIZATION OF UNKNOWN BRIDGE FOUNDATIONS

DISSERTATION

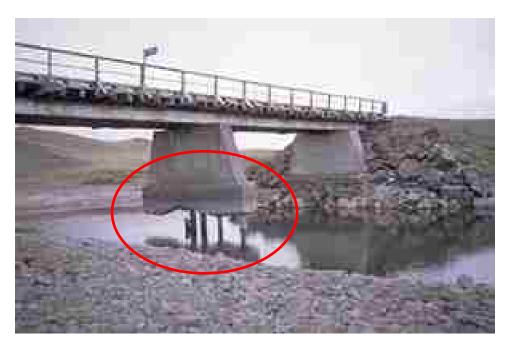
Figure 2. Complete Loss of Support under a Bridge Pier (3)

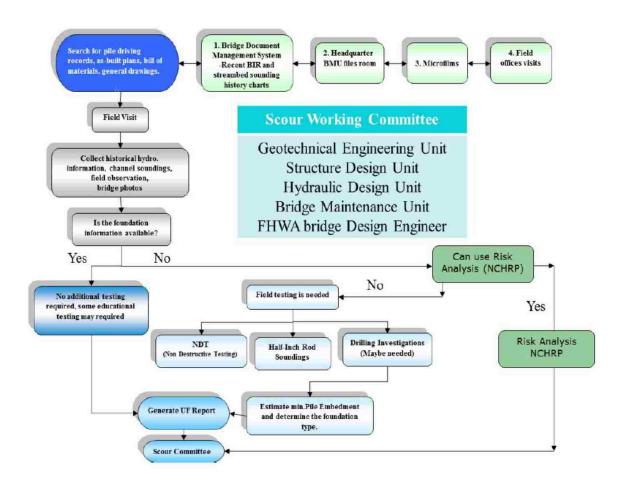
Figure 3 shows the unknown foundation process developed at North Carolina DOT for UBF in their bridge management system in 2005. The use of the risk-based management guidelines for scour was suggested in 2010 to evaluate remaining low-risk bridges with unknown foundation in North Carolina. The review of all unknown foundation bridges was completed in 2012.

Figure 3. Flowchart for North Carolina Unknown Bridge Foundation Process (17)

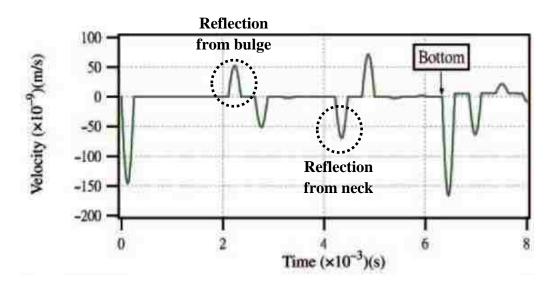
Figure 9. Velocity Graph of a Defective Pile with a Bulge and a Neck (30)

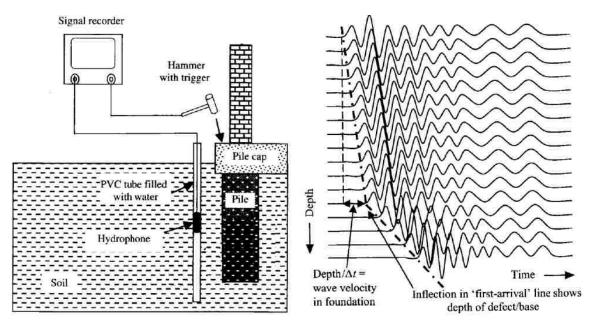
Figure 11. Typical Setup and Test Data of PS Test (12)

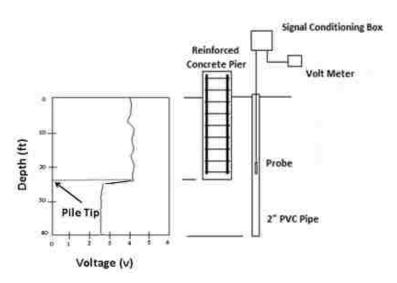
by passing a DC current through a polarized magnetic field sensor which is lowered into a PVC cased borehole adjacent to the test pile. A magnetic field is consequently induced in the pile's metal which can be detected by the probe. The depth of the foundation is determined by measuring the magnetic field strength at various depths, and identifying the changes in magnetic field strength. A typical IF setup and associated data are indicated in Figure 12.

Figure 12. The IF Result and a Typical IF Setup

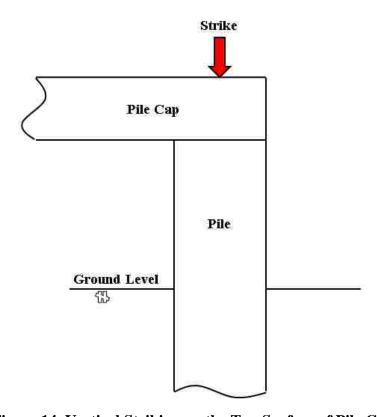
Setup for Striking on Piles with Inaccessible Top For piles with inaccessible top, the longitudinal wave can be generated by striking other parts of the foundation as shown in Figures 14 to 19. When the superstructure is not placed exactly atop the pile, longitudinal waves can be produced by striking the top surface of the pile cap as indicated in Figure 14. If the presence of the girders on the top of the pile cap does not allow striking on the pile cap top surface, other options indicated in Figures 15 to 19 can be applied.

Figure 14. Vertical Striking on the Top Surface of Pile Cap

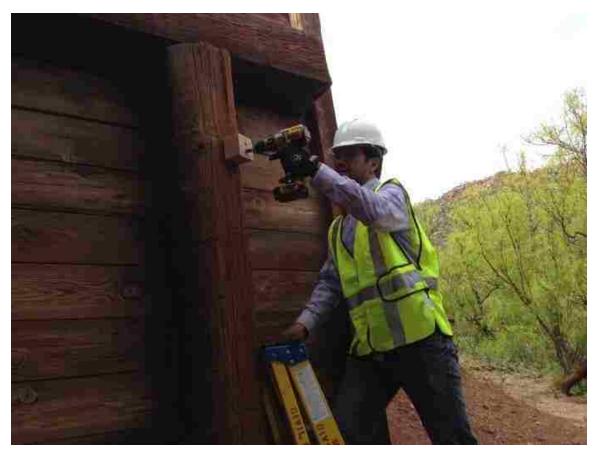
Figure 25. Attachment of a Wooden Striking Block onto the Test Pile

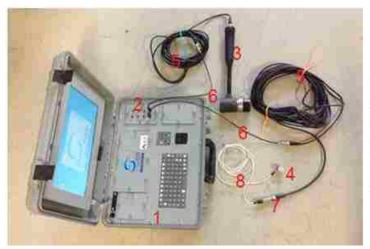
The equipment utilized for conducting SE/IR tests should be assembled as indicated in Figure 27. Four different hammer tips are available as shown in Figure 28.

- 1. Olson Freedom Data PC
- 2. Input Module
- 3. Impulse Hammer
- 4. Accelerometer
- 5. BNC Cable
- 6. BNC to 4 Pin Adapter Cable
- 7. Female-Female BNC Adapter
- 8. Microdot to BNC Cable

Figure 27. SE/IR Test Equipment

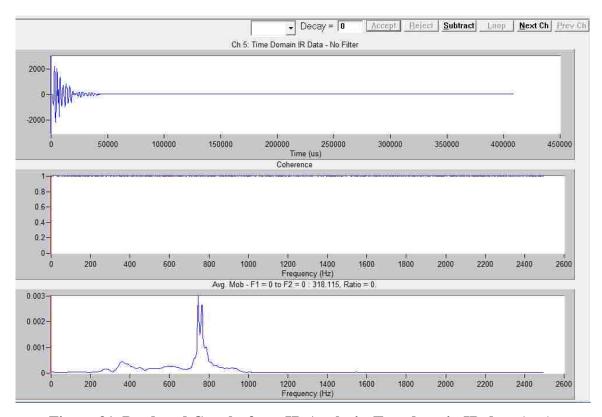
in frequency between the resonant frequencies in this report. Δf was used to determine the pile length associated with IR analysis through Eq. 4.

Figure 31. Produced Graphs from IR Analysis, Tme domain IR data (top), Coherence (middle) and Average Mobility (bottom)

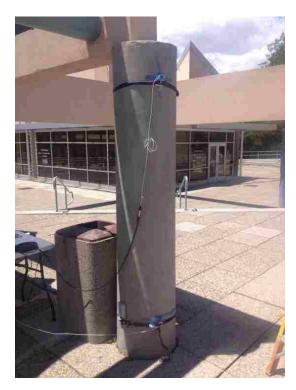
Twelve SE tests were conducted on a reinforced concrete column on UNM campus shown in Figure 37. The column is one of the 3-story columns of the Centennial Engineering Library on UNM campus. The total length of the column is 43 ft. Only the top 7.5 ft of the column is visible as shown in the photo.

Figure 37. The Reinforced Concrete Column of Centennial Library on UNM Campus

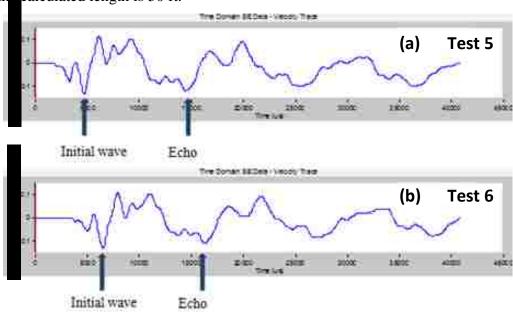
Results of Vertical Striking with Medium-soft Tip Medium-soft tip was used and the obtained velocity graphs are shown in Figure 41. Again, the results are similar to the velocity graphs using medium-hard tip (see Figure 40). In addition, no high frequency content can be found as seen in the velocity graph of hard tip (Figure 39b). Δt is still 10 ms and the calculated length is 50 ft.

Figure 41. Velocity Graphs for Tests 5 and 6 on the Concrete Column of Centennial Library on UNM Campus

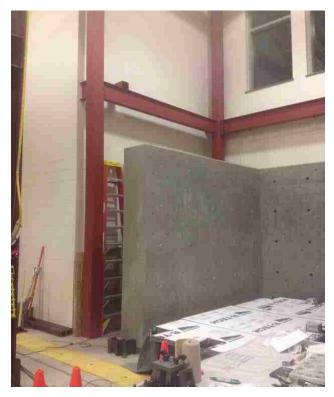
Since there are similarities in relative dimensions between a pier wall foundation and the reinforced concrete strong-wall at the Structural Lab of the Department of Civil Engineering at UNM (Figure 43), SE tests were conducted in the lab to study the applicability of the method on non-slender foundations. SE tests were carried out using vertical and horizontal striking with hard, medium-hard, medium-soft and soft hammer tips. Figure 44 shows the source (A~D) and the accelerometer locations (E, F and G). The accelerometer was mounted vertically on Points E, F or G. Wooden blocks were utilized to mount the accelerometers at Points F and G. Figure 49 shows the setup of one SE test.

Figure 43. The Reinforced Concrete Wall in the Structural Lab

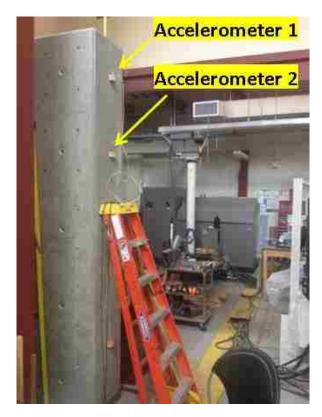
Figure 45. An SE Setup on the Reinforced Concrete Wall

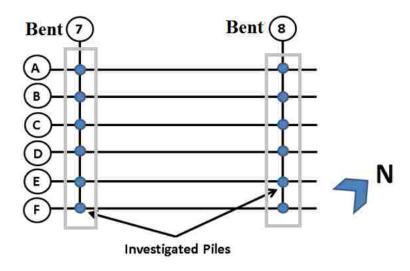
Sixteen SE tests were conducted on two timber piles at Bents 7 and 8. Figure 50 depicts the foundation plan and test piles.

Figure 50. Foundation Plan and Investigated Piles of Santo Domingo Bridge

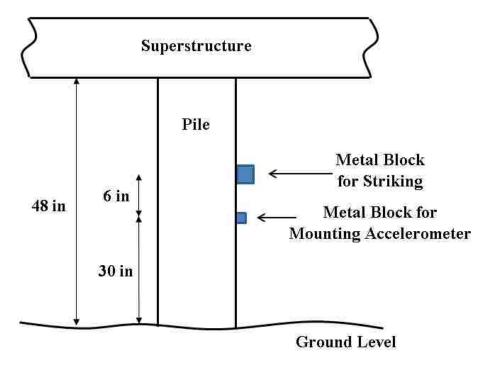
Six SE tests were performed on Pile 7-F and seven on Pile 8-E. The test setup is shown in Figure 51. Although horizontal striking did not result in interpretable velocity signals in preliminary tests, it was decided to examine if horizontal striking on the side of a pile could produce useful result in the field. Vertical striking on a metal block was used on Pile 8-E as the source. The metal block used for vertical striking was attached to the pile surface tightly. The accelerometer was attached vertically on a metal block attached to the pile. The specifications of SE tests are indicated in Table 8.

Figure 51. SE Tests Setup for the Santo Doming Bridge Piles (Not to Scale)

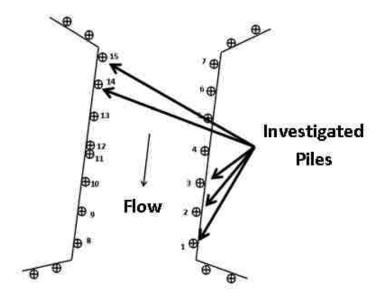
tests were conducted on 5 round timber piles. The foundation plan and investigated piles are indicated in Figure 62.

Figure 62. Foundation Plan and the Investigated Piles of Bridge No. 6922

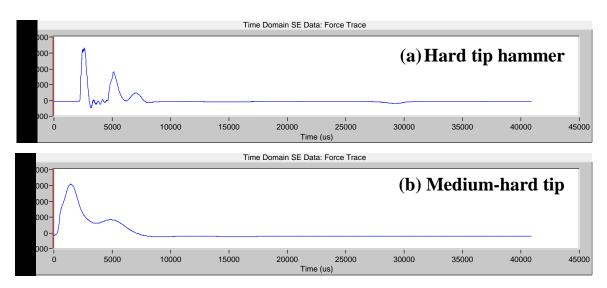
SE/IR Tests with Aluminum Striking Block Three SE/IR tests were conducted by striking an aluminum block with hard, medium-hard and medium-soft hammer tips (Tests 4 to 6 respectively). The force graphs of the hammer for Tests 4 and 5 are shown in Figure 72. The shapes of the impulses are different from the typical hammer impulse shown in Figure 73. Multiple peaks were shown in the graphs produced by striking on the aluminum block. The peaks may be due to the small sliding of the block on the surface of pile and occurrence of a momentary contact loss or multiple contacts between the block and pile surface.

Figure 72. Impulse Signals of Striking on an Aluminum Block

shapes compared to sources produced by aluminum blocks (Figure 72). The corresponding velocity graphs for Tests 11 to 13 are indicated in Figures 79 to 81 respectively.

SE/IR Tests Performed with Aluminum Striking Block In Tests 17 to 19, different energies were imparted into the piles by striking an aluminum block attached to the side of the pile with hard hammer tip. As shown in Figure 86 the impulse graphs show multiple peaks similar to the previous observations of Pile 1 (see Figure 72).

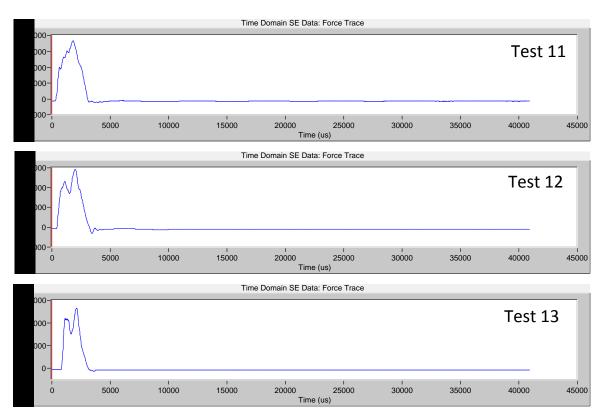
SE Tests Performed with Wooden Striking Block and Hard tip Hammer SE tests were conducted by hard hammer tips in Tests 11 to 13. Since the source was applied manually, the only difference between Tests 11 to 13 was the difference between their input energies and impulse shapes (Figure 78). These source signal graphs show more regular

Figure 78. Initial Impulse from the Hammer's Force Sensor (Wooden block, Hardtip)

that of hard tip (see Figure 78). The corresponding velocity graphs obtained from Accelerometer 1 and 2 are shown in Figures 83 to 85 for Tests 14 to 16 respectively.

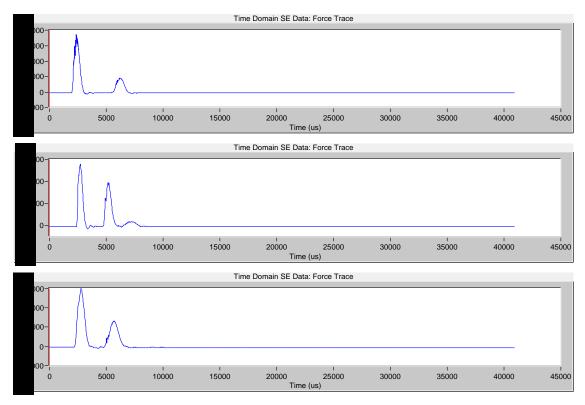
Figure 86. Impulse Signals Generated by Striking the Aluminum Block with Hard Hammer Tips (Tests 17 to 19)

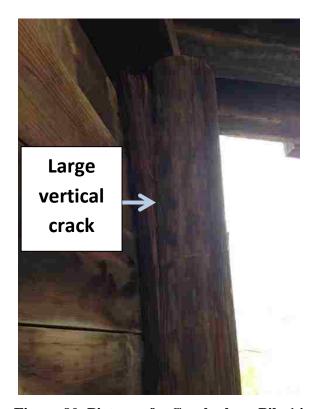
Figure 90. Picture of a Crack along Pile 14

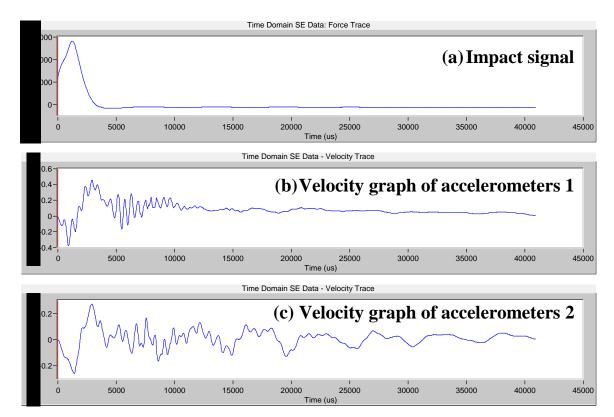
- Care must be taken on mounting the striking block onto the test pile. Clean and clear source signal may not be generated due to imperfect coupling between the block and pile surface. The result also depends on the hammer tip as shown in Figures 107 and 108 Multiple peaks in the impact signal were found while using a hard tip (see Figure 107a). These peaks interfered with the determination of the echo in the velocity graph (see Figures 107b and 107c). When a softer hammer tip was used, the multiple peaks disappeared for the accelerometer mounted farther from the source (see Figure 108a).

Figure 108. Impact Signal and Velocity Graphs Using a Medium-soft Tip

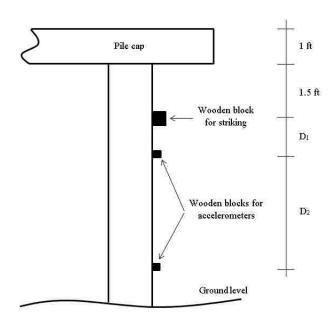
SE Tests on Pile M-1 Twenty-eight SE tests have been performed on Pile M-1. The specifications of the tests are listed in Table 30. The accelerometers were placed at various locations. The SE setup for Pile M-1 is shown in Figure 112. Despite numerous attempts, none of the results could be used to determine the length of the pile.

Figure 112. Locations of Source and Receivers blocks for Pile M-1

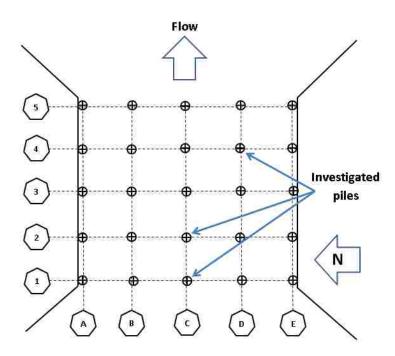
The foundation plan and the investigated piles are indicated in Figure 117. SE tests were performed on three timber piles indicated in the figure. The SE tests were done with four different hammer tips including hard, medium-hard, medium-soft, and soft. Two accelerometers were attached to the side of the piles as shown in Figure 118. The wooden blocks were glued onto the pile surface.

Figure 117. Foundation Plan and Investigated Piles of Bridge No. 1676

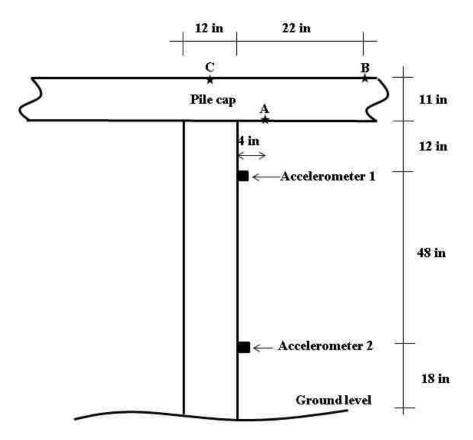
SE/IR Tests on Pile C-2 (SE Analysis) Twelve SE/IR tests were conducted on Pile C-2 with different hammer tips. The source was created by downward striking on pile cap above the pile, downward striking on the pile cap near the pile, and upward striking on the pile cap near the pile. Figure 121 shows the source (Points A, B, and C) and receiver locations and Table 36 lists the specifications of these SE/IR tests.

Figure 121. SE/IR Setup for Pile C-2

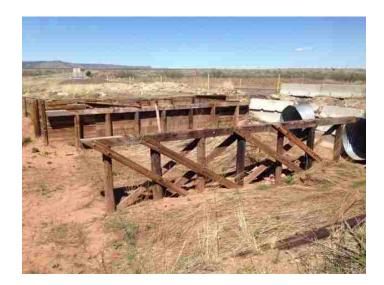
The partially dismantled bridge (Bridge No. 6253) is located 64 miles east of Las Vegas. The bridge was used to be on Route 419 (coordinates 34.211303, -106.921087). Figure 123 shows the location of the bridge. Route 419 was realigned and the bridge was no longer in service. The superstructure of the bridge was removed when the research team arrived at the site. Only pile caps and round timber piles were presented as shown in Figure 124.

Figure 124. Photo of the Partially Dismantled Bridge near Route 419

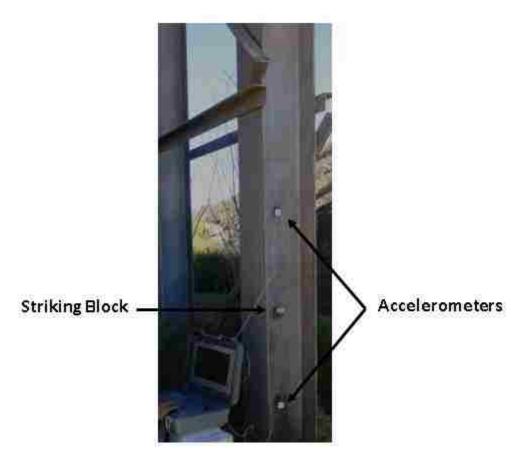
Holes had been predrilled by NMDOT engineers. Metal blocks for striking and mounting accelerometer were attached onto the web of the H-pile with bolts. Two accelerometers were used. A nonconventional SE test setup is shown in Figure 128. The source (hammer striking) was between two accelerometers. Although numerous SE tests of different setups were performed on different piles, none of the results were successful.

Figure 128. SE Test Setup for a H-pile of Bridge No. 7480

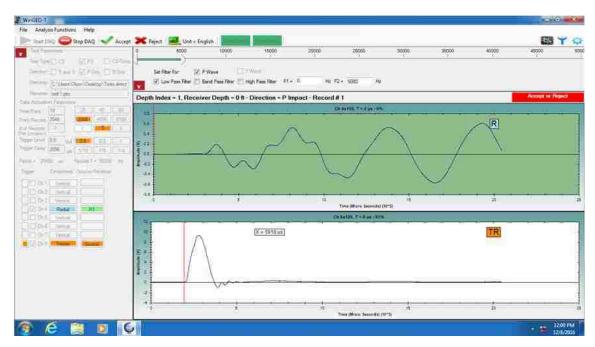
The hydrophone is lowered towards the bottom of the PVC tube in an increment of either 1 ft or 2 ft. At each depth, the foundation is struck with a hammer and the software records and plots the signals of the hammer and hydrophone. The software WinGEO-T installed in the Olson Freedom Data PC has been used for data acquisition. A screen shot of the program including the obtained signals is shown in Figure 139.

Figure 139. Screen Shot of Software WinGEO-T

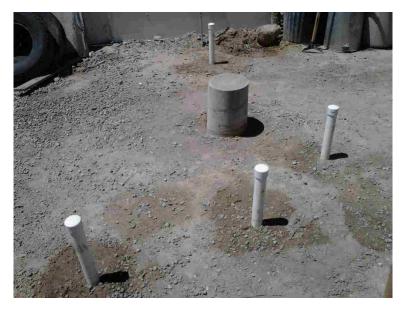
Initial PS tests were conducted at a test site off UNM campus to examine the capability of the equipment. The soil of the test site is silty clay with gravel. A 10-in diameter and 3-ft long reinforced concrete cylinder (pier) was installed at the test site. The PS test setup is shown in Figure 141. The depth of the concrete cylinder is 2 feet below ground. Four 2-in PVC pipes, each 5-ft in length, were installed at various distances from the center of the pile. The PVC pipes were then filled with water. PS tests were conducted by lowering a hydrophone into each of the pipes and impacting the center of the concrete pier with a hammer. The data were collected from each of the pipes at intervals of 1 foot starting at the ground level.

Figure 141. Configuration of the PS Testbed

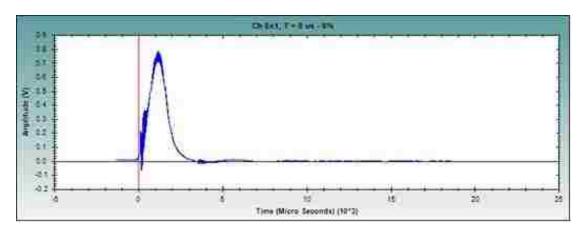
Figure 142 shows the signal generated by the hammer. Figure 143 shows the received signals when the hydrophone is at the ground level and four feet below grade. The distance between the borehole and the concrete cylinder is 2 ft. Comparing Figures 143a and 143b, a delay in arrival time was observed as expected. Figure 143a shows a peak at 8 μ s while Figure 143b shows a peak at 9 μ s. The 1st valleys in Figures 143a and 143b were found at 11 μ s and 13 μ s, respectively.

Figure 142. Duration and Amplitude of the Source Generated by a Hammer

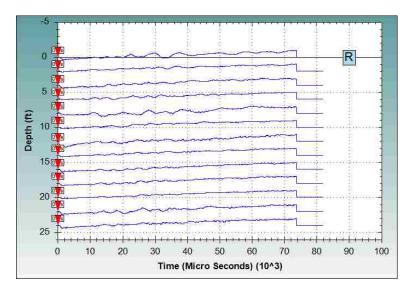
holes and the obtained poor result is shown in Figure 146. The hydrophone could not record good signals without the water coupling.

Figure 146. PS Test Result in a Dry Hole

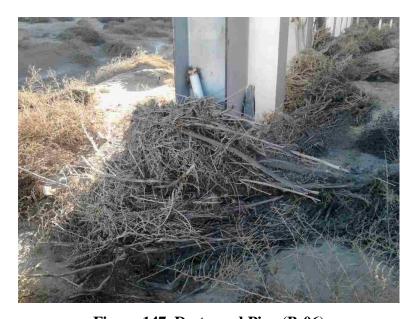
The second problem was the damage of one installed PVC tube. As shown in Figure 147, the PVC pipe at B-06 was destroyed due to the movement of debris from flooding. Therefore, conducting PS test was also impossible at this borehole.

Figure 147. Destroyed Pipe (B-06)

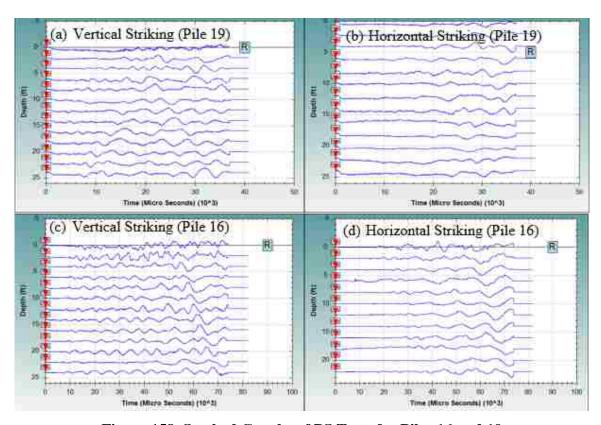
The results of these four PS tests are shown in Figure 158. Due to the great distance between the source and receiver, neither vertical striking nor horizontal striking can produce useful results to determine the inflection point. The hammer could not produce strong enough wave to reach the receiver. There is a certain horizontal distance between the source and the receiver. Beyond which, meaningful PS tests cannot be obtained. The certain horizontal distance depends on the strength of the input signal and soil condition. Our investigation showed that 12.7 ft was too far for our equipment to achieve interpretable results.

Figure 158. Stacked Graphs of PS Tests for Piles 16 and 19

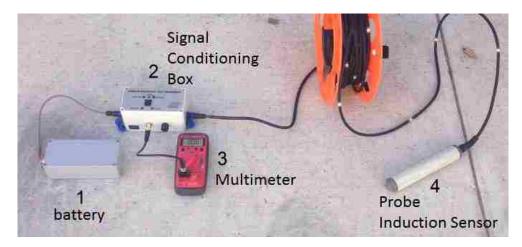
Figure 177 shows the correct assembly of the Length Inductive Test Equipment (LITE) for IF tests. The equipment includes battery, signal conditioning box, multimeter, and the Probe (induction sensor). The details of the signal conditioning box are shown in Figure 178.

Figure 177. Length Inductive Test Equipment (LITE) for IF tests

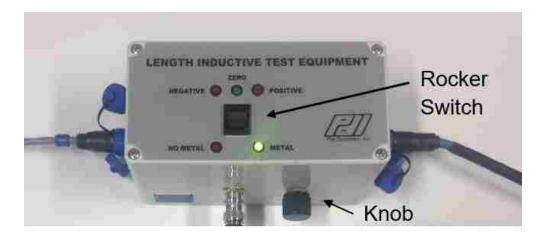
Figure 178. Details of Signal Conditioning Box

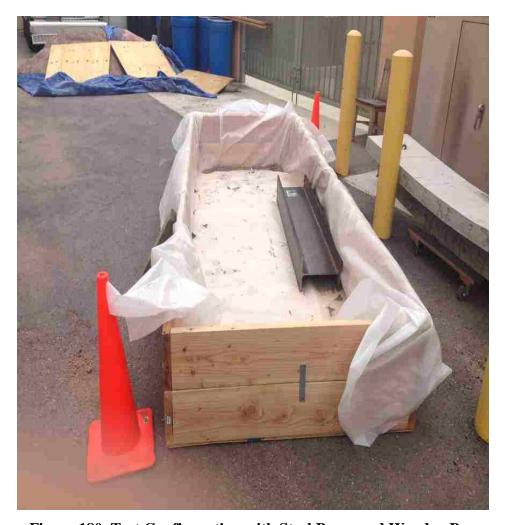
The first testbed contained a metal I-beam placed horizontally in a wooden box full of soil as shown in Figure 180. A metal beam buried in a wood box filled with soil was a suitable prototype of a real steel foundation of a bridge. The dimensions of the wooden box were 12 ft × 4 ft × 18 in. The I-beam was 5 ft long, 12 in depth and an 8 in flange width. The preliminary tests were supposed to be conducted in the structural lab at UNM. However, during conducting the IF tests in the structural lab, it was revealed that the test could not be conducted on the concrete floor due to the presence of steel reinforcement. The testbed was therefore moved outdoor on an asphalt paved driveway as shown in Figure 180. Before recording the data, three PVC tubes were placed horizontally at a distance of 1, 1.5 and 2 ft respectively from the steel beam.

Figure 180. Test Configuration with Steel Beam and Wooden Box

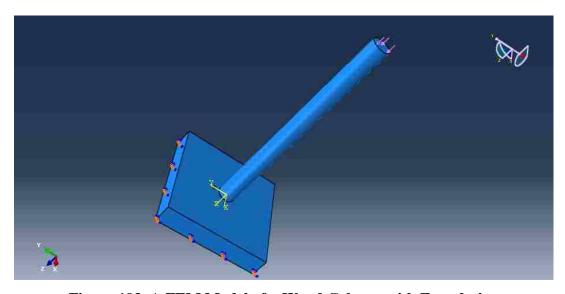
In the next step, a structure composed of a concrete foundation $(1.5 \times 1.5 \times 0.3 \text{ m})$ and a wood column was simulated. The FEM model is indicated in Figure 193. The concrete's properties are: E = 20 GPa, $\rho = 2400 \text{ kg/m}^3$, v = 0.2. Figure 194 shows the model with the snap shot of the stress distribution.

Figure 193. A FEM Model of a Wood Column with Foundation

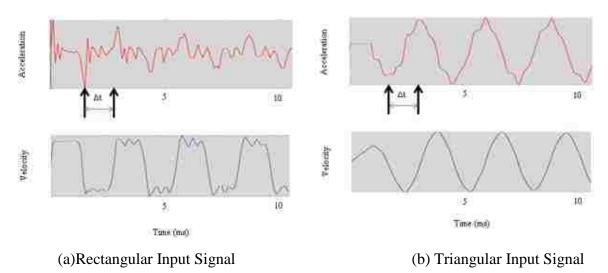
Rectangular and triangular impulses were applied. The acceleration and velocity graphs for the rectangular and triangular impulses are shown in Figure 195.

Figure 195. Results of Rectangular and Triangular Input Signals

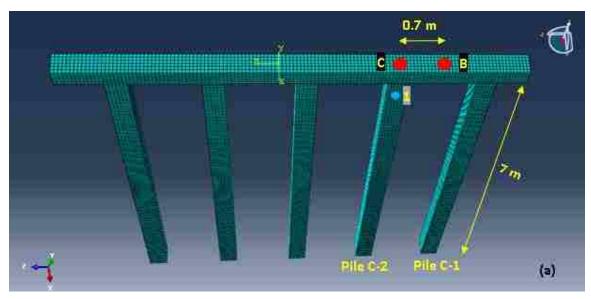
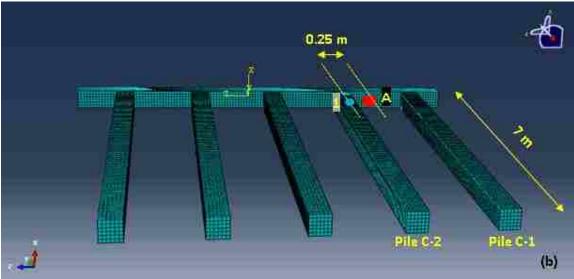
The results also show that, among all these three striking methods, the signals' amplitudes for striking at point C (center) is maximum whereas they are minimum for point B (eccentric). This can be one of the main reasons for superiority of striking at C over striking at points A and B and superiority of A over B in the field tests results. The amplitudes of the impulses and echoes are indicated in Table 82 for all striking methods.

Figure 198. FEM Model of Foundation Located at Bent C in Bridge No.1676 showing striking points (a) B, C and (b) A

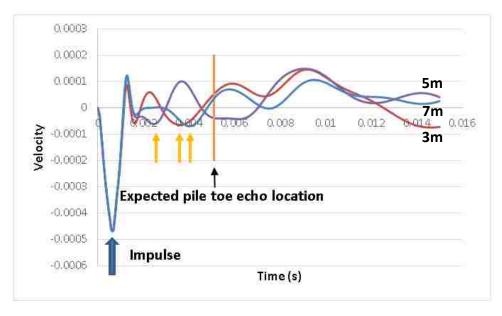
More investigations on such complicated foundations also show that the success of the SE tests depends on the reflections from the pier wall boundaries. Figure 227 shows the velocity graphs obtained at Node B for damped models with pier wall widths (b) of 3, 5 and 7m. The height of the pier wall is 1m. The vertical green line shows the expected location of the pile toe echo (corresponding to the distance between node B and pile toe (6.8m)). The graphs show that the boundaries affect the reflected waves from pile toe. The black arrows show the identifiable echoes on the velocity signals which are not the same as the expected echoes from pile toe. The adverse effect of the reflections from the pier wall sides were obvious when the pier wall widths were smaller than 12m. However, the effect of boundaries disappeared when the width of the pier wall was more than 12m. The velocity graphs obtained at Node B for damped models with pier wall widths 12, 14, 16 and 30m are indicated in Figure 228. The graphs show that the pier sides are far enough such that they do not affect the reflections from the pile toe and all the models show echo points corresponding to pile toe.

Figure 227. Velocity Graphs Obtained at Node B for Damped Models with Pier Wall Widths (B) of 3, 5 And 7m

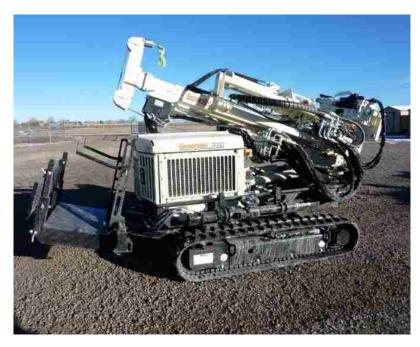
A bridge deck may have several variables that affect the quality of the test result. The clearance below the bridge deck is very important for PS and IF methods. Special drilling equipment (Geoprobe 7822DT) shown in Figure A1 may be required for low clearance bridges. Connections between the superstructure and the substructure determine the extent of traffic noise that is transmitted through the structure itself to the foundation, affecting the SE/IR and PS tests. PS and IF methods require drilling a hole with a depth at least 15 ft beyond the expected depth within the certain distance from the foundation. The foundation design is based on the subsurface conditions and the anticipated structural loads which depend on the length and width of the span. Historical standard bridge designs in New Mexico can be consulted to estimate the expected pile depth. If the piles are in soils, presumed resistance of soils can be used to roughly estimate the pile length.

Figure A1. Geoprobe 7822DT-Low Headroom Drill Rig

Conventional PS tests were conducted on two timber piles at Bridge No. 1676. The location and foundation plan of the bridge are shown in Figures 115 and 117 respectively. The test piles were Pile B-1 and C-1. Two test borings were drilled adjacent to the timber piles by NMDOT using the Geoprobe 7822DT (purchased during this project). The plan view of the location of the boreholes is indicated in Figure 162. The low headroom drill rig and the drilling operation are shown in Figure 163.

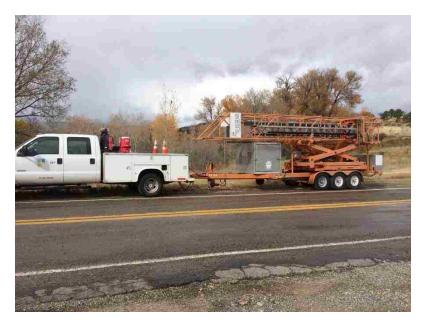
Seasonal weather fluctuations may affect the access of substructure. These impacts could be associated with variations in the water levels and flow velocities under a bridge. The running water may require the mobilization of a scaffold as shown in Figure A2.

Figure A2. Mobile Scaffold (NMDOT District 4)

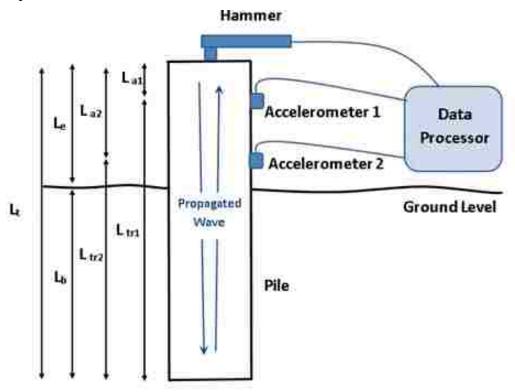
Figure A4. An SE/IR Test Setup

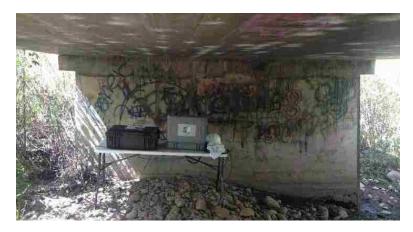
The equipment should be assembled on a flat surface close to the test pile. Figure A22 shows the SE/IR equipment on top of a table near the pier wall. There should not be any problem when the table is less than 45 ft from the substructure since the cables are 50 ft long.

Figure A22. SE/IR Equipment Placement near a Test Pier Wall

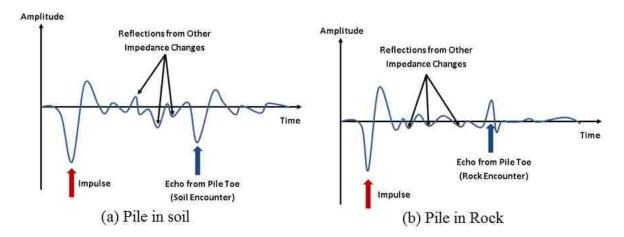
Figure A33. Schematic Velocity Graphs for Piles in Soil and Rock

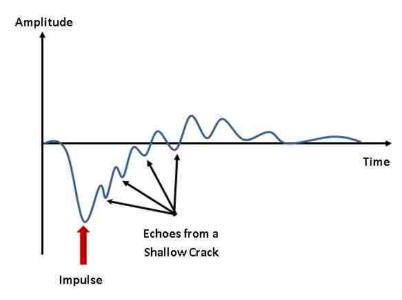
Figure A34. Schematic Velocity Signal Showing Consecutive Reflections from an Internal Crack

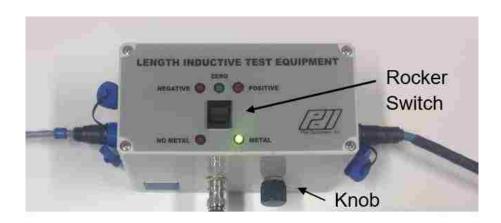
Figure A48. Details of Signal Conditioning Box
