## Coherence-based transmissibility as a damage indicator for highway bridges

A thesis submitted in partial fulfillment  
of the requirements for the Doctor of Philosophy  
degree in Civil and Environmental Engineering in the  
Graduate College of  
The University of Iowa

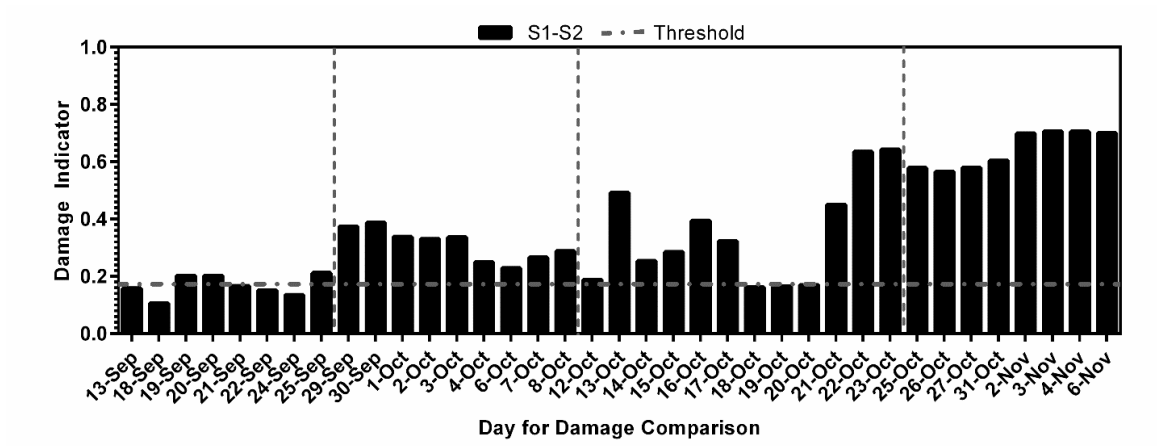
**Figure 23** Damage indicator of traffic data for multiple days compared to baseline set for sacrificial specimen: baseline set comprised from 14-Sep (19 °C). Refer to Figure 16 for sensor locations. Vertical dashed lines refer to creation/propagation of damage

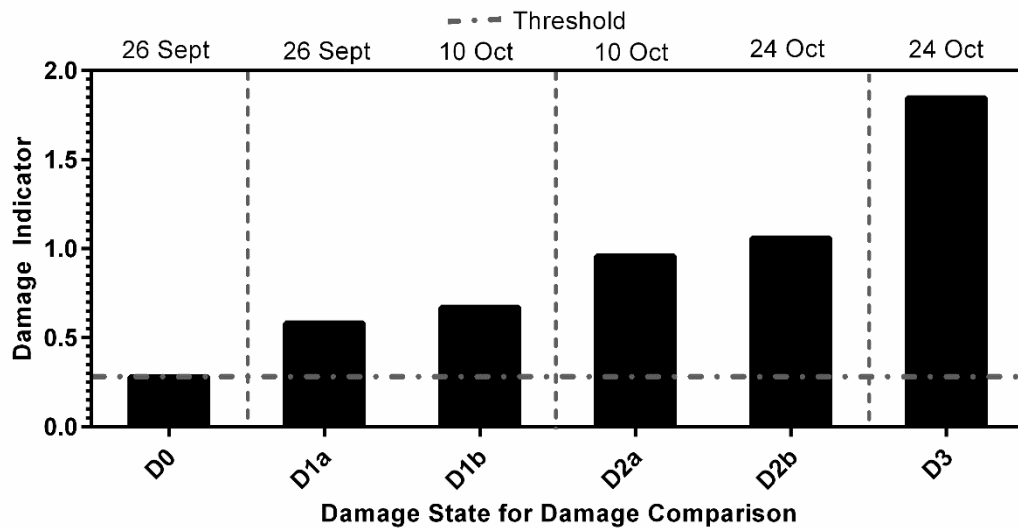
**Figure 24 Damage indicators of manual impacts for multiple damage states compared to baseline damage state for sacrificial specimen. Vertical dashed lines refer to creation/propagation of damage**

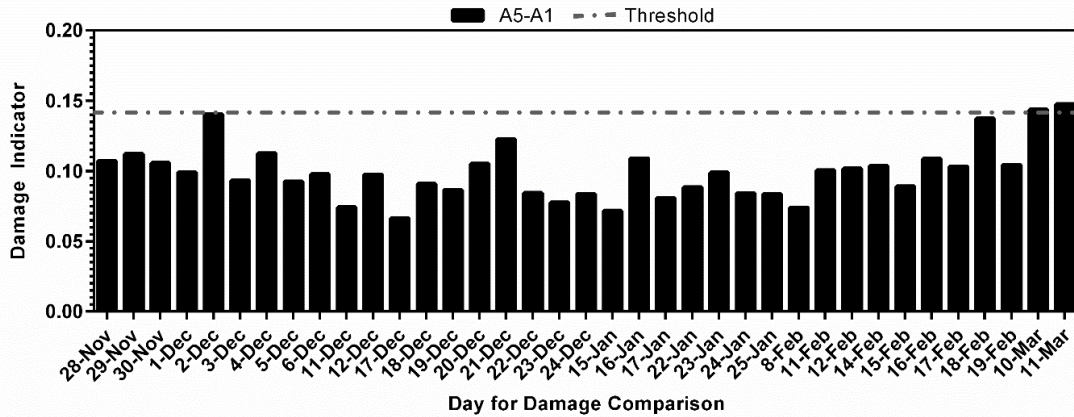
**Figure 26** Damage indicators of traffic data for multiple days compared to baseline set for sensors at Section A: baseline set comprised from 27-Nov (3 °C). Refer to **Figure 21** for sensor locations
