# Defect Growth Characterization in Modern Rail Steel

Sena Kizildemir

A Thesis

Structural Engineering

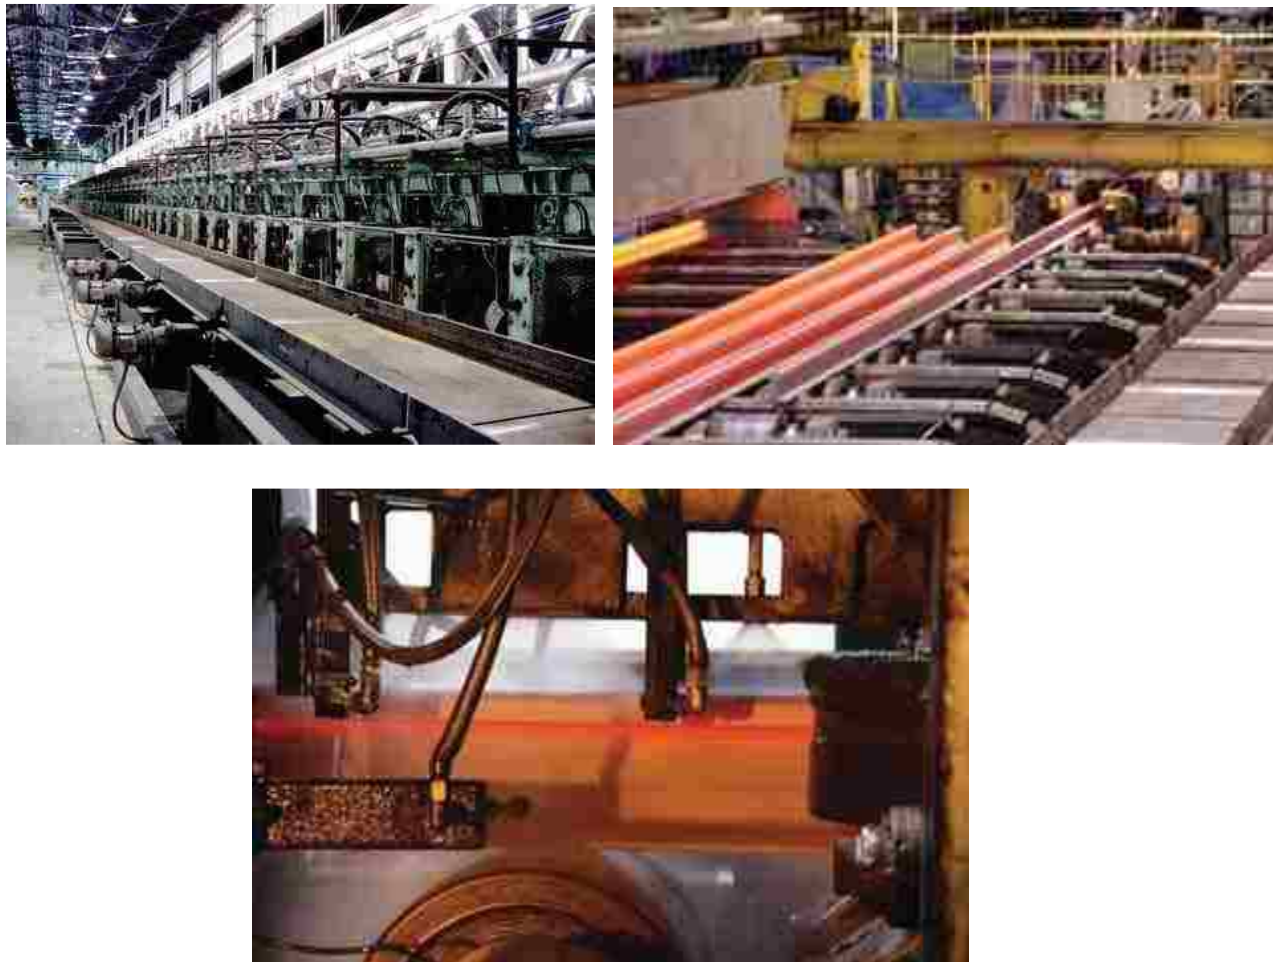
The head hardening processes that briefly mentioned above, involves a 100 meter long system that sprays either water, mist or oil on to rails to cool them as they passes through the cooling zones[58]. The process introduces a microstructural gradient inside the head (Figure 4c), which can lead to variable crack growth rate inside the head. These processes has been developed and used since 1994 to produce intermediate strength head hardened (ISHH), head hardened (HH), and advanced head hardened (AHH) rails.

The head hardening process described previously [58] is done at the facility at Steelton, which is in-line with the rail mill. To describe it better, we can say that the rolled hot rails directly proceed to the facility. The picture of it can be found below.

**Figure 3** – Head hardening facility at ArcelorMittal, Steelton.

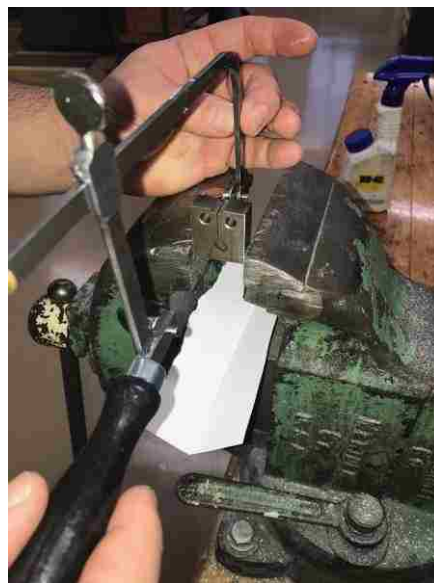
Additional machining steps included milling the CT specimens to obtain flat surfaces, boring the pin loading holes, and cutting the notch. In the initial phases of the test program, notches were cut with a very fine (0.006 in.) diameter wire (EDM). However, it was determined that waterjet cut notches (notch widths between 0.020 – 0.030 in.) were perfectly acceptable for the precracking process, especially if a fine jewelers saw (blade width 0.012 in.) was used to make a fine saw cut at the base of the waterjet cut notch as shown in Figure 52. All CT fracture specimens were precracked in fatigue to obtain a precrack length of  $a = 12.5$  mm using a constant amplitude sine loading with a maximum load of 4000 N and a minimum load of 400 N at a frequency of 15 – 20 Hz. Figure 53 shows a polished CT specimen with a close-up image showing the fatigue crack growth from the tip of the notch. The photomicrograph in Figure 54 also clearly shows the precrack from the notch tip in a CT specimen.

**Figure 52** – Cutting sharp notch at the base of waterjet cut notch using jeweler's saw.

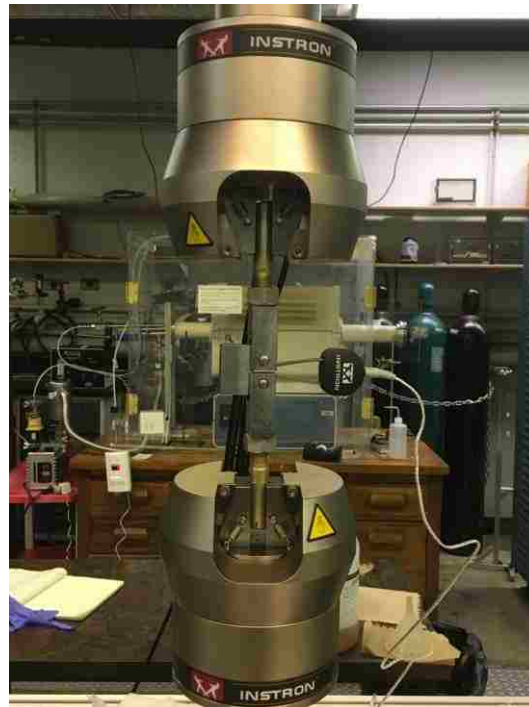
with the attached COD clip gauge during fracture toughness testing. Appendix C contains sample load vs COD measurements taken from valid  $K_{Ic}$  tests for the different rail types. This Appendix also contains the CT formulas for  $K_I$  and crack opening displacement  $d_1$ . The formulas for  $K_I$  and  $d_1$  are given as a polynomial function of the crack length  $a$  and applied load  $P$ . Thus, the crack length  $a$  and the stress intensity factor  $K_I$  can be determined indirectly from the measured values of  $P$  and  $d_1$  during a test.

**Figure 55** – Compact tension fracture toughness test showing COD clip gauge.

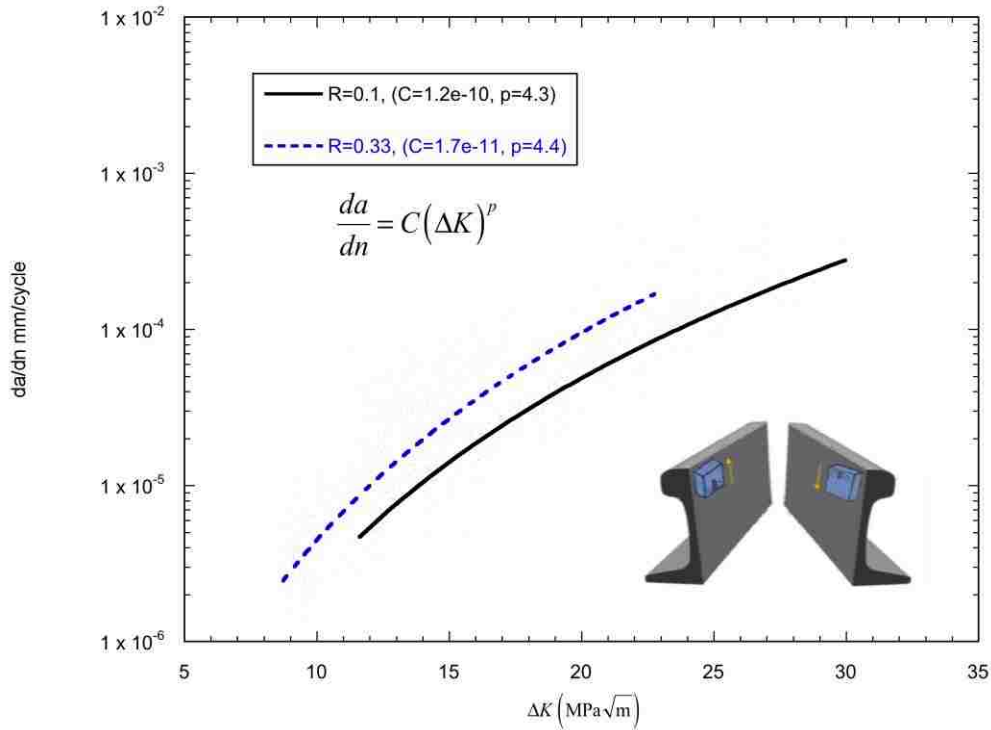
**Figure 71** – Comparison of vertical fatigue crack growth rates in AHH rail for CT specimens at two different R ratios,  $R=0.1$  and  $R=0.33$ .

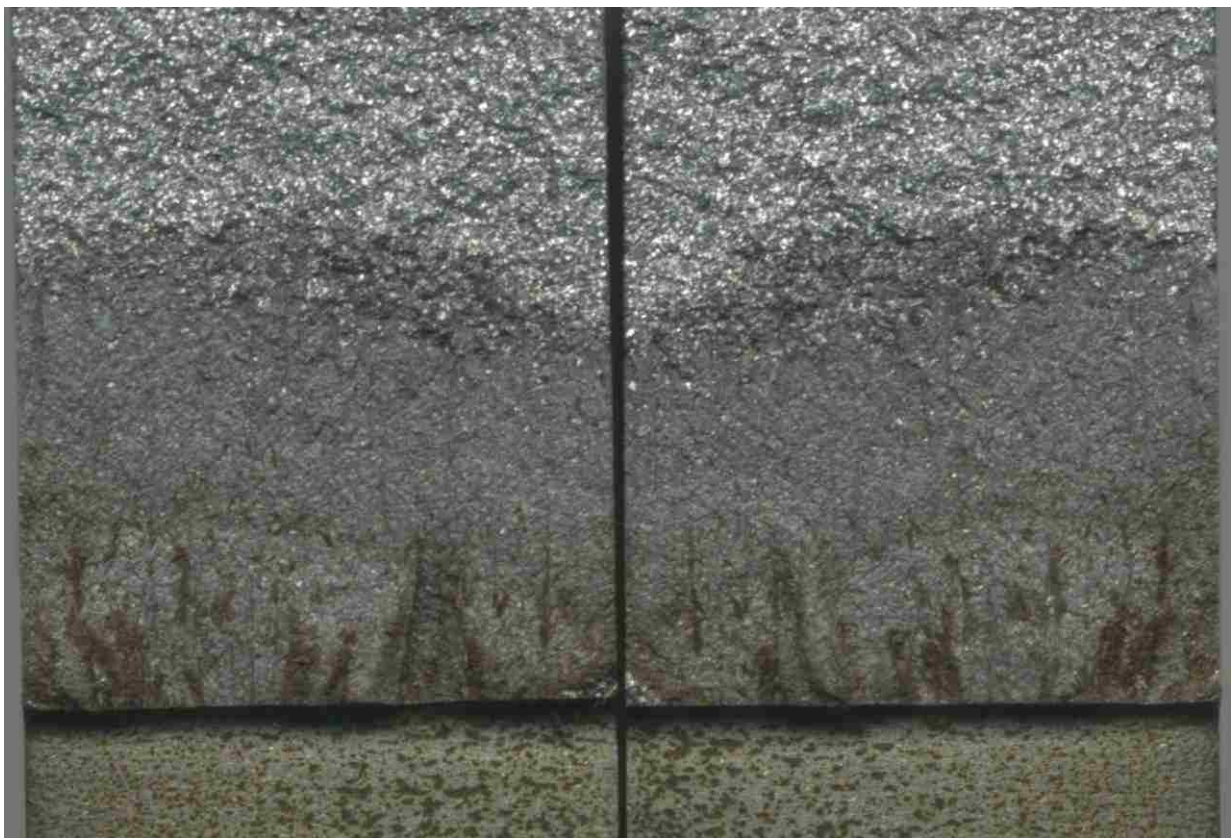
**Figure 75** – Fatigue/fracture surface for HH 3B tested at  $R=0.1$ .

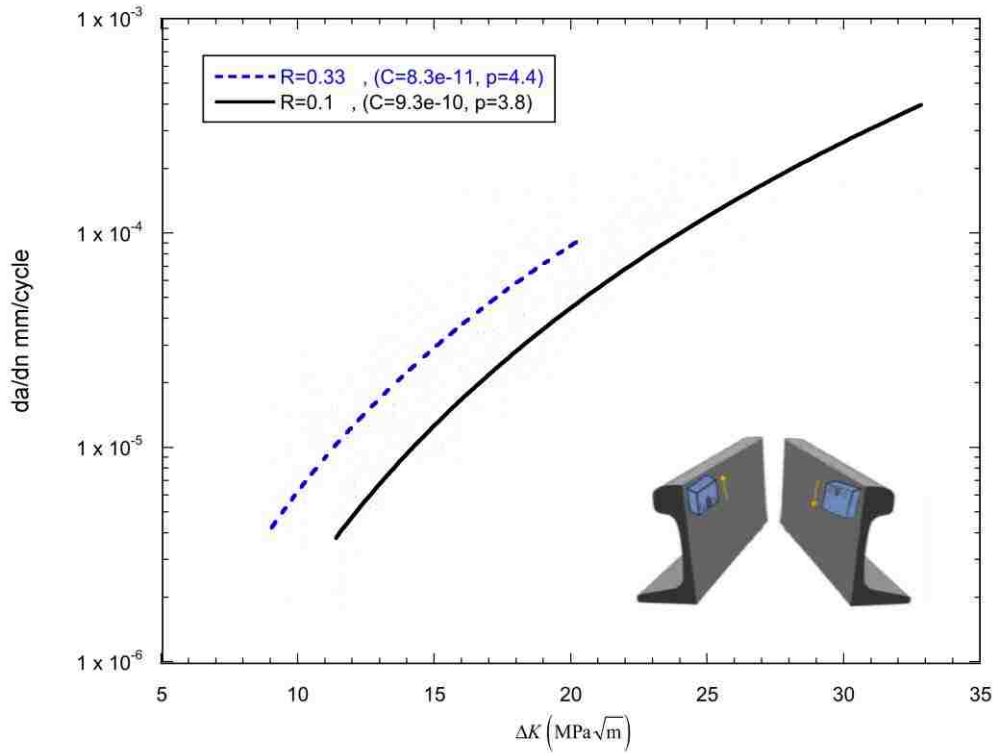
**Figure 77** – Comparison of vertical fatigue crack growth rates in HH rail for CT specimens at two different R ratios.  $R=0.1$  and  $R=0.33$ .

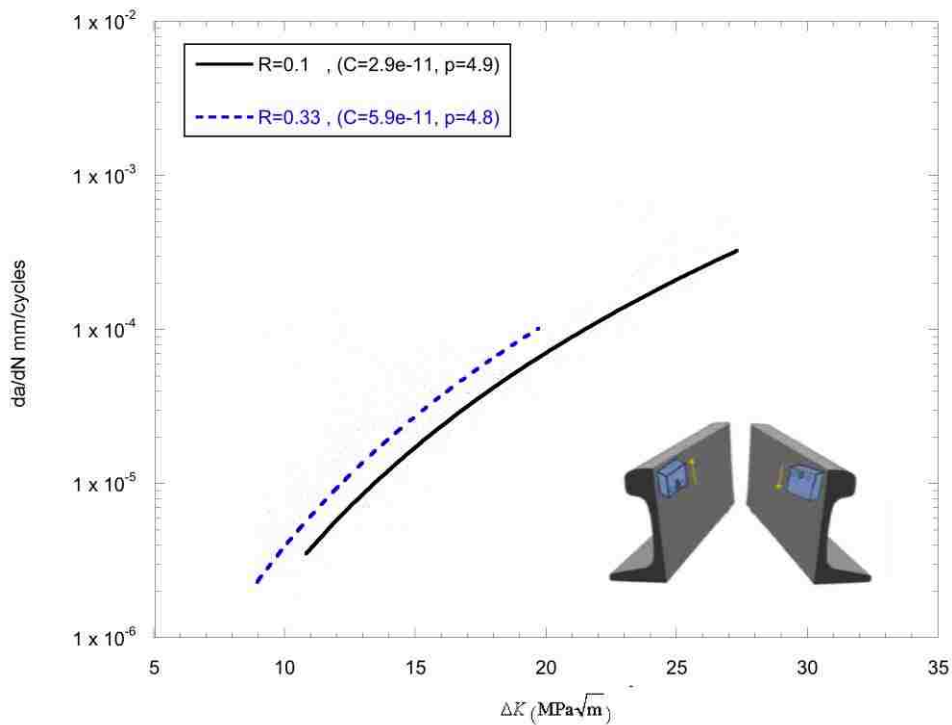
**Figure 80** — Comparison of vertical fatigue crack growth rates in the HAY84 rail for CT specimens at two different R ratios.  $R=0.1$  and  $R=0.33$ .

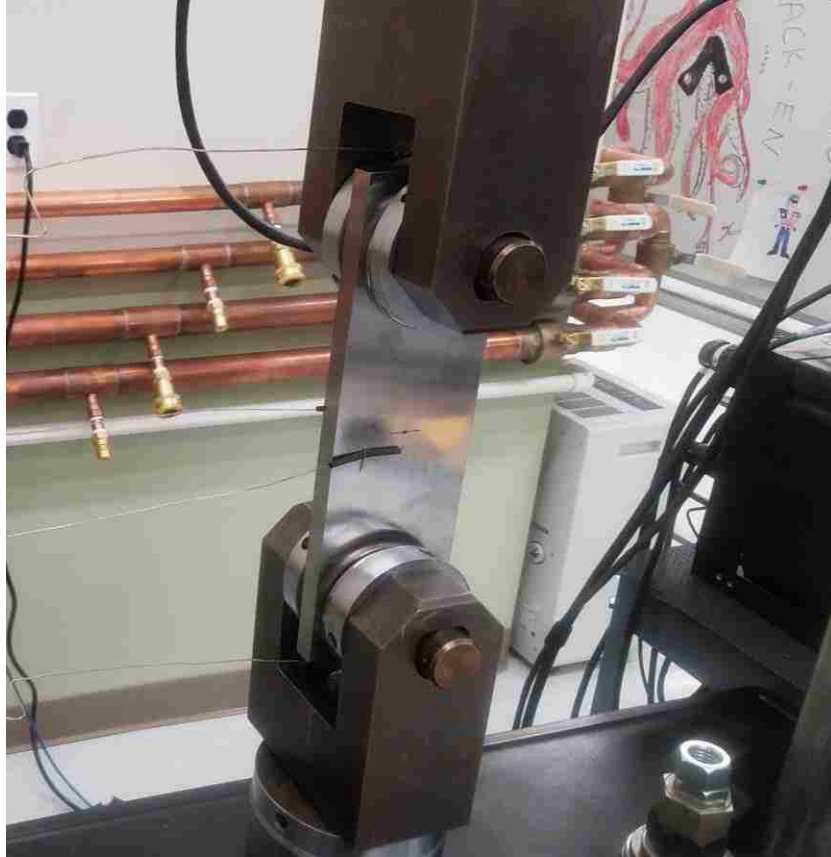
**Figure 86** – Testing of center cracked tension (CCT) specimen at LTI.

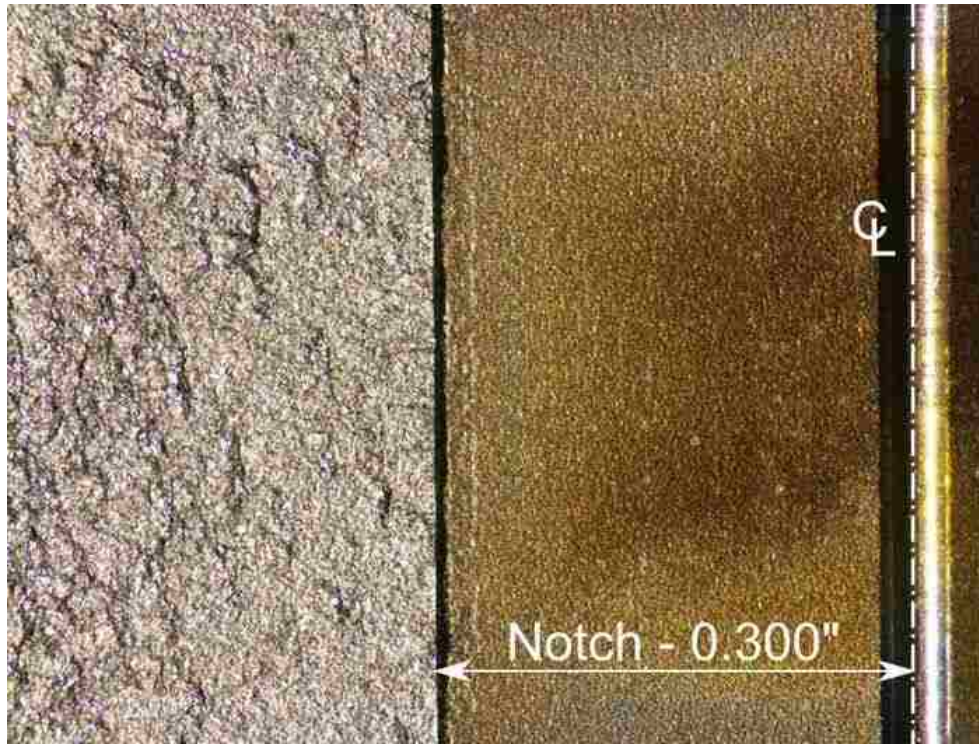
**Figure 89** – Fatigue/fracture surface taken from HH rail CCT test specimen showing rough fatigue crack surface.

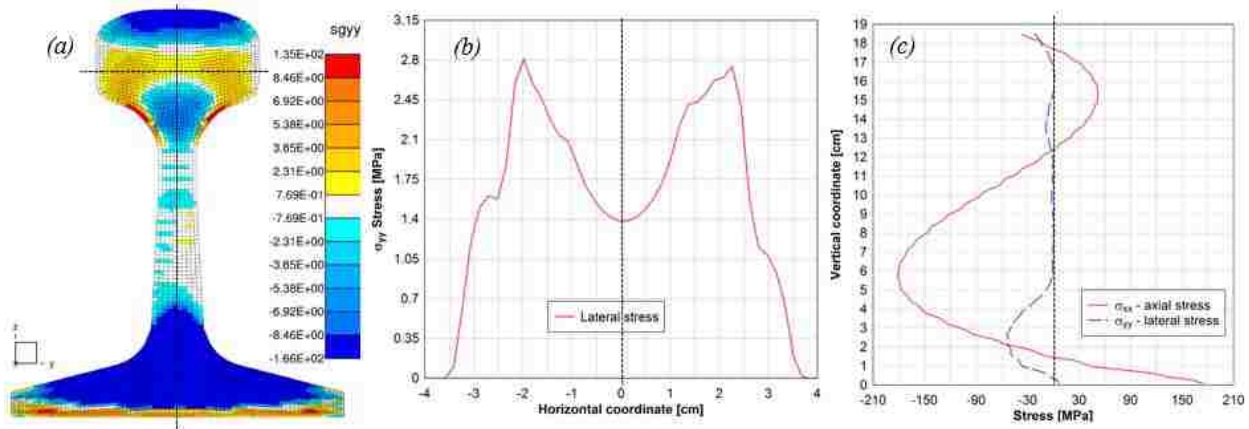
**Figure 96** – Lateral stress induced by the application of the longitudinal stress: (a) lateral stress maps on the rail surface where longitudinal stress was applied; (b) lateral stress across the width of the railhead; (c) longitudinal and lateral stresses along the height of the rail (units MPa, length in cm)

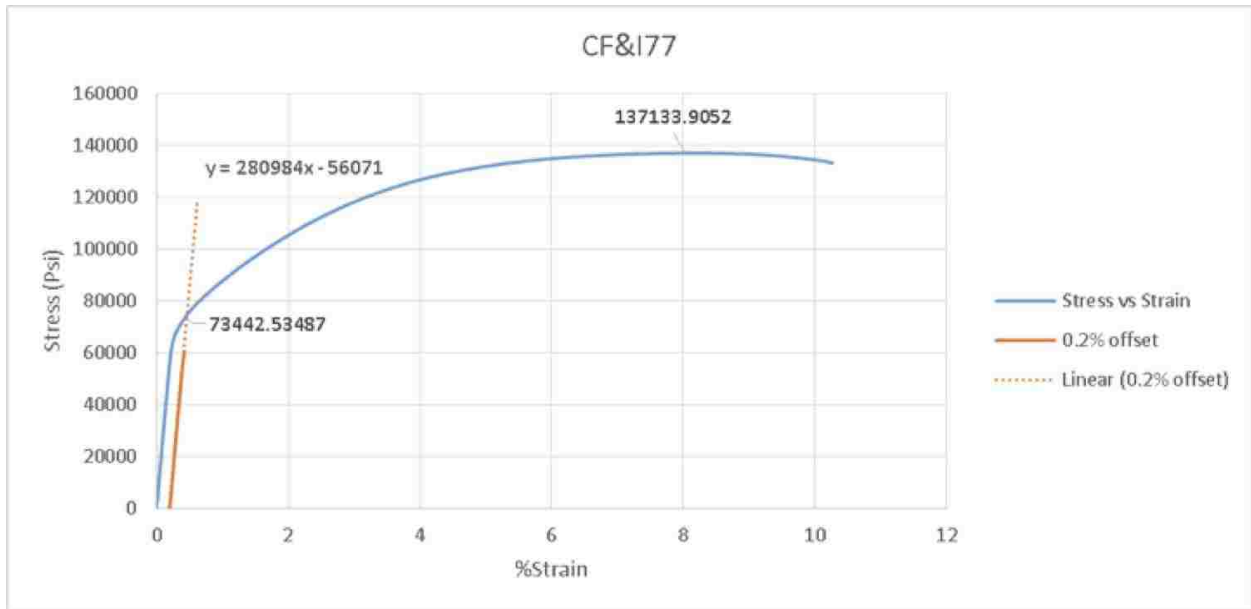
**Figure 124** – Stress vs Strain for CF&I77 rail, layer #2.

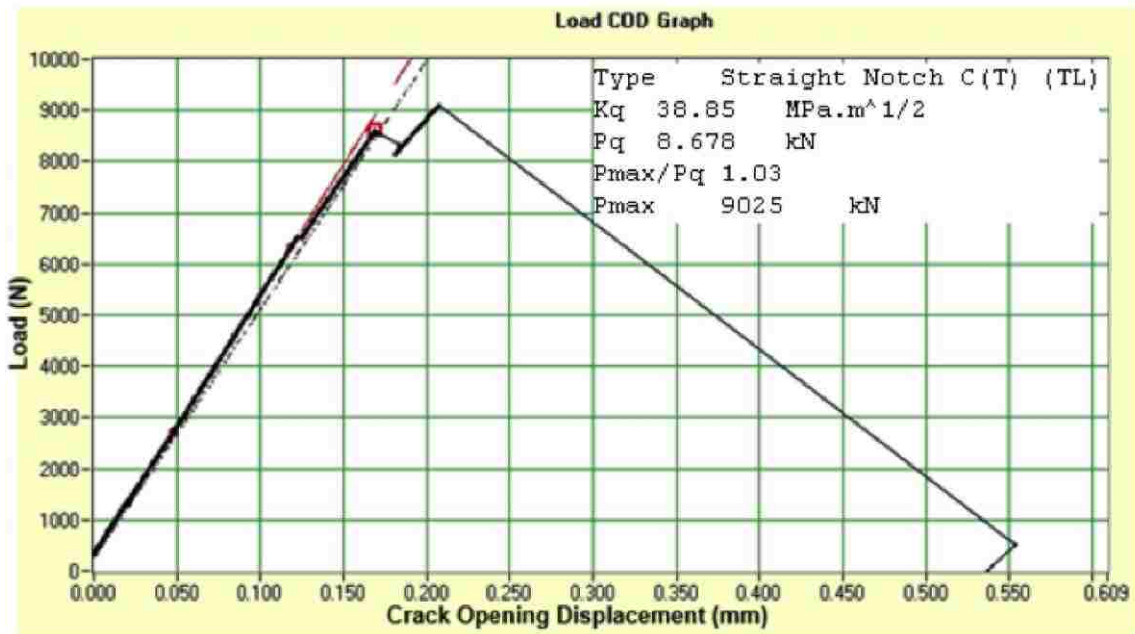
Figure 127 – Load vs COD for HH Rail Fracture Toughness Test.

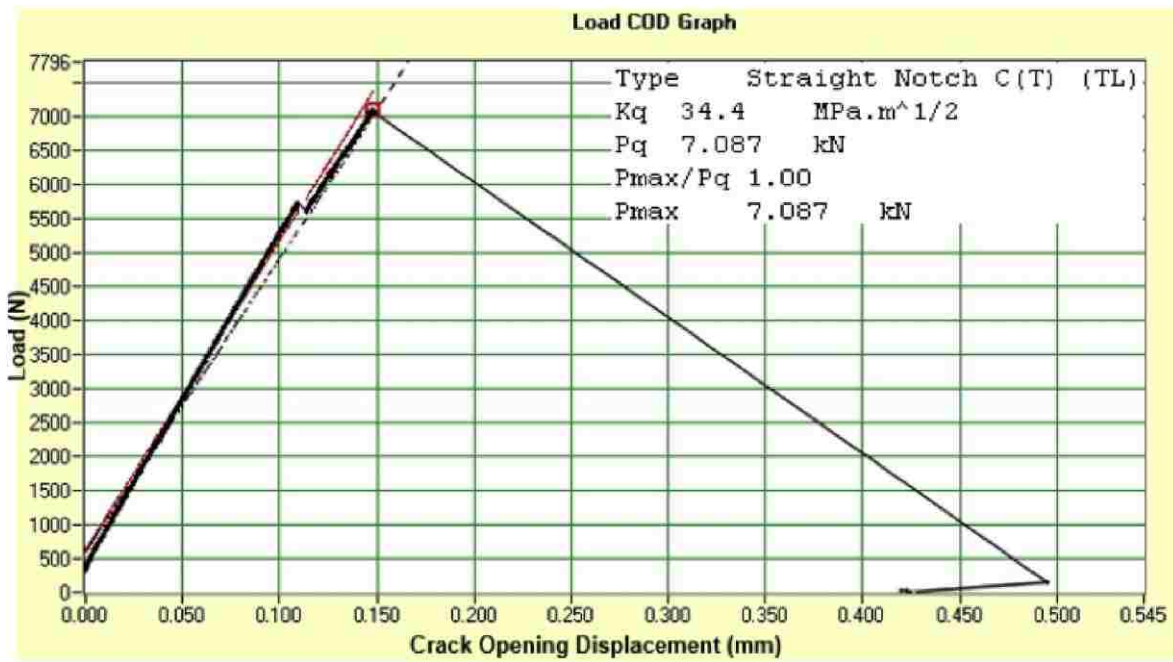
Figure 129 – Load vs COD for HAY84 Rail Fracture Toughness Test.

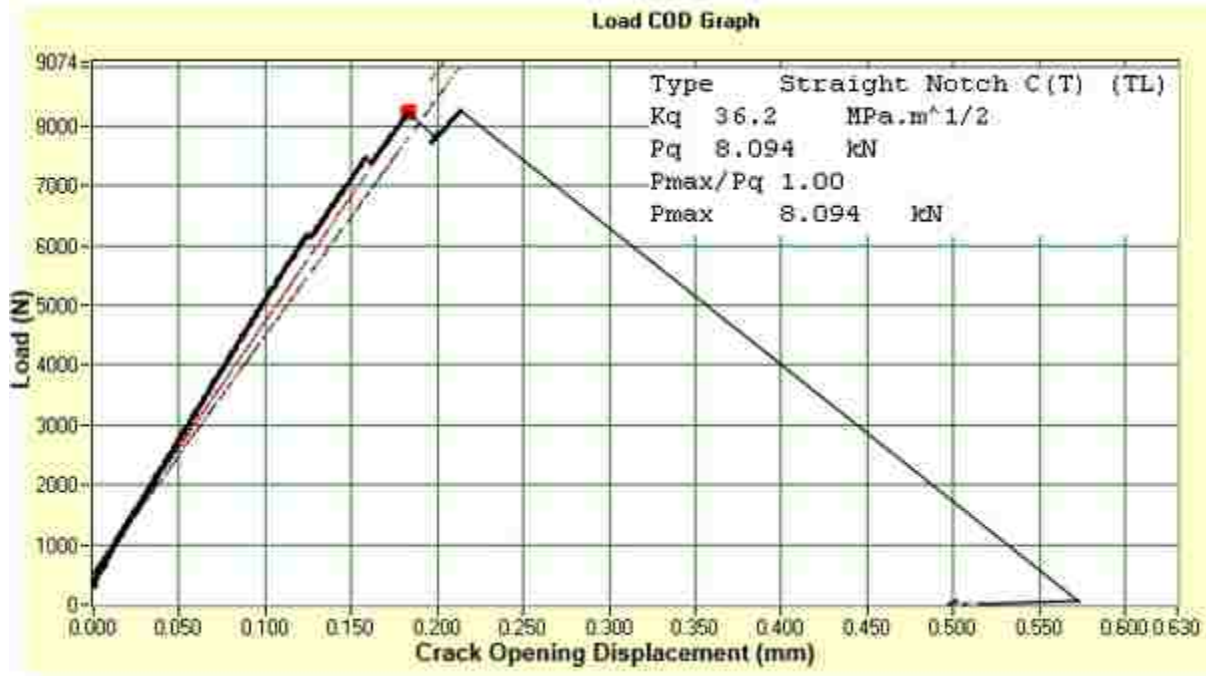
**Figure 130** – Load vs COD for CF&I77 Rail Fracture Toughness Test.

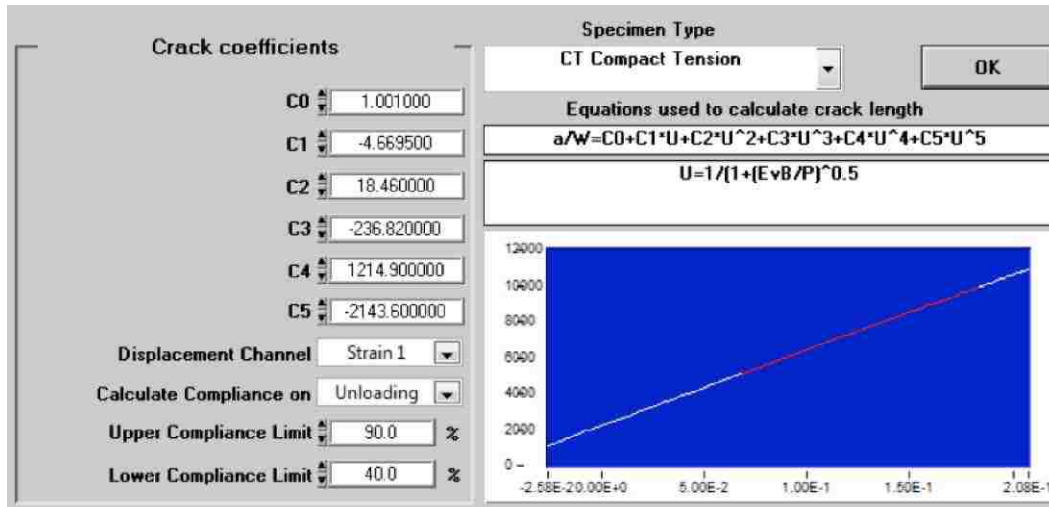
**Figure 131** – Crack length calculations based on compliance measurements during testing.
