Drilled Shaft Socket Connections for Precast Columns in Seismic Regions

A thesis

Master of Science in Civil Engineering

University of Washington

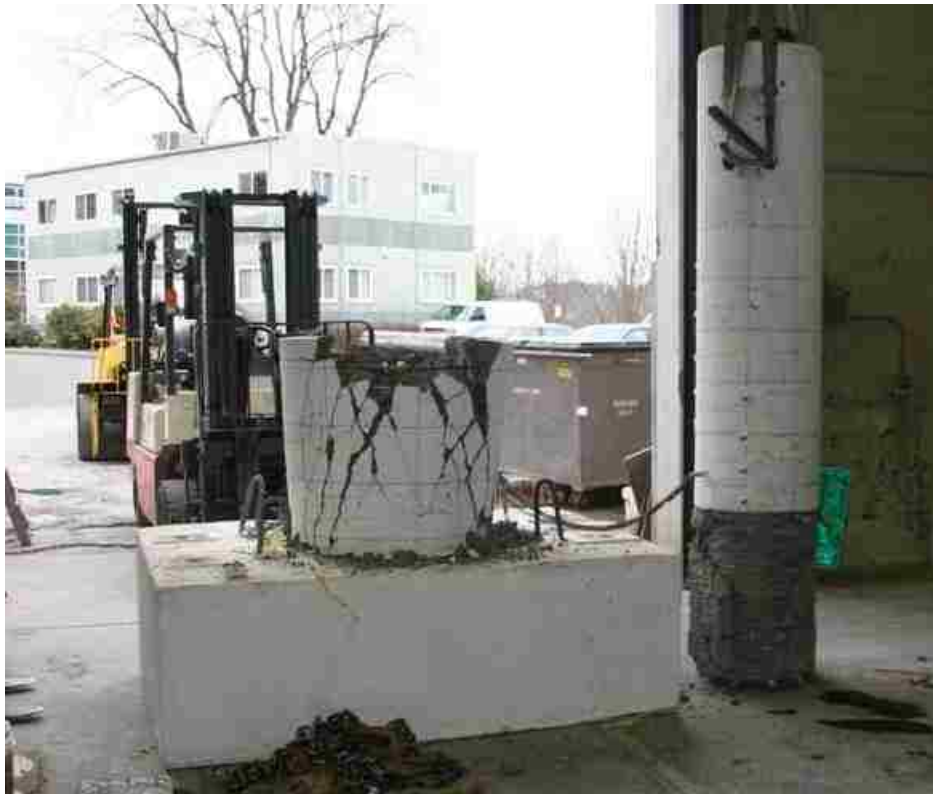
**Figure 4-3. Specimen DS-2 after testing**

In Specimen DS-2, the amount of spiral steel in the shaft was only half that in Specimen DS-1. It is therefore not surprising that, in it, the transverse reinforcement in the shaft yielded earlier than in DS-2, and subsequently fractured. The behavior of the specimen was characterized by very large cracks opening in the shaft, which suffered extensive shear deformations as a result. Failure was initiated by fracture of the spiral steel in the shaft, starting at the top and progressing downwards. The damage to the shaft caused the load to drop even though the drift was increasing. The longitudinal bars in the column did not buckle, and by observation, it was known that the spirals in the column never fractured.

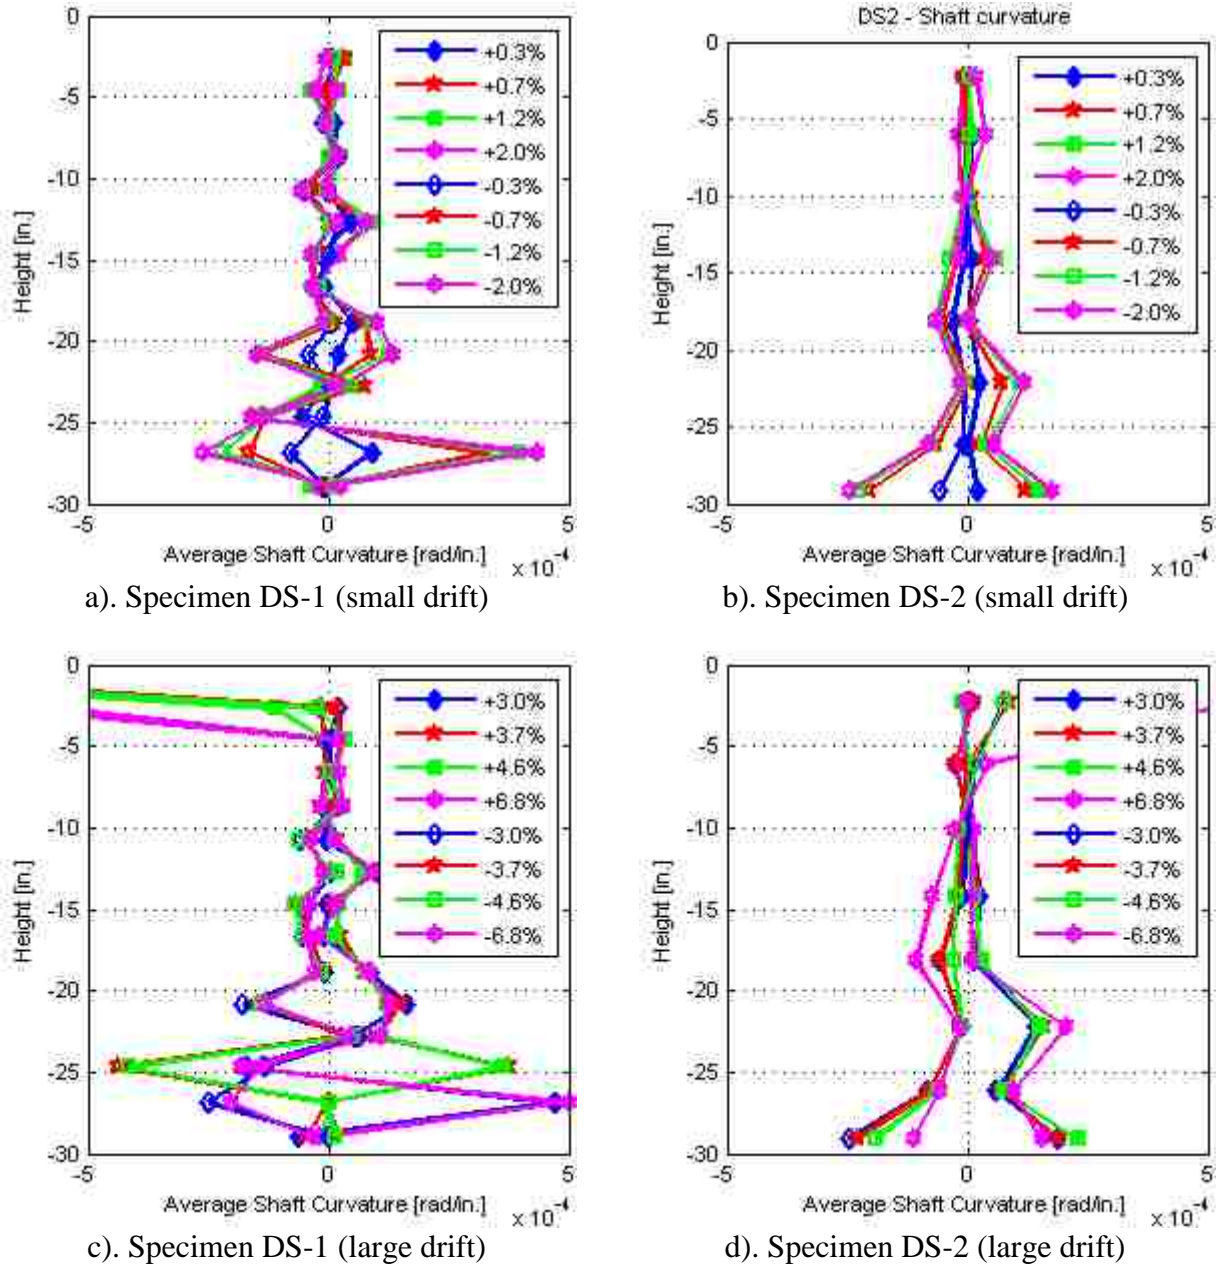
The average shaft curvature versus height for selected drift ratios is shown in Figure 5-7. The curvatures in the shafts were also distributed non-uniformly, with the largest values at the base. That distribution reflects the existence of a flexural crack at the base. Each of the peaks of curvature corresponds to a horizontal crack position. Note that the scales on the column and shaft plots are different, and that the shaft curvatures were smaller by about an order of magnitude than the column curvatures.

**Figure 5-7. Average Shaft Curvature (Specimen DS-1 and DS-2)**

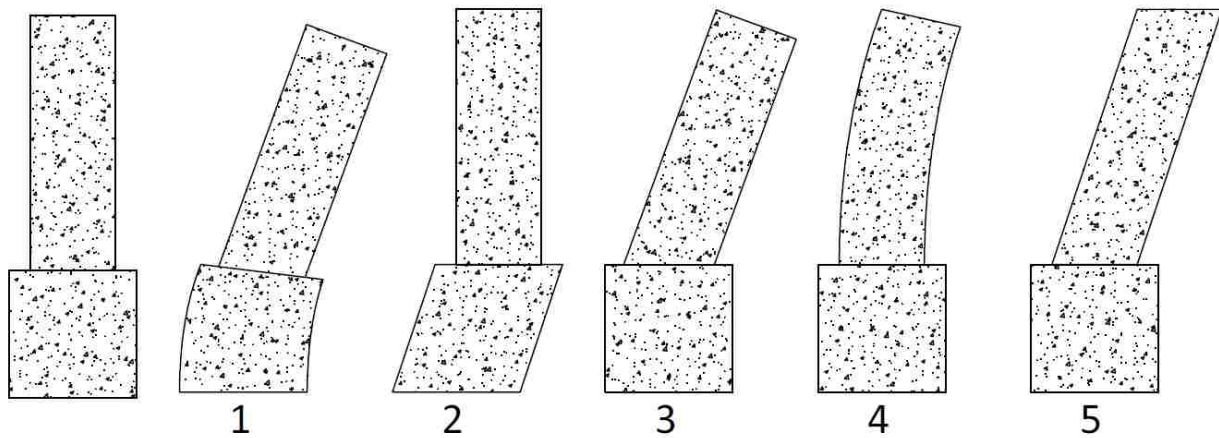
Vertical displacements were measured only by the Optotrak system. No values are presented here.

**Figure 5-8. Displacement types**

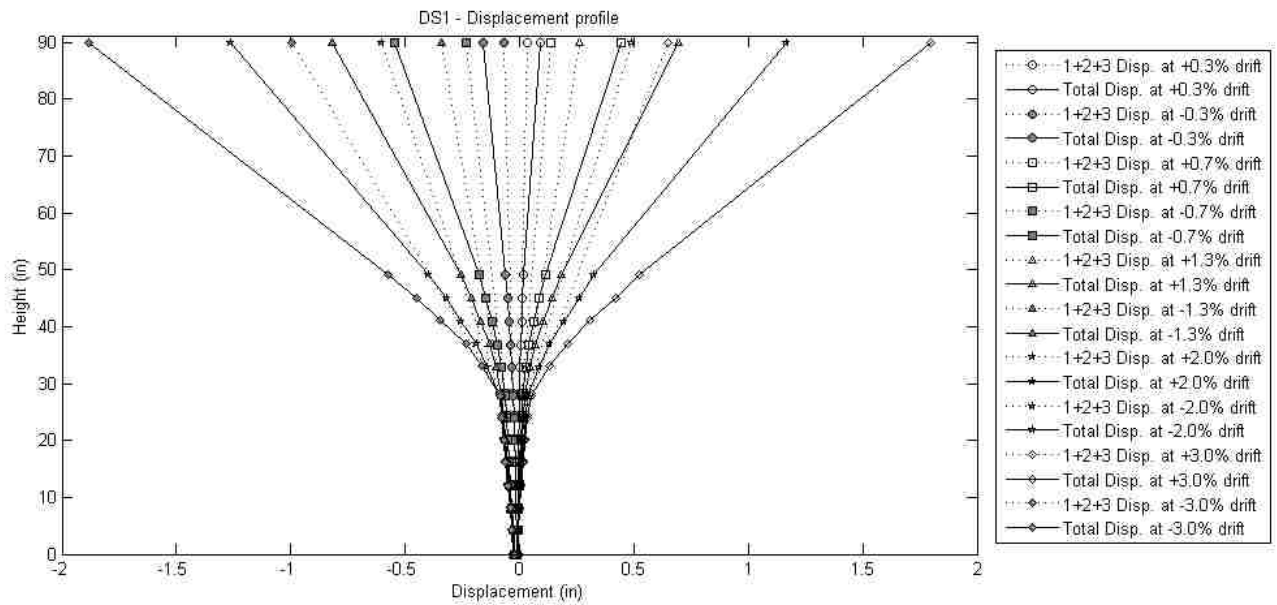
column base rotation, which was 0.012 rad (1.2% drift) in DS-1 and 0.007 rad (0.7% drift) in DS-2. However in DS-2 specimen, the percentage of column base rotation contributed to total deformation was higher than in DS-1 specimen.

Figure 5-11. Specimen DS-1 - Displacement profile

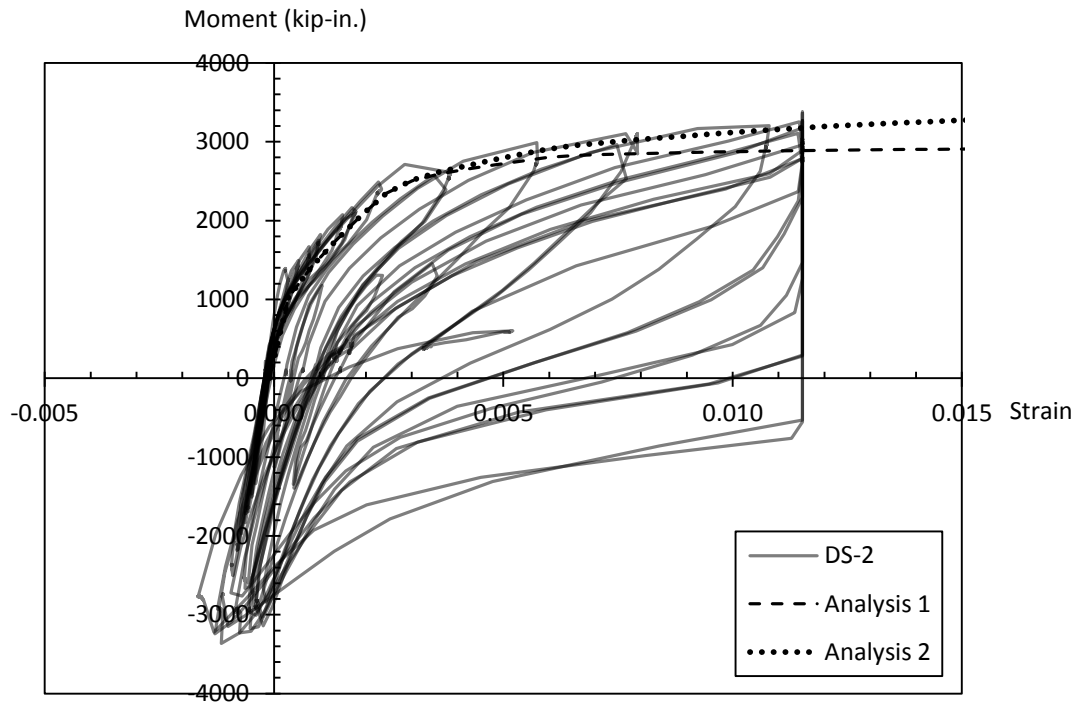
**Figure 6-7. Moment-extreme reinforcement tensile strain relationship for column (in DS-2)**

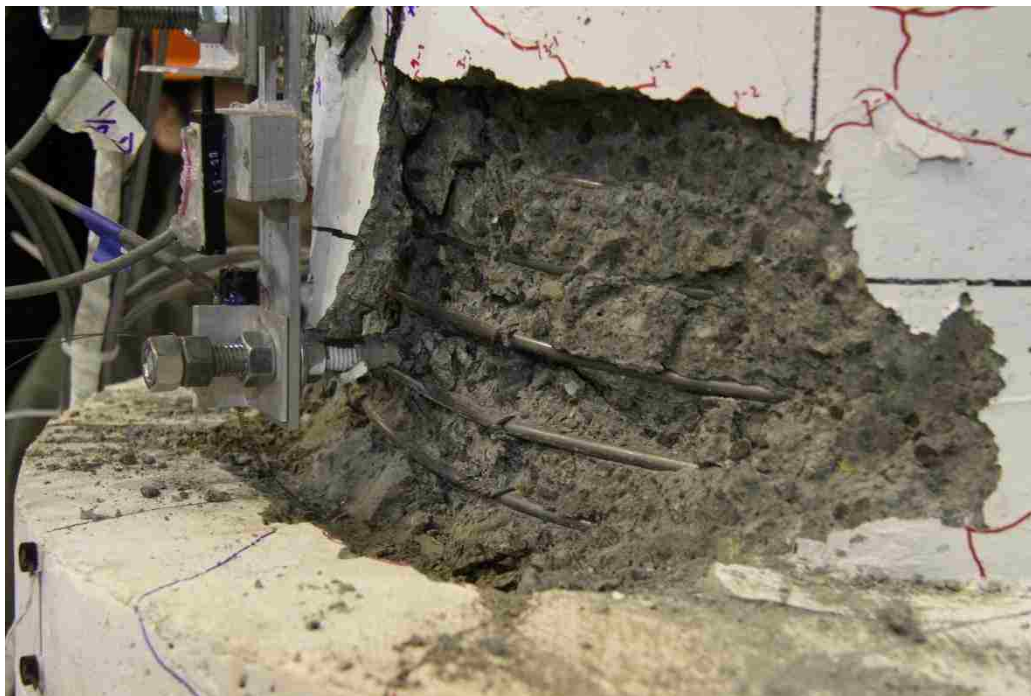
**Figure C-0-4. DS-1 – First noticeable bar buckling in the column in Cycle 9-3 (6.90/-6.81 percent drift)**

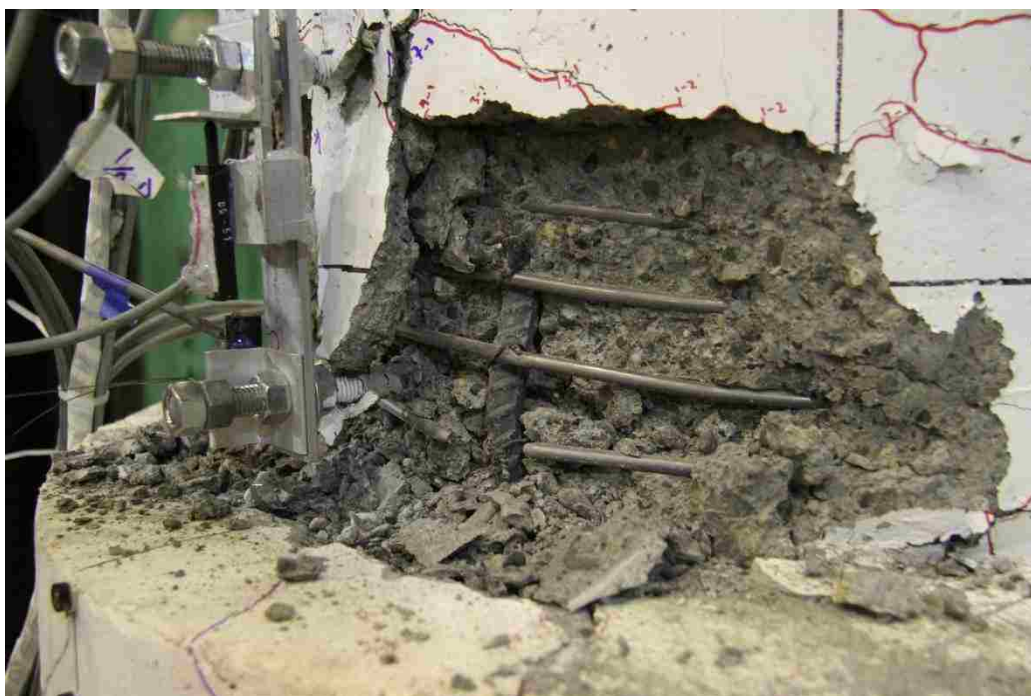
**Figure C-0-5. DS-1 – First column spiral fractured in Cycle 10-1 (8.43/-8.27 percent drift)**

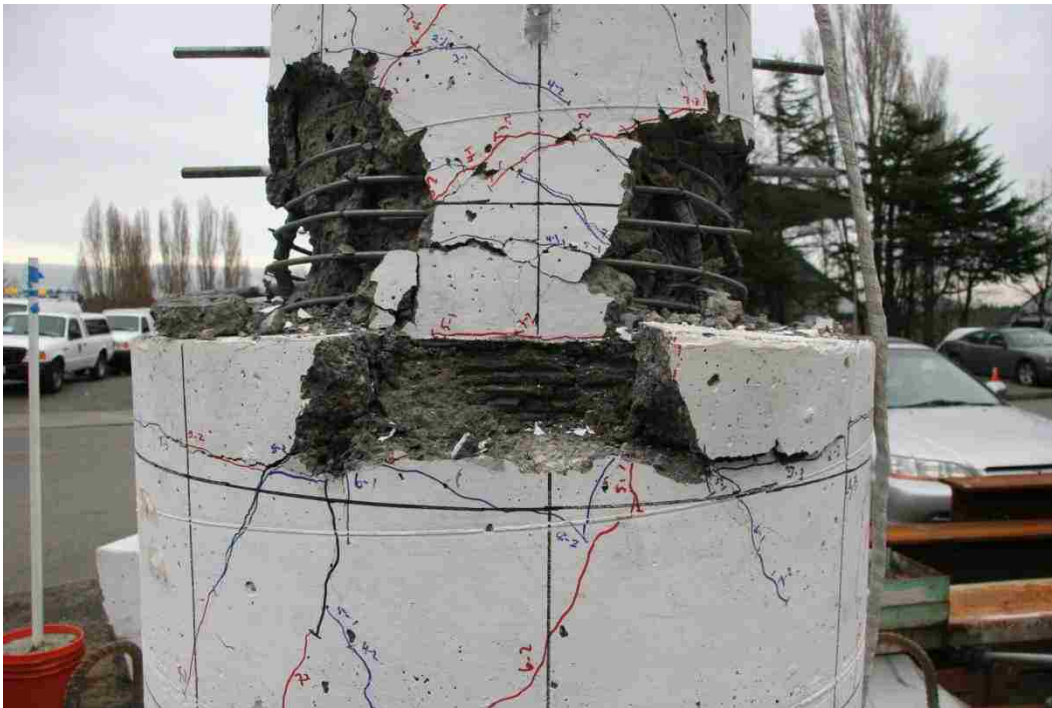
**Figure C-0-6. DS-1 – Column damage after cyclic testing**

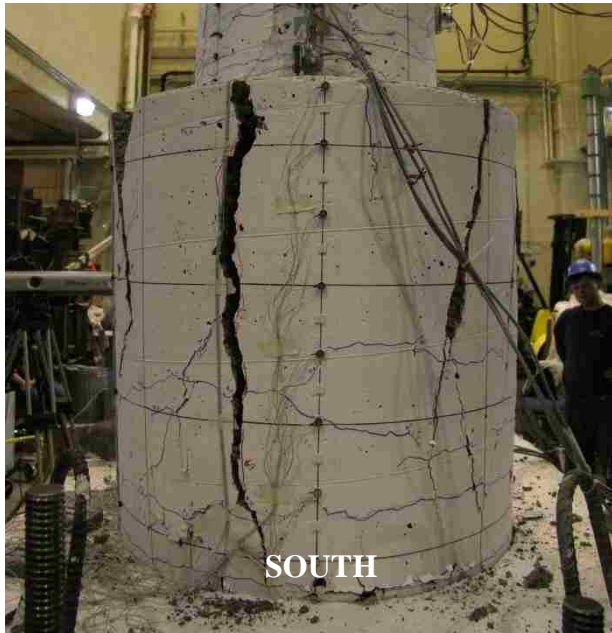
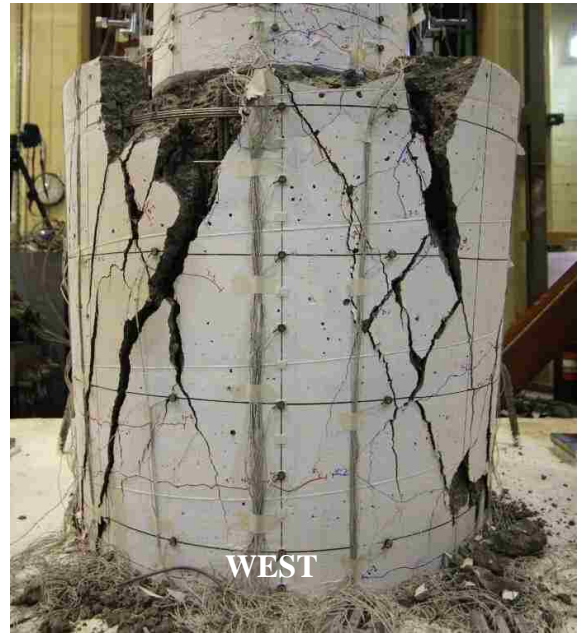
Figure C-0-12. DS-2 – Shaft damage after cyclic testing

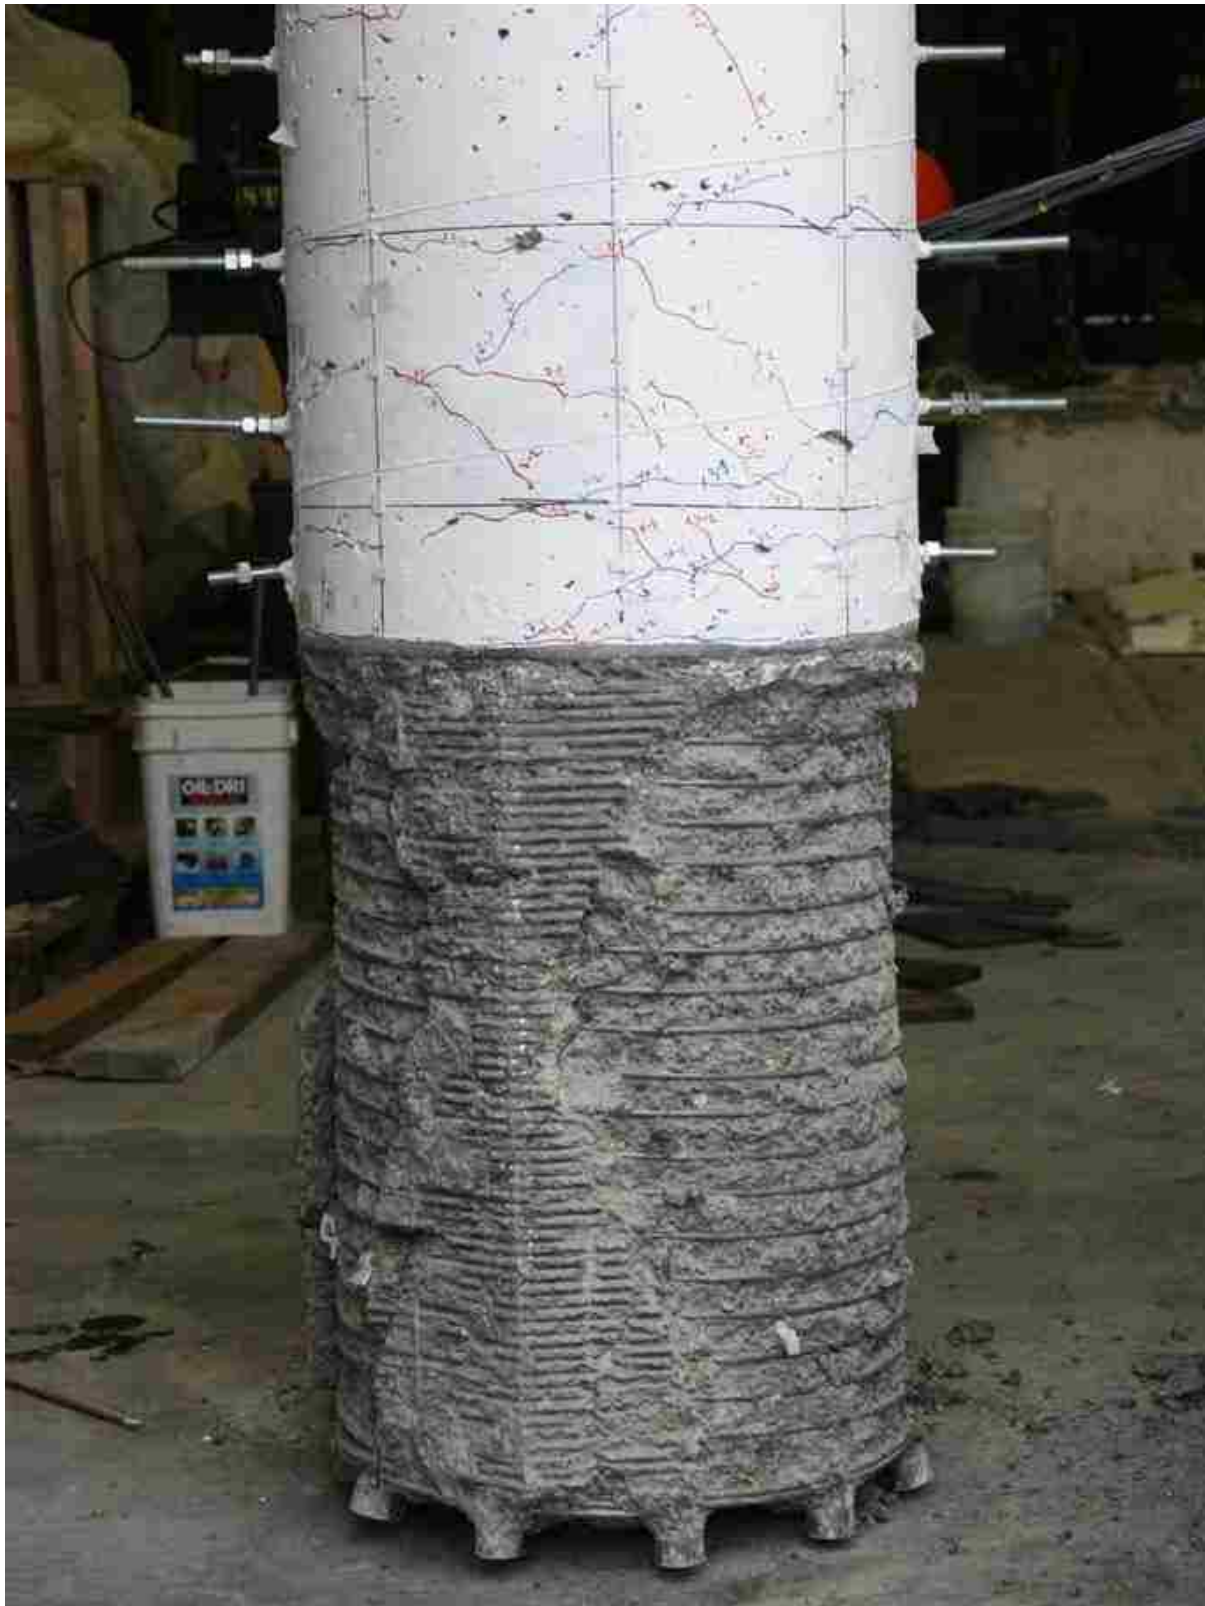
Figure C-0-13. DS-2 – Column damage after cyclic testing
