# Efficacy of Geosynthetic Separators and Filters: An Evaluation of Test Sections in Marked Tree, Arkansas

EFFICACY OF GEOSYNTHETIC SEPARATORS AND FILTERS: AN EVALUATION OF  
TEST SECTIONS IN MARKED TREE, ARKANSAS

A thesis submitted in partial fulfillment  
of the requirements for the degree of  
Master of Science in Civil Engineering

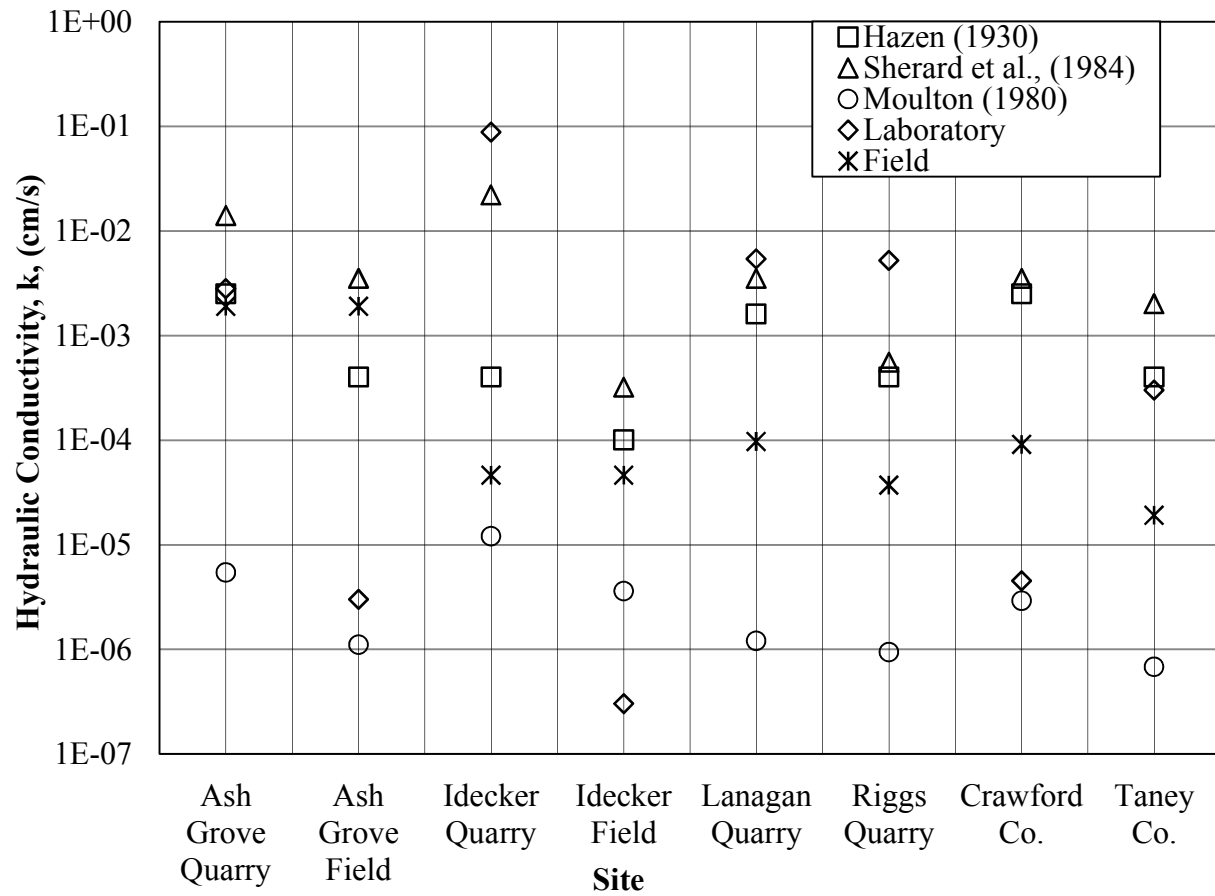
**Figure 2.6. Laboratory measured, field measured and estimated hydraulic conductivities of base course samples obtained from various sources (modified from Blanco, 2003).**

A comparison between the measured laboratory hydraulic conductivity values and the measured field hydraulic conductivity values and the estimated hydraulic conductivity values obtained using the Hazen (1930), Sherard et al., (1984) and Moulton (1980) equations is presented in Figure 2.6. The predicted hydraulic conductivity values based on the Hazen (1930) and Sherard et al., (1984) methods range from  $10^{-2}$  cm/s to  $10^{-4}$  cm/s (Blanco, 2003). These predictions are one to two orders of magnitude higher than the hydraulic conductivity values measured in laboratory using the CHP and the hydraulic conductivity values measured in field using the DRI. The hydraulic conductivity values obtained using the Moulton (1980) equation ranged from  $10^{-5}$  cm/s to  $10^{-7}$  cm/s (Blanco, 2003) which are within the range of values measured using the FWP but underestimate the field hydraulic conductivity values measured using the DRI (by one to two orders of magnitude); these empirically predicted values are also several orders of magnitude lower than the hydraulic conductivity measured using CHP.

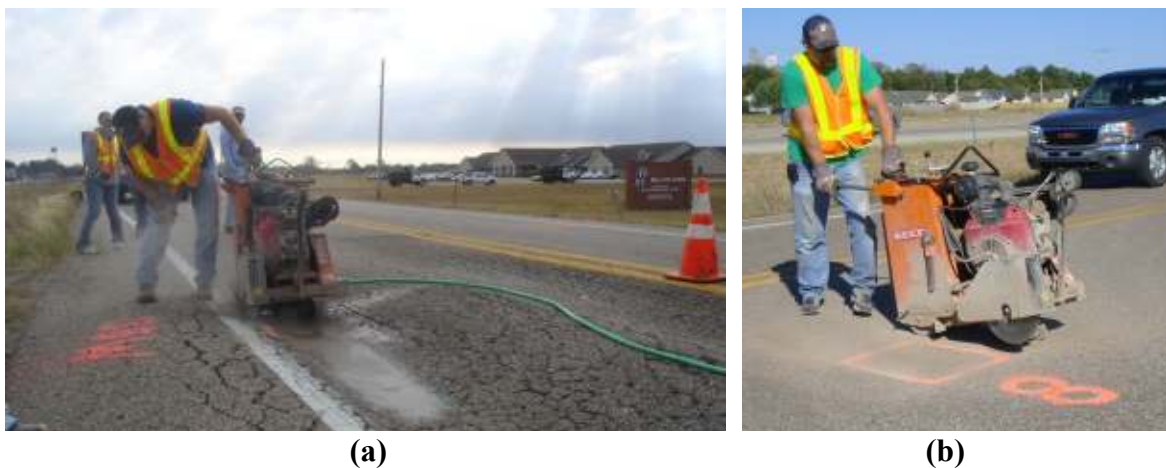
**Figure 3.3. Two foot by two foot test sections cut by Arkansas State Highway and Transportation Department (AHTD) personnel using a wet concrete saw a) Section 13W and b) Section 8.**

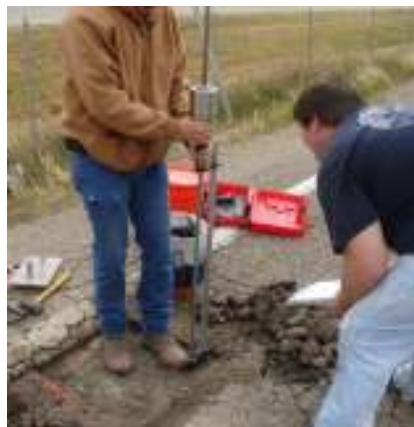
**Figure 3.7. Dynamic Cone Penetrometer (DCP) testing in progress.**

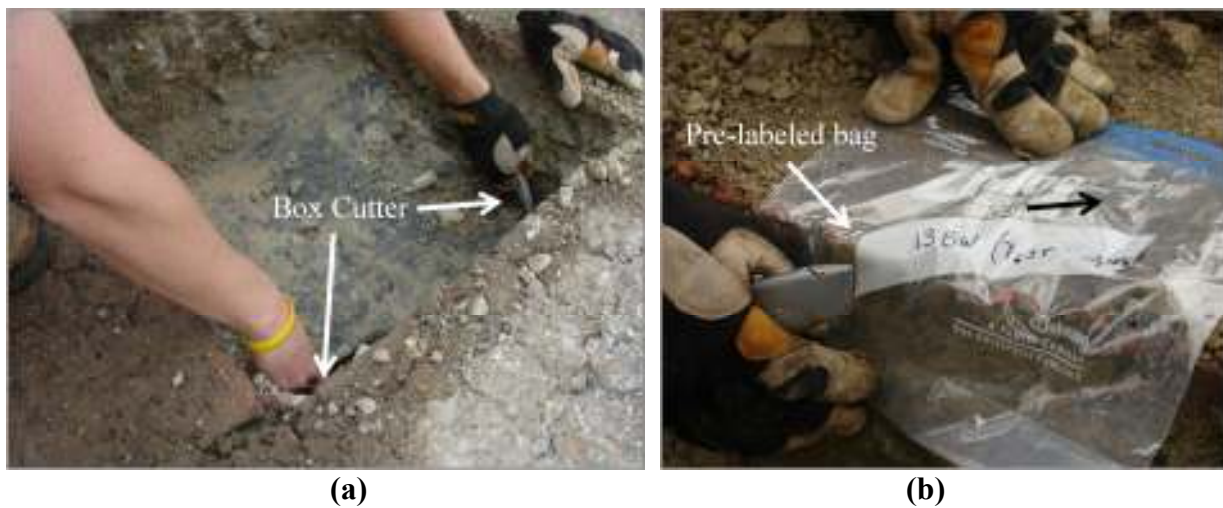
**Figure 3.13. Geosynthetic sample a) removal using a box cutter and b) pre-labeled bag ready for placement.**

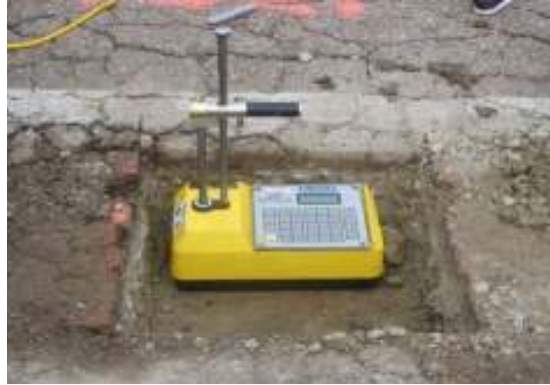
**Figure 3.15. Nuclear gauge positioned to obtain subgrade density and water content readings (Section13BW).**

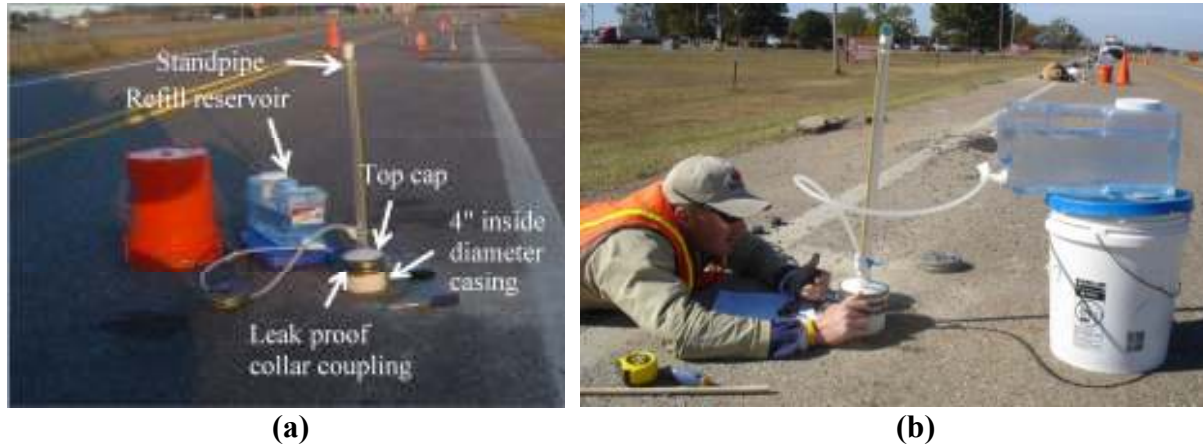
**Figure 3.20. a) Two stage borehole setup prior to testing and b) ongoing two stage borehole test.**

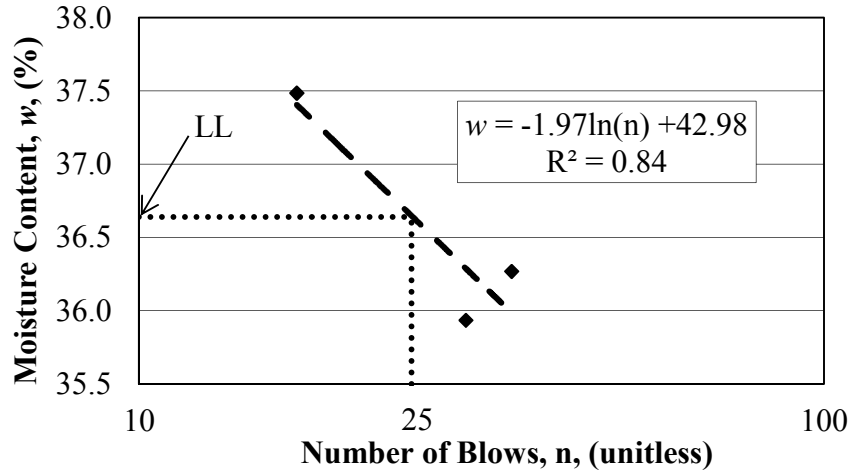
**Figure 3.33. Subgrade liquid limit plot for sample obtained from Section 1B at a depth of 0-2 inches below the base course/subgrade interface.**

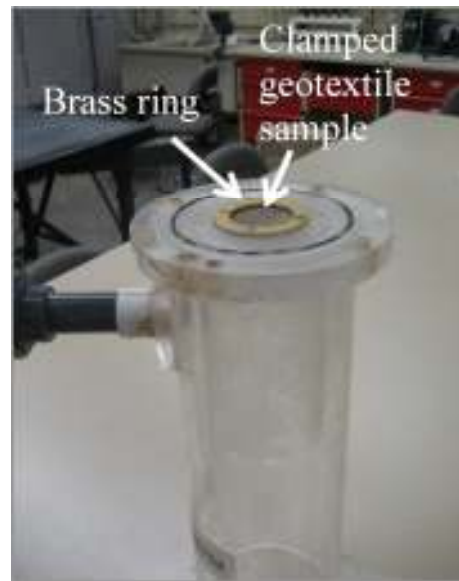
**Figure 3.41. Geotextile sample secured using brass plate in the permeability device.**

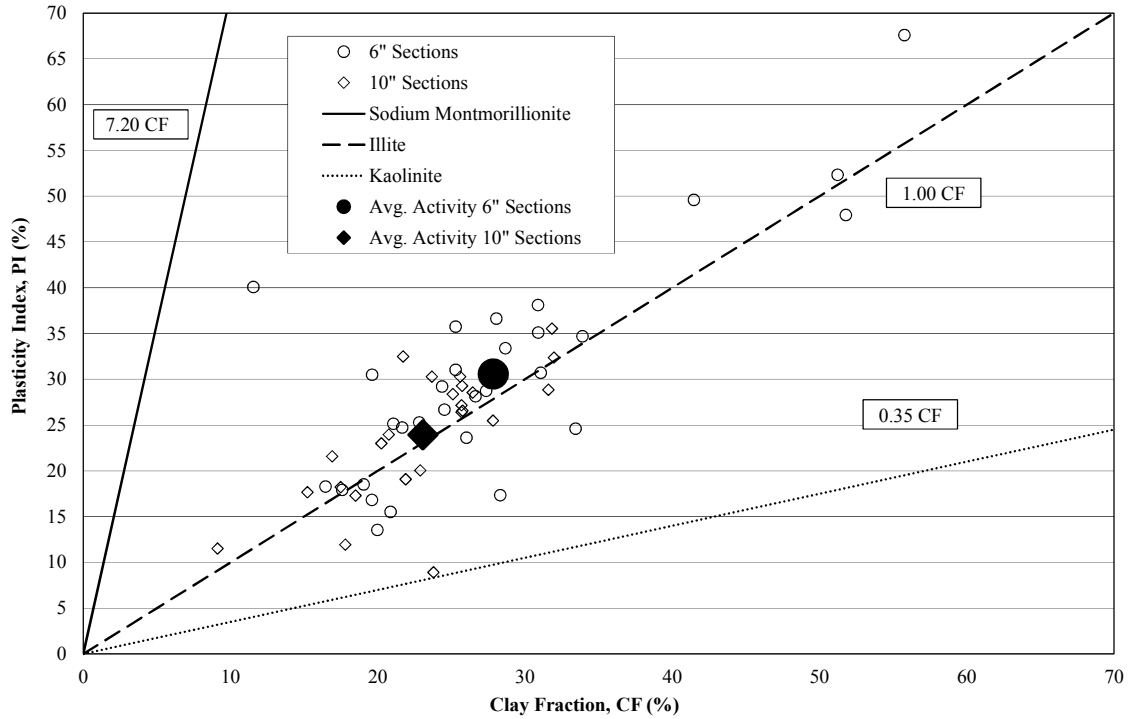
**Figure 4.12. Subgrade soil mineralogy classification based on activity (Activity = Plasticity Index/Clay Content).**

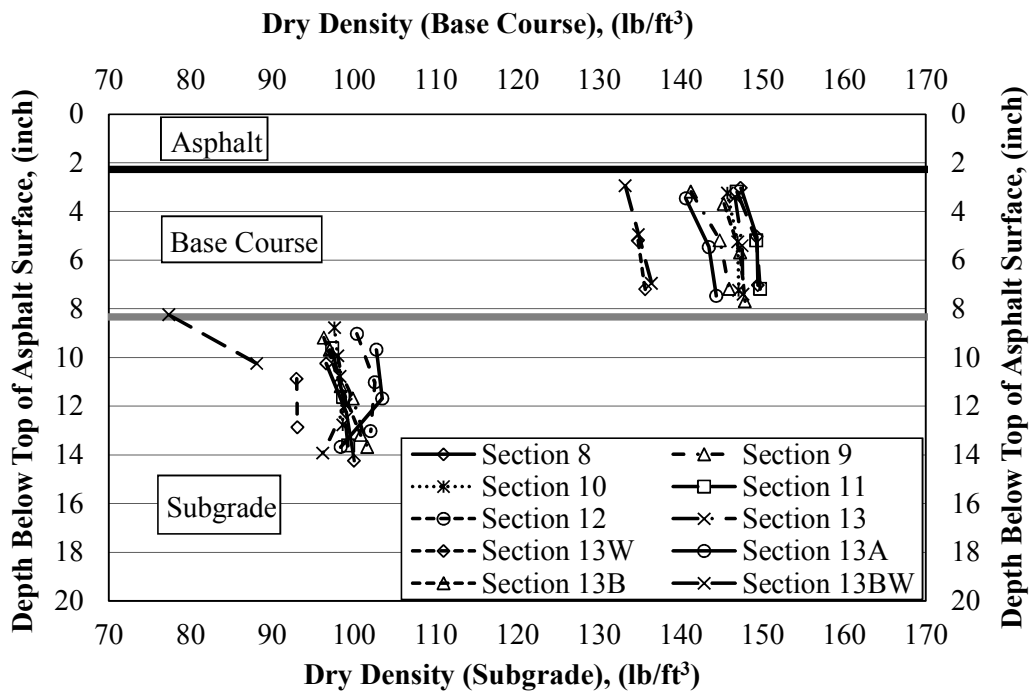
Figure 4.14. Dry density profiles (as calculated using Equation 3.1) for the six-inch thick sections.

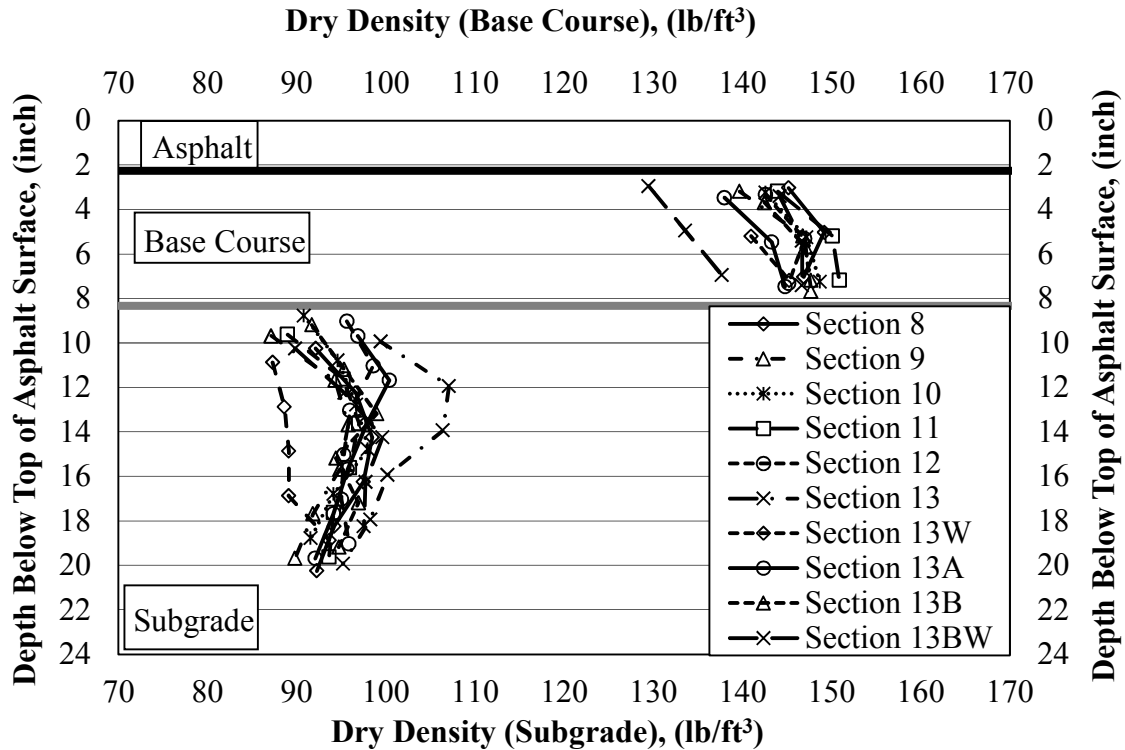
**Figure 4.15. Dry density profiles (based on nuclear gauge) for the six-inch thick sections.**

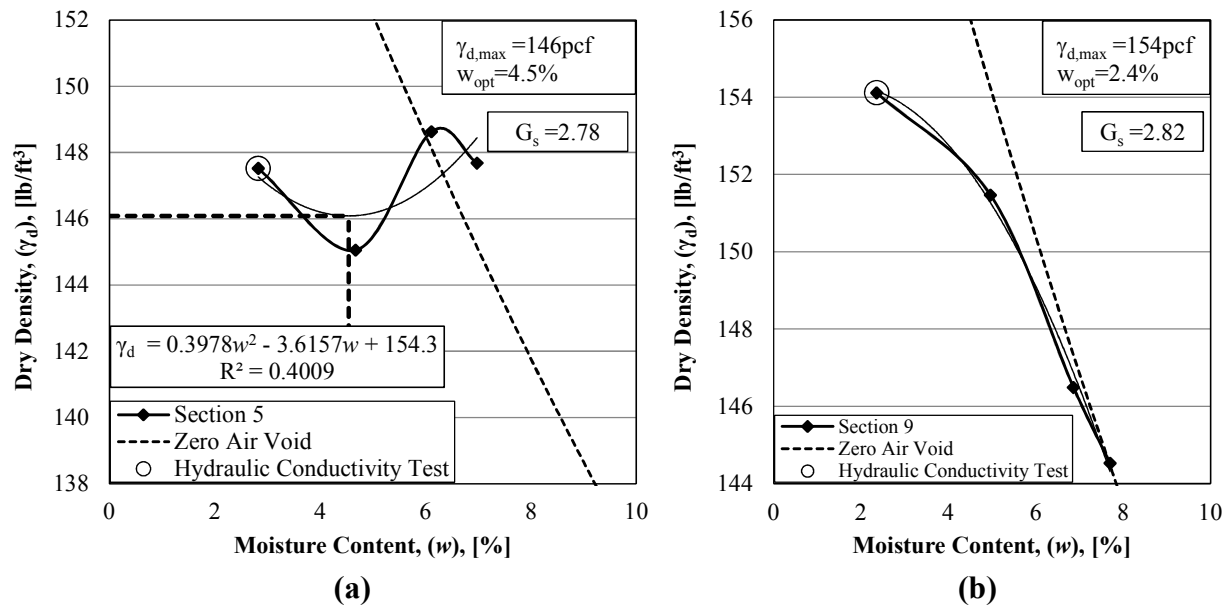
**Figure 4.21. a) Proctor curve for Section 5 (ten-inch thick section), and b) Proctor curve for Section 9 (six-inch thick section).**

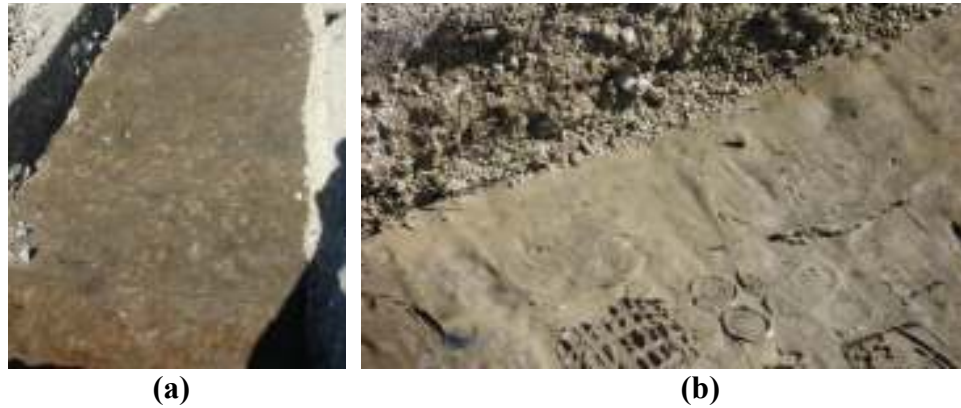
**Figure 4.31. Section 13BW subgrade a) after the geotextile removed and b) the zoomed in view after geotextile removal.**

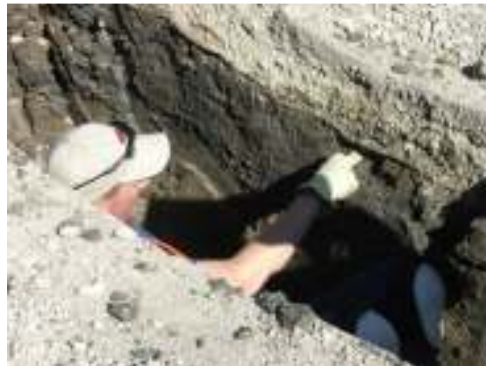
**Figure 4.32. Void space observed (Section 13BW) underneath the geotextile.**

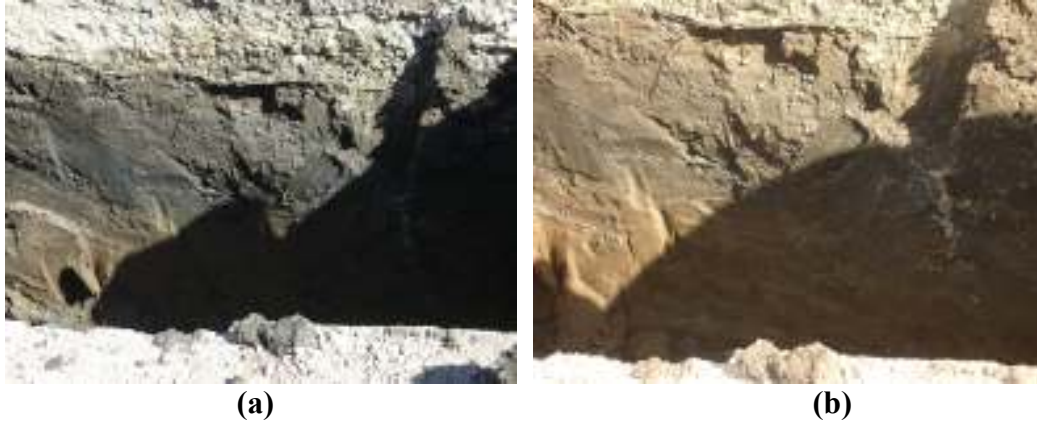
**Figure 4.33. Discoloration in subgrade soil in Section 13BW after trench excavation on the a) east side and b) west side of the trench.**

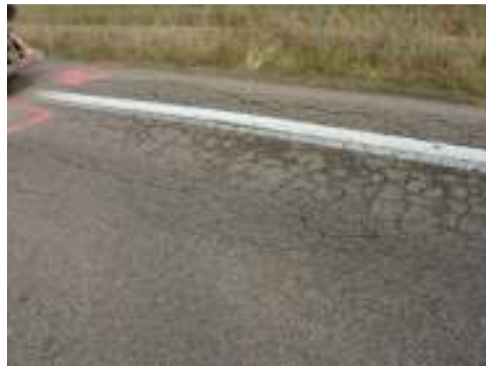
**Figure 4.34. Alligator cracking in the outer wheel path of Section 13W.**

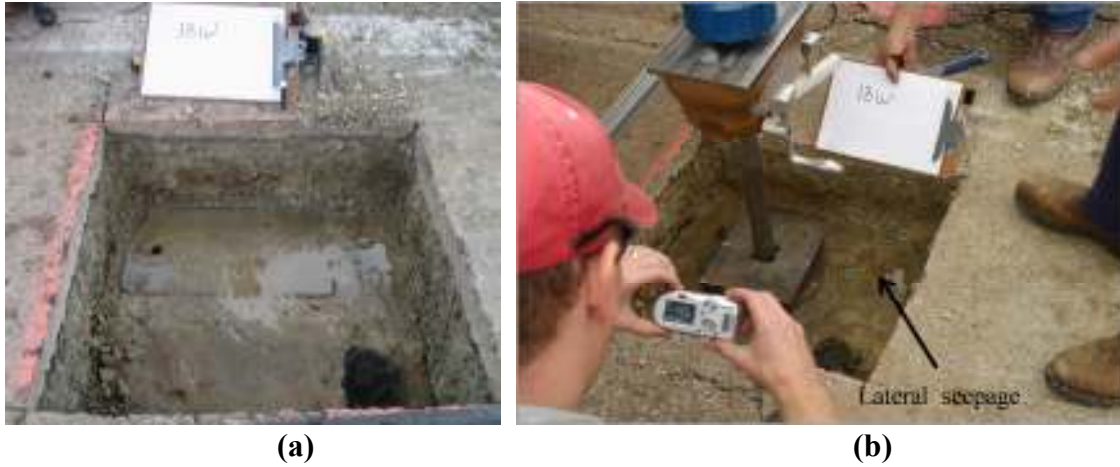
**Figure 4.35. Lateral seepage observed in subgrade of Section 13W a) after DCP testing and b) after completion of CBR testing.**

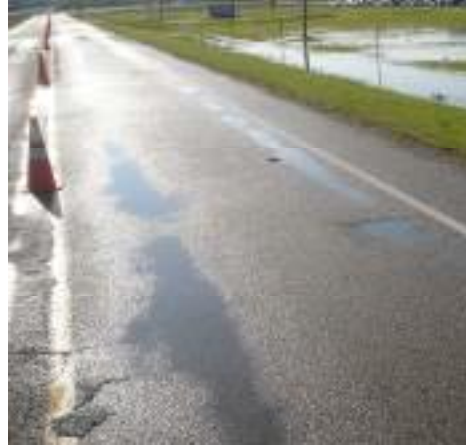
**Figure 4.37. Ponding in six-inch thick sections in May, 2011 (from Goldman, 2011) [view from Section 13W looking East].**
