Elevation and frequency of occurrence of floods in Squaw Creek basin in Ames, Iowa

A Thesis Submitted to the
Graduate Faculty in Partial Fulfillment of
The Requirements for the Degree of
MASTER OF SCIENCE

Major Subject: Sanitary Engineering (Water Resources)

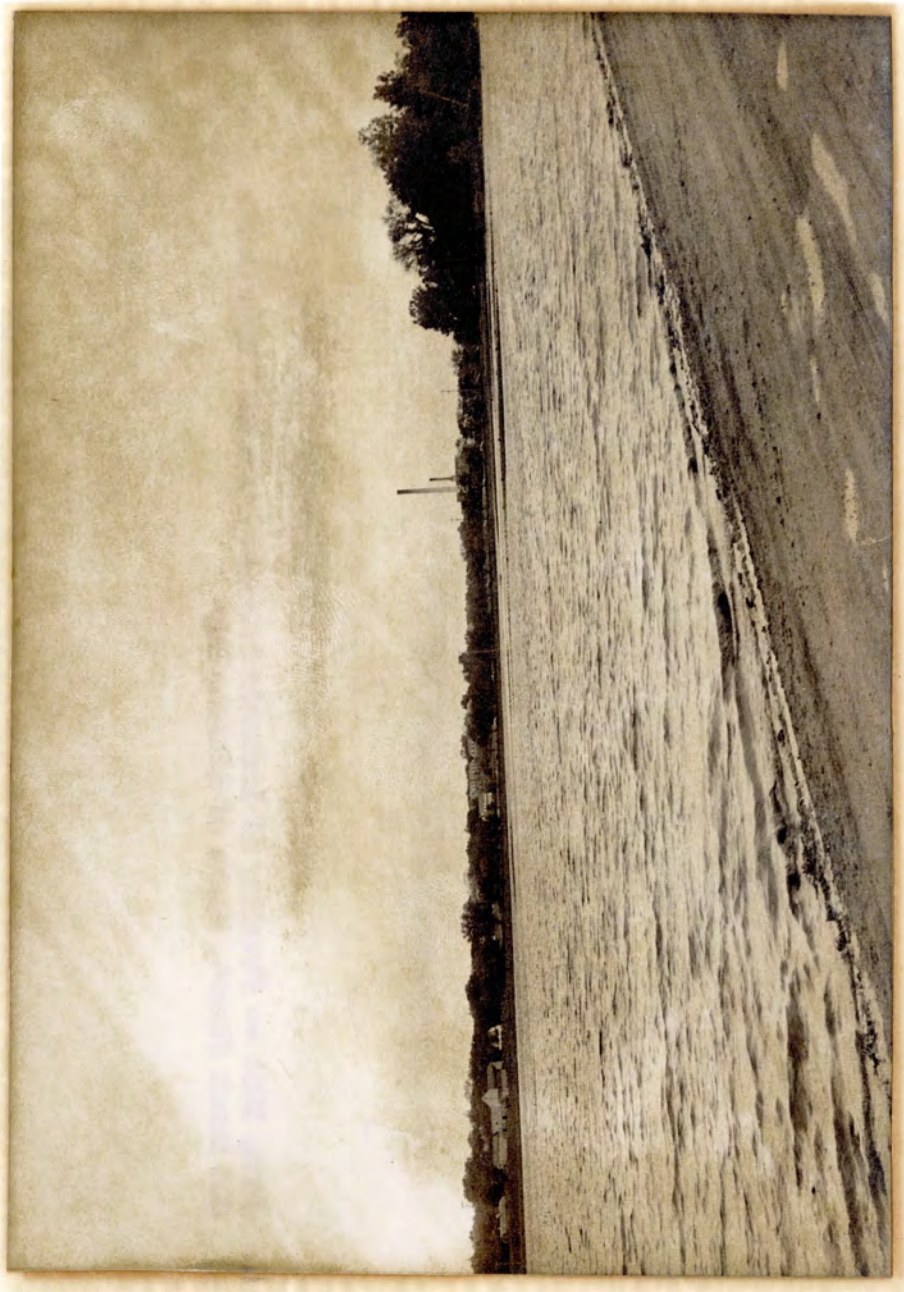
Figure 2. June, 1954 --- flooding of lowlands between South Riverside Drive
and Beech Street, South of Lincoln Way

Views of some of these floods taken from various locations along Squaw Creek are shown in Figures 2, 3, 4, 5, 6, and 7. These photographs show that although extensive areas have been flooded in the past, the flooding has generally been relatively shallow.

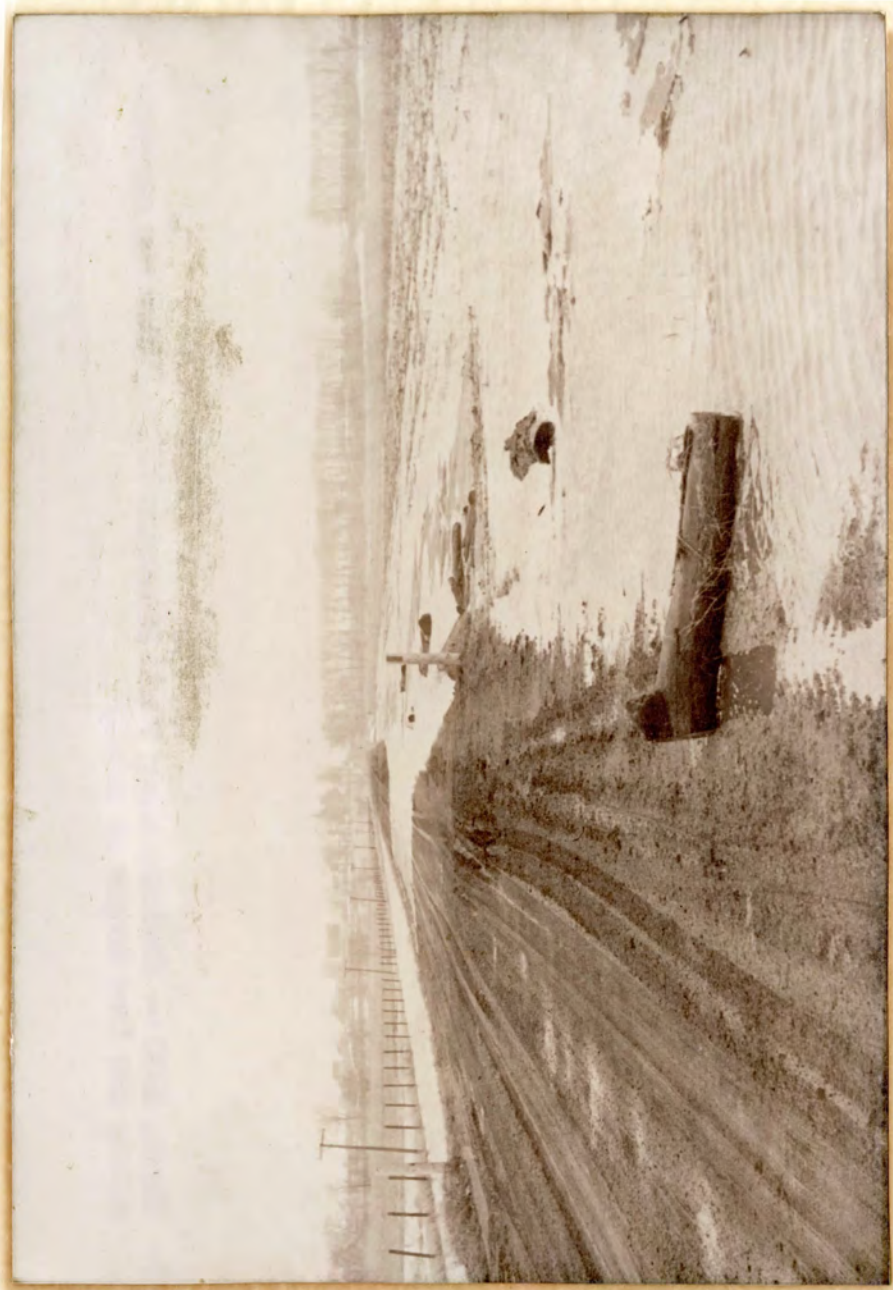
Figure 3. March, 1960 --- Flooding along South Riverside Drive (water was approximately one foot deeper at crest)

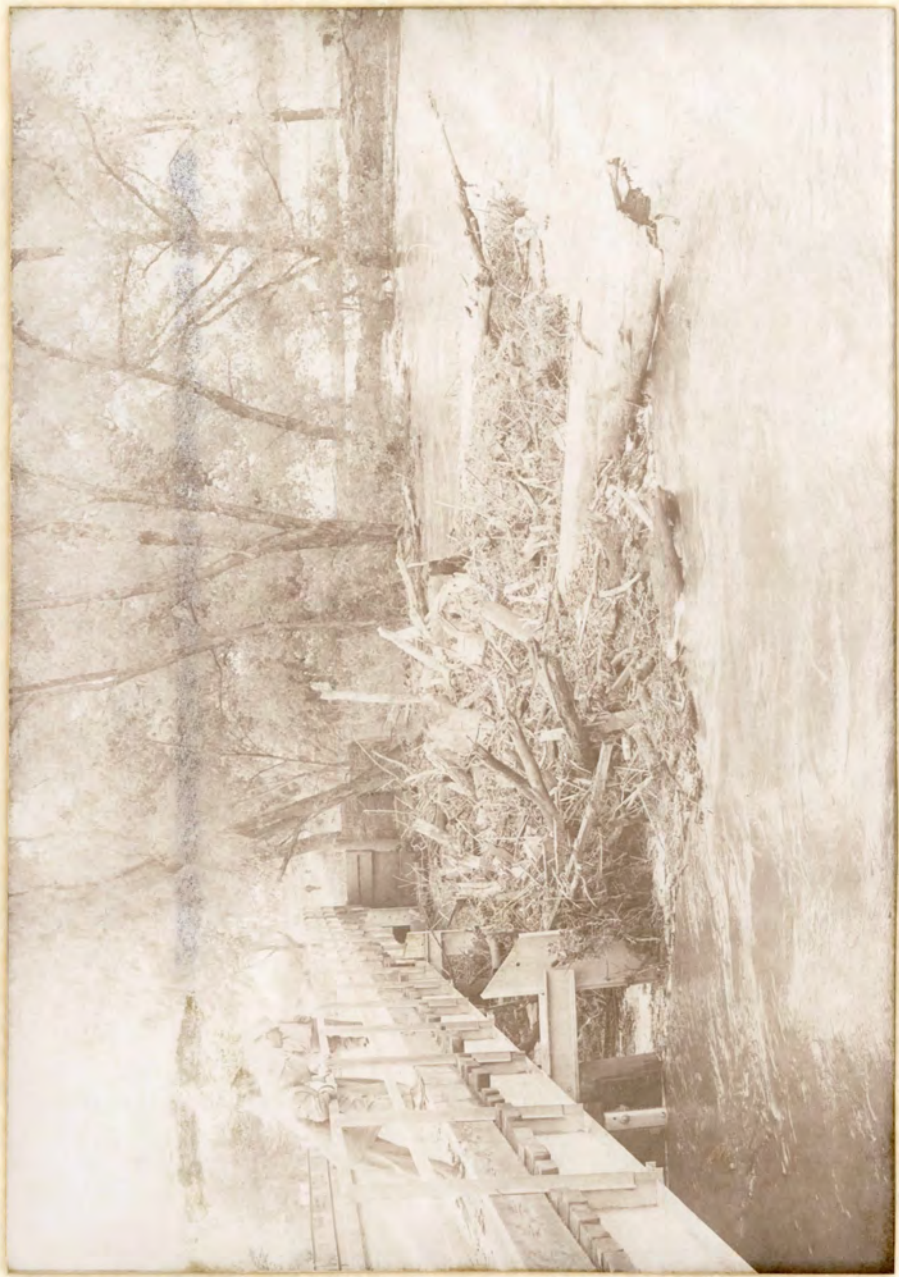
Figure 4. June, 1954 - debris accumulation at South Riverside Drive bridge

Allowances were made in backwater calculations for a slight accumulation of debris on bridge piers. It is possible for large quantities of debris to accumulate on the piers which would cause backwater and possibly flooding in excess of normal. However, the probability of this occurrence cannot be estimated. Design engineers using this data should make allowance for this occurrence by adding freeboard above that indicated by the flood profile curves.

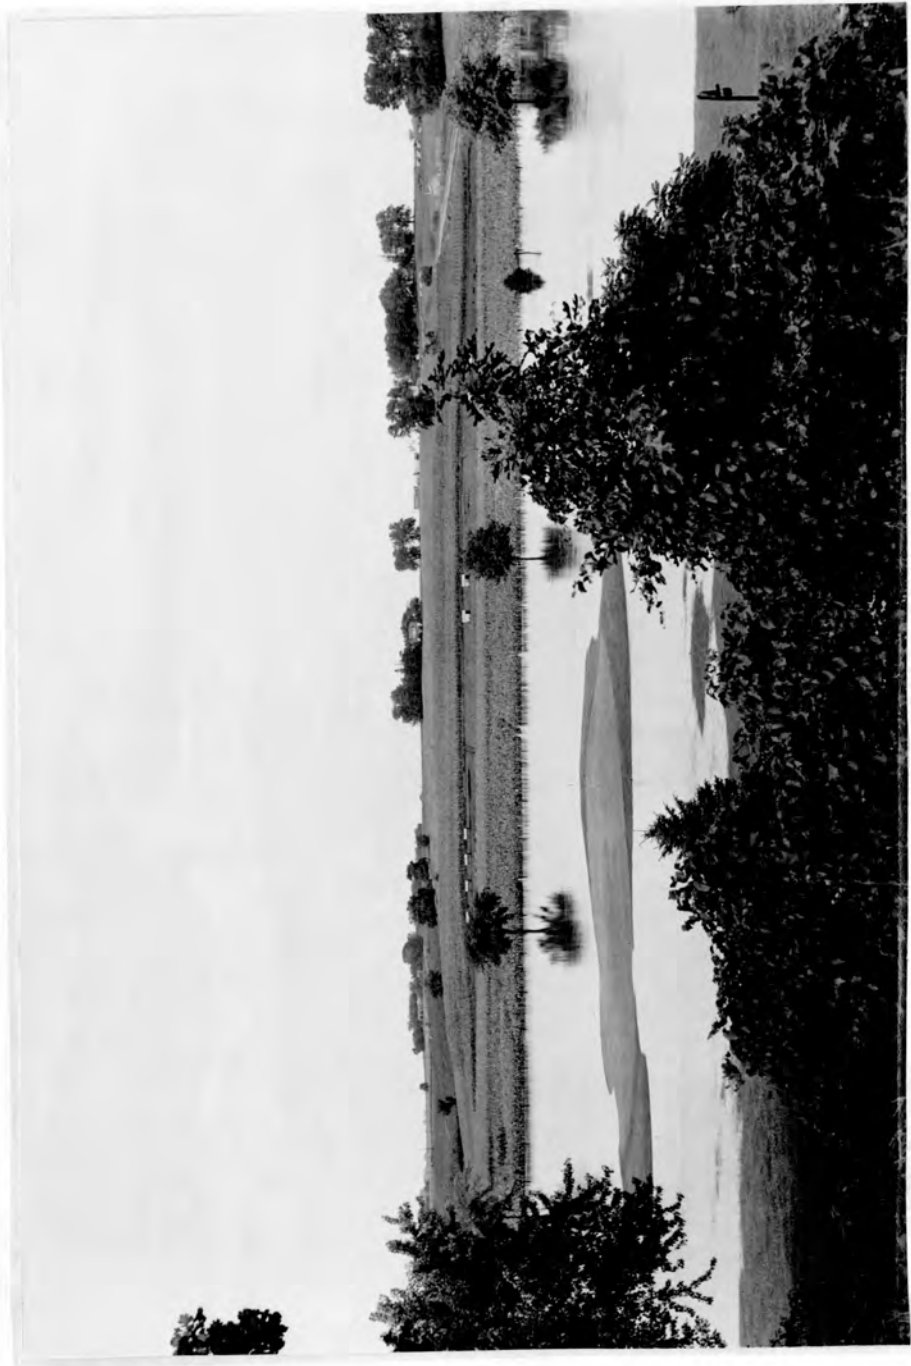
Figure 6. August, 1954 --- flooding of the University Golf Course
(The area is being considered as the new location of the University Golf
Course Club House.)

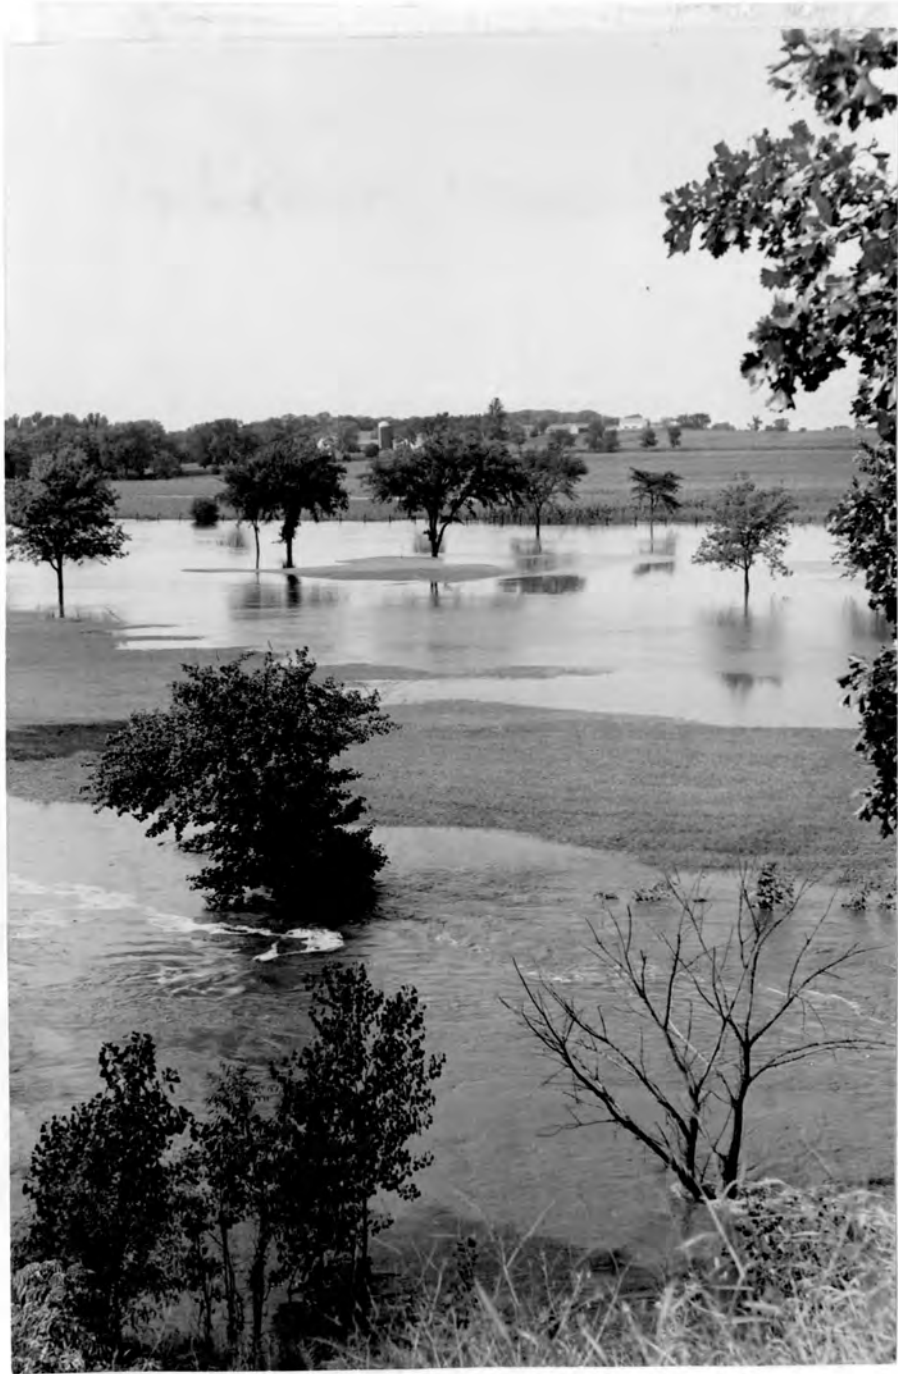
Figure 7. August, 1954 -- flooding of the University Golf Course
