Article

Estimating Costs and Effectiveness of Upgrades in Forestry Best Management Practices for Stream Crossings

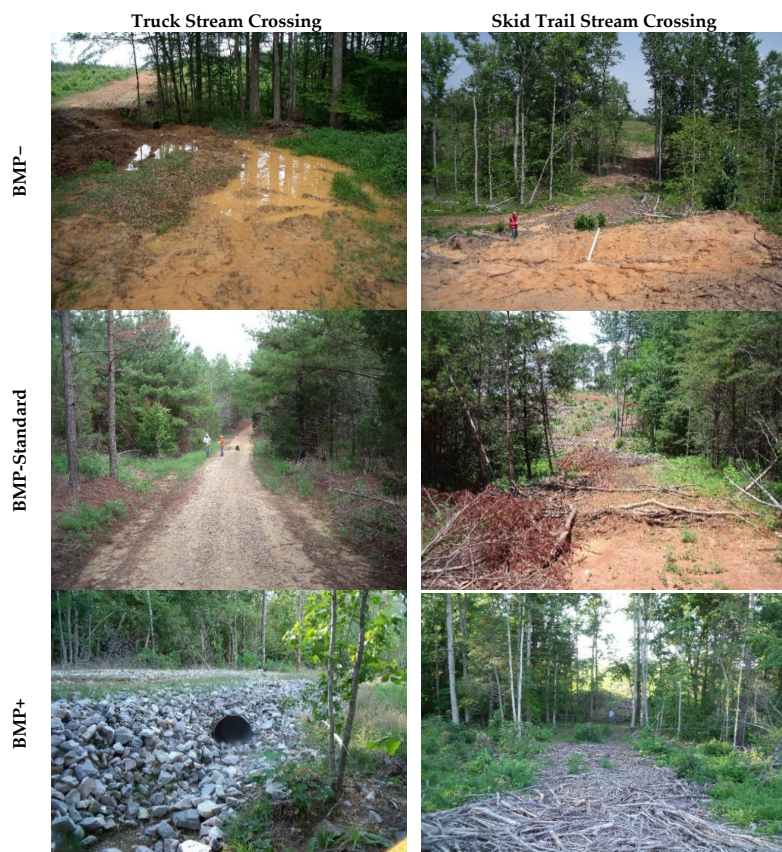
Figure 3. Representative photographs of the three BMP levels for the two crossing types.

The third rating of stream crossings and BMP quality involved evaluation of the road template, drainage structure, cover BMPs, and stream crossing structure in order to develop an overall rating of the crossing and approaches (Table 4). The majority of the truck road crossings (55%) and skid trail crossings (45.5%) were rated BMP-standard. Stream crossing BMPs were typically less implemented on skid trail crossings than on road stream crossings; thus, the BMP− category was more common on skid trail crossings (31.8%) than on truck road crossings (15%). Overall, the BMP− category represented 23.8% of the total roads and skid trails. Mean BMP audit scores were lower for skid trail than for truck crossings for the three levels of BMPs, with BMP− having lower means (58% truck, 43.9% skid) and BMP+ having higher means (98.4% truck, 96.7% skid). Representative photographs of the three levels of BMP ratings and crossing types are presented in Figure 3.
