**EVALUATING THE USE OF  
STEADY BURN WARNING LIGHTS ON DRUMS  
FOR WORK ZONE SAFETY**

**DISSERTATION**

MAJOR: CIVIL ENGINEERING

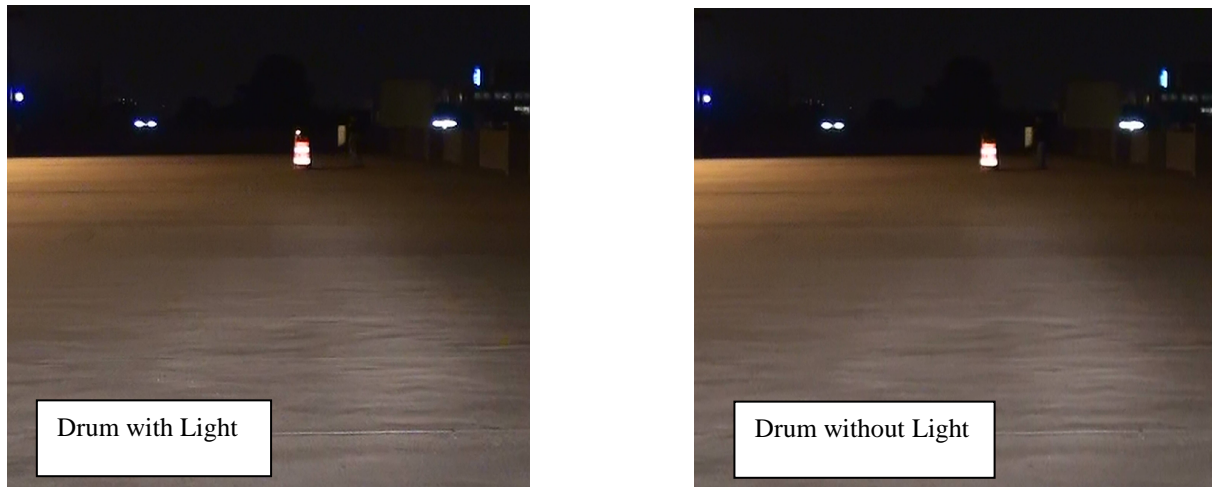
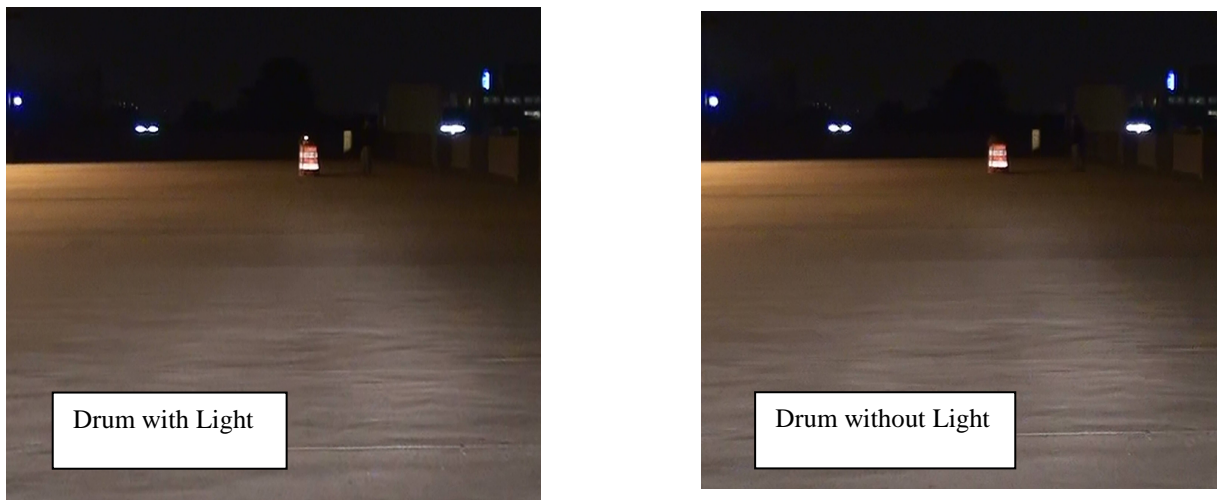
**Figure 4: Example Drum Scenarios Used in the Controlled Evaluation**

(a) Used prismatic drum

(b) Used high intensity drum

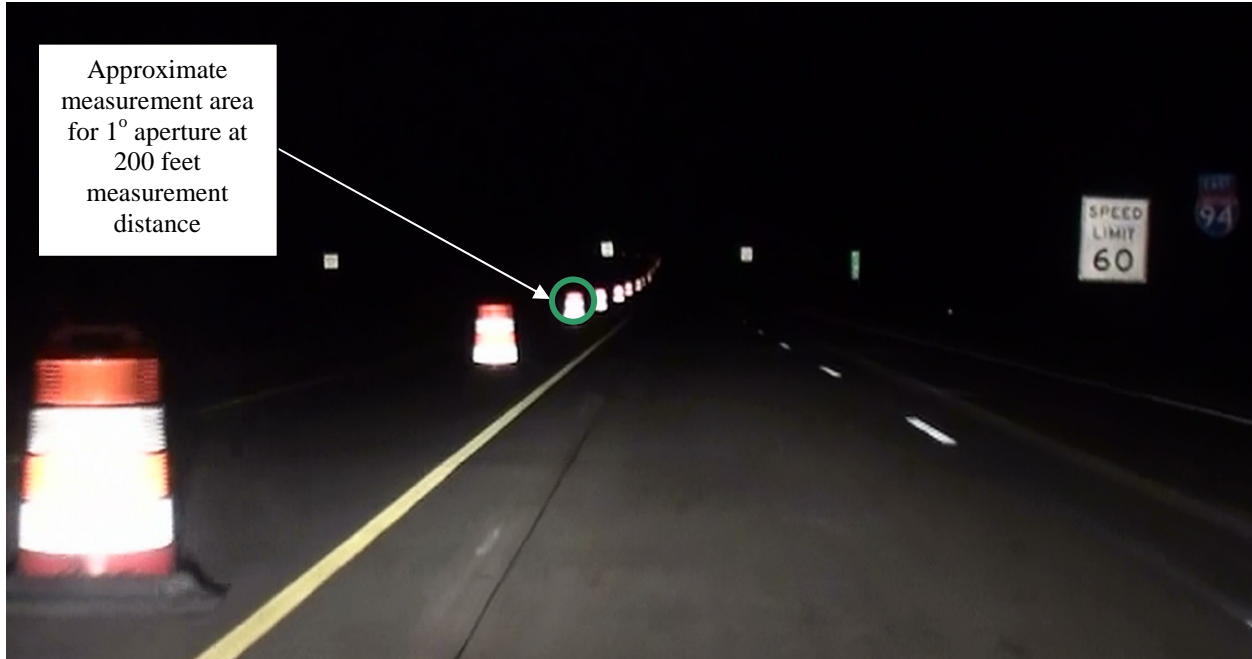
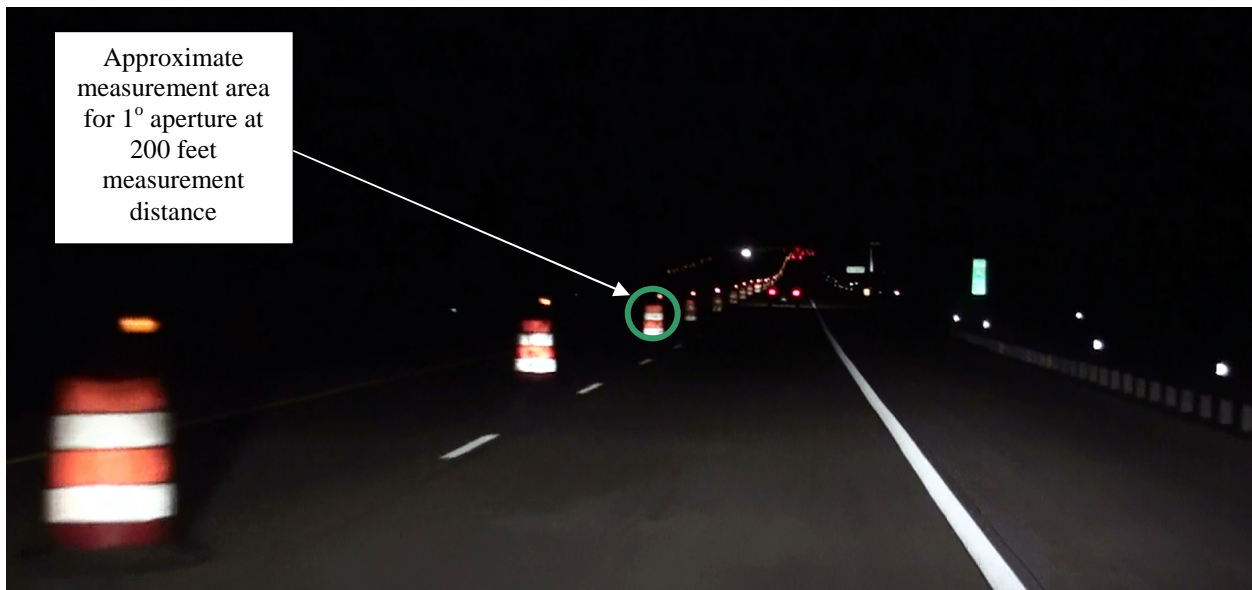
**Figure 5: Field Luminance Measurement Examples**

**(a) Drums without steady burn warning lights, unlit freeway, prismatic sheeting**

**(b) Drums with steady burn warning lights, unlit freeway, high intensity sheeting**

- Taper sections – Readings were only obtained on drums that were parallel to the travel lane to ensure that the headlight beams were consistently striking the drums at a similar angle;
- Roadway segments with excessive horizontal or vertical curvature – Changes in horizontal or vertical alignment would also impact the angle at which the headlights reflect off of the drums, resulting in higher or lower luminance measurements as a result;
- One or more vehicles were closely following the data collection vehicle – If a another vehicle were traveling closely behind the data collection vehicle, stray light from the

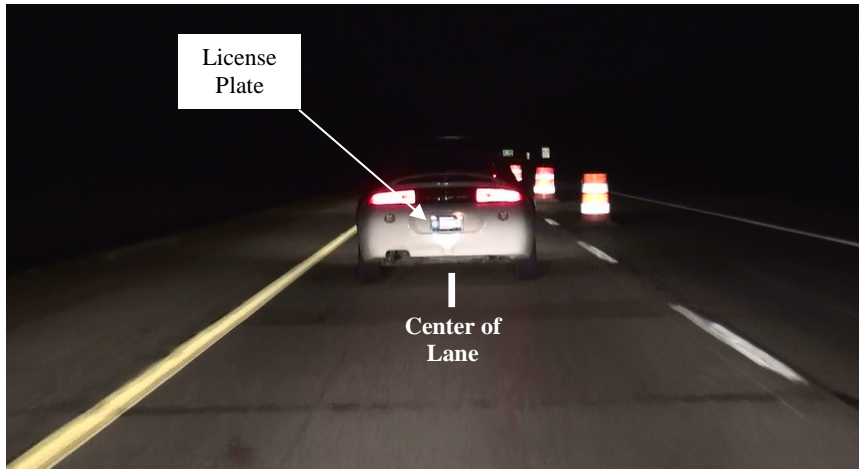
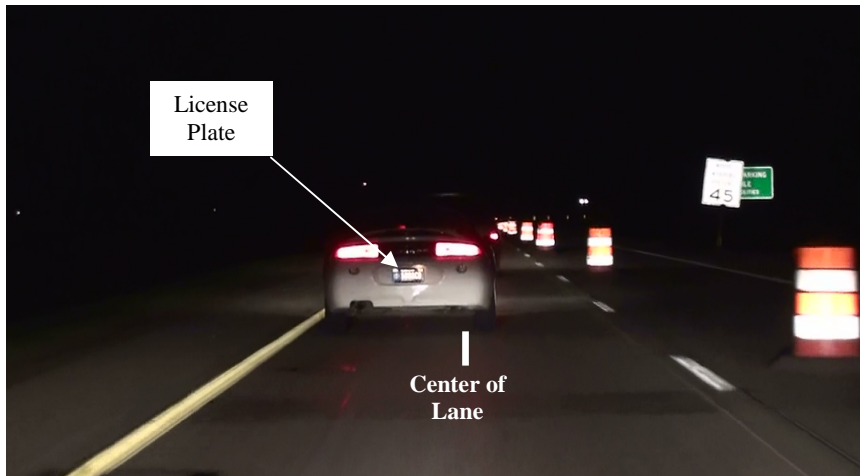
**Figure 6: Example of Vehicular Lateral Lane Position Assessment**

**a. Center Lane Position**

**b. Left-of-Center Lane Position**

**c. Right-of-Center Lane Position**

The amount of time spent in each lateral position was determined using the clock embedded in the video review software. All times were recorded to the nearest second. The total tracking time was equal to the sum of the time spent in each of the three lateral positions. Data were collected only for vehicles that were tracked for a minimum of 10 seconds, as this was assumed as the minimum duration for which an accurate driver behavioral assessment could be made. After the videos were reviewed, the data were tabulated and coded into a single data set for analysis.

Each MOE was computed such that equal weighting was given to all subject vehicles, regardless of the amount of time that each vehicle was tracked. The following example provides an explanation of the procedure by which each MOE was computed for a subject vehicle.
