Evaluation of Hand Augered Well Technologies' Capacity to Improve Access to Water in Coastal Ng[oumlaut]be Communities in Panama

Evaluation of Hand Augered Well Technologies' Capacity to
Improve Access to Water in Coastal Ngöbe Communities in Panama

A thesis submitted in partial fulfillment
of the requirements for the degree of
Master of Science in Environmental Engineering
Department of Civil and Environmental Engineering
College of Engineering
University of South Florida

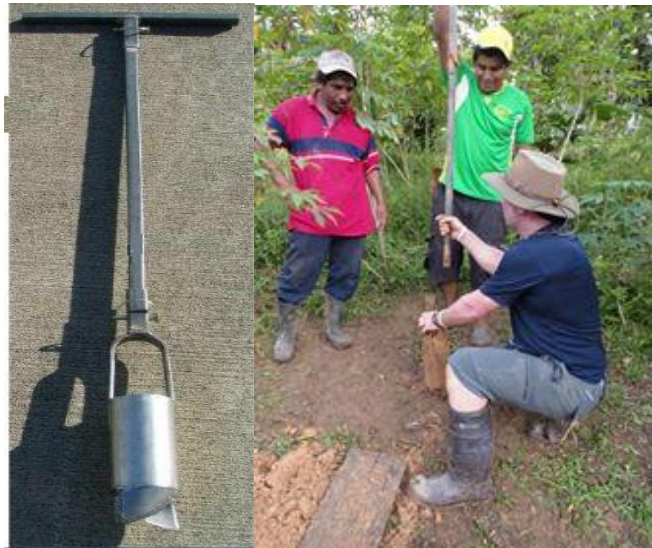
Figure 4: (a) Hand Auger (b) Hand Auger in Operation, Detaching Bit to Remove Soil

Hand augered (or hand drilled with an auger) wells are wells in which a borehole or tube well is created through the use of a manually operated auger, as depicted in Figure 4. Typically, two people turn the crossbar, or “T” attached to the auger rod, while applying a downward force that causes the drill bit to cut away at the soil beneath. When the bit fills with soil, drillers extract the auger and remove the accumulated soil material known as “cuttings” (Naugle, 1996). As the well reaches deeper below the ground surface, a pin attaching the drill bit to the “T” frame is removed and extension rods are added to the body of the hand auger.

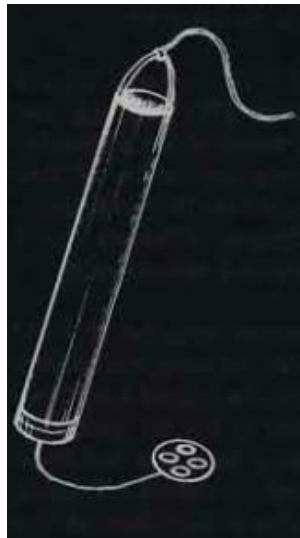
Figure 5: Bailer with Bottom Disk for Valve Attachment

for deep wells leaky valves are more problematic (due to the volume of water lost during the time it takes for a user to lift the bailer) (Fraenkel, 1986).

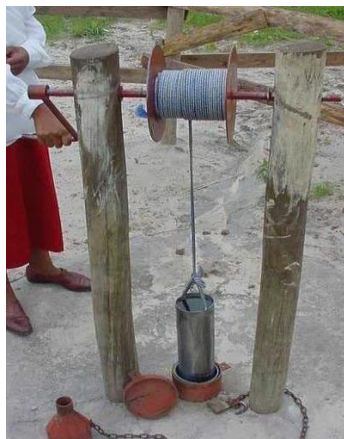
Figure 6: Bailers with Windlasses in South Africa (known as “Blair Bucket Pumps”)

It is acknowledged that bailers have been installed across the world as part of development efforts associated with organizations such as Hydromissions International, Lutheran World Relief, Blair Research Laboratory, V & W Engineering, however the true scope of their implementation is unclear due to gaps in monitoring and documentation (Naugle, 1996; Morgan, 2003; Hydromissions, 2011). Bailers specifically using a windlass mechanism as a lifting apparatus have been documented to be implemented as part of development projects that improve rural water access through programs rehabilitating existing hand dug wells and or installing tubewells in South Africa and Zimbabwe (Morgan et al., 1996; Morgan, 2003; MacCarthy, 2004). An example of these bailer systems with windlasses is depicted in Figure 6.

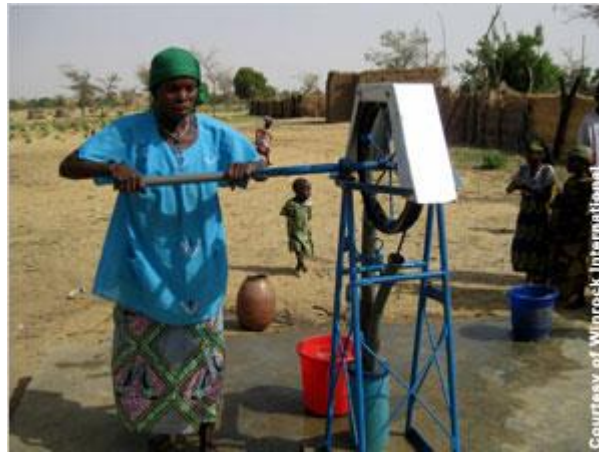
Figure 7: Rope Pump in Operation

2012). An estimated 110,000 are in use worldwide by nearly 5 million people (Holtslag, 2011). The successful application of rope pump technology can be largely attributed to its low cost, available materials, durability, and simple operation in comparison to other hand pump options (Smet et al., 1995; MacCarthy, 2004). However, it is critical to consider that successful programs included adequate training of local community members in rope pump construction, use, and repair.

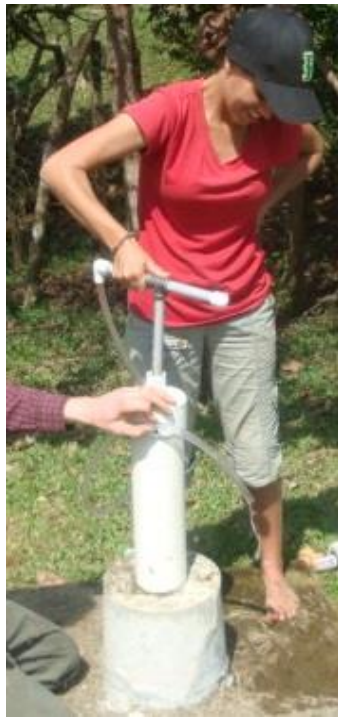
Figure 8: EMAS Hand Pump in Operation

As shown in Figure 8, the EMAS pump consists of two major pieces, an inner PVC pipe with a one way piston valve at the bottom which fits inside an outer PVC pipe with a one way foot valve at the bottom. The outer pipe remains static and when the handle (attached to the inner pipe) is lifted, suction force causes the foot valve to open (while the piston valve remains closed), lifting water from the tubewell into the outer pipe. When the handle is alternately lowered, the foot valve on the outer pipe closes and the piston valve on the inner pipe opens, causing water to flow upwards into the inner pipe and finally out of the spout that is an elbow in pump handle (MacCarthy et al., 2013).

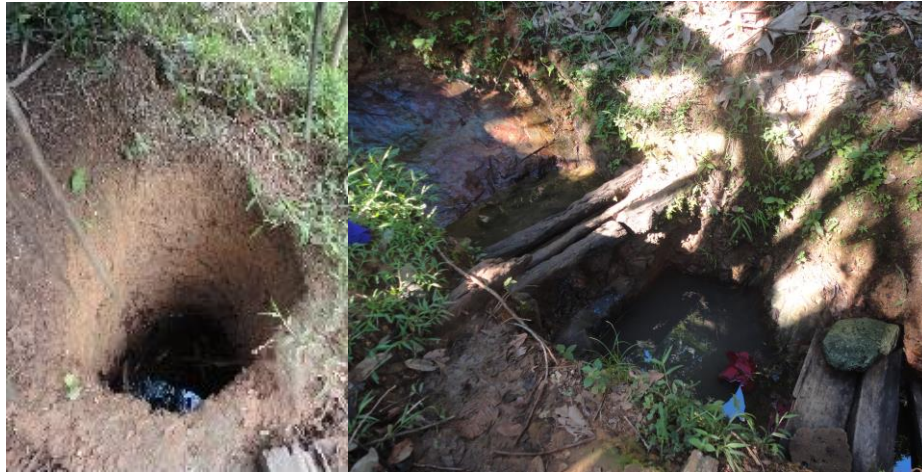
Figure 9: (a) Hand Dug Drinking Well (b) Partitioned Drinking (upper) and Washing (lower) Unimproved Well Sources in La Ensenada

contamination is an issue for washing wells, as soap from bathing and washing clothes mixes with well water. Hand dug well sources included in this study vary widely in dimension with diameters between 1.5 and 8 feet and total excavated depths between less than 1 foot and 4 feet.

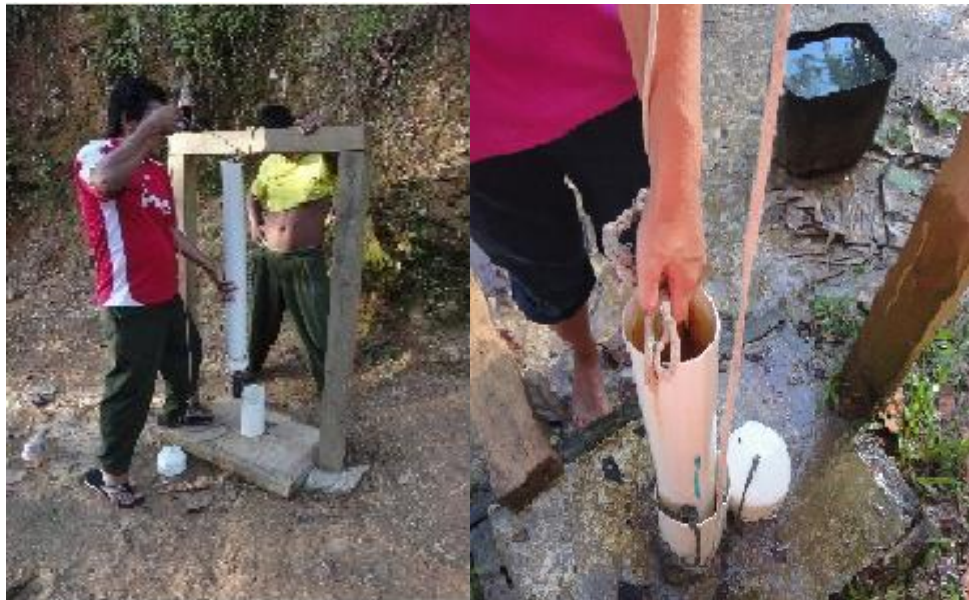
Figure 10: (a) Bailer Demonstrated in La Ensenada (b) Bailer System Top View

initially very turbid and brown. Well owners were advised that continued bailing would allow the wells to recharge with clean, “fresh” water, but that infrequent bailing would keep “old” dirtier water stored in the well body. This concept was generally understood by users, especially those who had access to unimproved hand dug wells. Although well owners were typically discouraged in the first few months upon extracting visibly turbid water from the source, they were often encouraged by recognizing the water clarity of other local improved wells and through sharing experiences with other well owners.

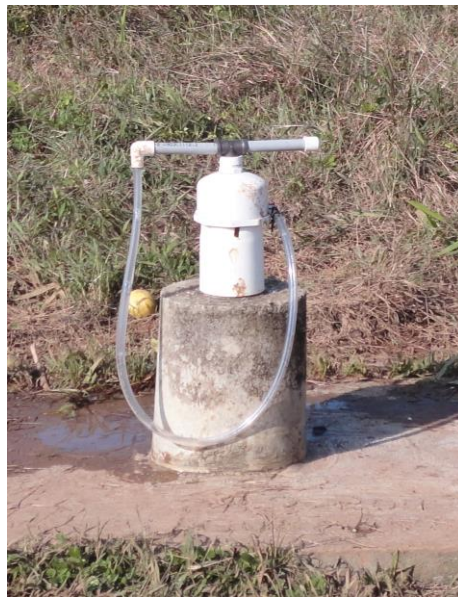
Figure 11: EMAS Pump Installed by the Healing Fund

The design of the EMAS pumps installed (as shown Figure 11) differs slightly from manufacturer recommendations in two ways: (1) pumps with 0.5-inch diameter PVC pistons were implemented, although 0.75-inch diameter PVC pistons are recommended for implementation specifically in shallow wells, and (2) pumps incorporated threaded PVC as bars in the pump handle, only using galvanized iron for the “T” (EMAS, 2008). It was decided by the Healing Fund that the 0.5-inch diameter design was more appropriate to implement in Panama, because the larger 0.75-inch diameter pump is more difficult for users to pump and more

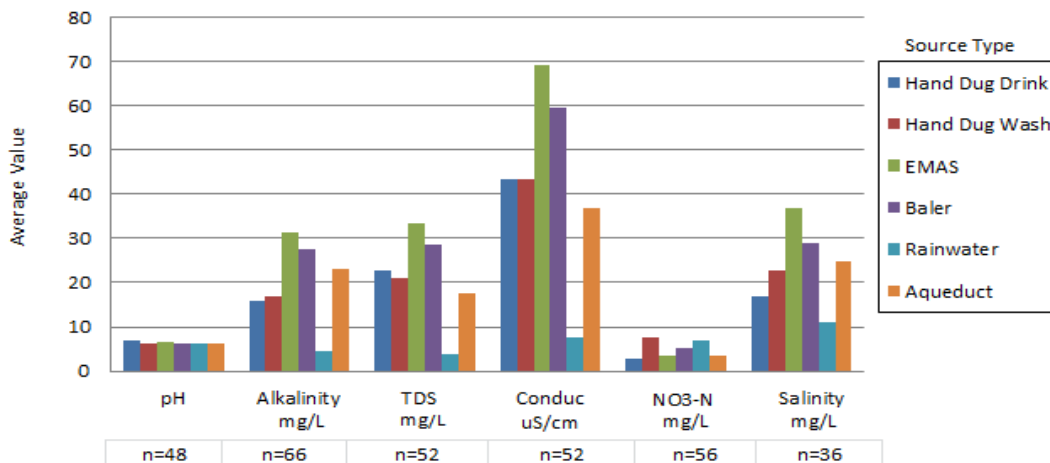
Figure 12: Water Quality Parameter Averages by Water Source Type Measured from Jun. – Dec. 2013

to samples obtained from hand dug drinking and washing wells. Both the improved hand augered well technologies demonstrated water with notably higher conductivity, alkalinity, TDS, and salinity values in comparison to unimproved hand dug well sources. This may be from increased dissolved ion presence intrinsic in subsurface materials. As hand augered wells reach depths much greater than those of shallow hand dug wells, they can tap into embedded aquifer sources that reach deeper below the groundwater table in the subsurface environment that may release dissolved ions from contact with groundwater. Thus water samples from improved wells demonstrate higher dissolved ion related water quality parameter concentrations relative to shallower unimproved wells which are also likely to fill with surface water (during rain events, due to their characteristics as open and unprotected) and thus, are not considered representative of pure groundwater. The trends noted among conductivity, alkalinity, and TDS concentrations are not of concern to associated human health risk.

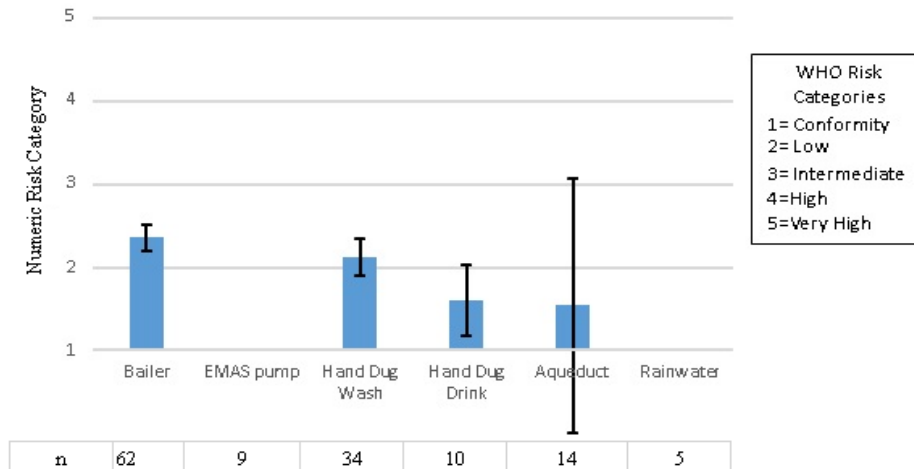
Figure 14: Categorized Bacteriological Risk by Water Source Type: Based on WHO Risk Categories Samples Measured Aug. – Dec. 2013; Total n=133

Samples from unimproved washing wells were rated to have an average risk of 2.12 out of 5. These water sources were however known to be affected by the introduction of soap and liquid chlorine in the form of liquid bleach while people washed clothes in well water. The degree to which the presence of chlorine affected bacteriological findings is unknown, as chlorine concentrations were not measured and no quantitative data was obtained regarding chlorine related behaviors in water use interviews. Bailer systems had the highest associated risk of the water sources assessed, with an average of 2.35 out of 5. Thus, water from bailer systems were furthest from conforming with WHO guidelines with respect to *E. coli*, with water that corresponded to low to intermediate health risk categories.

Overall, the results show that the bacteriological water quality of all sources was generally good, with the majority of risk averages based on source type indicating conformity or low associated health risks. When comparing results shown in Figure 14 between the two improved well technologies, it is observed that EMAS hand pumps appear to produce water with less risk than the bailer systems (with averages of 1 and 2.35 respectively). However, it is important to note that differences in sample size between these two groups (n= 62 for bailers and n=9 for EMAS systems) could be a major factor impacting the suggested trend. Additional results related to the comparative performance of these two systems will be presented in Section 4.3.1.

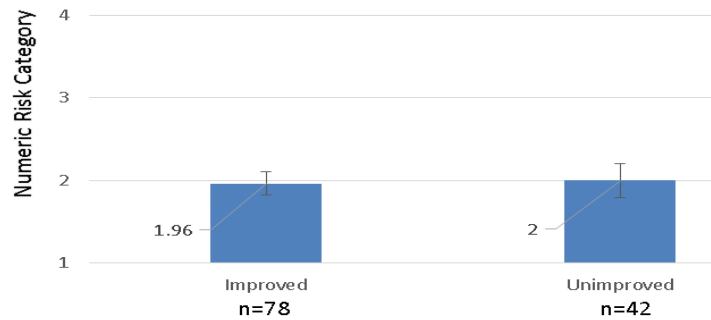
Figure 15: Categorized Bacteriological Risk of Improved Versus Unimproved Sources: Based on WHO Risk Categories Samples Measured Aug. – Dec. 2013; Total n=133

washing wells) solely comparing the relative performance of improved hand augered well technologies to unimproved drinking water wells. This improved versus unimproved grouping of the data also shows very similar bacteriological quality, with associated health risk averages of 1.675 and 1.6 respectively. These trends illustrate details discussed in Section 1.1 which proclaim that classification of water sources by UN defined improved and unimproved categorization does not necessarily reflect differentiation in these sources with respect to water quality or safety (UN, 2013).

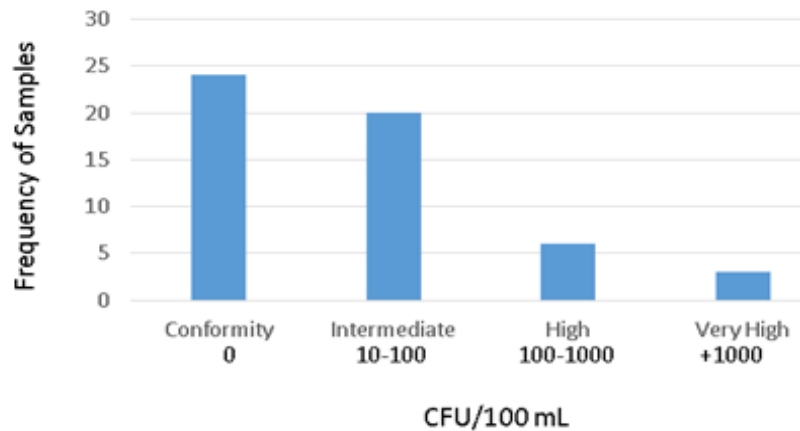
Figure 16: Categorized Bacteriological Risk Histogram for Bailer Systems Using WHO Risk Categories, Sampled Jun. – Dec. 2013; Total n=53

Figure 16 shows that 83% of the water samples collected from bailer systems fell into the categories of conformity and intermediate risk according to WHO guidelines. It is possible that the observed variance in bacteriological water quality could be attributed to external factors such as rainfall well age, or frequency of use. It is also possible that bailer systems produced samples with higher measured *E.coli* as contaminants entered the tubewell through handling of the bailer and the rope by the user, or the bailer coming into contact with the ground or other potentially contaminated objects during the transfer of water from the bailer to a water storage receptacle when users collect well water.

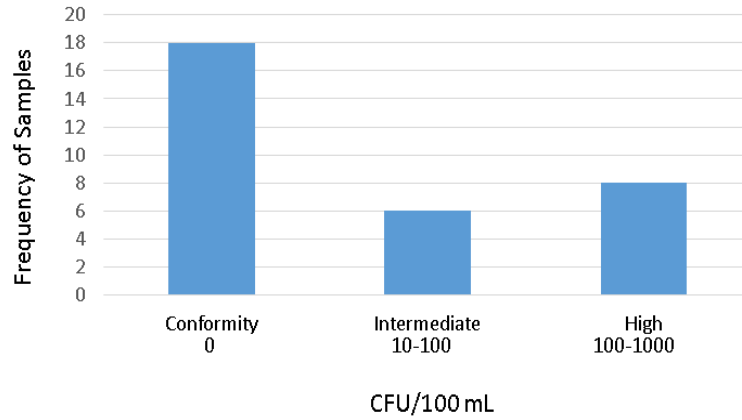
Figure 17: Categorized Bacteriological Risk Histogram for Hand Dug Washing Wells Based on WHO Risk Categories, Sampled Jun. – Dec. 2013; Total n=32

samples, with 44% of samples suggesting poor water quality in associated categories of intermediate and high risk.

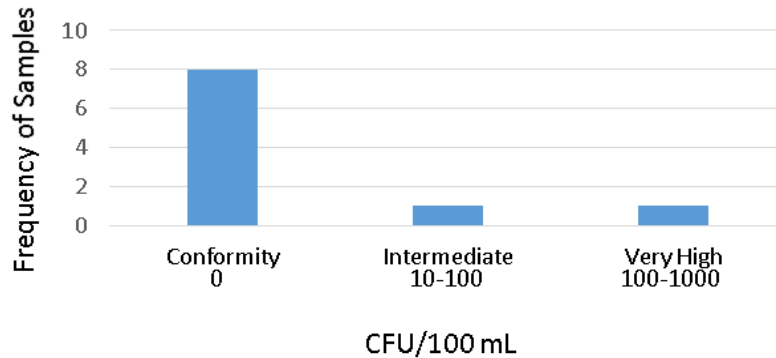
Figure 18: Categorized Bacteriological Risk Histogram for Hand Dug Drinking Wells Based on WHO Risk Categories, Sampled Jun. – Dec. 2013; Total n=10

results, but unfortunately it is unknown at what concentrations and at what time in relation to sampling this chlorine was added to the sources.

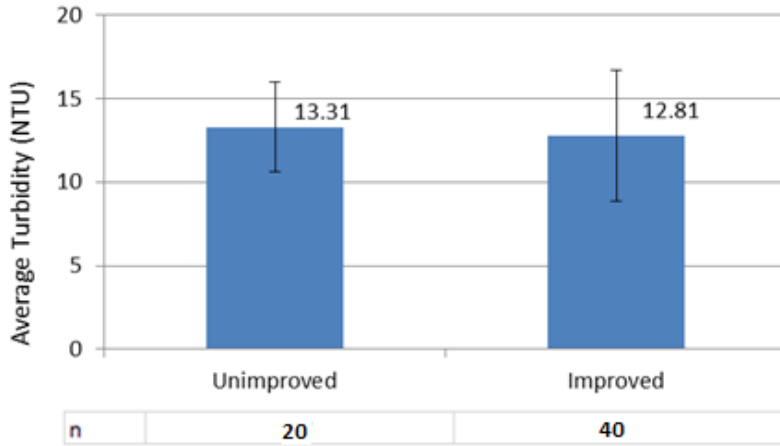
Figure 20: Average Measured Turbidity Values in NTU Improved Versus Unimproved, Sampled Jun. – Dec. 2013; Total n=60

Similar to bacteriological water quality, when assessing the turbidity data it must be considered that there were notable different in sample sizes between water source types (e.g., $n=29$ for bailers while $n=6$ for EMAS pumps and $n=3$ for aqueduct sources). Additional factors that may influence measured turbidity values and overall trends include well age, frequency of well use, the time of last use of a well when the sample was recorded, and seasonality concerns with rainfall events.

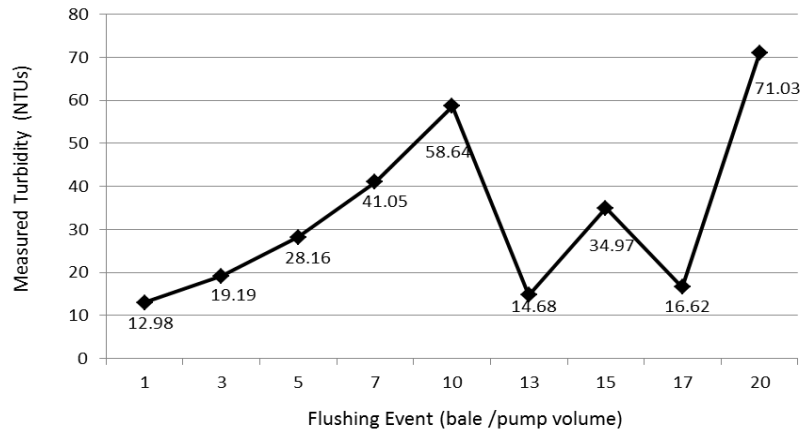
Figure 21: Frequency of Peak Values of Average Measured Turbidity Versus Number of Bail Volumes Removed During Flushing Test; Sampled Jun. - Dec. 2013; n=31

factors that could influence the turbidity during well flushing include: the type of water lifting mechanism (EMAS pump or bailer), well age, and rainfall.

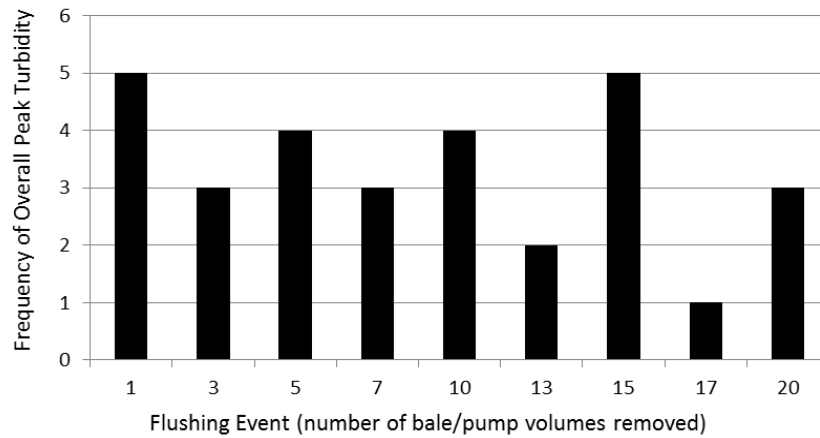
Figure 22: Frequency of Peaks of Measured Average Turbidity Versus Number of Bail Volumes Removed During Flushing Test; Sampled Jun. - Dec. 2013; n=31

had average turbidity values of less than 5 NTU and 67.7% of samples had average turbidity values of less than 10 NTU at the first flush.

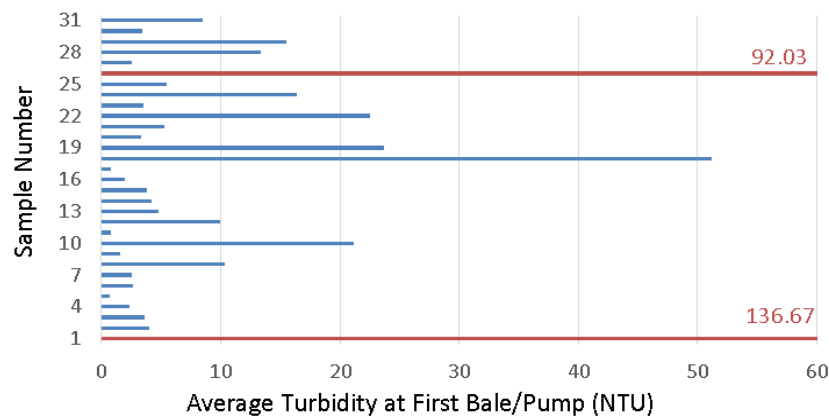
Figure 23: Average Measured Turbidity at First Flush from Improved Well Sources Sampled Jun. - Dec. 2013; n=31

of water are removed with every bail in comparison to EMAS pumps which were measured to remove approximately 325 mL of water by volume with each pump stroke. Since bailers remove larger volumes of water, higher recharge activity is incurred when greater volumes of water are expected to seep or infiltrate from the aquifer into the tubewell casing and further, up into the bailer body. This level of disturbance of the groundwater during this process could cause increased number of particles to enter into the well body. However, one could also expect that any increase in number of particles in the water would be counteracted by the volume of fresh groundwater (with presumably low NTU) entering the tubewell, in essence it should be diluted. Overall, the dynamics of well recharge and the flushing effect with respect to turbidity are not evident in the data and further investigation is required.

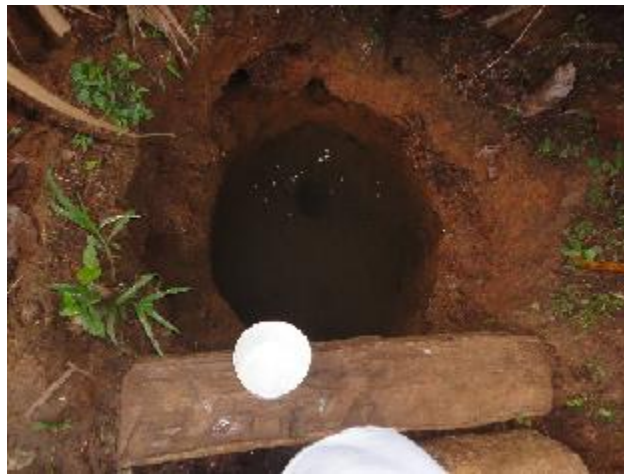
Figure D.2: Unimproved Drinking Water Source and Water Scoop Top View (which demonstrates soil and depth characteristics)

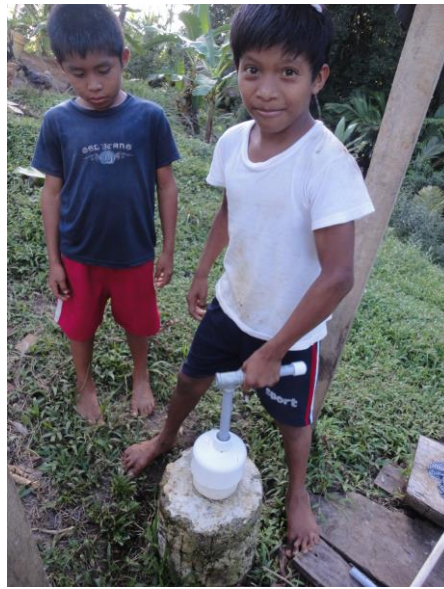
Figure D.4: Broken Handle of EMAS Pump at Attachment between Galvanized Iron “T” and PVC Half Inch Pipe La Ensenada

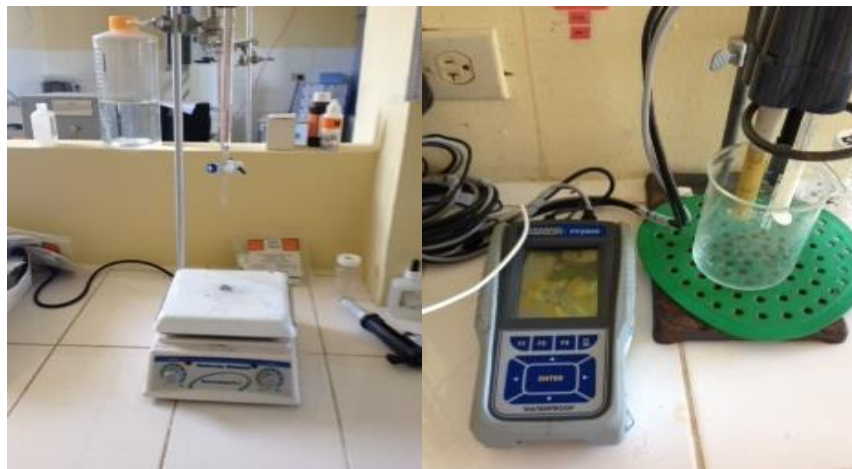
Figure D.6: (a) Alkalinity Titration Apparatus (b) OAKTON PCD 650 Probe

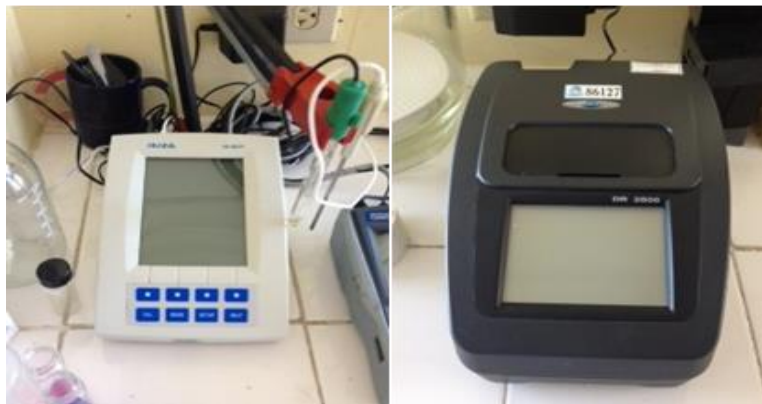
Figure D.7: (a) HANNA HI 4211 Bench Meter (Ann Arbor, MI) (b) HACH Spectrophotometer DR 2800

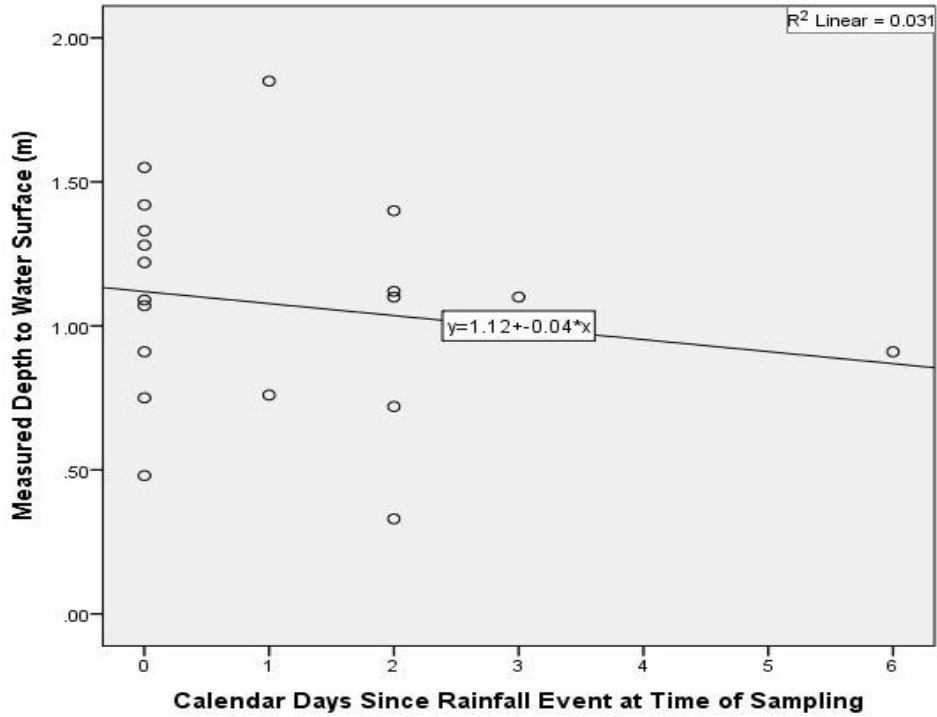
Figure E.3: Depth to Water Table in Improved Wells Versus Calendar Days Since Rainfall Sampled between Jun. and Dec. 2013; n=19
