Evaluation of aerogel as a material additive for the creation of synthetic defects in carbon fiber reinforced plastics

**Evaluation of aerogel as a material additive for the creation of synthetic defects
in carbon fiber reinforced plastics**

Major: Aerospace Engineering

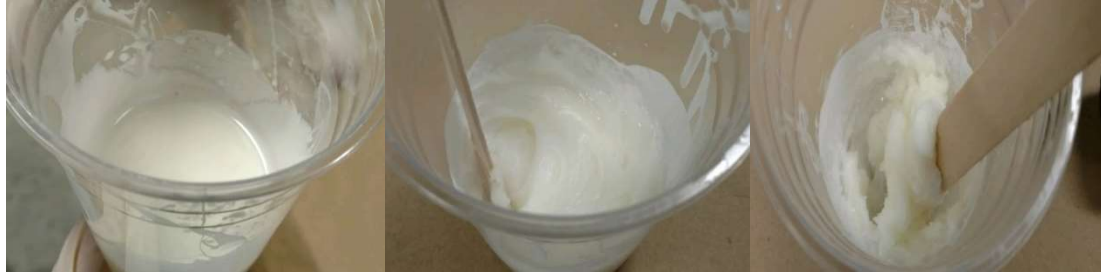
Figure 18: Progression of Aero-Epoxy Viscosity a.) Less Than 1:1 b.) Between 1:1 and 1:2 c.) 1:2 and Greater

When reviewing the results of the partial set test, it seemed as though increasing the amount of aerogel contained in the epoxy increased the amplitude of the signal attained when scanned. A new set of tests was designed to explore the relationship between the ratio of Epoxy to Aerogel and the damage signal and backwall attenuation. Using a constant amount of Epoxy and increasing amounts of Aerogel, several ratios from 1:0.2 Epoxy:Aerogel to 1:2 Epoxy:Aerogel were mixed and samples created. During the process of creating the mixtures it was noted that there was an increase of mixture viscosity with each increase in ratio, to a point where the mixture became so thick in consistency that it could no longer be mixed via the electric mixer and no more aerogel could be added.

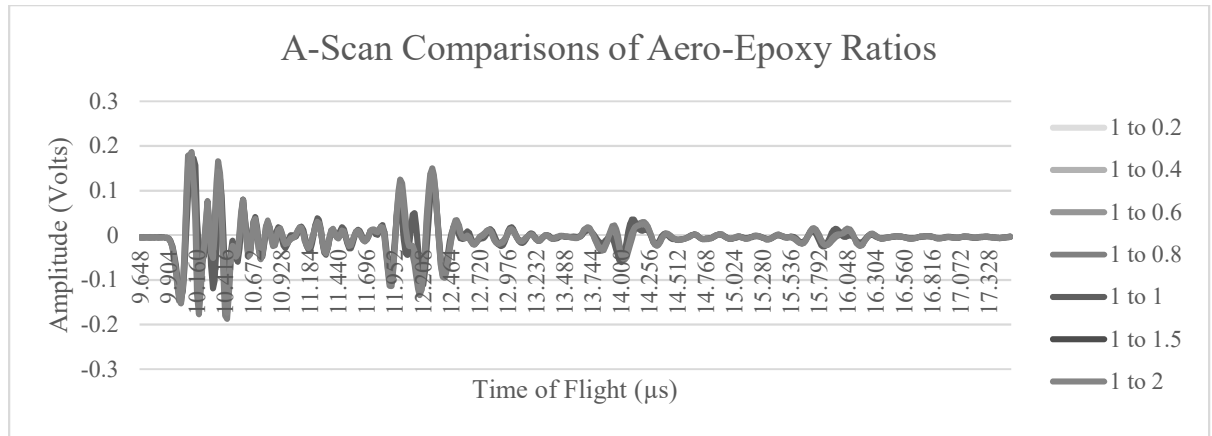
Figure 19: A-Scan Comparison of Aero-Epoxy Ratios

A-Scans from the locations in the CFRP containing Aero-Epoxy were gathered for each sample. Peak amplitudes for the damage region and backwall were gathered and plotted versus increasing ratio of inclusion as seen in Figures 19-20. The amalgamation of graphs in figure 19 does not show a clear picture of the behavior occurring with each increase. In figure 20 no clear trend can be seen in the data, as the damage signal peak amplitude varies across the ratios quiet a bit. In contrast, the backwall amplitude does not vary near as much along the spread of ratios. In general, most damages present both a prominent signal somewhere between the front and back plies and a corresponding reduction of the backwall signal due to the reflection and scattering the incoming energy. Taking this into account, the ratio of 1:1 displayed the best combination of defect amplitude and backwall reduction and was chosen as the metric to compare with existing damages to determine how well they could be approximated with Aero-Epoxy.

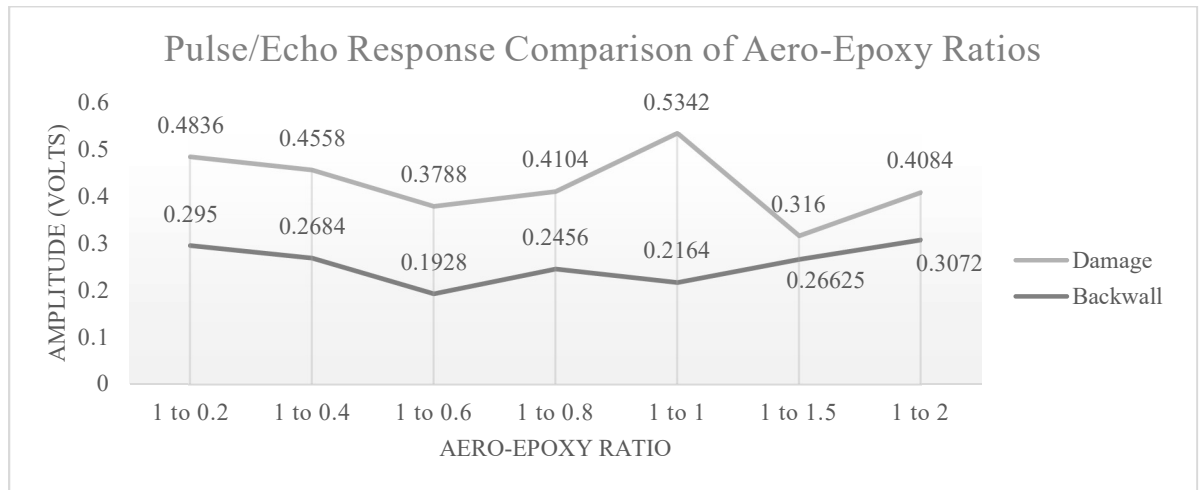
Figure 20: Graph of Amplitudes of Damage Signals and Backwall Signals for Aero-Epoxy Ratios

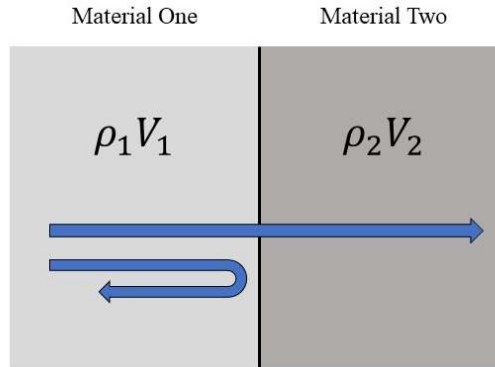
Figure 23: Diagram of Acoustic Reflection at Material Interfaces

With the impedances now known, the coefficient of reflection could be calculated, as it is based on the impedance mismatch between the mediums the signal is passing through. Z_2 refers to the impedance of the second medium (in this case Aero-Epoxy block) and Z_1 refers to the impedance of the traveling medium (air, water, aluminum, etc.).

$$C_r = \frac{\rho_2 v_2 / \rho_1 v_1 - 1}{\rho_2 v_2 / \rho_1 v_1 + 1} = \frac{Z_2 / Z_1 - 1}{Z_2 / Z_1 + 1} \quad (\text{Achenbach})$$

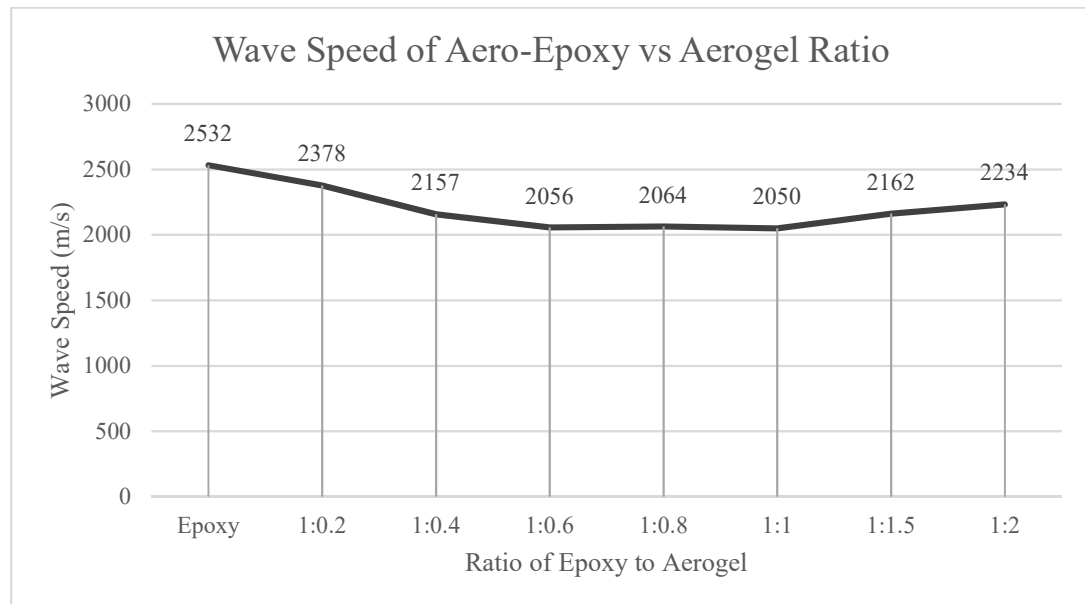
Figure 24: Wave Speed of Aero-Epoxy as Aerogel Ratio Increases

Mix Ratio	Epoxy	1 to 0.2	1 to 0.4	1 to 0.6	1 to 0.8	1 to 1	1 to 1.5	1 to 2
Wave Speed (m/s)	2532 ±0.09%	2378 ±0.11%	2157 ±0.11%	2056 ±0.11%	2064 ±0.11%	2050 ±0.08%	2162 ±0.08%	2234 ±0.08%
Density (g/cm ³)	1.135	0.996	0.919	0.879	0.870	0.878	0.946	0.980
Impedance (kg/m ² s x 10 ⁶)	2.874	2.368	1.982	1.807	1.795	1.800	2.046	2.189
C _r (Water)	0.320	0.231	0.145	0.100	0.096	0.098	0.160	0.193
C _r (Aluminum)	-0.711	-0.755	-0.791	-0.808	-0.809	-0.808	-0.785	-0.772
C _r (CFRP)	-0.183	-0.274	-0.354	-0.394	-0.397	-0.396	-0.341	-0.310

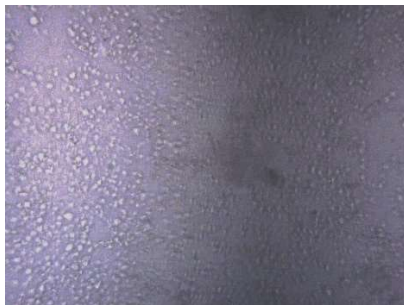
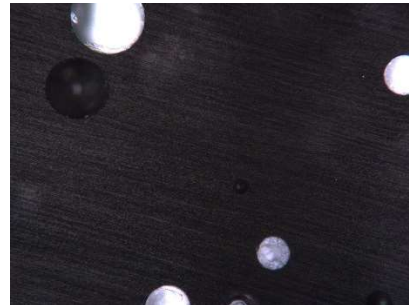
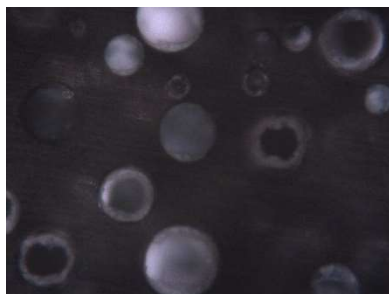
Figure 25: Microscopy of Aerogel Particles and Aero-Epoxy Samples

To learn more about the Aero-Epoxy mixture itself microscopy was performed on a few samples of the Aero-Epoxy. The goal was to better understand the wave speed behavior that was observed from the TTU measurements. As seen in Figure 25, the Aerogel powder is an amalgamation of jagged crystalline particles. At 1:0.2 the Aerogel particles can be seen coating the outer edges of small air bubbles spread out within the epoxy. As the ratio increases (1:0.8 shown), the density of these small orbs increases with larger bubbles beginning to form. By 1:2, the bubbles had grown in size but spacing between them had also increased. It seems as though at low amounts of Aerogel, the inclusions begin to reduce the wave speed. As more aerogel is included, more of the bubbles begin to form, further reducing the wave speed. Finally, as the ratio approaches 1:2, the bubbles increase in size but the relative density of aerogel inclusions within the epoxy decreases leading to the increase in wave speed seen from the TTU measurements

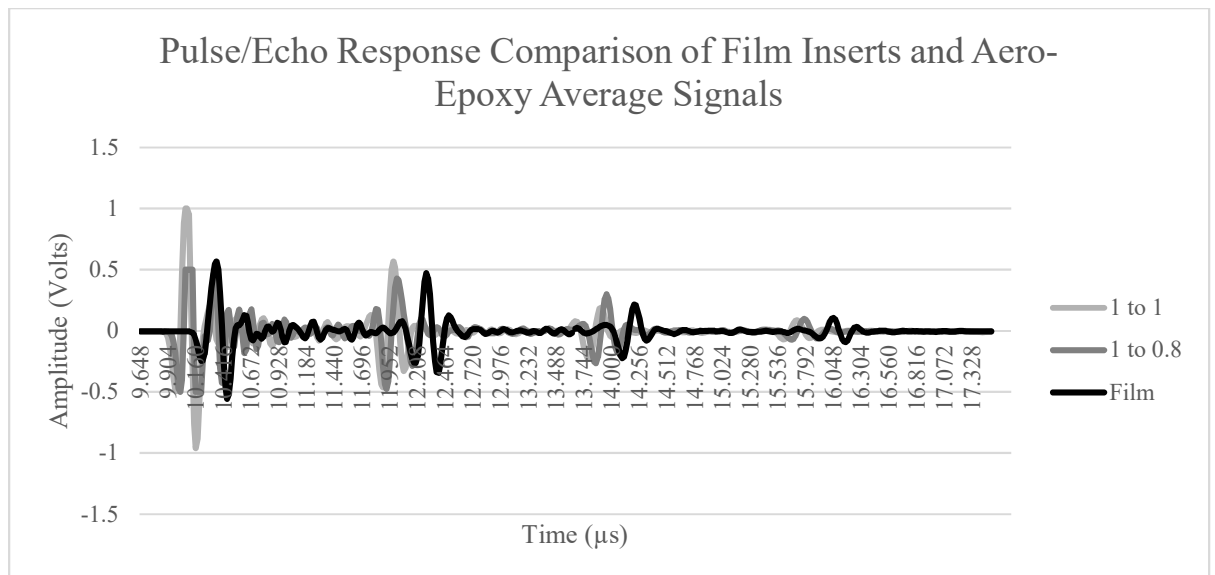
Figure 28: Signature Comparison of Film Insert, 1:0.8 Aero-Epoxy, and 1:1 Aero-Epoxy Samples

It is worth noting that the manufacturing time for film inserts is faster than the time for the full process of creating the solidified Aero-Epoxy sheet due to the curing time required for the mixture. However, if some of the mixture was reserved from other applications, it could be hardened and then used for this process. In terms of attenuation and signal, the waveform response of 1:0.8 Epoxy to Aerogel is very close to that of the film inserts.

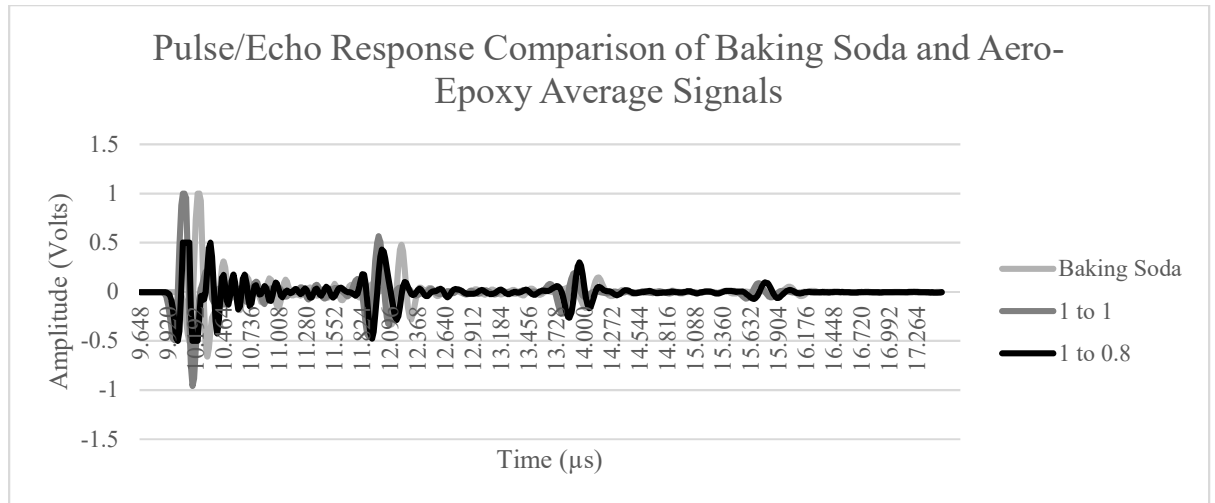
Figure 30: Signature Comparison of Baking Soda, 1:0.8 Aero-Epoxy, and 1:1 Aero-Epoxy Samples

Unlike Film, baking soda appears as amorphous blobs even when care is taken to neatly place it in square piles during the manufacturing process; it simply spreads during curing/pressing. Due to the varying thickness of the inclusion, there is more variability in the signal peaks leading to a more non-uniform look. This could be achieved with the partial curing method augmented with the variability method, partial cure to hold the shape and variability to achieve the non-uniform look of the real defect. The 1:1 ratio and 1:0.8 ratio of Aero-Epoxy captures the signature of Baking Soda defects fairly well, but 1:1 would be preferred due to increased viscosity of mixtures with higher percentages of Aerogel which leads to less spread during curing.
